## Cairngorm Mountain Clear Up Project

*This post will concentrate on examining the work done on the Coire na Ciste Chairlift Lift Line and Aonach Poma loading area.*

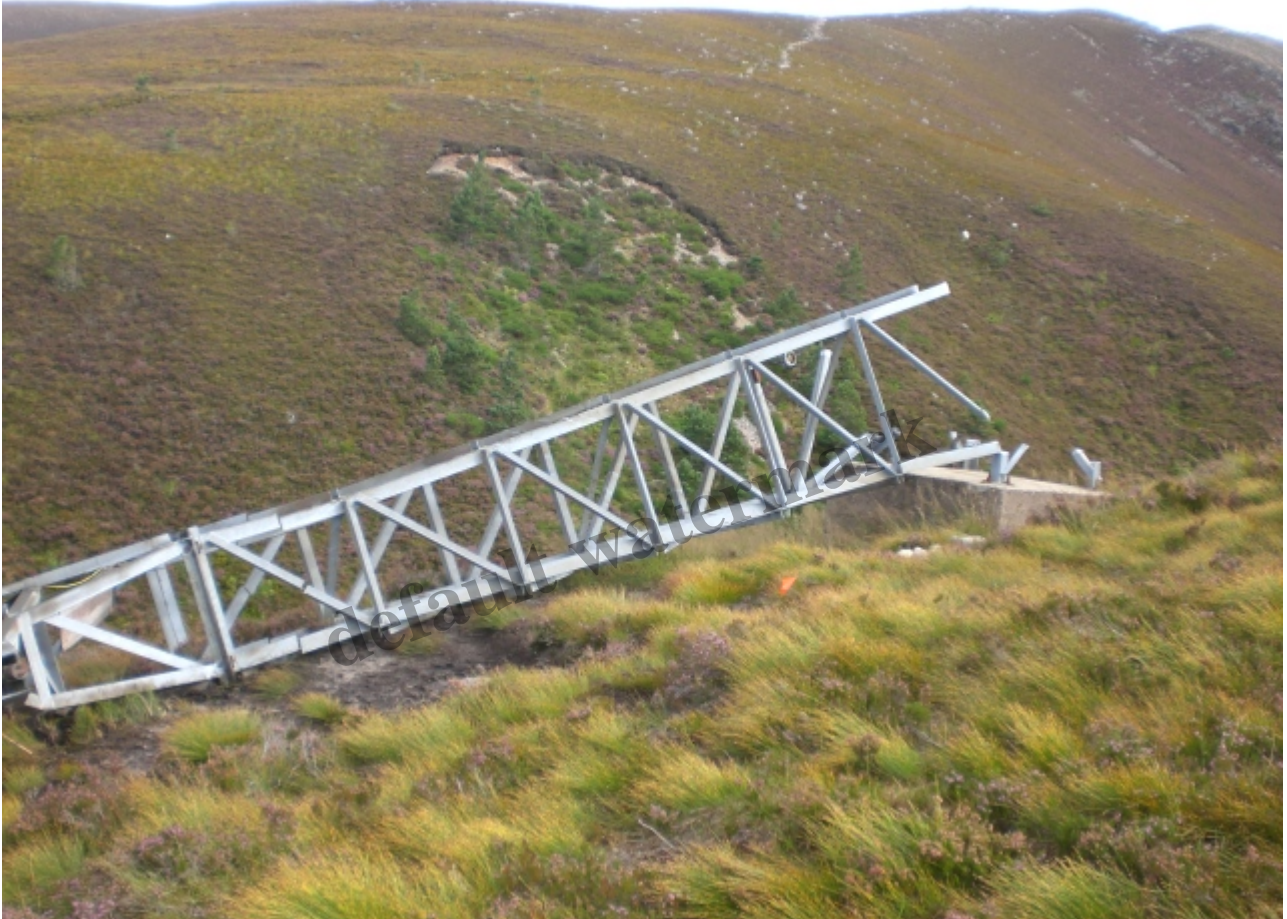
Demolition of lift tower in Coire na Ciste – the cleanup was used as an excuse to destroy potentially re-usable lift infrastructure ([see here](#)).

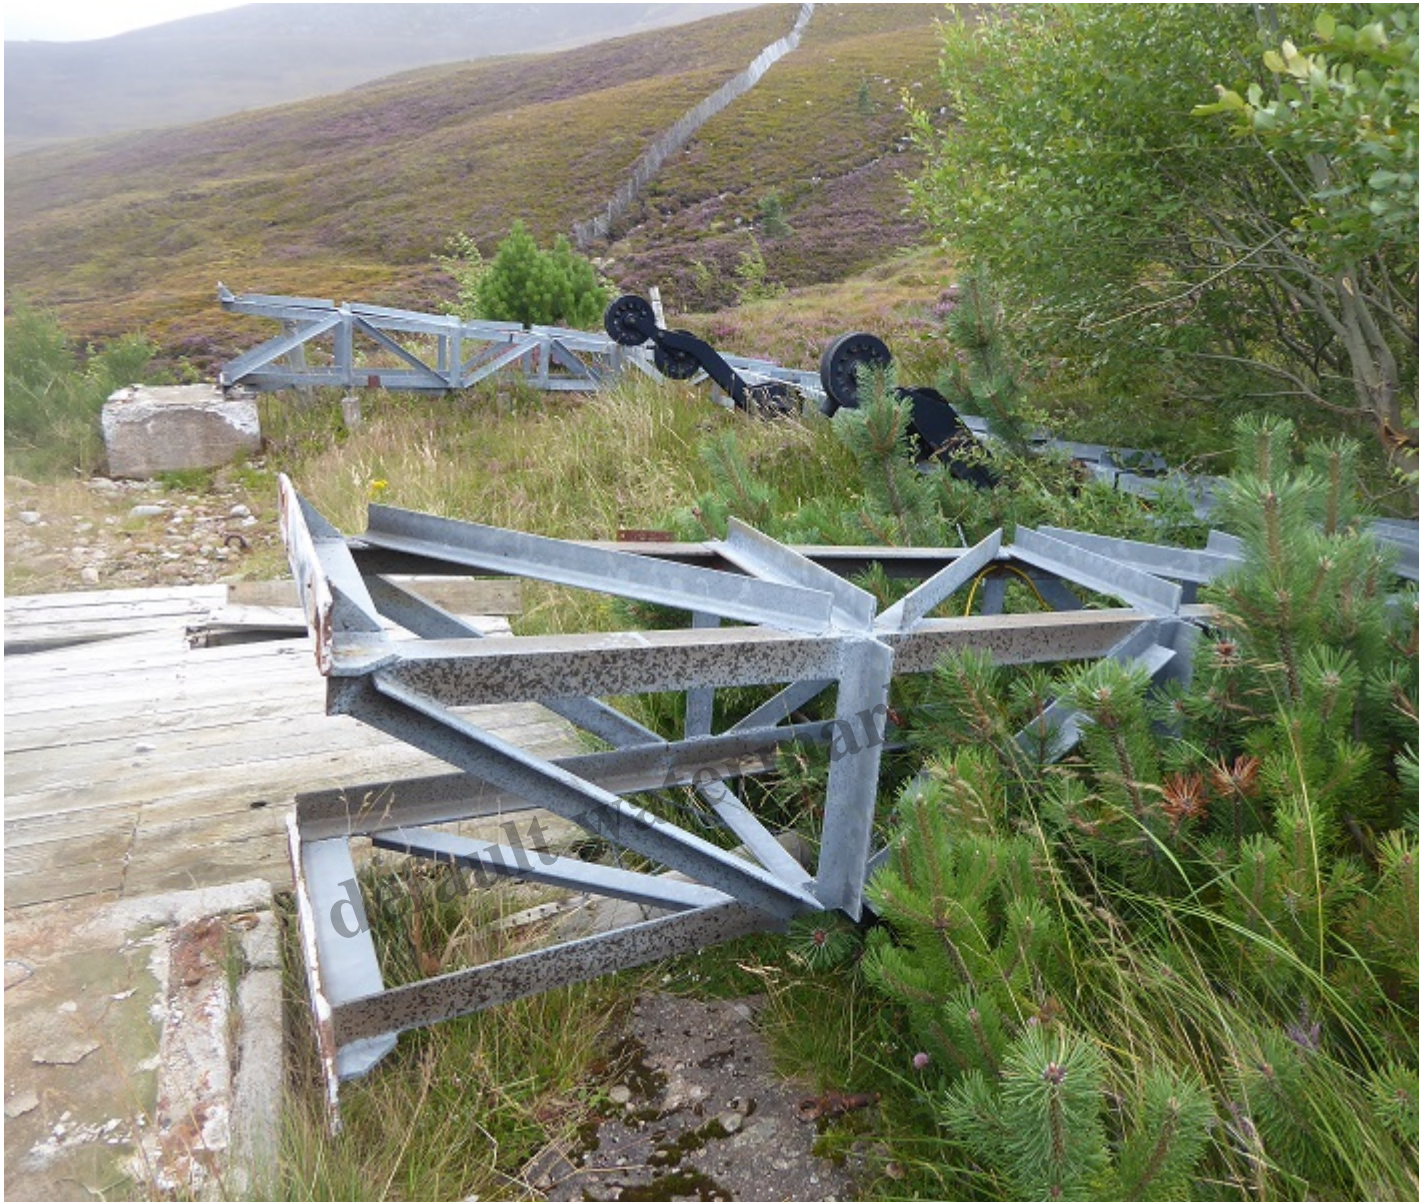
The former lift towers in Coire na Ciste have been completely removed

**Steel Structures and Towers:** These have been completely removed from the mountain and there is no evidence of anything having been left behind. The Coire na Ciste carpark is a different matter though and there are many many pieces of splintered wood and metal shards that await the tyres of unsuspecting vehicle owners.

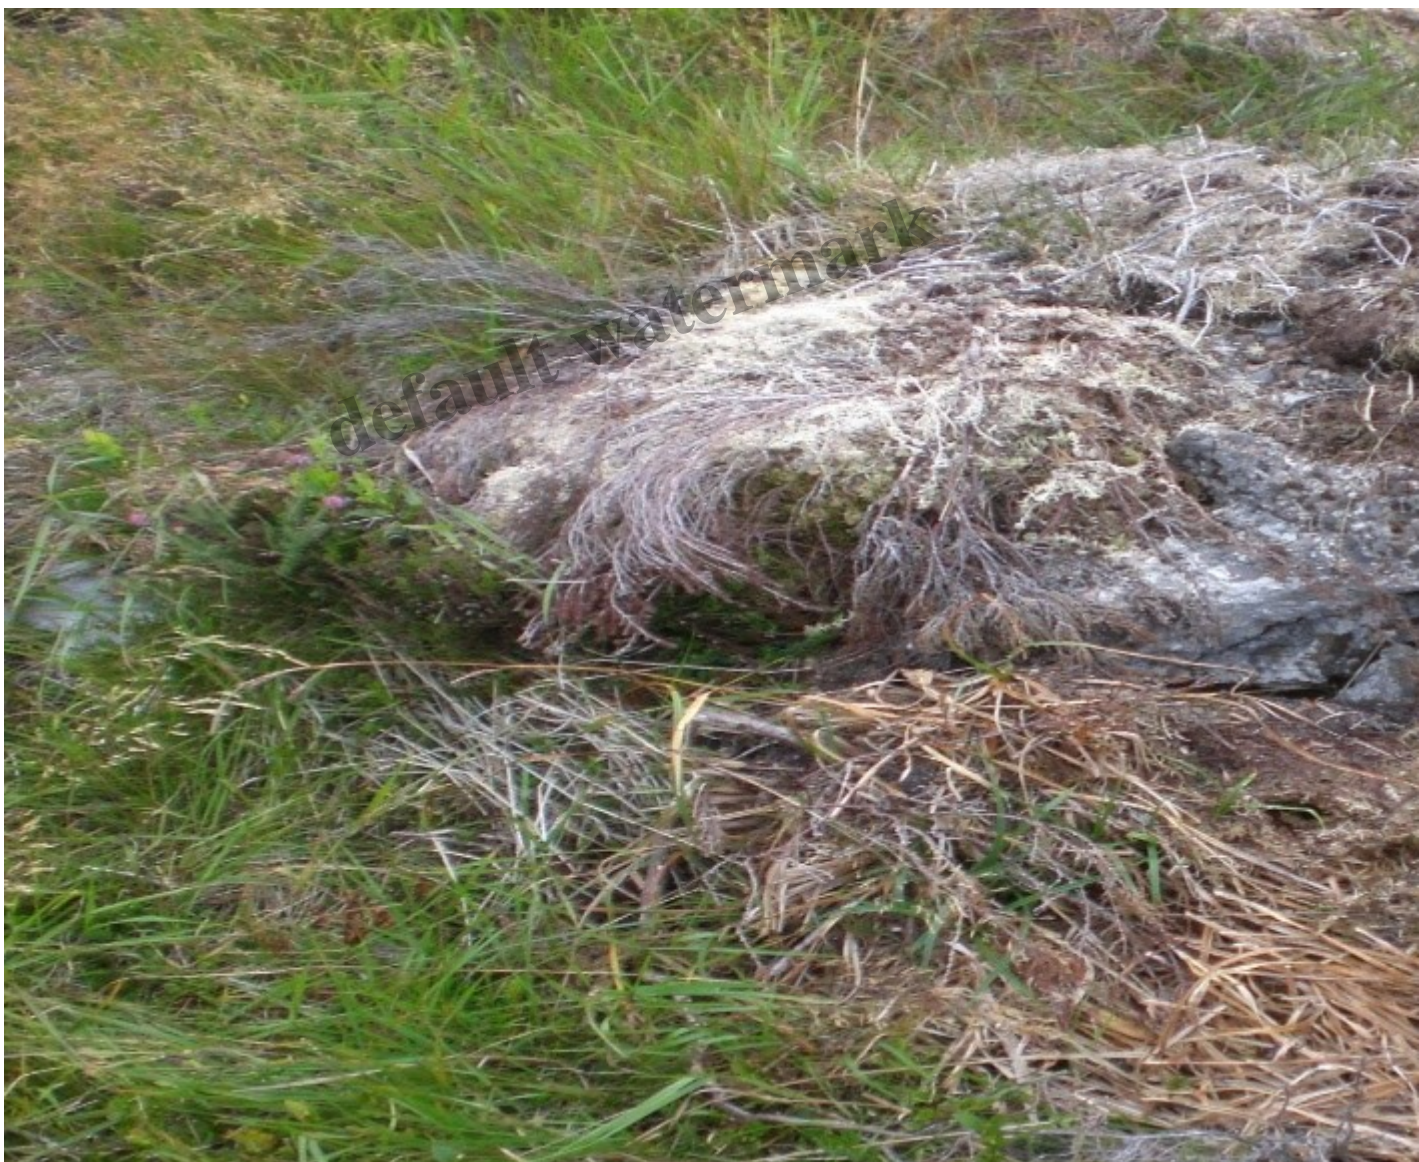
There is multiple evidence that this has not been satisfactorily done. Concrete has not been broken out to 200mm below surface and several of the old tower foundations are clearly identified as mounds that are significantly higher than the surrounding ground. Exposed concrete can be seen and there are steel shards and wood that remain at the site of the Aonach Poma loading area.

Exposed concrete which has not been broken out to 200mm below surface. Photo Credit Alan Bratt

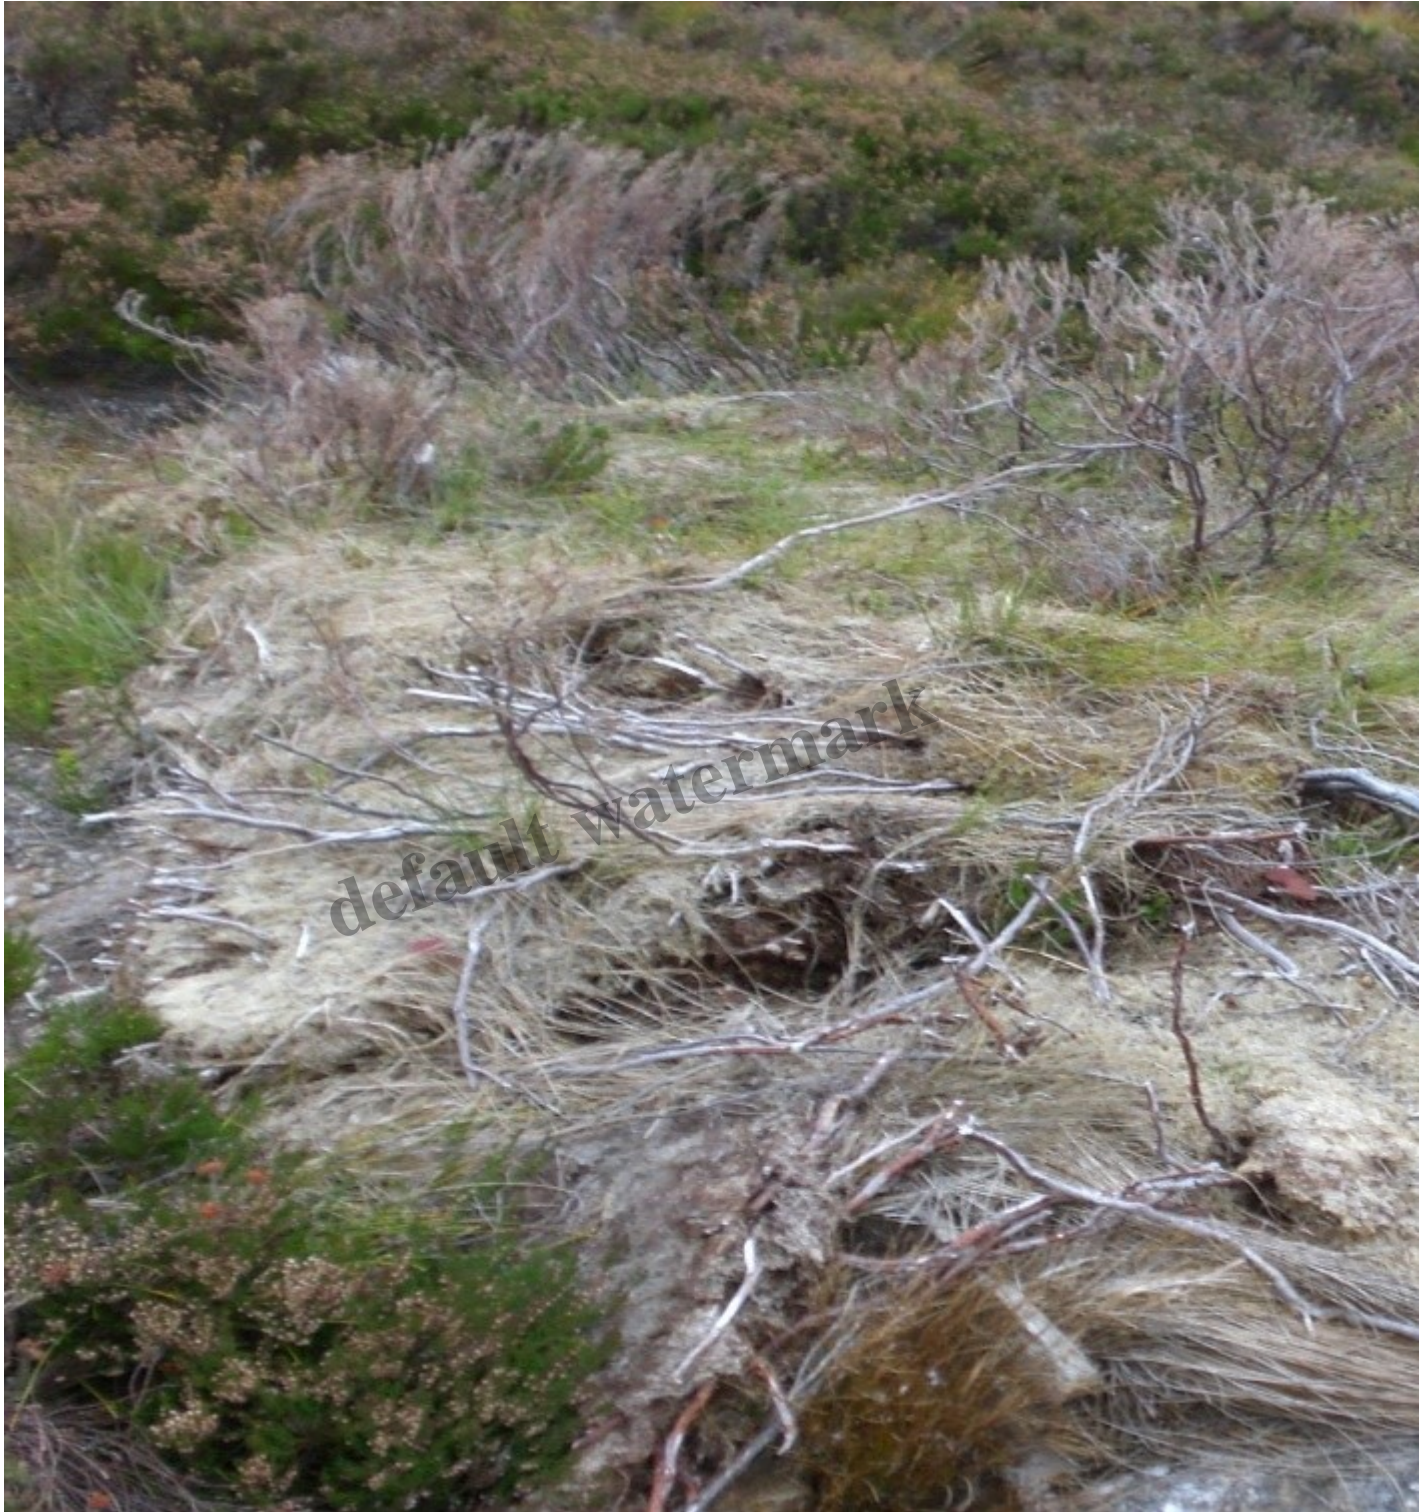
Concrete coverage: Note how the vegetation has died. Photo Credit Alan Bratney

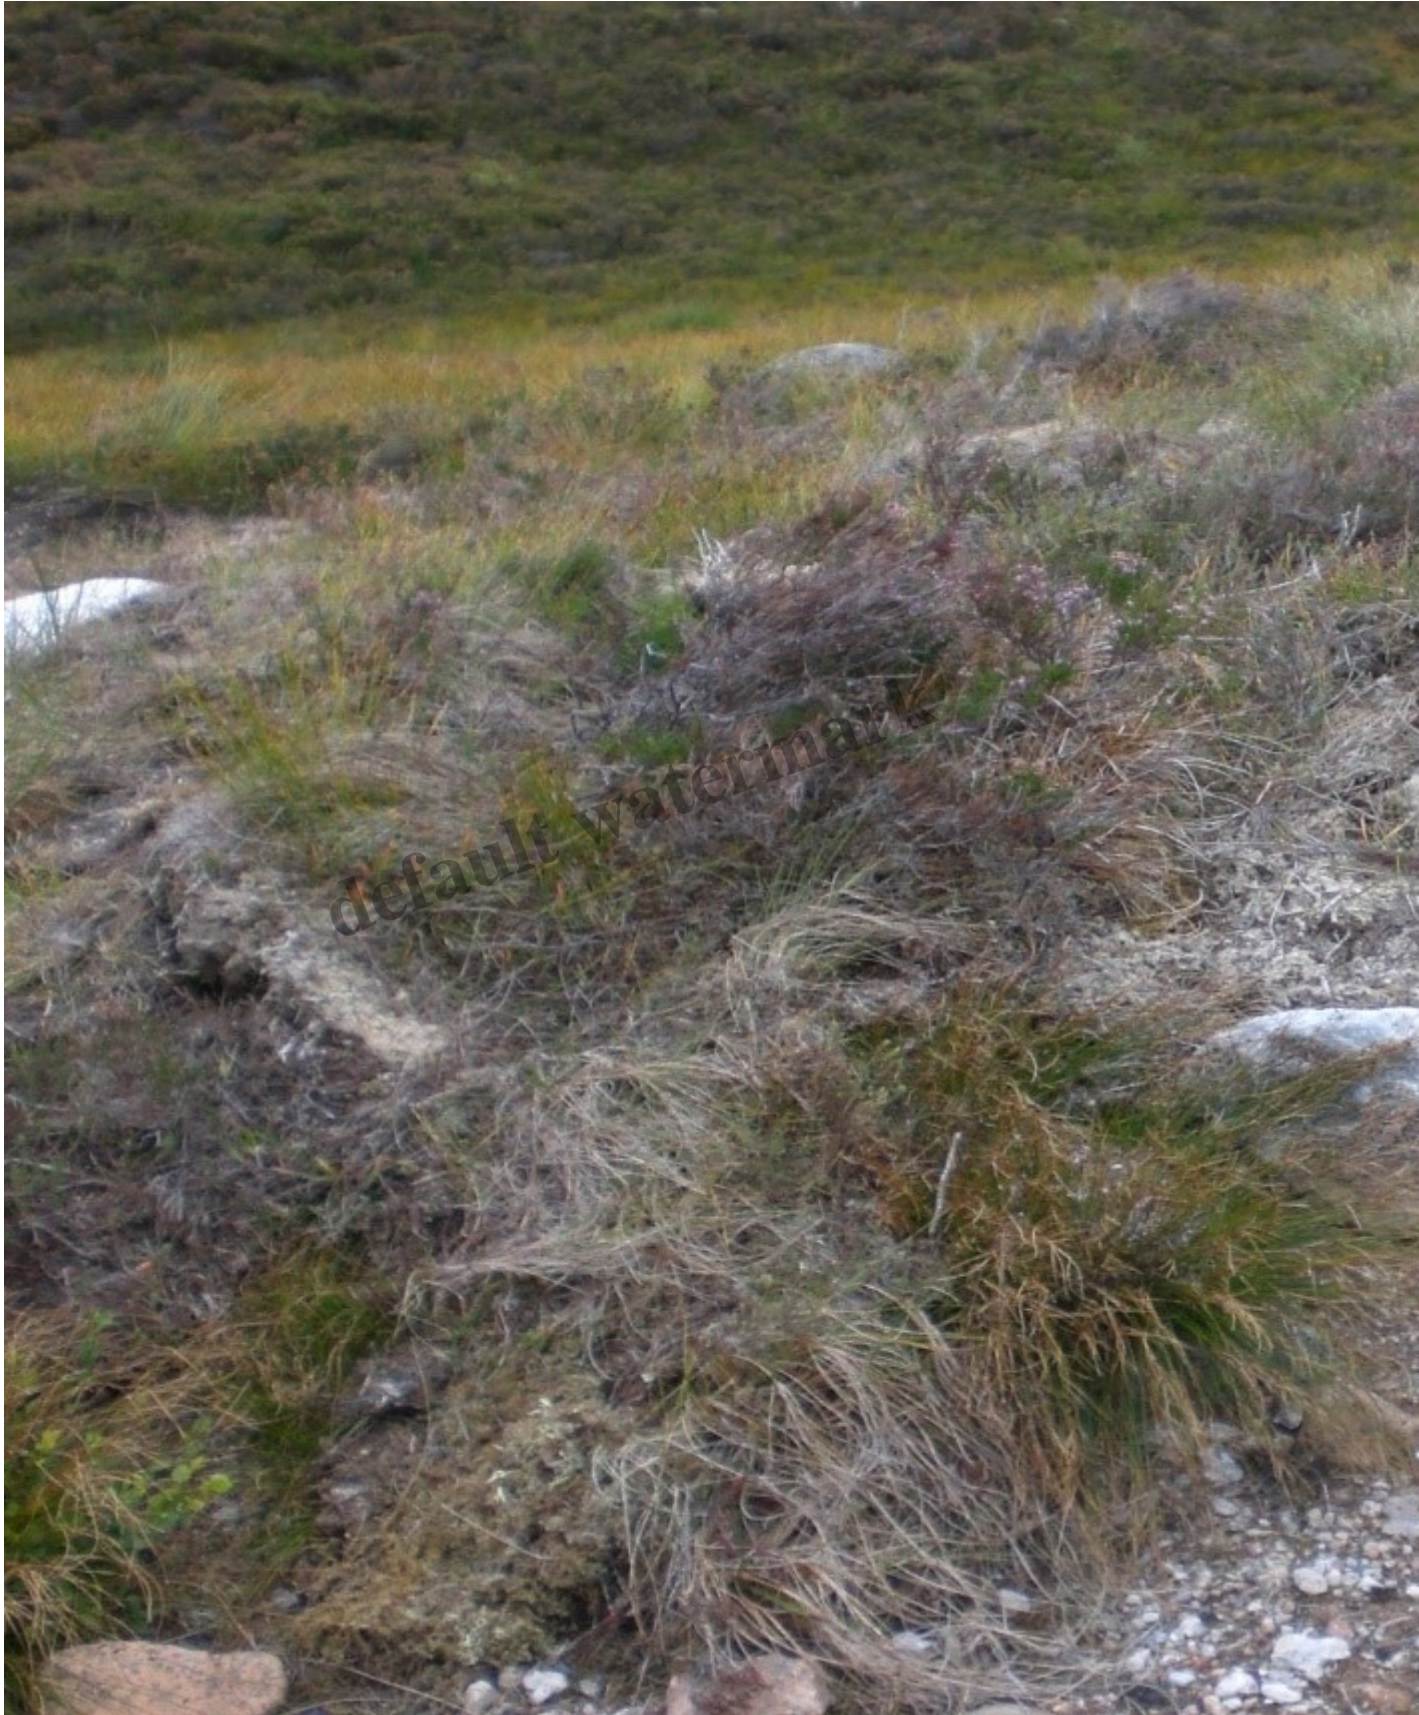
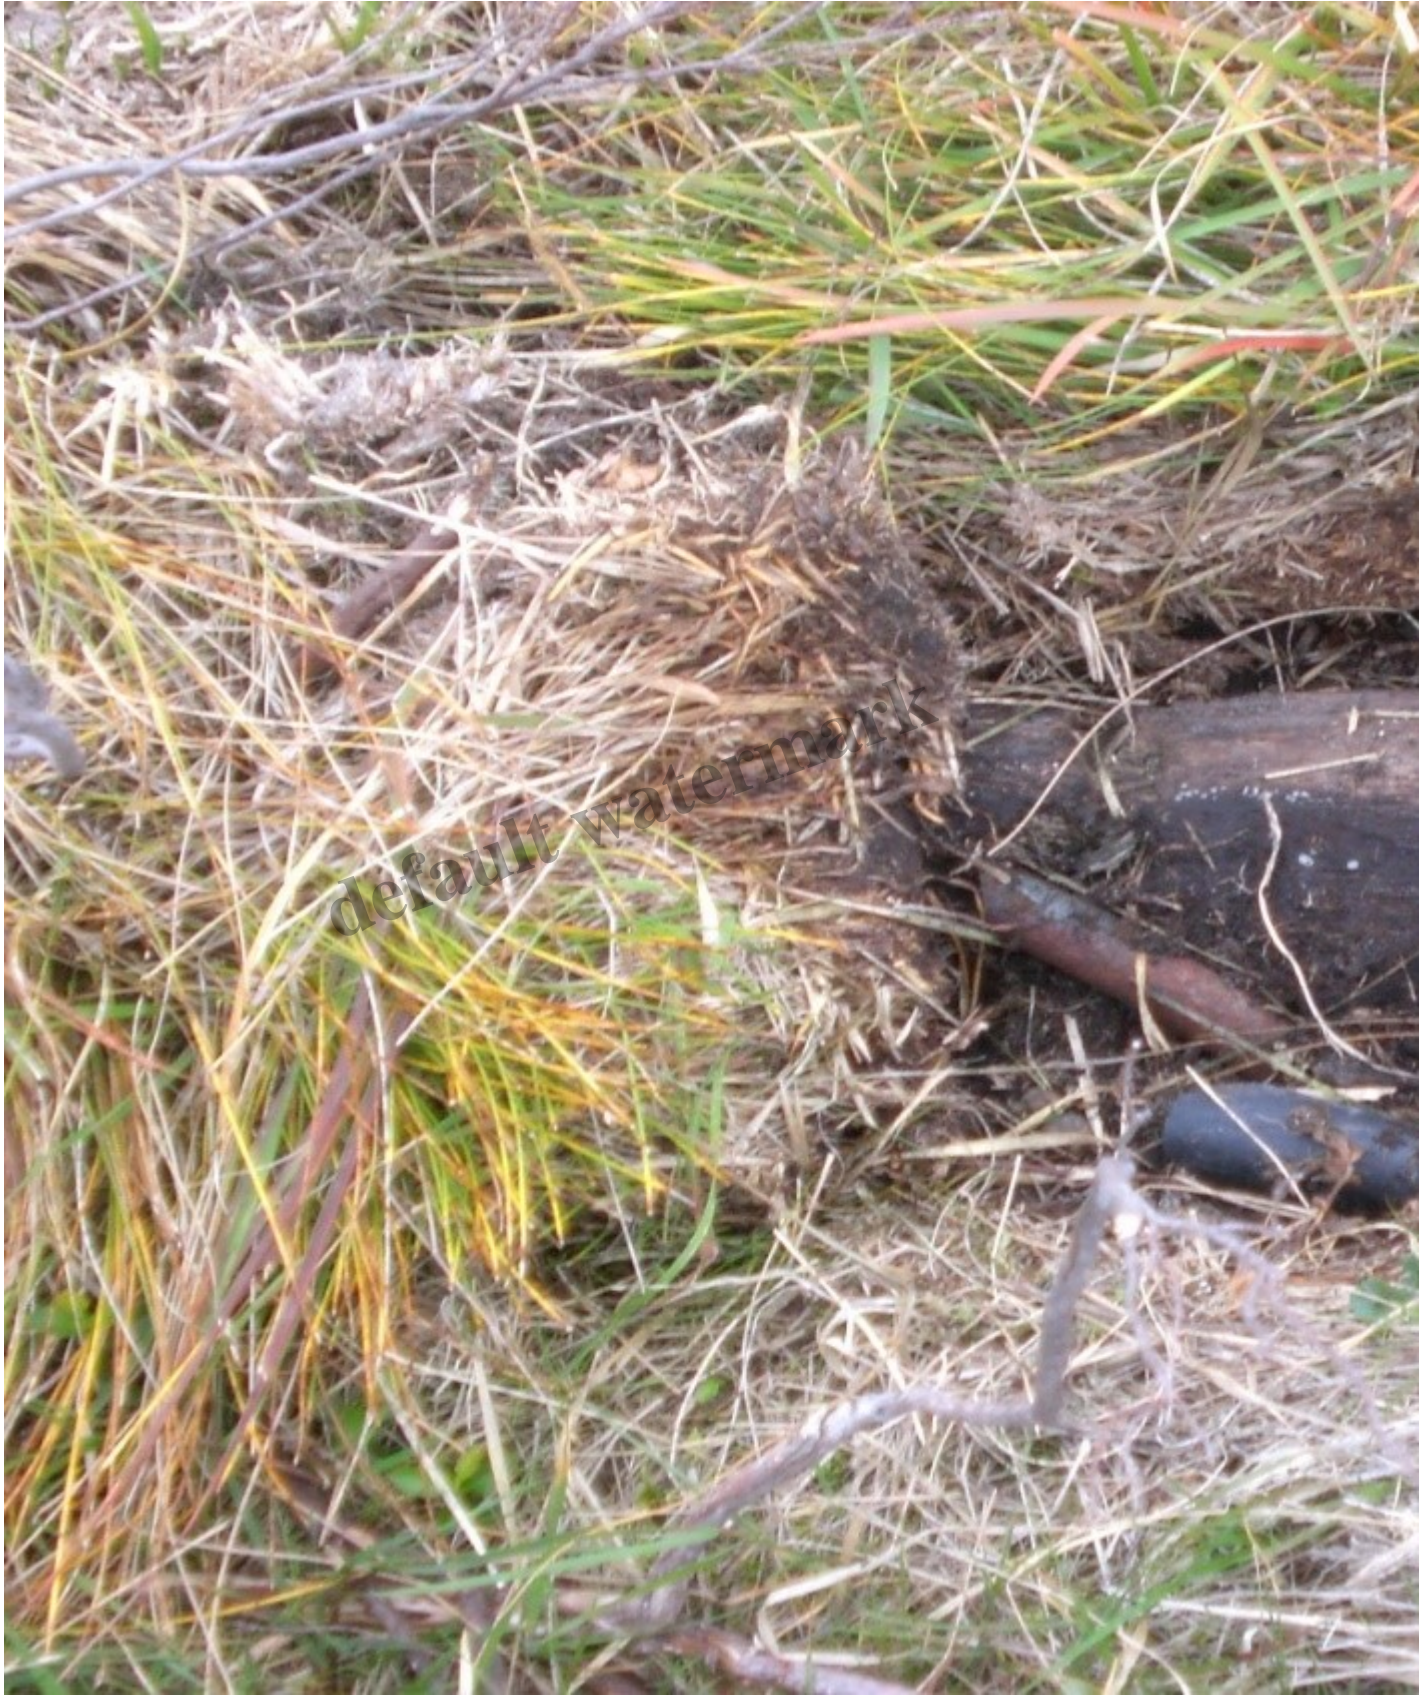
It's very clear that there are tower foundations that remain higher than the surrounding ground.

Steel Shard, wood and cable not removed just buried. Someone had clearly been there making checks

before us. They had removed turves to see underneath but we kindly replaced them

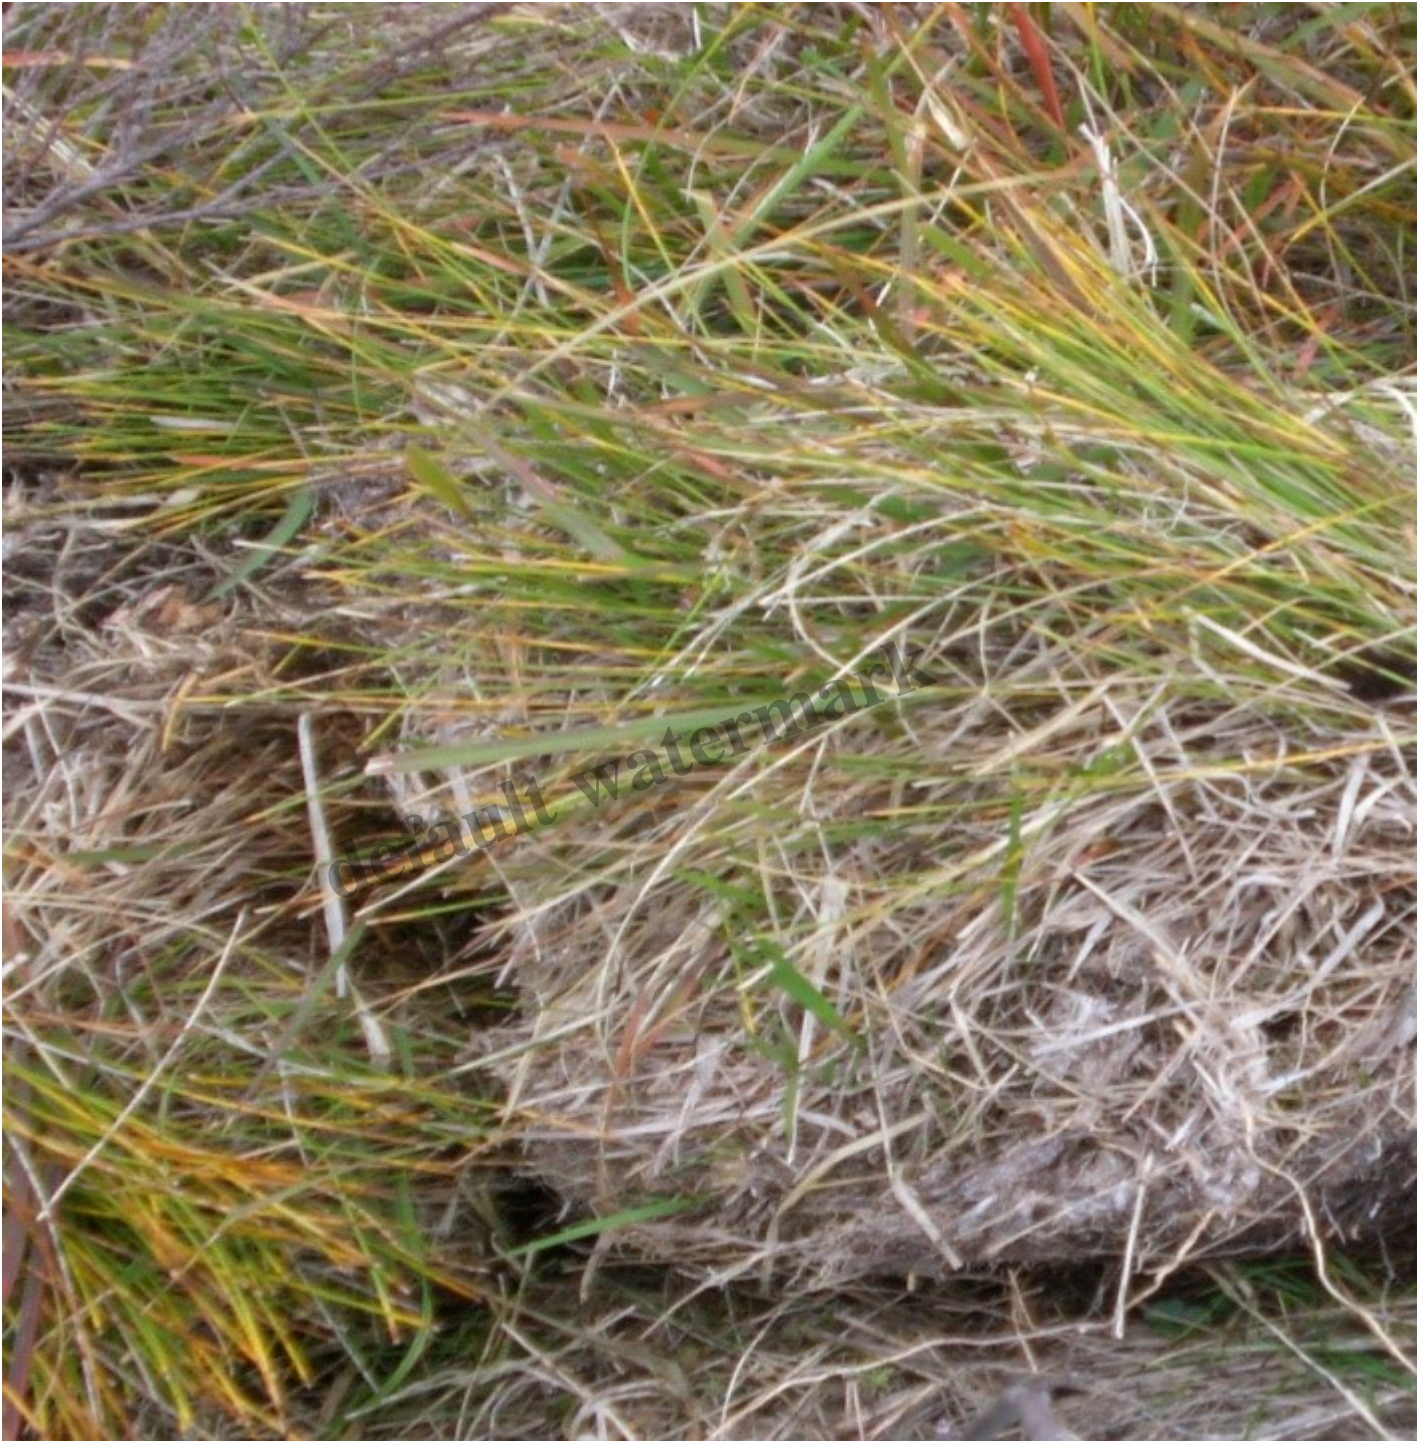
The reinstatement, such as it is, has been done merely by a machine ripping out turves placing them on top of the old foundations. The resultant damage has had no remedial work done whatsoever.

Ripped out turves and no reinstatement work done

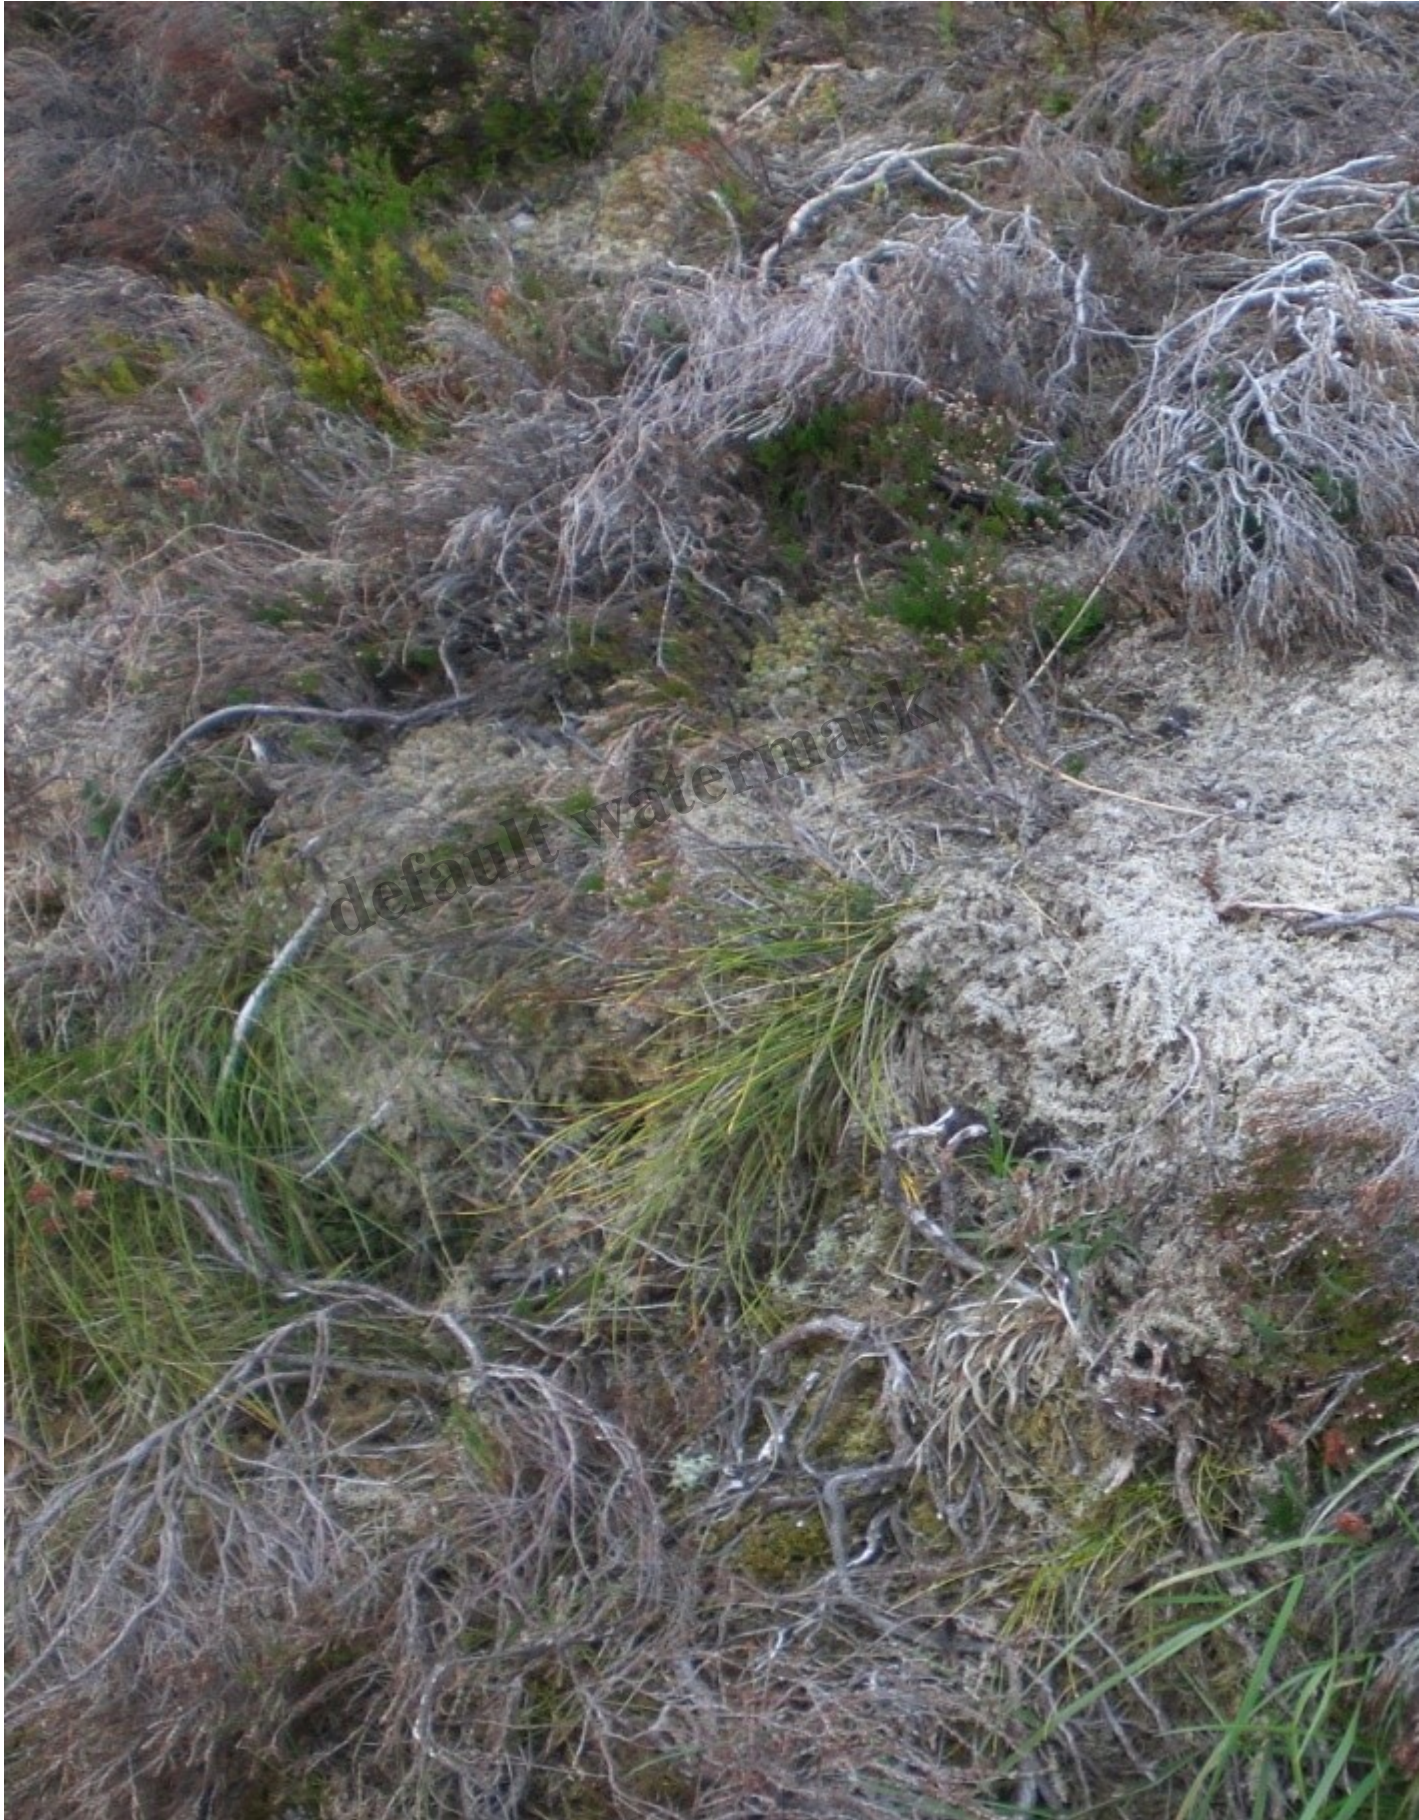
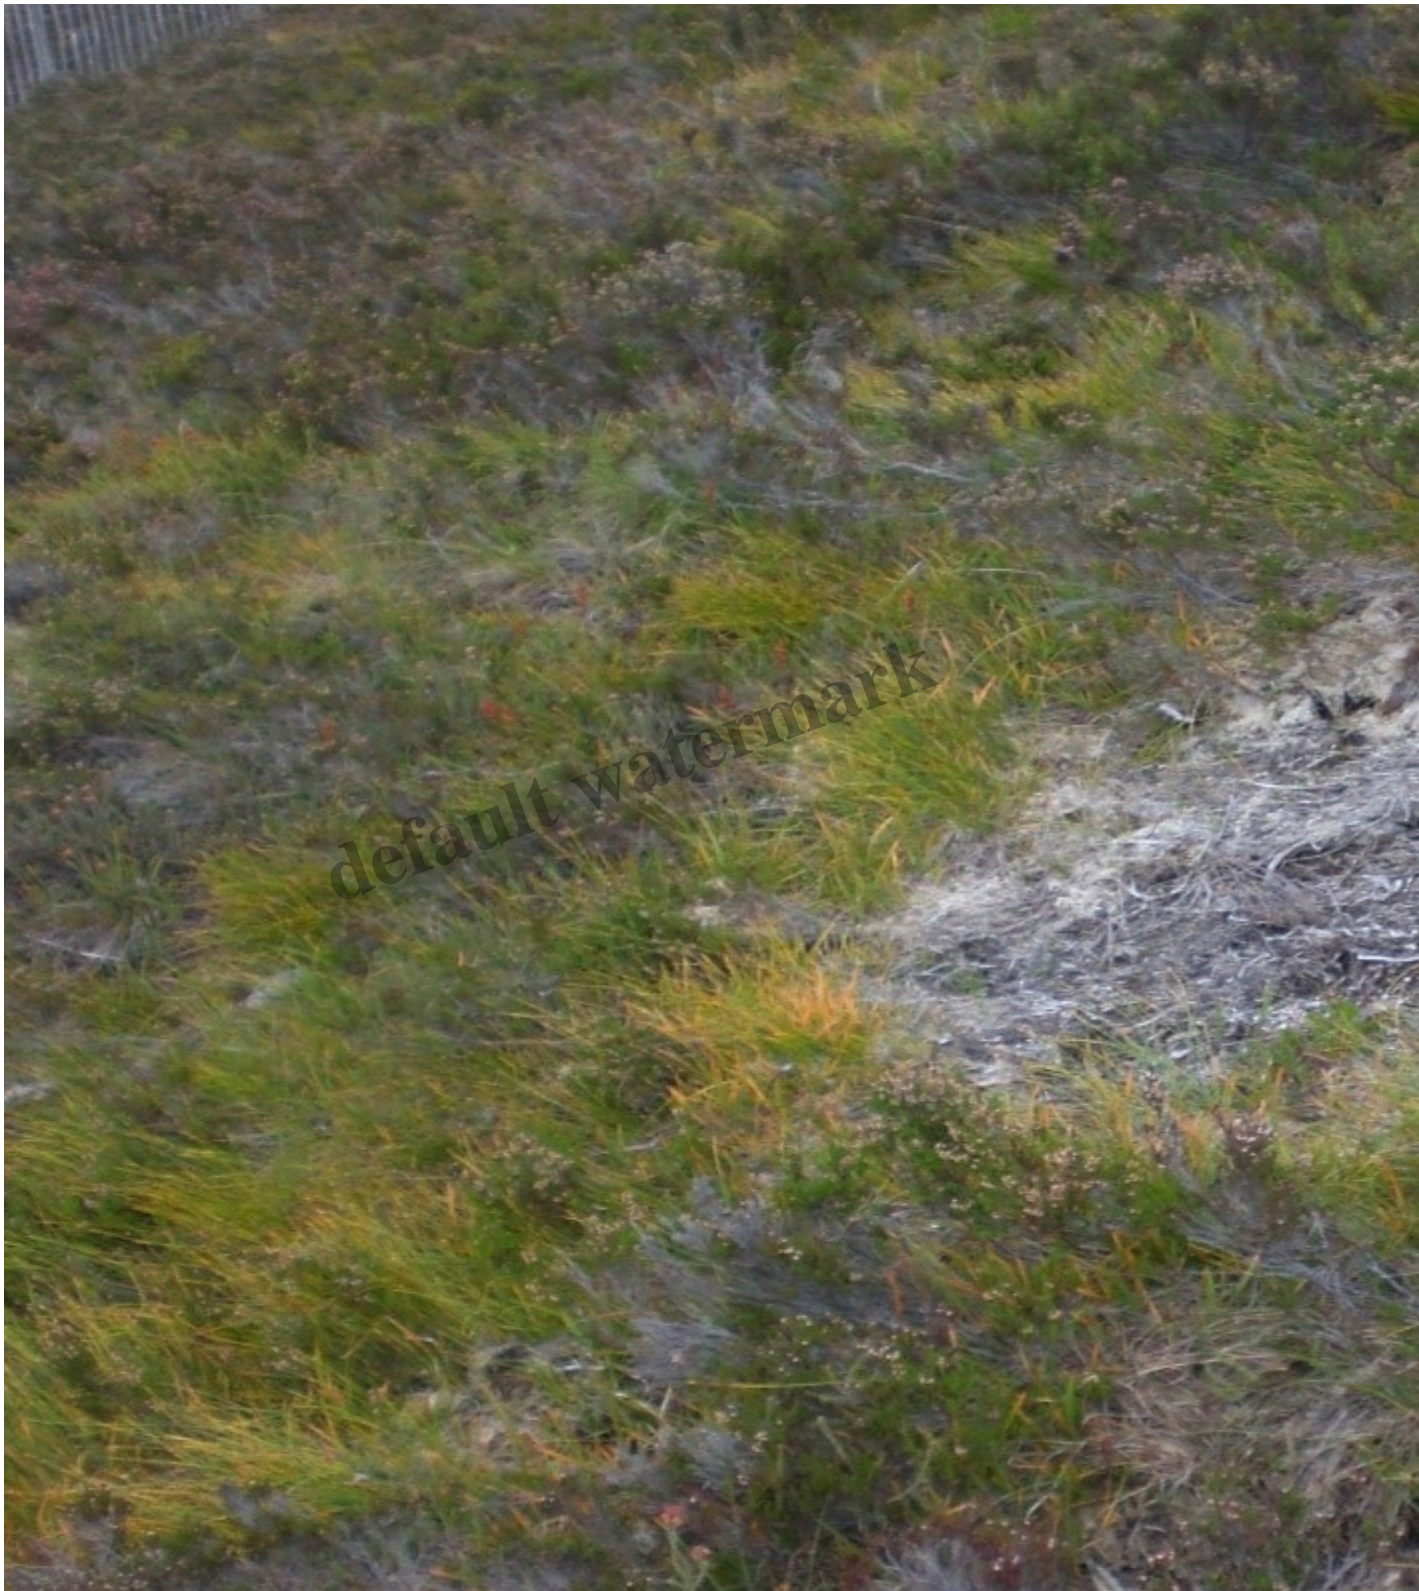
The quality of the job is of an unacceptable standard with concrete not ground out and with vegetation simply dumped on top to cover up the remains of the concrete foundations. The dumped vegetation

has died because it has nothing to root into and the areas from where it was ripped out have had zero reinstatement work done.
