## Cairngorm Mountain Clear Up Project

*This post will concentrate on examining the work done on the Coire na Ciste Chairlift Lift Line and Aonach Poma loading area.*

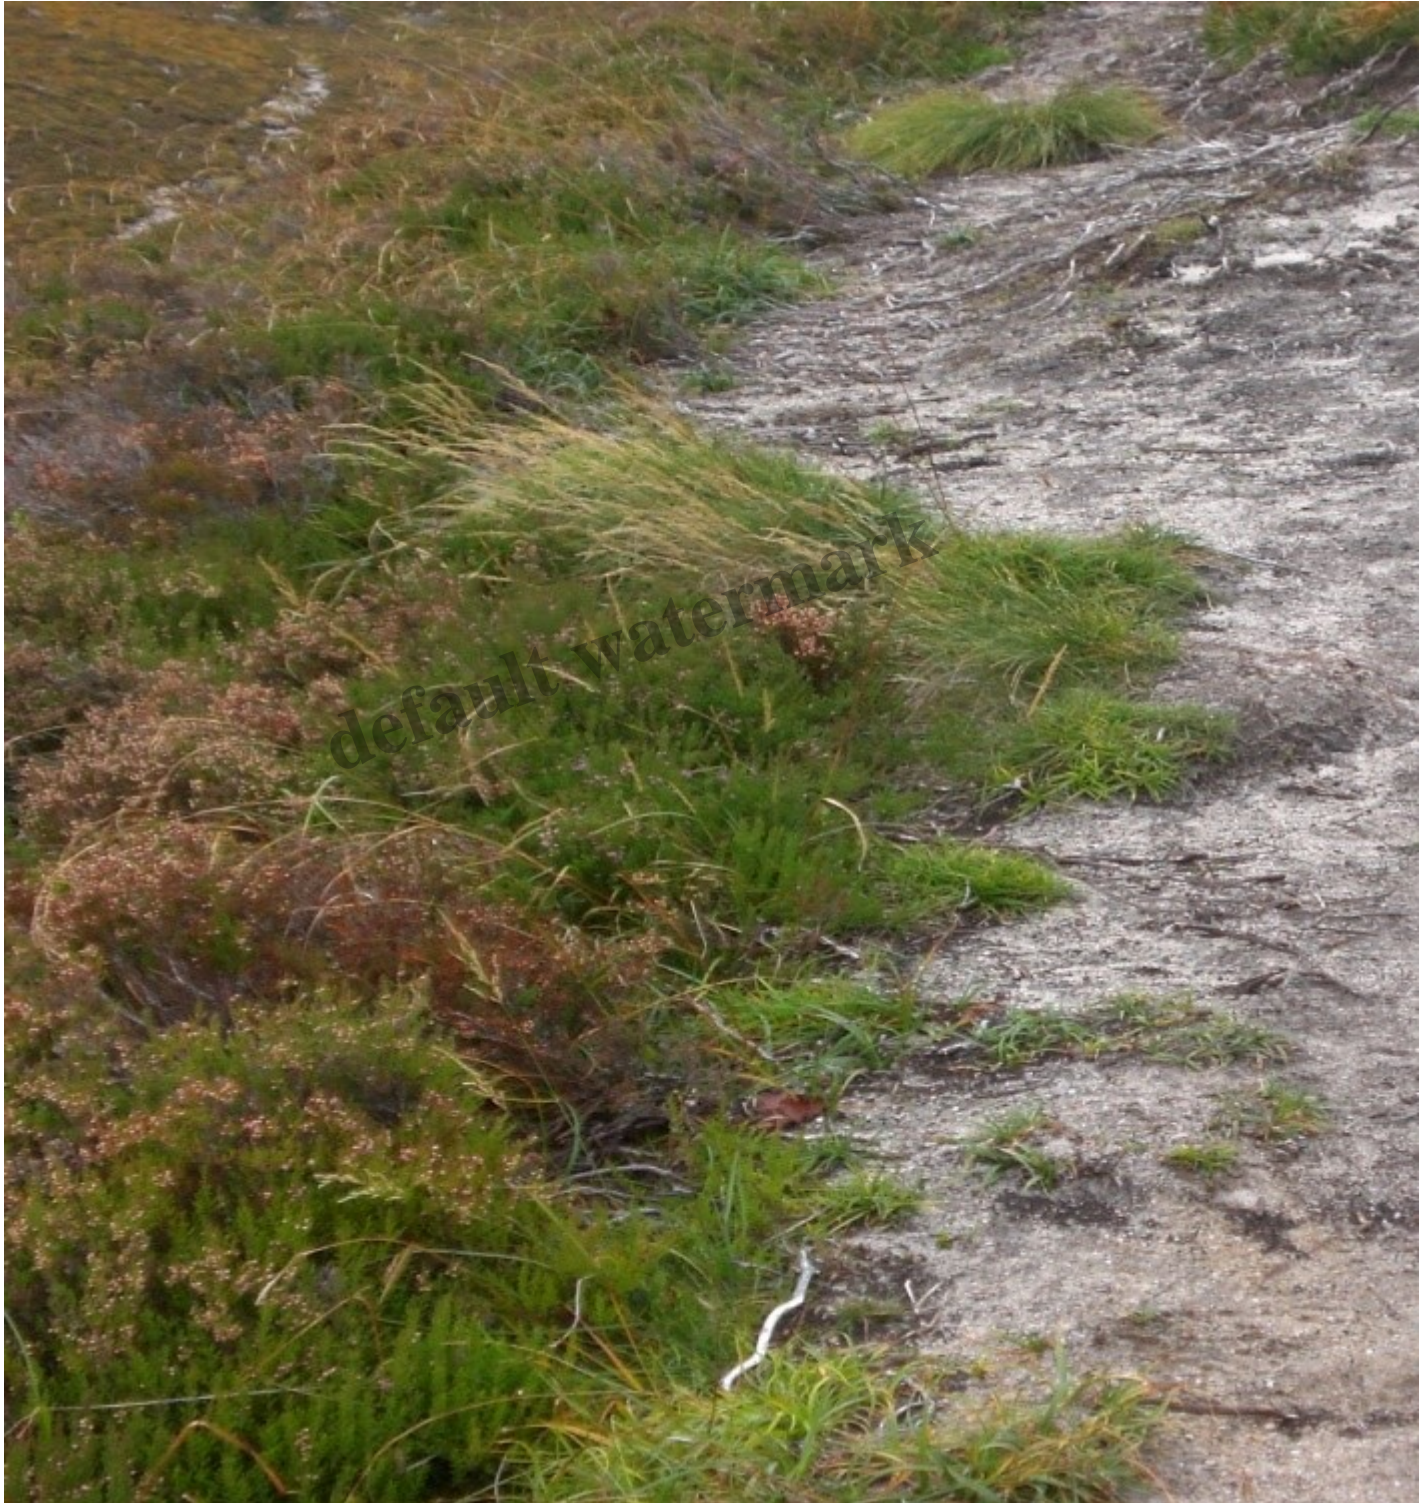
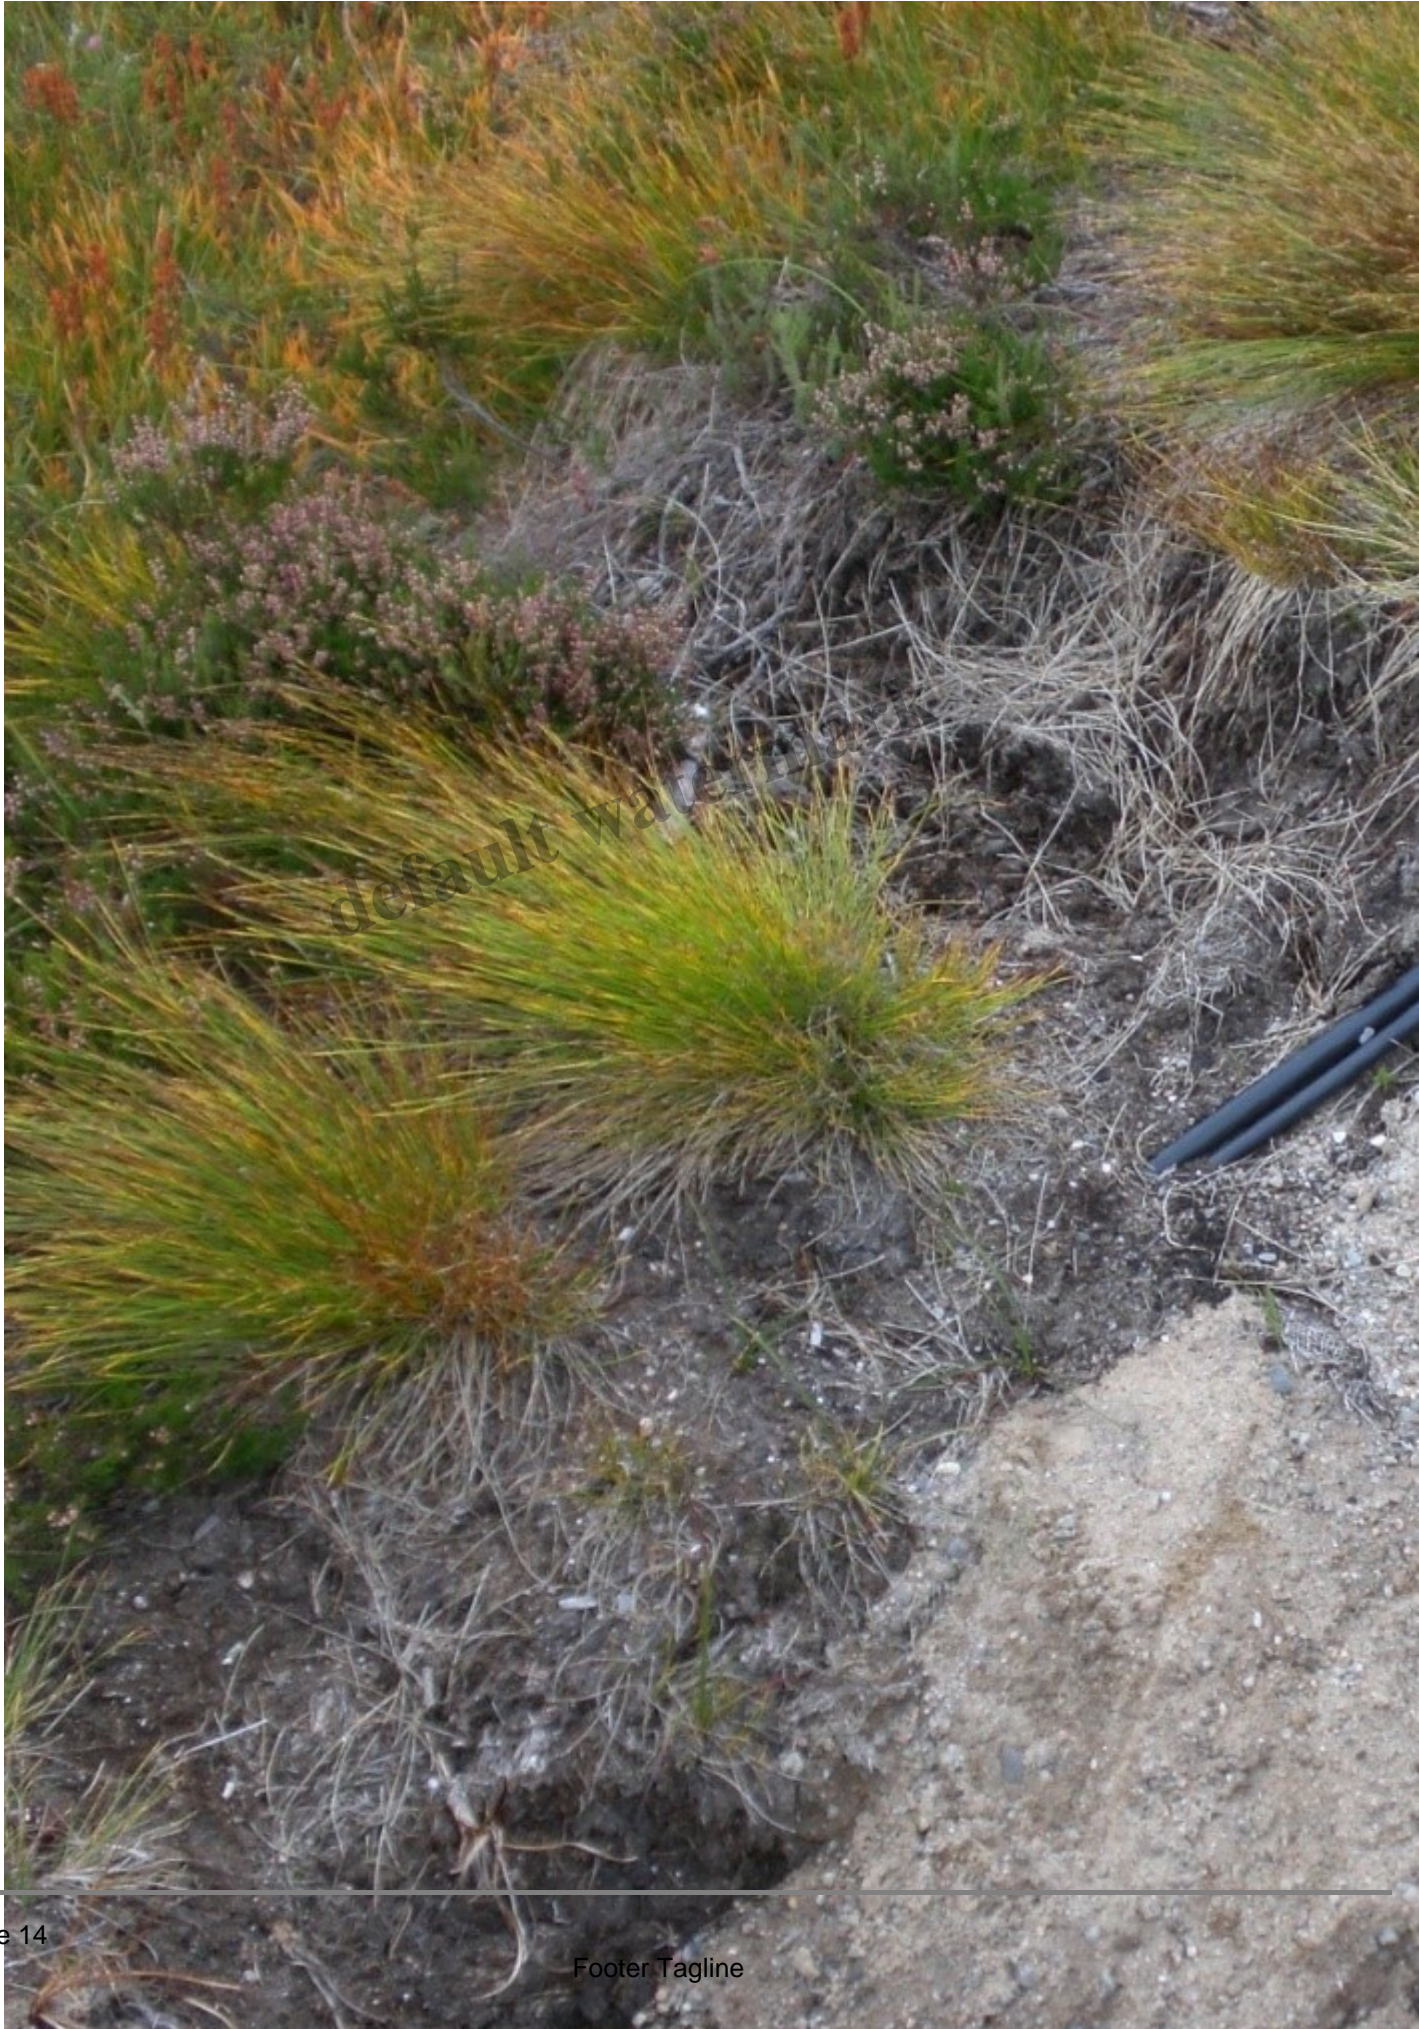
There are multiple points where cabling is on the surface and others where sandbags have been used to cover the exposed cable.

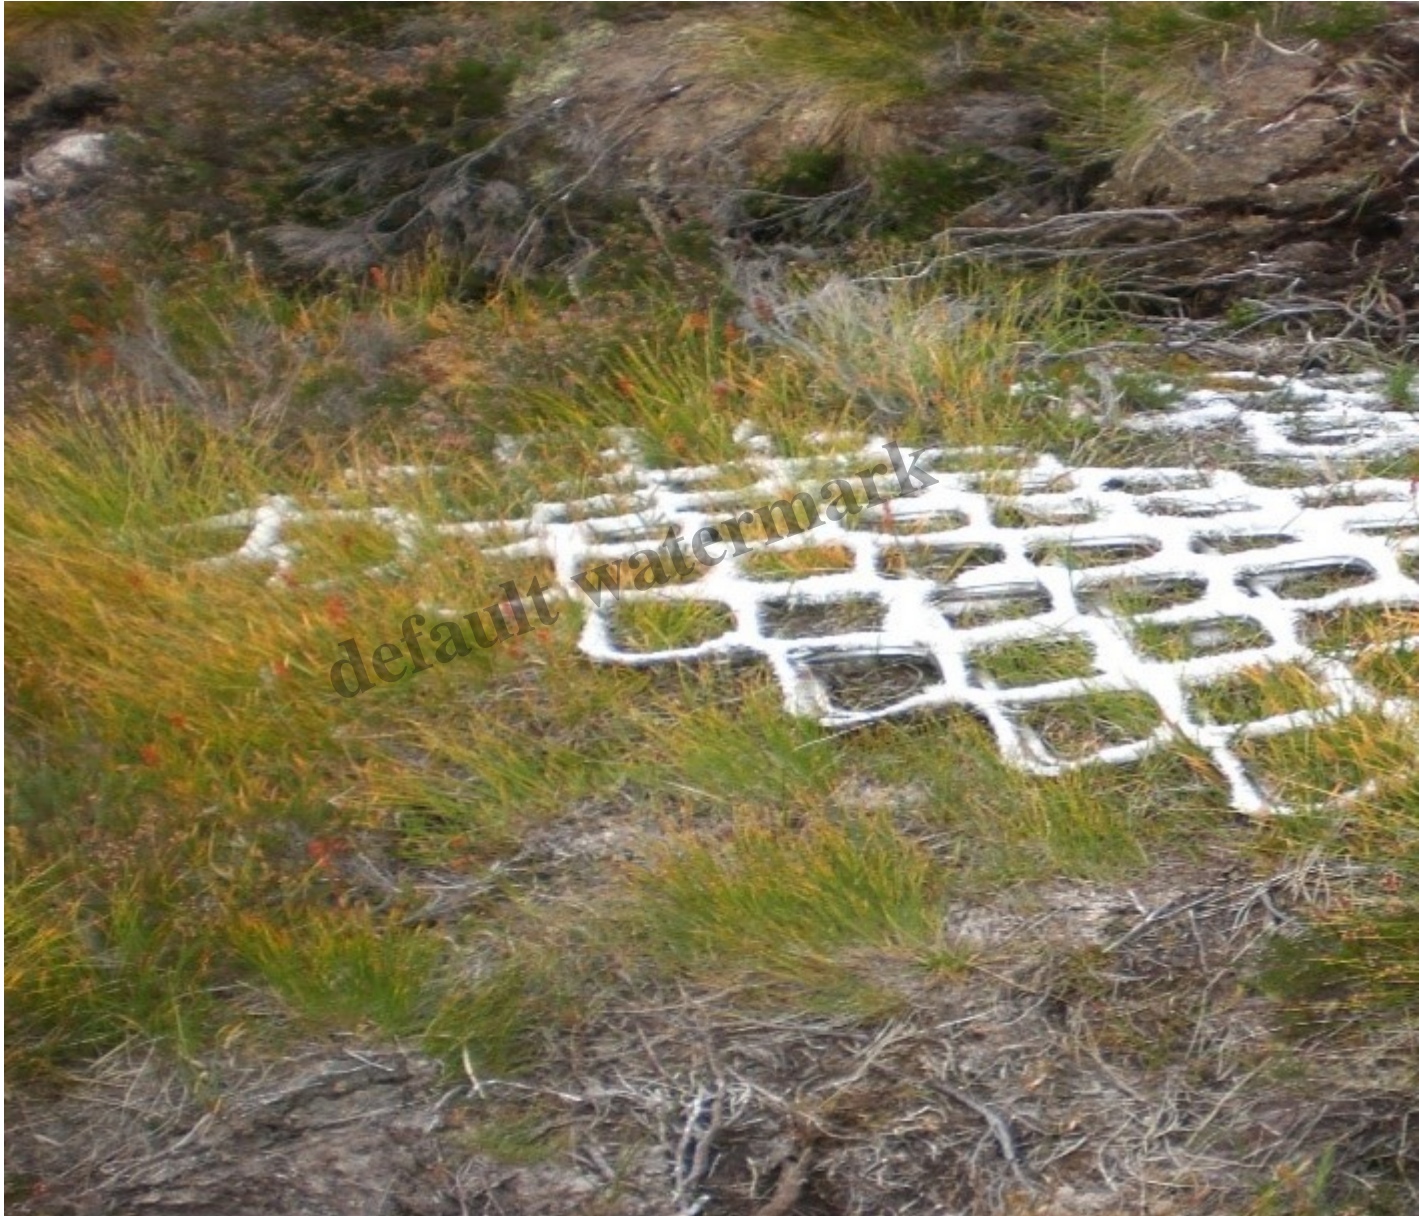
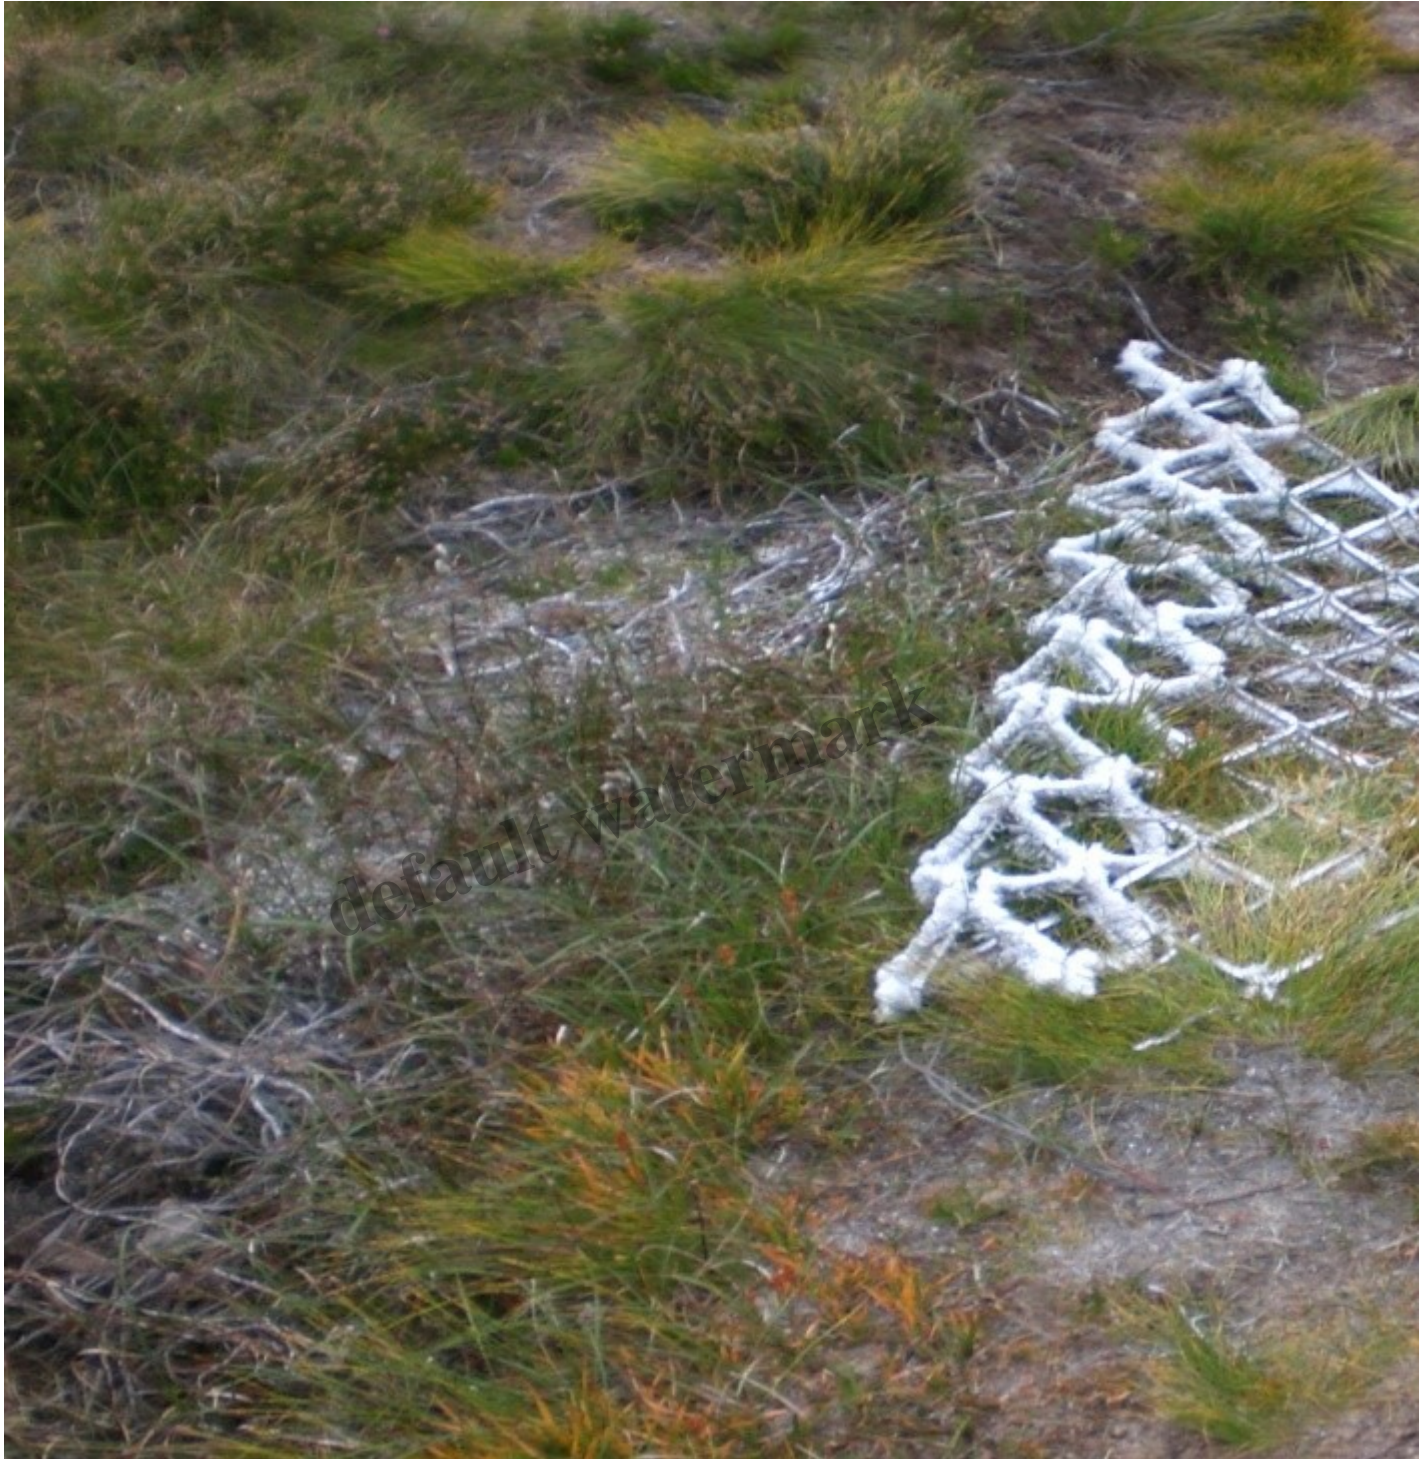
These section of ski matting have been used to bridge wet areas but they are clearly foreign to the area, have no place there and should have been removed.

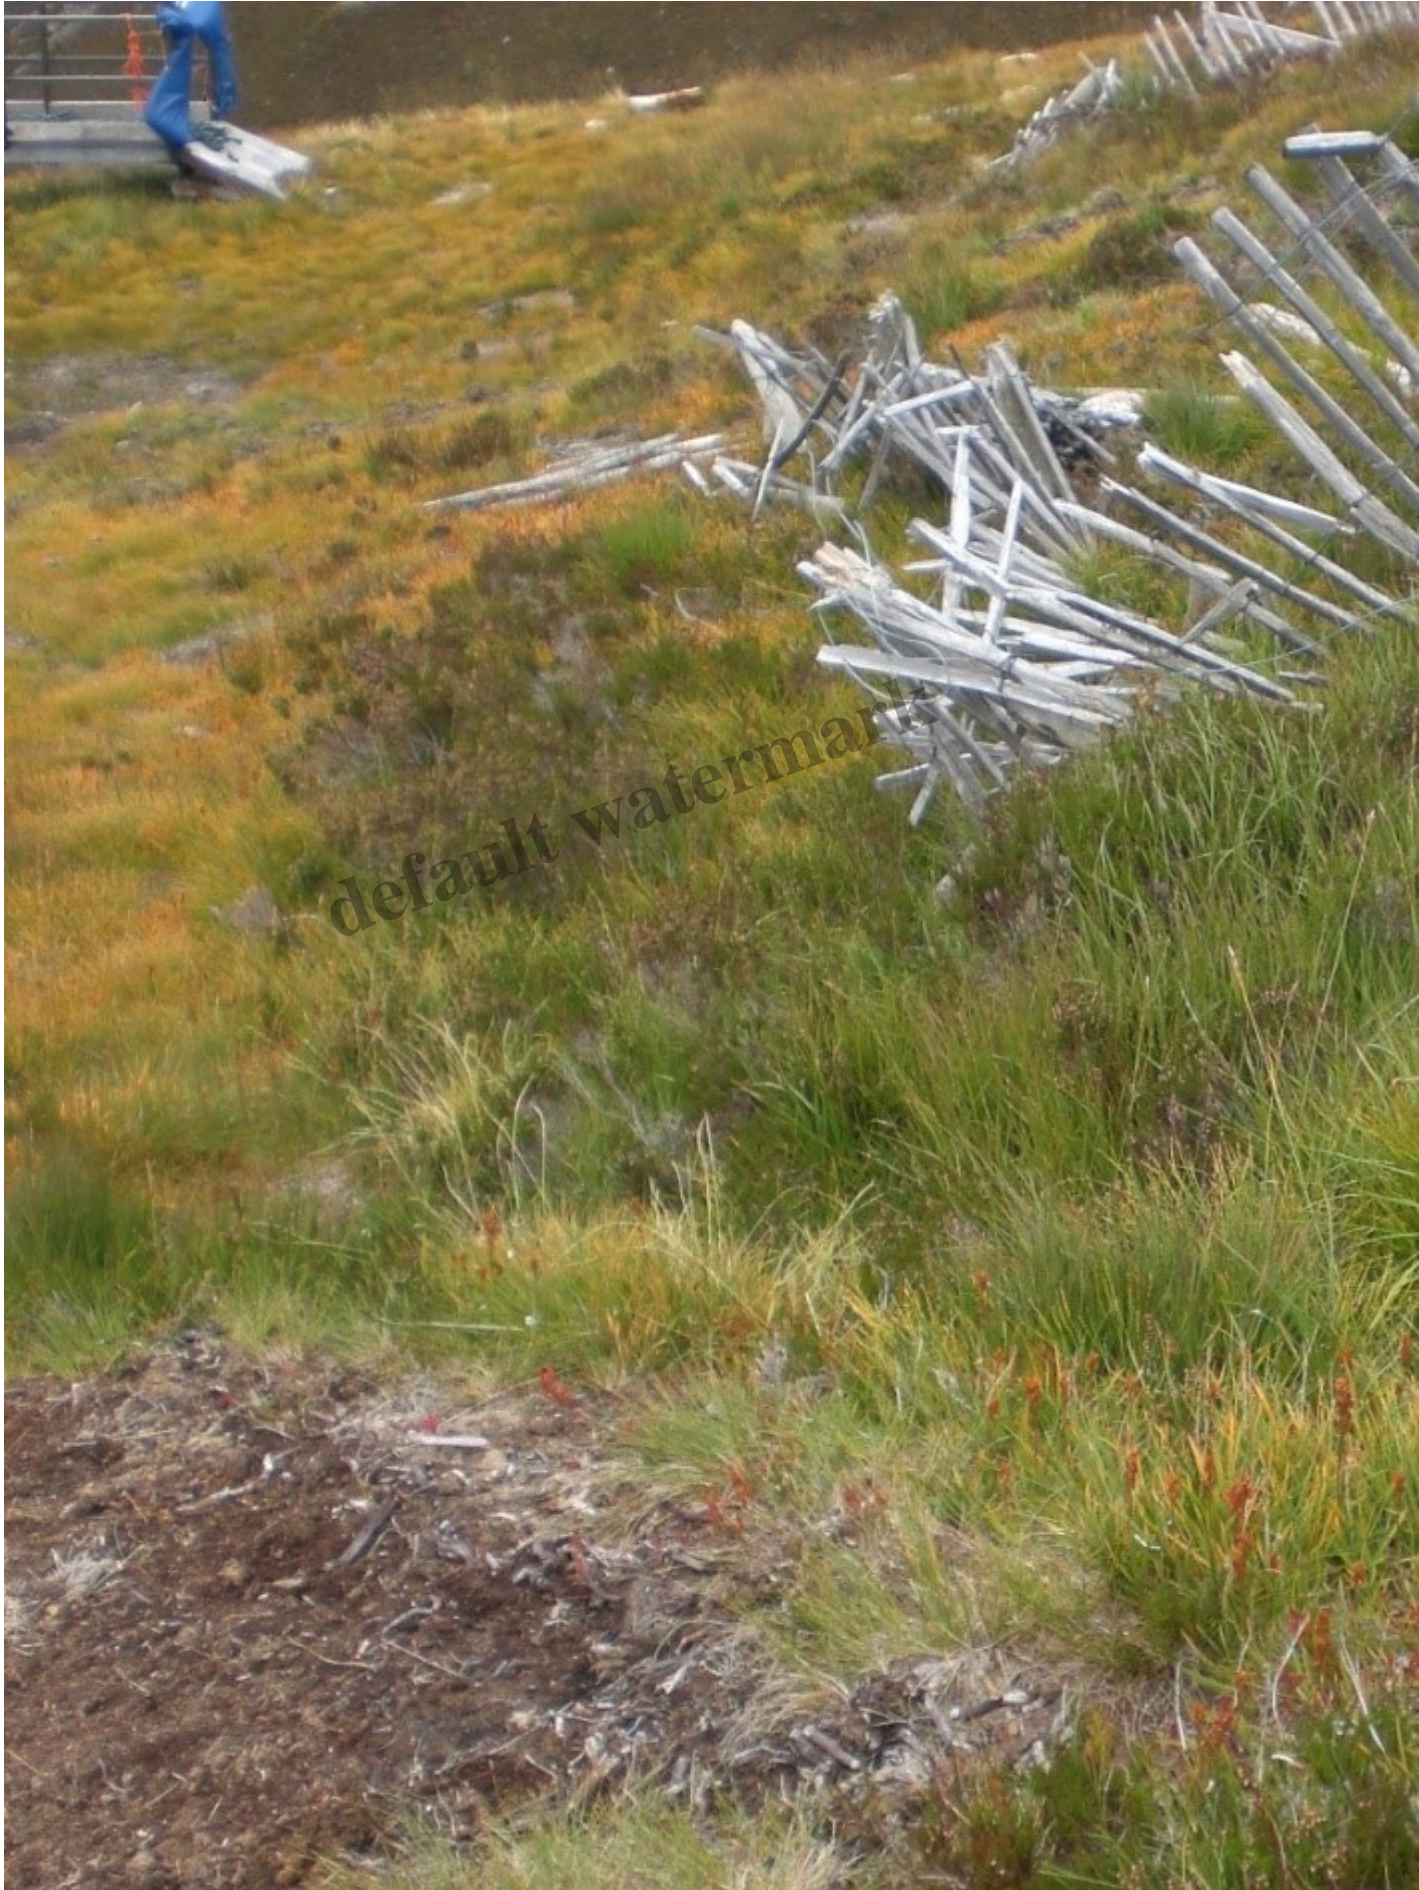
**How about redundant/damaged paling snow fencing?**

The evidence speaks for itself.
