Burn of Mar, a National Park scar and right next to the West Highland Way.

## The hydro pipeline

## **The intake and surrounding area**

## **The new access track**

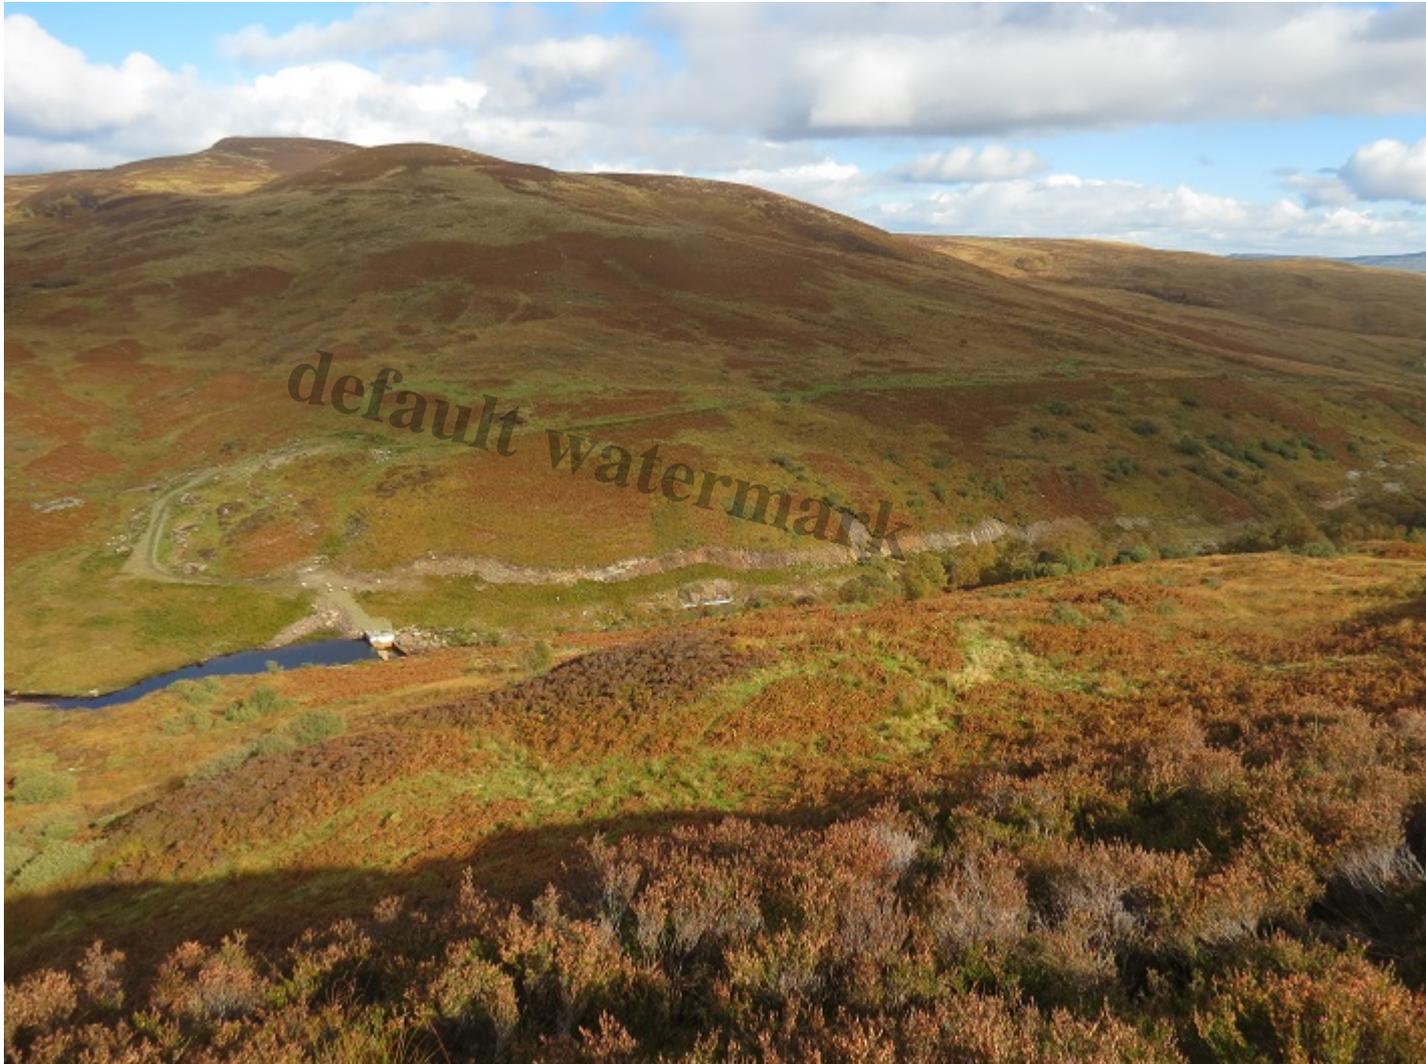
The upper section of the Burn of Mar hydro scheme from from Conic Hill showing the intake, the new track curving up and back across the hill and the scar left by the construction of the pipeline. Maol O Photo Credit Louise Brimelow.

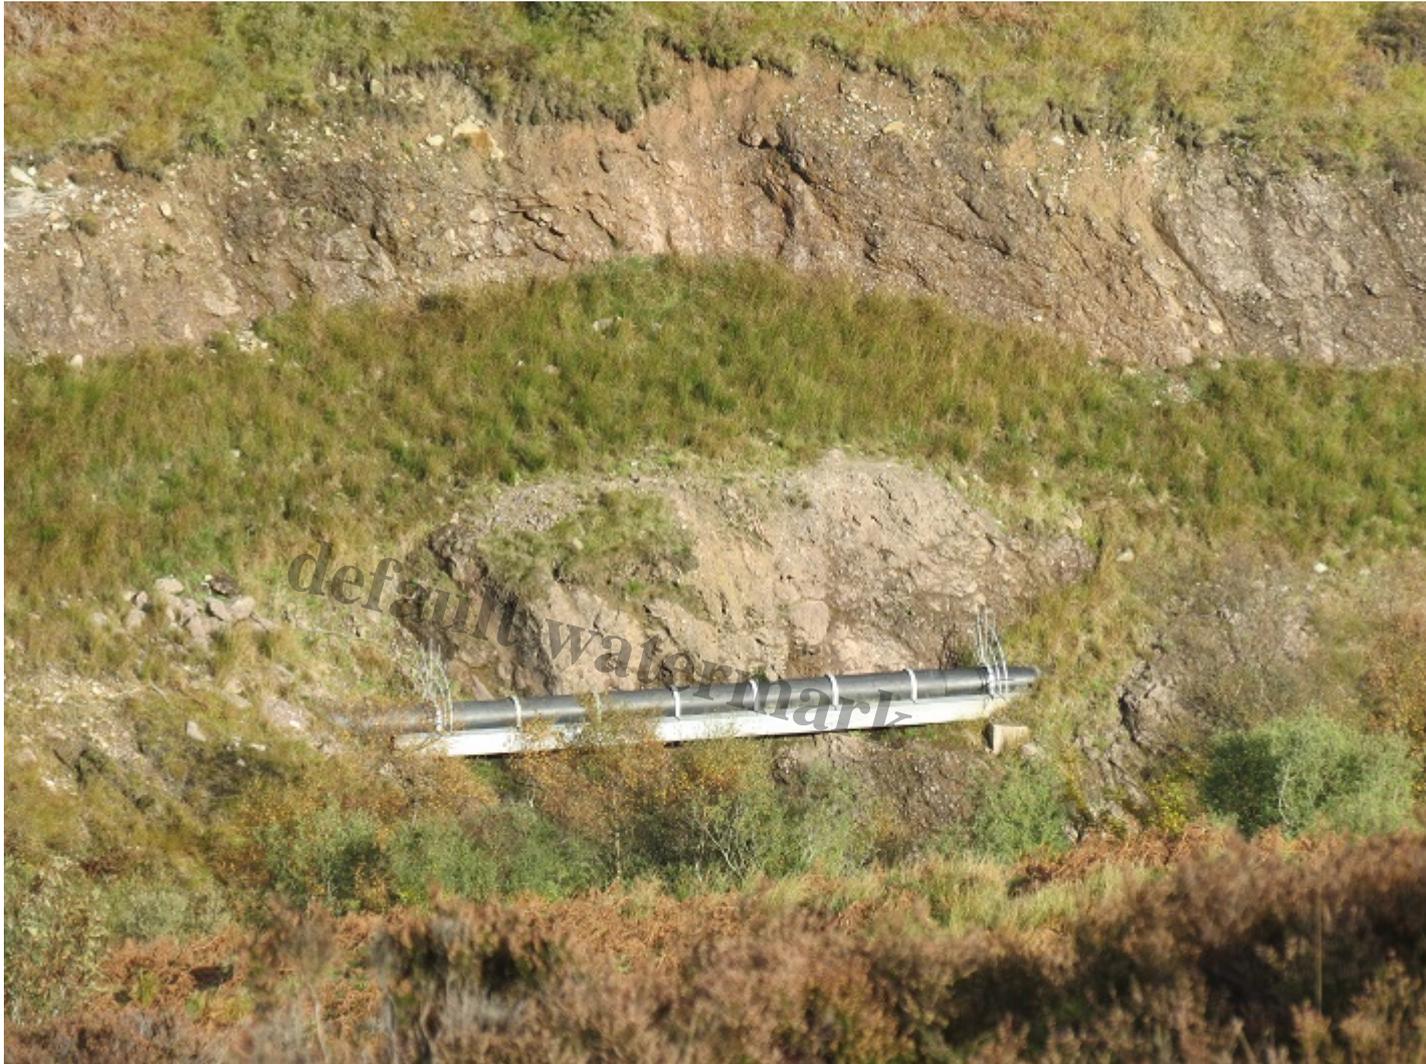
Close up of pipe bridge below two areas of excavated hillside. The line of rush between the two marks the "restored" construction track. The construction corridor here was supposed to be a maximum wide

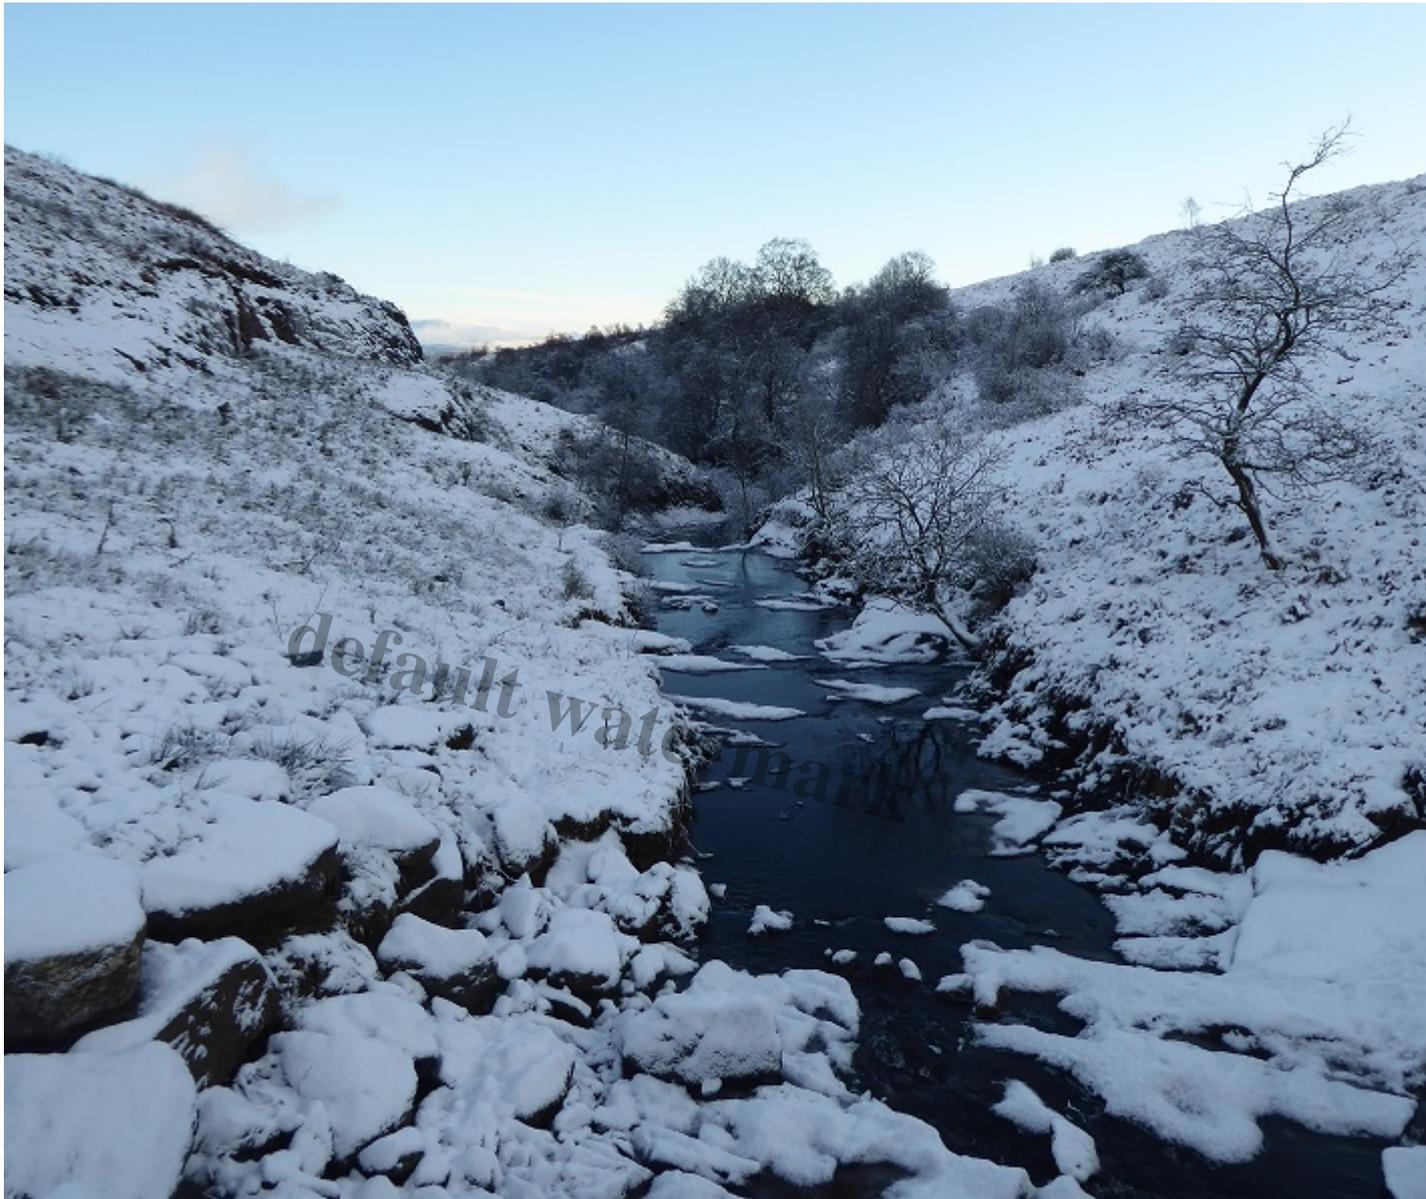
The pipeline construction corridor viewed from the intake last December

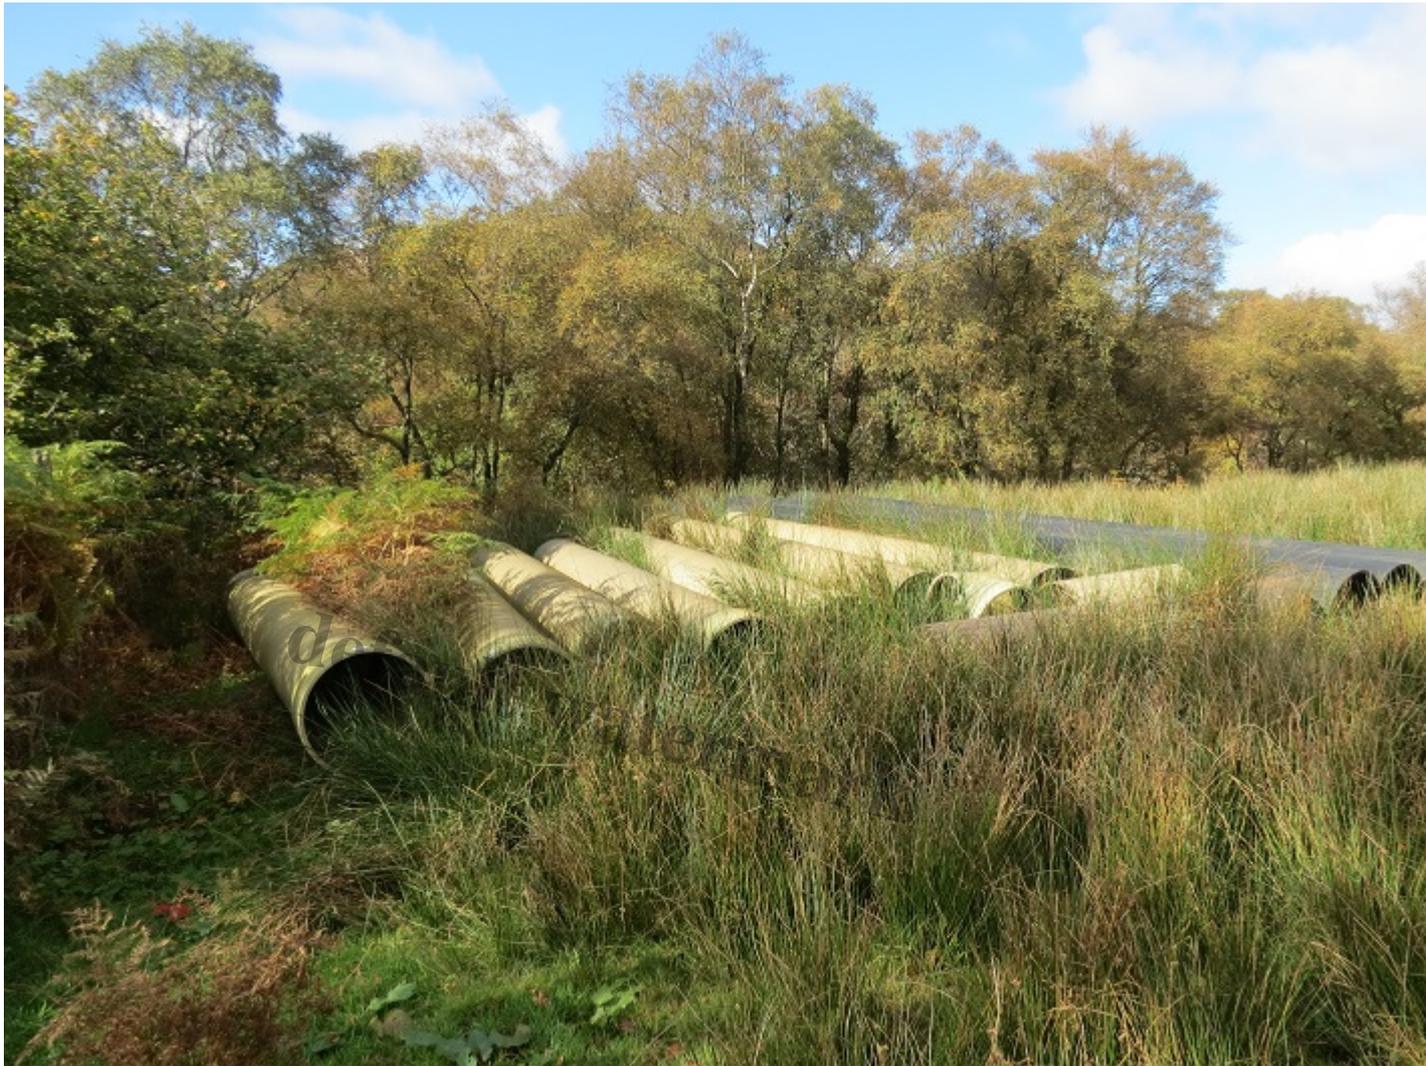
Two types of hydro pipes, glass reinforced plastic for use lower down where the water pressure is high and black for use higher up. Photo credit Louise Brimelow.

Walking up the track along the Burn of Mar from Milton of Buchanan the first sign that all might not be well is an area of what appear to be abandoned pipes in what the planning application described as a *temporary lay down area*. So why are they here 2 years later? Is the LLTNPA's planning enforcement strategy simply to hope the pipes will eventually grow over and be concealed from public view?

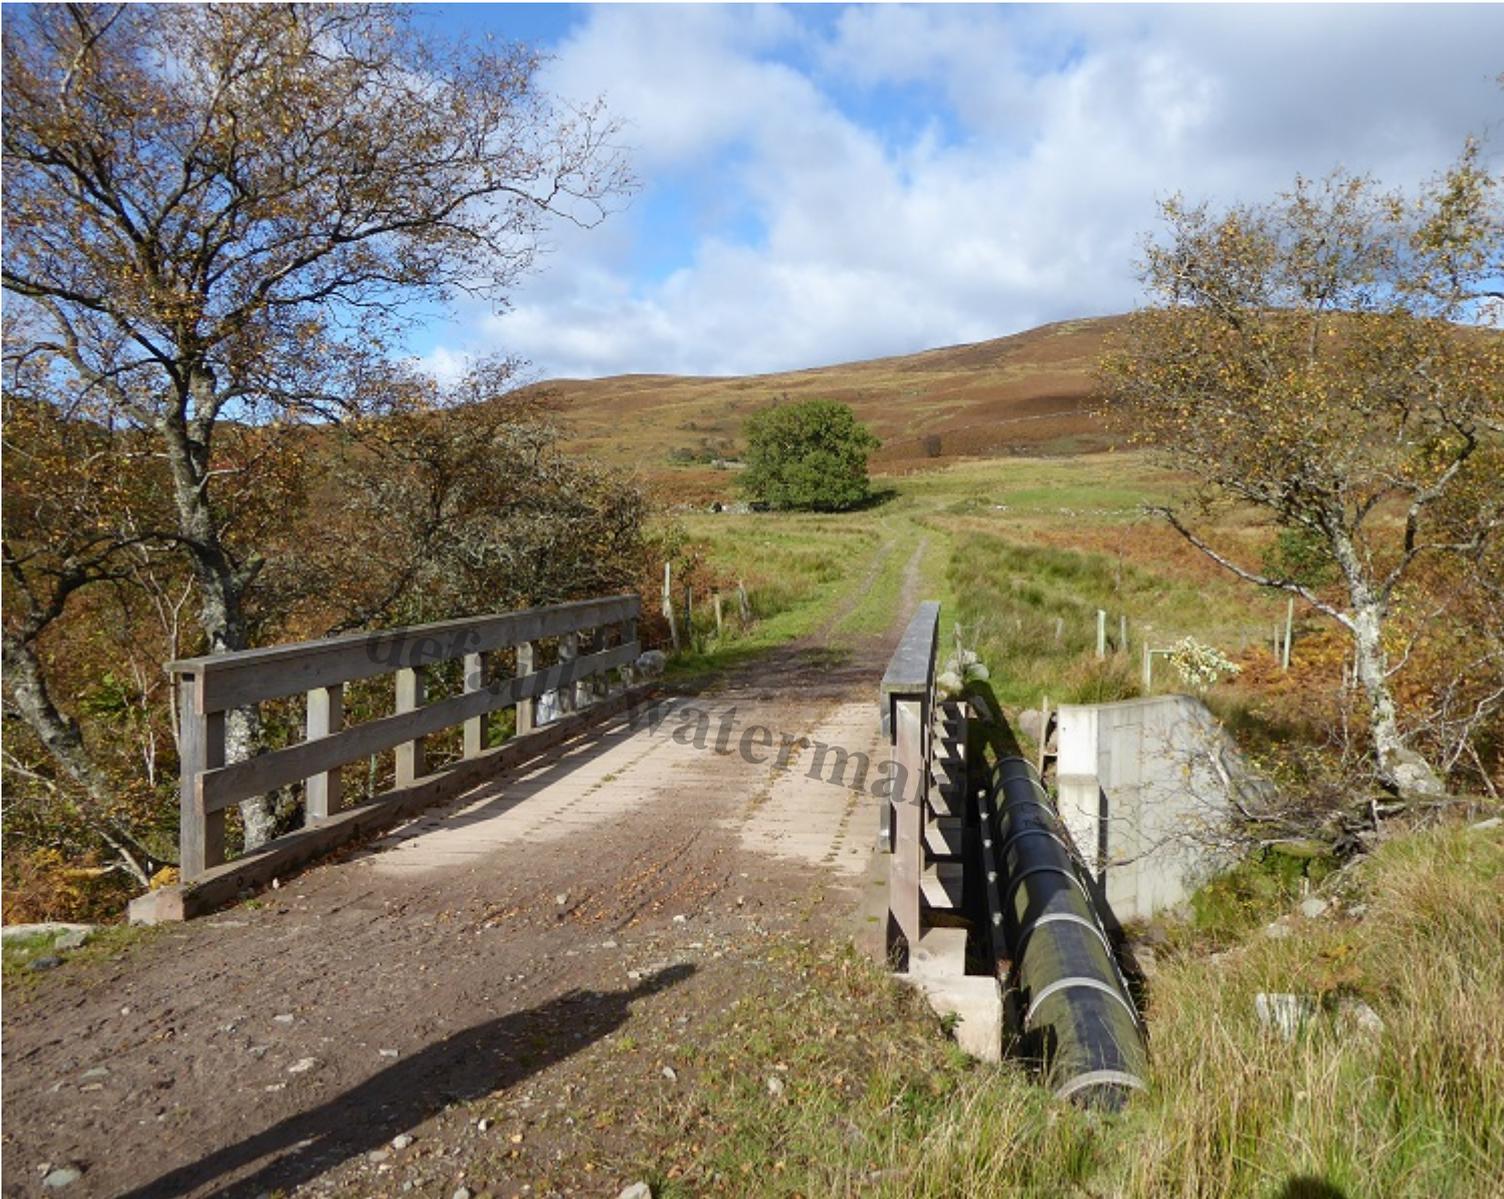
Just a little further up the pipeline has been located next to the bridge instead of beneath it as per the LLTNPA's award winning guidance on renewables. Why?

Two of these photos show issues which could be fixed quite easily given the will. As a reader pointed out a couple of weeks ago, part of the problem is that the LLTNPA has NO quality control system. Until it does, its never going to enforce its own policies or ensure hydro developments meet the standards we should expect in National Parks.

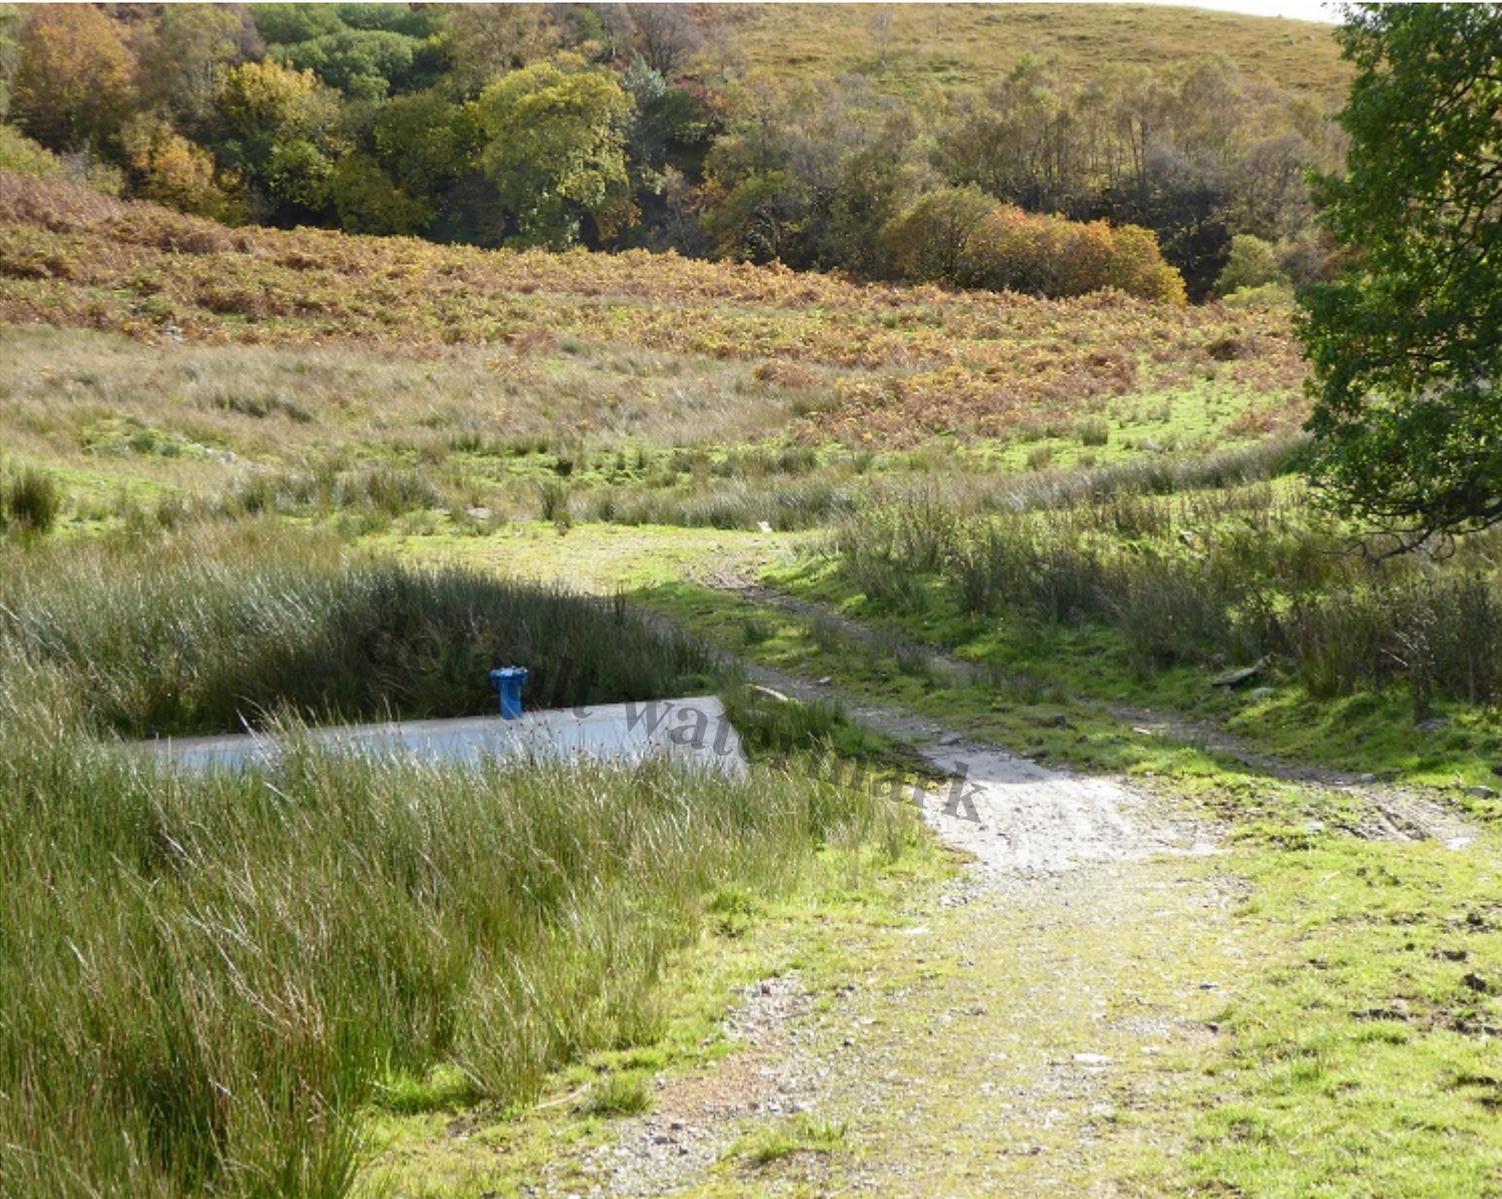
Then at the junction of the two intake pipes â?? we did not go to look at second intake which appears far less an issue â?? there was the seemingly inevitable protruding blue pipe. These are contrary to LLTNPA policy. One lower down had been painted green so why has this been allowed to remain?

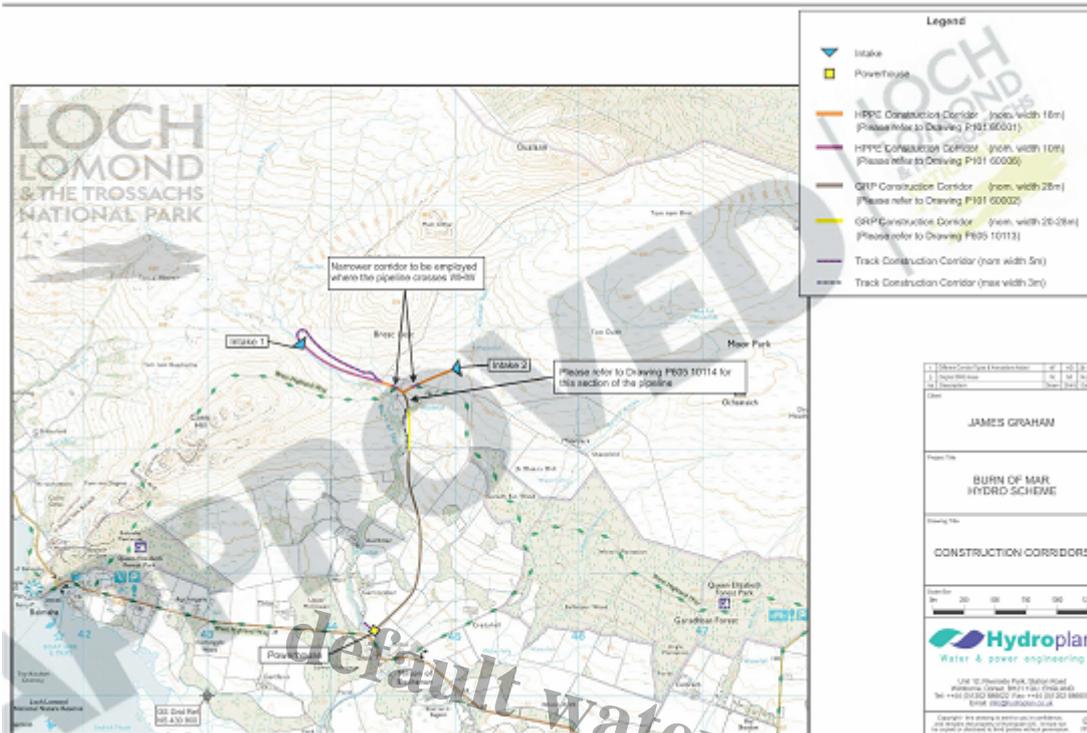
Extract from plans. The lines looping to intake 1, show the section of pipeline and new track which are the main subject of this post.

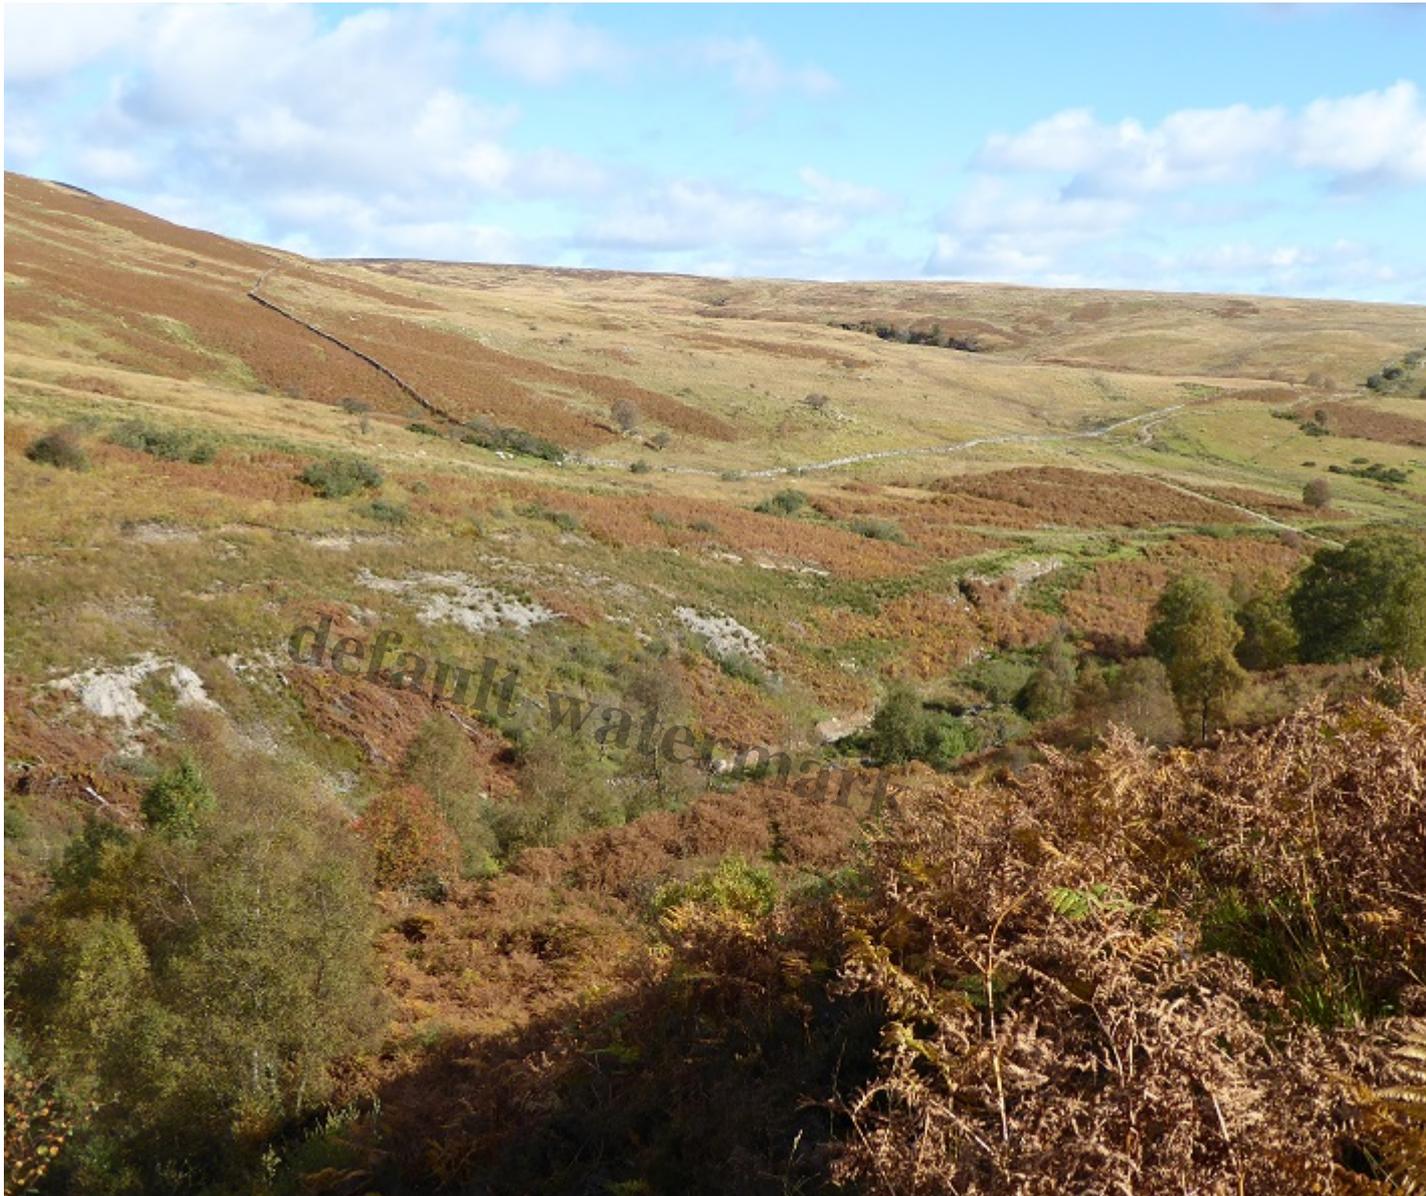
The first part of the upper section of the pipeline which lies just outwith the NSA whose boundary here is the Burn of Mar. The view is from the West Highland Way and from within the NSA with the line of trees coming down from the top left to meet the broad swathe of damaged ground middle left of photo,. Just where the two come together you can see where they cross the West Highland Way.

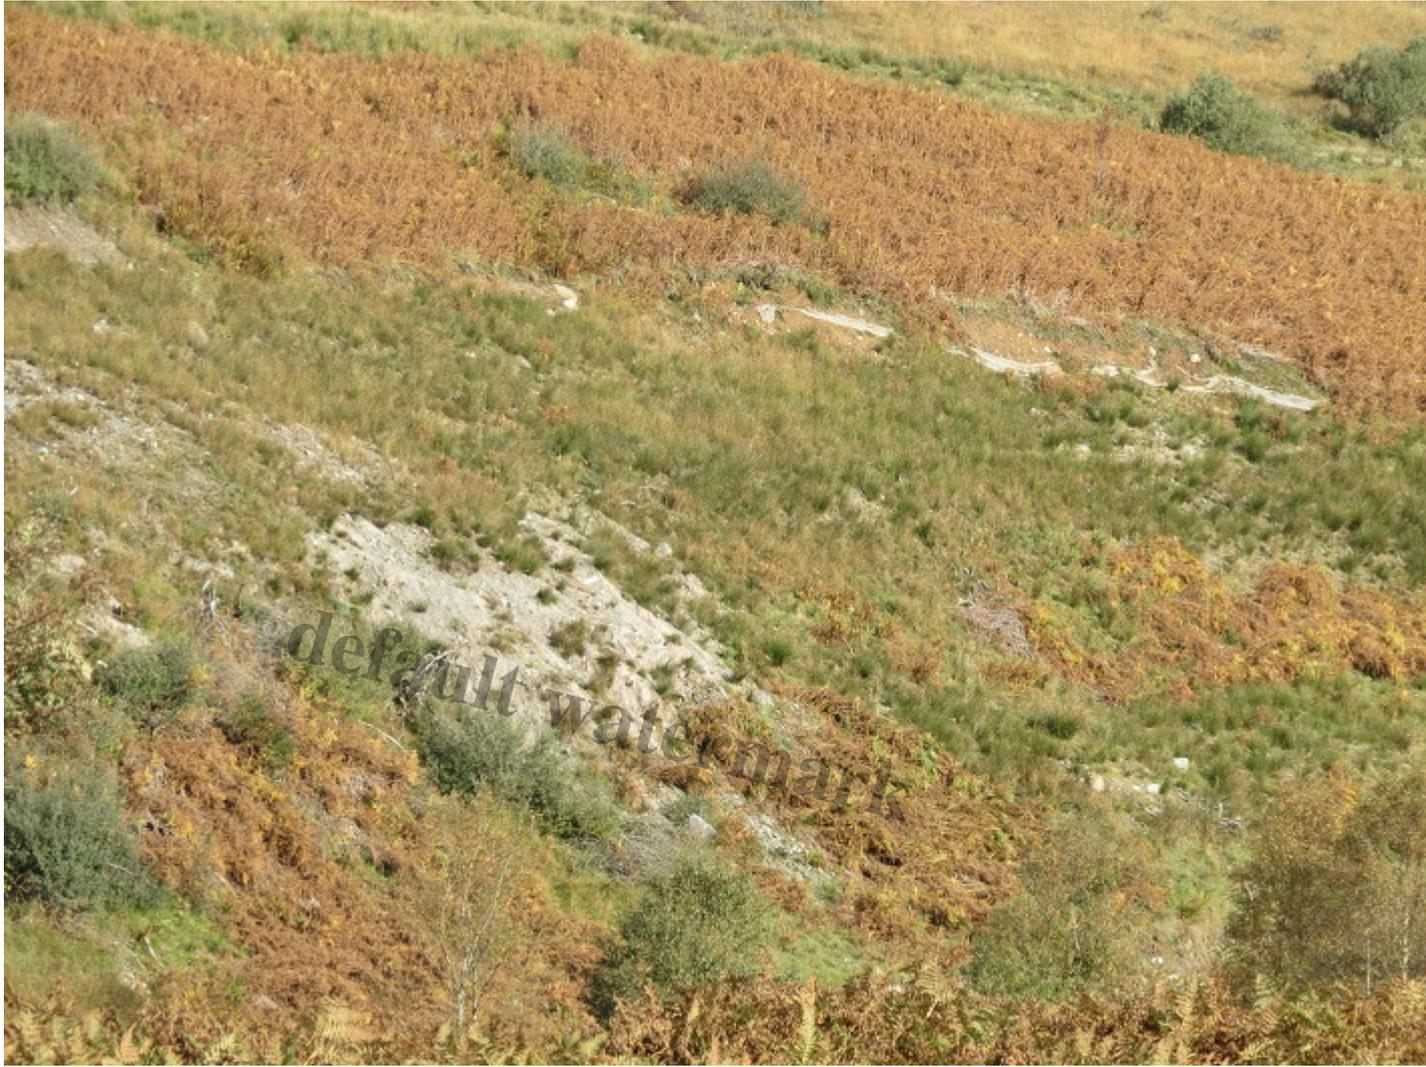
Same view, through telephoto lens. Note the textile matter across the bare earth slope and the spoil appears to have been dumped below the line of the pipe. Photo Credit Louise Brimelow.

While the restoration of this part of the pipeline, which is highly visible from the West Highland Way as it rises from the Burn of Mar, is far worse than is usual in the Loch Lomond and Trossachs National Park, it could still be restored properly with a bit of care. The section above this, however, which is partly hidden from the West Highland Way but clearly visible from just below it, is another matter.

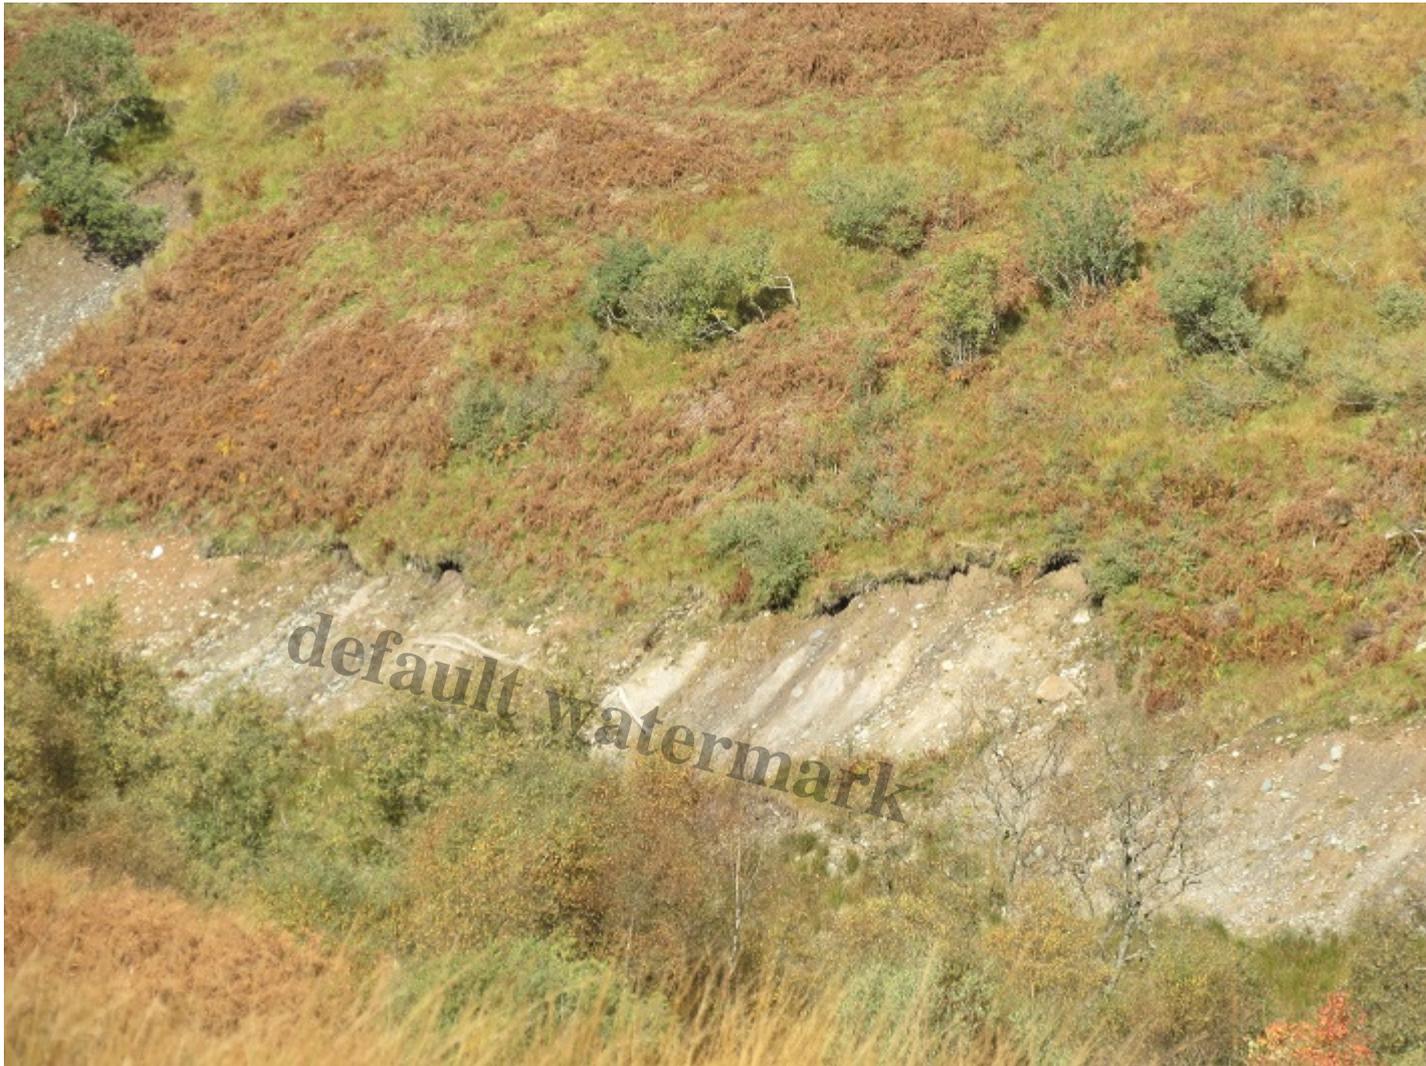
Near the southern edge of the serious landscape scar which lies in the National Scenic Area ?? view just below the West Highland Way Photo Credit Louise Brimelow

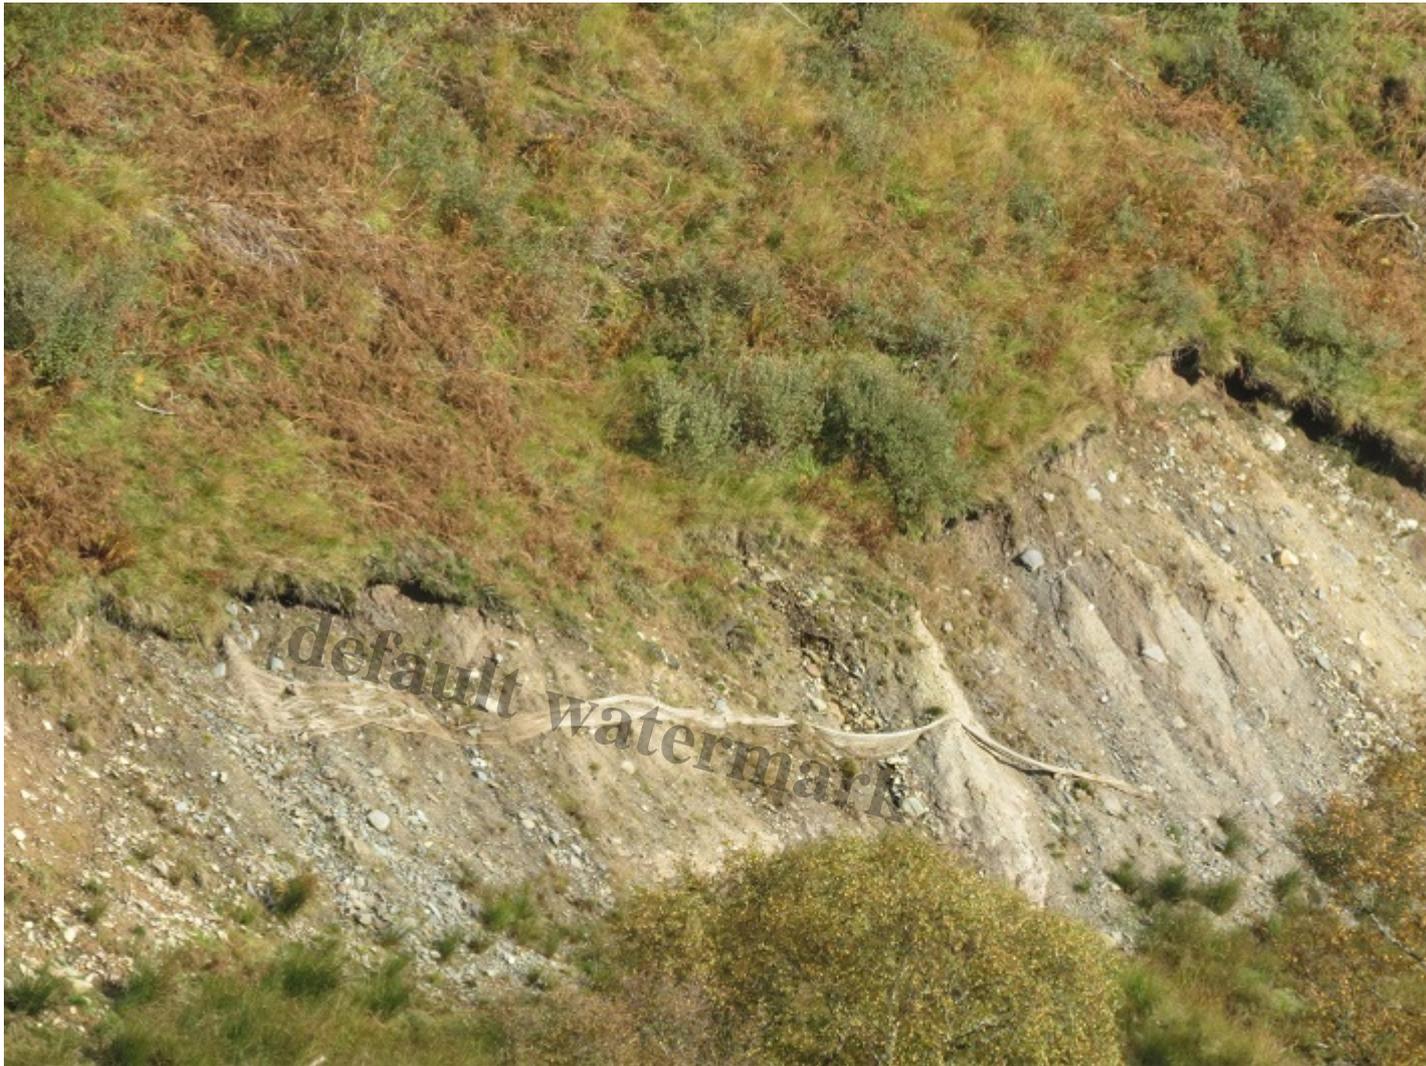
Same section more or less viewed from different angle. Note how the textile matting has clearly failed and water has eroded the exposed slope to the right of this

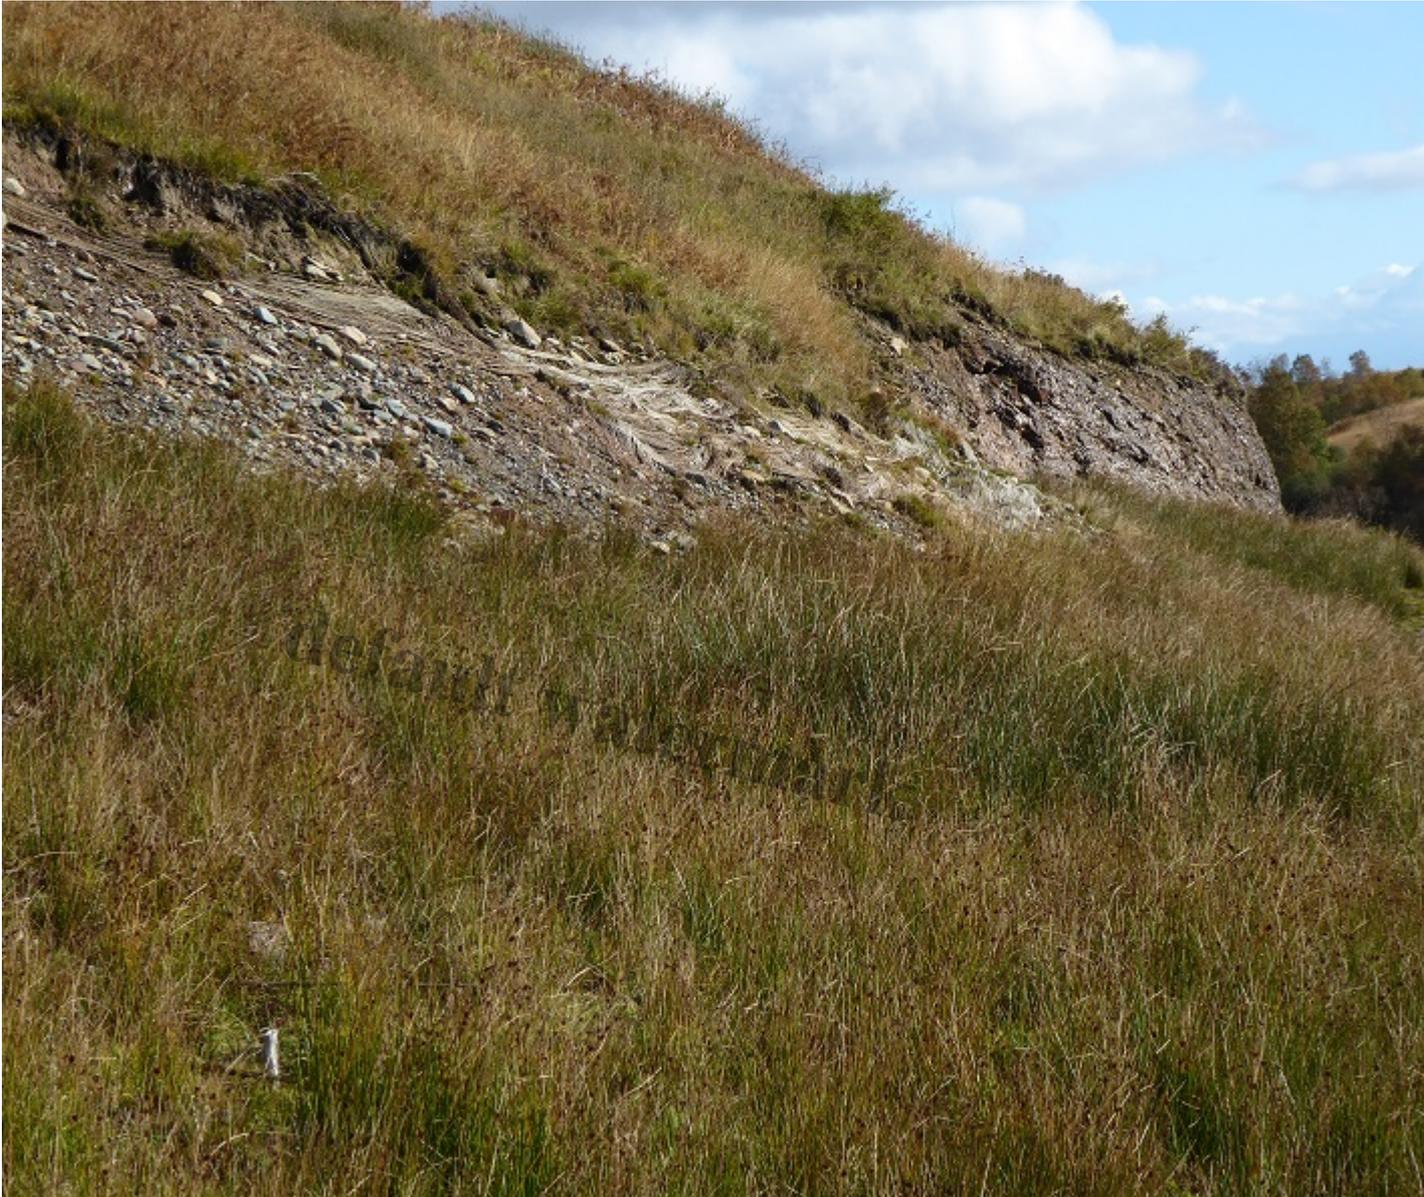
The landscape scar viewed from round the corner closer to the intake

Is this what Hydroplan claimed in the Planning Application claimed would be *“integration of slopes into the adjoining landform”*?

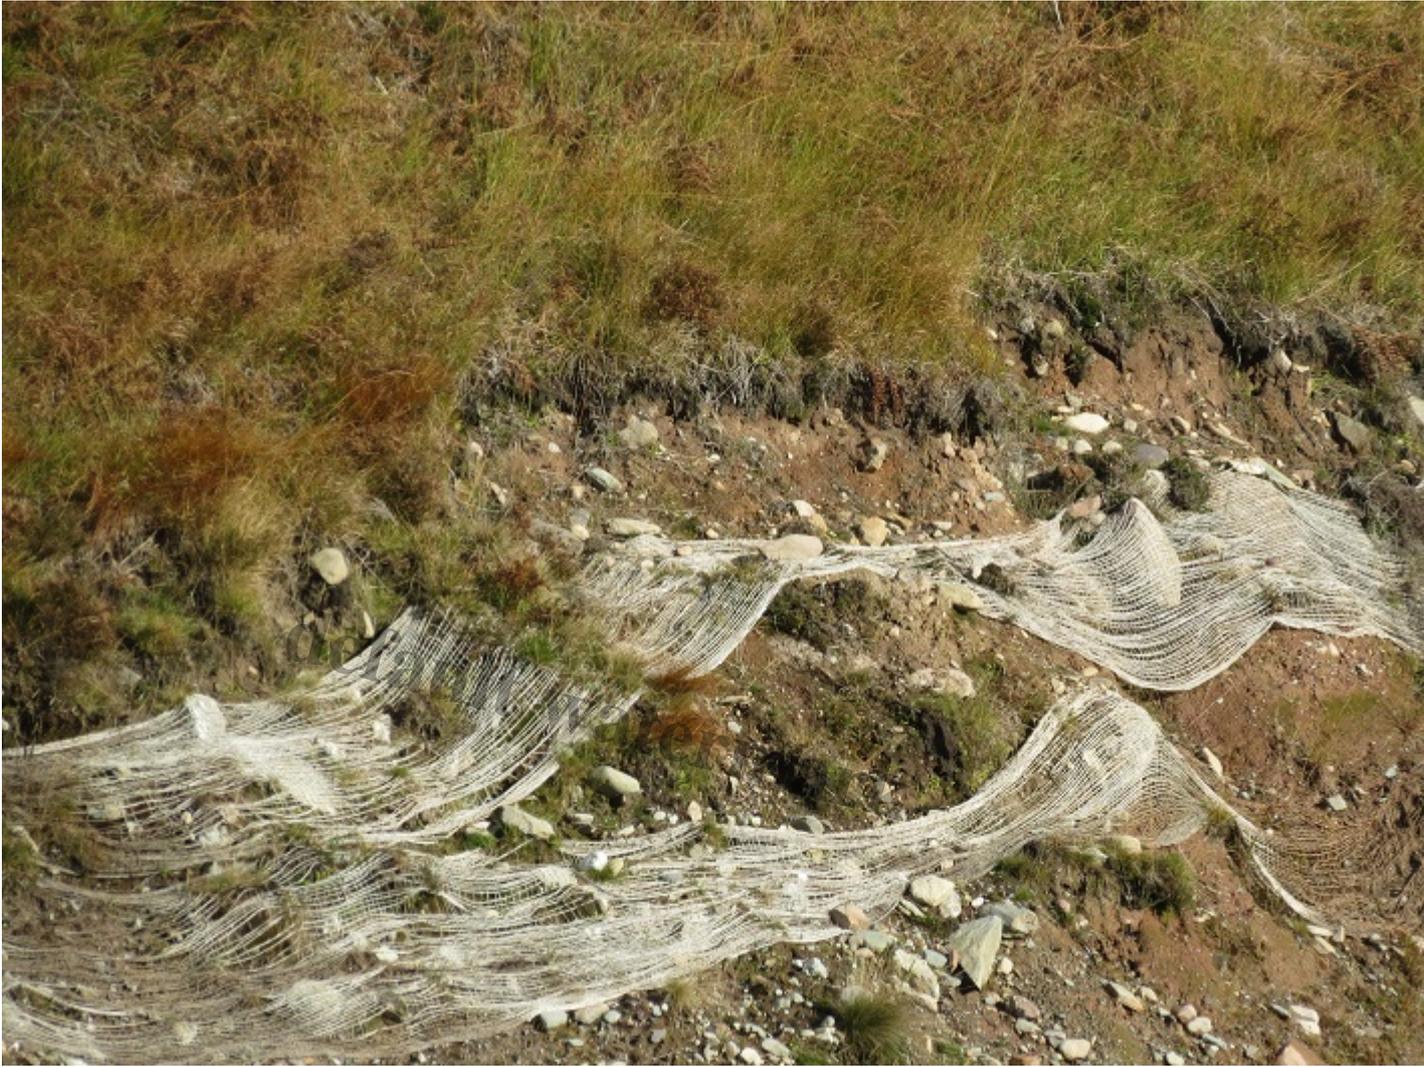
Failed restoration

The original Construction method statement contained all the usual claims about how turf and soils would be separated and stored carefully to enable restoration. Either these were changed or not followed - it's impossible to know because of the LLTNPA's secretive approach to planning in which they try and cover up anything that goes wrong.

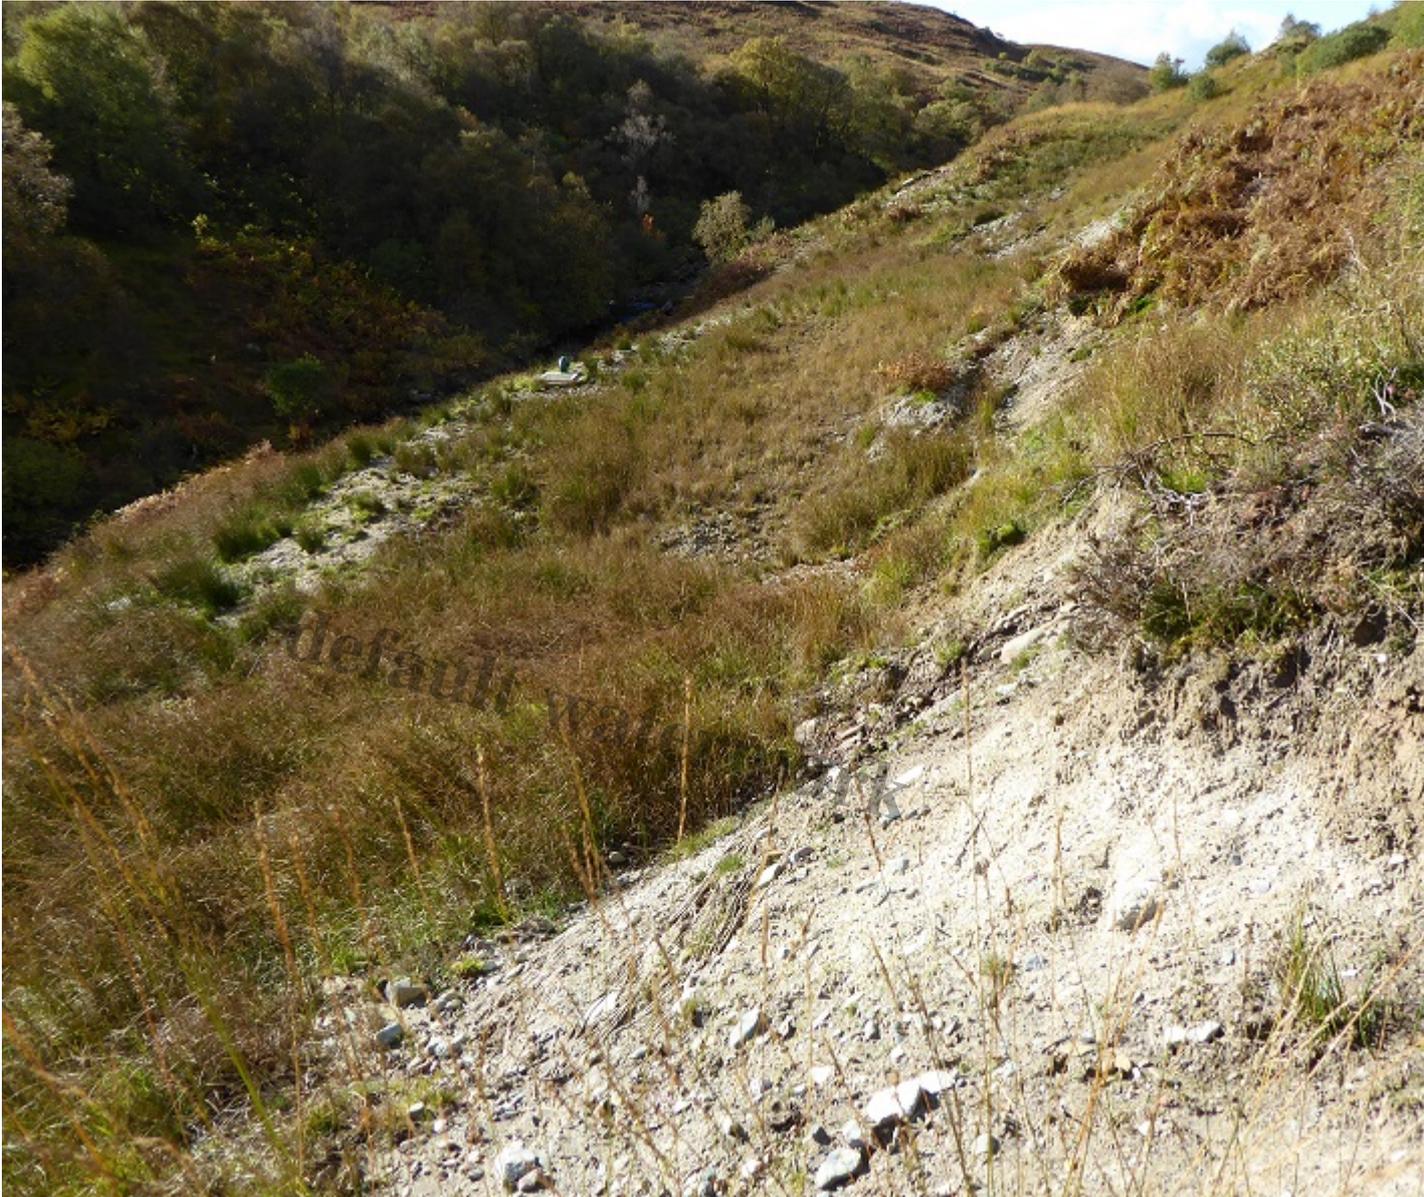
Looking up the southern section of the landscape scar with line of pipe (together with blue protruding pipe) forming a low raised ridge to the right of the burn.

One possible explanation for the destruction here is instead of excavating a proper trench for the pipeline, it has only been partially buried and the developers have then scraped rock and glacial deposits from the hillside to bury it creating the scar. The fundamental thing that the LLTNPA should be determining in the planning process is whether hydro schemes can be created without any significant long-term landscape impacts. In my view, if this section of pipeline could not be constructed without creating bare damaged slopes, the LLTNPA should have refused or withdrawn planning consent. If the pipeline could have been constructed without causing this damage, the LLTNPA should have had systems in place to prevent this damage taking place and now to be taking enforcement action. Either way they have got it wrong and there needs to be an investigation.
