Burn of Mar, a National Park scar and right next to the West Highland Way.

## The hydro pipeline

## **The intake and surrounding area**

## **The new access track**

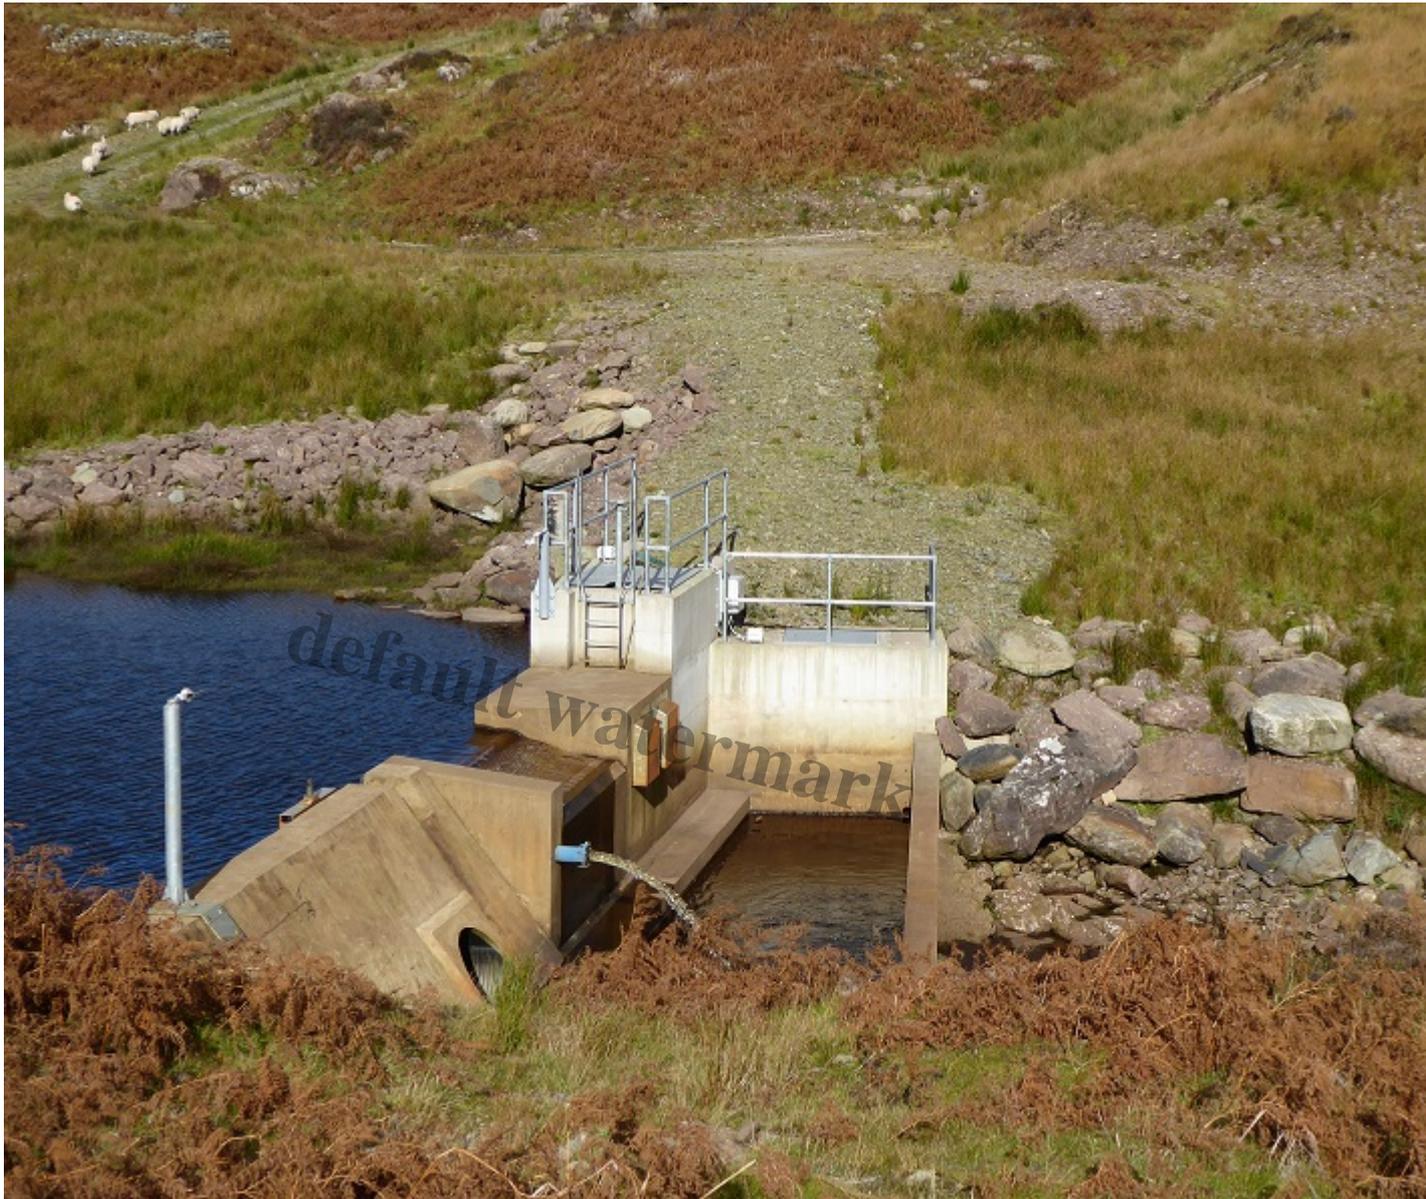
Another blue pipe is the least of the landscaping problems around the intake

The area around the intake is as bad as the pipeline: large extents of rip rap bouldering which have been poorly landscaped (rip rap bouldering almost never appears in the design plans for intakes); unnecessarily large turning areas with unfinished sides; the extent of the bare concrete walls; and the bank denuded of vegetation (upper right).

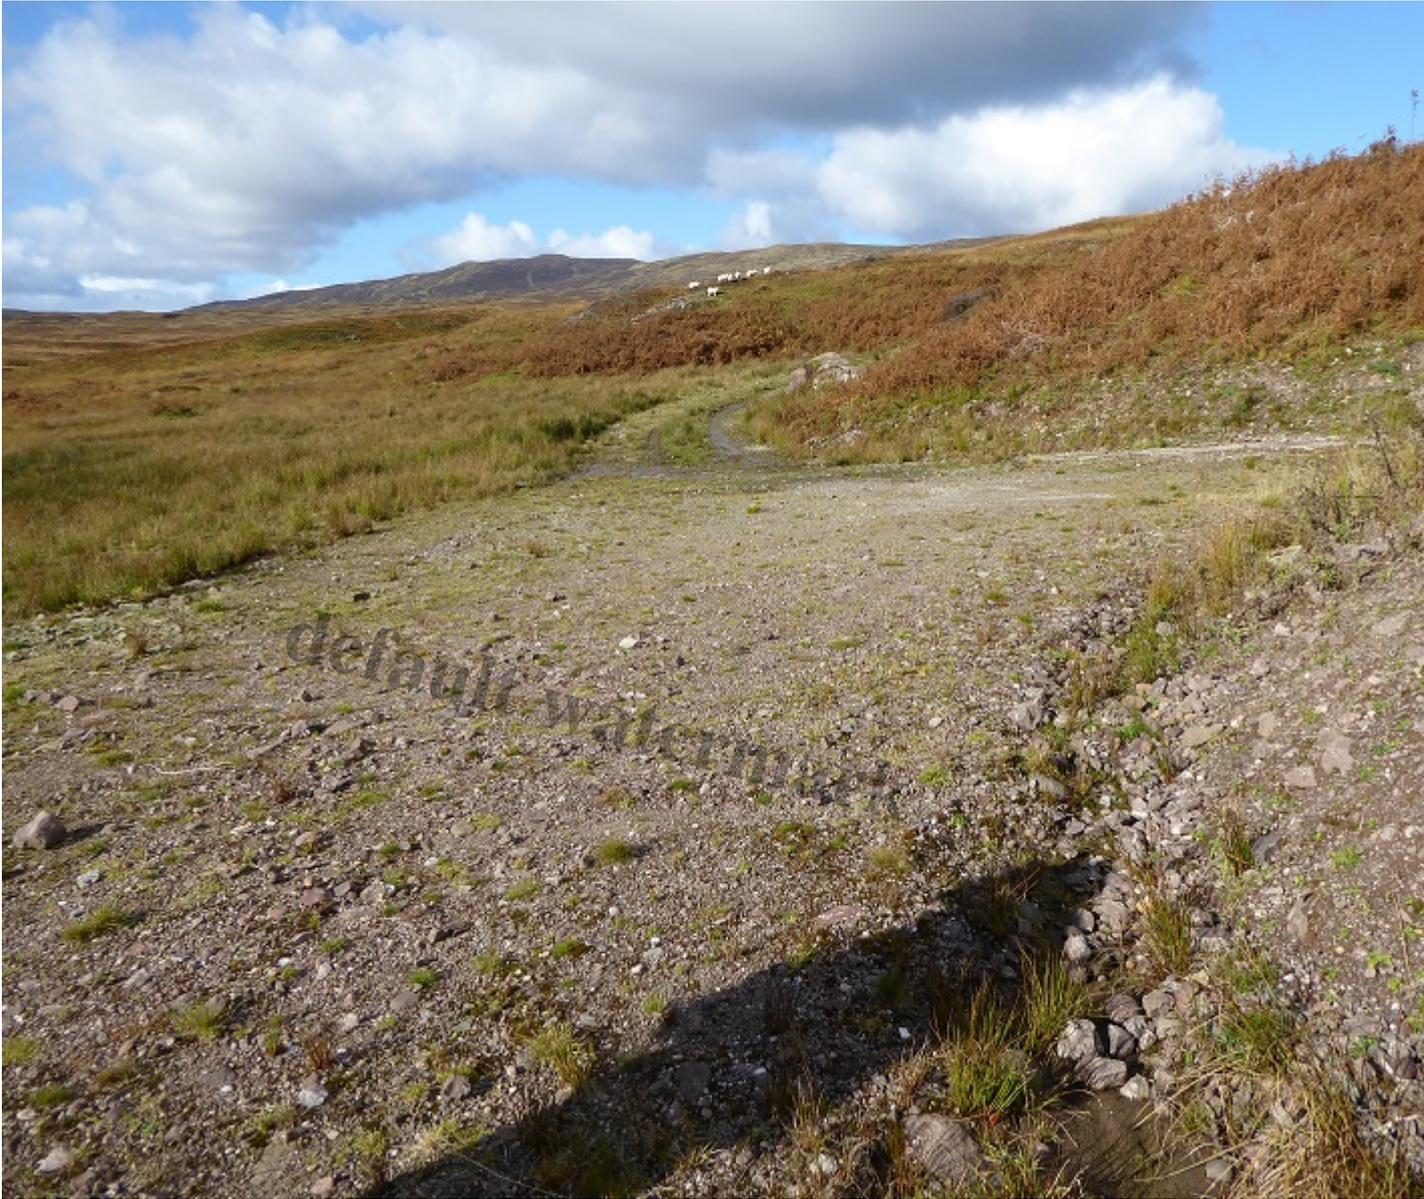
Detail of part of the turning area

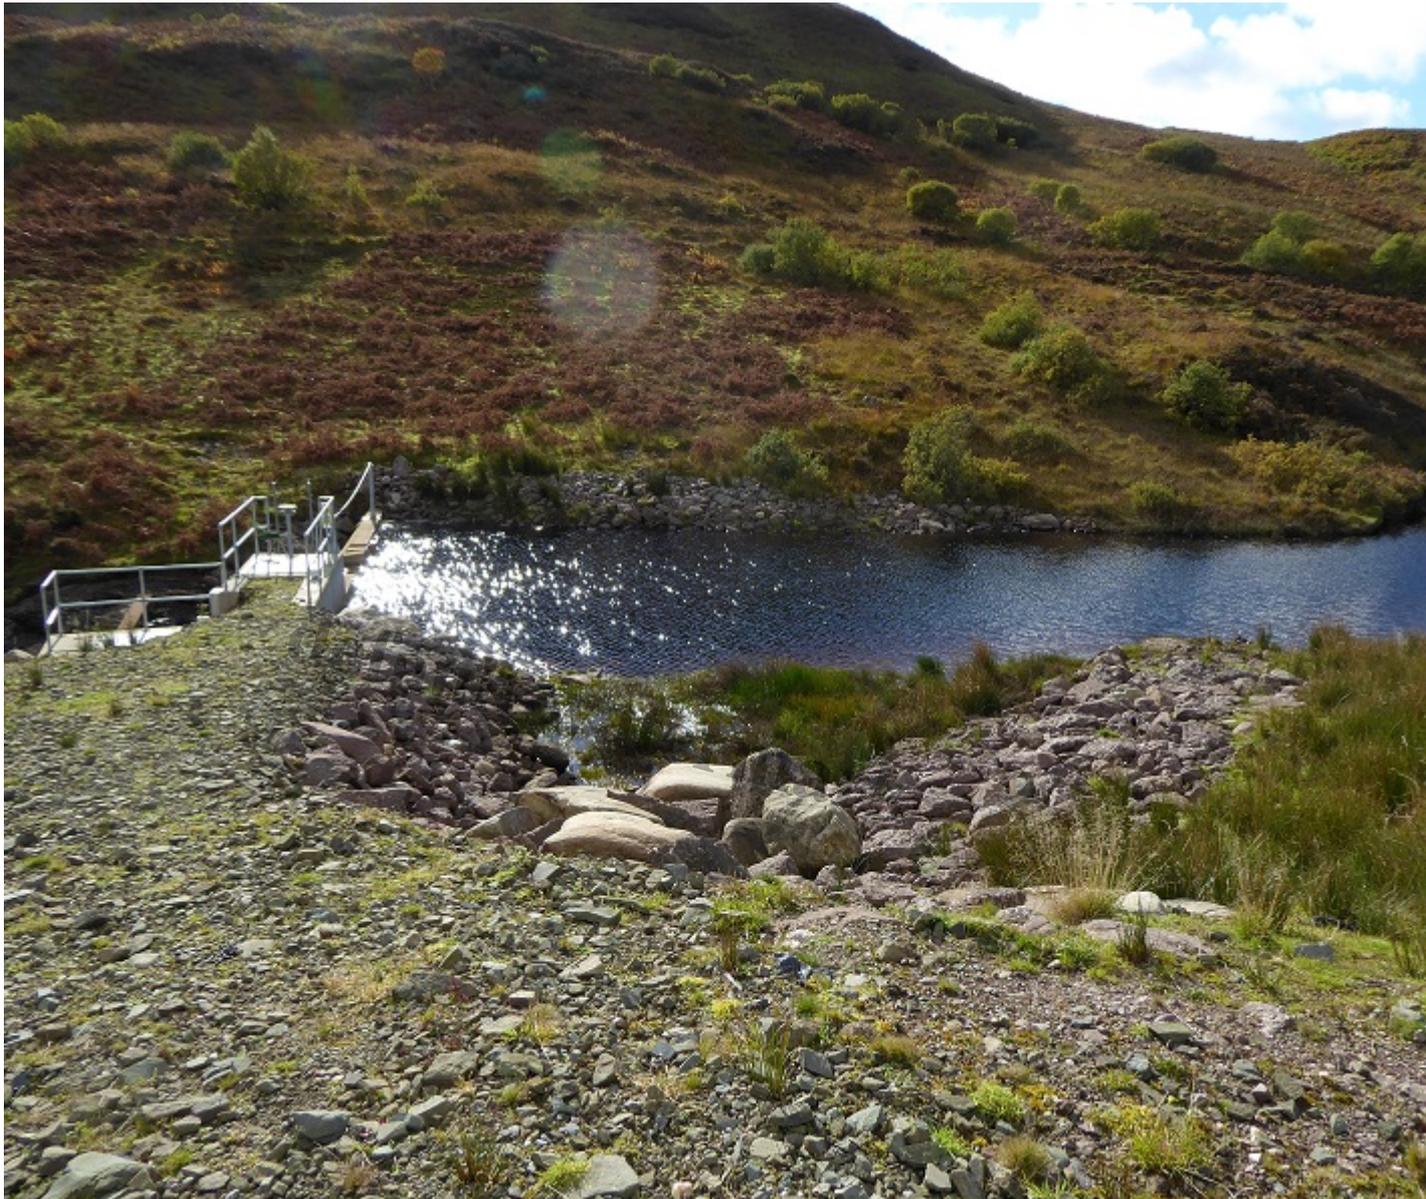
View in opposite direction back to intake

A good yardstick to measure the success of the restoration here is to compare the ground on the nearside of the intake with the land opposite.

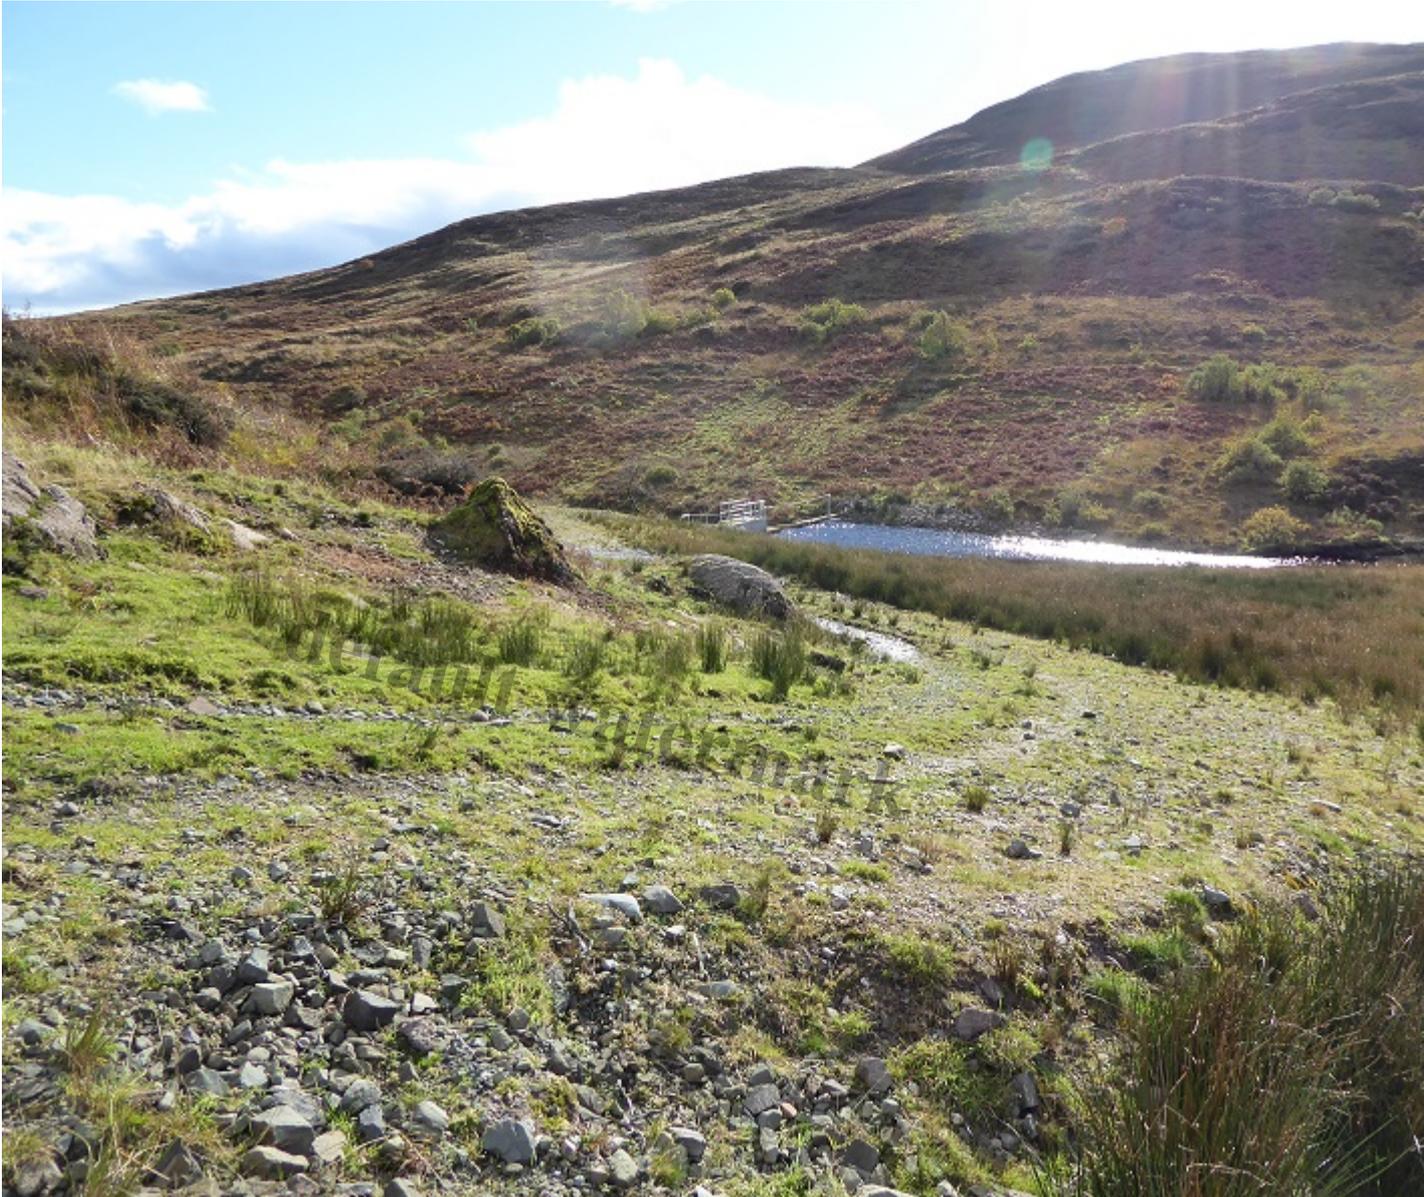
It is concluded that a fixed route permanent track that is constructed at 2.5m width, with a vegetated strip, has potential to have the lesser residual impact than the alternative option of no permanent track to the intakes. It is time for all Planning Staff to be issued with measuring tapes.

The worst section of track is just above the intake where it curves up and round. Its too broad and fails to meet planning requirements. The finishing on the more or less horizontal section of track above which runs parallel to the pipeline and Burn of Mar is a lot better:

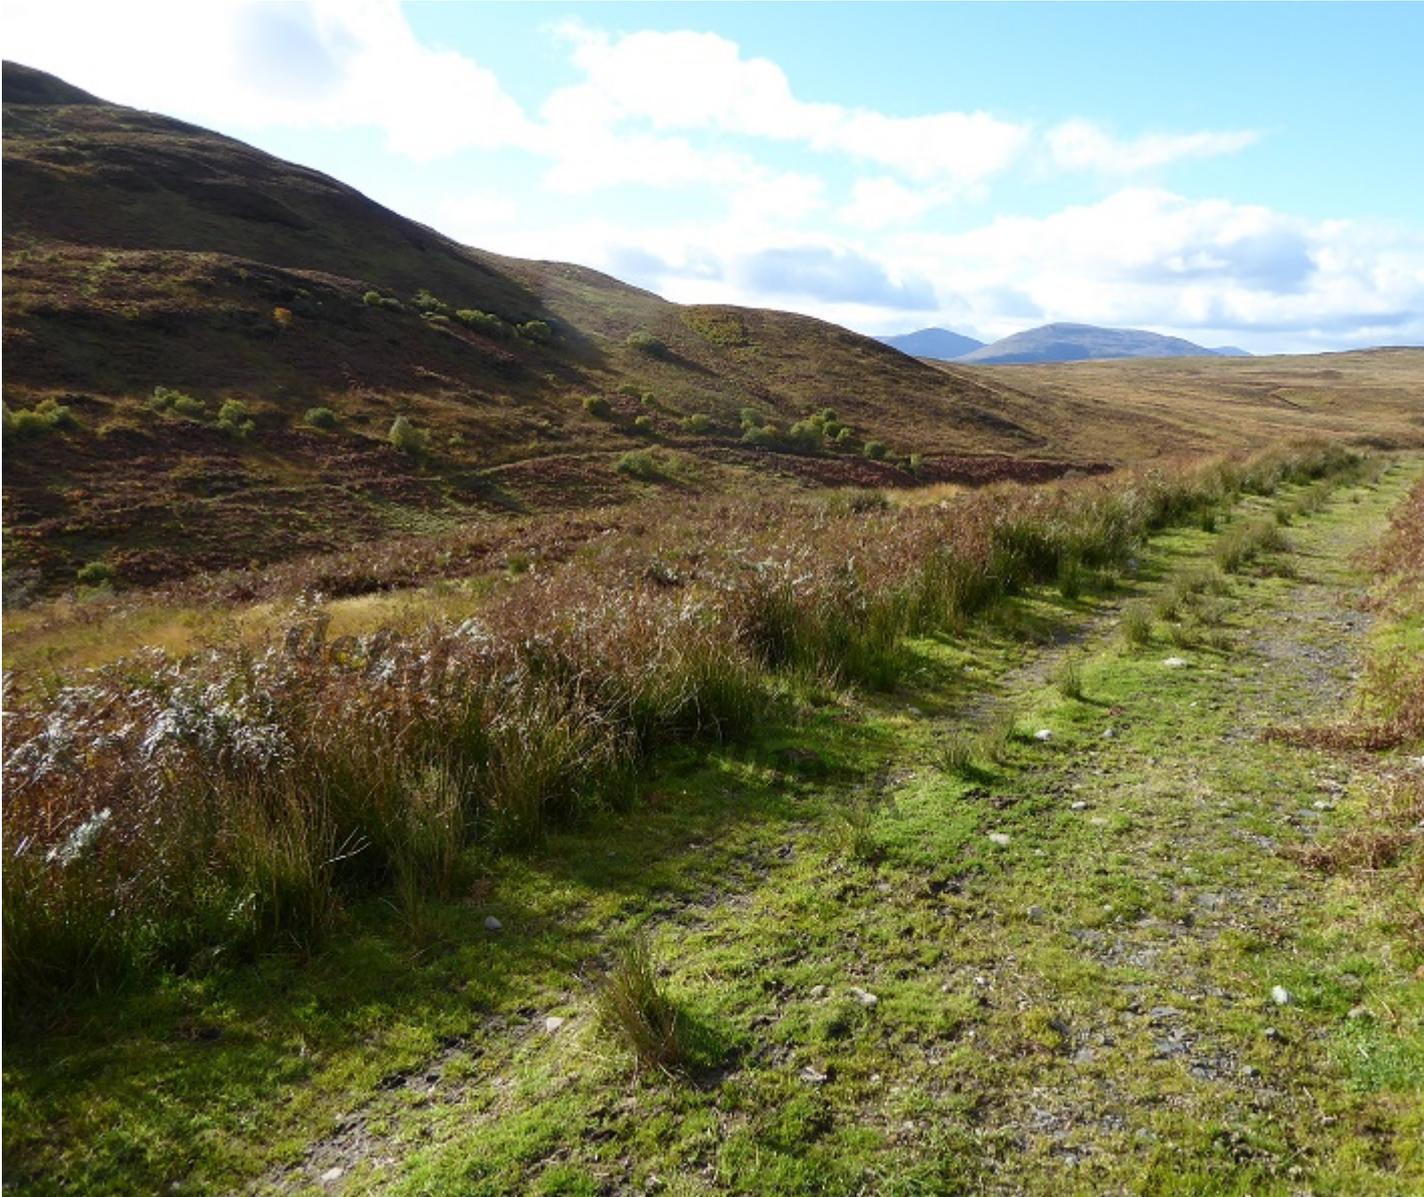
How many times a week do you think vehicles come up here? Note the track on the far side of the WHW running across the bottom of Conic Hill

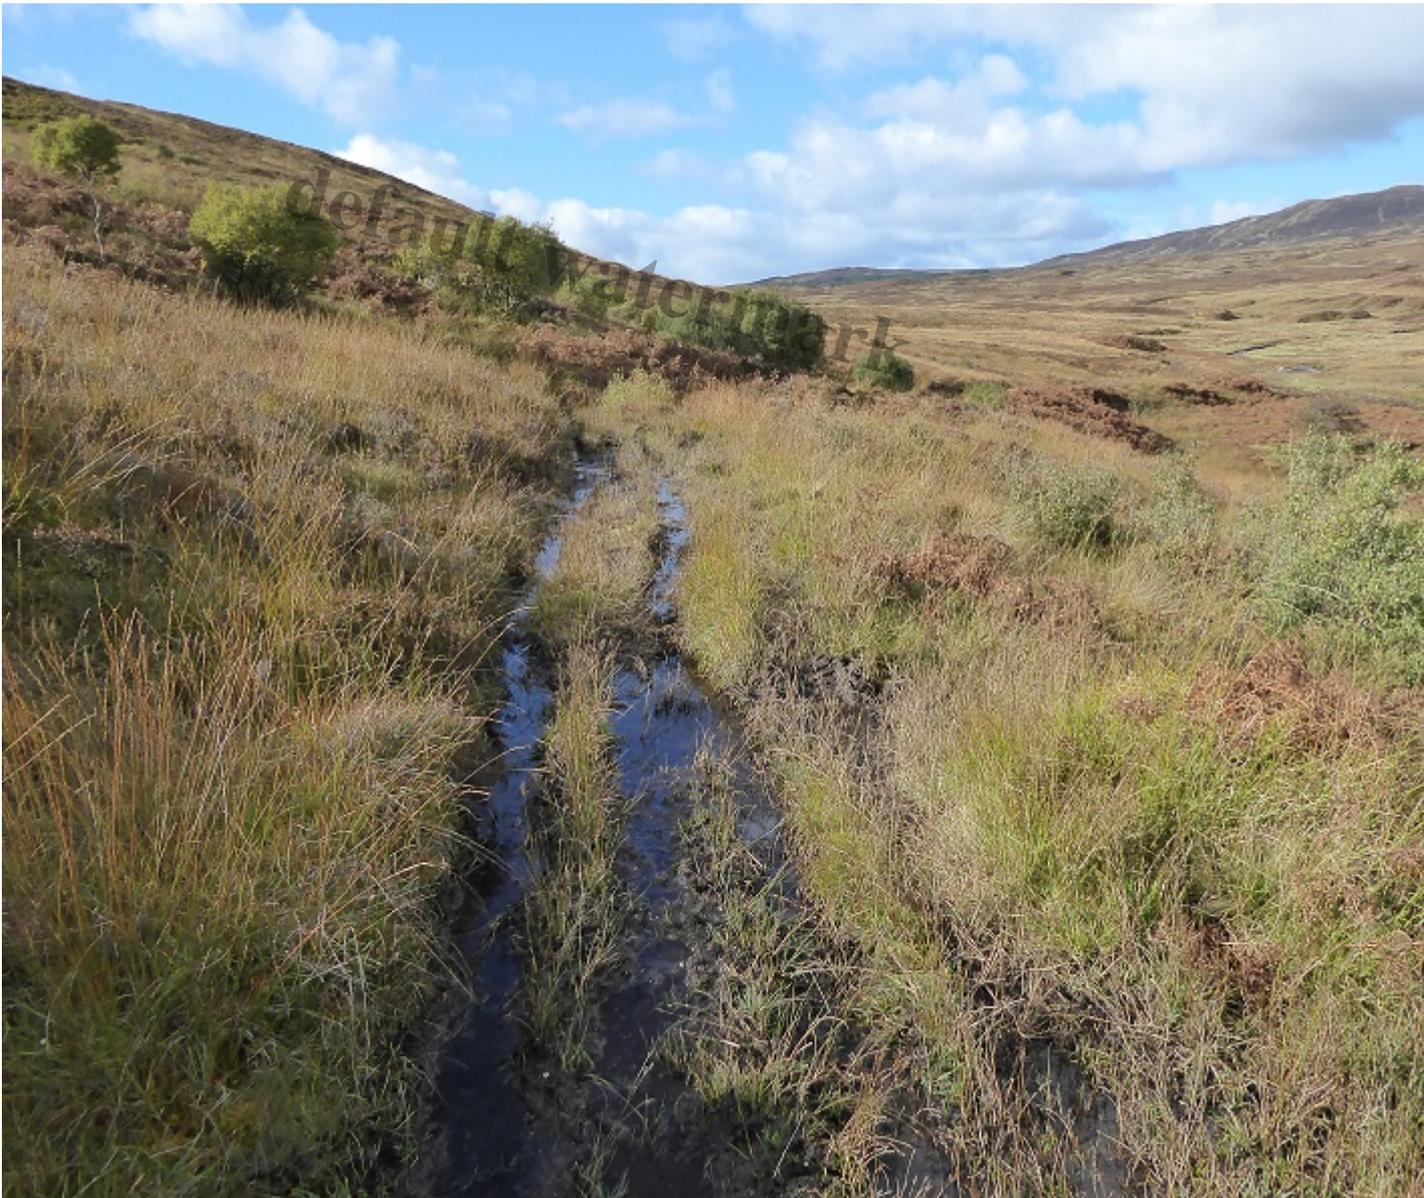
ATV track on Conic Hill side of Burn of Mar – the hydro intake is just down to the right

What the photos above and the evidence on the ground show is that estate has still continued to drive ATVs all over the place, despite the new track. There are now in effect two tracks, not one. This rather

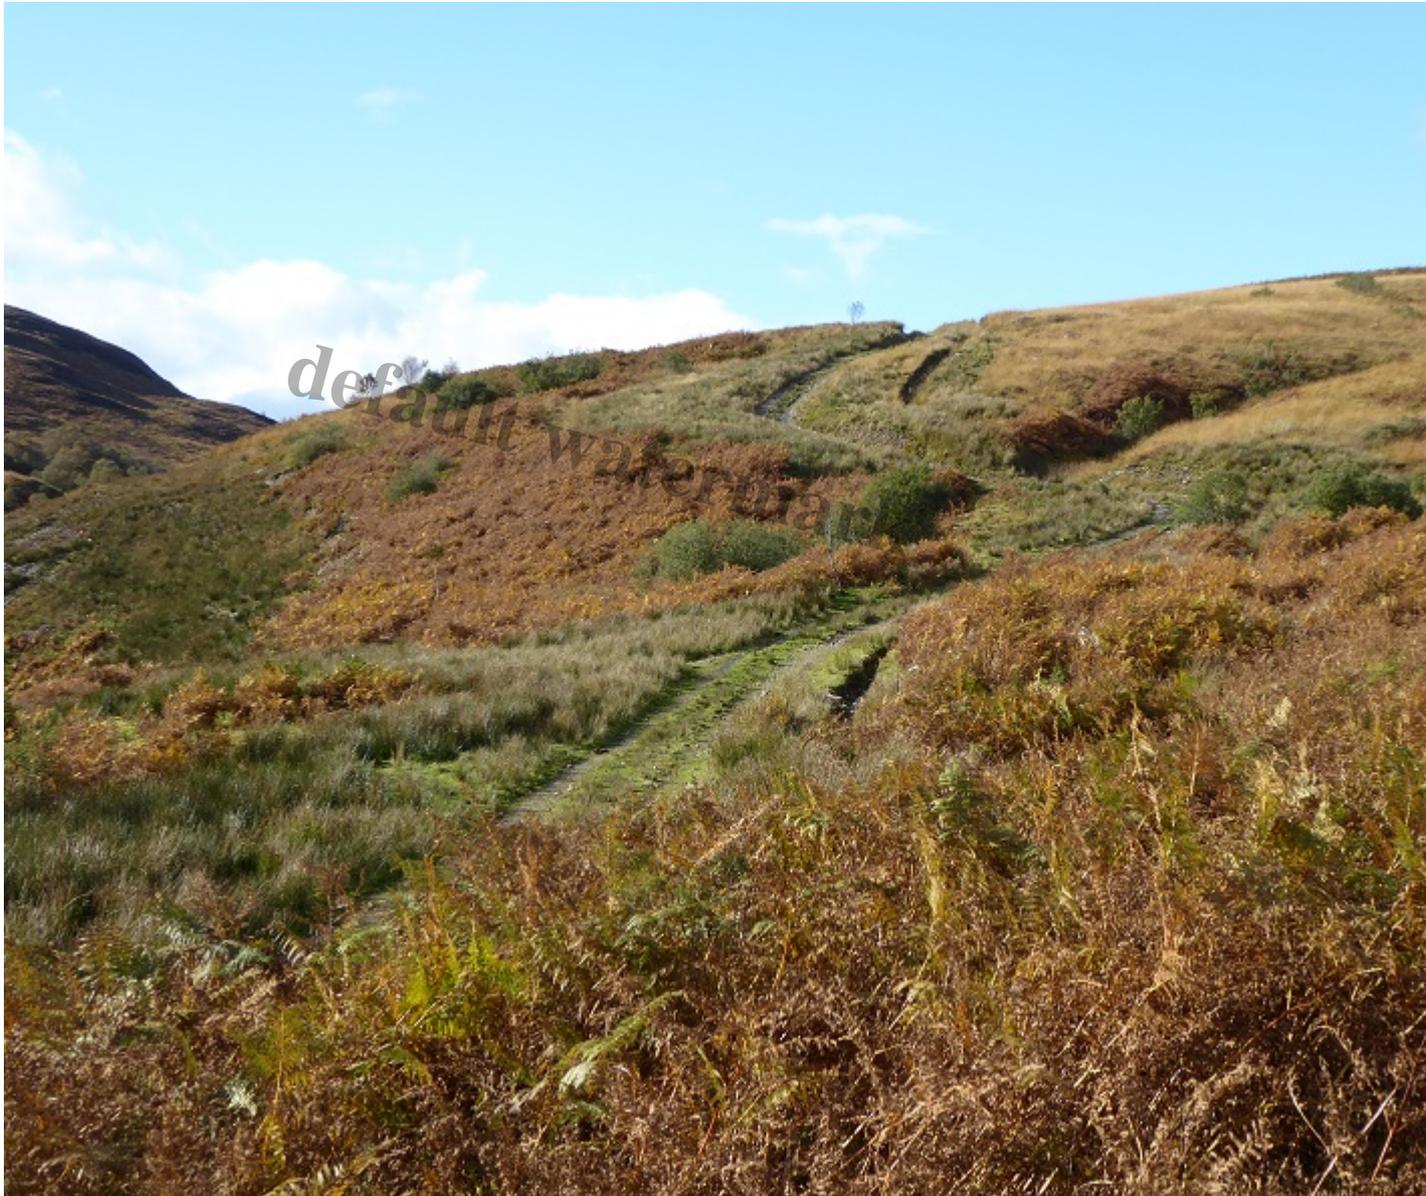
The new track from just above where it crosses the West Highland Way â?? note how the enormous ditch on the right has almost as much impact as the track itself.

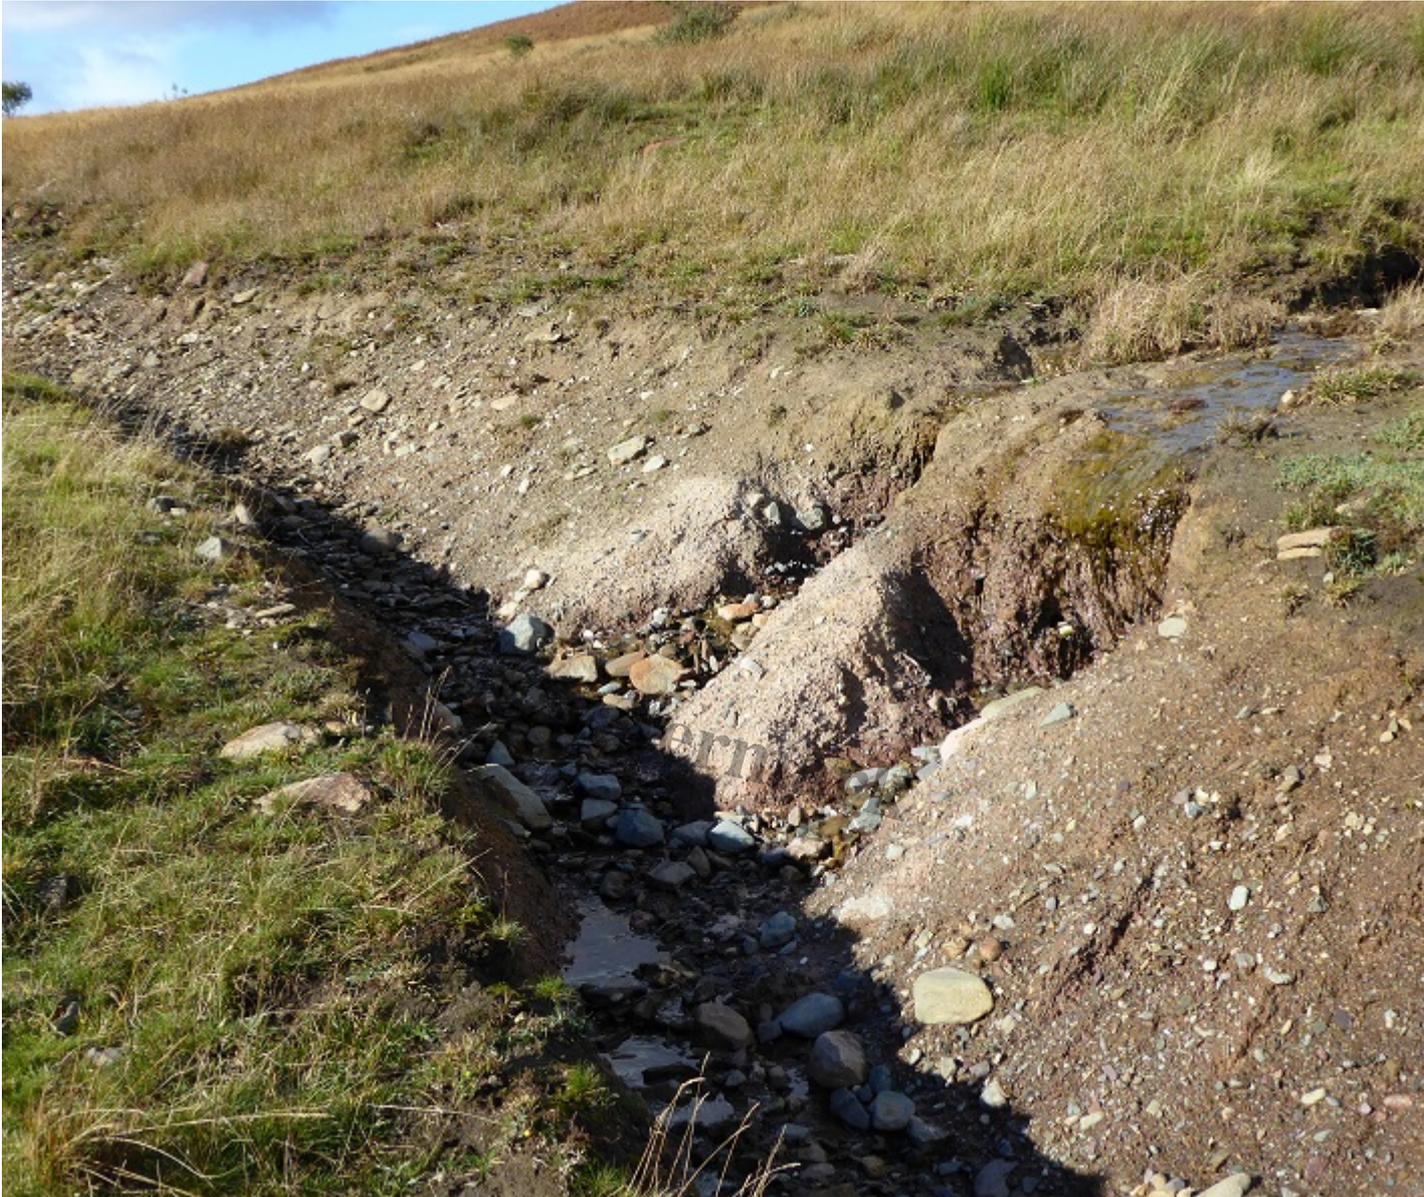
Unrestored drainage ditch showing impact of water erosion running down the bare sides from above
