Time for the EC to hold the Scottish Government to account for the destruction at Drumochter?

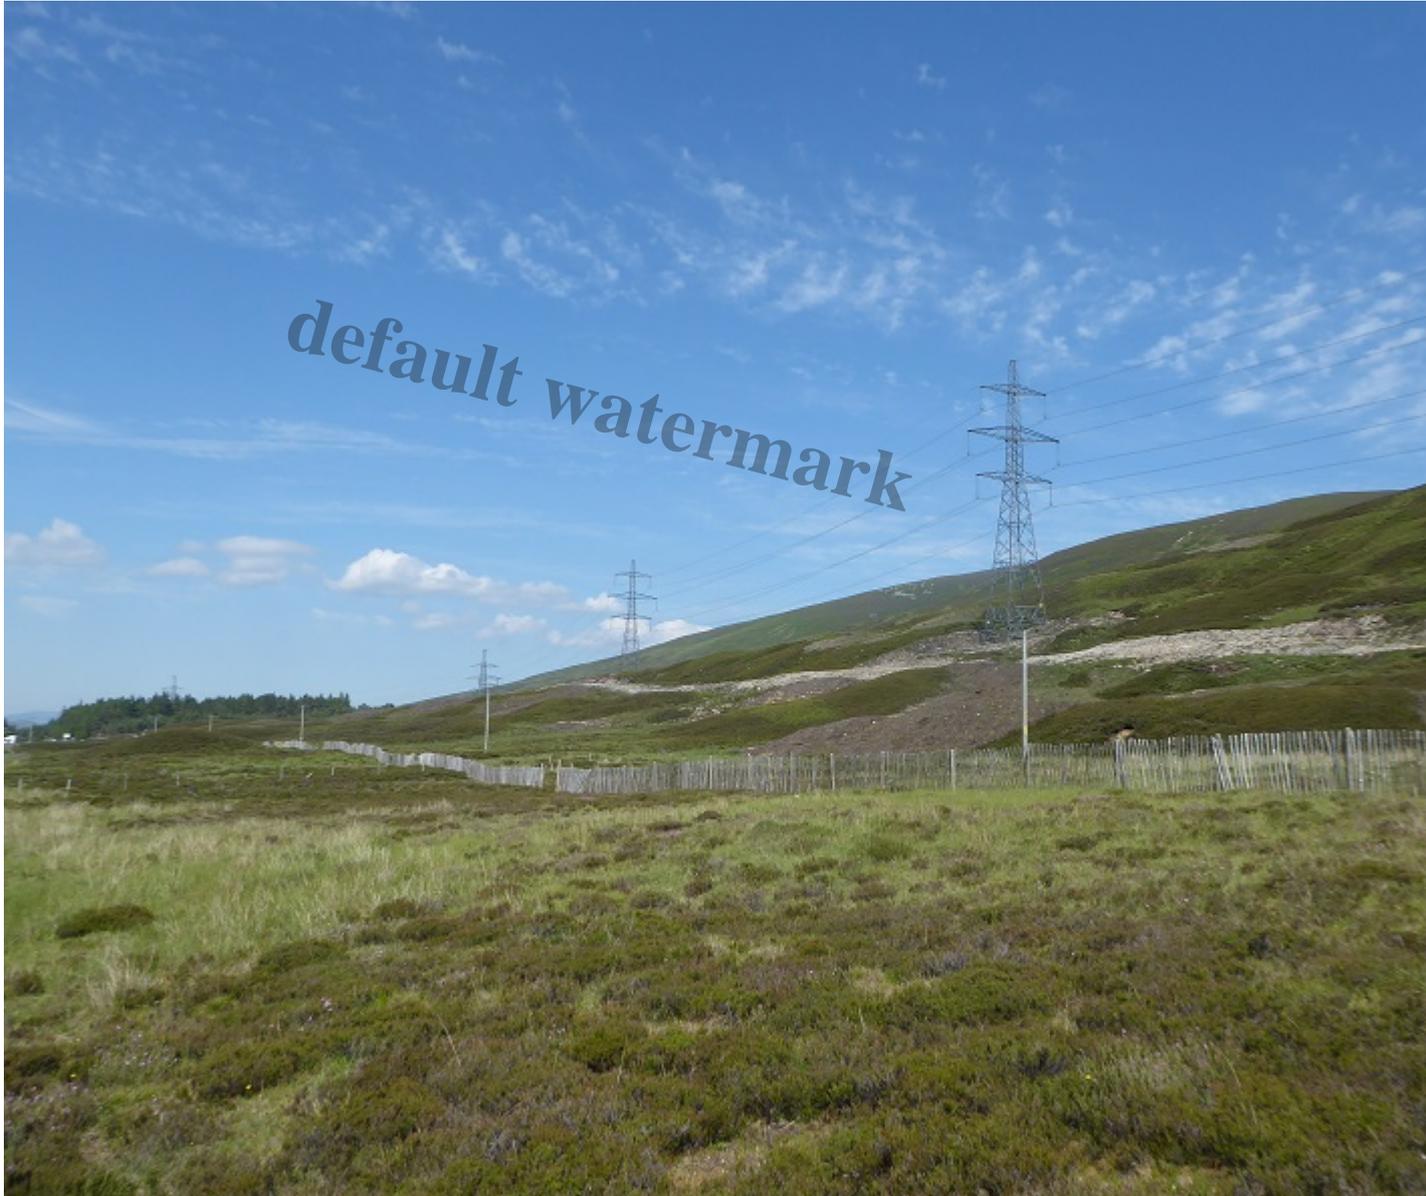
The scar just south of North Drumochter Lodge (in plantation) viewed from the edge of the A9 2018

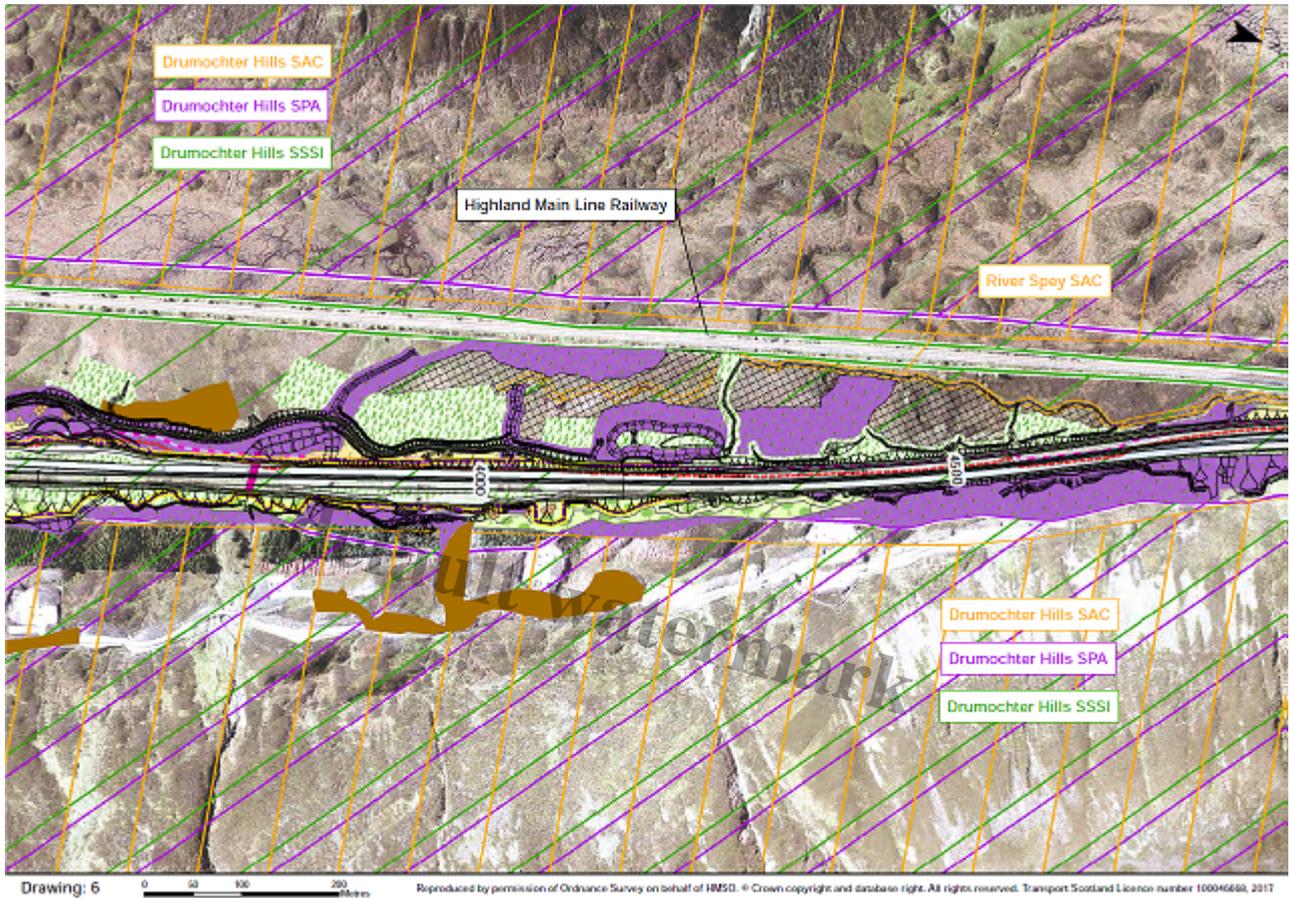
Extract from A9 dualling proposals for a section of the Drumochter pass. The SAC boundary is marked by the purple line running on either side of the corridor. The construction track for the Beauly Denny appears as a broad white scar running across the bottom third of the aerial photo. The brown marks areas where peatland restoration is proposed.

The potential power of the SAC designation to stop development is illustrated by the more recent A9 dualling project. The current A9 follows a corridor between the two sides of the Drumochter Hills SAC. Transport Scotland has taken great care to ensure the new dual carriage remains entirely within the corridor and will not encroach on the SAC in any way. That is welcome. Transport Scotland's plans however also provide more evidence for the destruction caused by the Beauly Denny. That they are proposing areas of peatland restoration within the SAC appears a tacit admission from the Scottish Government that serious damage has been caused. Why though has Transport Scotland, rather than Scottish and Southern Electric who constructed the Beauly Denny, proposed this? And why restore some areas but not all?

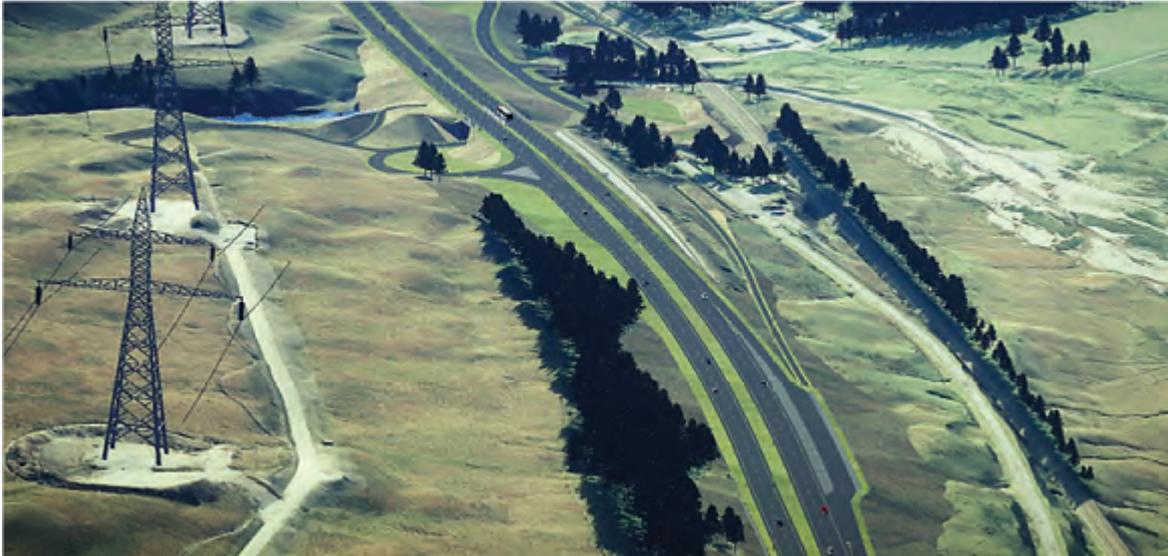
View to Dalnaspidal with new junction top centre. The construction road for the powerlines, is clearly visible on the left, though hidden from the A9 by the shelterbelt. Photo Credit: A9 Dualling, Non-technical summary Dec 2017.

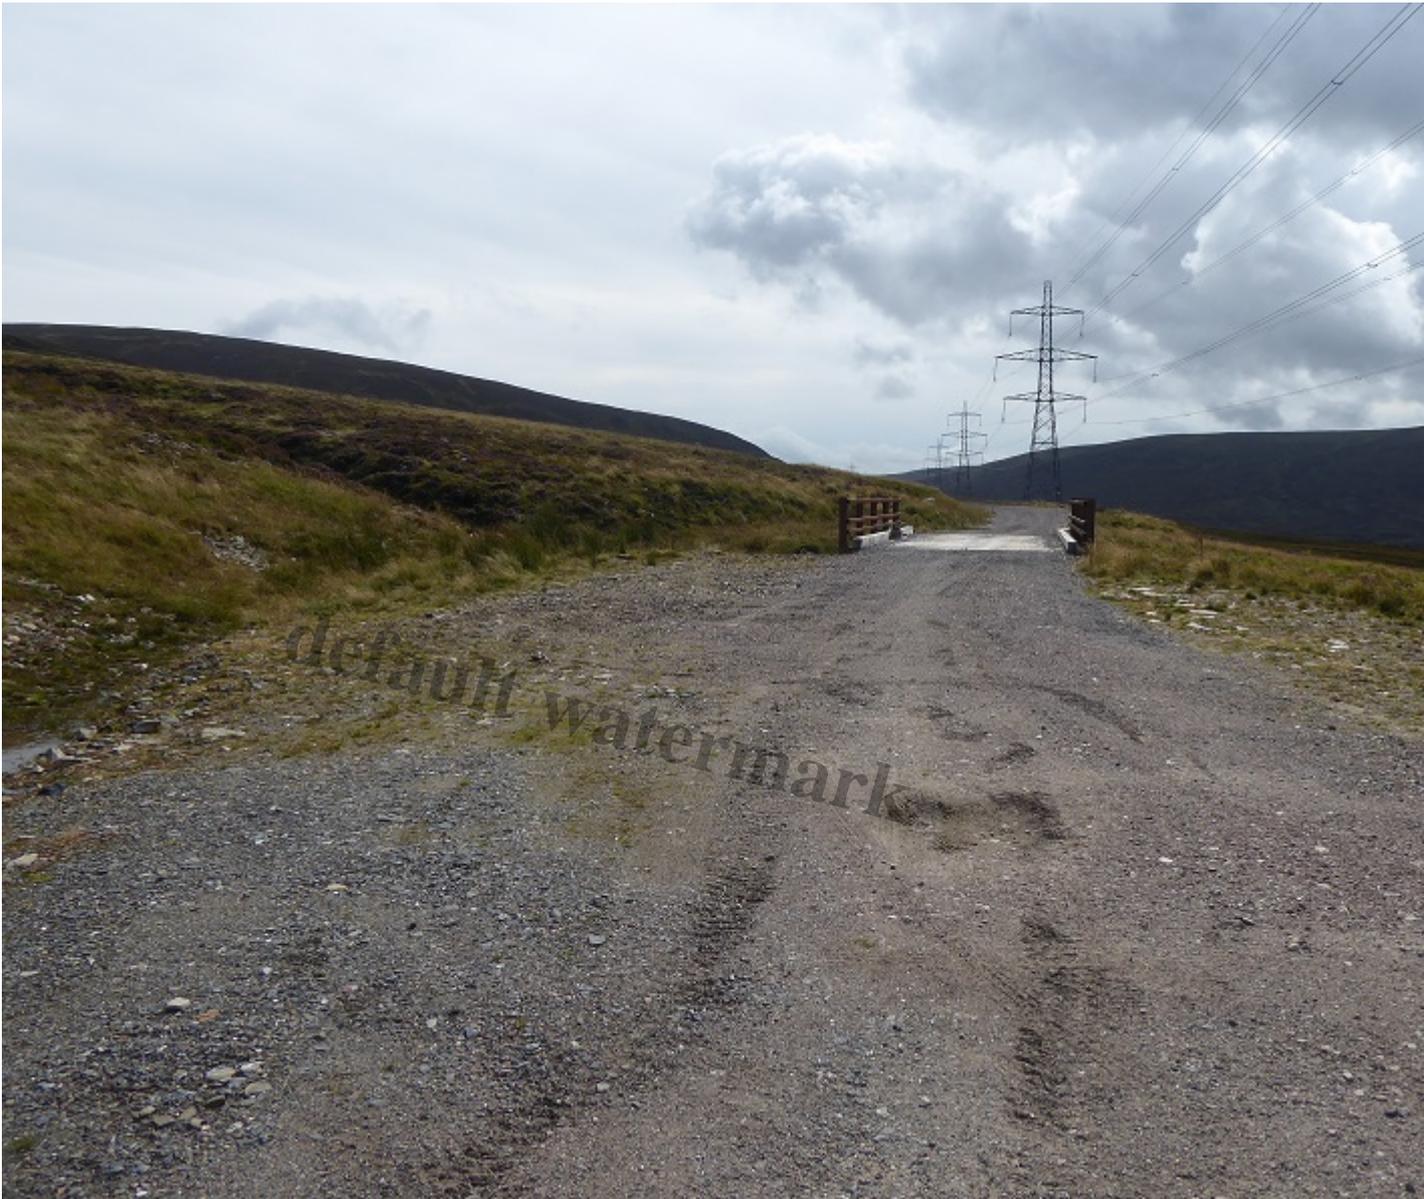
The new road is over 10m broad in places, which has not only destroyed a great swathe of natural habitat but has also changed the ecology of the land on either side (eg through changing the drainage)

The main damage to the southern part of the SAC has been caused by the construction road being left in place. ([see here](#)), although there have also been failures to restore the ground under and around the towers. The Scottish Government's Planning consent allowed for an "upgrade" to Wade's military road which was then supposed to be fully restored. Somehow, in a manner yet to be explained, it was then just left. I understand from fairly recent contact with the Cairngorms National Park Authority that agreement has now been reached with SNH and SSE that the road should be narrowed to landrover track width.

That is a change to the original planning permission. In my view therefore there should be further public consultation from the Scottish Government, informed by scientific surveys, on whether this represents an acceptable loss of protected habitat.

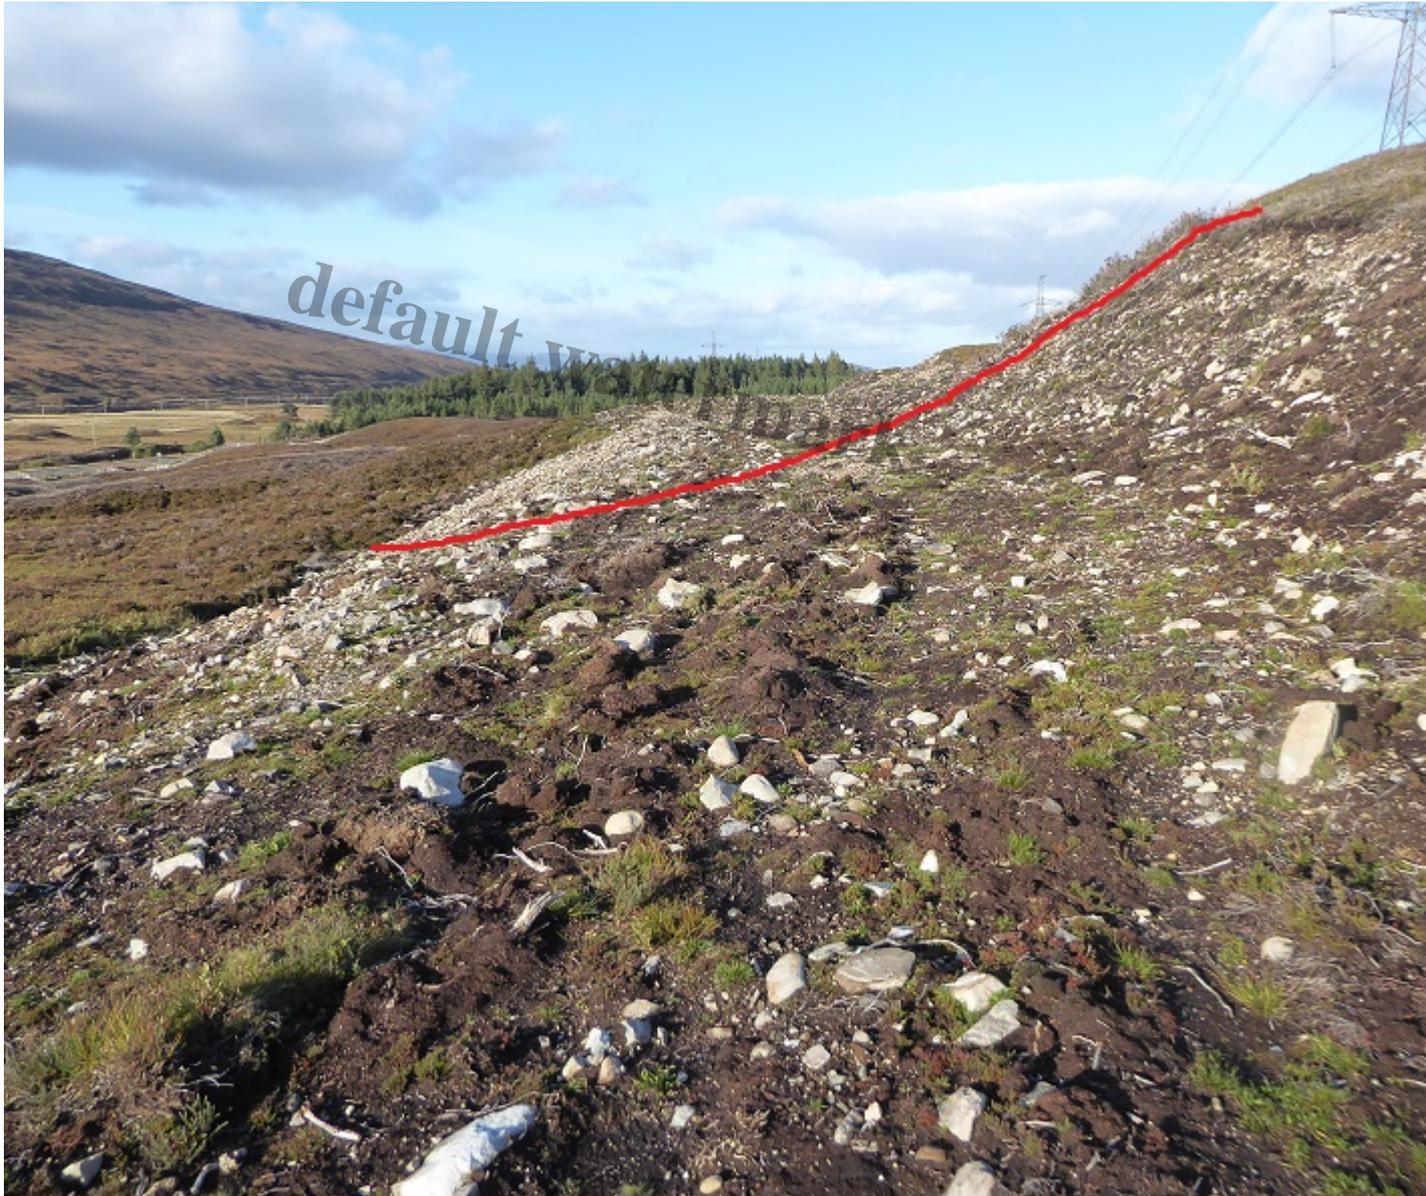
The red line is my attempt at depicting how the profile of this section of slope might have looked BEFORE the track was constructed. A great shelf has been cut across the hillside and the track constructed using the fill technique the fill being the material above the red line. Oct 2018.

The planning consent required the original landforms to be restored. That has not happened.

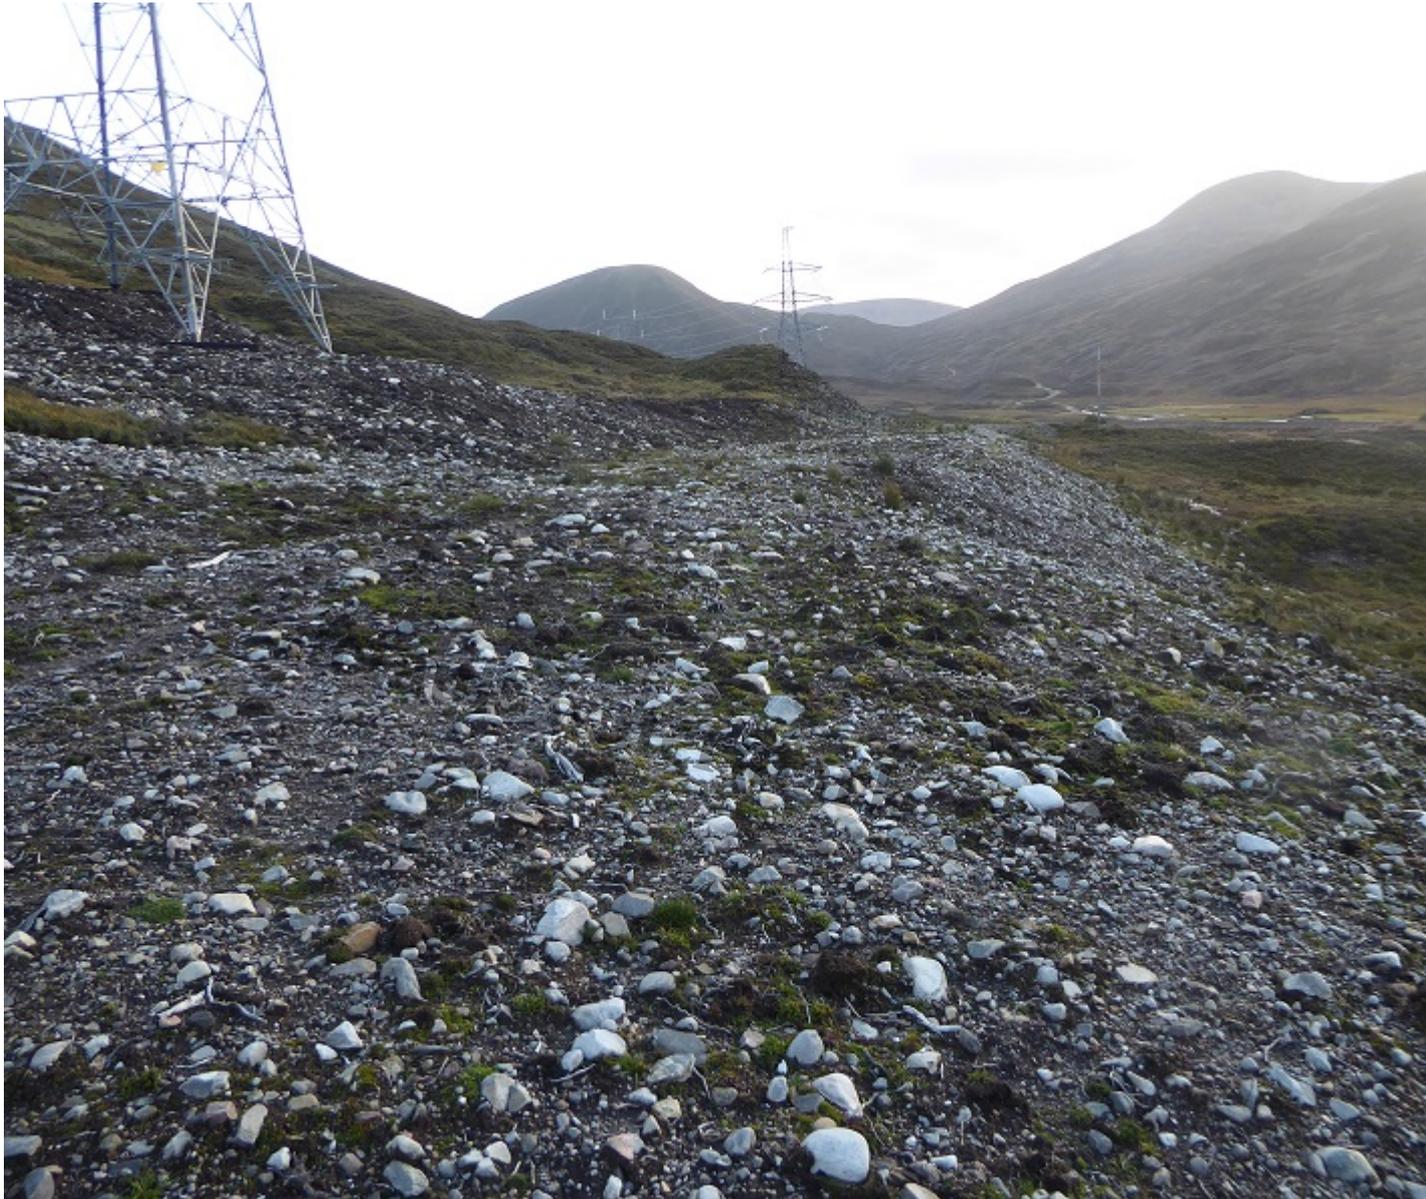
Another illustration of how spoil from the cut was moved to the moor below to create the track line. C

The alterations to the landforms caused by the creation of the temporary construction road have completely changed the ecology of this slope, changing both soils and drainage.

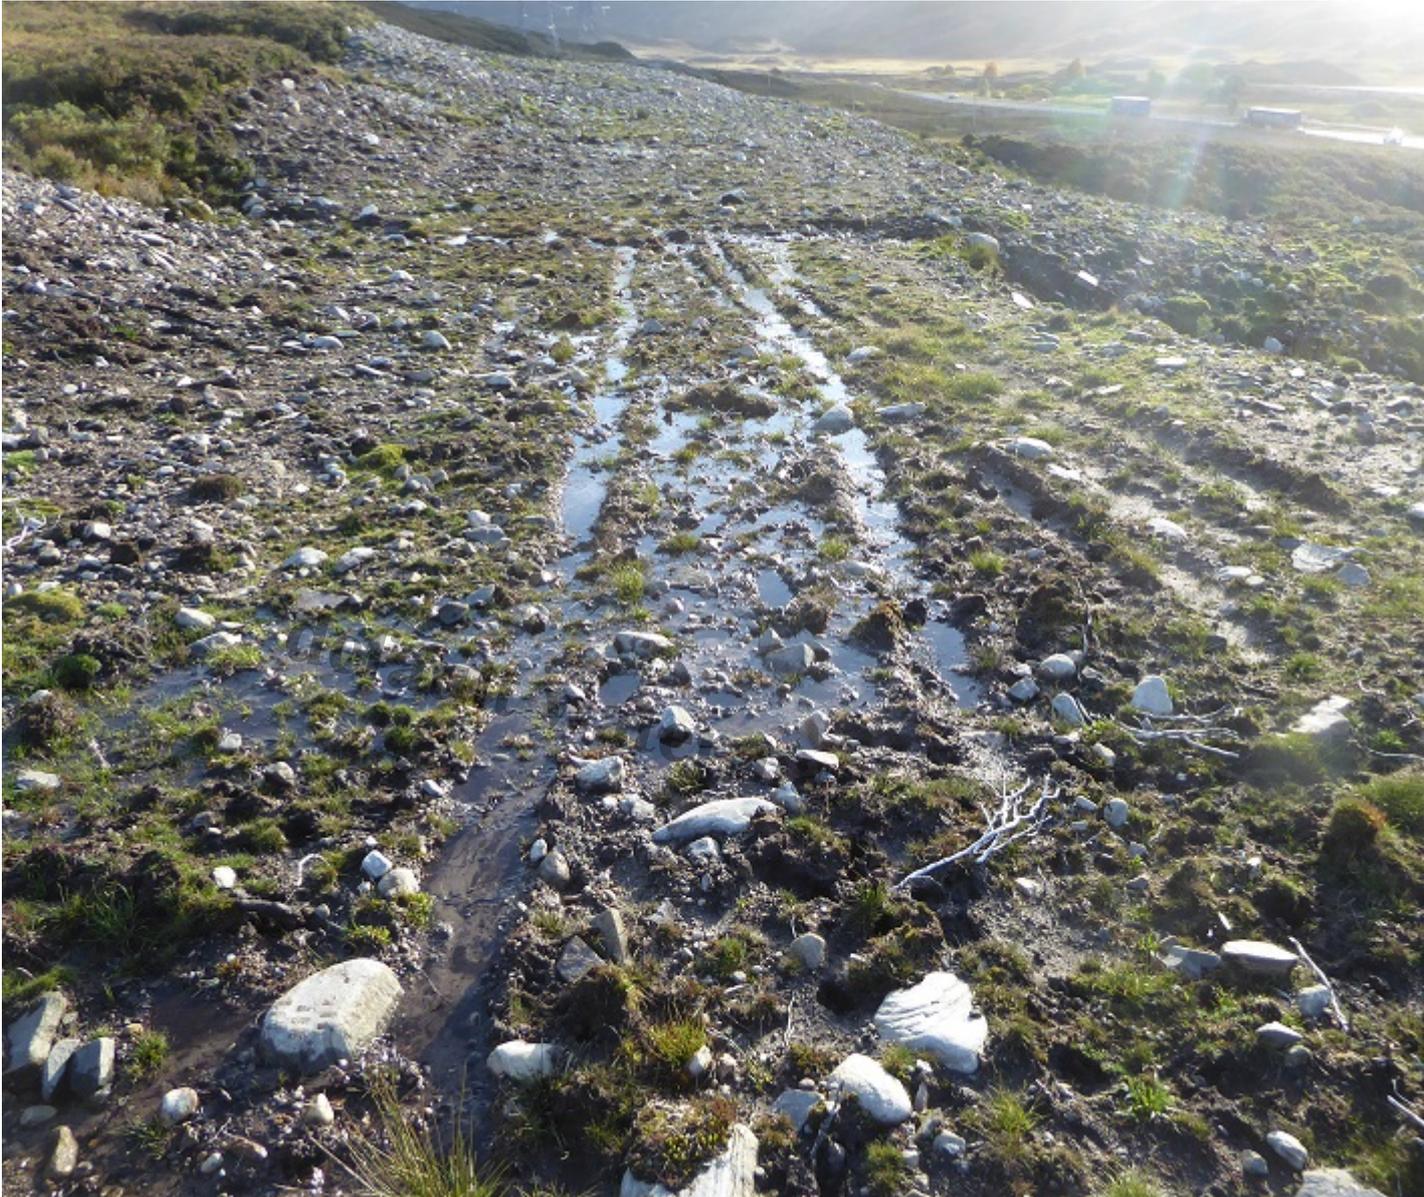
Evidence of continued vehicle use. Note the burn cutting across the road line near the top of the photo.

The flat bench across the hillside not only stands out as a scar, its an invitation to the estate to continue to drive vehicles here, doing further damage to the ground and preventing vegetation recovery. Note how the profile of the burn has not been restored either - you can see how it has cut through the ground on either side - but where it crosses the road the banks have been left flattened enabling vehicles to drive over it.

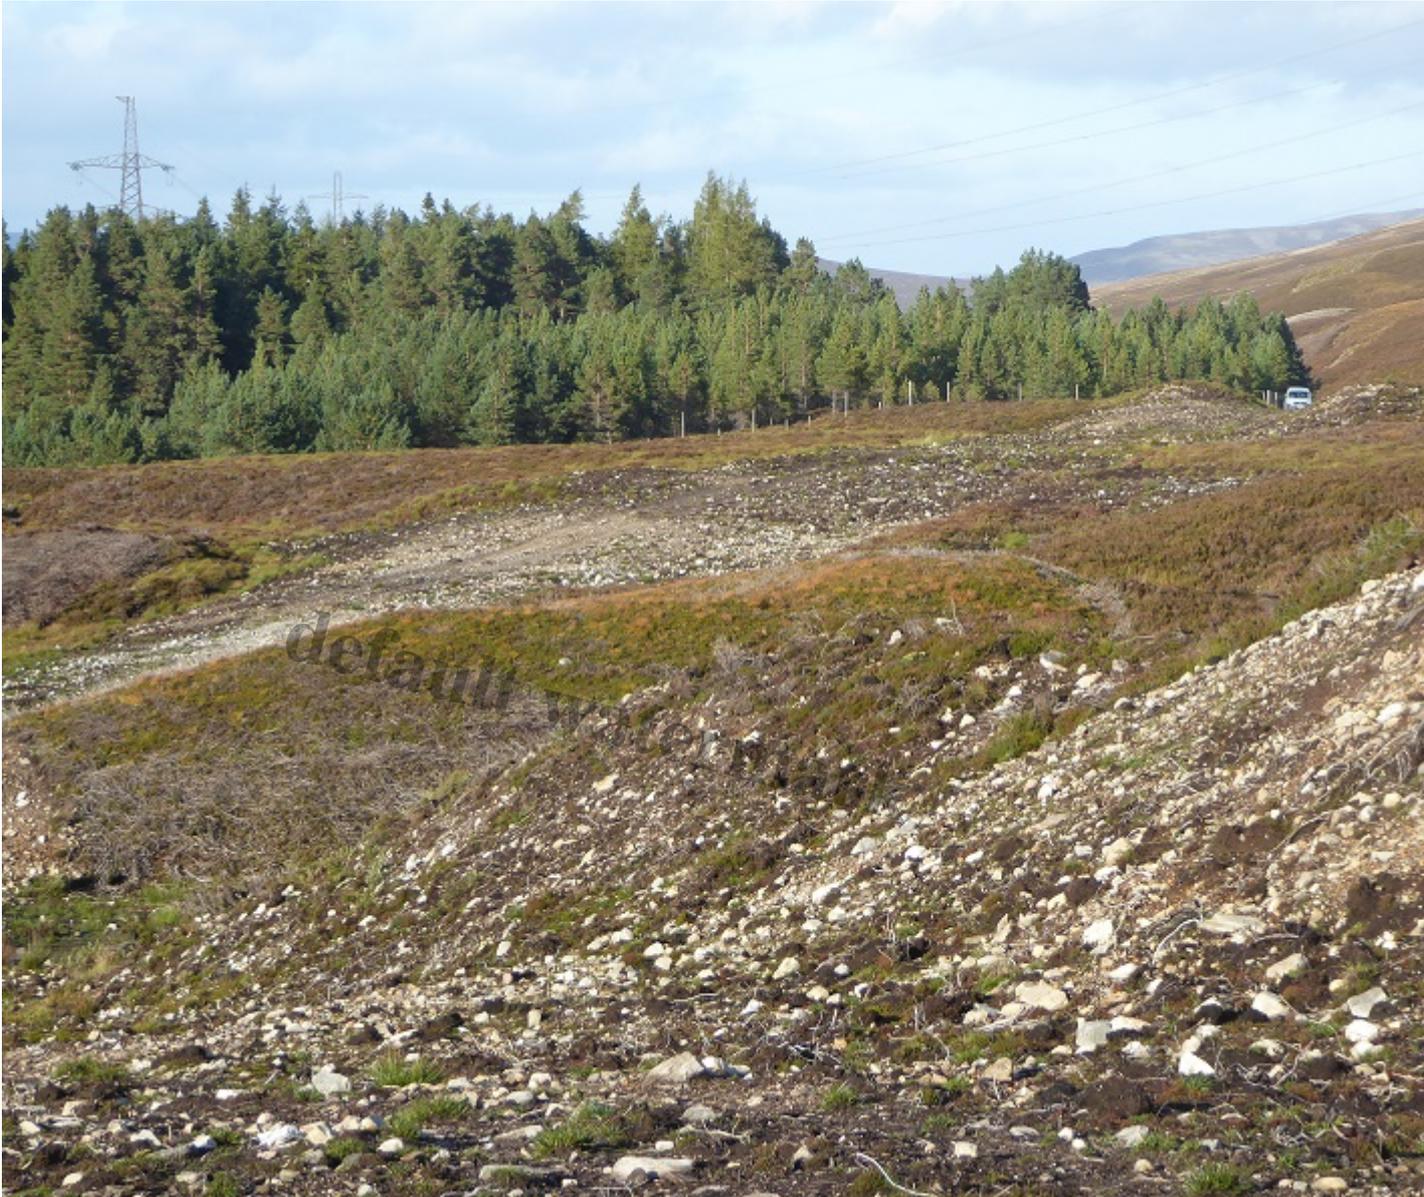
More evidence of continued vehicle use Oct 2018 just south of North Drumochter Lodge. Oct 2018

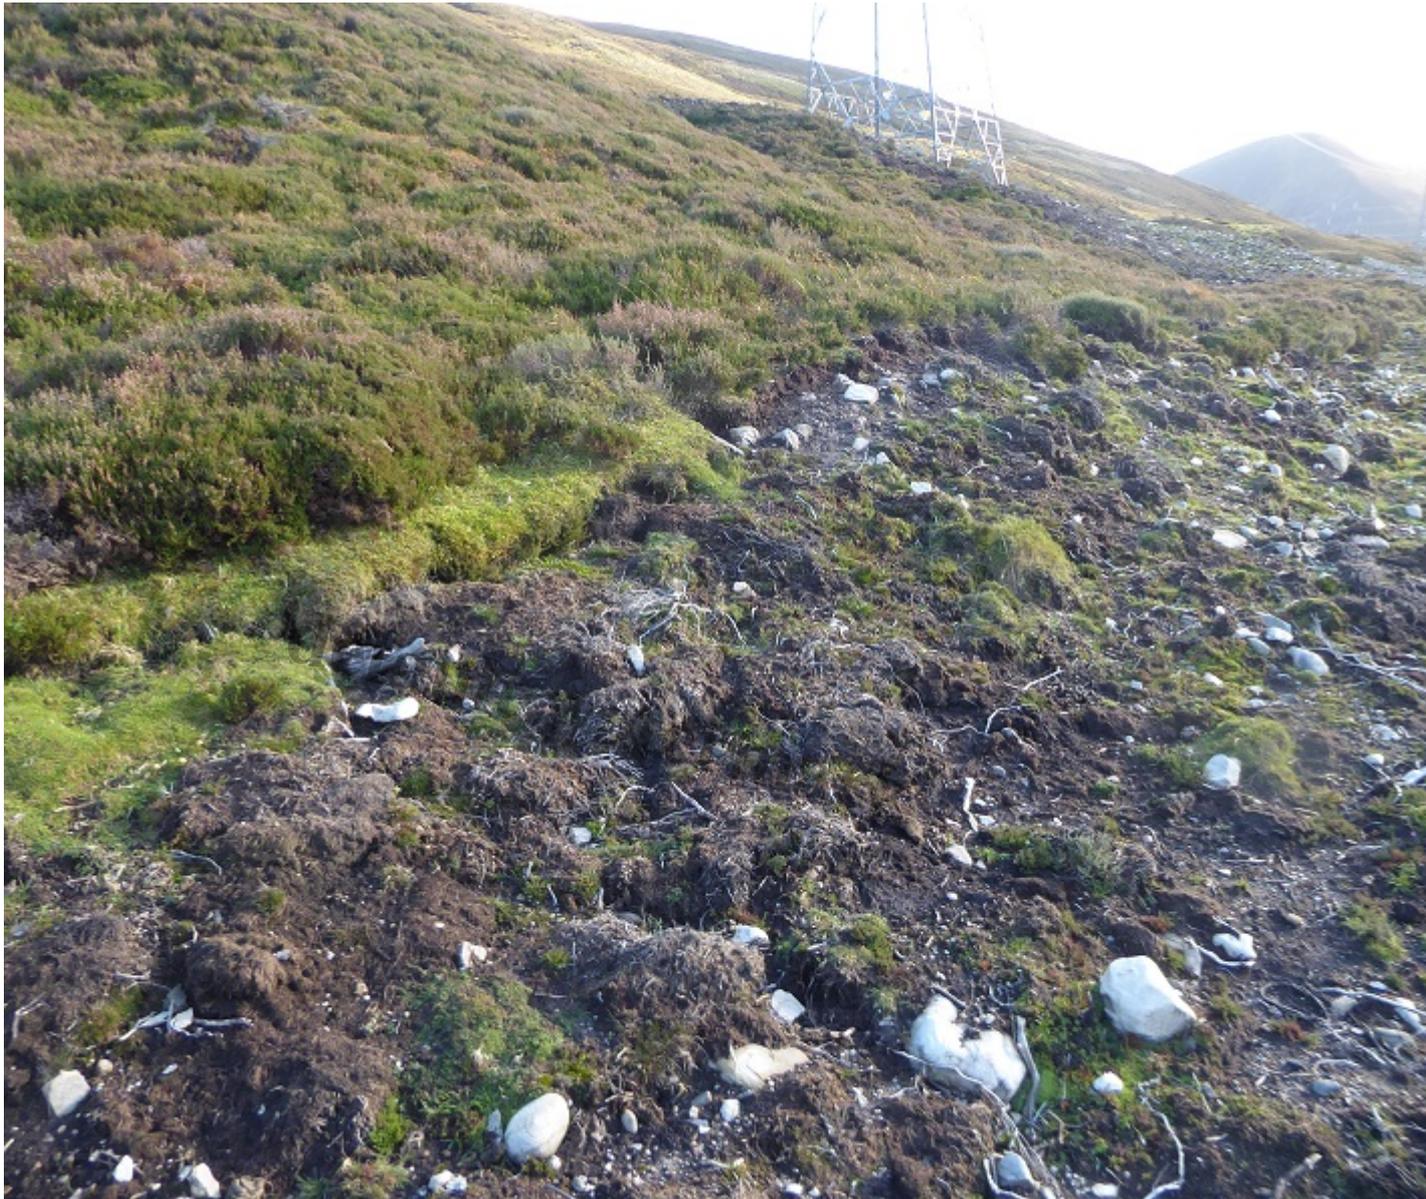
An area of ground where peat has been used to cover up what lay beneath. Oct 2018. In places there is evidence that some attempt has been made to restore the ground. Unfortunately, this has been poor with vegetation dying and the peat at high risk of drying out.

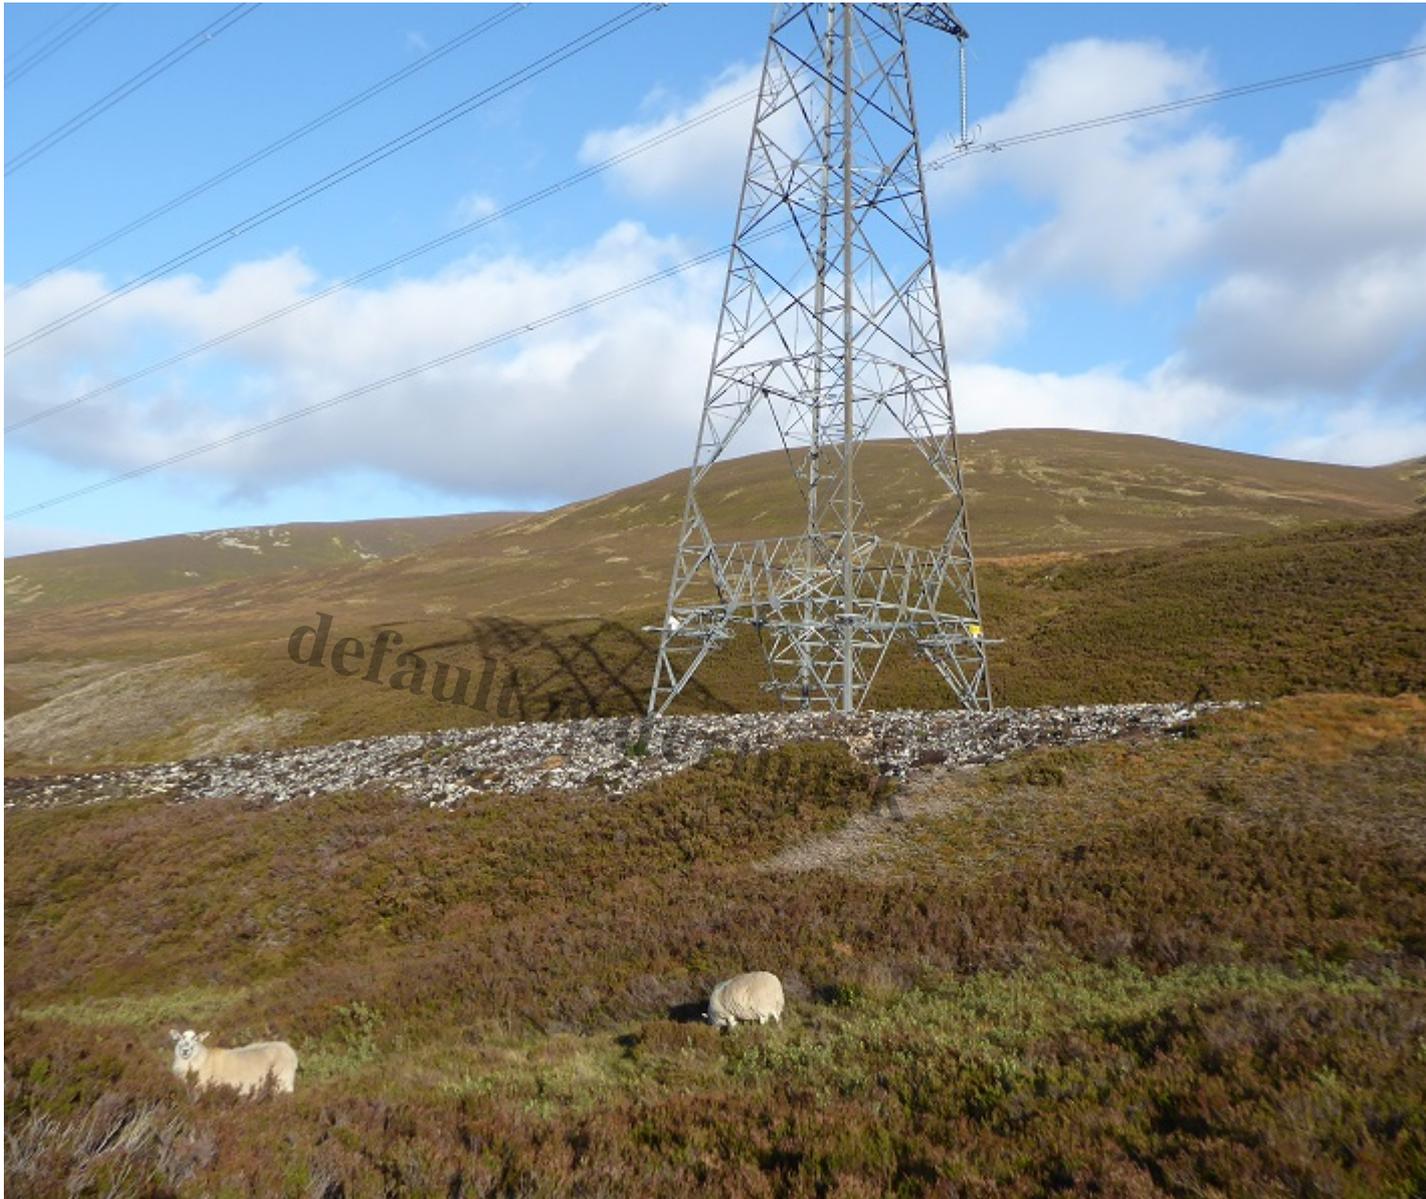
Oct 2018

Unbelievably, sheep are still being grazed along the line of construction track, most probably as tick mops in an attempt to increase grouse numbers here. Its little wonder there has been so little vegetation recovery along the line of the track.

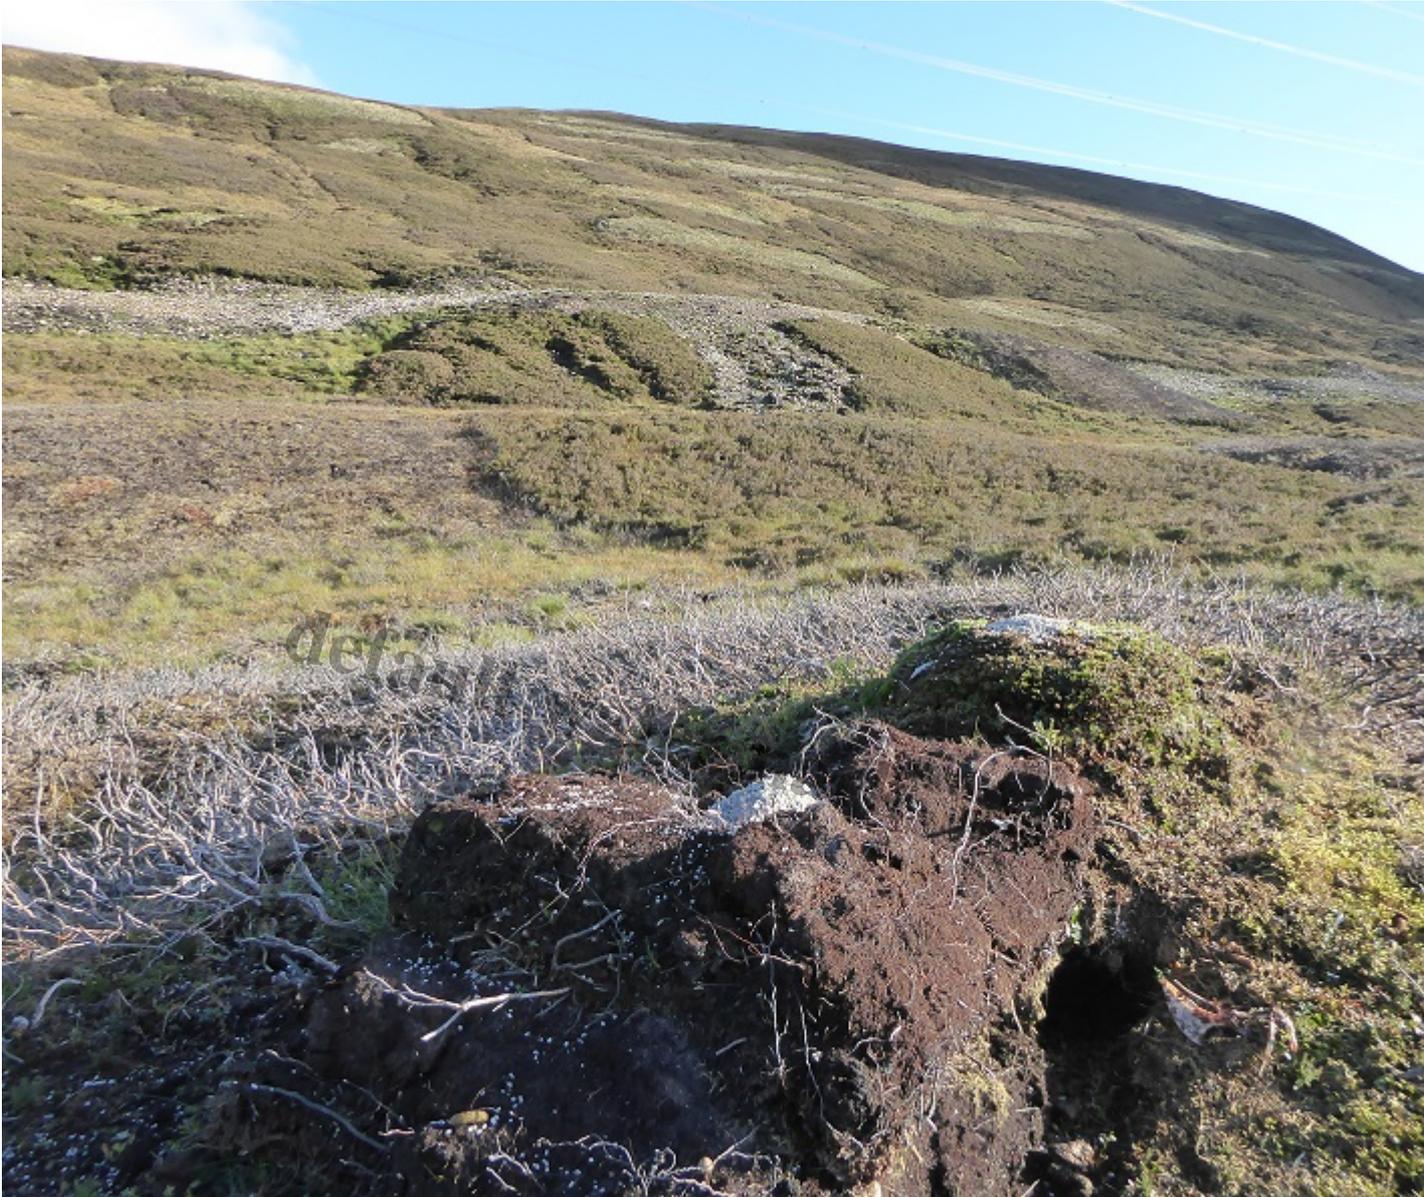
Medicated grit and muirburn. Oct 2018.

Continuing with further intensive grouse moor management along here before the vegetation has been fully restored is yet more madness. There appears to be no will within the Scottish Government to tackle the way grouse moors are managed even when the restoration of a SAC is at stake.

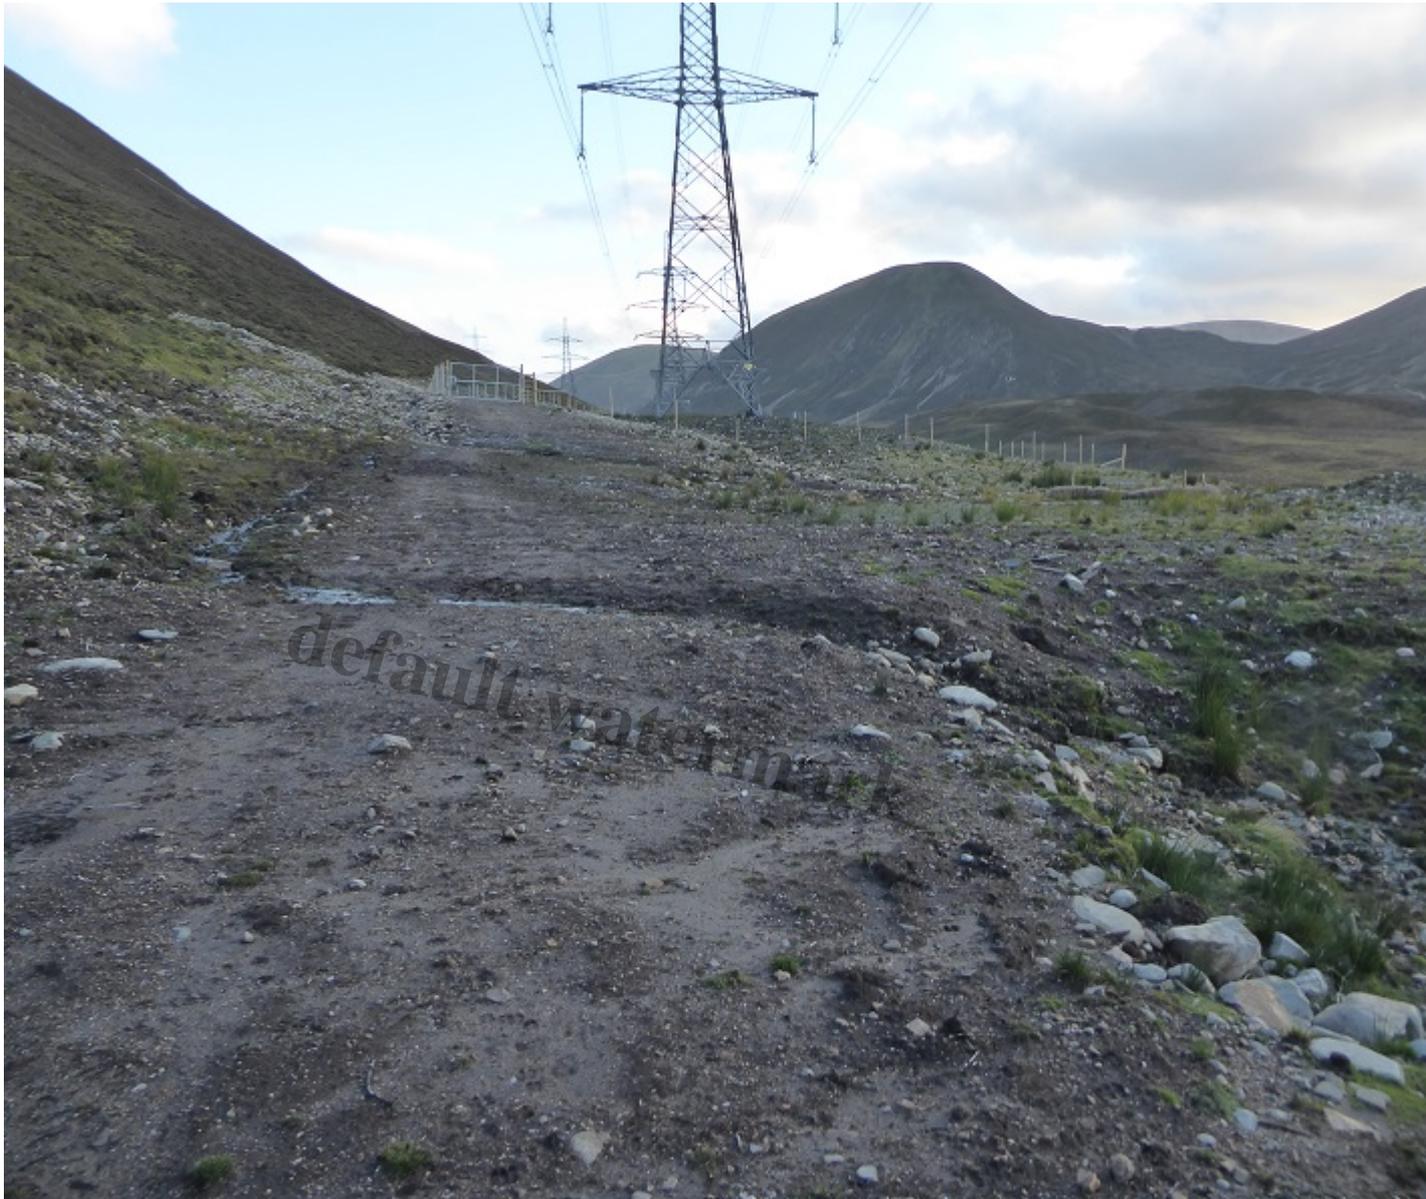
Oct 2018

Further south a fenced enclosure has been created around a section of the former construction track, apparently in order to help reduce grazing pressure and allow the vegetation to recover. Unfortunately it has resulted in the creation of a NEW road!

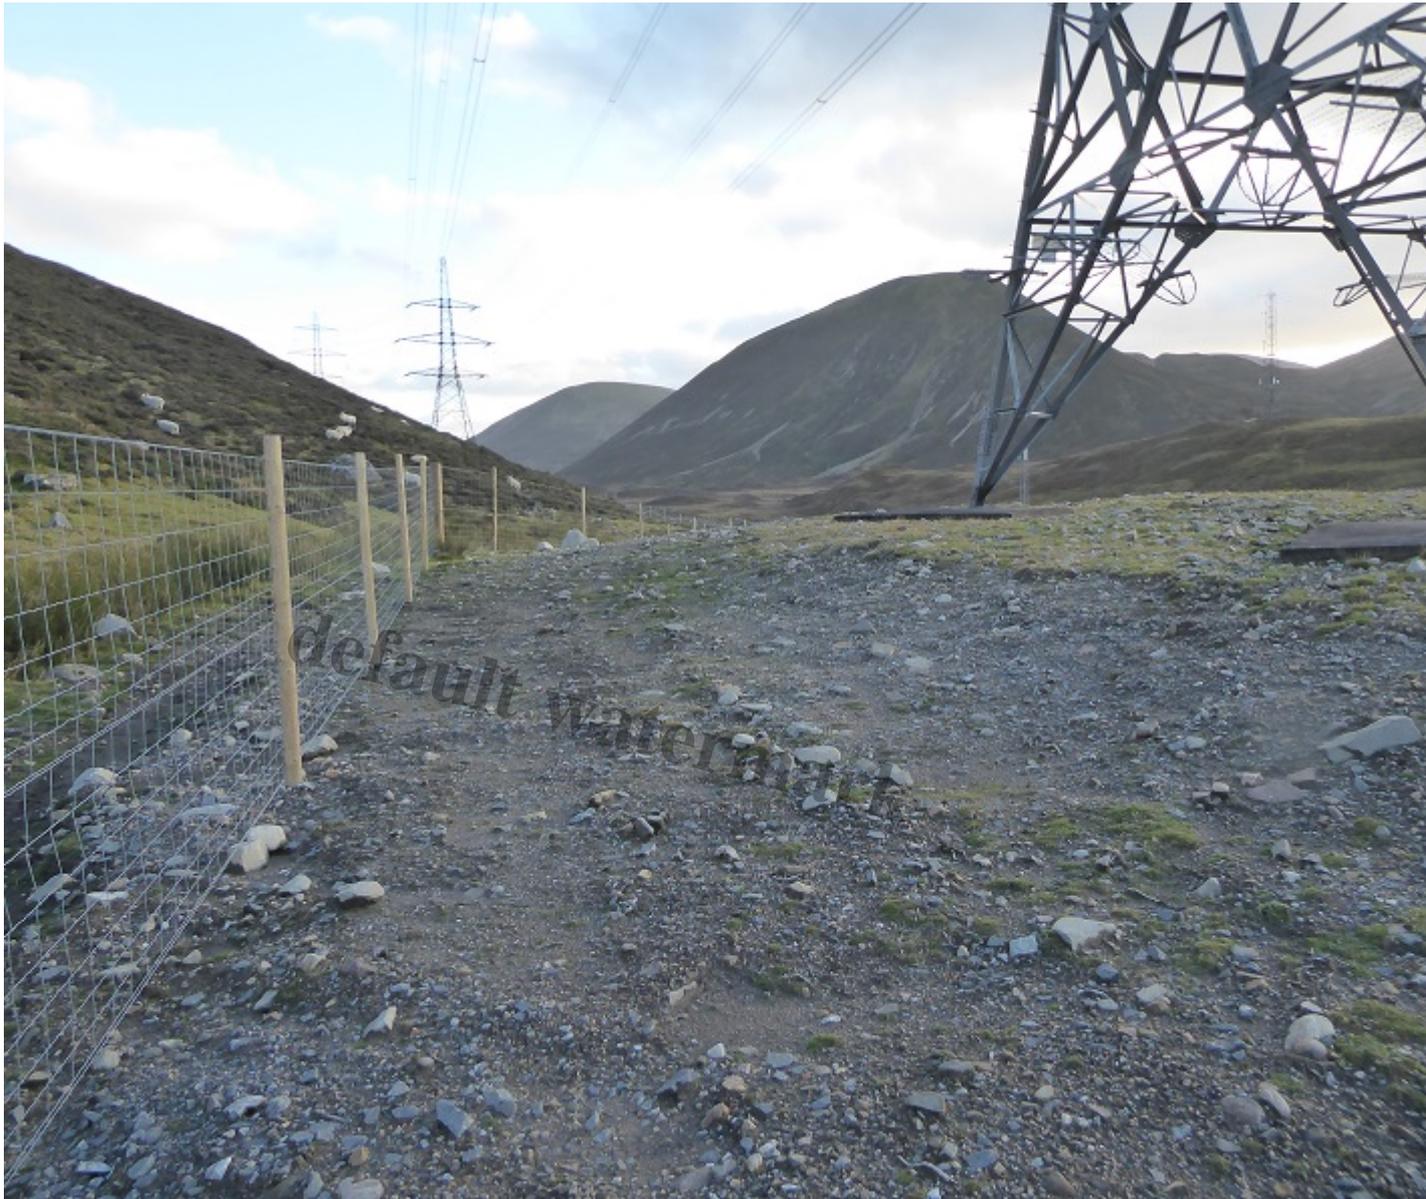
Towards the south end of the fenced enclosure. Note the sheep on the left and the grass outside the enclosure. Photo taken in 2018.

The enclosure covers a slightly raised area which is less affected by drainage from the slope above than the rest of the former construction track and probably always had more mineral soils. Compared to the ground about, this would be highly attractive to the sheep that still graze here. An alternative to the fence would be to have removed the sheep and to have stalked deer here regularly. Fencing this area is not going to address the problem just outside the fence on the left or indeed the rest of the construction destruction outside the enclosure.
