Time for the EC to hold the Scottish Government to account for the destruction at Drumochter?

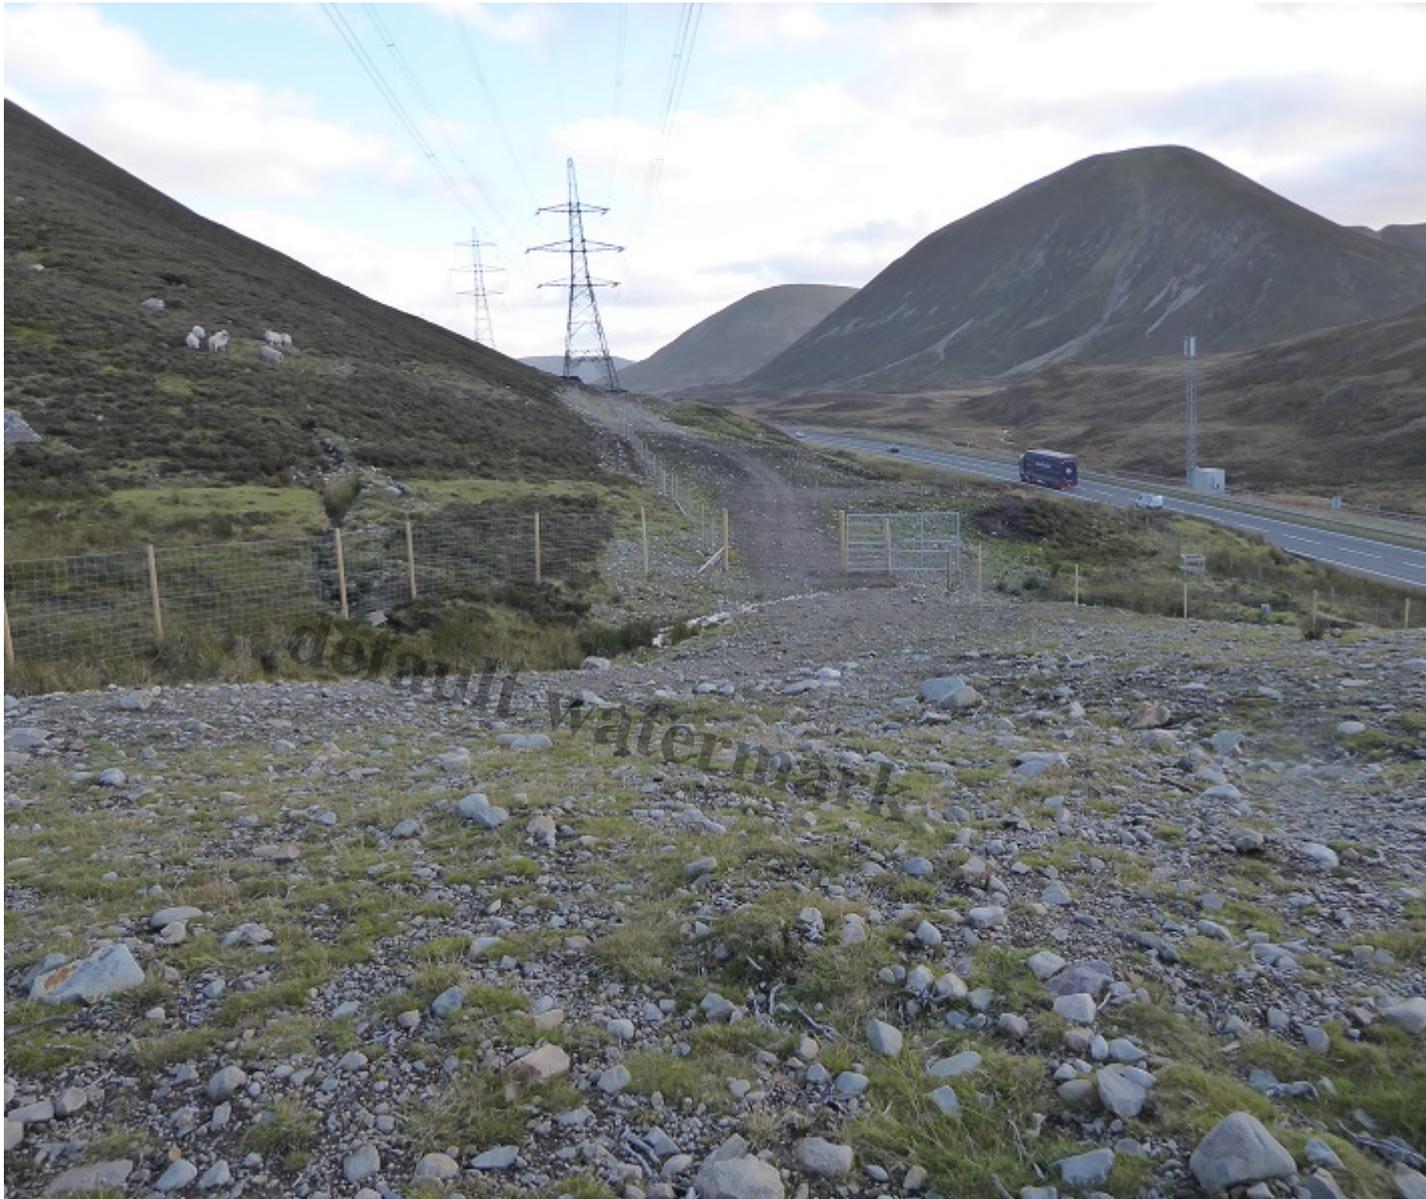
More track heading south from the enclosure. On the right just outside the fence you can just see or drilling points for the A9 works. Oct 2018.

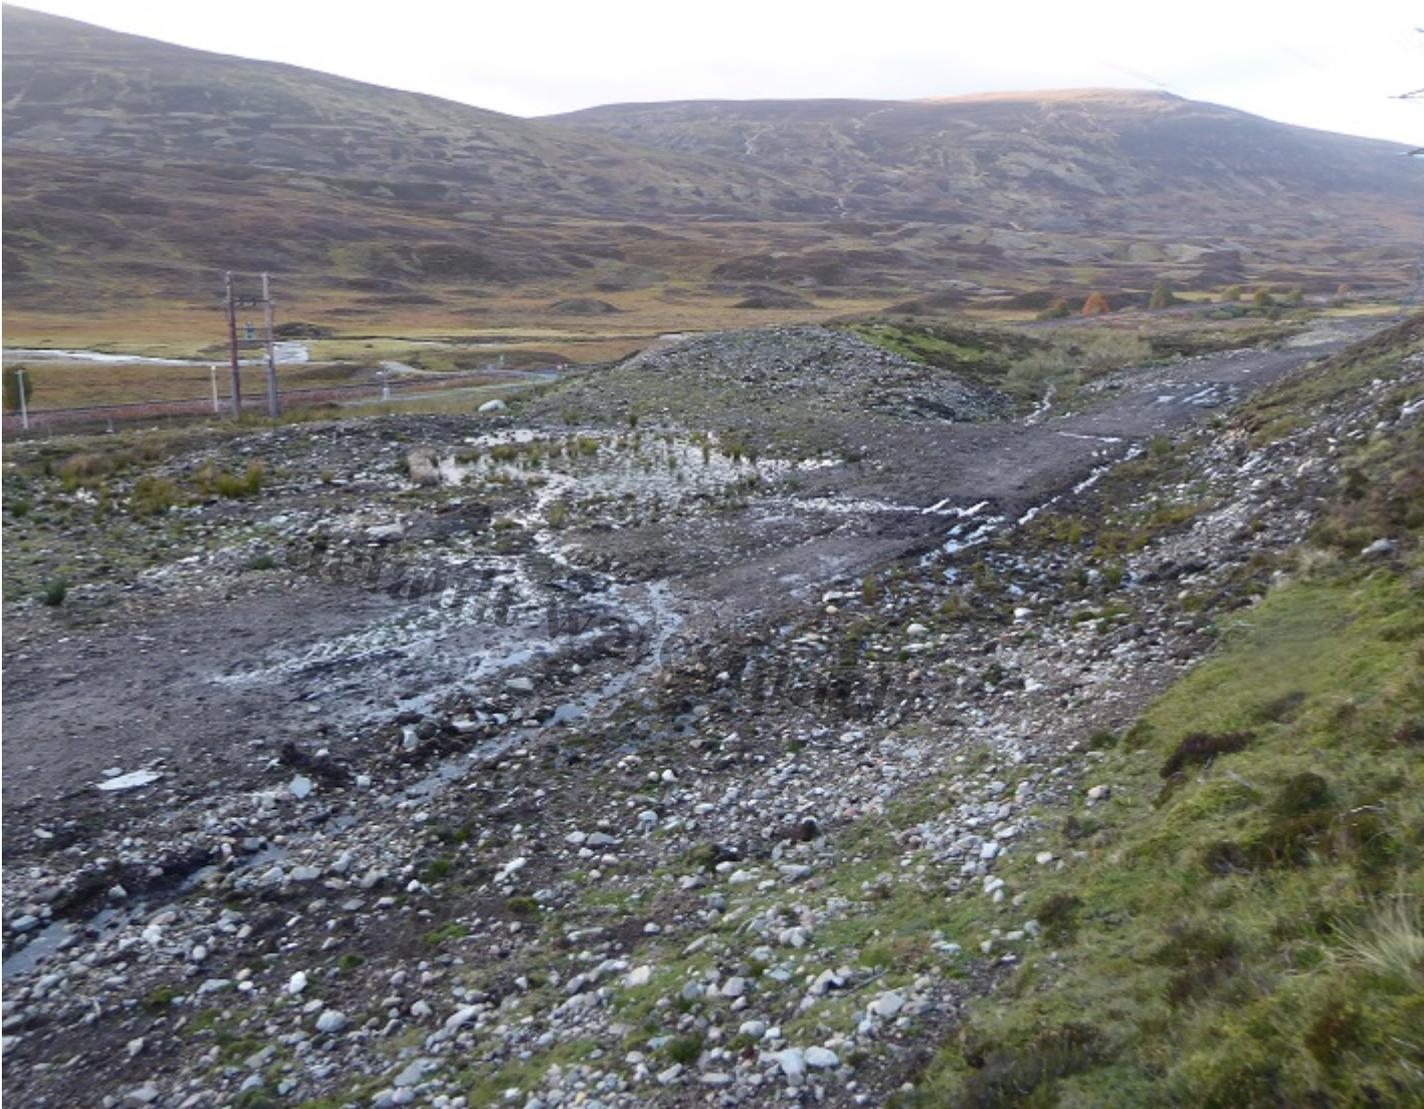
More Beaulieu Denny destruction – just north of enclosure – with further destruction of the hillside muirburn
