Time for the EC to hold the Scottish Government to account for the destruction at Drumochter?

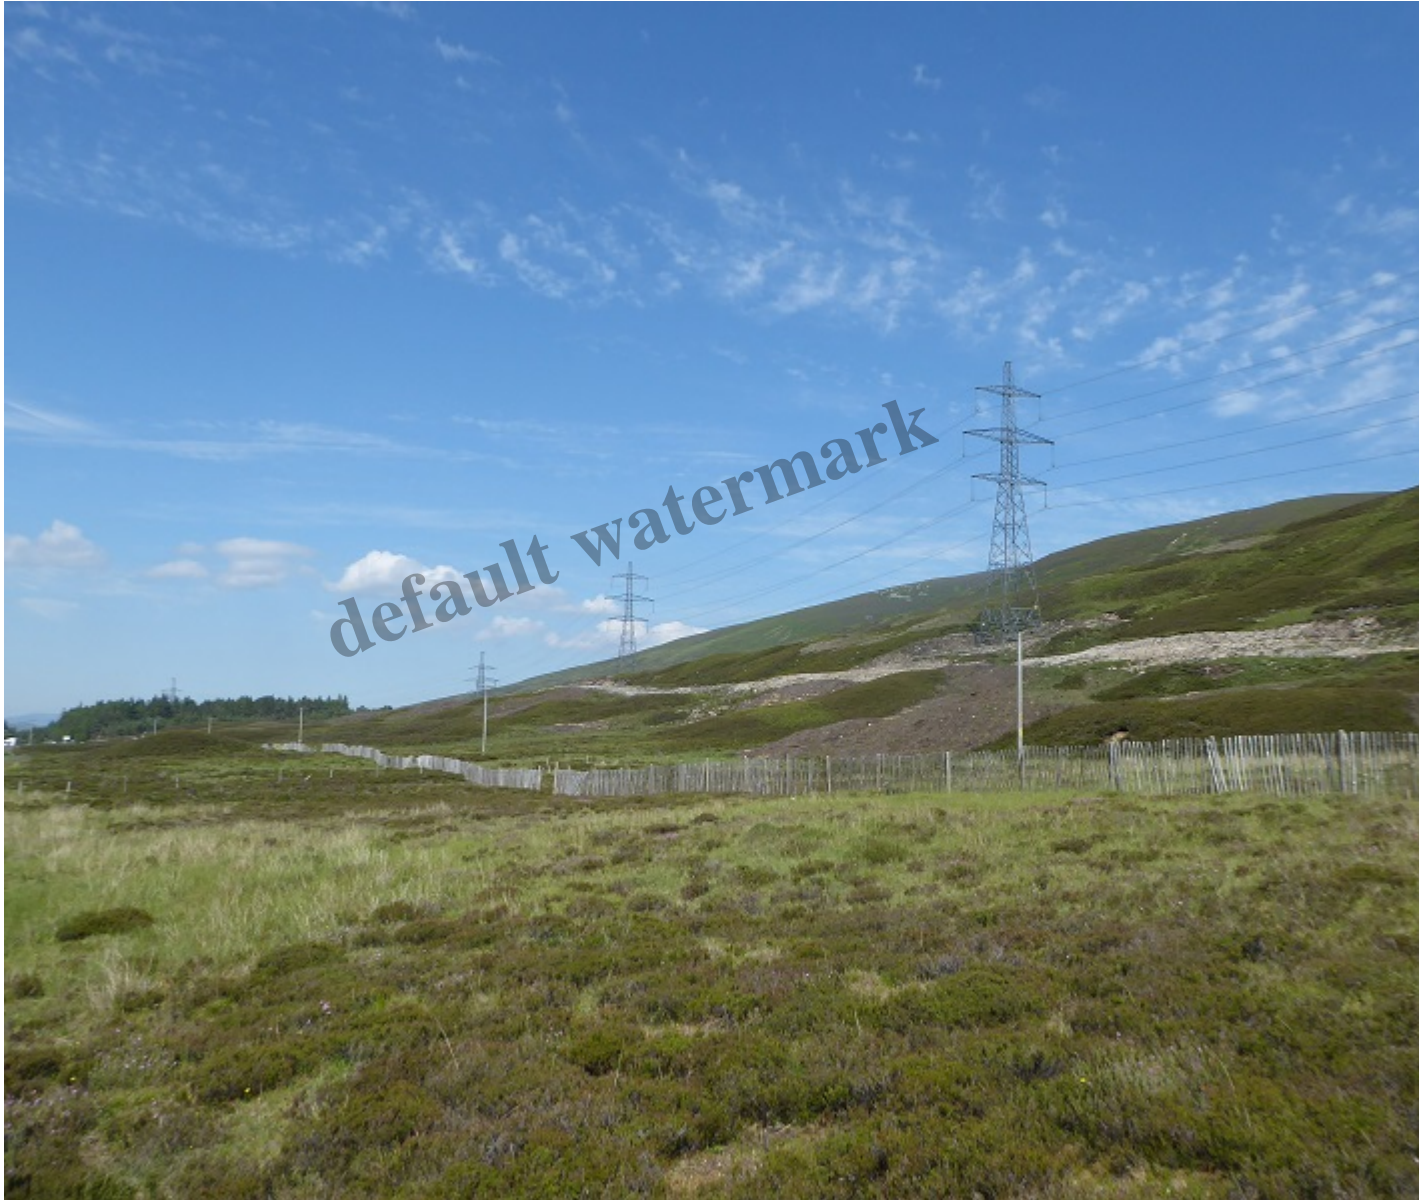
The scar just south of North Drumochter Lodge (in plantation) viewed from the edge of the A9 – Photo

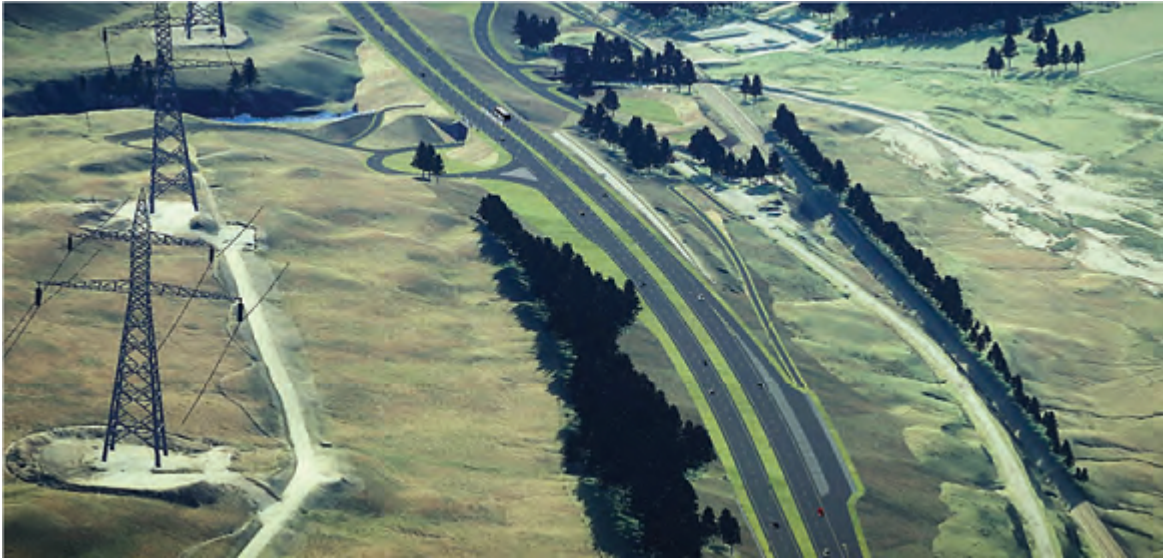
View to Dalnaspidal with new junction top centre. The construction road for the powerlines, is clearly visible on the left, though hidden from the A9 by the shelterbelt. Photo Credit: A9 Dualling, Non-technical summary Dec 2017.

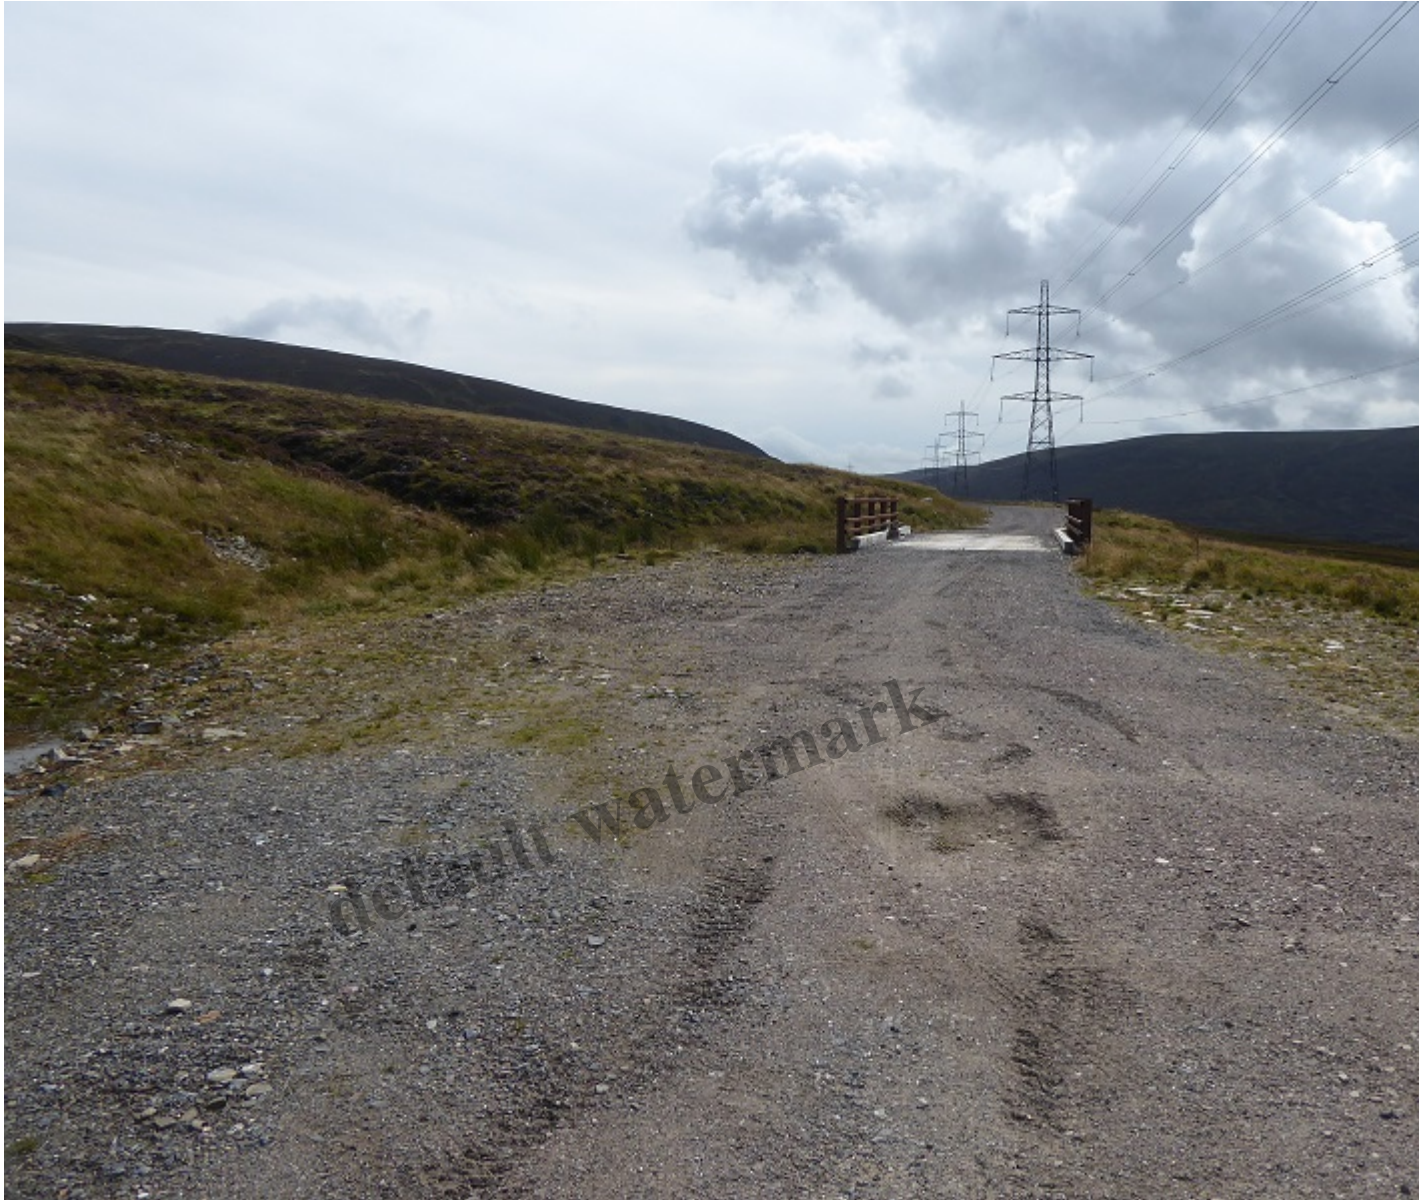
The new road is over 10m broad in places, which has not only destroyed a great swathe of natural h changed the ecology of the land on either side (eg through changing the drainage)

The main damage to the southern part of the SAC has been caused by the construction road being left in place.[\(see here\)](#), although there have also been failures to restore the ground under and around the towers. The Scottish Government's Planning consent allowed for an "upgrade" to Wade's military road which was then supposed to be fully restored. Somehow, in a manner yet to be explained, it was then just left. I understand from fairly recent contact with the Cairngorms National Park Authority that agreement has now been reached with SNH and SSE that the road should be narrowed to landrover track width.

That is a change to the original planning permission. In my view therefore there should be further public consultation from the Scottish Government, informed by scientific surveys, on whether this represents an acceptable loss of protected habitat.

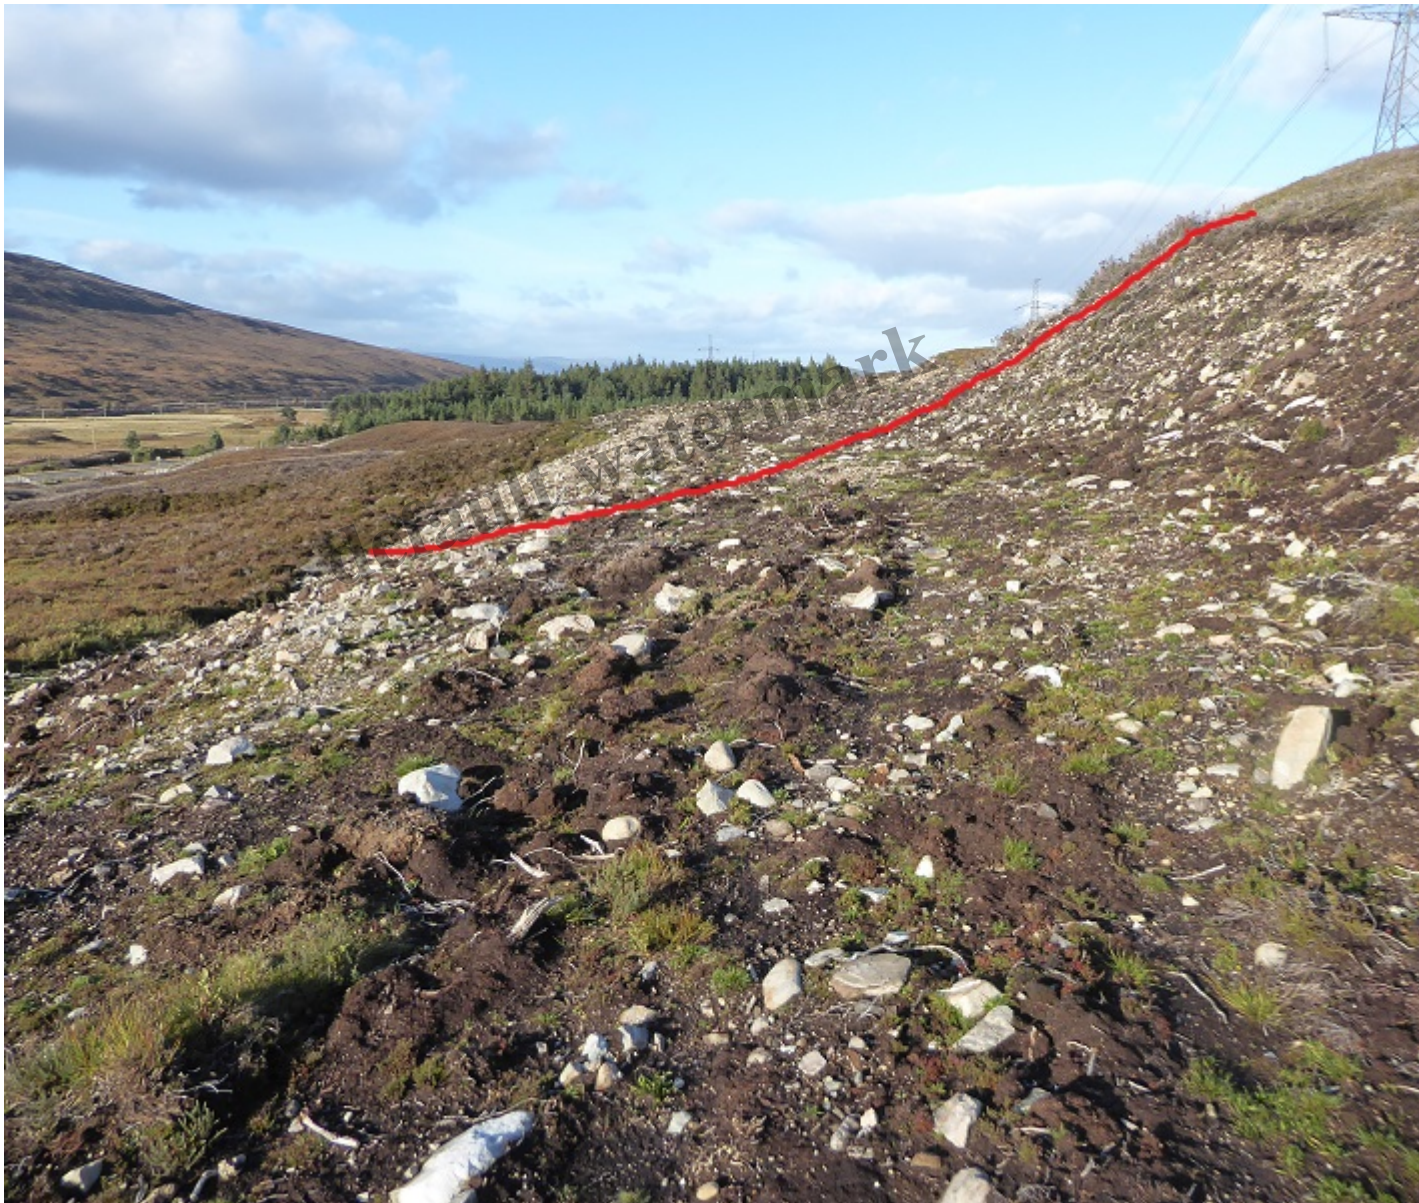
The red line is my attempt at depicting how the profile of this section of slope might have looked BEFORE the track was constructed. A great shelf has been cut across the hillside and the track constructed using the "cut and fill" technique – the fill being the material above the red line. Oct 2018.

The planning consent required the original landforms to be restored. That has not happened.

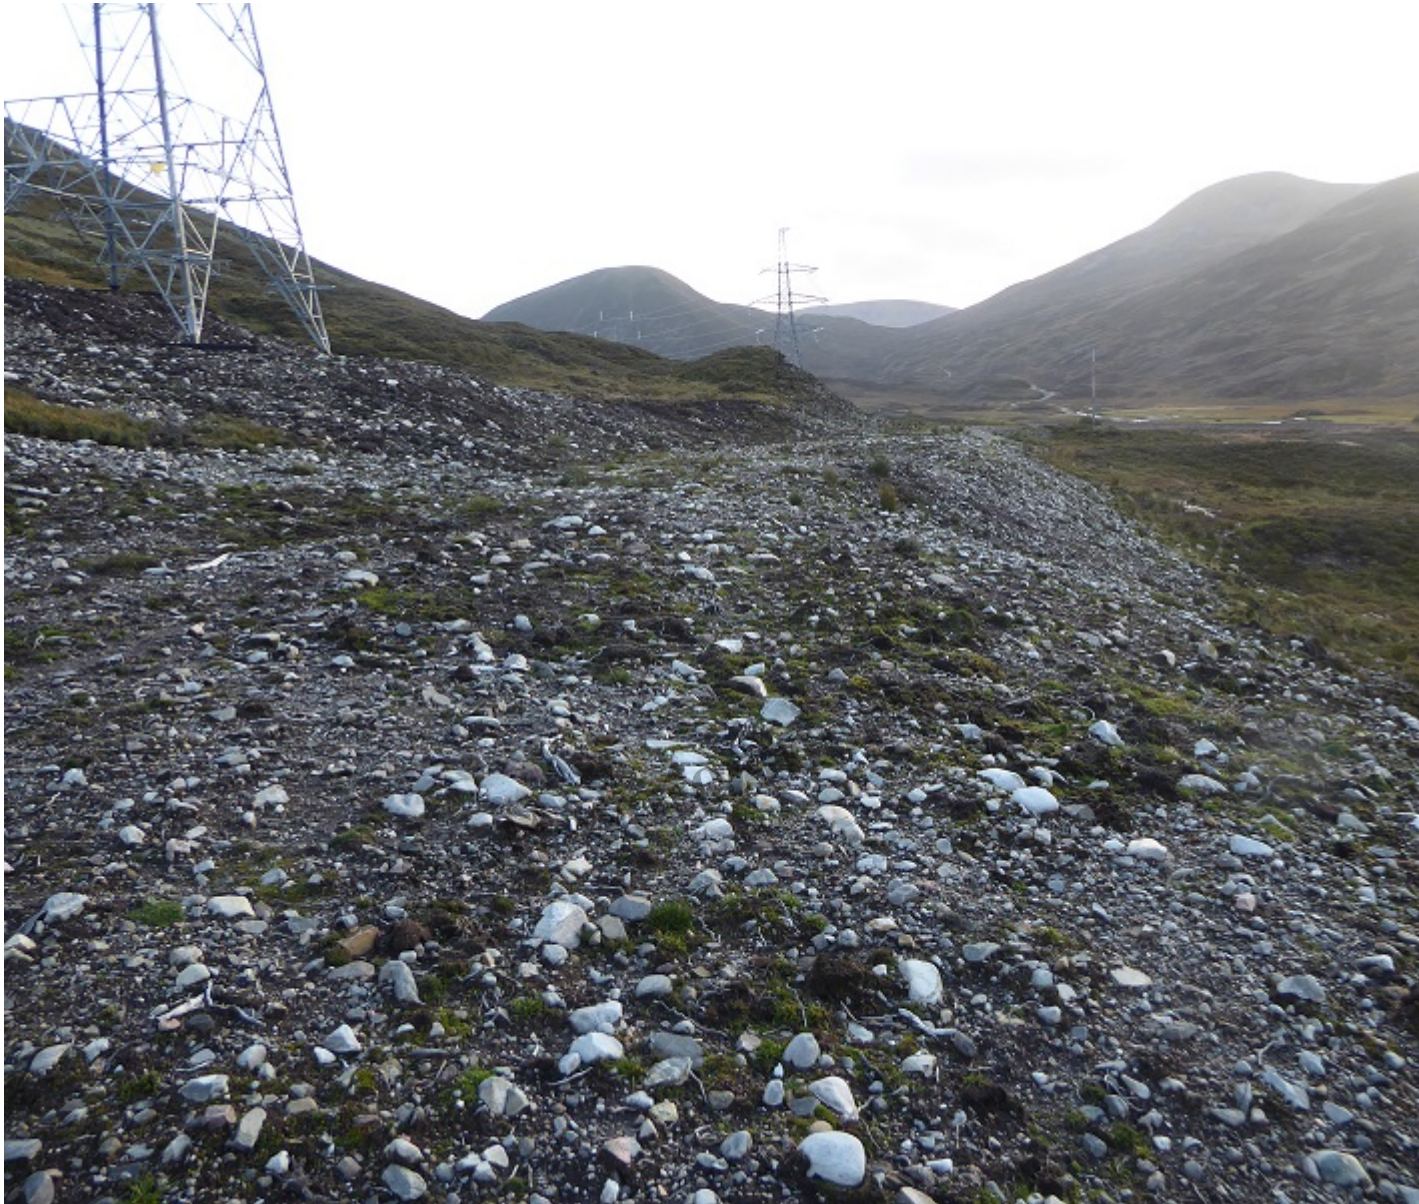
Another illustration of how spoil from the cut was moved to the moor below to create the track line. C

The alterations to the landforms caused by the creation of the temporary construction road have completely changed the ecology of this slope, changing both soils and drainage.

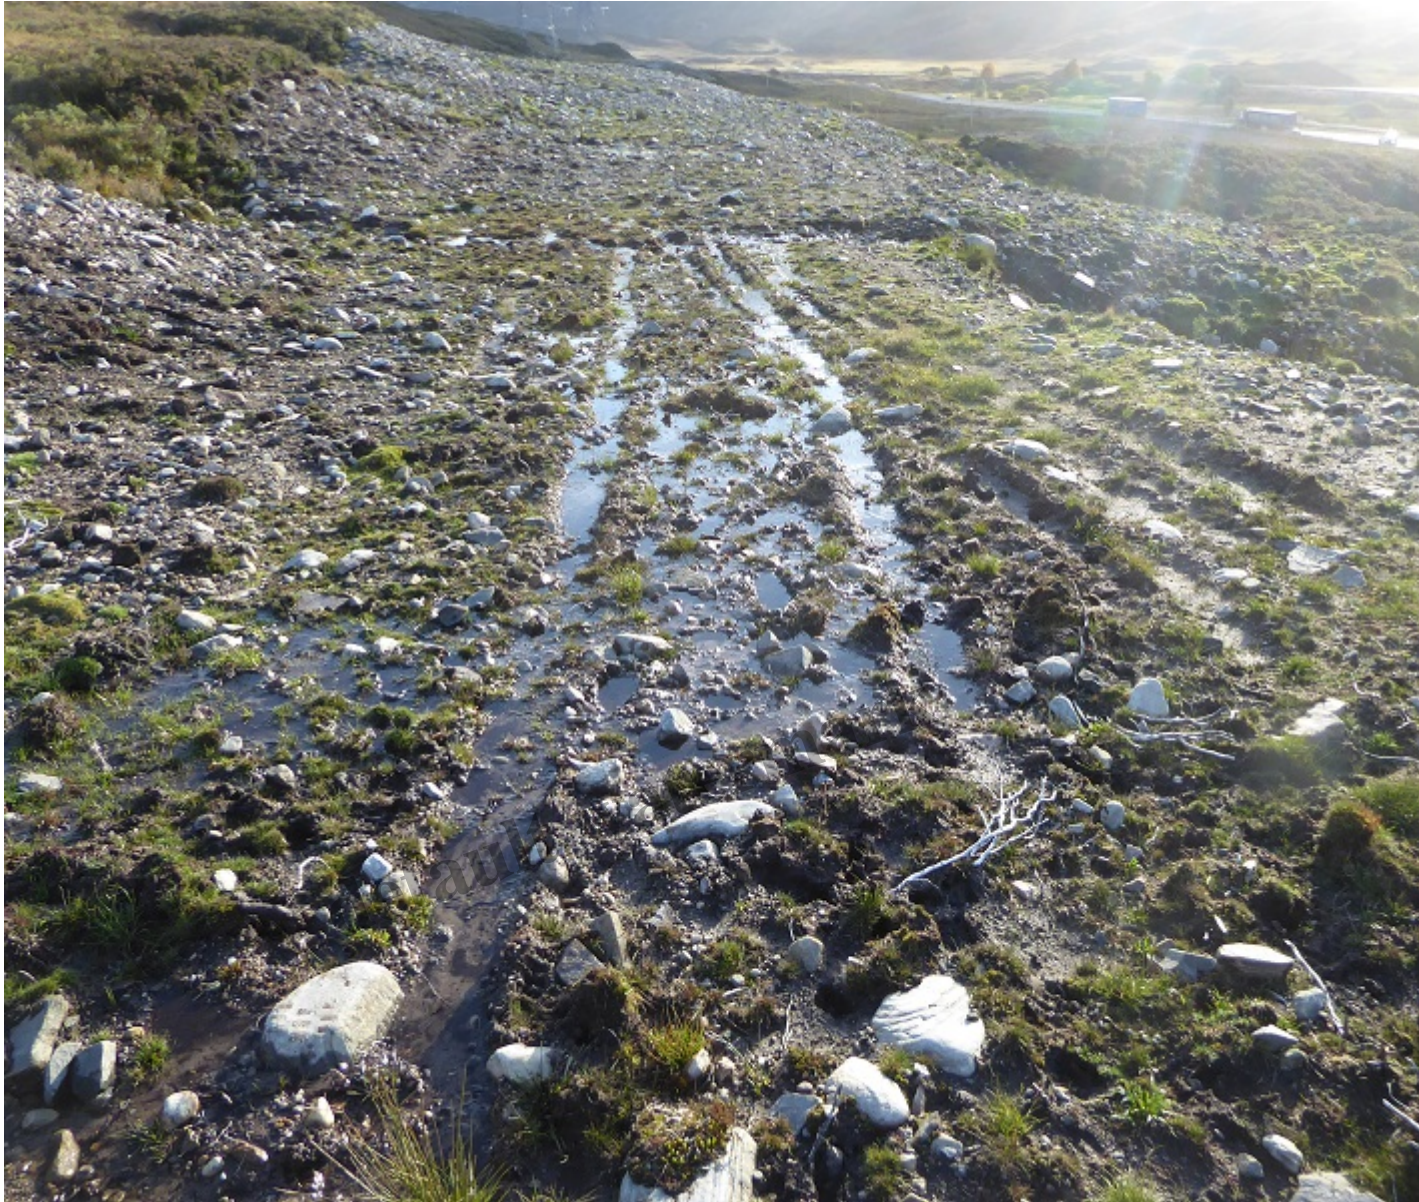
Evidence of continued vehicle use. Note the burn cutting across the road line near the top of the photo.

The flat bench across the hillside not only stands out as a scar, its an invitation to the estate to continue to drive vehicles here, doing further damage to the ground and preventing vegetation recovery. Note how the profile of the burn has not been restored either – you can see how it has cut through the ground on either side – but where it crosses the road the banks have been left flattened enabling vehicles to drive over it.

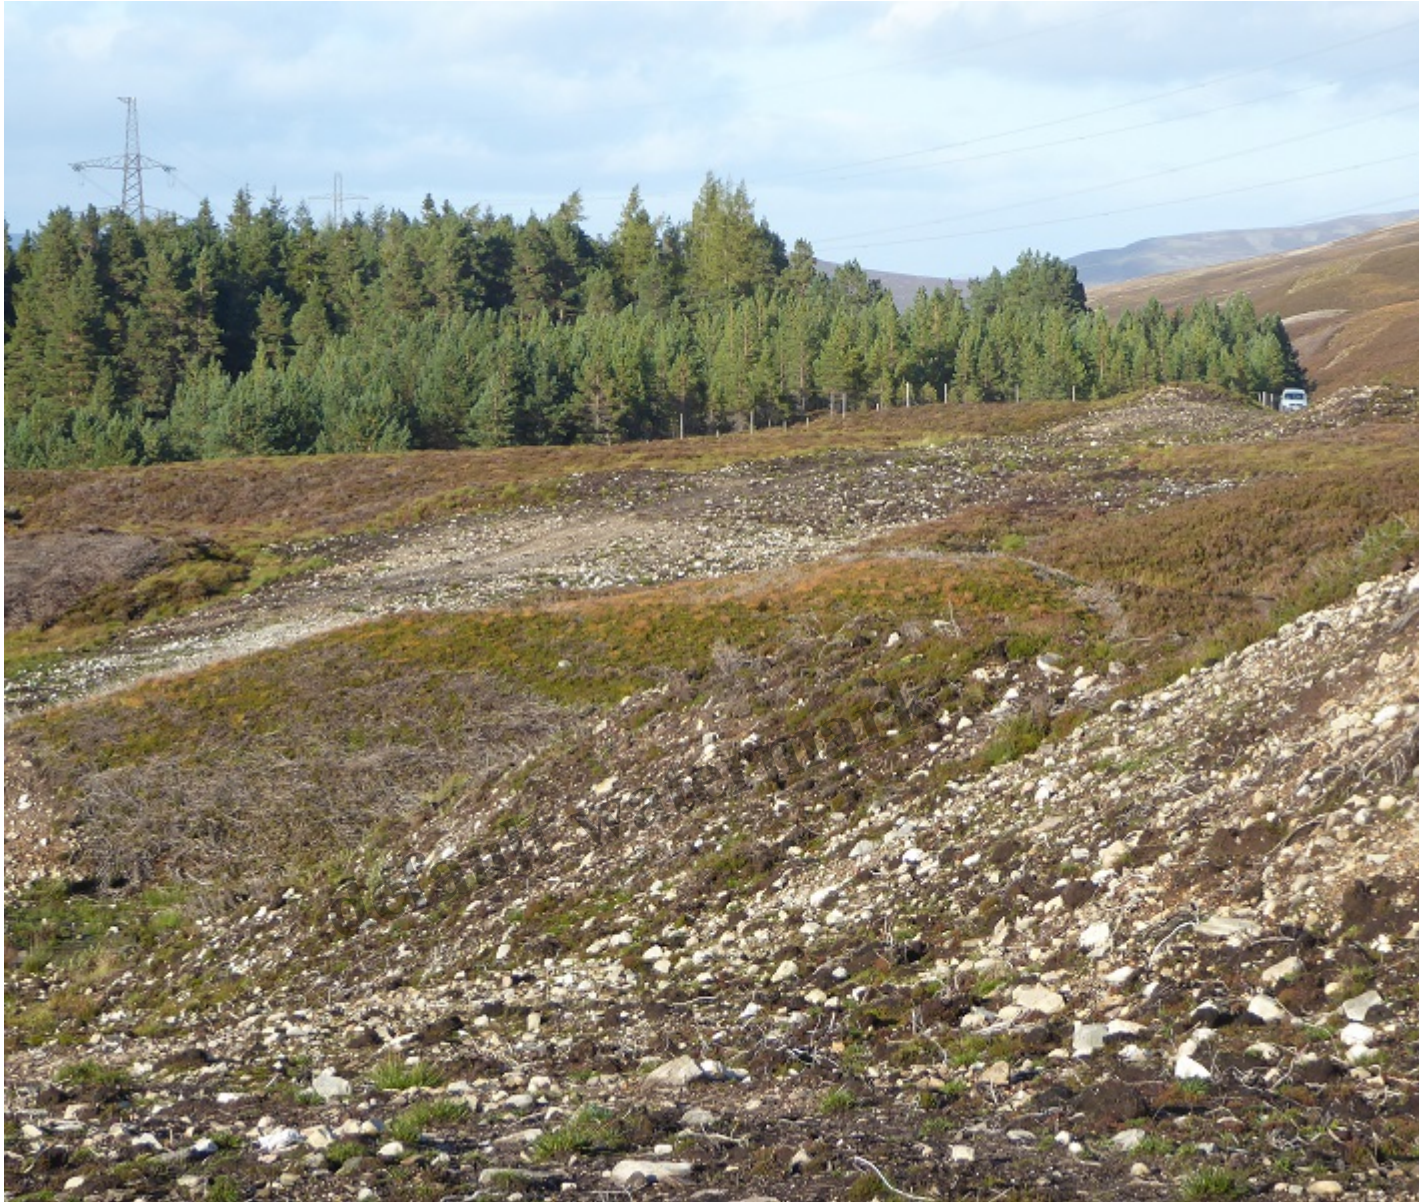
More evidence of continued vehicle use Oct 2018 just south of North Drumochter Lodge. Oct 2018

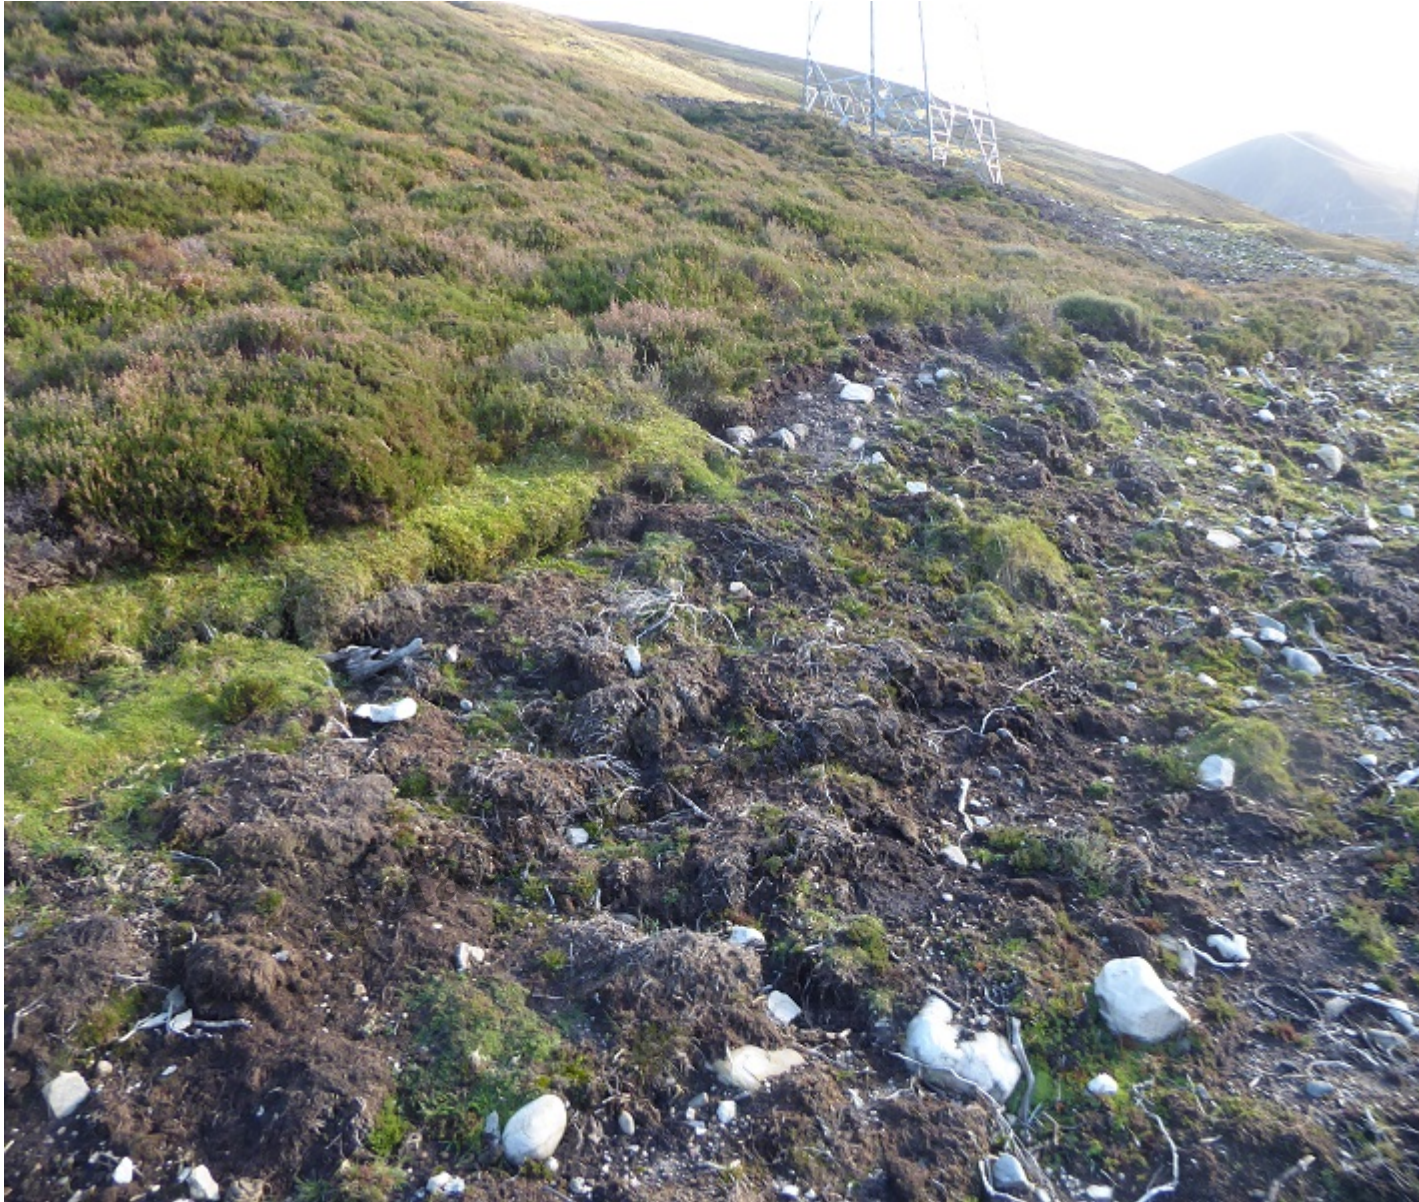
An area of ground where peat has been used to cover up what lay beneath. Oct 2018. In places there is evidence that some attempt has been made to restore the ground. Unfortunately, this has been poor with vegetation dying and the peat at high risk of drying out.

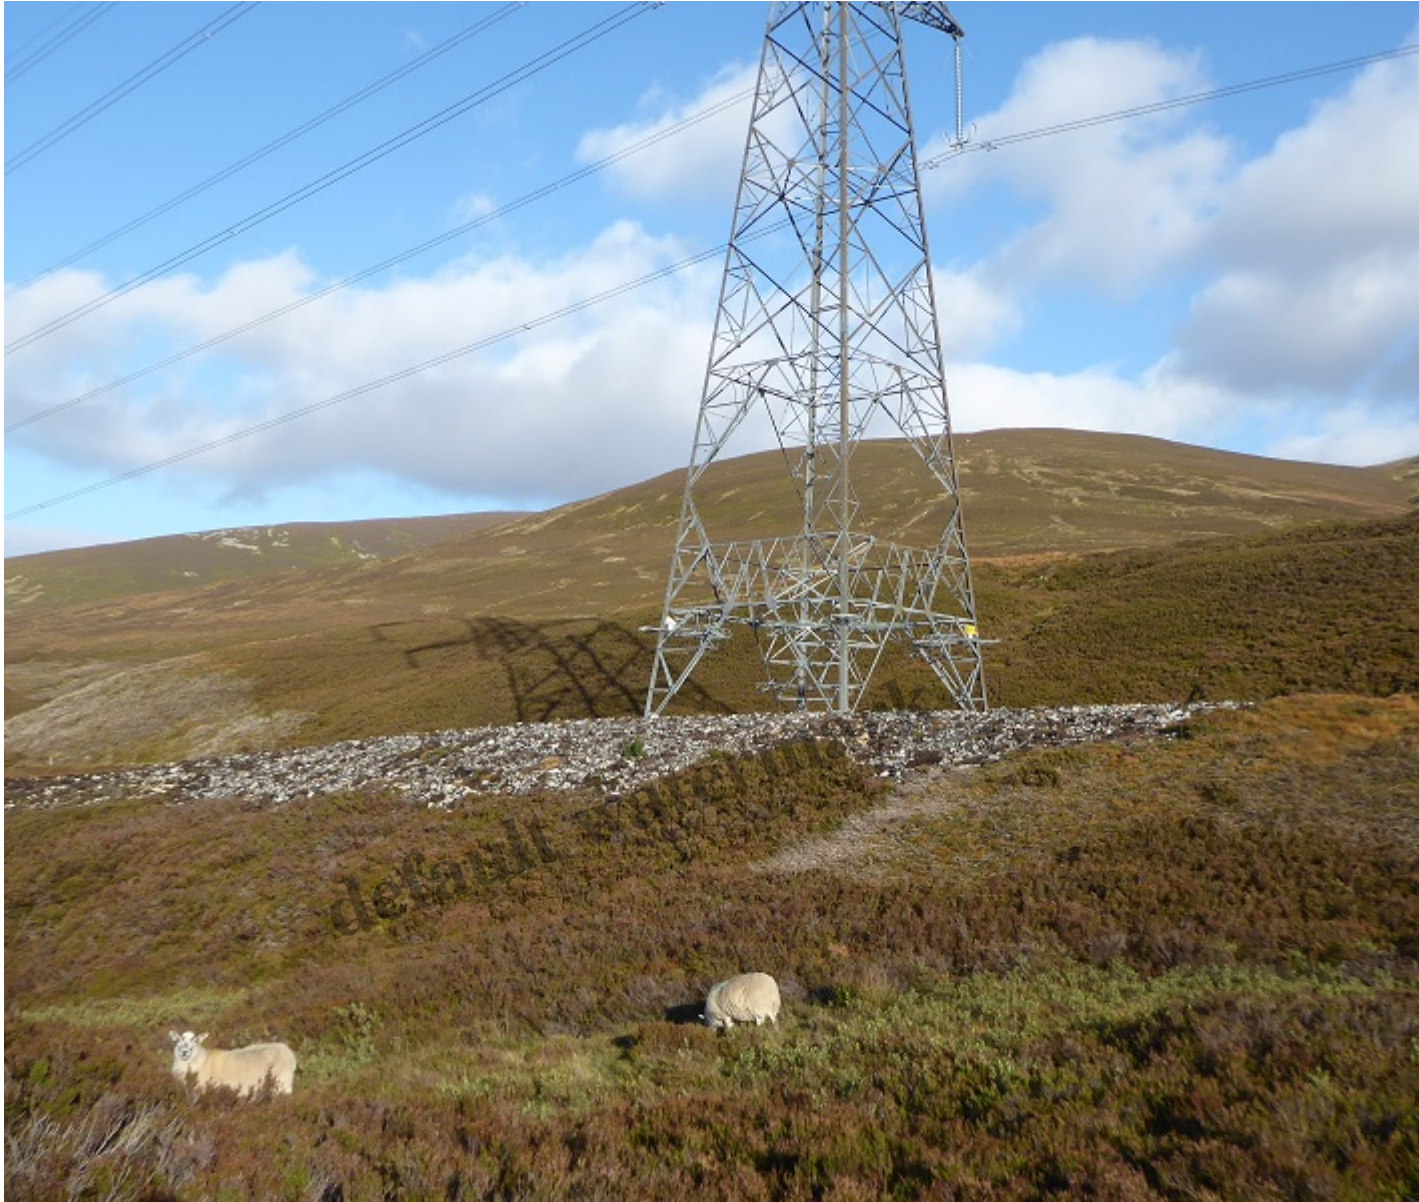
Oct 2018

Unbelievably, sheep are still being grazed along the line of construction track, most probably as tick mops in an attempt to increase grouse numbers here. Its little wonder there has been so little vegetation recovery along the line of the track.

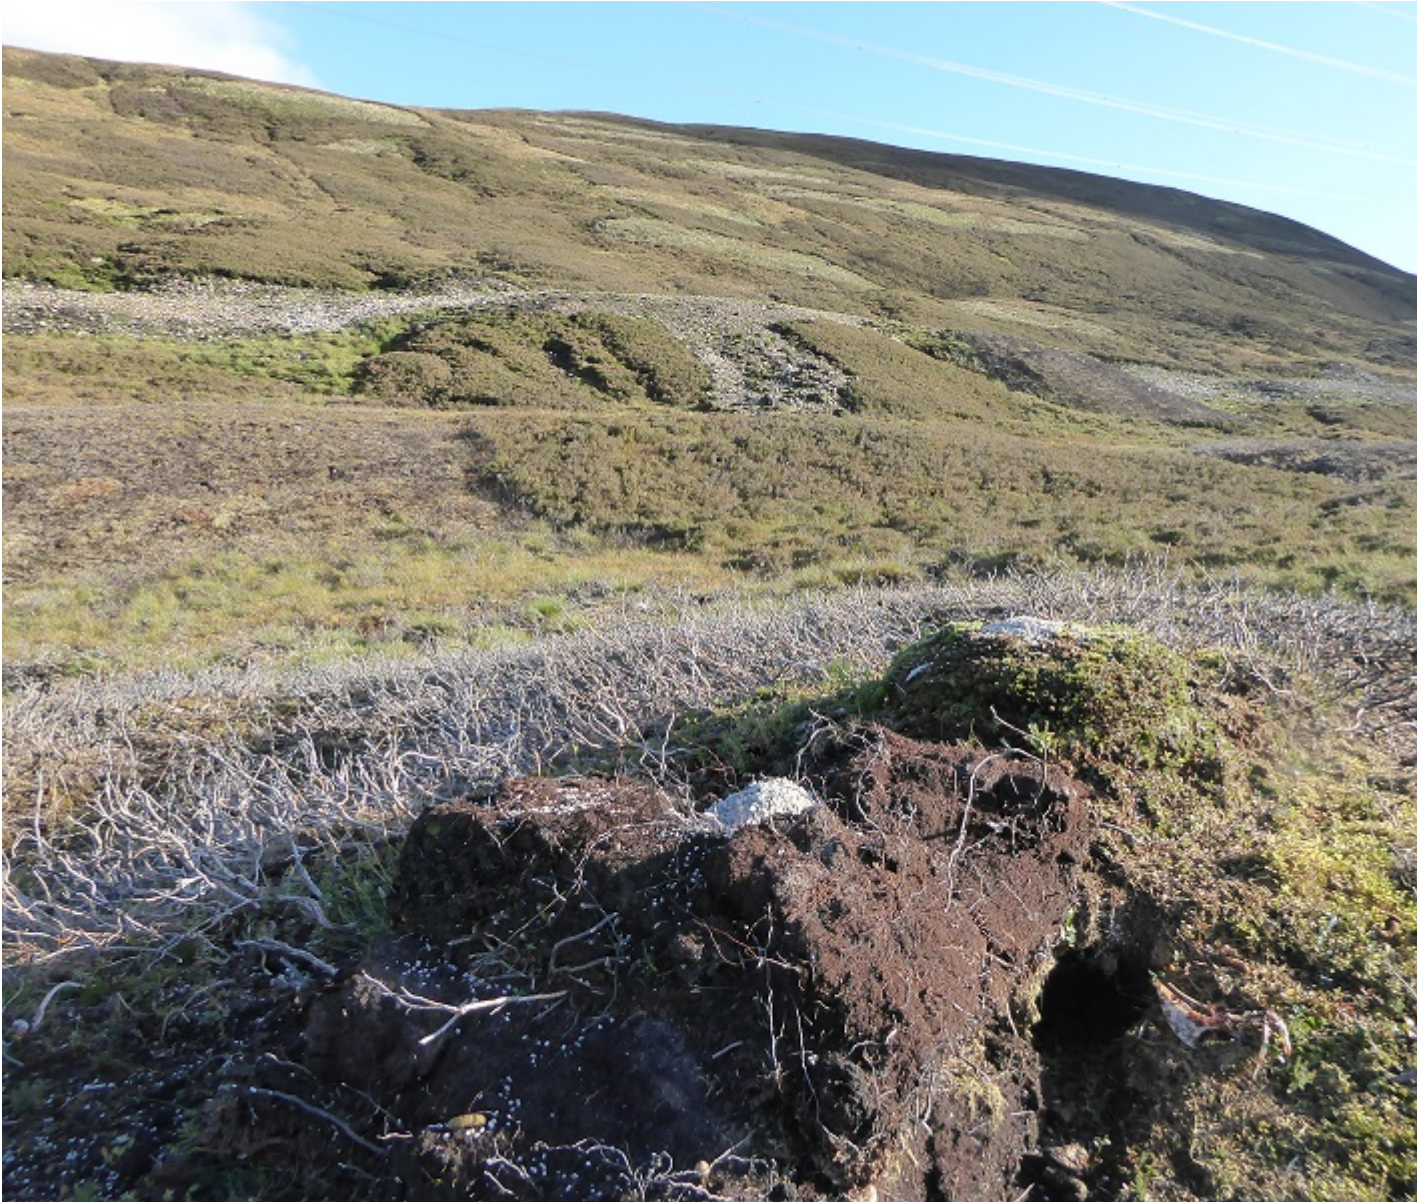
Medicated grit and muirburn. Oct 2018.

Continuing with further intensive grouse moor management along here before the vegetation has been fully restored is yet more madness. There appears to be no will within the Scottish Government to tackle the way grouse moors are managed even when the restoration of a SAC is at stake.

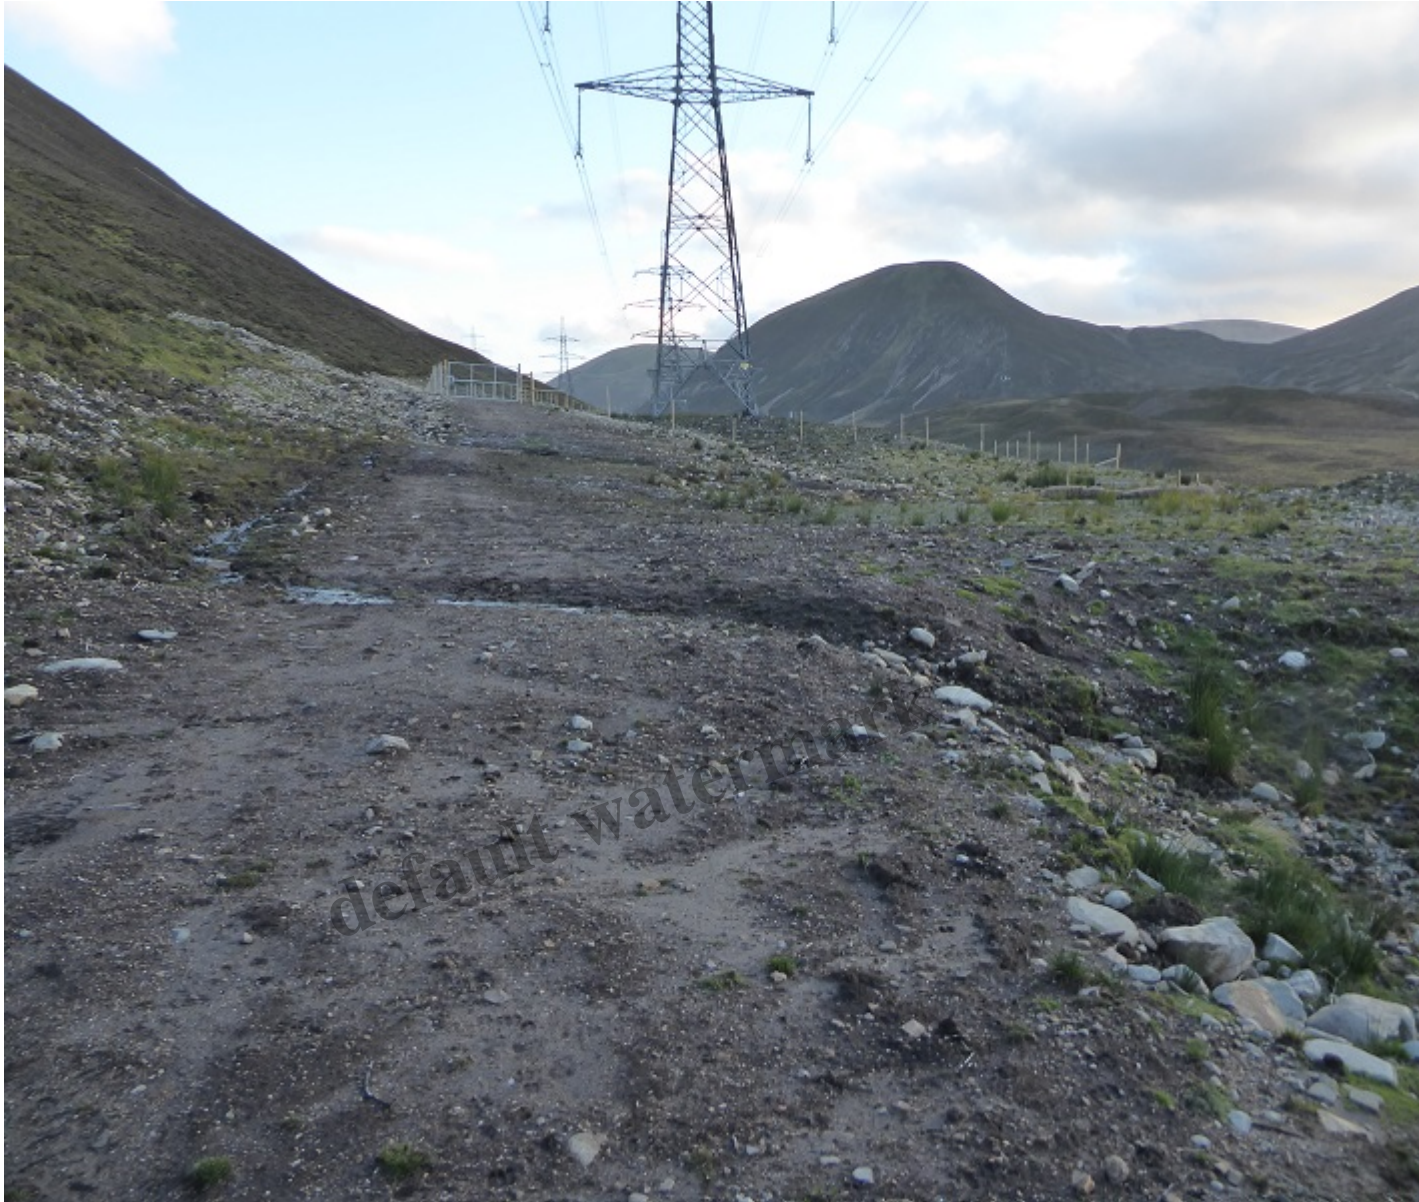
Oct 2018

Further south a fenced enclosure has been created around a section of the former construction track, apparently in order to help reduce grazing pressure and allow the vegetation to recover. Unfortunately it has resulted in the creation of a NEW road!

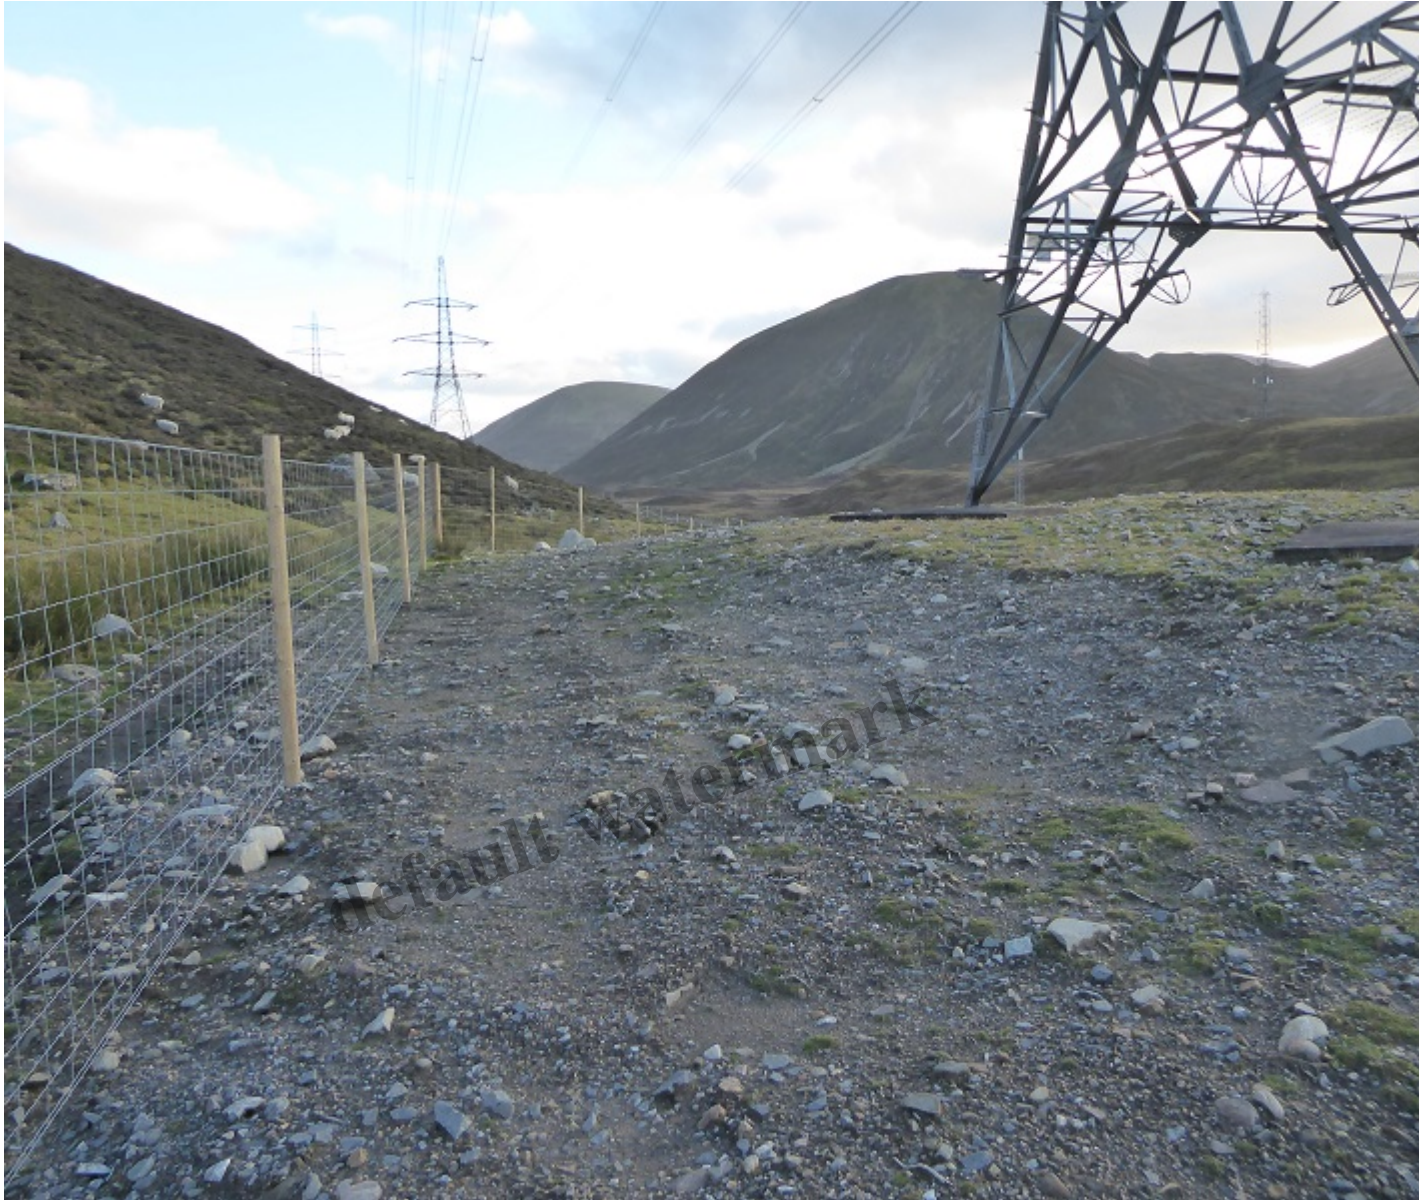
Towards the south end of the fenced enclosure. Note the sheep on the left and the grass outside the 2018.

The enclosure covers a slightly raised area which is less affected by drainage from the slope above than the rest of the former construction track and probably always had more mineral soils. Compared to the ground about, this would be highly attractive to the sheep that still graze here. An alternative to the fence would be to have removed the sheep and to have stalked deer here regularly. Fencing this area is not going to address the problem just outside the fence on the left or indeed the rest of the construction destruction outside the enclosure.

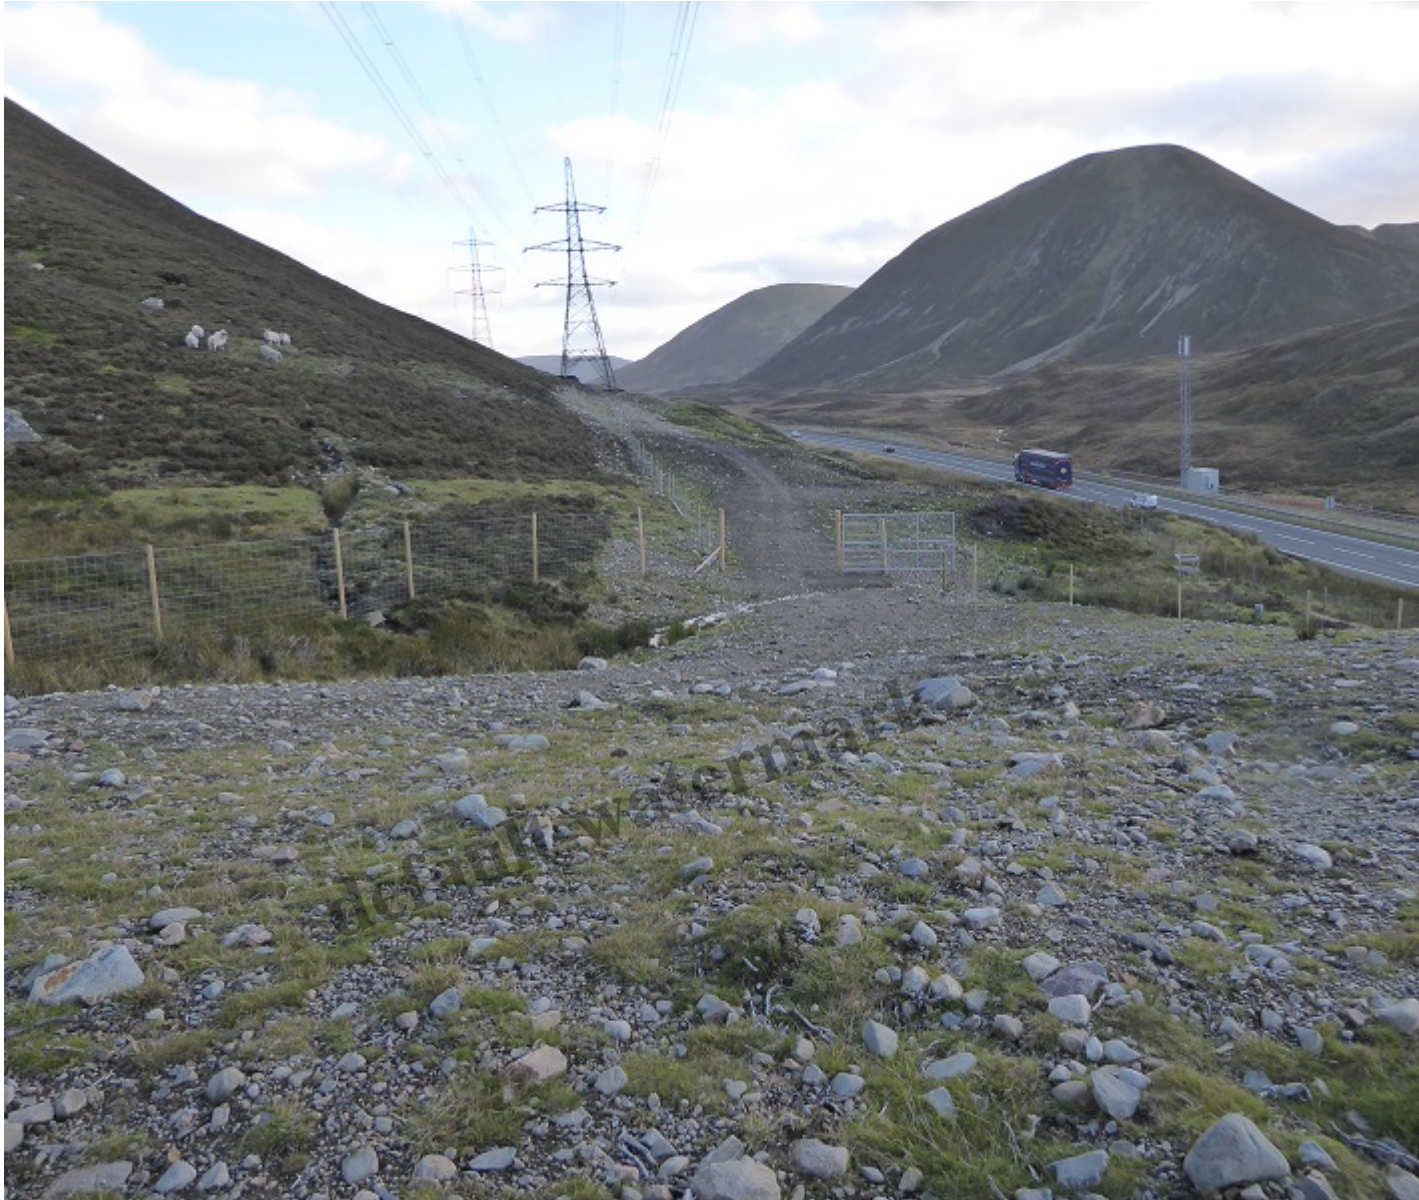
More track heading south from the enclosure. On the right just outside the fence you can just see one of the test drilling points for the A9 works. Oct 2018.
