Time for the EC to hold the Scottish Government to account for the destruction at Drumochter?

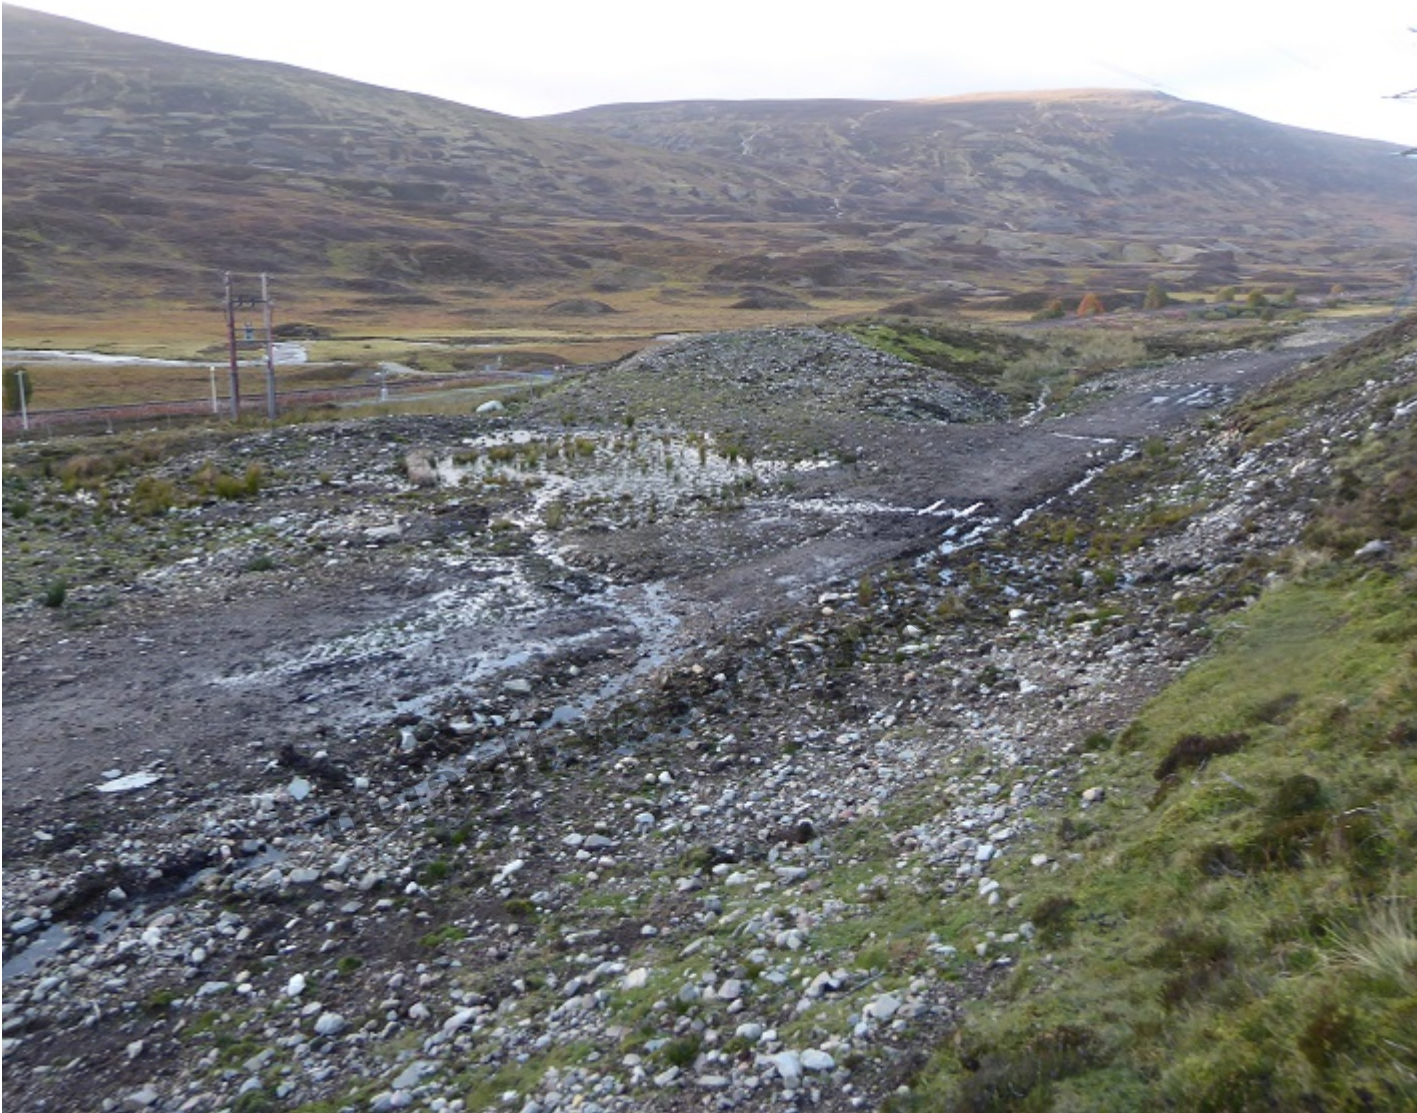
More Beauly Denny destruction – just north of enclosure – with further destruction of the hillside beyond muirburn
