The upgrade to the West Highland Way at Keilator, Glen Falloch

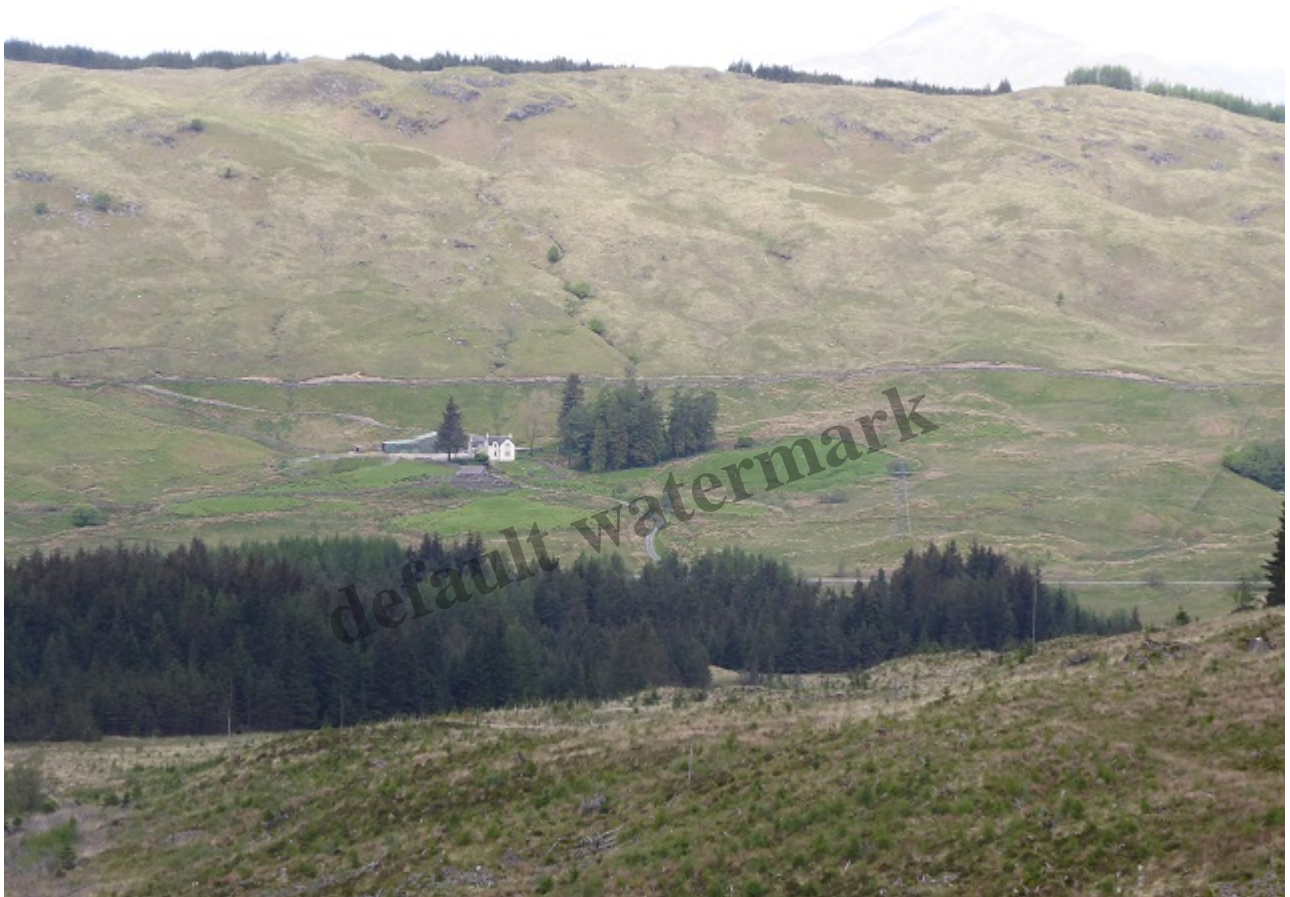
Keilator Farm with the “upgraded” section of the West Highland Way behind it visible as a scar across the landscape

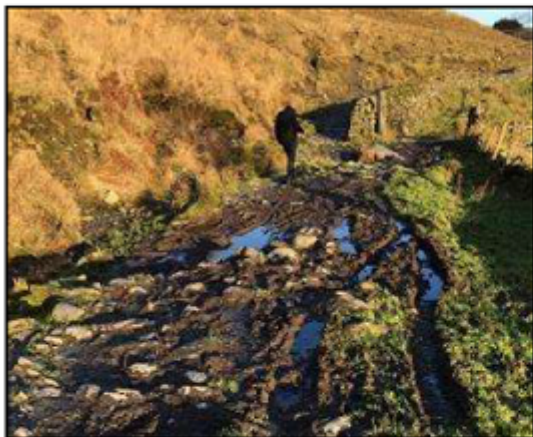
WHW Keilator – before upgrade
Loch Lomond & The Trossachs Access Forum Meeting
9 May 2019

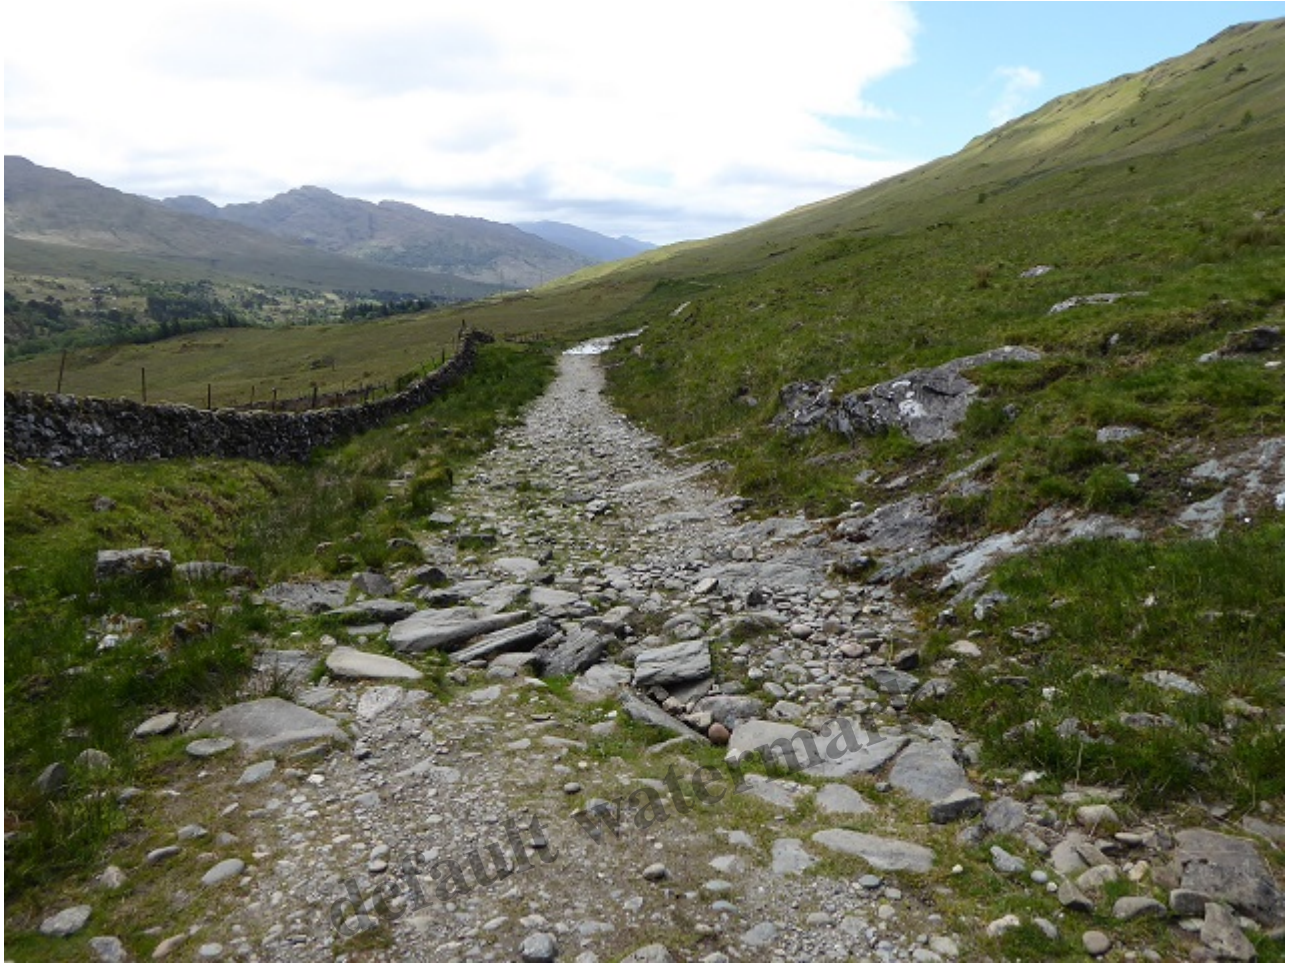
The West Highland Way by Keilator follows the line of the old military road. This photo shows the “unimproved” path just before where the recent work started. Its a fairly rough path but not difficult walking.

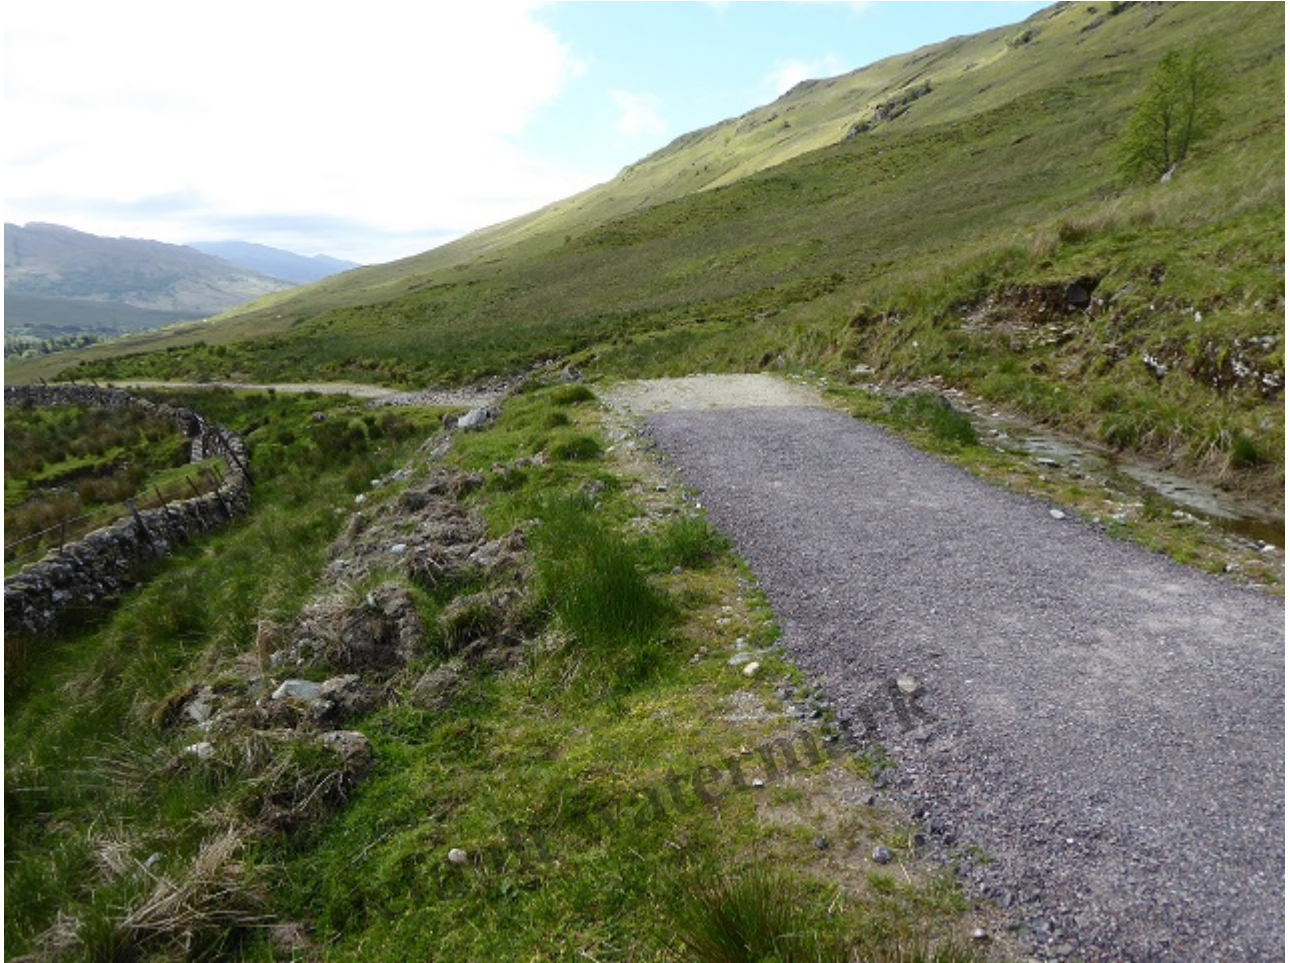
The join between the old and the new, the difference in appearance between the two is striking. One can understand how some people thought from the photos on FB that the new section had been finished with tarmac!

Setting aside its appearance, the first I noticed on reaching the new path were the turves which had been dumped on the lower side of the track. That is contrary to standard pathwork good practice. Moreover, while the LLTNPA's requirements are often ignored, a standard condition for all new hydro tracks is that turves should be properly stored and replaced. If the specifications for works under the Improving Public Access scheme allows work of this poor quality its not fit for the purpose.

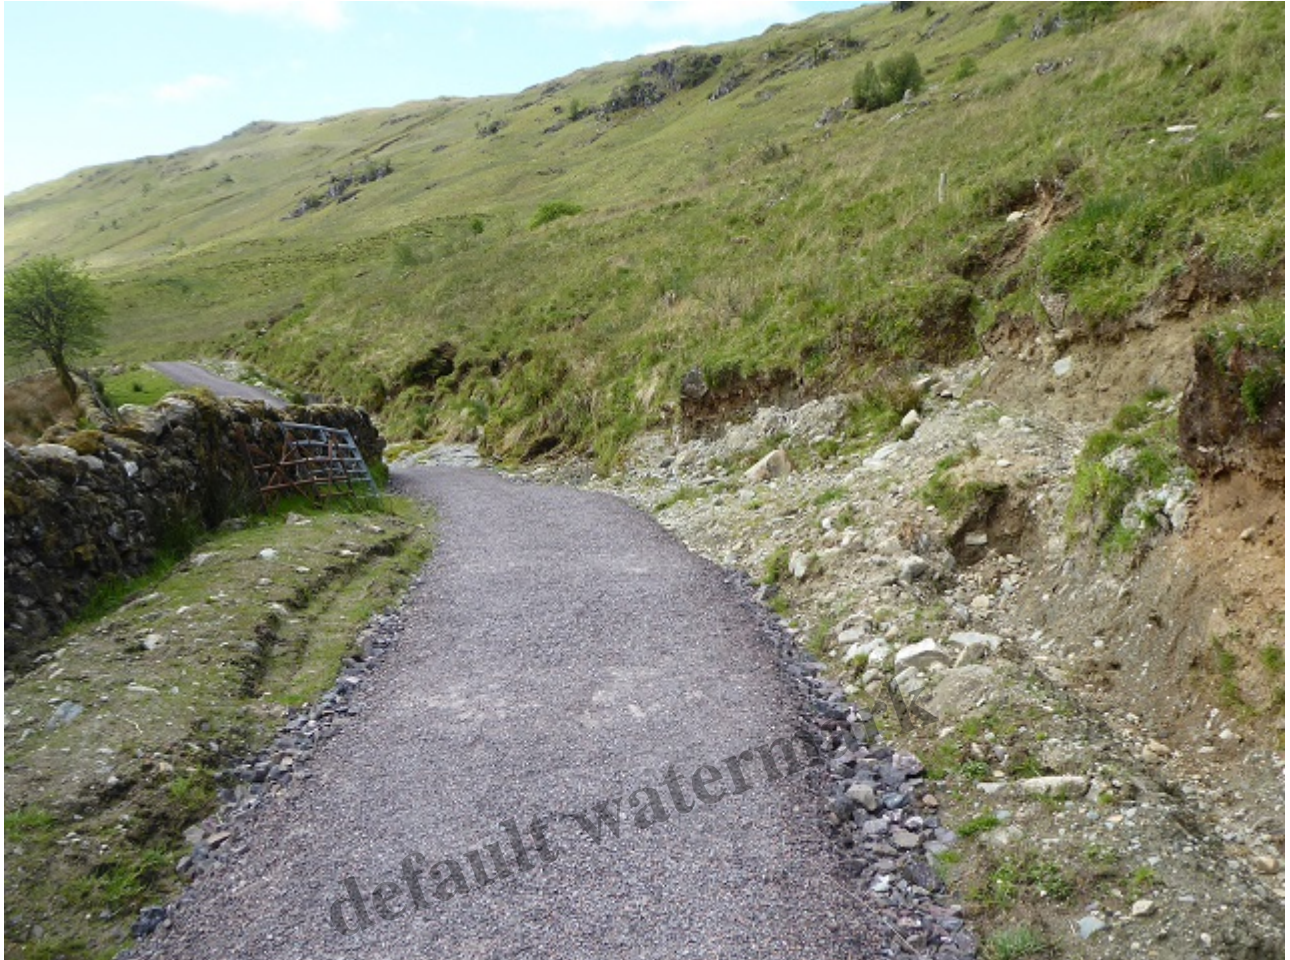
Note the wheel damage that has already been done to the ground on the left side of the track.

You don't have to walk far to find plenty of places where the turves could have been re-used. Nor to find evidence that the damage that had been done to the West Highland Way by agricultural use appears to be continuing. What's the point of spending public money on repairing paths – this section of the West Highland Way had previously I understand been upgraded using machine tools – unless proper measures are in place to prevent further unnecessary damage and the work is done to appropriate standards?

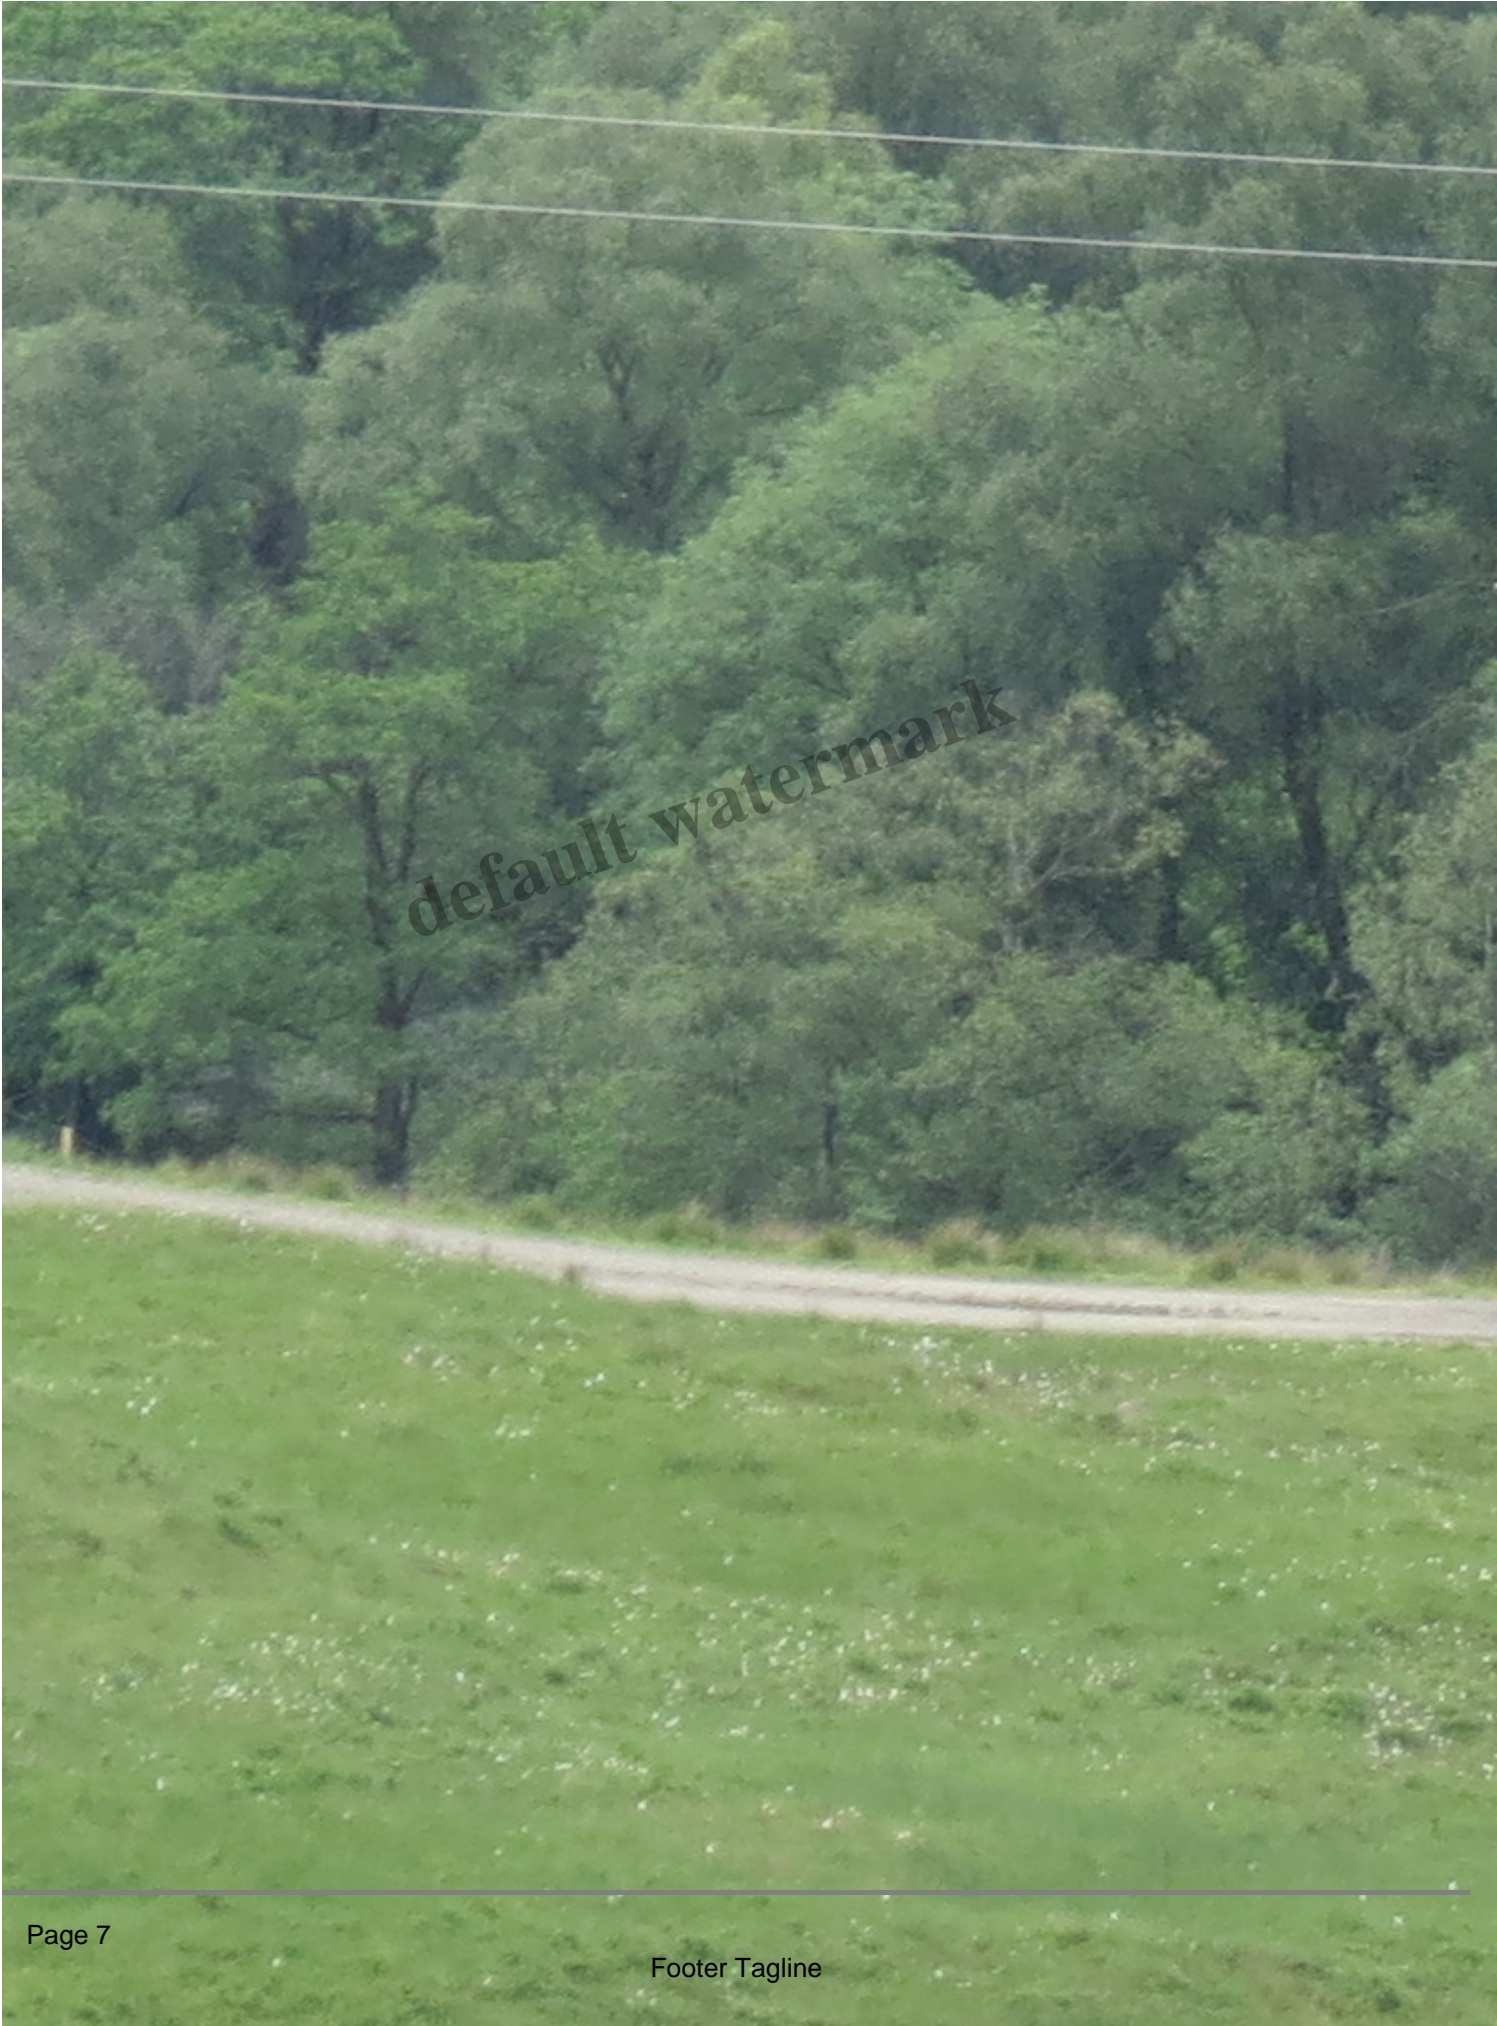
A little further on the path “upgrade” gets even worse

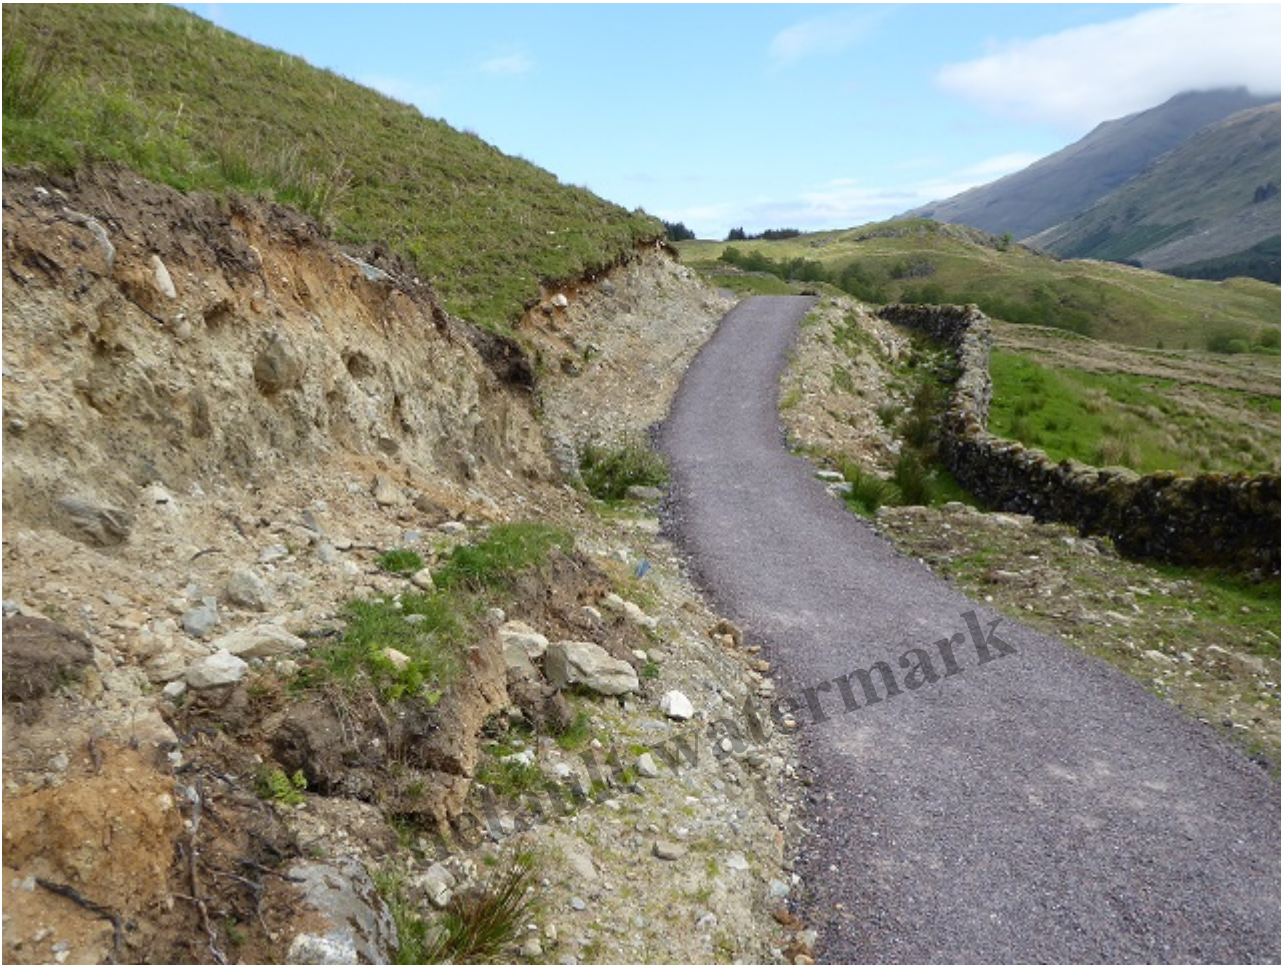
I have to say that however critical I have been about hydro schemes, I can think of few scars apart from the Conic Hill hydro as bad as this. Prior to the upgrade, there was a bad scar here, but the amount of the scarring appears to have increased as a result of the works and there has been no apparent attempt to restore past damage (the LLTNPA has subsequently informed me that restoration of past damage above the drainage ditch was not in the specification). The upper bank is far too steep. Meanwhile the excavated material has been dumped on the lower side without any apparent attempt at restoration. This doesn't just impact on the walking experience, it has done nothing to address the landscape scar that can be seen from the other side of the Glen (top photo).

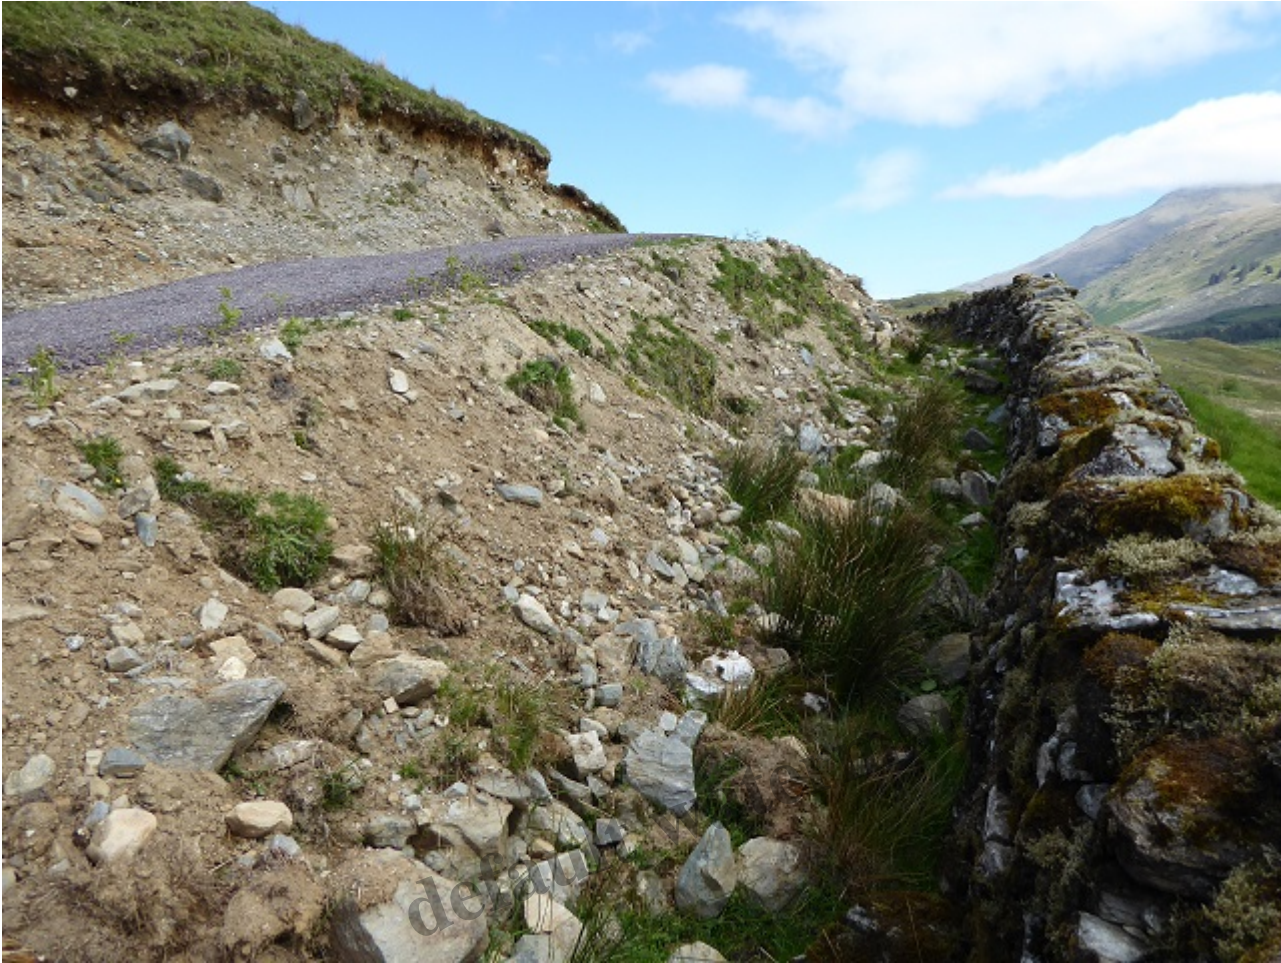
One of the great things about this section of the West Highland Way previously was the fine wall that ran alongside it. While much more recent than the military road, somehow it befitted the route, well built and moss covered. Unfortunately the path upgrading work has treated the wall as being of no account or perhaps as a retaining wall which will prevent the rubble eroding further. To use SNH and National Park terminology jargon, the “landscape character” of the wall has been to a great extent destroyed.

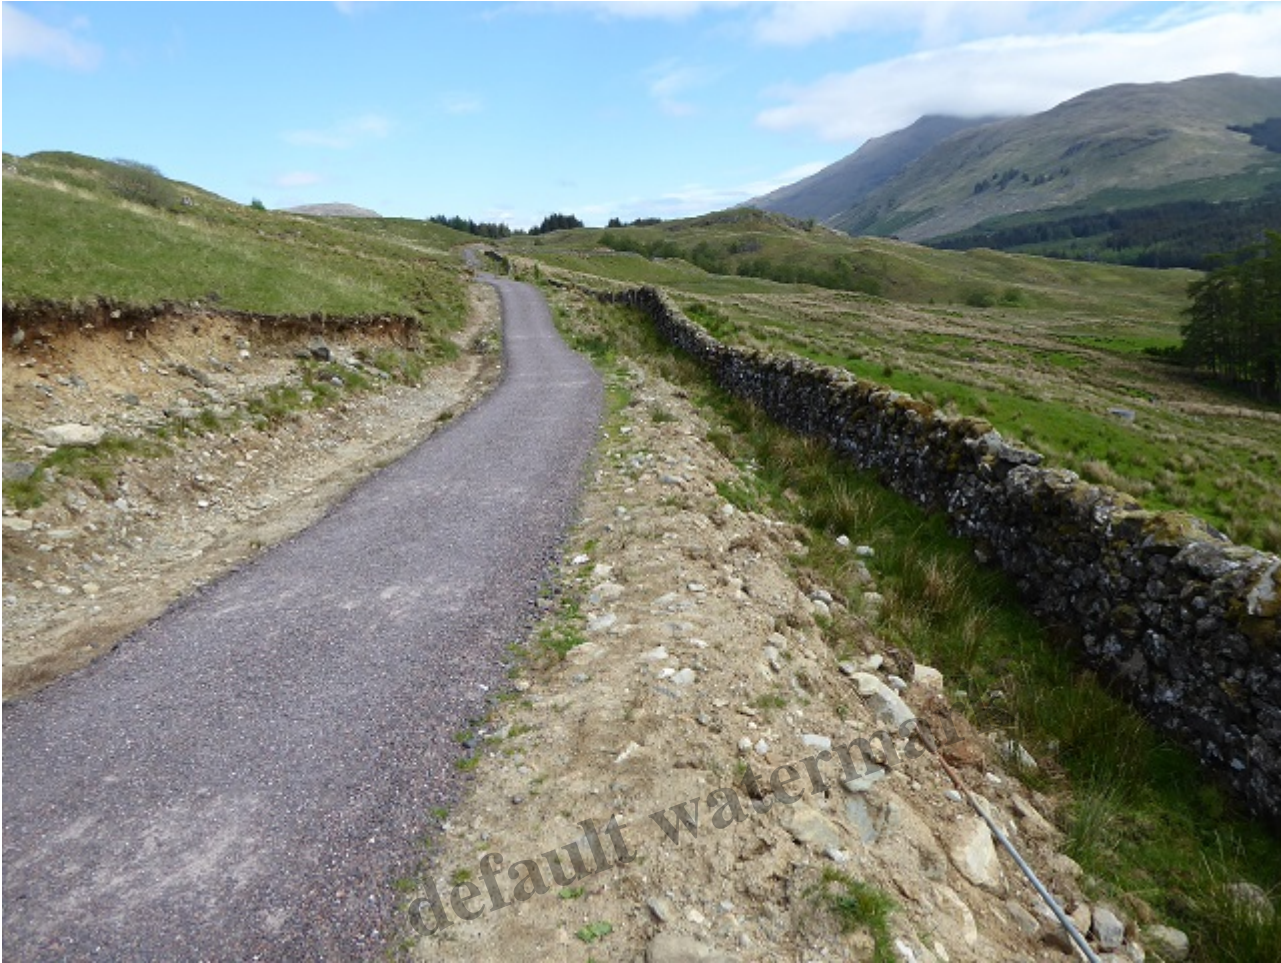
None of this damage required planning permission. Under the LLTNPA's best practice guidance on renewables they recommend that benches cut across hillsides should be avoided but this is precisely what they have allowed to remain at Keilator. The LLTNPA urgently needs to set standards for footpath design and work which are appropriate for a National Park.

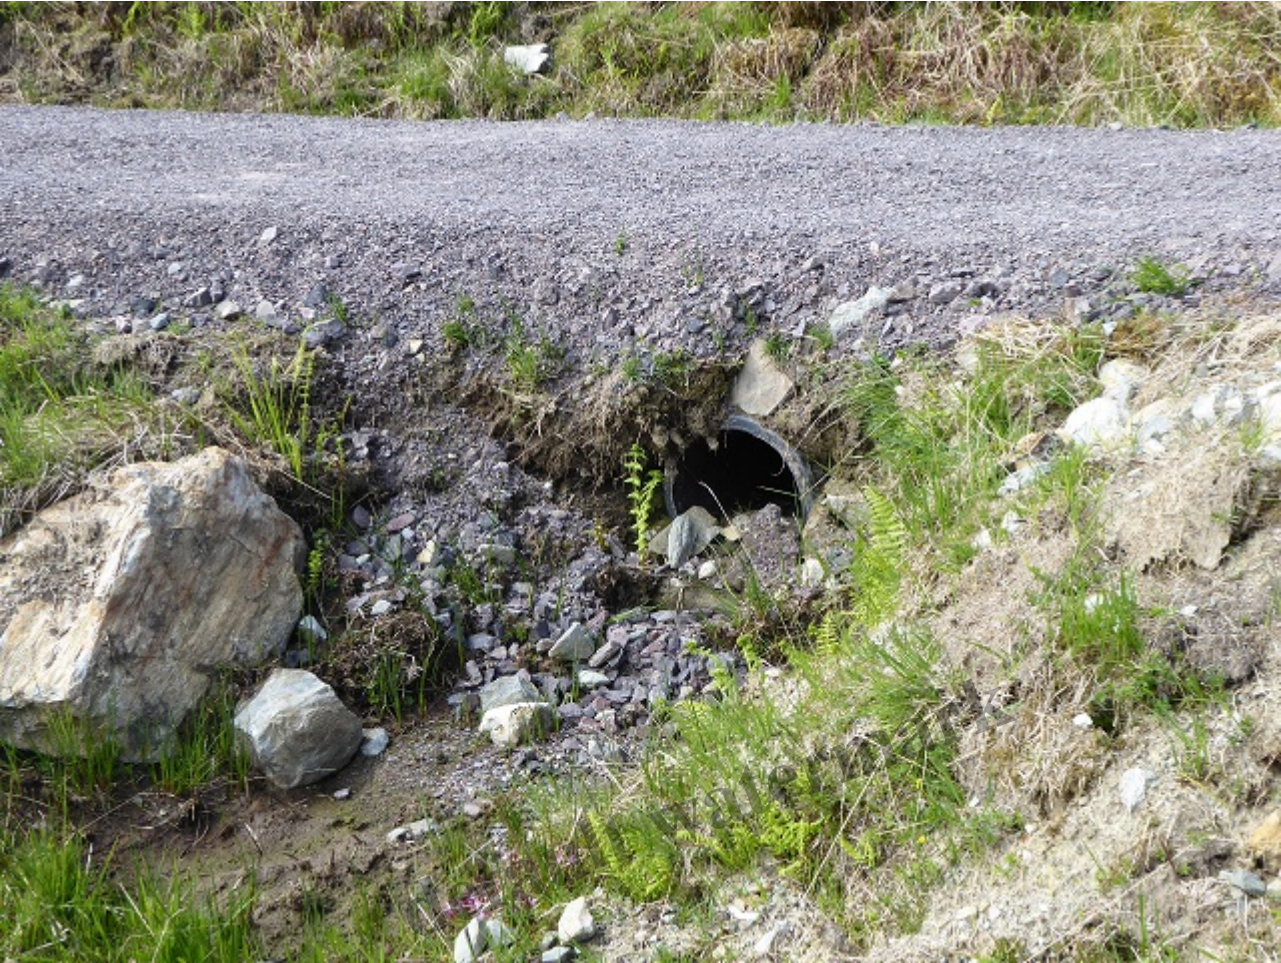
Surfacing from the path is already eroding away and the standard of finishing around the culverts is as poor as any old bulldozed track. Is this the way to treat the old military road and what is our best known long distance walking route?

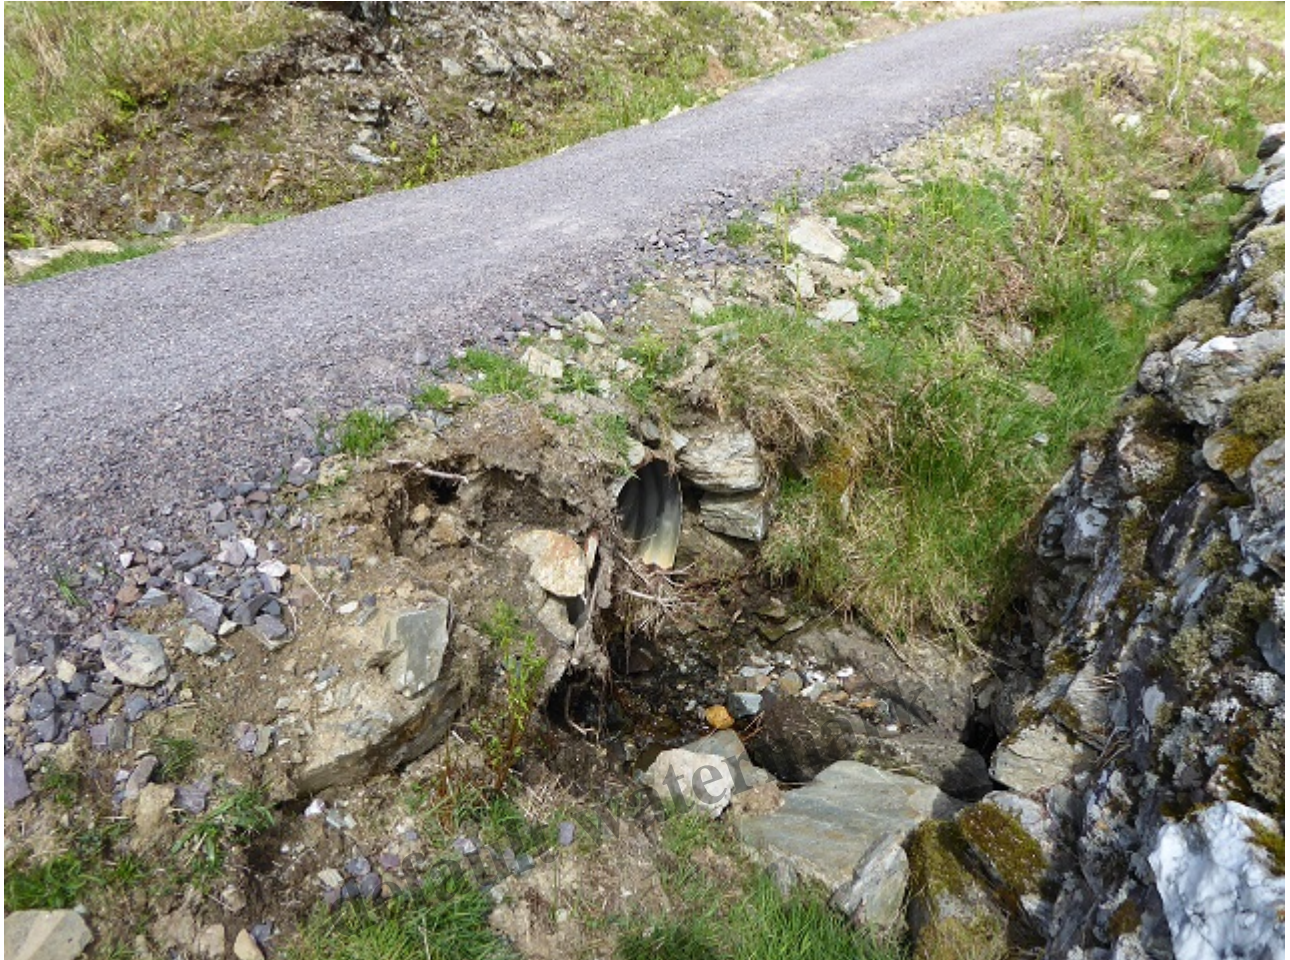
Another collapsing culvert which unless addressed is likely to erode back into the path surface in the near future

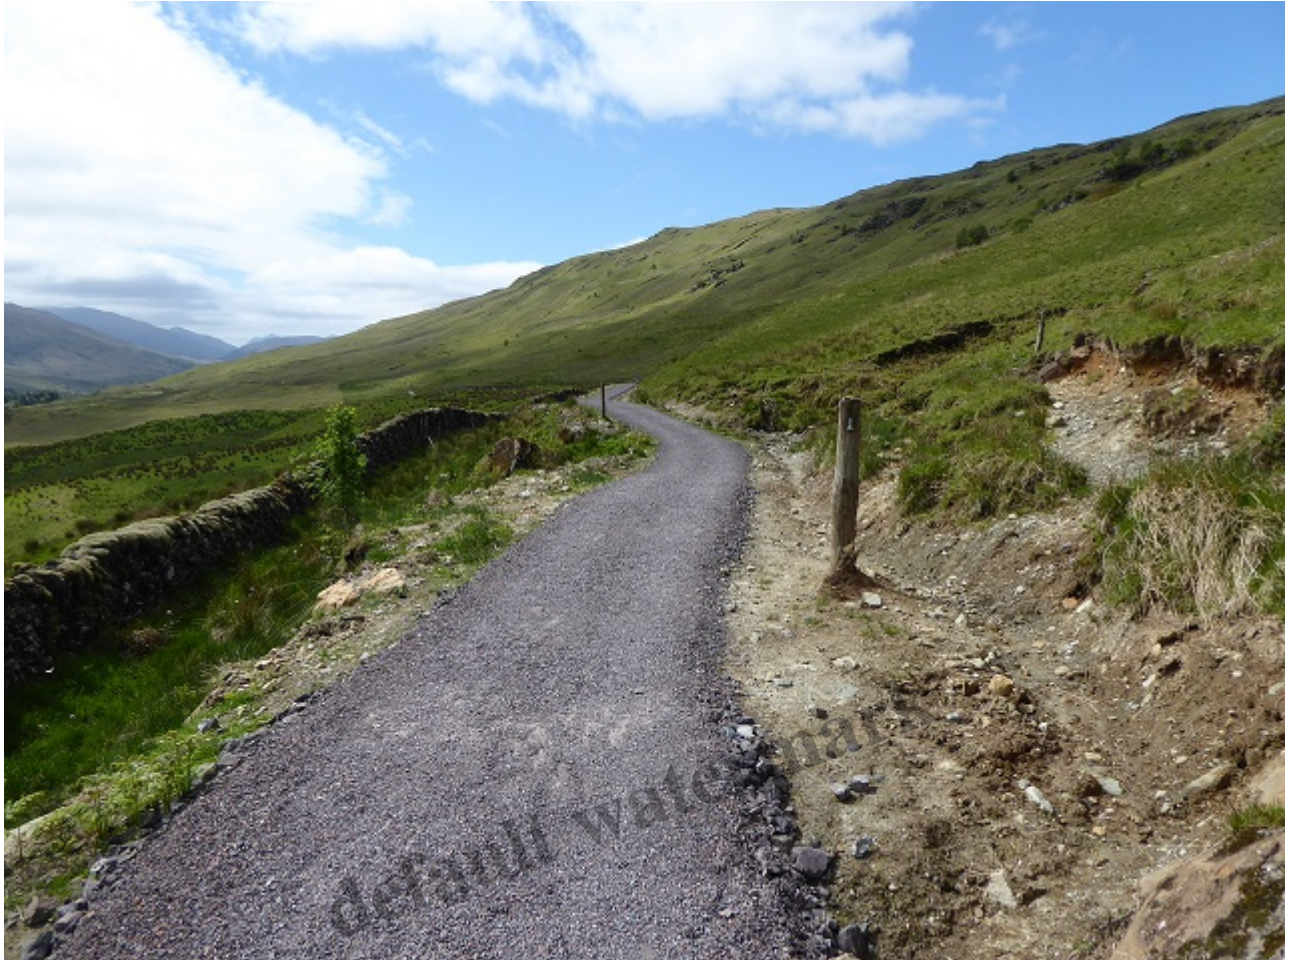
The ground in this photo could have immediately been restored with turves if they had been kept instead of dumped on the lower side of the path. Instead its likely to take several years to revegetate.

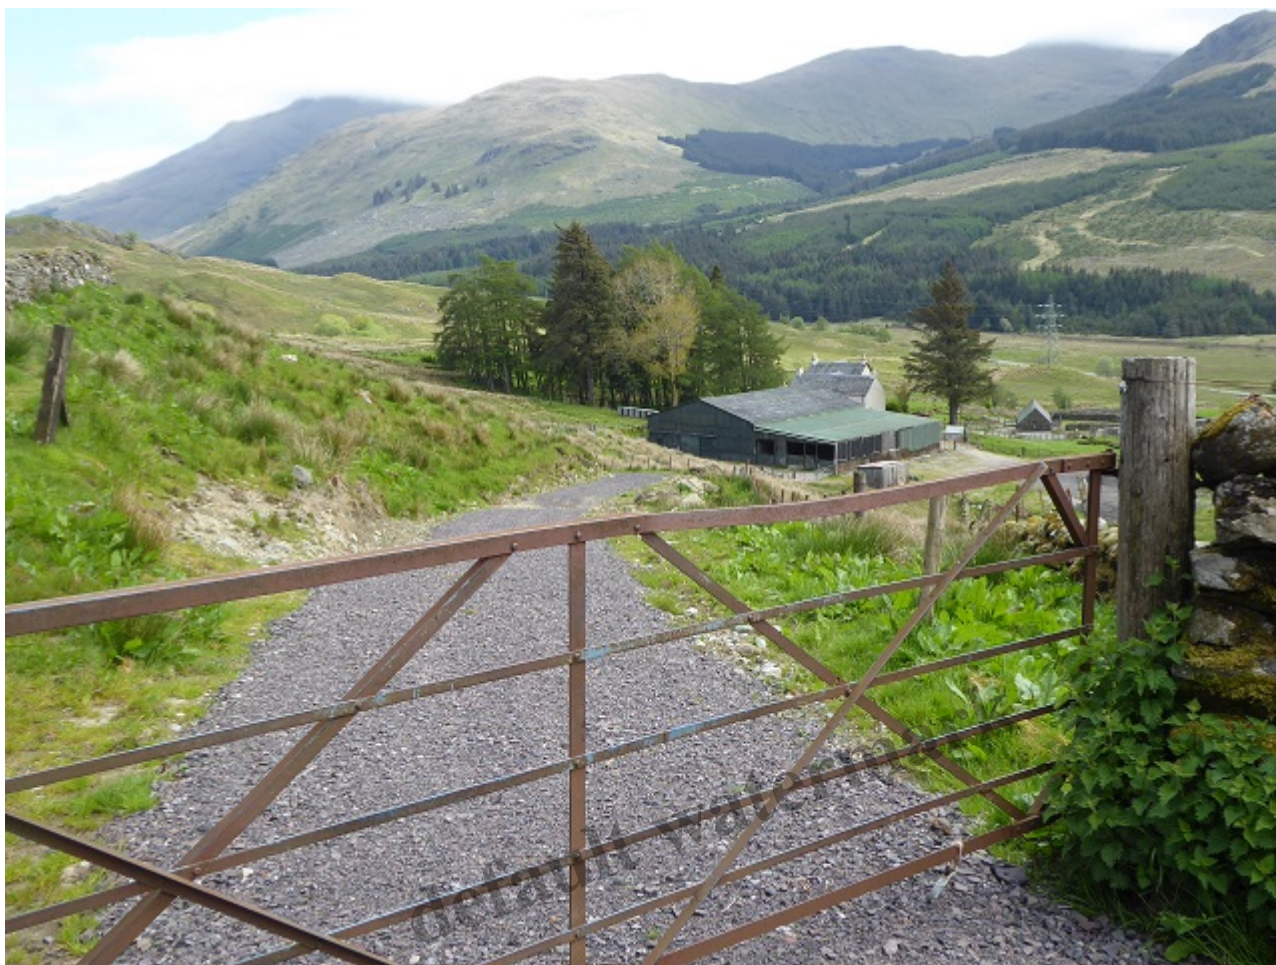
I also noted that the track down from the WHW to the farm had been upgraded using the same material and at the same time (photo above). I asked the LTTNPA whether this formed “*any part of the grant agreement or was it arranged and paid for completely separately by the farm?*”

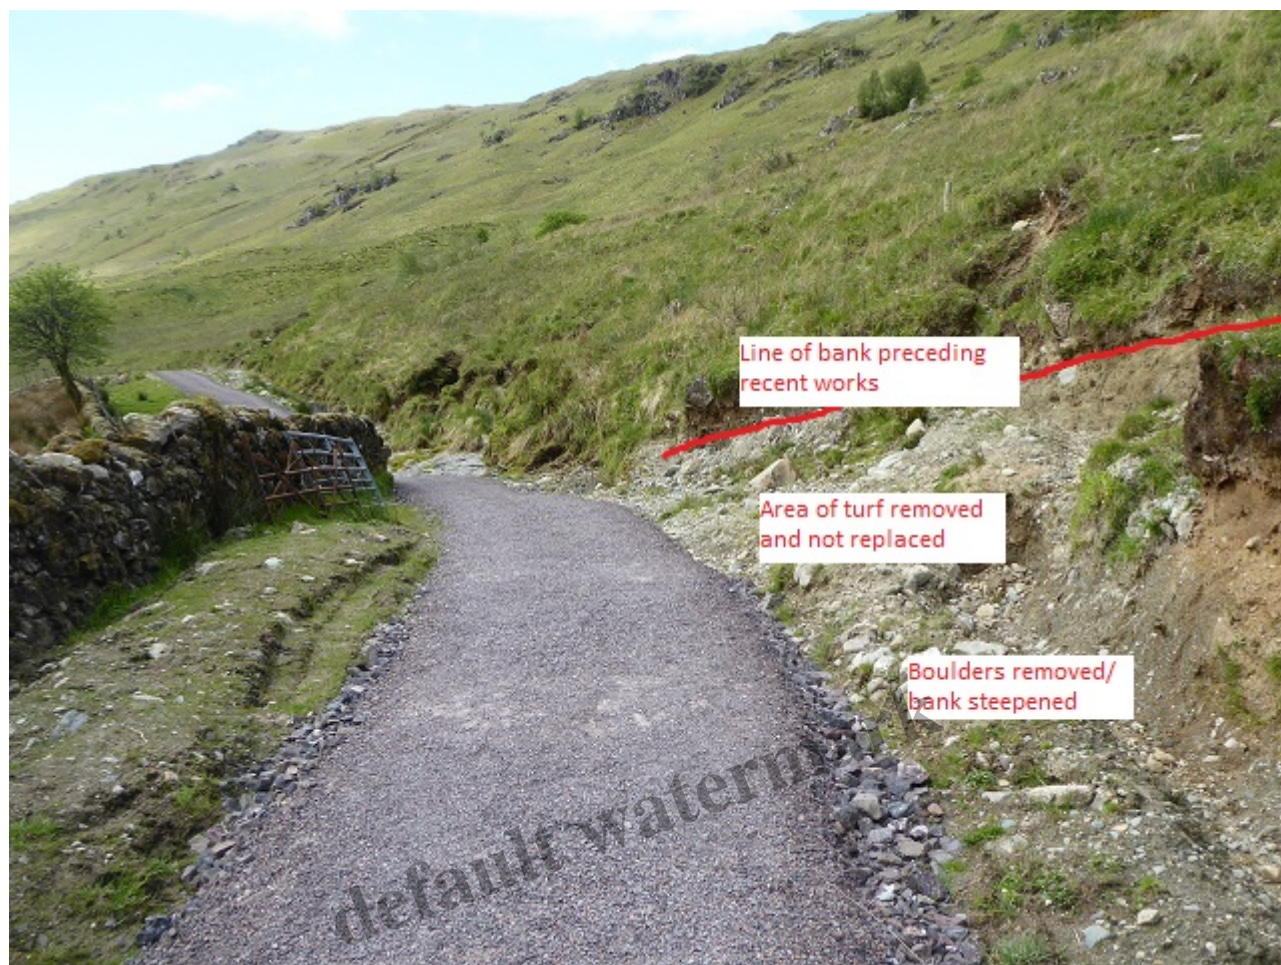
Photo is taken several metres closer to the farm junction than that by Gordon Baillie

I am not disputing the track had been messed up by farm vehicles prior to the works. Indeed the right hand edge of the Gordon Baillie photo shows a section of path above the track and it appears that the deep mud forced walkers off the track eroding the land above. That needed to be fixed. However, the photo clearly shows how an area of ground has been scraped free of turf leaving it bare. That, and the removal of the boulders has increased the area of exposed bank making it more visible.
