The upgrade to the West Highland Way at Keilator, Glen Falloch

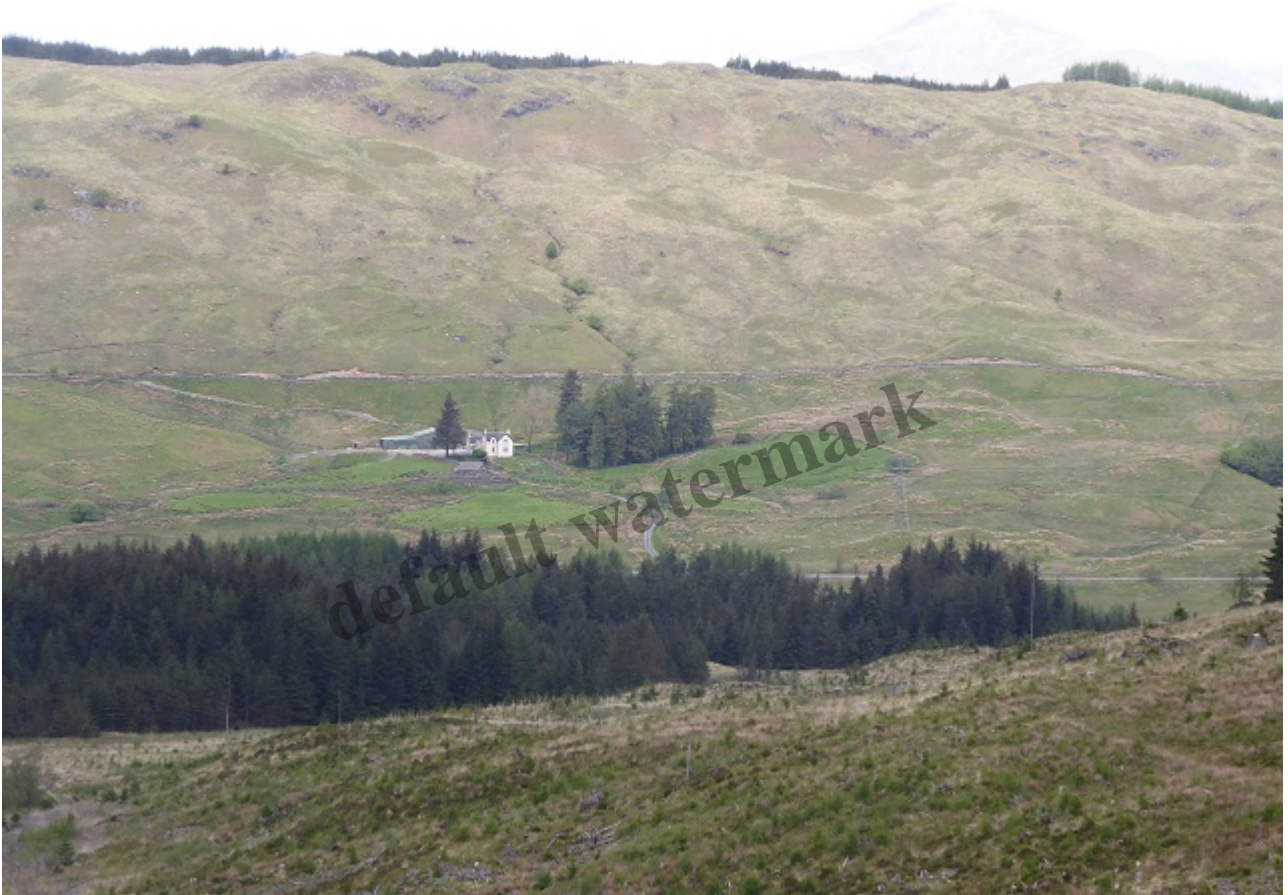
Keilator Farm with the “upgraded” section of the West Highland Way behind it visible as a scar across the landscape

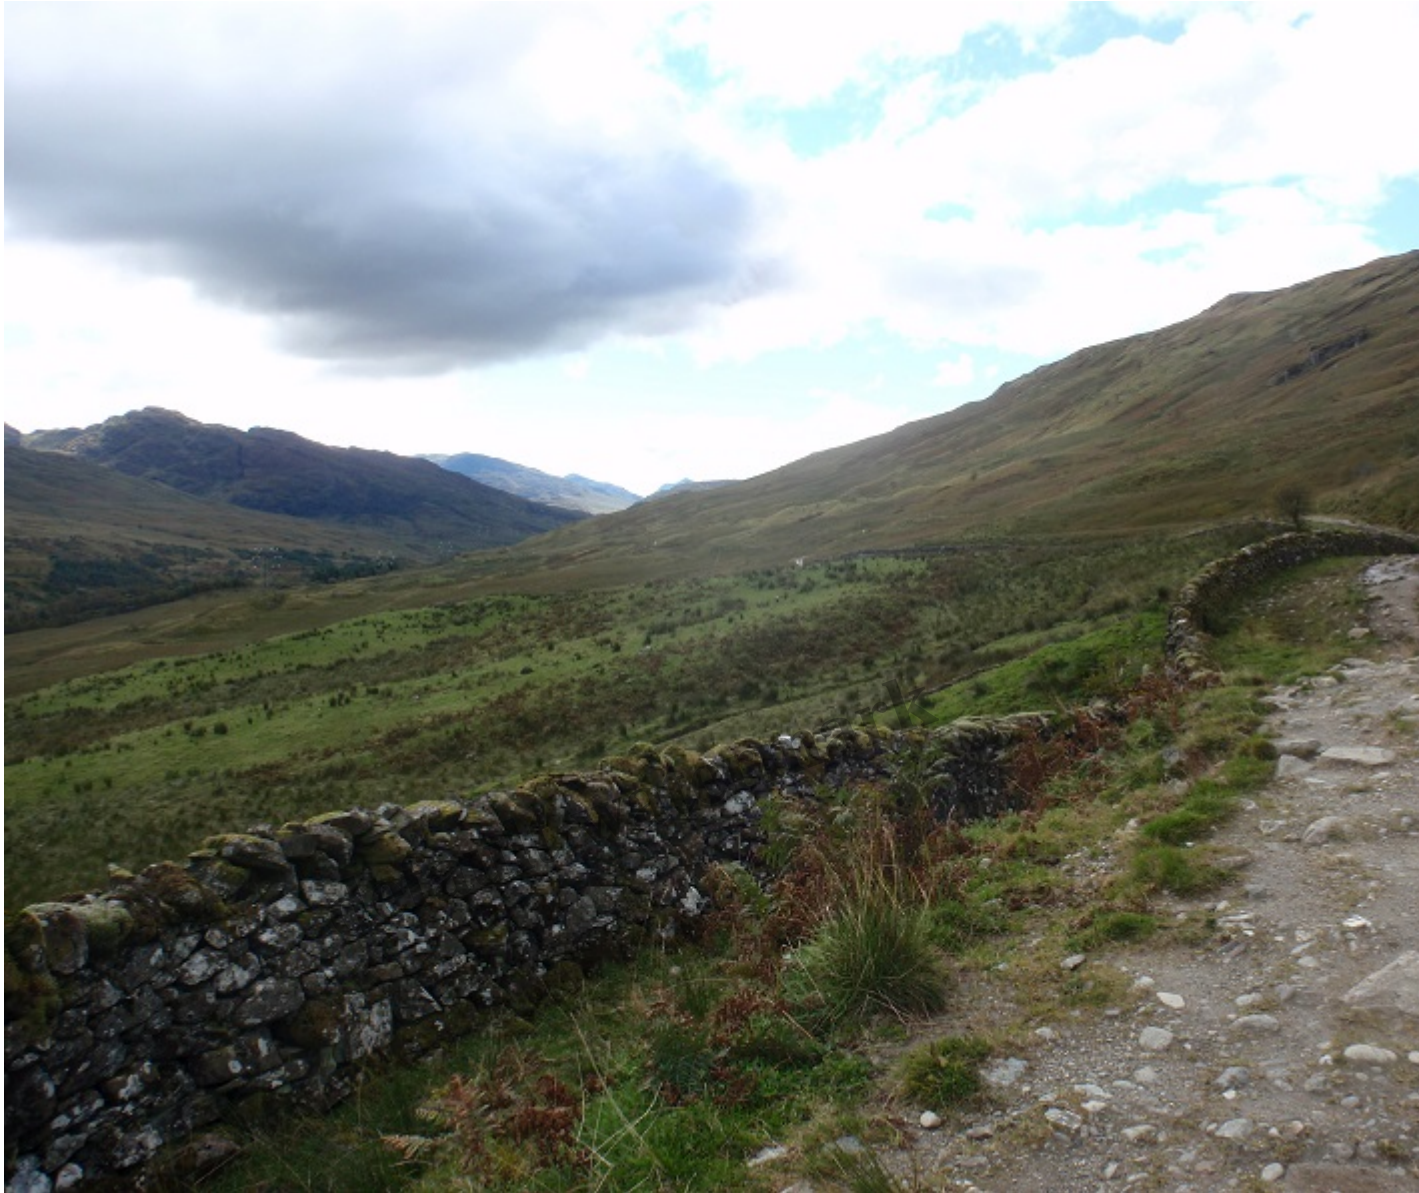
Part of the section of path that has now been upgraded showing how it looked in September 2012.

The West Highland Way by Keilator follows the line of the old military road above a wall which has a very fine topping of *Rhacometrion* or woolly hair moss. Back in 2012 it offered uneven but not particularly difficult walking.

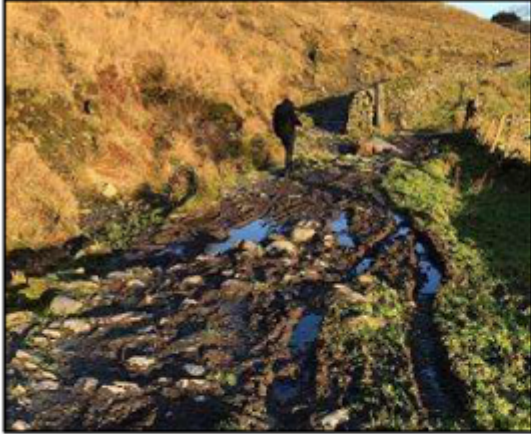
WHW Keilator – before upgrade

This report didn't explain why the path appears to have degraded so badly since the photo I took in 2012 (I had been subsequently but not taken the photos). From the left hand photo, which shows ATV tracks, and from the comments on Facebook about wading ankle deep through cow shit, some of the deterioration at least appears to have been caused by agricultural use rather than by walkers. There is no mention here of the debate that had taken place on Facebook or of all the critical comments there but possibly staff were unaware of this. I therefore decided to go and take a look for myself at the end of May.

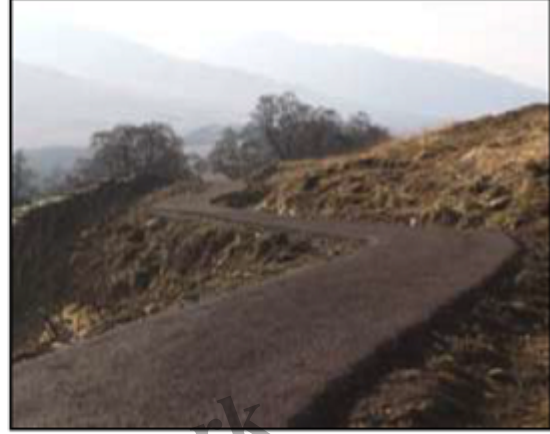
After

The new path is built to IPA specification using locally sourced material and dressed with a whin-type surface for a good 'landscape-fit' and recreational feel - the path has started to bed-in well and the NPA has received many positive comments.

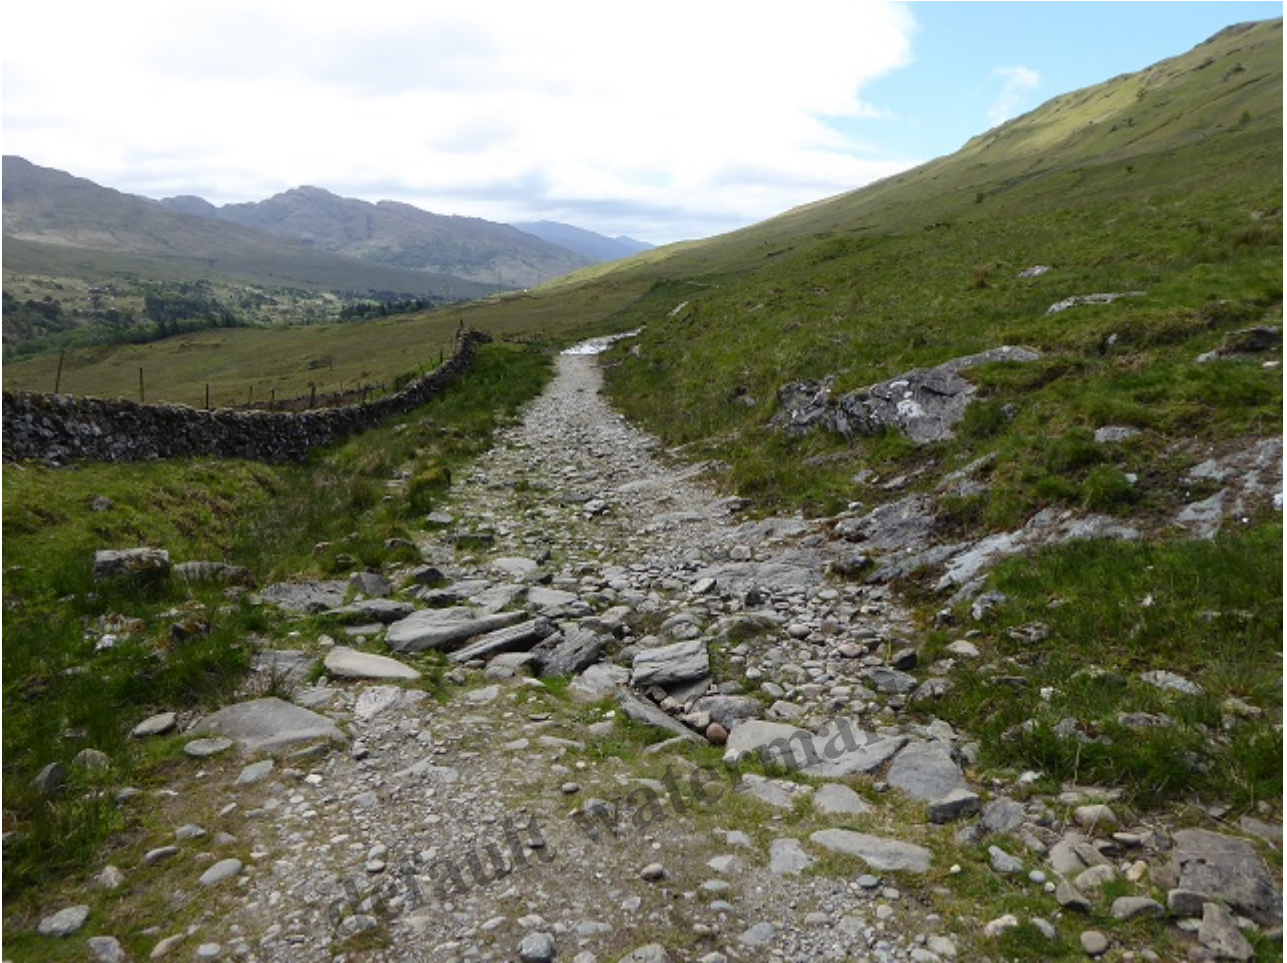
The West Highland Way by Keilator follows the line of the old military road. This photo shows the “unimproved” path just before where the recent work started. Its a fairly rough path but not difficult walking.

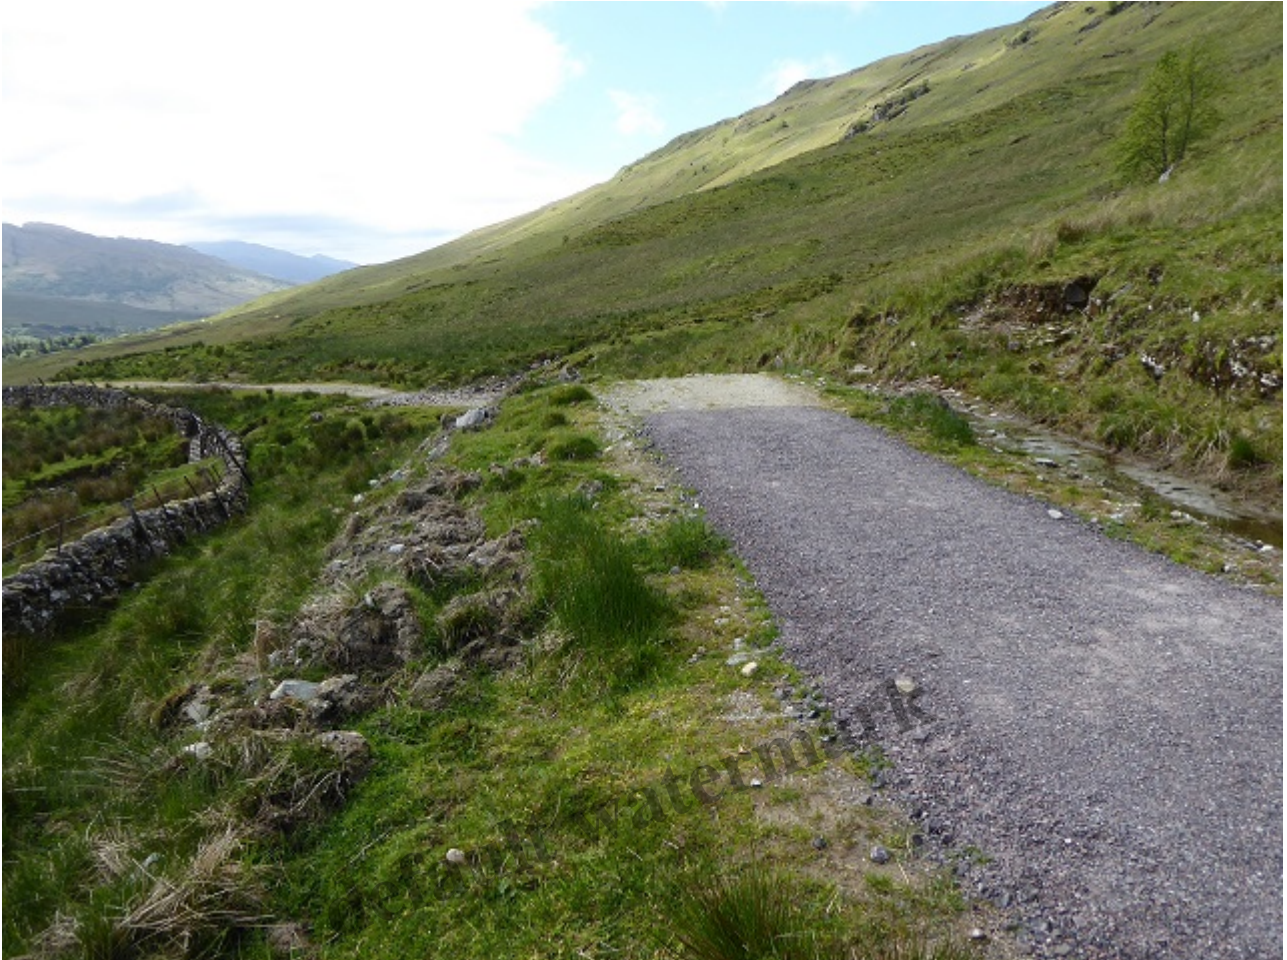
The join between the old and the new, the difference in appearance between the two is striking. One can understand how some people thought from the photos on FB that the new section had been finished with tarmac!

Setting aside its appearance, the first I noticed on reaching the new path were the turves which had been dumped on the lower side of the track. That is contrary to standard pathwork good practice. Moreover, while the LLTNPA's requirements are often ignored, a standard condition for all new hydro tracks is that turves should be properly stored and replaced. If the specifications for works under the Improving Public Access scheme allows work of this poor quality its not fit for the purpose.

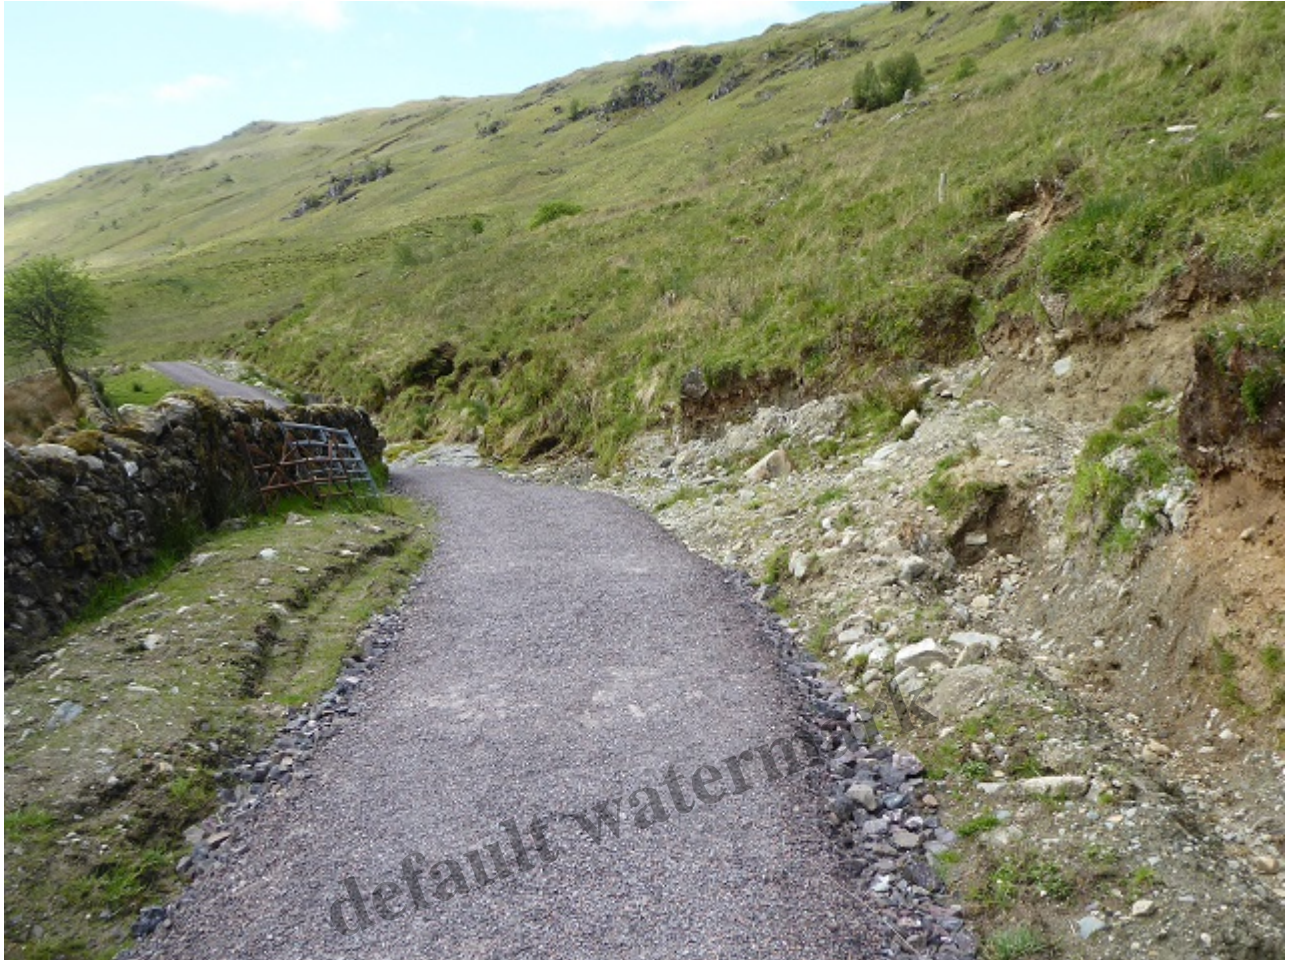
Note the wheel damage that has already been done to the ground on the left side of the track.

You don't have to walk far to find plenty of places where the turves could have been re-used. Nor to find evidence that the damage that had been done to the West Highland Way by agricultural use appears to be continuing. What's the point of spending public money on repairing paths – this section of the West Highland Way had previously I understand been upgraded using machine tools – unless proper measures are in place to prevent further unnecessary damage and the work is done to appropriate standards?

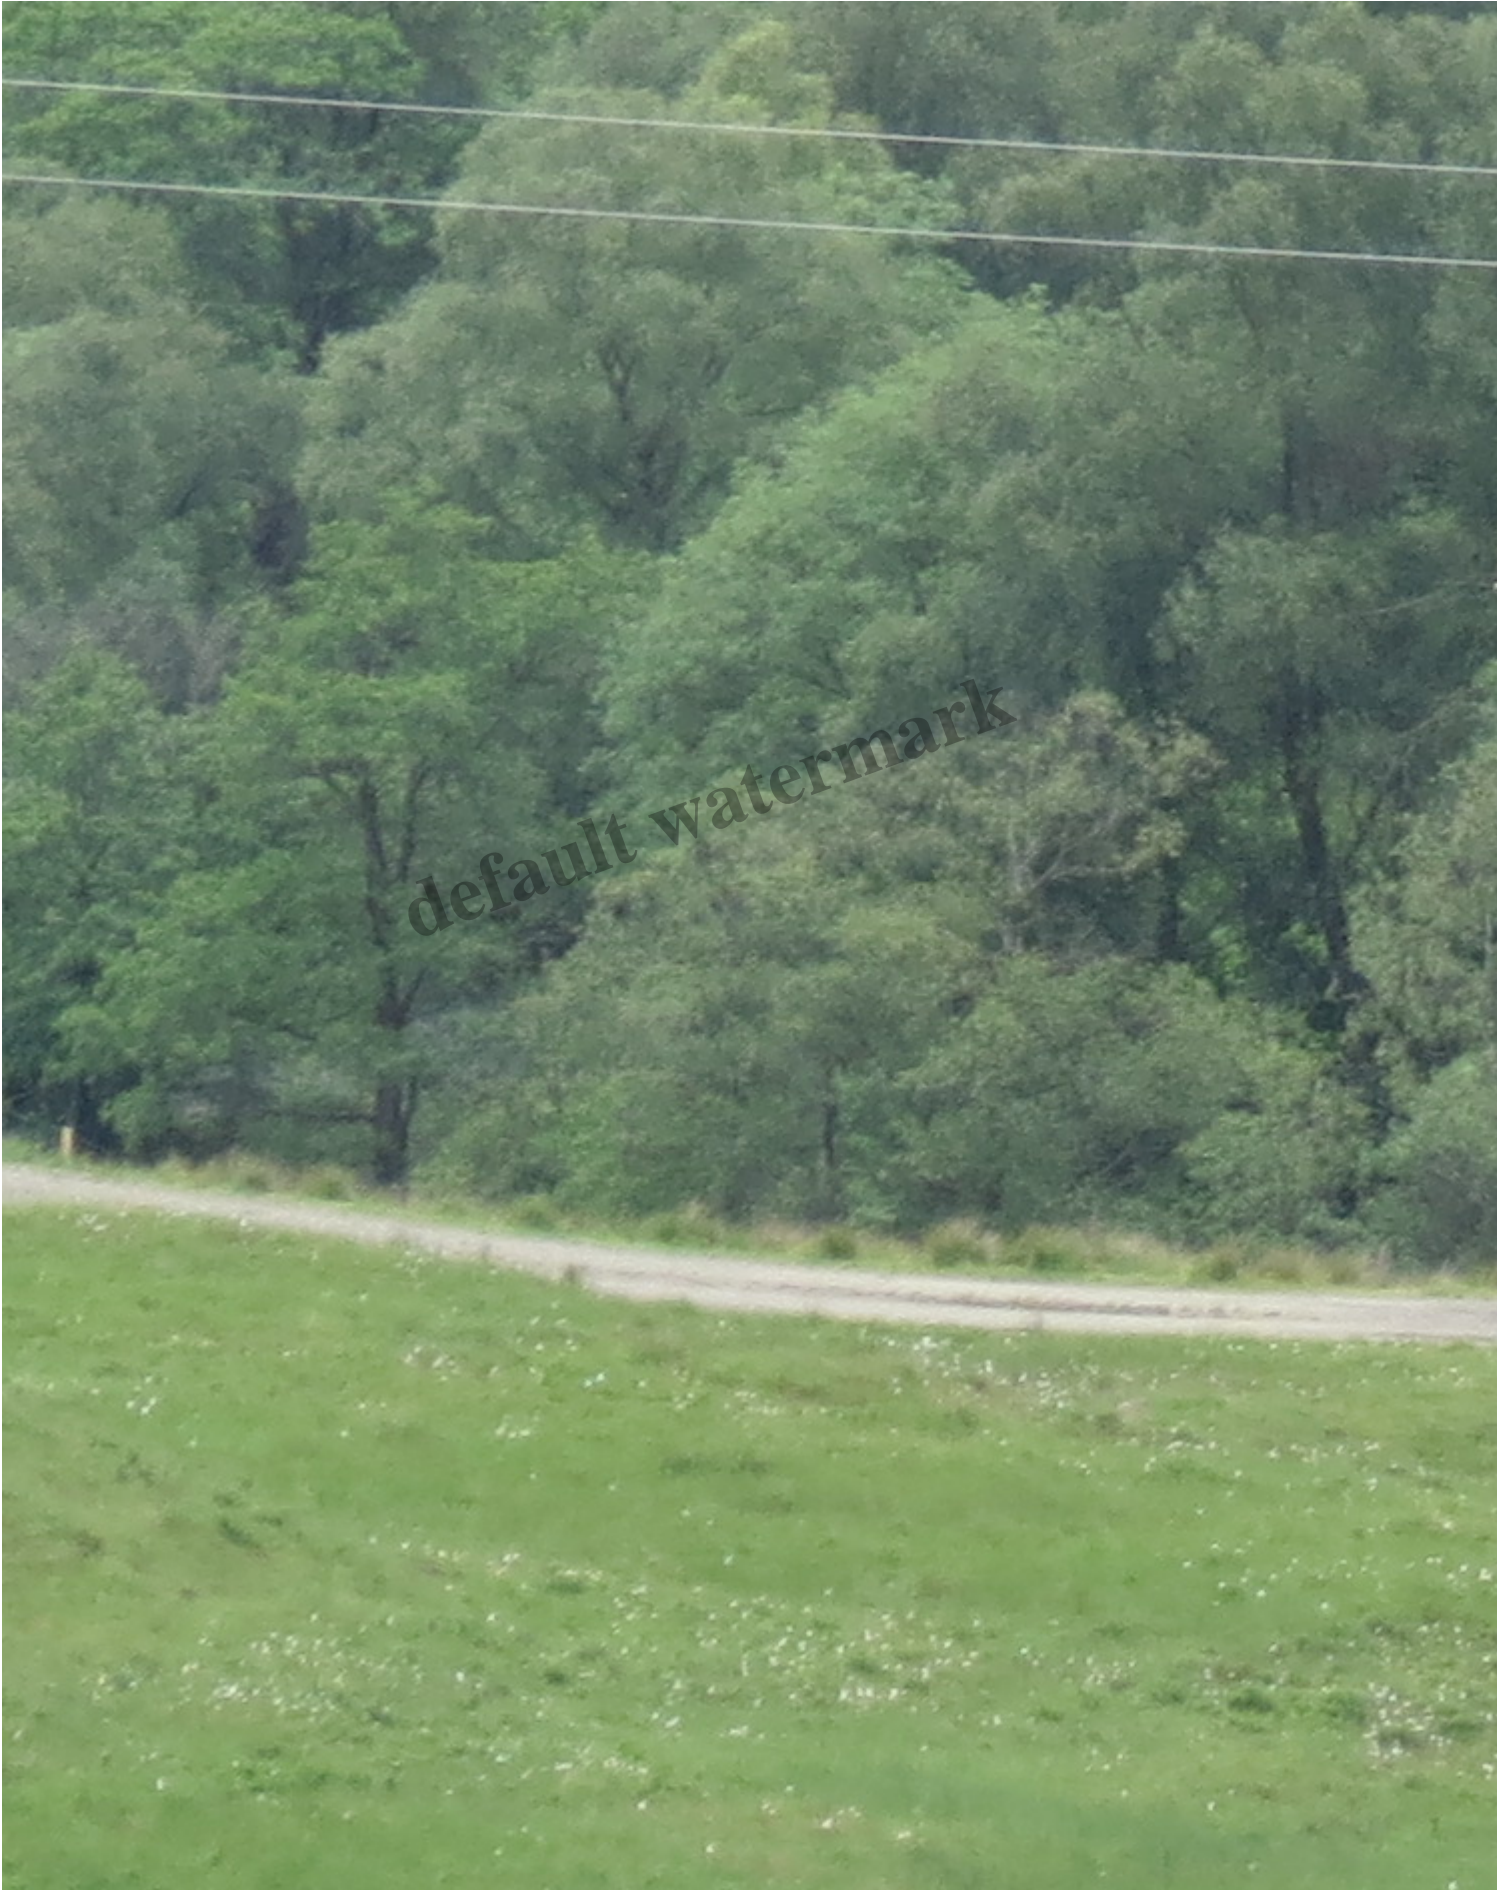
A little further on the path “upgrade” gets even worse

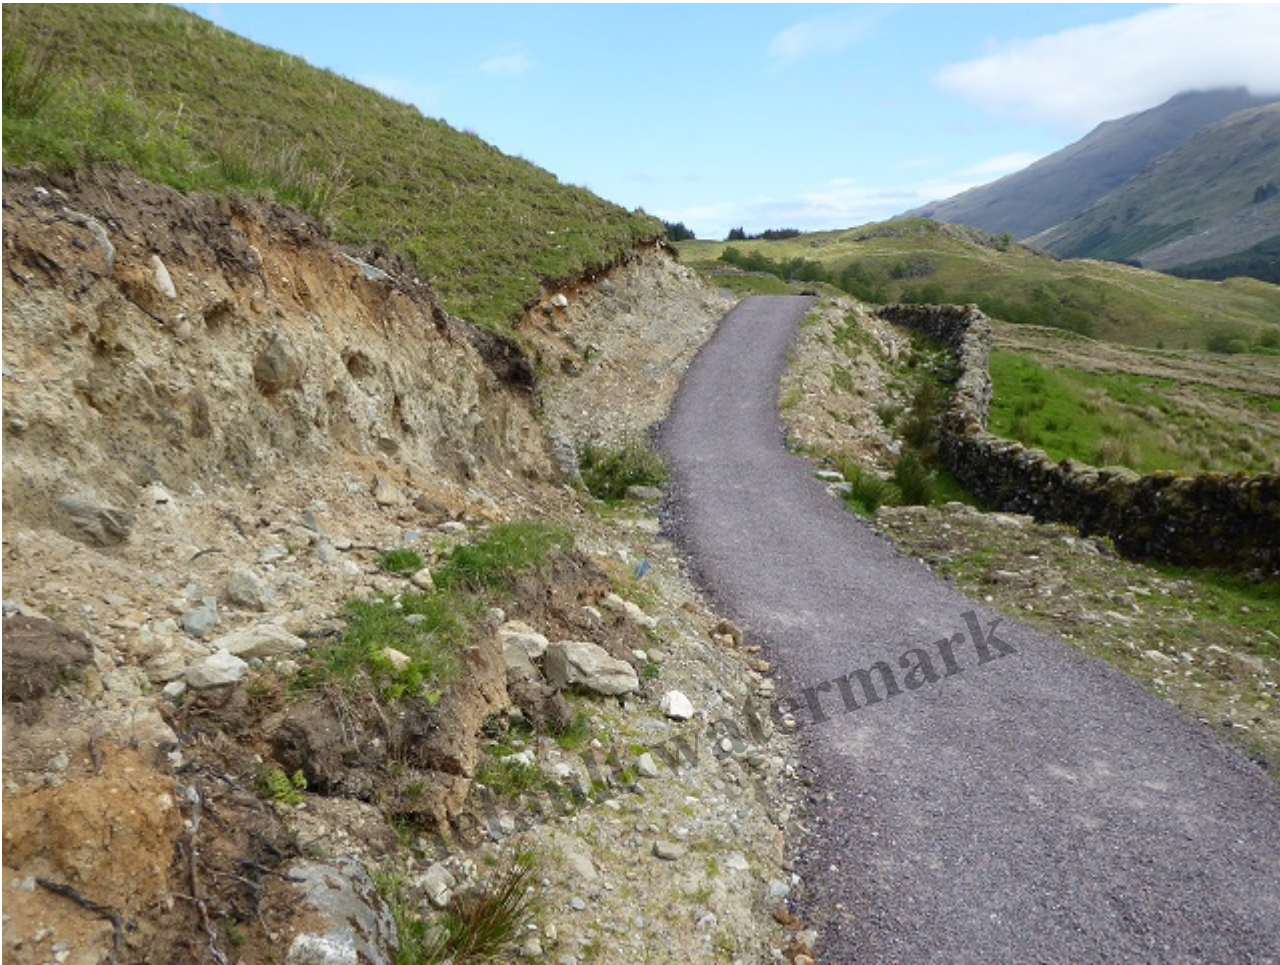
I have to say that however critical I have been about hydro schemes, I can think of few scars apart from the Conic Hill hydro as bad as this. Prior to the upgrade, there was a bad scar here, but the amount of the scarring appears to have increased as a result of the works and there has been no apparent attempt to restore past damage (the LLTNPA has subsequently informed me that restoration of past damage above the drainage ditch was not in the specification). The upper bank is far too steep. Meanwhile the excavated material has been dumped on the lower side without any apparent attempt at restoration. This doesn't just impact on the walking experience, it has done nothing to address the landscape scar that can be seen from the other side of the Glen (top photo).

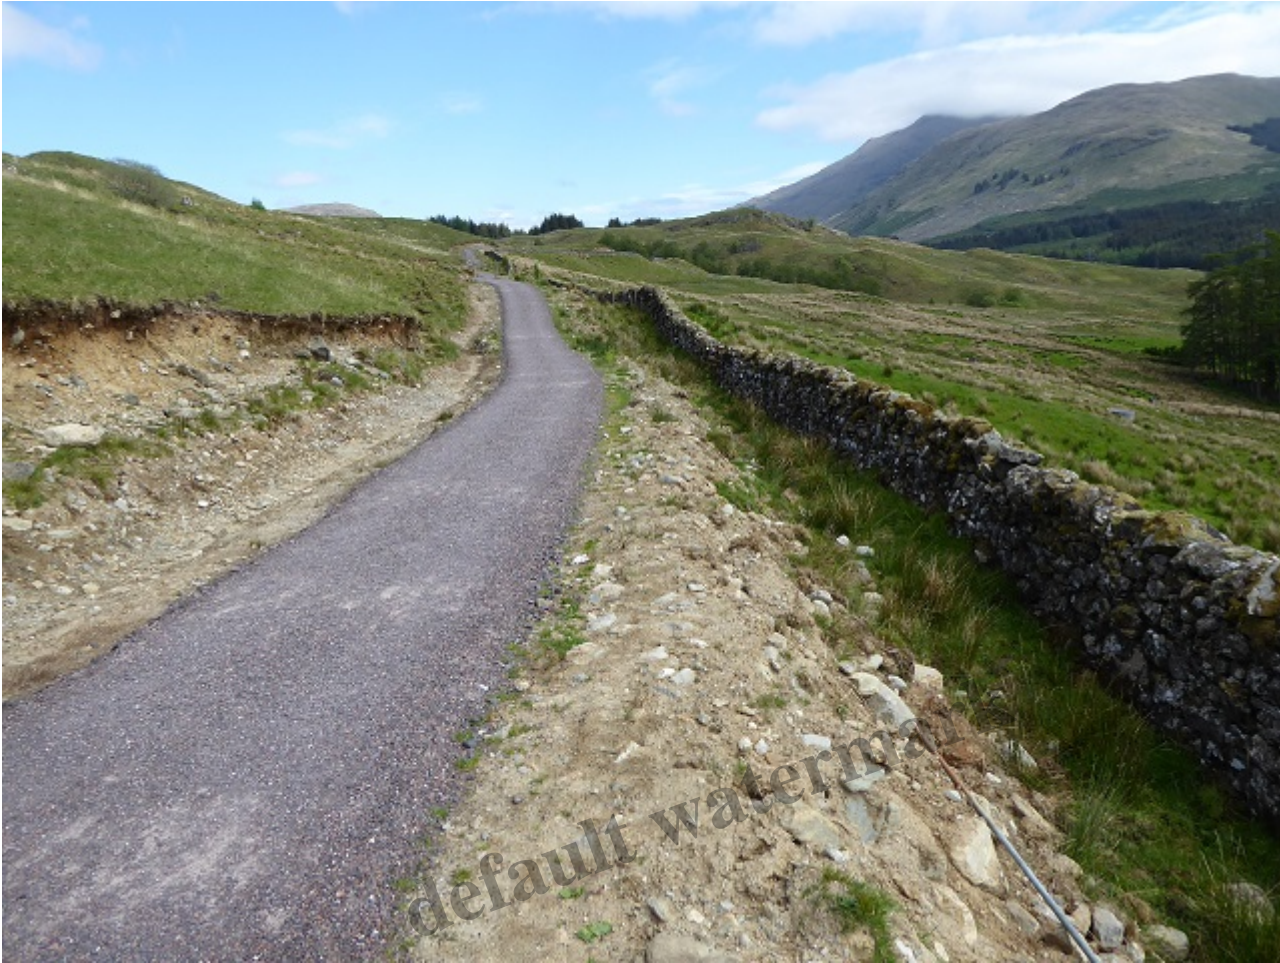
None of this damage required planning permission. Under the LLTNPA's best practice guidance on renewables they recommend that benches cut across hillsides should be avoided but this is precisely what they have allowed to remain at Keilator. The LLTNPA urgently needs to set standards for footpath design and work which are appropriate for a National Park.

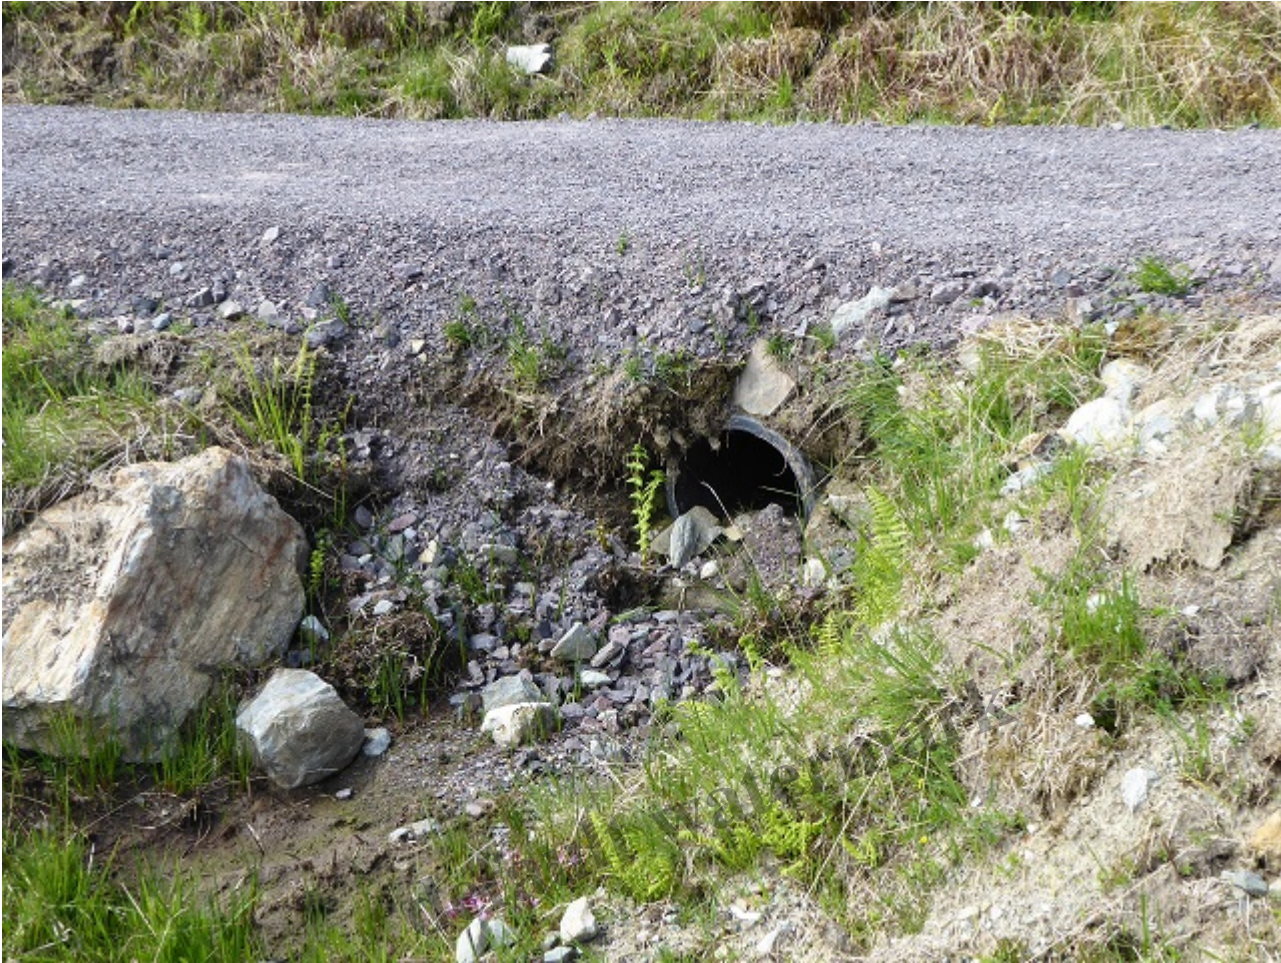
Surfacing from the path is already eroding away and the standard of finishing around the culverts is as poor as any old bulldozed track. Is this the way to treat the old military road and what is our best known long distance walking route?

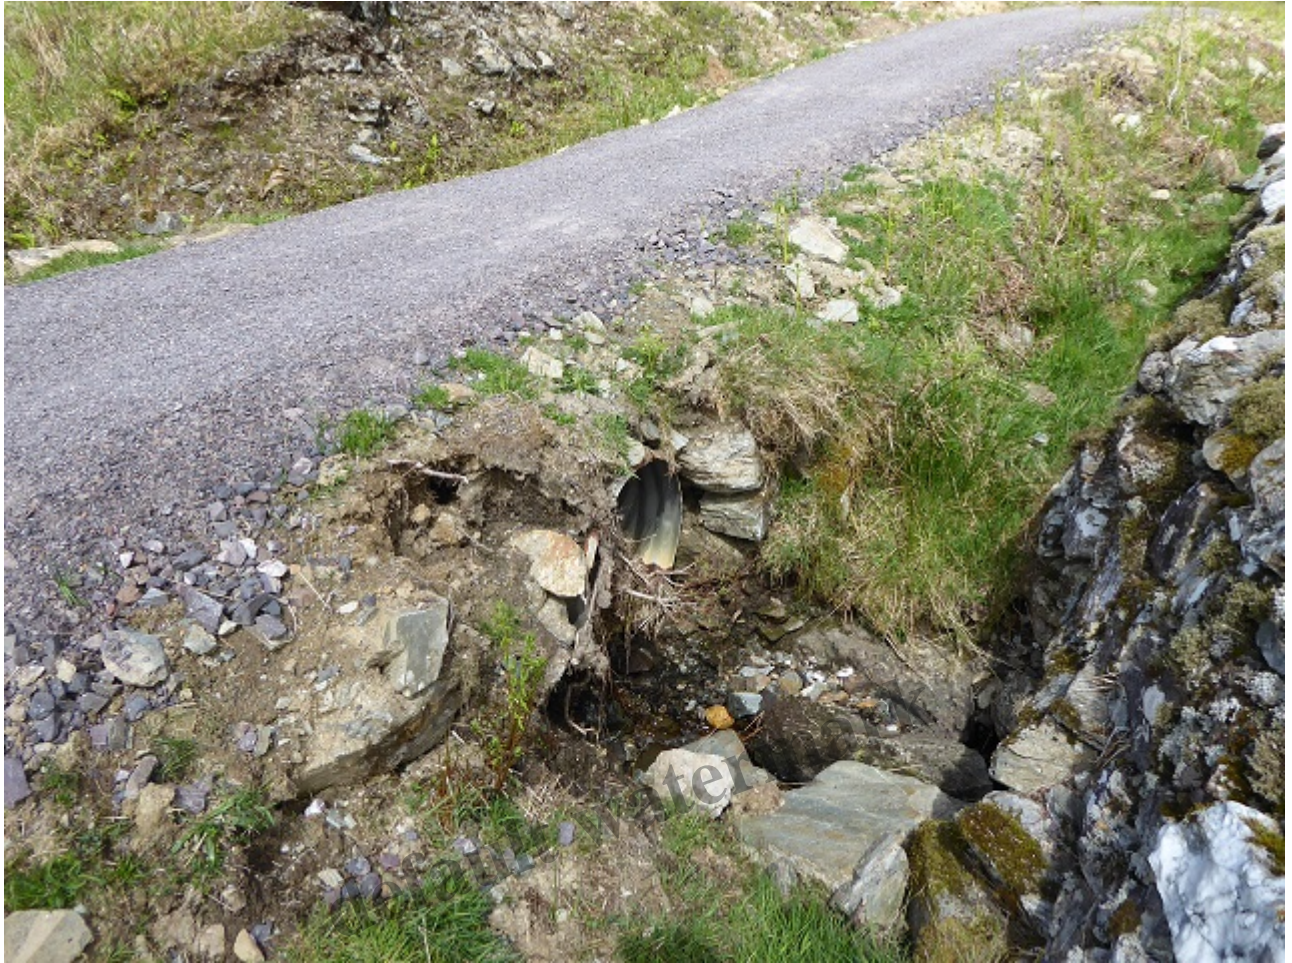
Another collapsing culvert which unless addressed is likely to erode back into the path surface in the near future

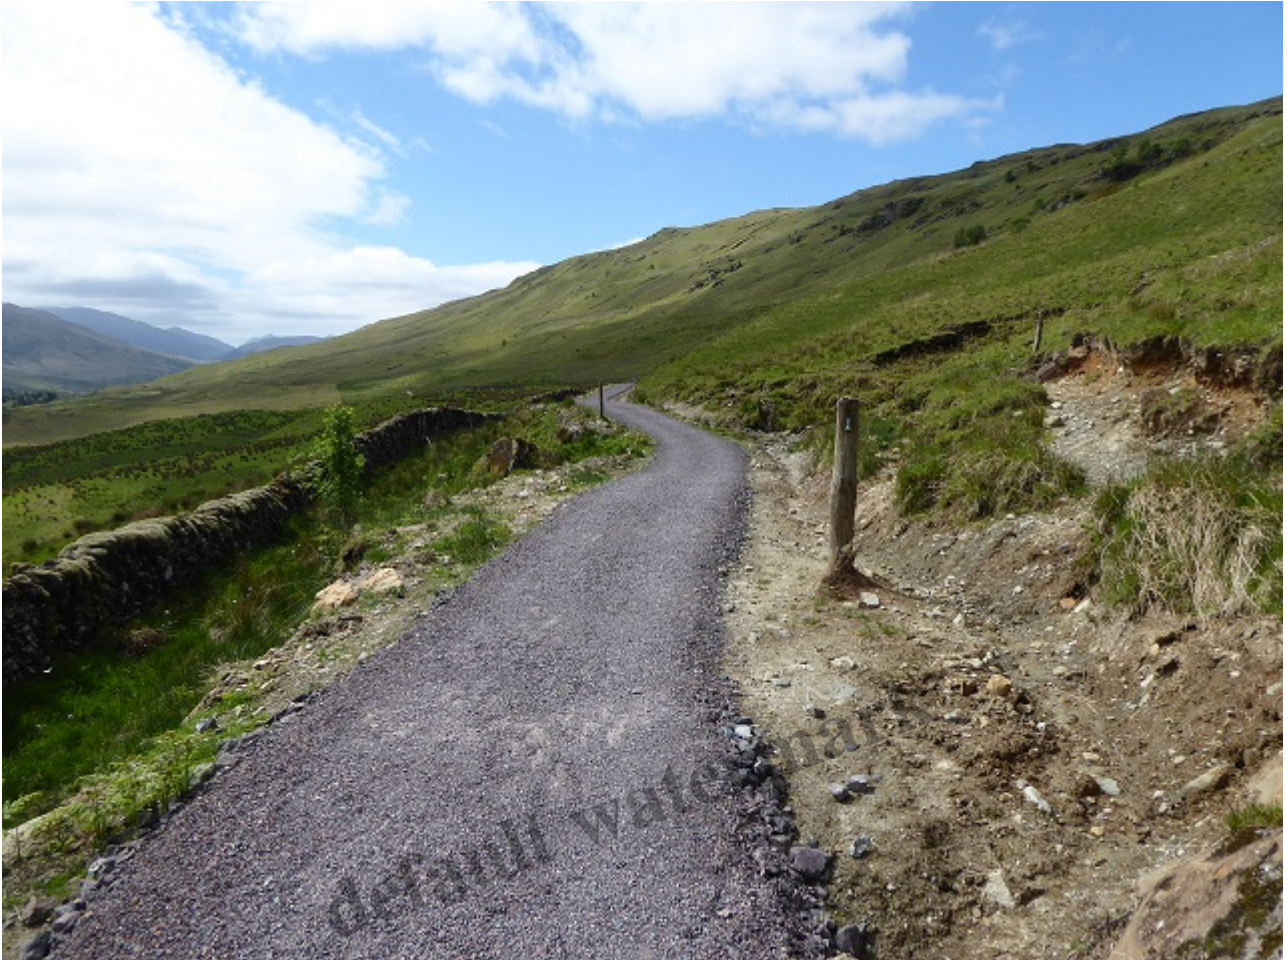
The ground in this photo could have immediately been restored with turves if they had been kept instead of dumped on the lower side of the path. Instead its likely to take several years to revegetate.

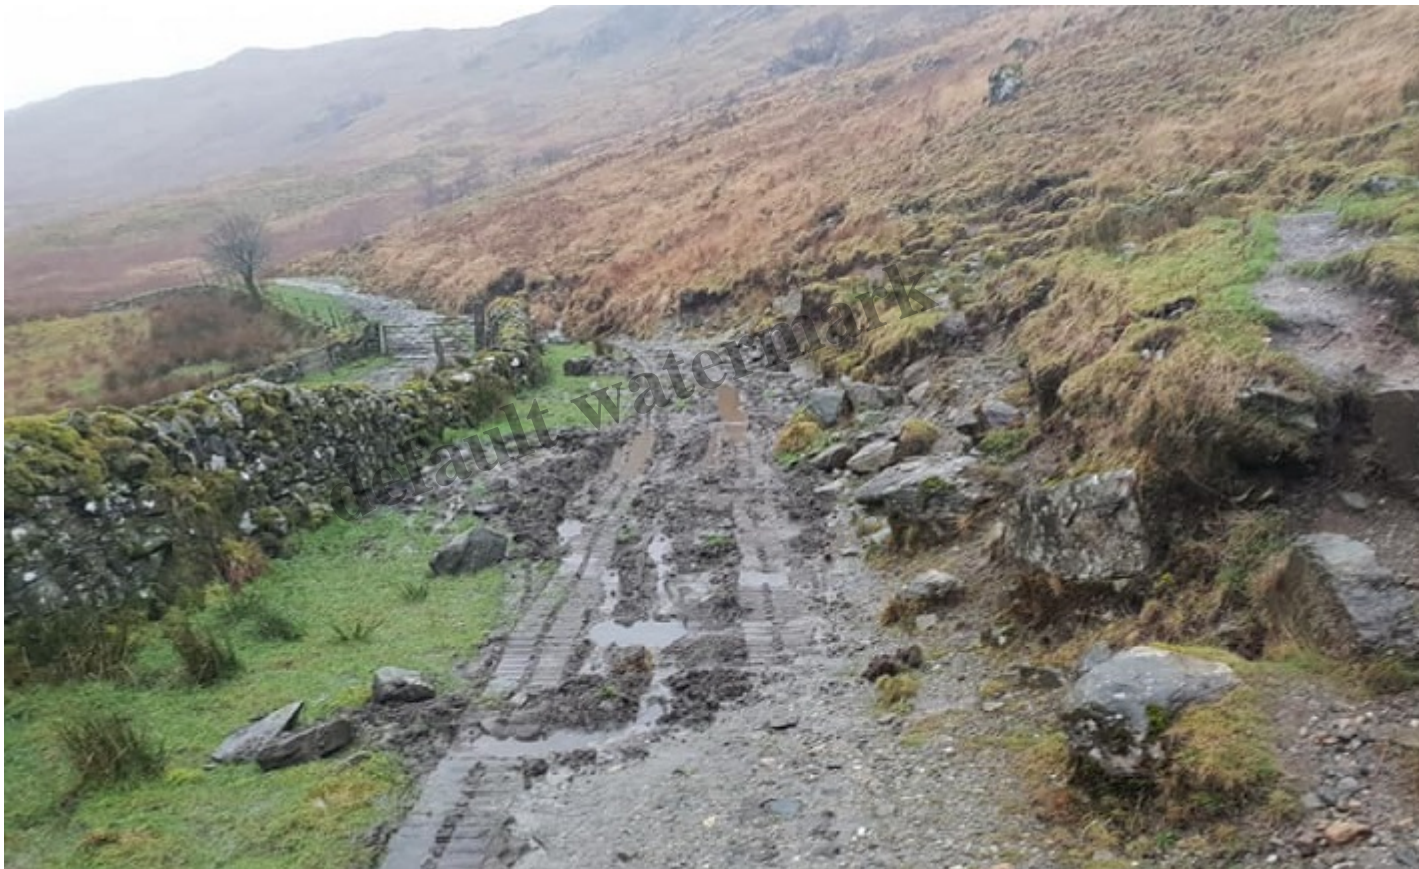
Looking west along West Highland Way to junction with Keilator farm prior to works. Photo credit Gordon Baillie Contracting Ltd

I am not disputing the track had been messed up by farm vehicles prior to the works. Indeed the right hand edge of the Gordon Baillie photo shows a section of path above the track and it appears that the deep mud forced walkers off the track eroding the land above. That needed to be fixed. However, the photo clearly shows how an area of ground has been scraped free of turf leaving it bare. That, and the removal of the boulders has increased the area of exposed bank making it more visible.

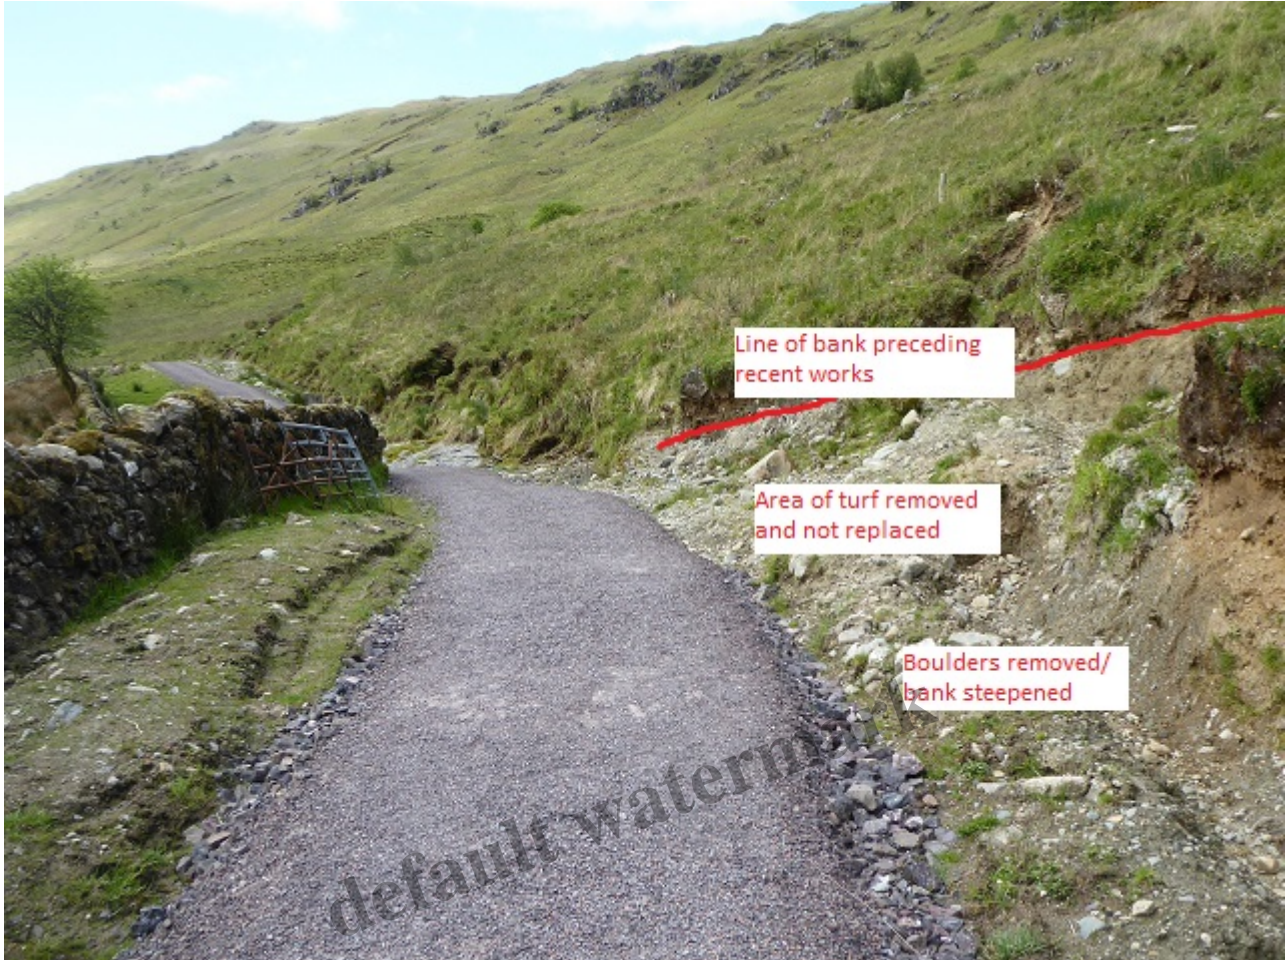
Photo is taken several metres closer to the farm junction than that by Gordon Baillie
