The upgrade to the West Highland Way at Keilator, Glen Falloch

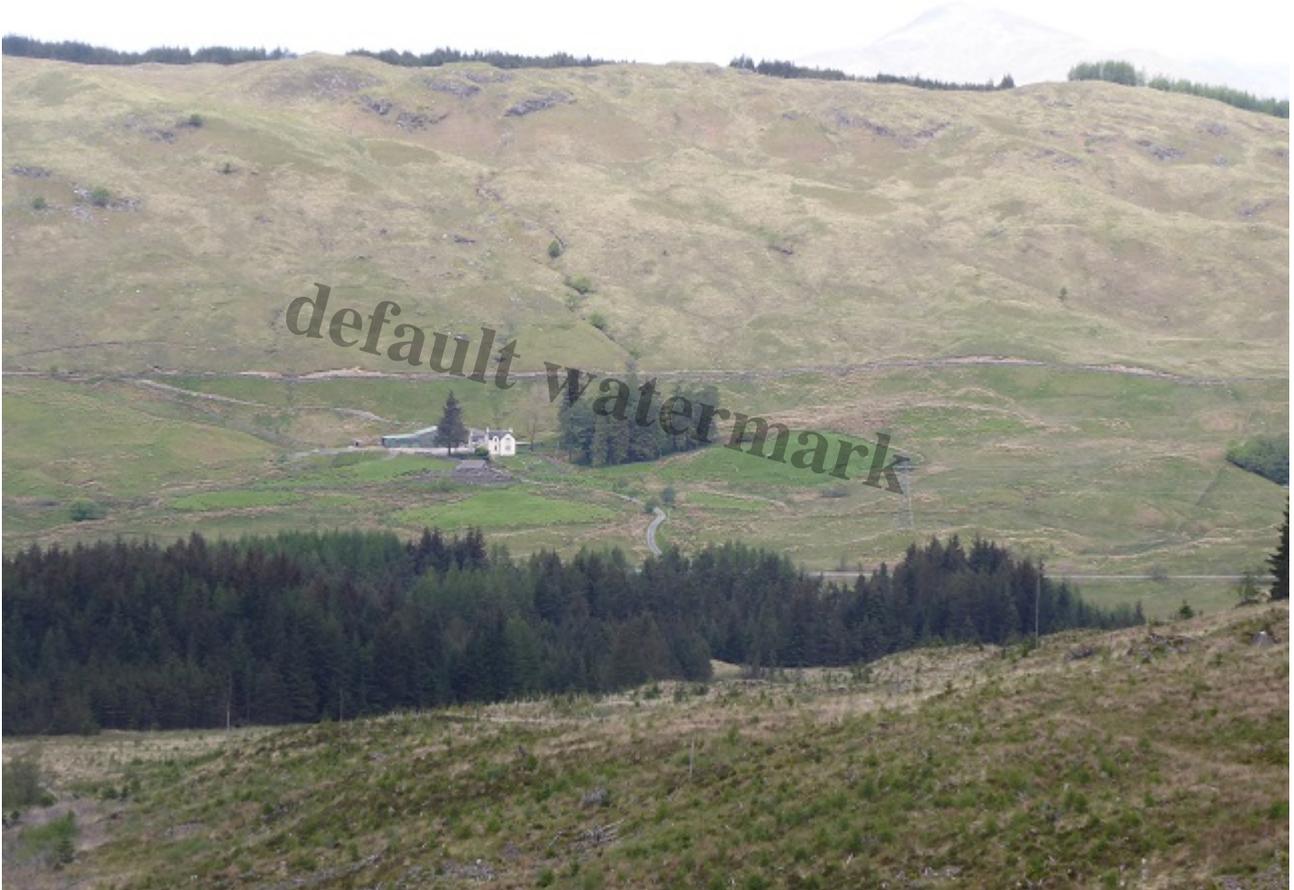
Keilator Farm with the 'upgraded' section of the West Highland Way behind it visible as a scar across the landscape

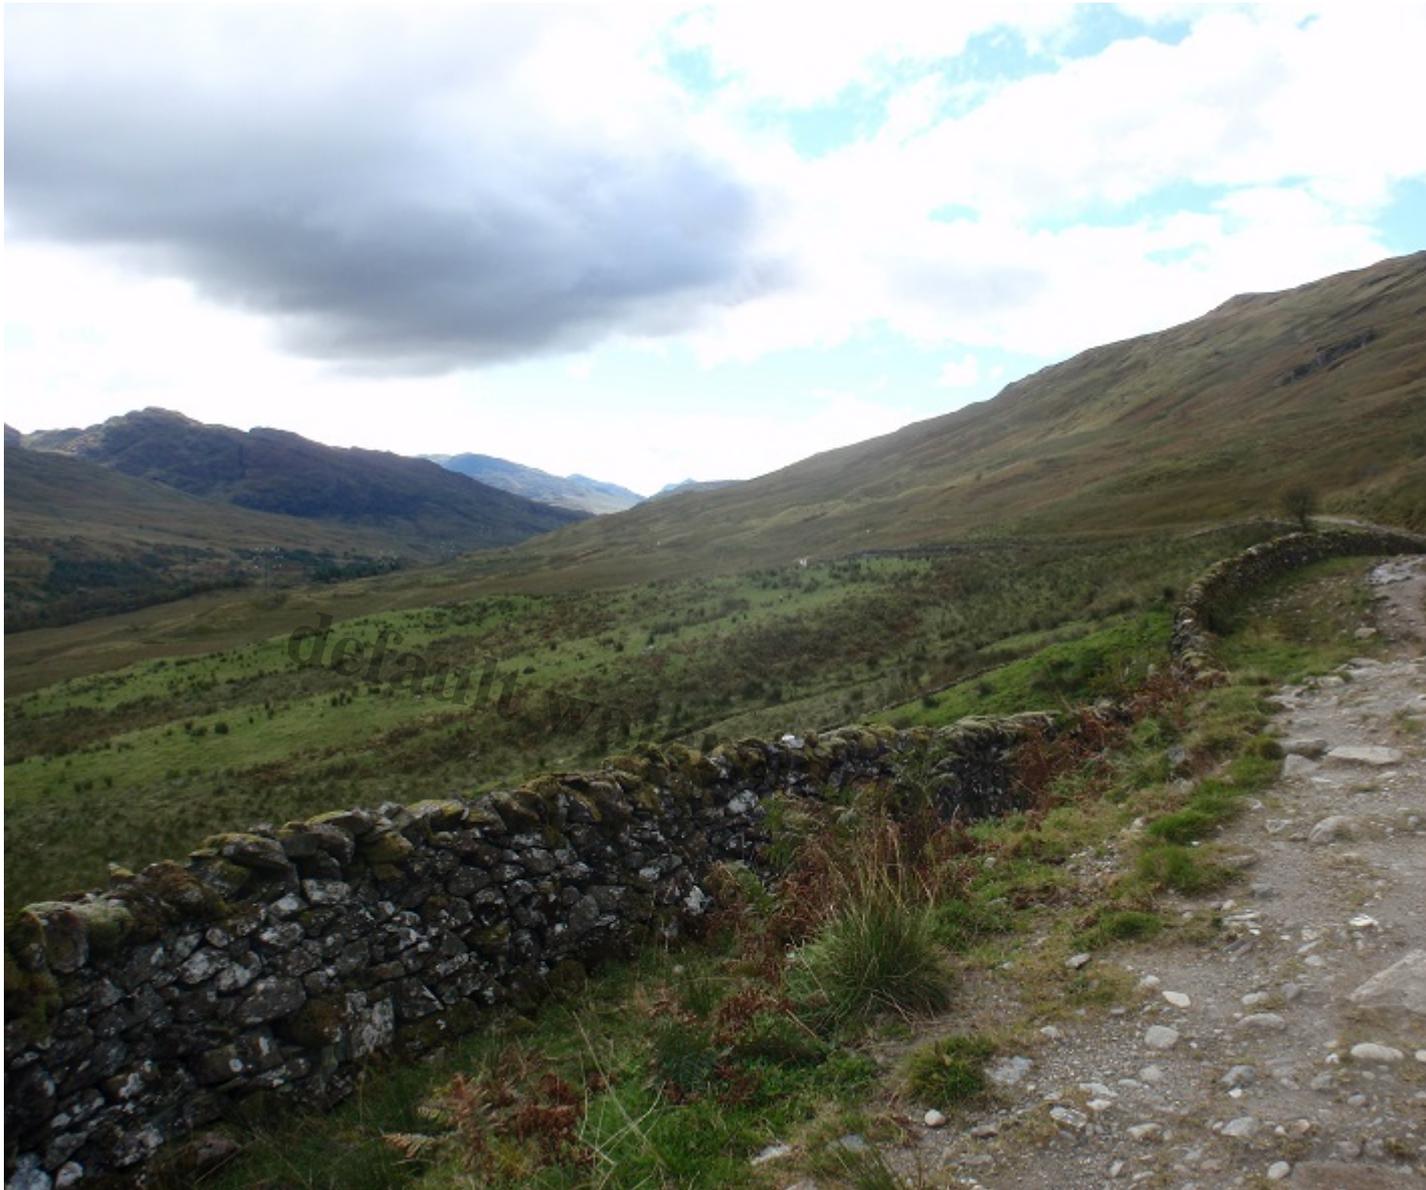
Part of the section of path that has now been upgraded showing how it looked in September 2012.

The West Highland Way by Keilator follows the line of the old military road above a wall which has a very fine topping of *Rhacometrion* or woolly hair moss. Back in 2012 it offered uneven but not particularly difficult walking.

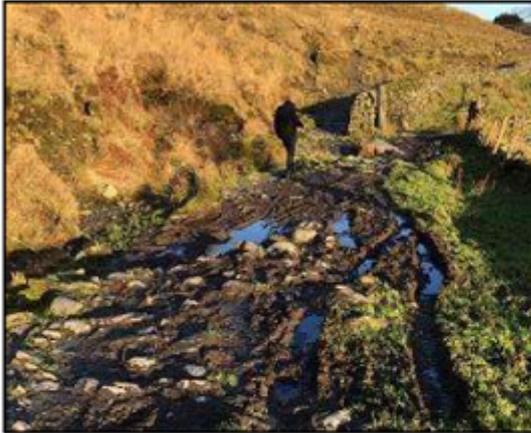
WHW Keilator – before upgrade

This report didn't explain why the path appears to have degraded so badly since the photo I took in 2012 (I had been subsequently but not taken the photos). From the left hand photo, which shows ATV tracks, and from the comments on Facebook about wading ankle deep through cow shit, some of the deterioration at least appears to have been caused by agricultural use rather than by walkers. There is no mention here of the debate that had taken place on Facebook or of all the critical comments there but possibly staff were unaware of this. I therefore decided to go and take a look for myself at the end of May.

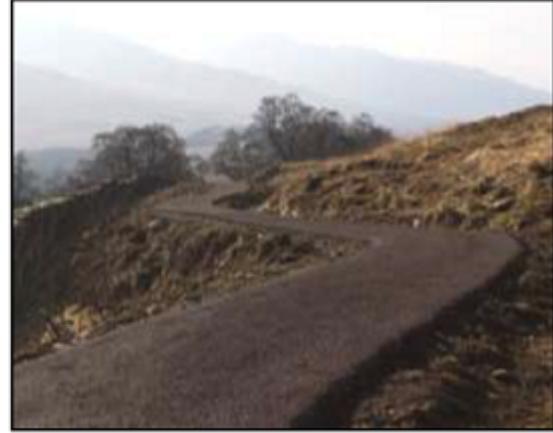
After

The new path is built to IPA specification using locally sourced material and dressed with a whin-type surface for a good 'landscape-fit' and recreational feel - the path has started to bed-in well and the NPA has received many positive comments.

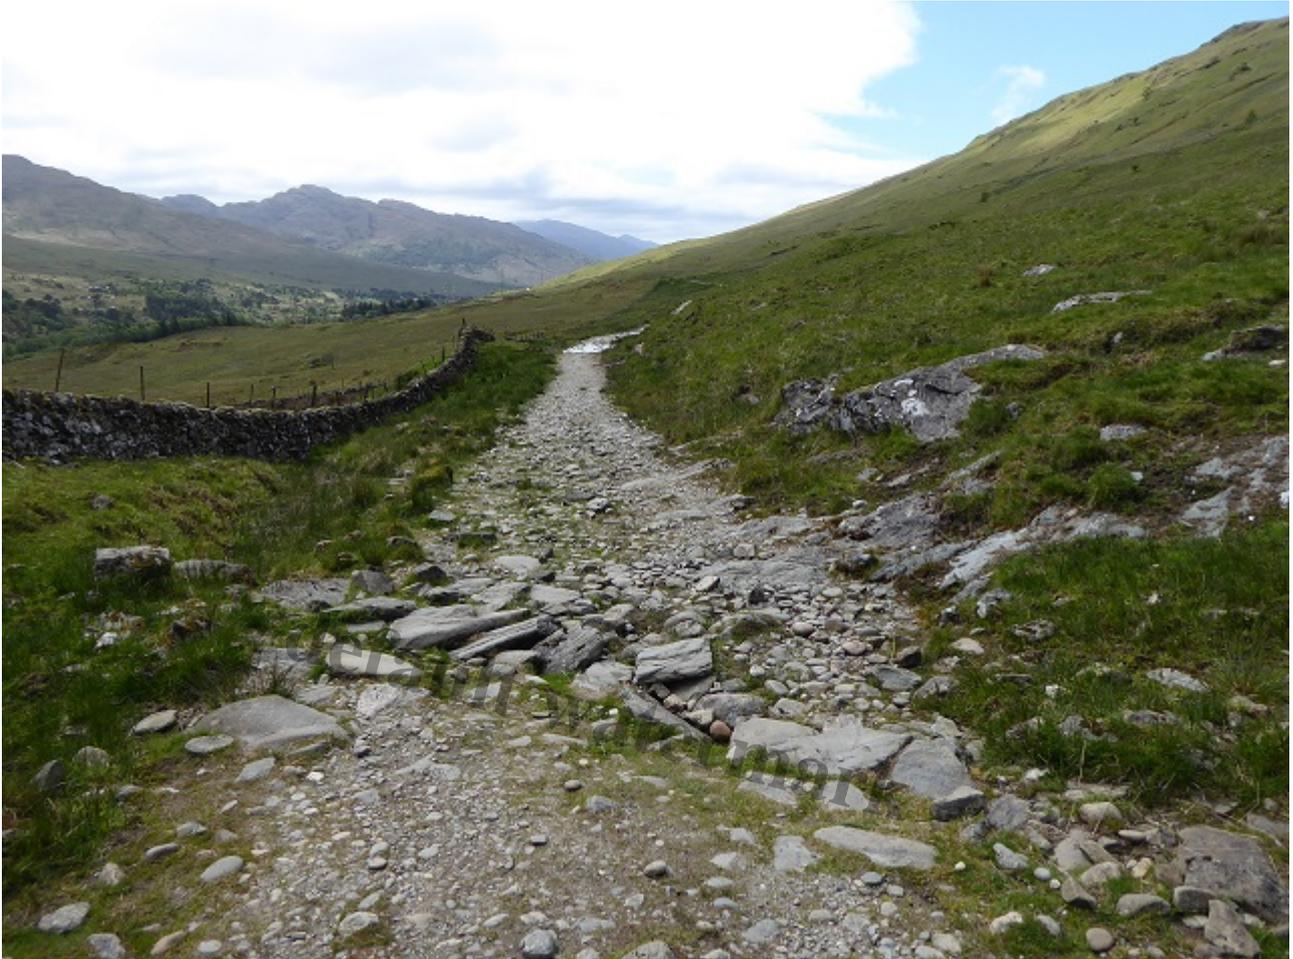
The West Highland Way by Keilator follows the line of the old military road. This photo shows the "unimproved" path just before where the recent work started. Its a fairly rough path but not difficult walking.

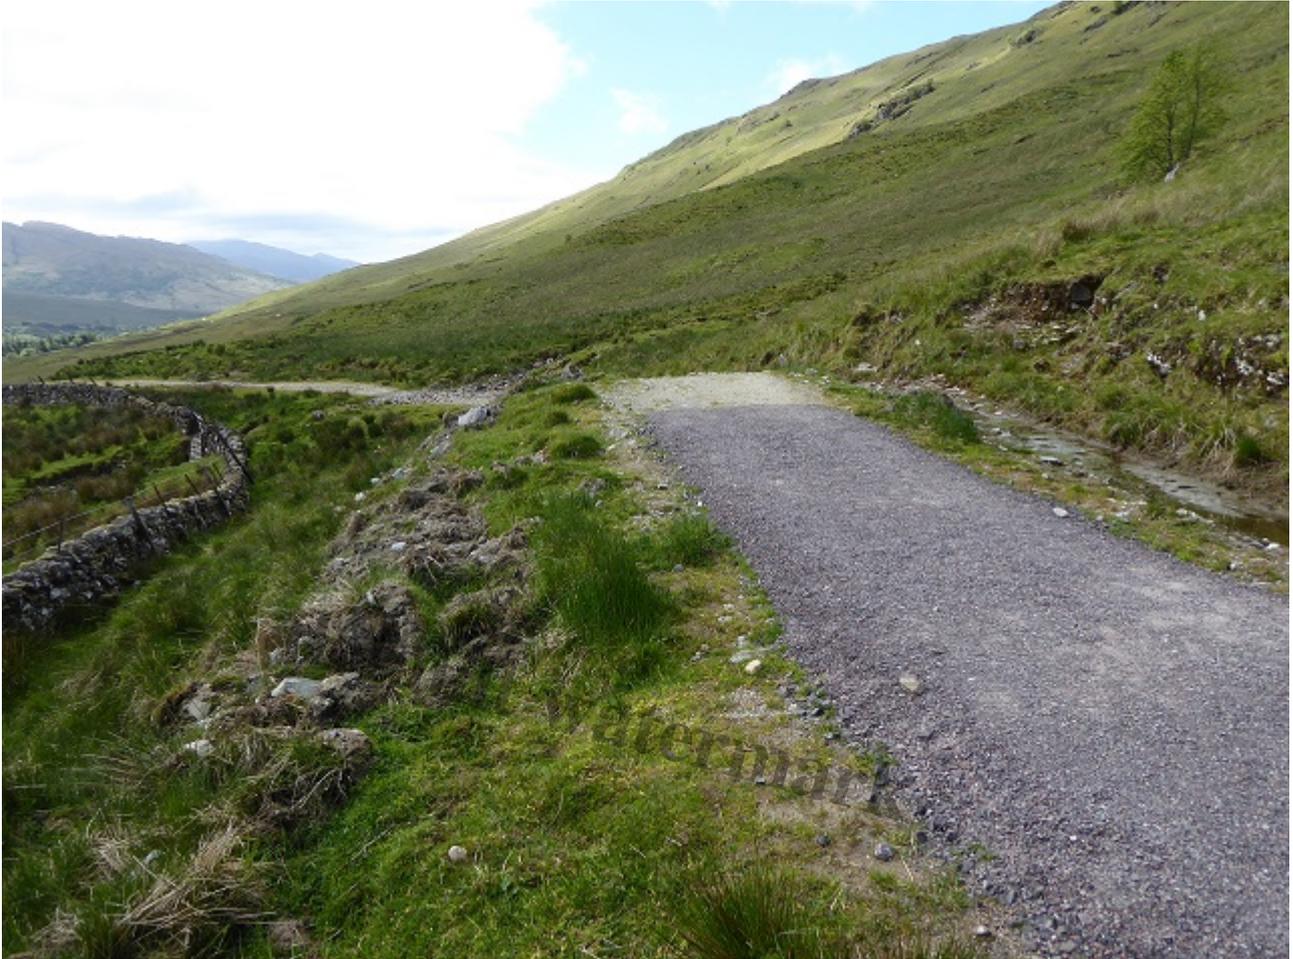
The join between the old and the new, the difference in appearance between the two is striking. One can understand how some people thought from the photos on FB that the new section had been finished with tarmac!

Setting aside its appearance, the first I noticed on reaching the new path were the turves which had been dumped on the lower side of the track. That is contrary to standard pathwork good practice. Moreover, while the LLTNPA's requirements are often ignored, a standard condition for all new hydro tracks is that turves should be properly stored and replaced. If the specifications for works under the Improving Public Access scheme allows work of this poor quality its not fit for the purpose.

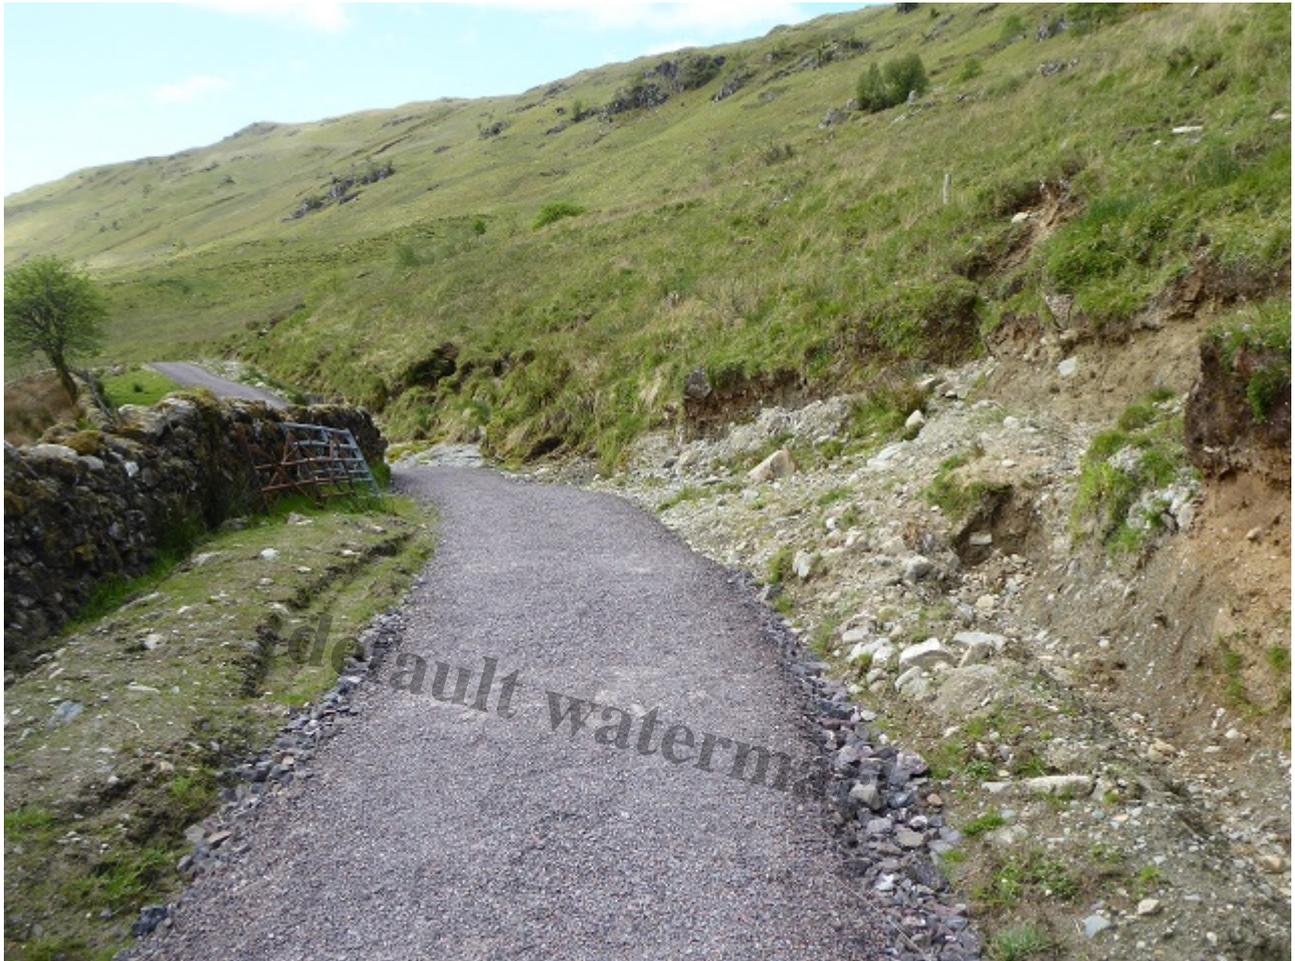
Note the wheel damage that has already been done to the ground on the left side of the track.

You don't have to walk far to find plenty of places where the turves could have been re-used. Nor to find evidence that the damage that had been done to the West Highland Way by agricultural use appears to be continuing. What's the point of spending public money on repairing paths if this section of the West Highland Way had previously I understand been upgraded using machine tools unless proper measures are in place to prevent further unnecessary damage and the work is done to appropriate standards?

The wheel damage reminded me of the cows on the other side of the Glen which had three years ago effectively destroyed the green central strips running down the middle of the new hydro tracks.

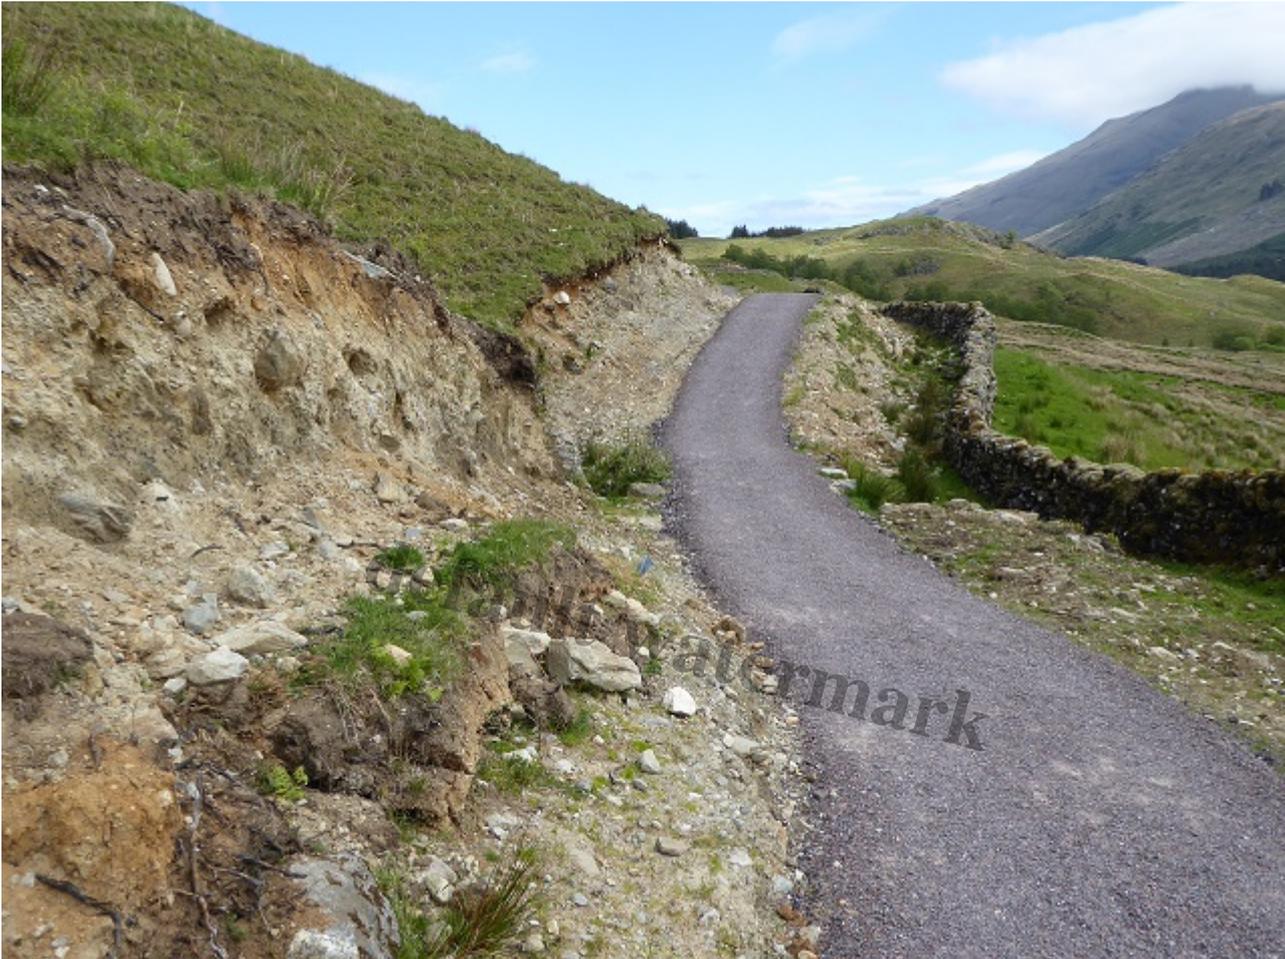
I have to say that however critical I have been about hydro schemes, I can think of few scars apart from the Conic Hill hydro as bad as this. Prior to the upgrade, there was a bad scar here, but the amount of the scarring appears to have increased as a result of the works and there has been no apparent attempt to restore past damage (the LLTNPA has subsequently informed me that restoration of past damage above the drainage ditch was not in the specification). The upper bank is far too steep. Meanwhile the excavated material has been dumped on the lower side without any apparent attempt at restoration. This doesnâ??t just impact on the walking experience, it has done nothing to address the landscape scar that can be seen from the other side of the Glen (top photo).

- agreeing a programme of remedial action to restore the damage that has been done
- investigating the reasons why this section of the West Highland Way has needed extensive work not that many years after it was last upgraded
- consulting with recreational organisations to adopt a clear set of standards for footpath work in the National Park and set up mechanisms to enforce this

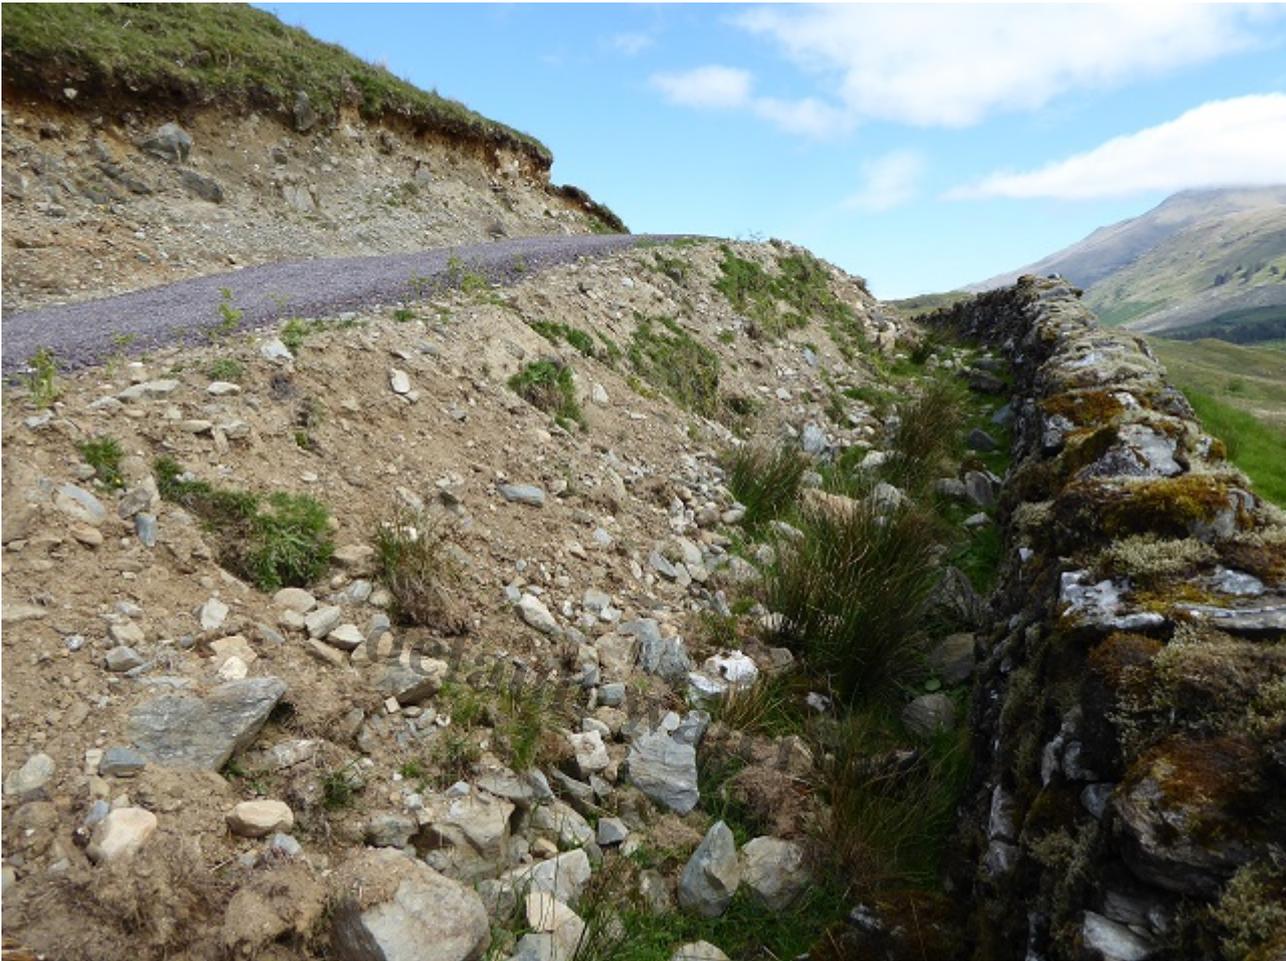
One of the great things about this section of the West Highland Way previously was the fine wall that ran alongside it. While much more recent than the military road, somehow it befitted the route, well built and moss covered. Unfortunately the path upgrading work has treated the wall as being of no account or perhaps as a retaining wall which will prevent the rubble eroding further. To use SNH and National Park terminology jargon, the "landscape character" of the wall has been to a great extent destroyed.

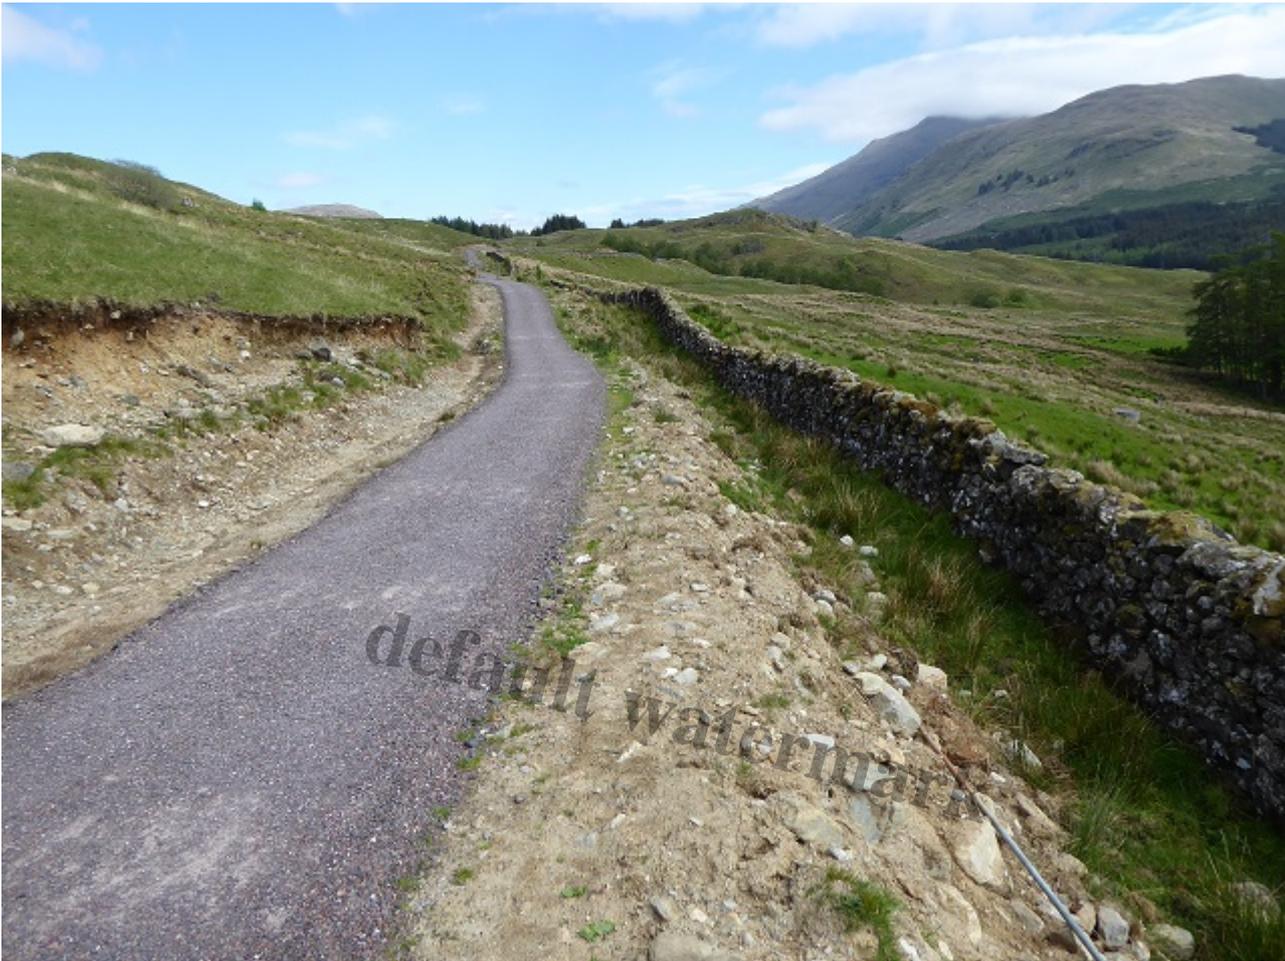
None of this damage required planning permission. Under the LLTNPA's best practice guidance on renewables they recommend that benches cut across hillsides should be avoided but this is precisely what they have allowed to remain at Keilator. The LLTNPA urgently needs to set standards for footpath design and work which are appropriate for a National Park.

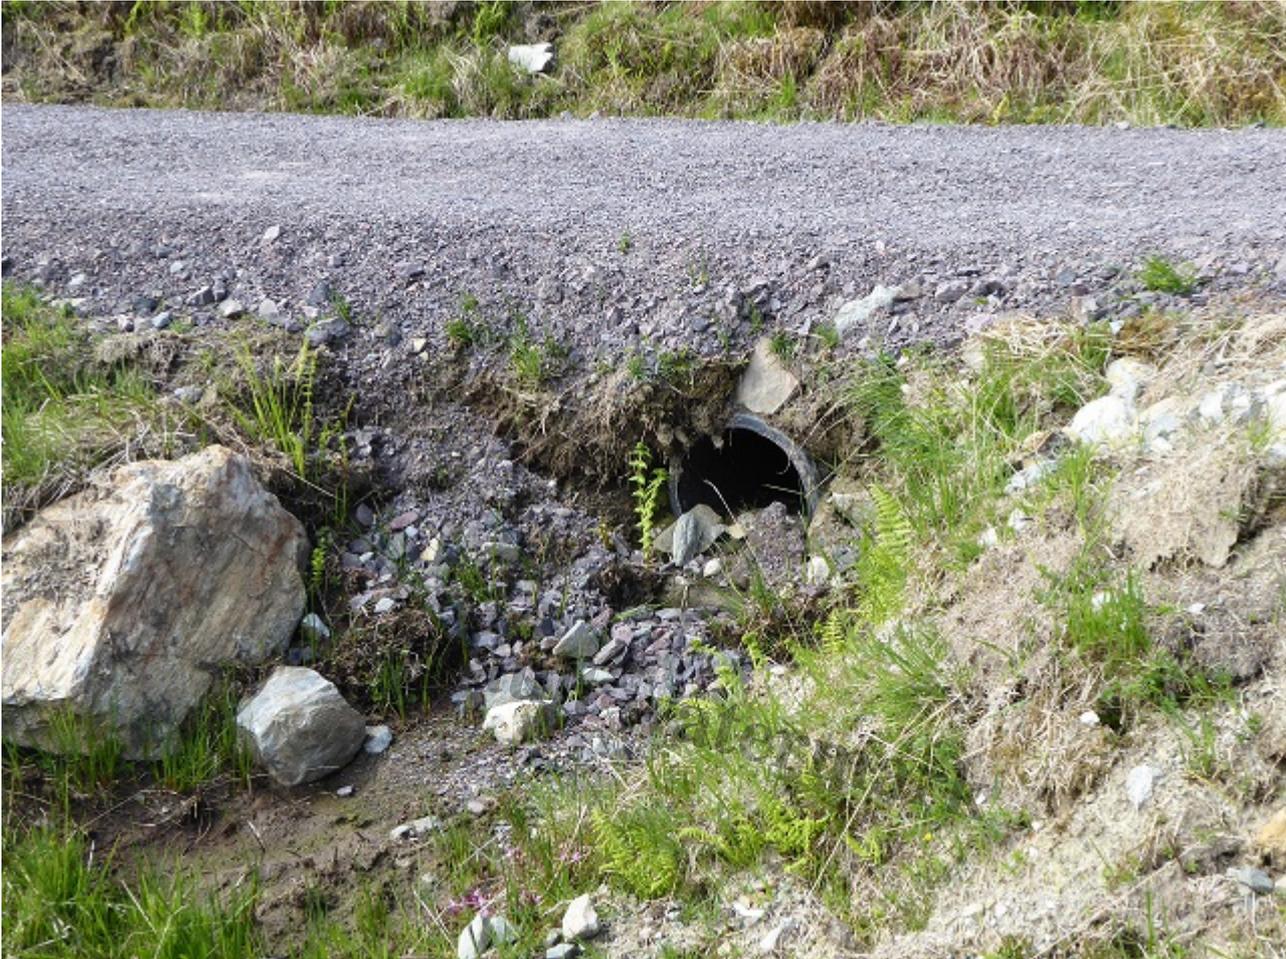
Surfacing from the path is already eroding away and the standard of finishing around the culverts is as poor as any old bulldozed track. Is this the way to treat the old military road and what is our best known long distance walking route?

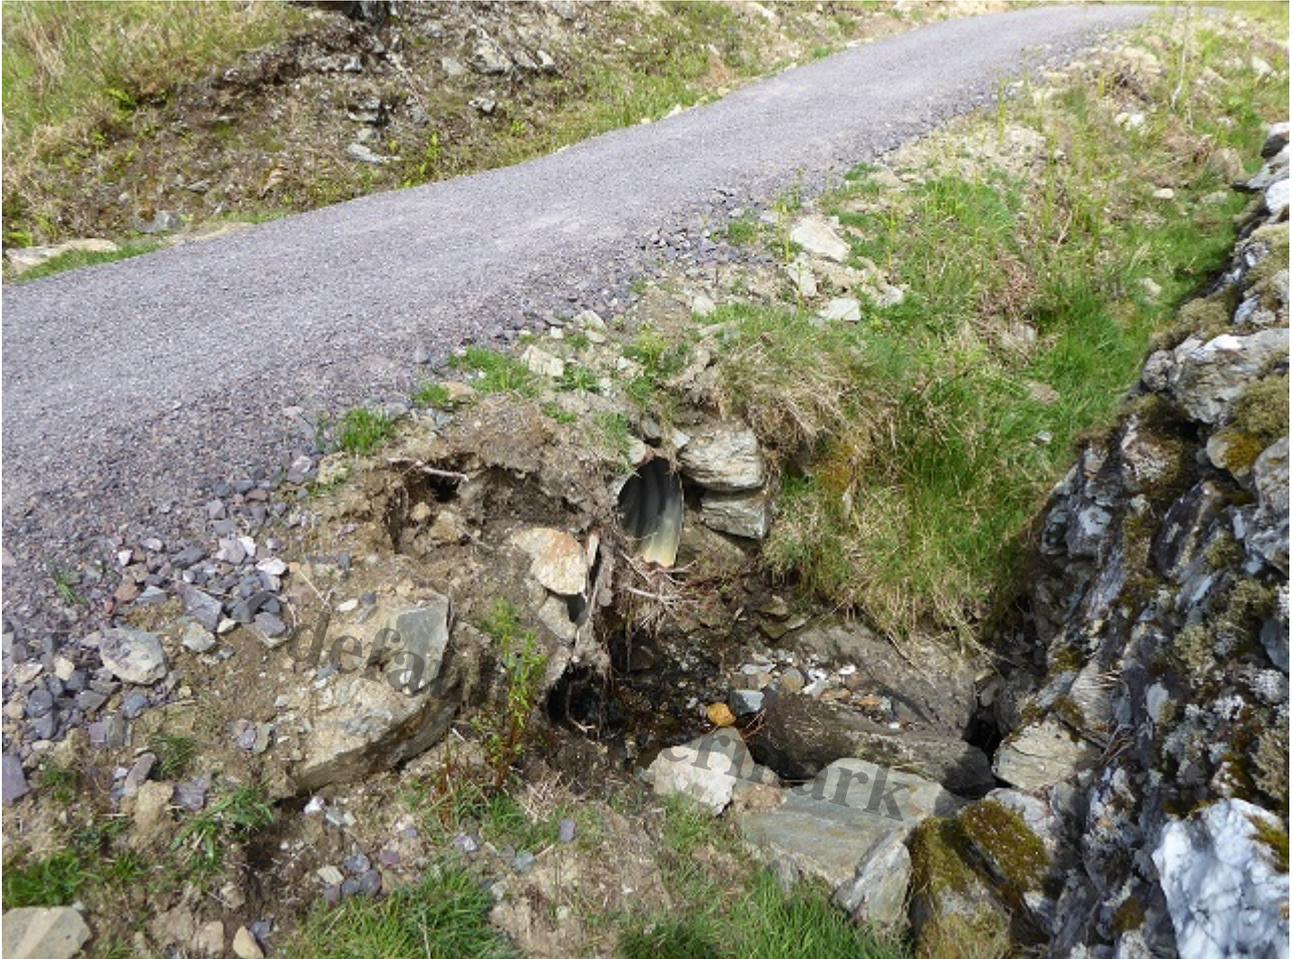
Another collapsing culvert which unless addressed is likely to erode back into the path surface in the near future

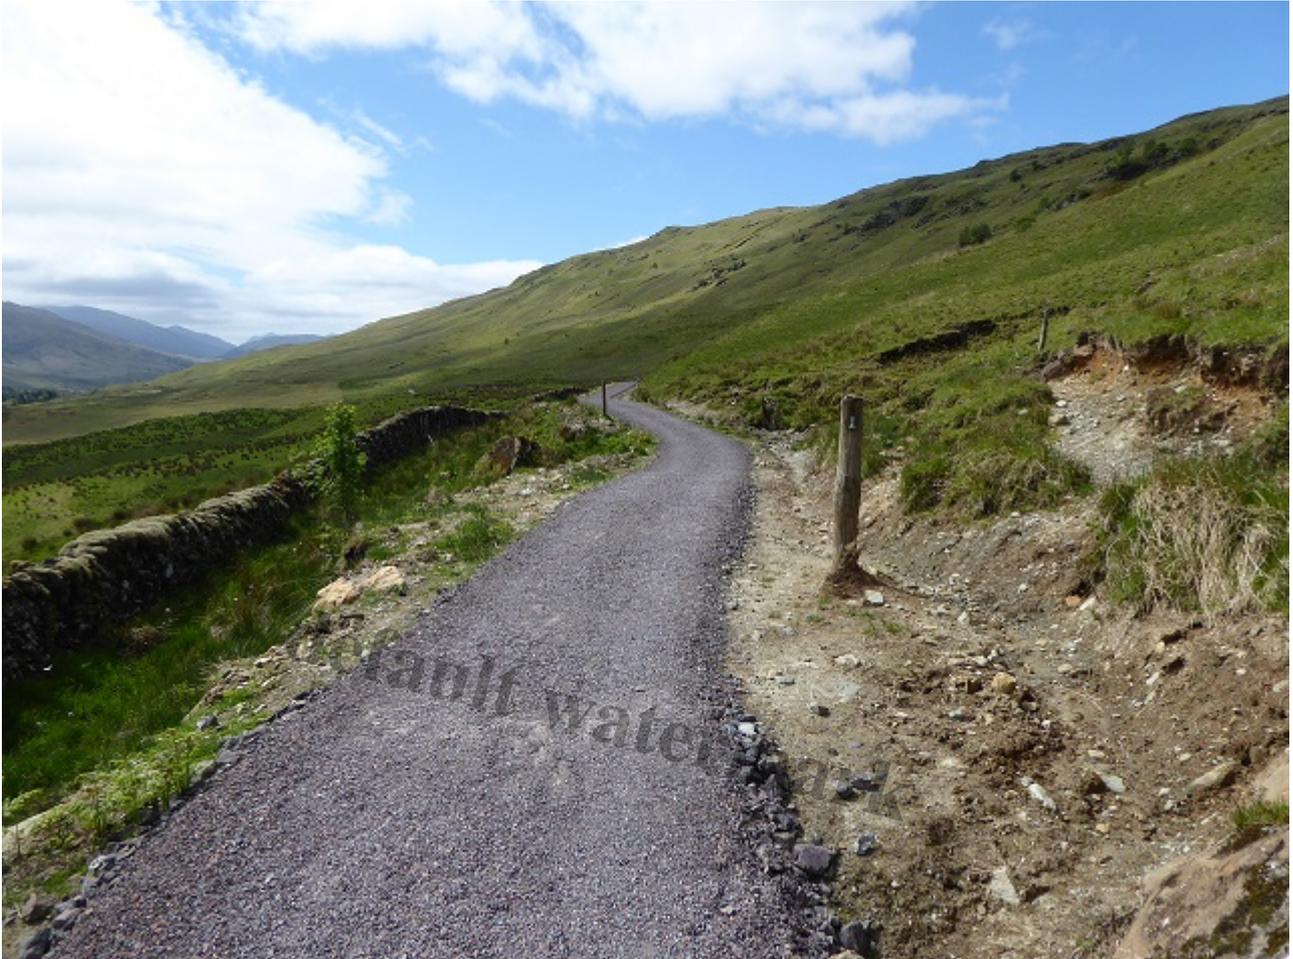
The ground in this photo could have immediately been restored with turves if they had been kept instead of dumped on the lower side of the path. Instead its likely to take several years to revegetate.

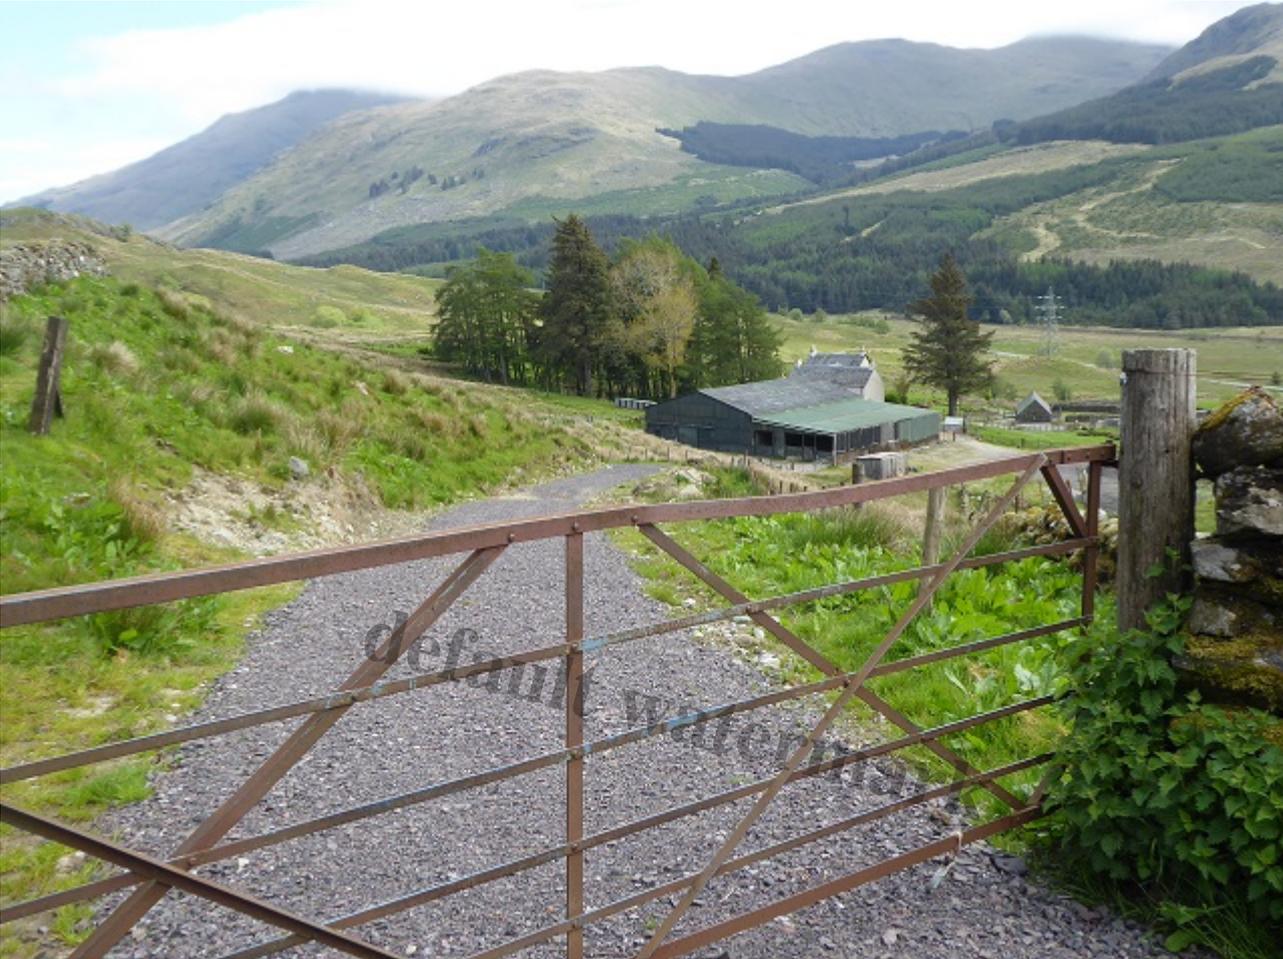
I also noted that the track down from the WHW to the farm had been upgraded using the same material and at the same time (photo above). I asked the LTTNPA whether this formed *any part of the grant agreement or was it arranged and paid for completely separately by the farm?*

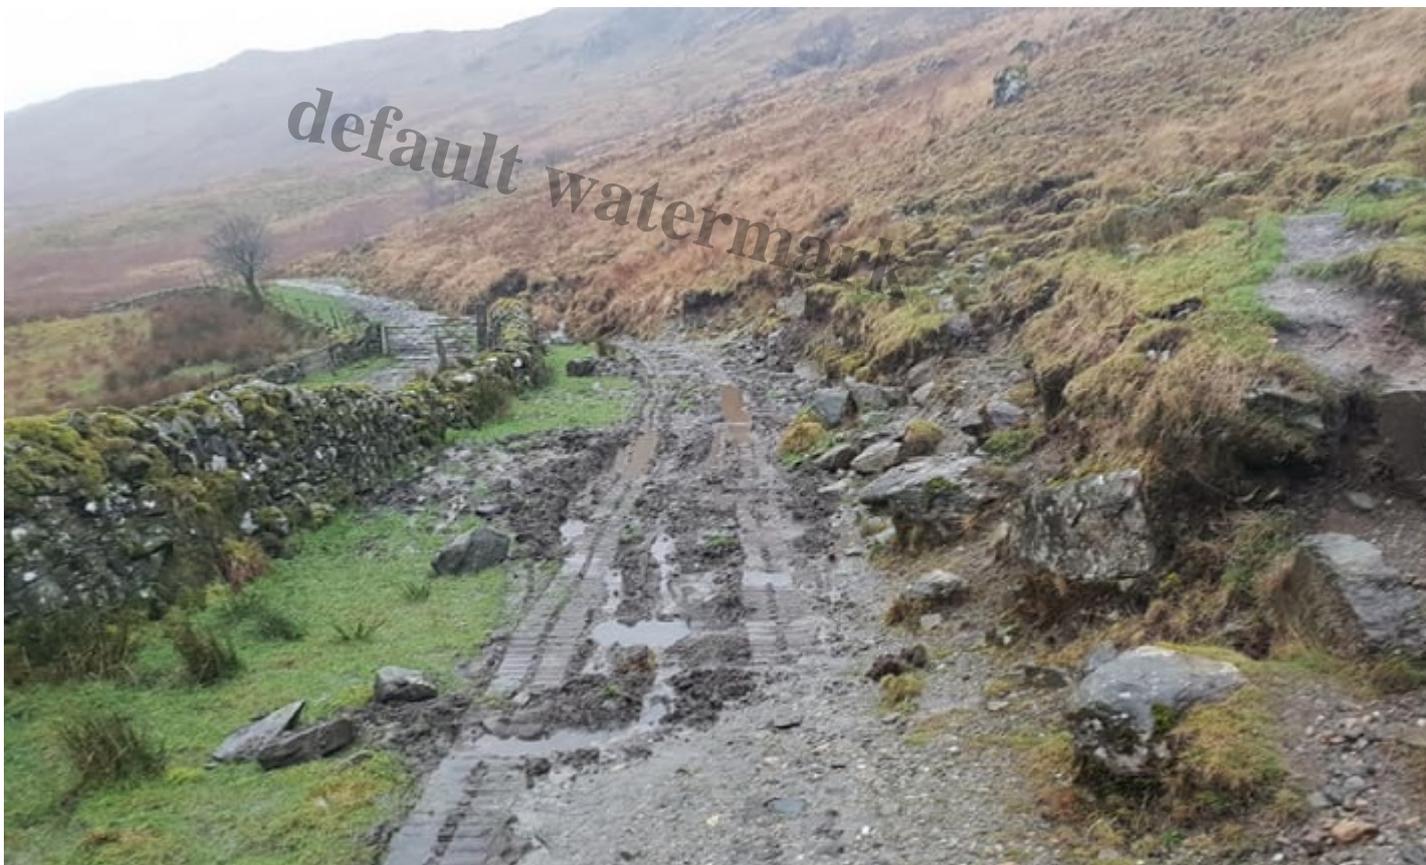
Looking west along West Highland Way to junction with Keilator farm prior to works. Photo credit Gordon Baillie Contracting Ltd

I am not disputing the track had been messed up by farm vehicles prior to the works. Indeed the right hand edge of the Gordon Baillie photo shows a section of path above the track and it appears that the deep mud forced walkers off the track eroding the land above. That needed to be fixed. However, the photo clearly shows how an area of ground has been scraped free of turf leaving it bare. That, and the removal of the boulders has increased the area of exposed bank making it more visible.

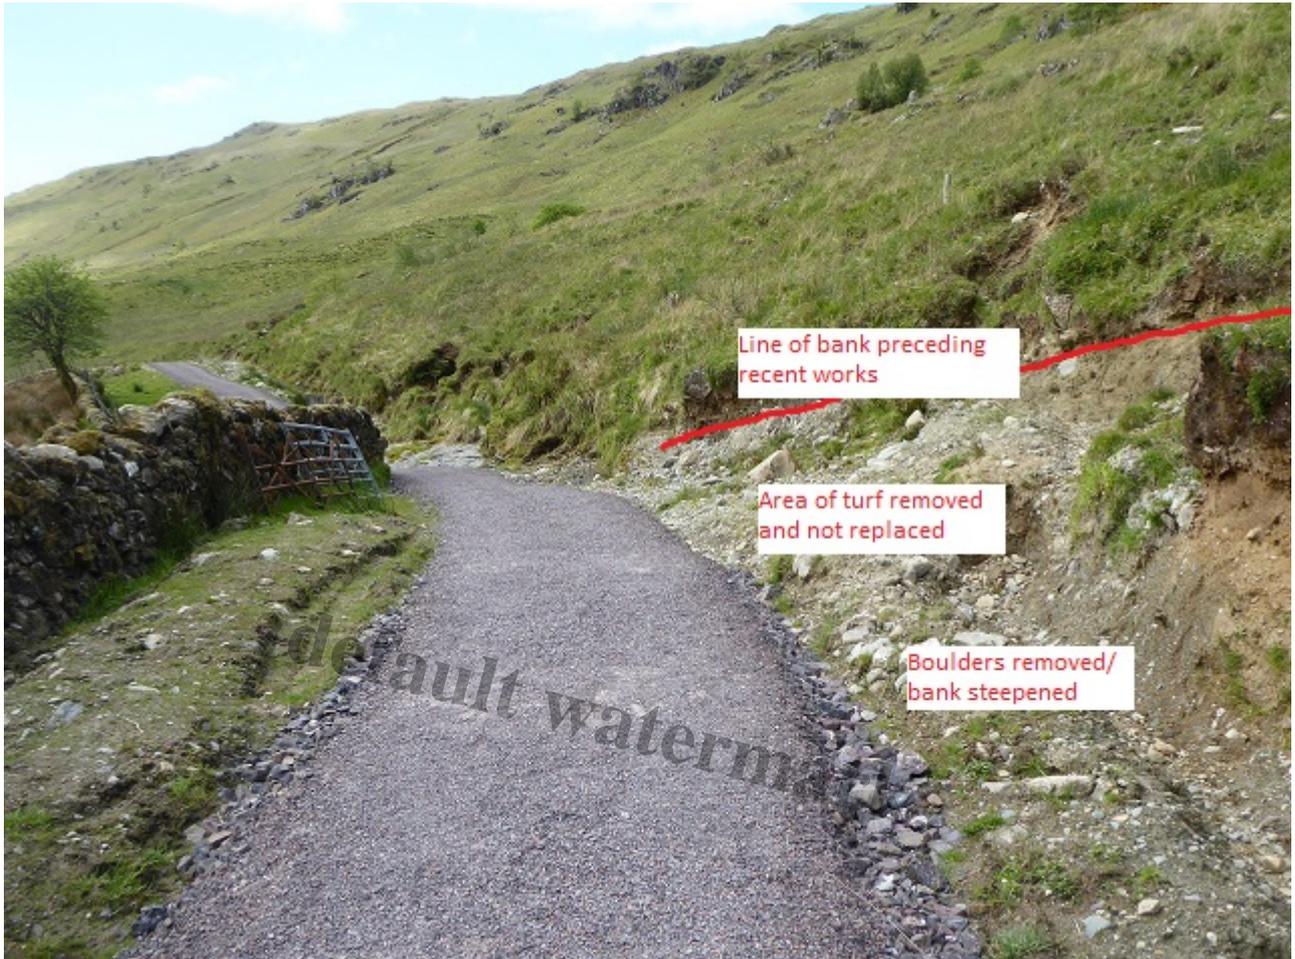
Photo is taken several metres closer to the farm junction than that by Gordon Baillie
