## Climate change and Glen Falloch (2) – the impact of increased rainfall on the natural environment

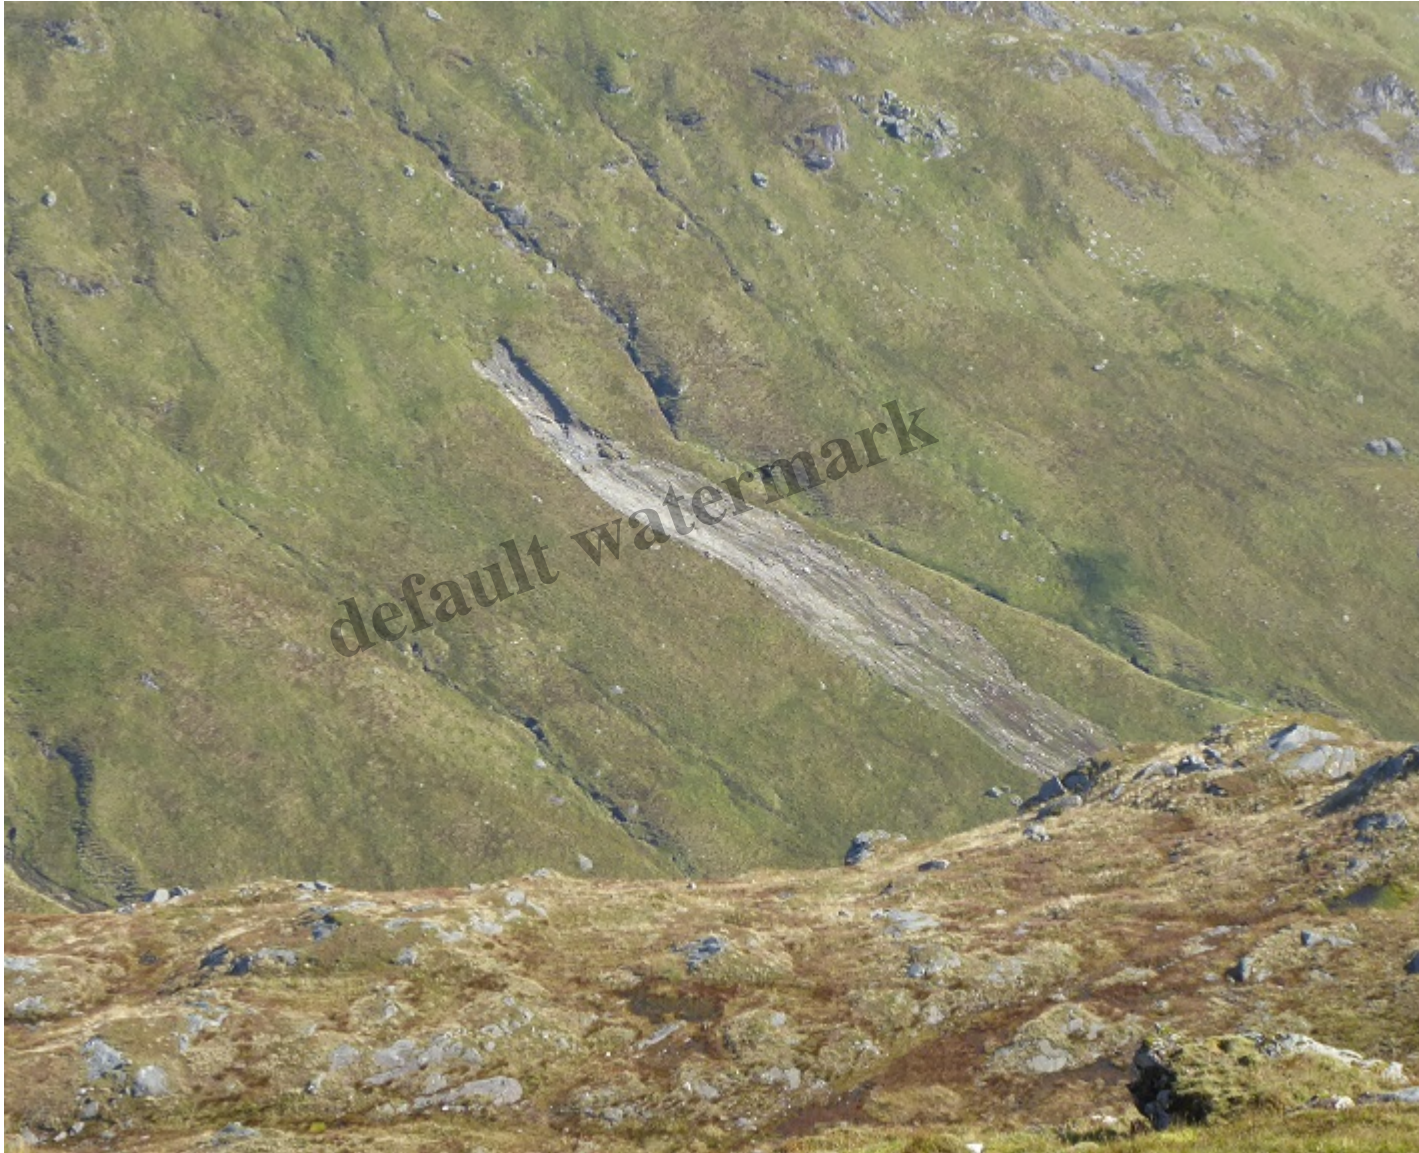
Landslip on west slopes of Beinn a Chroin. This appears to have been triggered by the downpour in August which seriously damaged the West Highland Line and is one of over a dozen I saw last Saturday on the hills south of Glen Falloch

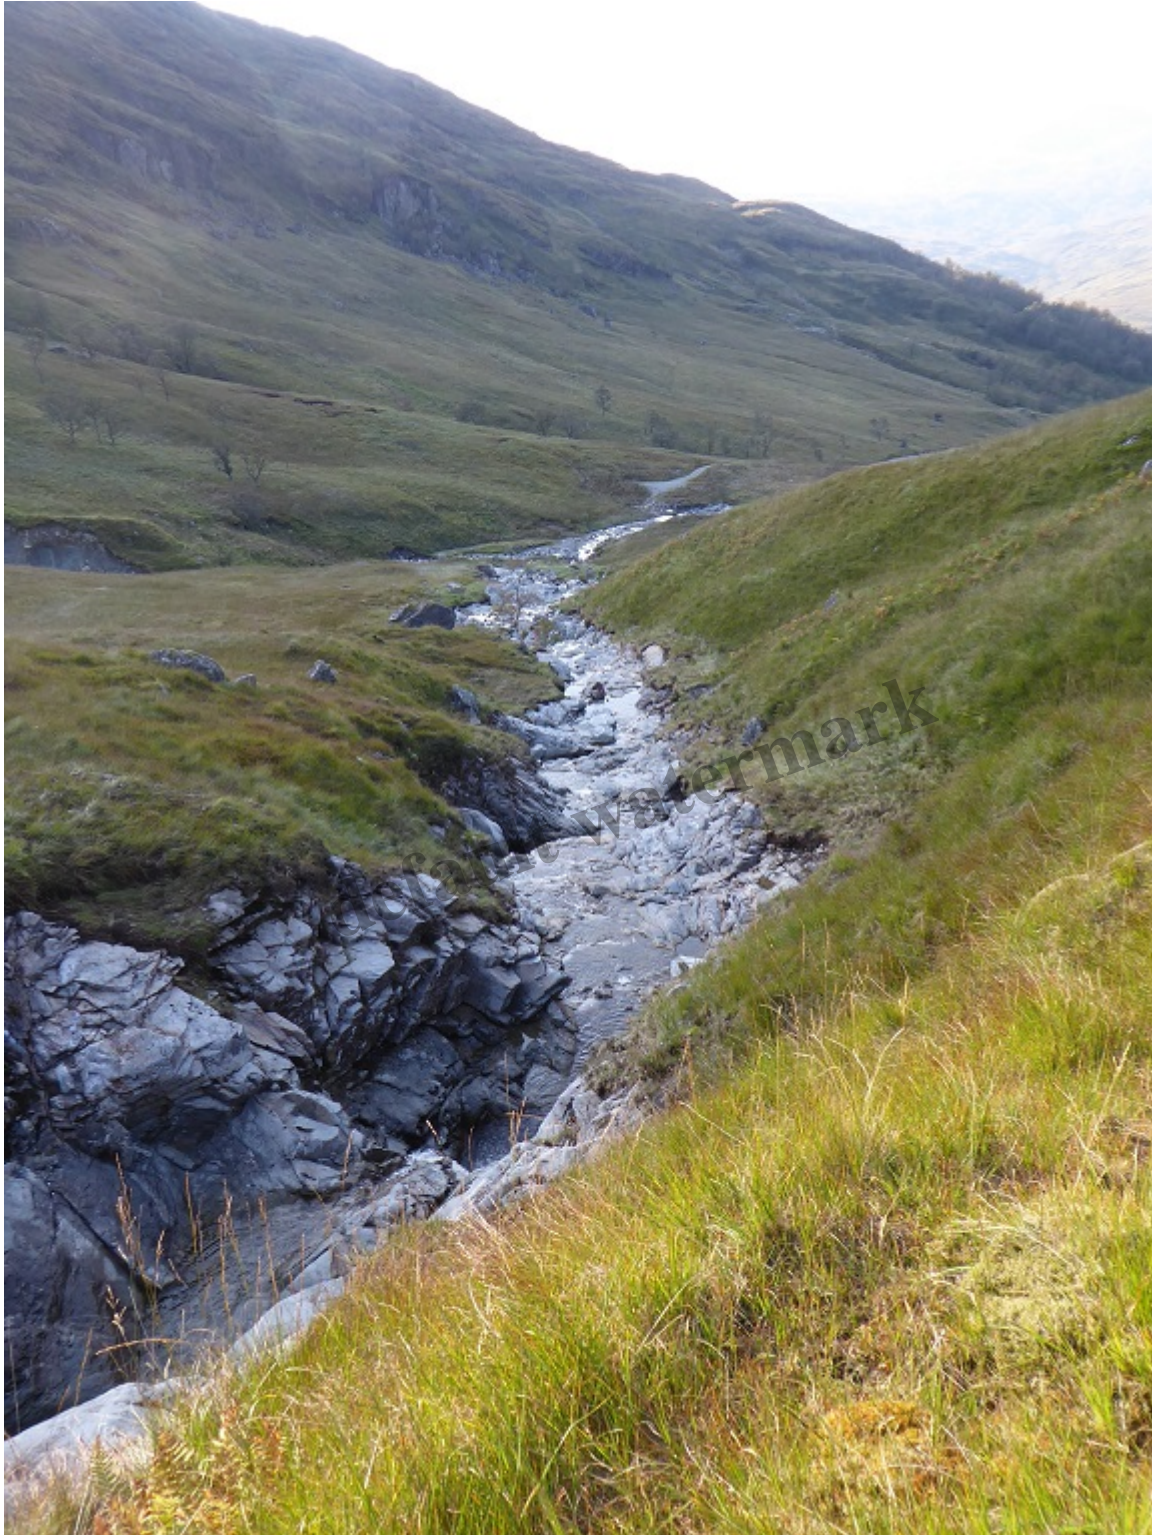
The Allt a Chuillinn, which flows between Beinn Chabhair and An Caisteal into Glen Falloch.

In the photo above, in the left foreground the flood has stripped vegetation from the rocks. Below, on the right bank from mid-picture onwards, you can see where vegetation has been flattened by the flood. In places, caused by waves perhaps, this is about 6 metres higher than the water levels last Saturday. The bare rock below the vegetation here gives an indication of more normal maximum flood levels. The volume and power of the water would have been incredible to witness.

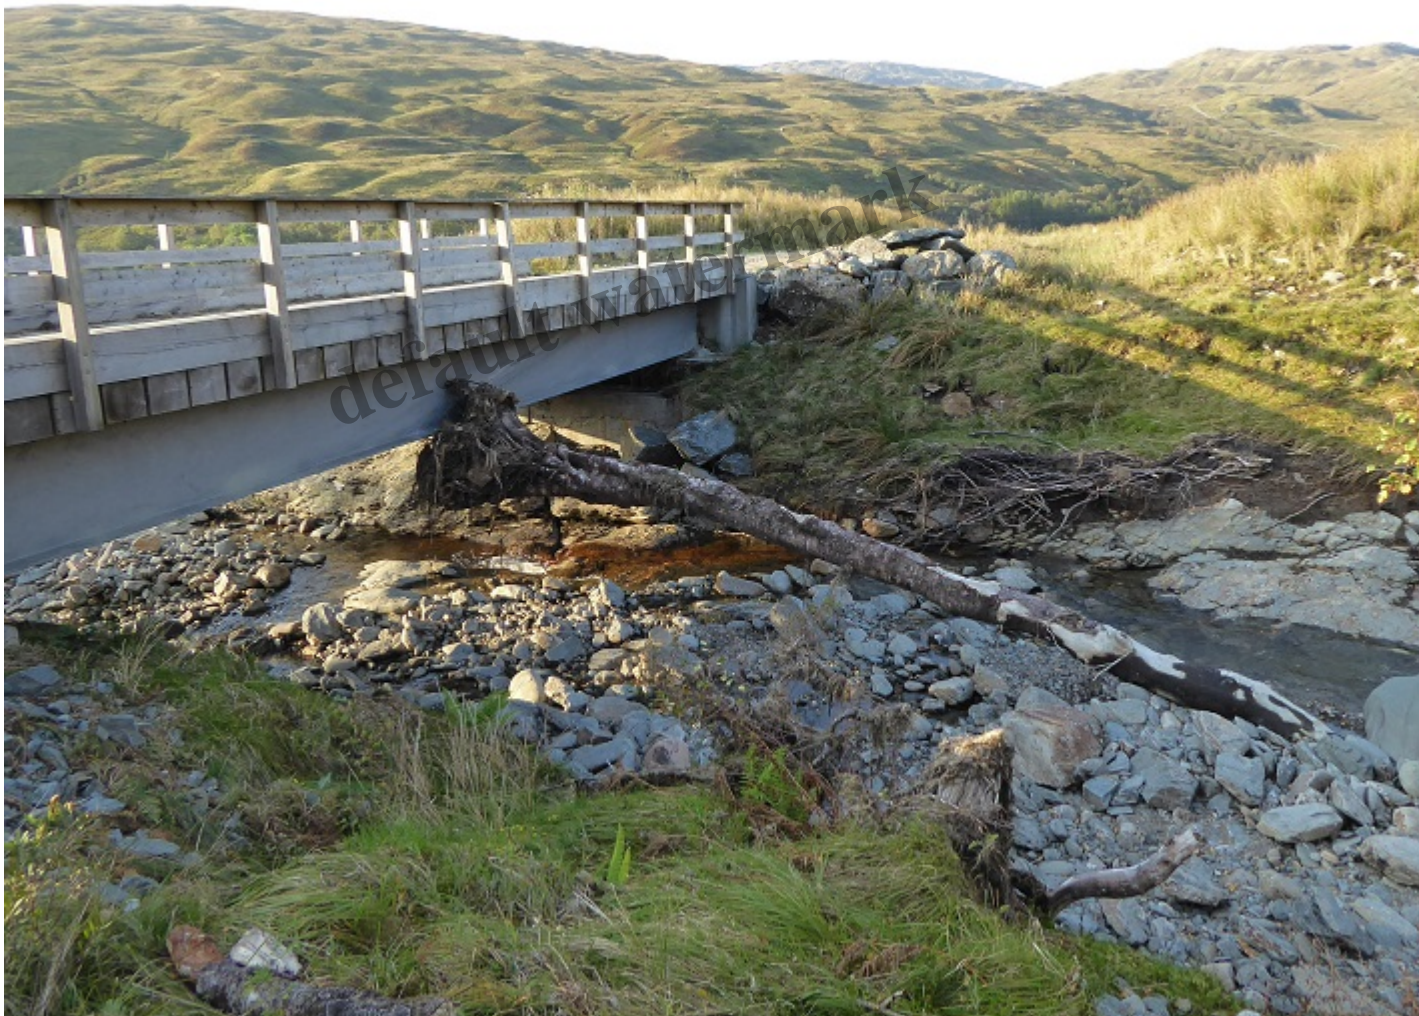
One scene from lower down the Allt a Chuillinn at the new bridge constructed for the hydro scheme. how vegetation has also been removed from the bank on the right

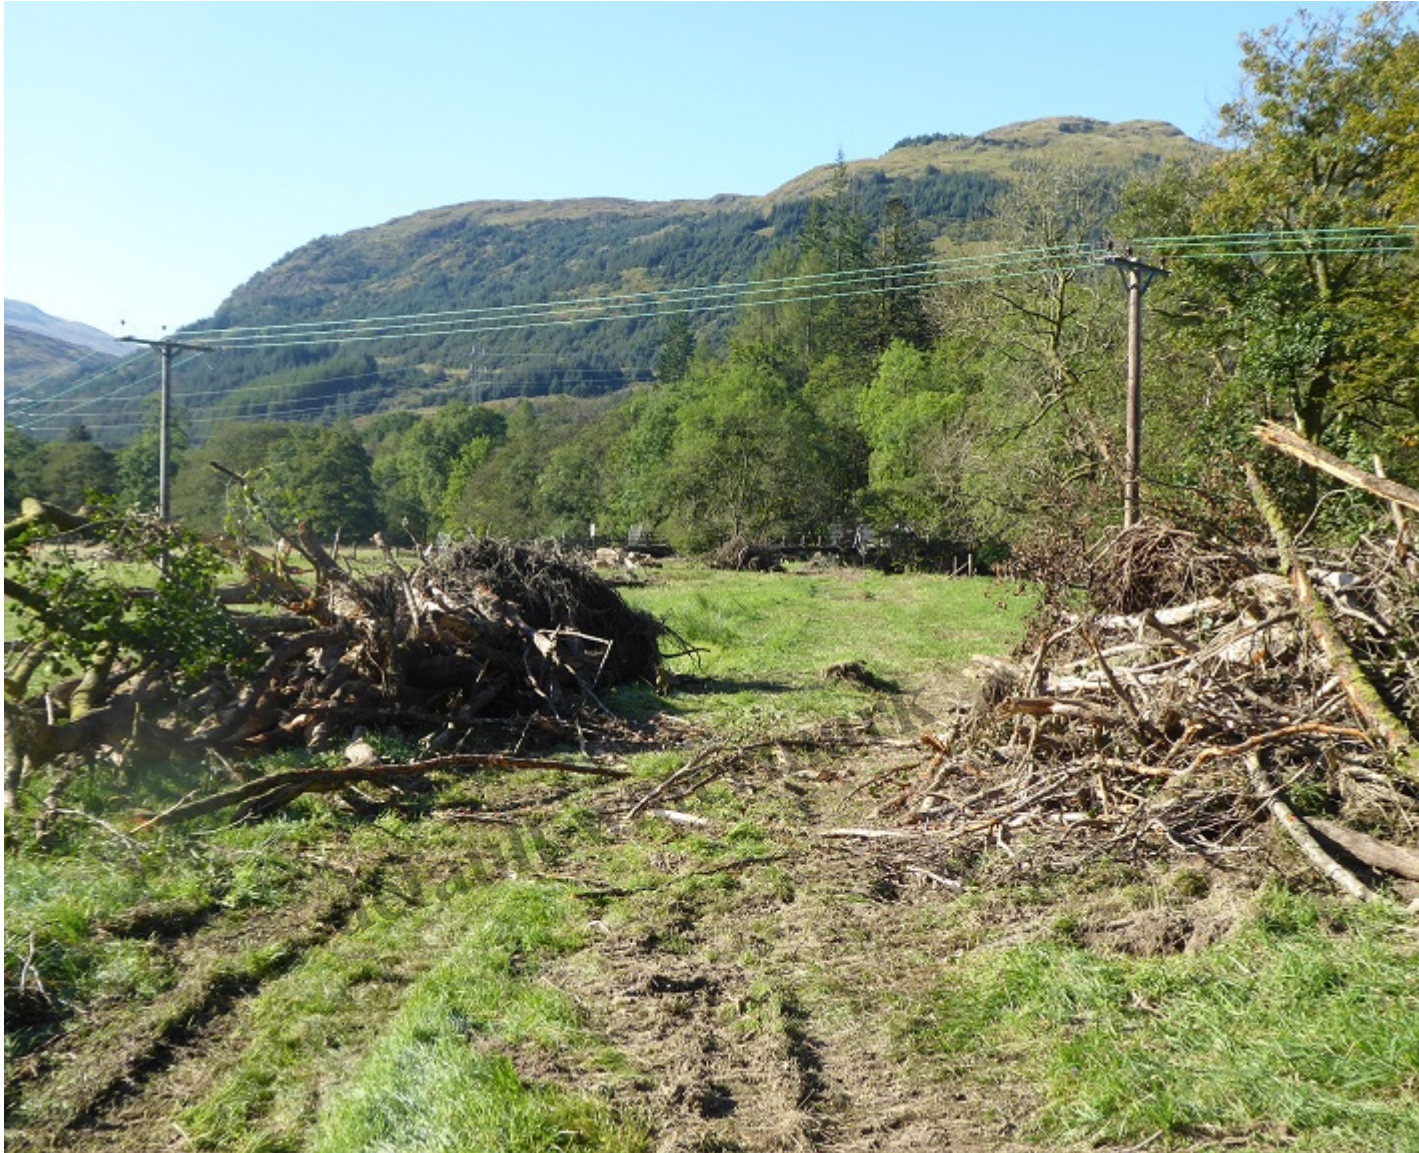
Looking along the floor plain towards the damaged bridge to the Bein Glas farm campsite which has closed. The piles of uprooted trees and broken branches have been created by the estate tidying up damage.

The standing telegraph poles provide a good illustration that flood plains work and why its so important that we protect them. The power of water reduces dramatically as soon as its allowed to spread out.

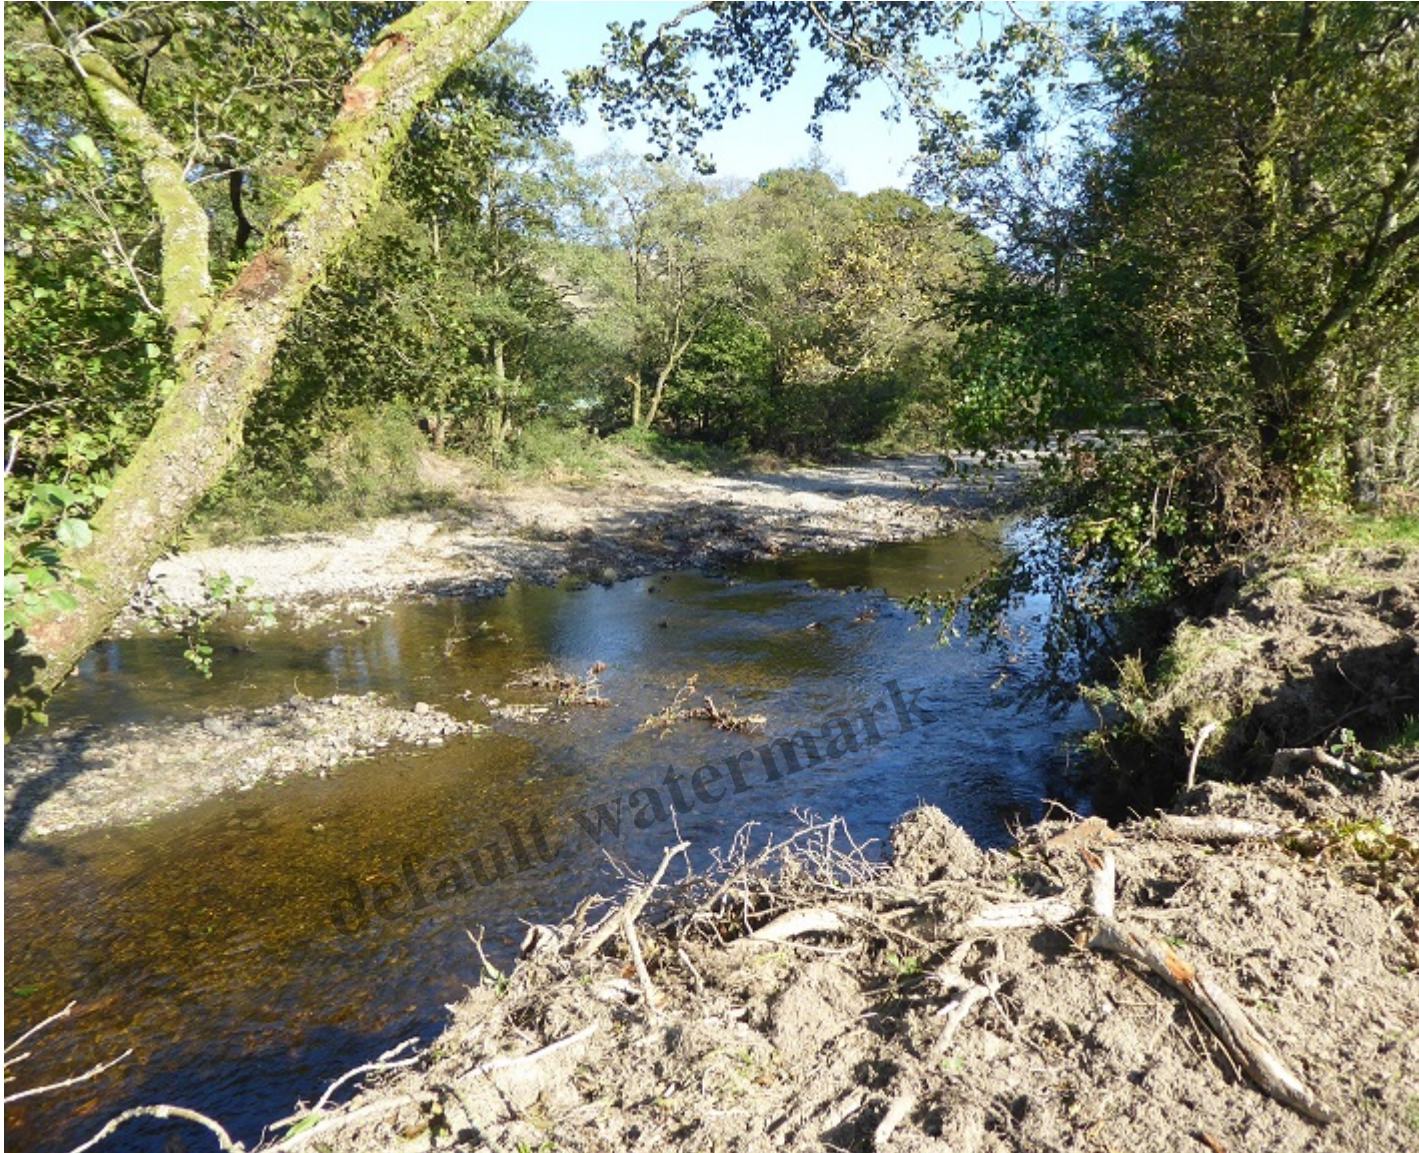
Several sections of bank have been completely stripped of trees and vegetation

Within the normal confines of the river the flood has caused extensive damage, not unprecedented perhaps but judging by the alder that previously grew here, damage of this scale has not happened for many years.

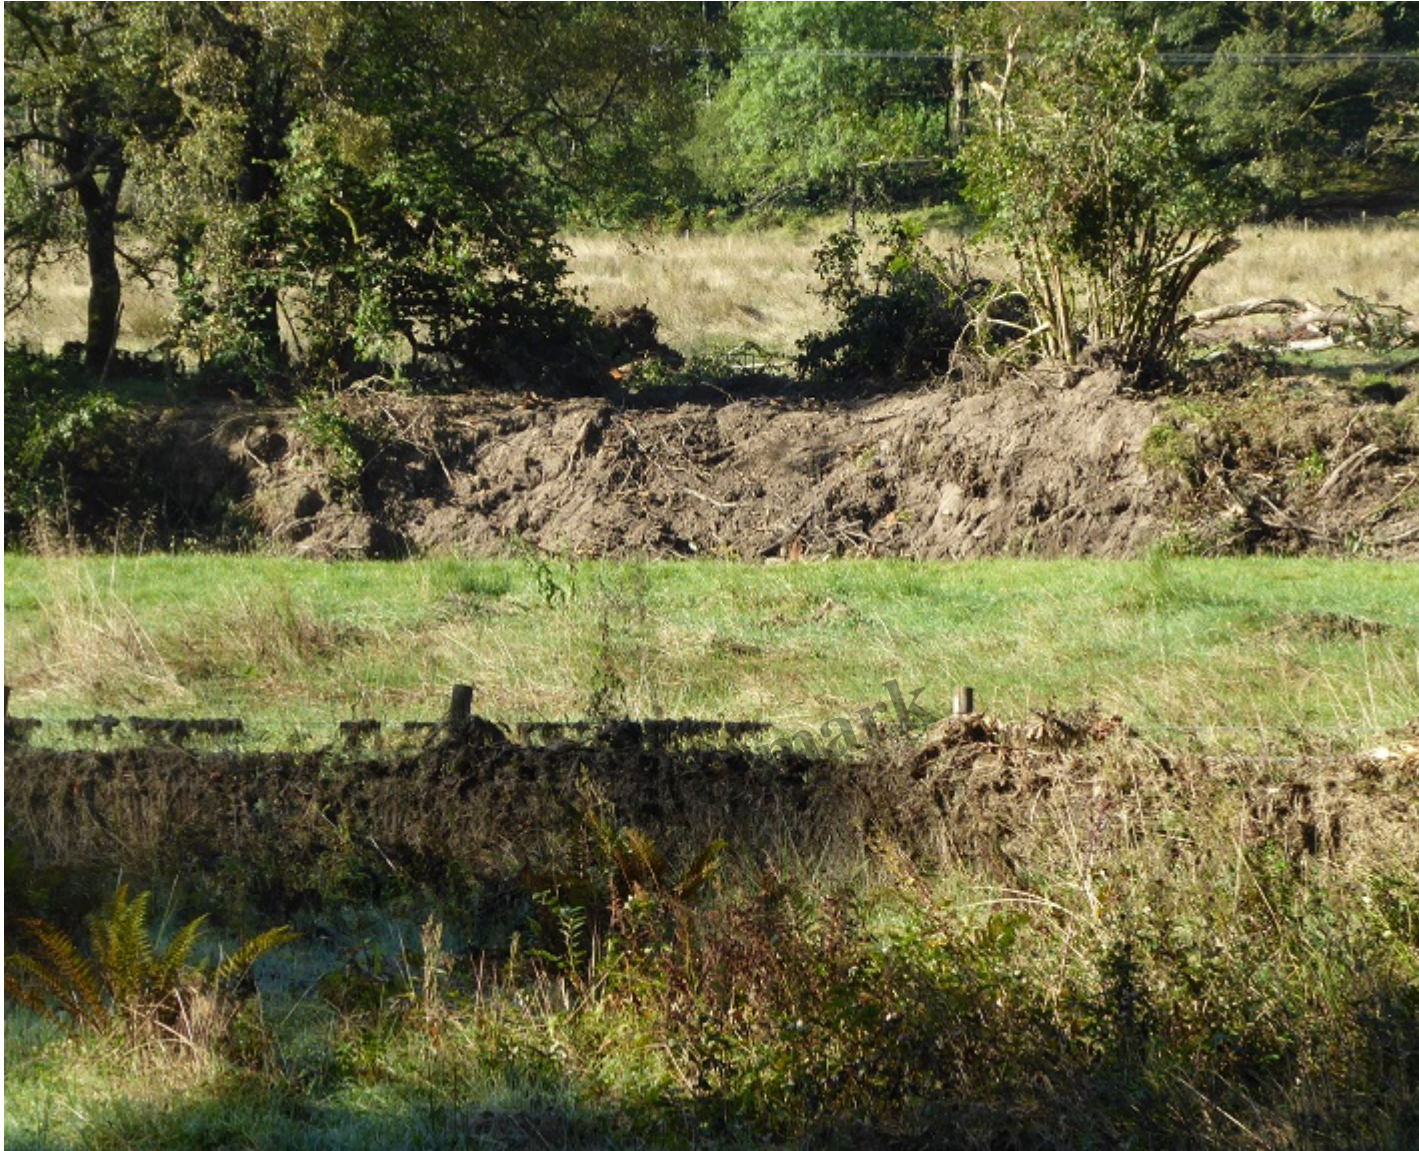
The vegetation on the fence in the foreground gives some indication of the level of water on the flood while a section of bank on the far side of the river has been partially destroyed

Without the alder, the damage to the banks would have been far worse and the likelihood of the river changing its course much higher. With catastrophic events like this increasing in frequency, there may not be the time now for the alder to grow back before the next one. It appears to me there is now a real risk of us entering a vicious circle of ever-increasing damage.

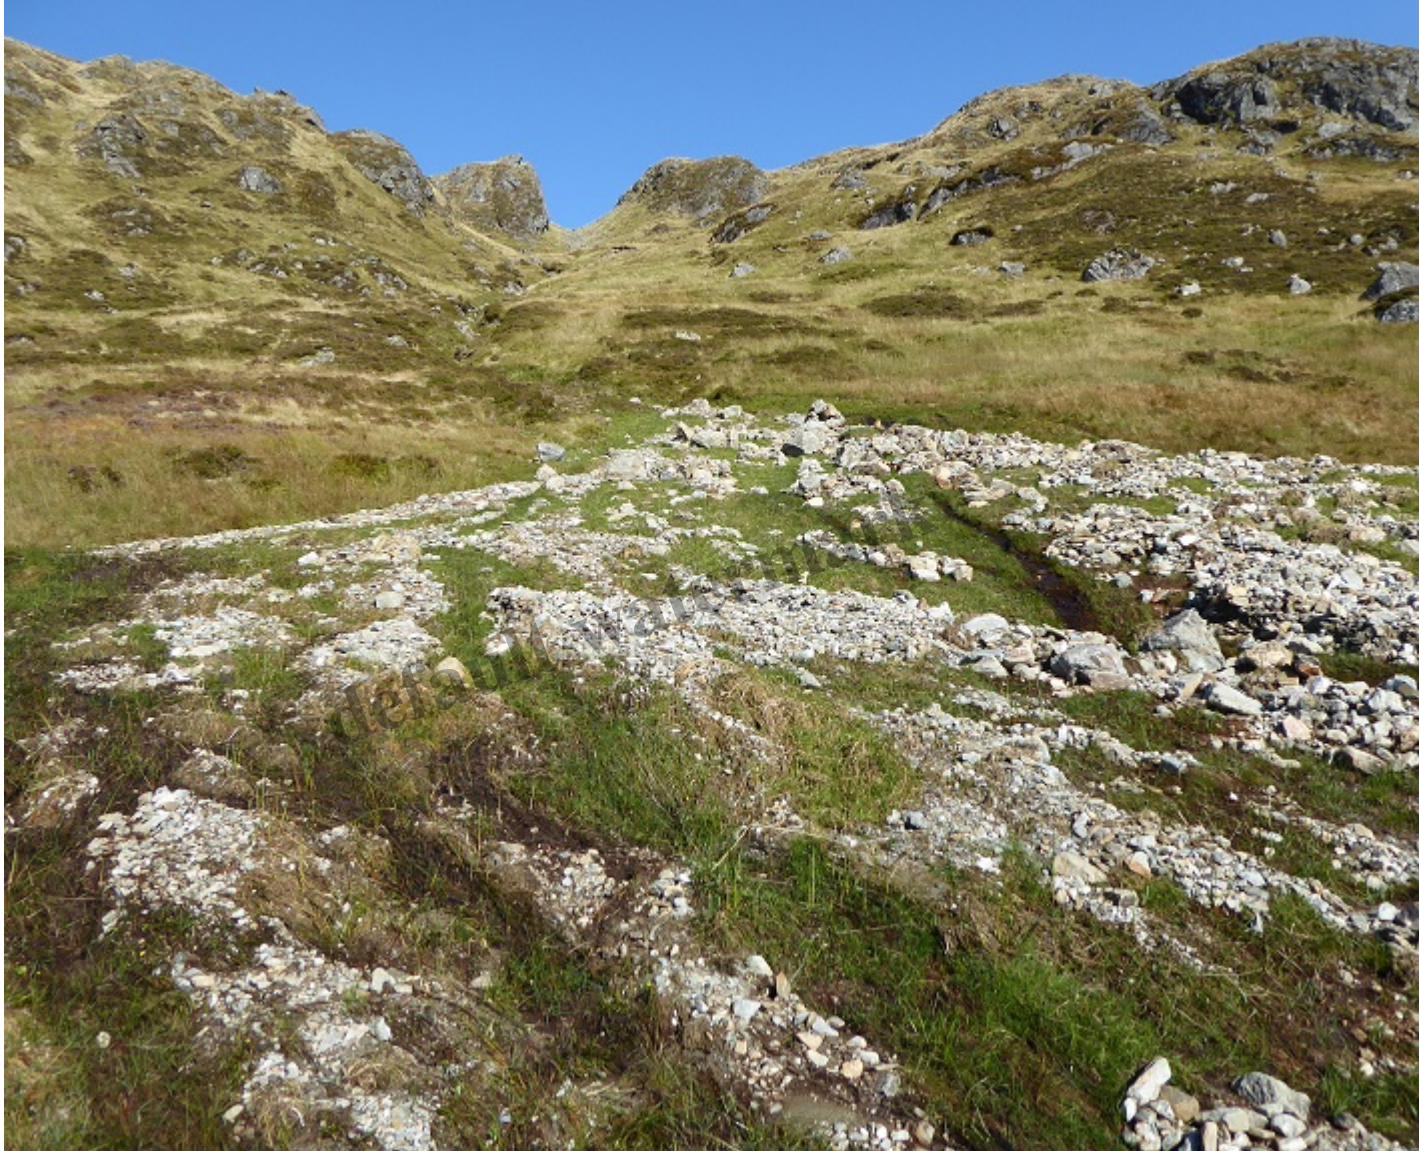
Note the dark trench just right of centre. This marks the normal course of the burn and is less than 1m wide. The flood has deposited boulders, vegetation and gravel for 10 metres either side of this.

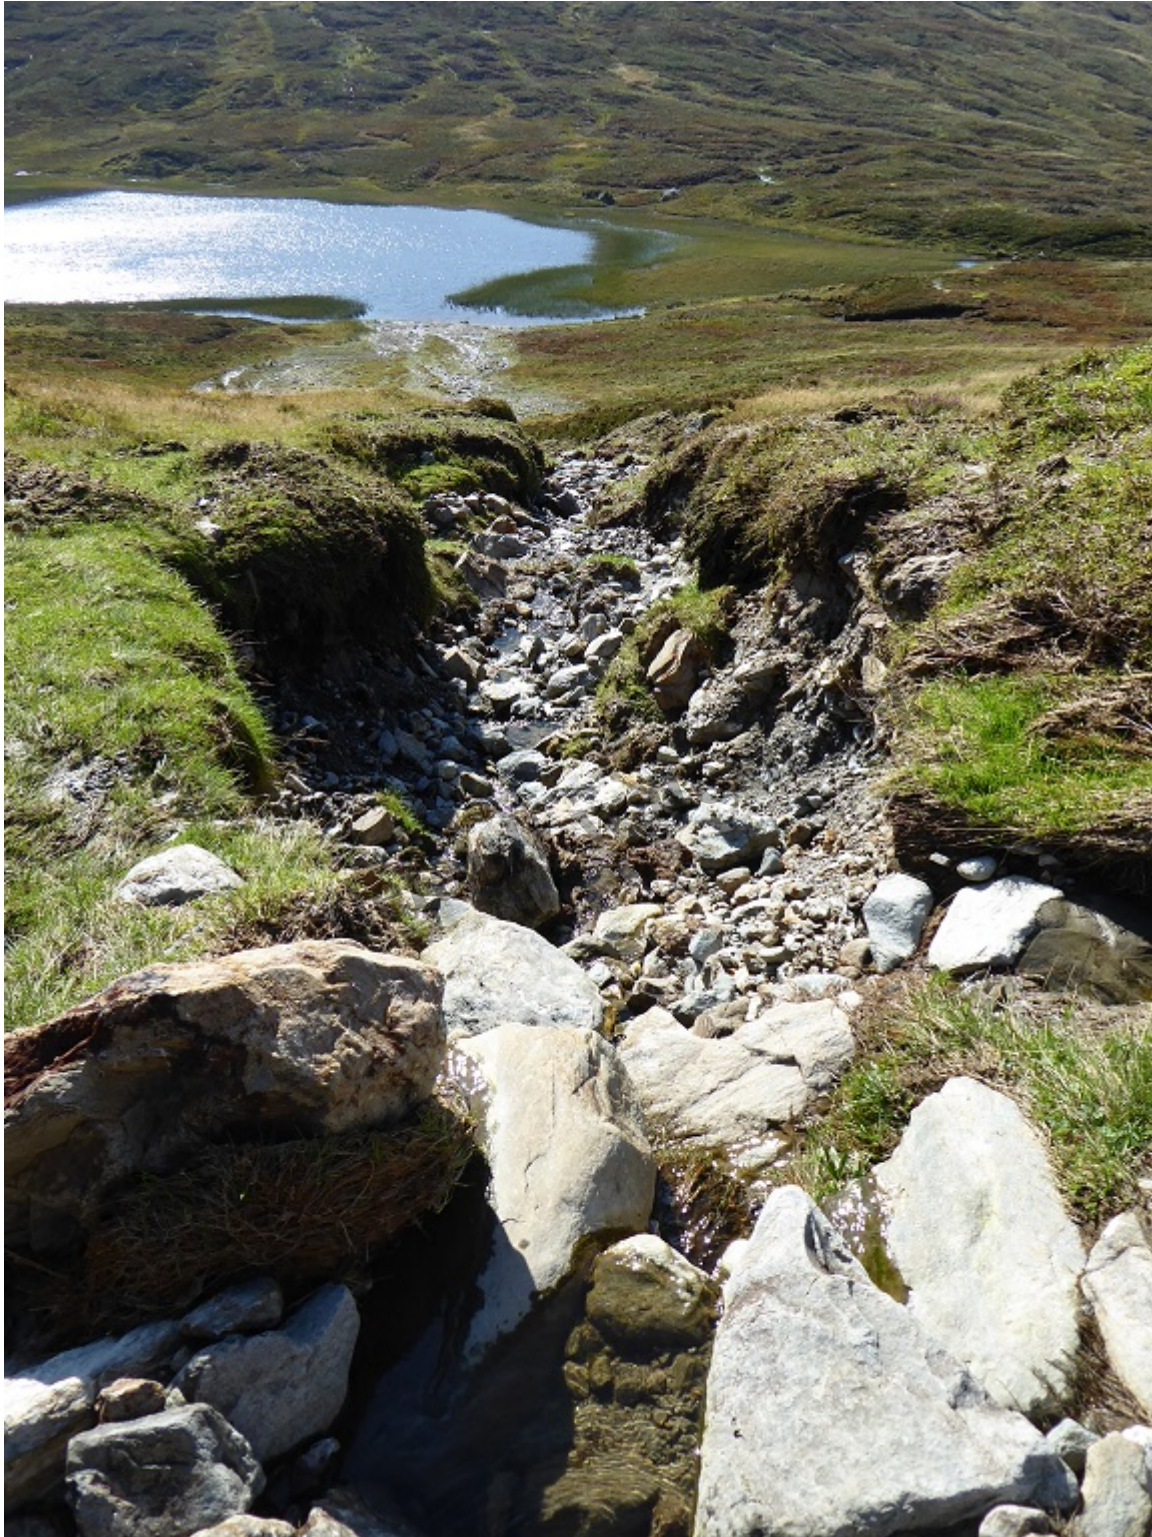
The view looking down the same burn to Lochan Beinn Chabhair. Note how debris has been washed all the way to the Loch.

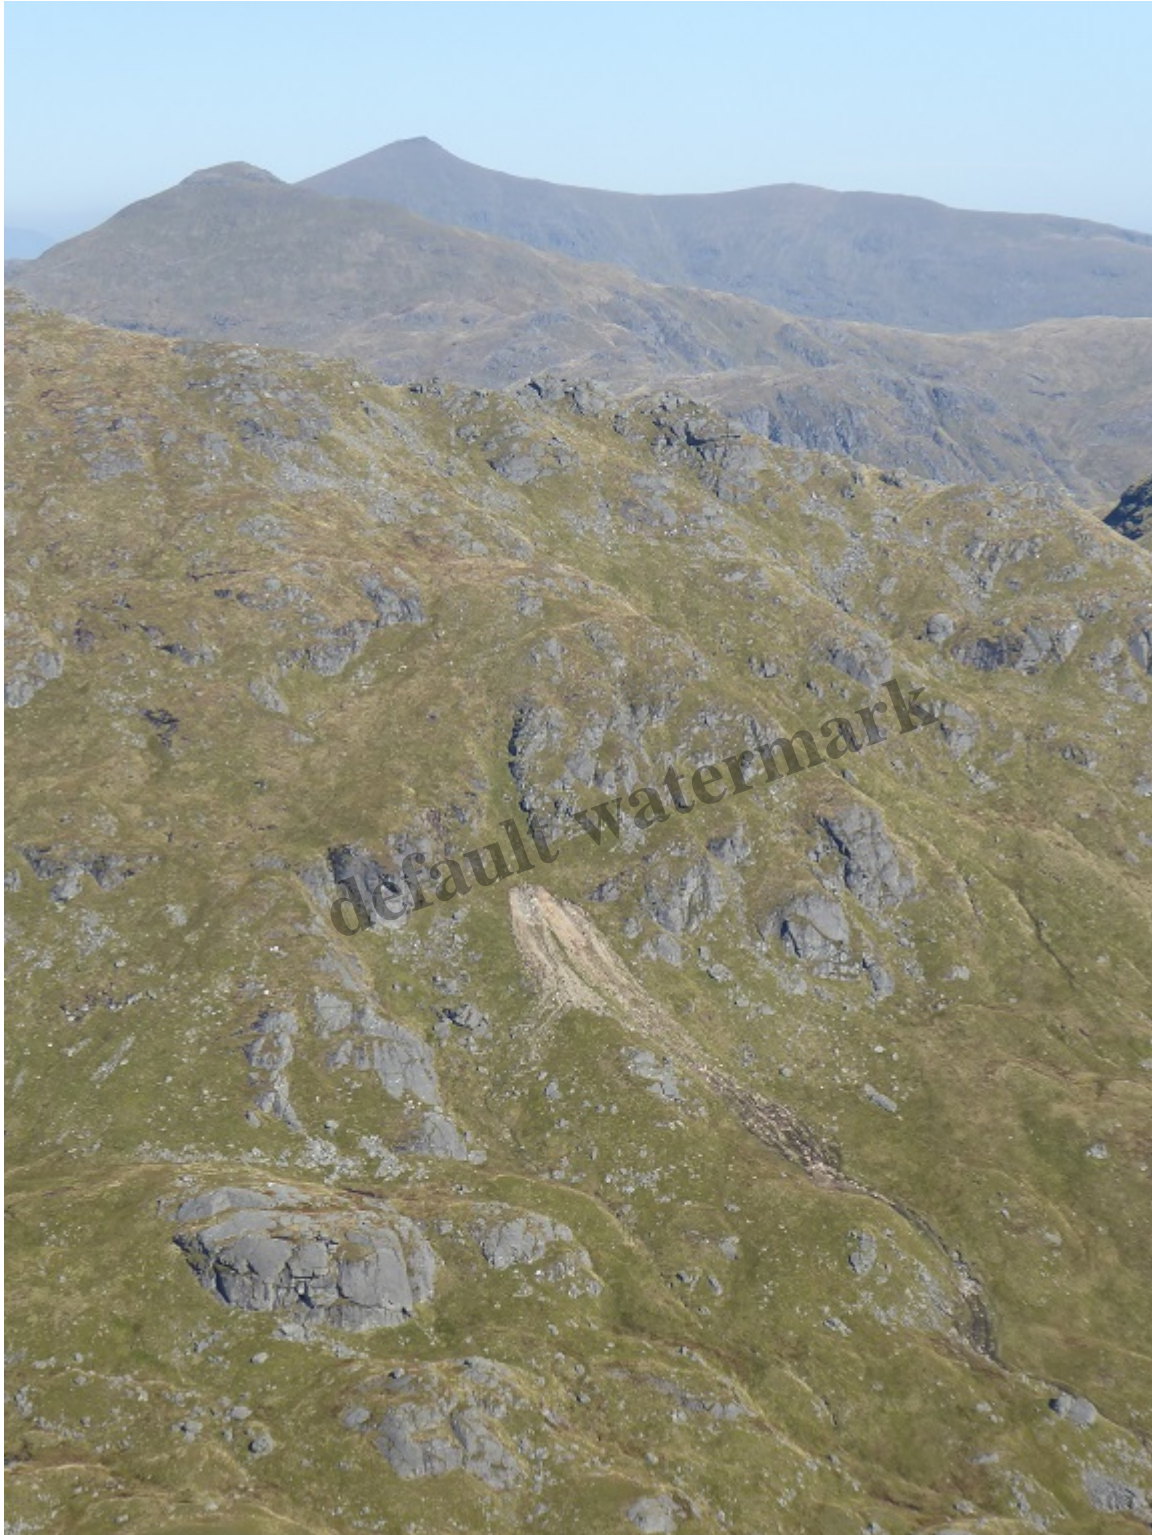
New landslip on An Caisteal, Cruach Ardrain and Stobinian behind. Note how the debris has flowed down to the bottom right corner of photo

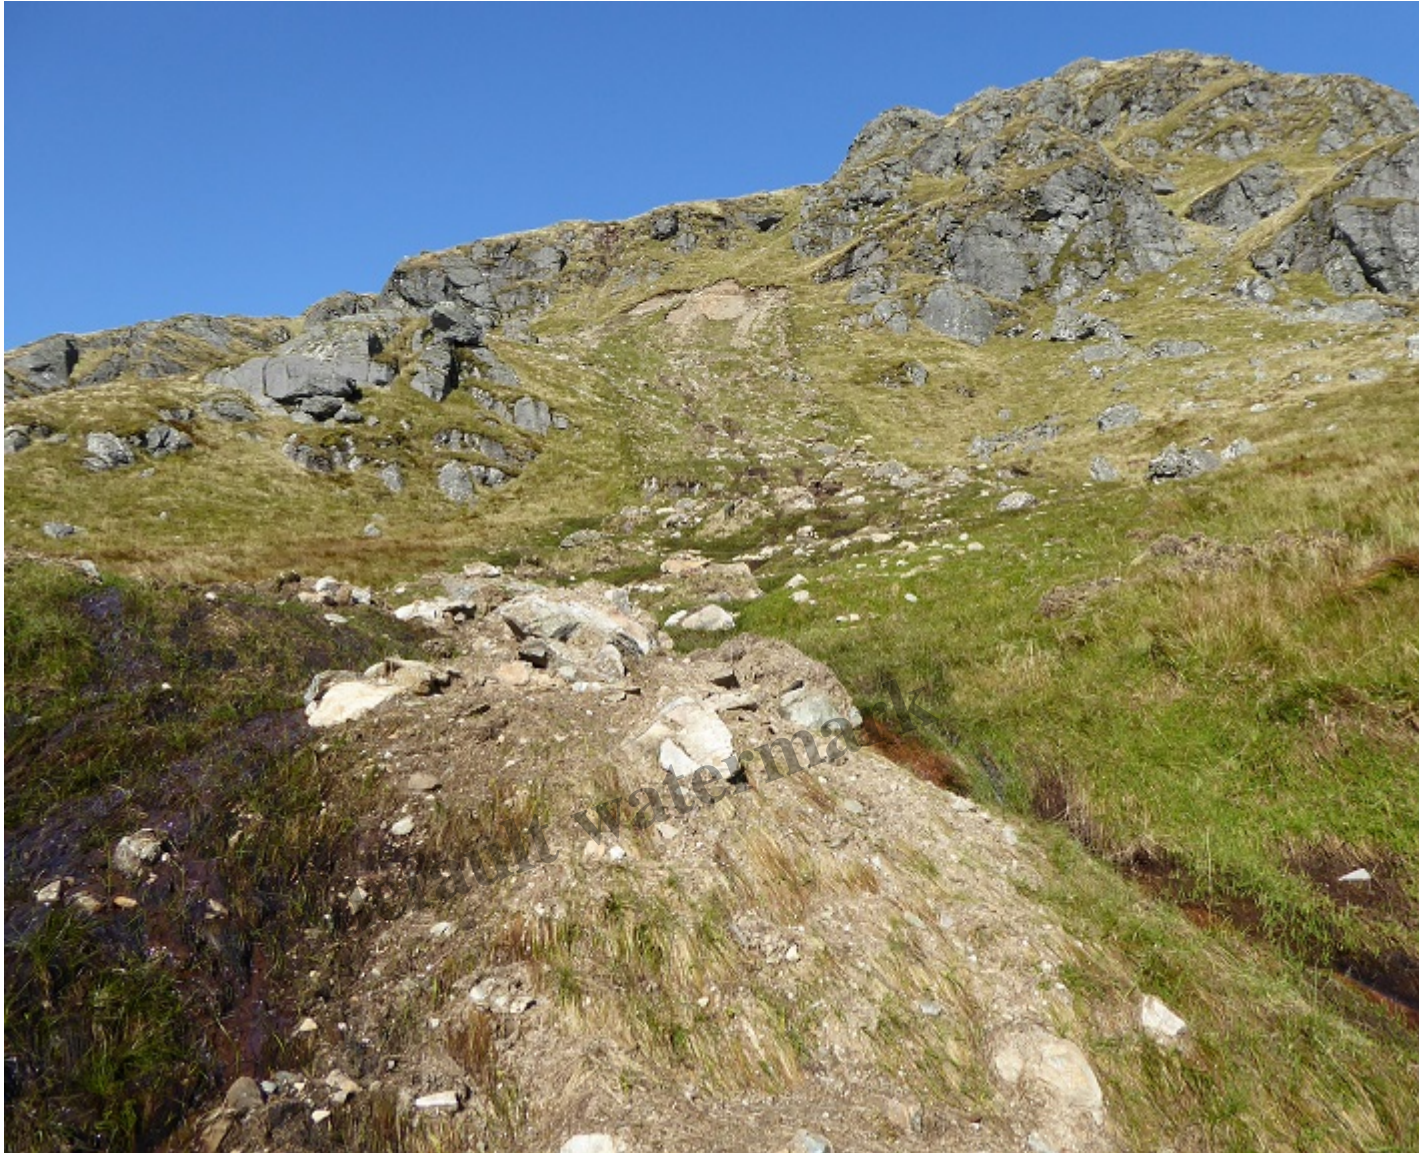
Looking up the same landslip from below

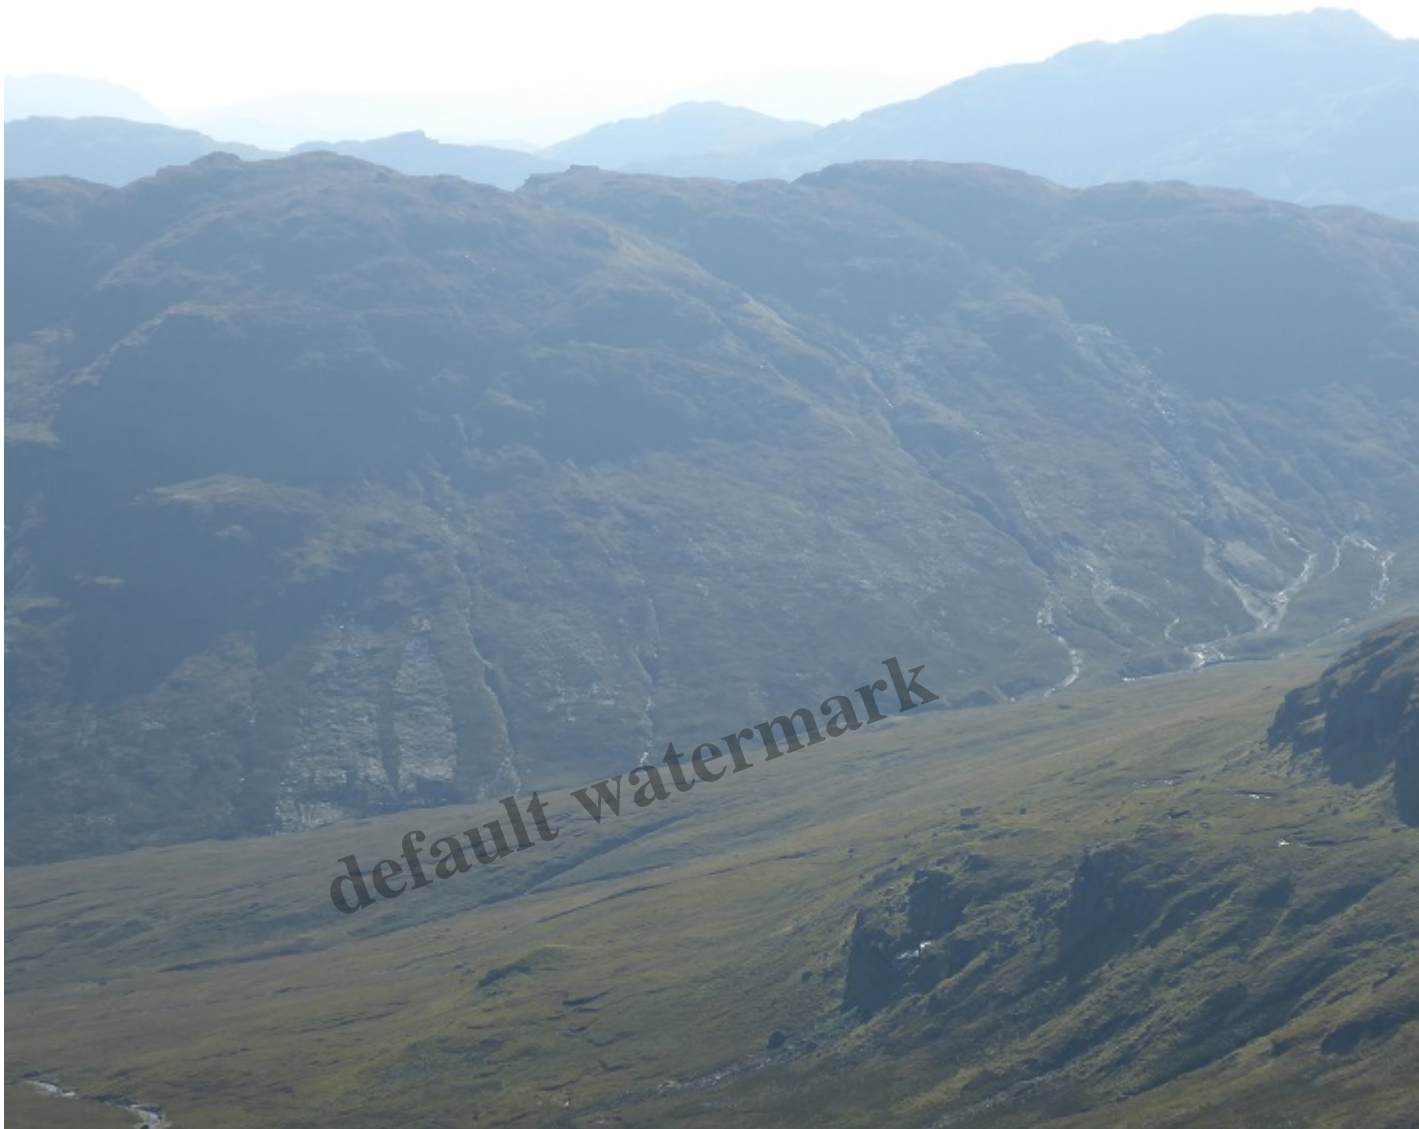
It was very hazy to the south but across the Allt Lairig several major landslips were visible on the north slopes of Meall Mor

The two landslips on the left bear a strong resemblance to avalanches triggered at particular point and which then spread out as they gain momentum down the hill carrying all before them. Maybe they were caused by avalanches and not the recent rain? I was not close enough to check..

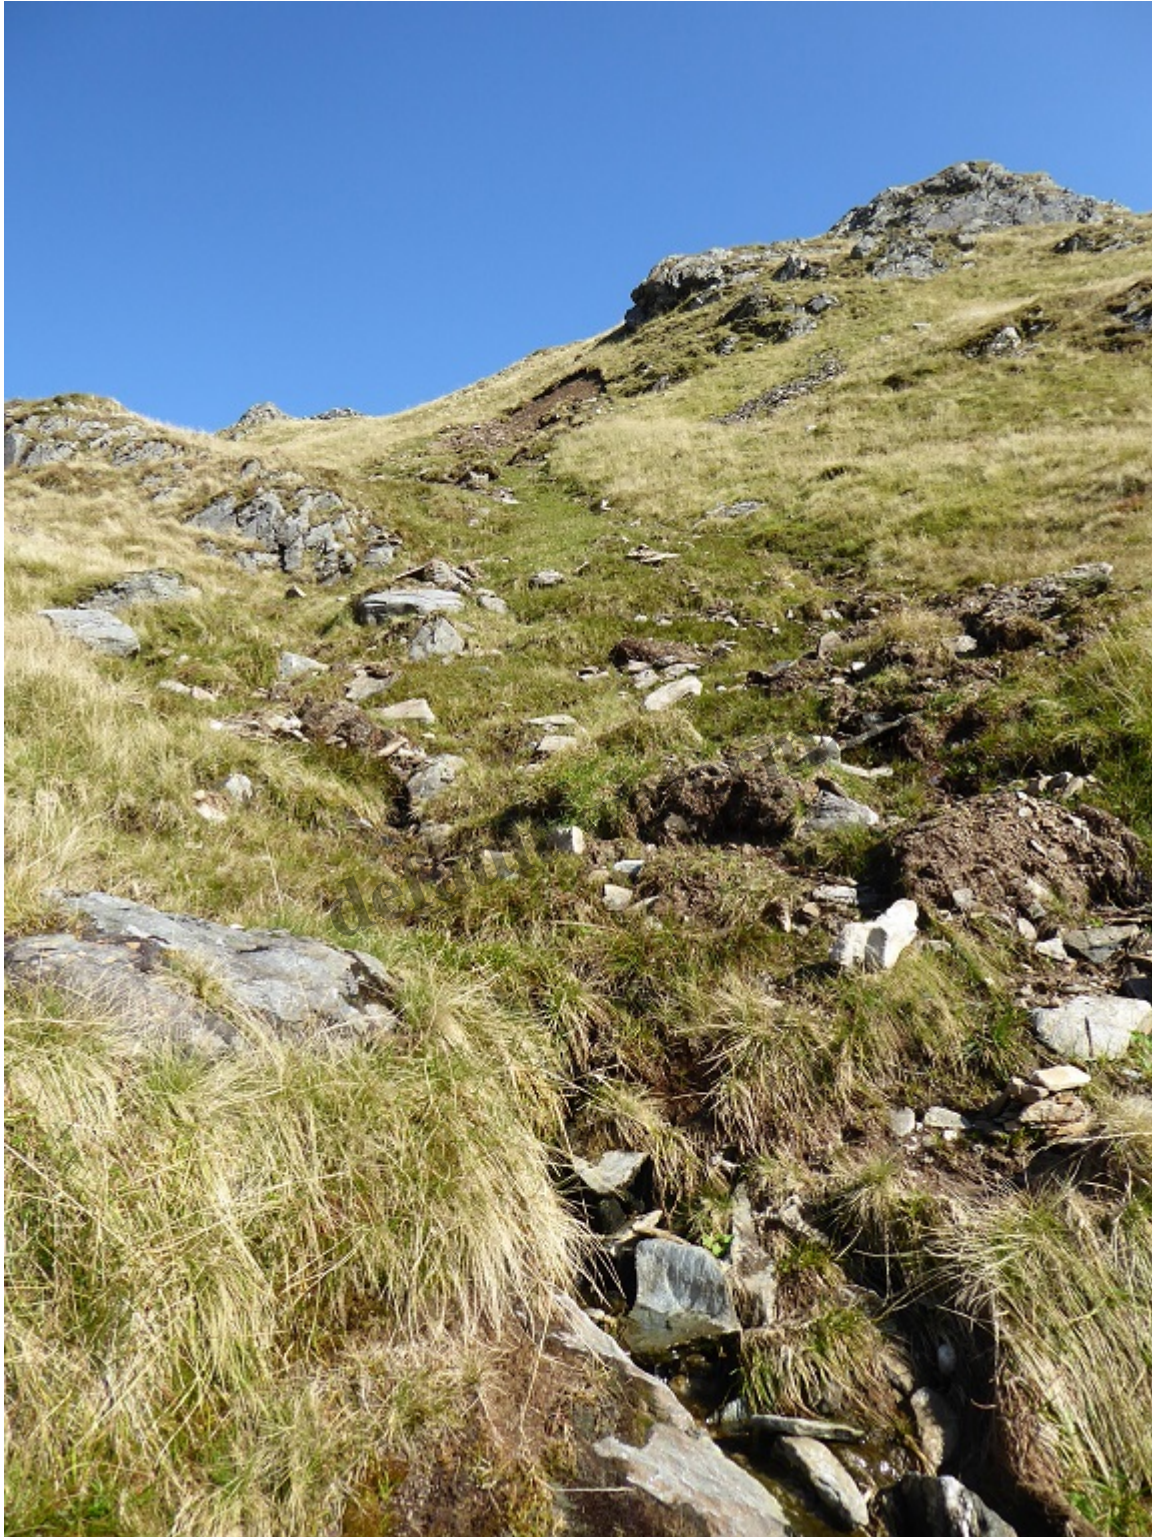
Landslip and debris below col between An Caisteal and Beinn a Chroin

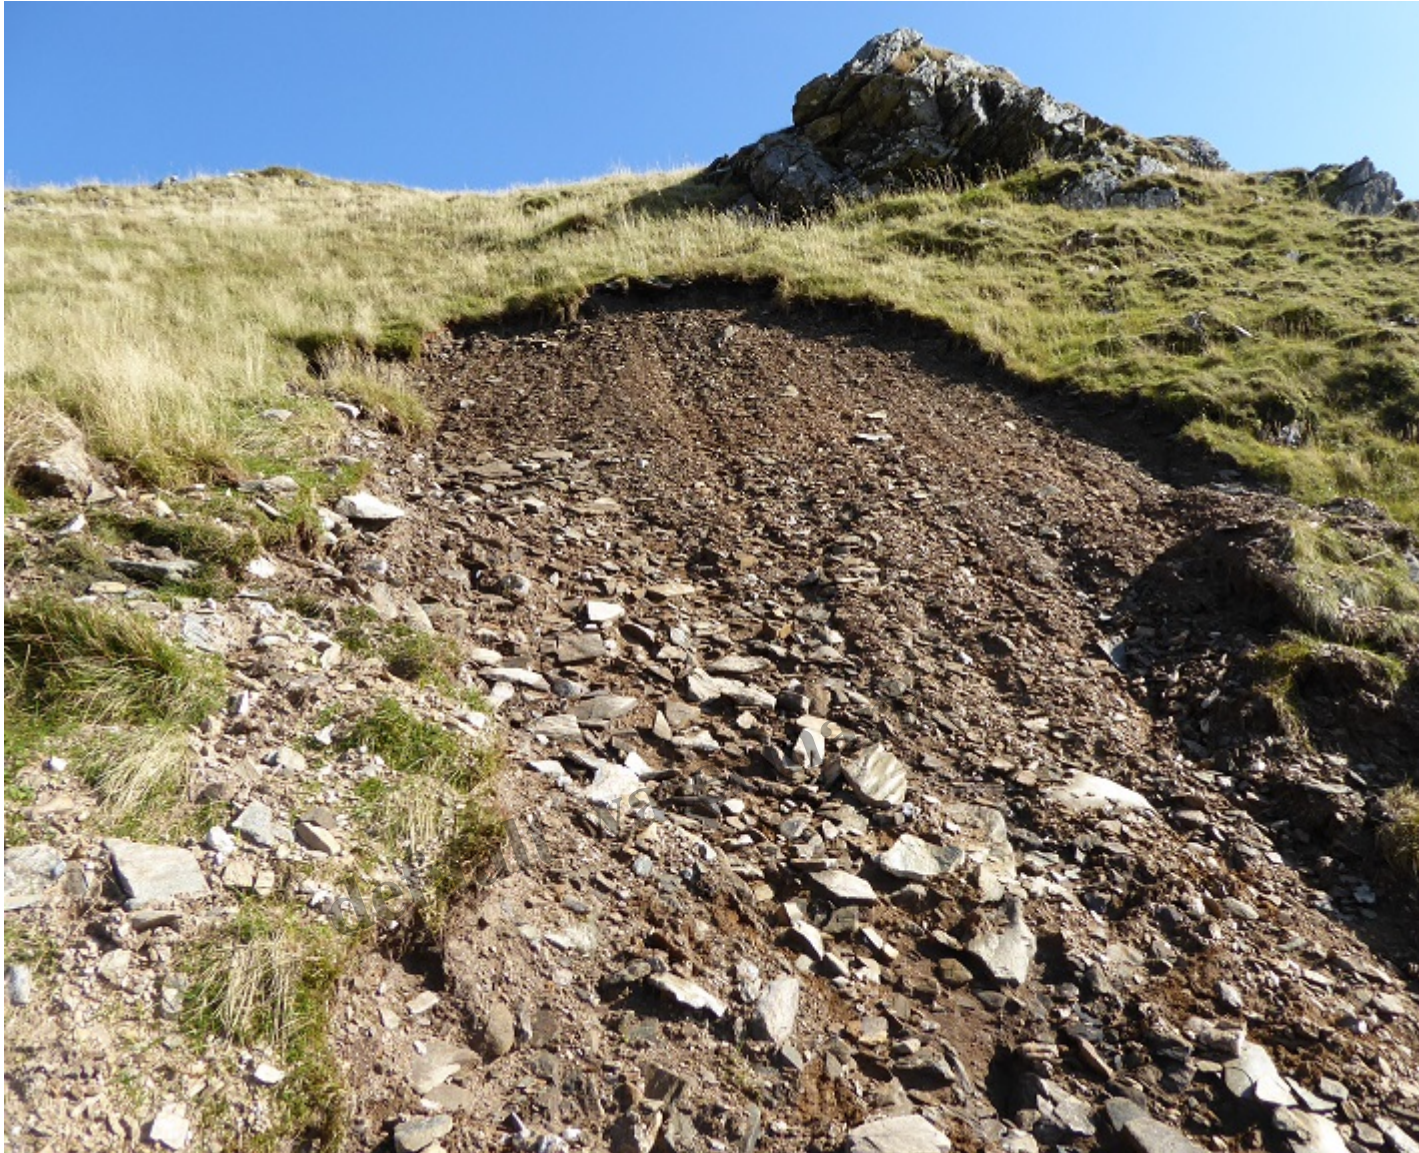
Close up of top of same landslide. The area of slope that initially failed was quite small. The soil that has been exposed is now being rapidly eroded by water, increasing erosion further.
