## Climate change and Glen Falloch (2) – the impact of increased rainfall on the natural environment

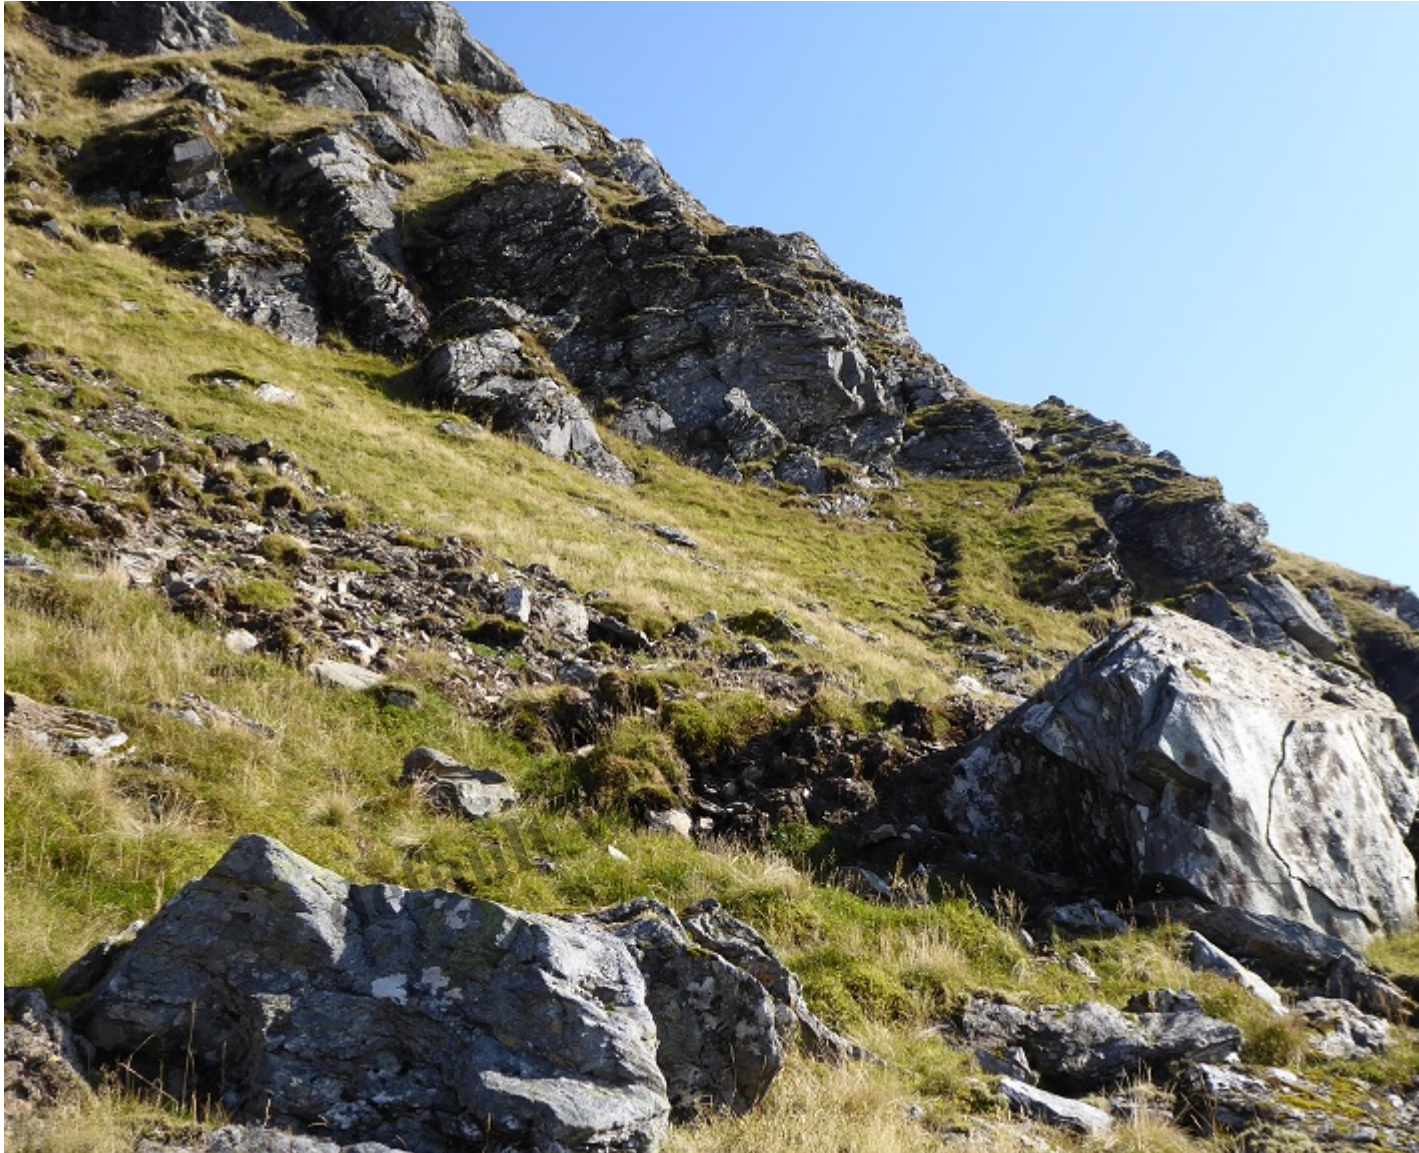
Landslip halted by boulder just above walkers path up Beinn a Chroin – path visible beyond

This landslip was quite scary from a hillwalking perspective. It appears that landslips have become a risk which, like avalanches, walkers need to consider when planning routes. Time to revise the mountain leader training courses and mountaineering manuals?

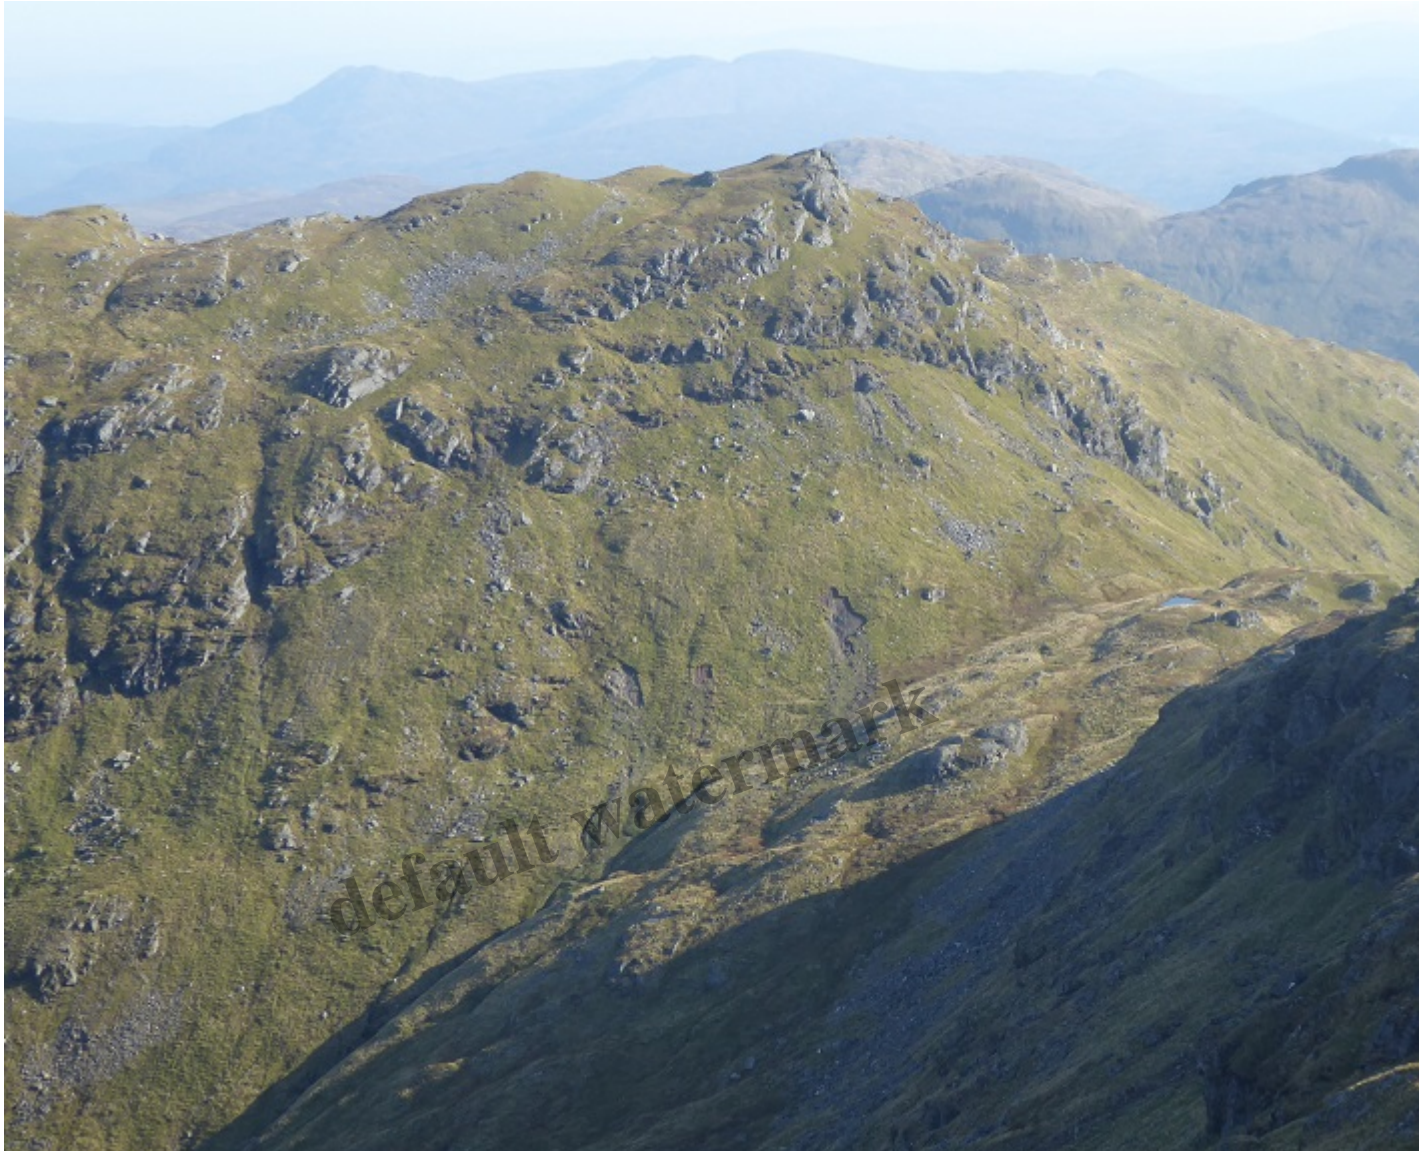
Looking to West summit Beinn a Chroin from An Caisteal. Three landslips of varying size visible mid and the landslip above the walker's path just visible above and to the right.

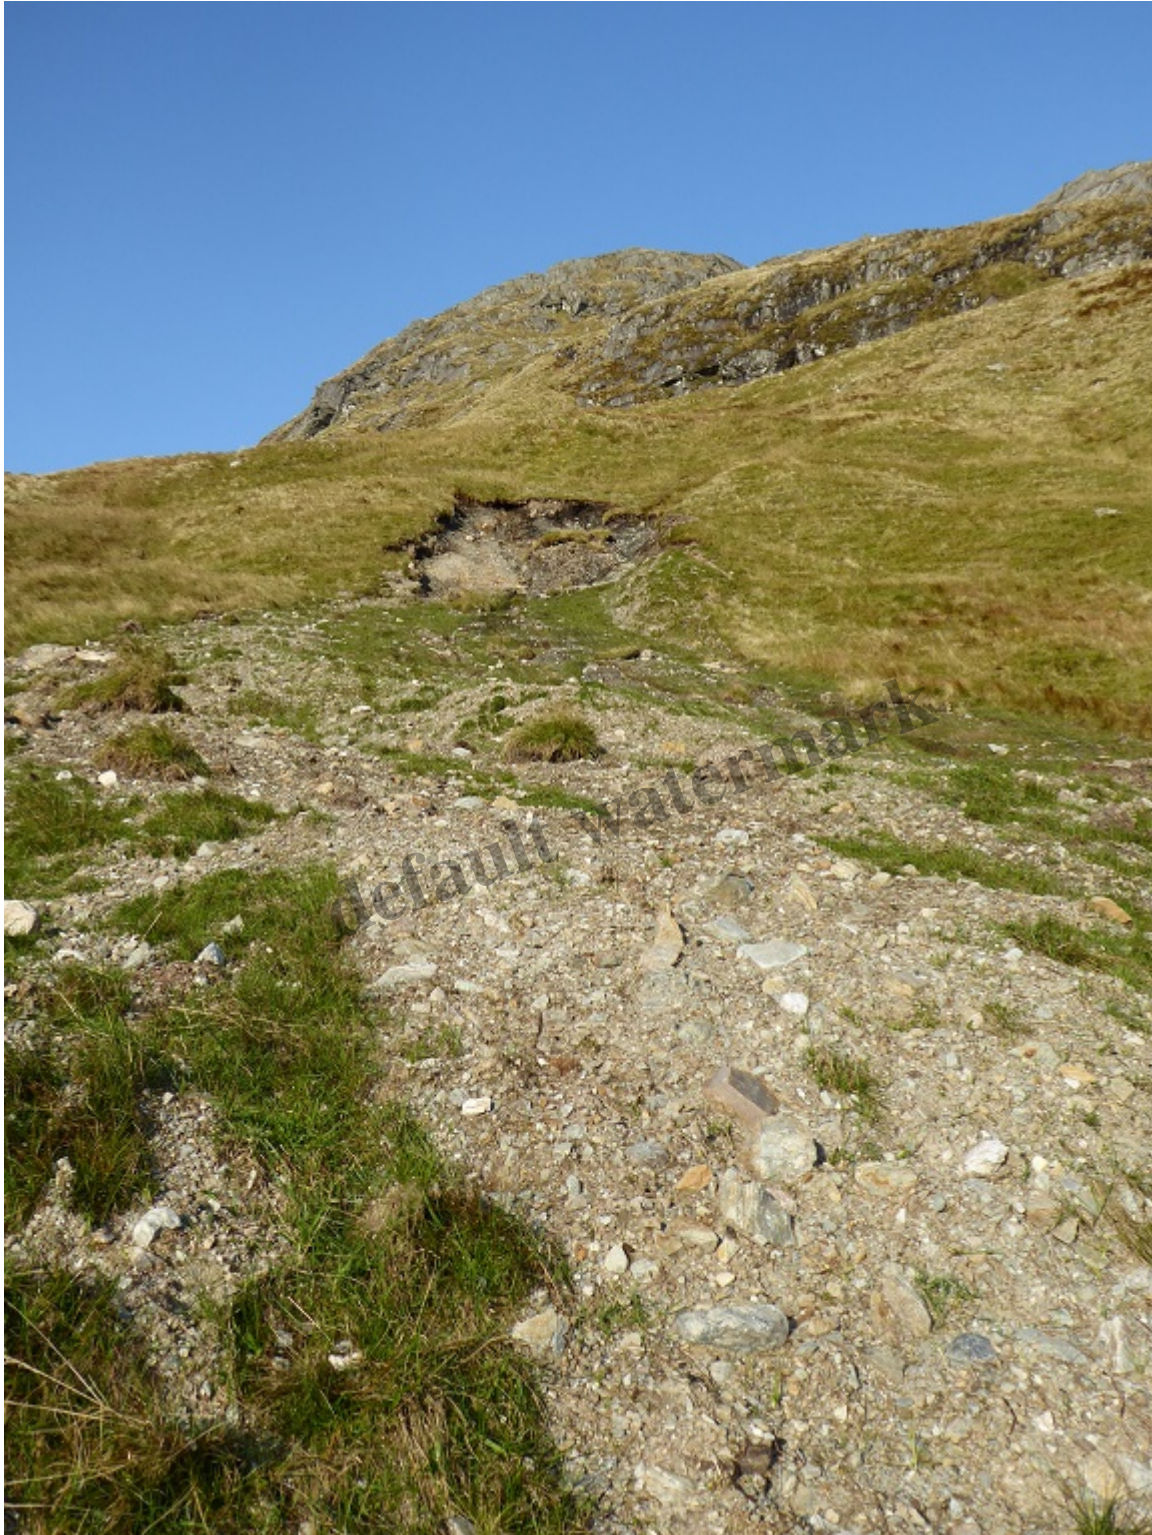
Landslip No 3 on An Caisteal descending from the North West ridge to the Allt a Chuillinn

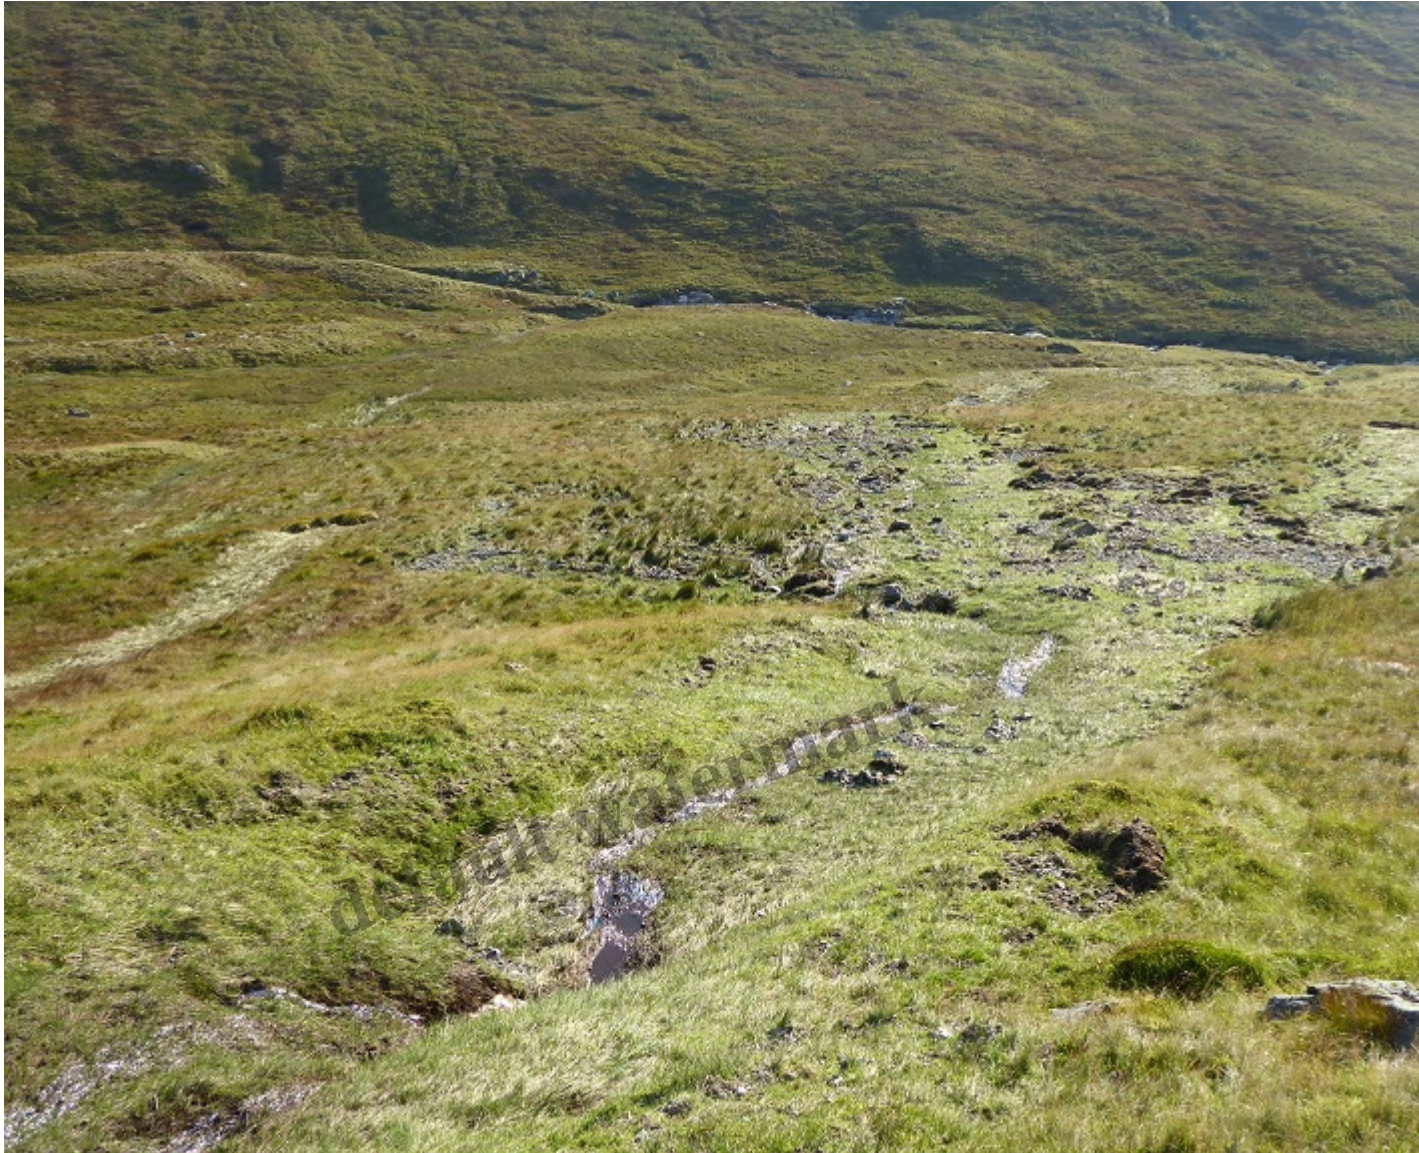
View down taken from just below the viewpoint in the photo above

While the soil and rock from this landslip came to a halt half way down the slope, the amount of water flowing down the hill must have been extraordinary, both to flatten this amount of vegetation and to carry huge lumps of peat down with it.

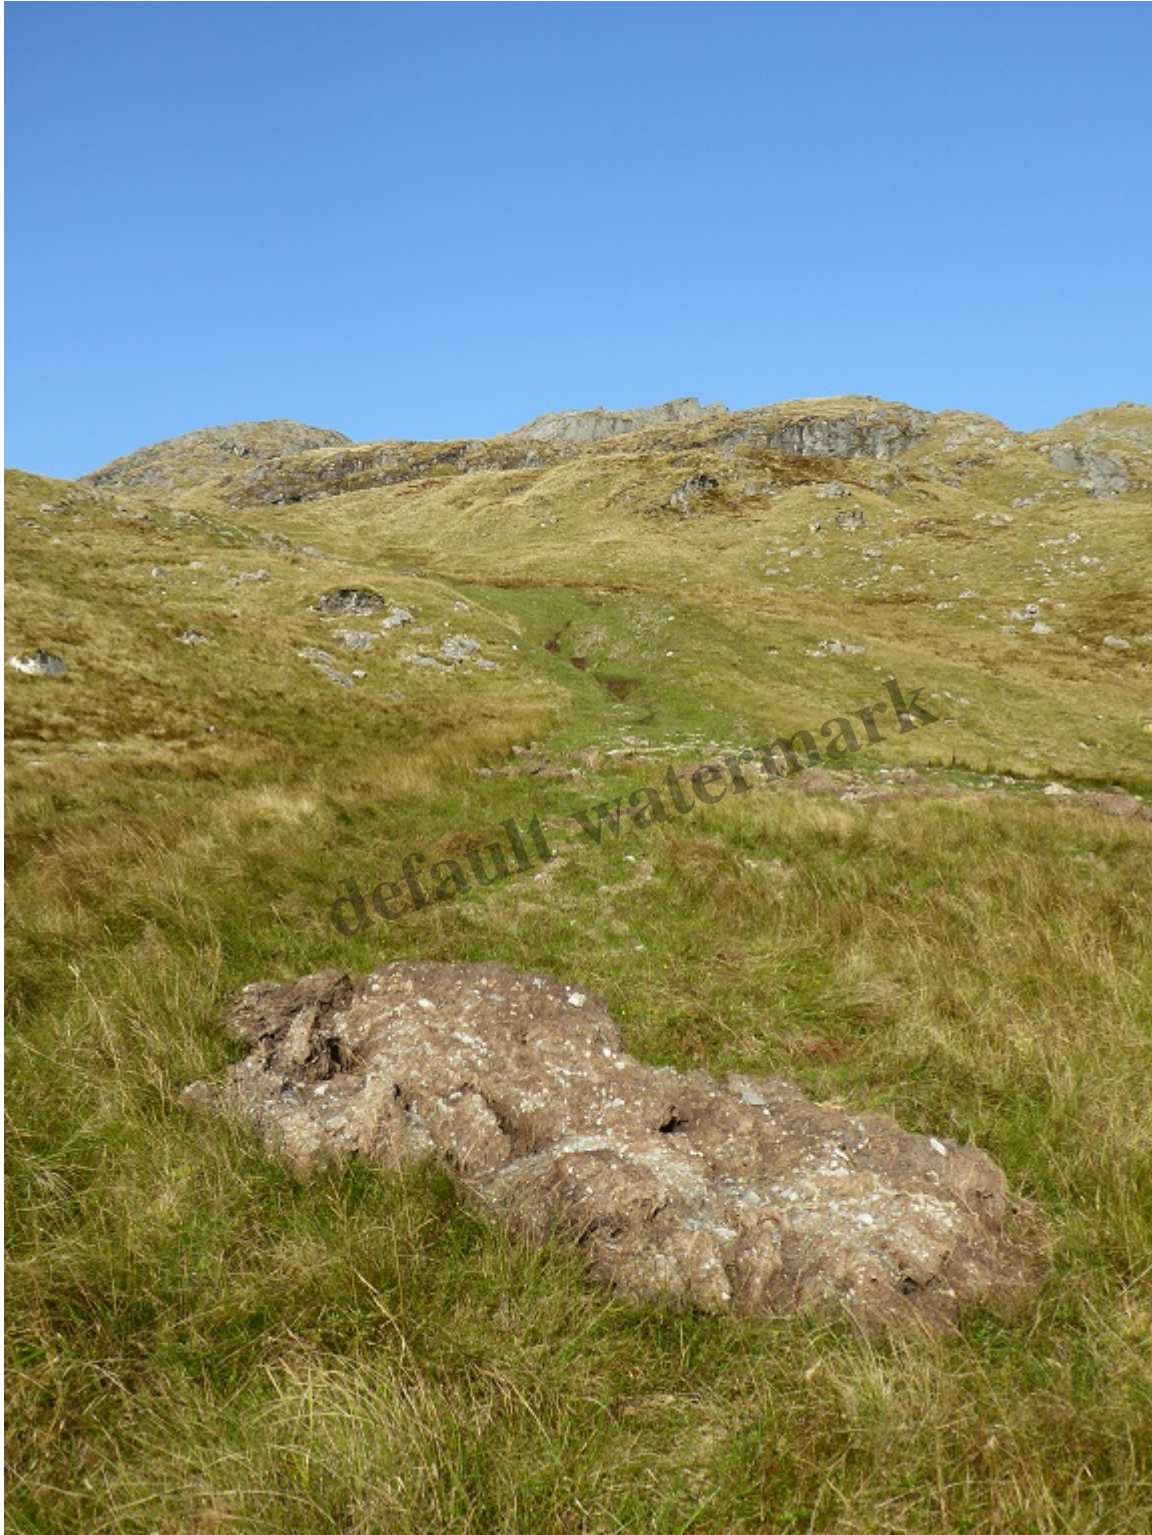
Peat deposited at bottom of water flattened area. I tried lift a small bit – its very heavy. What sort of force and sequence of events explains how it ended up here?

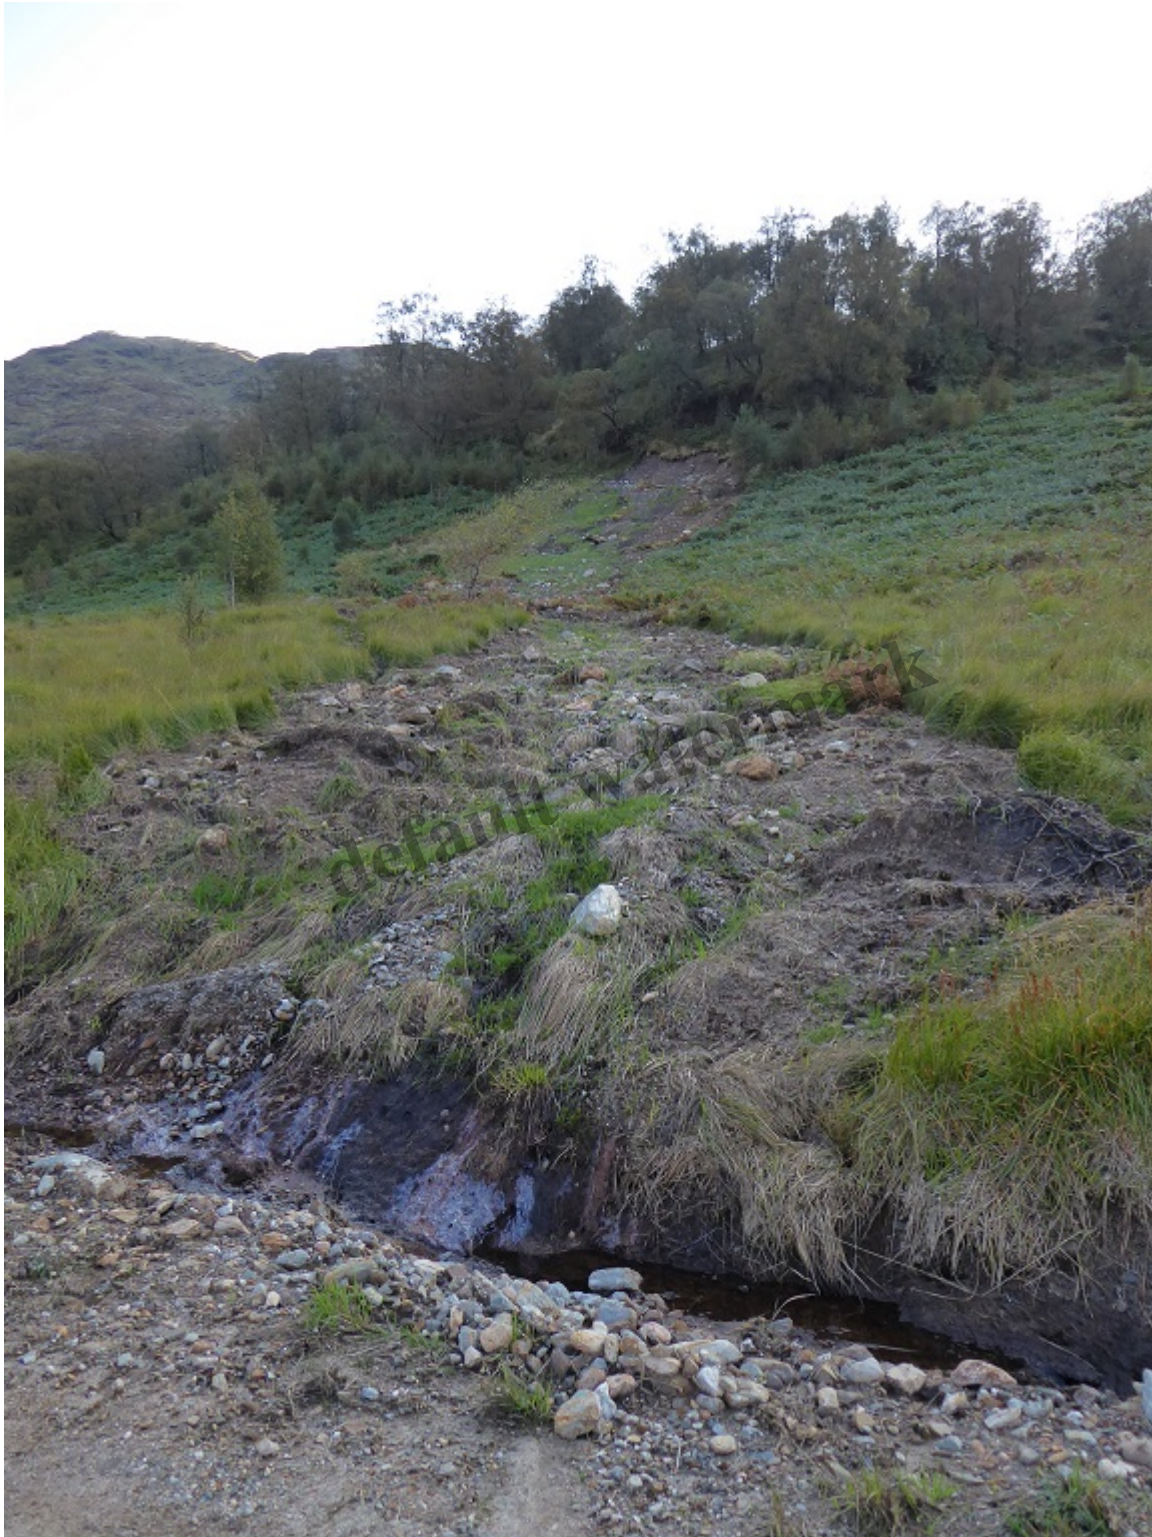
Landslip below Allt a Chuillinn hydro intakes

The one large landslide I saw lower down the hill started in woodland, which is not to say that had there been more trees lower down this would stemmed the flow of water and debris down hill.
