Climate change and Glen Falloch (2) – the impact of increased rainfall on the natural environment

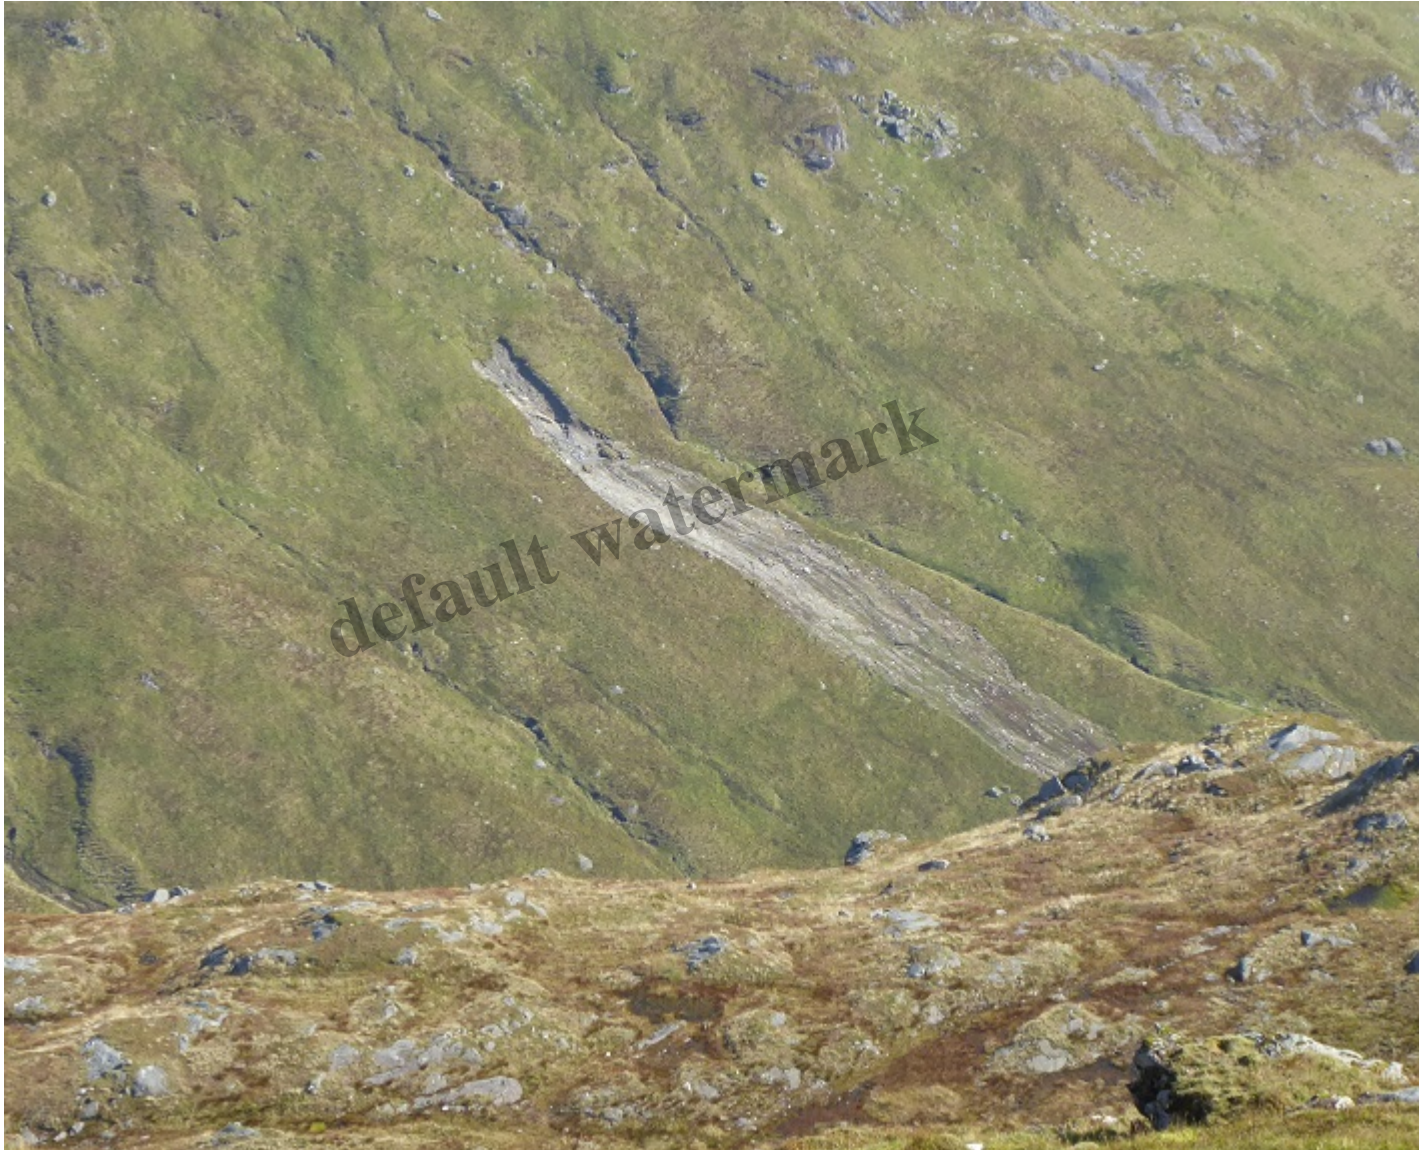
Landslip on west slopes of Beinn a Chroin. This appears to have been triggered by the downpour in August which seriously damaged the West Highland Line and is one of over a dozen I saw last Saturday on the hills south of Glen Falloch

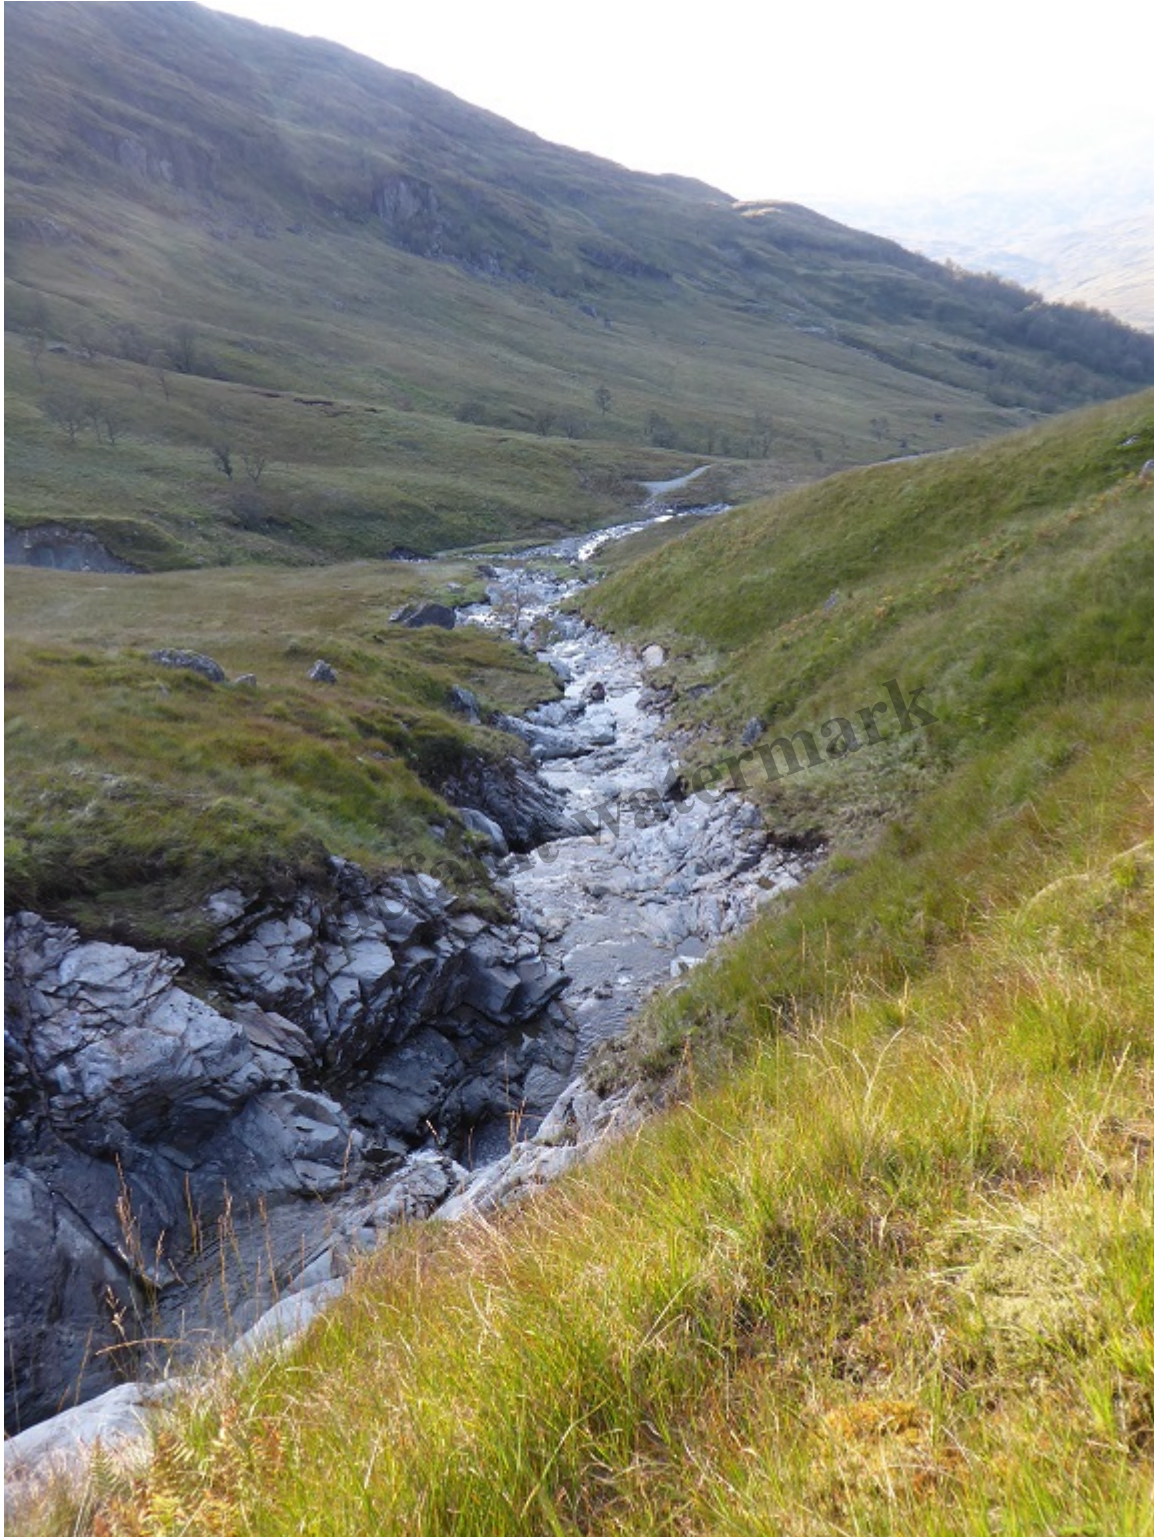
The Allt a Chuillinn, which flows between Beinn Chabhair and An Caisteal into Glen Falloch.

In the photo above, in the left foreground the flood has stripped vegetation from the rocks. Below, on the right bank from mid-picture onwards, you can see where vegetation has been flattened by the flood. In places, caused by waves perhaps, this is about 6 metres higher than the water levels last Saturday. The bare rock below the vegetation here gives an indication of more normal maximum flood levels. The volume and power of the water would have been incredible to witness.

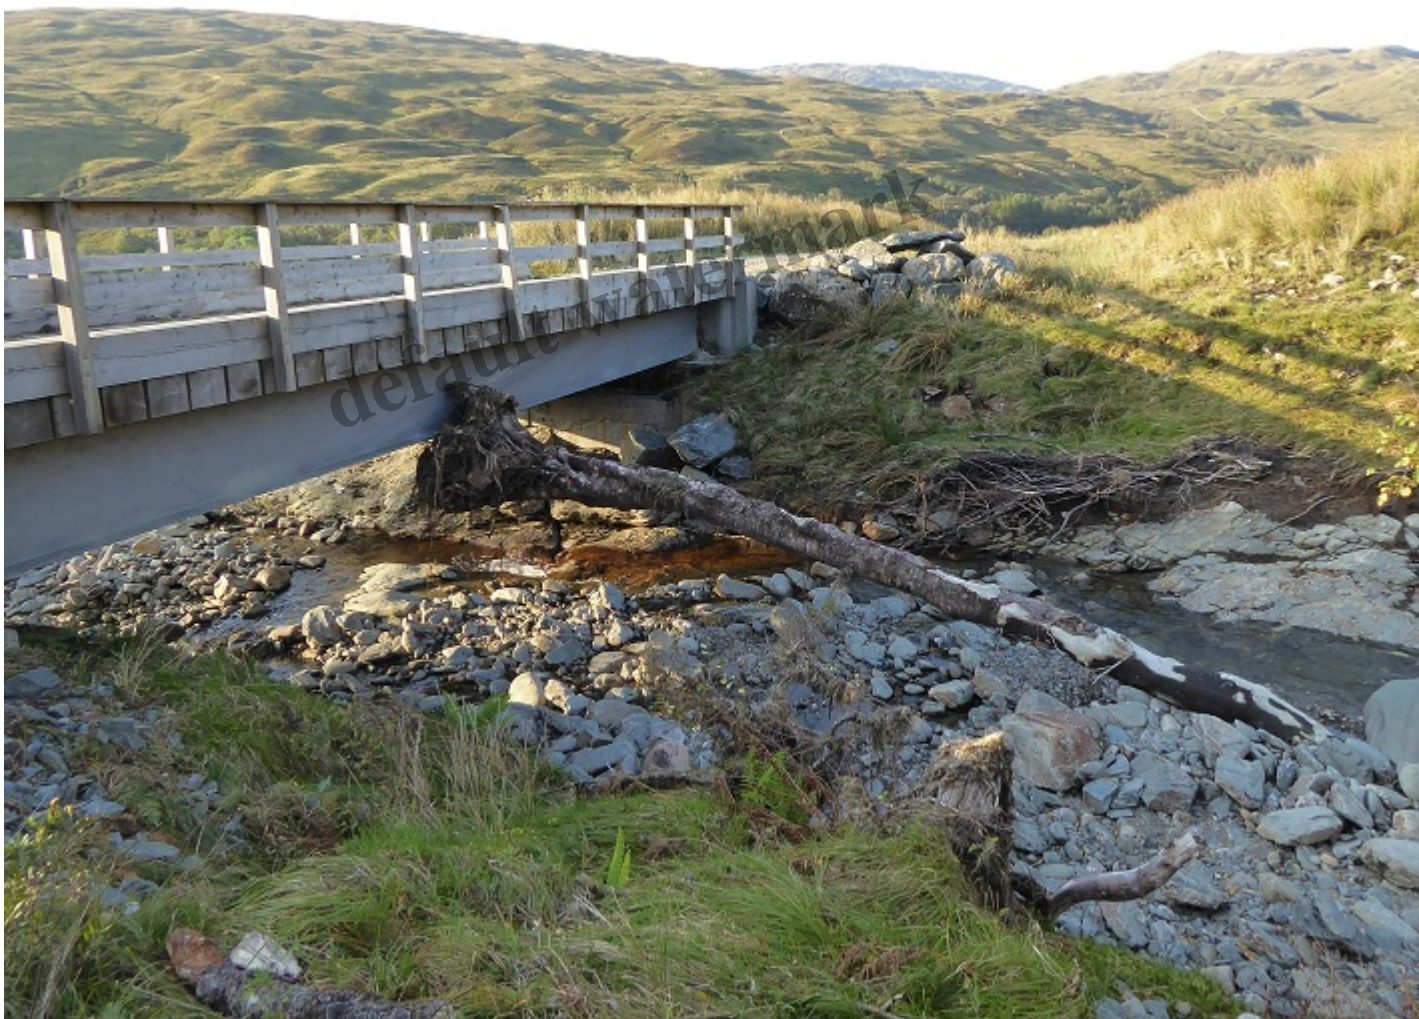
One scene from lower down the Allt a Chuillinn at the new bridge constructed for the hydro scheme. how vegetation has also been removed from the bank on the right

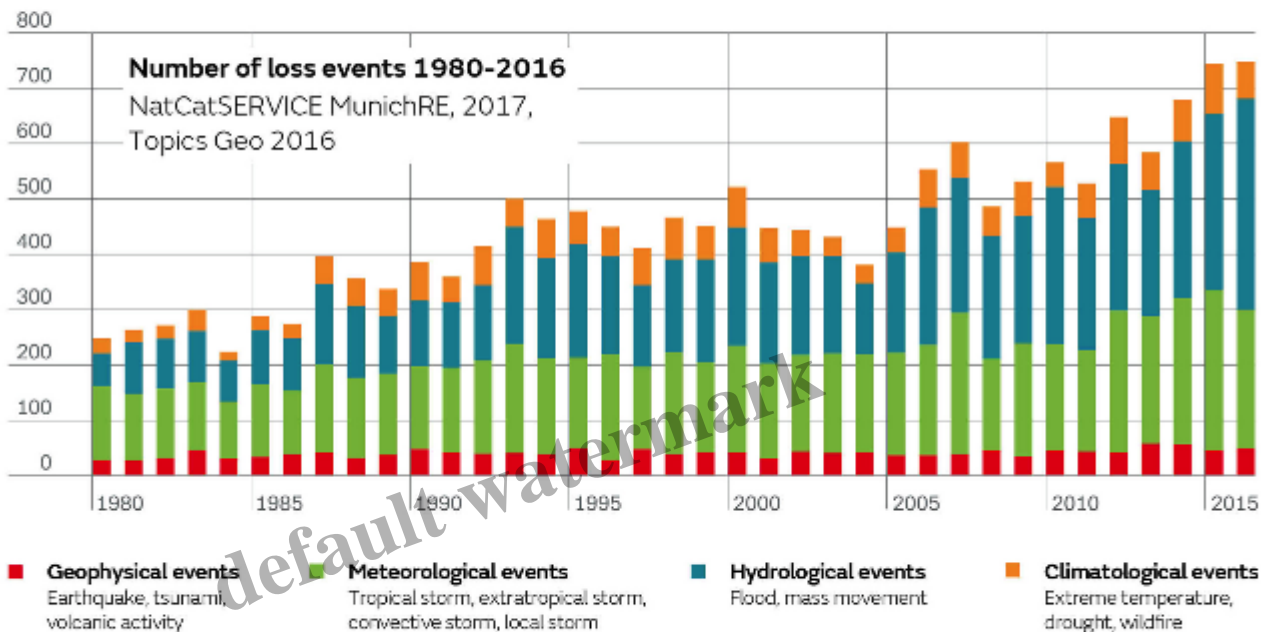
This graph, from Munich RE's Topics Geo Natural Catastrophes report, shows events causing loss are becoming more frequent.

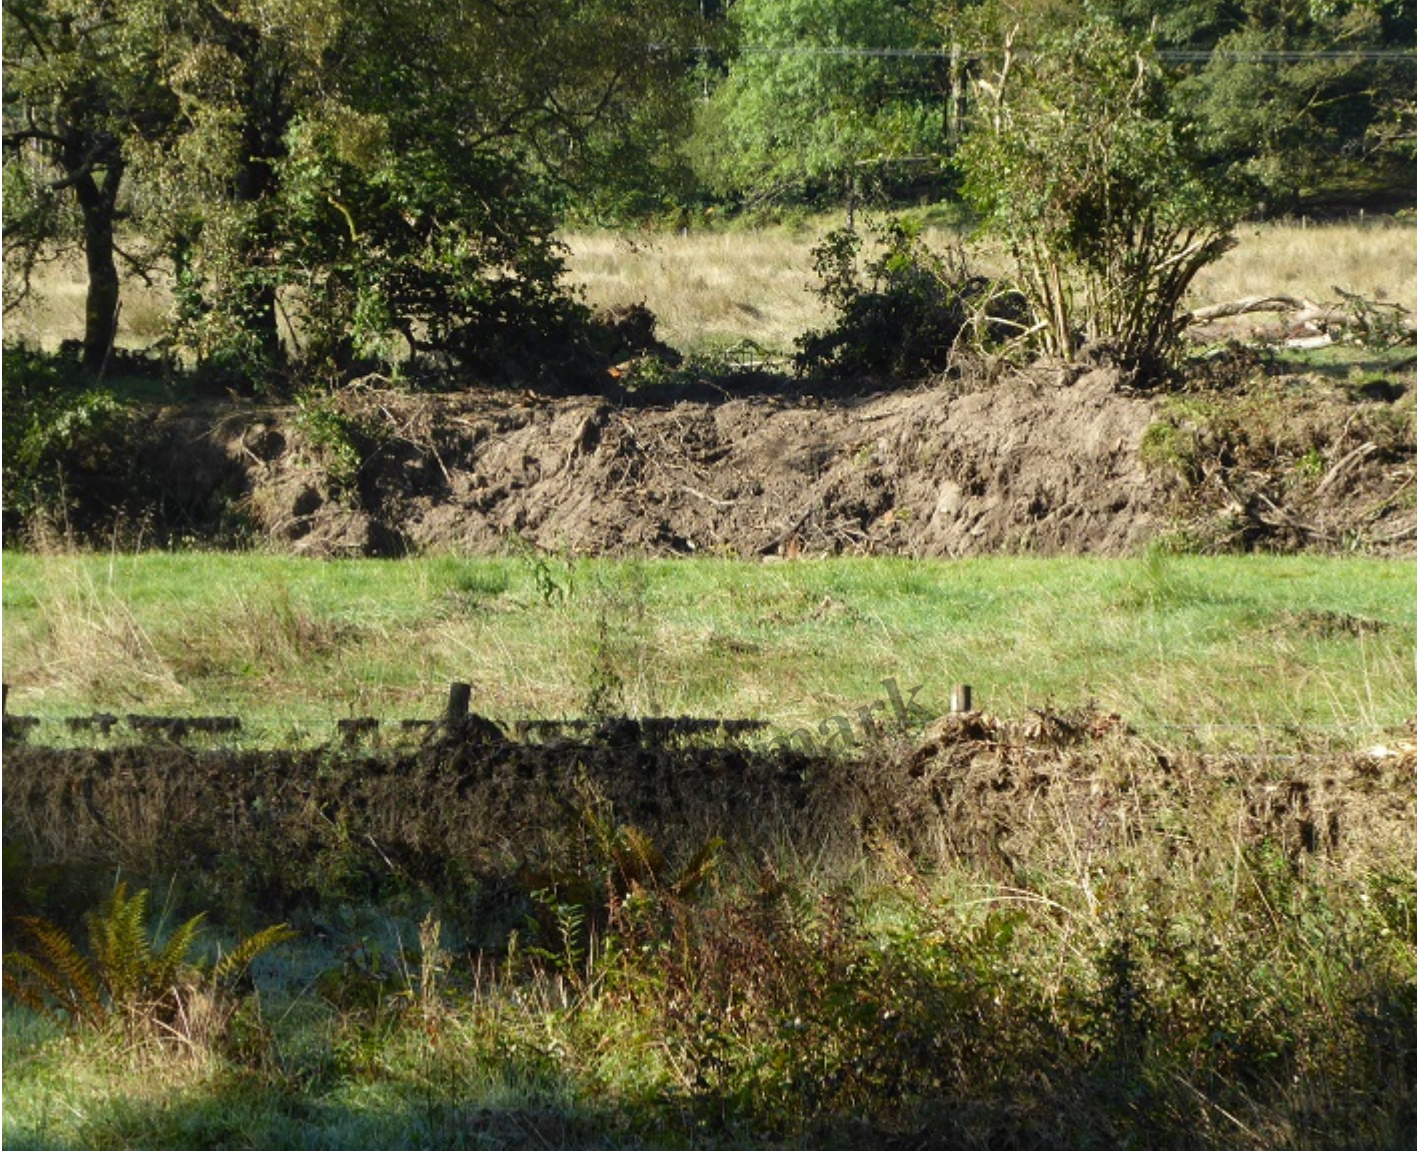
The vegetation on the fence in the foreground gives some indication of the level of water on the flood while a section of bank on the far side of the river has been partially destroyed

Without the alder, the damage to the banks would have been far worse and the likelihood of the river changing its course much higher. With catastrophic events like this increasing in frequency, there may not be the time now for the alder to grow back before the next one. It appears to me there is now a real risk of us entering a vicious circle of ever-increasing damage.

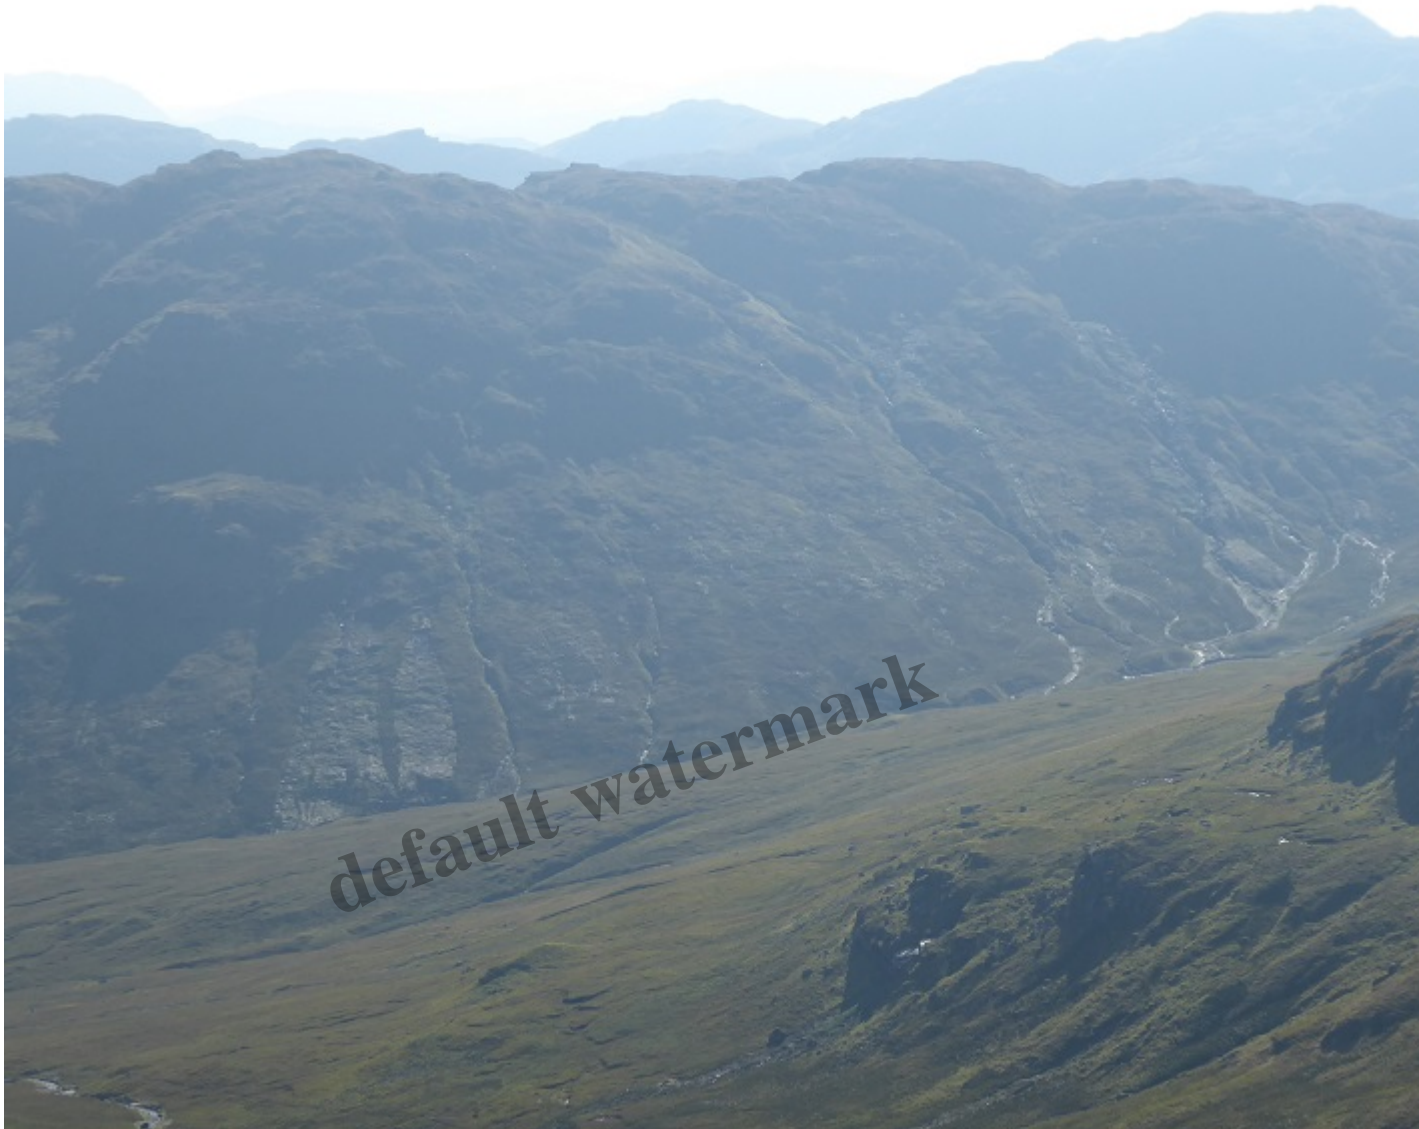
It was very hazy to the south but across the Allt Lairig several major landslips were visible on the north slopes of Meall Mor

The two landslips on the left bear a strong resemblance to avalanches triggered at particular point and which then spread out as they gain momentum down the hill carrying all before them. Maybe they were caused by avalanches and not the recent rain? I was not close enough to check..

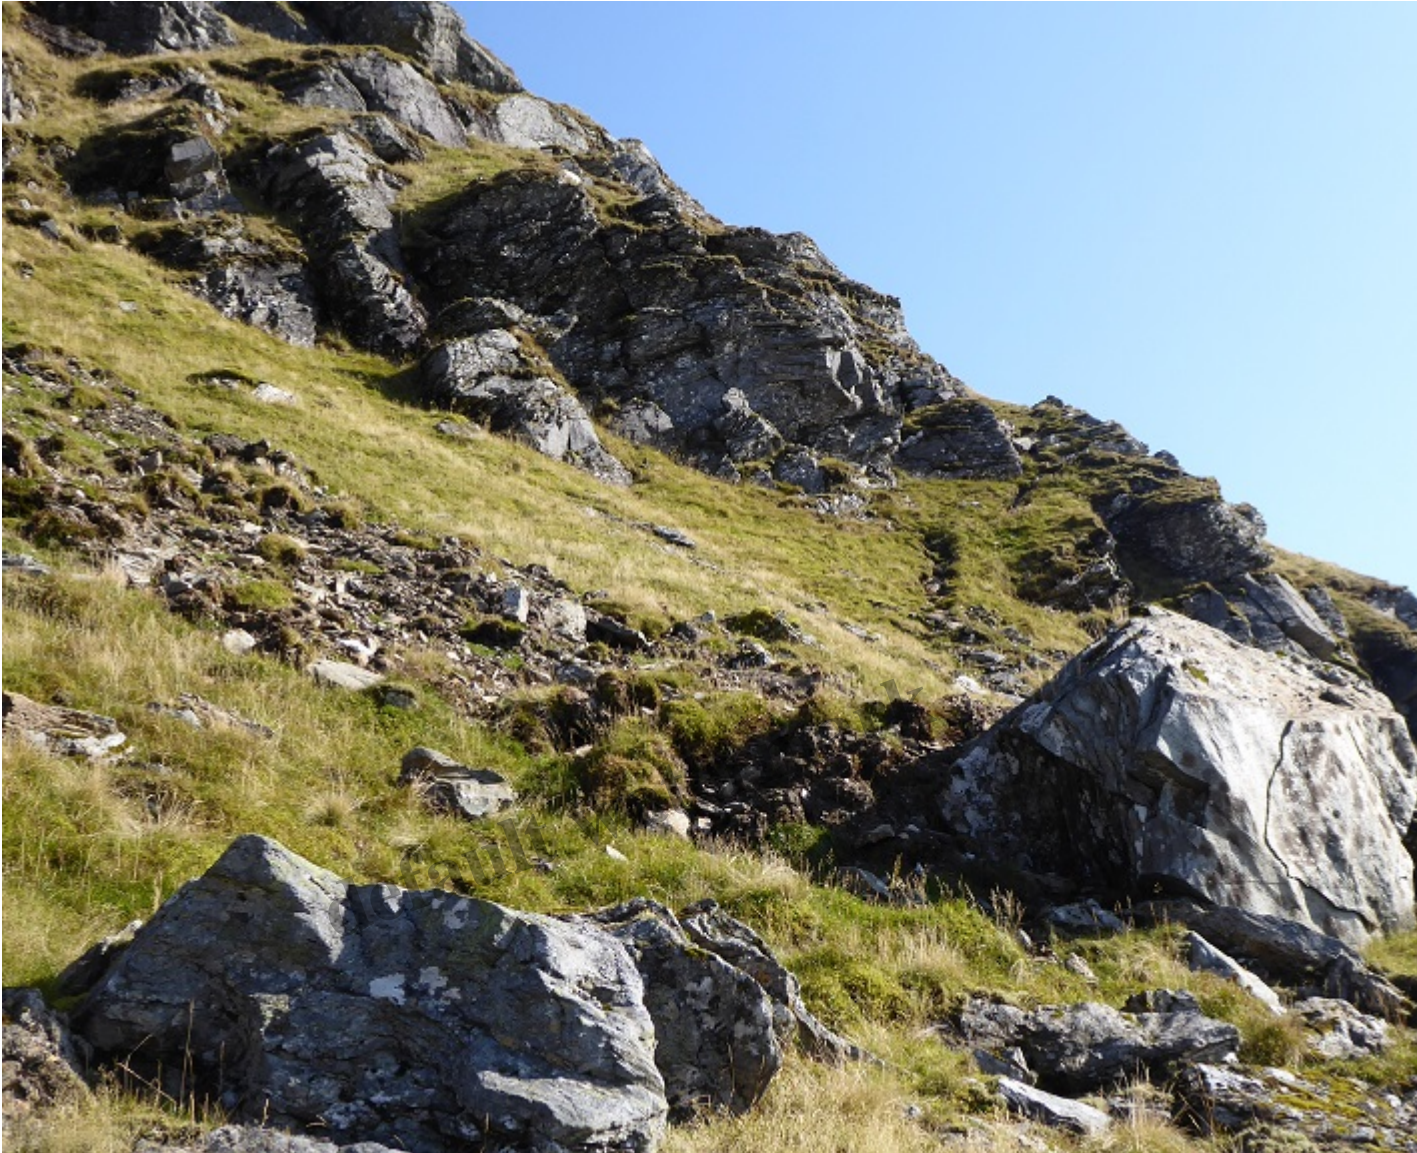
Landslip halted by boulder just above walkers path up Beinn a Chroin – path visible beyond

This landslip was quite scary from a hillwalking perspective. It appears that landslips have become a risk which, like avalanches, walkers need to consider when planning routes. Time to revise the mountain leader training courses and mountaineering manuals?

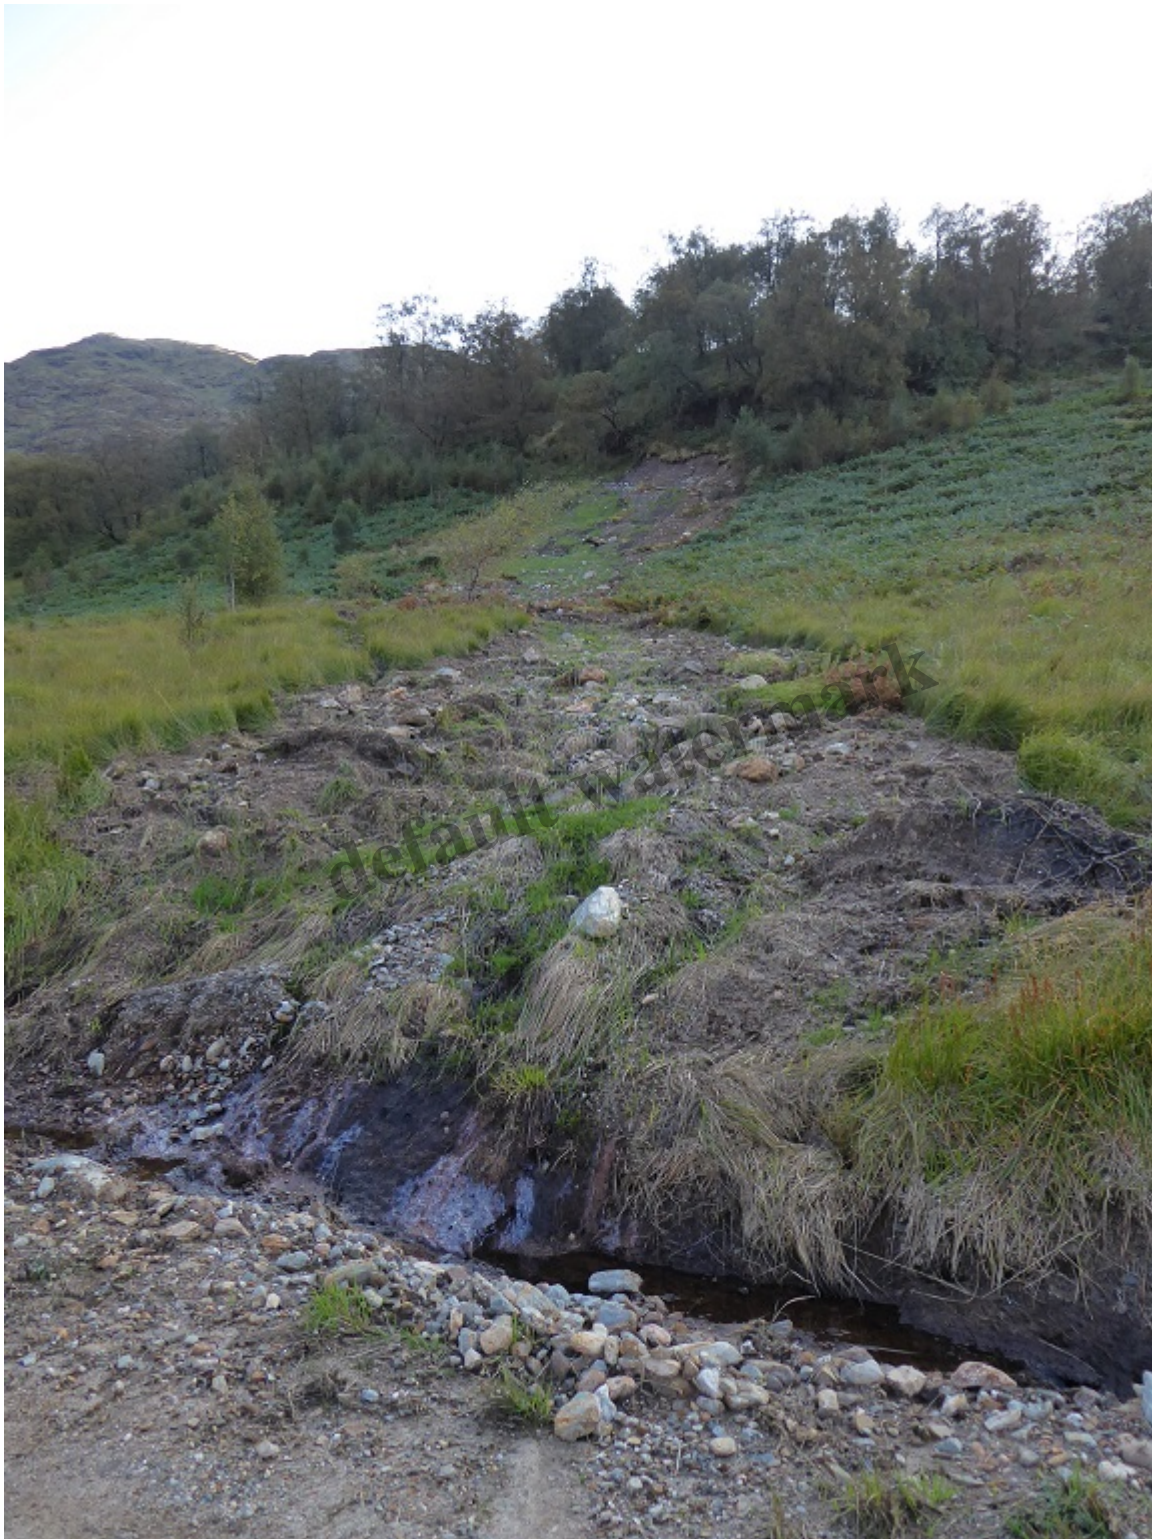
Landslip below Allt a Chuillinn hydro intakes

The one large landslide I saw lower down the hill started in woodland, which is not to say that had there been more trees lower down this would stemmed the flow of water and debris down hill.
