Climate change and Glen Falloch (2) – the impact of increased rainfall on the natural environment

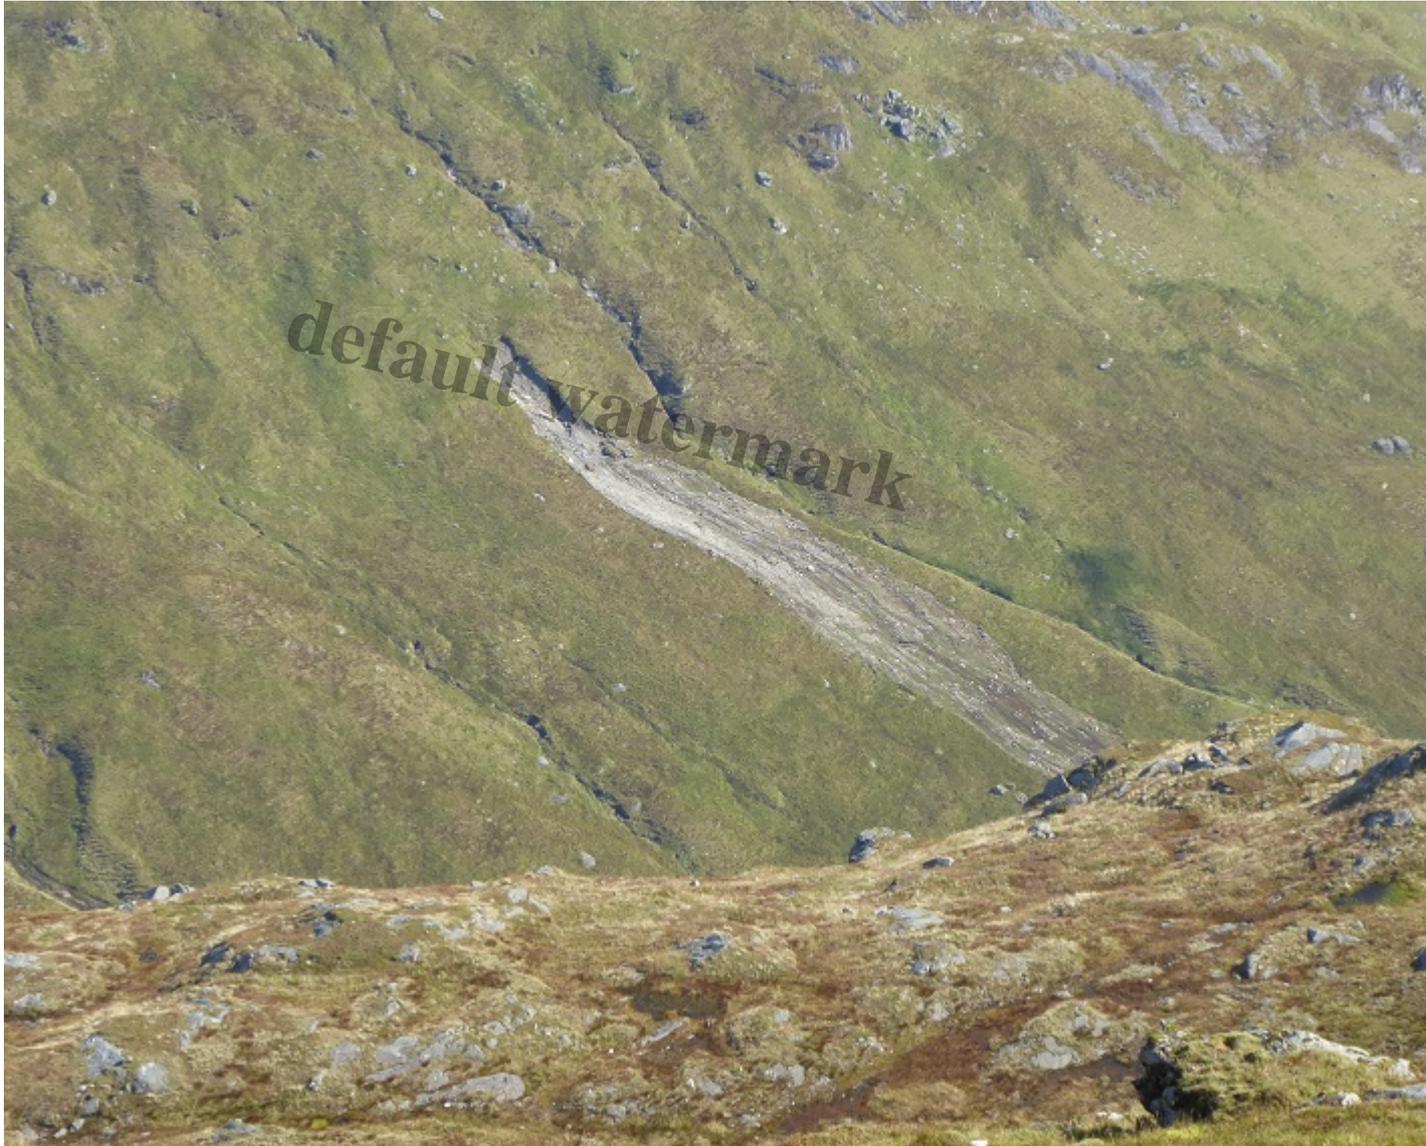
Landslip on west slopes of Beinn a Chroin. This appears to have been triggered by the downpour in August which seriously damaged the West Highland Line and is one of over a dozen I saw last Saturday on the hills south of Glen Falloch

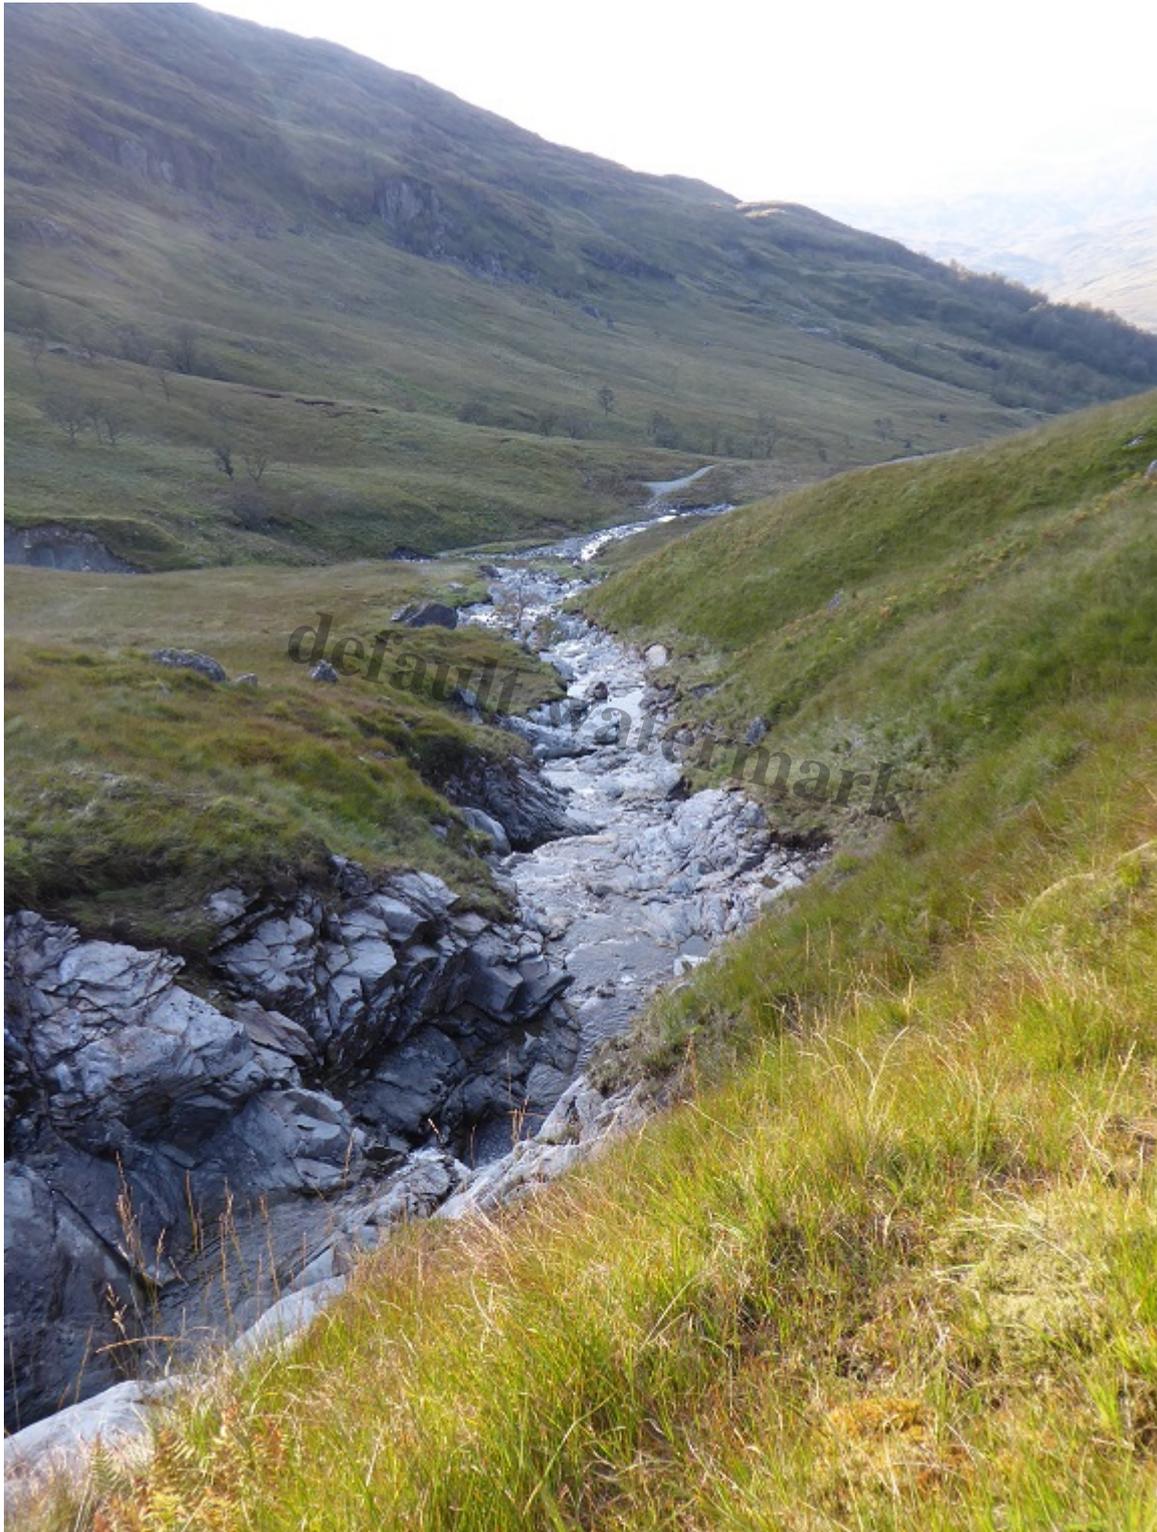
The Allt a Chuillinn, which flows between Beinn Chabhair and An Caisteal into Glen Falloch.

In the photo above, in the left foreground the flood has stripped vegetation from the rocks. Below, on the right bank from mid-picture onwards, you can see where vegetation has been flattened by the flood. In places, caused by waves perhaps, this is about 6 metres higher than the water levels last Saturday. The bare rock below the vegetation here gives an indication of more normal maximum flood levels. The volume and power of the water would have been incredible to witness.

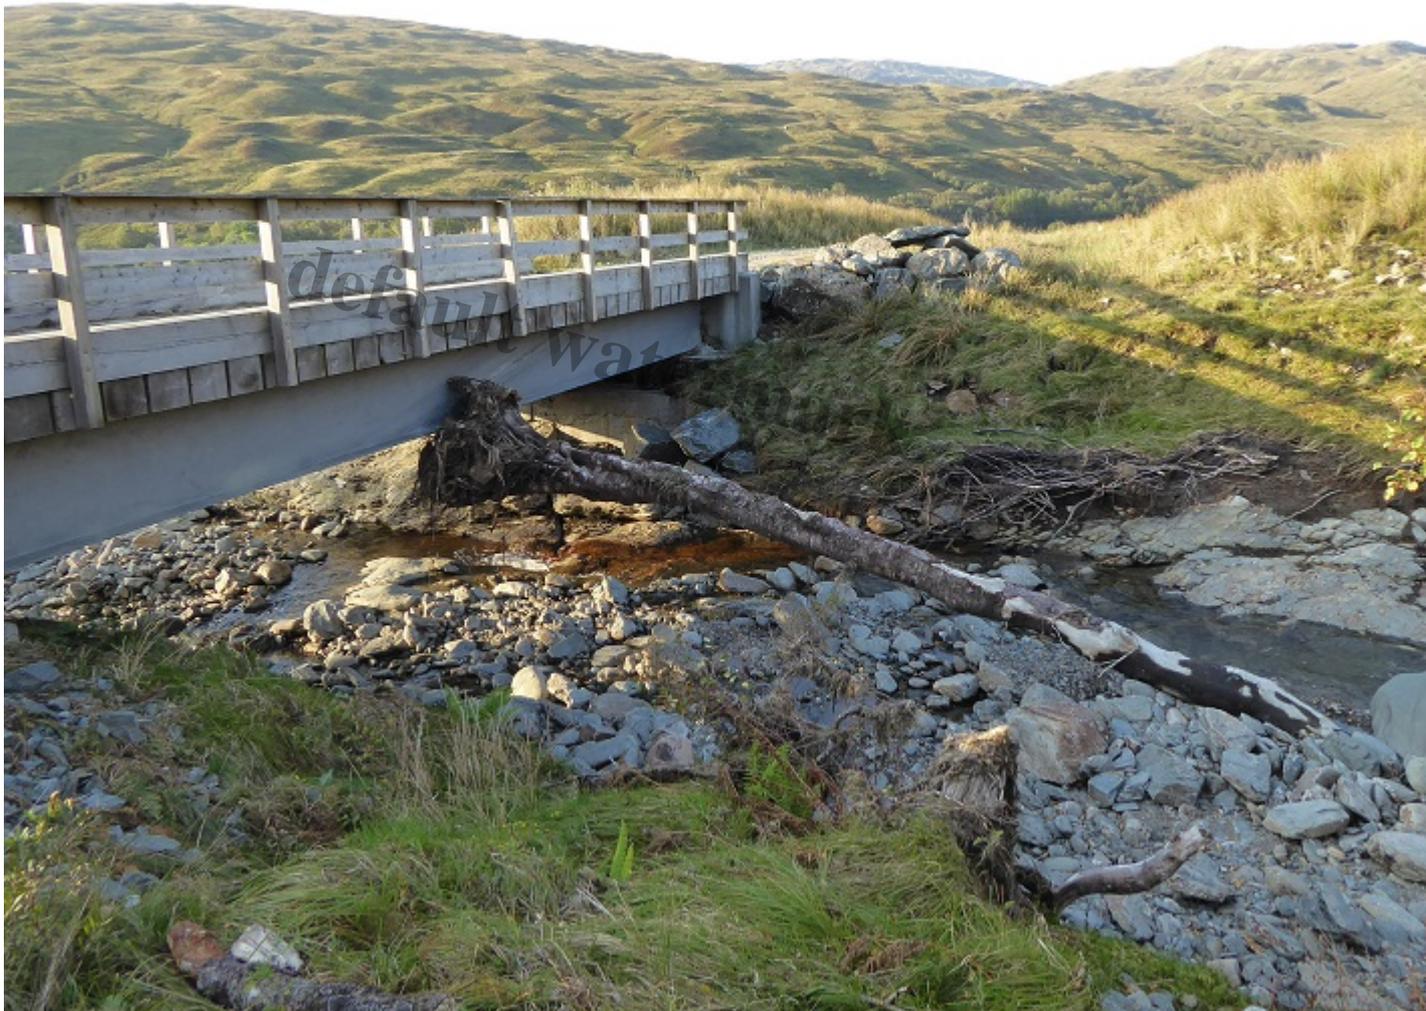
One scene from lower down the Allt a Chuillinn at the new bridge constructed for the hydro scheme. how vegetation has also been removed from the bank on the right

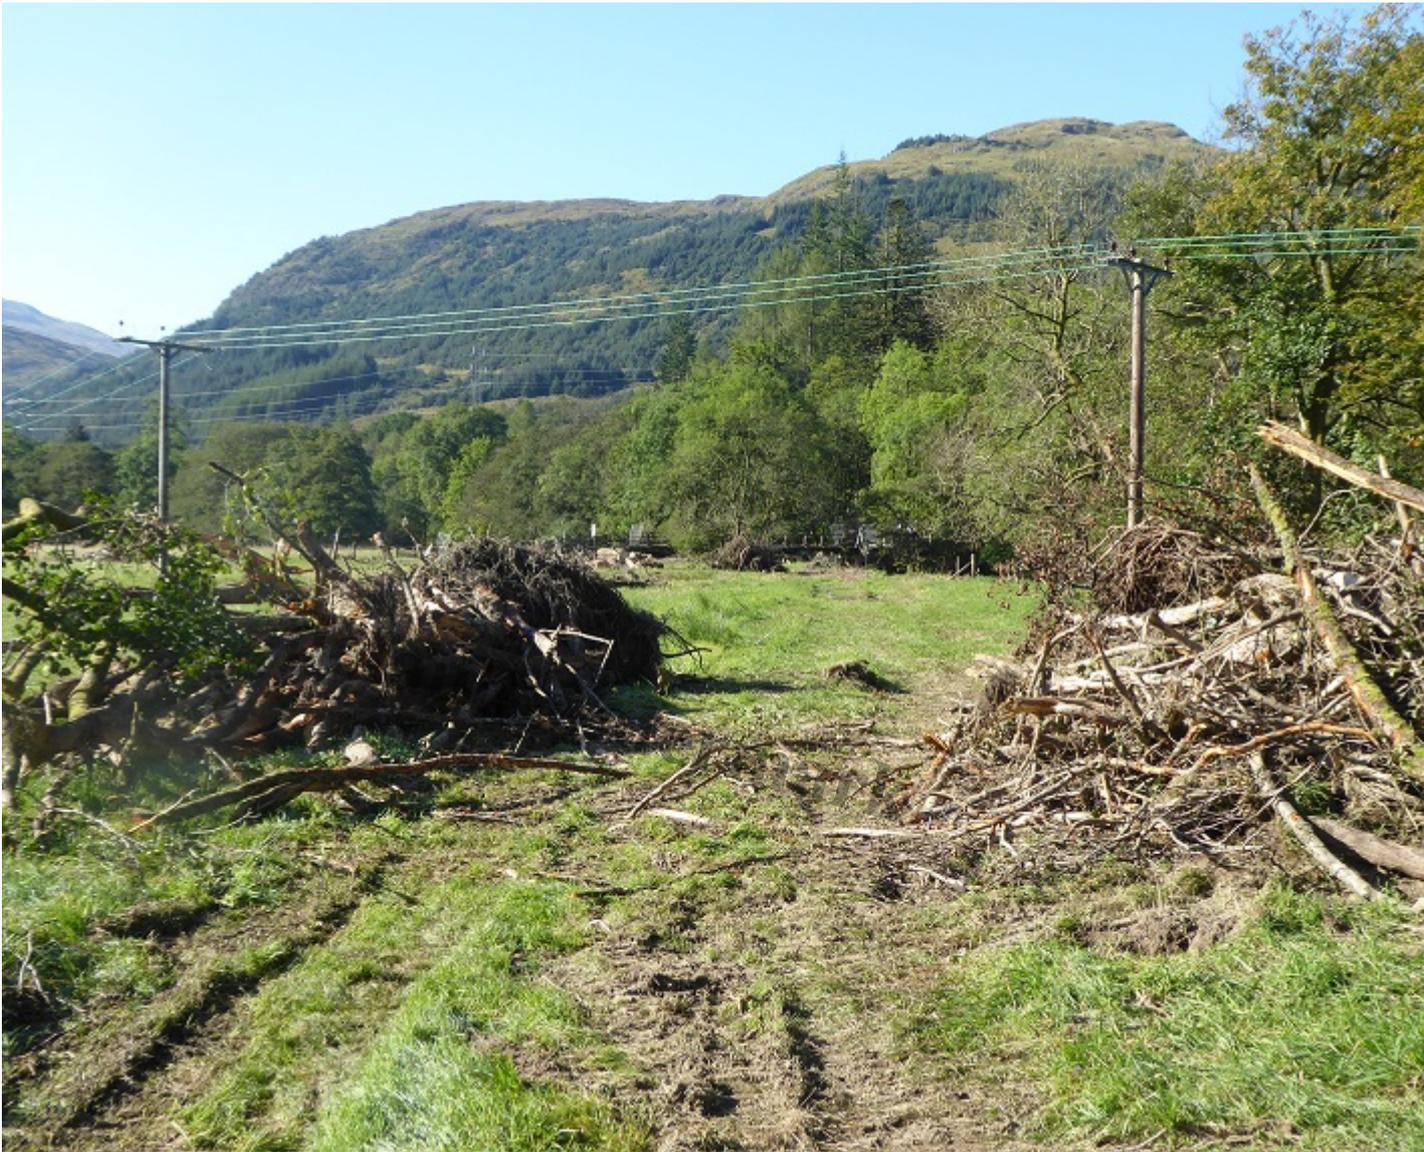
Looking along the floor plain towards the damaged bridge to the Bein Glas farm campsite which has closed. The piles of uprooted trees and broken branches have been created by the estate tidying up damage.

The standing telegraph poles provide a good illustration that flood plains work and why its so important that we protect them. The power of water reduces dramatically as soon as its allowed to spread out.

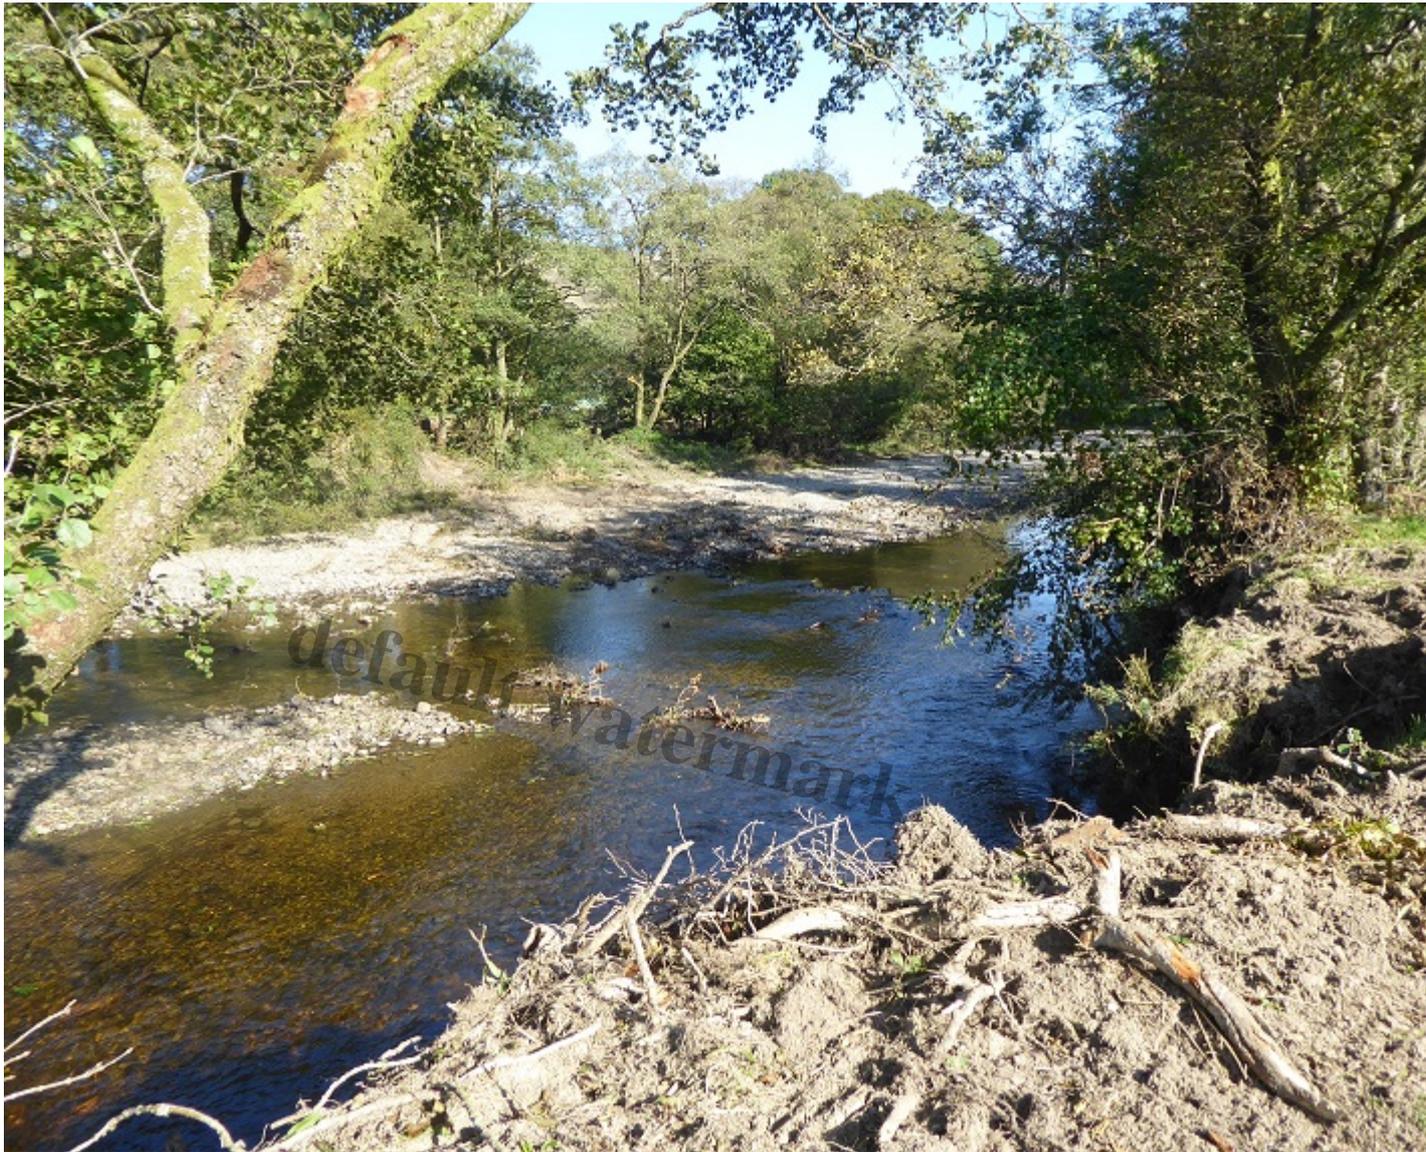
Several sections of bank have been completely stripped of trees and vegetation

Within the normal confines of the river the flood has caused extensive damage, not unprecedented perhaps but judging by the alder that previously grew here, damage of this scale has not happened for many years.

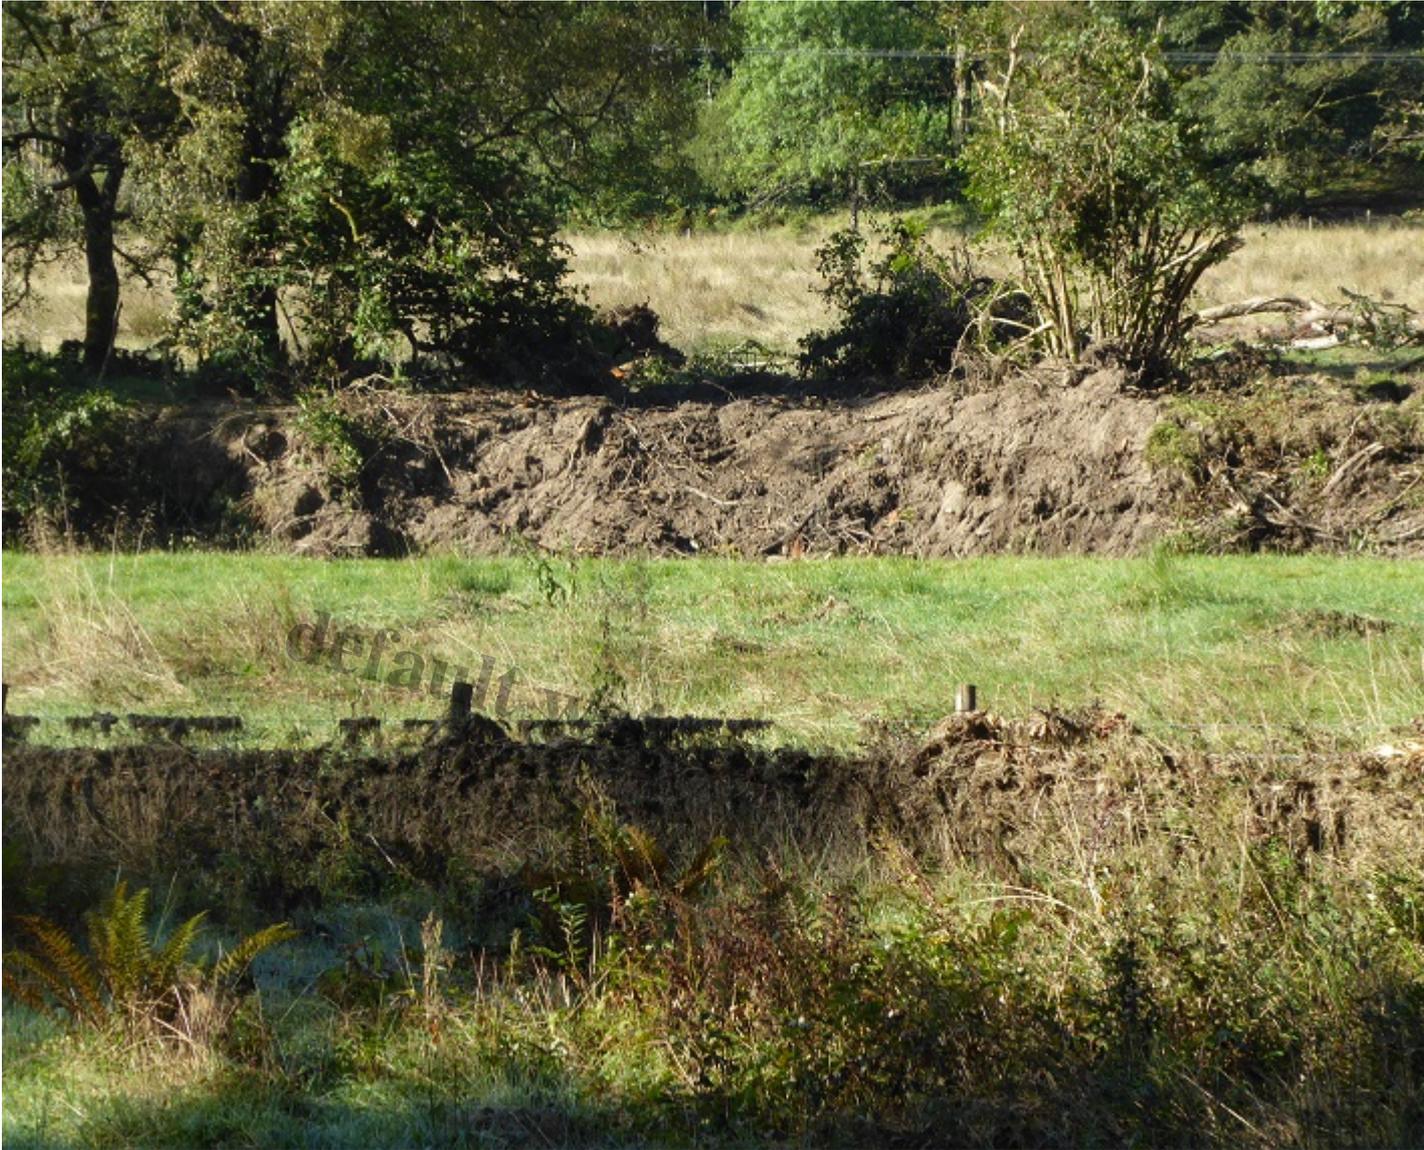
The vegetation on the fence in the foreground gives some indication of the level of water on the flood while a section of bank on the far side of the river has been partially destroyed

Without the alder, the damage to the banks would have been far worse and the likelihood of the river changing its course much higher. With catastrophic events like this increasing in frequency, there may not be the time now for the alder to grow back before the next one. It appears to me there is now a real risk of us entering a vicious circle of ever-increasing damage.

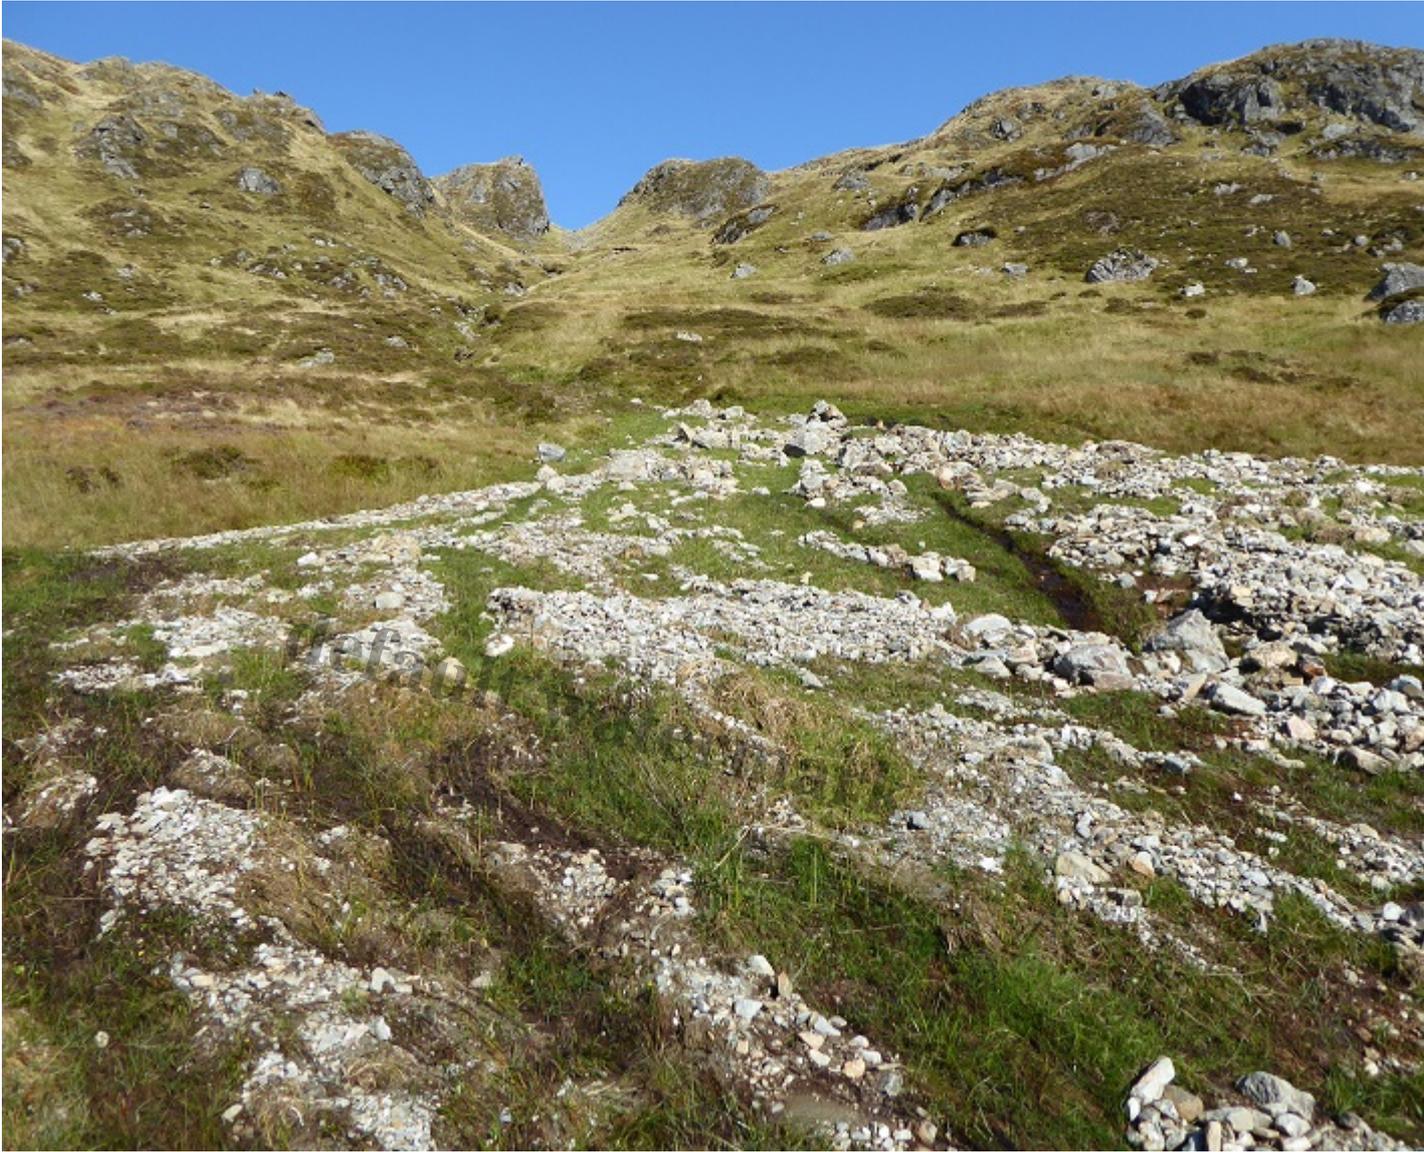
Note the dark trench just right of centre. This marks the normal course of the burn and is less than 1
The flood has deposited boulders, vegetation and gravel for 10 metres either side of this.

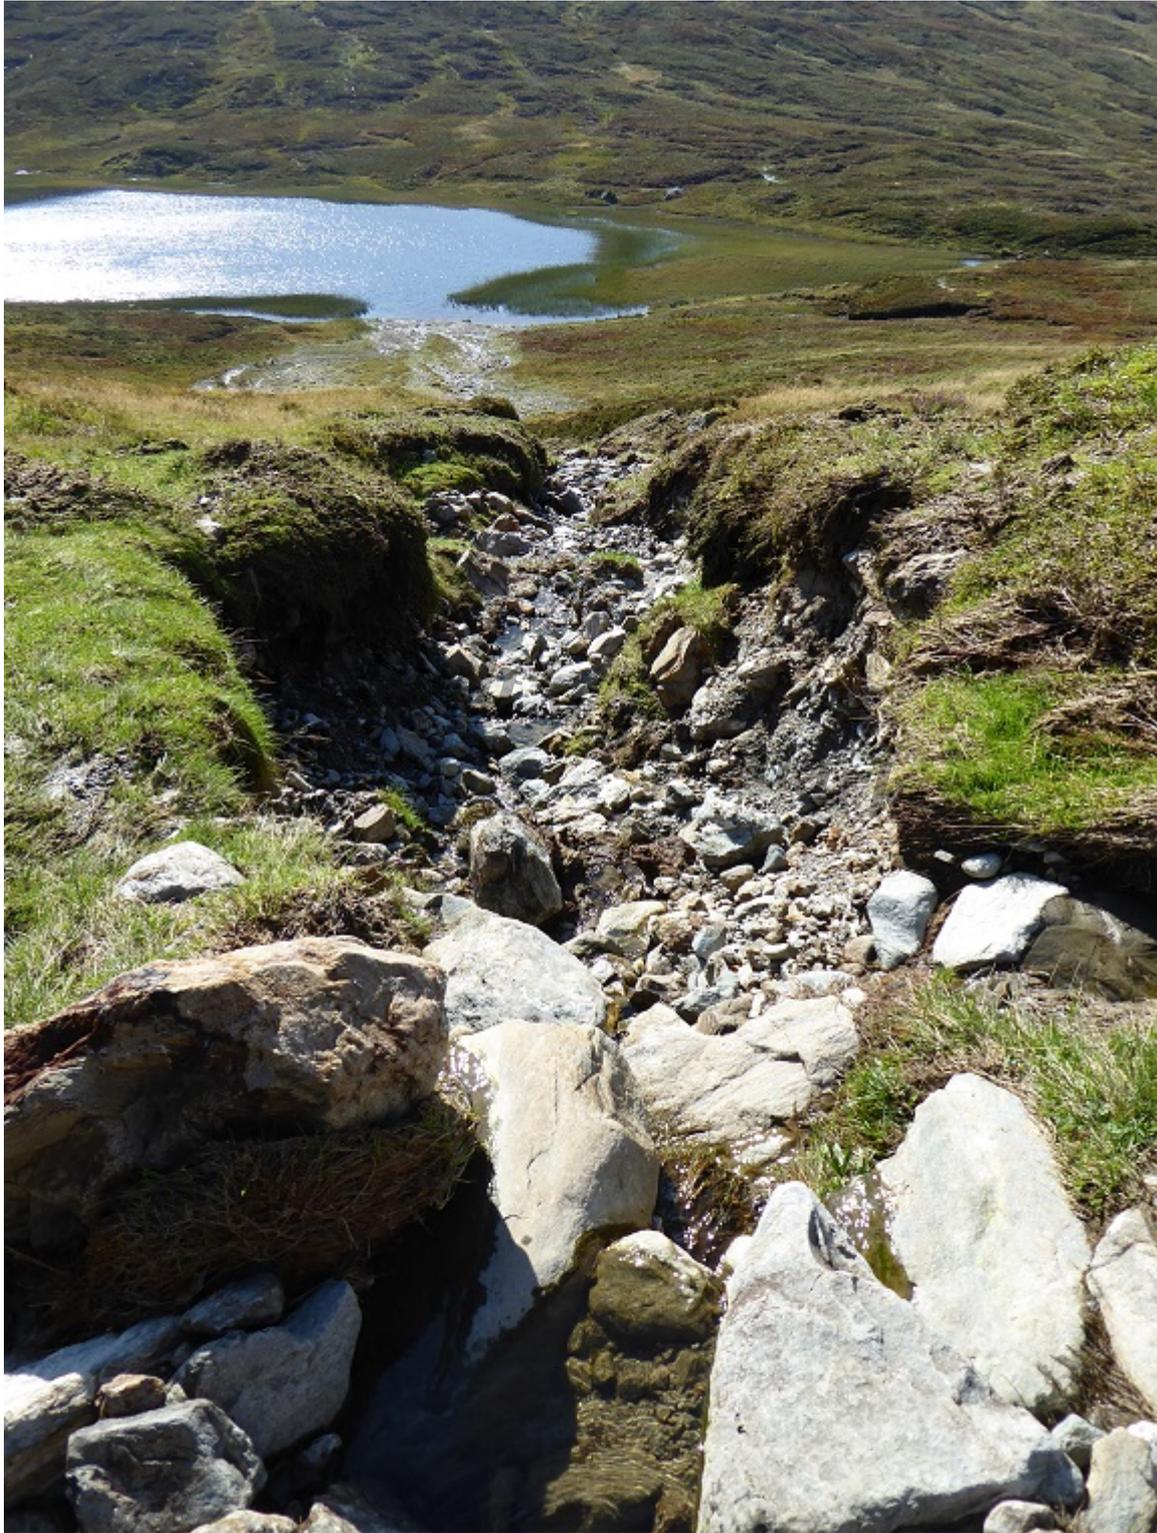
The view looking down the same burn to Lochan Beinn Chabhair. Note how debris has been washed all the way to the Loch.

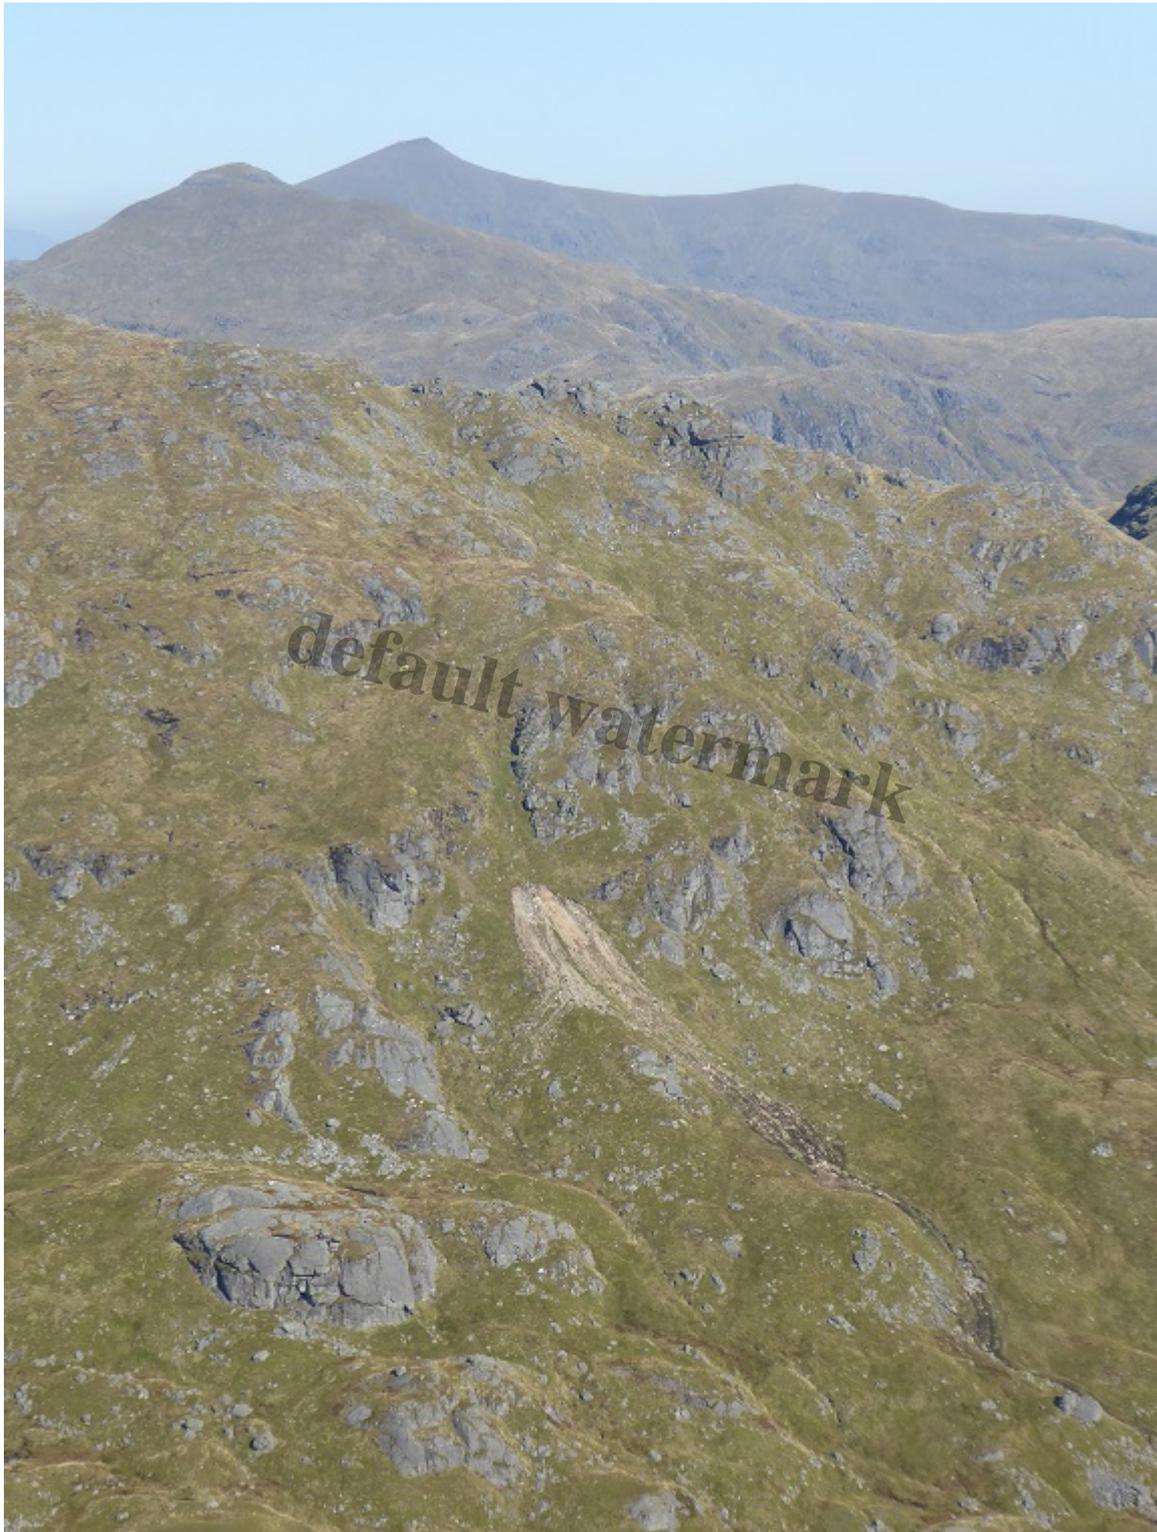
New landslip on An Caisteal, Cruach Ardrain and Stobinian behind. Note how the debris has flowed down to the bottom right corner of photo

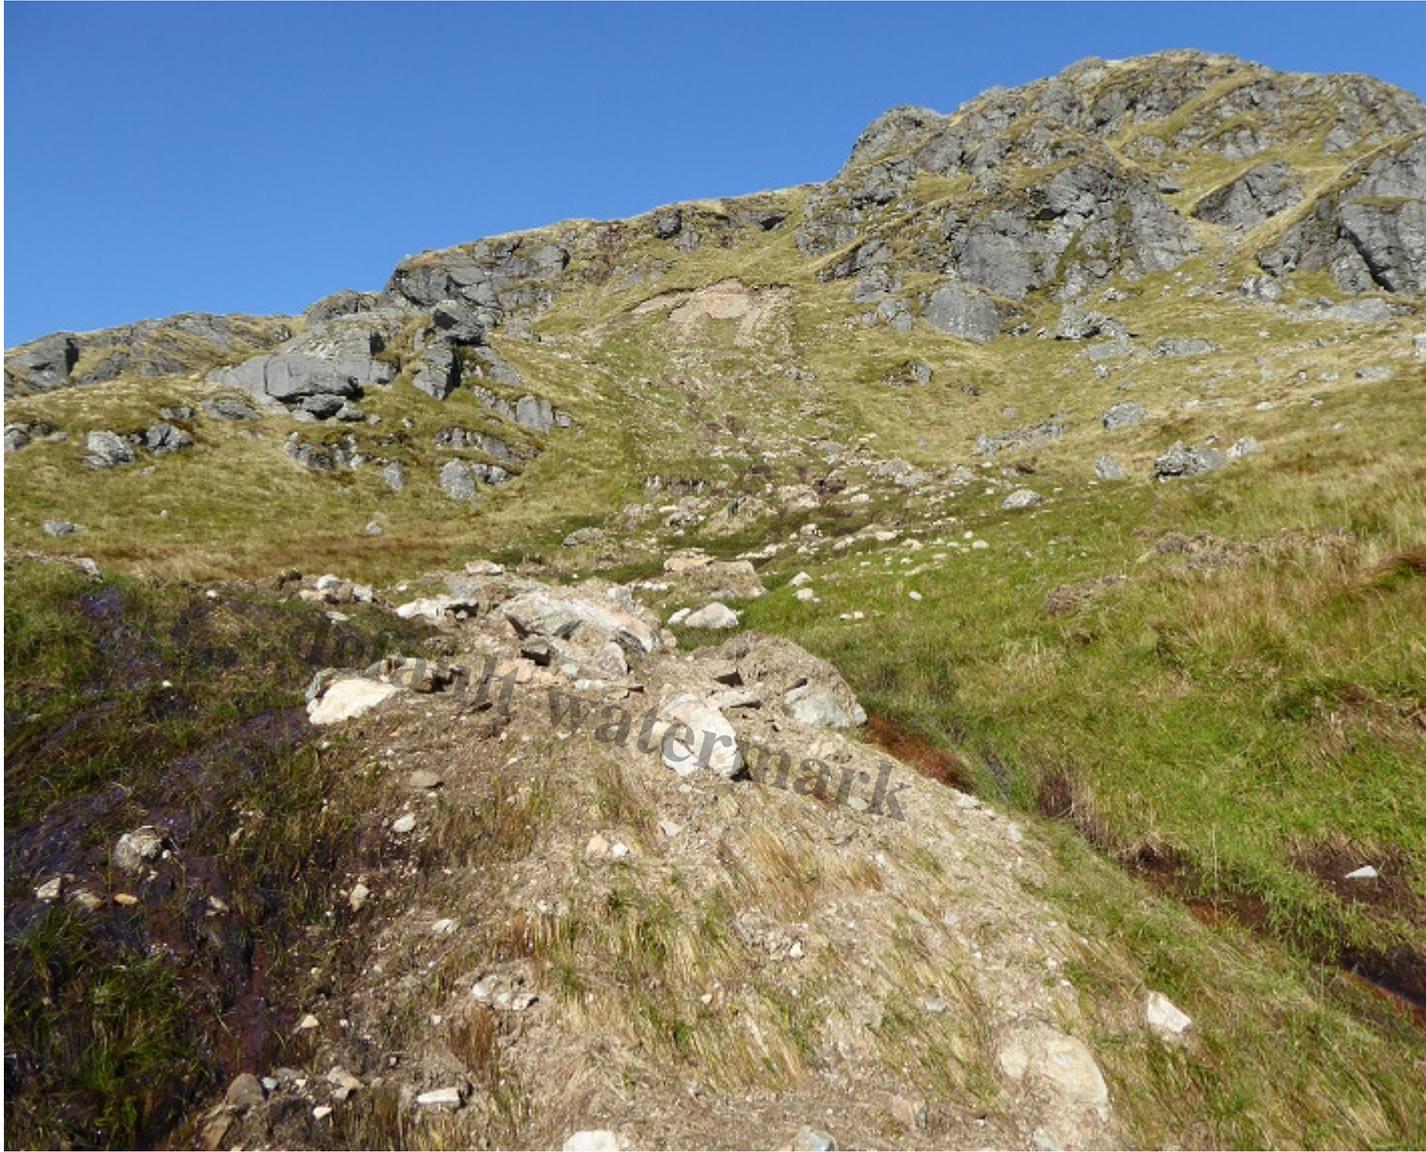
Looking up the same landslip from below

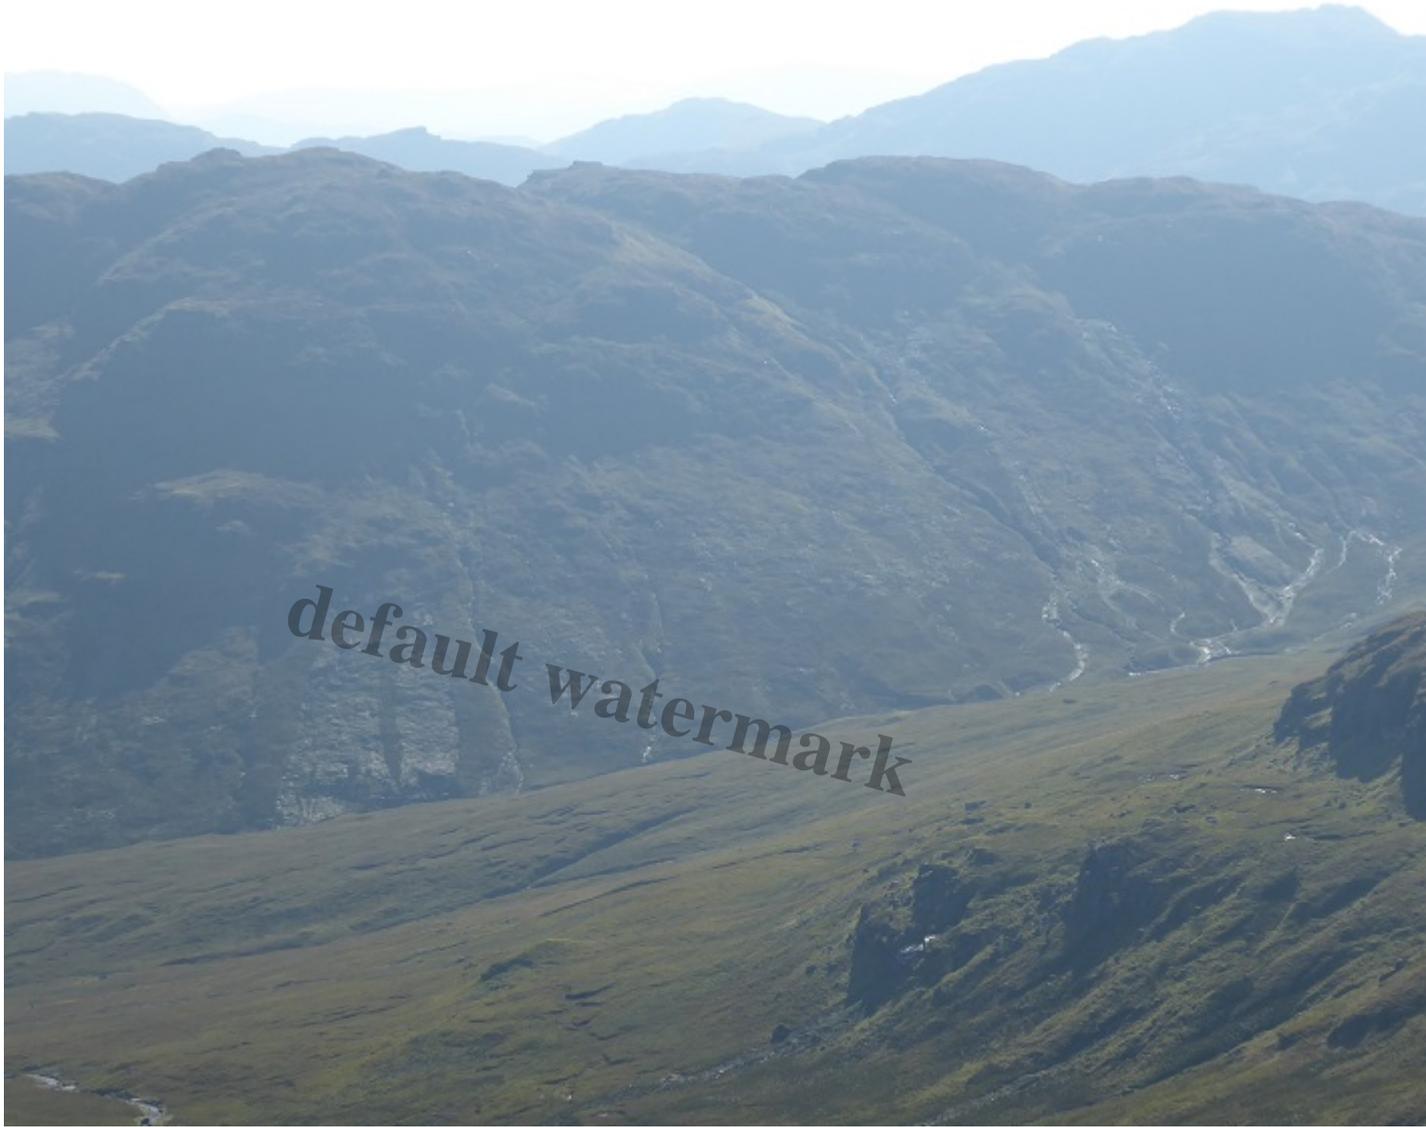
It was very hazy to the south but across the Allt Lairig several major landslips were visible on the north slopes of Meall Mor

The two landslips on the left bear a strong resemblance to avalanches triggered at particular point and which then spread out as they gain momentum down the hill carrying all before them. Maybe they were caused by avalanches and not the recent rain? I was not close enough to check..

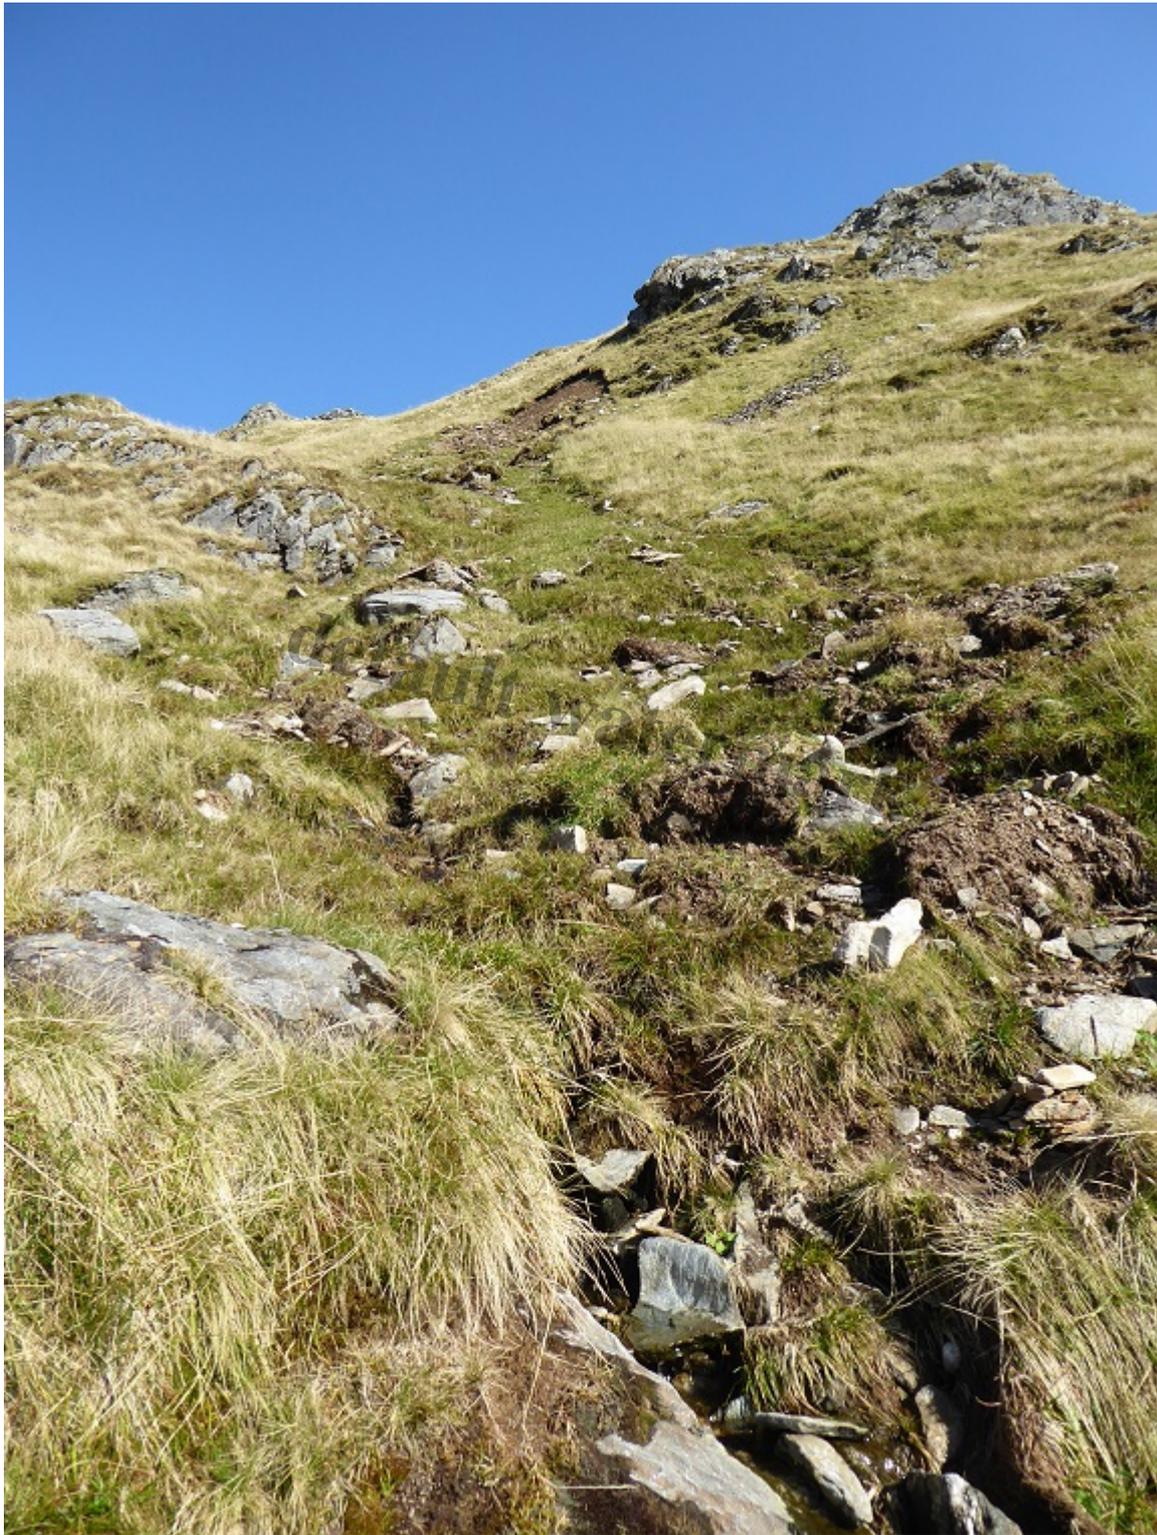
Landslip and debris below col between An Caisteal and Beinn a Chroin

Almost all the other erosion scars, however, were recent and appear to have been caused by the rainfall on 5th August

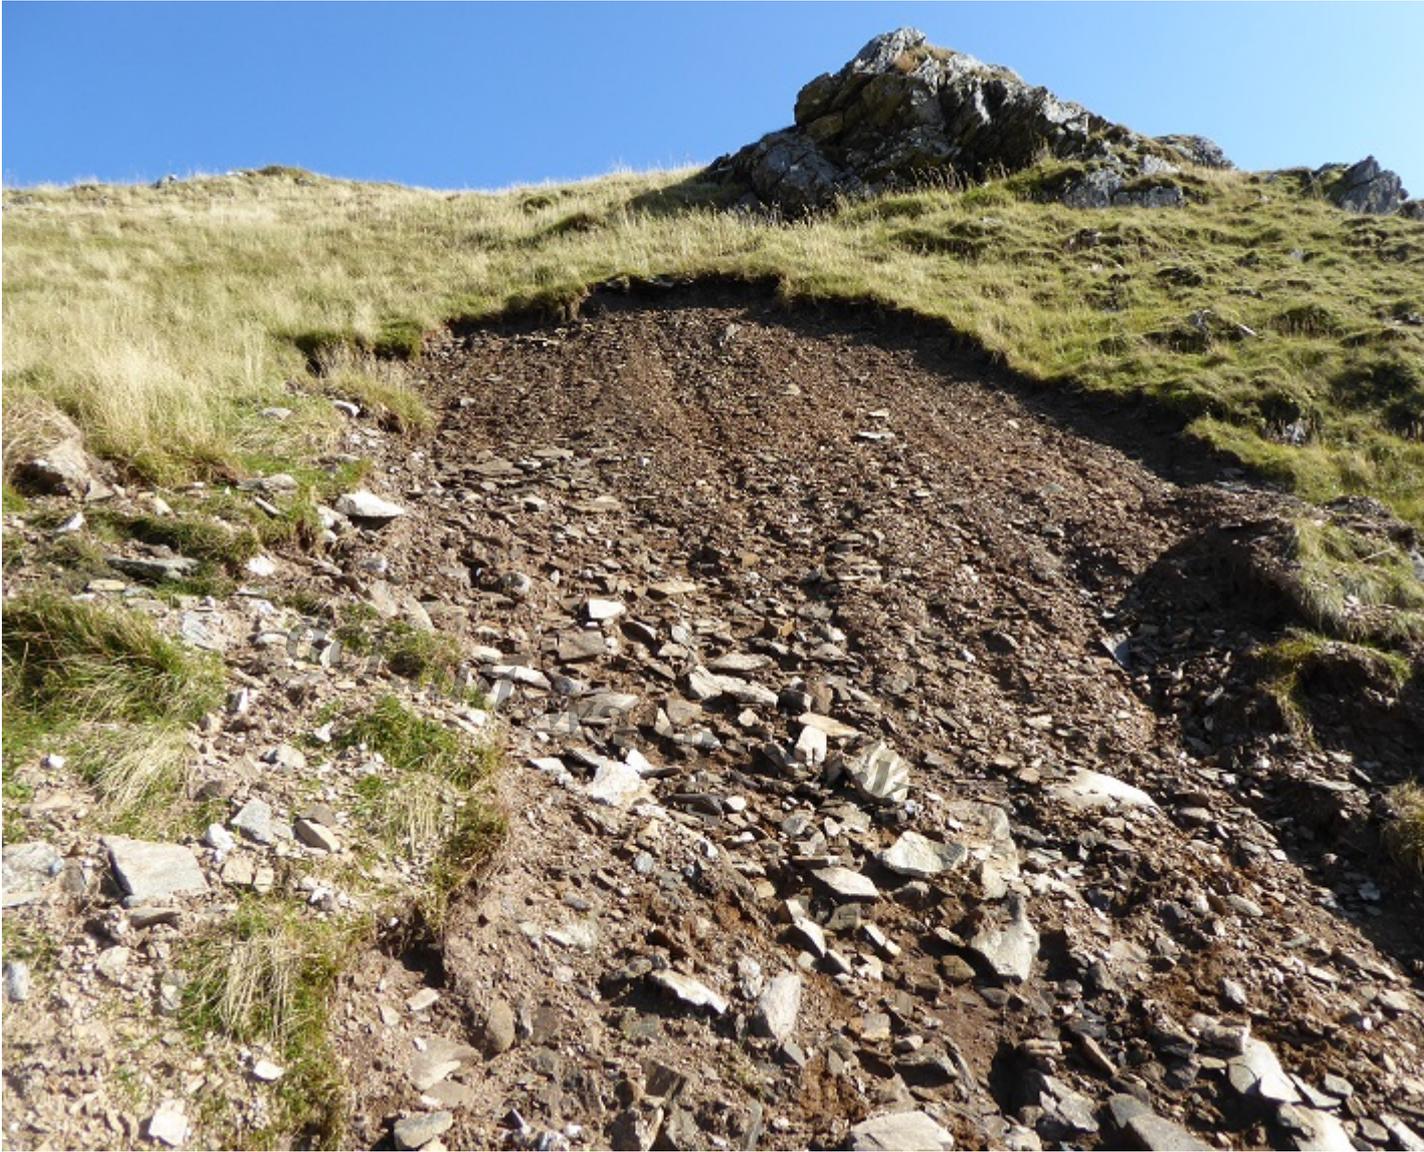
Close up of top of same landslide. The area of slope that initially failed was quite small. The soil that has been exposed is now being rapidly eroded by water, increasing erosion further.
