Climate change and Glen Falloch (2) – the impact of increased rainfall on the natural environment

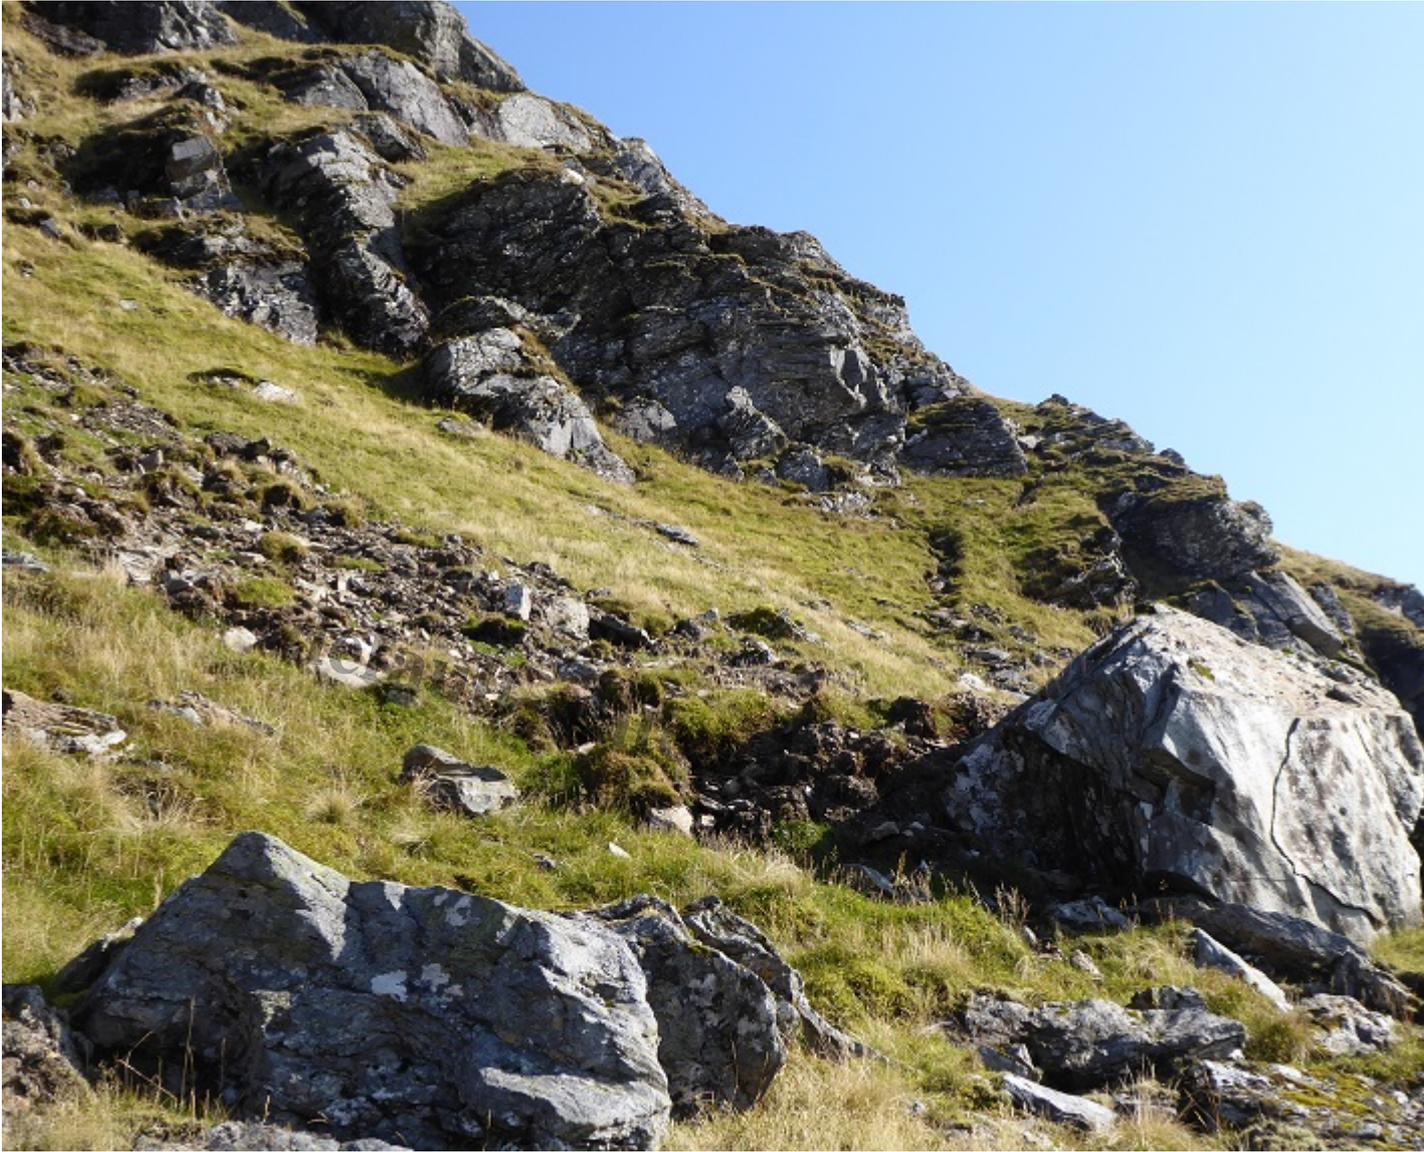
Landslip halted by boulder just above walkers path up Beinn a Chroin â?? path visible beyond

This landslip was quite scary from a hillwalking perspective. It appears that landslips have become a risk which, like avalanches, walkers need to consider when planning routes. Time to revise the mountain leader training courses and mountaineering manuals?

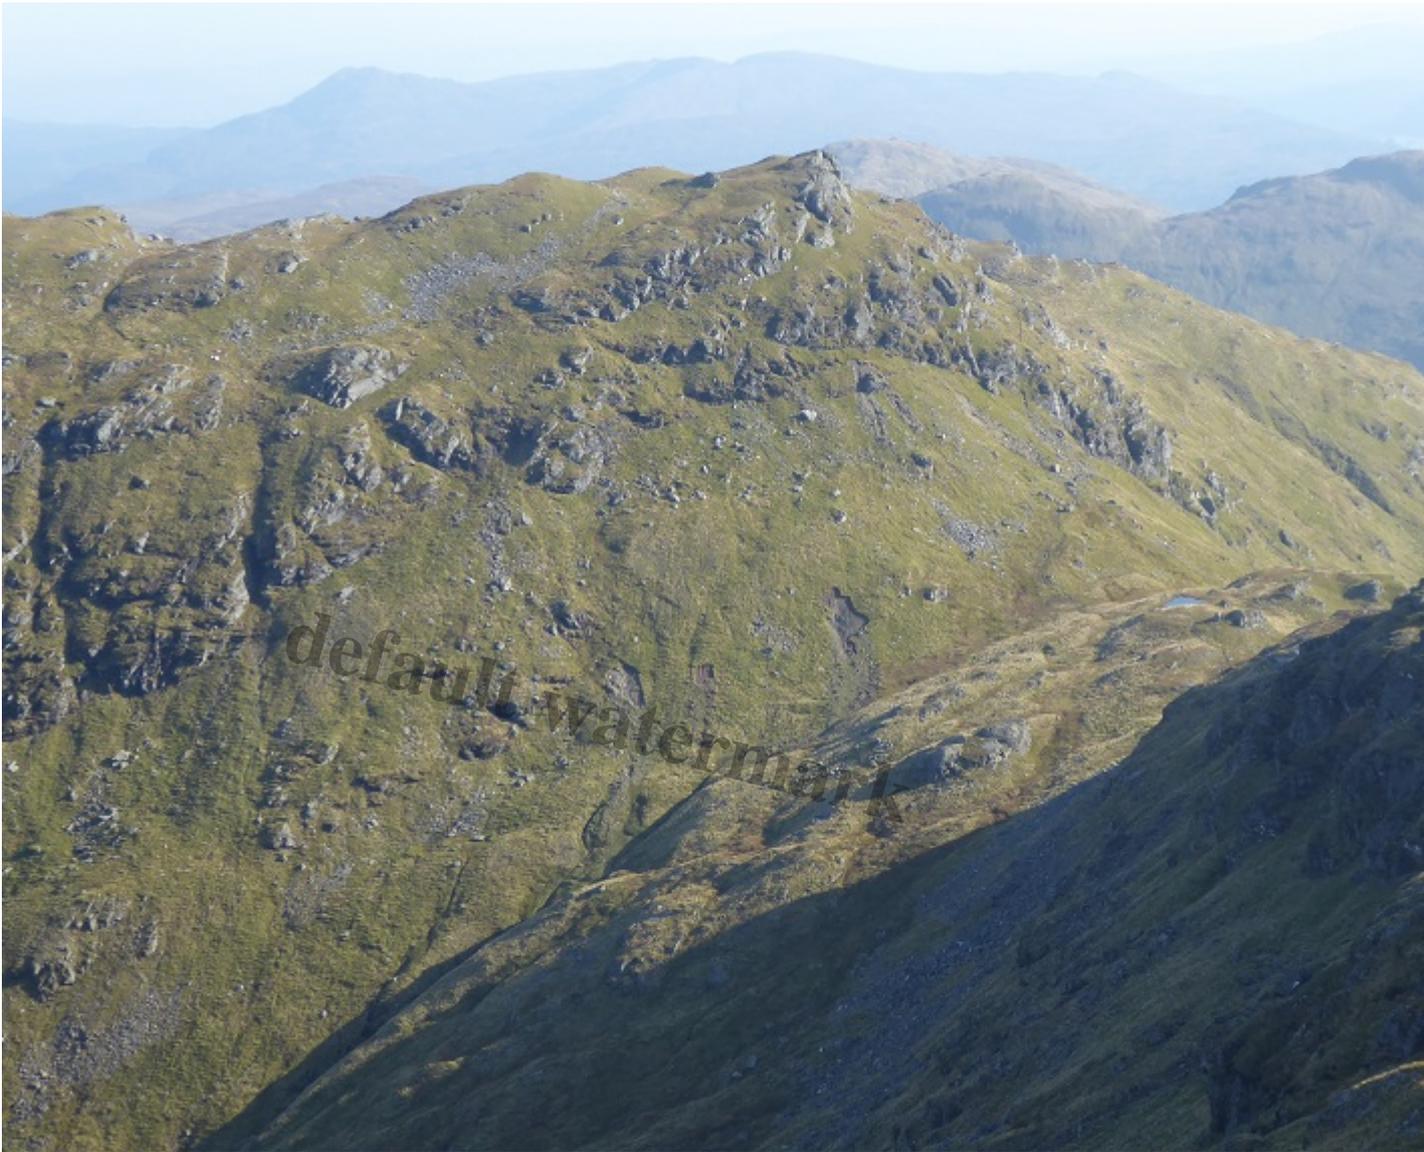
Looking to West summit Beinn a Chroin from An Caisteal. Three landslips of varying size visible mid and the landslip above the walker's path just visible above and to the right.

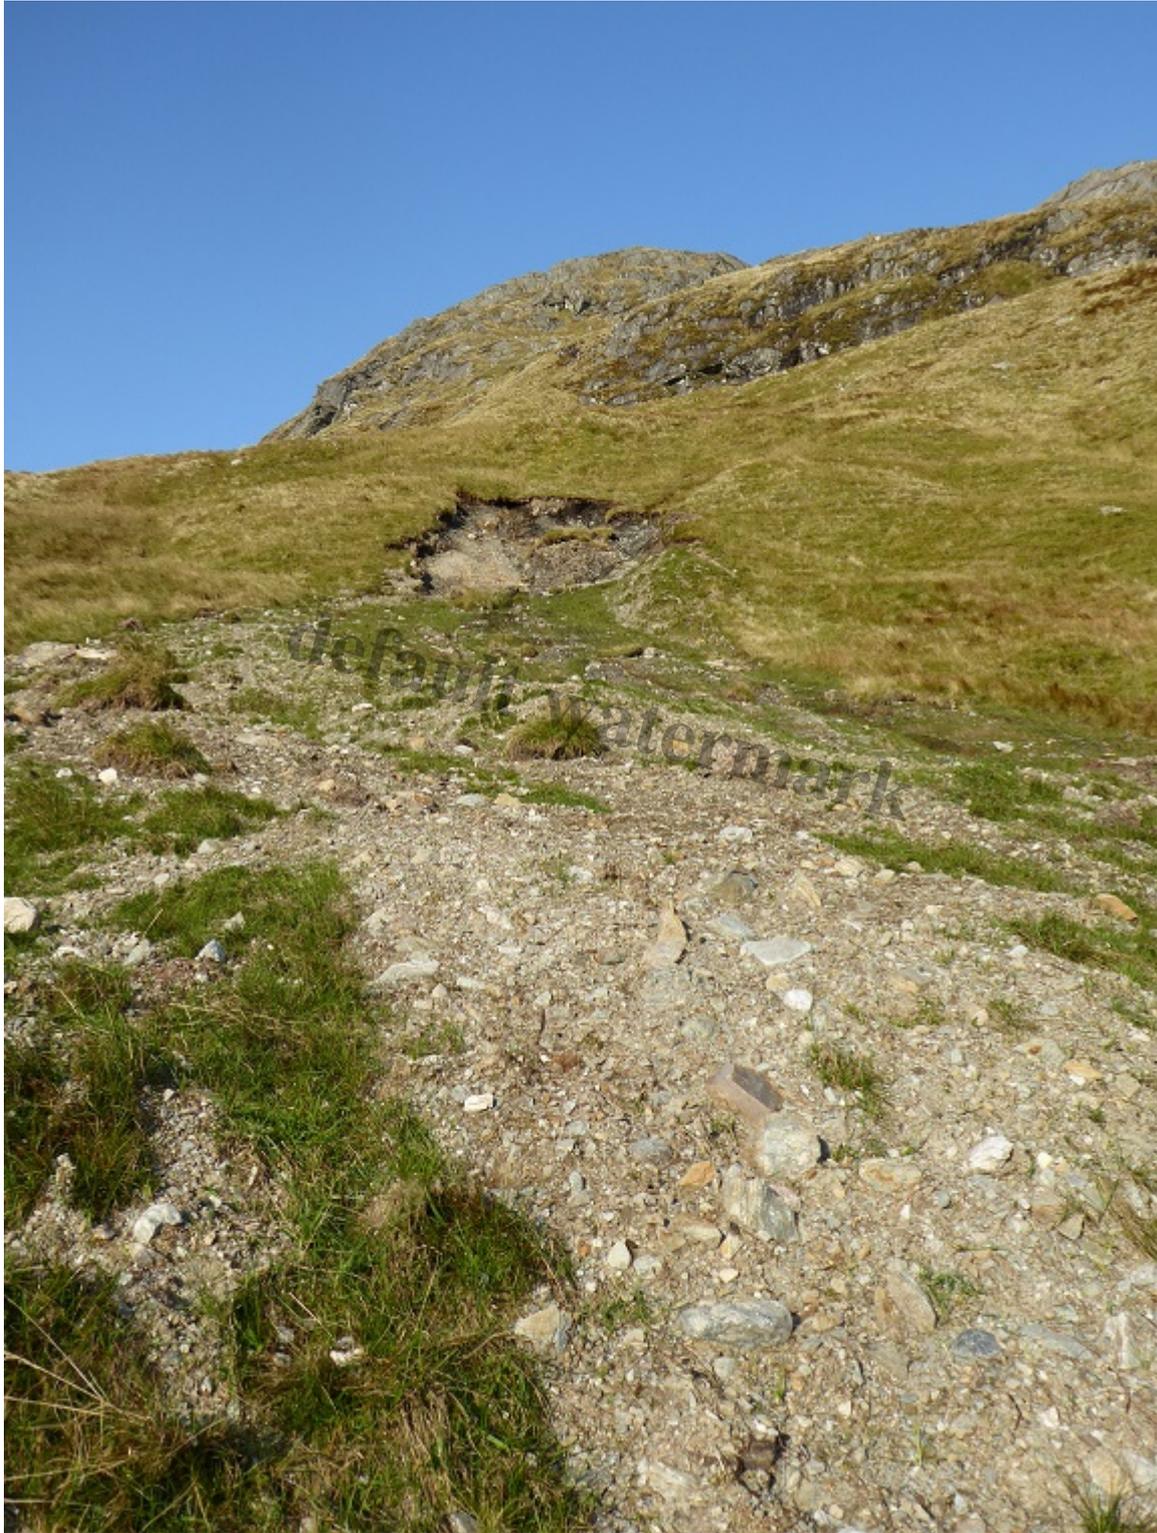
Landslip No 3 on An Caisteal descending from the North West ridge to the Allt a Chuillinn

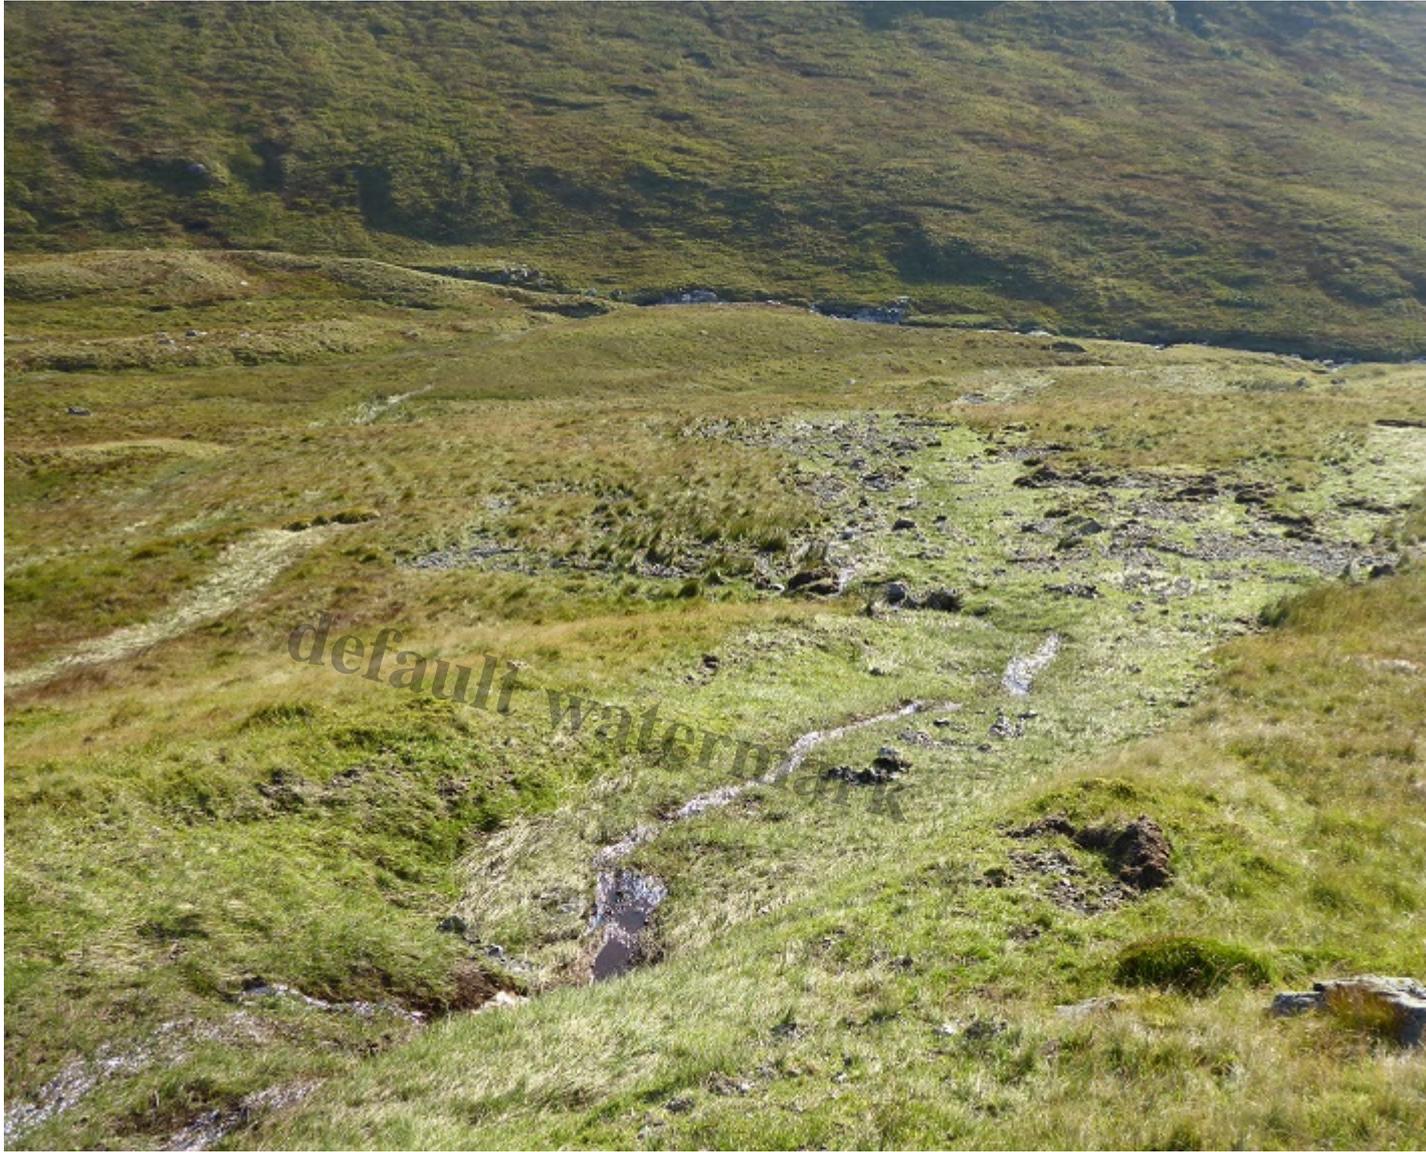
View down taken from just below the viewpoint in the photo above

While the soil and rock from this landslip came to a halt half way down the slope, the amount of water flowing down the hill must have been extraordinary, both to flatten this amount of vegetation and to carry huge lumps of peat down with it.

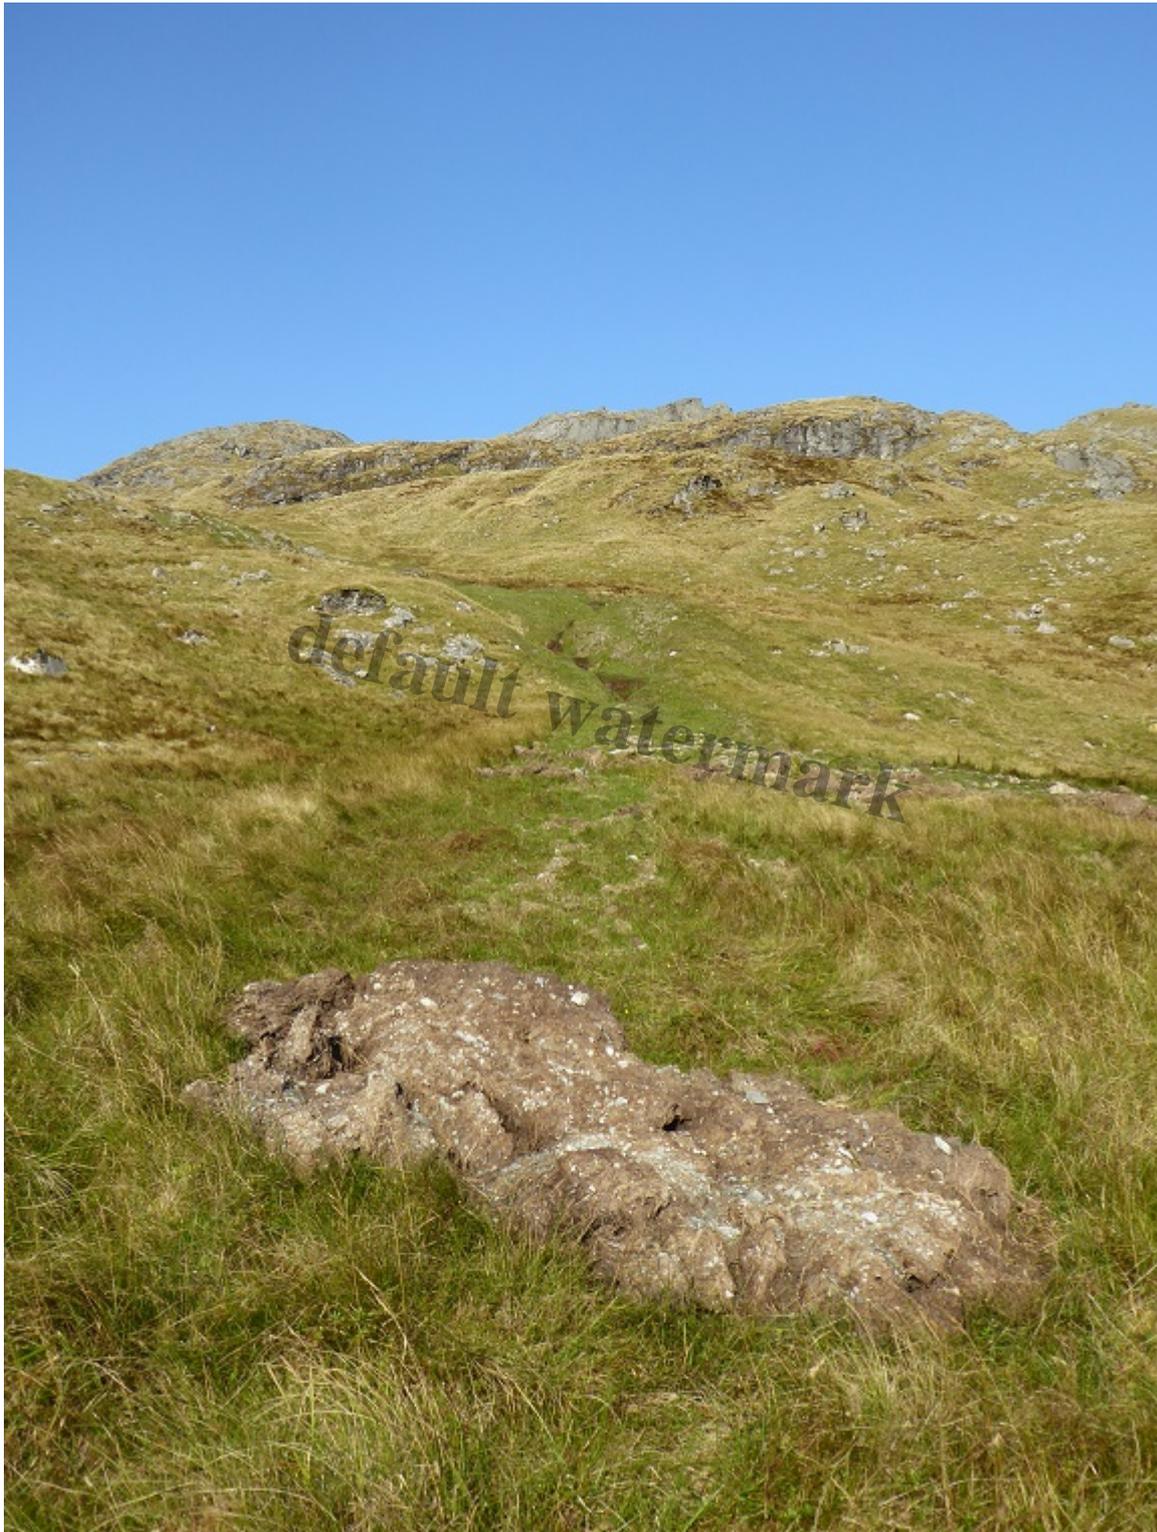
Peat deposited at bottom of water flattened area. I tried lift a small bit â?? its very heavy. What sort of force and sequence of events explains how it ended up here?

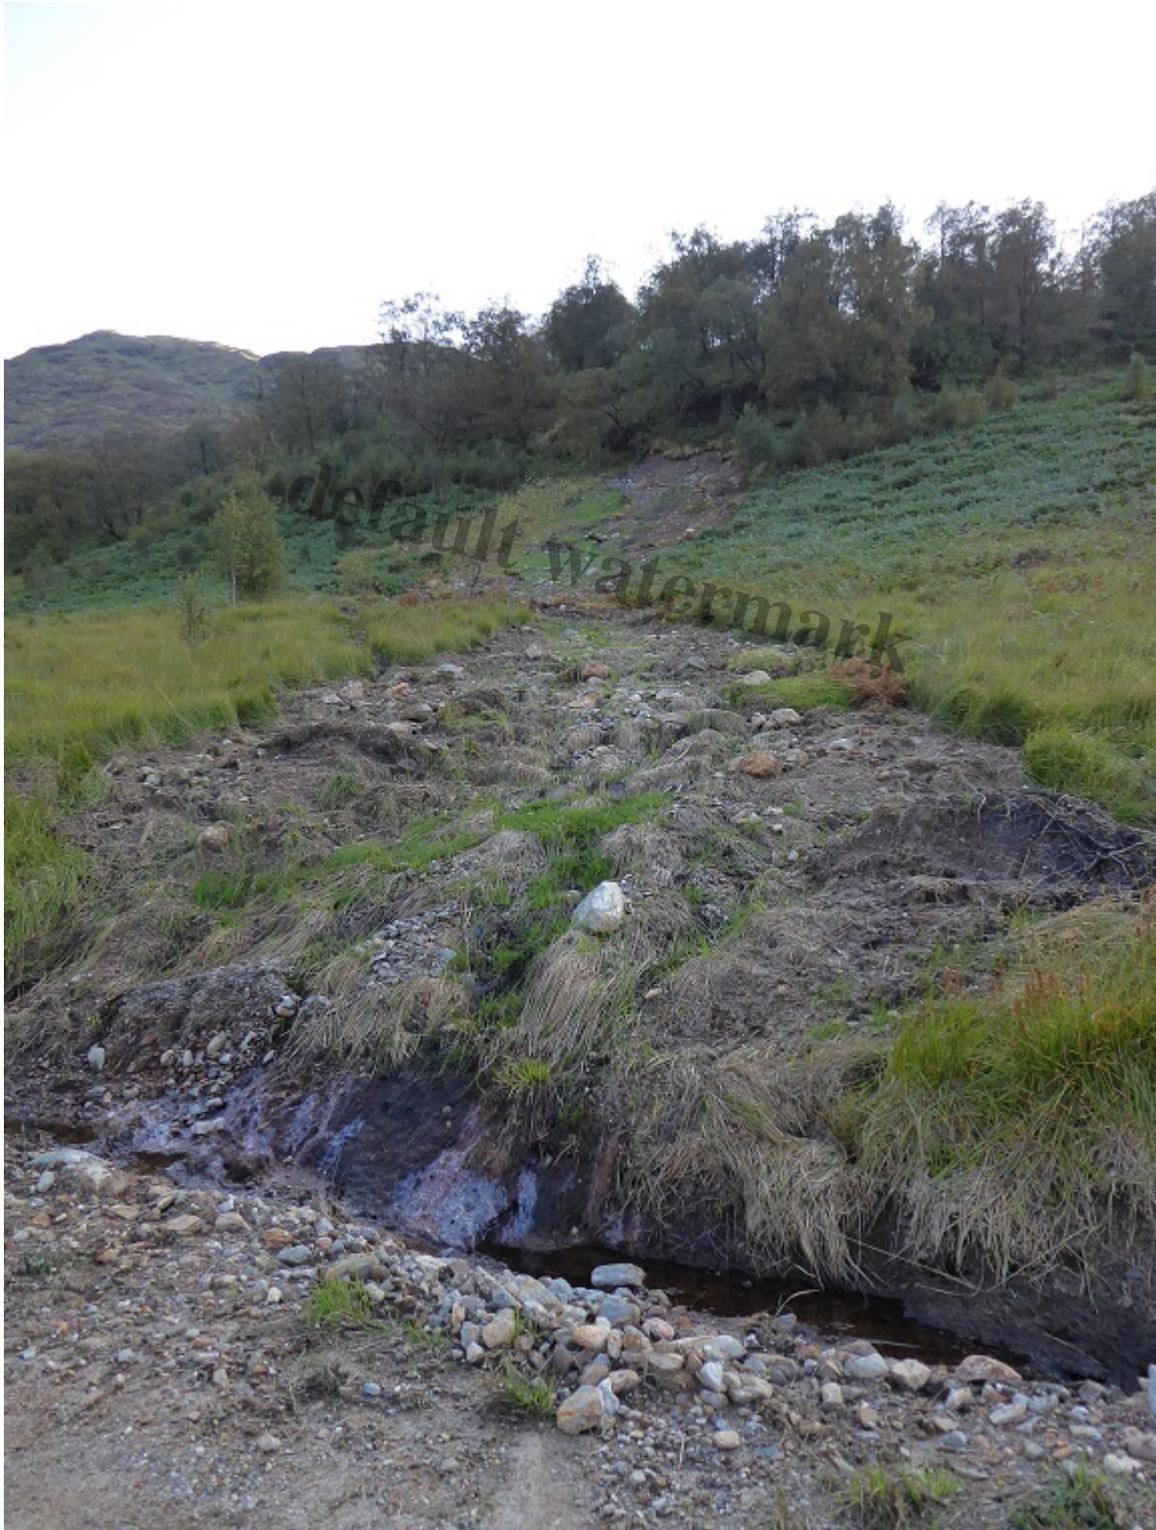
Landslip below Allt a Chuillinn hydro intakes

The one large landslide I saw lower down the hill started in woodland, which is not to say that had there been more trees lower down this would stemmed the flow of water and debris down hill.
