Climate change and Glen Falloch (3) – the hydro schemes have failed, literally!

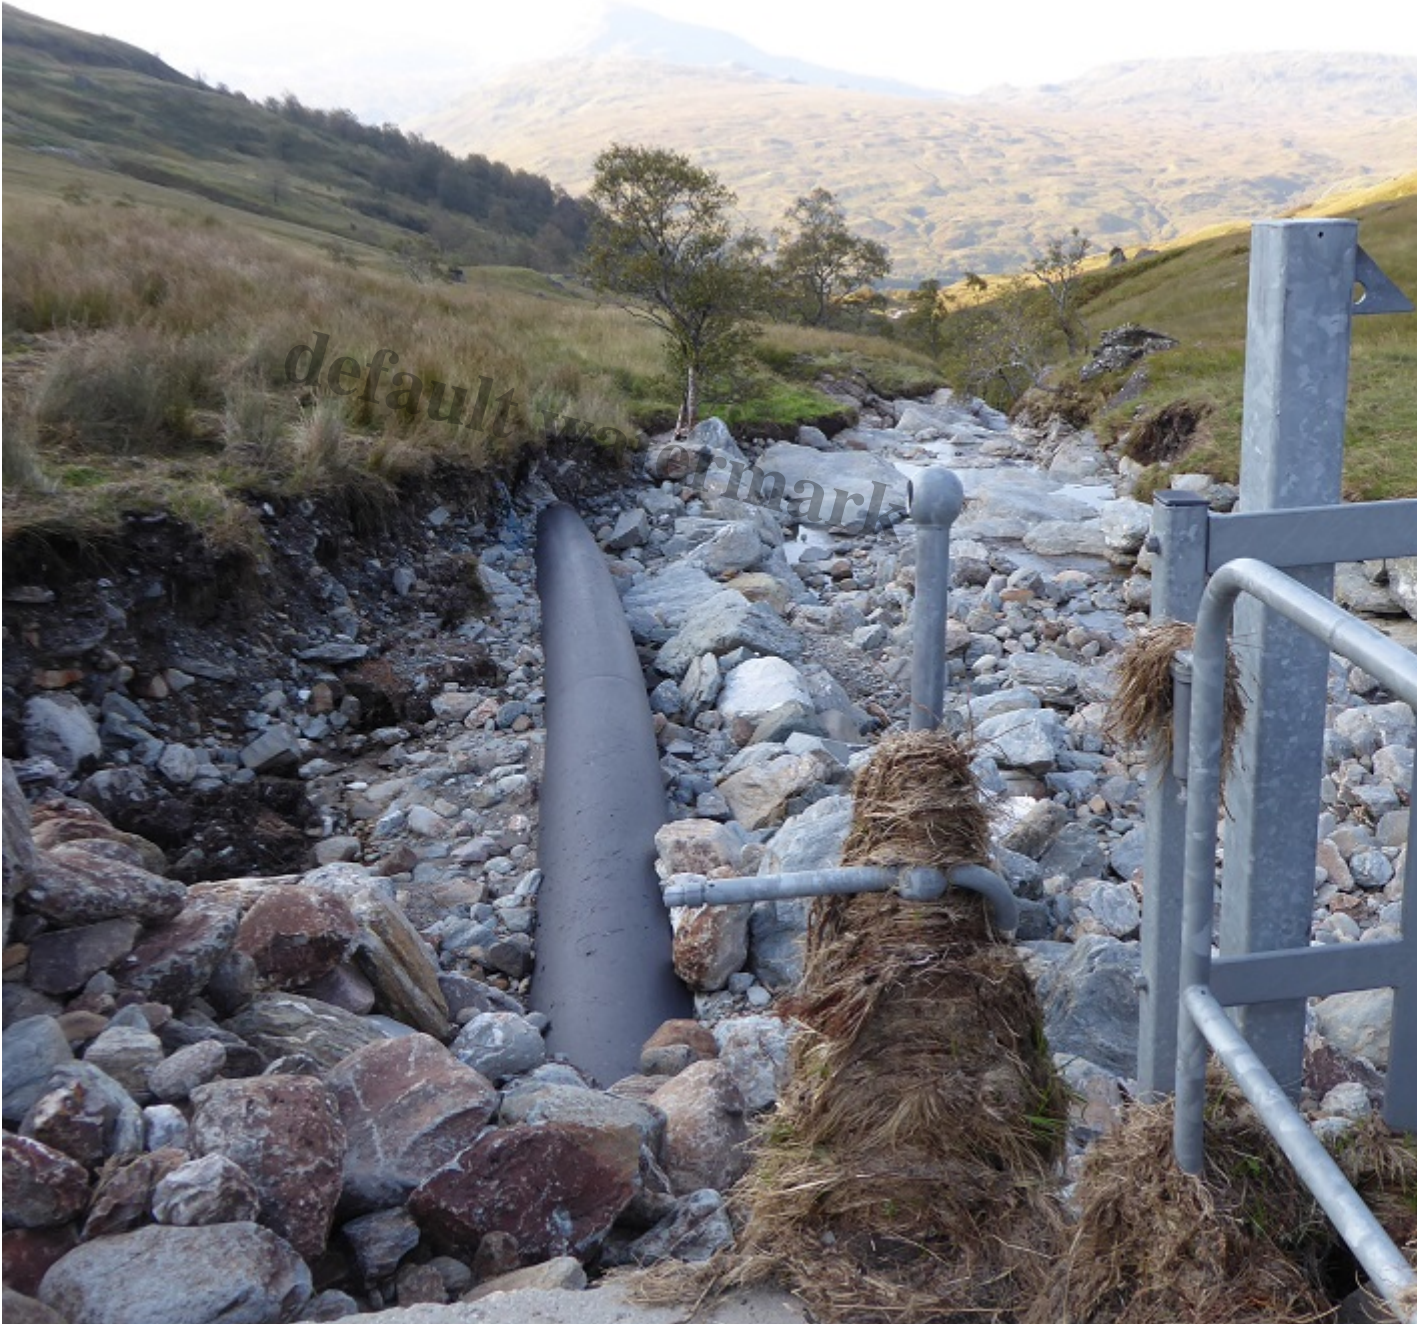
Looking down the Allt a Chuillinn from the top of the main intake. The storm of the 5th August has done a lot of damage on top of the dam will and swept away a large section of the restored river bank below to reveal the

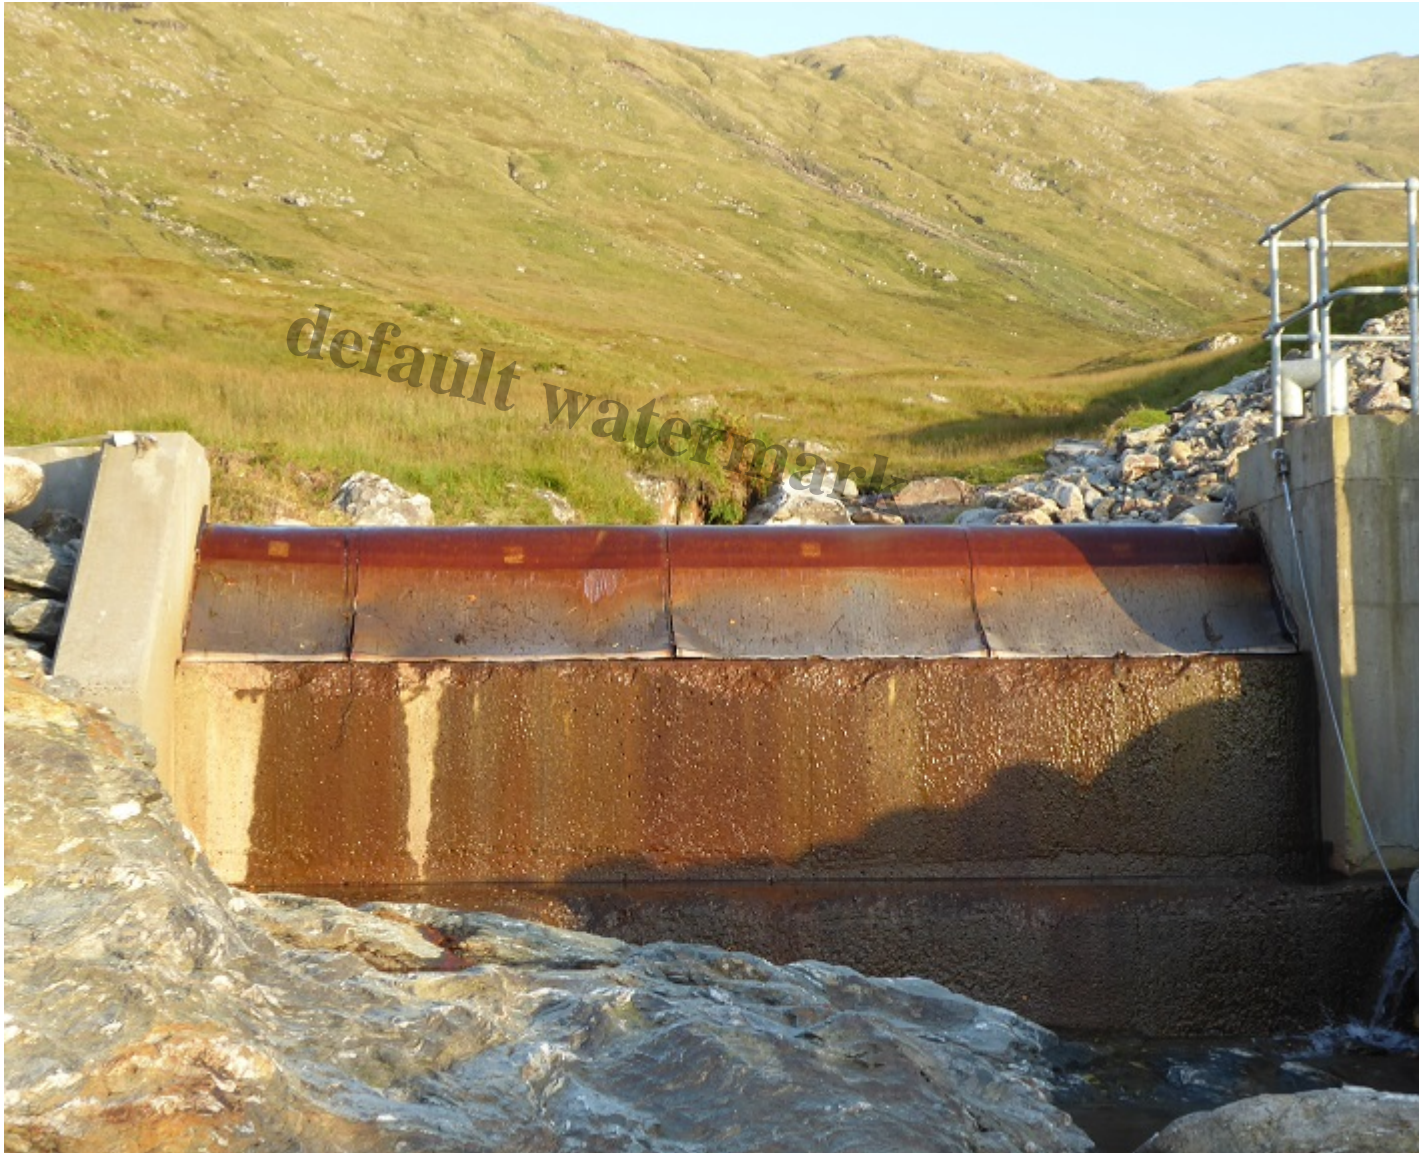
View from below the Allt Andoran intake, part of the Derrydarroch hydro scheme, looking up to the S Garbh â?? An Caisteal ridge. with a large landslip visible behind extending almost from the ridge to valley floor.

Debris from the landslip above and other more minor erosion events, along with rocks, gravel and sand in the river bed have all been swept down by the storm â?? nature at work â?? until they reached the artificial barrier created by the hydro dam wall which act like a rock wall. Its not surprising that the intake pools behind start to fill up with debris â?? parkswatch has covered this before â?? but the extent of the infilling caused by the storm event took me by surprise.

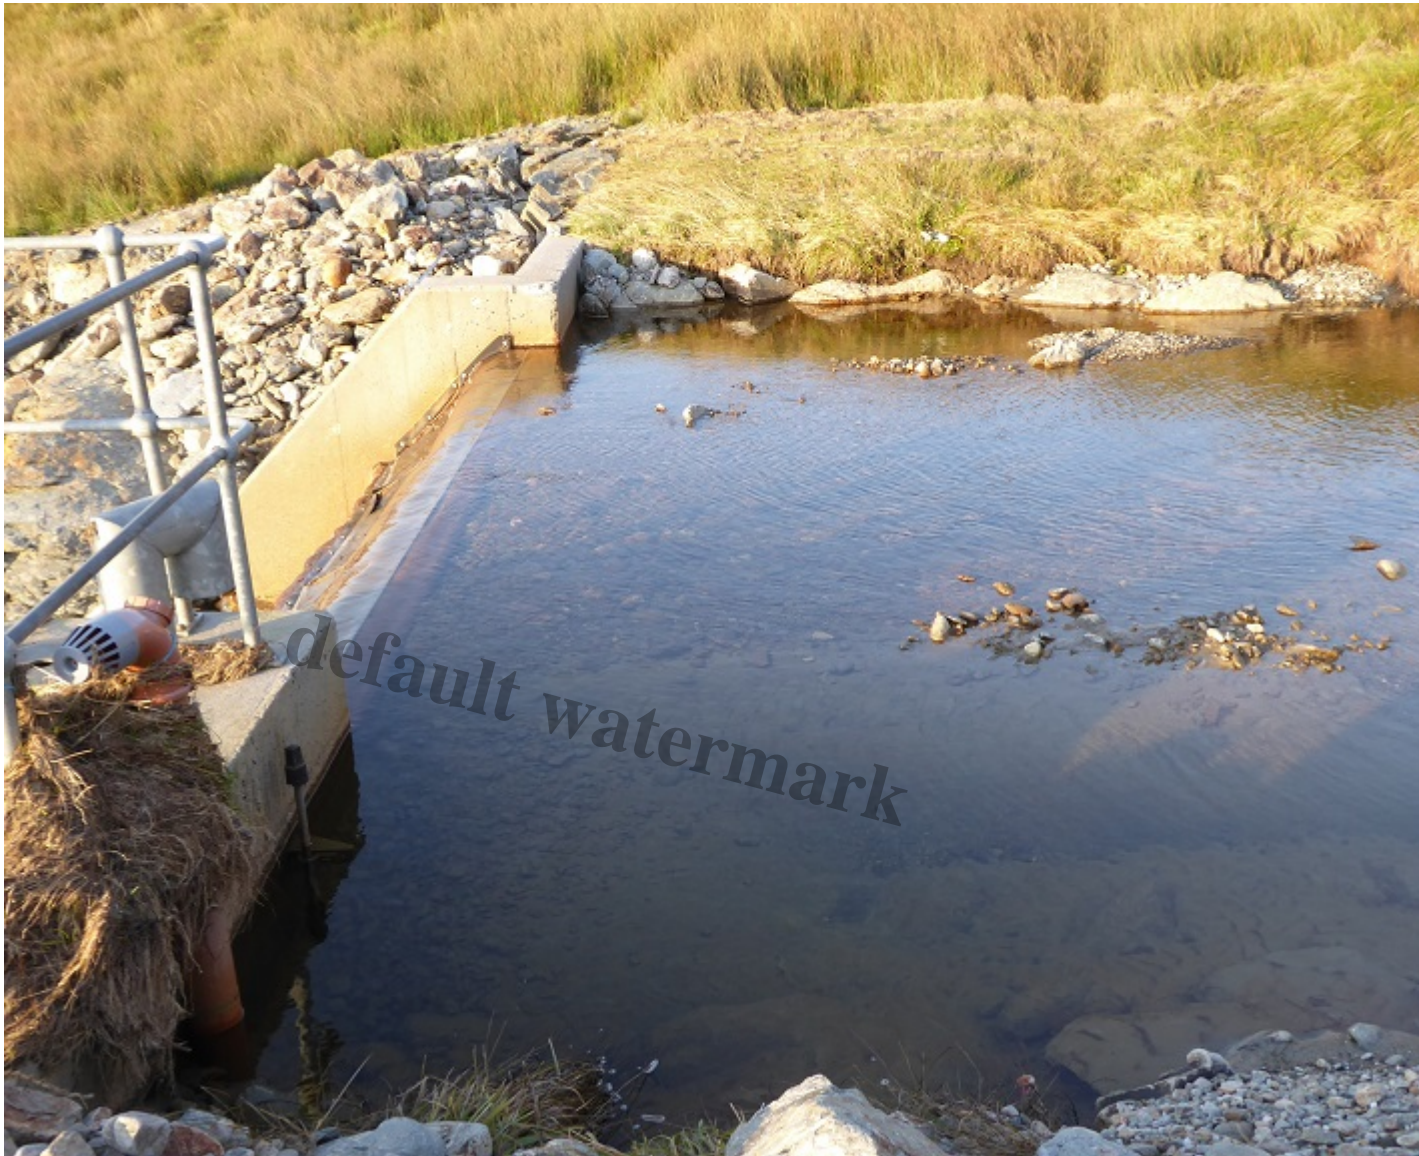
Gravel and silt trapped by the Allt Andoran dam wall. You can see below the lip of the dam a piece of damaged metal from the intake screen sticking up.

The intake pool has almost filled in and as a consequence boulders have been swept over the intake screen damaging it.

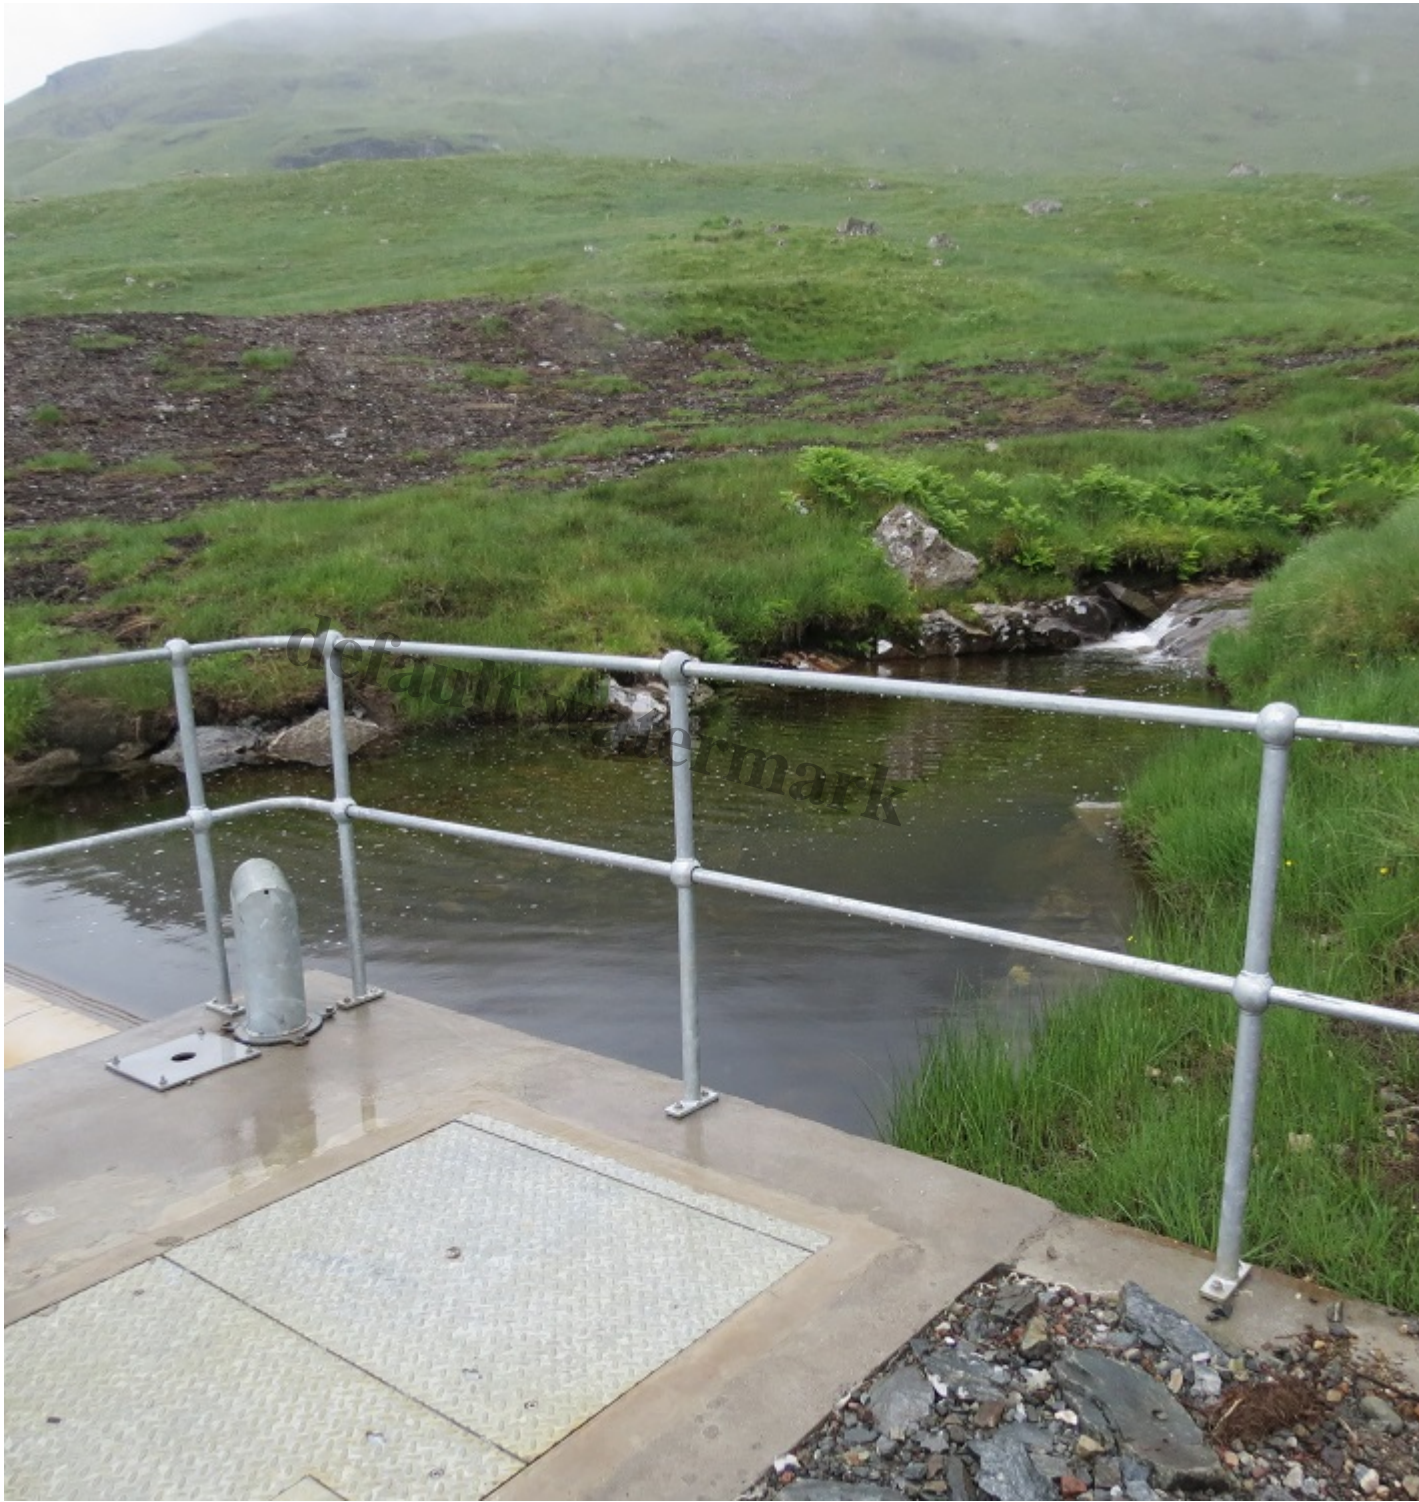
Compare the Allt Andoran intake pool pictured in 2016â?iâ?iâ?iâ?i.

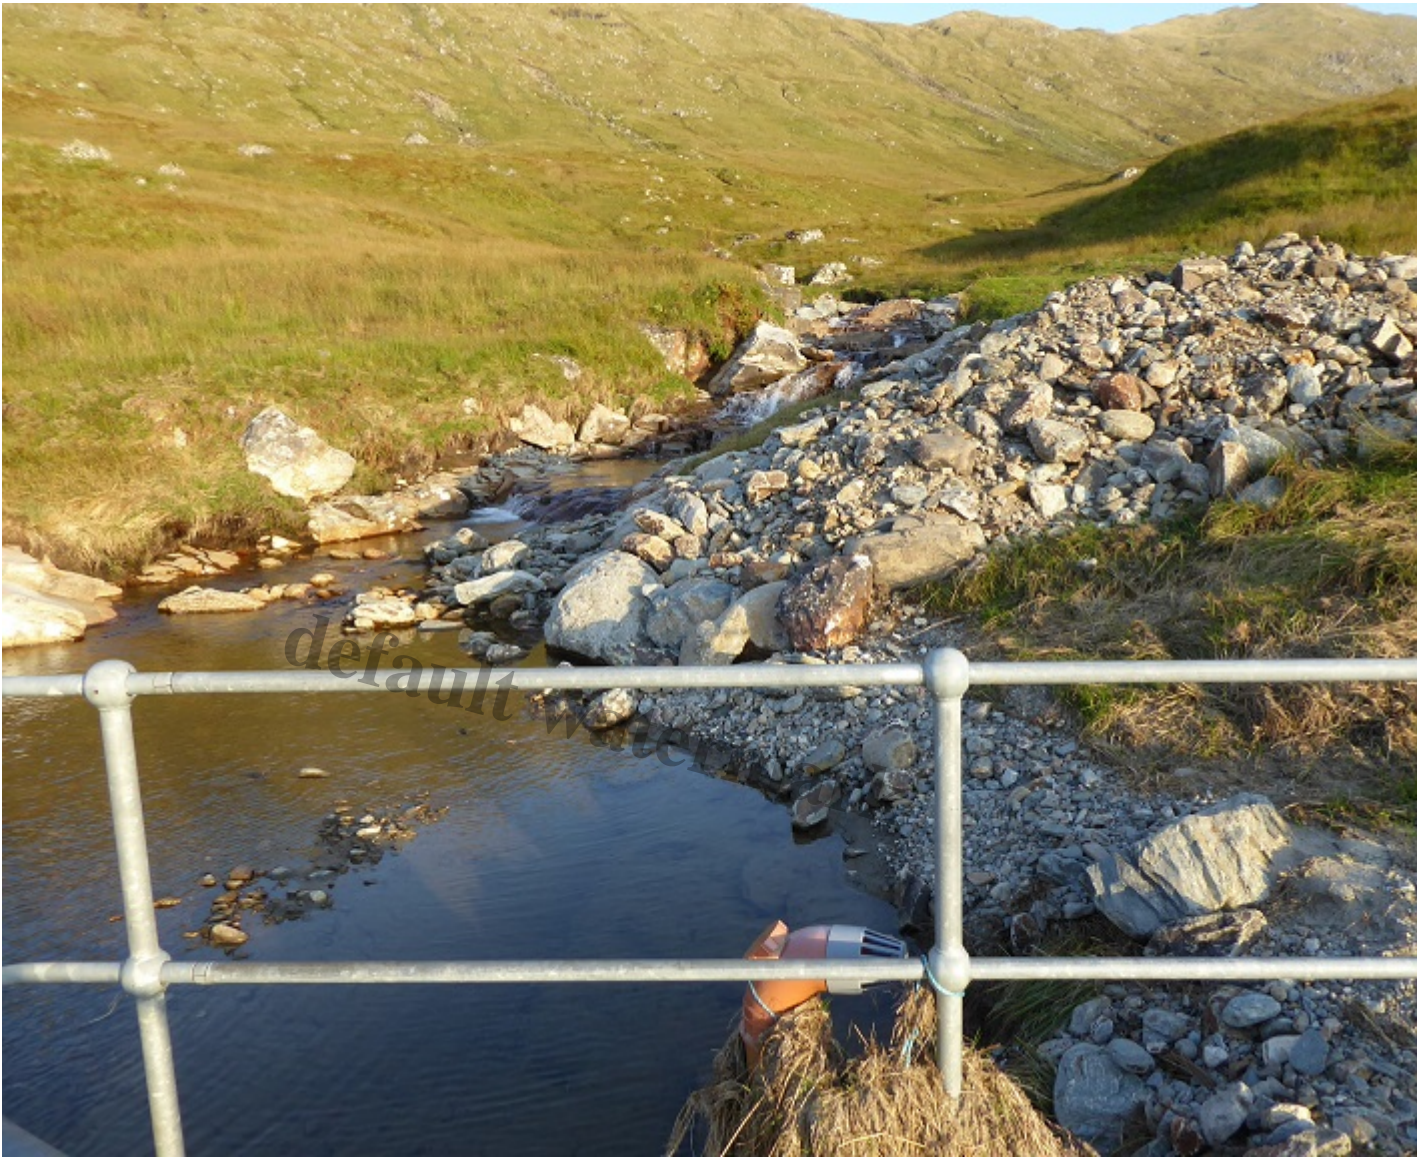
with the Allt Andoran Intake pool 2019.

The deep grass sided pool I pictured 3 years ago has almost disappeared. I had been in a rush to catch my train when I got to the Allt Andoran and, until I compared my photos did not realise the pile of boulders behind the pool has almost certainly been excavated since the storm in order to prevent further damage to the intake and to keep it functioning.

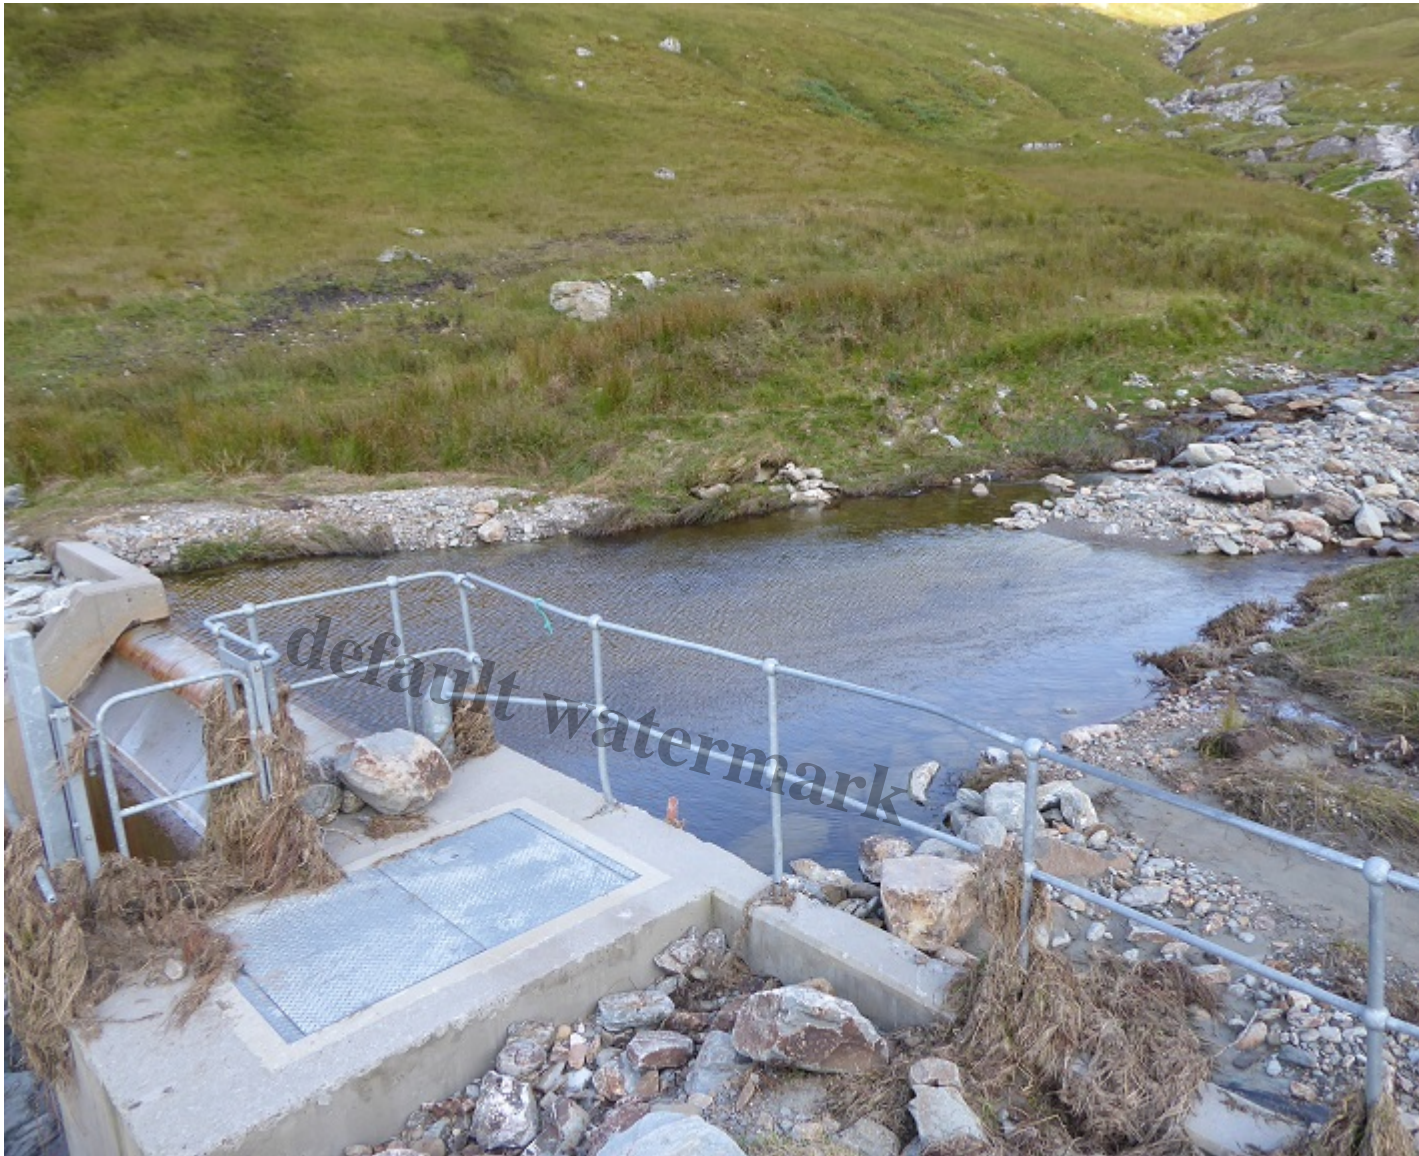
There was conclusive evidence from two of the Allt a Chuillinn intakes that they have been excavated since the storm.

Note vehicle tracks on right down into the pool â?? which again was far shallower than it had been la
when I last visited

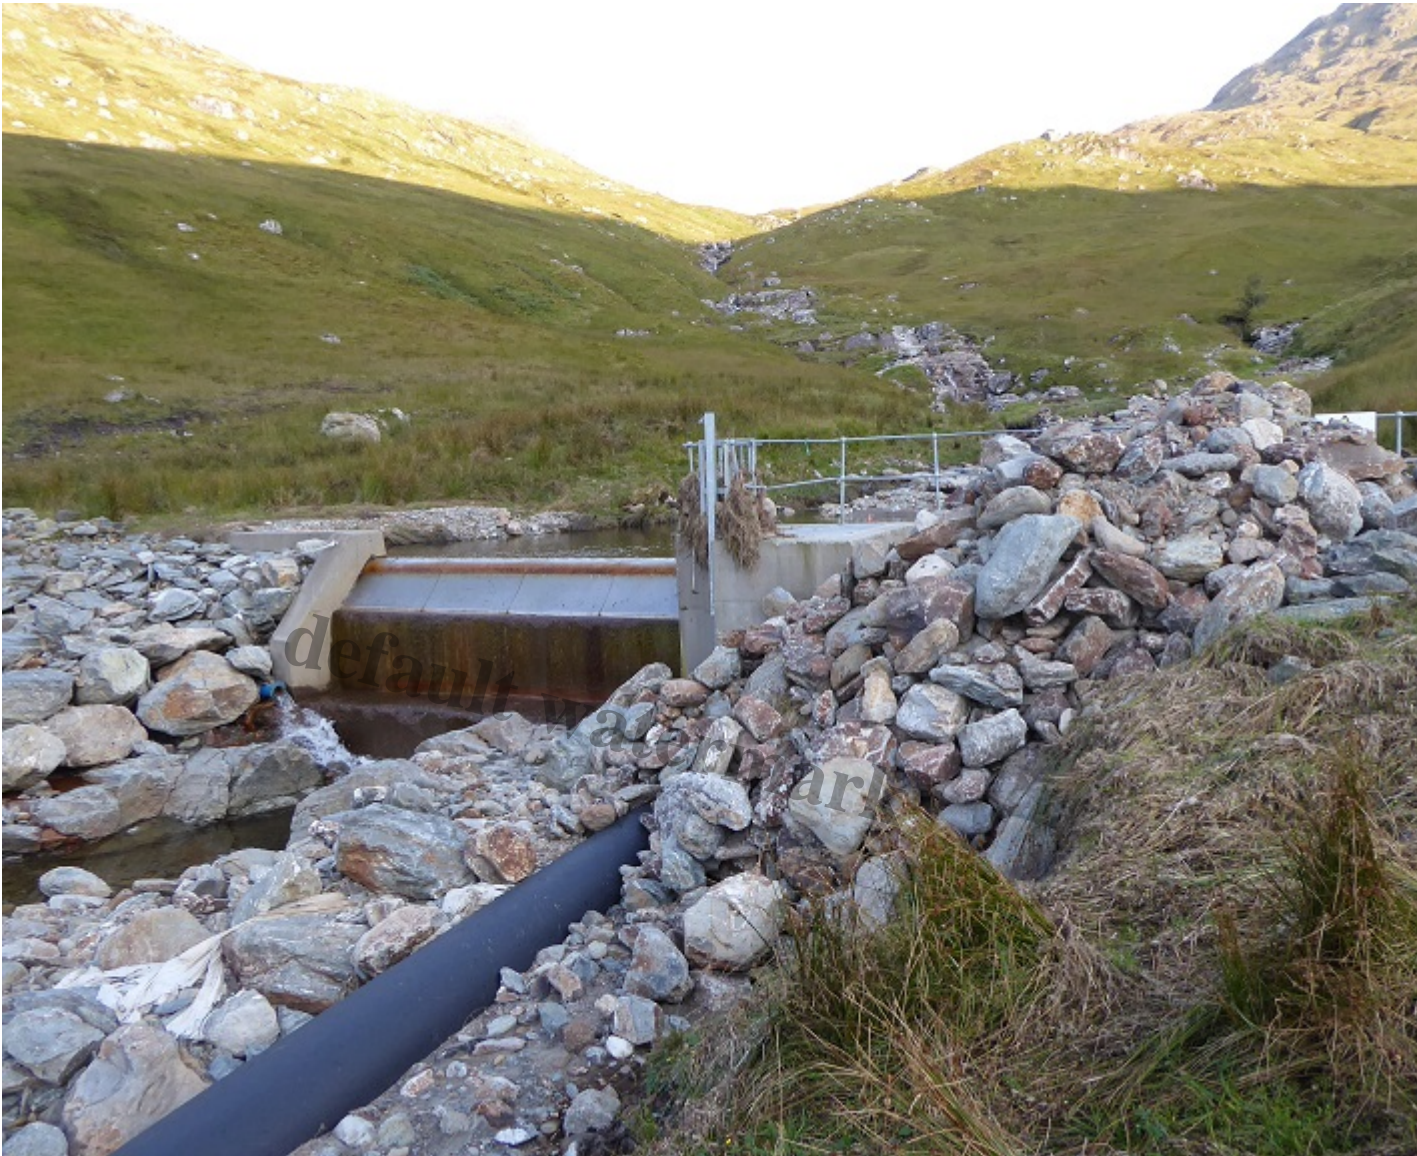
Pile of boulders excavated from pool placed on dam wall – the section of fence behind the boulder intake so the boulders could not have been swept here.

Construction and management of hydro intakes is regulated by the Scottish Environmental Protection Agency under the Controlled Activities Regulations. While routine maintenance of dams does not require permission, more extensive works do require permission. It would be interesting to know if SEPA have authorised the work in this case as it appears the pile of boulders has been placed on the dam prior to being used to cover up the exposed pipe below. I believe SEPA, who also regulate works to river banks, need to fully investigate what has happened here before deciding whether covering up the pipe again with boulders, when this has already failed once, is a sustainable proposition.

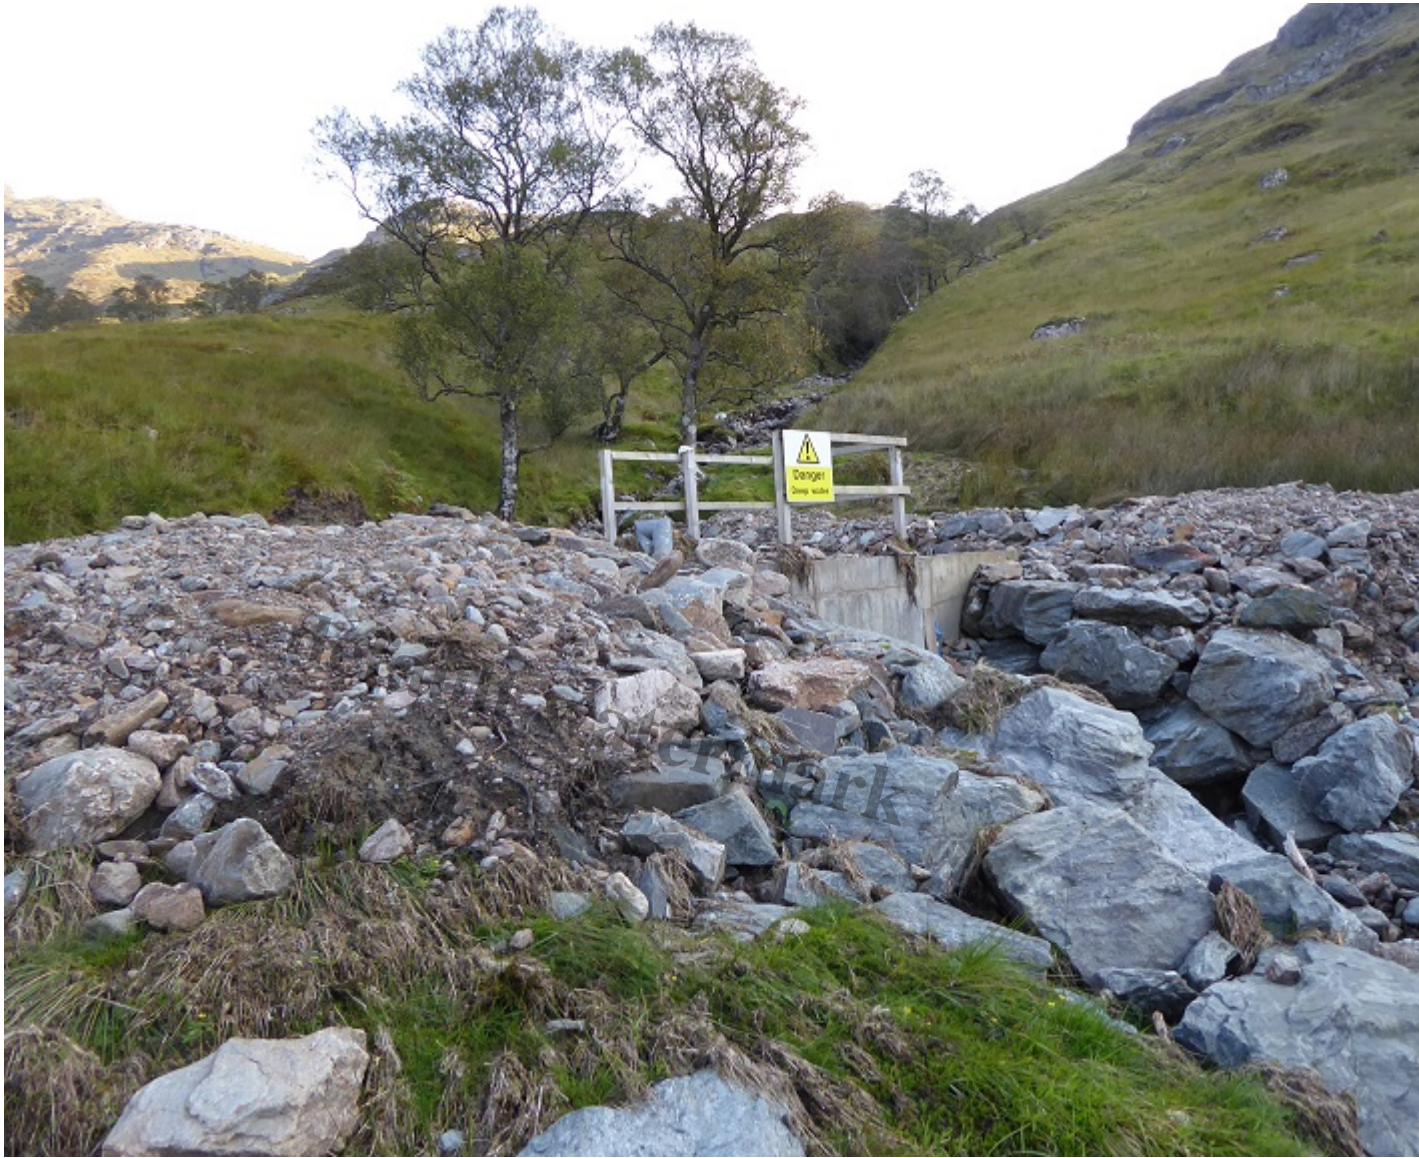
The secondary Allt Chuillinn intake closest to the main intake

This second Allt A Chuillinn intake has also served to trap silt, mud, stones and boulders swept down the hill before being overwhelmed by it. The deep water danger sign is nowâ?â?â?â?â?â?!

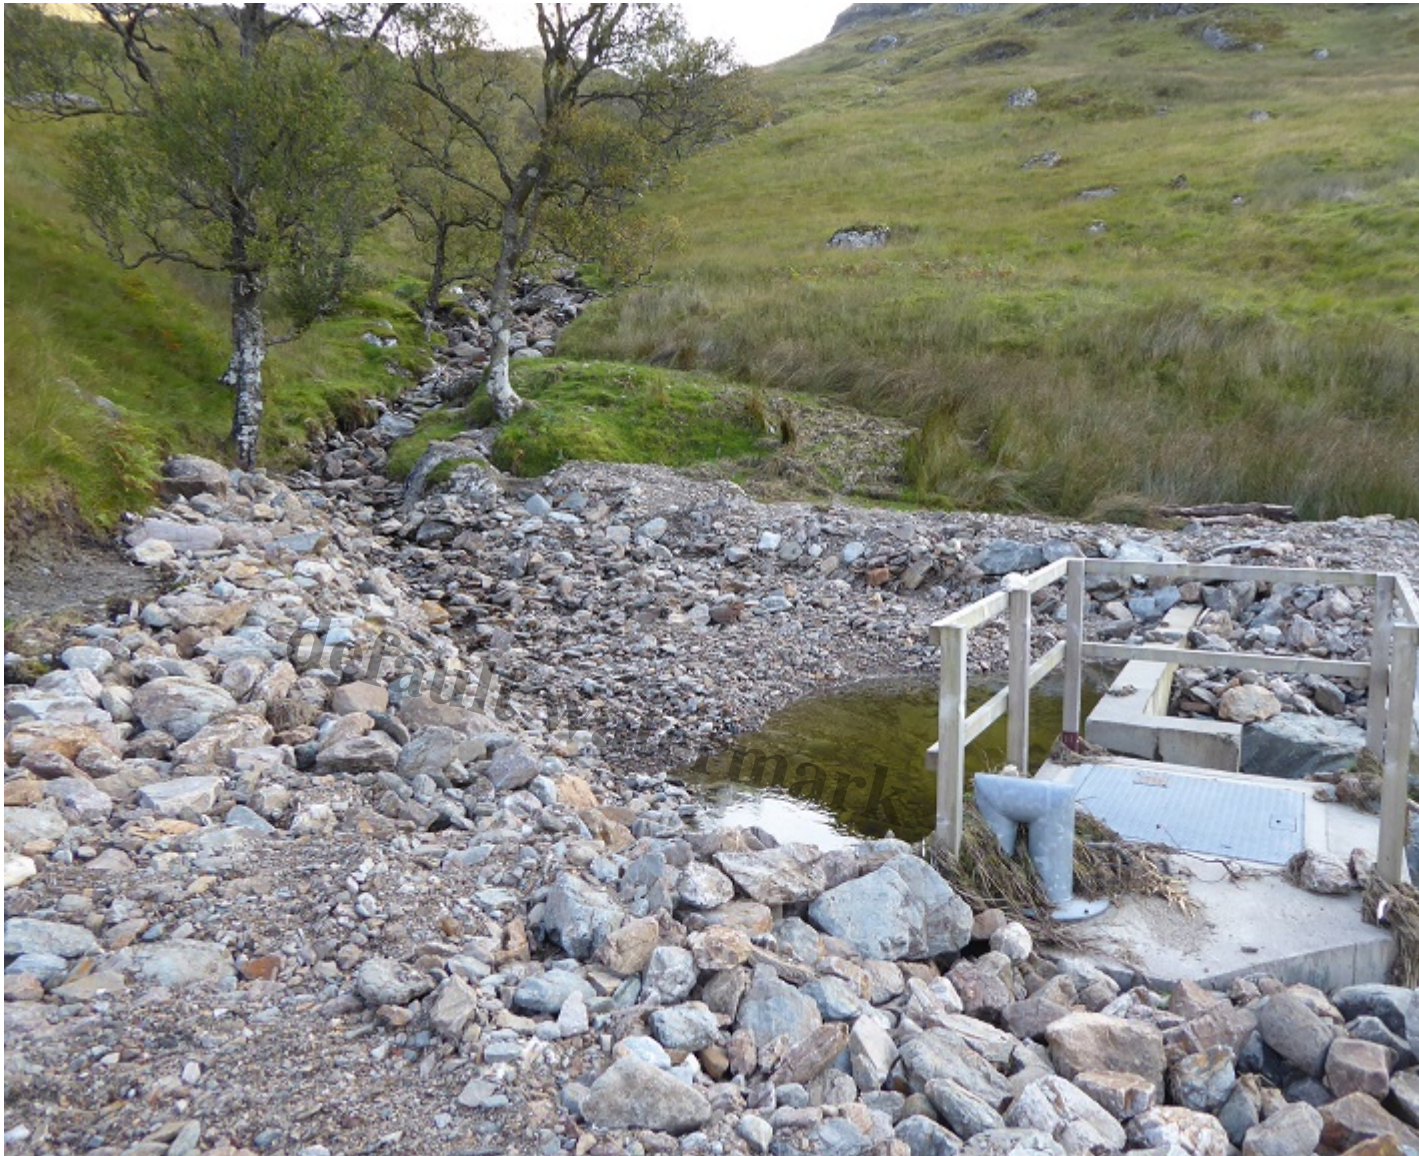
The neat sides and the flat bottom to the burn are signs that it has recently been engineered

and is now redundant. What was the intake pool has however had to be excavated, probably to get the hydro working again but also to prevent the burn changing course and making the intake permanently redundant.

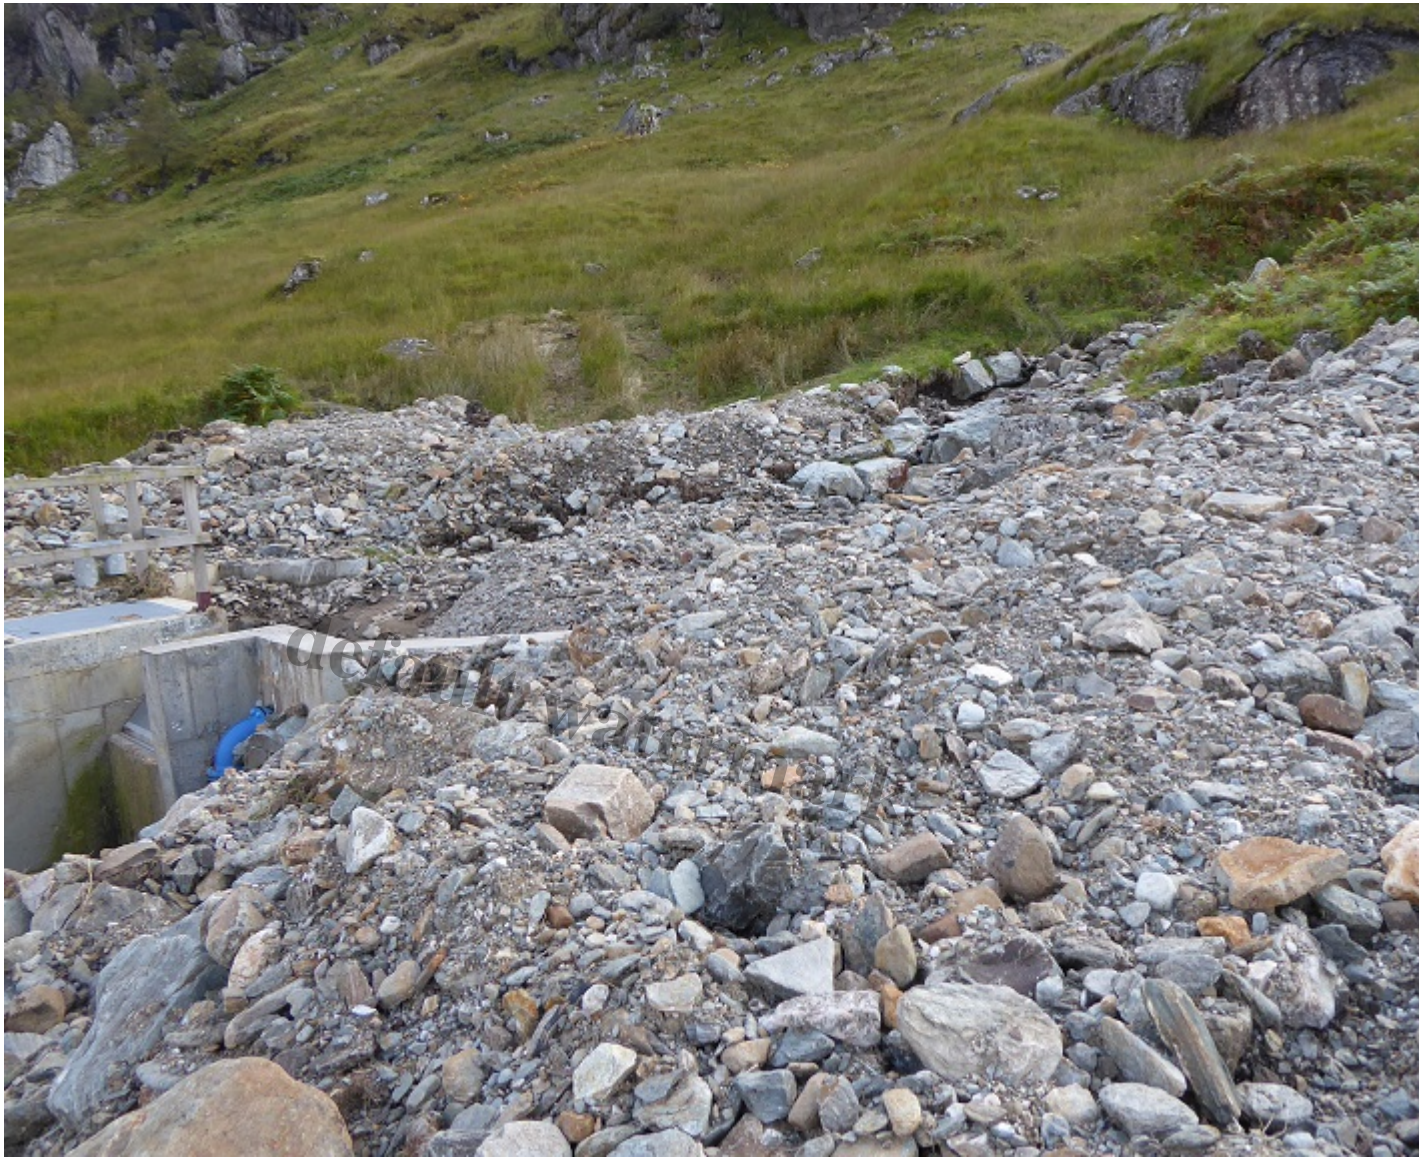
The second secondary intake to the Allt a Chuillinn. The wooden barriers appear to have survived by chance rather than design.

The third of the Allt a Chuillinn intakes has also been overwhelmed by flood debris, is high and dry and not functioning at all.

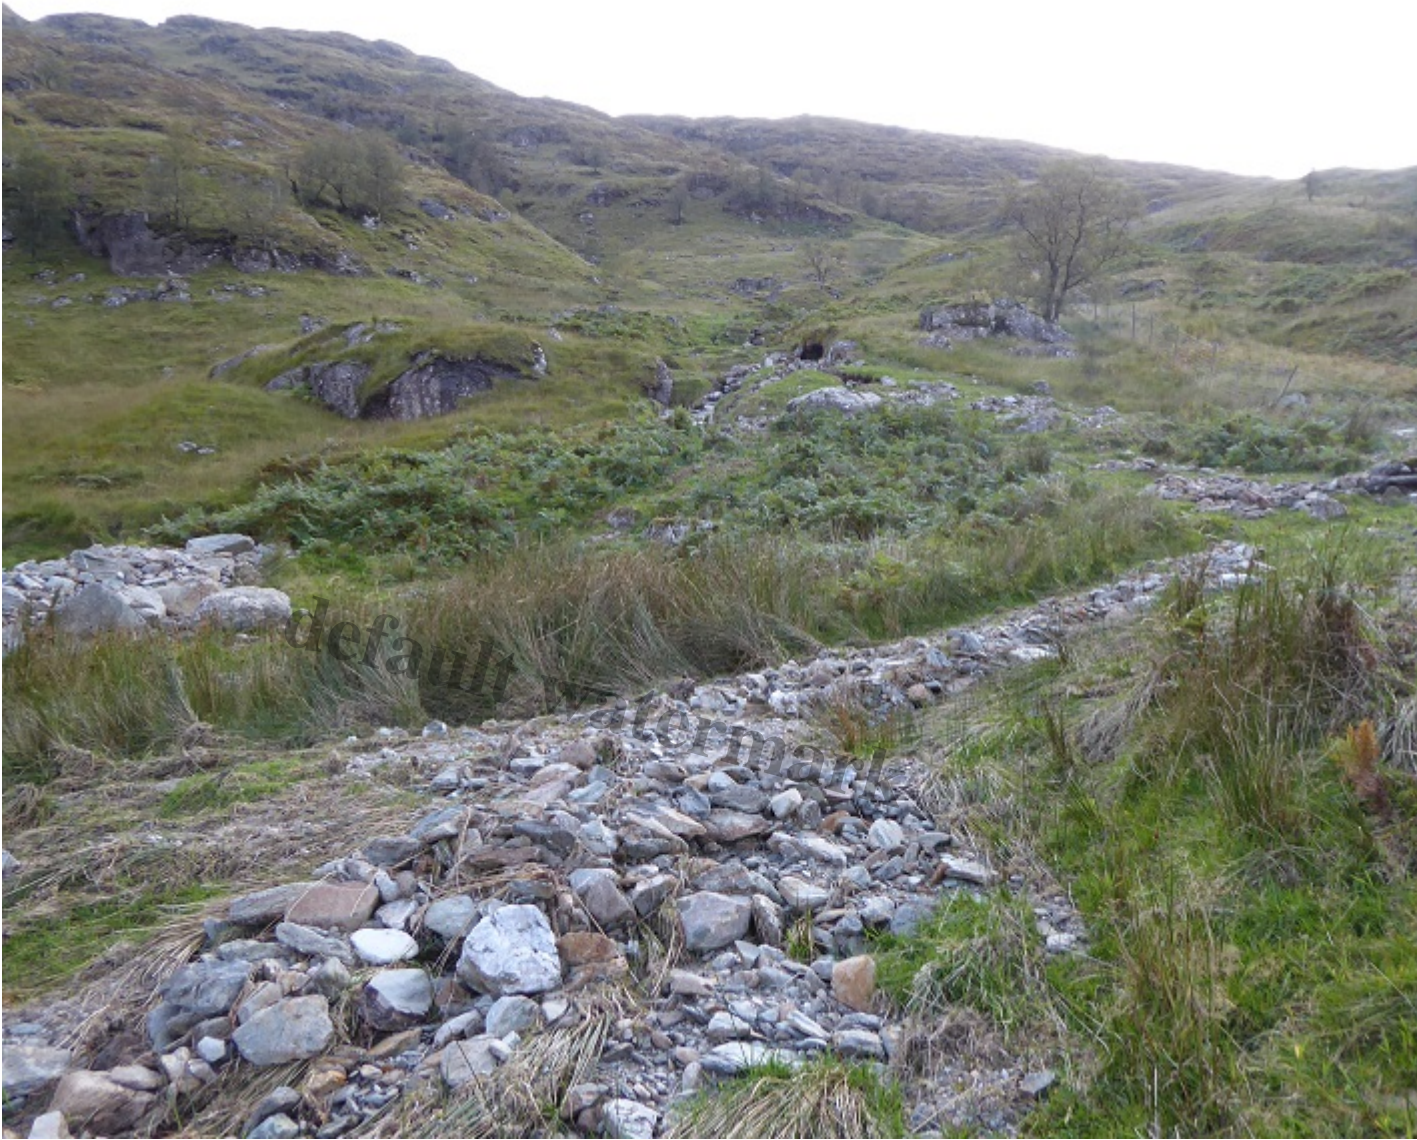
Looking up above the hydro intake. The burn, a trickle on the day I visited, runs down to the left of pi boulders mid-photo and the intake lies just beyond the bottom left hand corner of the photo.

The burn appears almost to have changed course as a result of the flood event. Had that happened, further extensive engineering might have been required.

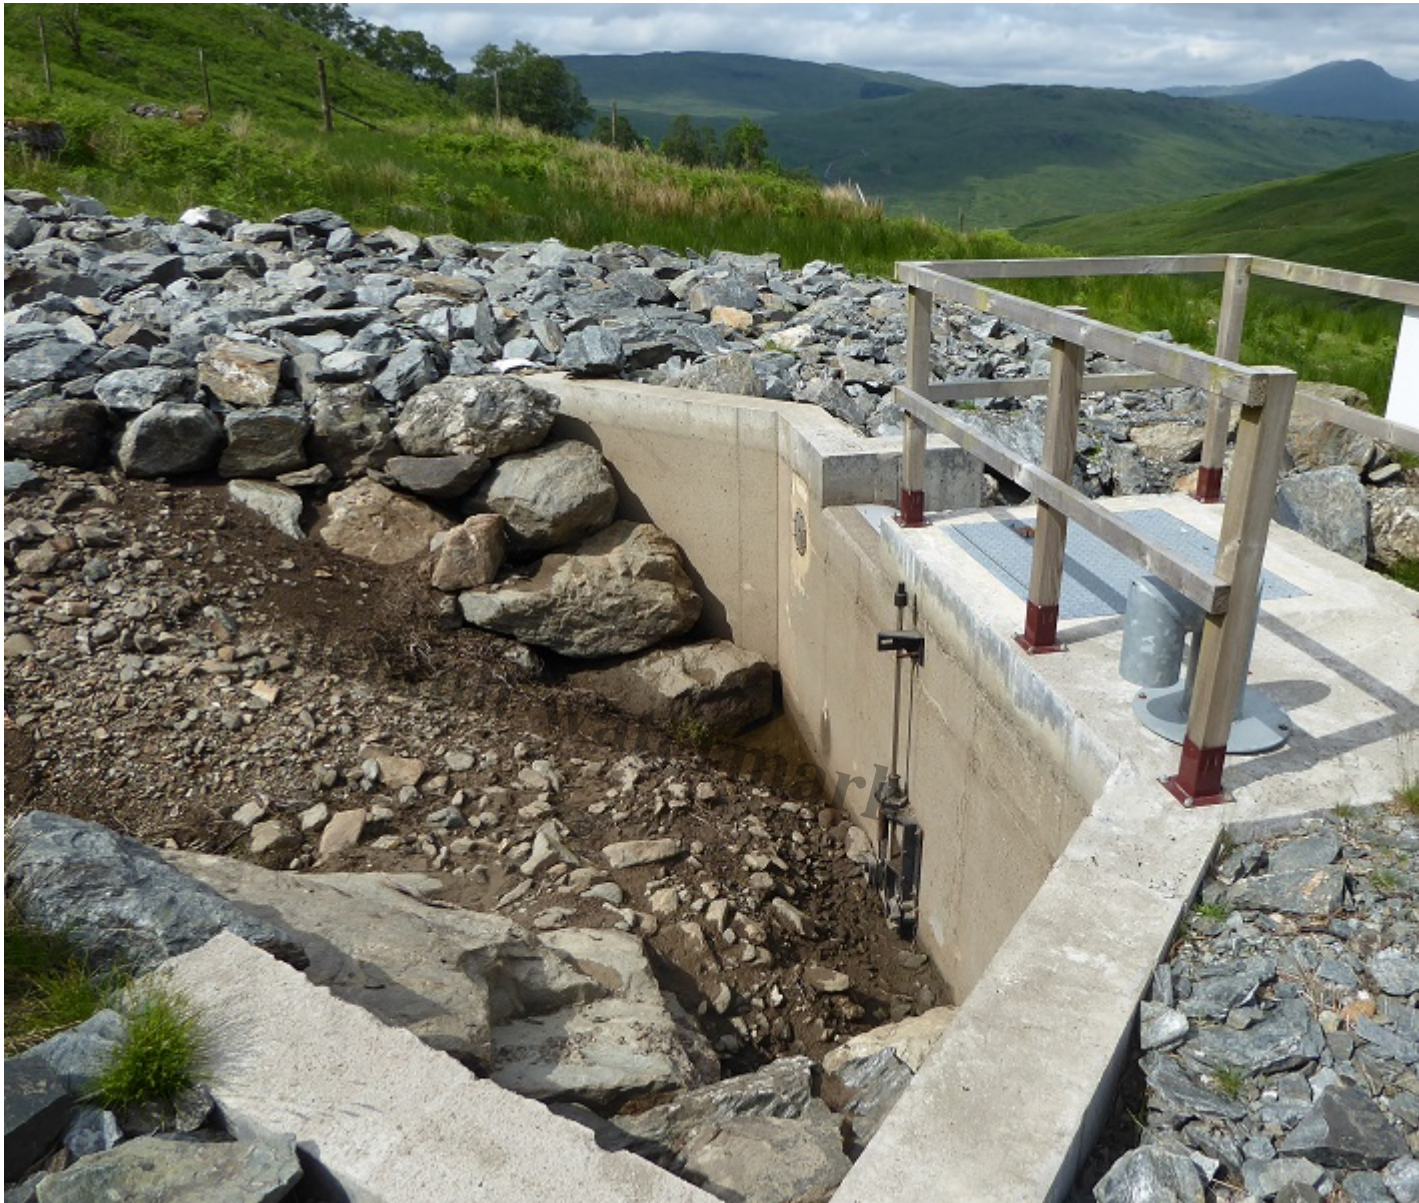
Photo of same dried up intake June 2018. Intake just to left of far post.

This intake, however, appears not to have been functioning for some time. 15 months ago when I visited, it appeared that due to poor design the water from the burn had found its way beneath it leaving what should have been a pool high and dry. Ironically, it could have started working for a time in the flood as the water which swept more rubble onto the ugly and highly artificial embankments was way above the level of the intake screen

Taken together all this raises doubts about whether this intake will ever be restored to working order. The issue now is not just that the intake was so badly designed that water flows under it. Its that the intake appears to be in the wrong place, if indeed there is a right place on a hillside like this, where its not uncommon for burns to change course.

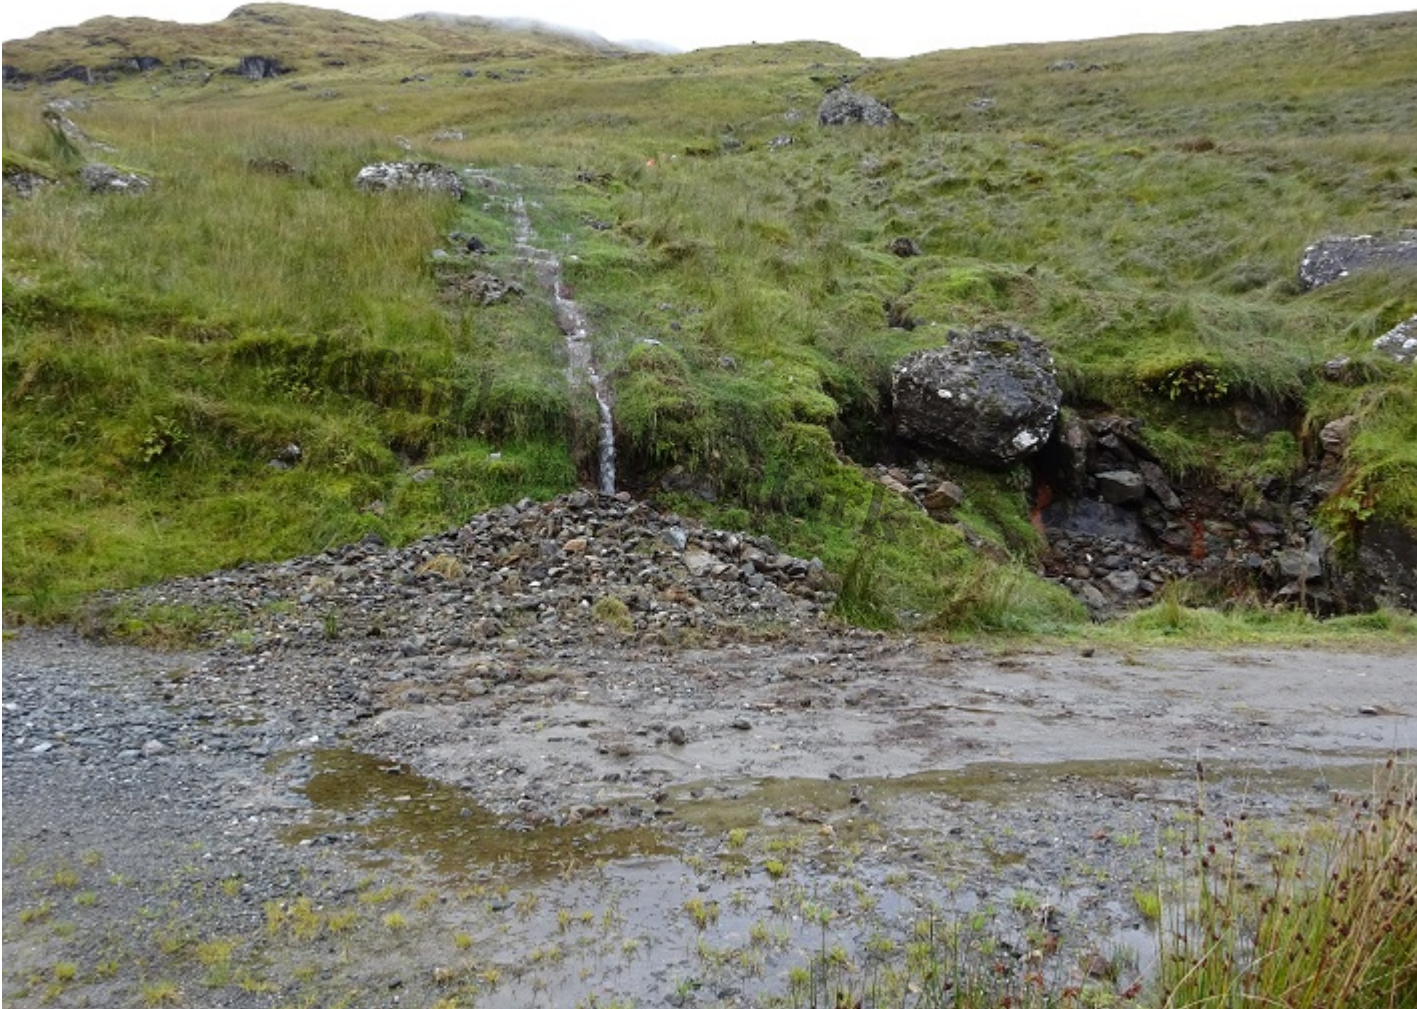
Burn by track up to Upper Glen Falloch hydro intake. Until recently it flowed down by the boulder on right. Note the amount of debris washed down by the burn onto the track. Photo credit Kevin McGra 25th September.
