Climate change and Glen Falloch (3) – the hydro schemes have failed, literally!

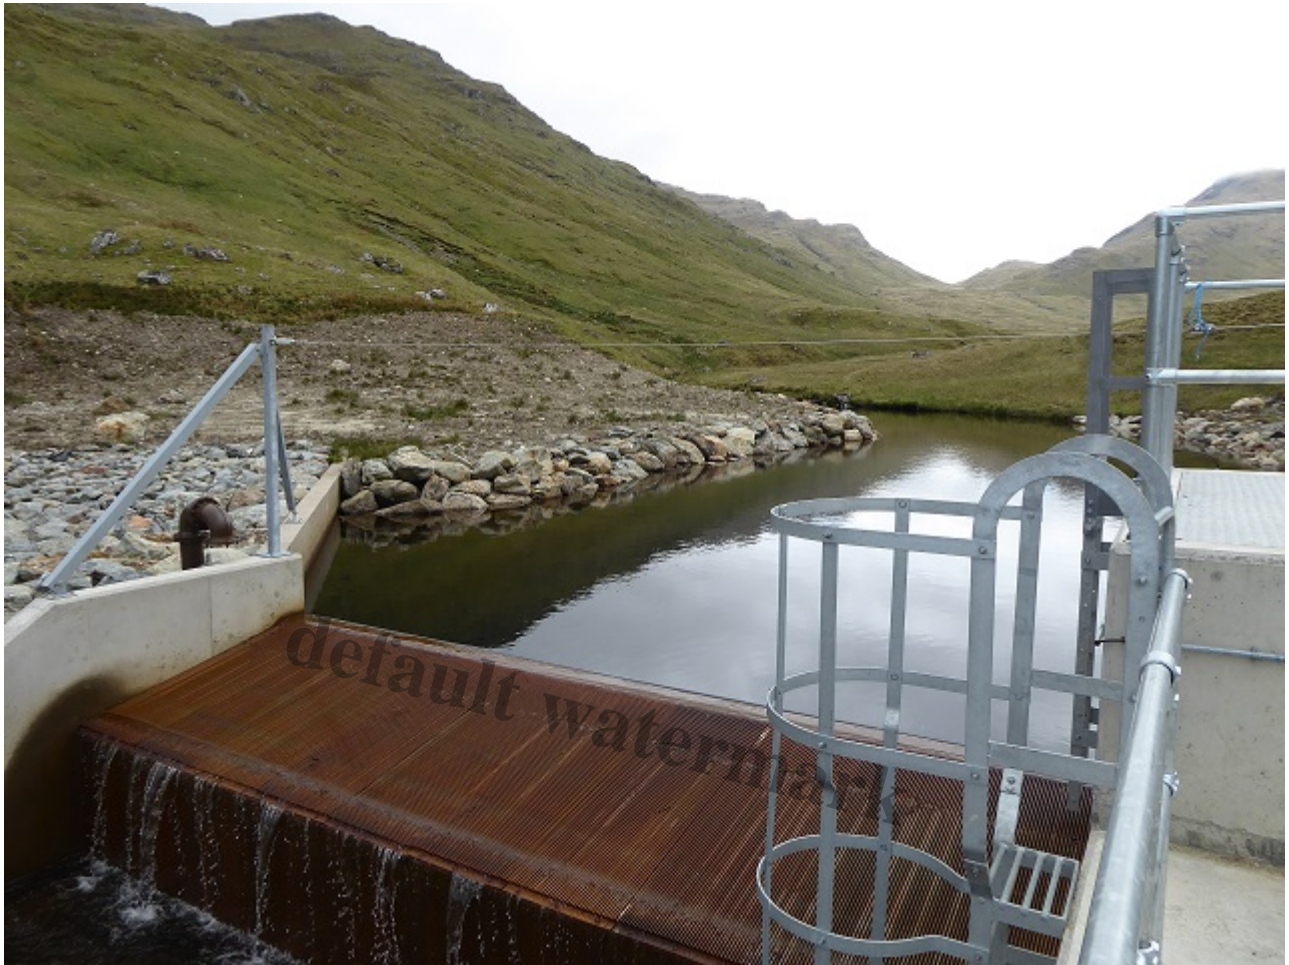
Upper Glen Falloch intake pool May 2019

Back in May, when I last visited, behind the Upper Glen Falloch intake was a large deep artificially created pool ([see here](#)). I had up till now been critical of this pool from a landscape perspective, it formed a large ugly engineered area within what had been a wild glen and it appeared that the rip rap bouldering on the banks could take decades to revegetate. It was totally out of place in landscape terms.

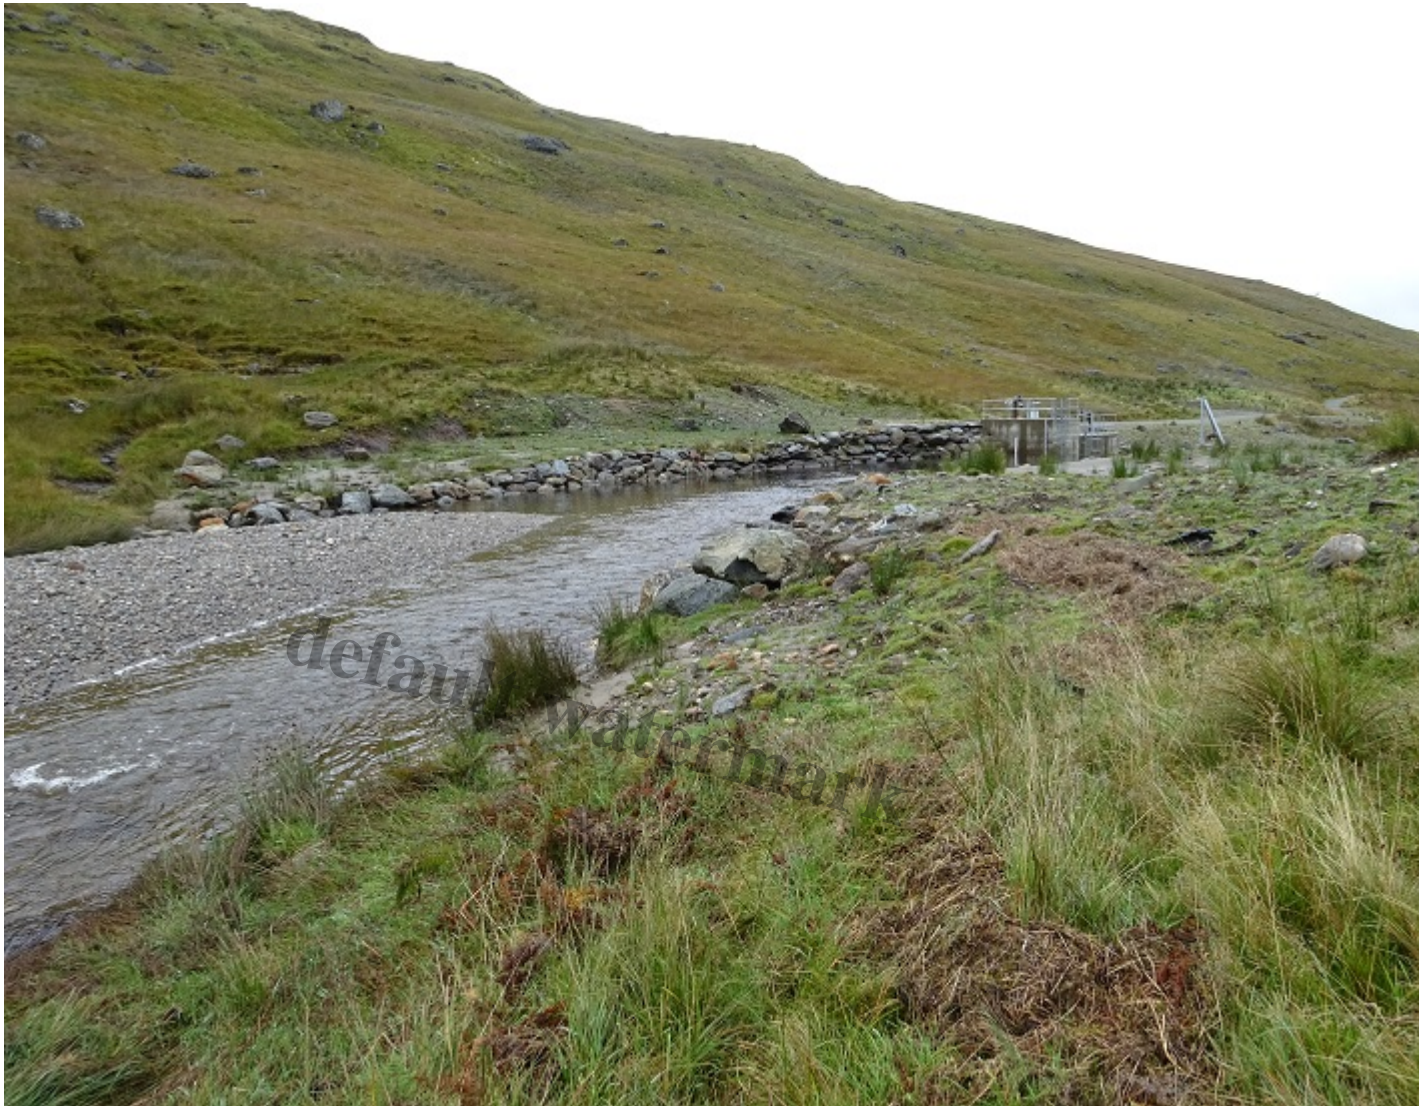
Shingle beach in Upper Glen Falloch intake pool. Photo credit Kevin McGrath September 2019

The deep pool however is no longer!

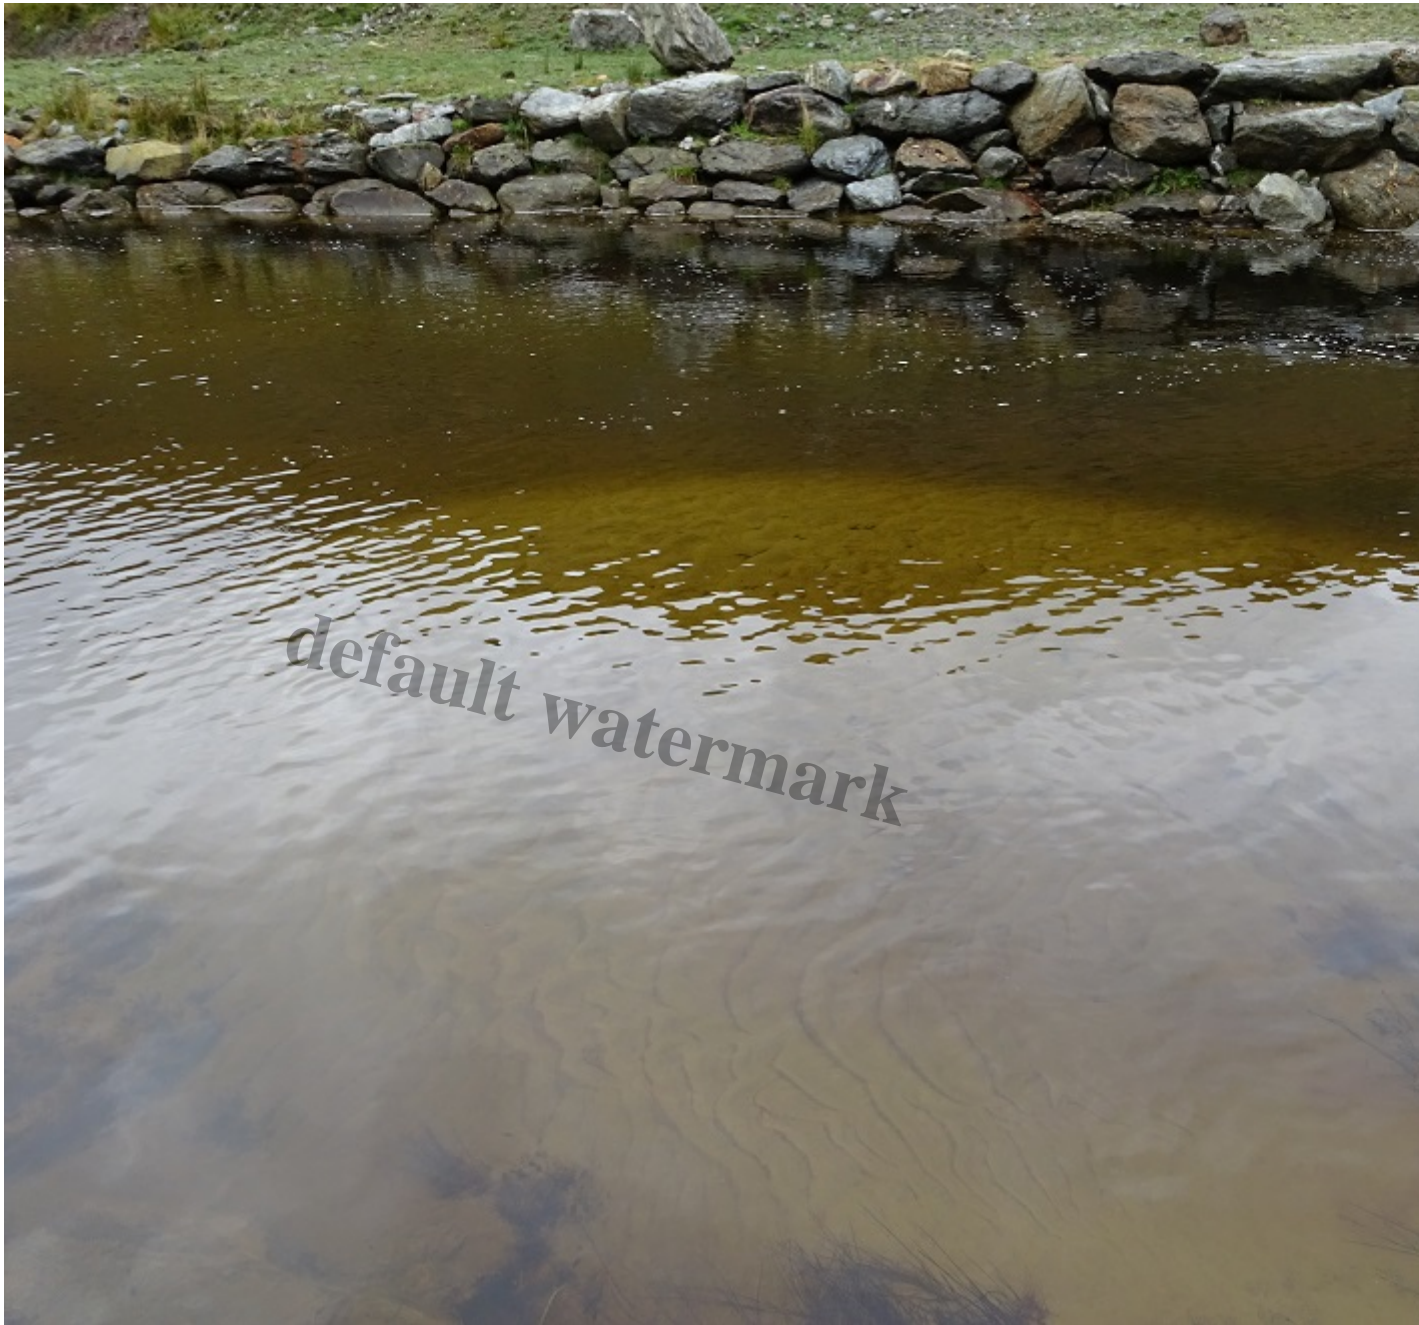
Bottom of intake pool September 2019 – the dam wall is just to the right. Photo Credit Kevin McG

The extent to which this pool has been infilled is striking, its being reclaimed by nature – a good thing, which has softened to an extent its artificial contours, but quite incompatible with the ability of this scheme to generate electricity in the long-term.

The LLTNPA consented to the Upper Falloch hydro intake being re-engineered just last year to increase the volume of water flowing down the pipe. Another indication that the original design of these schemes was poor from a civil engineering perspective. That work destroyed much of the previous attempts to restore the ground around the intake (see link above). With the infilling, it now looks now as though this intake may become a permanent works site. Is that appropriate in a National Park?

The risk of infilling should, I believe, have been quite predicable had the LLTNPA and other Planning Authorities ensured people with appropriate expertise been involved. The intake sits in a wide open glen with an extensive catchment (see third photo above). What made this location attractive to the hydro pushers also made it vulnerable to storm events and material swept down from above. Unfortunately, the LLTNPA at the time these schemes were approved employed almost no conservation staff and in their rush to meet Scottish Government targets for renewable developments, failed to think through the issues. In this they were no different to Planning Authorities across Scotland except that, if anyone should have known better, it should have been our National Parks.

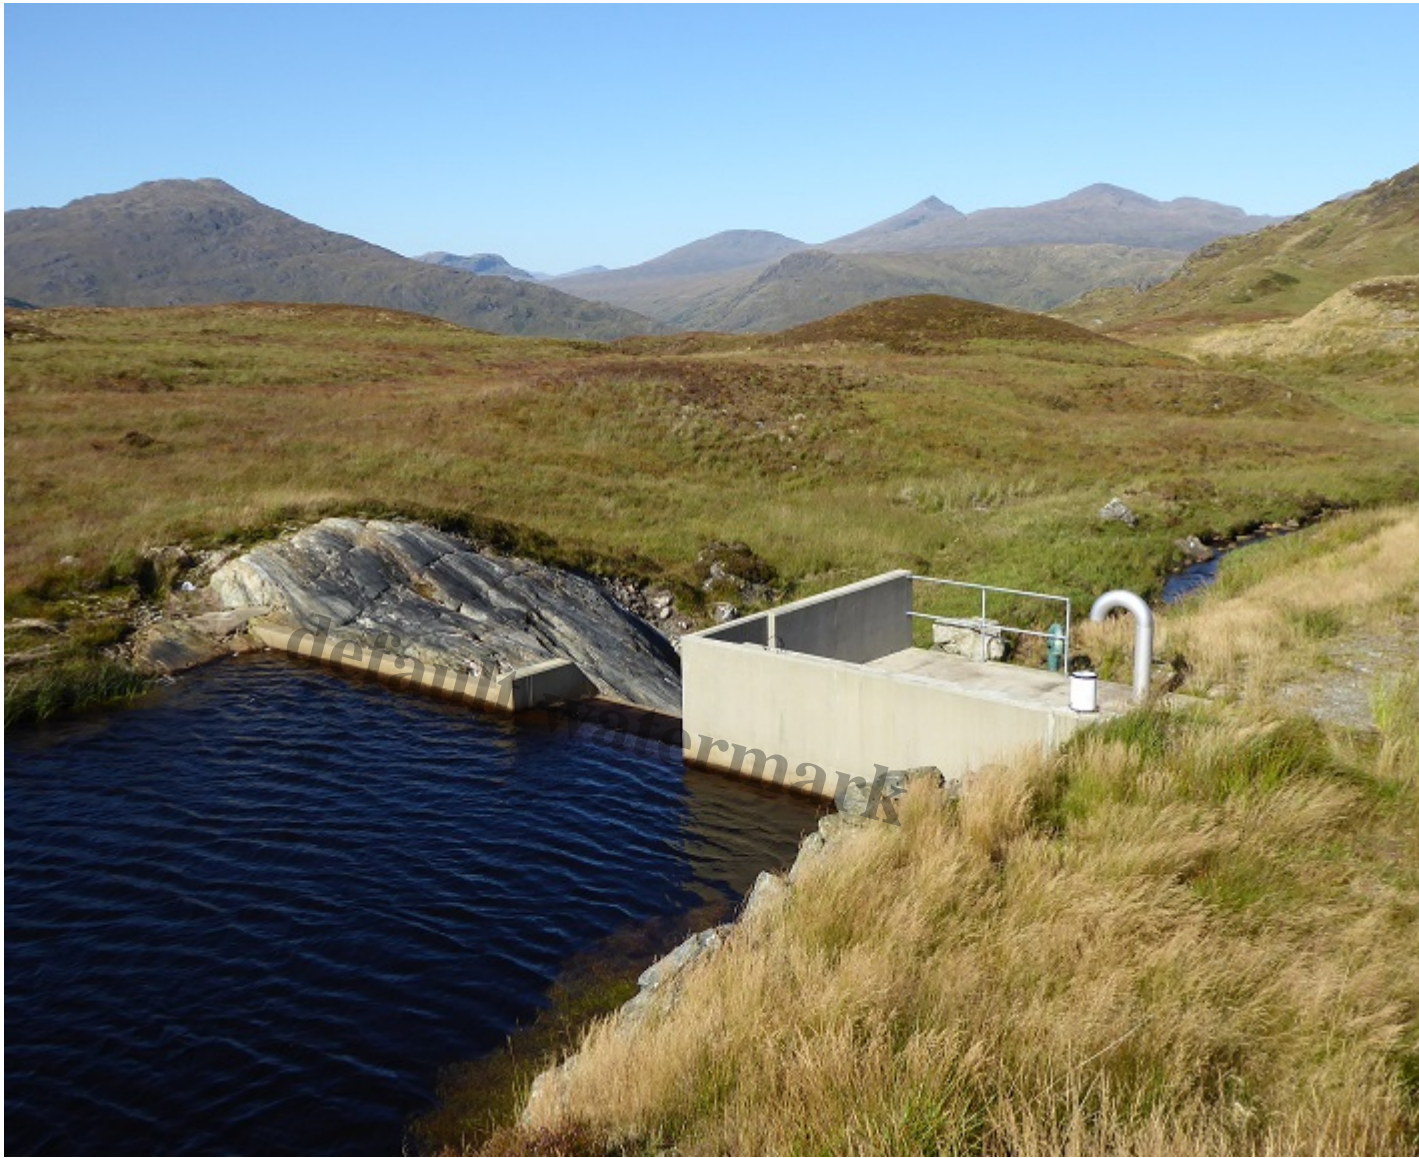
Southern Ben Glas hydro intake, Ben Lui massif in background

Ben Glas was the first of the hydro intakes I visited and there was very little sign of flood damage or infilling – it was still not possible to see the bottom of the pool. That doesn't mean to say there has been no infilling but does suggest that where intakes are located matters. (The Allt Fionn scheme, which also appears unaffected, is tucked away in a high sided rocky gorge ([see here for some old photos](#)))

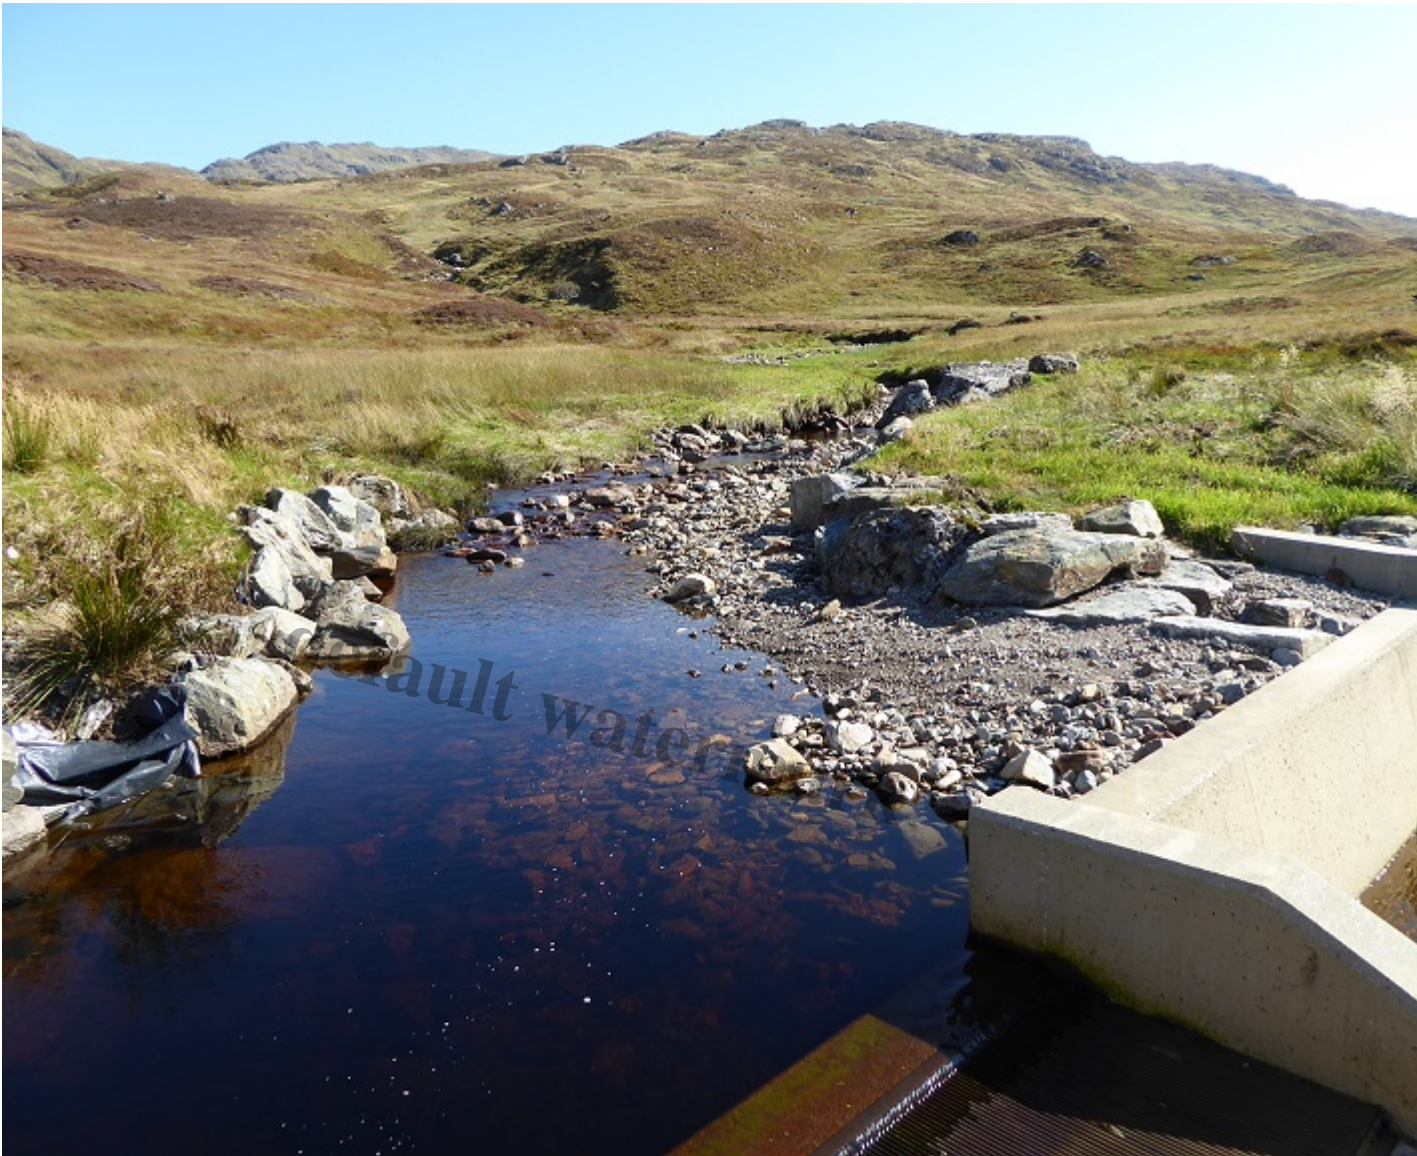
Second Ben Glas intake by walkers path to Beinn Chabhair. Note the black plastic on left of photo, an indication that a large rip rap boulder protecting the bank has been swept away and the shingle beach that has developed by the right bank and intake wall.

The other Ben Glas intake had been affected by some infilling and damage although this appears significantly far less than in the Allt a Chuillinn schemes. The flat beach on the right suggests some work might have been undertaken since 5th August to excavate the pool.

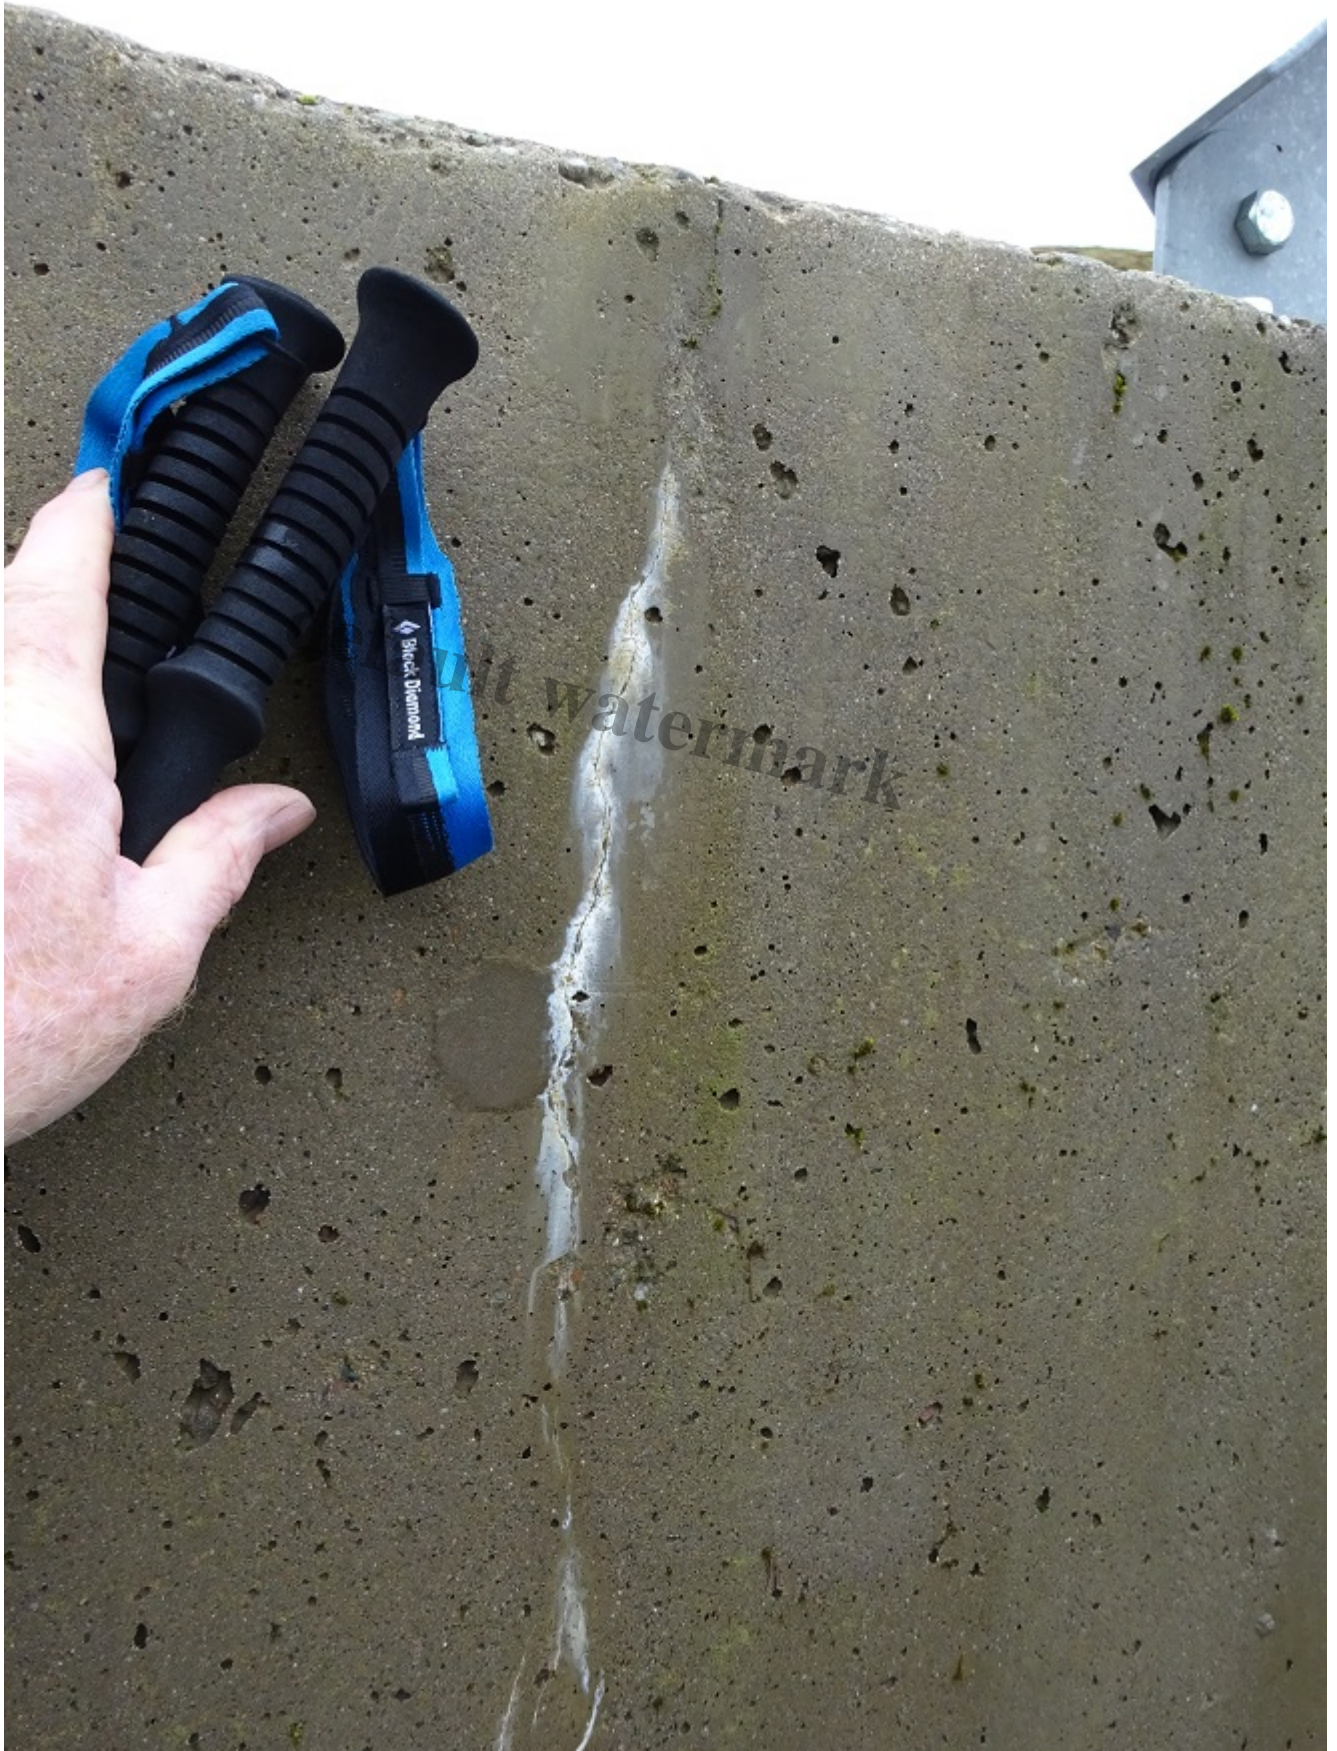
Crack, with seepage, and holes caused by air bubbles in the concrete on the intake wall of the Upper Falloch hydro. The air bubbles at least are an indication of poor construction techniques. Photo Credit Kevin McGrath.
