Climate change and Glen Falloch (3) – the hydro schemes have failed, literally!

The infilling of the hydro intakes

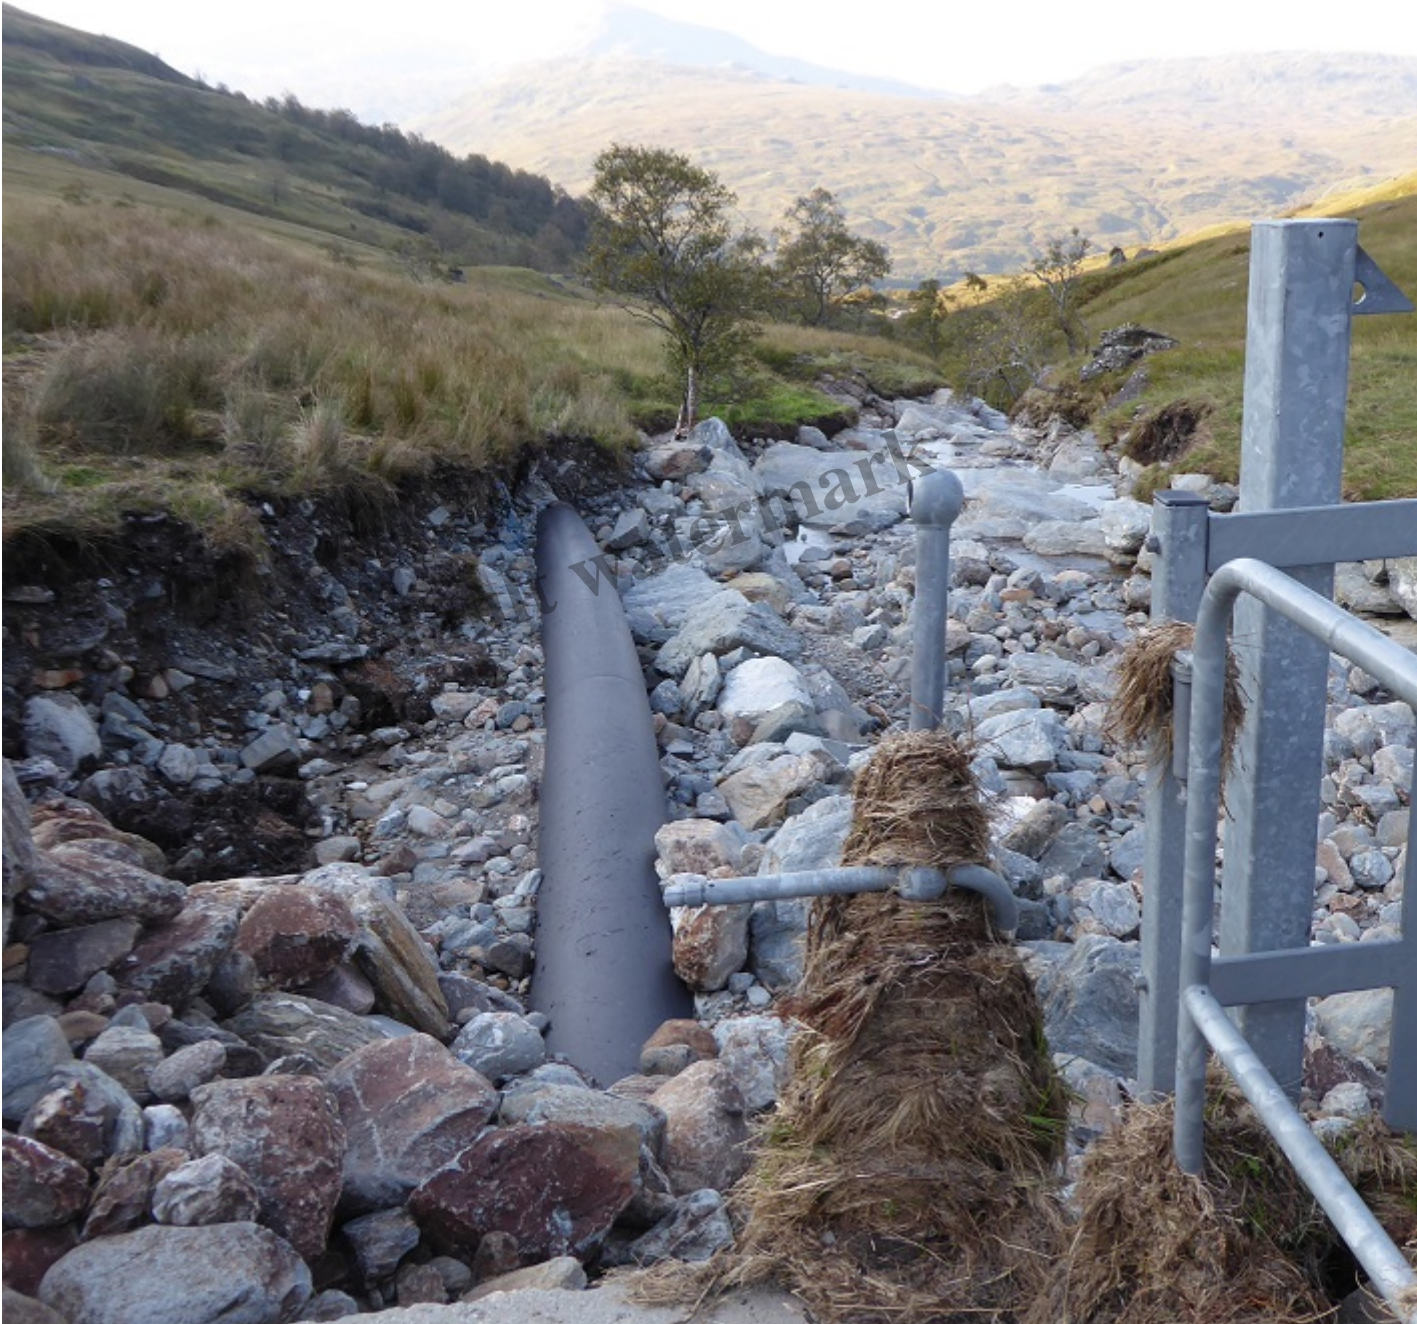
Looking down the Allt a Chuillinn from the top of the main intake. The storm of the 5th August has done what it can on top of the dam will and swept away a large section of “restored” river bank below to reveal the hydro intake.

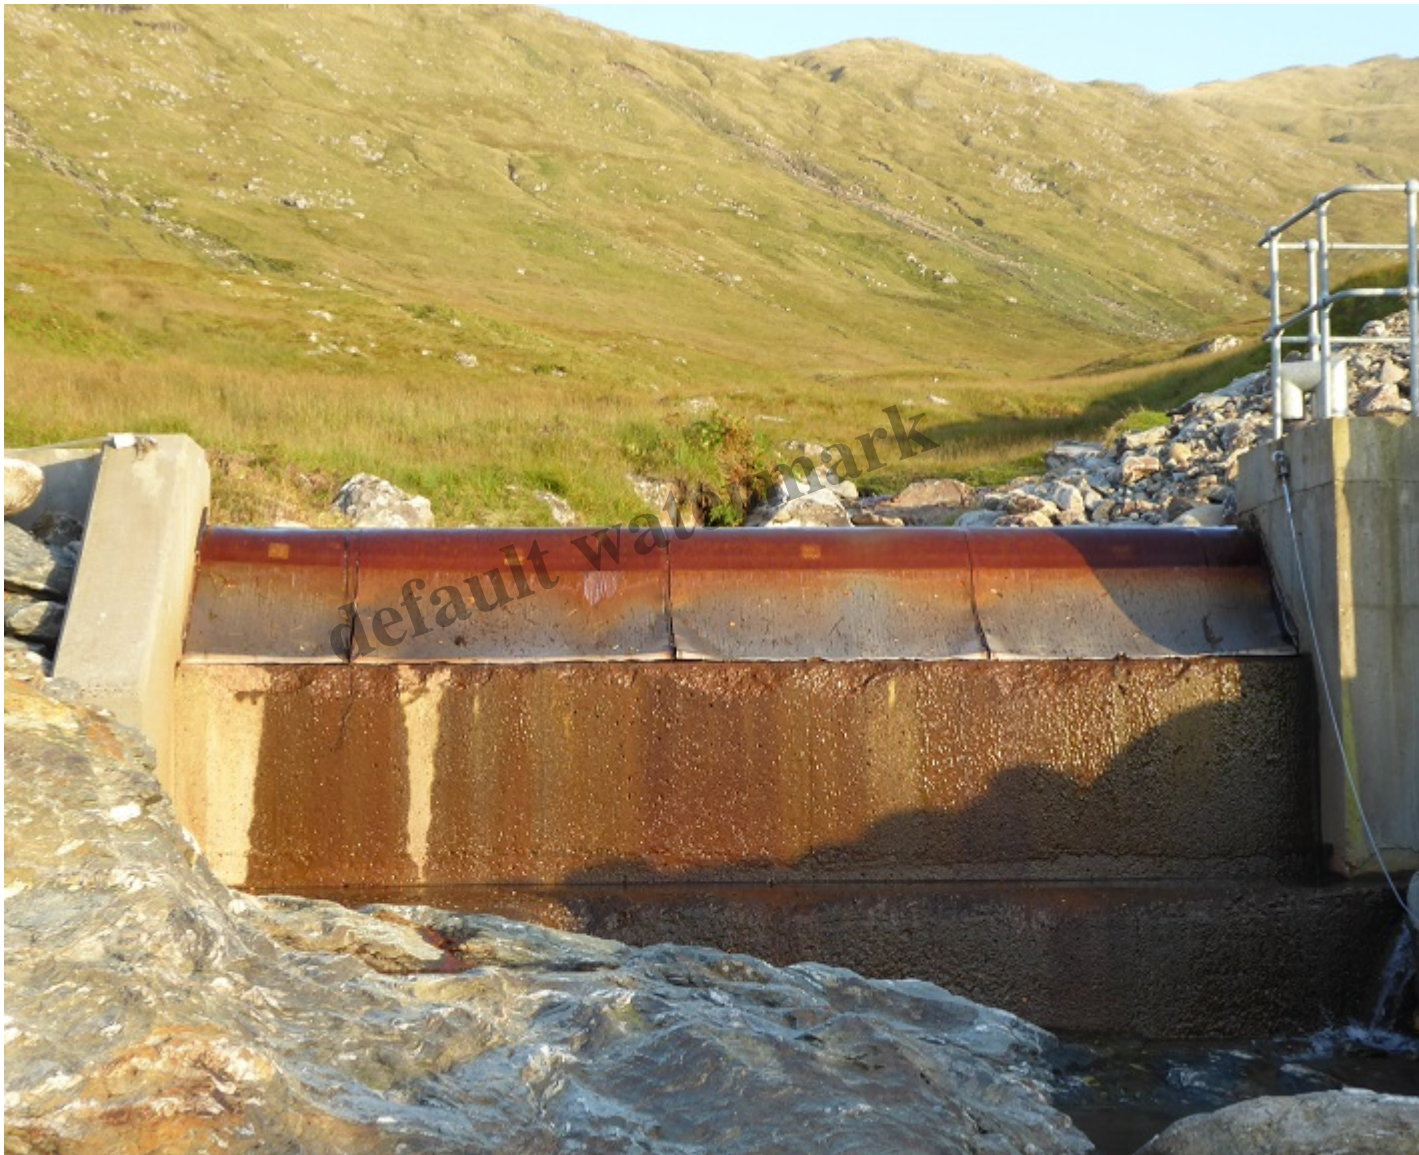
View from below the Allt Andoran intake, part of the Derrydarroch hydro scheme, looking up to the S Garbh – An Caisteal ridge. with a large landslide visible behind extending almost from the ridge to the floor.

Debris from the landslip above and other more minor erosion events, along with rocks, gravel and sand in the river bed have all been swept down by the storm – nature at work – until they reached the artificial barrier created by the hydro dam wall which act like a rock wall. Its not surprising that the intake pools behind start to fill up with debris – parkswatch has covered this before – but the extent of the infilling caused by the storm event took me by surprise.

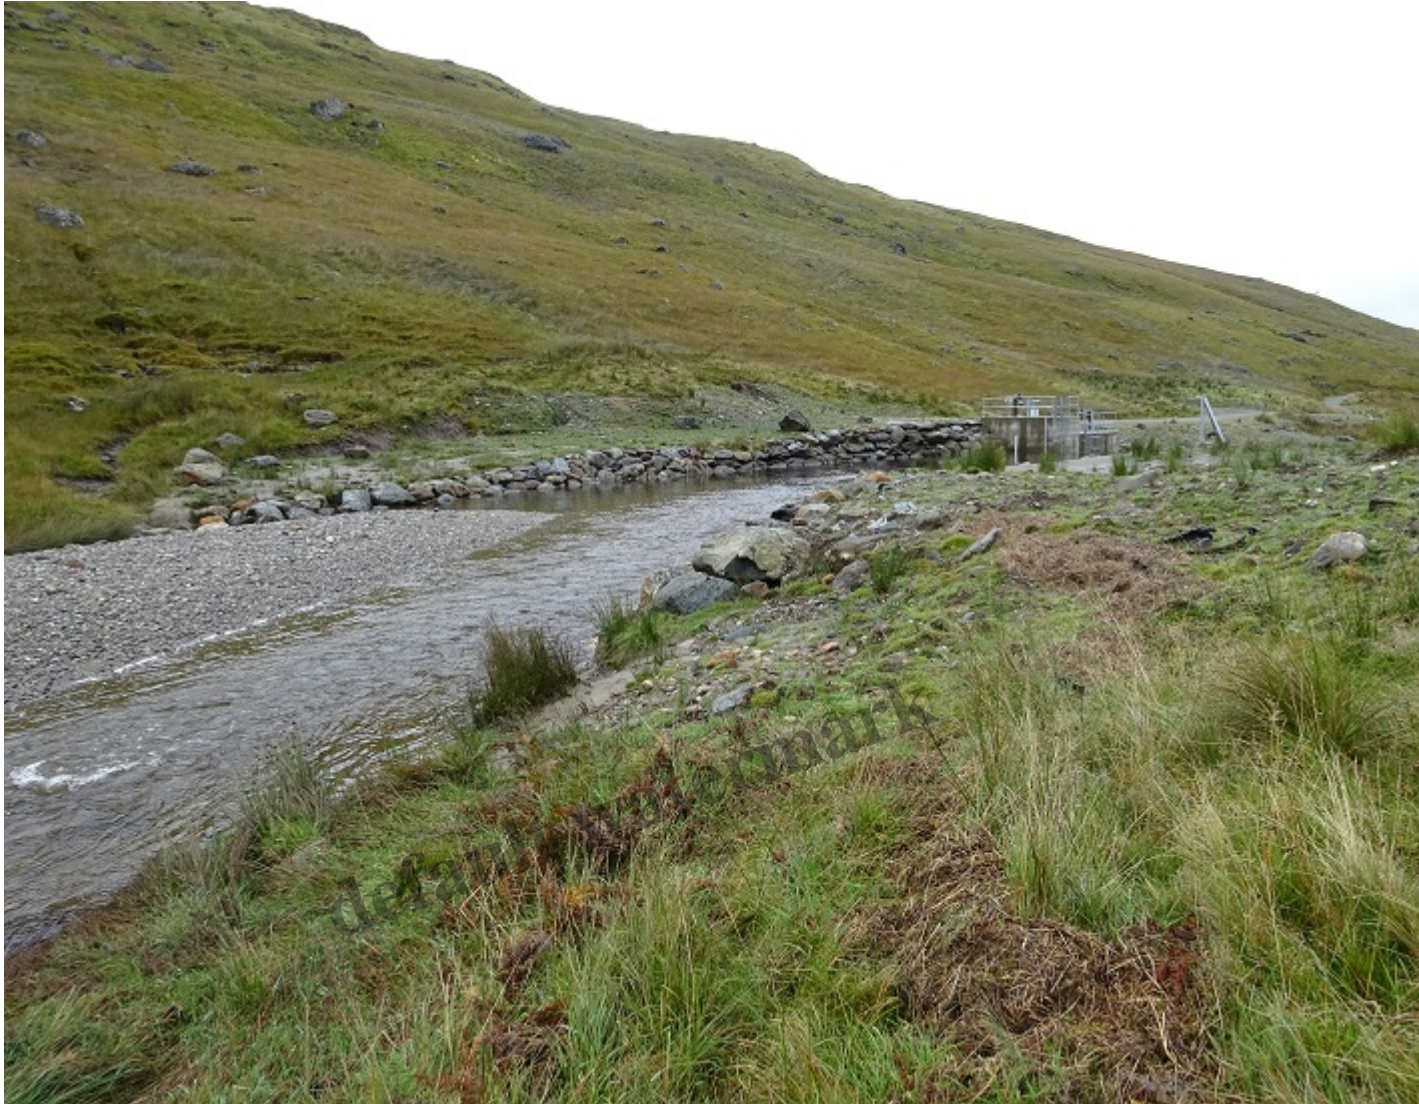
Shingle beach in Upper Glen Falloch intake pool. Photo credit Kevin McGrath September 2019

The deep pool however is no longer!
