Climate change and Glen Falloch (3) – the hydro schemes have failed, literally!

The infilling of the hydro intakes

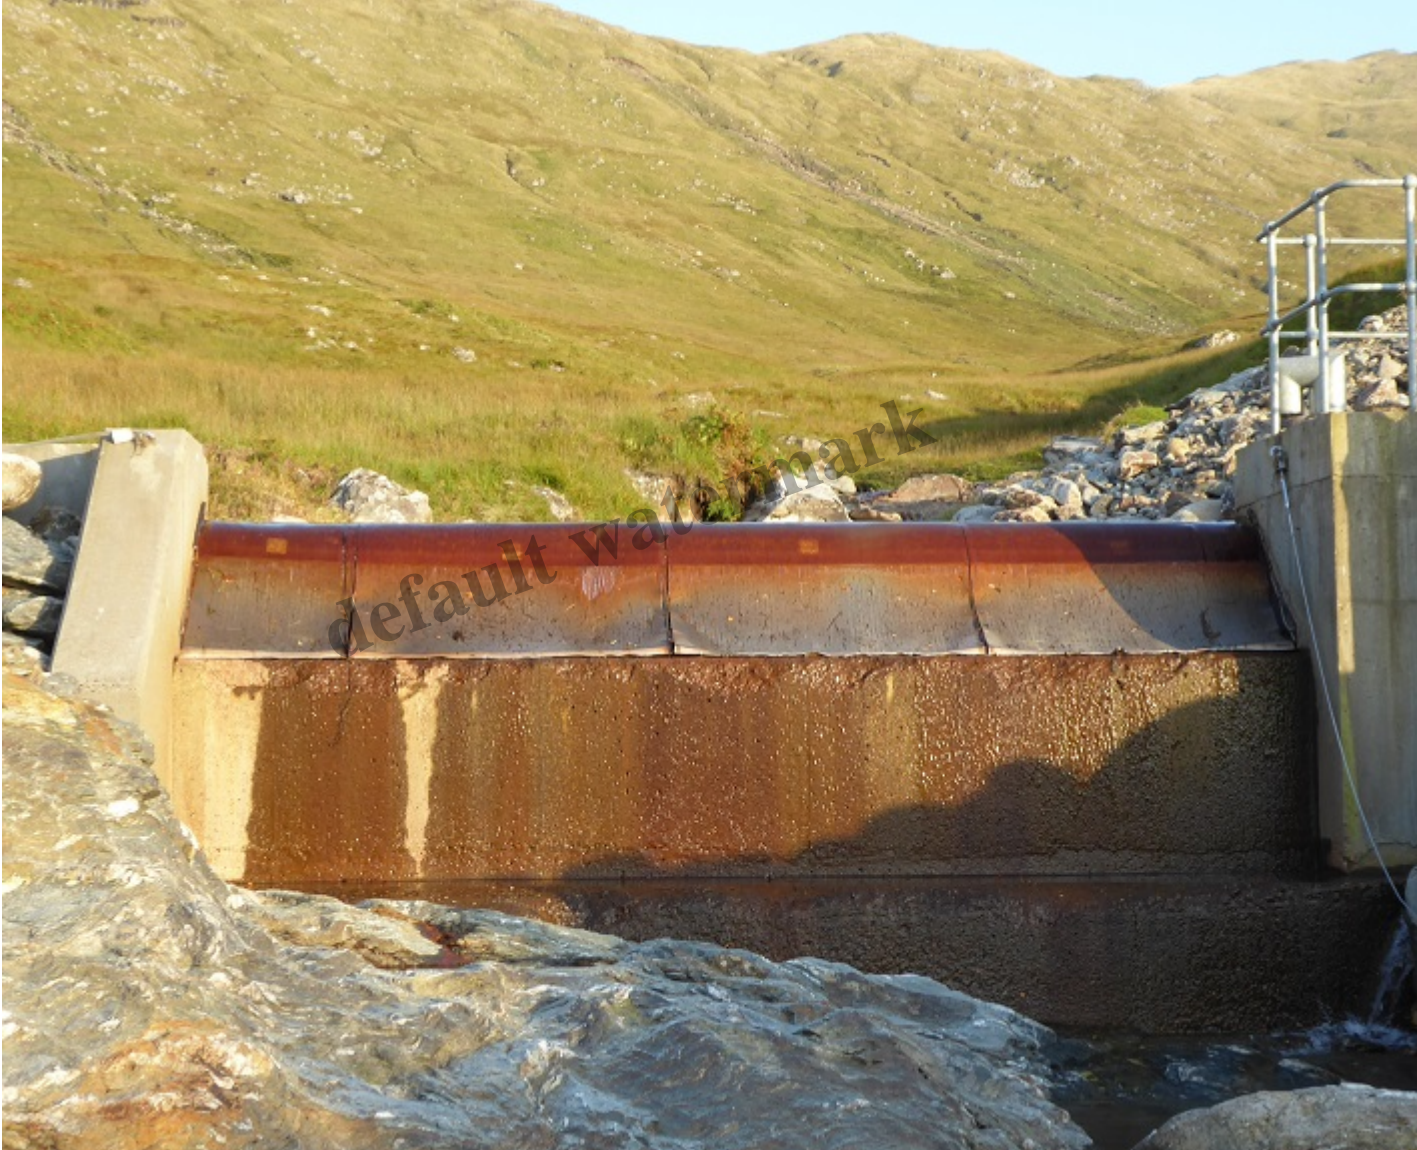
View from below the Allt Andoran intake, part of the Derrydarroch hydro scheme, looking up to the S Garbh – An Caisteal ridge. with a large landslide visible behind extending almost from the ridge to the floor.

Debris from the landslip above and other more minor erosion events, along with rocks, gravel and sand in the river bed have all been swept down by the storm – nature at work – until they reached the artificial barrier created by the hydro dam wall which act like a rock wall. Its not surprising that the intake pools behind start to fill up with debris – parkswatch has covered this before – but the extent of the infilling caused by the storm event took me by surprise.

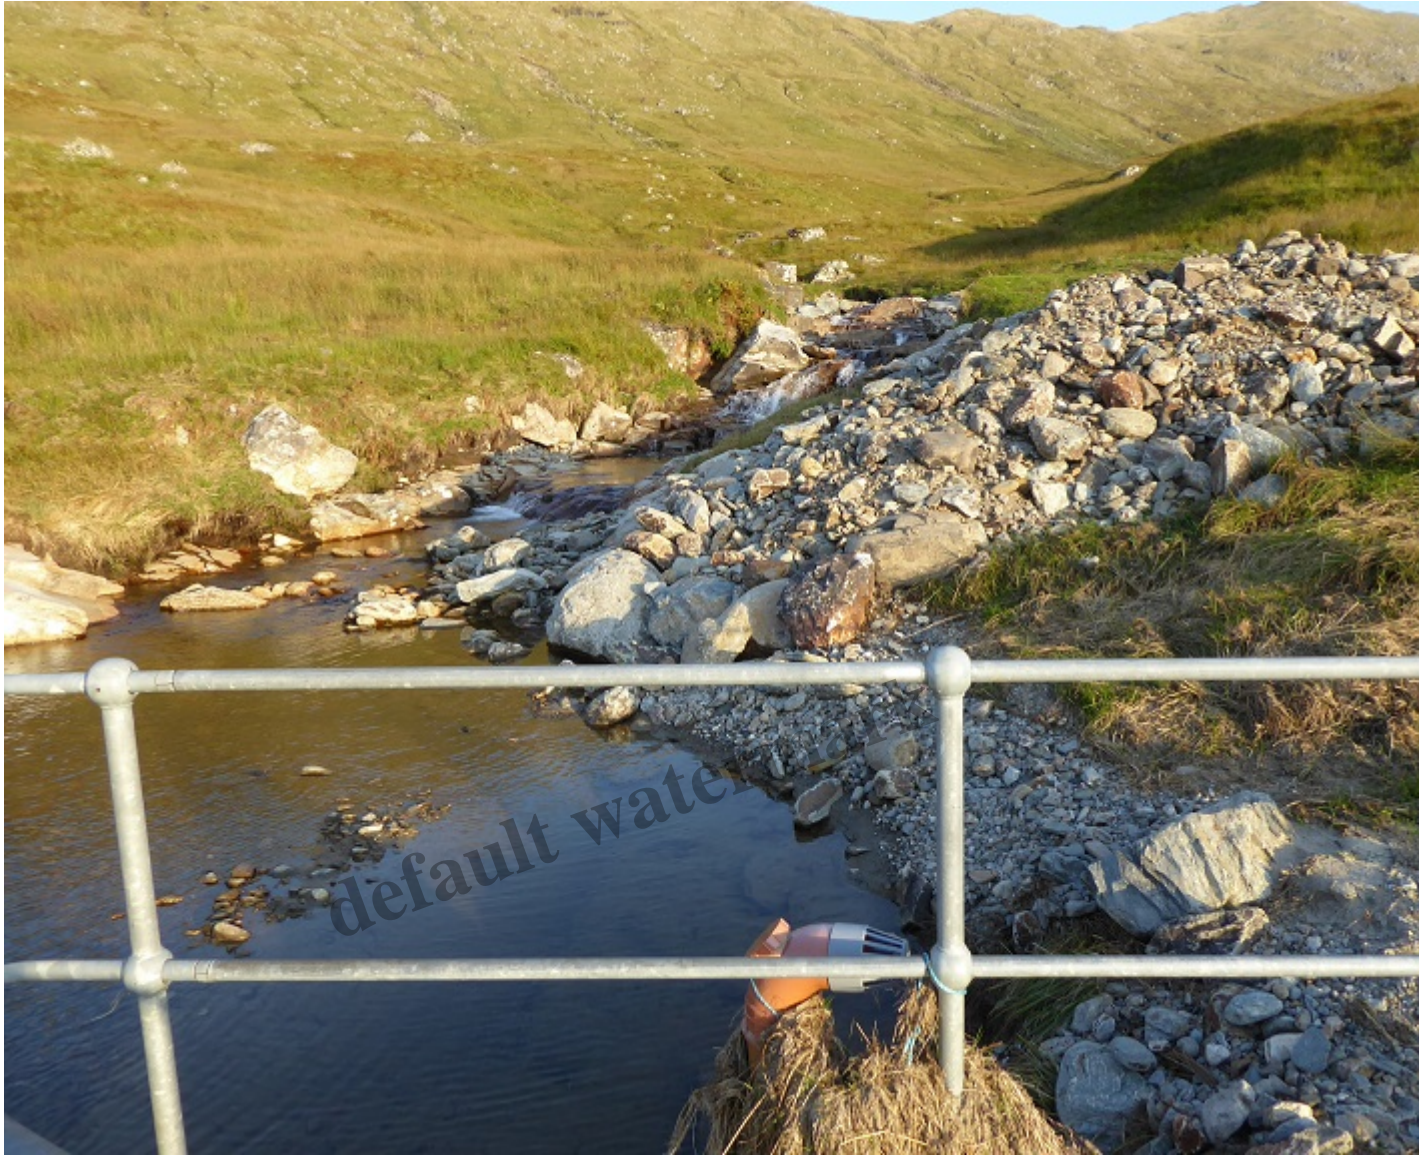
.....with the Allt Andoran Intake pool 2019.

The deep grass sided pool I pictured 3 years ago has almost disappeared. I had been in a rush to catch my train when I got to the Allt Andoran and, until I compared my photos did not realise the pile of boulders behind the pool has almost certainly been excavated since the storm in order to prevent further damage to the intake and to keep it functioning.

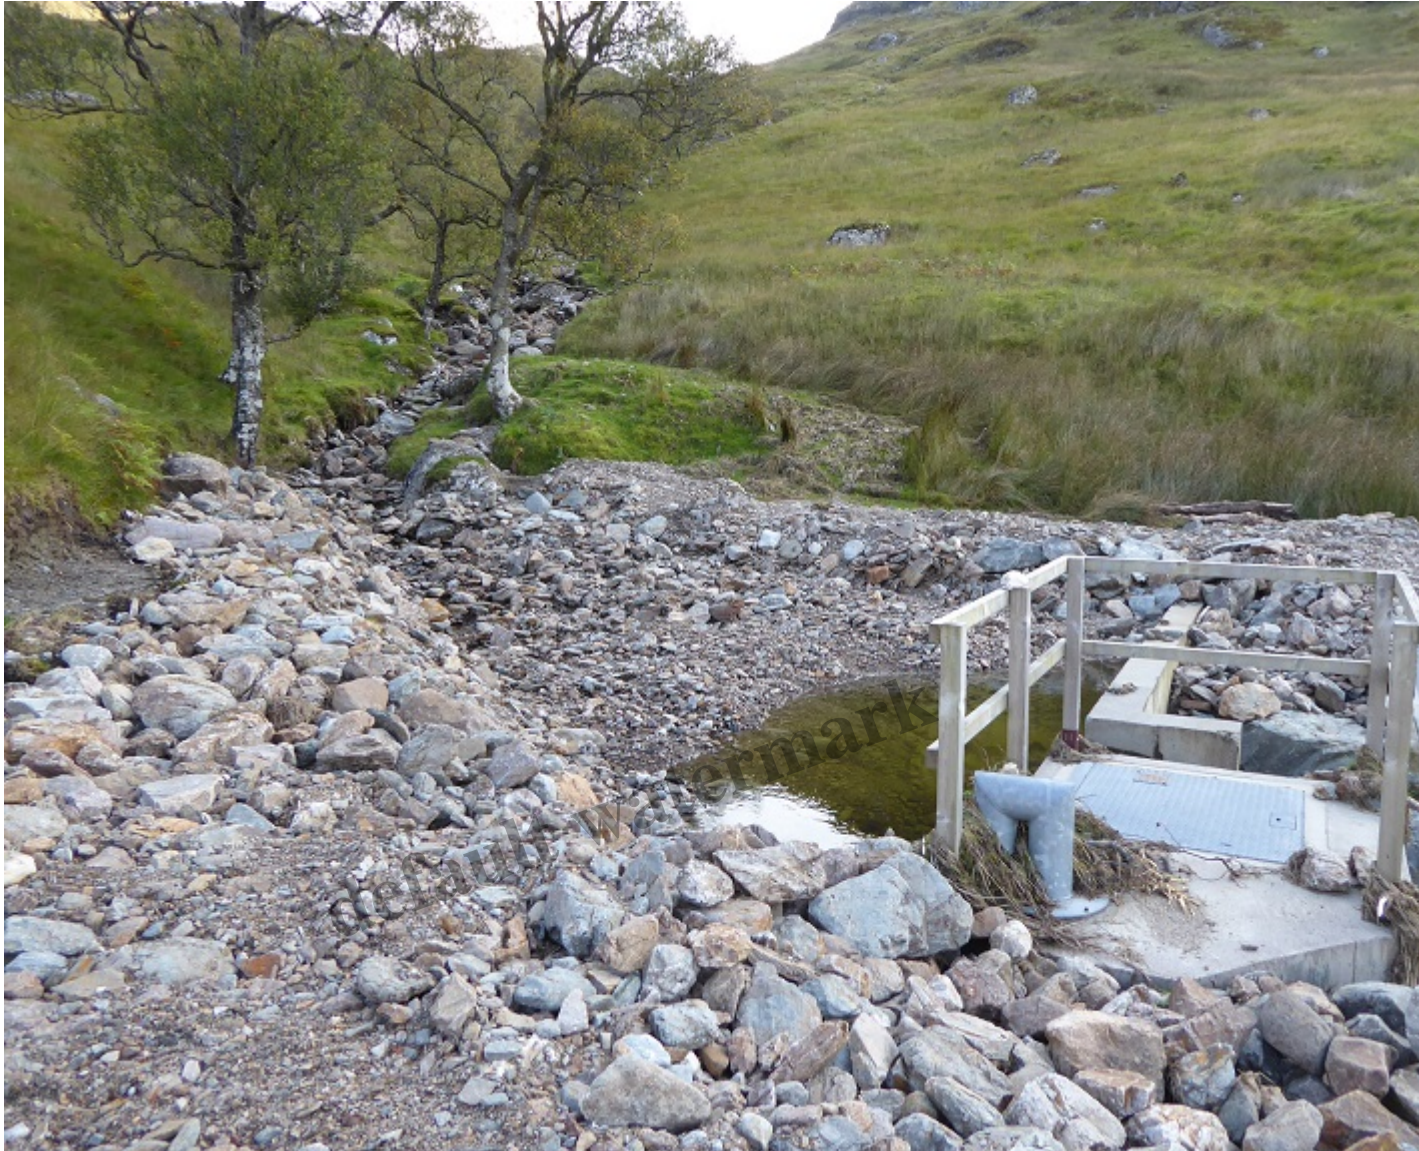
The neat sides and the flat bottom to the burn are signs that it has recently been engineered

.....redundant. What was the intake pool has however had to be excavated, probably to get the hydro working again but also to prevent the burn changing course and making the intake permanently redundant.

Whether the Loch Lomond and Trossachs National Park Authority has been notified of this work and consented to it is another question. There are no new planning applications for the Allt Chuillinn Scheme on the Park's planning portal though the flood damage has clearly affected the "restoration" of all these schemes.
