Climate change and Glen Falloch (3) – the hydro schemes have failed, literally!

The infilling of the hydro intakes

The extent and nature of the problem

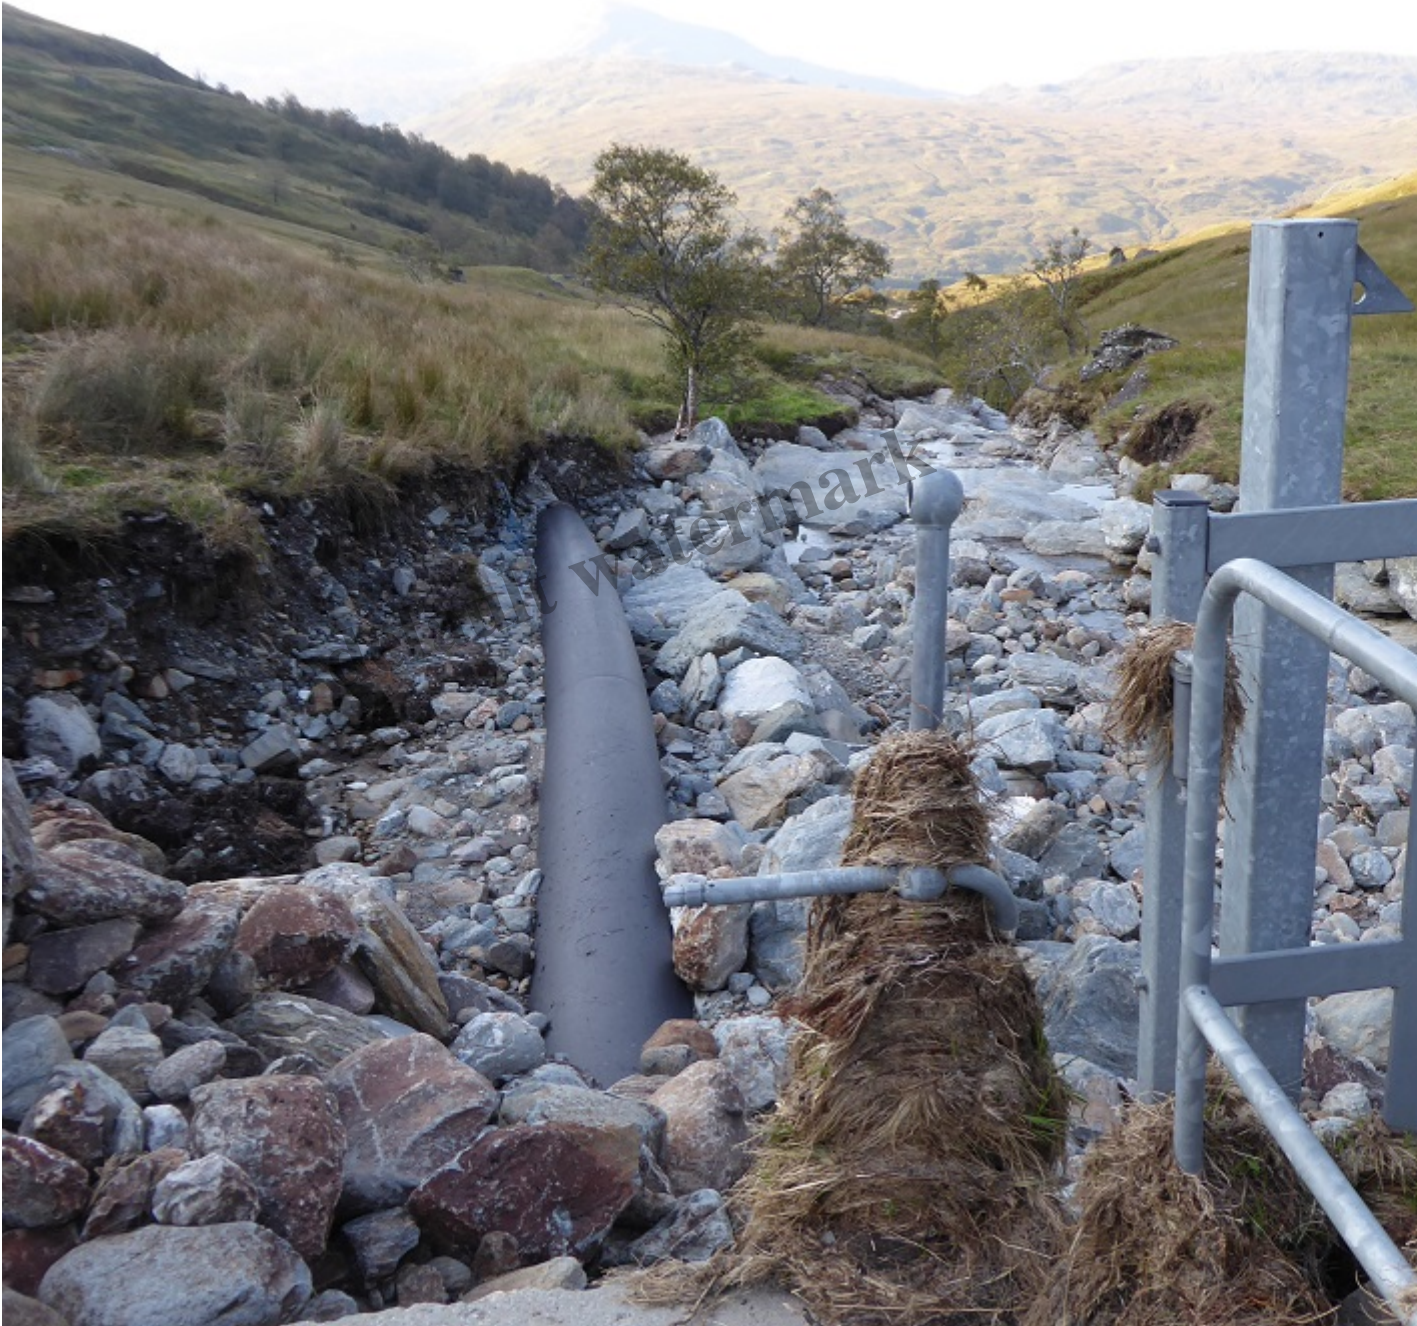
Looking down the Allt a Chuillinn from the top of the main intake. The storm of the 5th August has done what it can on top of the dam will and swept away a large section of “restored” river bank below to reveal the hydro intake.

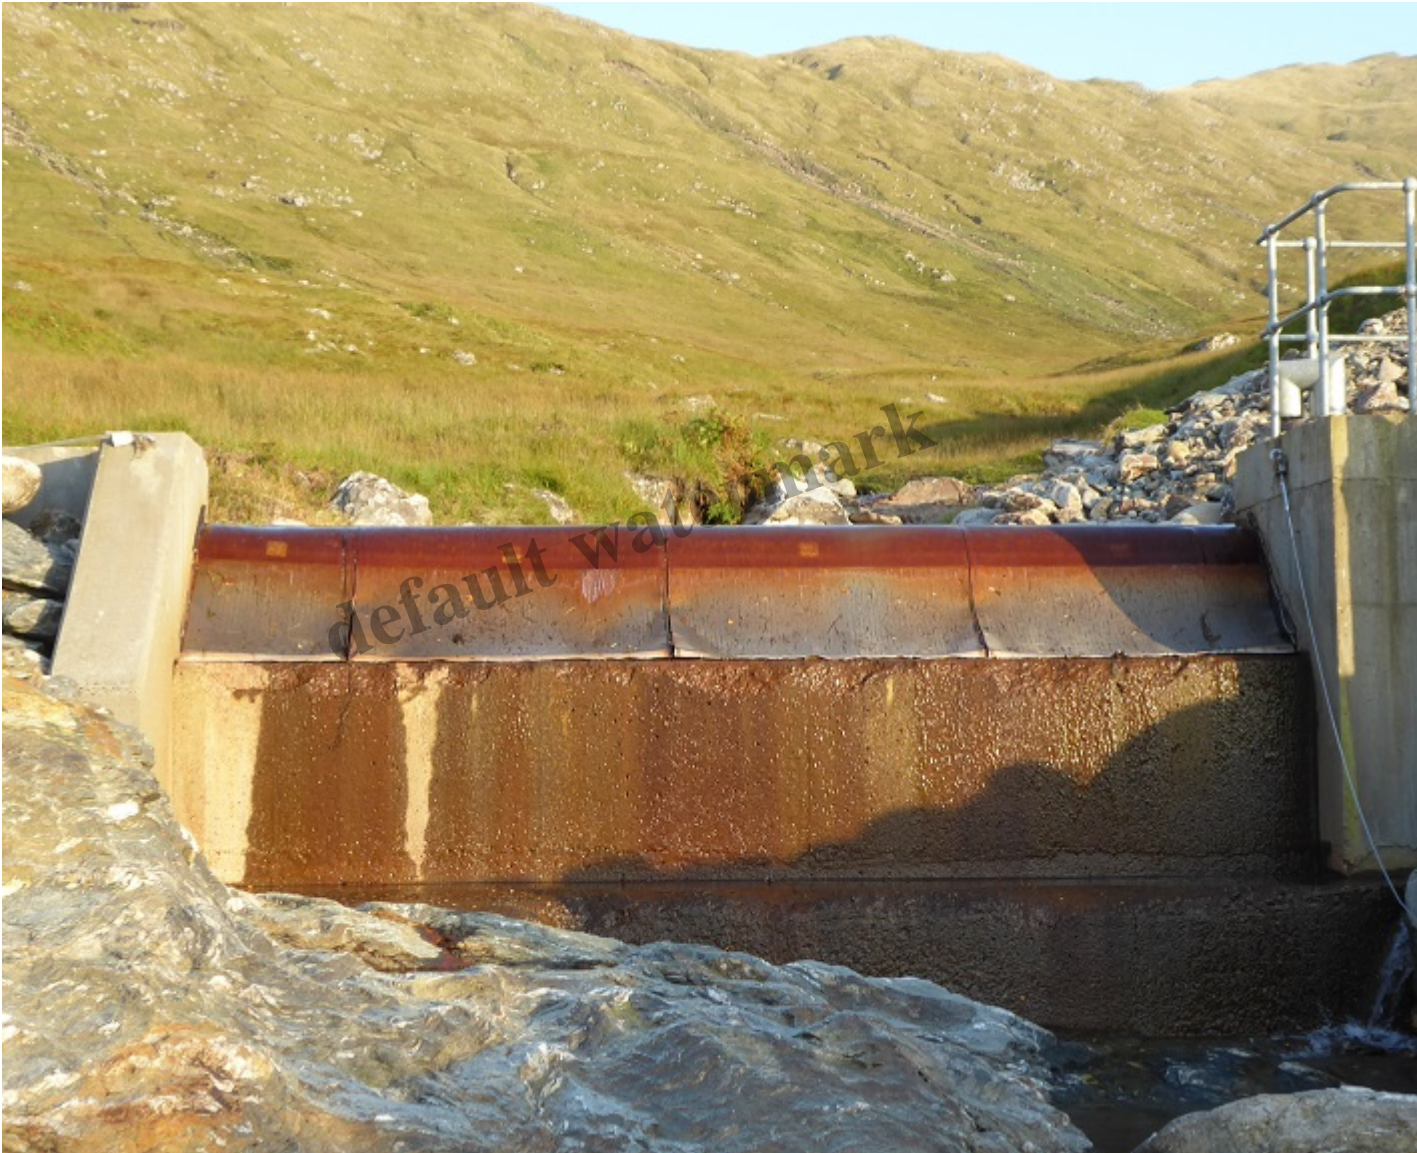
View from below the Allt Andoran intake, part of the Derrydarroch hydro scheme, looking up to the S Garbh – An Caisteal ridge. with a large landslip visible behind extending almost from the ridge to the valley floor.

Debris from the landslip above and other more minor erosion events, along with rocks, gravel and sand in the river bed have all been swept down by the storm – nature at work – until they reached the artificial barrier created by the hydro dam wall which act like a rock wall. It's not surprising that the intake pools behind start to fill up with debris – parkswatch has covered this before – but the extent of the infilling caused by the storm event took me by surprise.

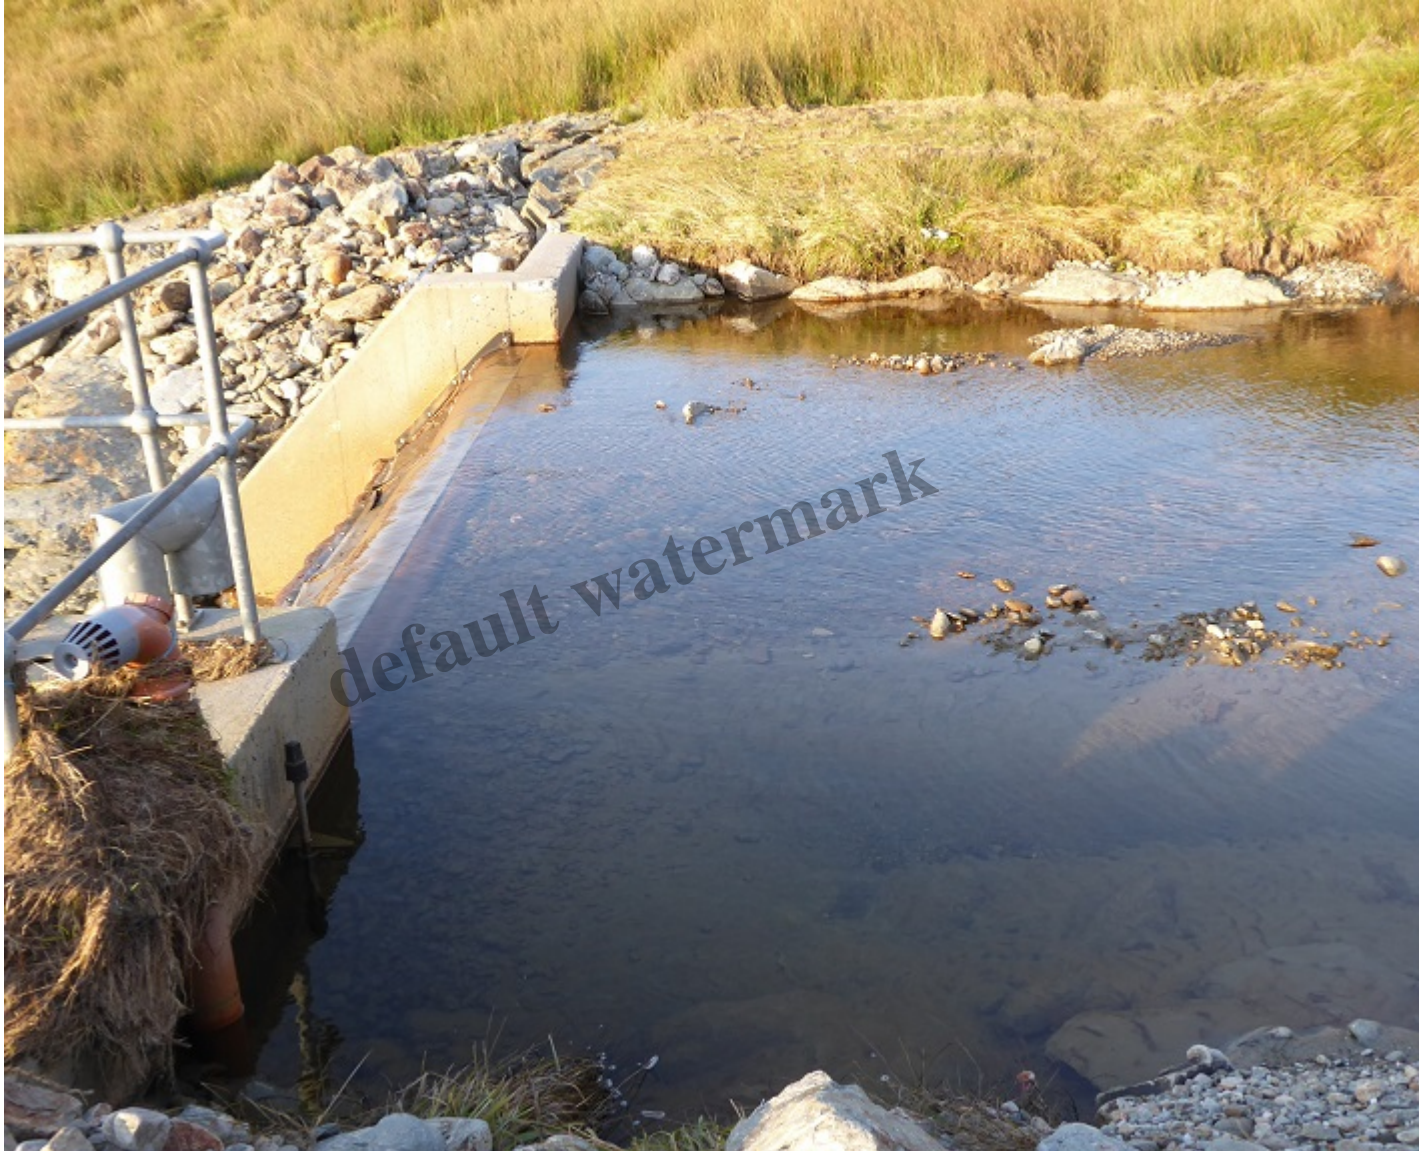
Gravel and silt trapped by the Allt Andoran dam wall. You can see below the lip of the dam a piece of damaged metal from the intake screen sticking up.

The intake pool has almost filled in and as a consequence boulders have been swept over the intake screen damaging it.

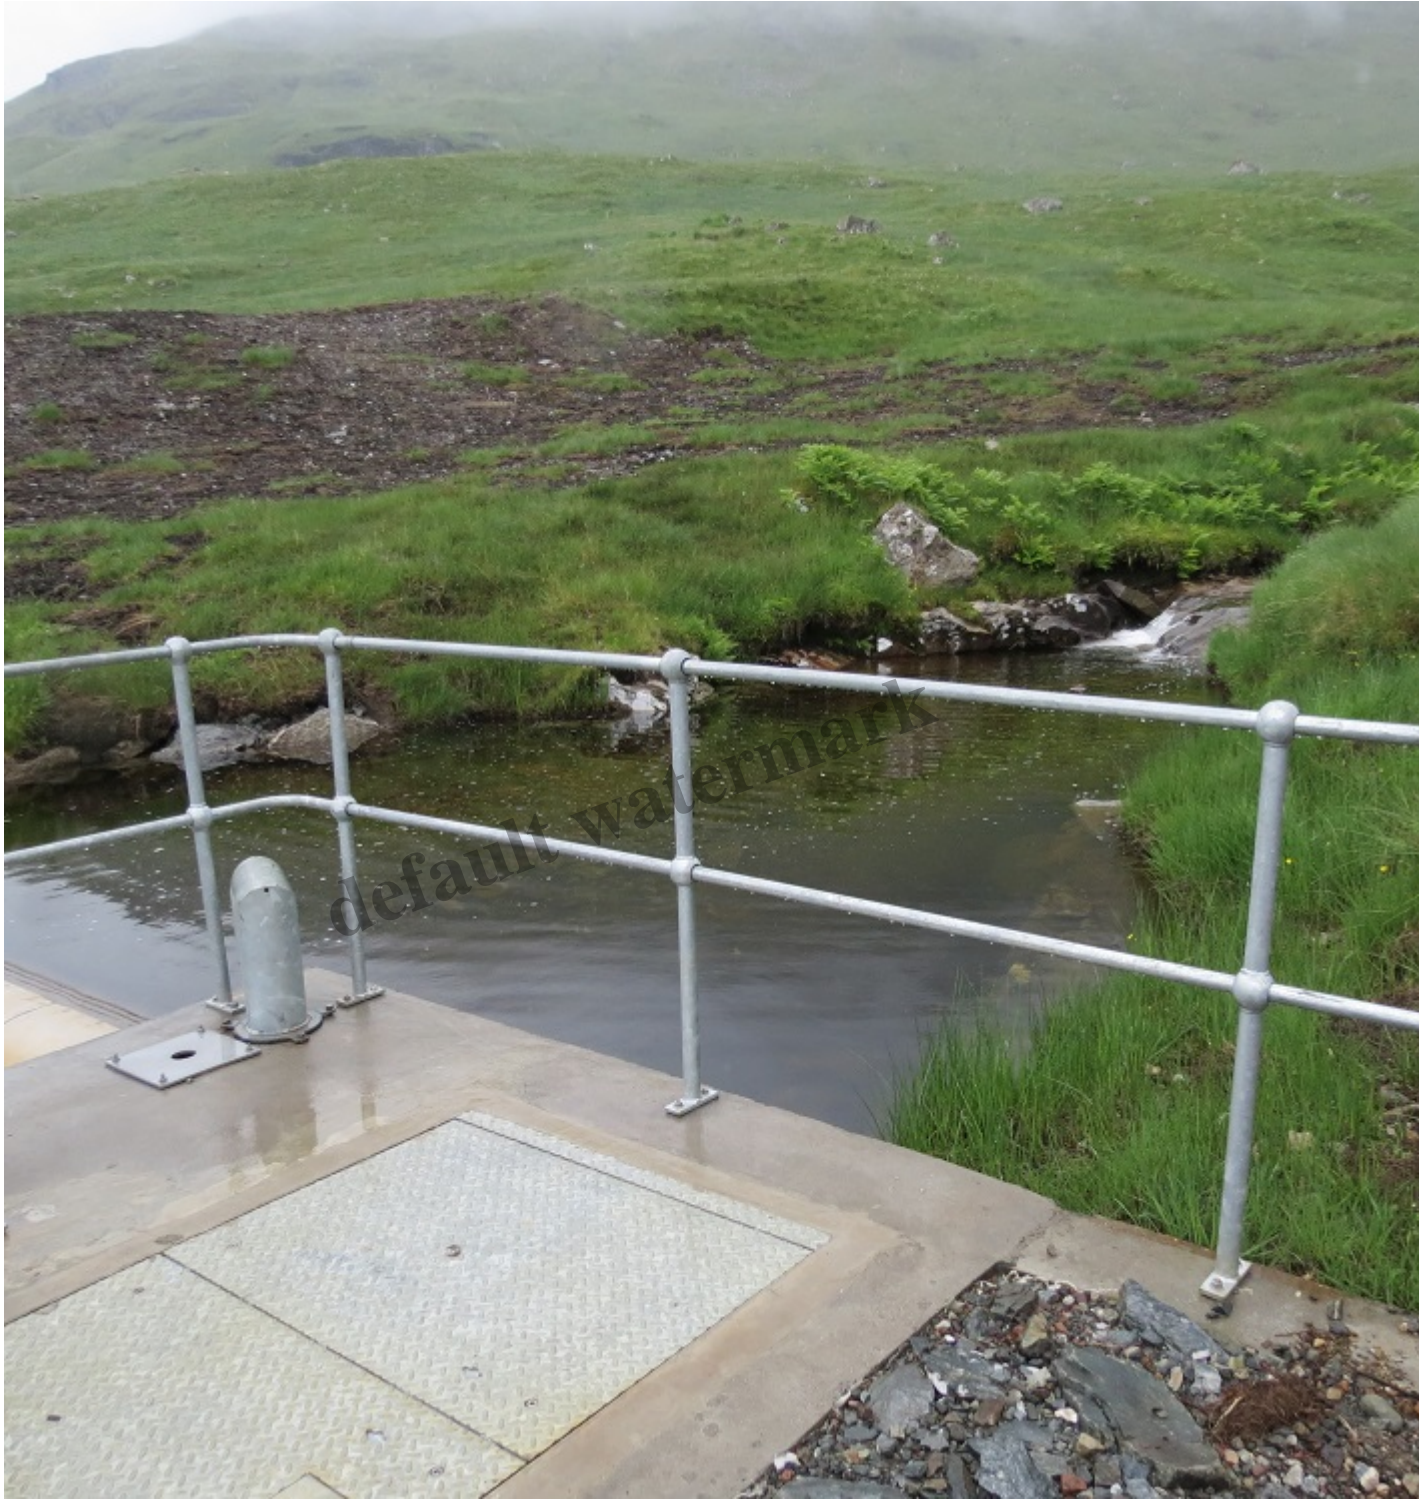
Compare the Allt Andoran intake pool pictured in 2016.....

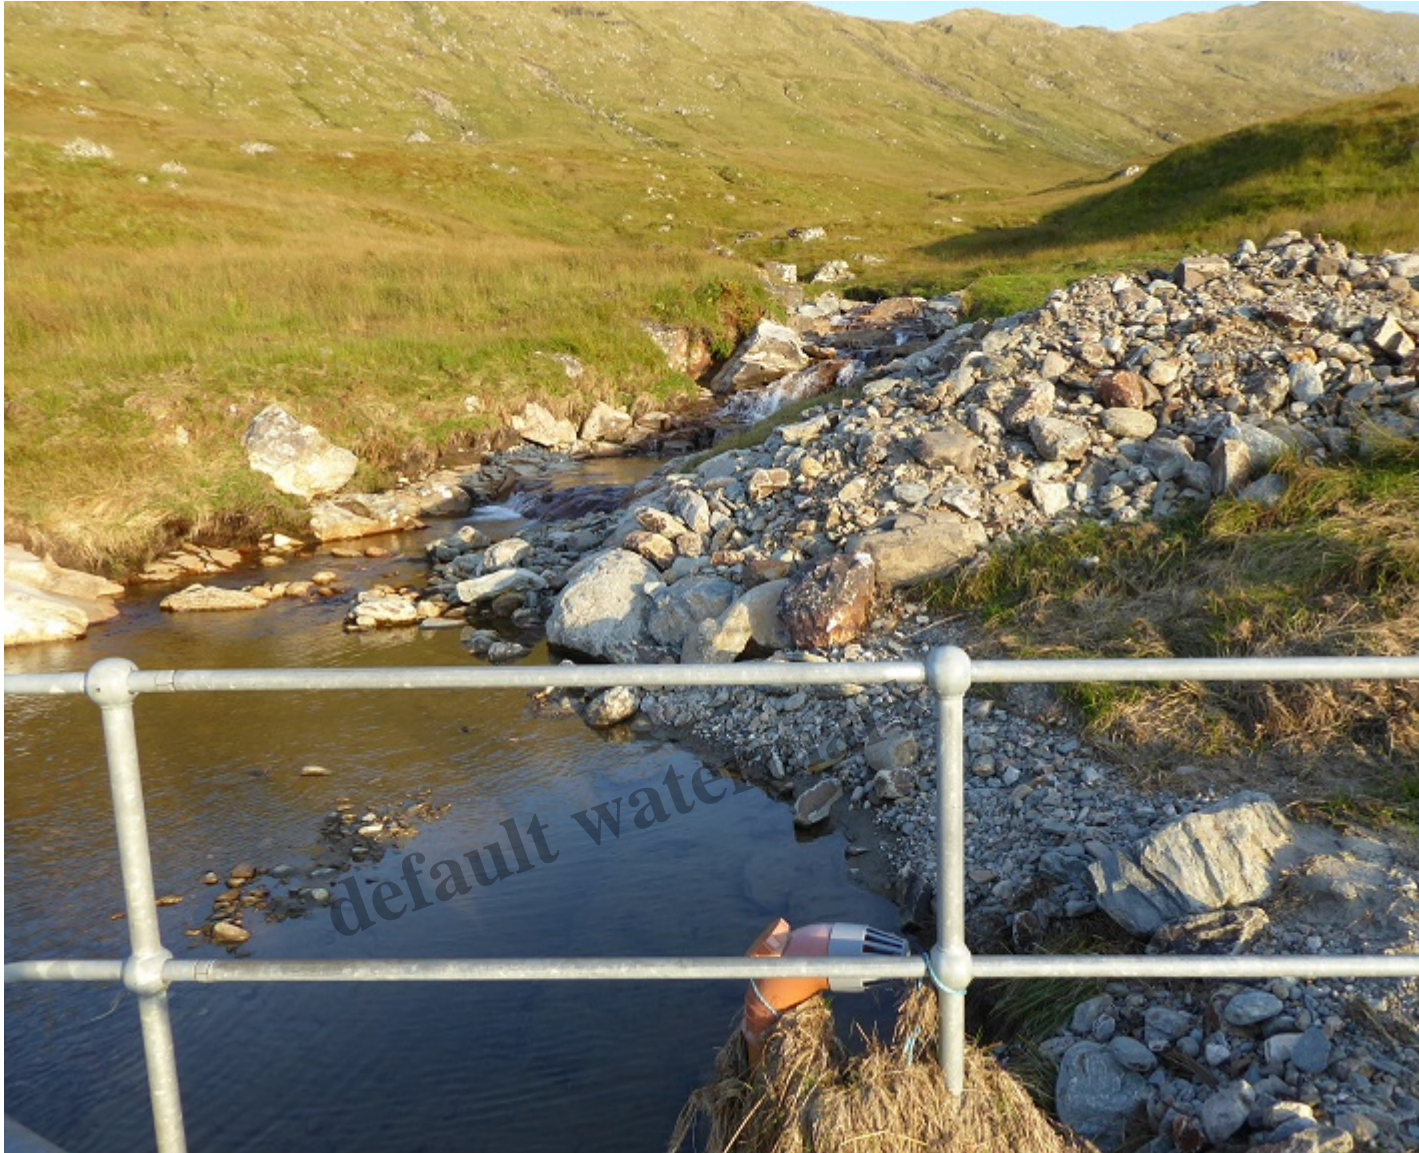
.....with the Allt Andoran Intake pool 2019.

The deep grass sided pool I pictured 3 years ago has almost disappeared. I had been in a rush to catch my train when I got to the Allt Andoran and, until I compared my photos did not realise the pile of boulders behind the pool has almost certainly been excavated since the storm in order to prevent further damage to the intake and to keep it functioning.

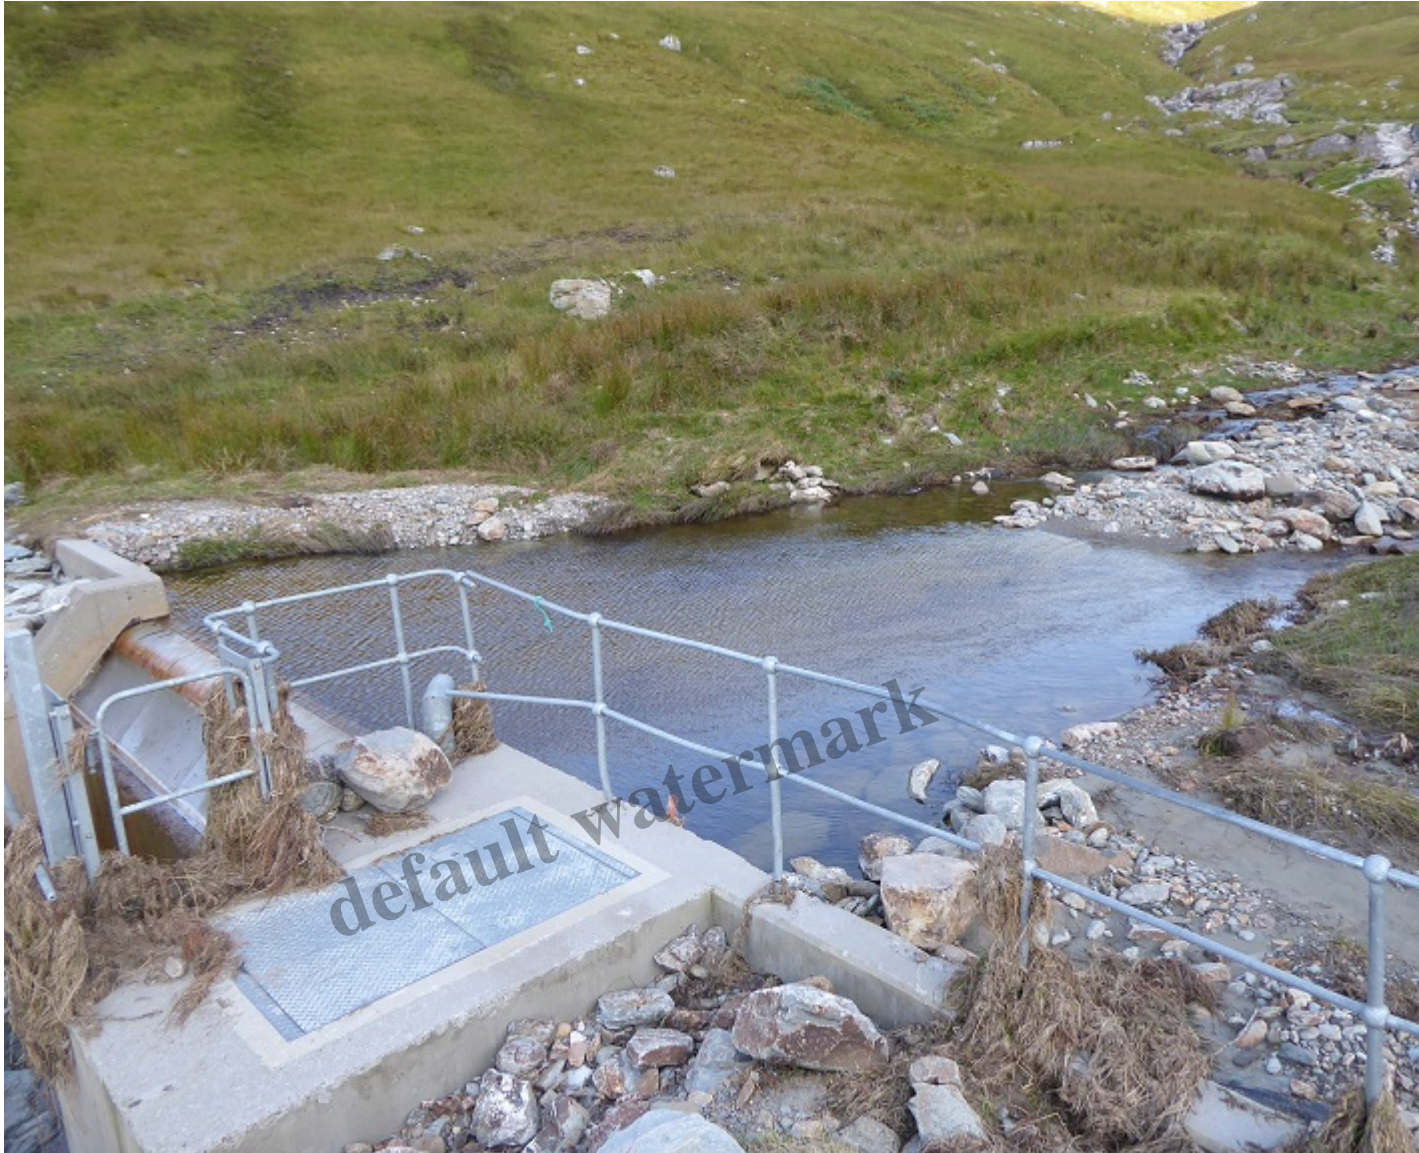
There was conclusive evidence from two of the Allt a Chuillinn intakes that they have been excavated since the storm.

Note vehicle tracks on right down into the pool – which again was far shallower than it had been last when I last visited

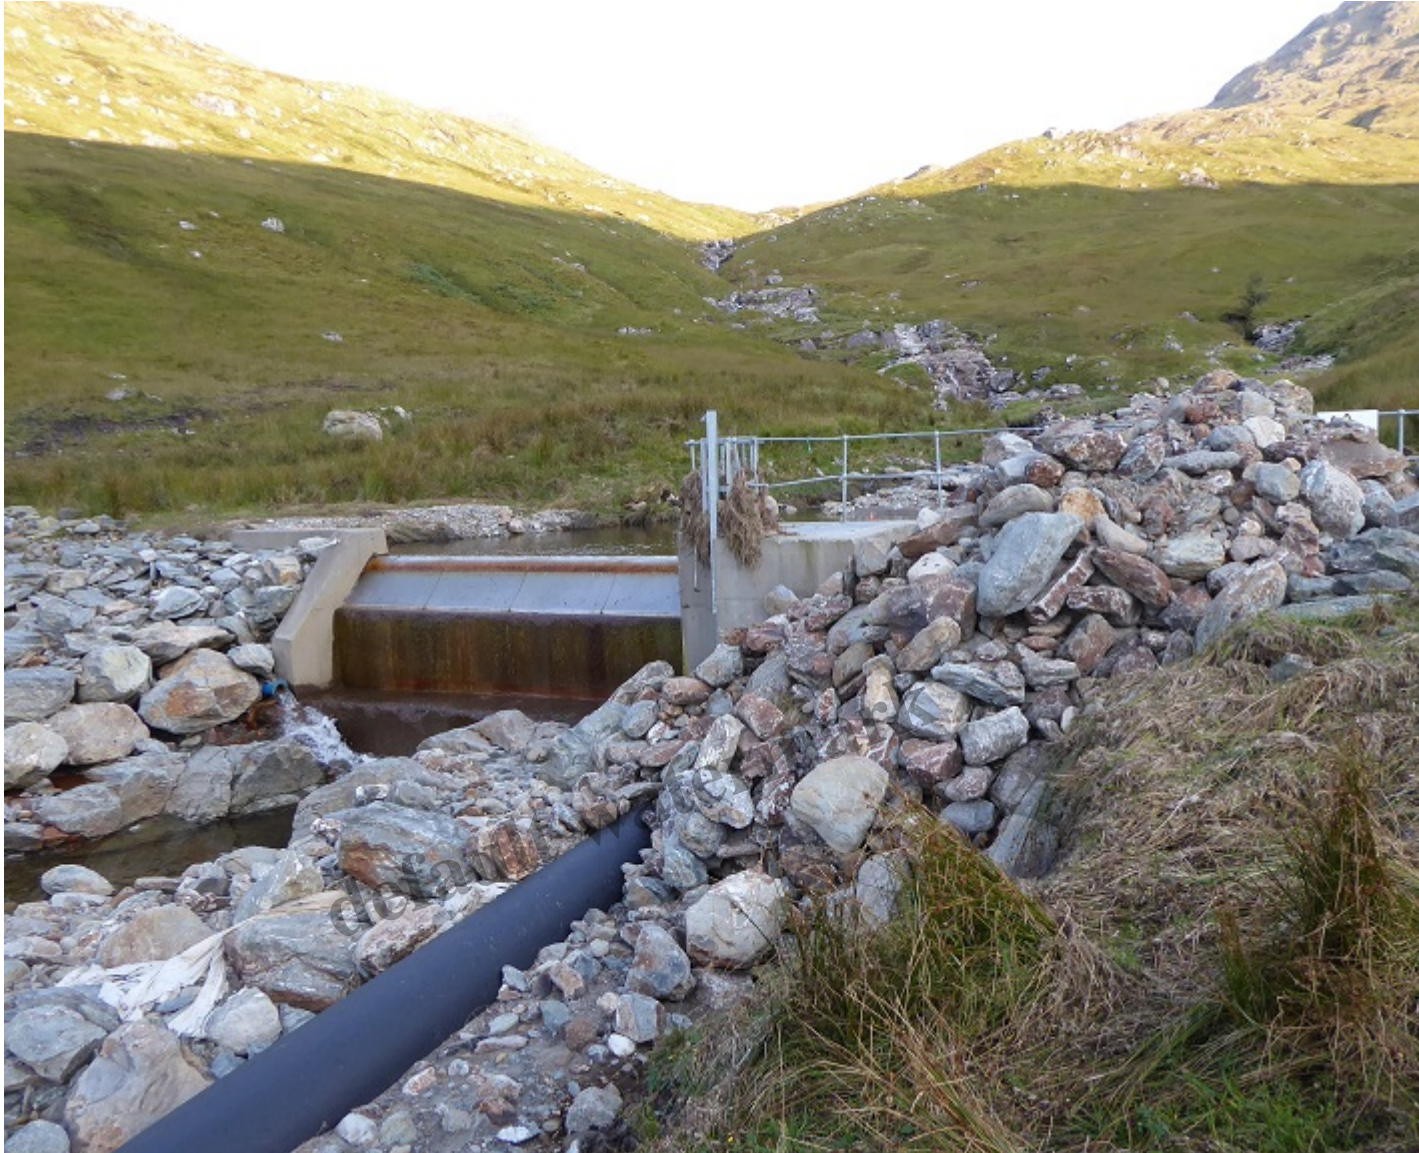
Pile of boulders excavated from pool placed on dam wall – the section of fence behind the boulders intake so the boulders could not have been swept here.

Construction and management of hydro intakes is regulated by the Scottish Environmental Protection Agency under the Controlled Activities Regulations. While routine maintenance of dams does not require permission, more extensive works do require permission. It would be interesting to know if SEPA have authorised the work in this case as it appears the pile of boulders has been placed on the dam prior to being used to cover up the exposed pipe below. I believe SEPA, who also regulate works to river banks, need to fully investigate what has happened here before deciding whether covering up the pipe again with boulders, when this has already failed once, is a sustainable proposition.

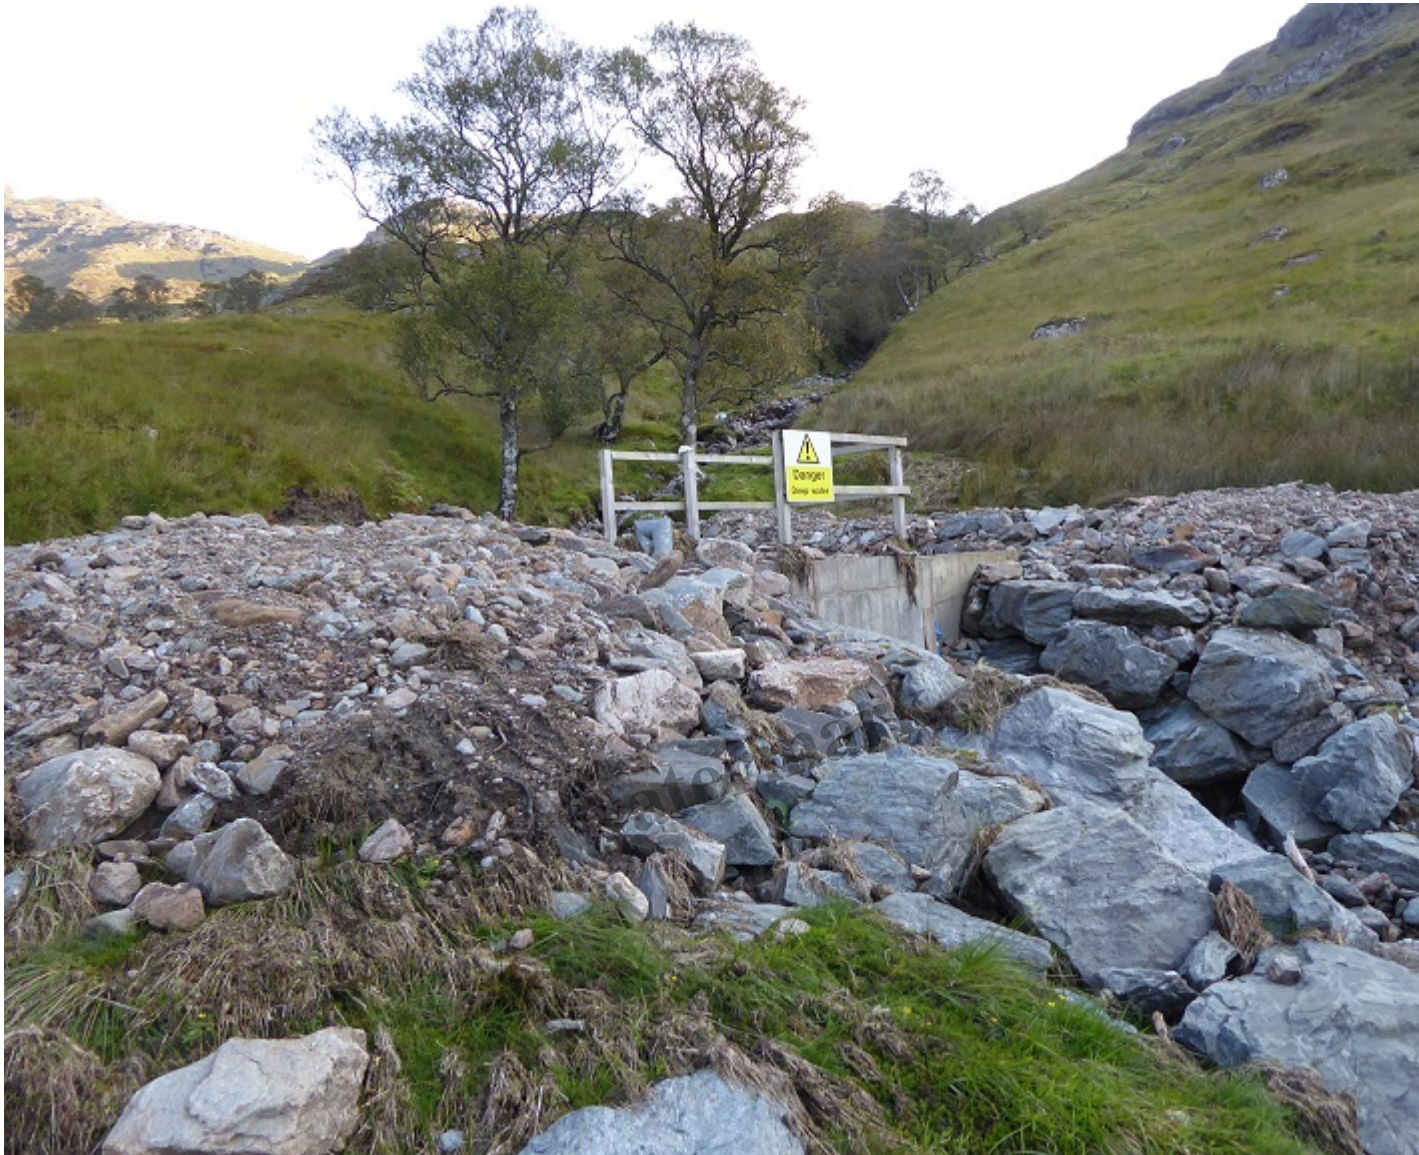
The secondary Allt Chuillinn intake closest to the main intake

This second Allt A Chuillinn intake has also served to trap silt, mud, stones and boulders swept down the hill before being overwhelmed by it. The deep water danger sign is now.....

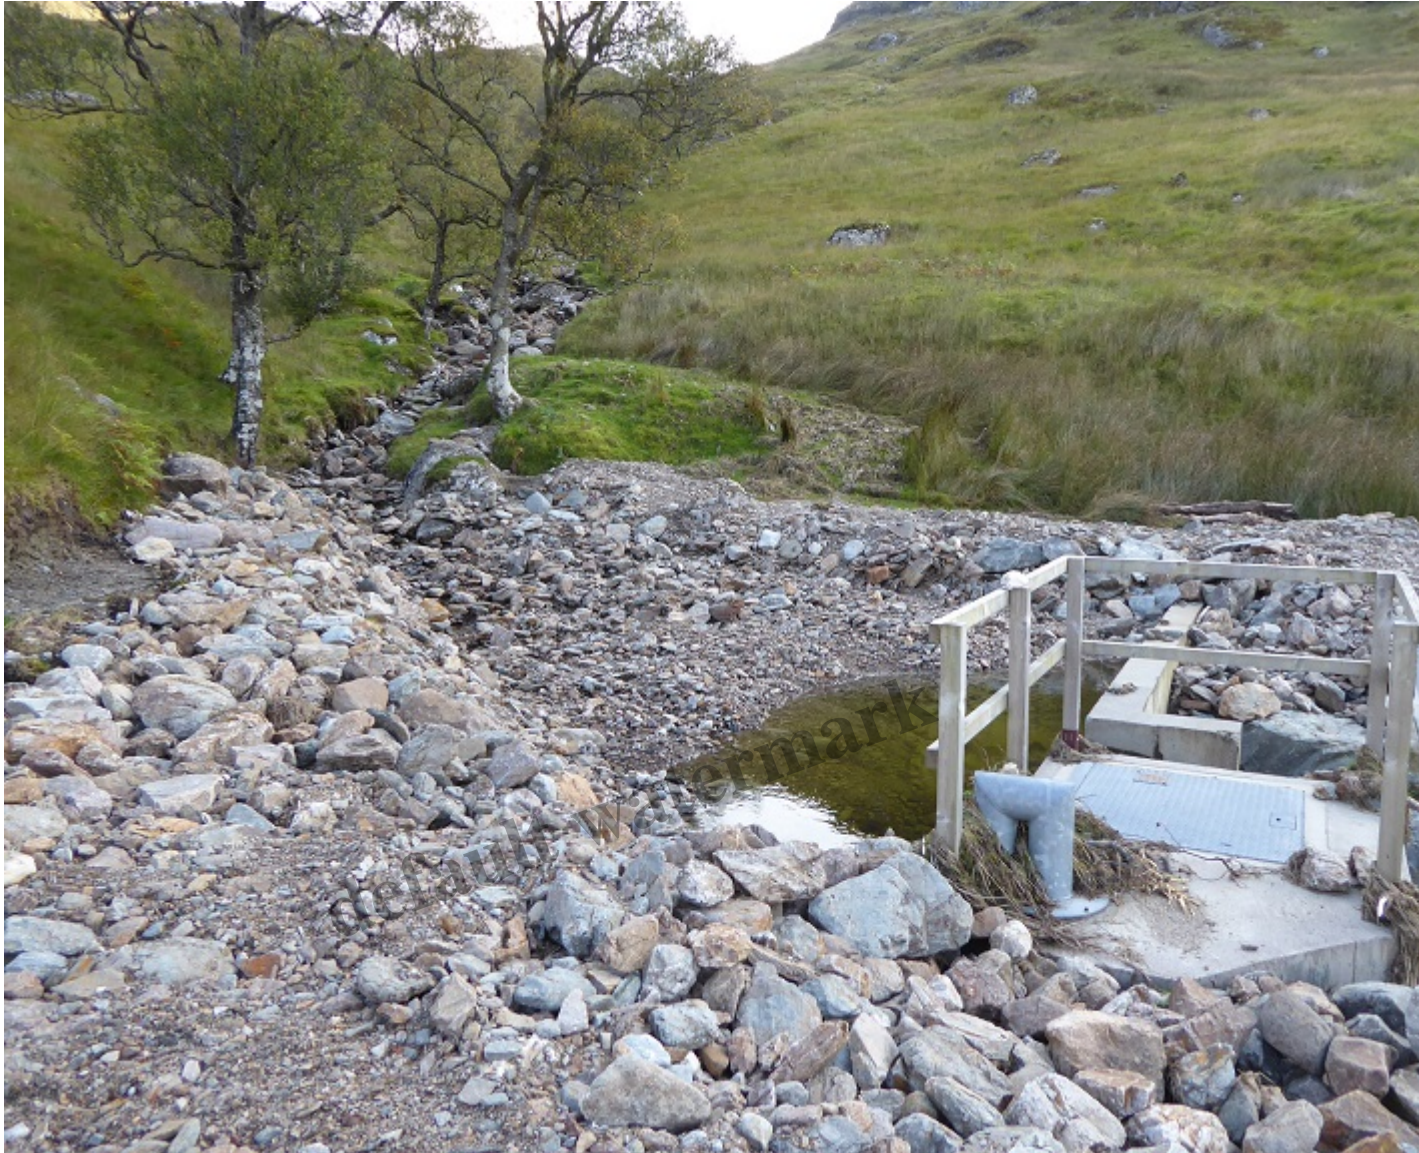
The neat sides and the flat bottom to the burn are signs that it has recently been engineered

.....redundant.Â What was the intake pool has however had to be excavated, probably to get the hydro working again but also to prevent the burn changing course and making the intake permanently redundant.

Whether the Loch Lomond and Trossachs National Park Authority has been notified of this work and consented to it is another question.Â There are no new planning applications for the Allt Chuillinn Scheme on the Park's planning portal though the flood damage has clearly affected the "restoration" of all these schemes.

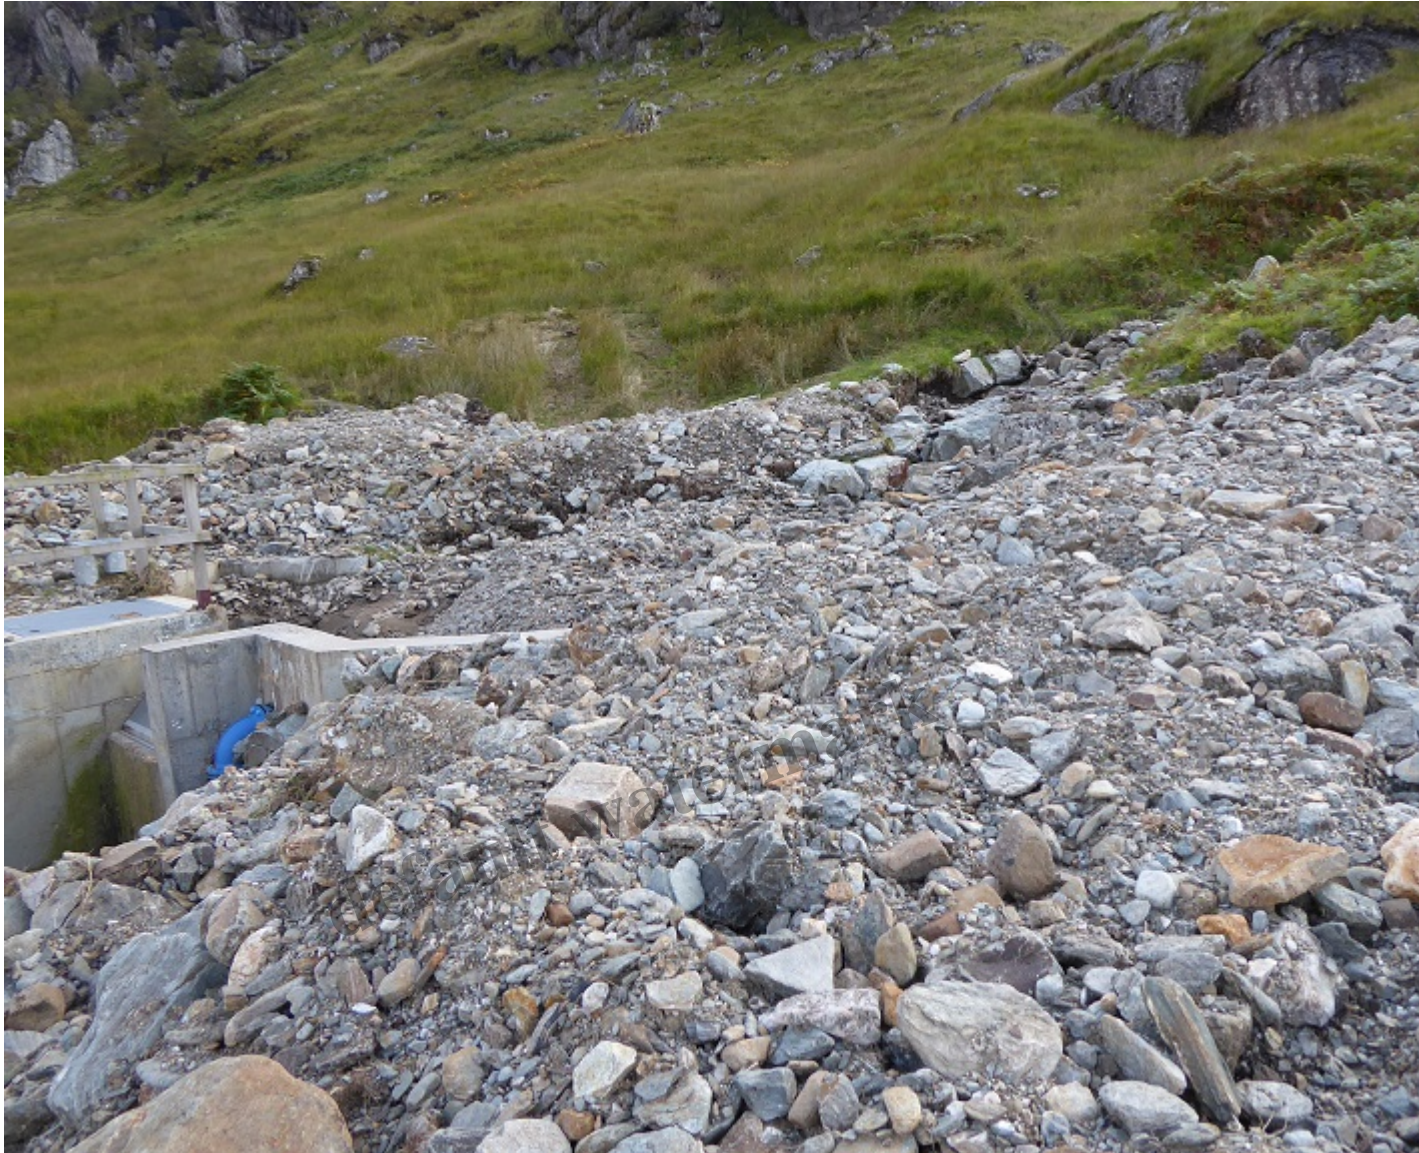
The second secondary intake to the Allt a Chuillinn.Â The wooden barriers appear to have survived chance rather than design.

The third of the Allt a Chuillinn intakes has also been overwhelmed by flood debris, is high and dry and not functioning at all.

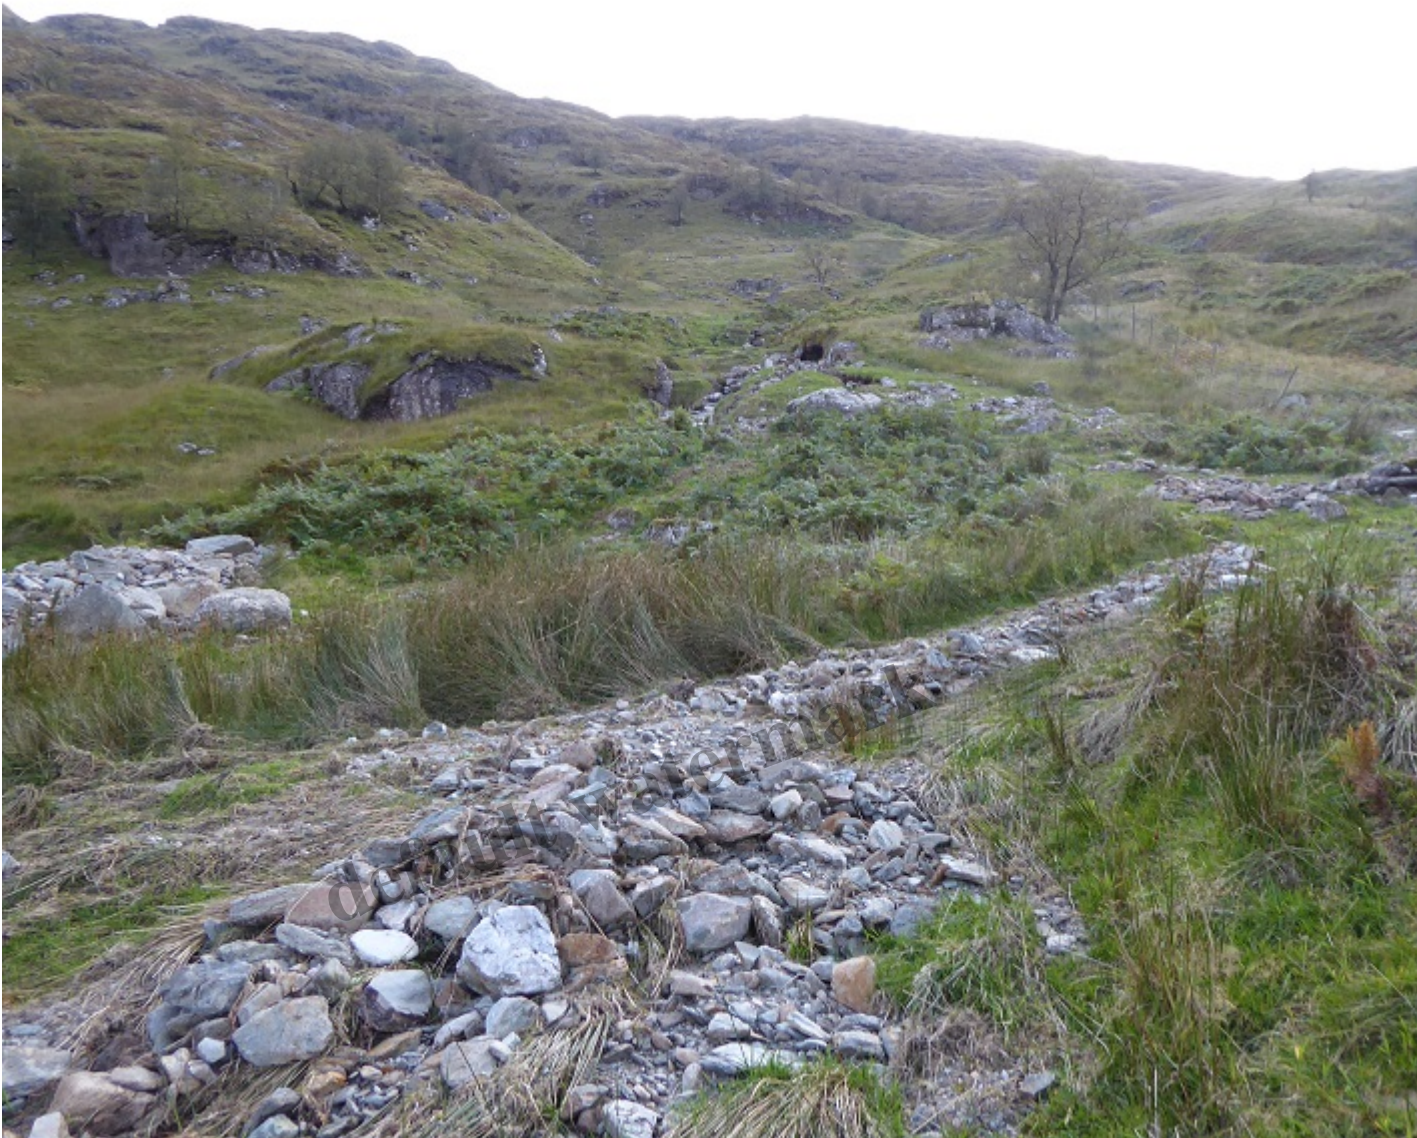
Looking up above the hydro intake. The burn, a trickle on the day I visited, runs down to the left of pi boulders mid-photo and the intake lies just beyond the bottom left hand corner of the photo.

The burn appears almost to have changed course as a result of the flood event.Â Had that happened, further extensive engineering might have been required.

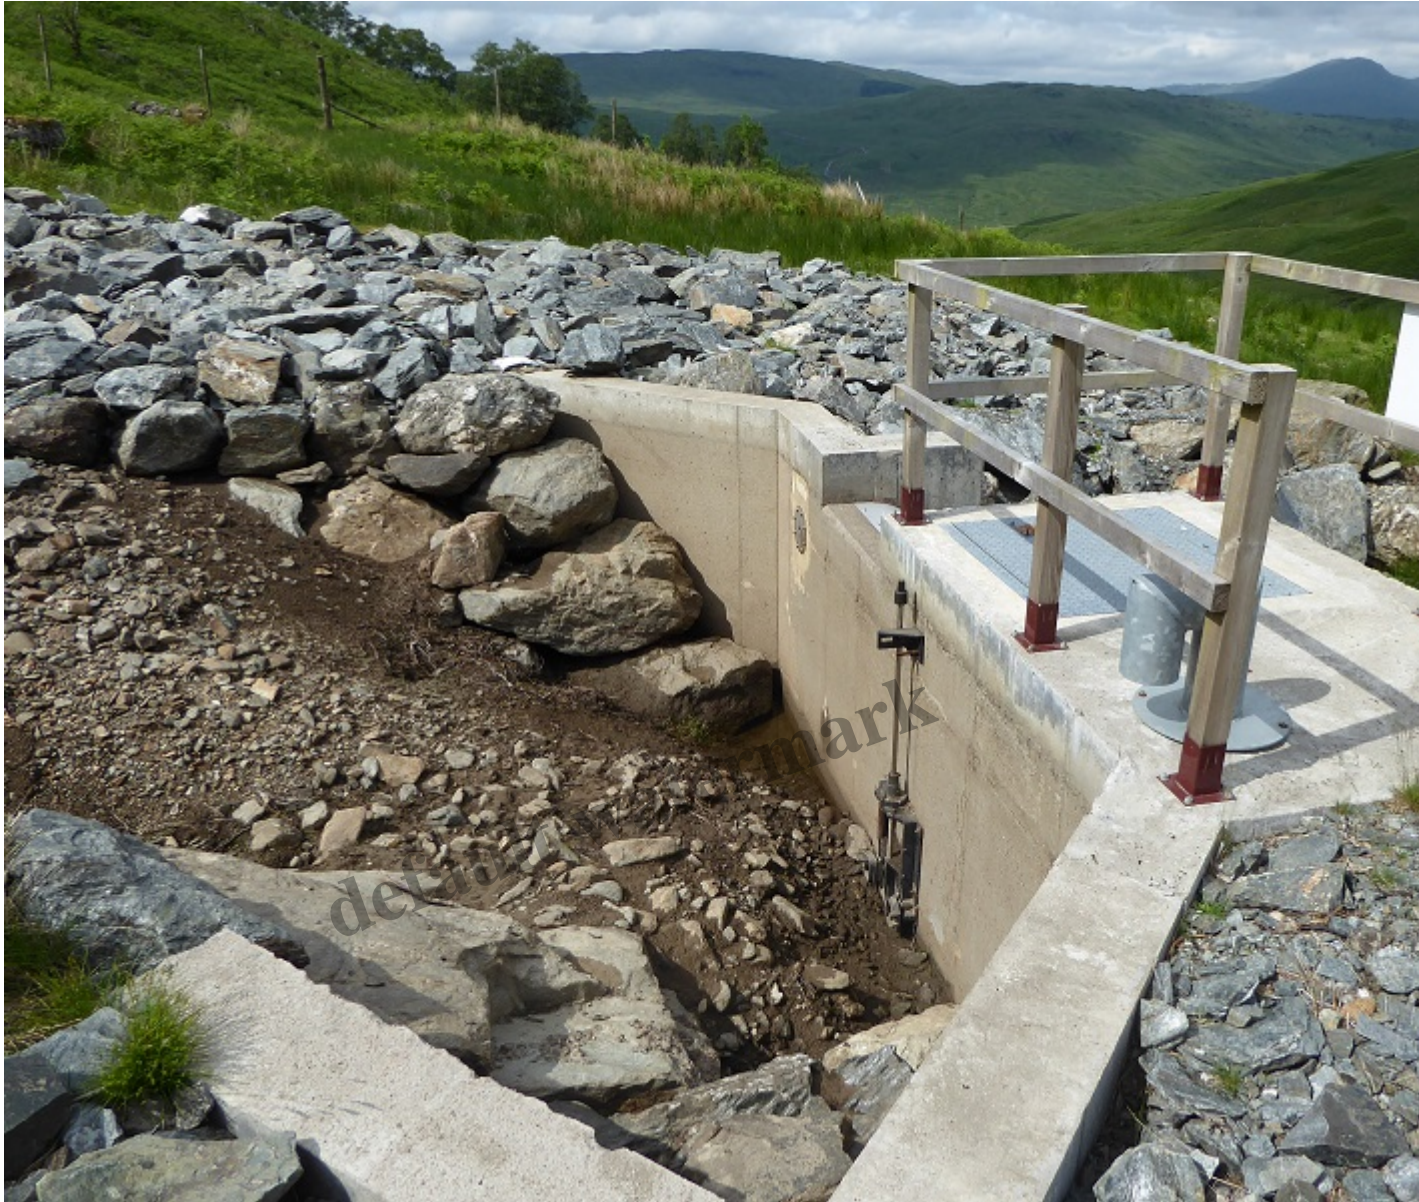
Photo of same dried up intake June 2018. Intake just to left of far post.

This intake, however, appears not to have been functioning for some time. 15 months ago when I visited, it appeared that due to poor design the water from the burn had found its way beneath it leaving what should have been a pool high and dry. Ironically, it could have started working for a time in the flood as the water which swept more rubble onto the ugly and highly artificial embankments was way above the level of the intake screen

Taken together all this raises doubts about whether this intake will ever be restored to working order.Â Â The issue now is not just that the intake was so badly designed that water flows under it.Â Its that the intake appears to be in the wrong place, if indeed there is a right place on a hillside like this, where its not uncommon for burns to change course.
