Climate change and Glen Falloch (3) – the hydro schemes have failed, literally!

The infilling of the hydro intakes

The extent and nature of the problem

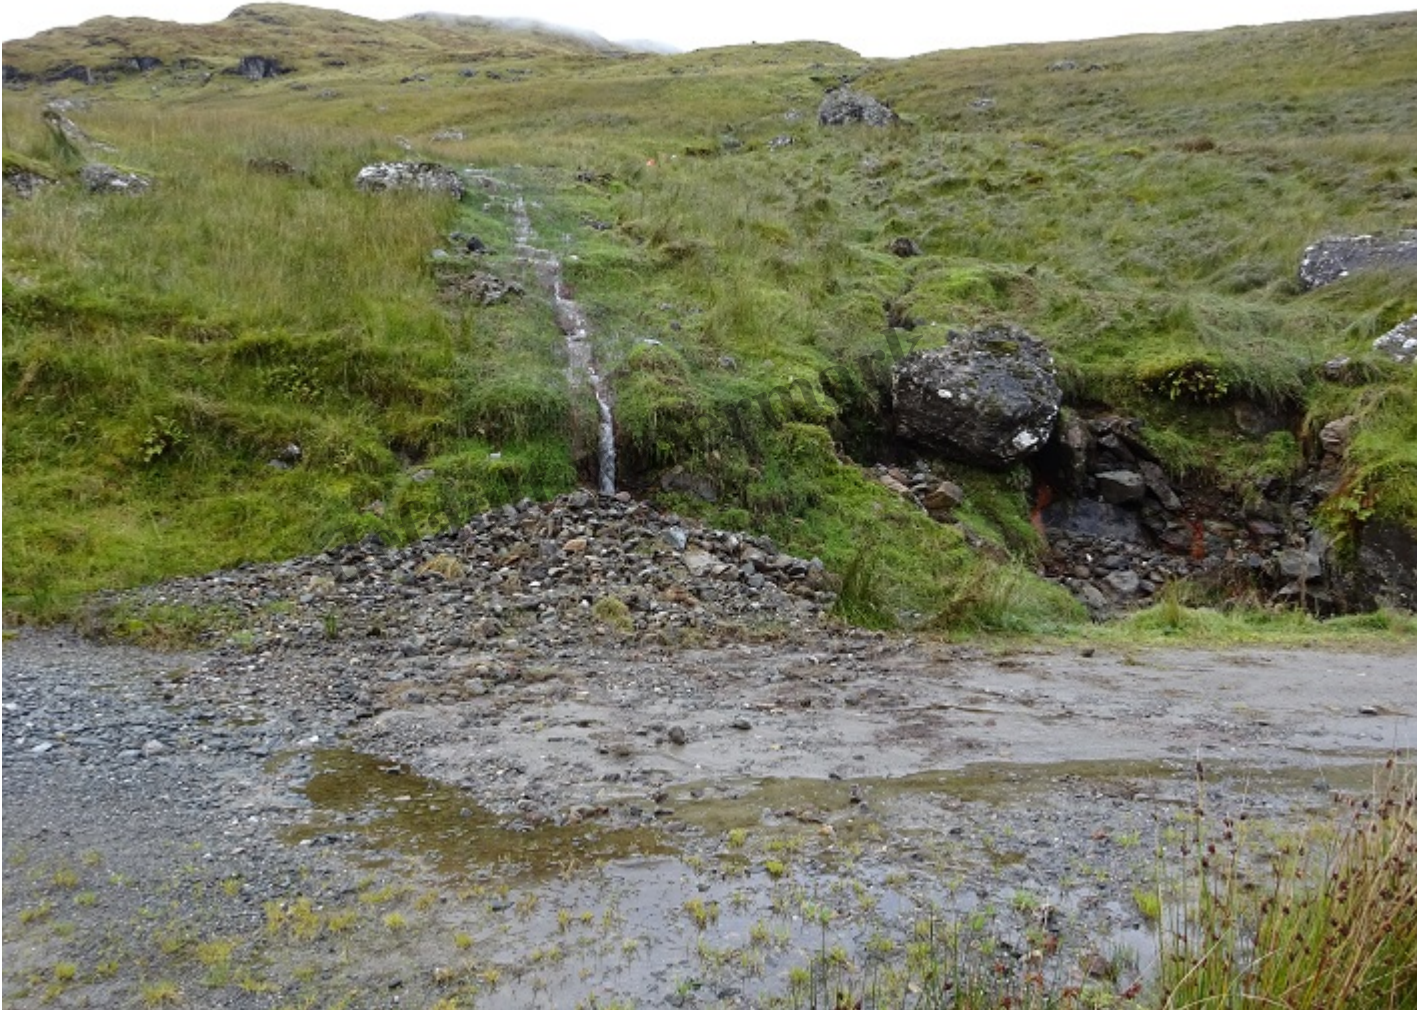
Burn by track up to Upper Glen Falloch hydro intake. Until recently it flowed down by the boulder on right.Â Note the amount of debris washed down by the burn onto the track. Photo credit Kevin McGrath 25th September.

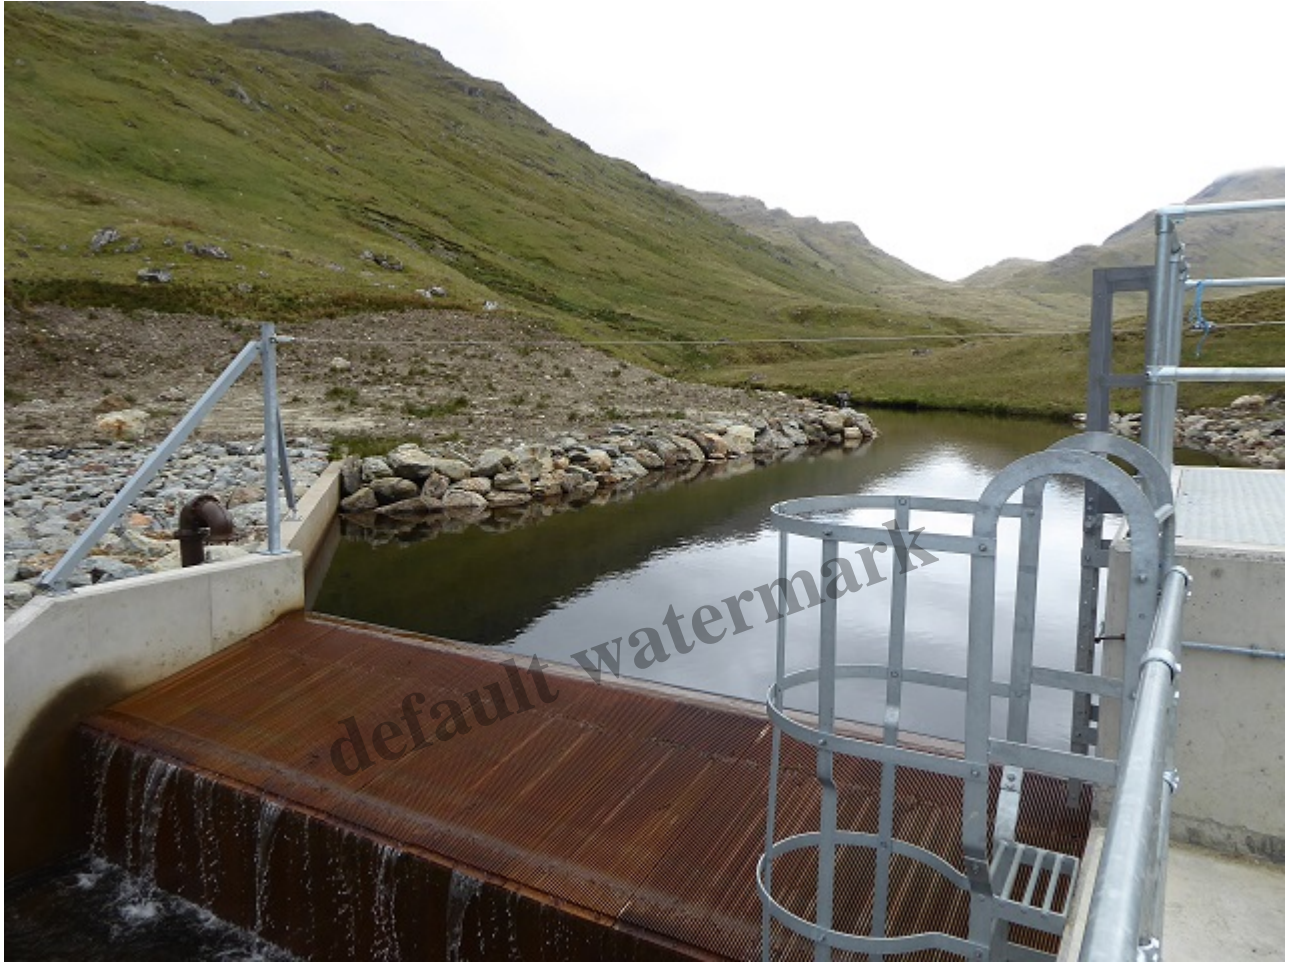
Upper Glen Falloch intake pool May 2019

Back in May, when I last visited, behind the Upper Glen Falloch intake was a large deep artificially created pool ([see here](#)). I had up till now been critical of this pool from a landscape perspective, it formed a large ugly engineered area within what had been a wild glen and it appeared that the rip rap bouldering on the banks could take decades to revegetate. It was totally out of place in landscape terms.

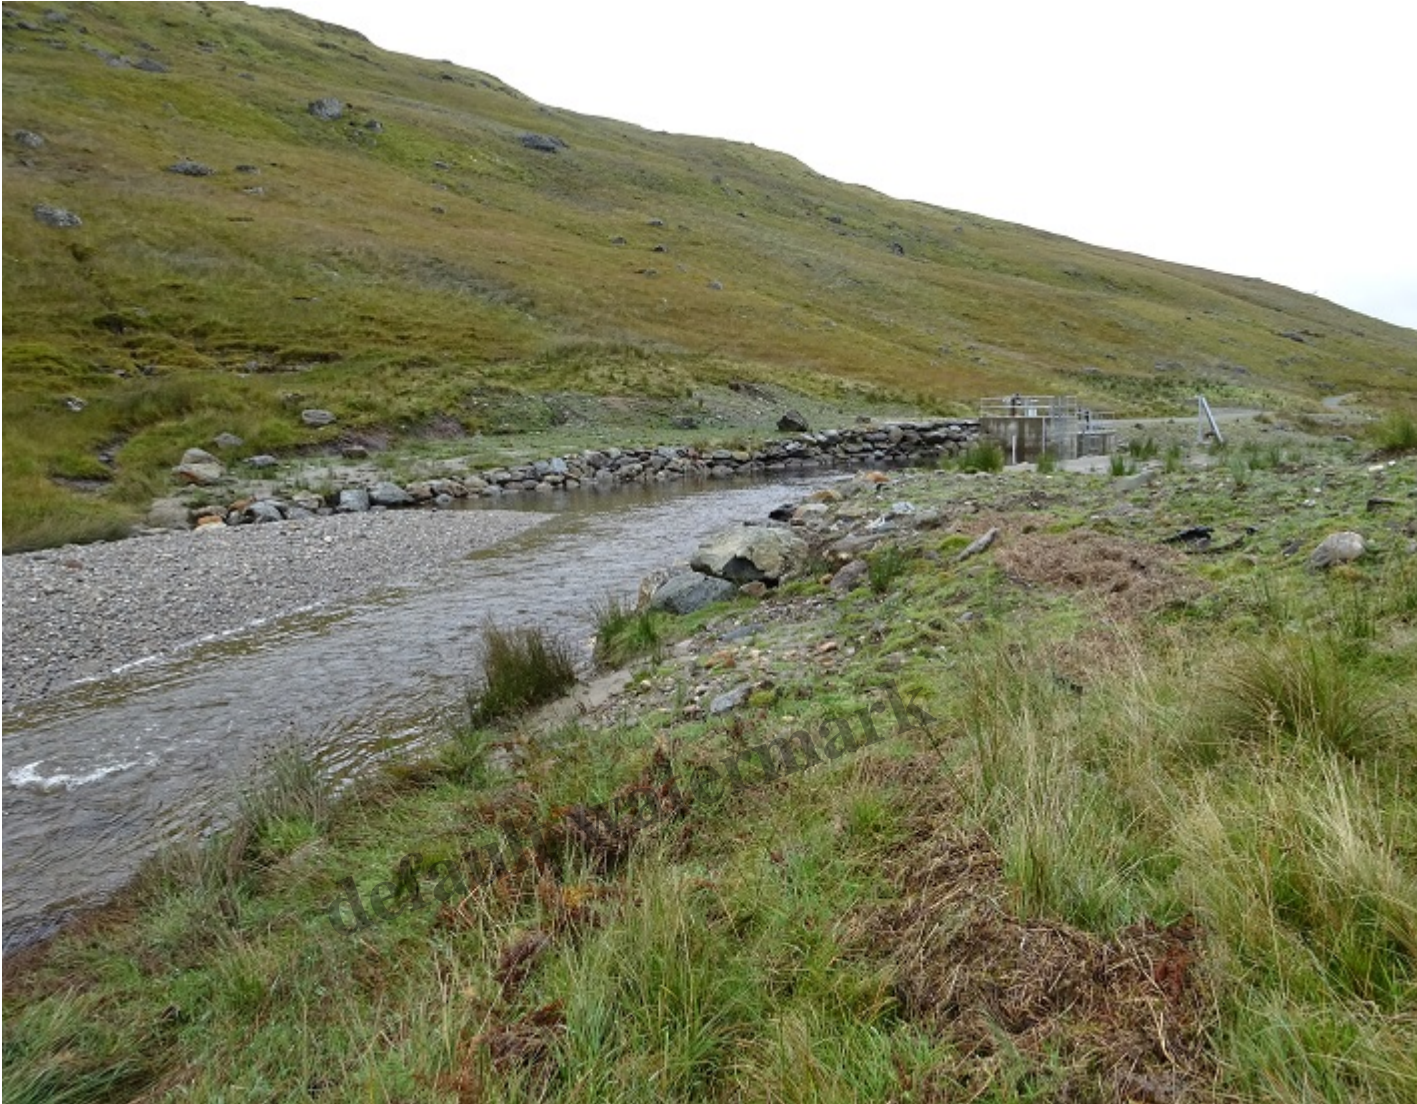
Shingle beach in Upper Glen Falloch intake pool. Photo credit Kevin McGrath September 2019

The deep pool however is no longer!

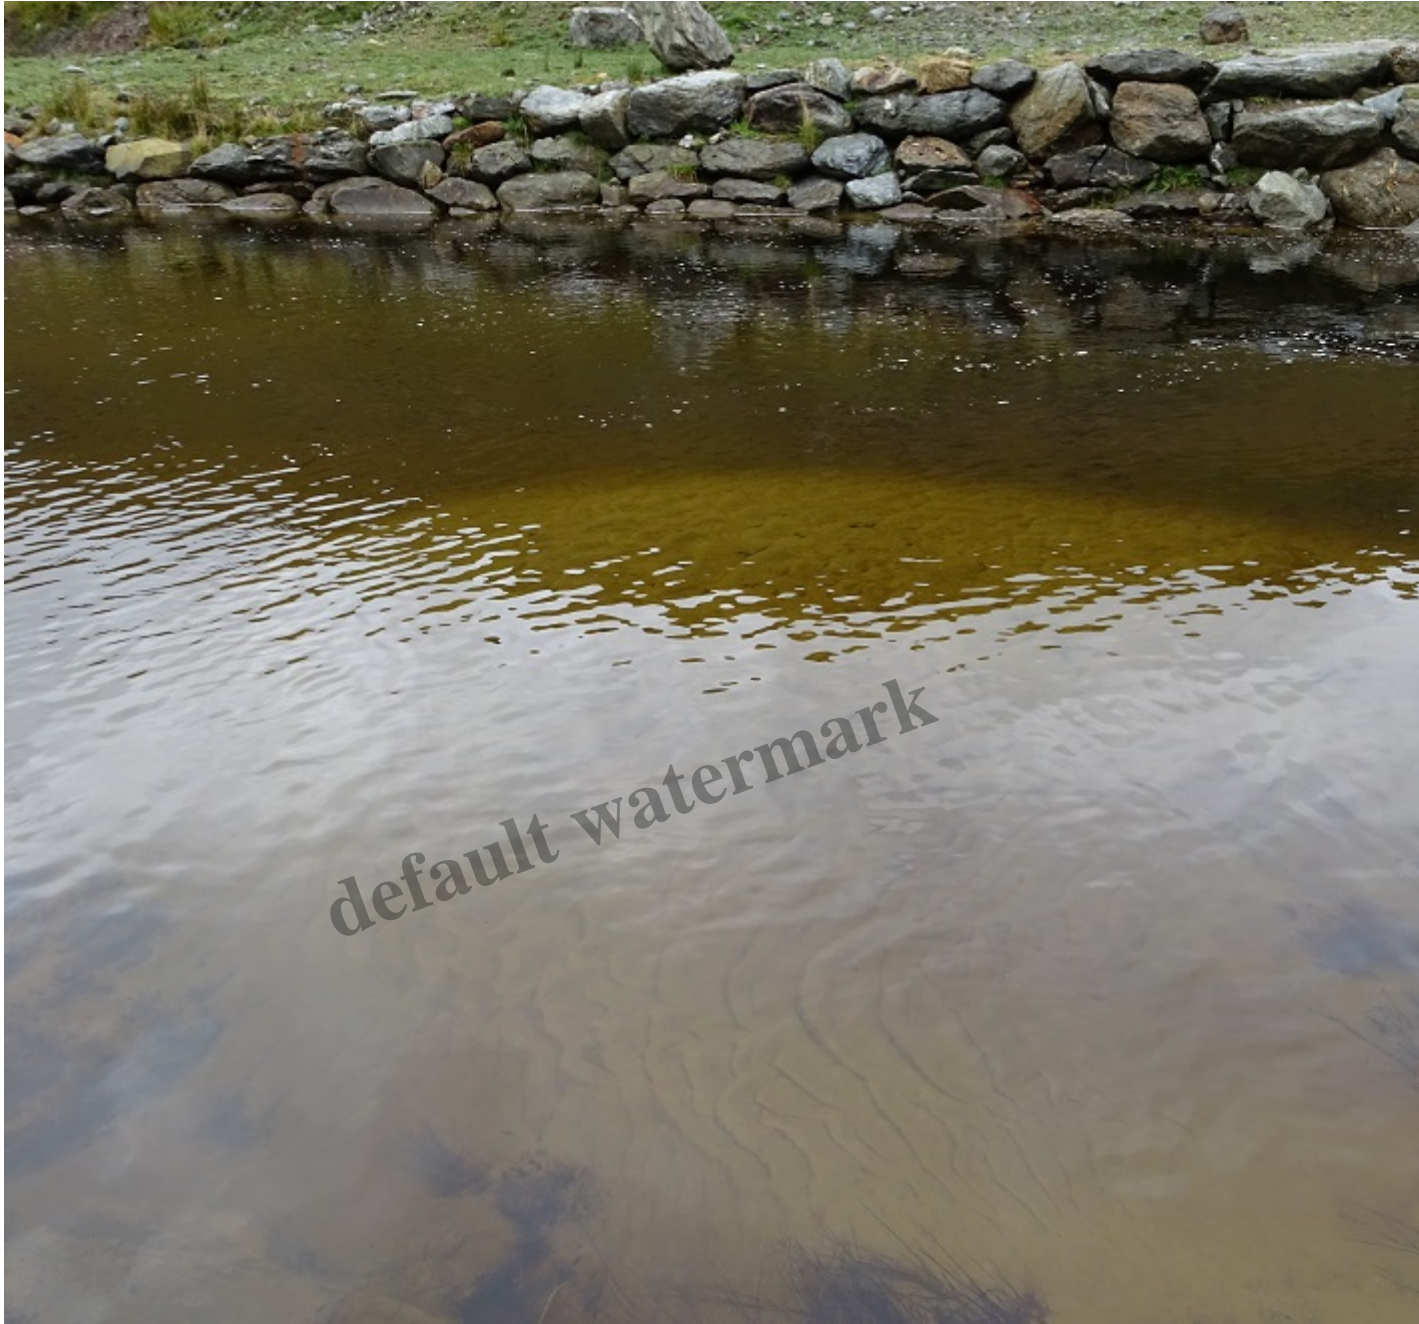
Bottom of intake pool September 2019 – the dam wall is just to the right. Photo Credit Kevin McGrath

The extent to which this pool has been infilled is striking, its being reclaimed by nature.....a good thing, which has softened to an extent its artificial contours, but quite incompatible with the ability of this scheme to generate electricity in the long-term.

The LLTNPA consented to the Upper Falloch hydro intake being re-engineered just last year to increase the volume of water flowing down the pipe. Another indication that the original design of these schemes was poor from a civil engineering perspective. That work destroyed much of the previous attempts to restore the ground around the intake (see link above). With the infilling, it now looks now as though this intake may become a permanent works site. Is that appropriate in a National Park?

The risk of infilling should, I believe, have been quite predicable had the LLTNPA and other Planning Authorities ensured people with appropriate expertise been involved. The intake sits in a wide open glen with an extensive catchment (see third photo above). What made this location attractive to the hydro pushers also made it vulnerable to storm events and material swept down from above. Unfortunately, the LLTNPA at the time these schemes were approved employed almost no conservation staff and in their rush to meet Scottish Government targets for renewable developments, failed to think through the issues. In this they were no different to Planning Authorities across Scotland except that, if anyone should have known better, it should have been our National Parks.

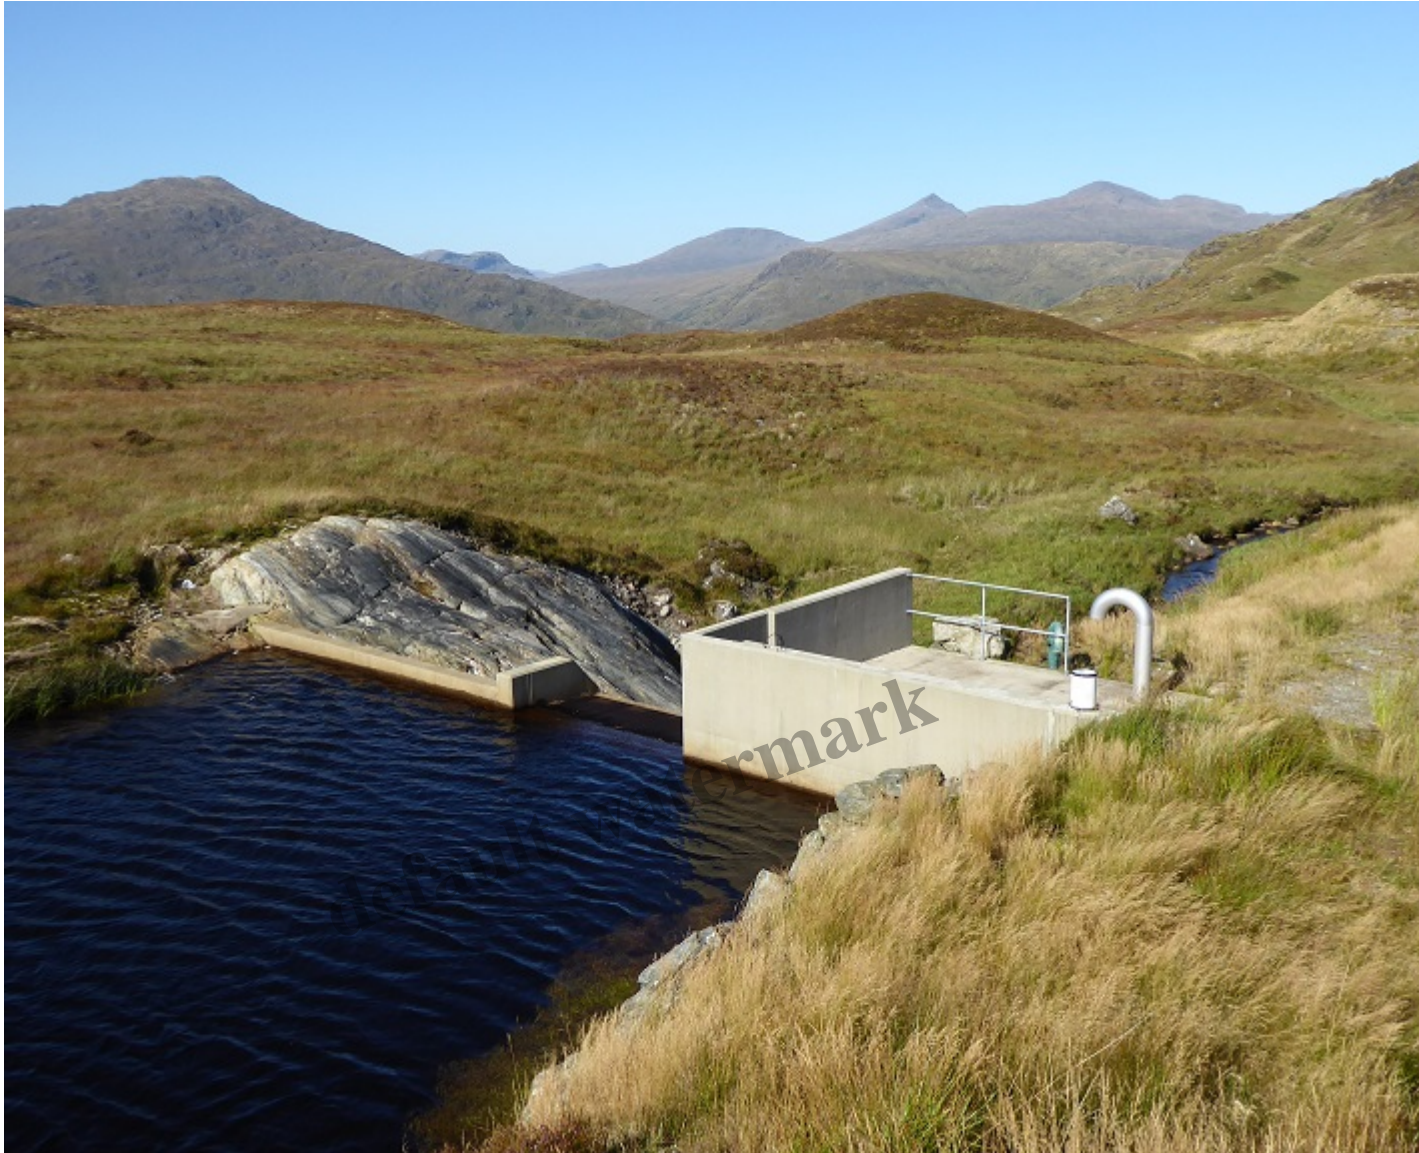
Southern Ben Glas hydro intake, Ben Lui massif in background

Ben Glas was the first of the hydro intakes I visited and there was very little sign of flood damage or infilling – it was still not possible to see the bottom of the pool.Â That doesn't mean to say there has been no infilling but does suggest that where intakes are located matters.Â (The Allt Fionn scheme, which also appears unaffected, is tucked away in a high sided rocky gorge ([see here for some old photos](#)))

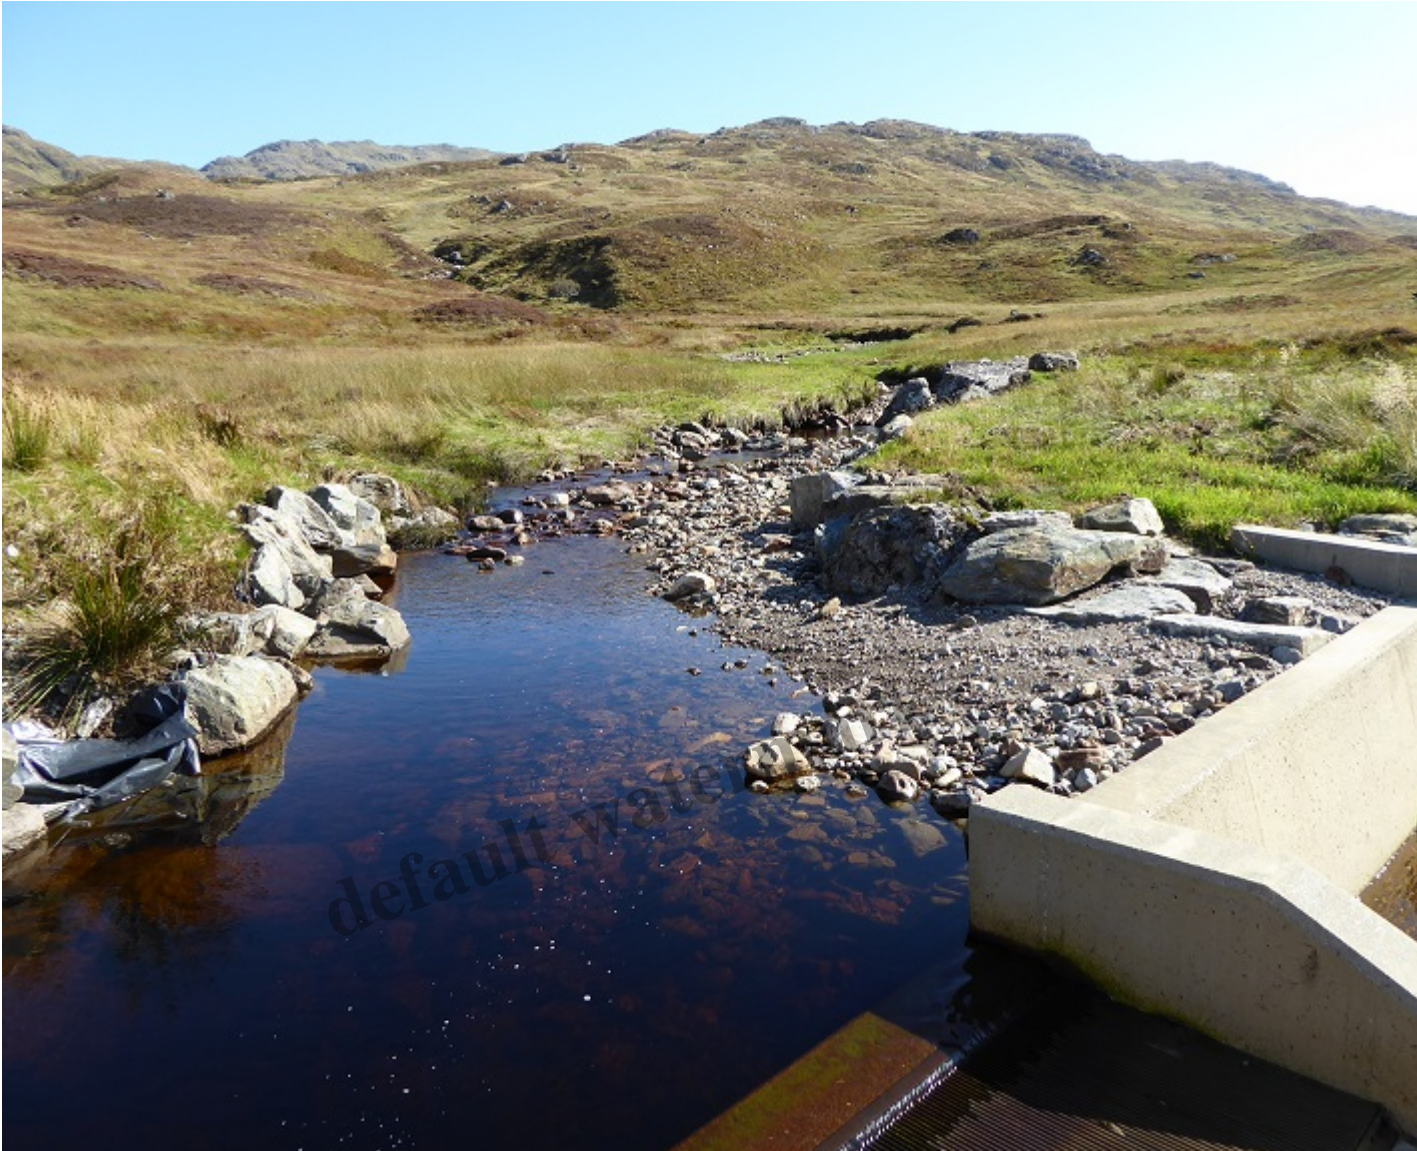
Second Ben Glas intake by walkers path to Beinn Chabhair. Note the black plastic on left of photo, an indication that a large rip rap boulder “protecting” the bank has been swept away and the shingle beach has developed by the right bank and intake wall.

The other Ben Glas intake had been affected by some infilling and damage although this appears significantly far less than in the Allt a Chuillinn schemes. The flat beach on the right suggests some work might have been undertaken since 5th August to excavate the pool.

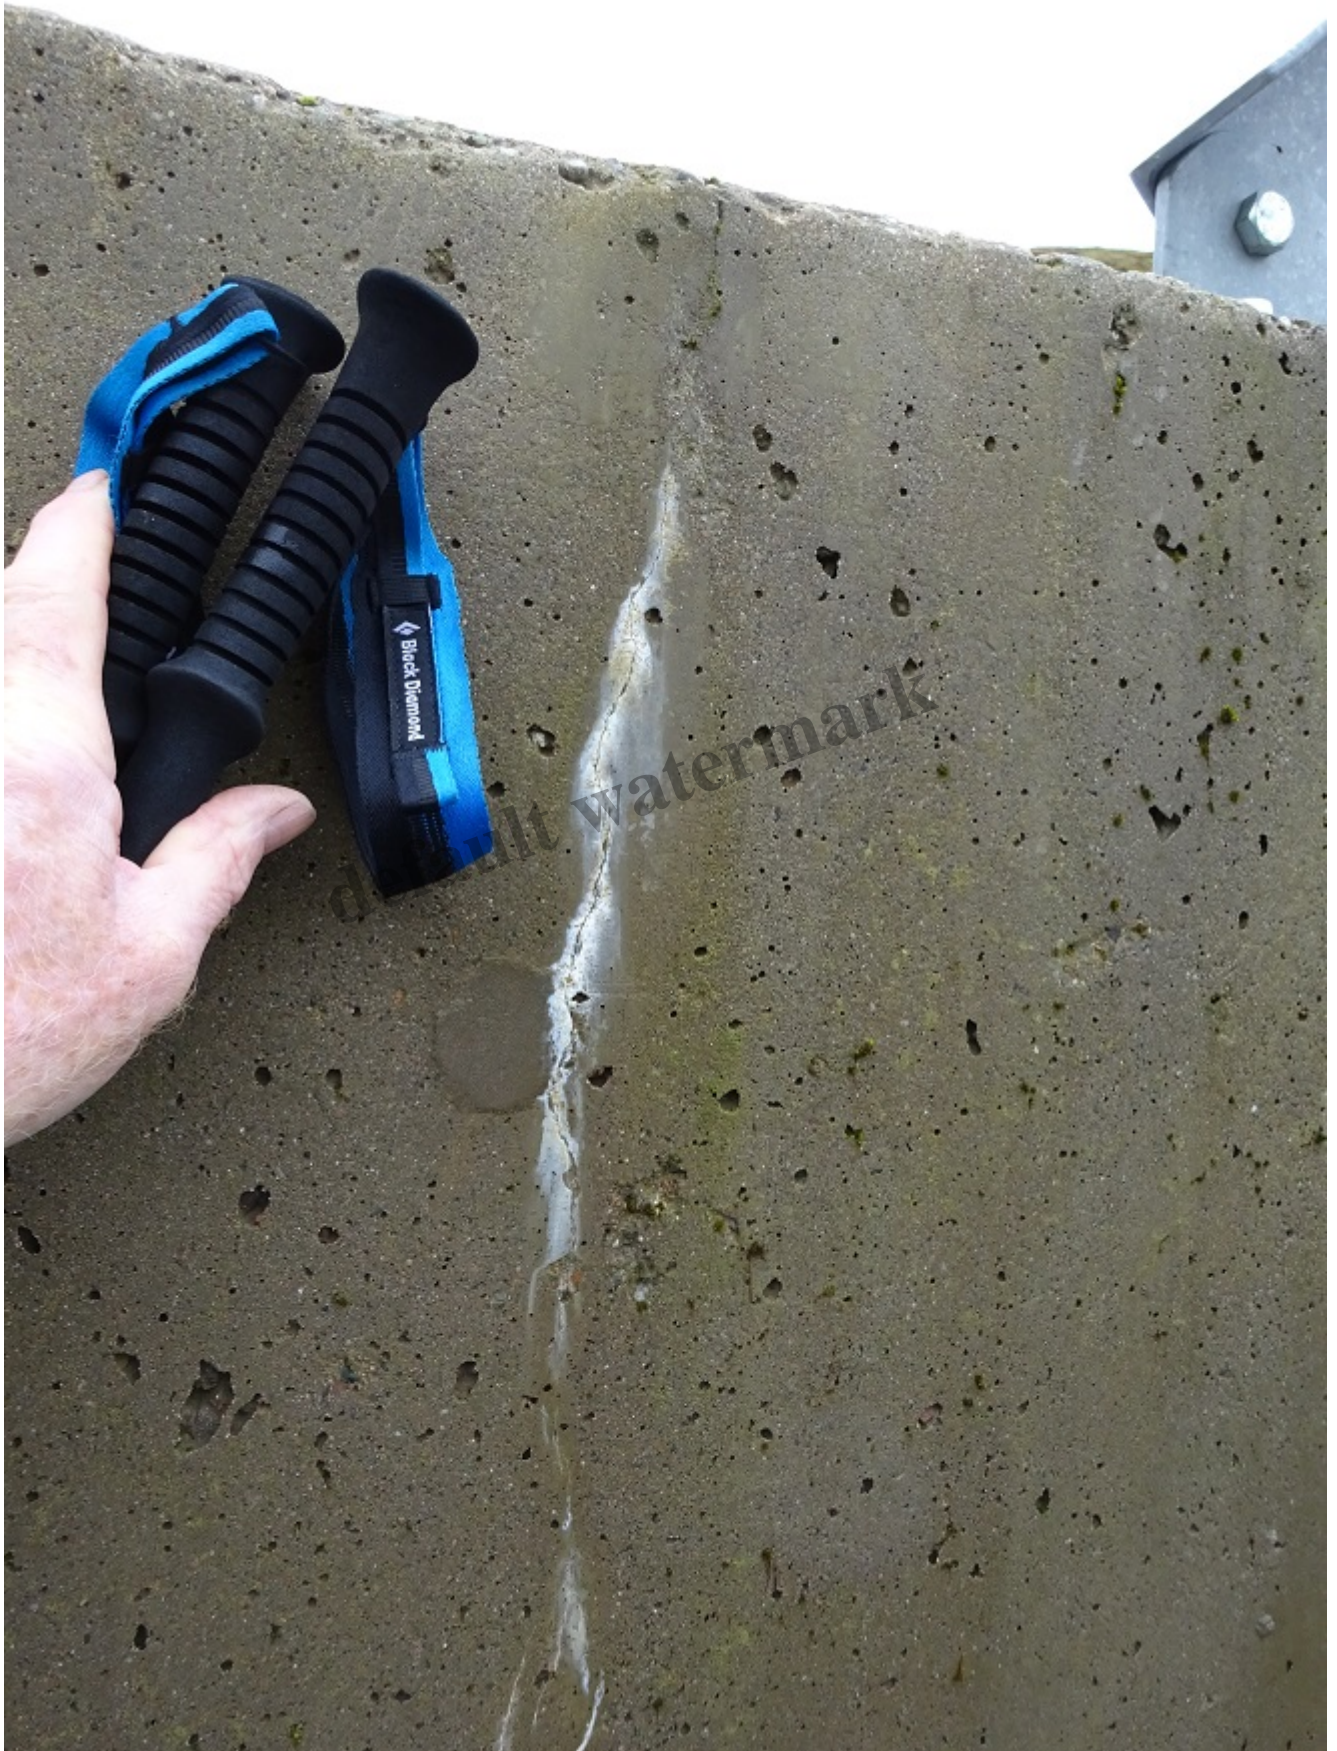
Crack, with seepage, and holes caused by air bubbles in the concrete on the intake wall of the Upper Falloch hydro. The air bubbles at least are an indication of poor construction techniques. Photo Credit Kevin McGrath.
