Climate change and Glen Falloch (5) – the impact of the hydro roads on the natural environment

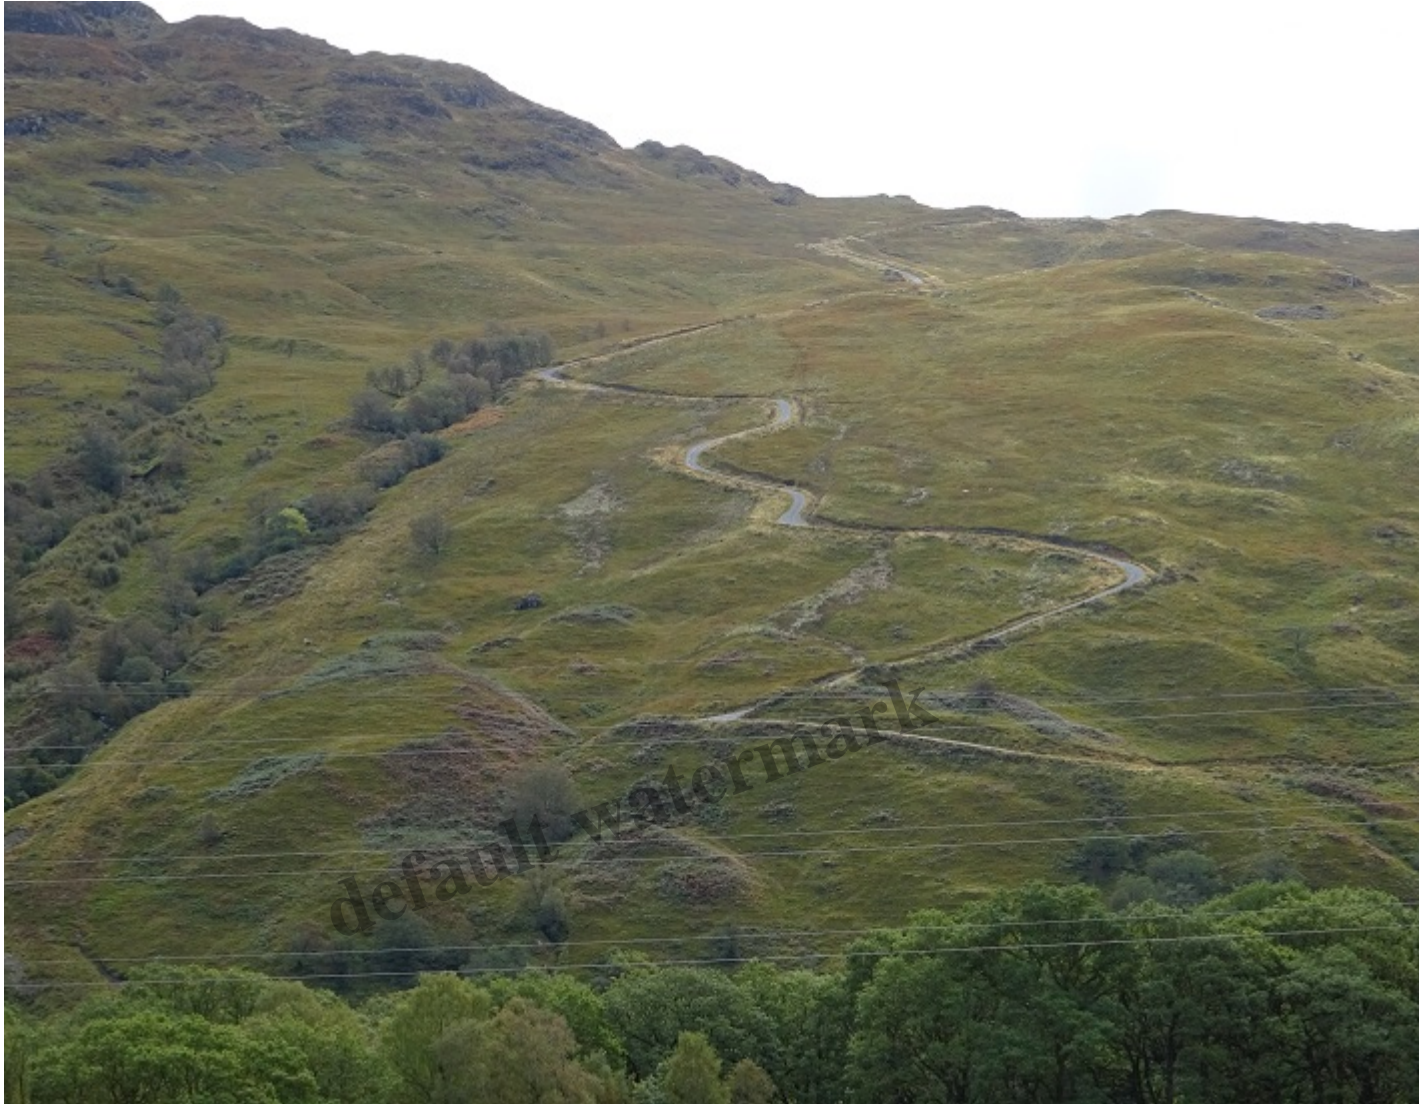
Ben Glas hydro road showing how material has been swept down from the road – from the second bend – onto the slopes below. Photo Credit Kevin McGrath Sept 2019

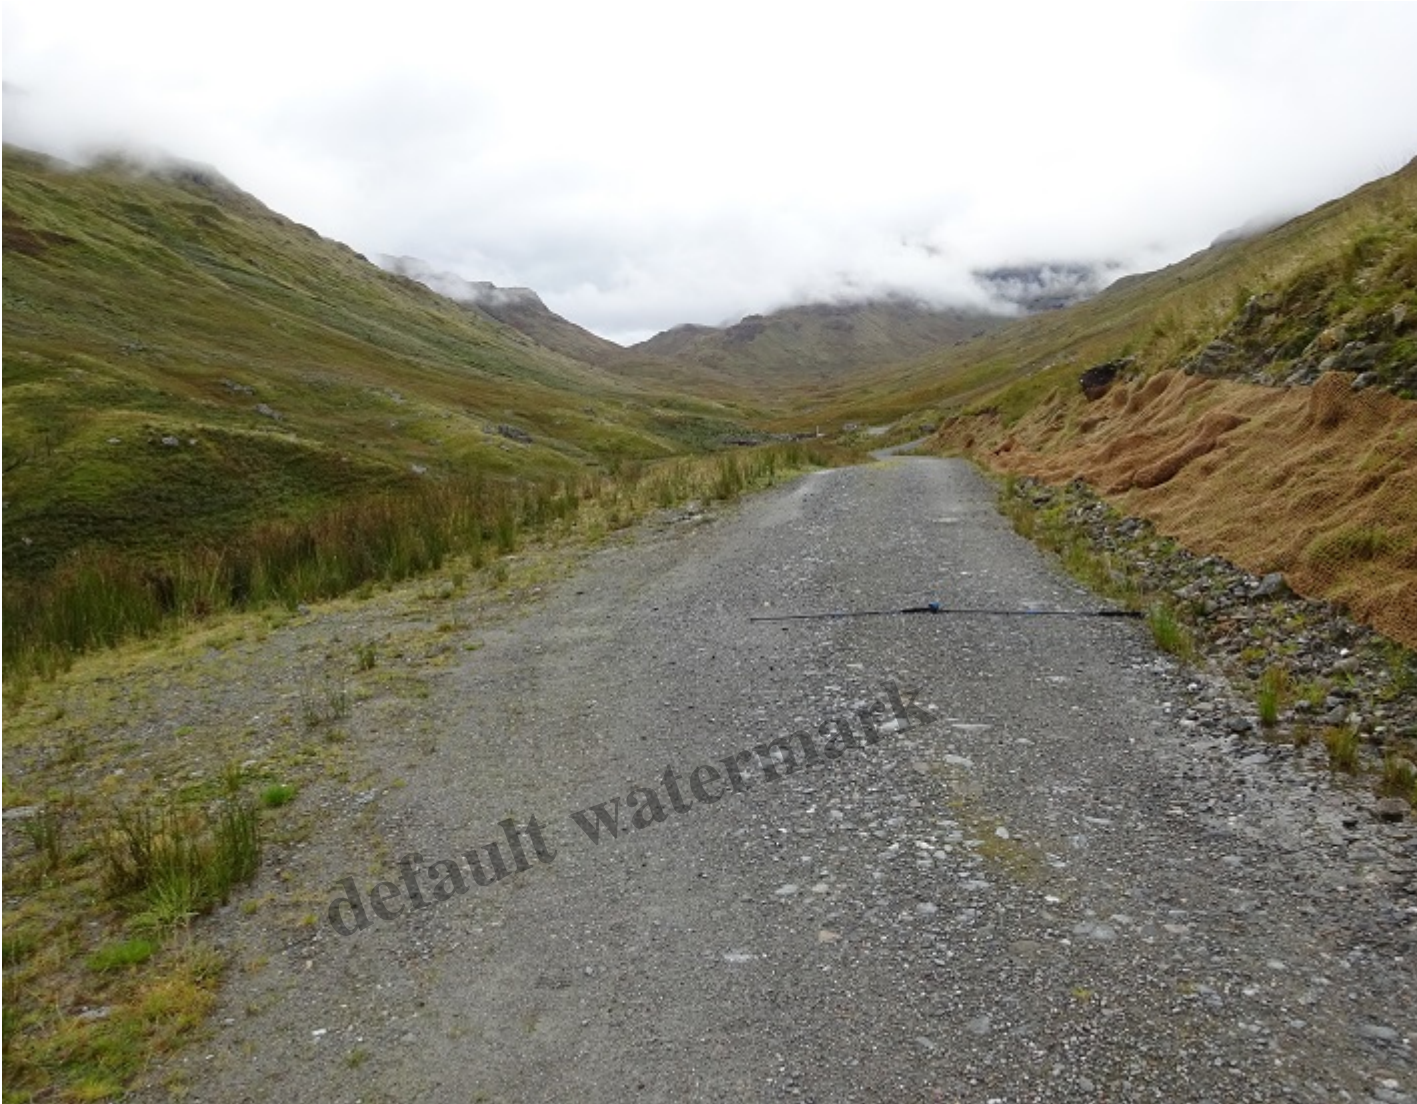
The road to the Glen Falloch Intake. Note how silt has been washed from the upper side to the lower side of the road widening it still further. The new textile matting that has been placed on the bank on the right is the consequence of a fundamental failure in design – the bank is too steep. Photo Credit Kevin McGrath Sept 2019

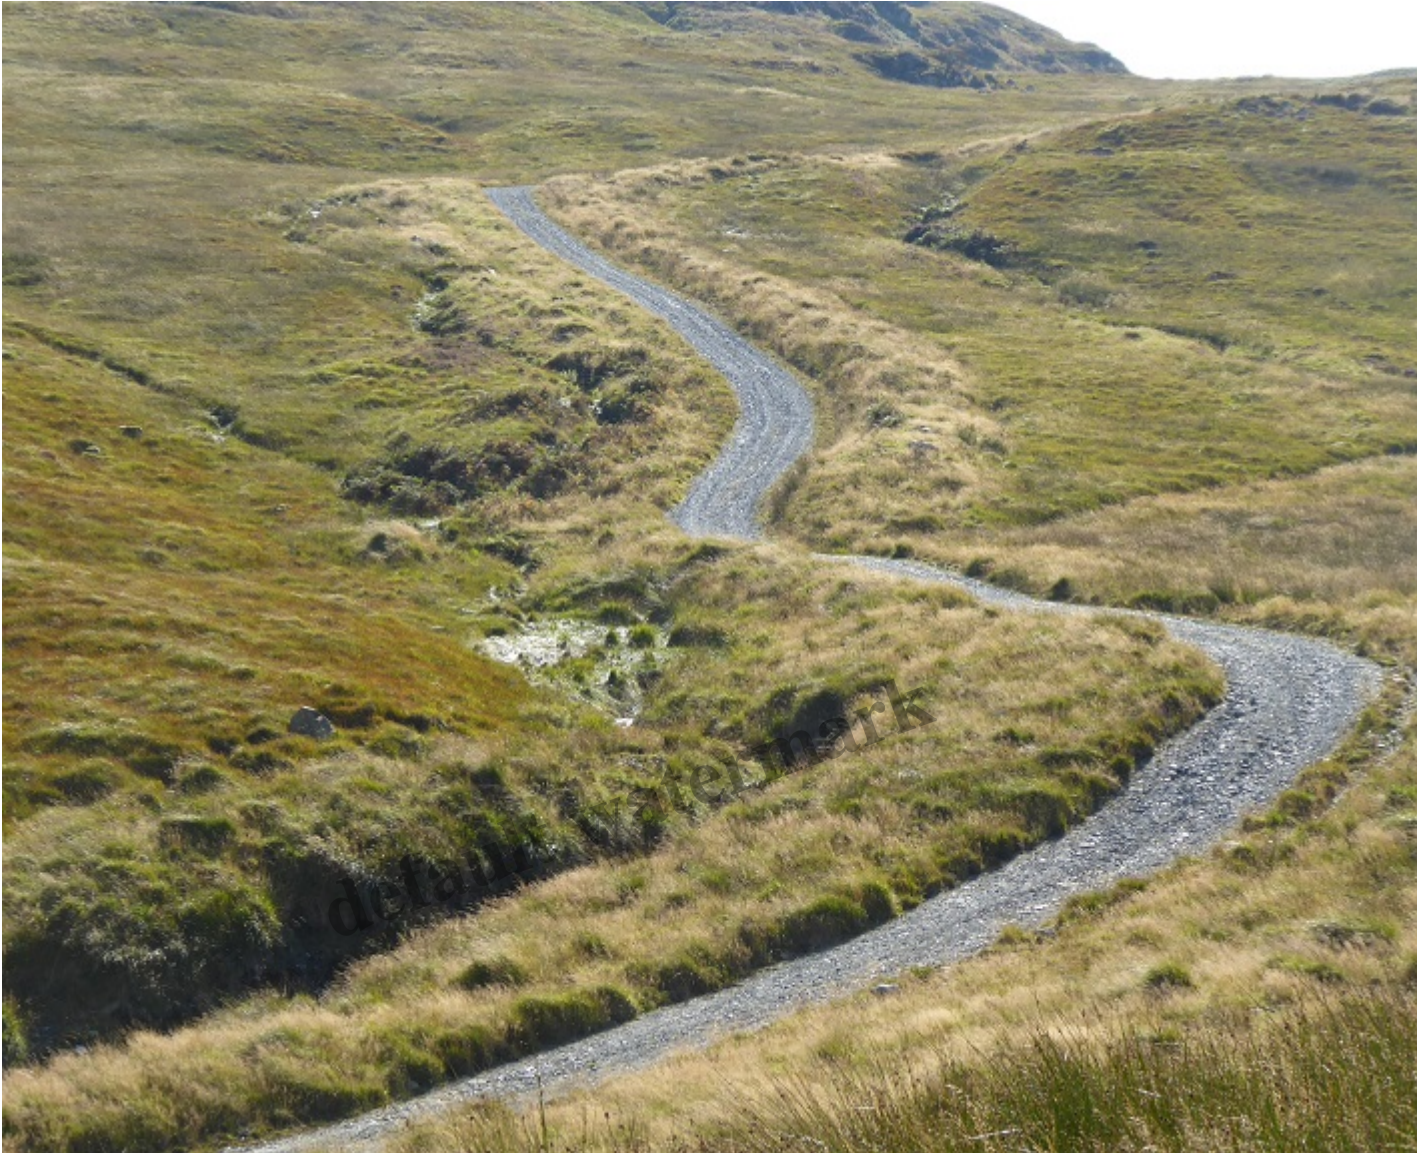
One of the middle sections of the road. The water is channelled down between the new banks that have been created here and is now seriously eroding the steep sections. As an illustration of how much water might have flowed here, note the flood flattened vegetation along the burn on the left.

The LLTNPA has effectively created a new course for water to flow down the hillside in times of heavy rain. On footpaths this steep the standard practice is to install water bars to channel water off the path in order to prevent erosion. On the Glen Falloch roads there is nothing, adding to the watercourse effect.

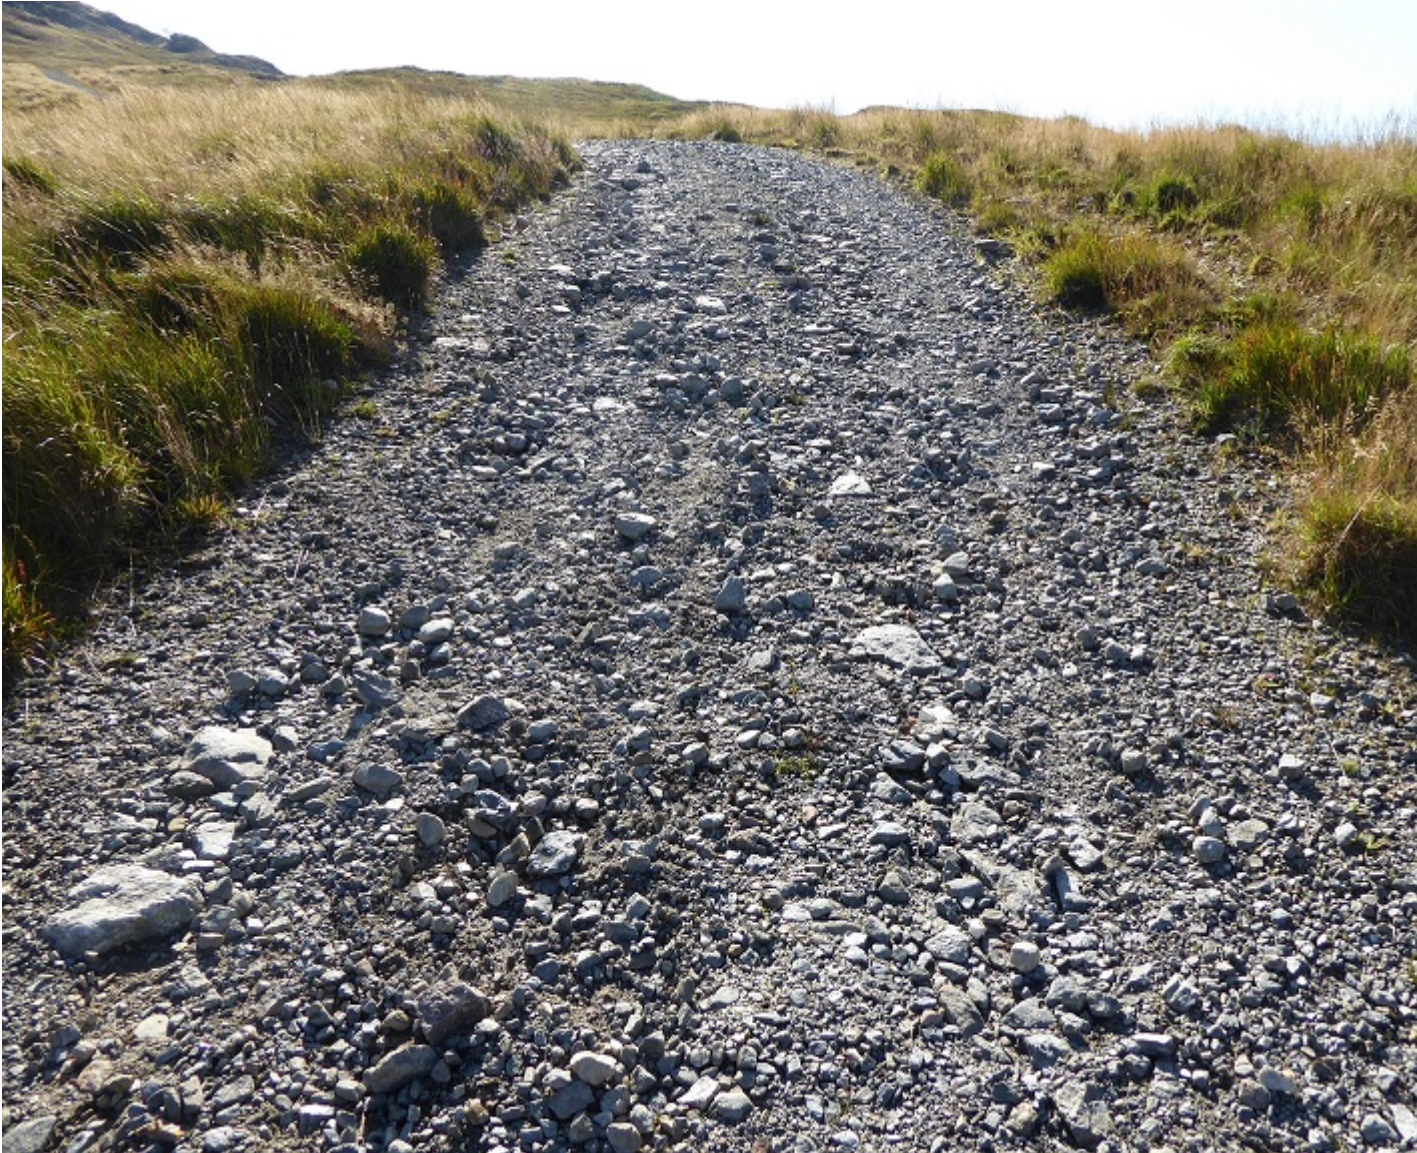
Example of section of road where the fine material has been washed out and where larger stones have started to be moved by the water.

During construction, the Scottish Environment Protection Agency required the contractors to install silt traps to stop fine material flowing into rivers below. That now appears to have been a waste of time because the fine material from the road surface has mostly been washed out leaving a pebbly surface.

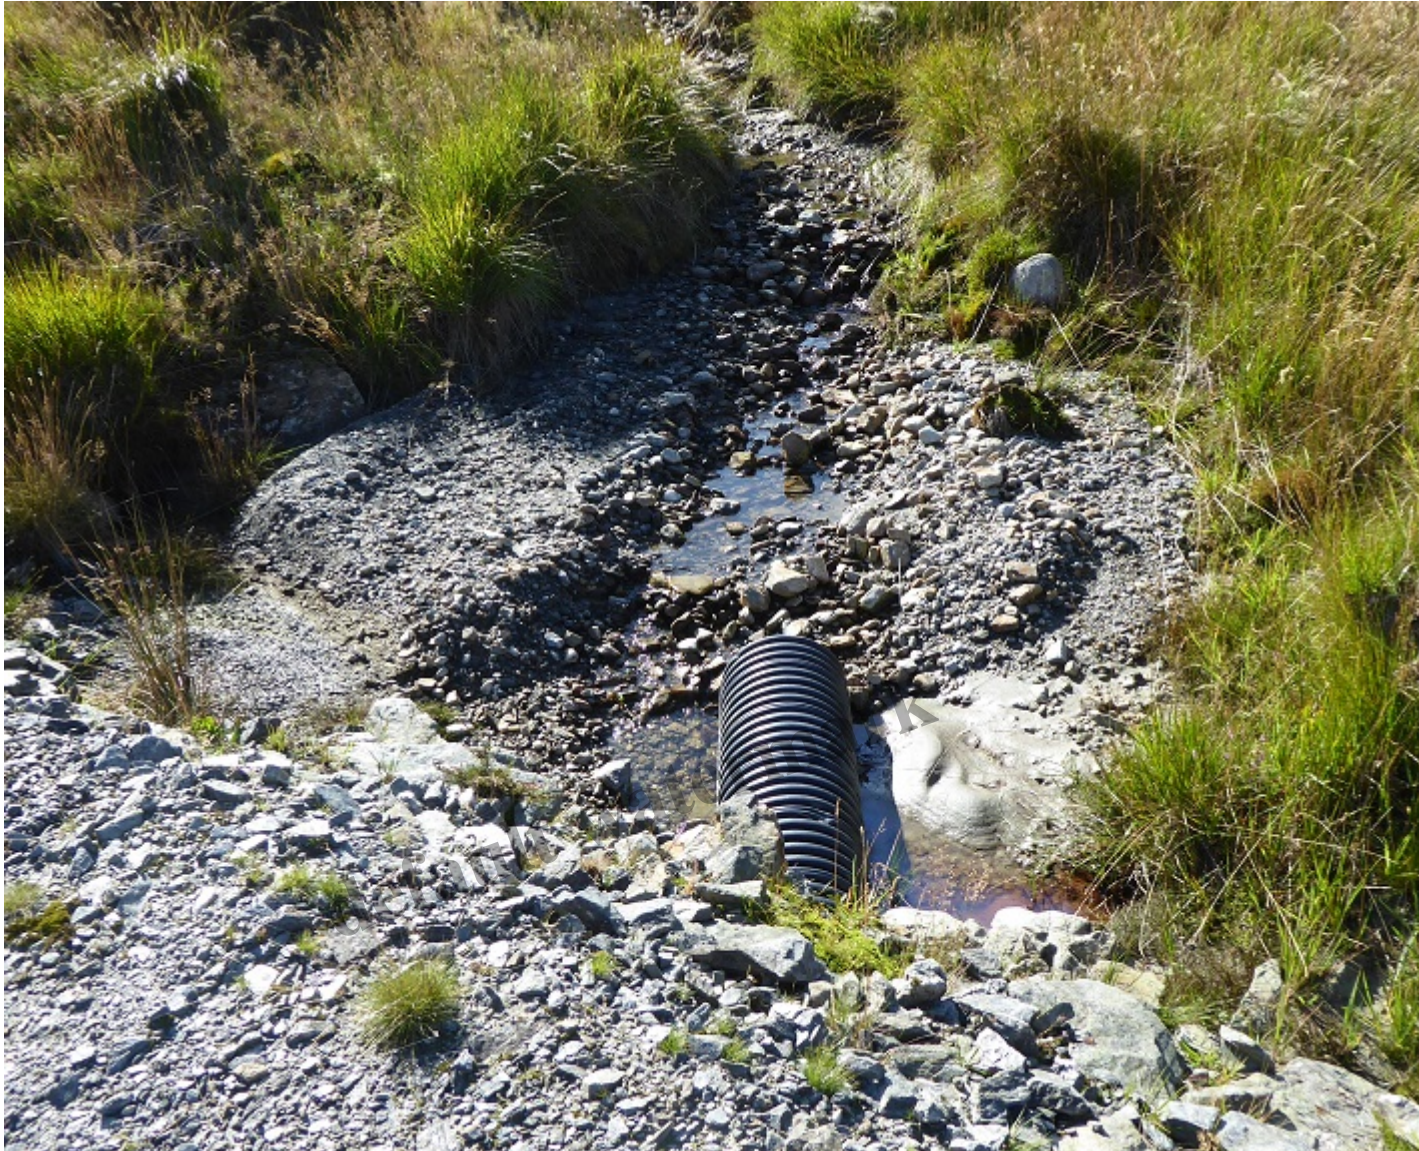
One of many protruding plastic pipes along the new road, silt visible to right, gravel wash out to left. also the eroding side of the track above the pipe.

The lack of finishing, betrays a lack of concern about both the landscape and the environmental consequences of these roads.

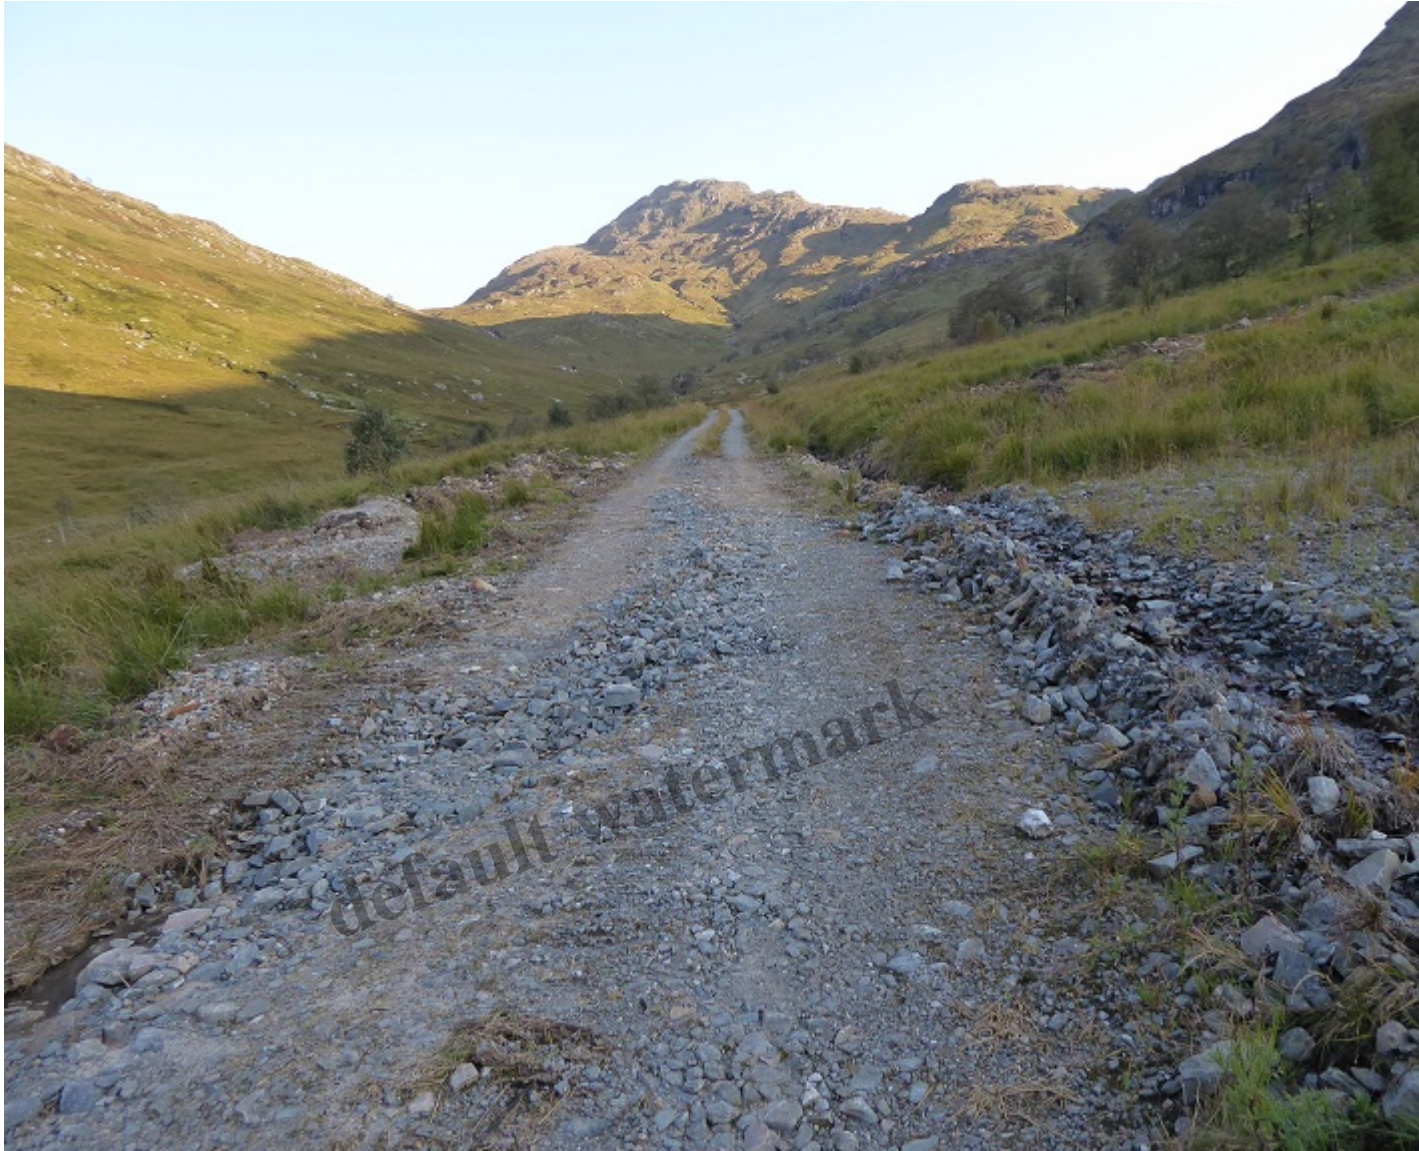
The view of the flood damaged area from below, showing how the central grass strip and part of surface was swept away, with recent ditch work on right.

Another explanation is that this road, sitting as it does below the slope on the right, was exposed to debris and water coming down the hillside for far more of its length while the absence of zig zags, as on the Ben Glas road, meant there was little to interrupt the flow of the water once it reached the road.

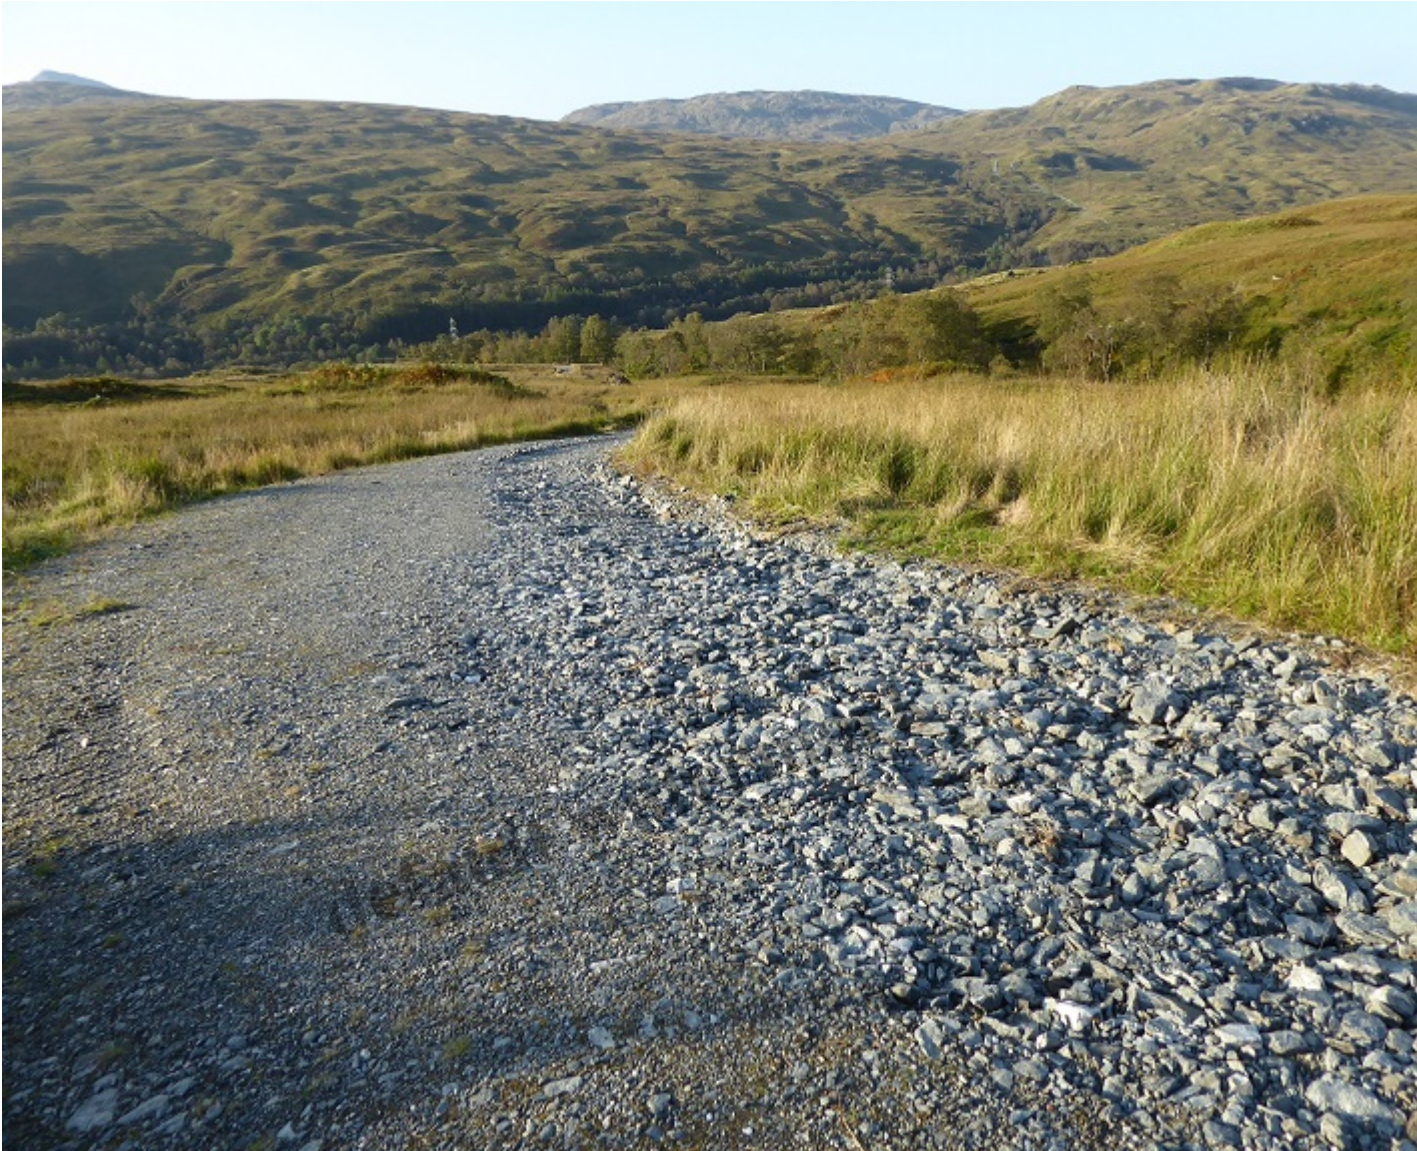
Section of Allt a Chuillinn road, which is more like a motorway than a track and contrary to LLTNPA specifications, with serious wash out on right side

That water was channelled down the road is supported by evidence of increasing levels of damage lower down.
