## Climate change and Glen Falloch (5) – the impact of the hydro roads on the natural environment

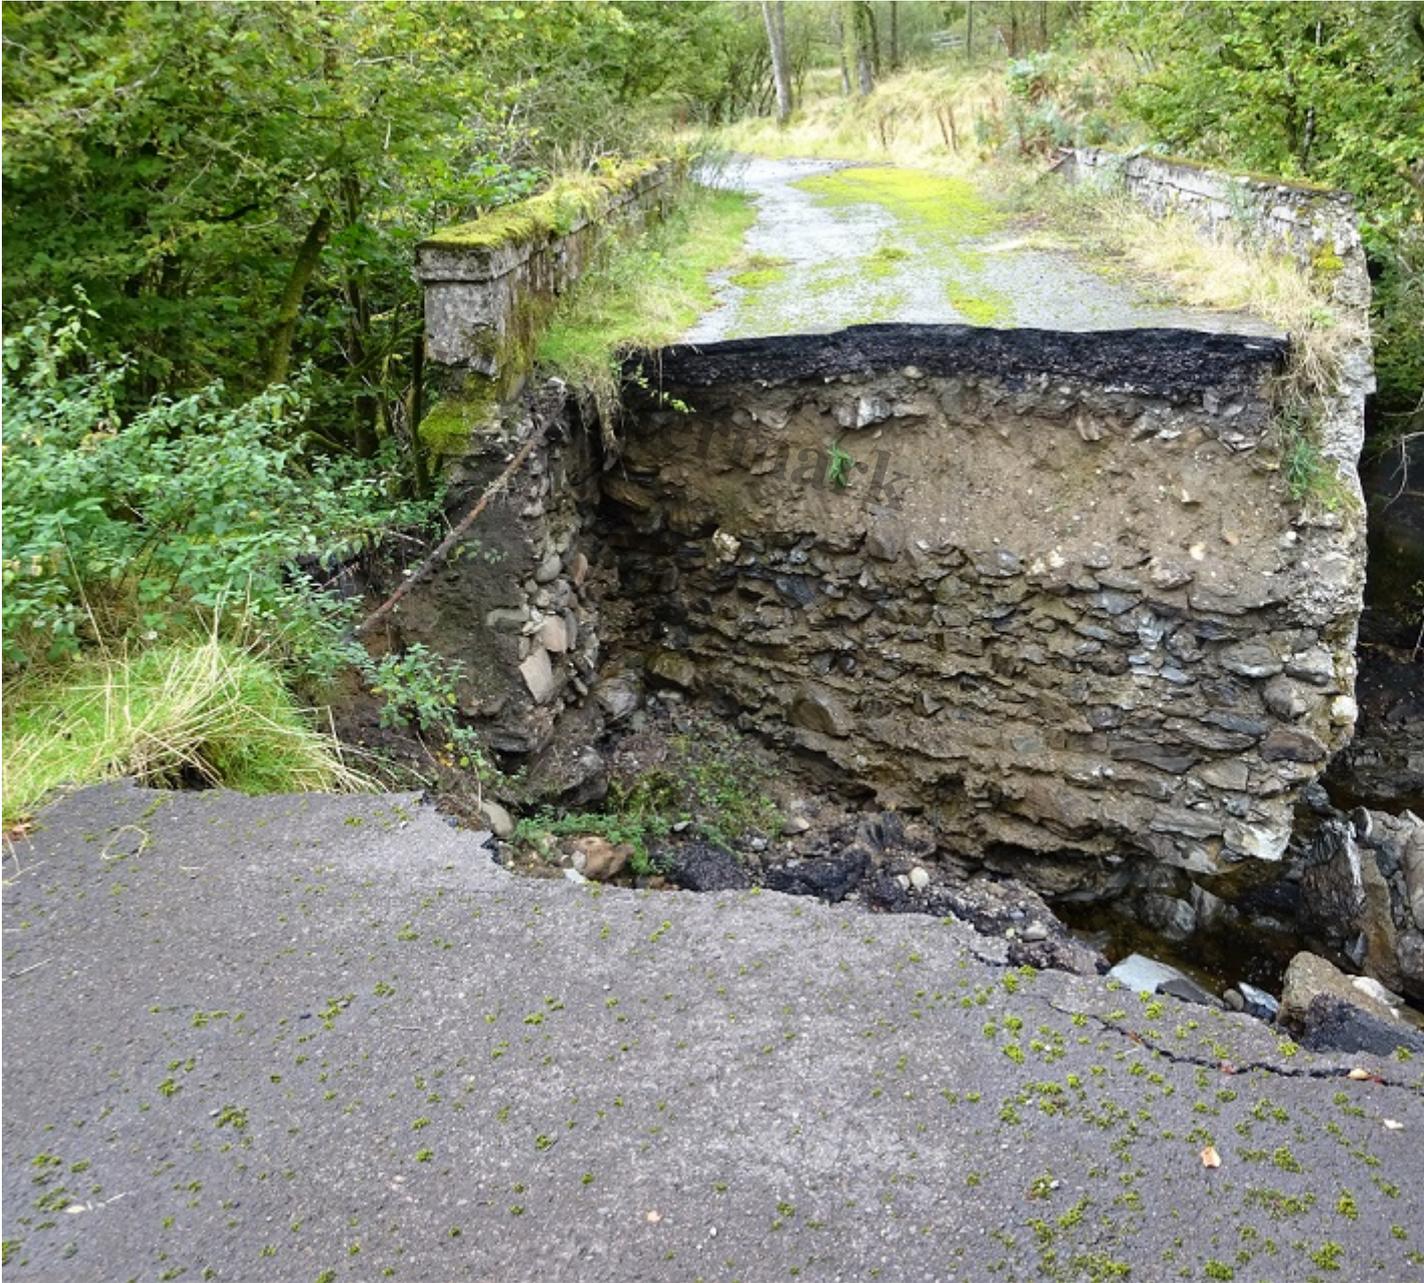
Bridge on the old road in Glen Falloch over the Eas Eonan swept away by the floods – could the Eonan intake have helped cause this?

Returning to the first photo in this post, could flow of water down the new Eas Eonan hydro road have been what triggered destruction of the bridge over the burn?

Assuming the Eas Eonan hydro continued to function during the storm, some of the water that would have descended the burn would have gone through the pipe avoiding the bridge and lessening the flow there. One could argue therefore that by reducing the amount of water flowing down the burn the hydro pipes delayed the destruction of the bridge.

At the same time, however, the new track, its bare banks and associated ditches have served to drain and channel water and debris off the hill far more quickly than previously and, in the case of the Eas Eonan track, all the drainage ditches feed water into the main burn above the former bridge.

We will never know whether this is what caused the road bridge to fail. What we can be fairly certain of, however, is that hydro schemes do speed the rate of water run-off from the hill, both because of the pipes â?? which take a direct and unimpeded course compared to the burns â?? and the hill roads. They have therefore added to the flood damage caused further down the glen ([see here](#)).

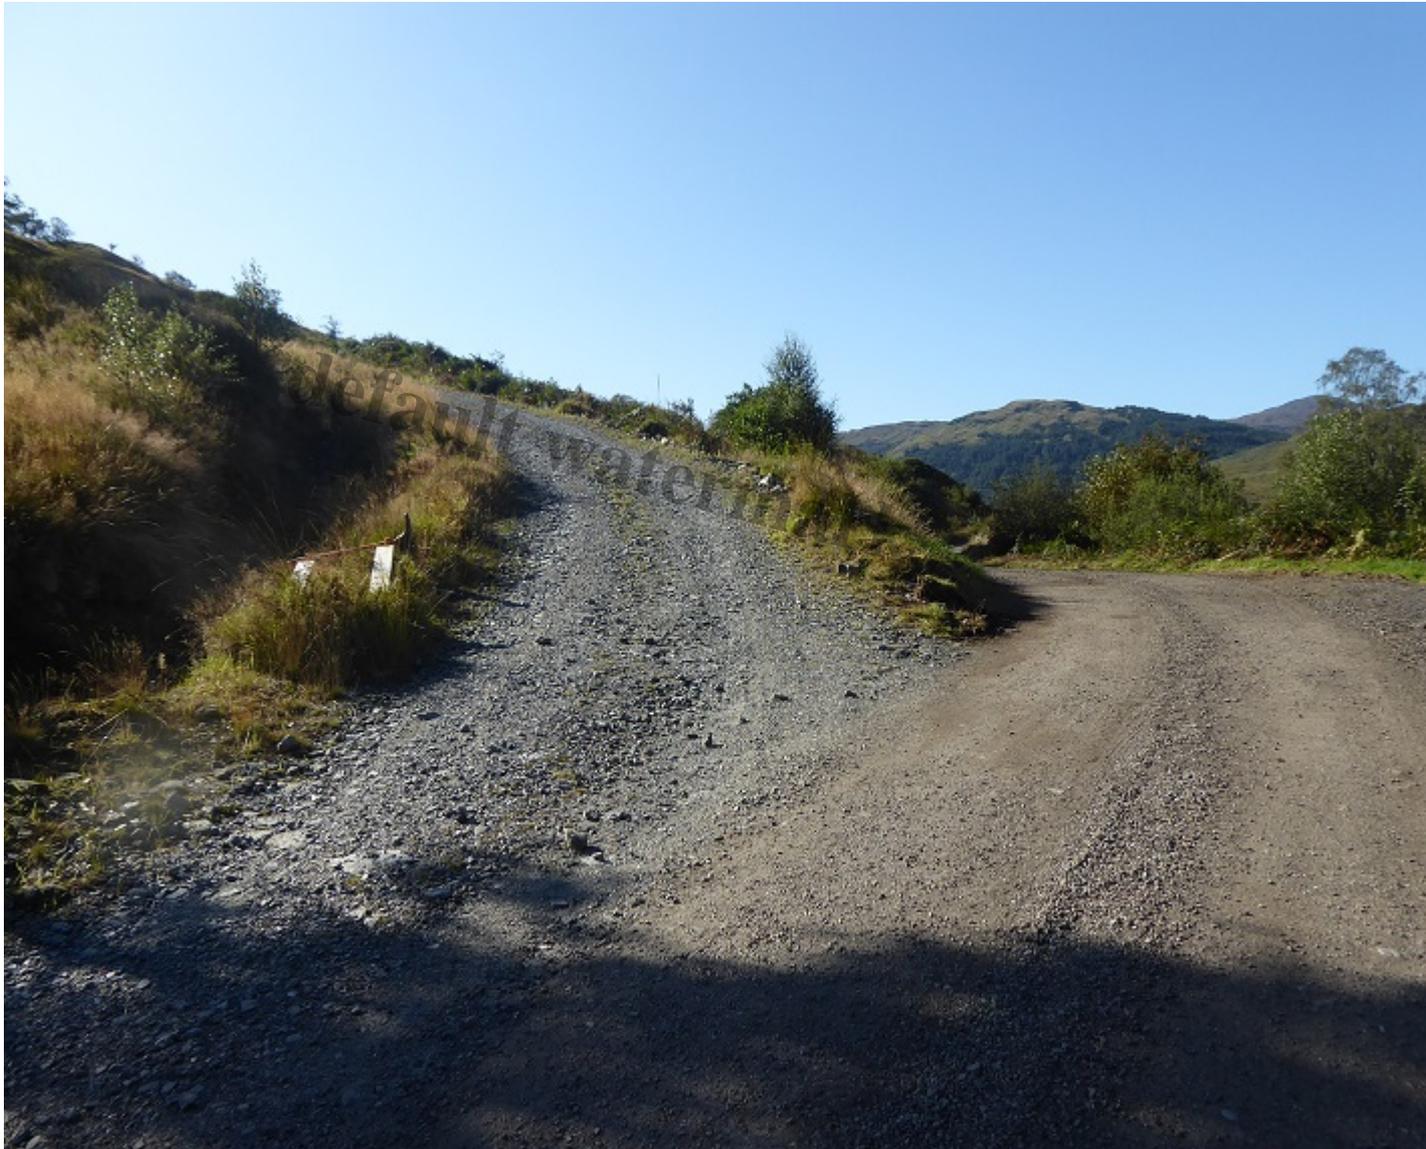
The start of the new Ben Glas hydro hill road illustrating the contrast between its surface, which is already eroding significantly, and the surface of the road below which has retained much finer material

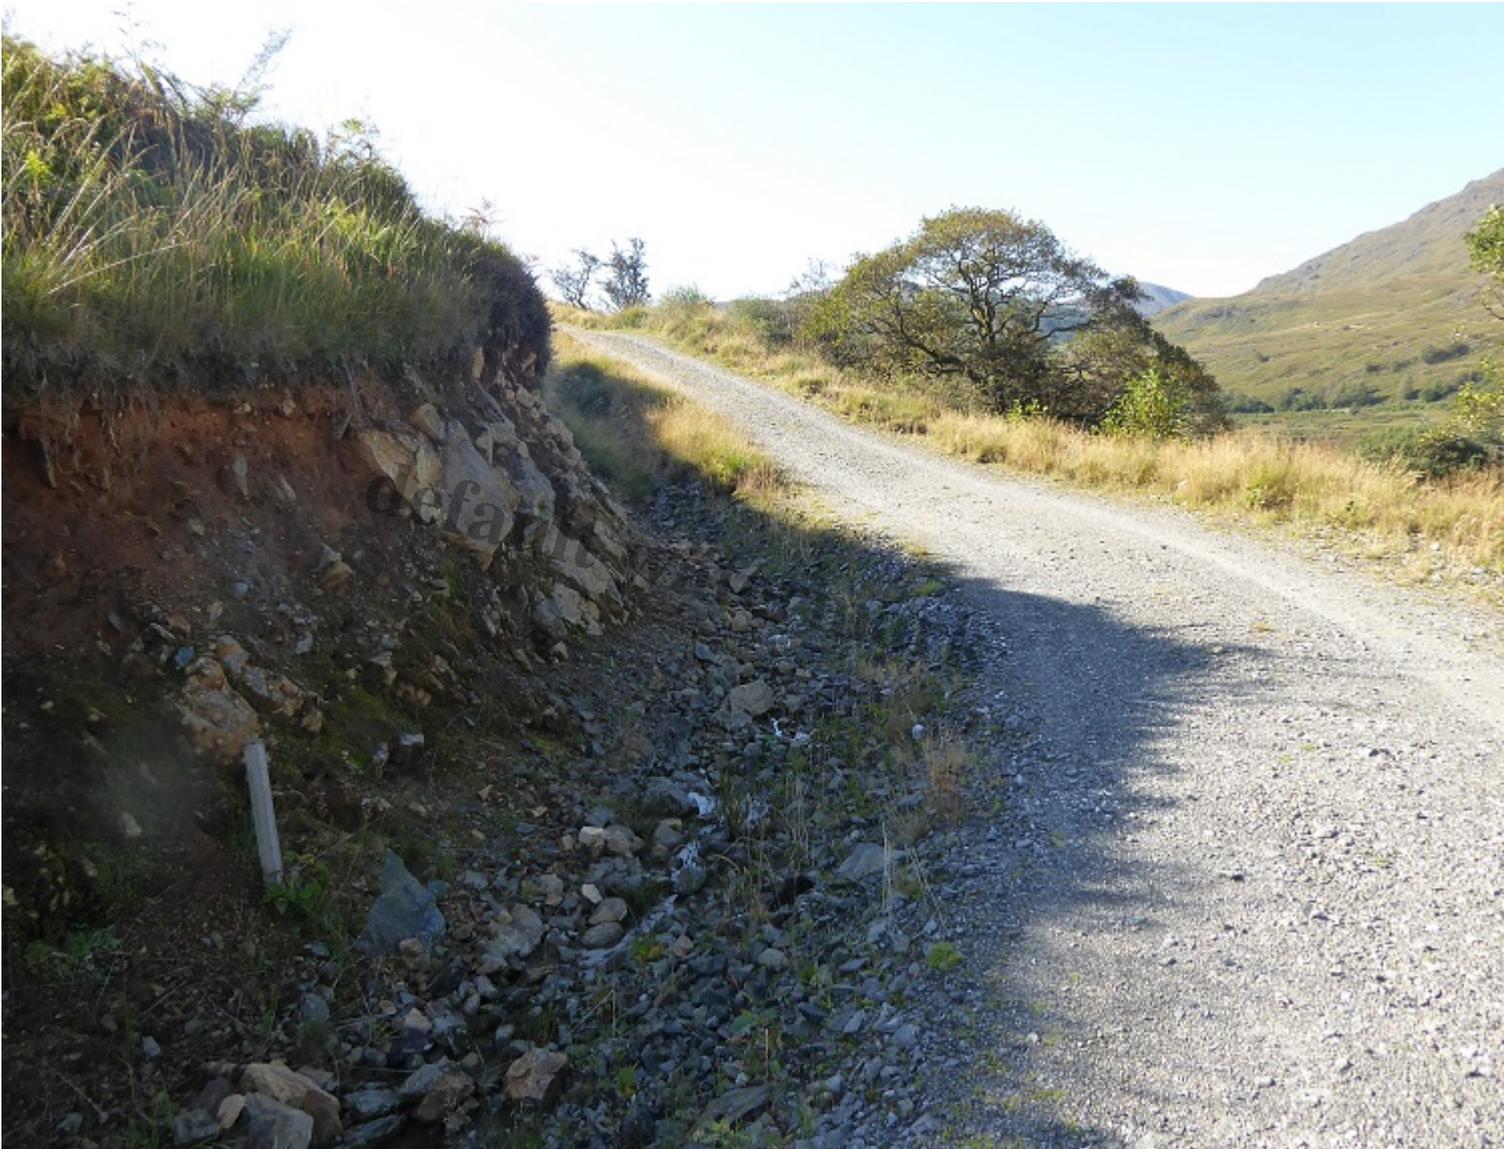
The design flaws are evident from the start. It is too steep and the LLTNPA's Best Practice Guidance on Renewables states that hill tracks should not be cut through banks like this (because they are impossible to restore). Why then has the LLTNPA allowed Glen Falloch Estate to leave this in place?

While there had previously been a much smaller landrover track up this slope, which had been followed by the old drove road, the new road forms a great landscape scar. It is also too steep, too wide and has been badly restored.

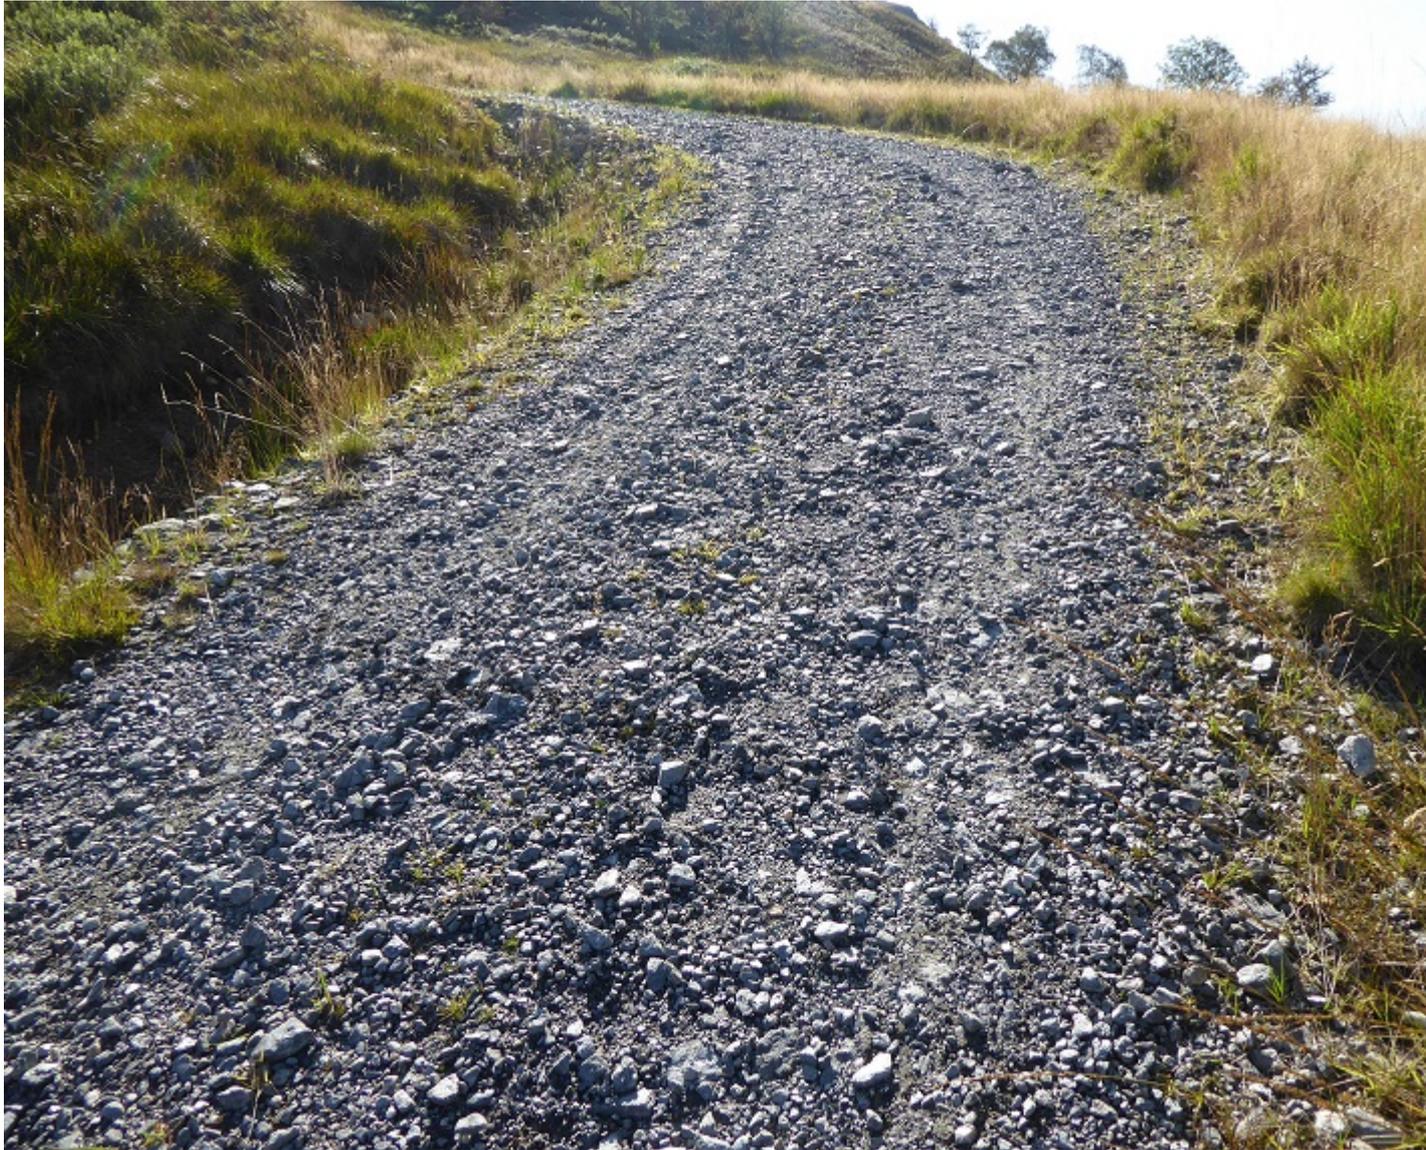
Fine material has been washed out from several sections of the new road and there is now a serious deep ruts developing which would make it unusable for vehicles.

Scottish Natural Heritage's Best Practice Guidance on Constructed Tracks in the Scottish Uplands states that unsurfaced hill roads should not be steeper than 14 degrees. This is because more than that and they are at severe risk of erosion. The LLTNPA's own Best Practice Guidance endorses SNH's guidance, yet their planners have allowed this road, with several very steep sections, to remain. The consequence is that it is eroding badly and the estate will sooner or later need to bring in more material to repair the surface, material which in its turn will then get washed away.

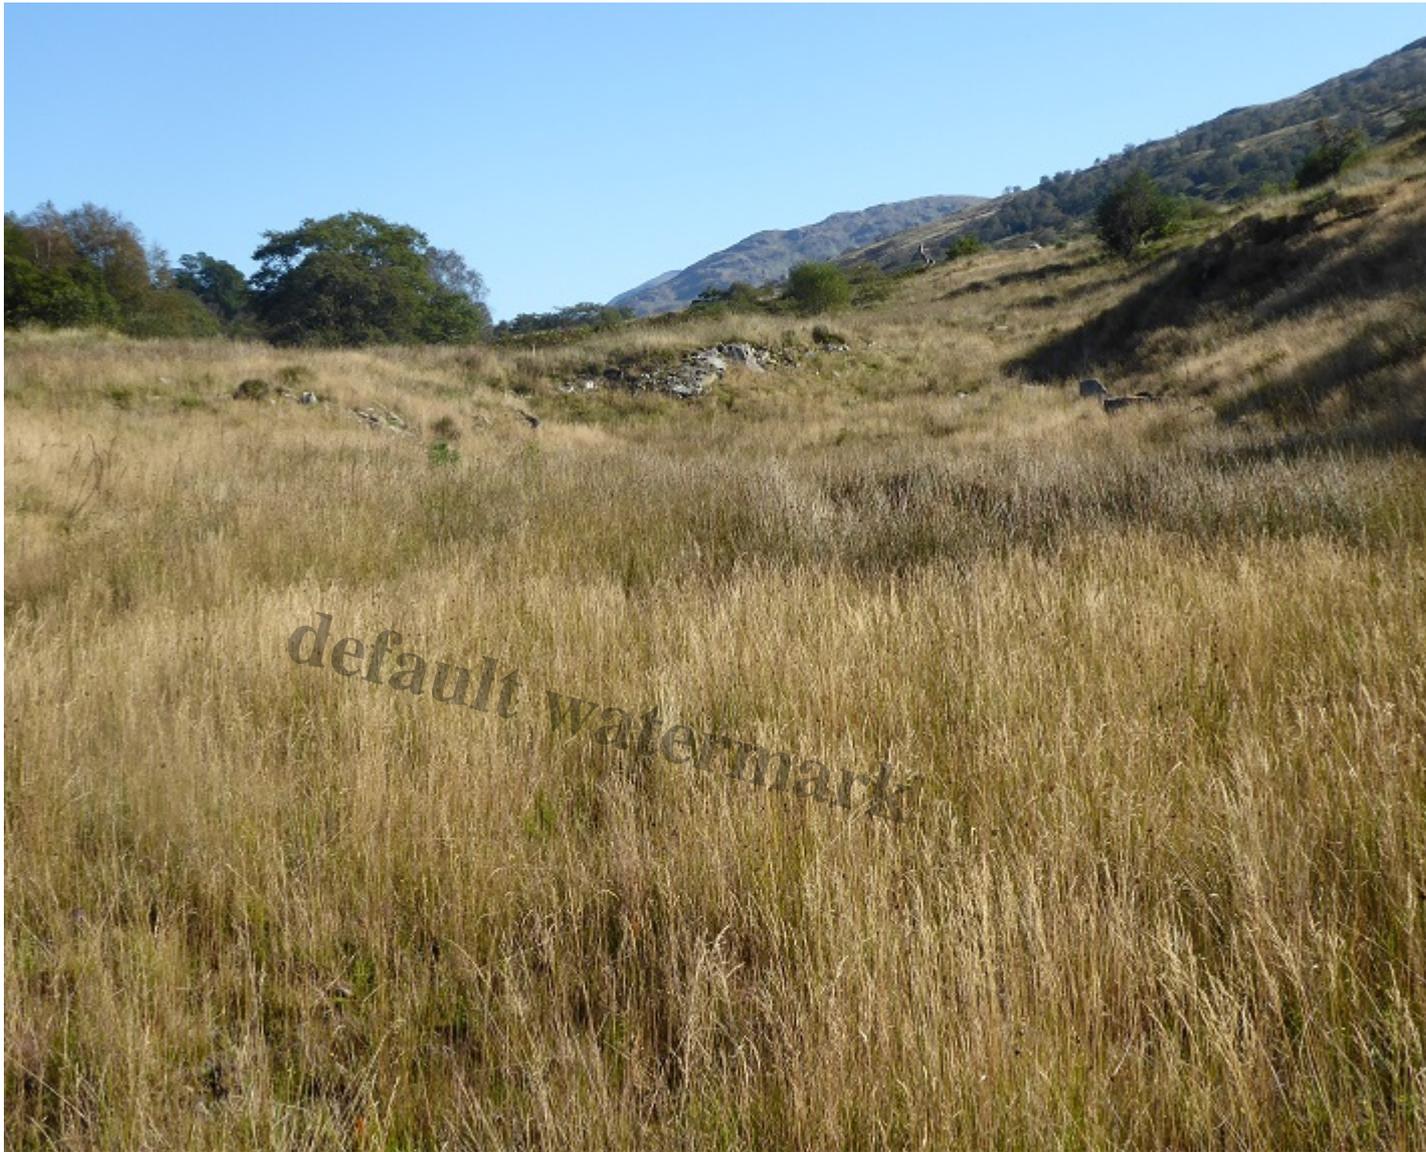
The very large borrow pit just above the Ben Glas powerhouse. Material to construct the new roads excavated from between the bank on the left to the bank on the right to leave this wide depression.

While the borrow pit itself is low down, which has helped vegetation recolonise the site, much of the material taken from it up the mountain is now washing back down the hillside:

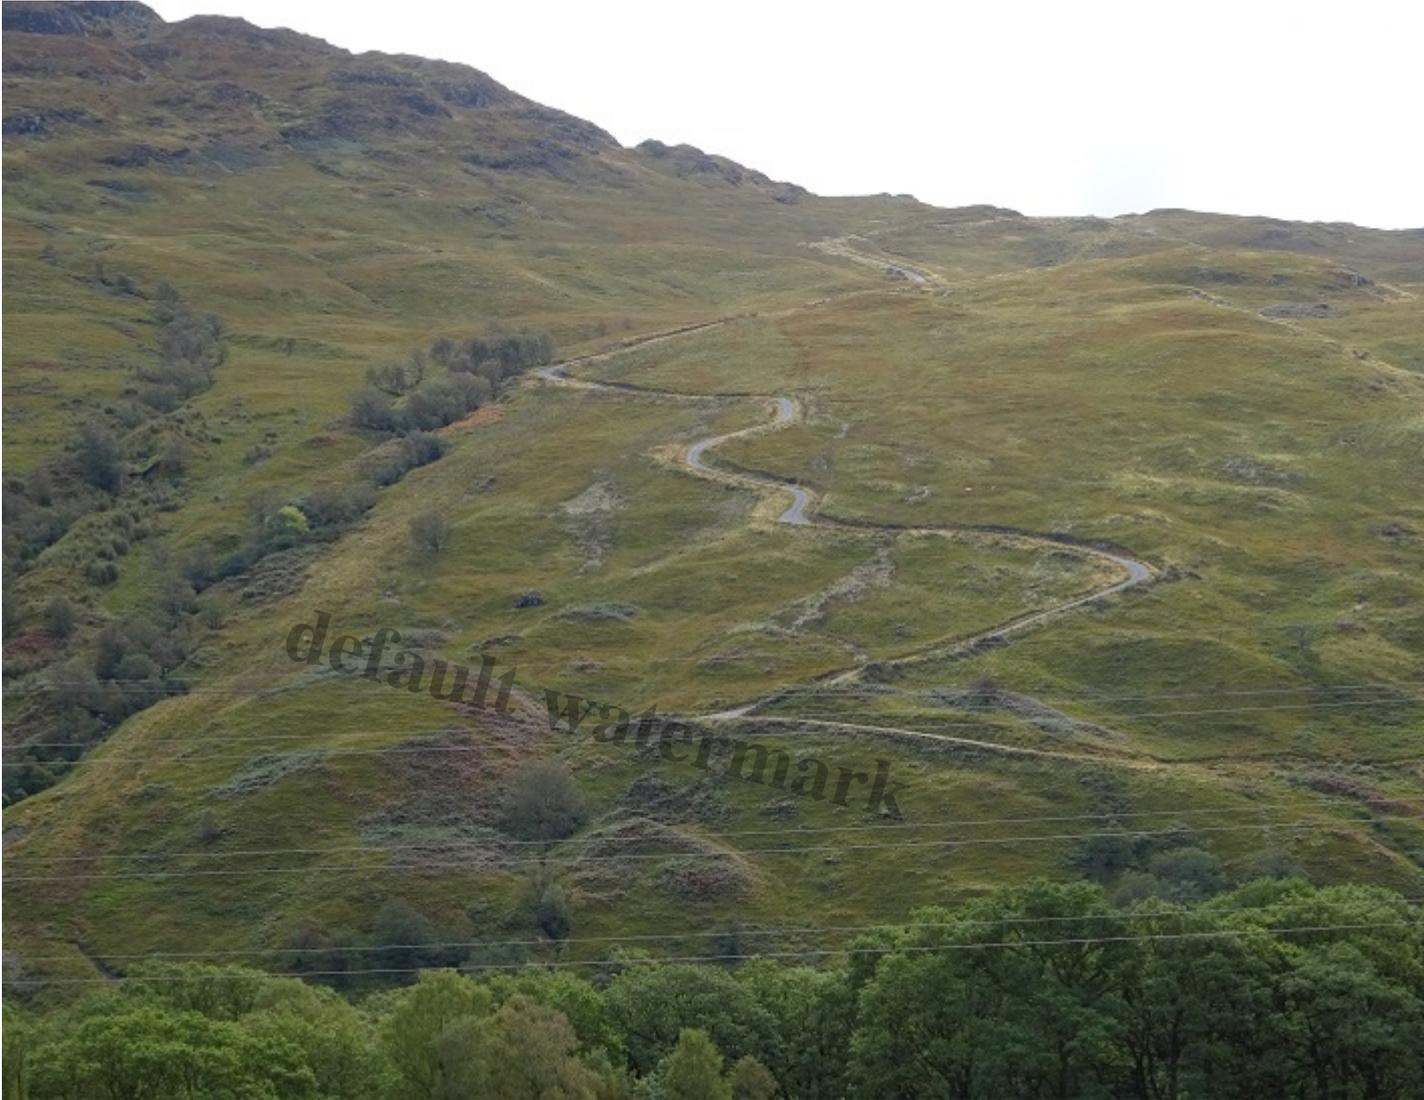
Ben Glas hydro road showing how material has been swept down from the road from the second bend onto the slopes below. Photo Credit Kevin McGrath Sept 2019

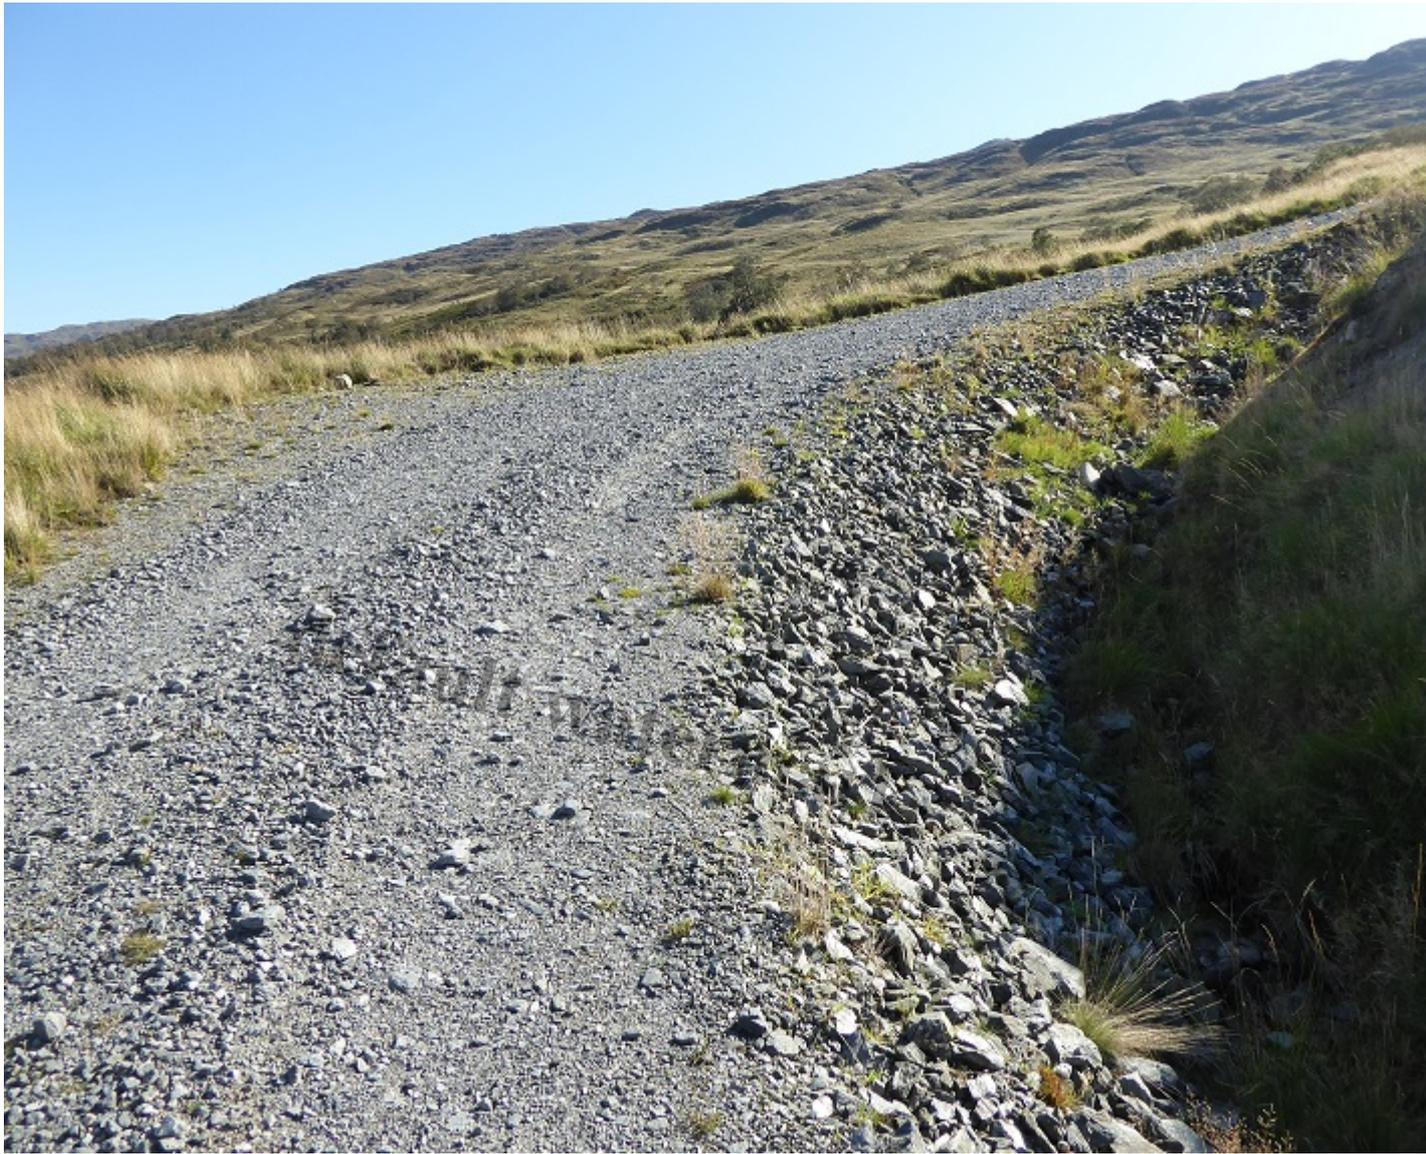
The right hand edge of the road is now starting to collapse into the enormous ditch

Besides their landscape impact, the new roads and their ditches allow water to flow down the hill far more quickly than previously. The significant sections of bare bank, which are very difficult to vegetate because they are also too steep, adds to the problem. The LLTNPA's Guidance states that access roads to renewable energy developments should be a maximum of 2.5 metres broad (3m at the bends). Much of this road and others in the glen are far wider than this.

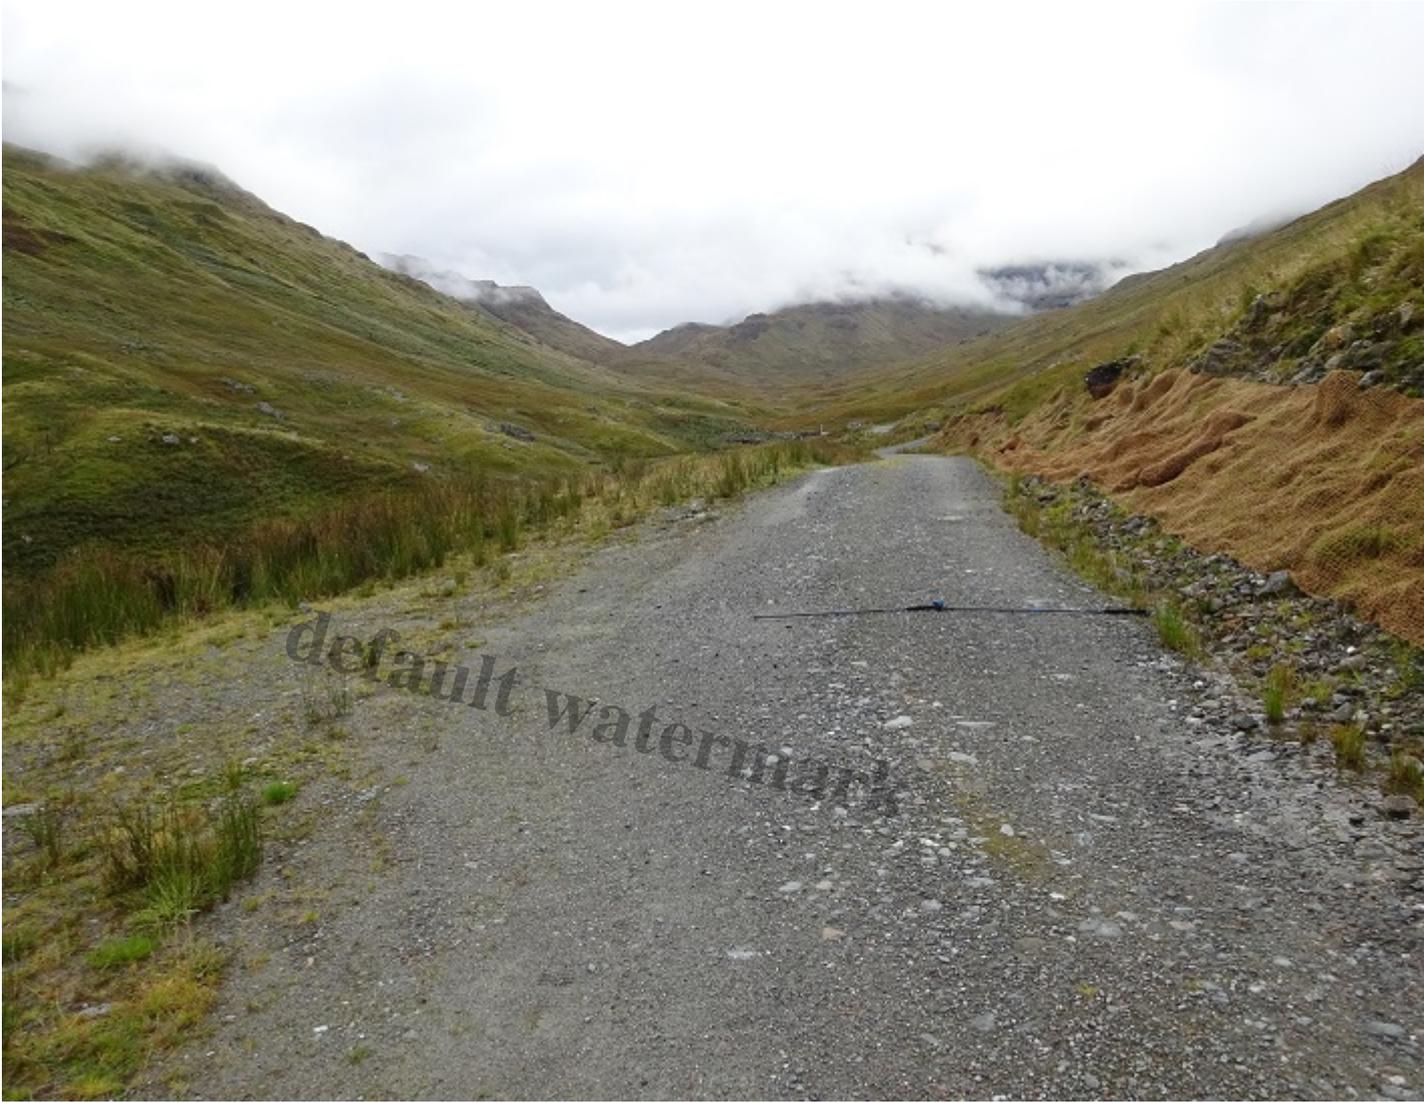
The road to the Glen Falloch Intake. Note how silt has been washed from the upper side to the lower side of the road widening it still further. The new textile matting that has been placed on the bank on right is the consequence of a fundamental failure in design – the bank is too steep. Photo Credit Kevin McGrath Sept 2019

The road up to the Ben Glas hydro also lacks any vegetated central strip which might have reduced the landscape impact, helped prevent erosion and retained some water.

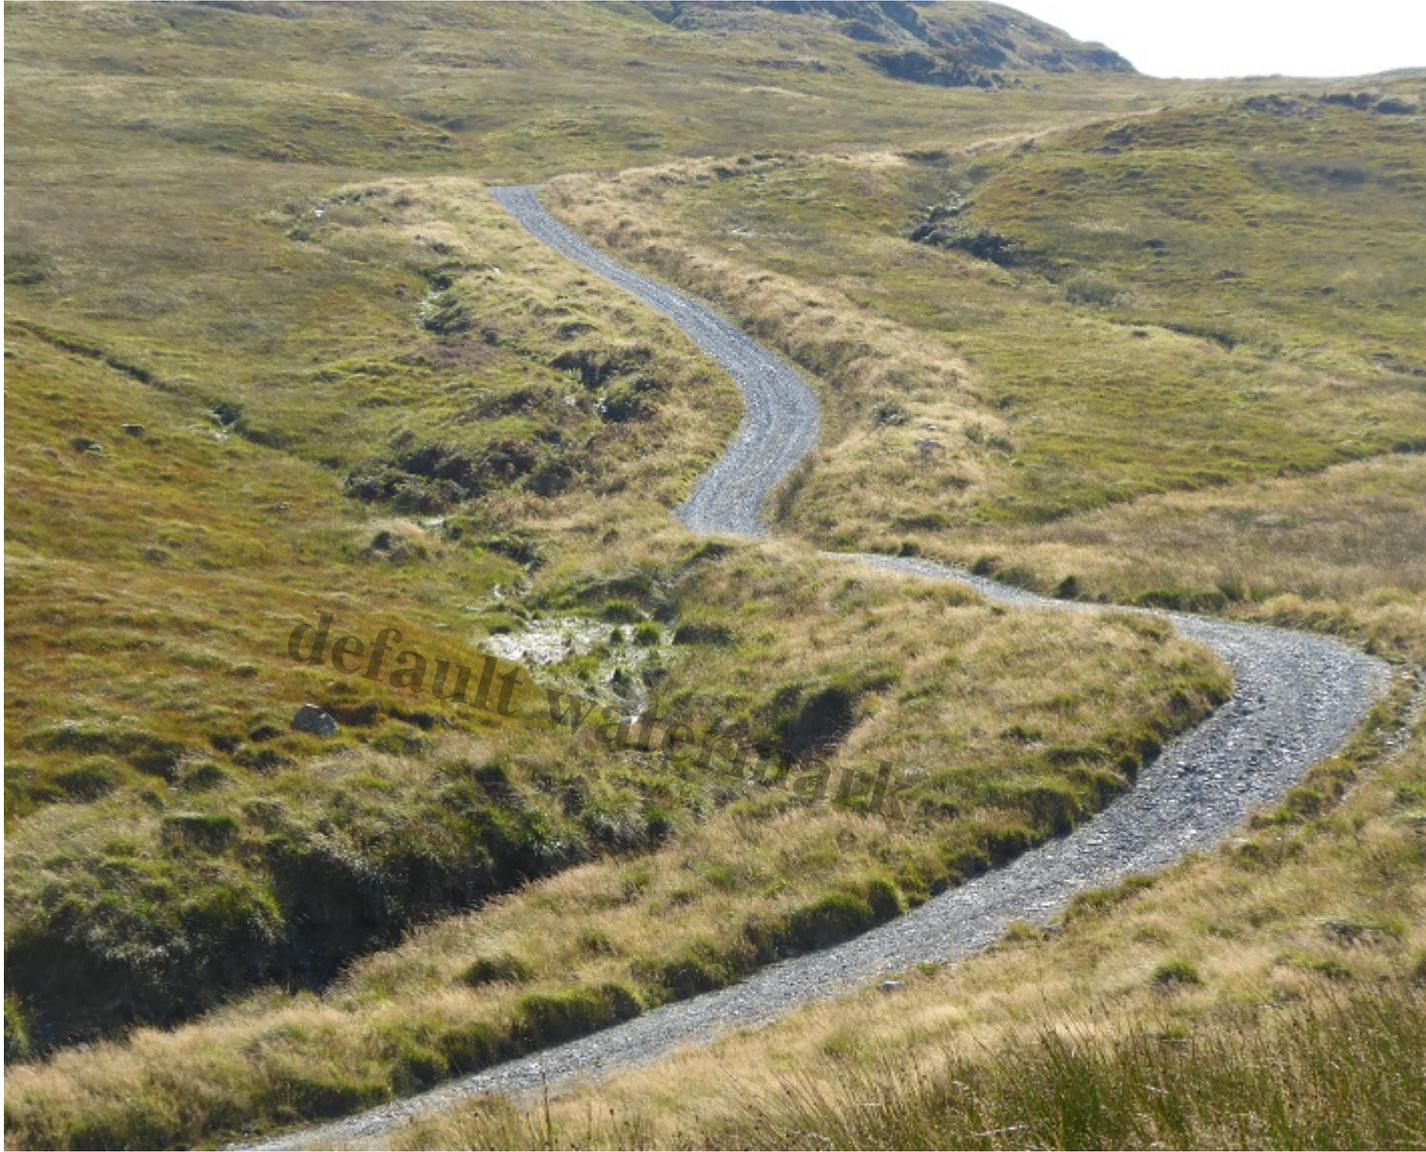
One of the middle sections of the road. The water is channelled down between the new banks that have been created here and is now seriously eroding the steep sections. As an illustration of how much water might have flowed here, note the flood flattened vegetation along the burn on the left.

The LLTNPA has effectively created a new course for water to flow down the hillside in times of heavy rain. On footpaths this steep the standard practice is to install water bars to channel water off the path in order to prevent erosion. On the Glen Falloch roads there is nothing, adding to the watercourse effect.

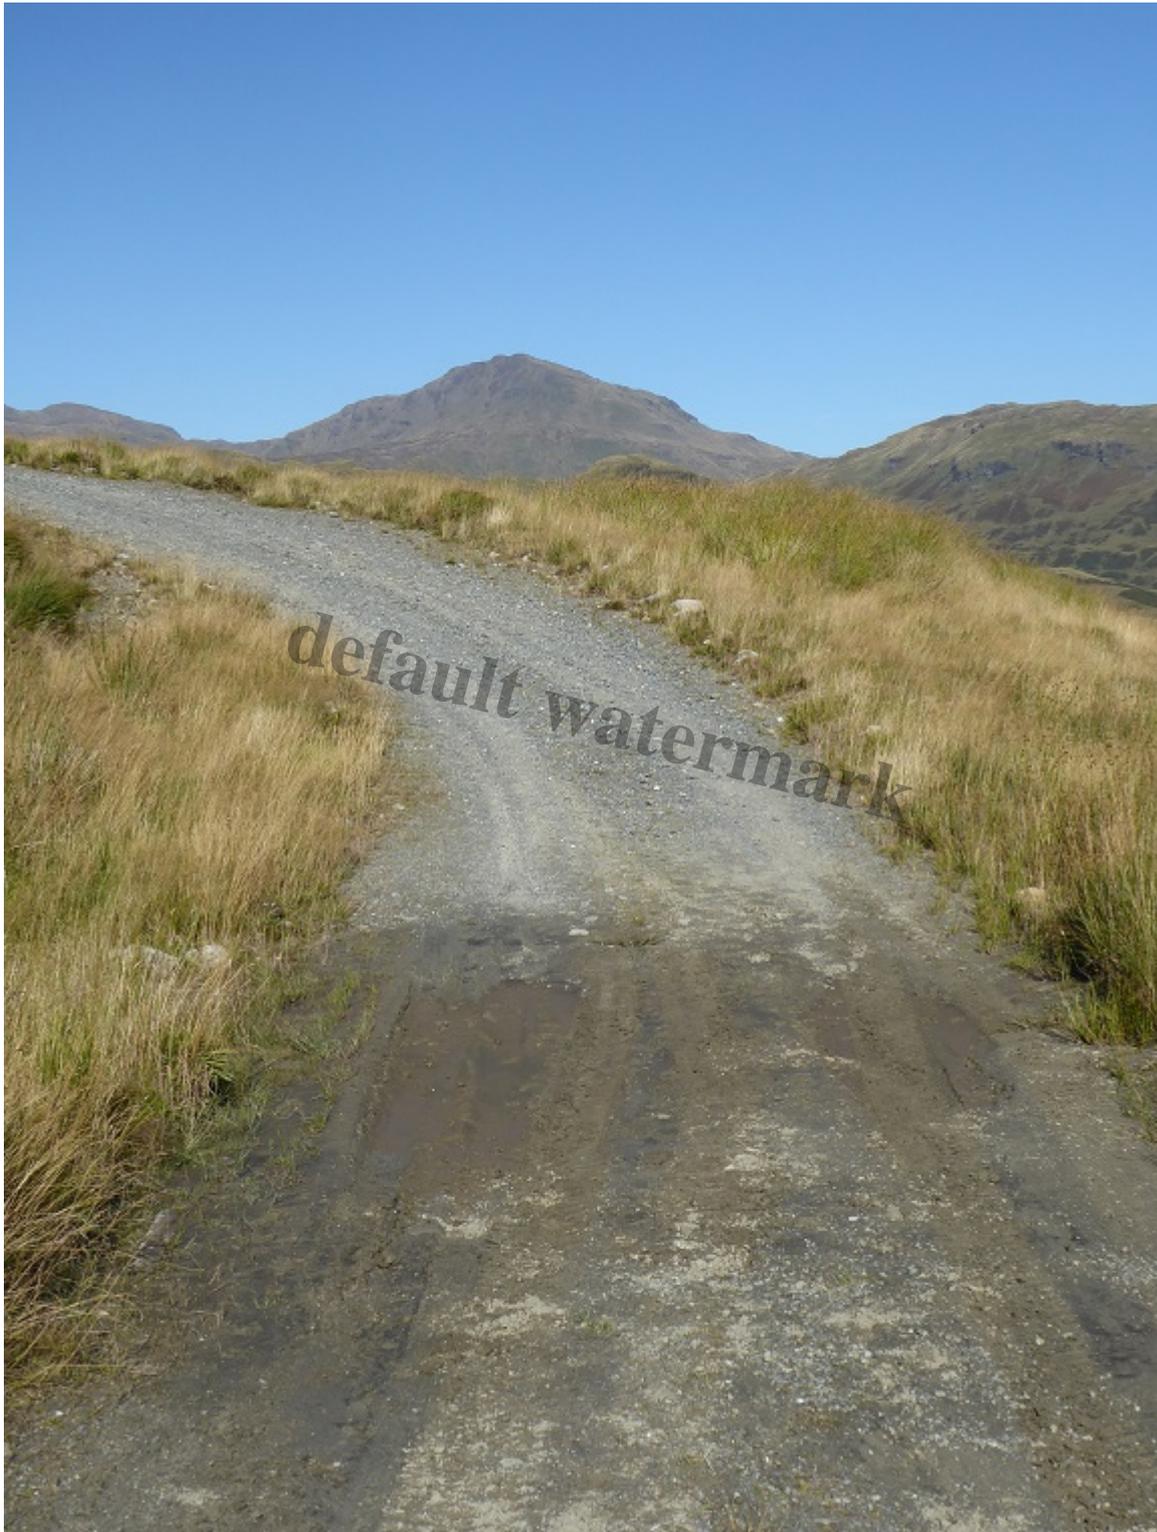
Silt, washed out from the road, accumulating in a dip

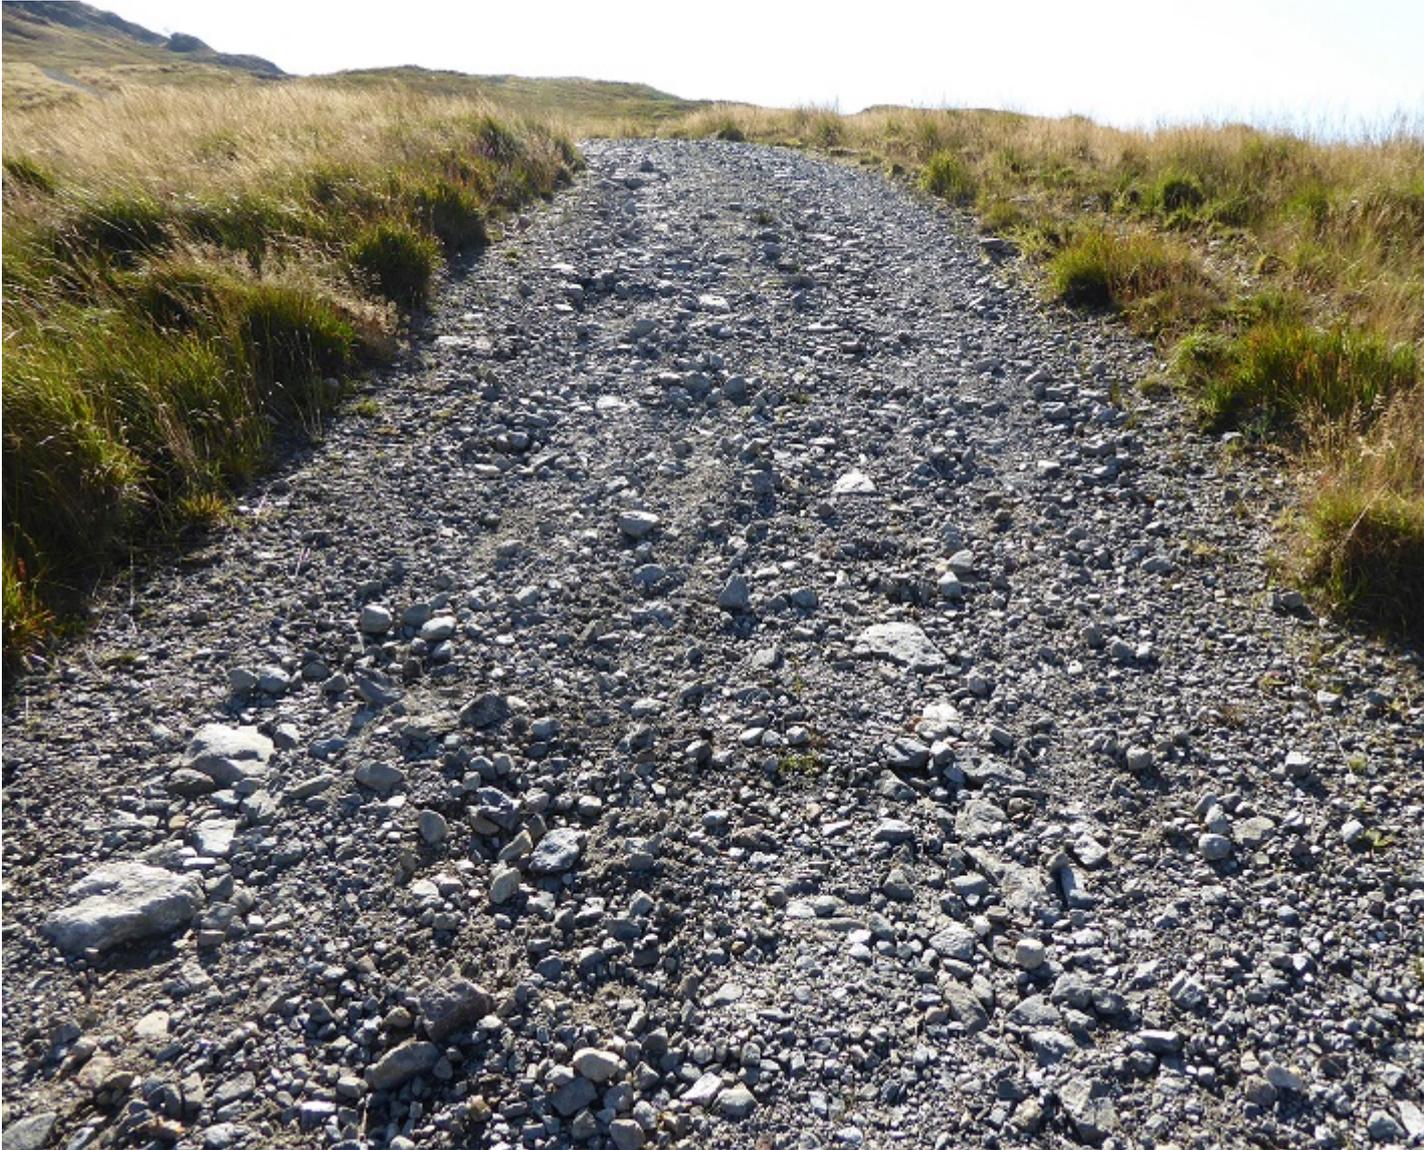
Example of section of road where the fine material has been washed out and where larger stones have started to be moved by the water.

During construction, the Scottish Environment Protection Agency required the contractors to install silt traps to stop fine material flowing into rivers below. That now appears to have been a waste of time because the fine material from the road surface has mostly been washed out leaving a pebbly surface.

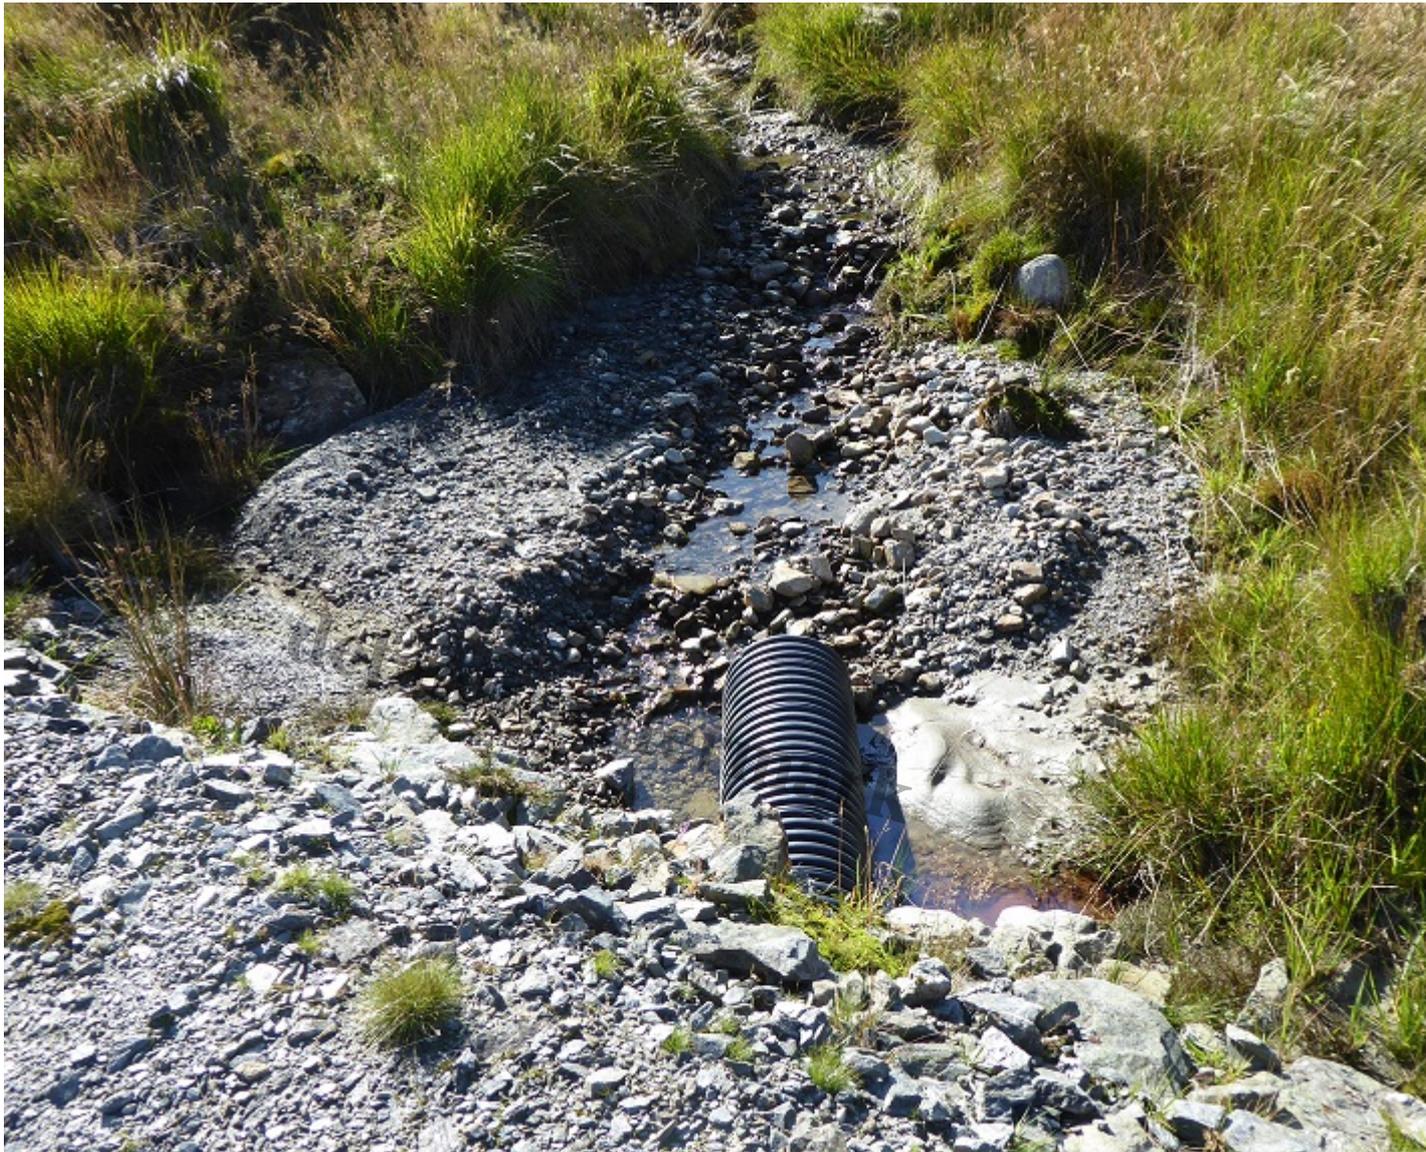
One of many protruding plastic pipes along the new road, silt visible to right, gravel wash out to left. also the eroding side of the track above the pipe.

The lack of finishing, betrays a lack of concern about both the landscape and the environmental consequences of these roads.
