## Climate change and Glen Falloch (5) – the impact of the hydro roads on the natural environment

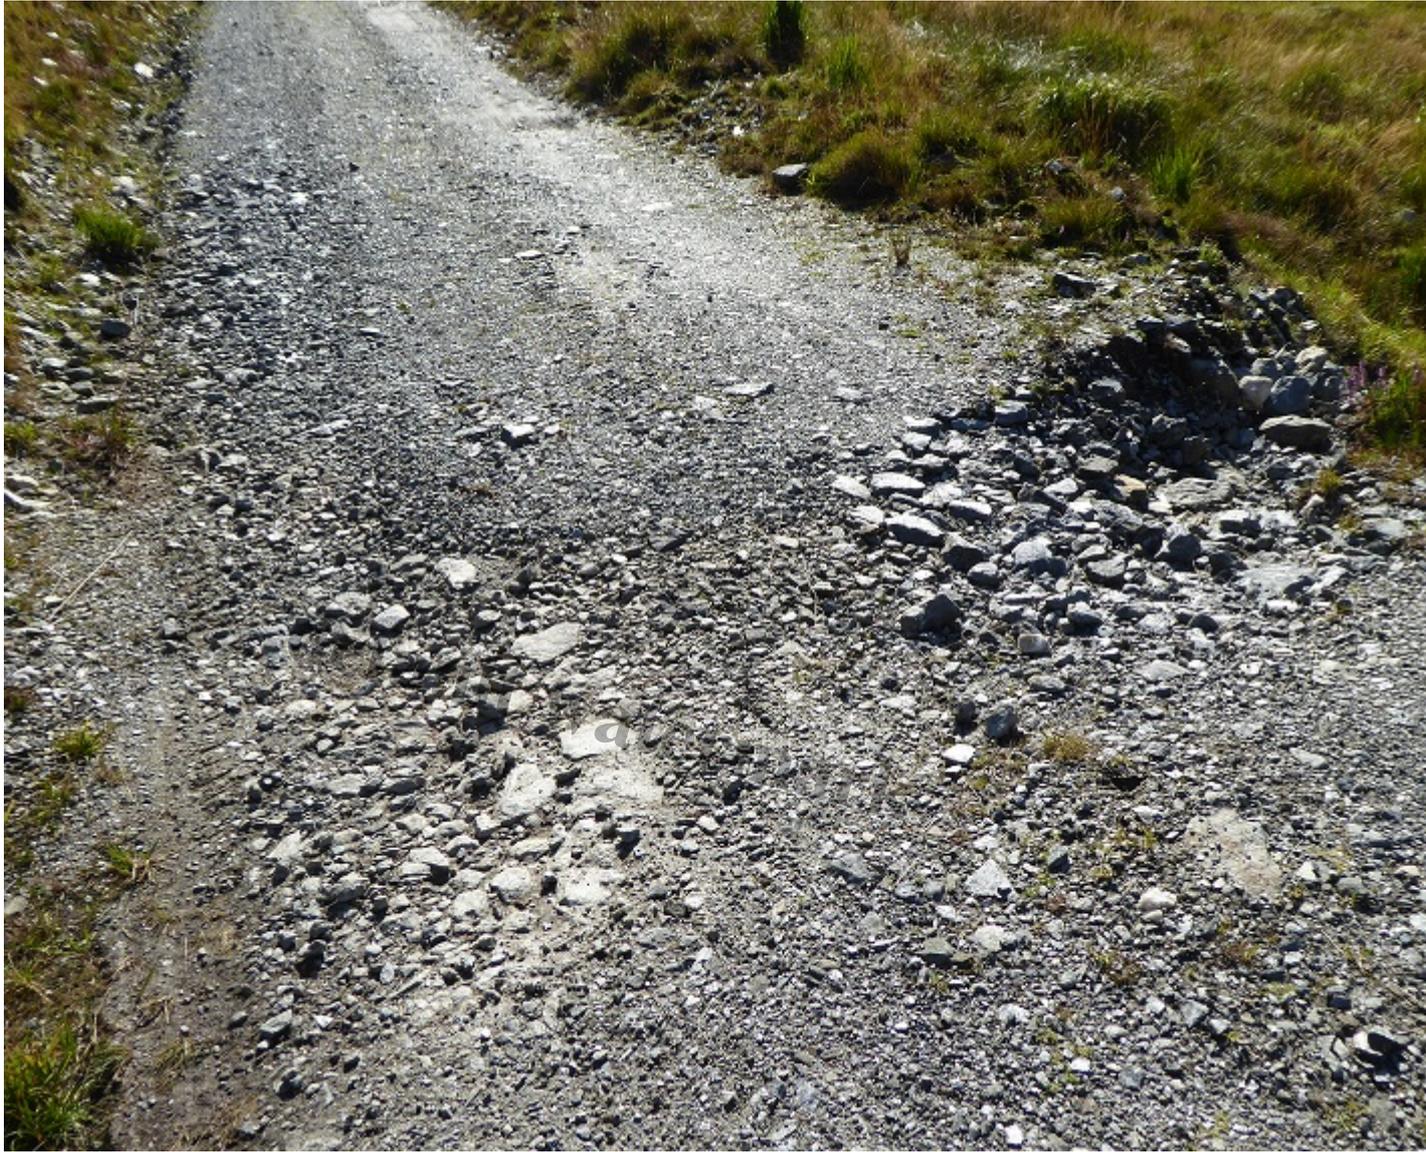
Collapsed section of road caused in part by water flowing across it and eroding its edge.

There was one place on the Ben Glas hydro road where its edge had completely collapsed. There are many other sections where this is likely to happen in future. Without remedial action the road risks becoming unusable just a couple of years after it was “finished”. This is not good either for the National Park or for the Estate who will need to fix the damage. The LLTNPA needs to ensure repairs are done properly and address the causes of the problems rather than allowing the estate to take the cheap option of bringing more material up the hill to fill in holes which will then erode again.

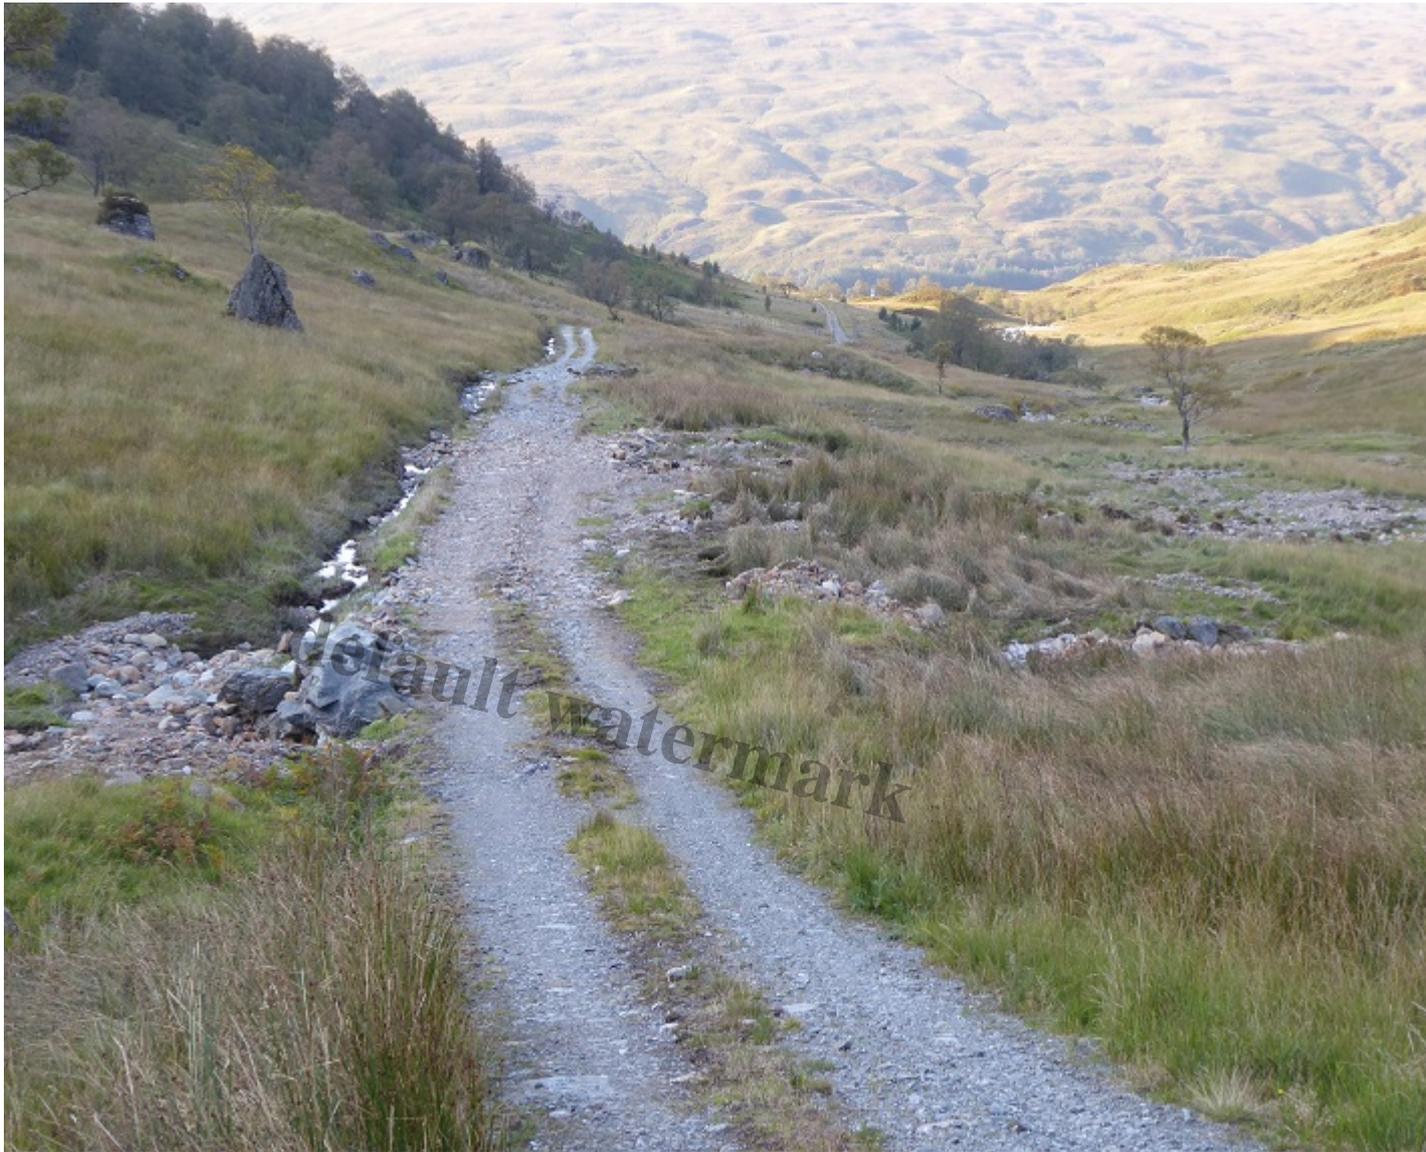
View down Allt a Chuillin road to where burn where third hydro intake is located flooded

The road on other side of Ben Glas appears to have been much better designed and restored, being narrower and having a central grass strip. Indeed its where the LLTNPA Director of Planning, Stuart Mearns, took Mountaineering Scotland and Ramblers Scotland a couple of years ago to show what a good job the LLTNPA was doing restoring hydro schemes ([see here](#)). It was interesting therefore to find that this road had been more seriously damaged by the flood event than the Ben Glas intake road. One possible explanation is that there was more rainfall on the Allt a Chuillin side of the hill.

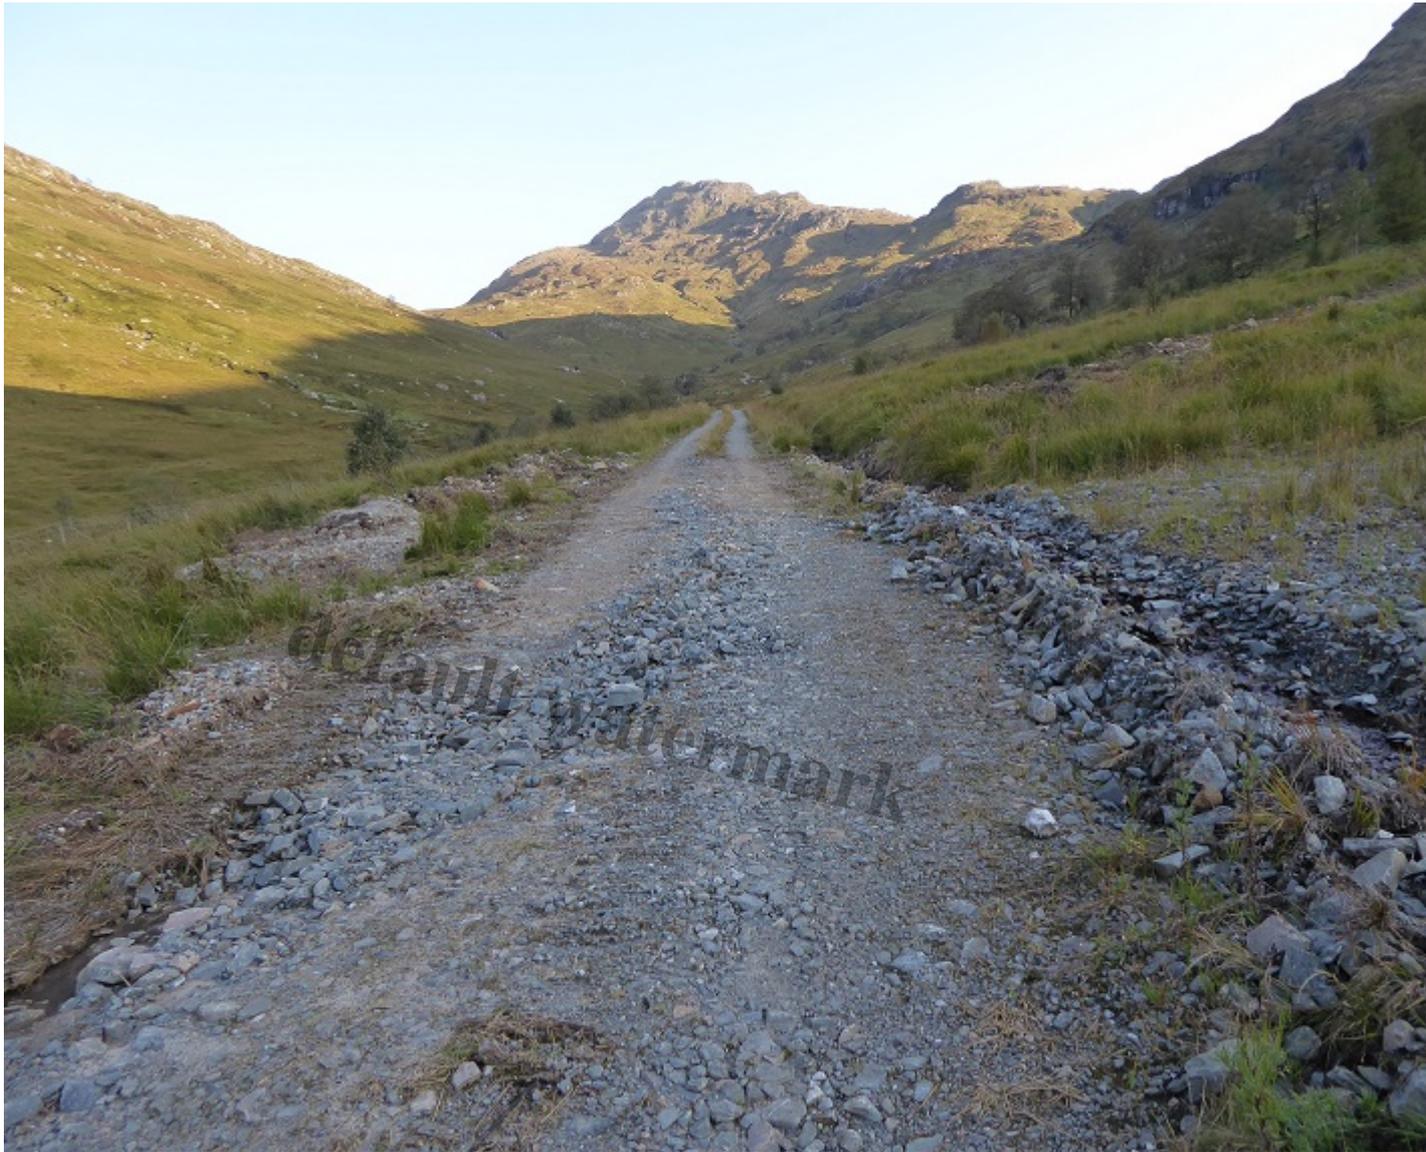
The view of the flood damaged area from below, showing how the central grass strip and part of surface swept away, with recent ditch work on right.

Another explanation is that this road, sitting as it does below the slope on the right, was exposed to debris and water coming down the hillside for far more of its length while the absence of zig zags, as on the Ben Glas road, meant there was little to interrupt the flow of the water once it reached the road.

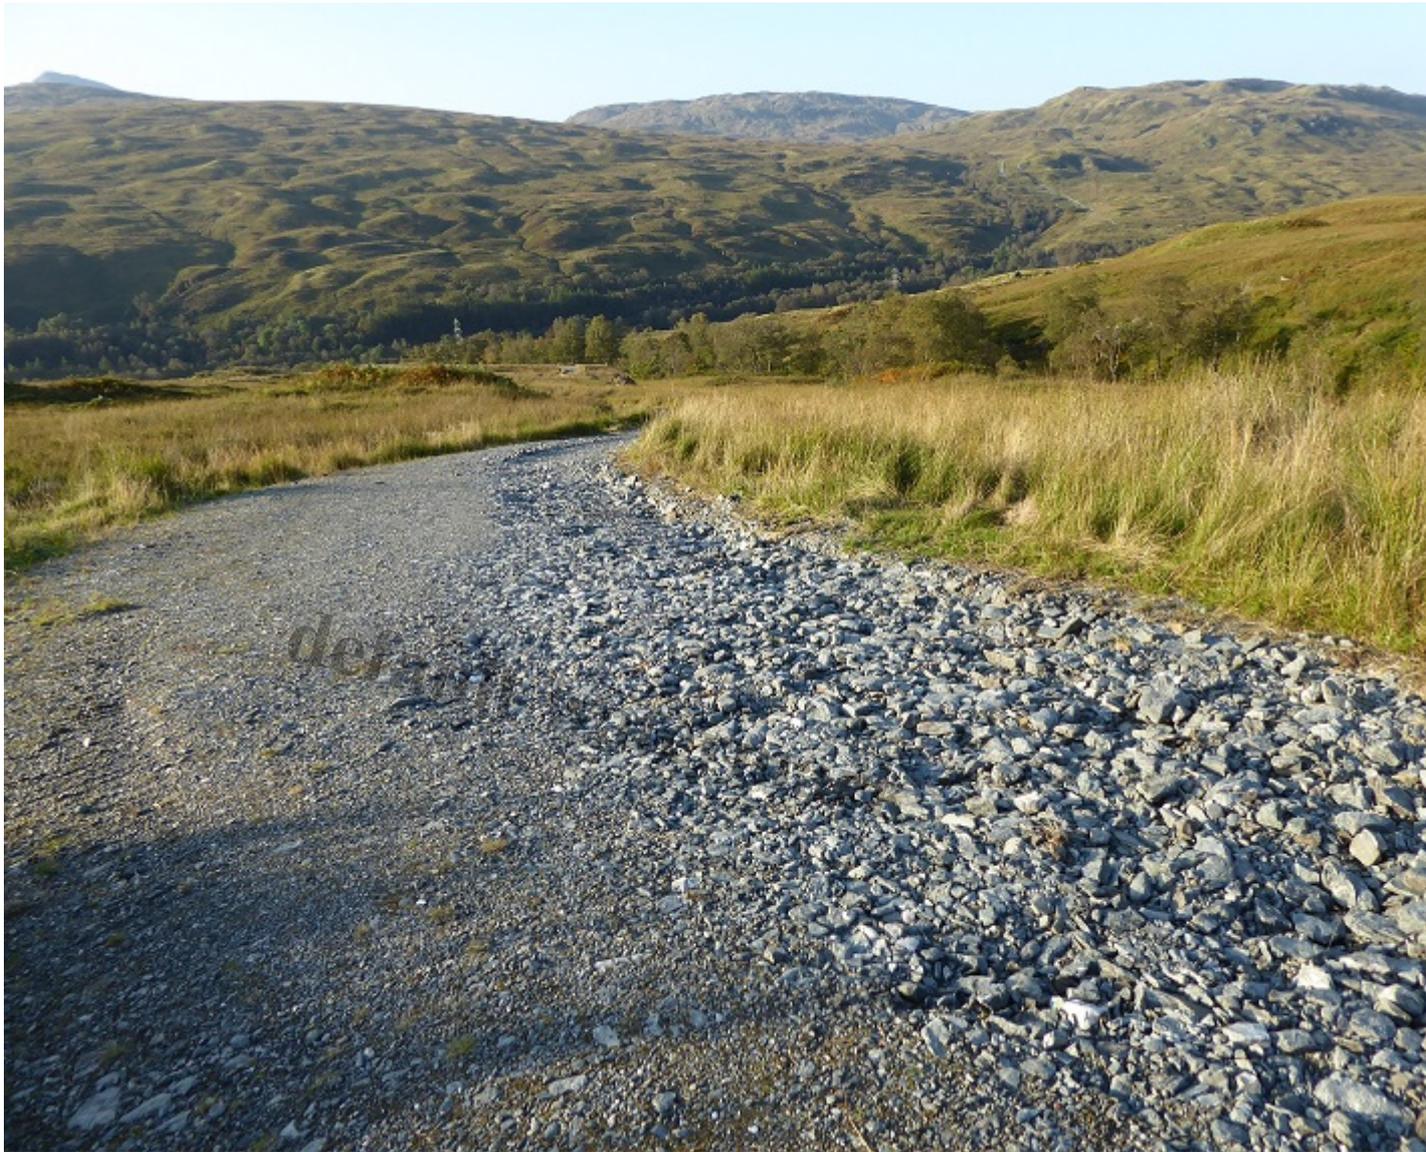
Section of Allt a Chuillinn road, which is more like a motorway than a track and contrary to LLTNPA specifications, with serious wash out on right side

That water was channelled down the road is supported by evidence of increasing levels of damage lower down.

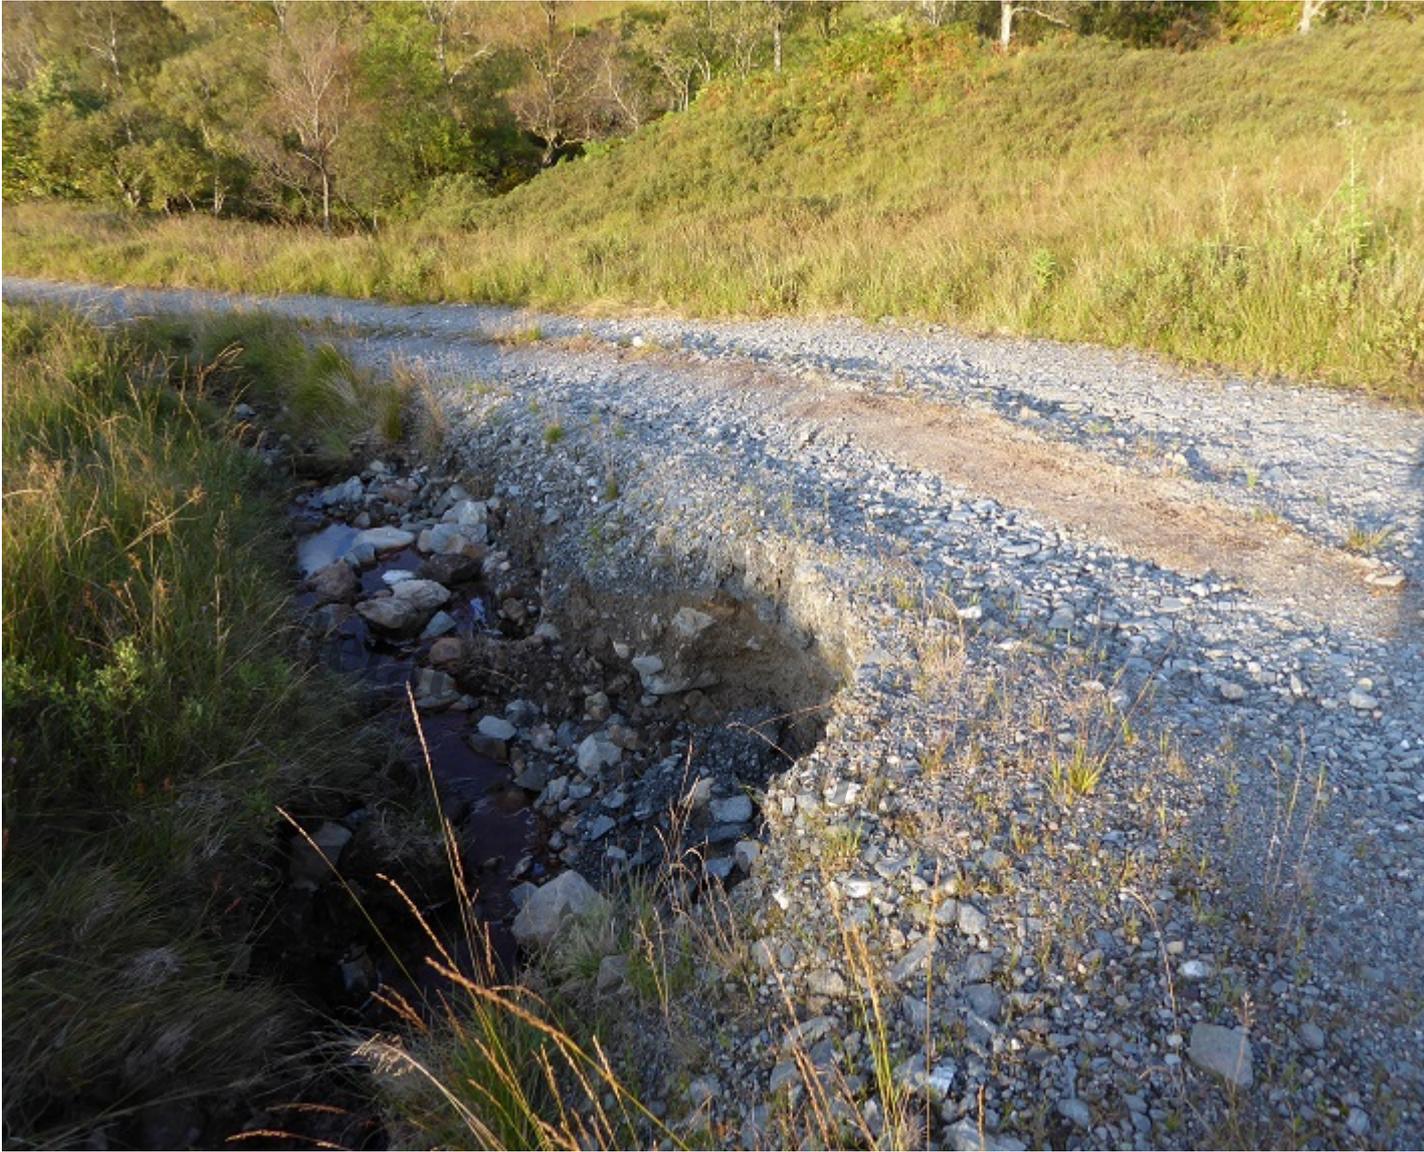
Edge of track eroded away by flood and now threatened with collapse

This section of eroded track side was below a well vegetated and restored section of ditch. It would appear that having vegetated ditches is not in itself sufficient to prevent damaging amounts of water being channelled down them during a storm event.

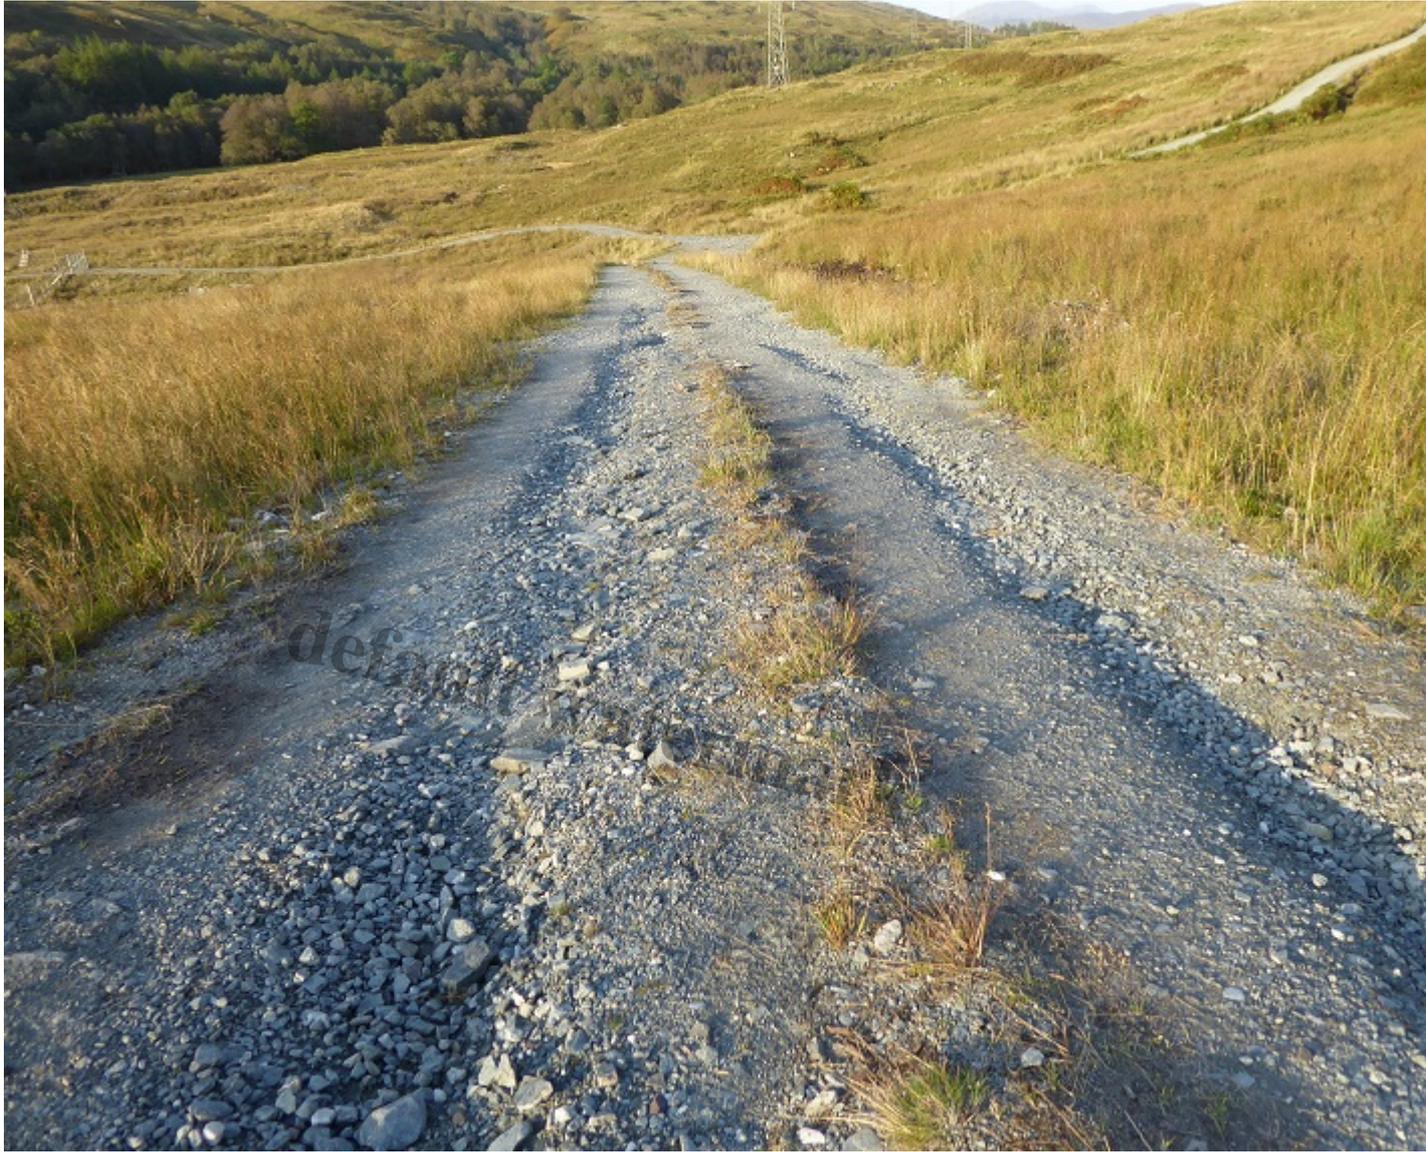
Approaching the junction with the West Highland Way erosion channels start to appear

All this provides evidence that these hydro roads, besides being prone to erosion and likely to cause a constant problem to the estate, have also served to increase the rate of water flow down the hill. The consequences of that are greater flooding and greater flood damage below.
