## Climate change and Glen Falloch (5) – the impact of the hydro roads on the natural environment

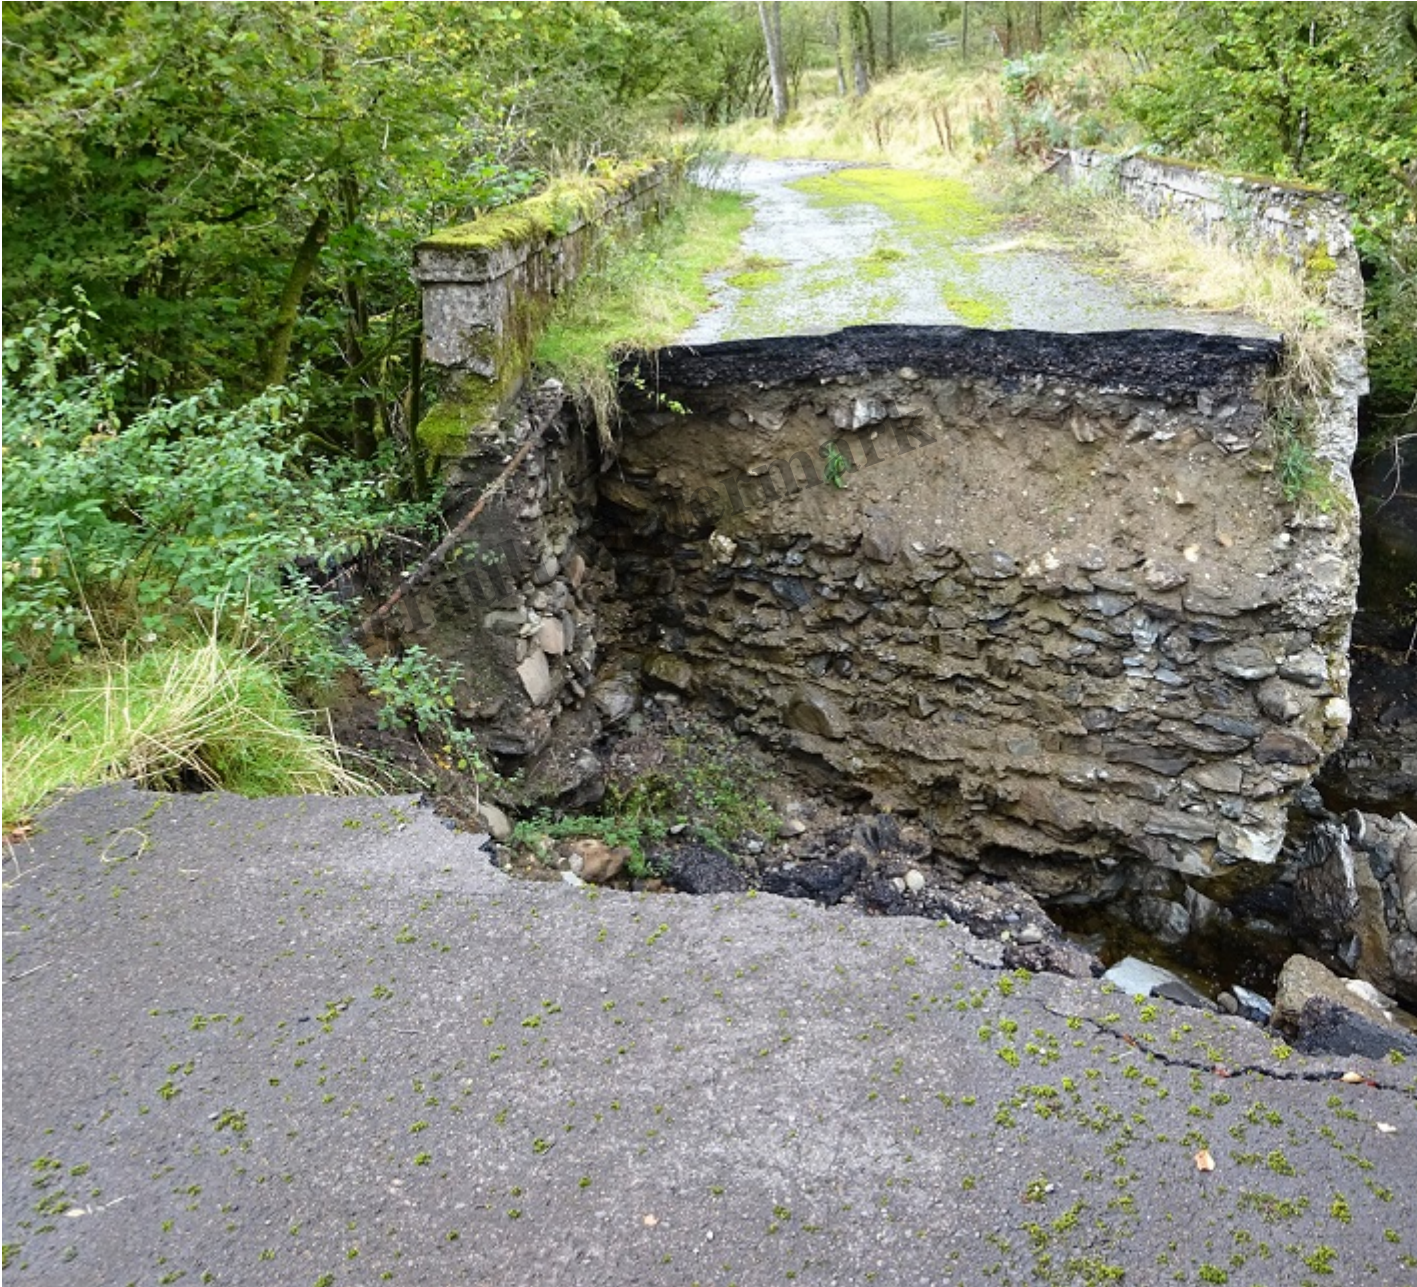
Bridge on the old road in Glen Falloch over the Eas Eonan swept away by the floods – could the hydro Eonan intake have helped cause this?

Returning to the first photo in this post, could flow of water down the new Eas Eonan hydro road have been what triggered destruction of the bridge over the burn?

Assuming the Eas Eonan hydro continued to function during the storm, some of the water that would have descended the burn would have gone through the pipe avoiding the bridge and lessening the flow there. One could argue therefore that by reducing the amount of water flowing down the burn the hydro pipes delayed the destruction of the bridge.

At the same time, however, the new track, its bare banks and associated ditches have served to drain and channel water and debris off the hill far more quickly than previously and, in the case of the Eas Eonan track, all the drainage ditches feed water into the main burn above the former bridge.

We will never know whether this is what caused the road bridge to fail. What we can be fairly certain of, however, is that hydro schemes do speed the rate of water run-off from the hill, both because of the pipes – which take a direct and unimpeded course compared to the burns – and the hill roads. They have therefore added to the flood damage caused further down the glen ([see here](#)).

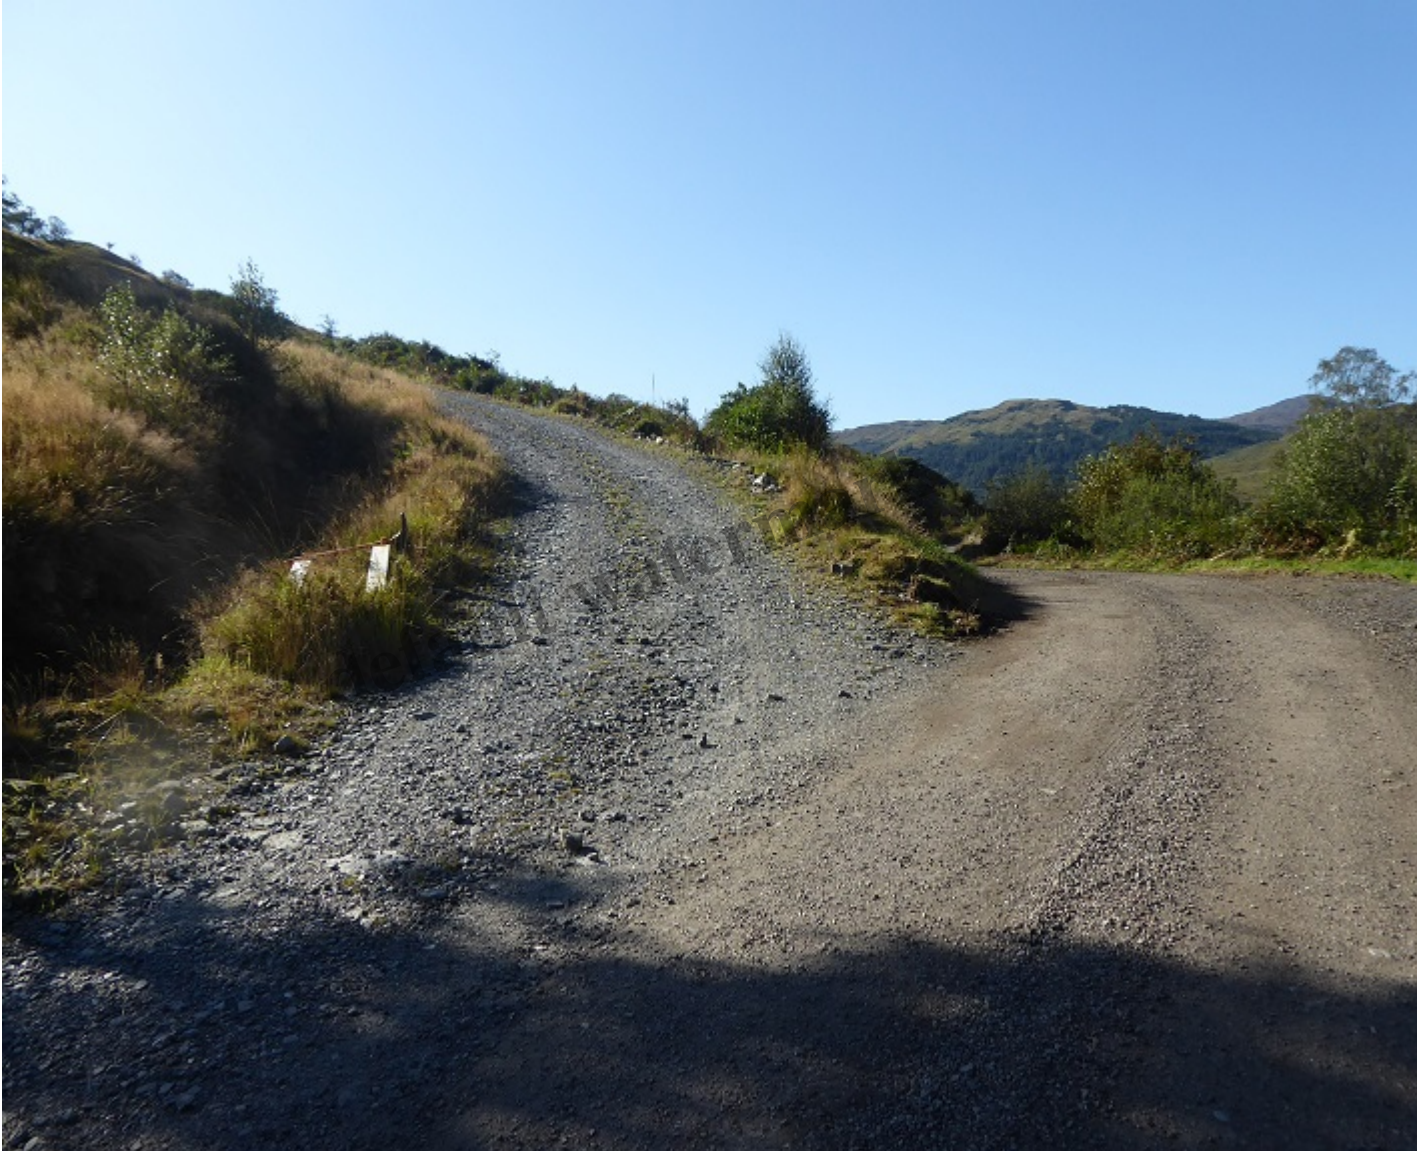
The start of the new Ben Glas hydro hill road illustrating the contrast between its surface, which is already eroding significantly, and the surface of the road below which has retained much finer material

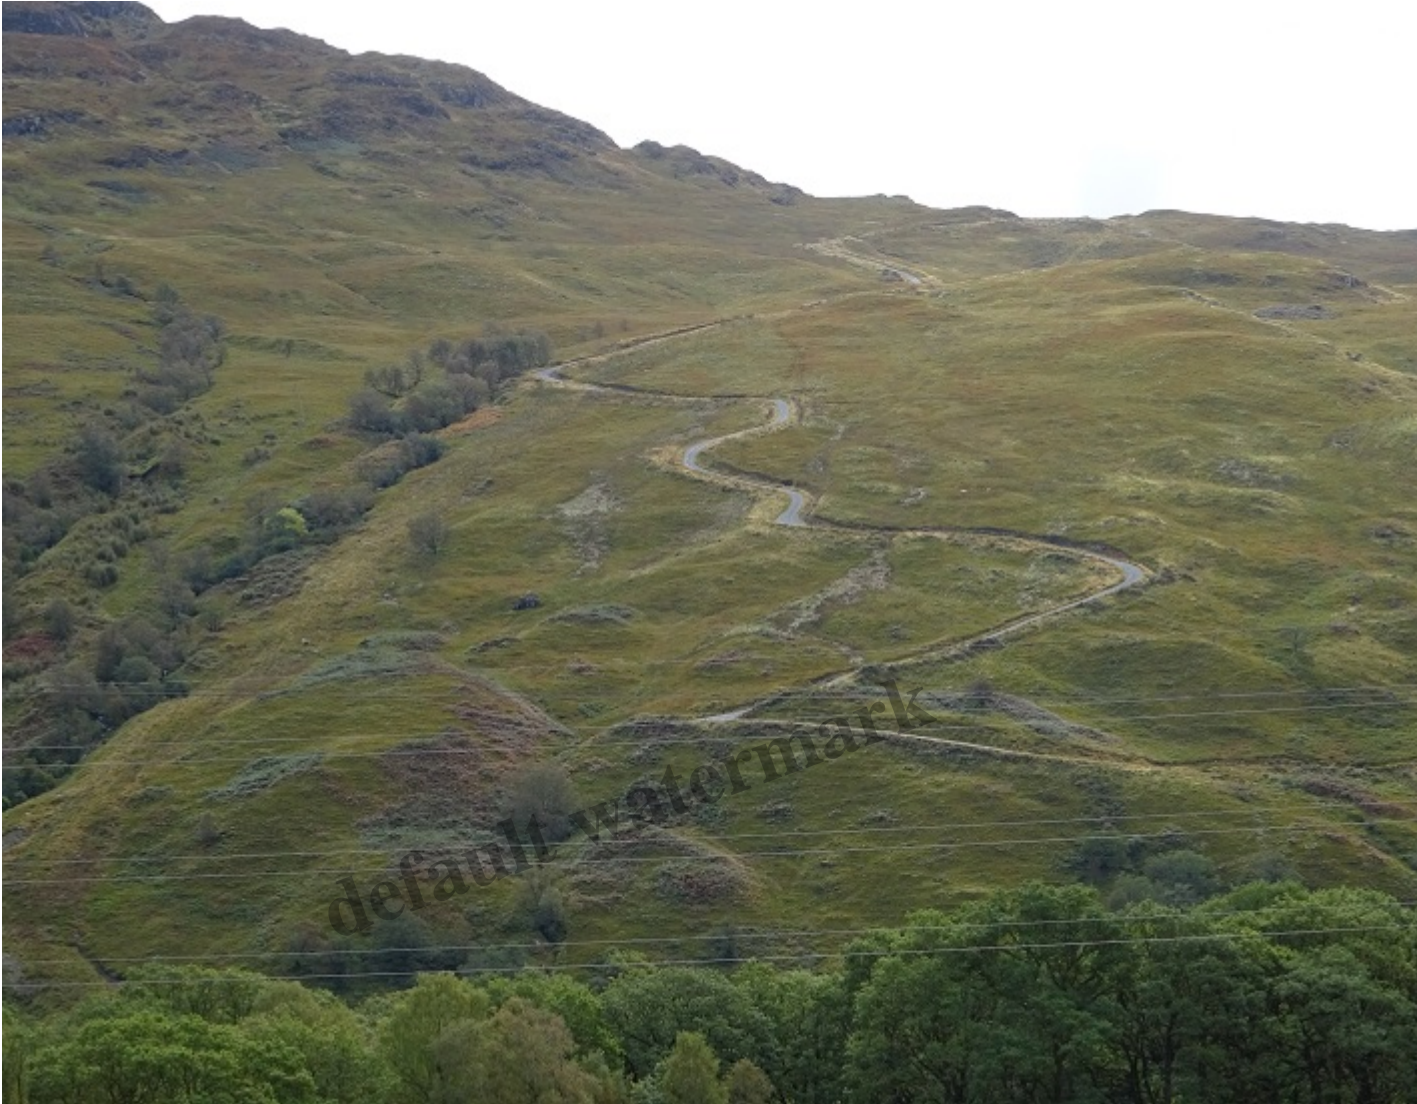
Ben Glas hydro road showing how material has been swept down from the road – from the second bend – onto the slopes below. Photo Credit Kevin McGrath Sept 2019

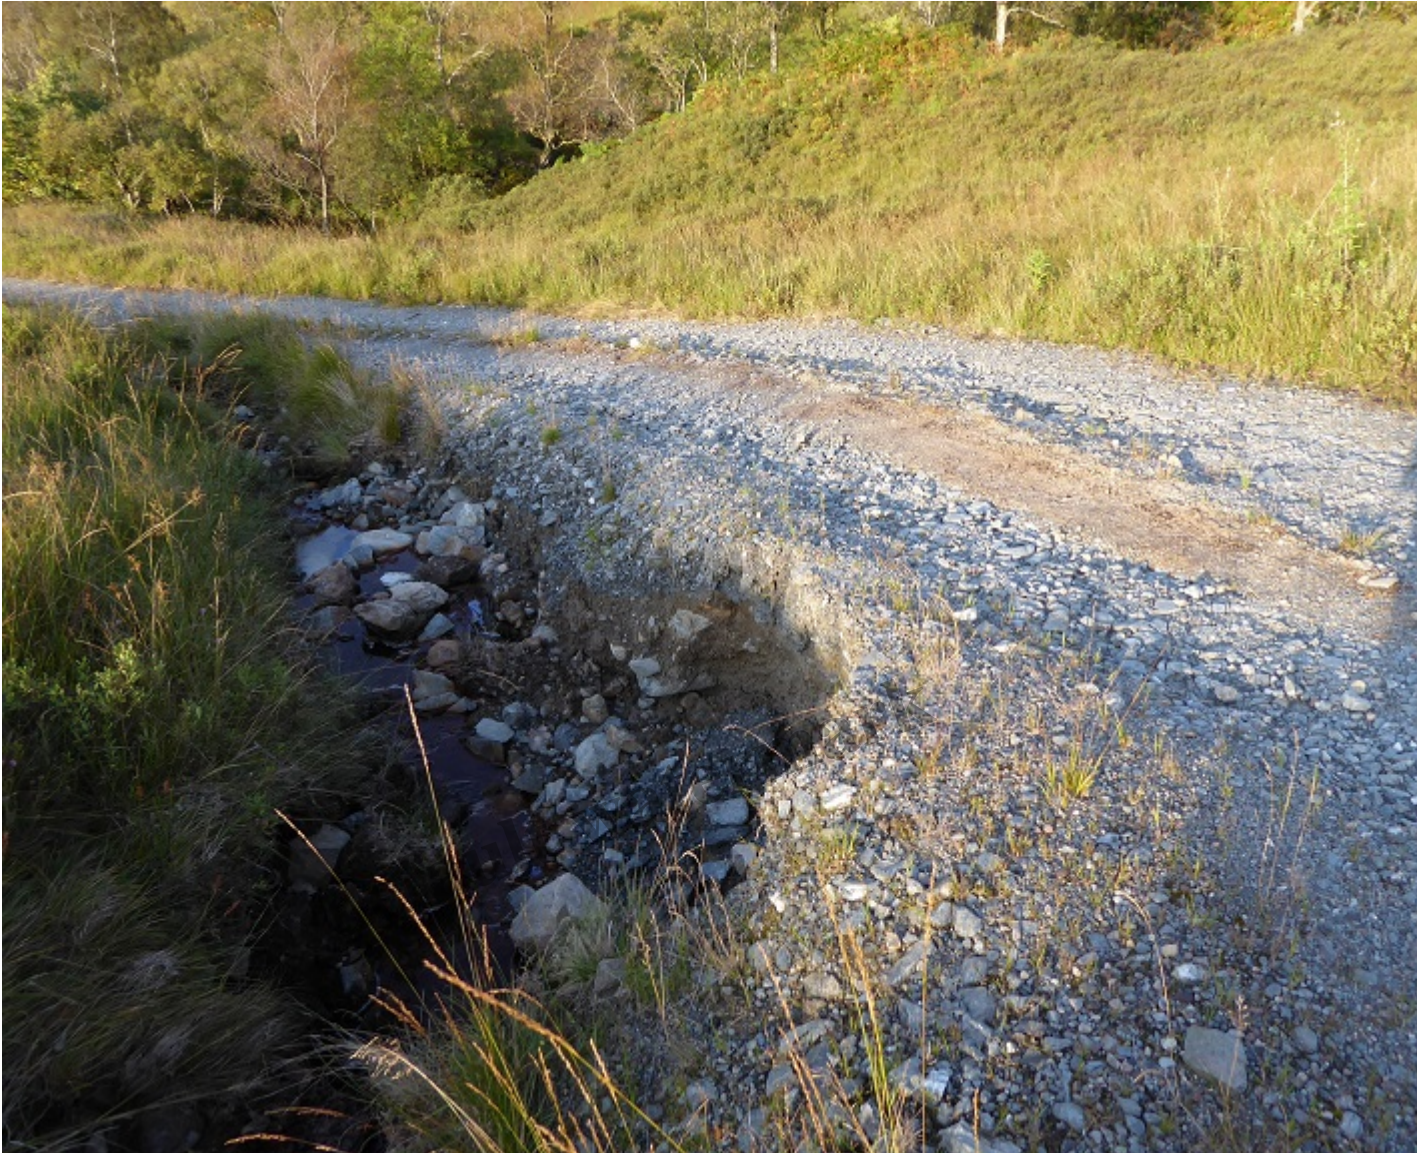
Edge of track eroded away by flood and now threatened with collapse

This section of eroded track side was below a well vegetated and restored section of ditch. It would appear that having vegetated ditches is not in itself sufficient to prevent damaging amounts of water being channelled down them during a storm event.
