Climate change and Glen Falloch (5) – the impact of the hydro roads on the natural environment

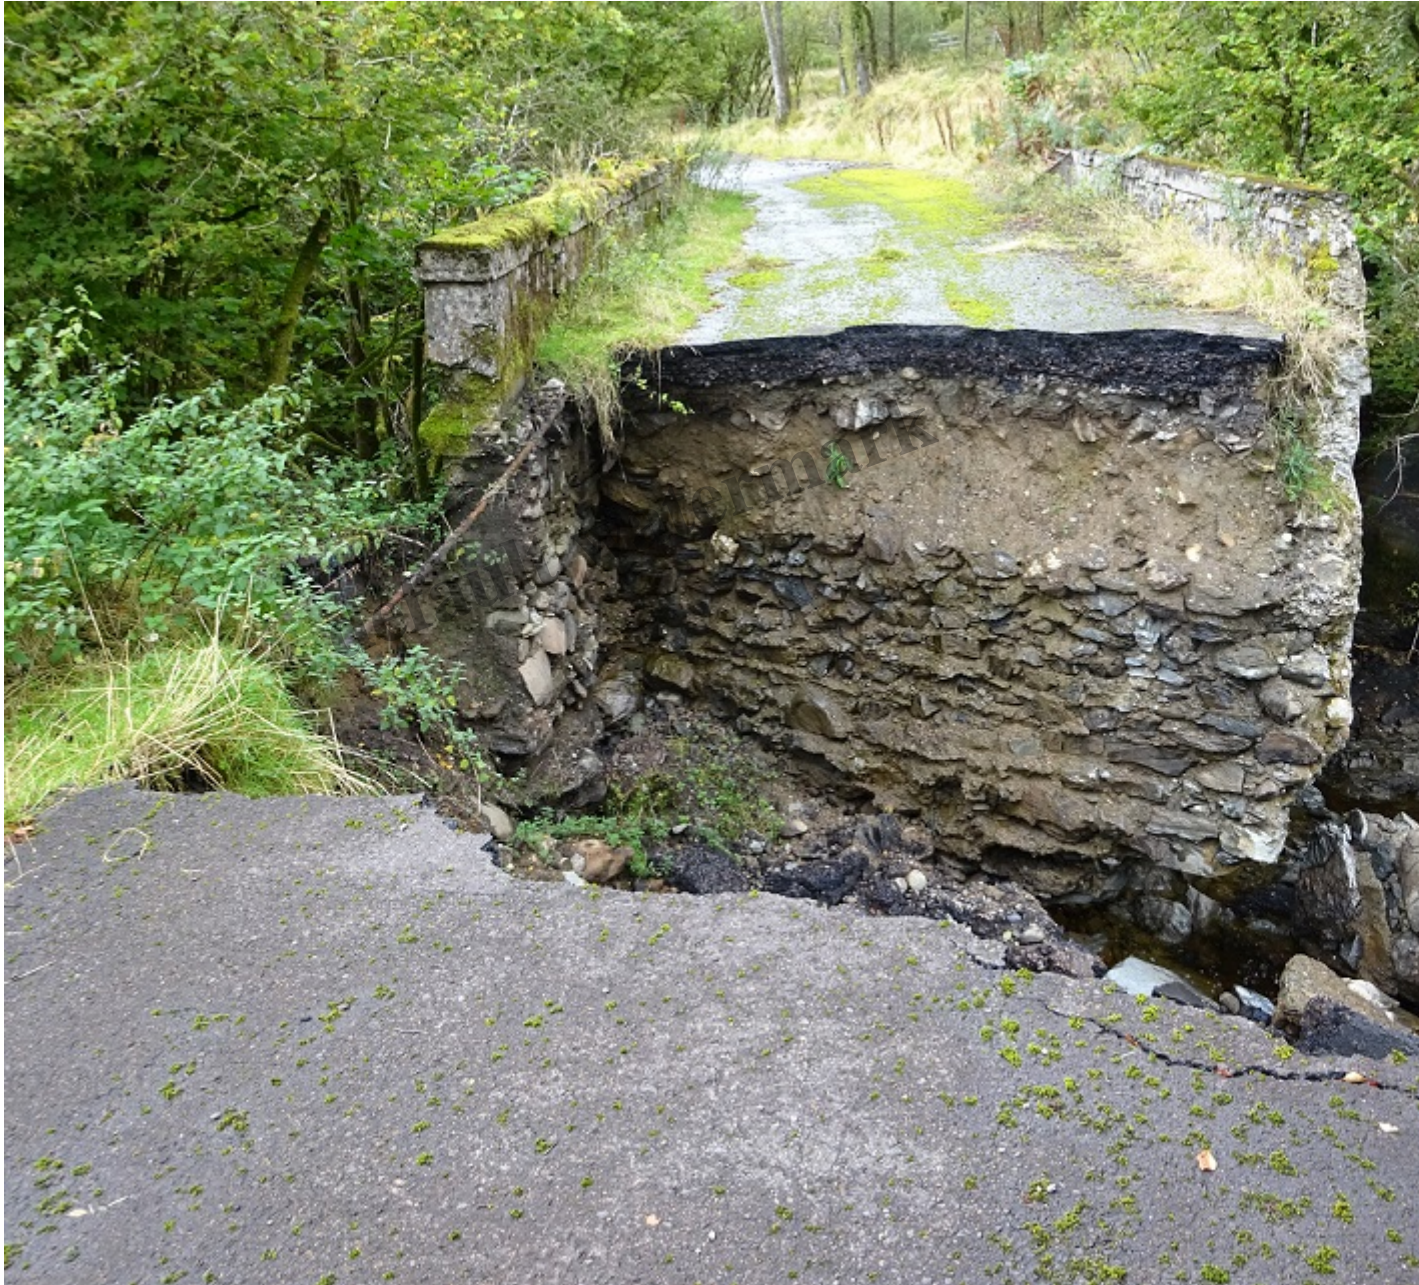
Bridge on the old road in Glen Falloch over the Eas Eonan swept away by the floods – could the hydro Eonan intake have helped cause this?

Returning to the first photo in this post, could flow of water down the new Eas Eonan hydro road have been what triggered destruction of the bridge over the burn?

Assuming the Eas Eonan hydro continued to function during the storm, some of the water that would have descended the burn would have gone through the pipe avoiding the bridge and lessening the flow there. One could argue therefore that by reducing the amount of water flowing down the burn the hydro pipes delayed the destruction of the bridge.

At the same time, however, the new track, its bare banks and associated ditches have served to drain and channel water and debris off the hill far more quickly than previously and, in the case of the Eas Eonan track, all the drainage ditches feed water into the main burn above the former bridge.

We will never know whether this is what caused the road bridge to fail. What we can be fairly certain of, however, is that hydro schemes do speed the rate of water run-off from the hill, both because of the pipes – which take a direct and unimpeded course compared to the burns – and the hill roads. They have therefore added to the flood damage caused further down the glen ([see here](#)).

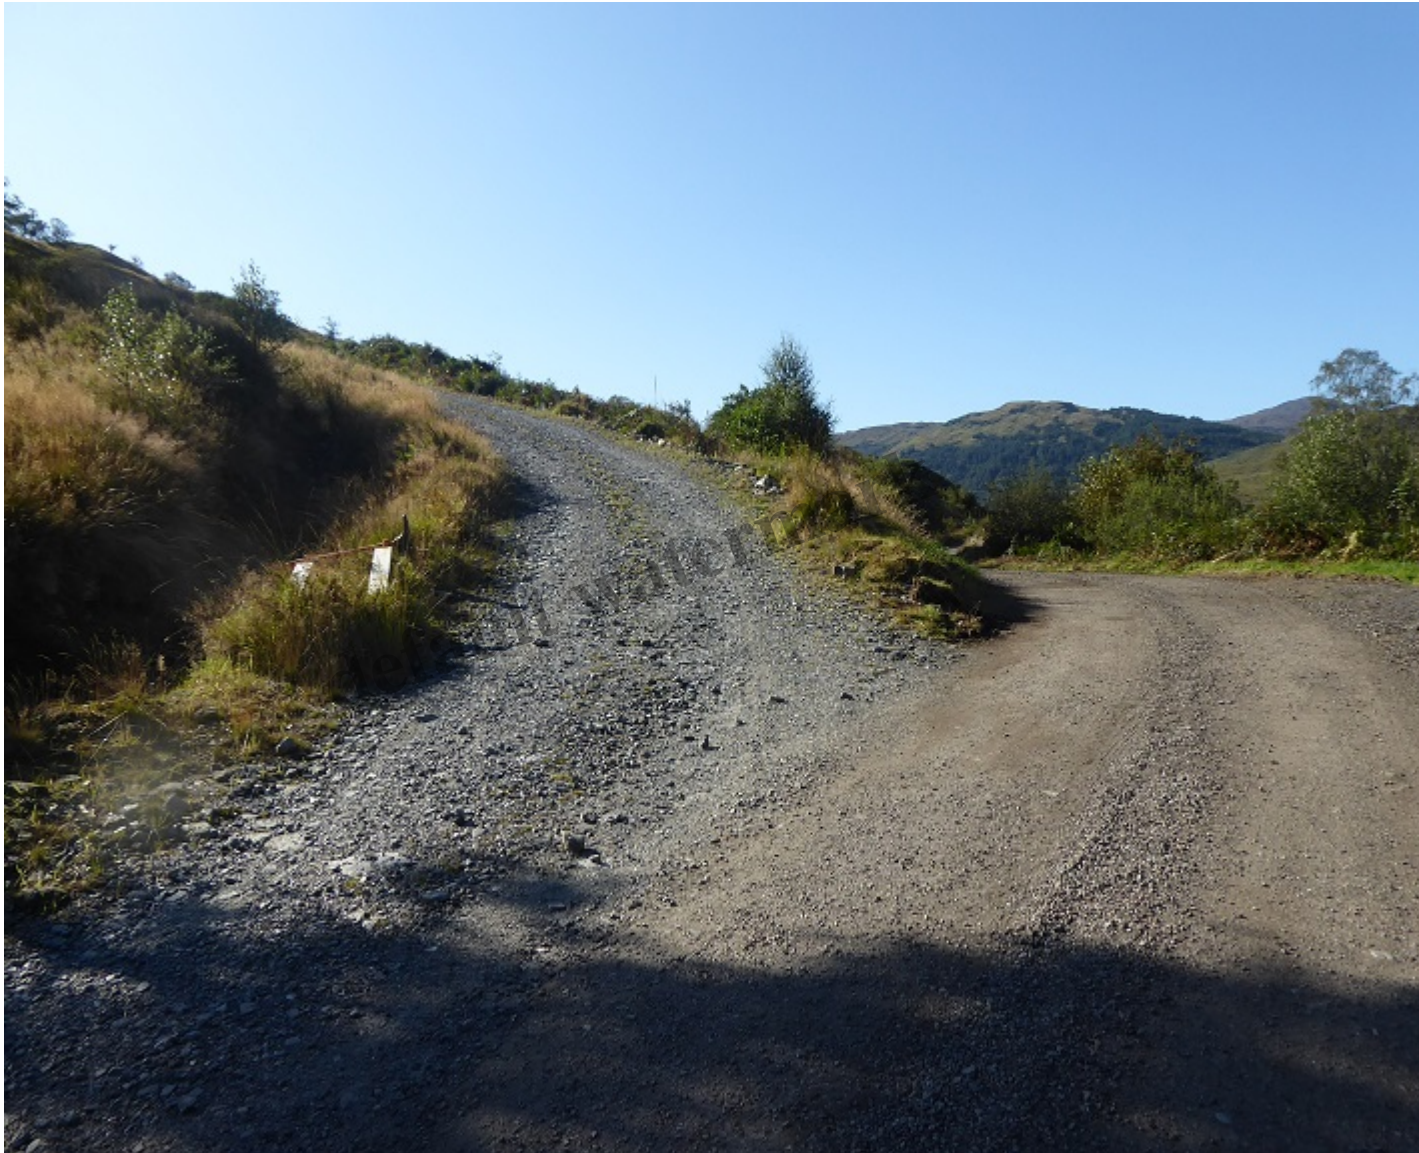
The start of the new Ben Glas hydro hill road illustrating the contrast between its surface, which is already eroding significantly, and the surface of the road below which has retained much finer material

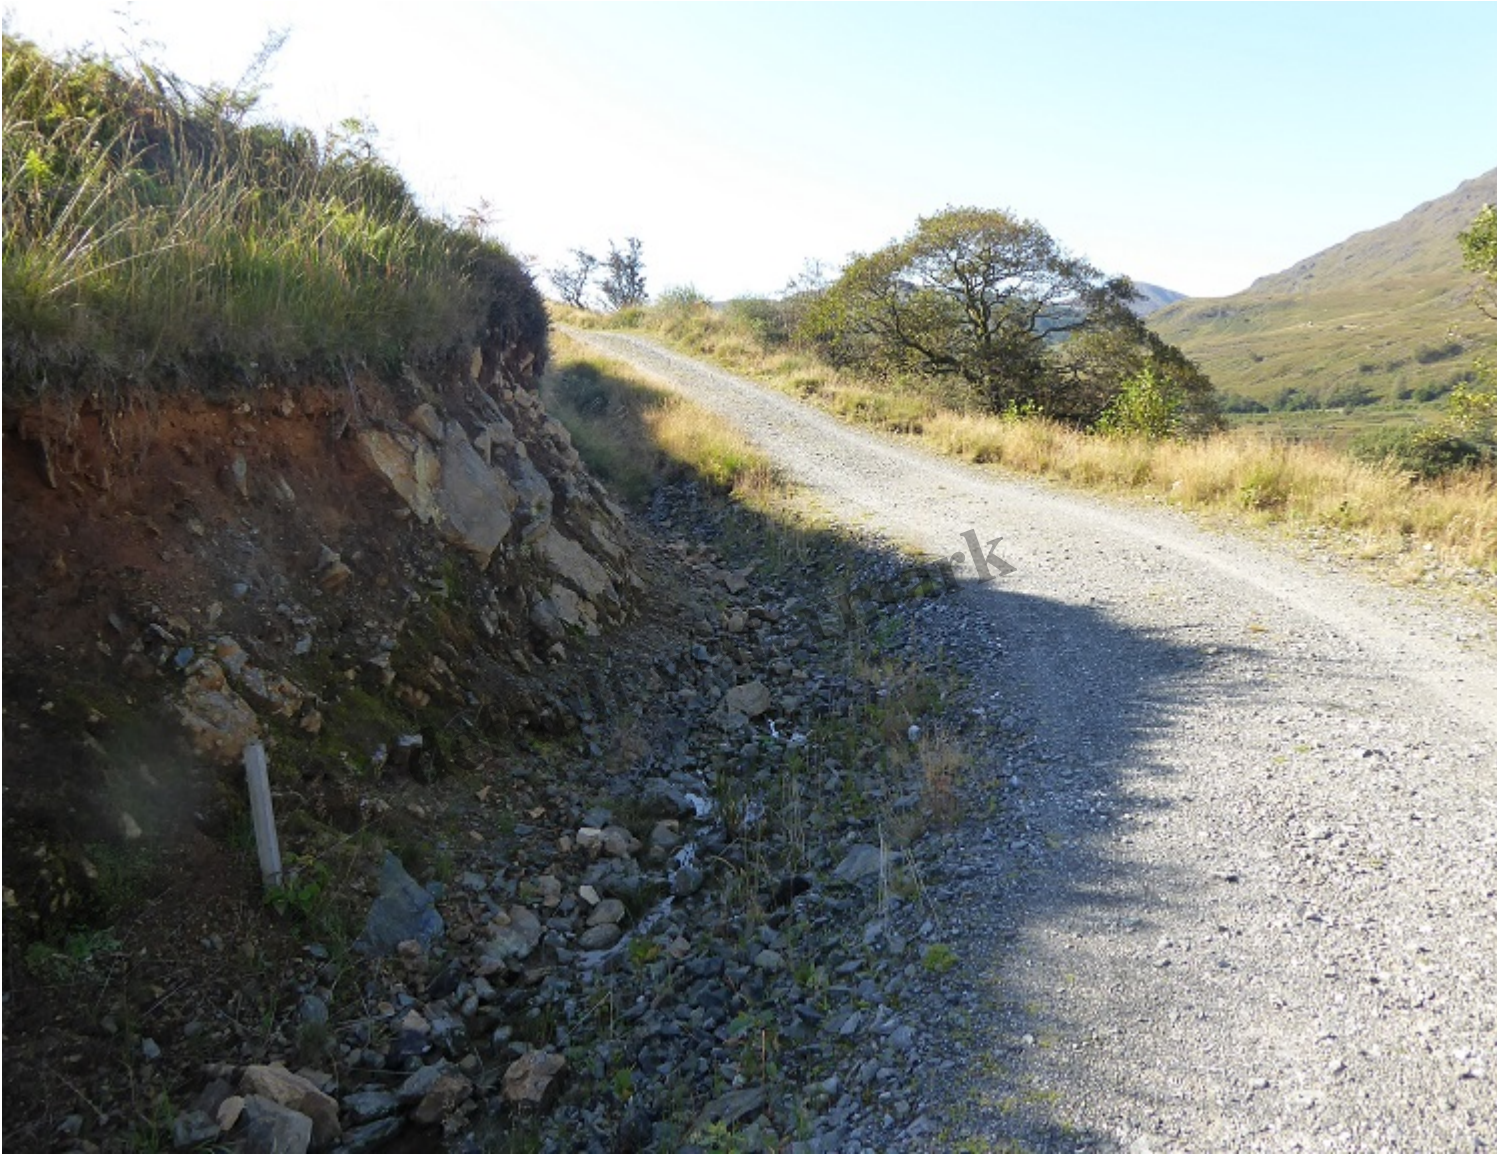
The design flaws are evident from the start. It is too steep and the LLTNPA's Best Practice Guidance on Renewables states that say that hill tracks should not be cut through banks like this (because they are impossible to restore). Why then has the LLTNPA allowed Glen Falloch Estate to leave this in place?

While there had previously been a much smaller landrover track up this slope, which had been followed by the old drove road, the new road forms a great landscape scar. It is also too steep, too wide and has been badly restored.

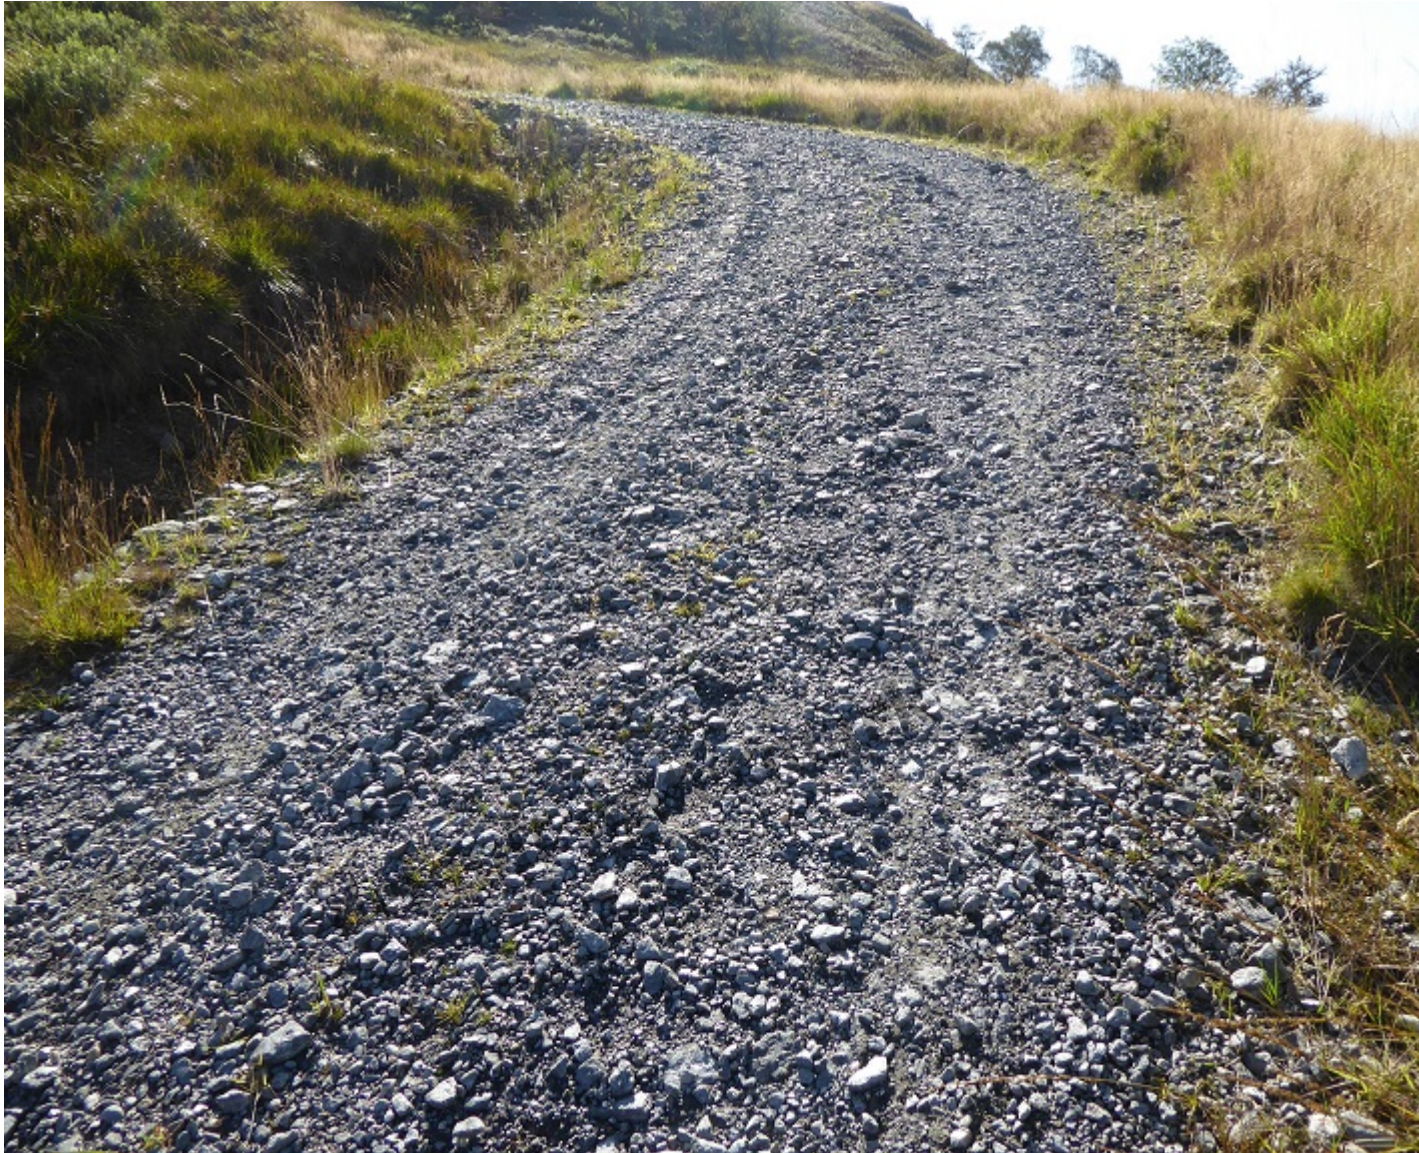
Fine material has been washed out from several sections of the new road and there is now a serious deep ruts developing which would make it unusable for vehicles.

Scottish Natural Heritage's Best Practice Guidance on Constructed Tracks in the Scottish Uplands states that unsurfaced hill roads should not be steeper than 14 degrees. This is because more than that and they are at severe risk of erosion. The LLTNPA's own Best Practice Guidance endorses SNH's guidance, yet their planners have allowed this road, with several very steep sections, to remain. The consequence is that it is eroding badly and the estate will sooner or later need to bring in more material to repair the surface, material which in its turn will then get washed away.

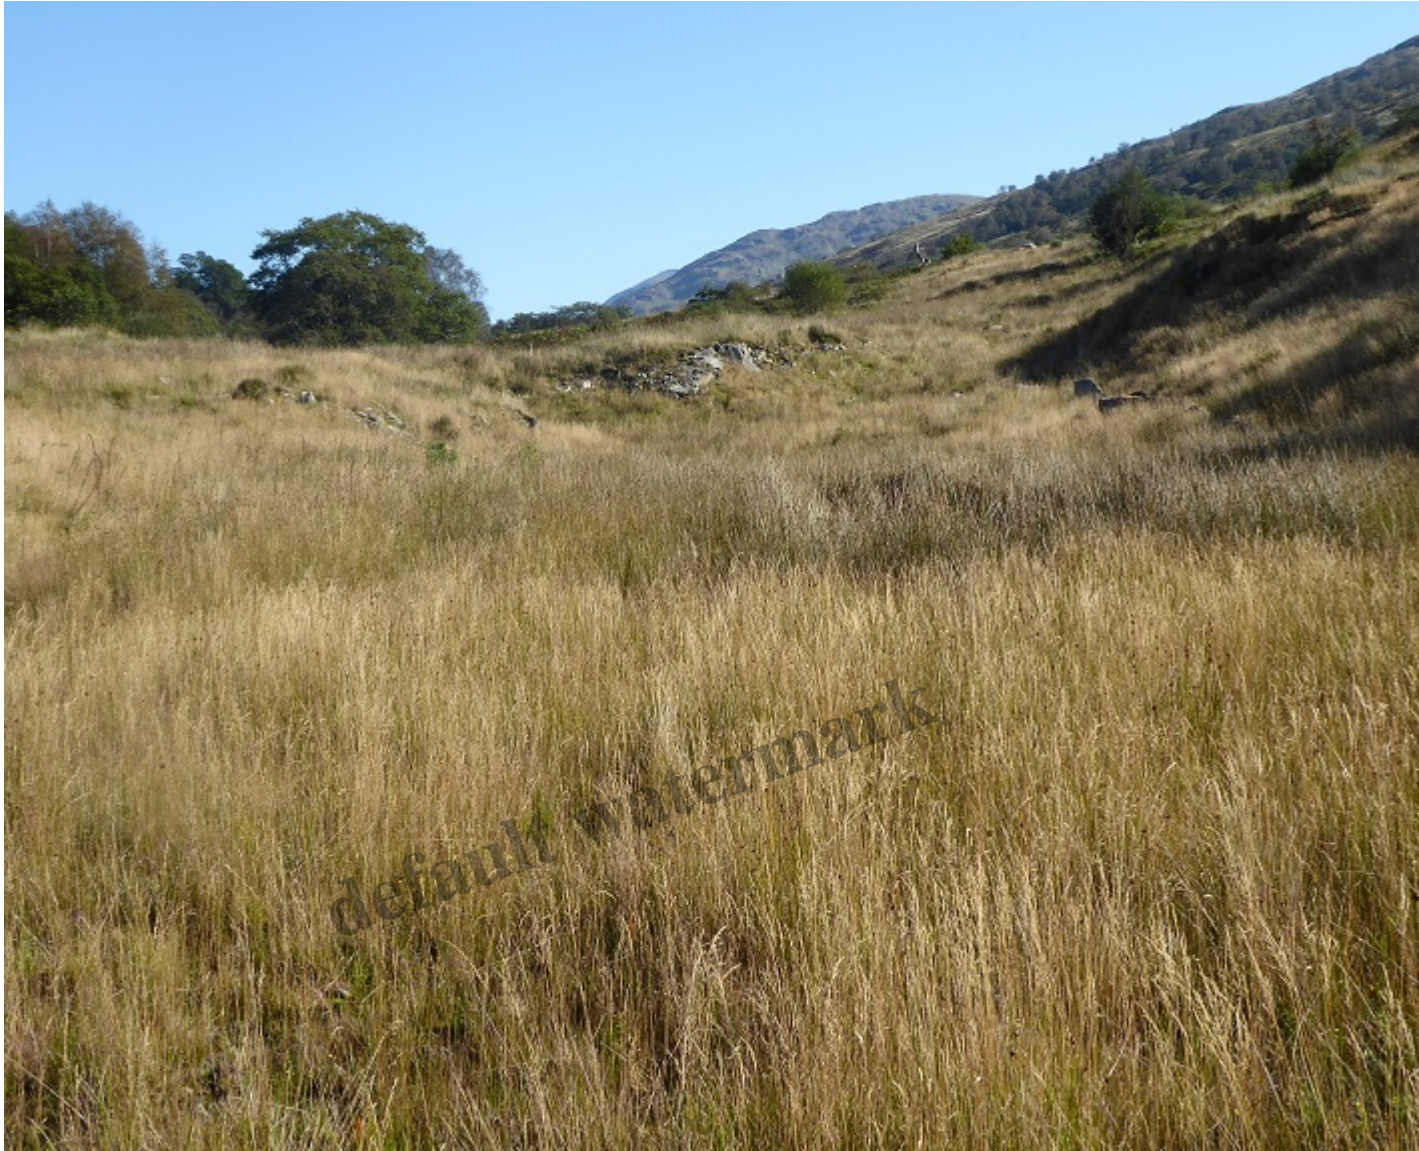
The very large borrow pit just above the Ben Glas powerhouse. Material to construct the new roads excavated from between the bank on the left to the bank on the right to leave this wide depression.

While the borrow pit itself is low down, which has helped vegetation recolonise the site, much of the material taken from it up the mountain is now washing back down the hillside:

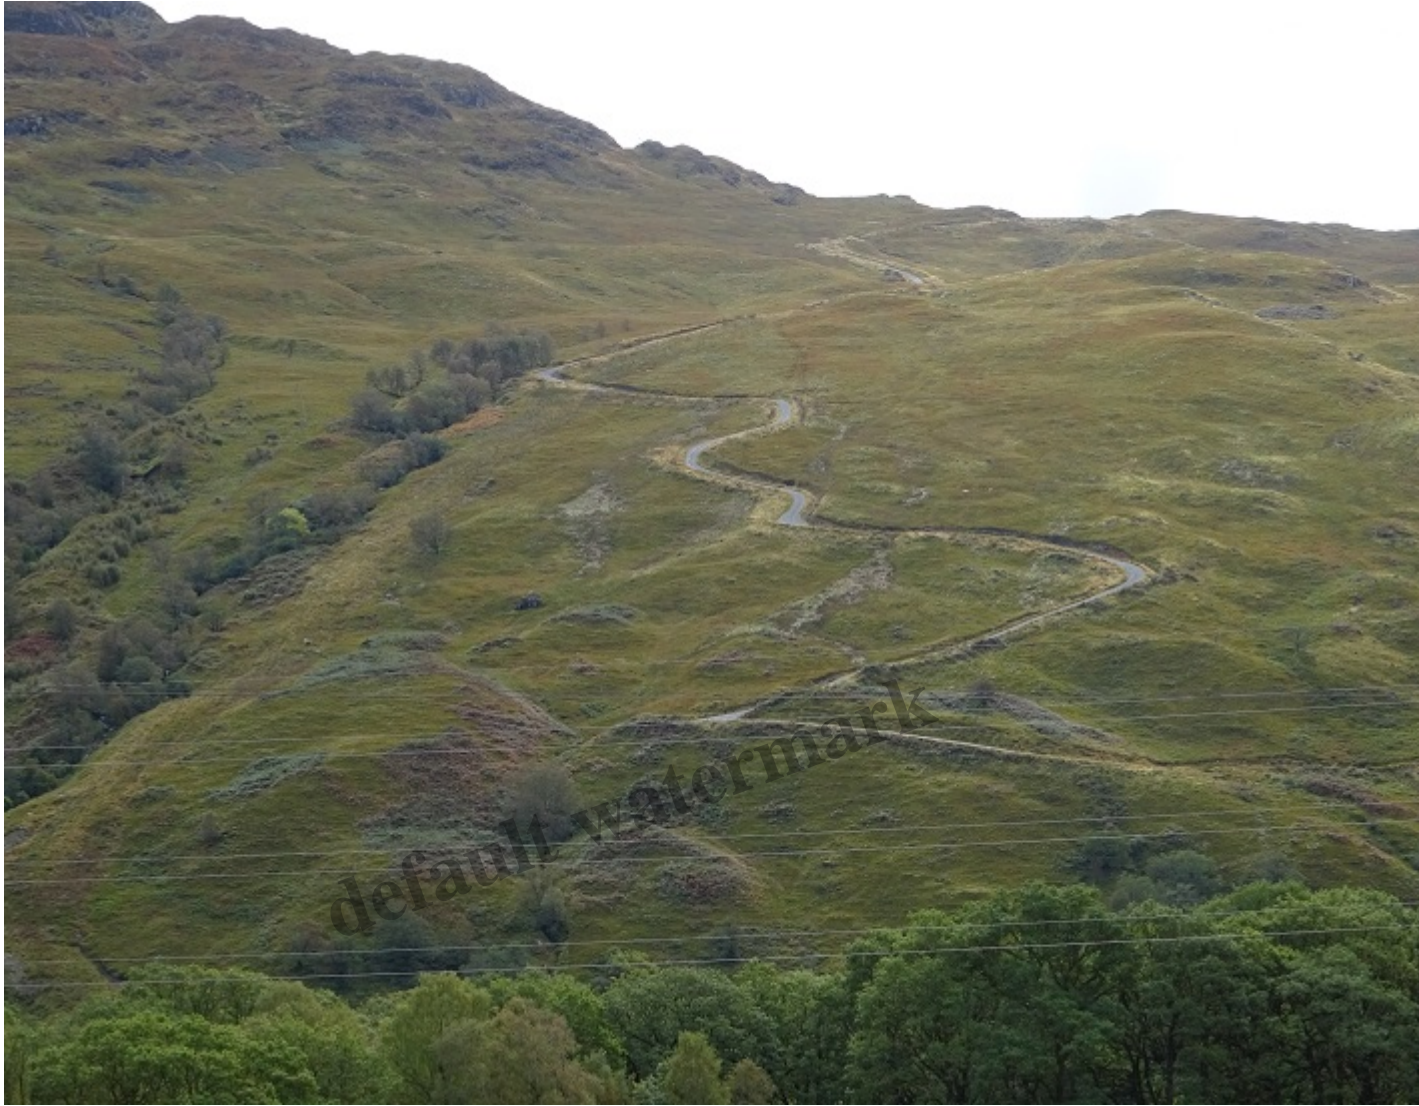
Ben Glas hydro road showing how material has been swept down from the road – from the second bend – onto the slopes below. Photo Credit Kevin McGrath Sept 2019

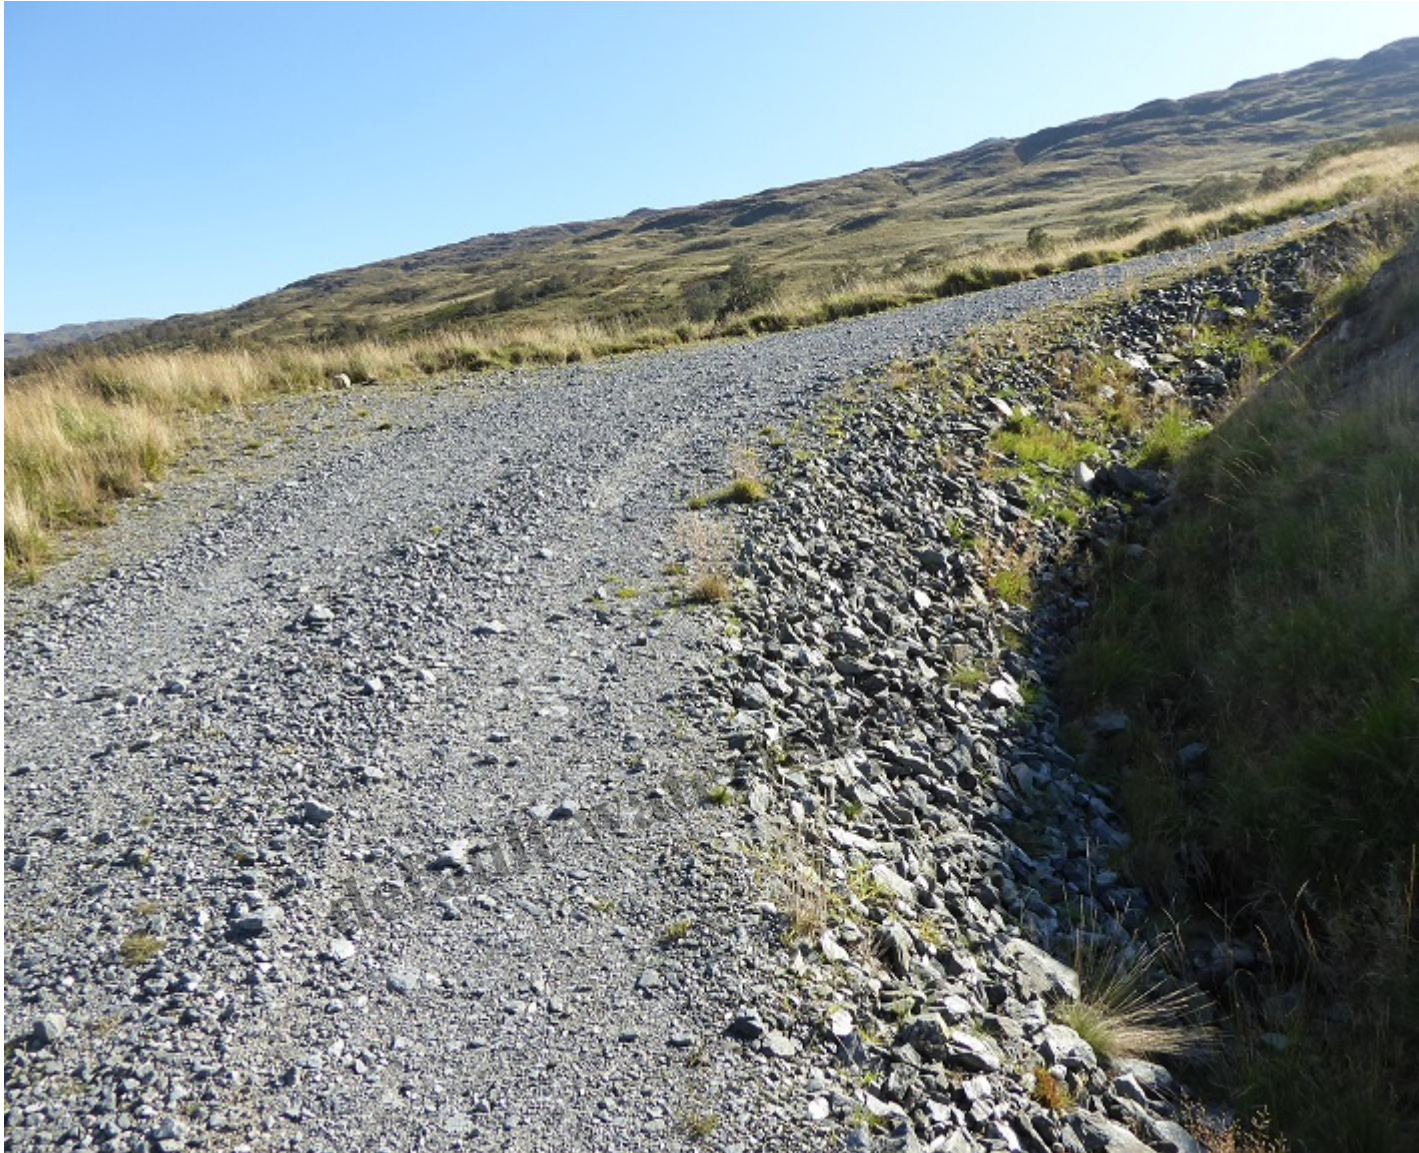
The right hand edge of the road is now starting to collapse into the enormous ditch

Besides their landscape impact, the new roads and their ditches allow water to flow down the hill far more quickly than previously. The significant sections of bare bank, which are very difficult to vegetate because they are also too steep, adds to the problem. The LLTNPA's Guidance states that access roads to renewable energy developments should be a maximum of 2.5 metres broad (3m at the bends). Much of this road and others in the glen are far wider than this.

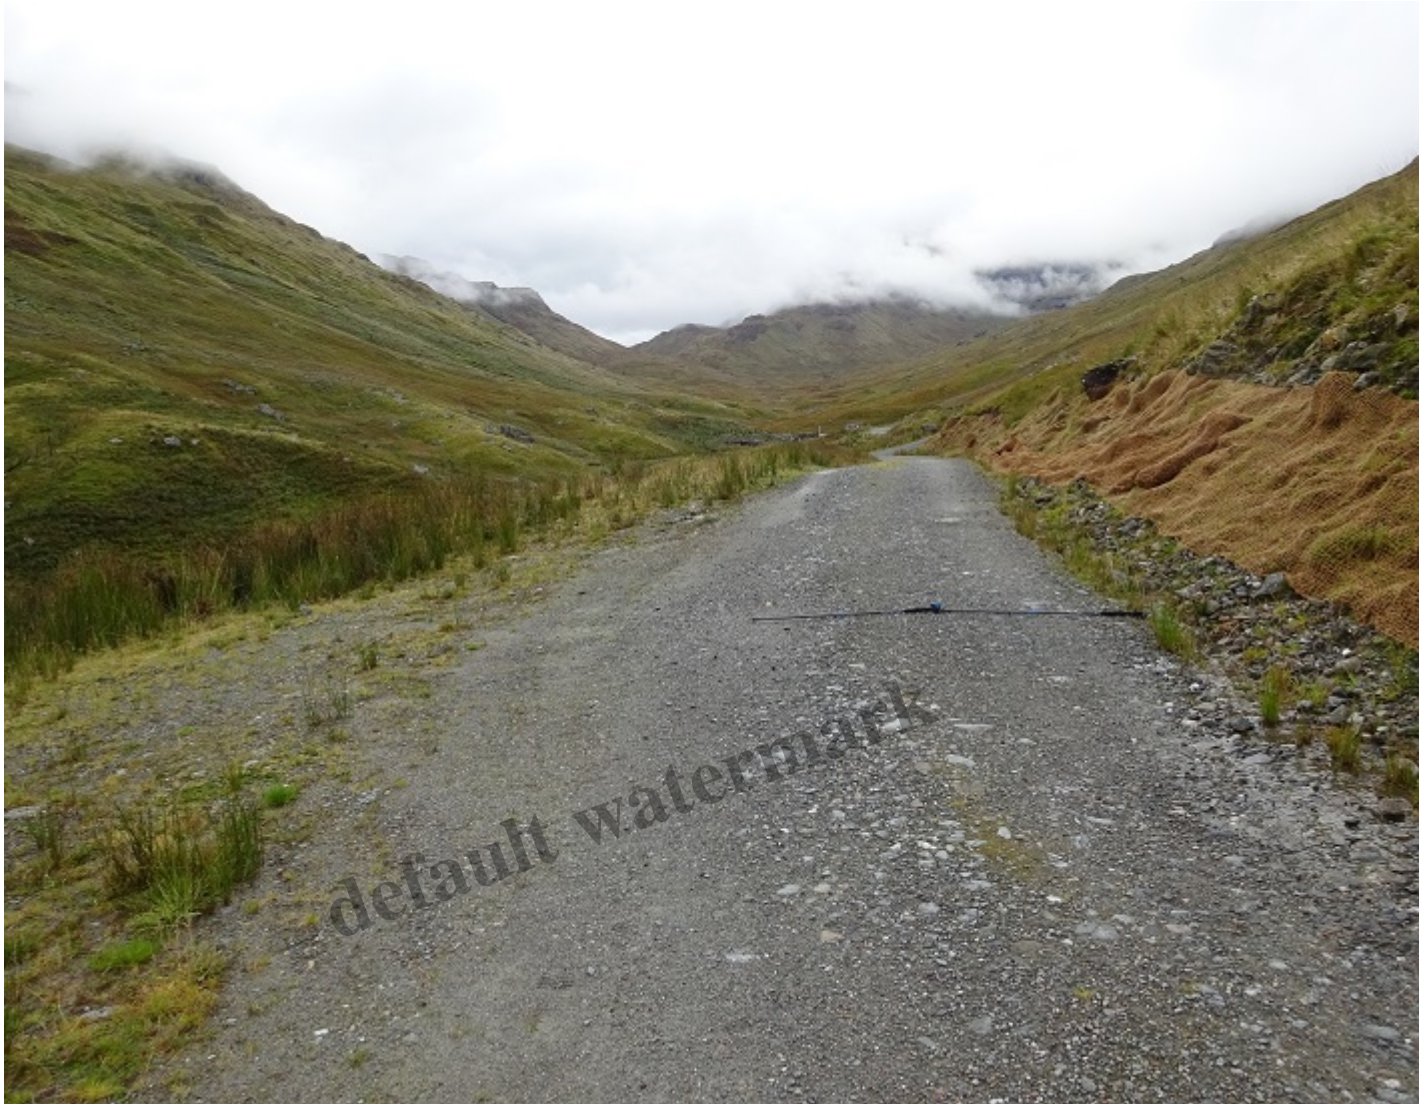
The road to the Glen Falloch Intake. Note how silt has been washed from the upper side to the lower side of the road widening it still further. The new textile matting that has been placed on the bank on the right is the consequence of a fundamental failure in design – the bank is too steep. Photo Credit Kevin McGrath Sept 2019

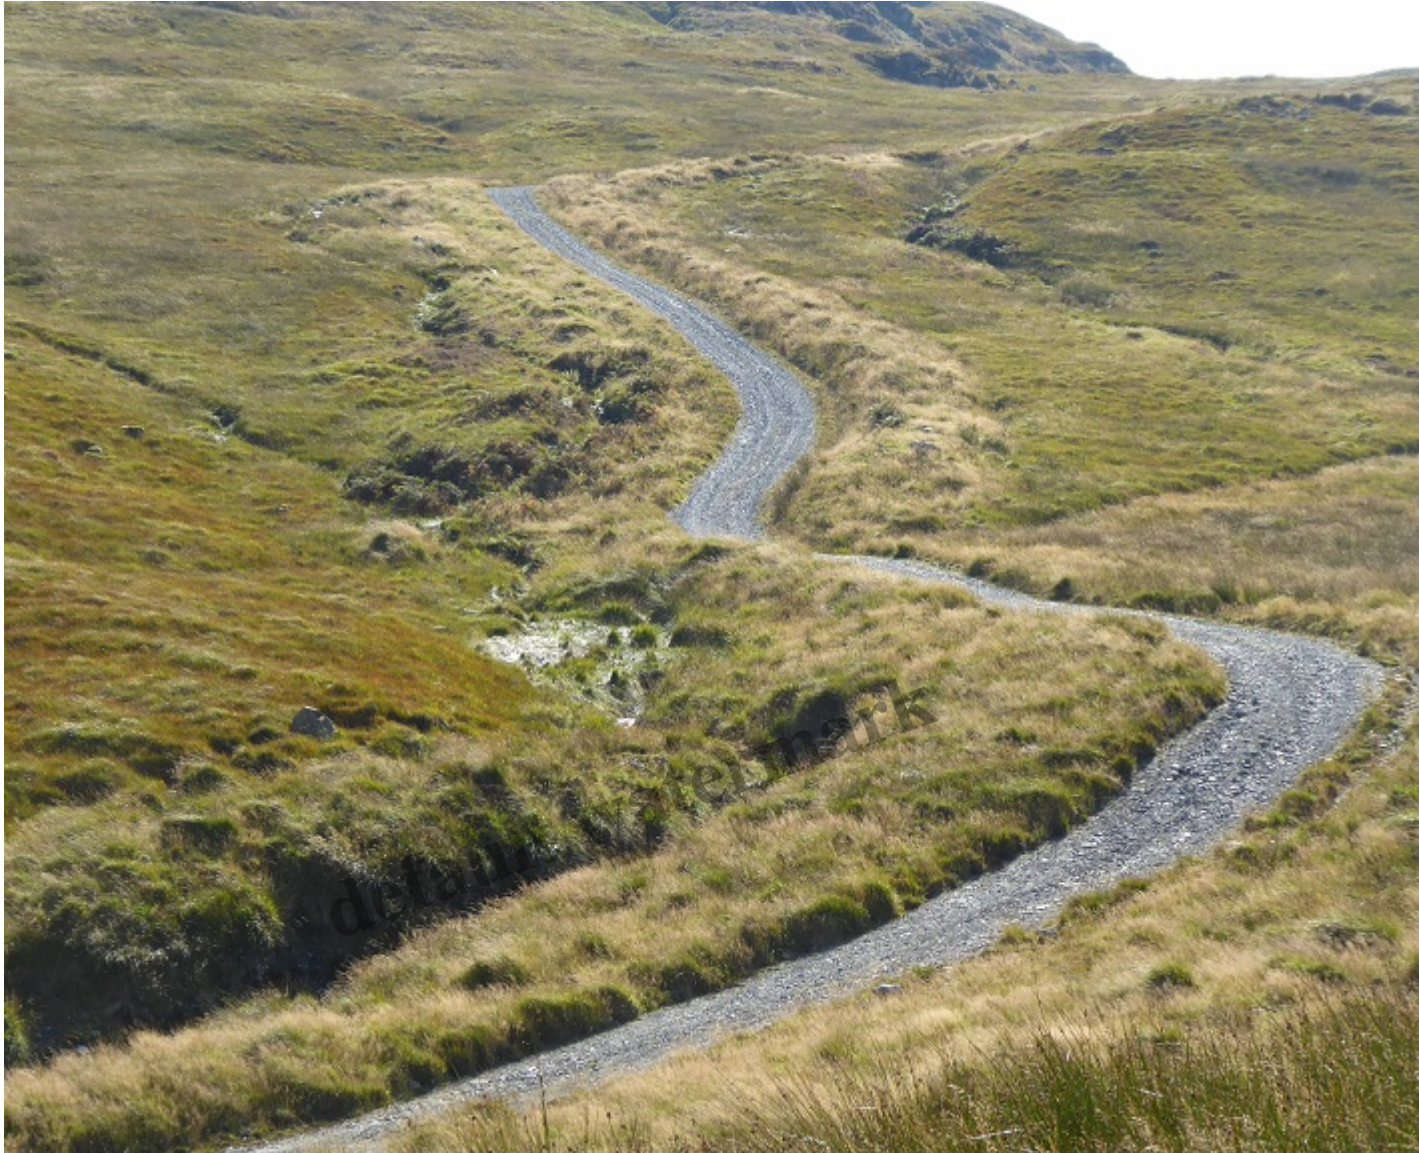
One of the middle sections of the road. The water is channelled down between the new banks that have been created here and is now seriously eroding the steep sections. As an illustration of how much water might have flowed here, note the flood flattened vegetation along the burn on the left.

The LLTNPA has effectively created a new course for water to flow down the hillside in times of heavy rain. On footpaths this steep the standard practice is to install water bars to channel water off the path in order to prevent erosion. On the Glen Falloch roads there is nothing, adding to the watercourse effect.

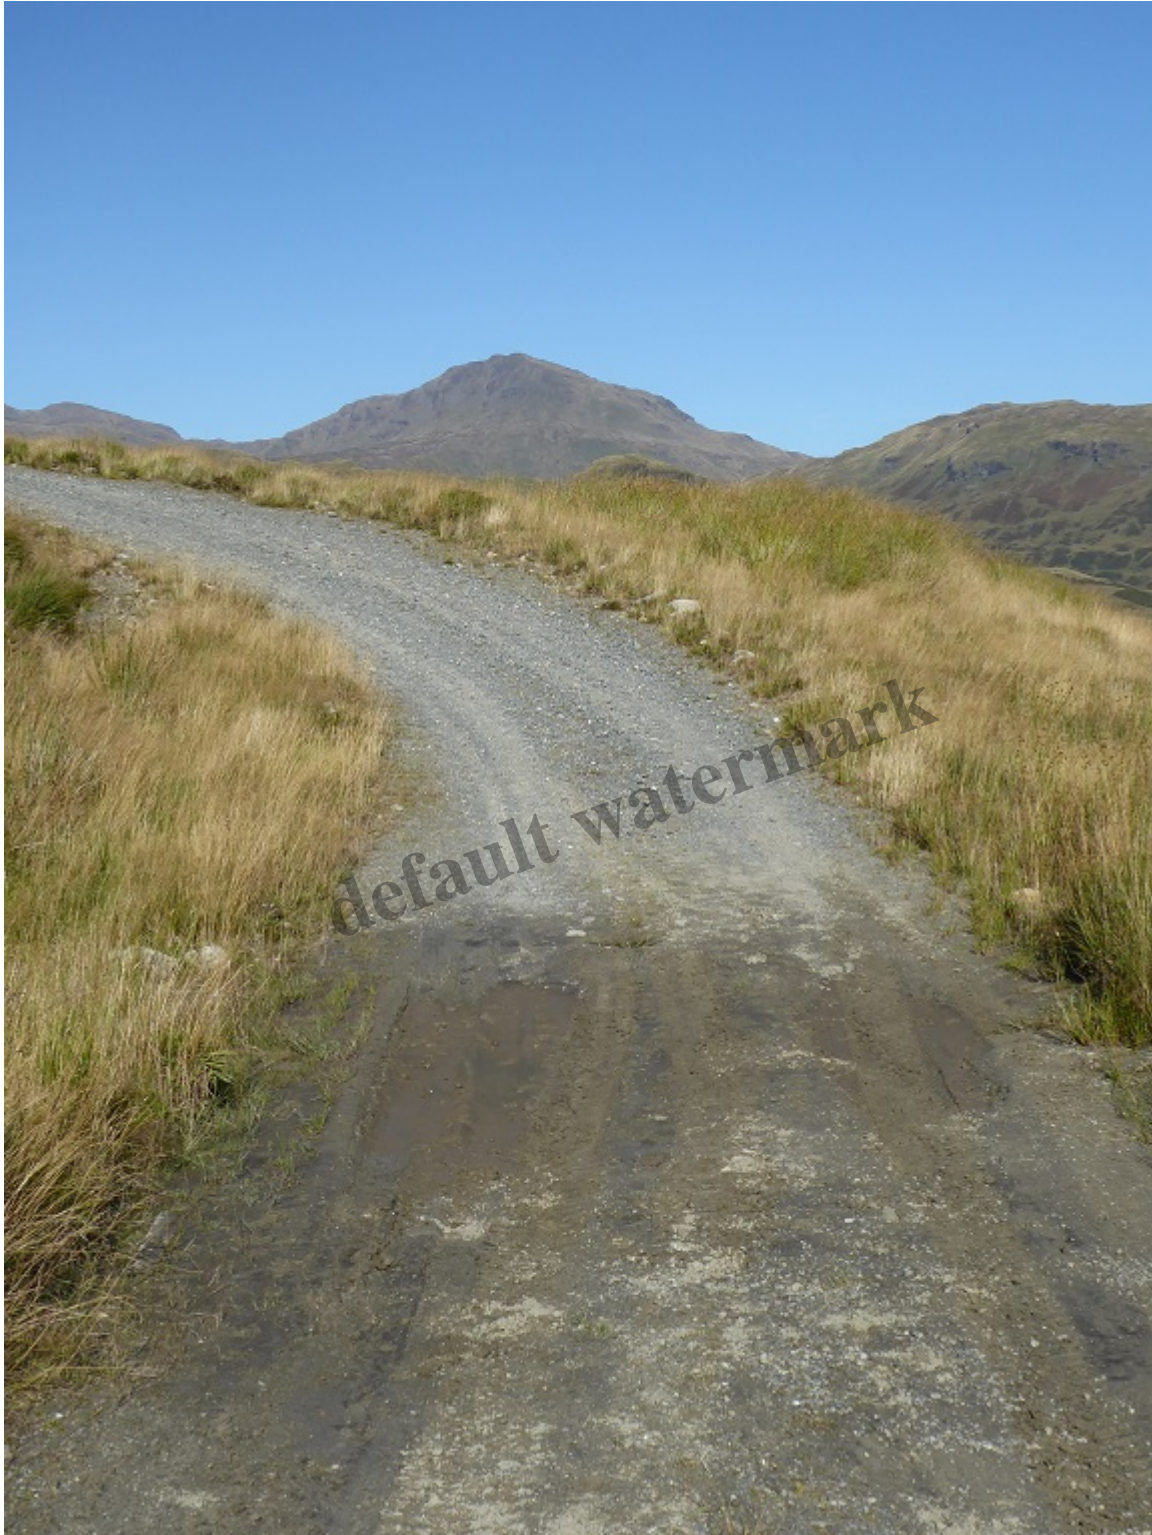
Silt, washed out from the road, accumulating in a dip

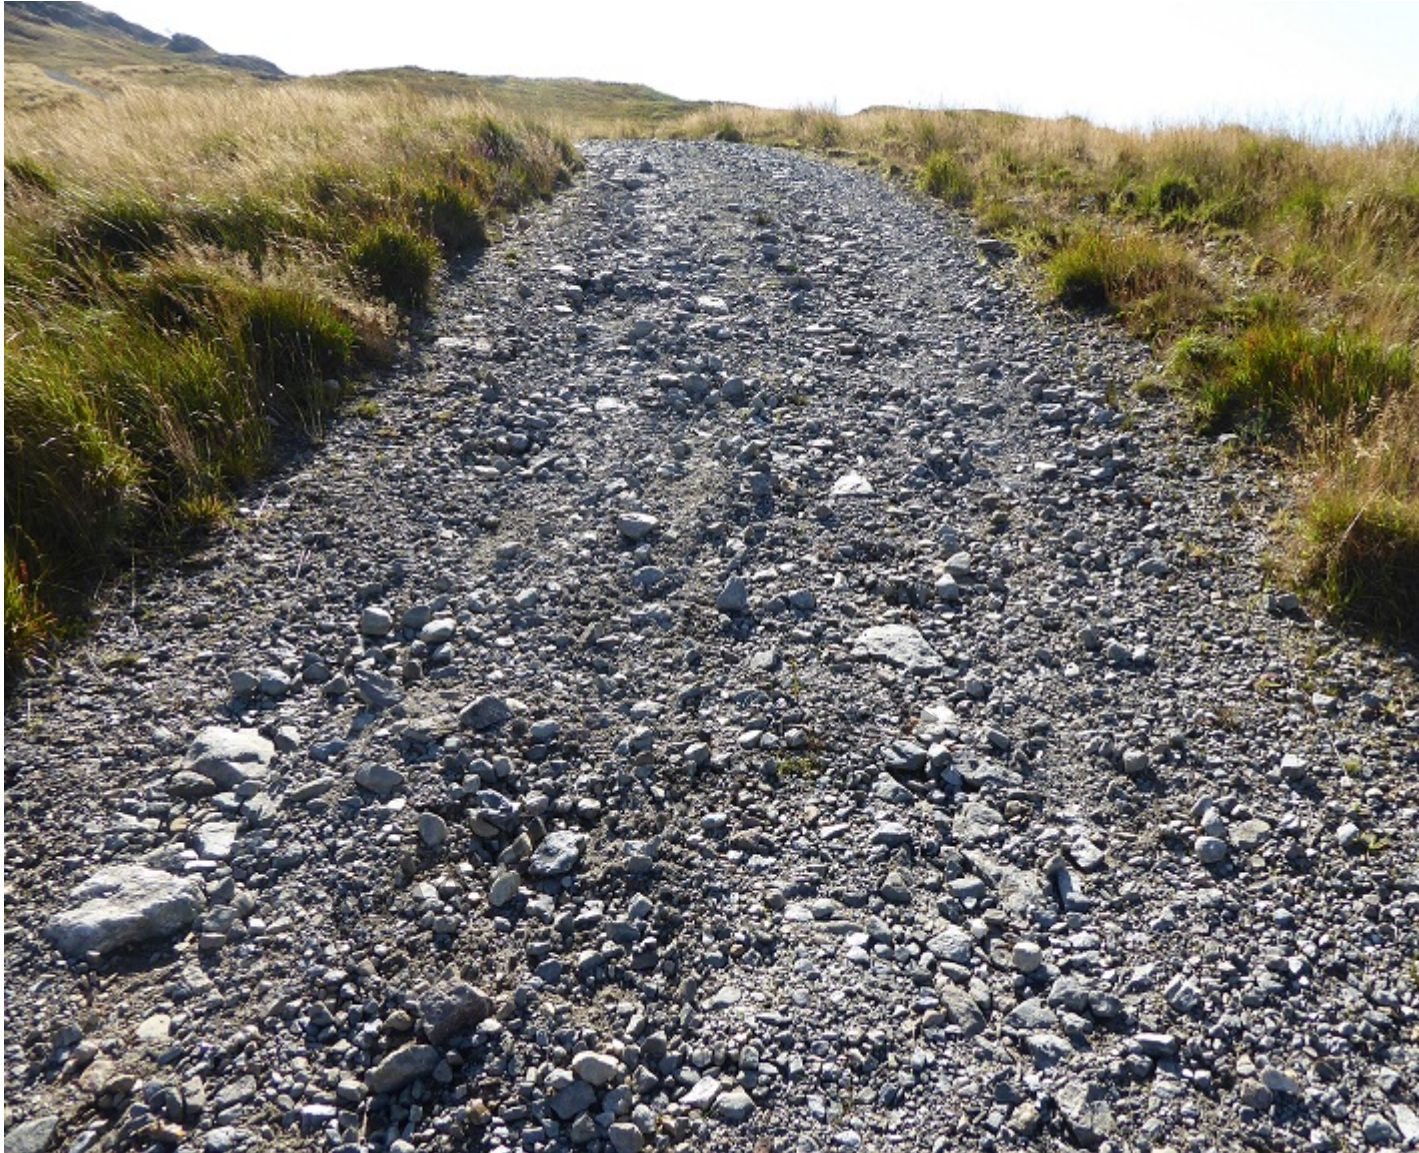
Example of section of road where the fine material has been washed out and where larger stones have started to be moved by the water.

During construction, the Scottish Environment Protection Agency required the contractors to install silt traps to stop fine material flowing into rivers below. That now appears to have been a waste of time because the fine material from the road surface has mostly been washed out leaving a pebbly surface.

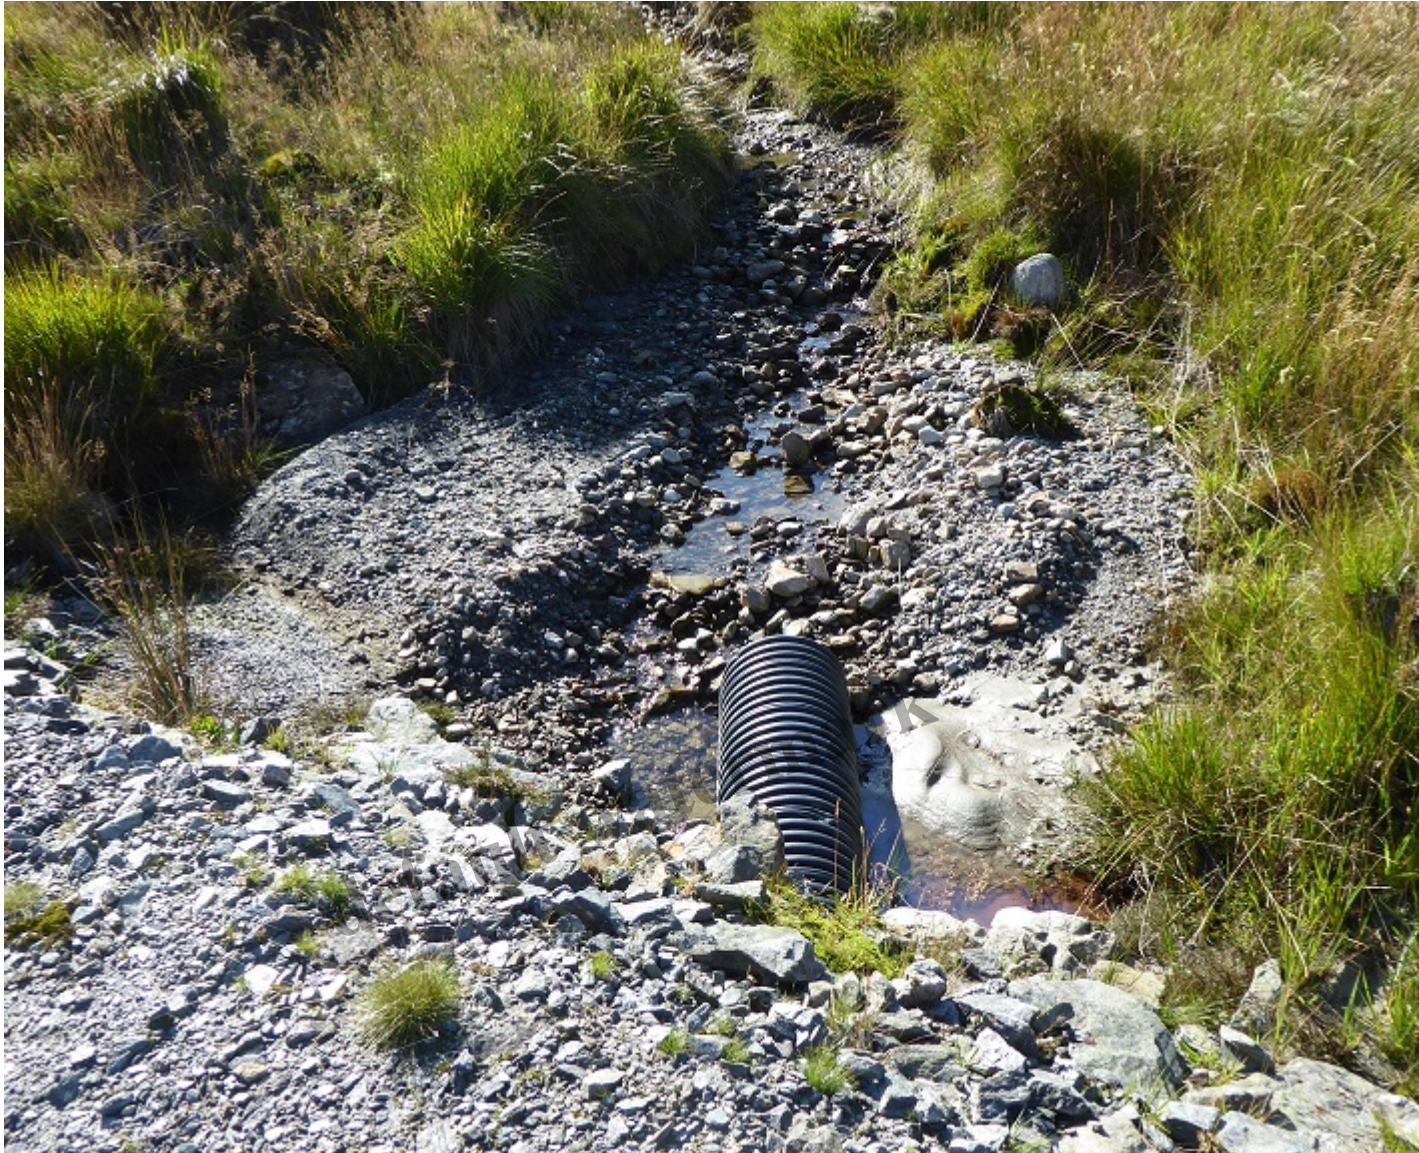
One of many protruding plastic pipes along the new road, silt visible to right, gravel wash out to left. also the eroding side of the track above the pipe.

The lack of finishing, betrays a lack of concern about both the landscape and the environmental consequences of these roads.
