Climate change and Glen Falloch (5) – the impact of the hydro roads on the natural environment

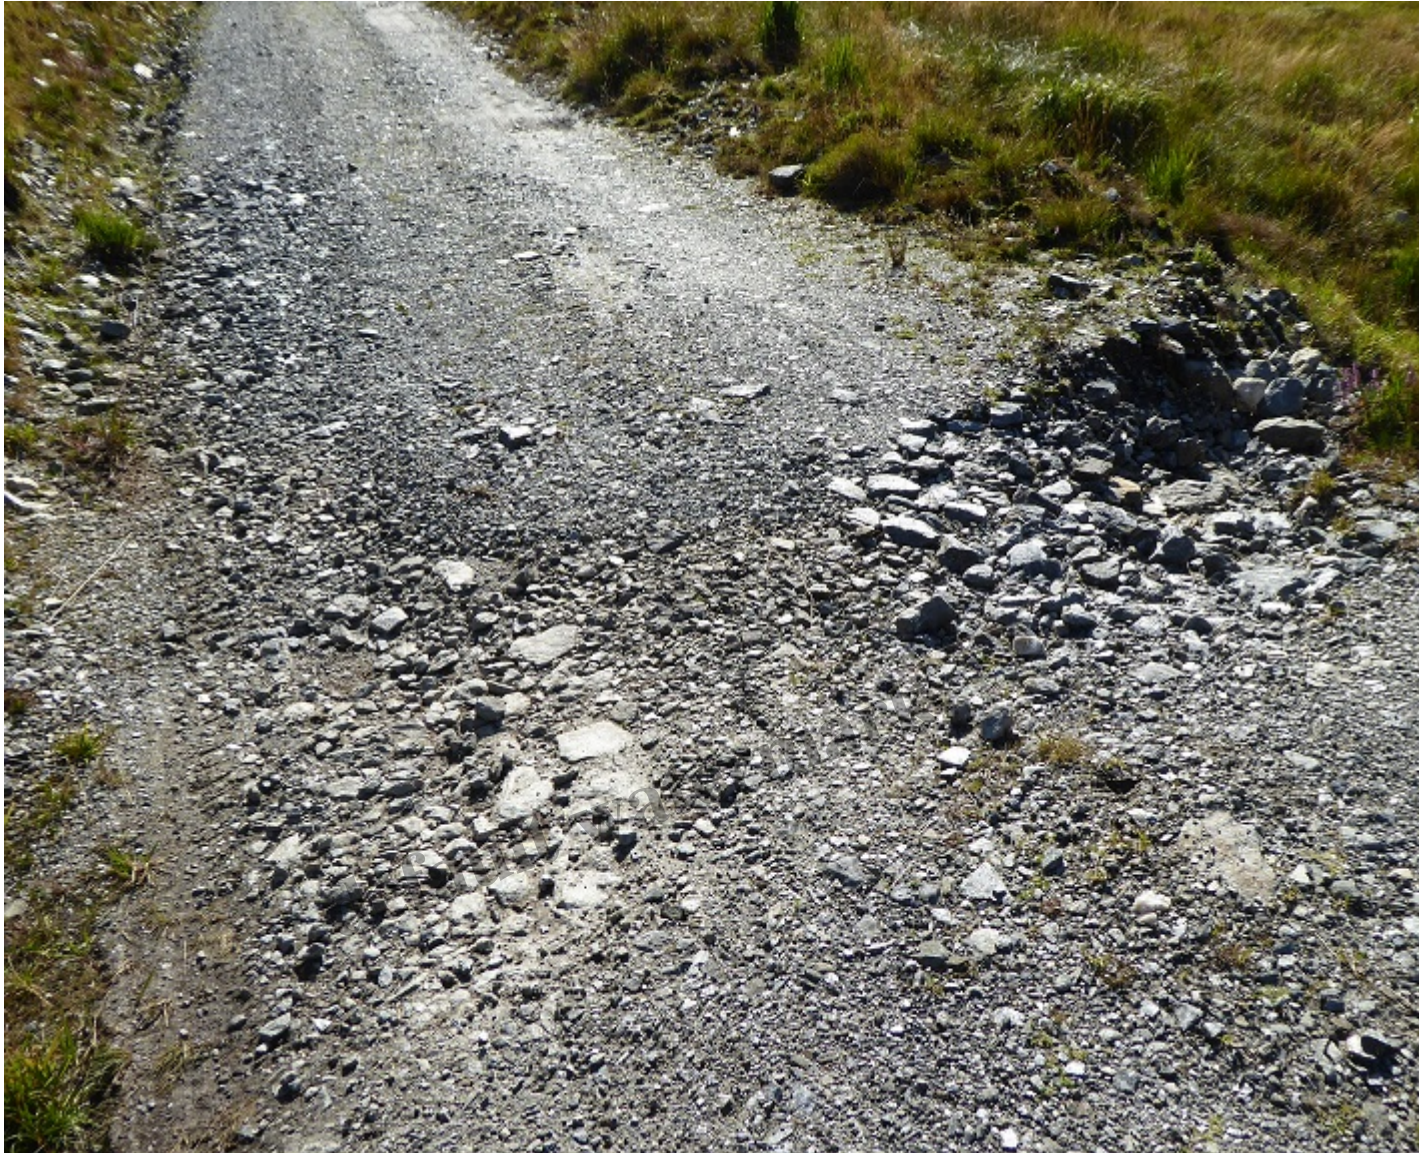
Collapsed section of road caused in part by water flowing across it and eroding its edge.

There was one place on the Ben Glas hydro road where its edge had completely collapsed. There are many other sections where this is likely to happen in future. Without remedial action the road risks becoming unusable just a couple of years after it was “finished”. This is not good either for the National Park or for the Estate who will need to fix the damage. The LLTNPA needs to ensure repairs are done properly and address the causes of the problems rather than allowing the estate to take the cheap option of bringing more material up the hill to fill in holes which will then erode again.

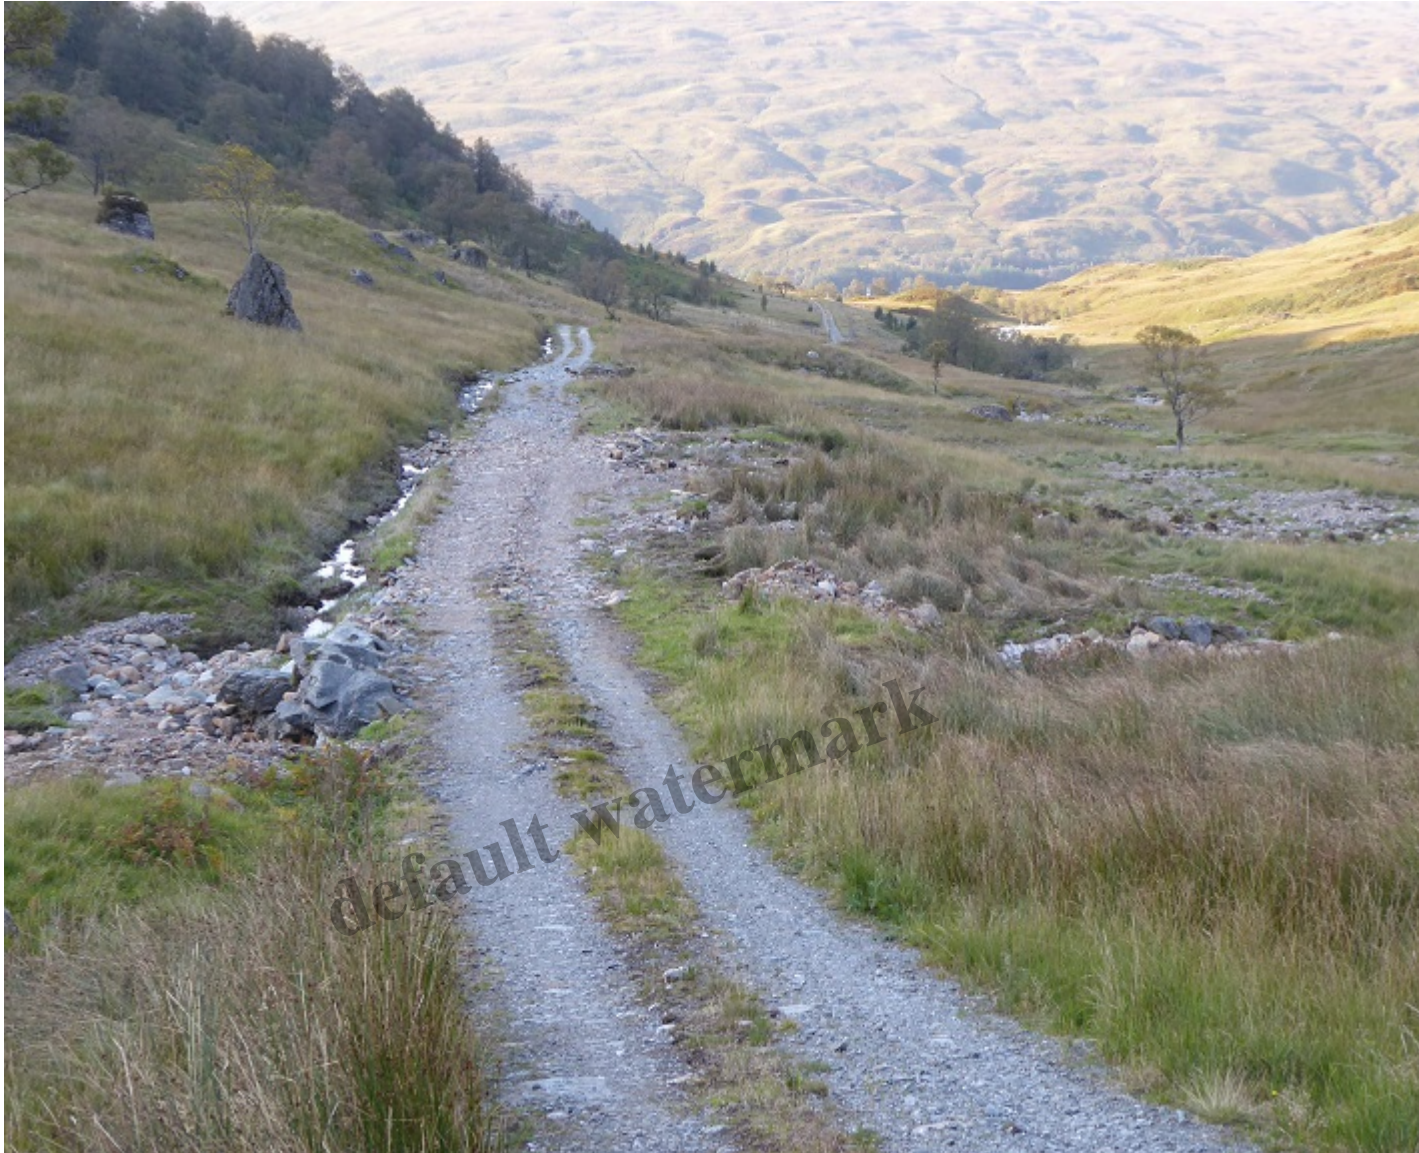
View down Allt a Chuillin road to where burn where third hydro intake is located flooded

The road on other side of Ben Glas appears to have been much better designed and restored, being narrower and having a central grass strip. Indeed its where the LLTNPA Director of Planning, Stuart Mearns, took Mountaineering Scotland and Ramblers Scotland a couple of years ago to show what a good job the LLTNPA was doing restoring hydro schemes ([see here](#)). It was interesting therefore to find that this road had been more seriously damaged by the flood event than the Ben Glas intake road. One possible explanation is that there was more rainfall on the Allt a Chuillinn side of the hill.

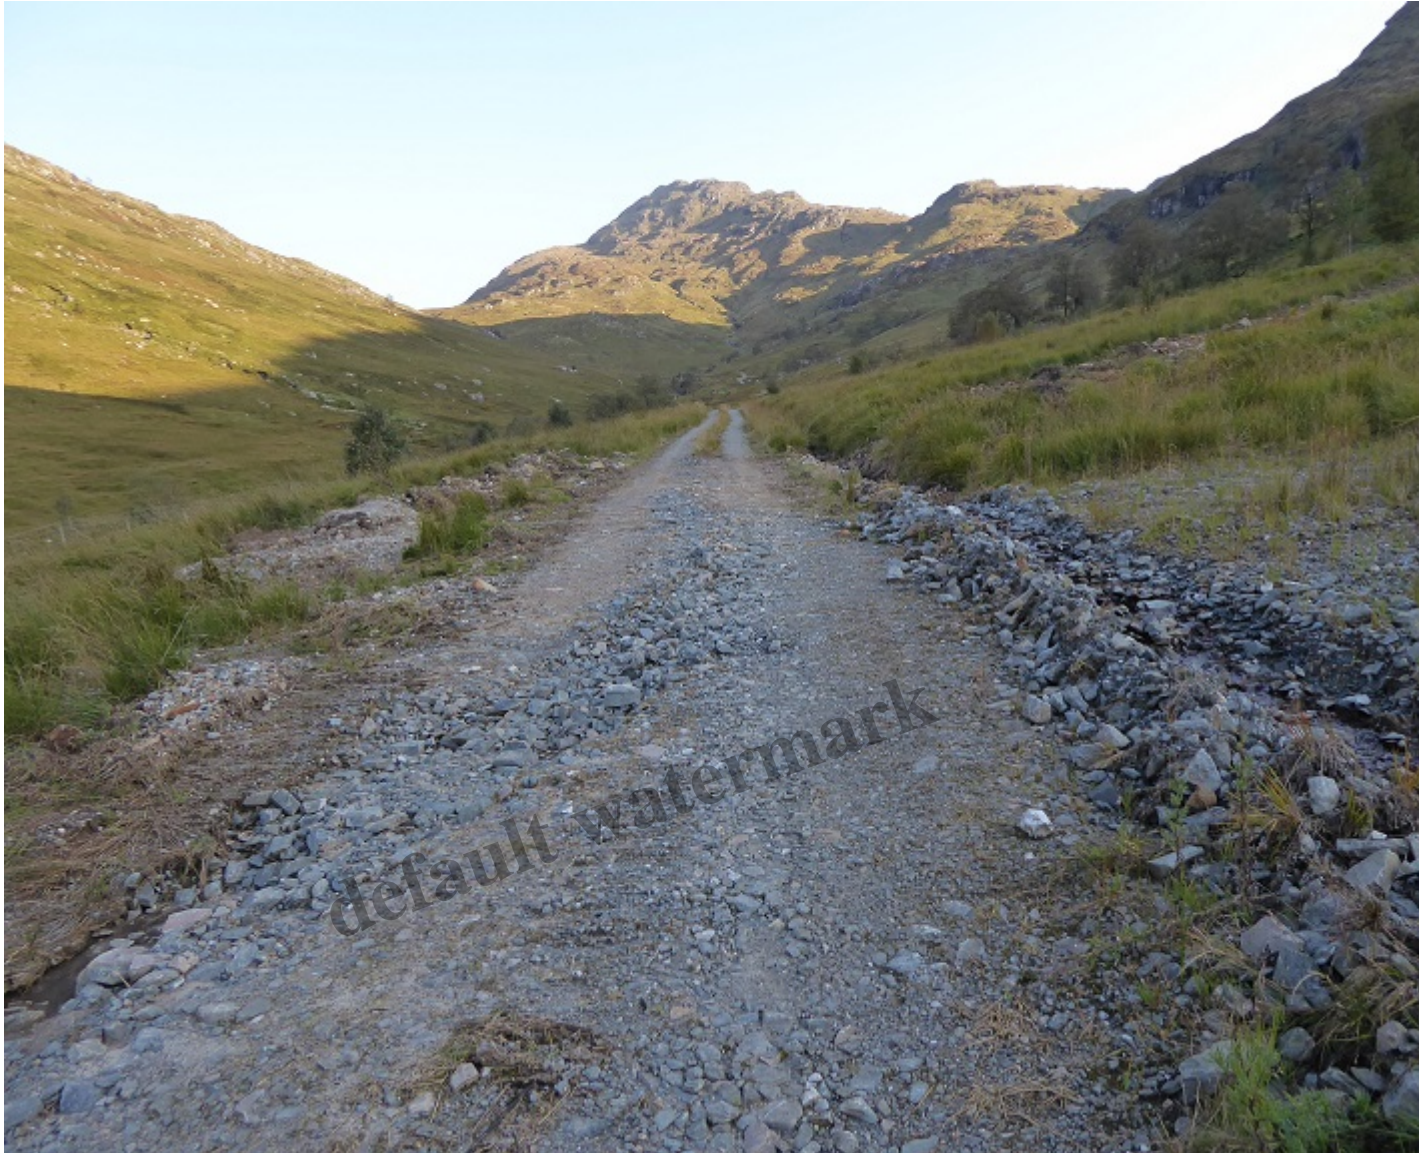
The view of the flood damaged area from below, showing how the central grass strip and part of surface was swept away, with recent ditch work on right.

Another explanation is that this road, sitting as it does below the slope on the right, was exposed to debris and water coming down the hillside for far more of its length while the absence of zig zags, as on the Ben Glas road, meant there was little to interrupt the flow of the water once it reached the road.

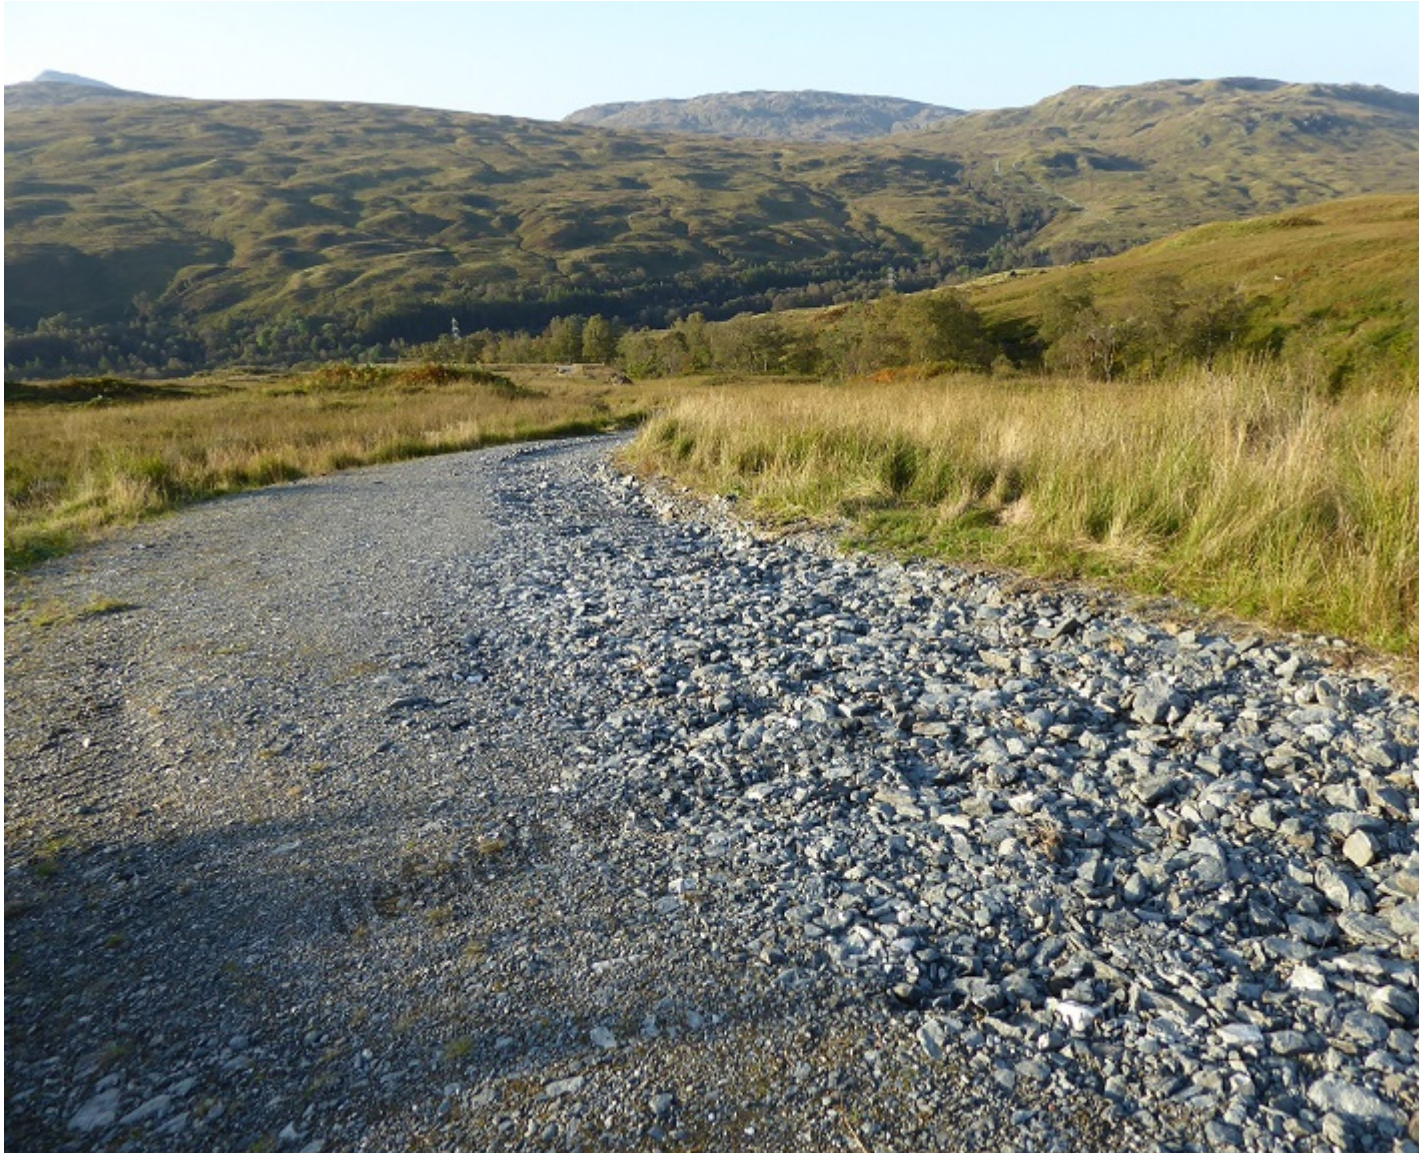
Section of Allt a Chuillinn road, which is more like a motorway than a track and contrary to LLTNPA specifications, with serious wash out on right side

That water was channelled down the road is supported by evidence of increasing levels of damage lower down.

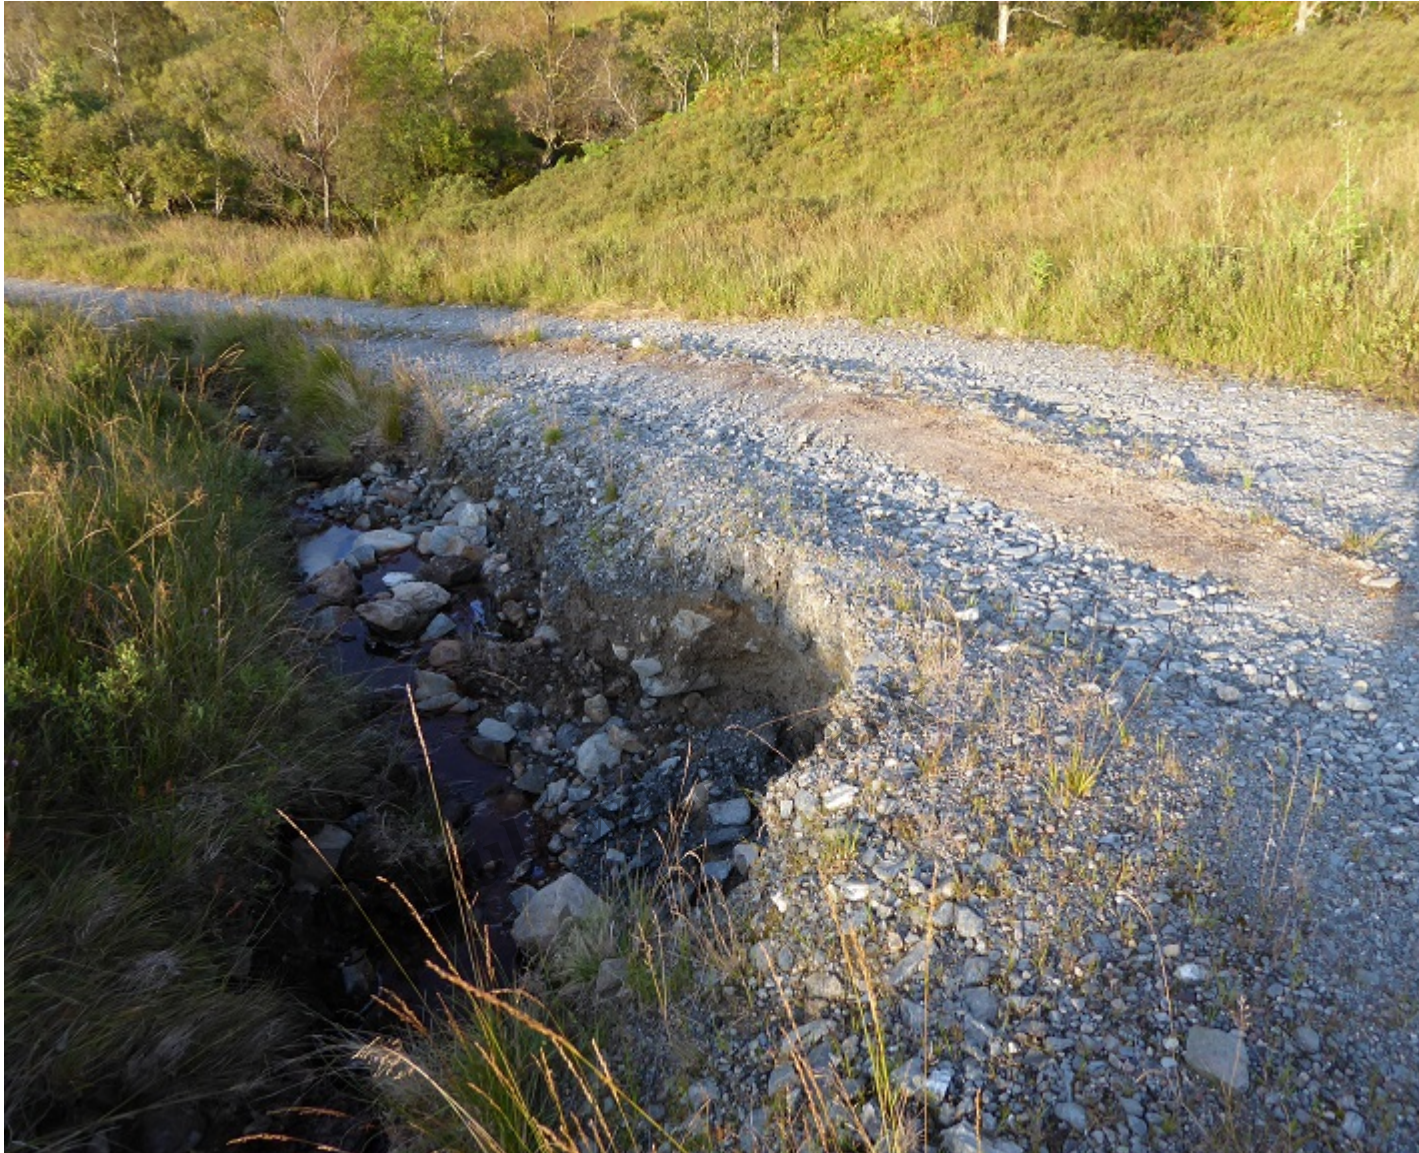
Edge of track eroded away by flood and now threatened with collapse

This section of eroded track side was below a well vegetated and restored section of ditch. It would appear that having vegetated ditches is not in itself sufficient to prevent damaging amounts of water being channelled down them during a storm event.

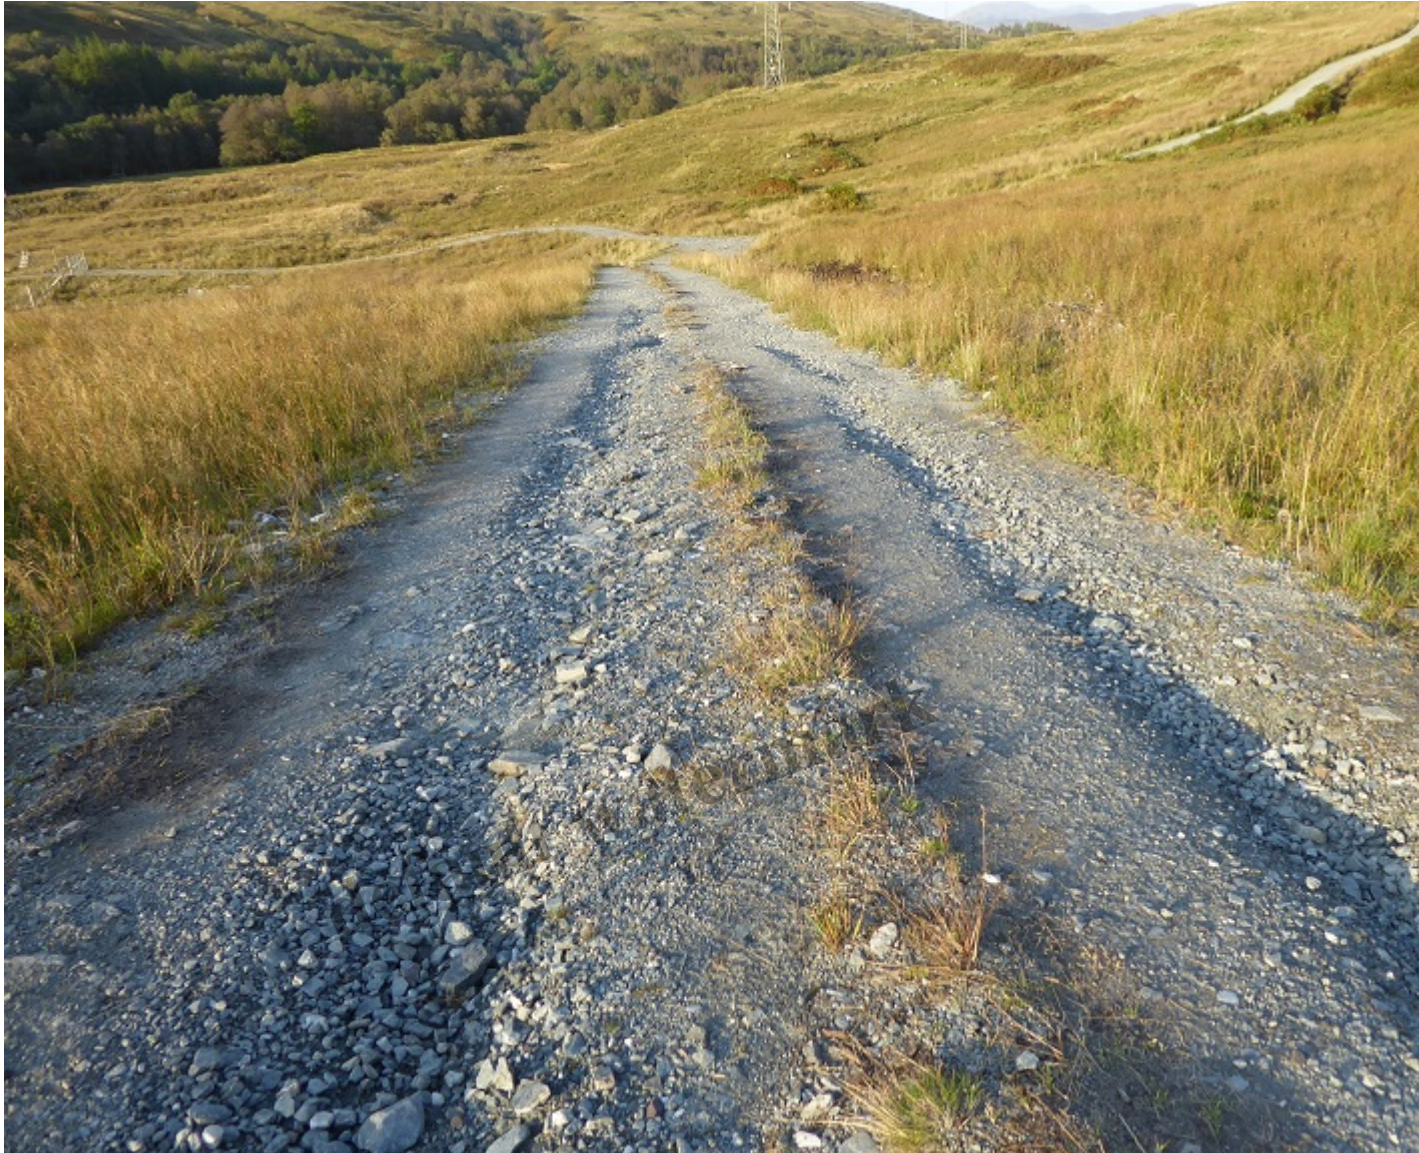
Approaching the junction with the West Highland Way erosion channels start to appear

All this provides evidence that these hydro roads, besides being prone to erosion and likely to cause a constant problem to the estate, have also served to increase the rate of water flow down the hill. The consequences of that are greater flooding and greater flood damage below.

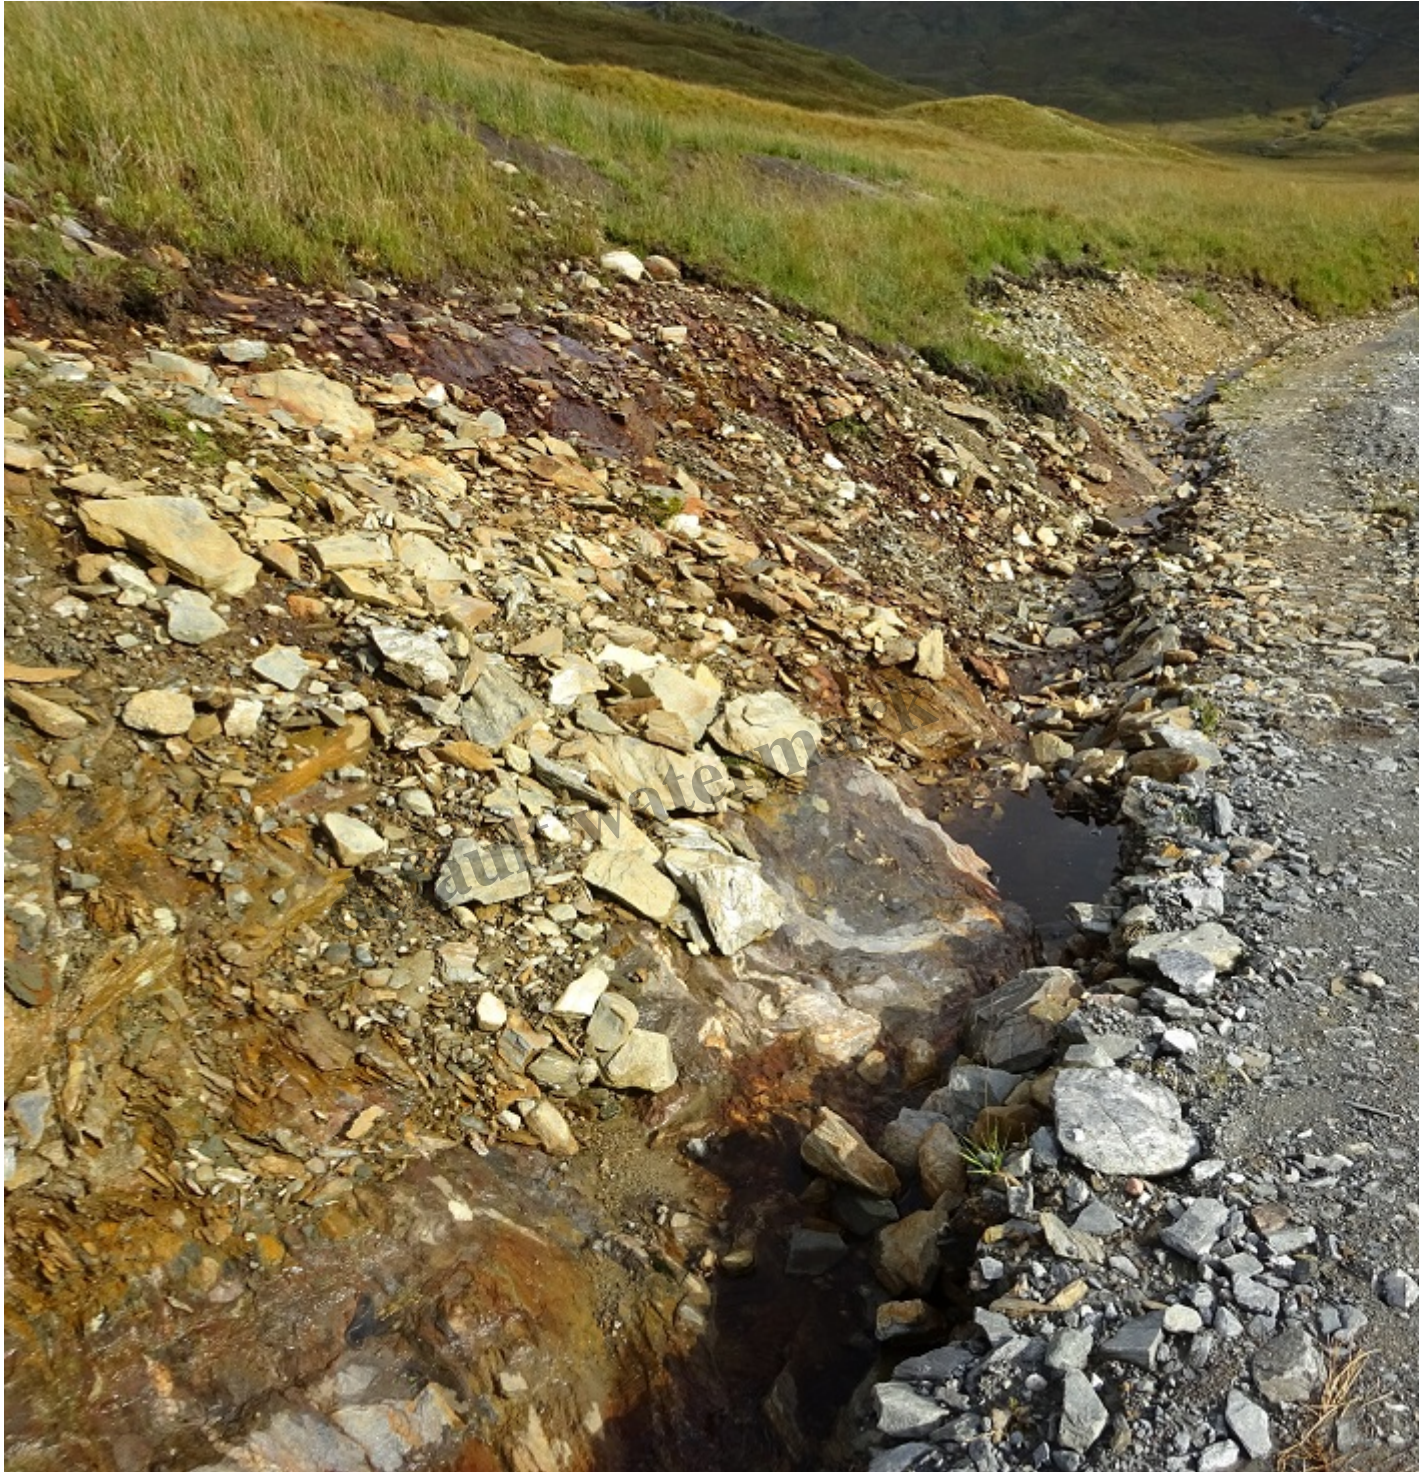
The Eas Eonan hydro road. The unrestored track sides – another failure to ensure planning conditions are met, leading to grassland above and dry out the peat. The width of the track and lack of a central vegetated strip also contribute to the problem. Water runs down it. There are no water bars, such as you find on hill footpaths, to divert the water back into the track and ditch have served to speed the rate water runs off the hill. The erosion of both the track and ditch have served to speed the rate water runs off the hill. The erosion of both the track and ditch have served to speed the rate water runs off the hill. The erosion of both the track and ditch have served to speed the rate water runs off the hill. Kevin McGrath Sept 2019
