Ben A'an – how not to provide for outdoor recreation in the National Park

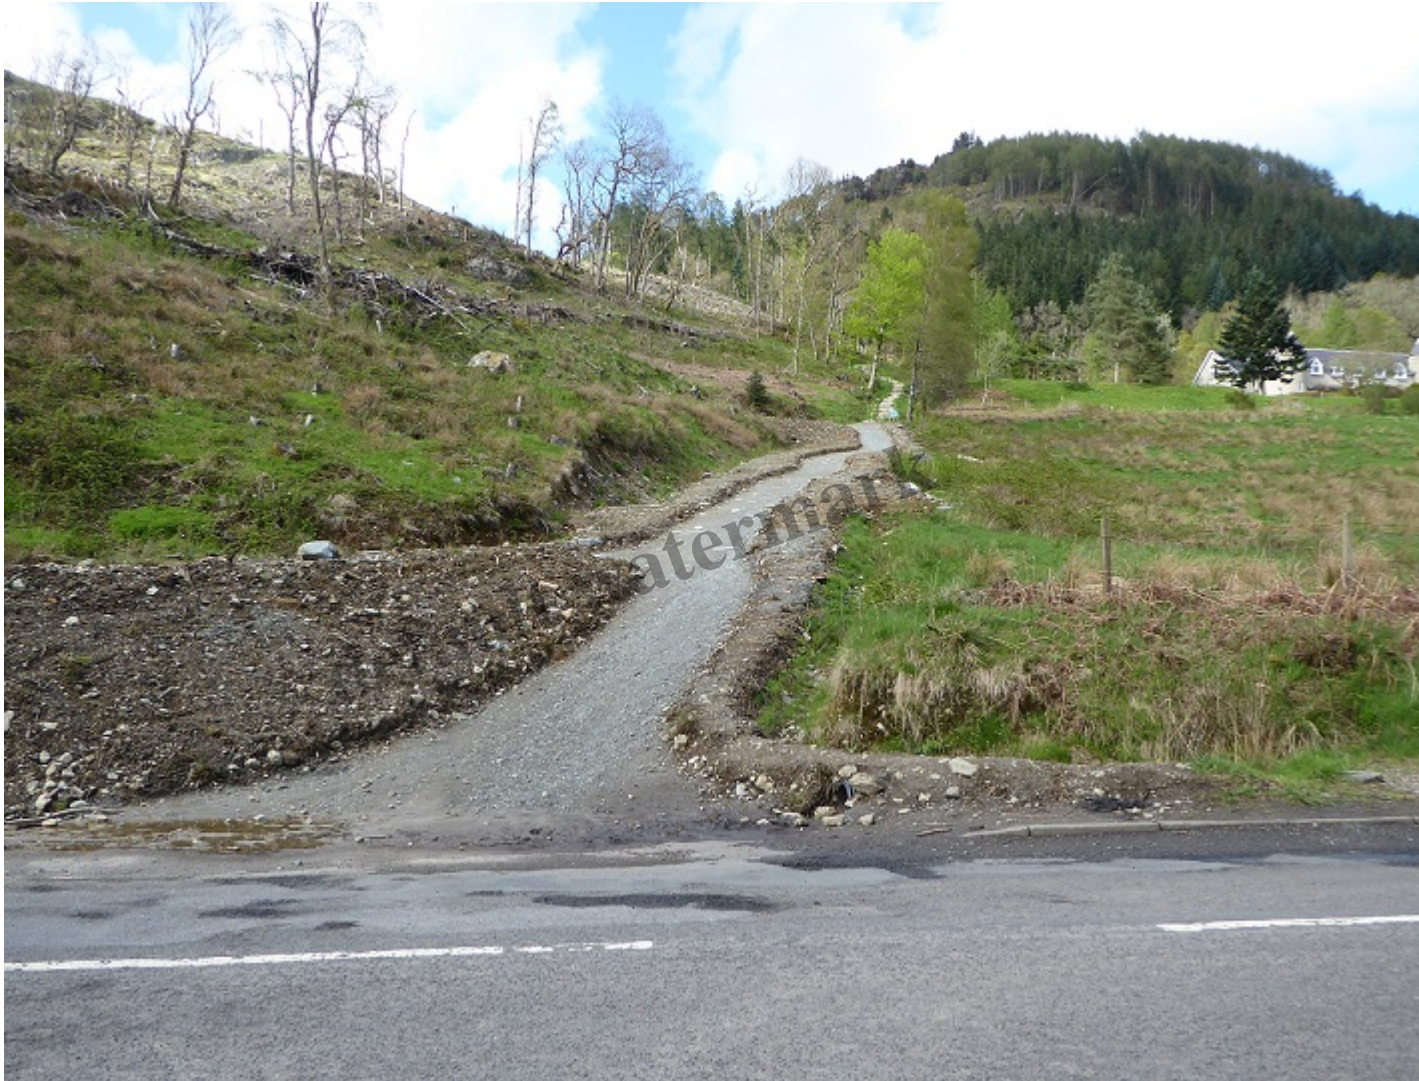
Path, soon after first completed in May 2018. The devastated area on the left was created as part of the Great Forest Trossachs Forest conservation project, with non-native conifers being removed to allow native woodland to develop.

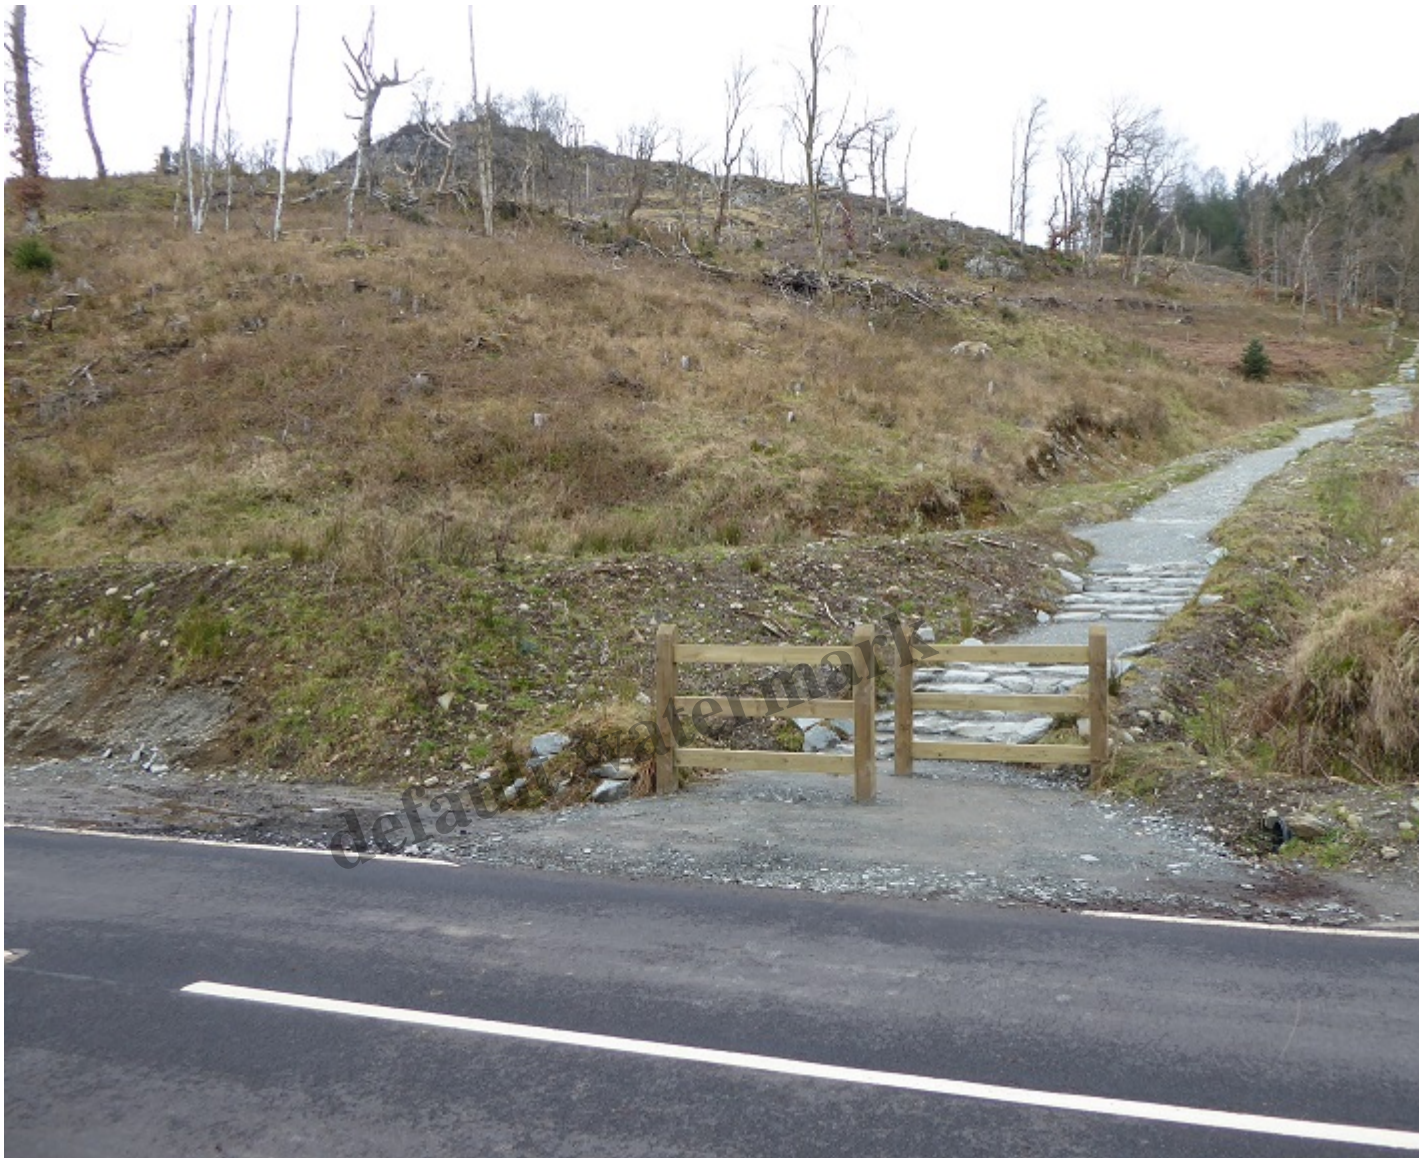
Start of path March 2019

Unfortunately, staff at the Mountains and People Project were also under pressure to repair and upgrade paths on as many hills as possible and, given a fixed budget, that affected how the paths were designed and constructed. You can see evidence of how shortcuts were attempted from comparing the two photos above. The first section of path was originally constructed as a smooth slope but was too steep – like hill roads paths start to erode once steeper than 14° – hence the steps, which are far more expensive to construct. The safety fencing appears to have been installed only after someone realised that large numbers of people striding or whizzing onto a public road on their bikes was an accident waiting to happen.

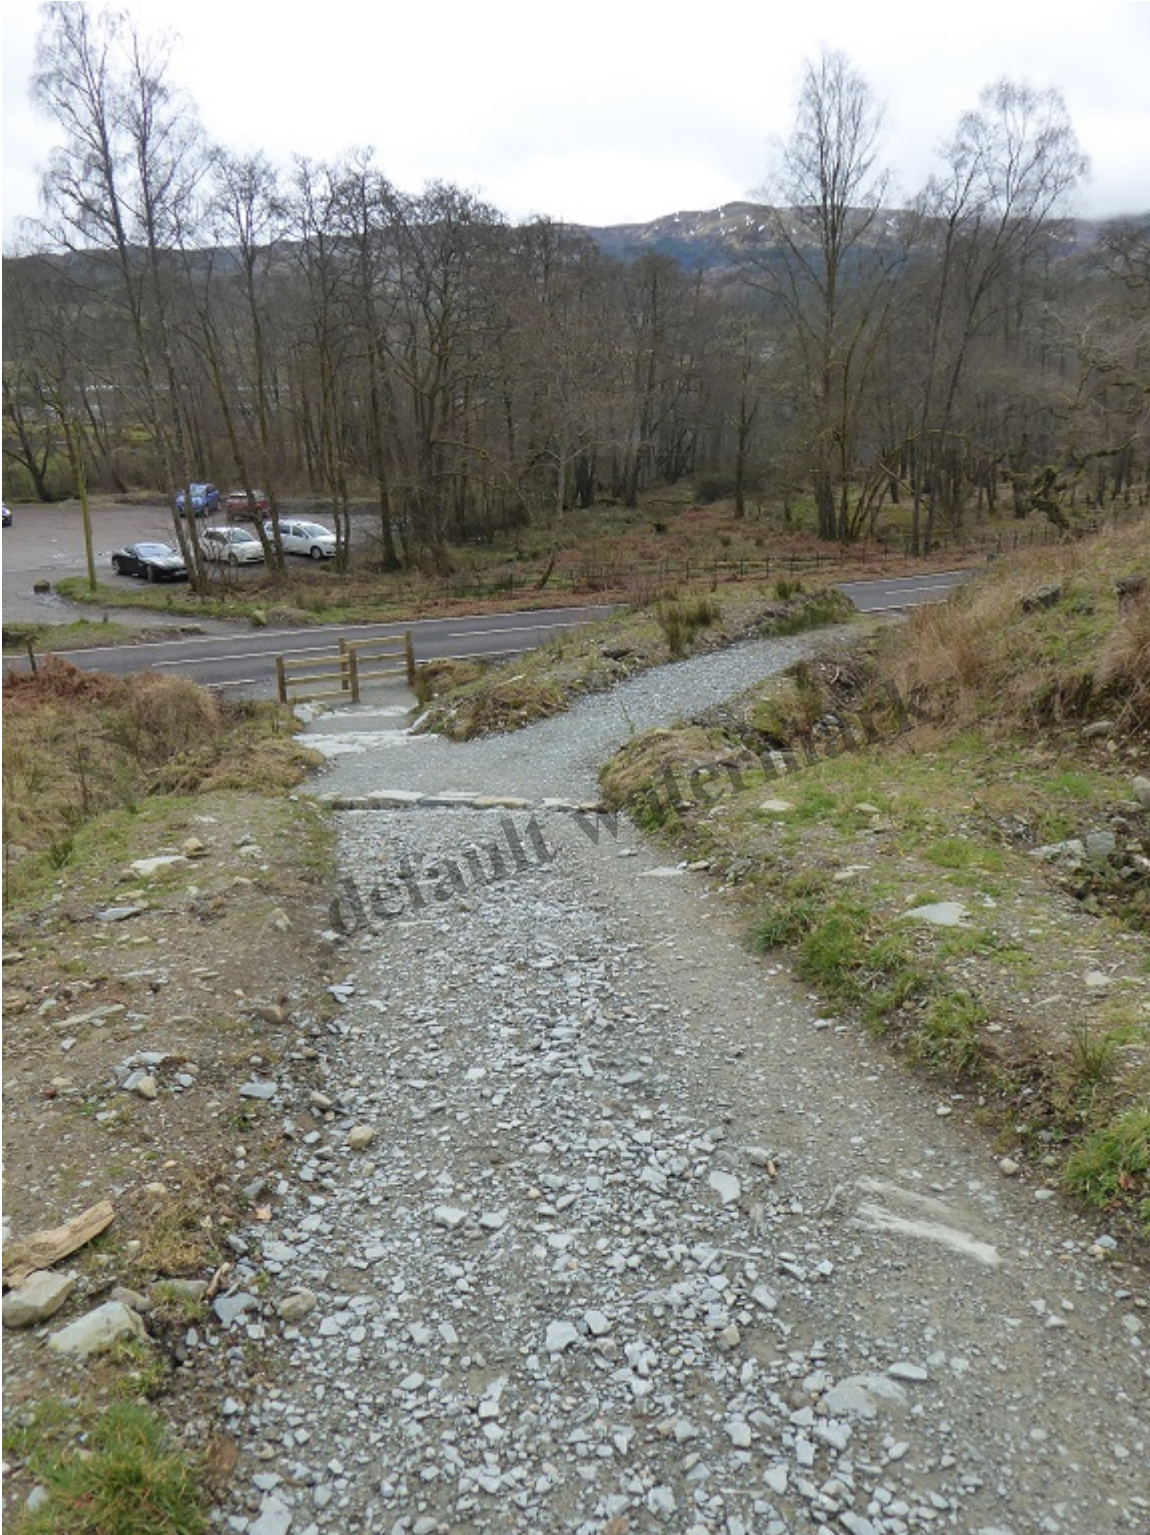
Tell tale signs of water erosion, not far above the steps, the fine material has been washed out from the left hand side of the path

One wonders how long this path surface, with its heavy usage will last.

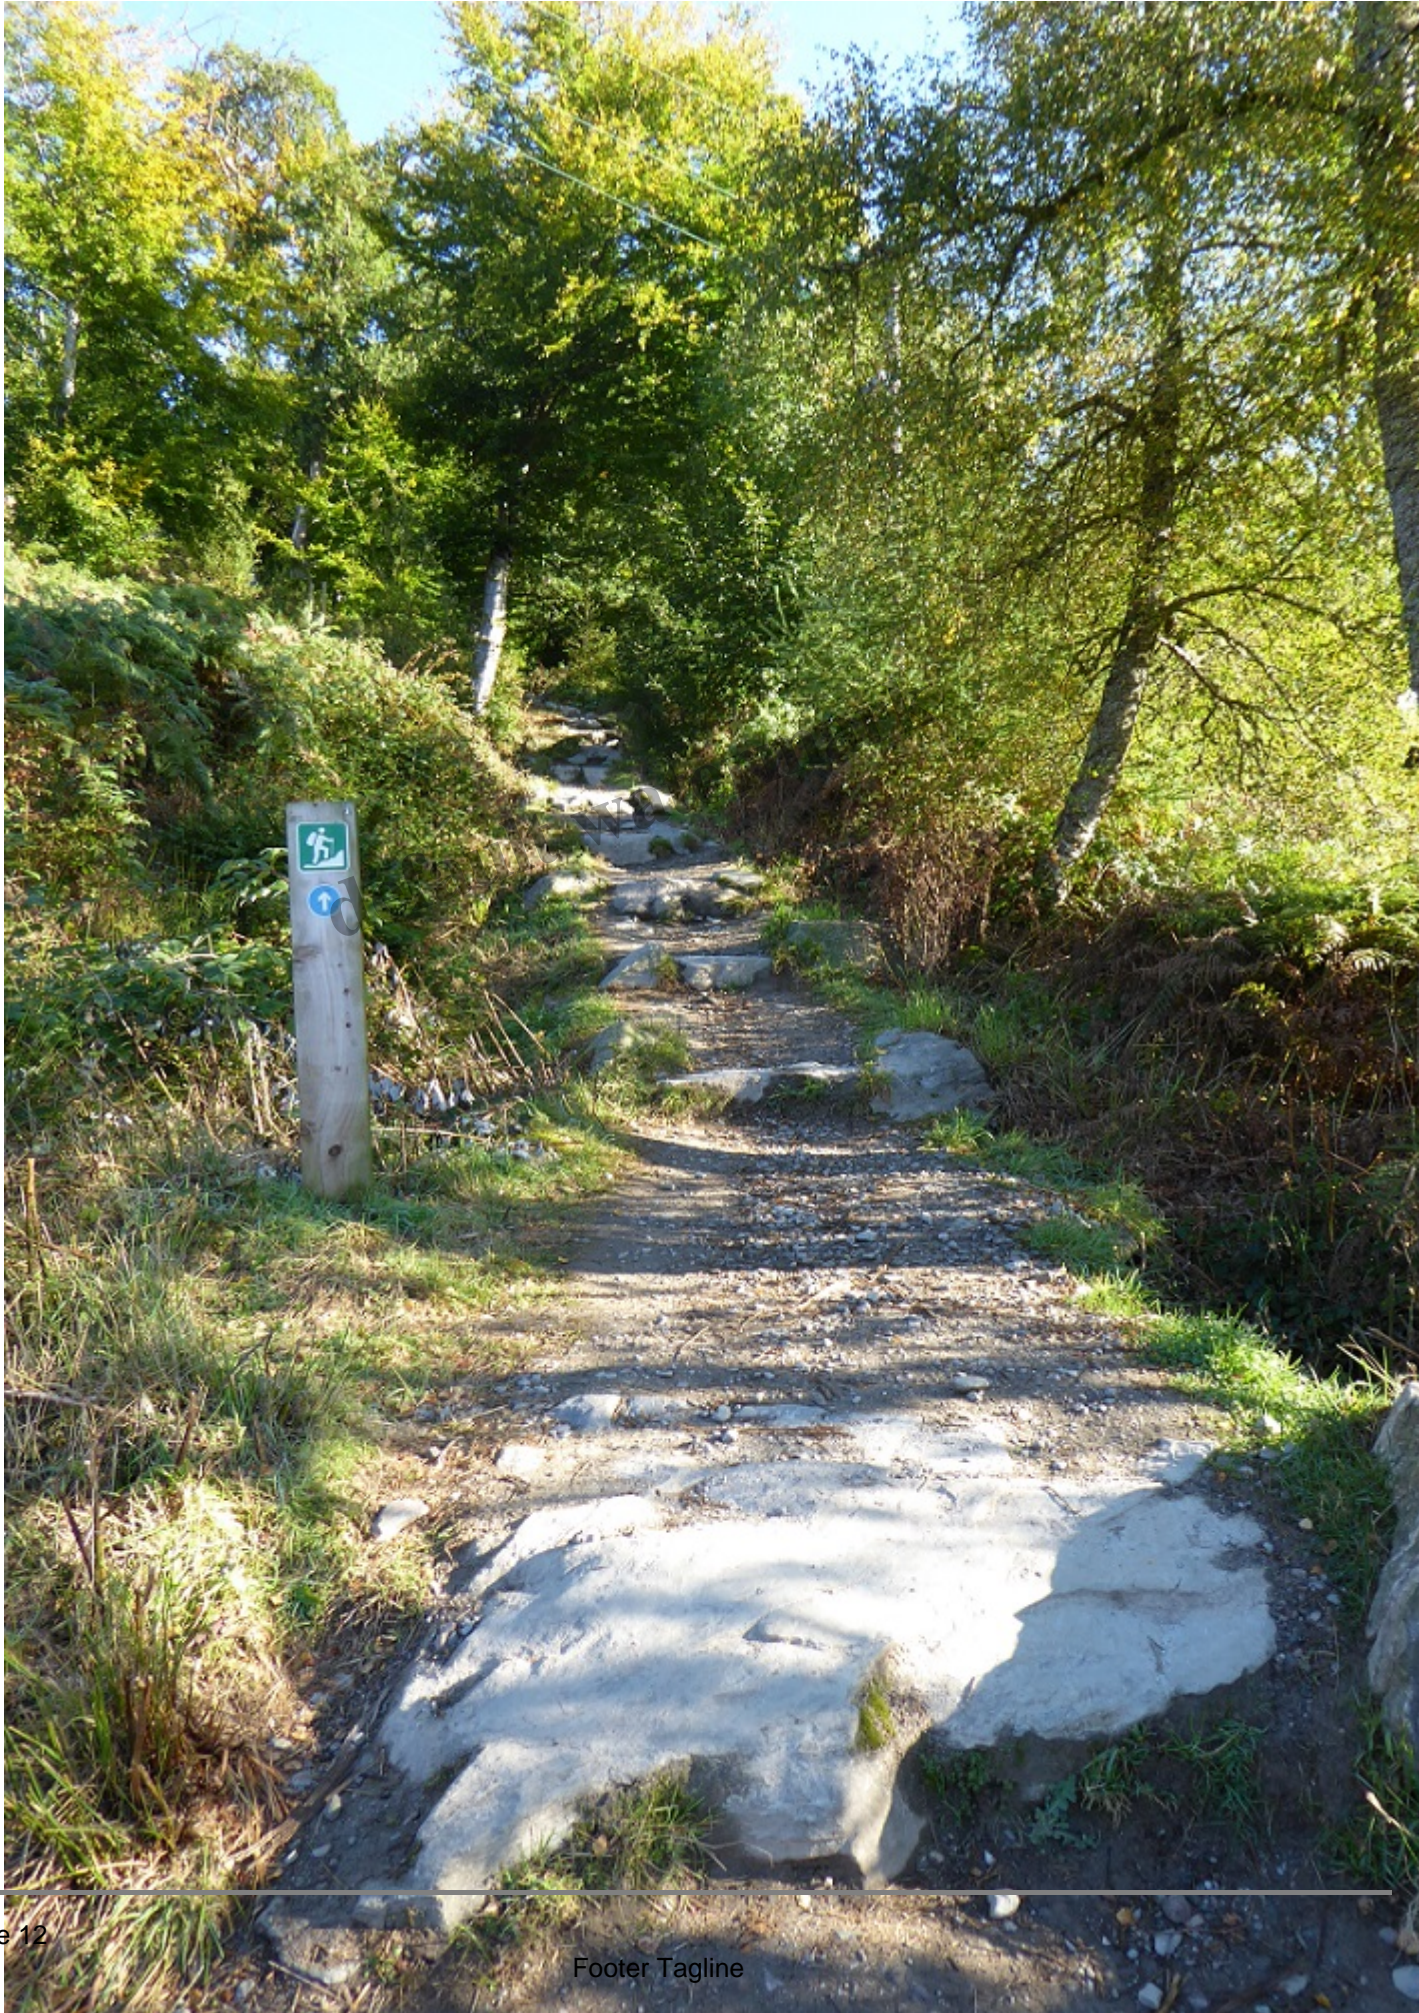
Note the signs of water erosion on the sections between the steps and the rocks on either side of each step, designed to prevent people walking round the edge.

While it is amazing what skilled machine operators can do, steep paths pose challenges. They need to be designed so they don't turn into watercourses and in ways that encourage walkers to remain on them. In this case, in a downpour, the angle of the inclined slope between the steps encourages water to flow down the path and there is no camber to shed the water on either side.

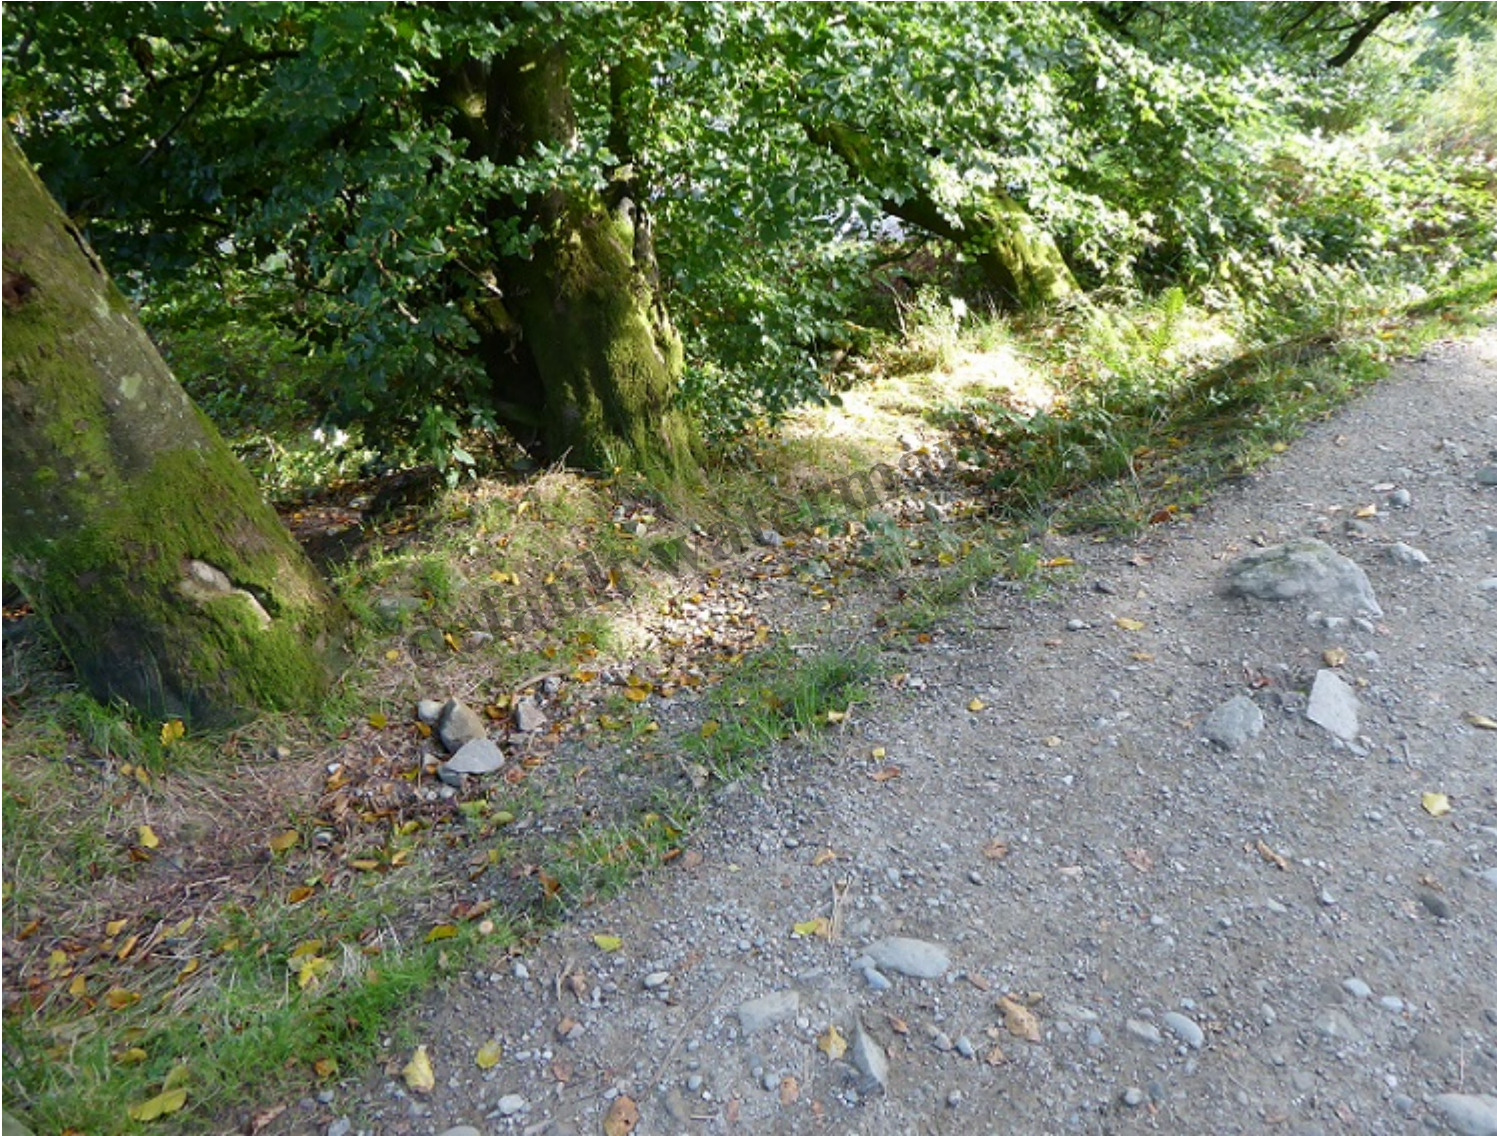
The eroded material ends up wherever the water takes it, often where the path bends.

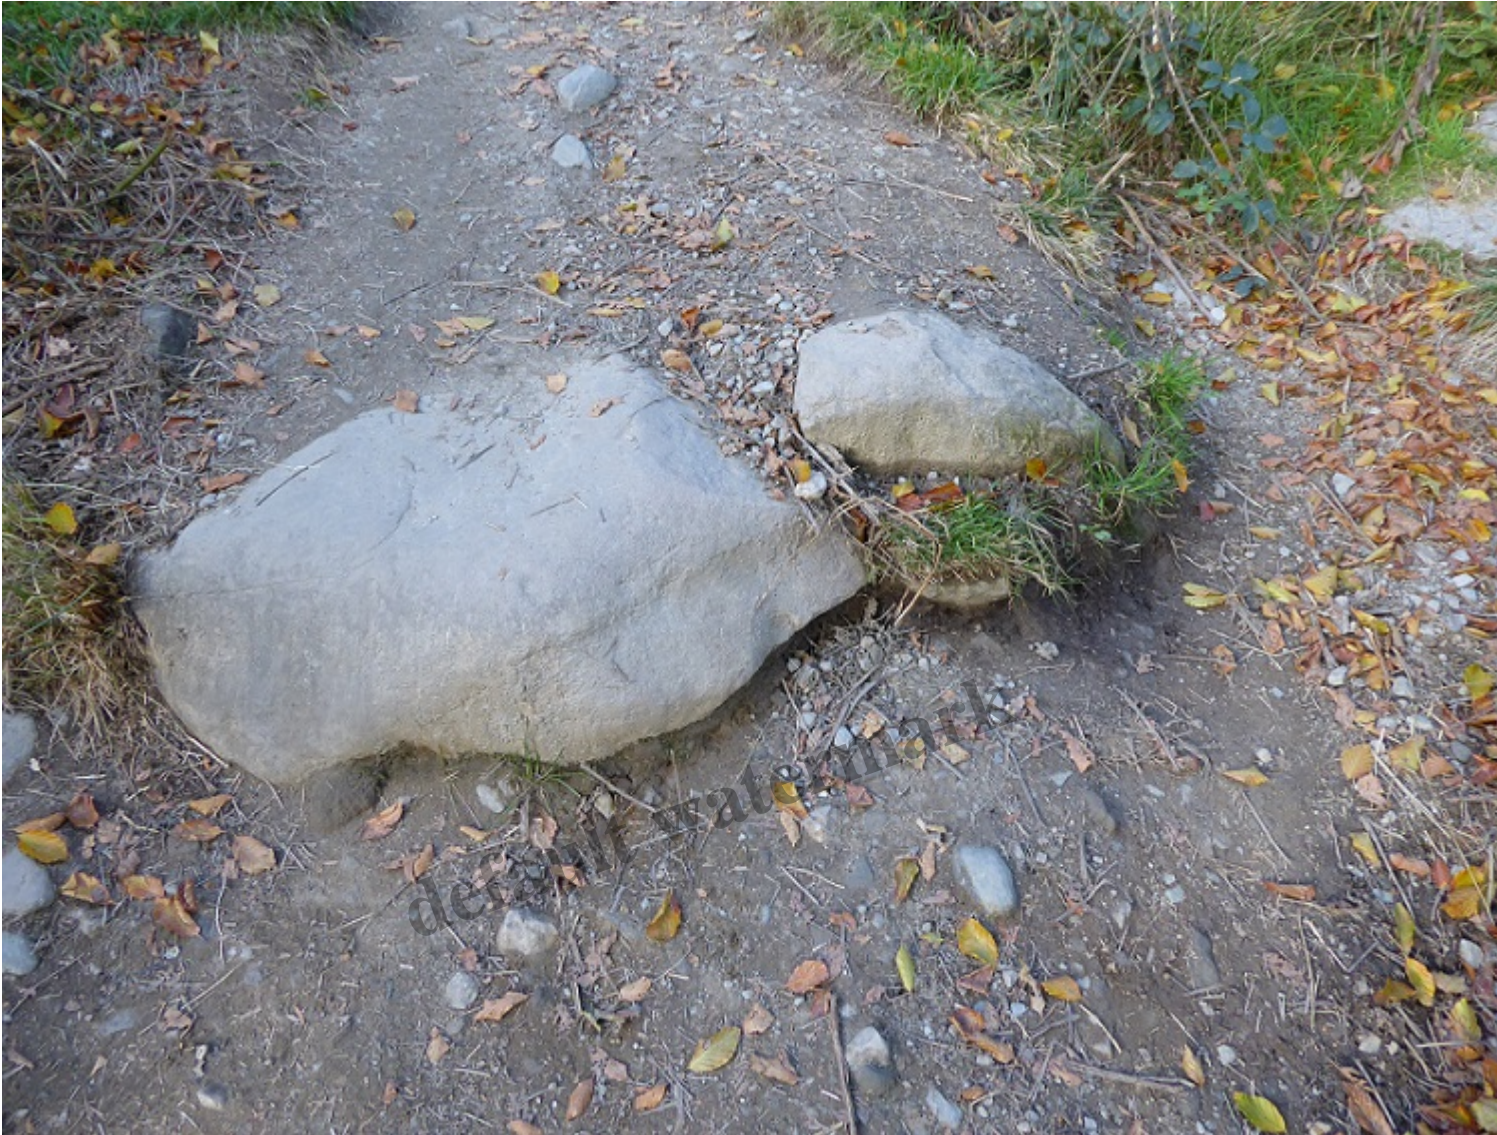
In terms of keeping people on the path, almost no walker likes high steps. They are hard work on the way up and jar the knees on the way down. If steps are greater than c10cm in height, people start trying to walk around them, as has happened here.

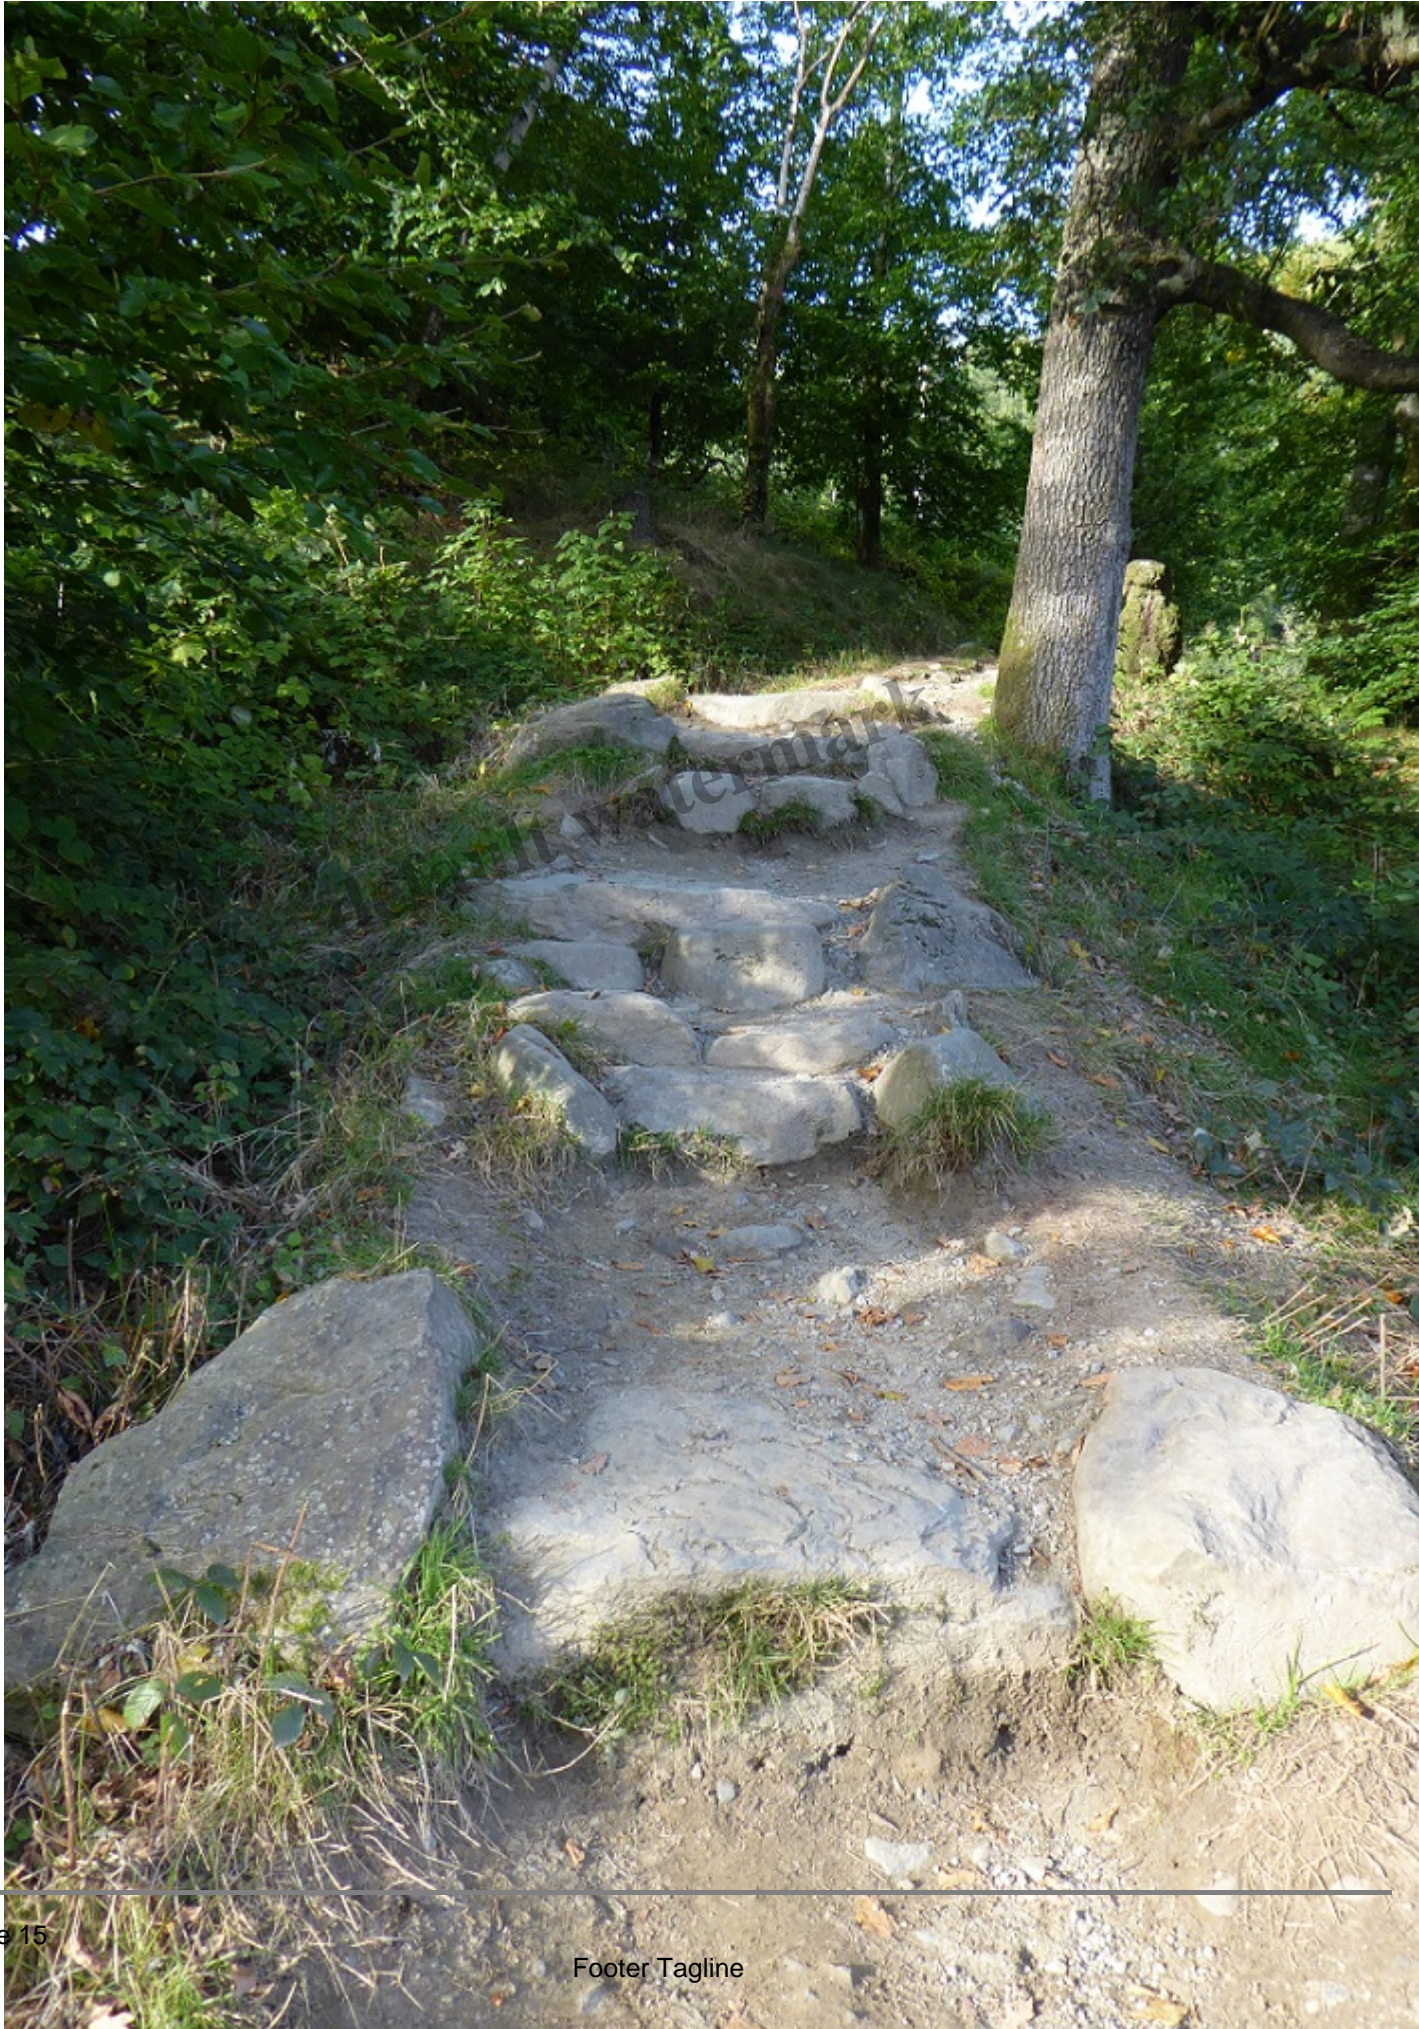
The Devil's Horns on the middle section and top steps have already failed.

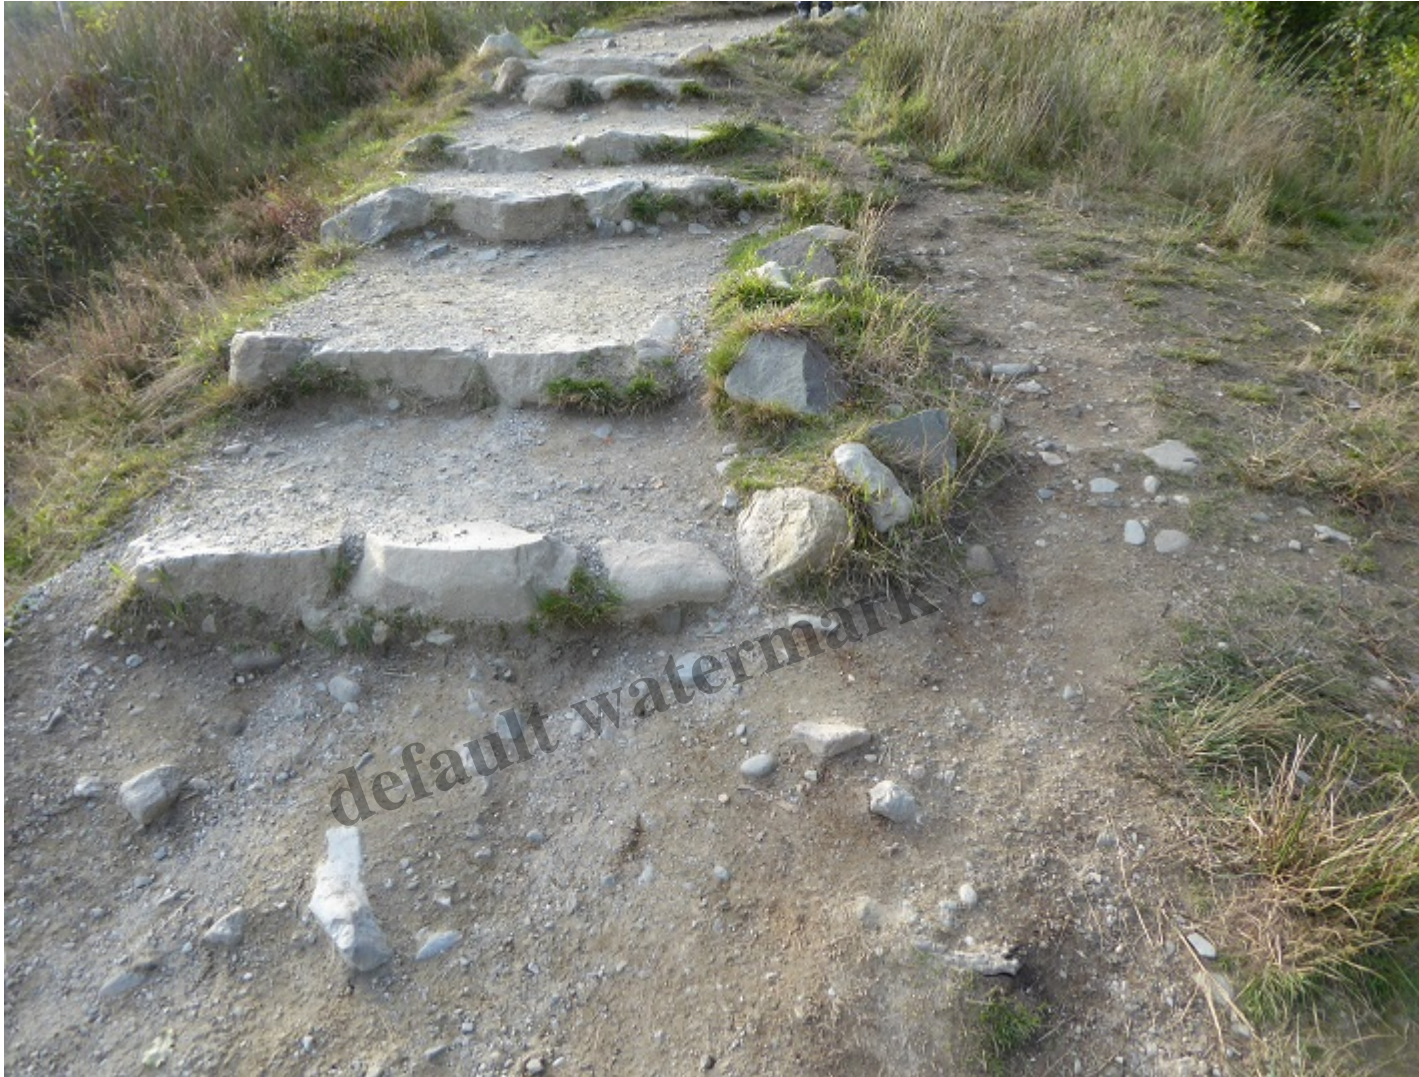
Clear signs of how the ground below the bottom step has eroded.

Note how the Devil's Horns have been left as islands in a spreading path. One wonders what will have happened in another two and a half years. The evidence suggests that much of the Ben A'An path will have disintegrated and much of the investment wasted.

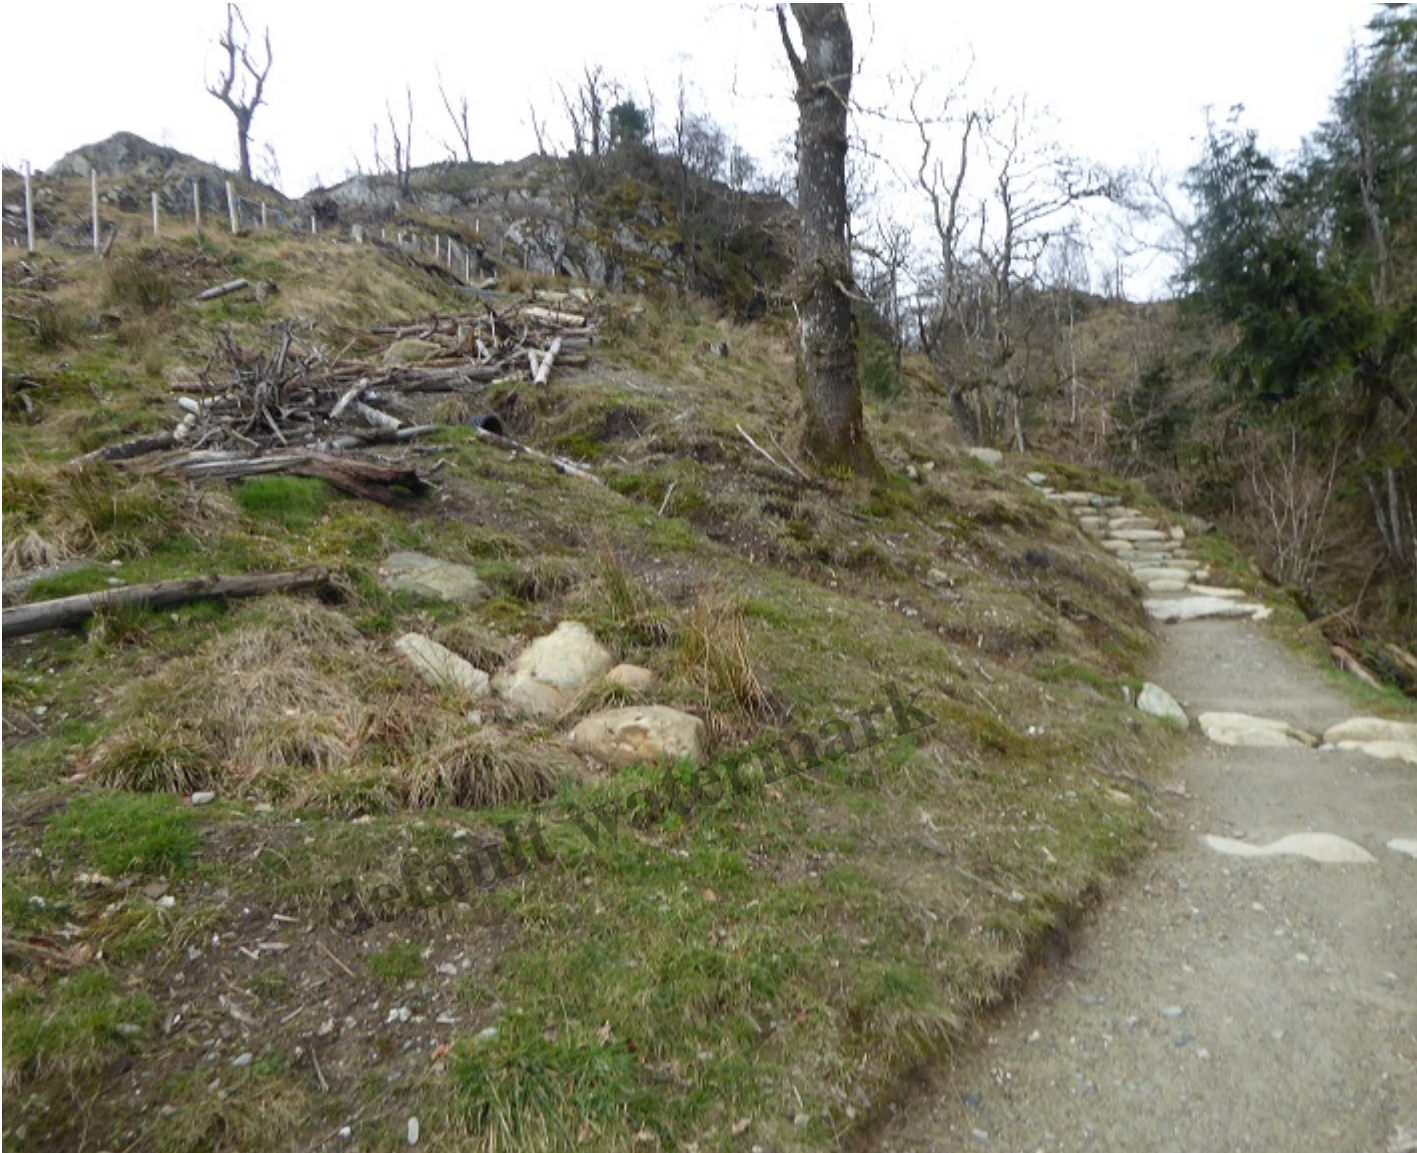
March 2019. Note the plastic culvert at the top of the obvious drainage ditch. The original new route directly up the hillside to the left of the large tree in the centre.

This steep section, about 800m after the start, began to erode very quickly after construction and as a result trainees from the Mountain and People project hand built the path you can see on the right. The logs were then placed over the steep section to prevent it being used as a shortcut. 18 months later, I don't know why, the logs had been removed but the decommissioned section of path is now being used as a shortcut:

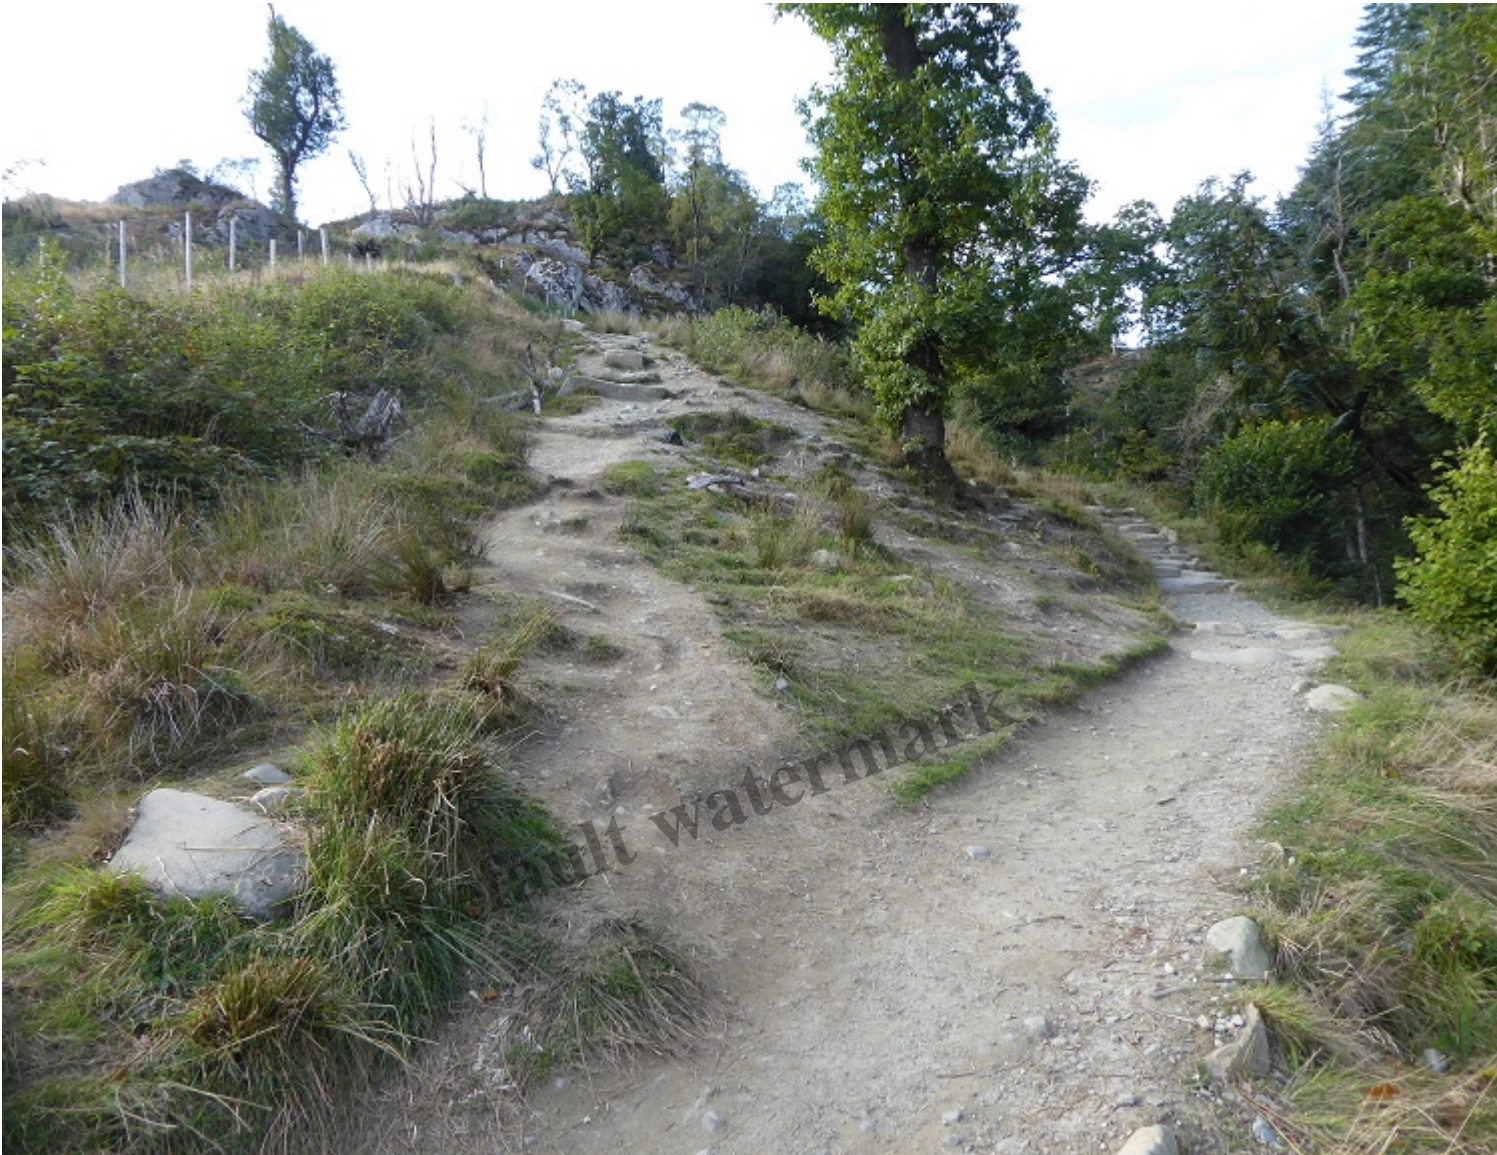
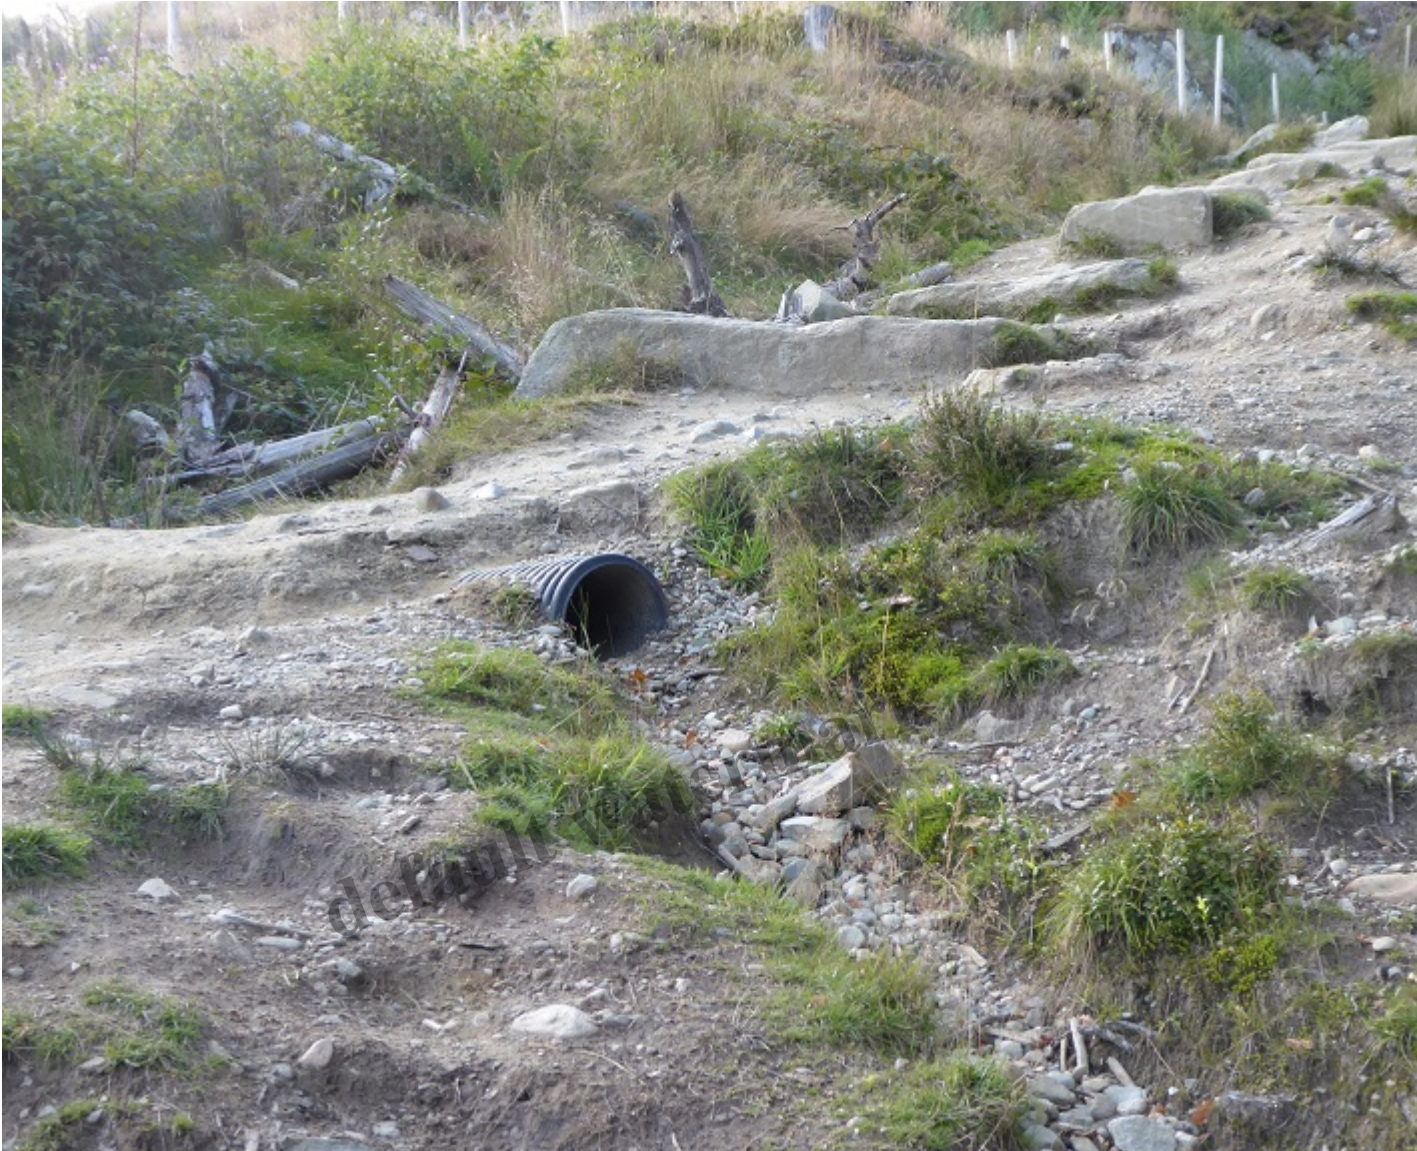
And viewed from closer up. Note how some of the former steps have become isolated islands of rock
how much of the surface has been eroded from the top of the pipe

A classic example of the consequences of getting path design wrong. One wonders how much money would now be needed to repair this damage?.

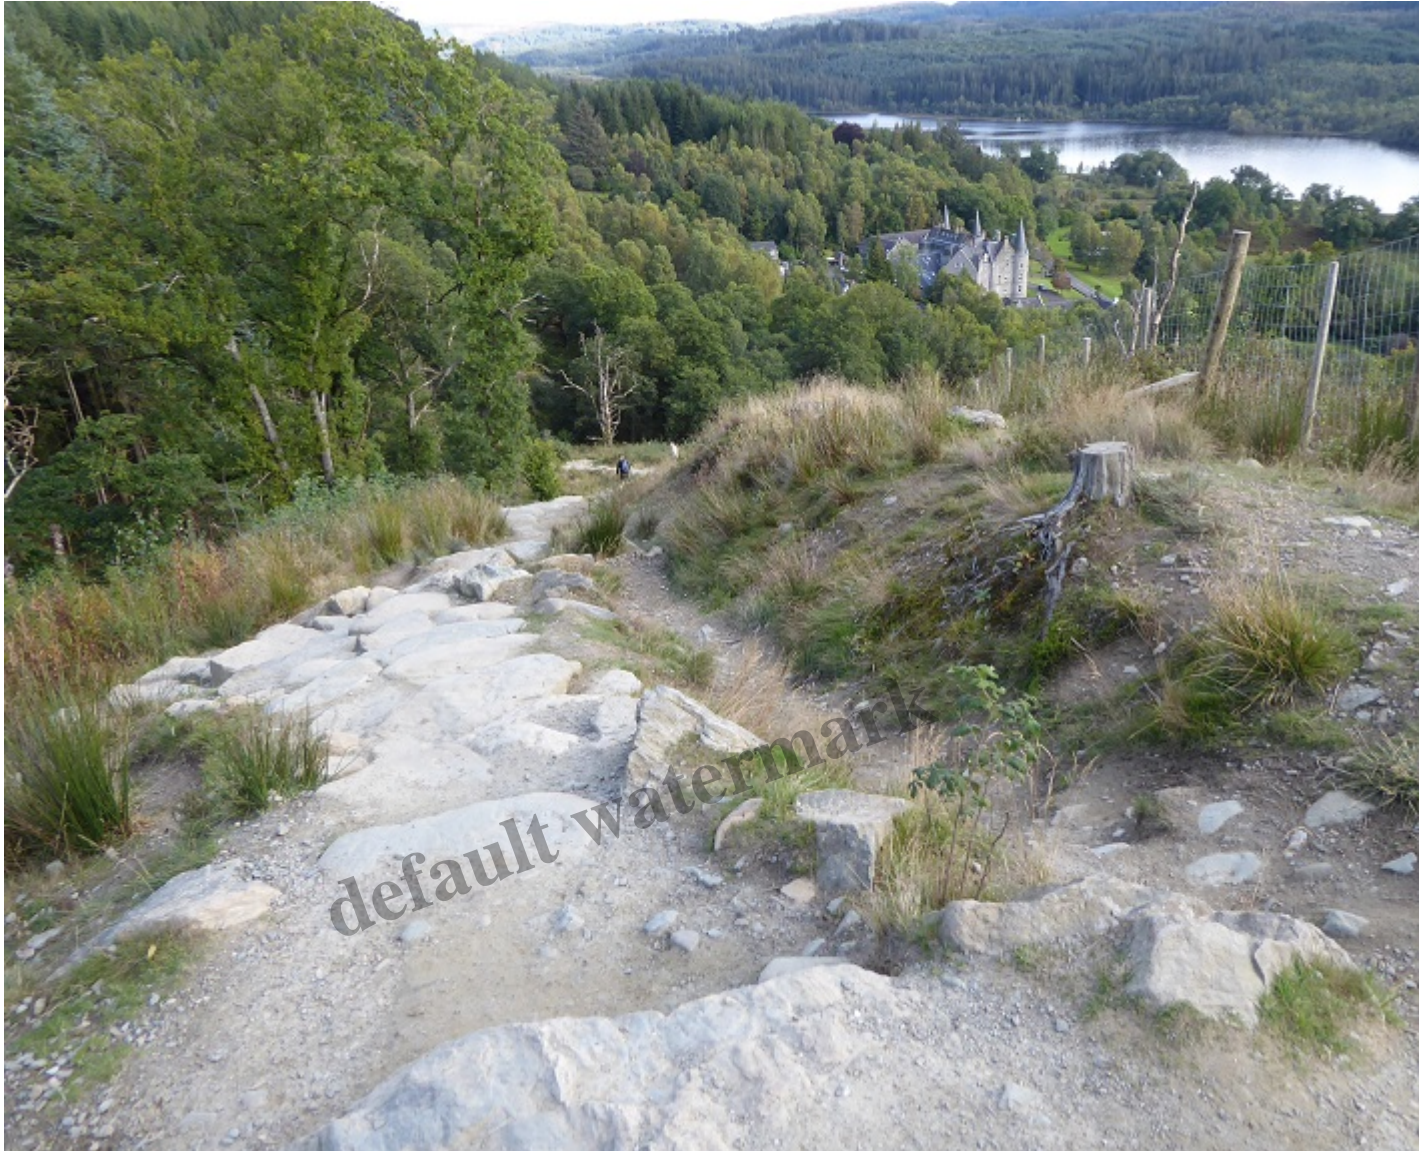
Looking down from above the short-cut, the original new section of path straight ahead and replacement section turning sharp left.

The problems are made worse because, from above, the easiest line on the feet and knees appears to be down what was originally intended as a drainage ditch. Once you have stepped onto it, you are directed straight down the hillside and unlikely to want to step back onto the flight of steps to your left until you are beyond them and it is too late.
