Ben A'an – how not to provide for outdoor recreation in the National Park

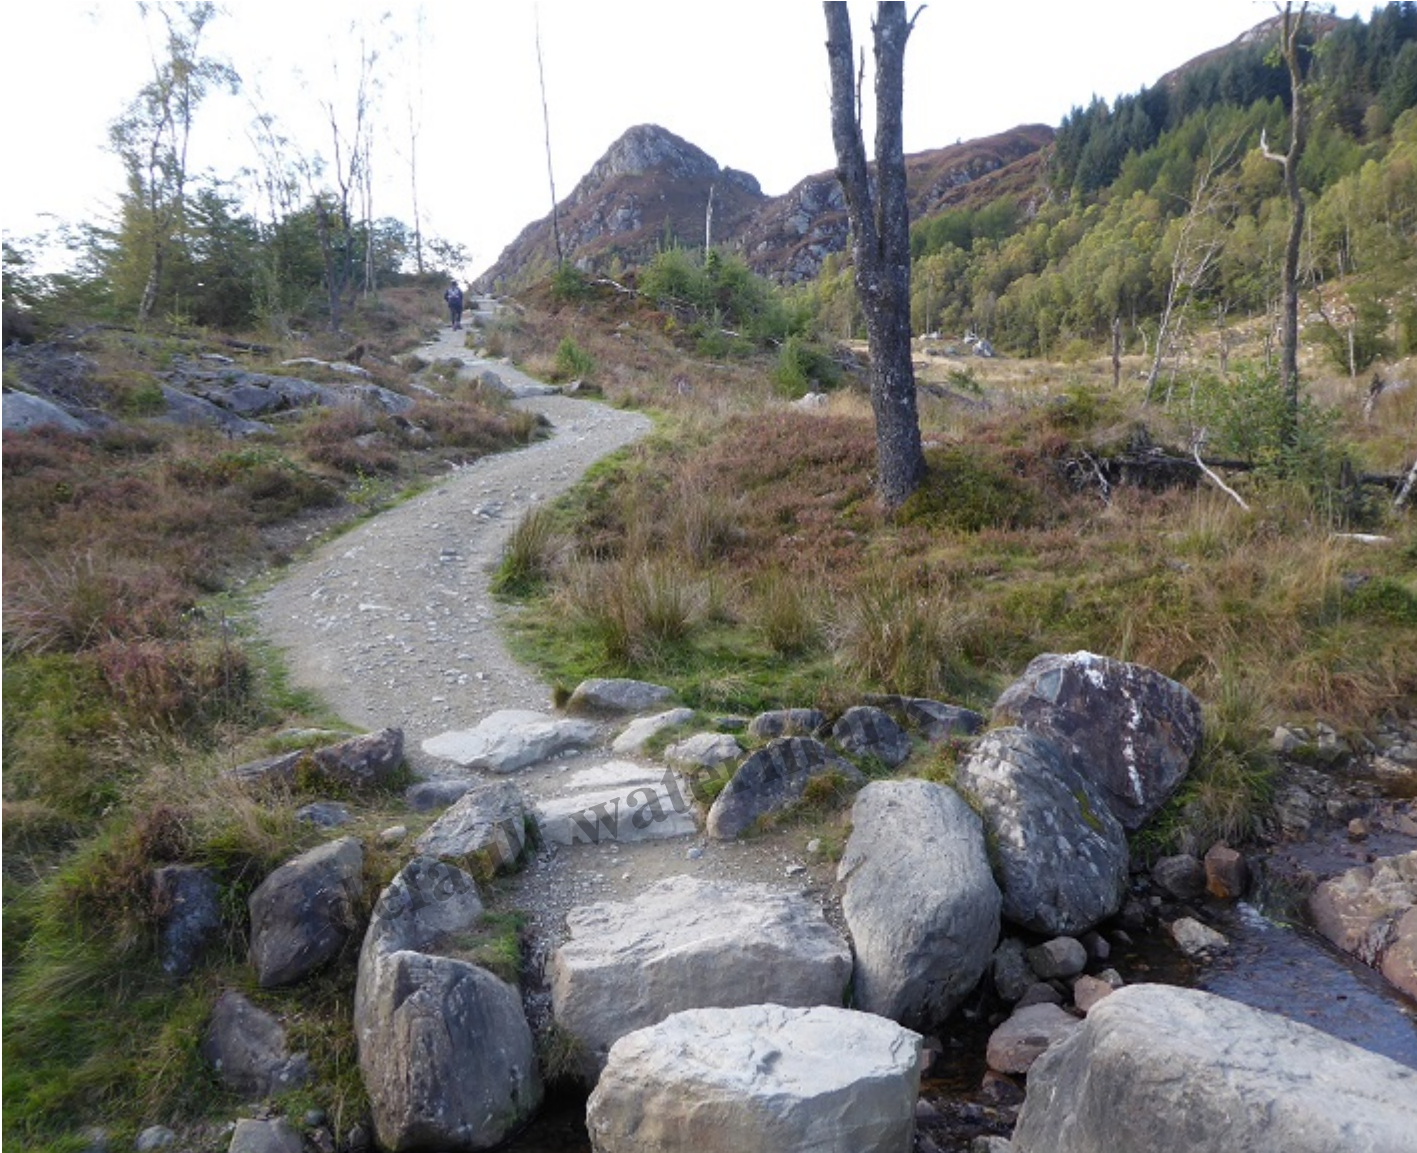
Crossing point over burn with large stepping stone

The large flat stepping stone reduces the chance of accidents when the burn is high, an important consideration on a popular path often used by inexperienced walkers, while the blocks on either side help prevent the banks eroding.

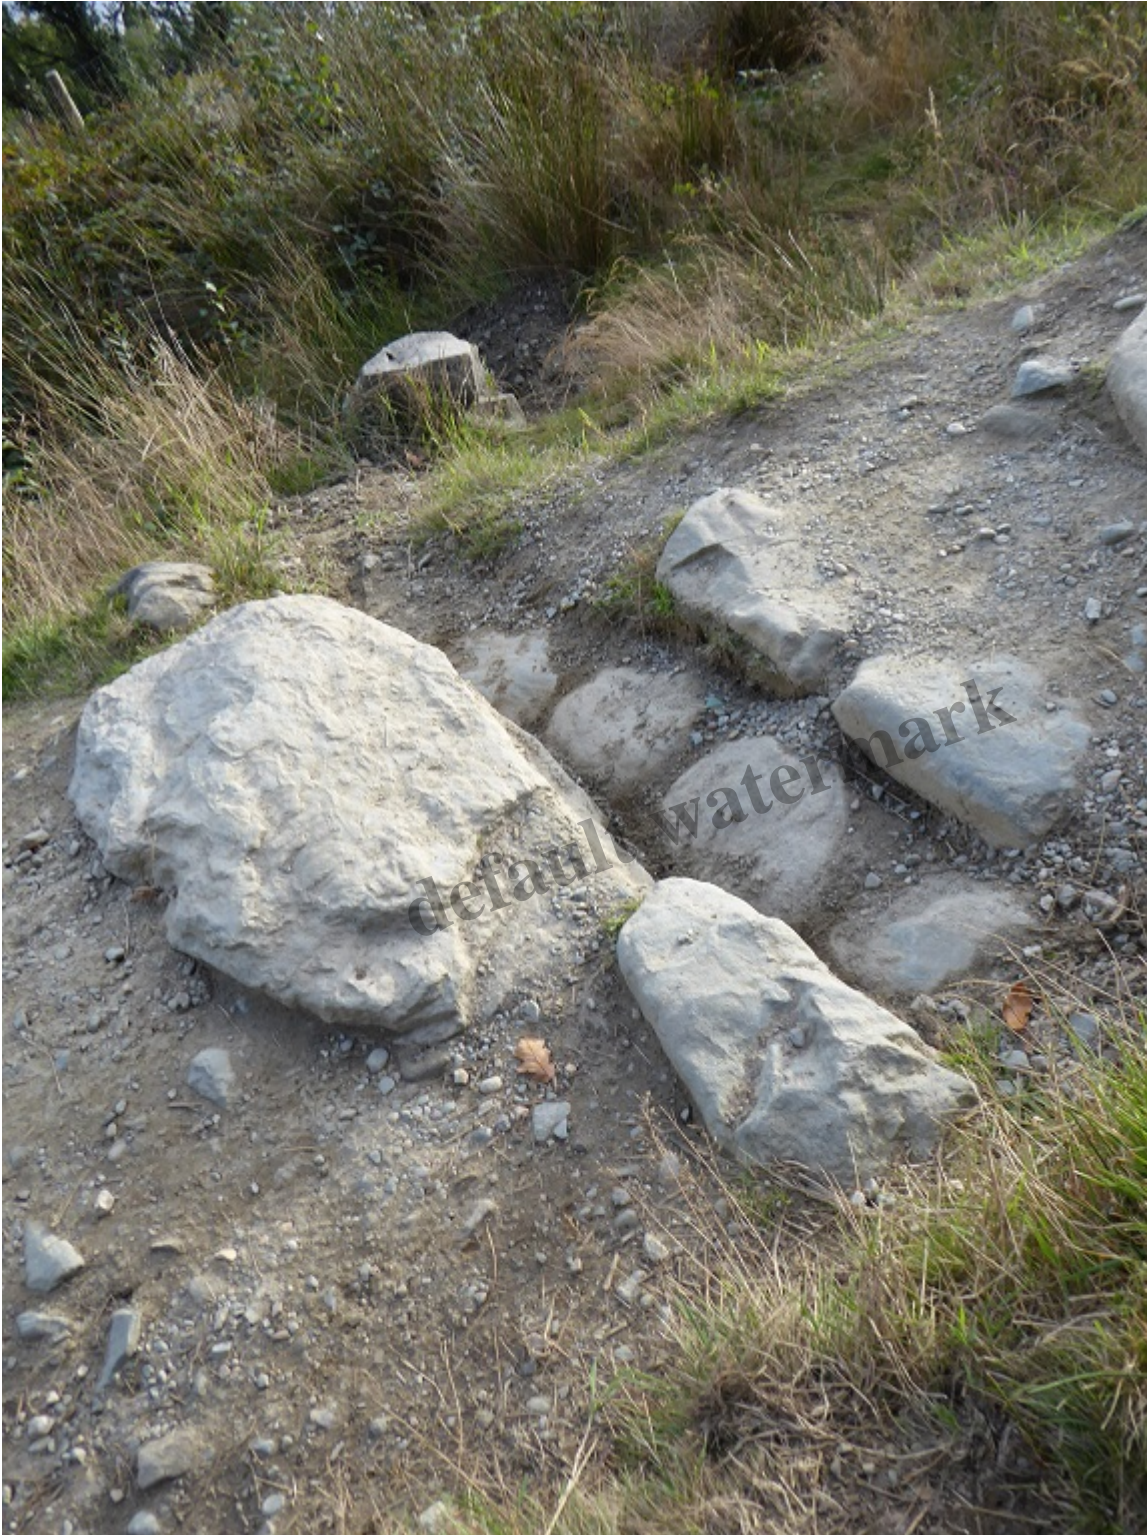
I found out subsequently from the Mountains and People website that there had been a volunteer work party a few days before my visit which had cleared out some blocked drainage: While maintenance like this is essential to keep paths in good condition, unfortunately in this case it appears to have been partly required because of yet more poor design. Unless a water bar is sufficiently angled, it will collect vegetation and other debris washed down from above and quickly block. There were several

examples of horizontal water bars along the path.
