## Ben Aonach how not to provide for outdoor recreation in the National Park

## **The Ben Aâ??an path**

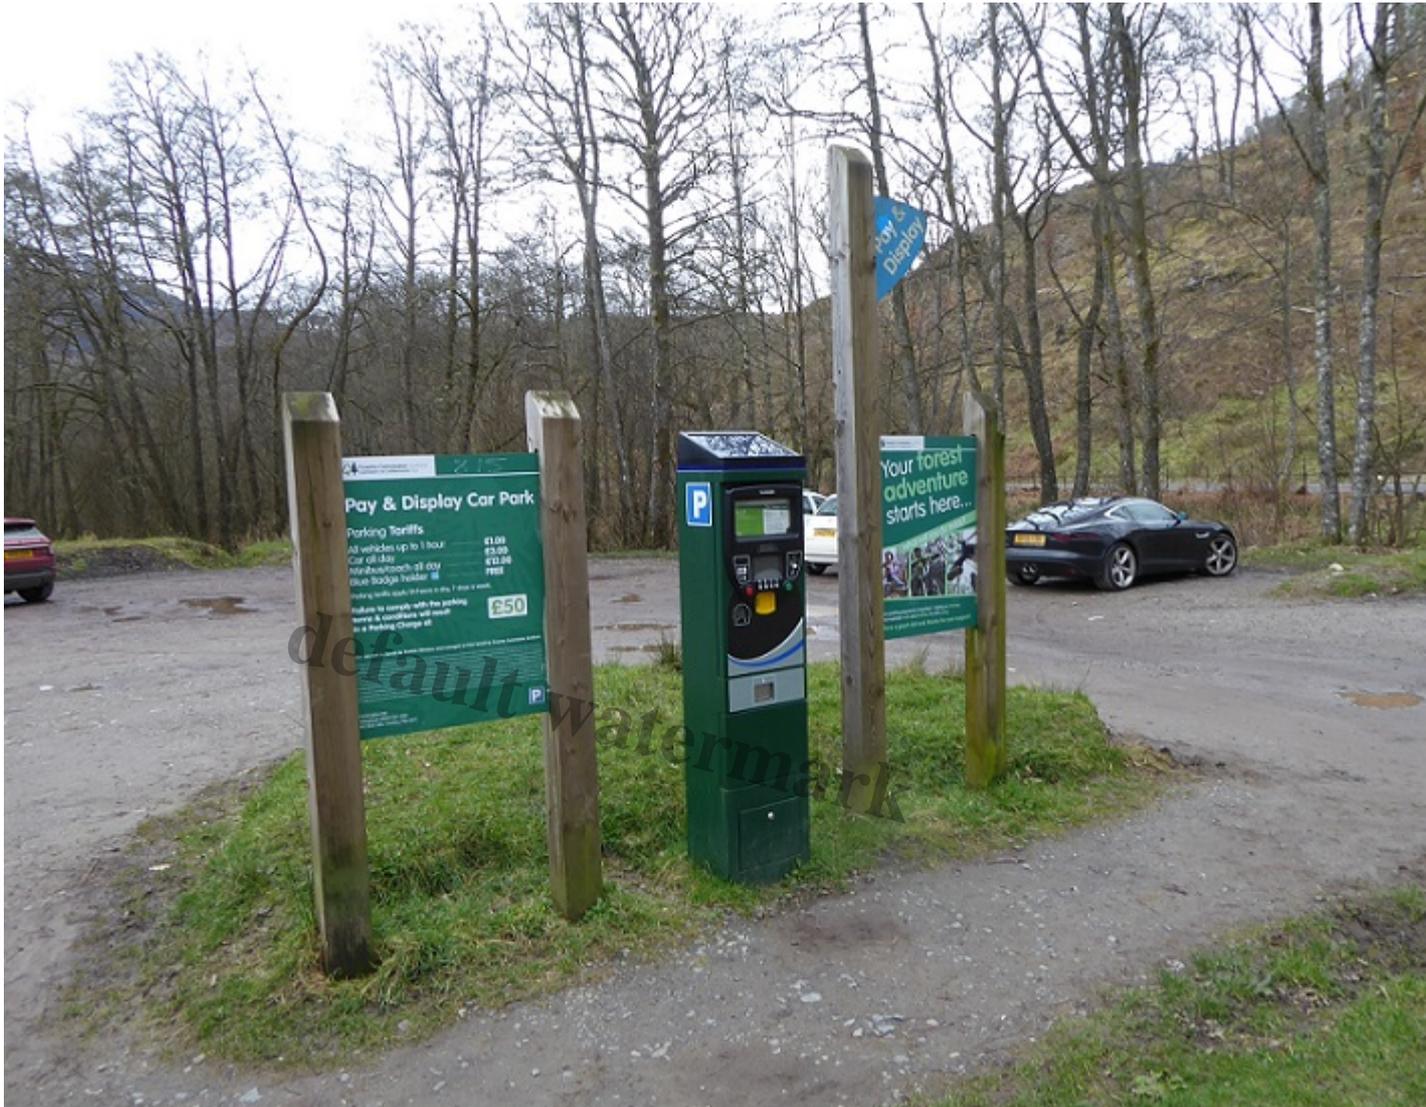
I have never found the pay and display machines at the car park in working order

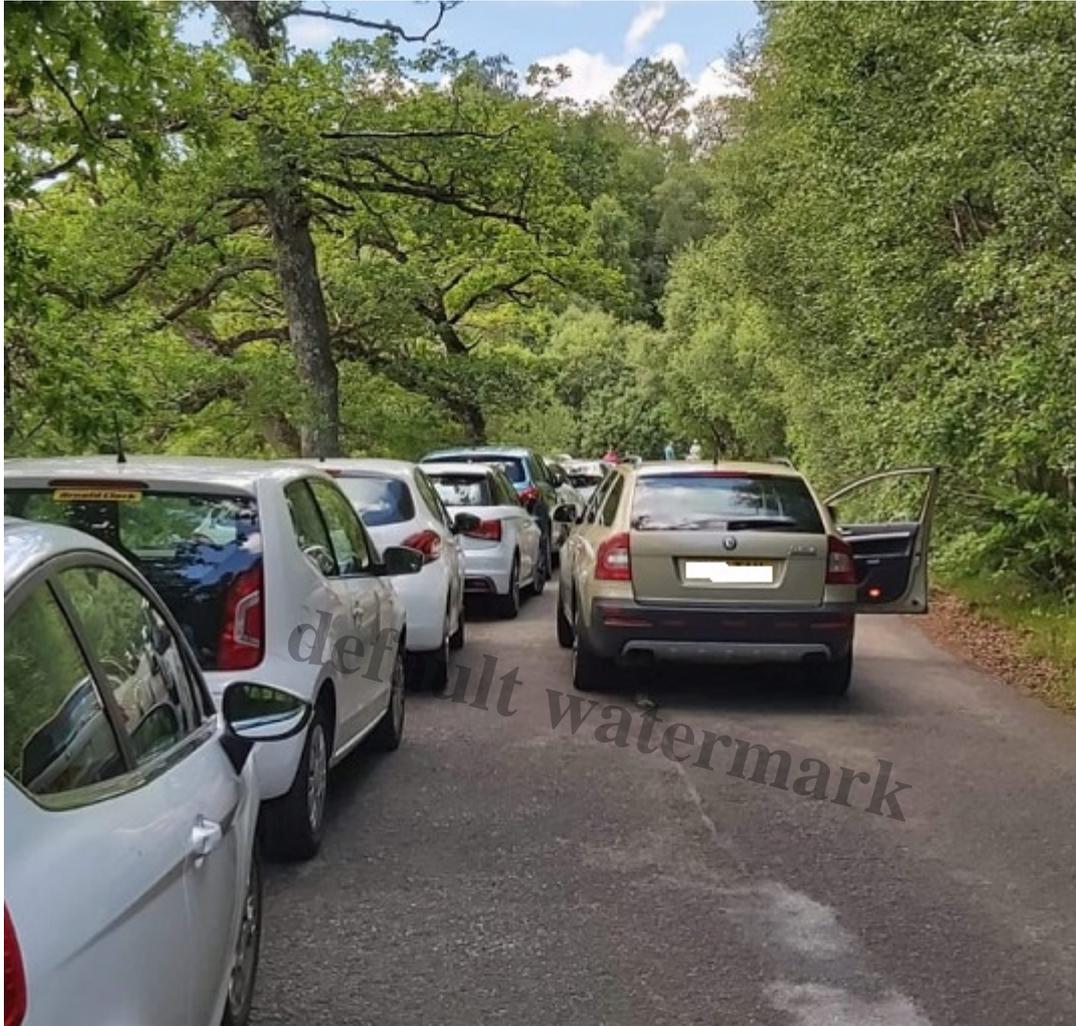
There is one main path up Ben Aâ?? an and this is accessed from a car park that is almost entirely used by people wanting to walk up the hill. While large enough to meet demand mid-week off-season, for years there have been problems at popular times. Once people started traveling after lockdown, it was overwhelmed. People started parking an dropping off along the road:

This created traffic problems for visitors and locals alike and, at times, could have made it very difficult for fire engines or ambulances to get through.

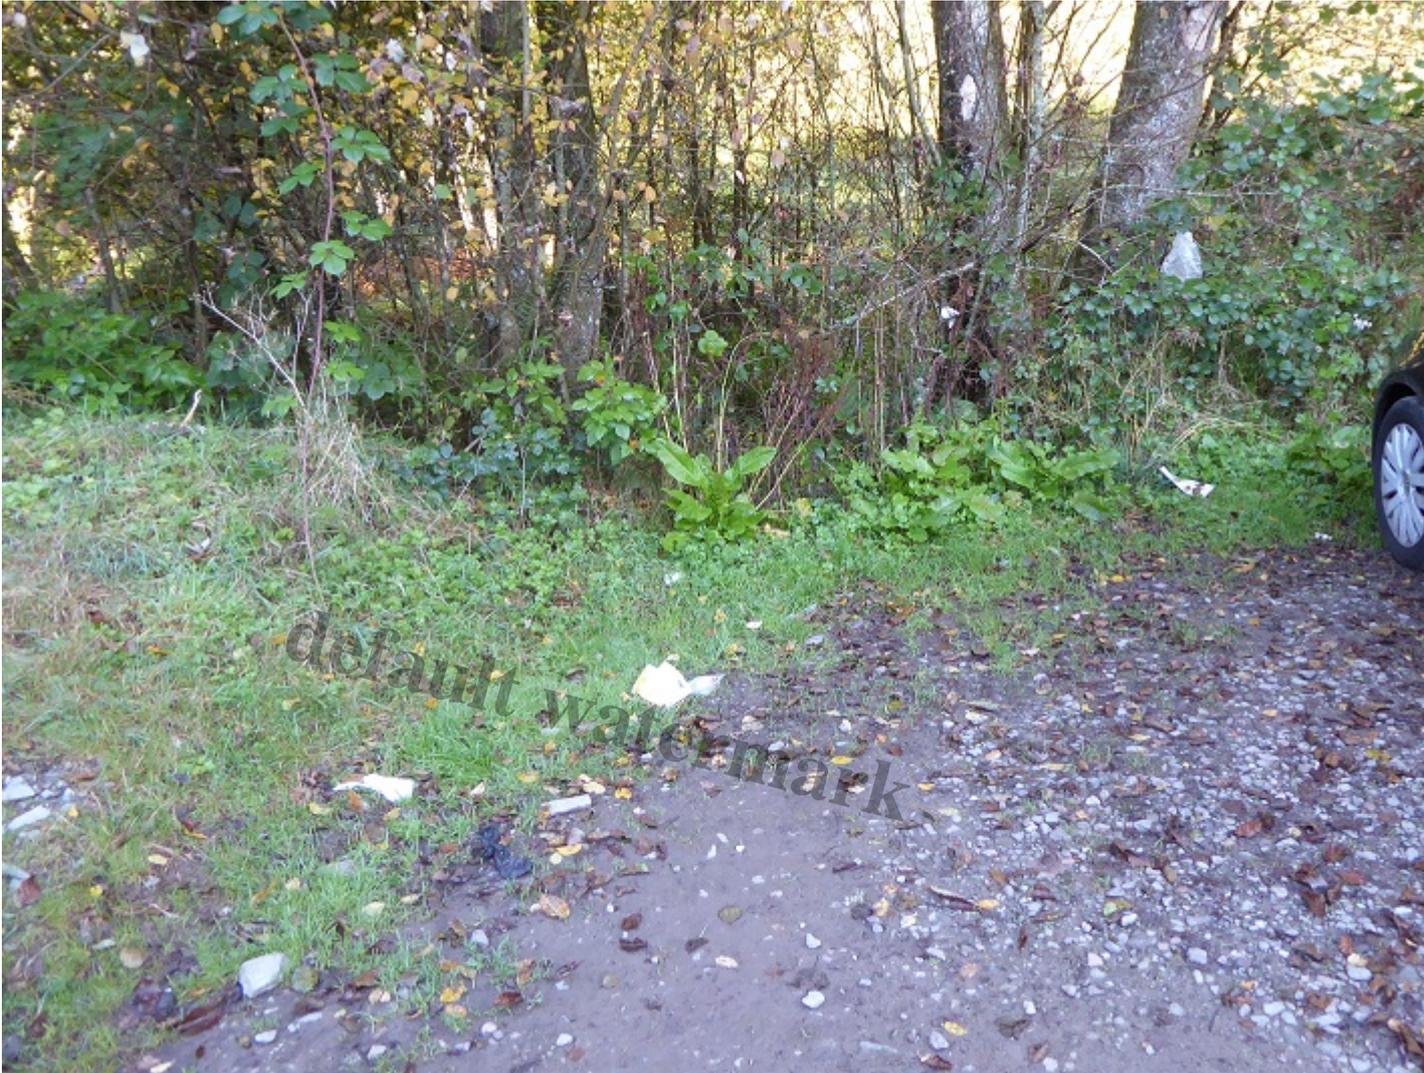
Low level littering in the car park most of which could be prevented if bins were provided.

At Ben A??an part of the solution is obvious. Below the car park is an open boggy glade in the woodland which, in the absence of any public convenience, is used as a toilet area and is pretty disgusting. Unfortunately, Forest and Land Scotland, which own the site, have shown no interest in improving the current facilities ?? both mobile toilets and litter bins are required ?? or extending the car park themselves.

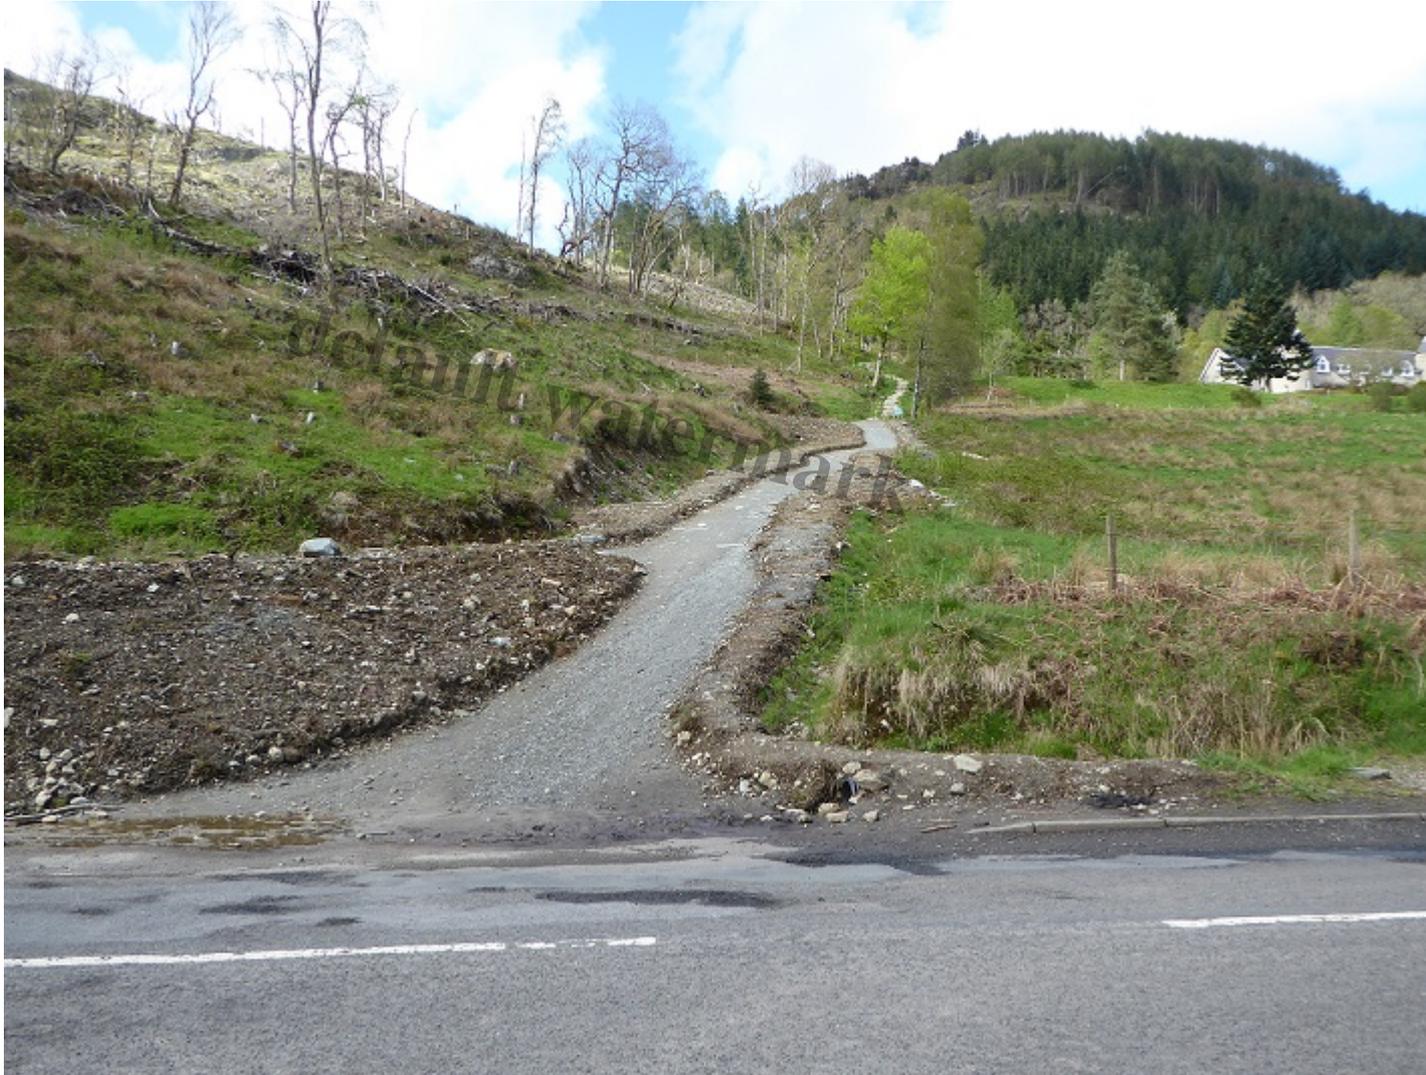
Path, soon after first completed in May 2018. The devastated area on the left was created as part of the Great Forest Trossachs Forest conservation project, with non-native conifers being removed to allow native woodland to develop.

On account of Ben A’an’s popularity, it should have been obvious that any upgrade to the main path would have to be constructed to the highest of standards to withstand wear and tear. Either that or, alternatively, a number of routes could have been created to disperse walkers. A good circular route would effectively halve levels of usage, while multiple paths, such as you find in the Lake District, would disperse people further. There are other routes up Ben A’an, including an old path from Loch Katrine, but not many people know about them and they are unpromoted and unmaintained.

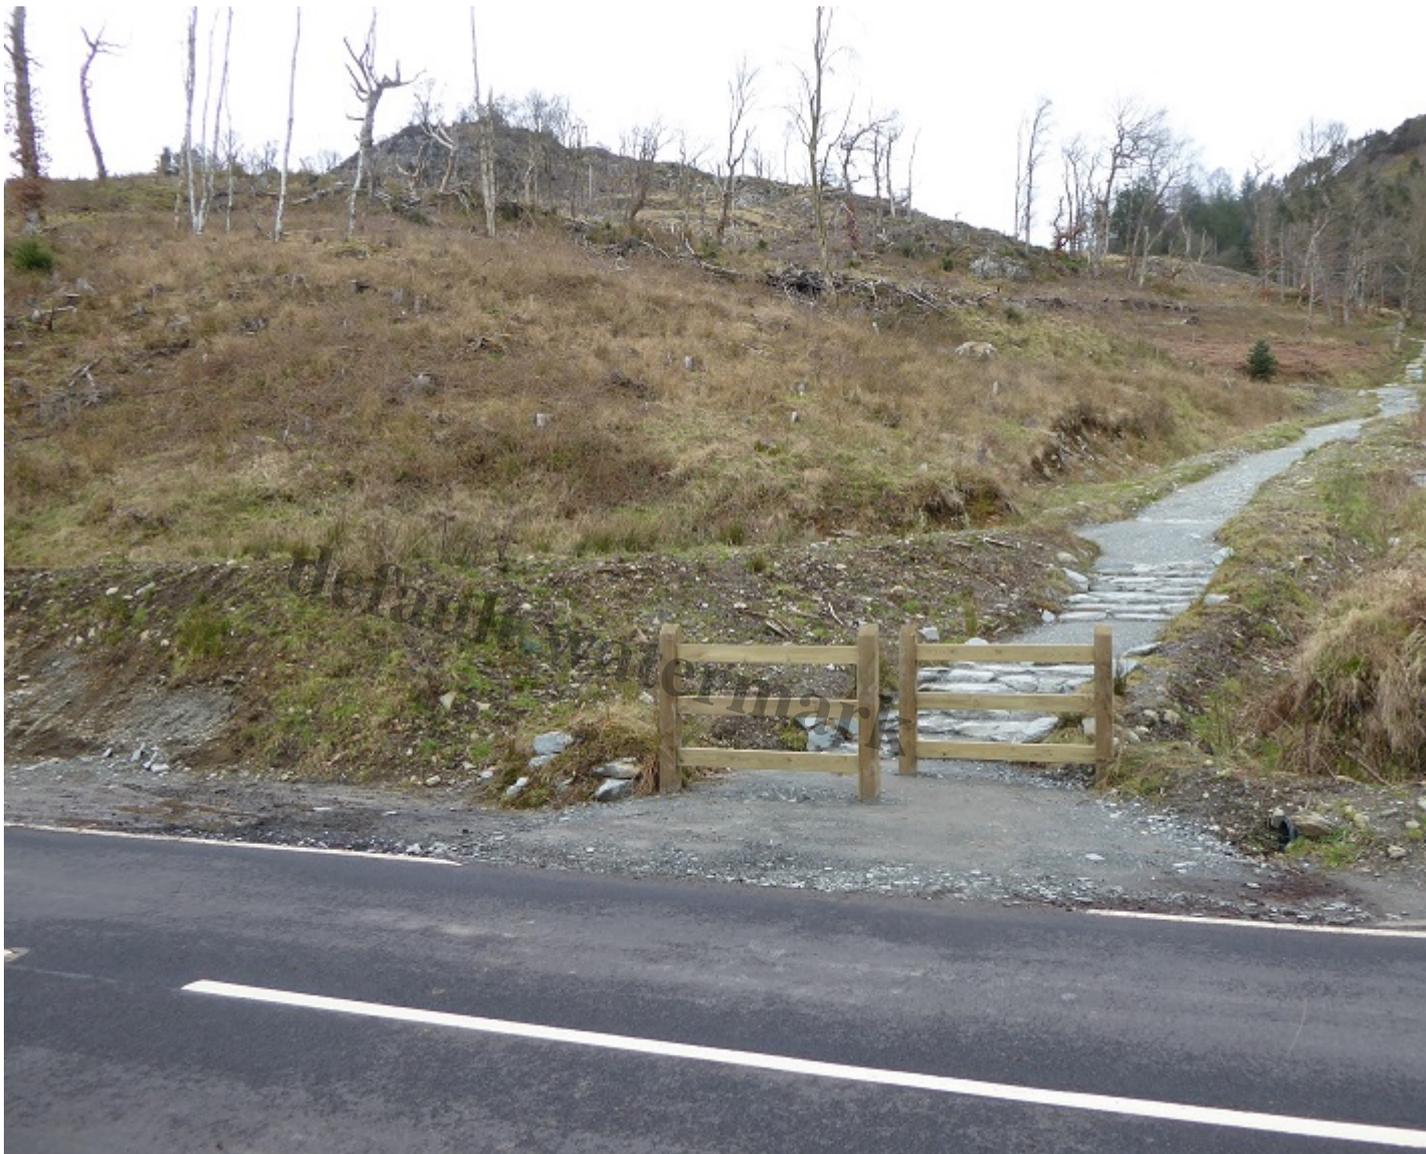
Start of path March 2019

Unfortunately, staff at the Mountains and People Project were also under pressure to repair and upgrade paths on as many hills as possible and, given a fixed budget, that affected how the paths were designed and constructed. You can see evidence of how shortcuts were attempted from comparing the two photos above. The first section of path was originally constructed as a smooth slope but was too steep – like hill roads paths start to erode once steeper than  $14^{\circ}$  – hence the steps, which are far more expensive to construct. The safety fencing appears to have been installed only after someone realised that large numbers of people striding or whizzing onto a public road on their bikes was an accident waiting to happen.

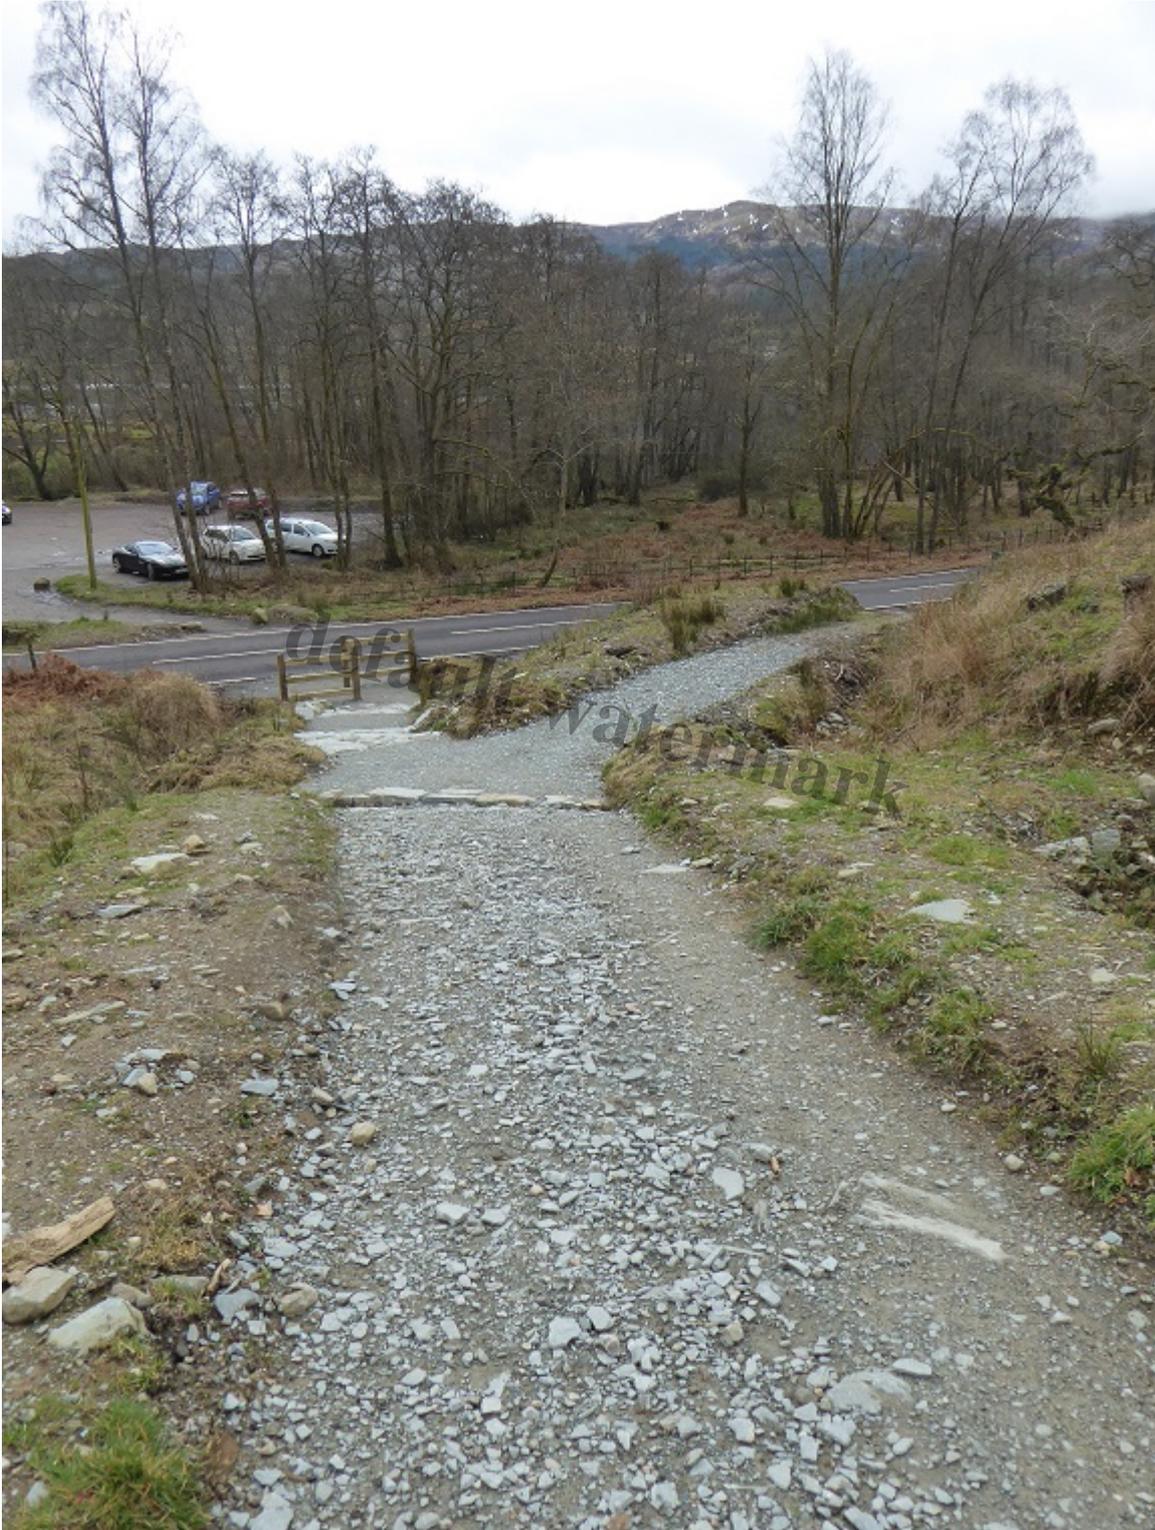
Tell tale signs of water erosion, not far above the steps, the fine material has been washed out from the left hand side of the path

One wonders how long this path surface, with its heavy usage will last.

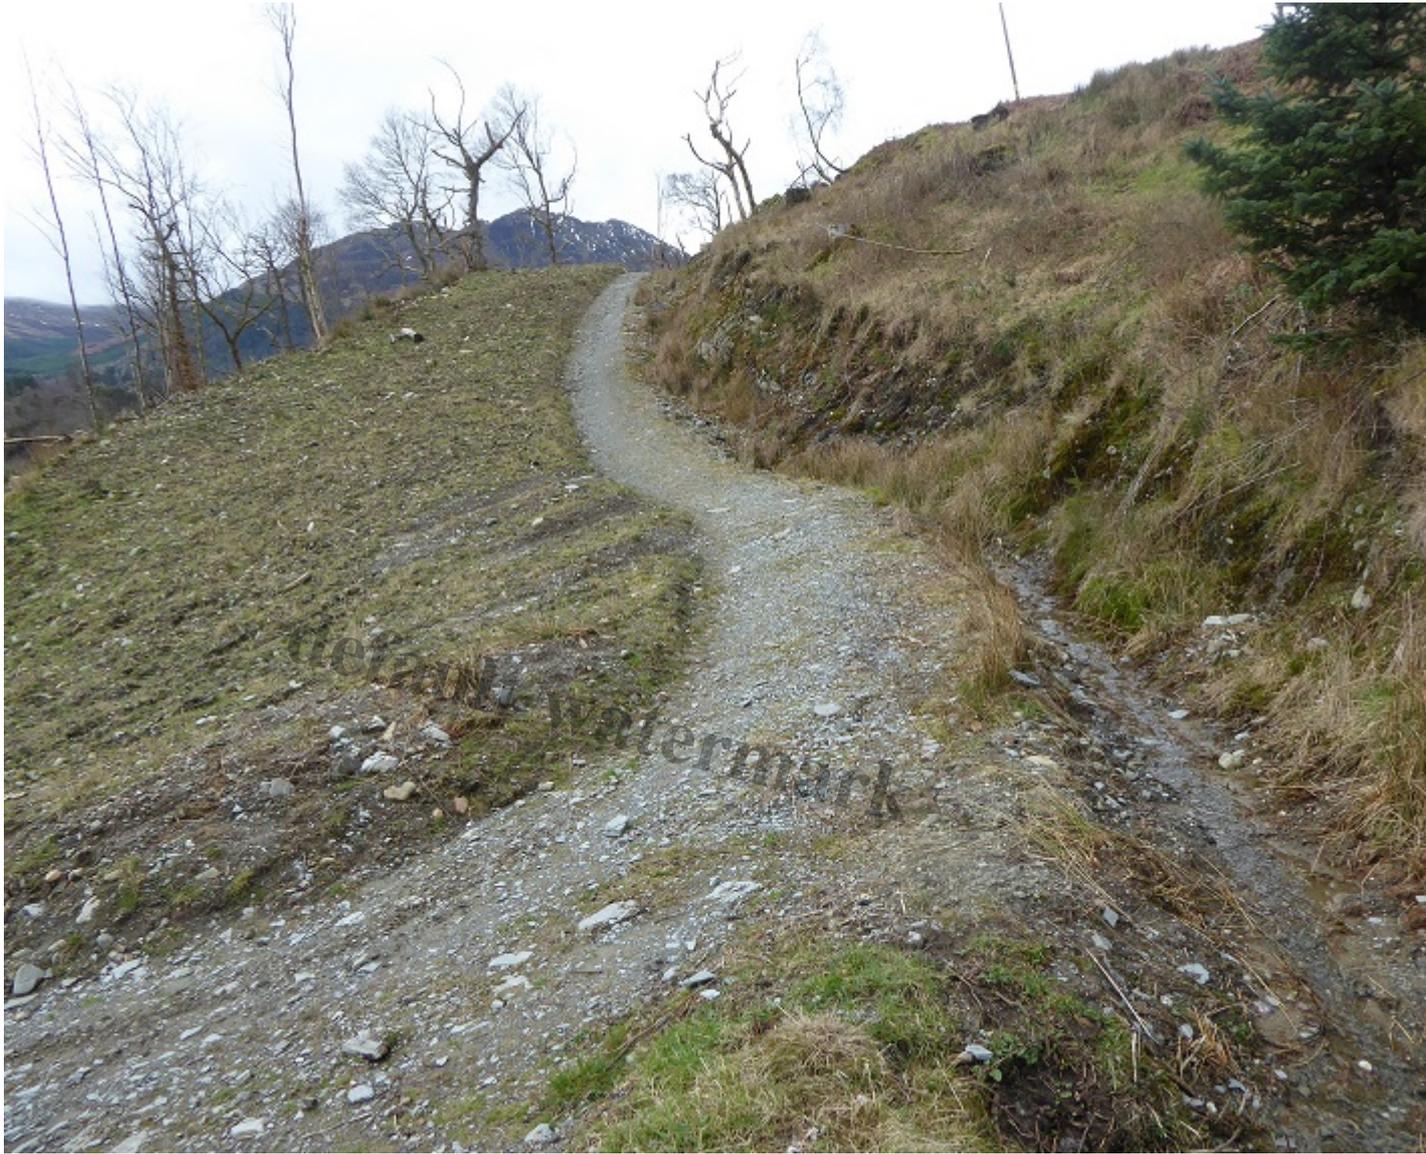
A little further up the former forest road, reduced to path width, branches off the from the main path

The old forest road could have provided a gentler route, at far less risk from erosion, with a new route constructed across the hillside to rejoin the main path above the first steep section. Instead the main path heads directly up the hill. A shorter route and therefore cheaper to construct, as long as this could be constructed by machine..

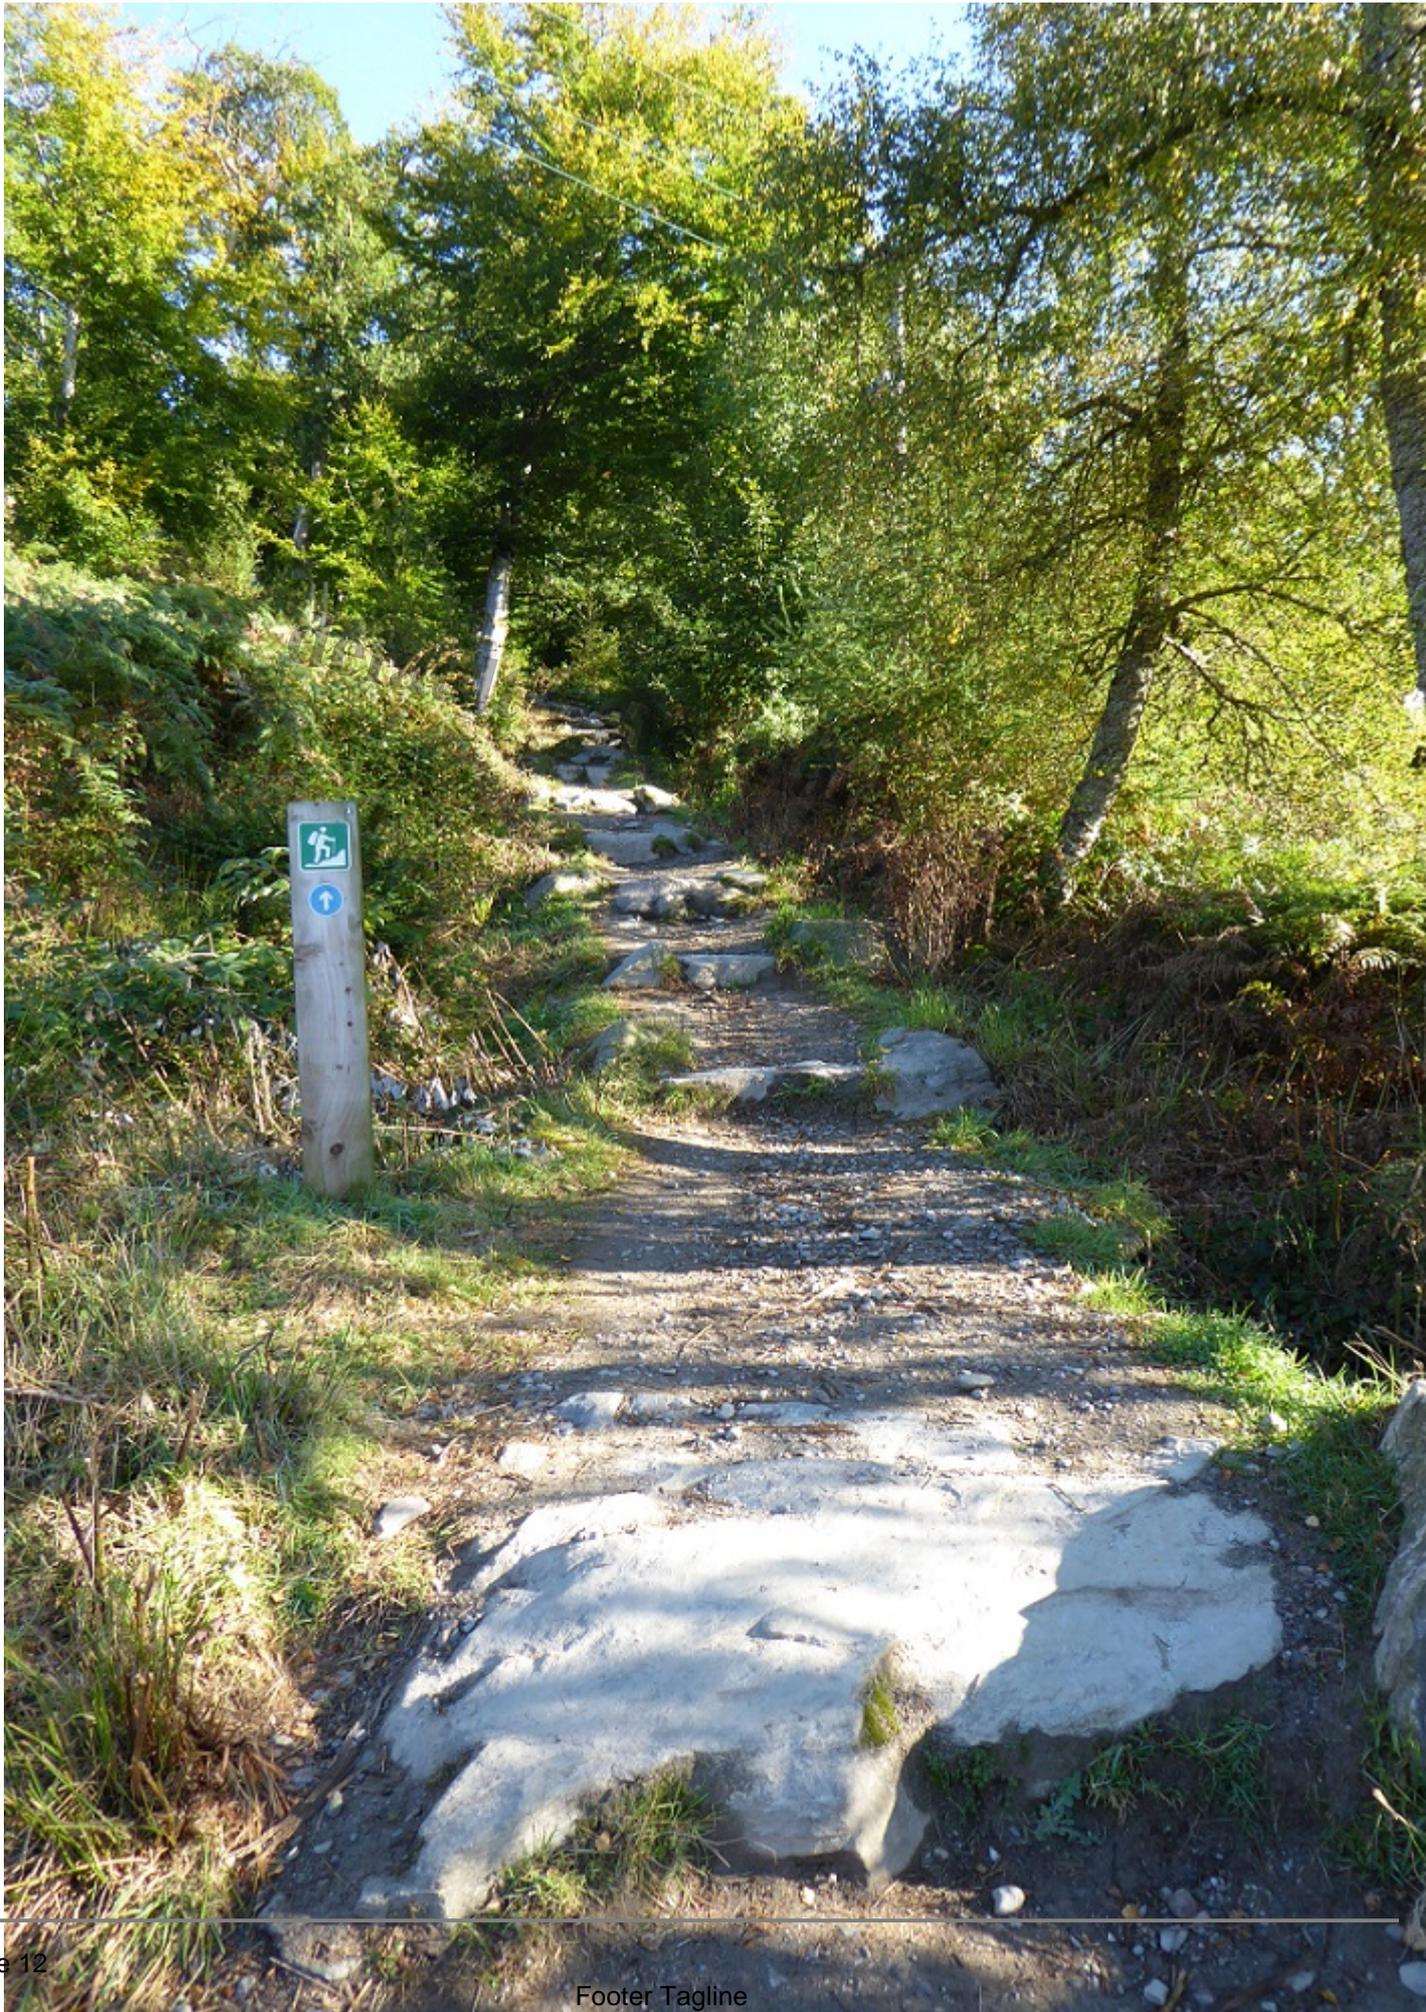
Note the signs of water erosion on the sections between the steps and the rocks on either side of each step, designed to prevent people walking round the edge.

While it is amazing what skilled machine operators can do, steep paths pose challenges. They need to be designed so they don't turn into watercourses and in ways that encourage walkers to remain on them. In this case, in a downpour, the angle of the inclined slope between the steps encourages water to flow down the path and there is no camber to shed the water on either side.

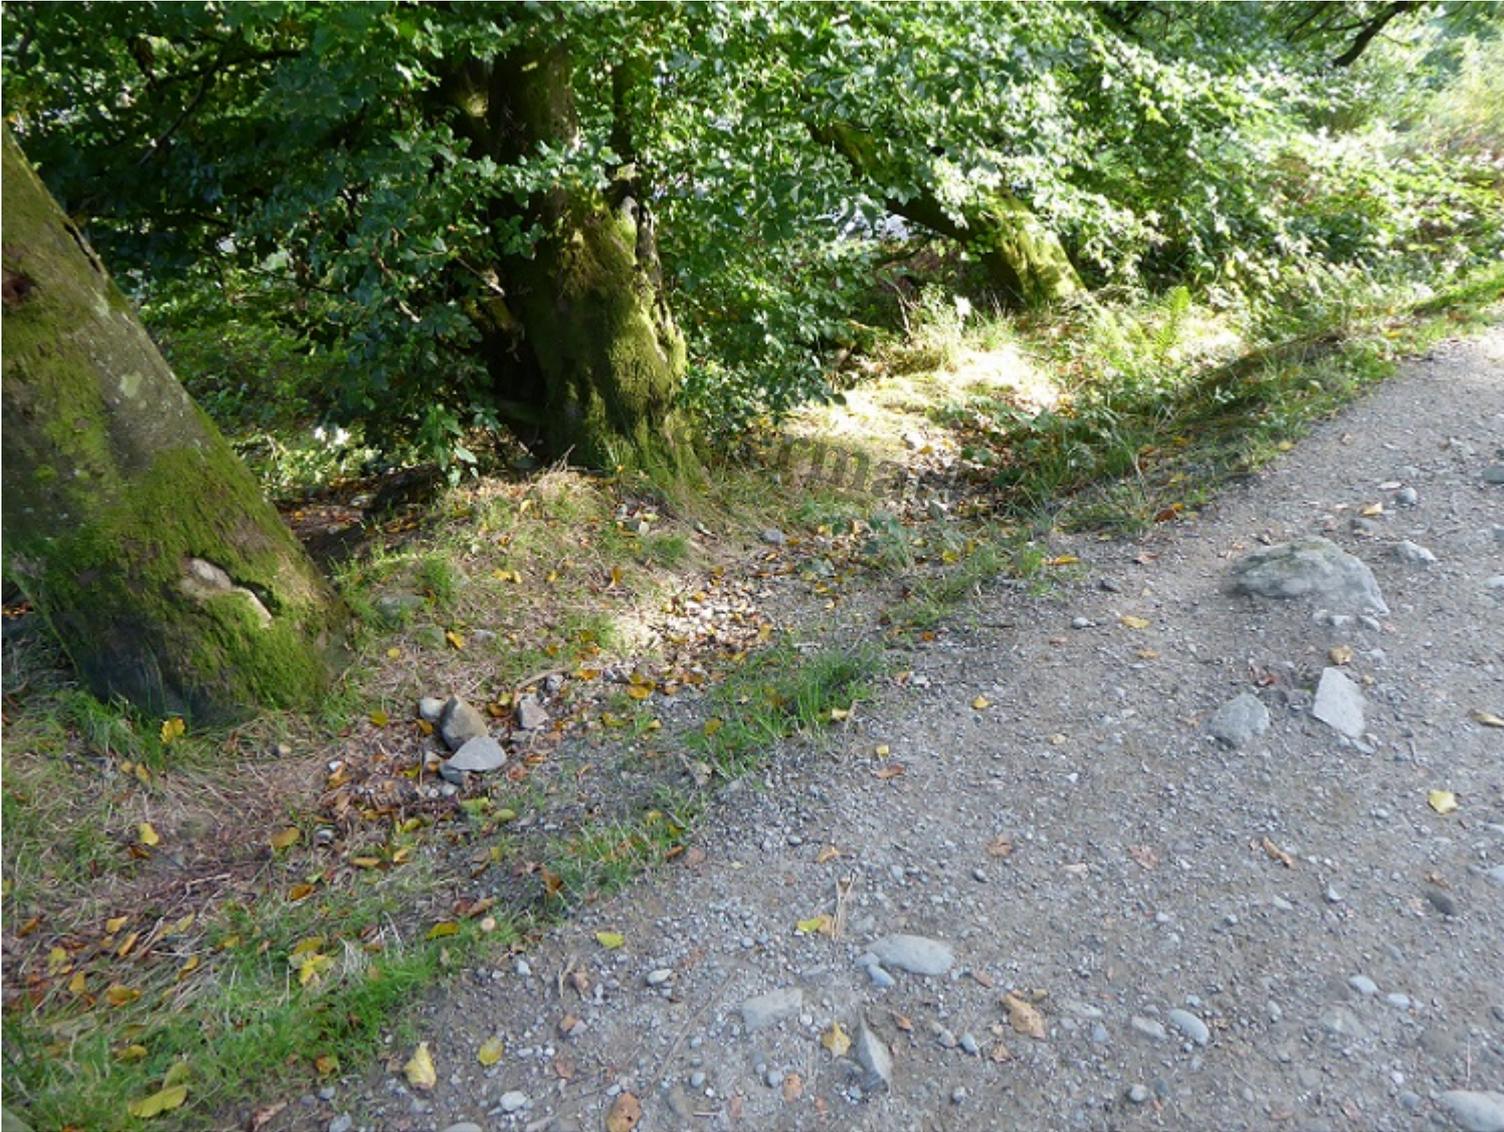
The eroded material ends up wherever the water takes it, often where the path bends.

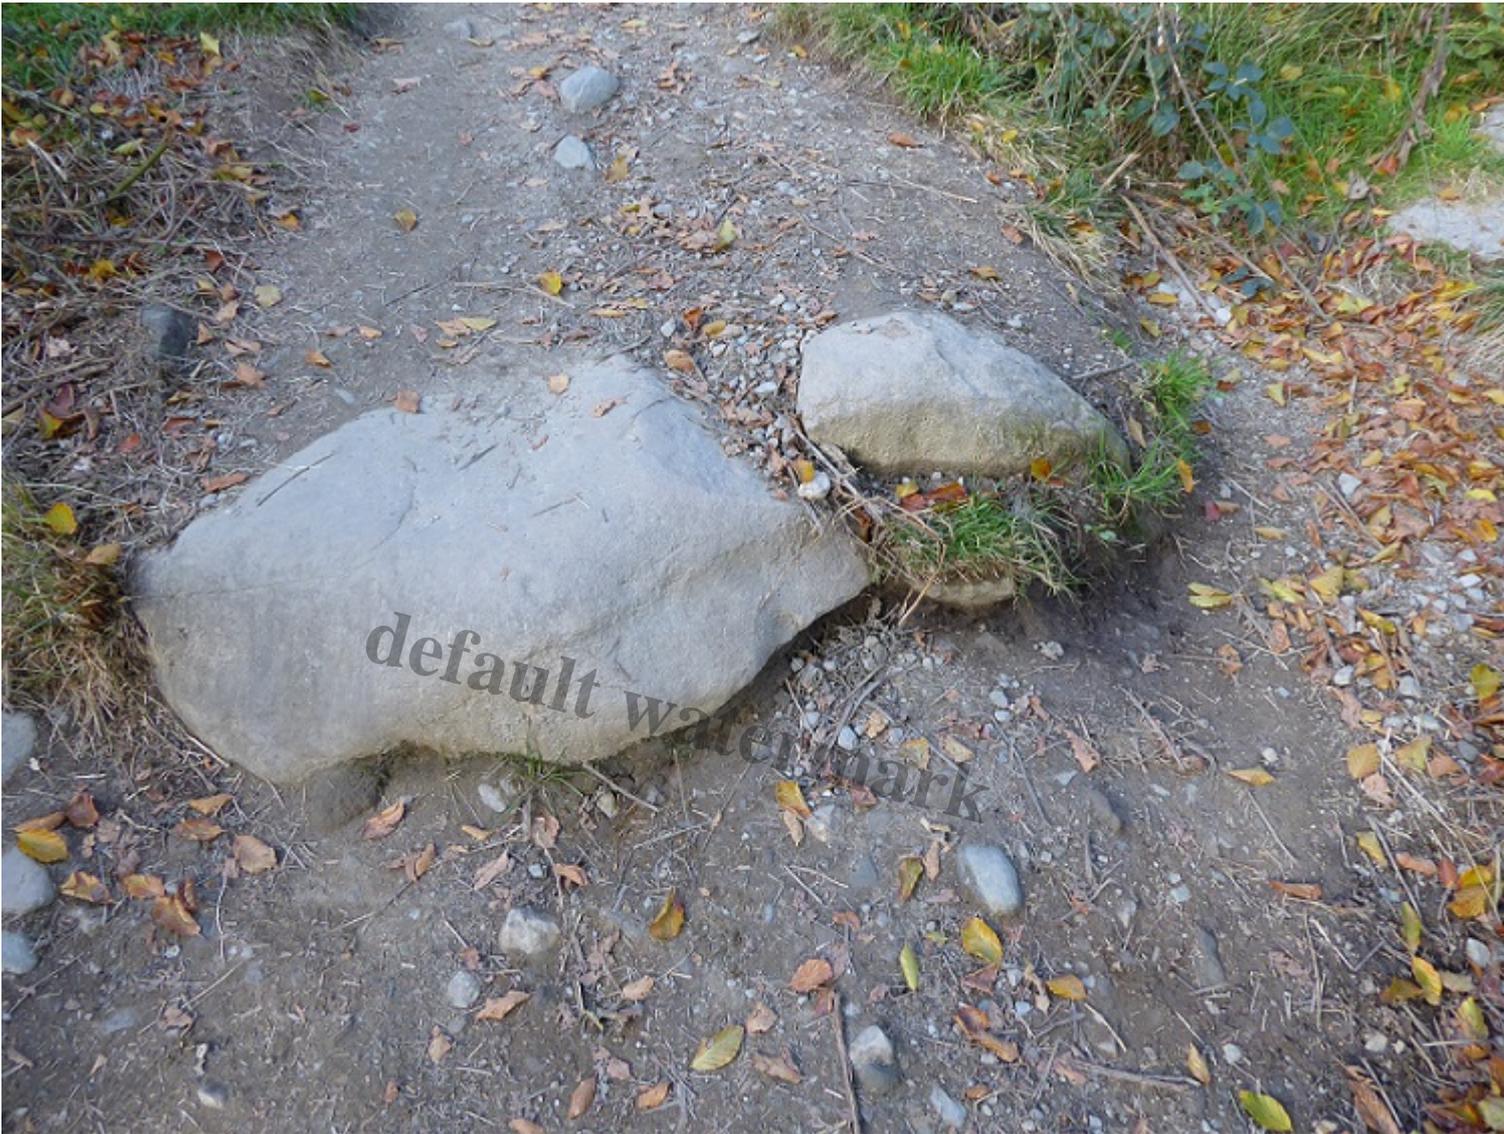
In terms of keeping people on the path, almost no walker likes high steps. They are hard work on the way up and jar the knees on the way down. If steps are greater than c10cm in height, people start trying to walk around them, as has happened here.

While erecting devilâ??s horns by each step can reduce the problem, they can be a bit too obvious. People will take considerable efforts to walk round them

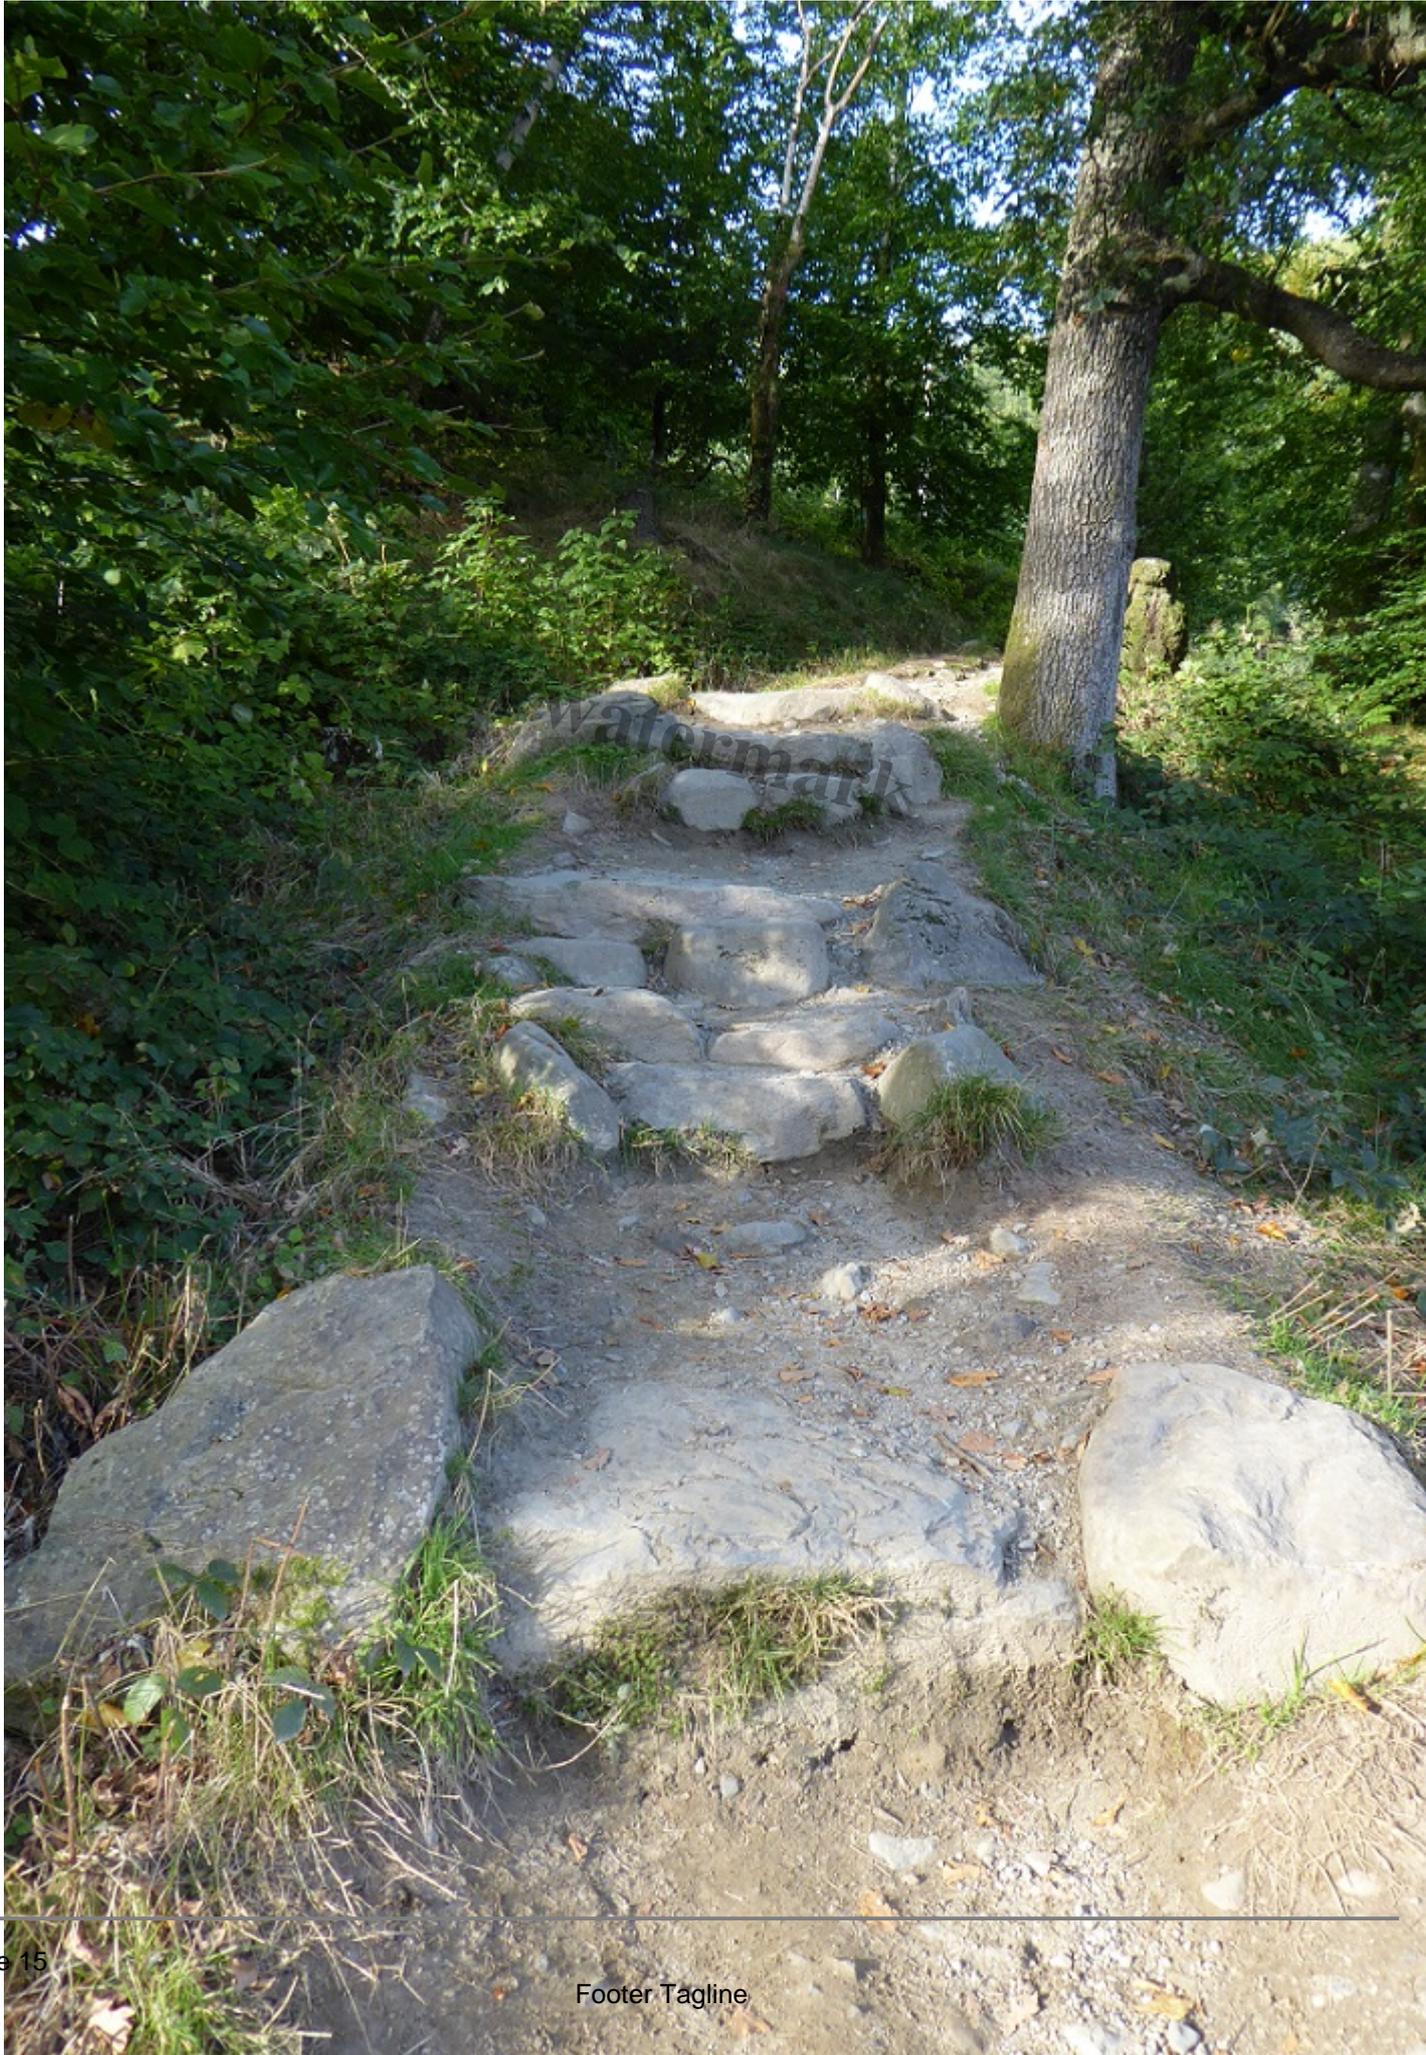
The Devil's Horns on the middle section and top steps have already failed.

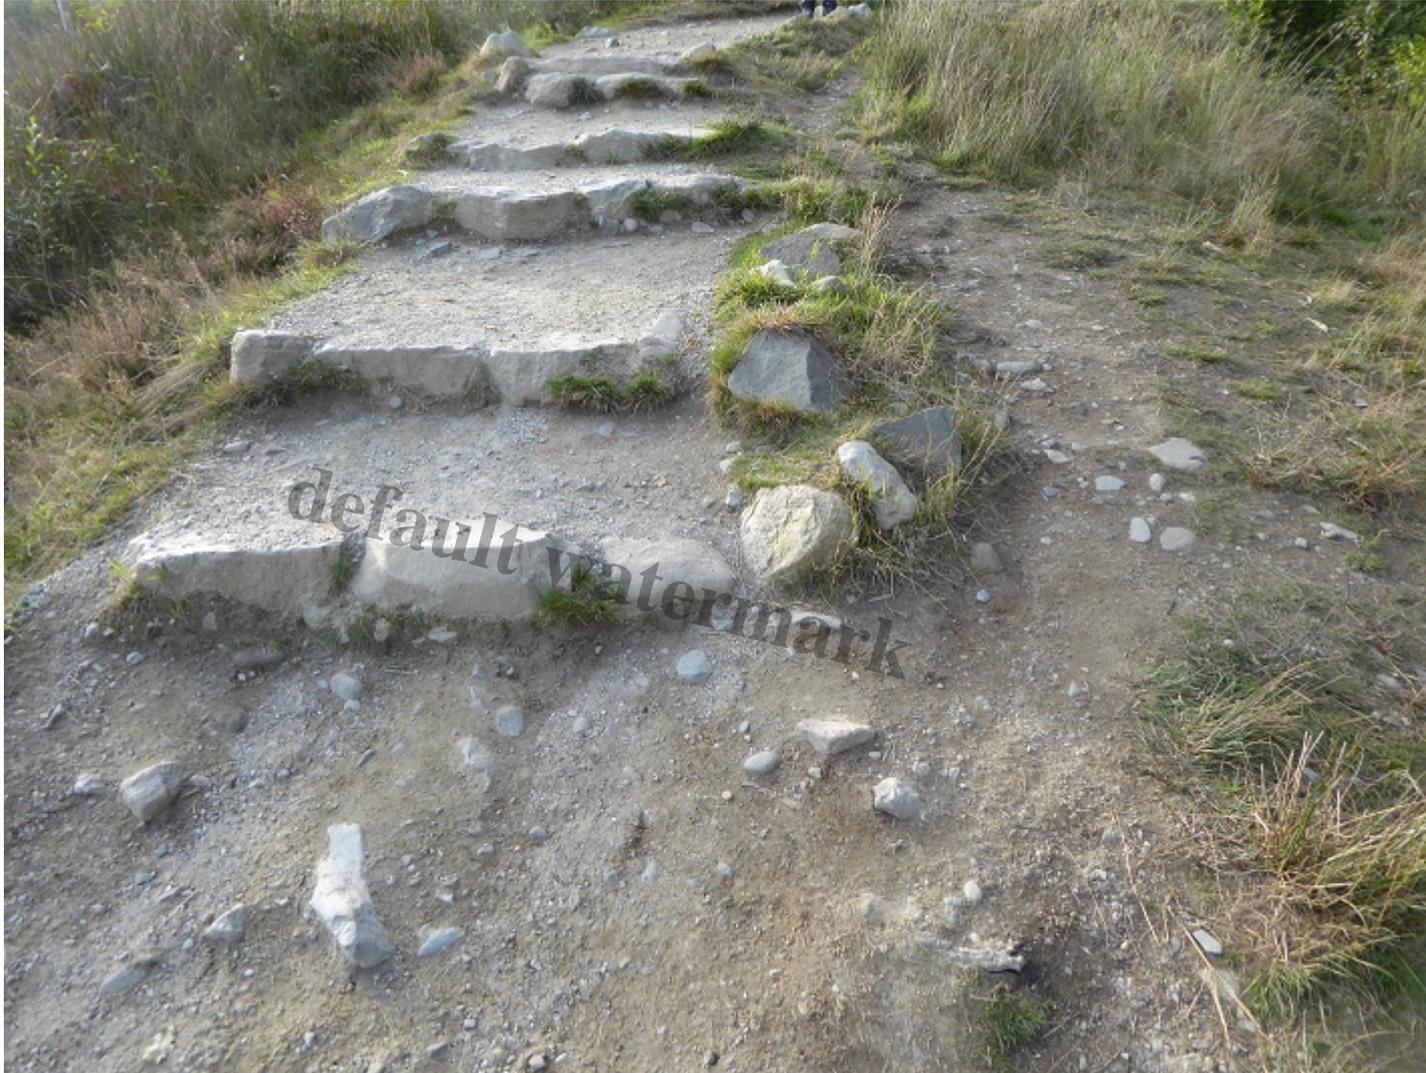
Clear signs of how the ground below the bottom step has eroded.

Note how the Devil's Horns have been left as islands in a spreading path. One wonders what will have happened in another two and a half years. The evidence suggests that much of the Ben A'an path will have disintegrated and much of the investment wasted.
