## Ben Aonach how not to provide for outdoor recreation in the National Park

## **The Ben Aâ??an path**

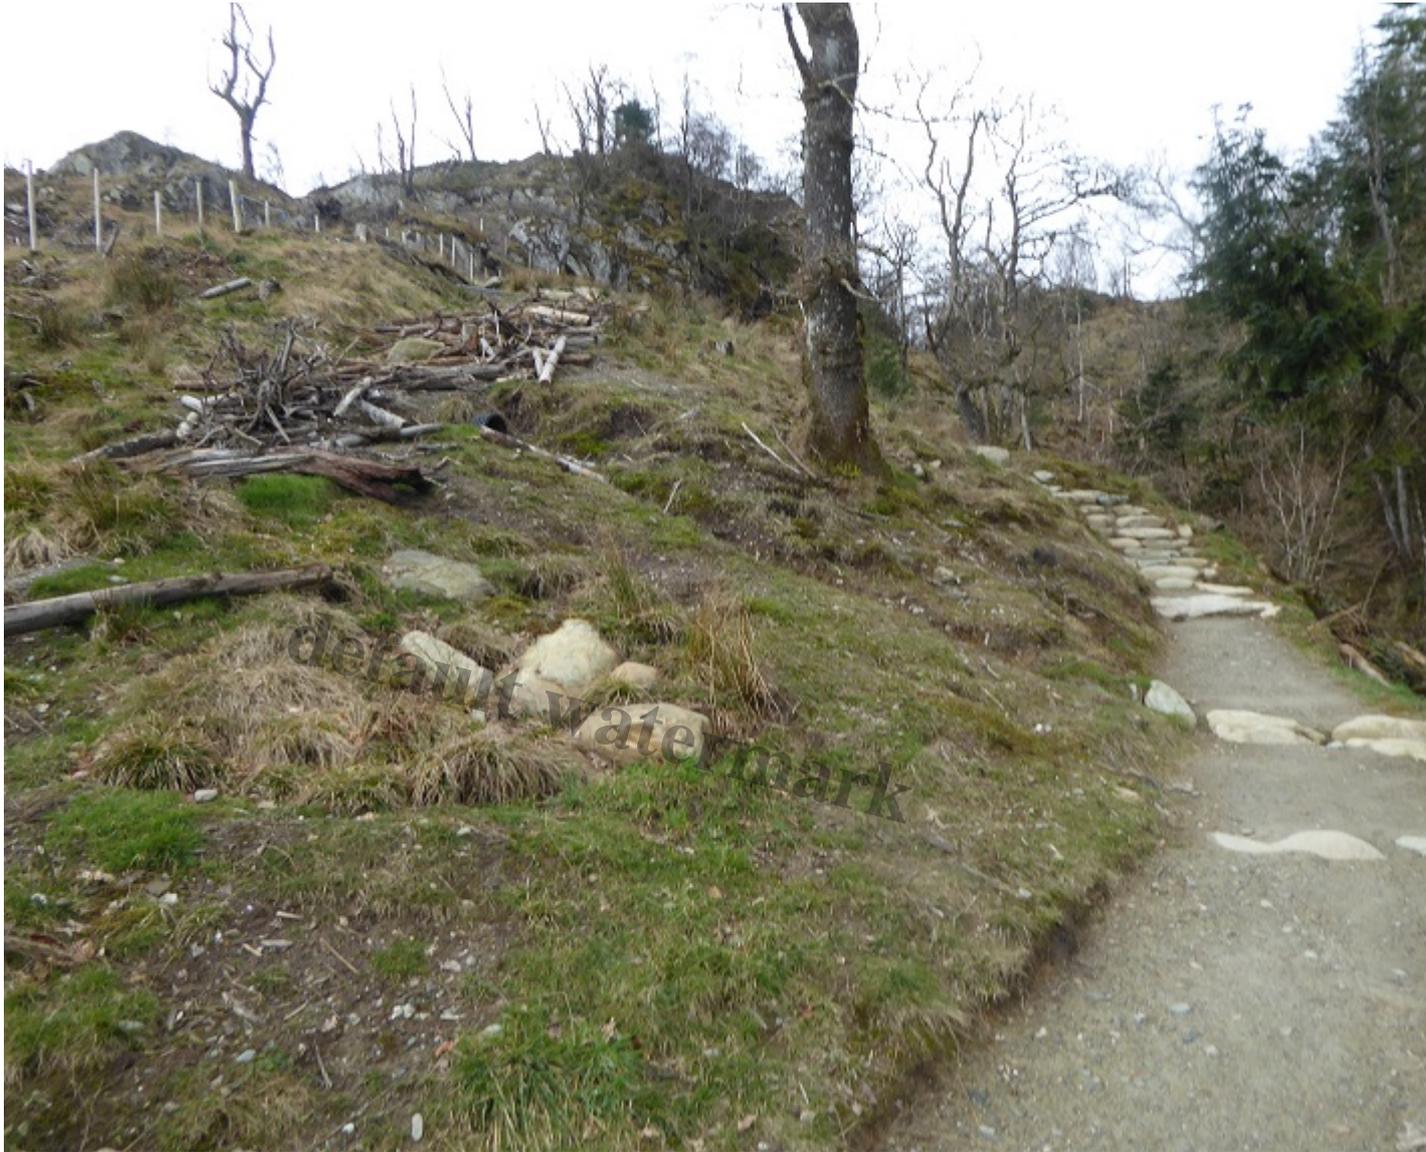
March 2019. Note the plastic culvert at the top of the obvious drainage ditch. The original new route directly up the hillside to the left of the large tree in the centre.

This steep section, about 800m after the start, began to erode very quickly after construction and as a result trainees from the Mountain and People project hand built the path you can see on the right. The logs were then placed over the steep section to prevent it being used as a shortcut. 18 months later, I don't know why, the logs had been removed but the decommissioned section of path is now being used as a shortcut:

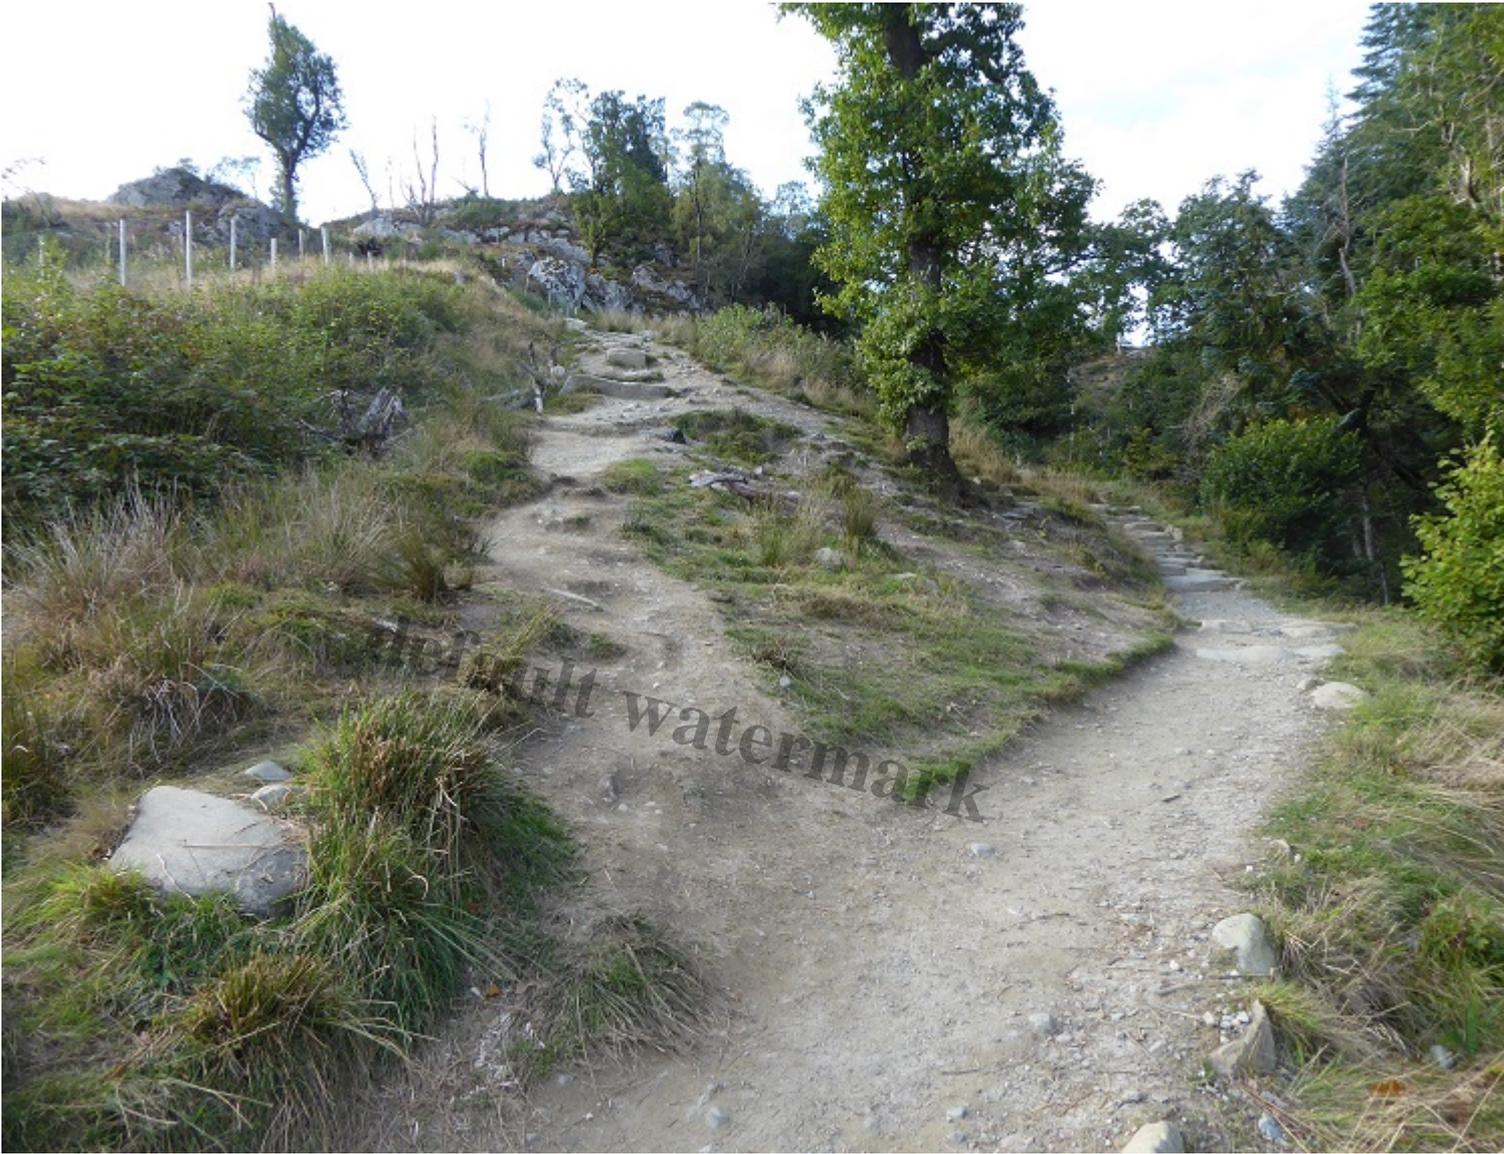
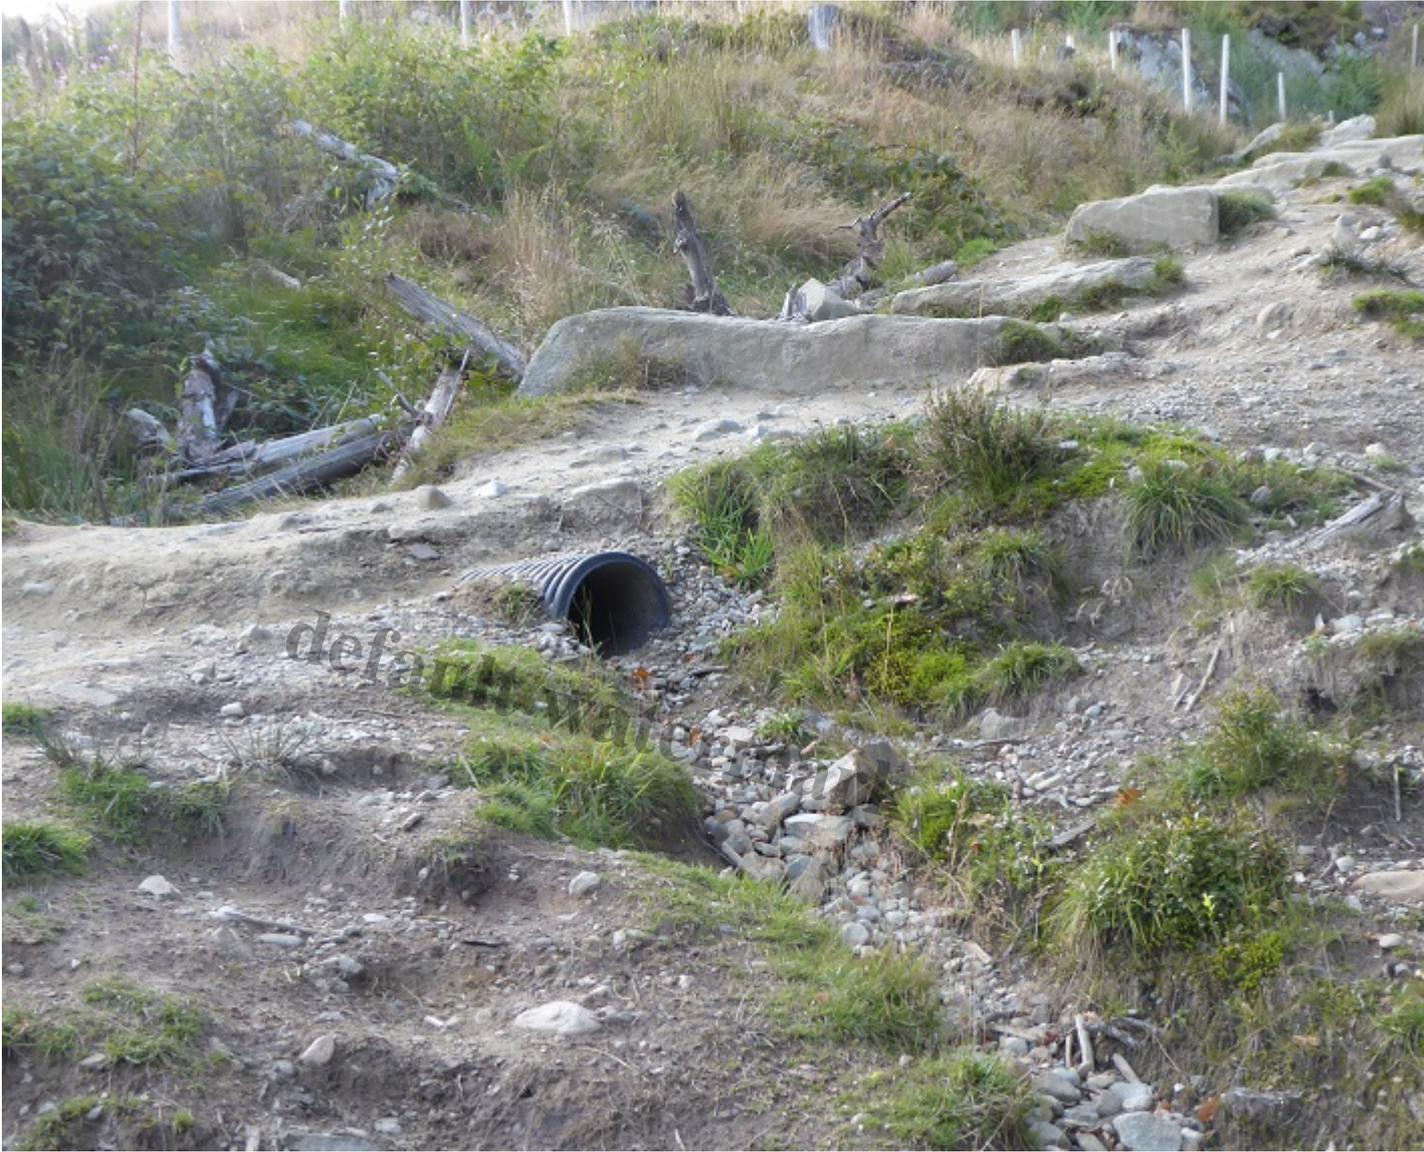
And viewed from closer up. Note how some of the former steps have become isolated islands of rock how much of the surface has been eroded from the top of the pipe

A classic example of the consequences of getting path design wrong. One wonders how much money would now be needed to repair this damage?.

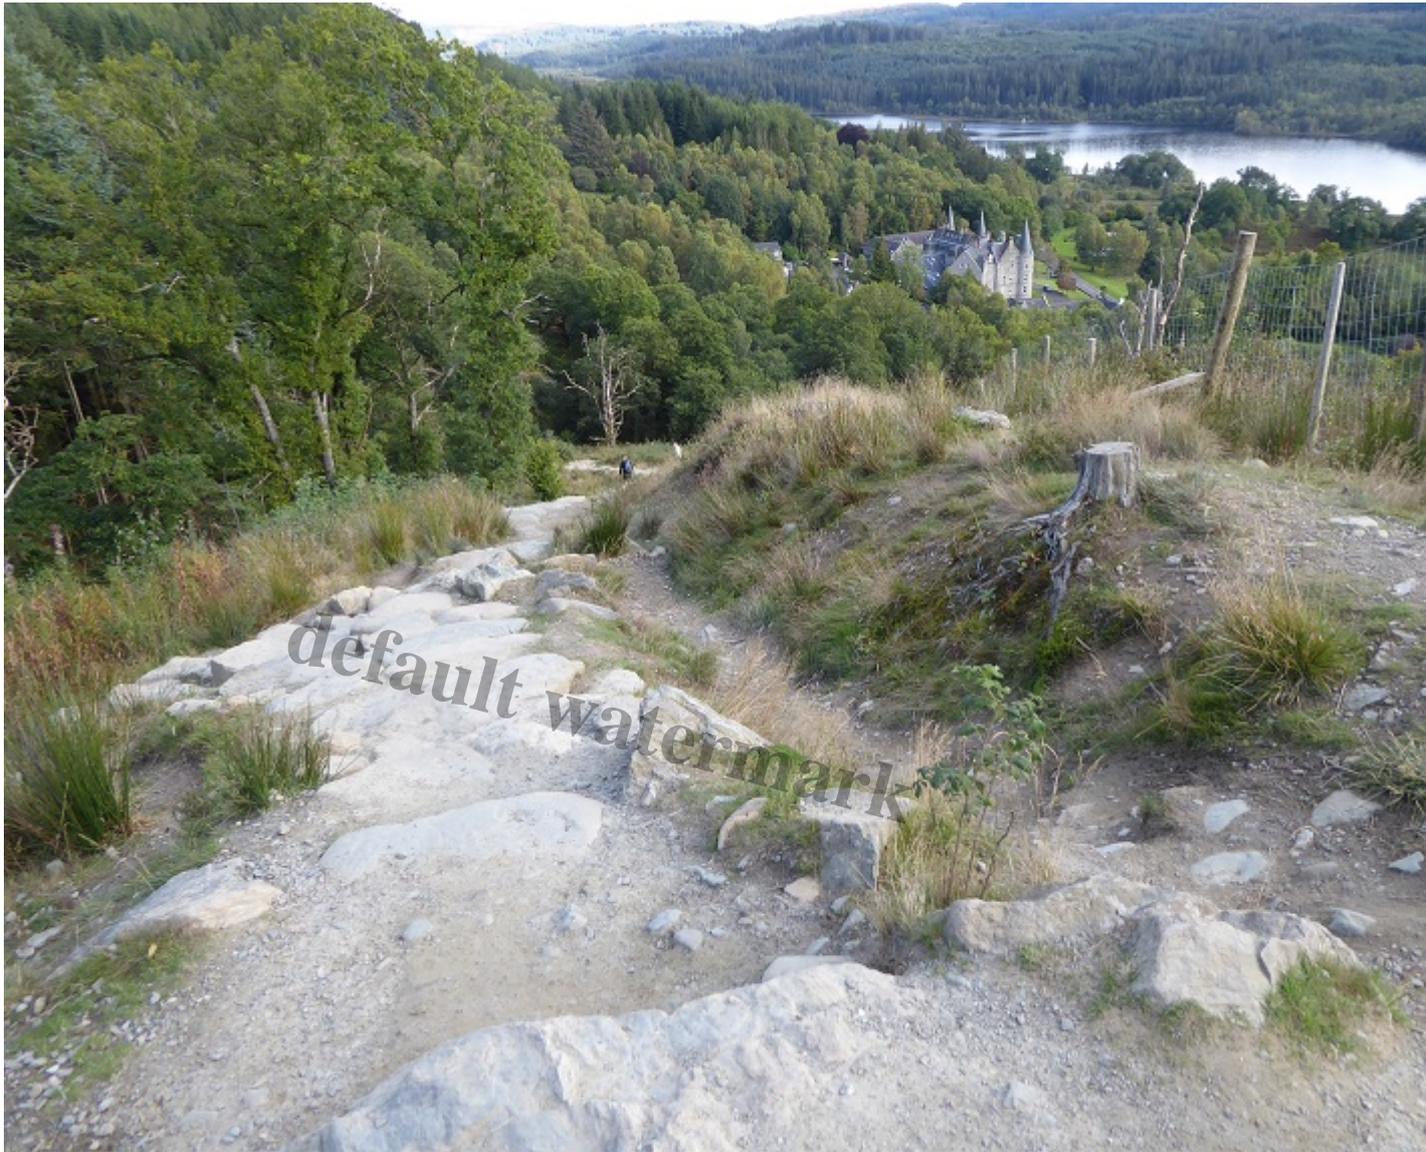
Looking down from above the short-cut, the original new section of path straight ahead and replacement section turning sharp left.

The problems are made worse because, from above, the easiest line on the feet and knees appears to be down what was originally intended as a drainage ditch. Once you have stepped onto it, you are directed straight down the hillside and unlikely to want to step back onto the flight of steps to your left until you are beyond them and it is too late.

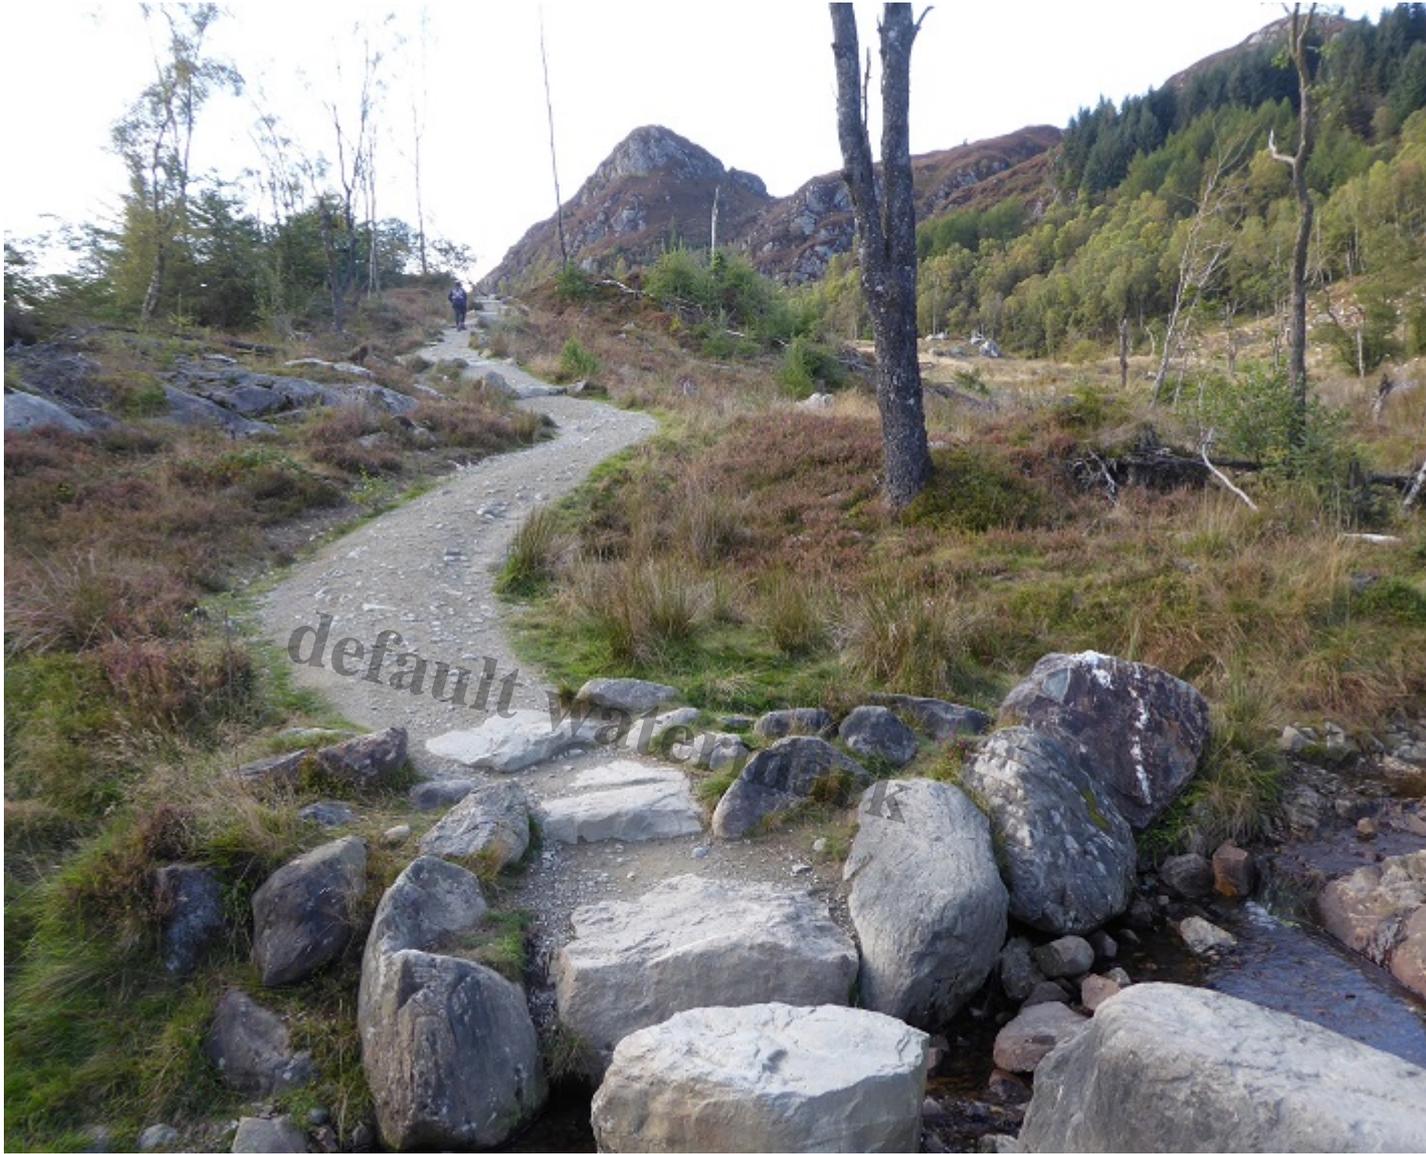
Crossing point over burn with large stepping stone

The large flat stepping stone reduces the chance of accidents when the burn is high, an important consideration on a popular path often used by inexperienced walkers, while the blocks on either side help prevent the banks eroding.

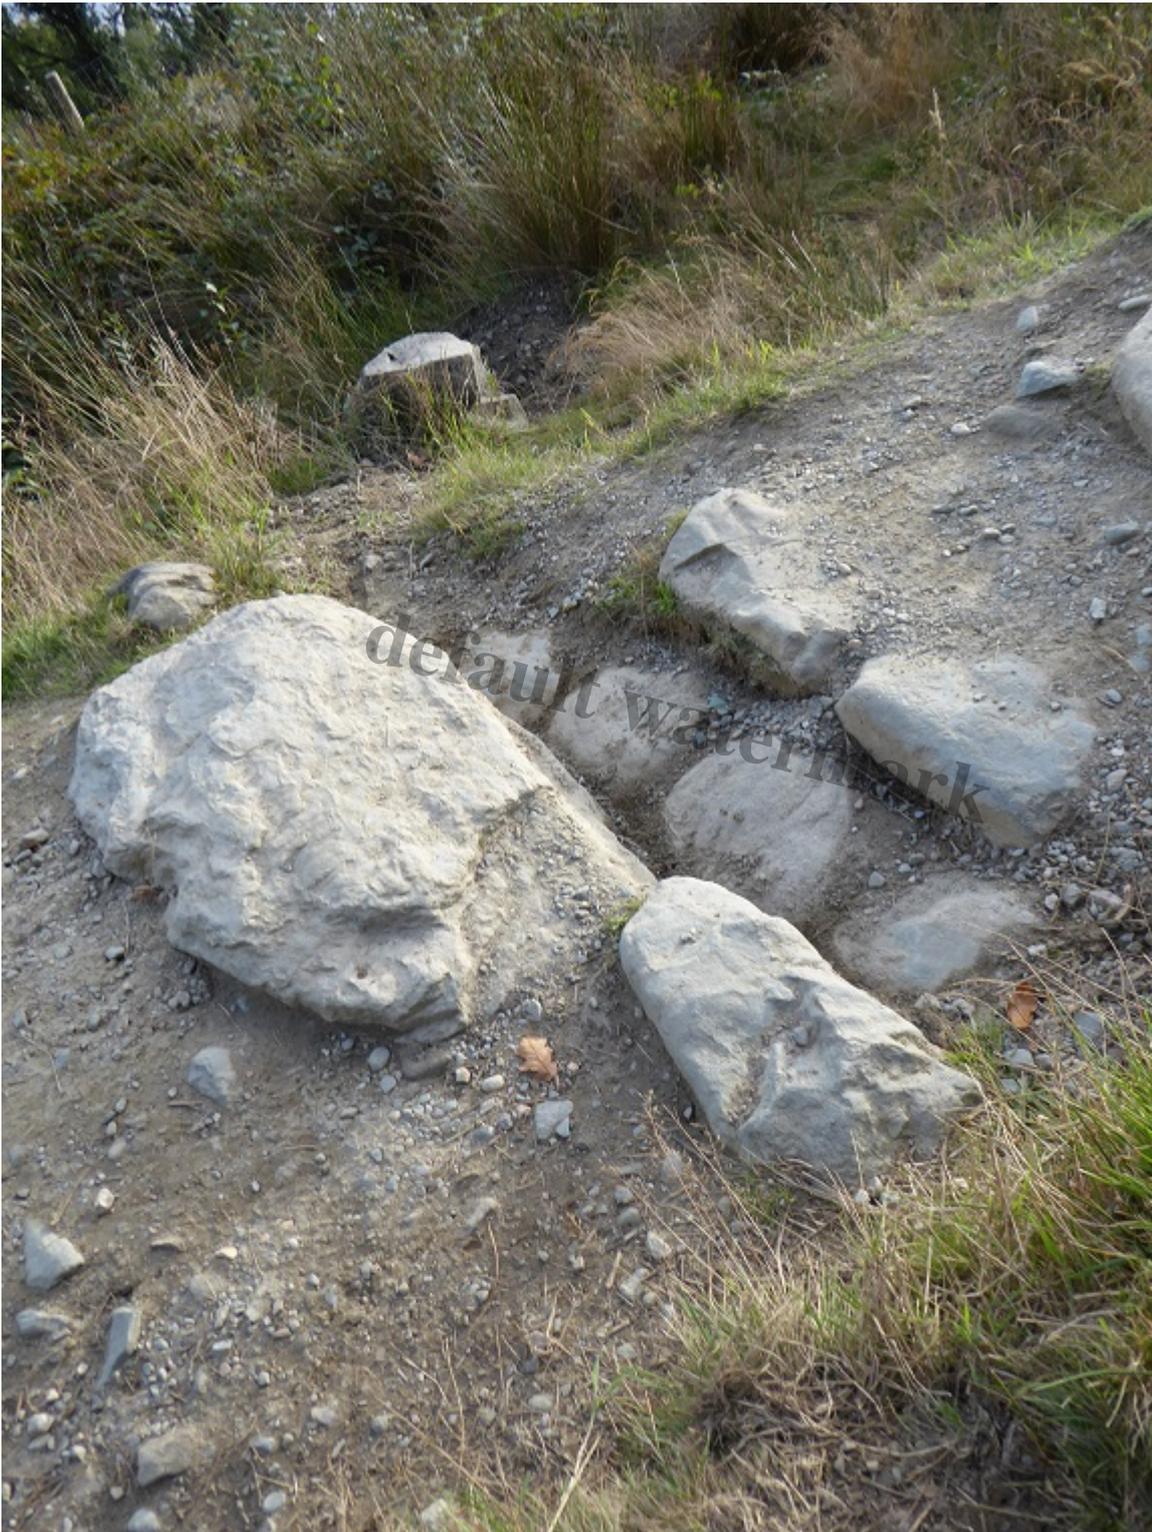
I found out subsequently from the Mountains and People website that there had been a volunteer work party a few days before my visit which had cleared out some blocked drainage: While maintenance like this is essential to keep paths in good condition, unfortunately in this case it appears to have been partly required because of yet more poor design. Unless a water bar is sufficiently angled, it will collect vegetation and other debris washed down from above and quickly block. There were several examples of horizontal water bars along the path.
