## Ben A'an – how not to provide for outdoor recreation in the National Park

## **The Ben A'an path**

## **What could we learn from what has gone wrong at Ben A'an?**

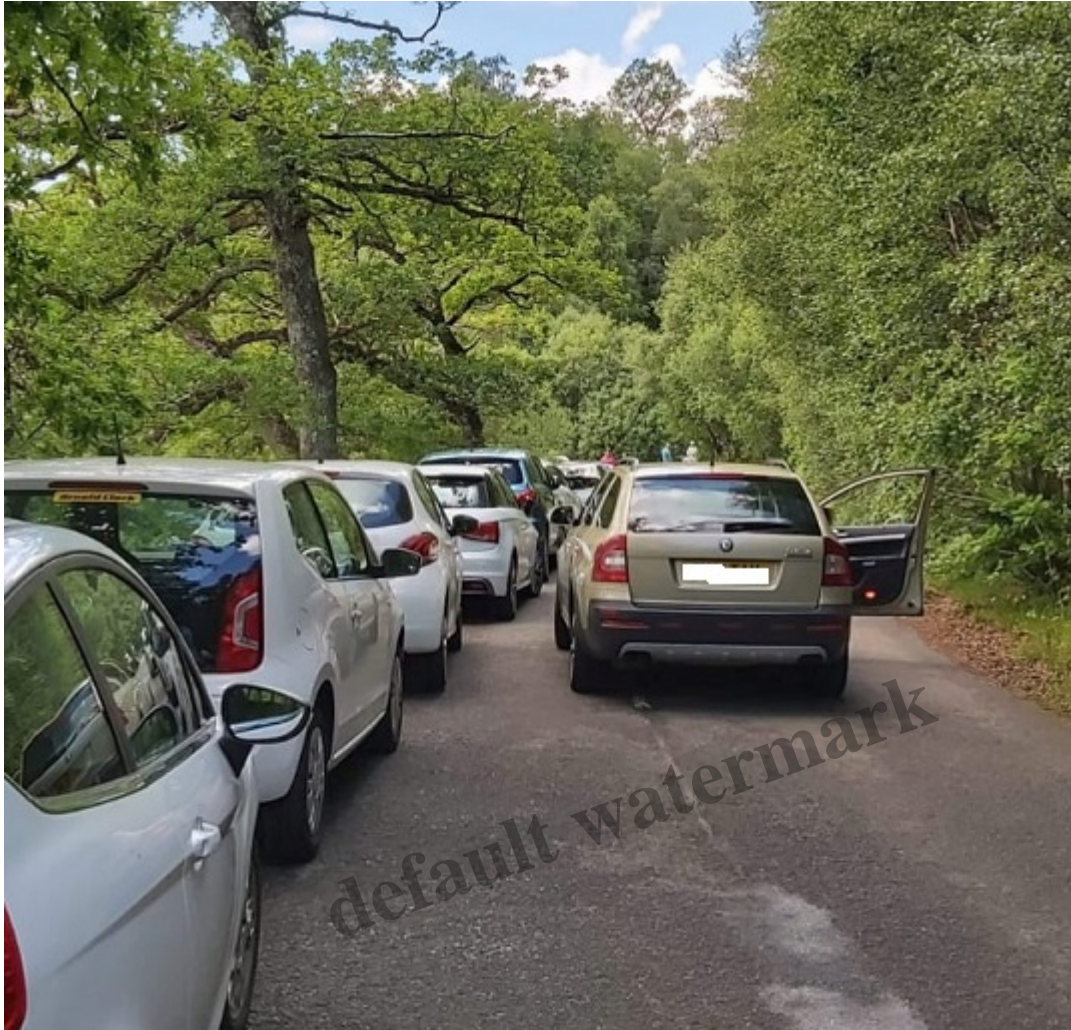
There is one main path up Ben A' an and this is accessed from a car park that is almost entirely used by people wanting to walk up the hill. While large enough to meet demand mid-week off-season, for years there have been problems at popular times. Once people started traveling after lockdown, it was overwhelmed. People started parking and dropping off along the road:

This created traffic problems for visitors and locals alike and, at times, could have made it very difficult for fire engines or ambulances to get through.

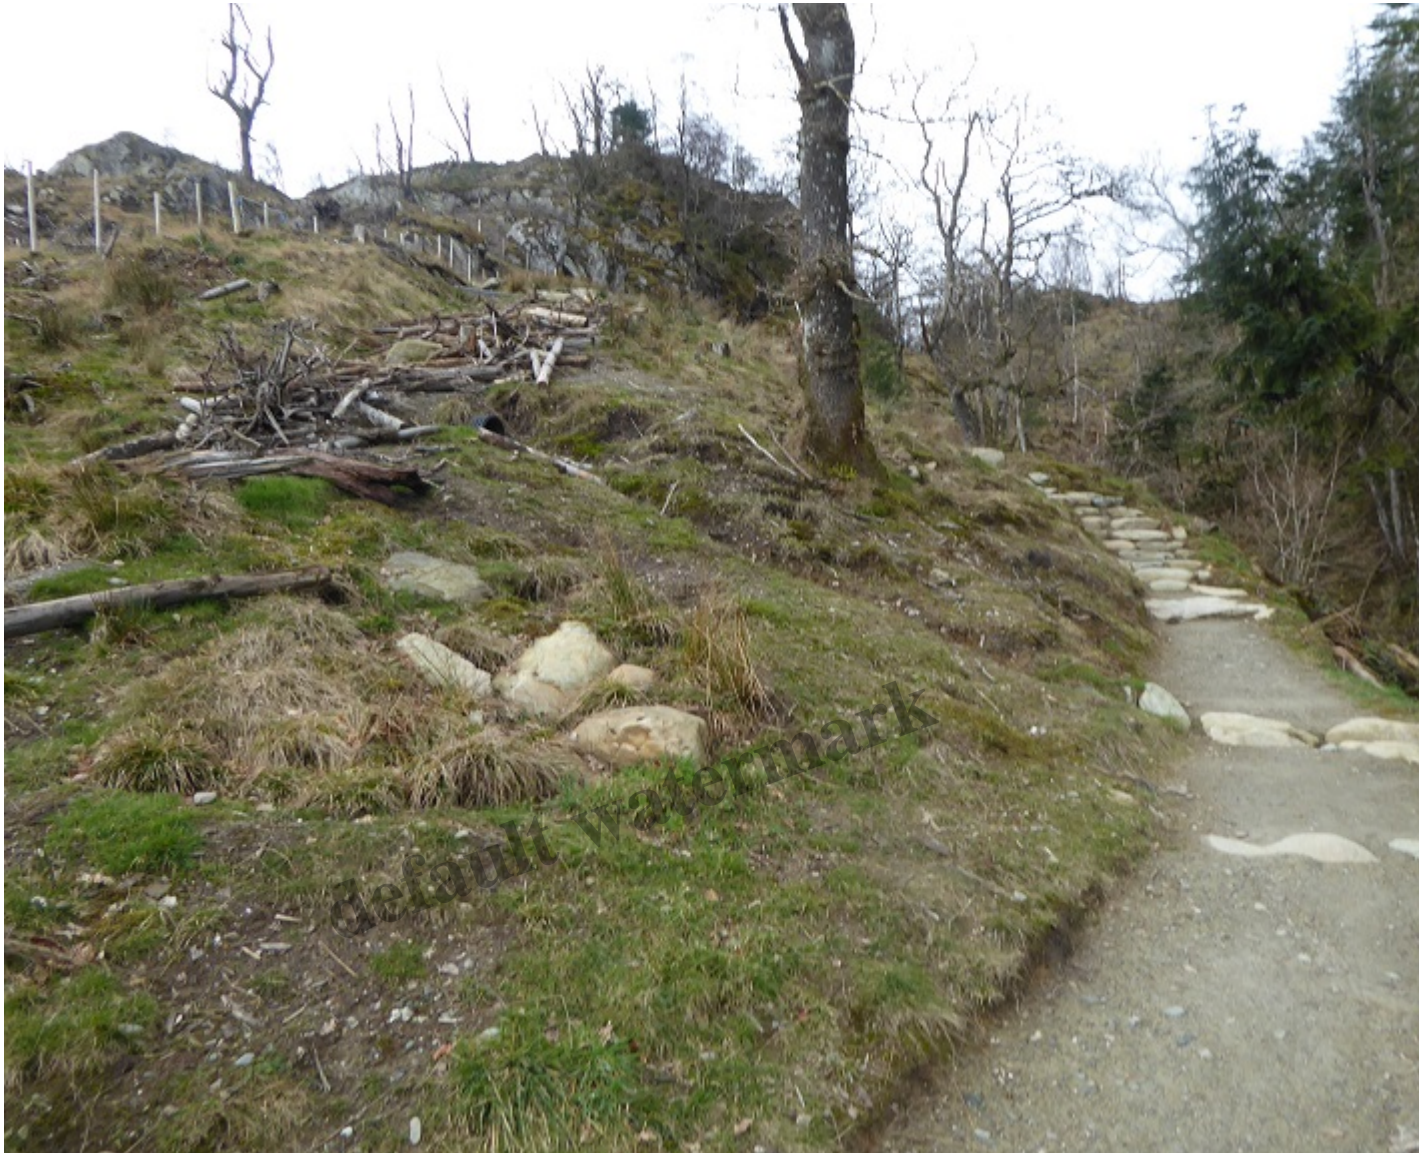
March 2019. Note the plastic culvert at the top of the obvious drainage ditch. The original new route directly up the hillside to the left of the large tree in the centre.

This steep section, about 800m after the start, began to erode very quickly after construction and as a result trainees from the Mountain and People project hand built the path you can see on the right. The logs were then placed over the steep section to prevent it being used as a shortcut. 18 months later, I don't know why, the logs had been removed but the decommissioned section of path is now being used as a shortcut:
