Ben A'an – how not to provide for outdoor recreation in the National Park

The Ben A'an path

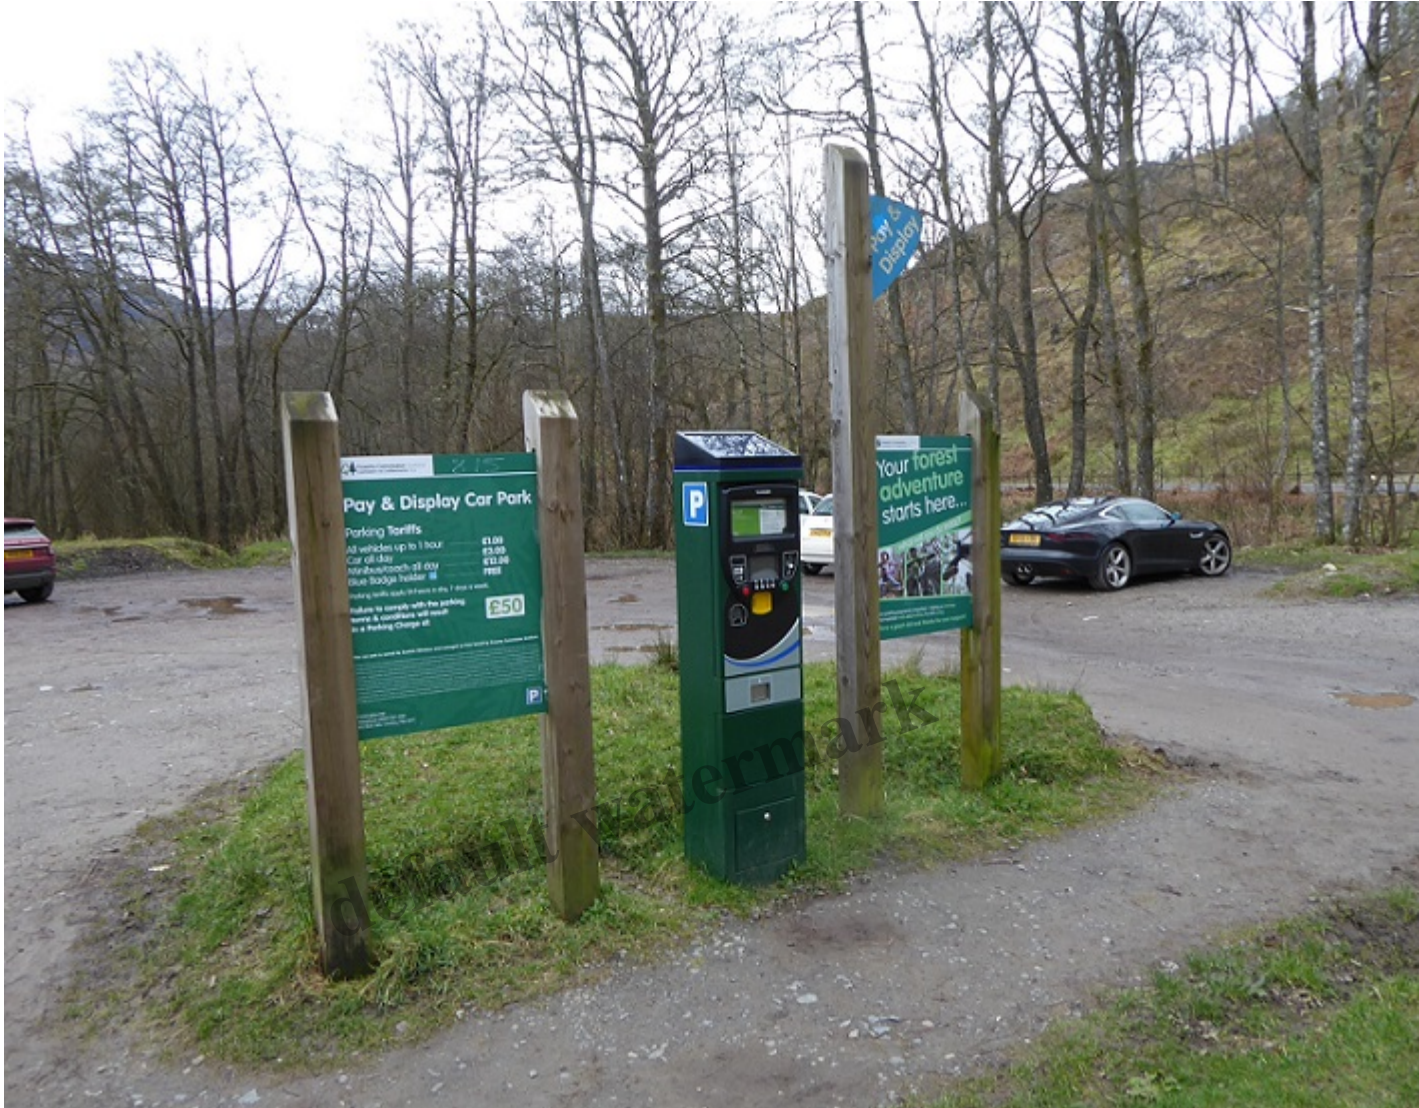
I have never found the pay and display machines at the car park in working order

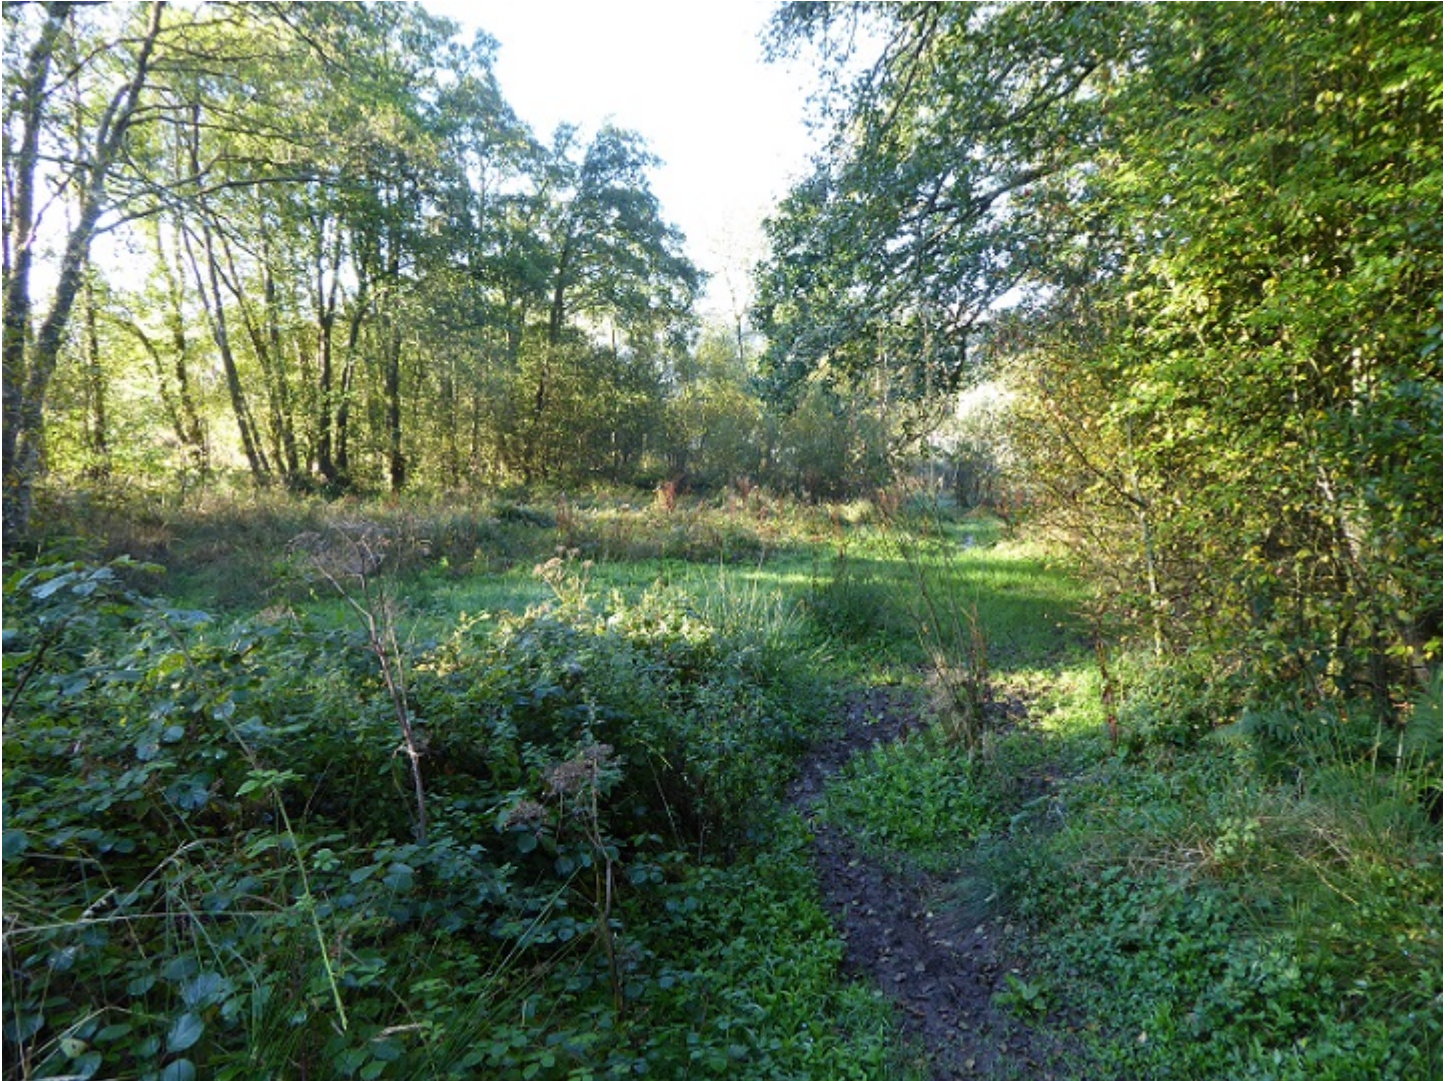
At Ben A'an part of the solution is obvious. Below the car park is an open boggy glade in the woodland which, in the absence of any public convenience, is used as a toilet area and is pretty disgusting. Unfortunately, Forest and Land Scotland, which own the site, have shown no interest in improving the current facilities – both mobile toilets and litter bins are required – or extending the car park themselves.

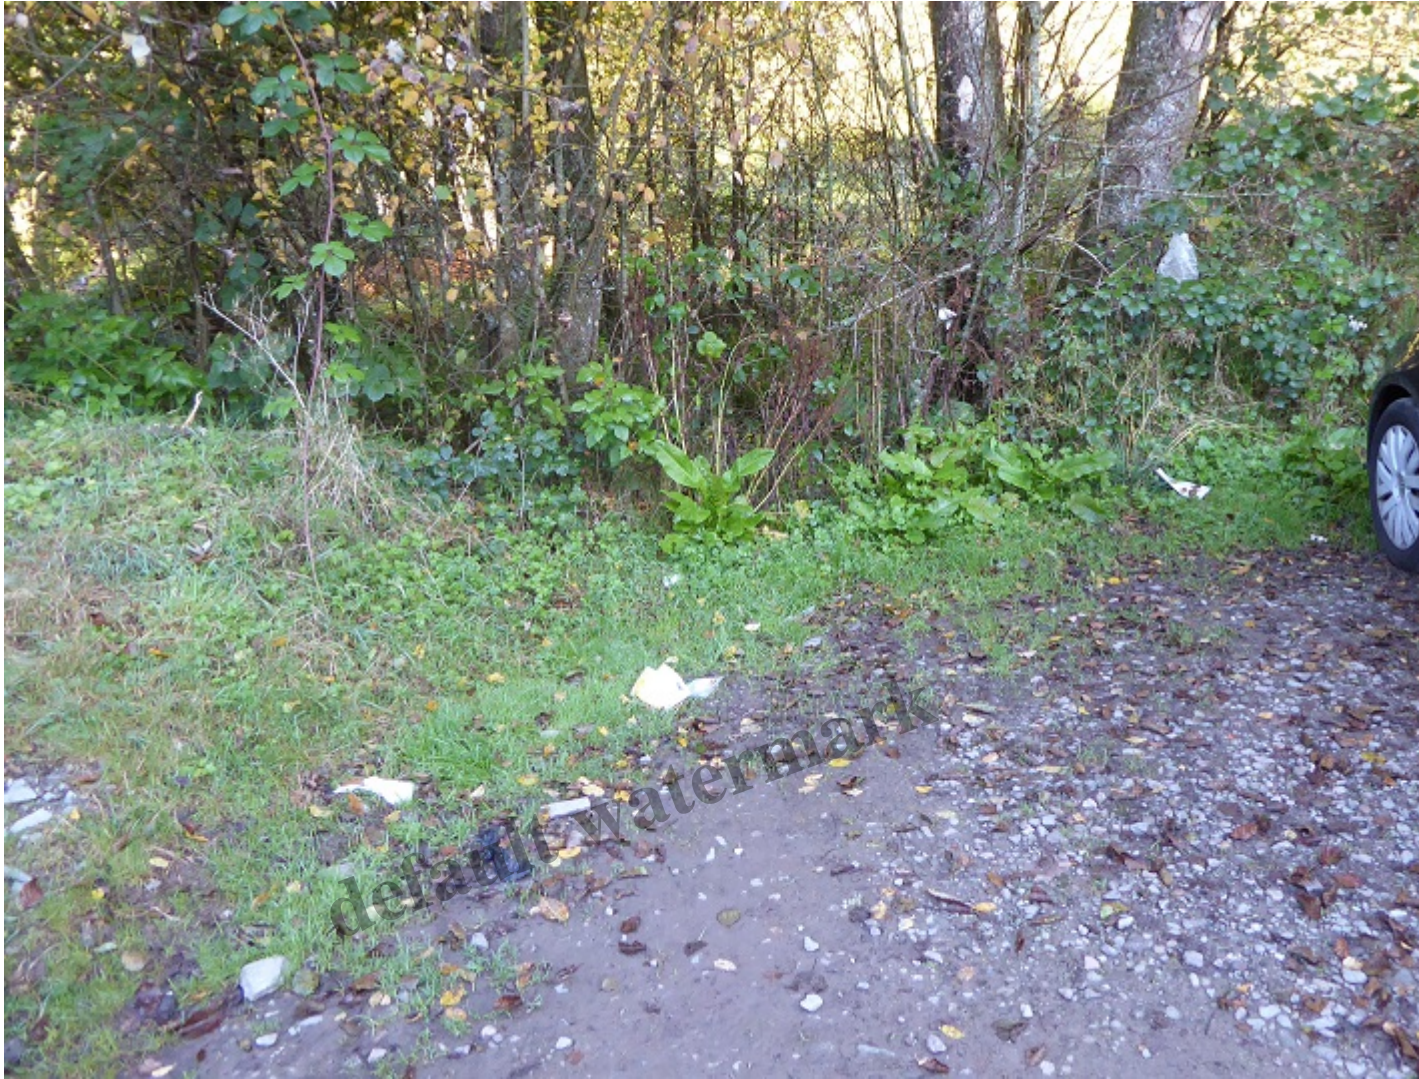
Low level littering in the car park most of which could be prevented if bins were provided.

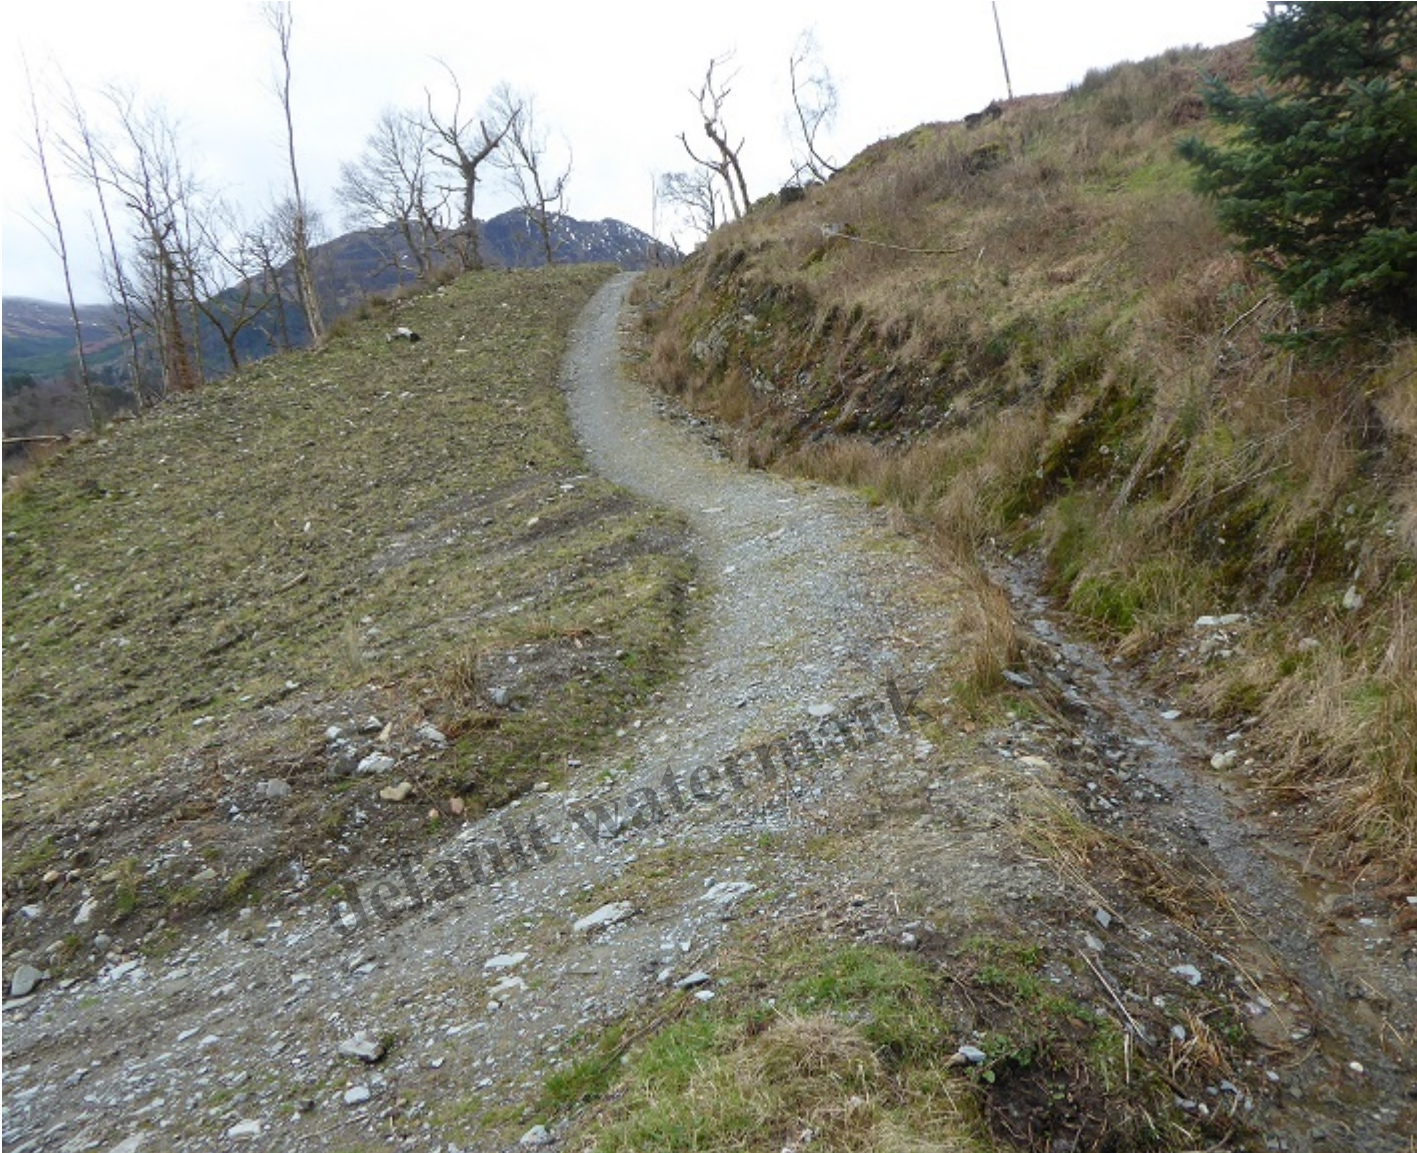
A little further up the former forest road, reduced to path width, branches off the from the main path

The old forest road could have provided a gentler route, at far less risk from erosion, with a new route constructed across the hillside to rejoin the main path above the first steep section. Instead the main path heads directly up the hill. A shorter route and therefore cheaper to construct, as long as this could be constructed by machine..

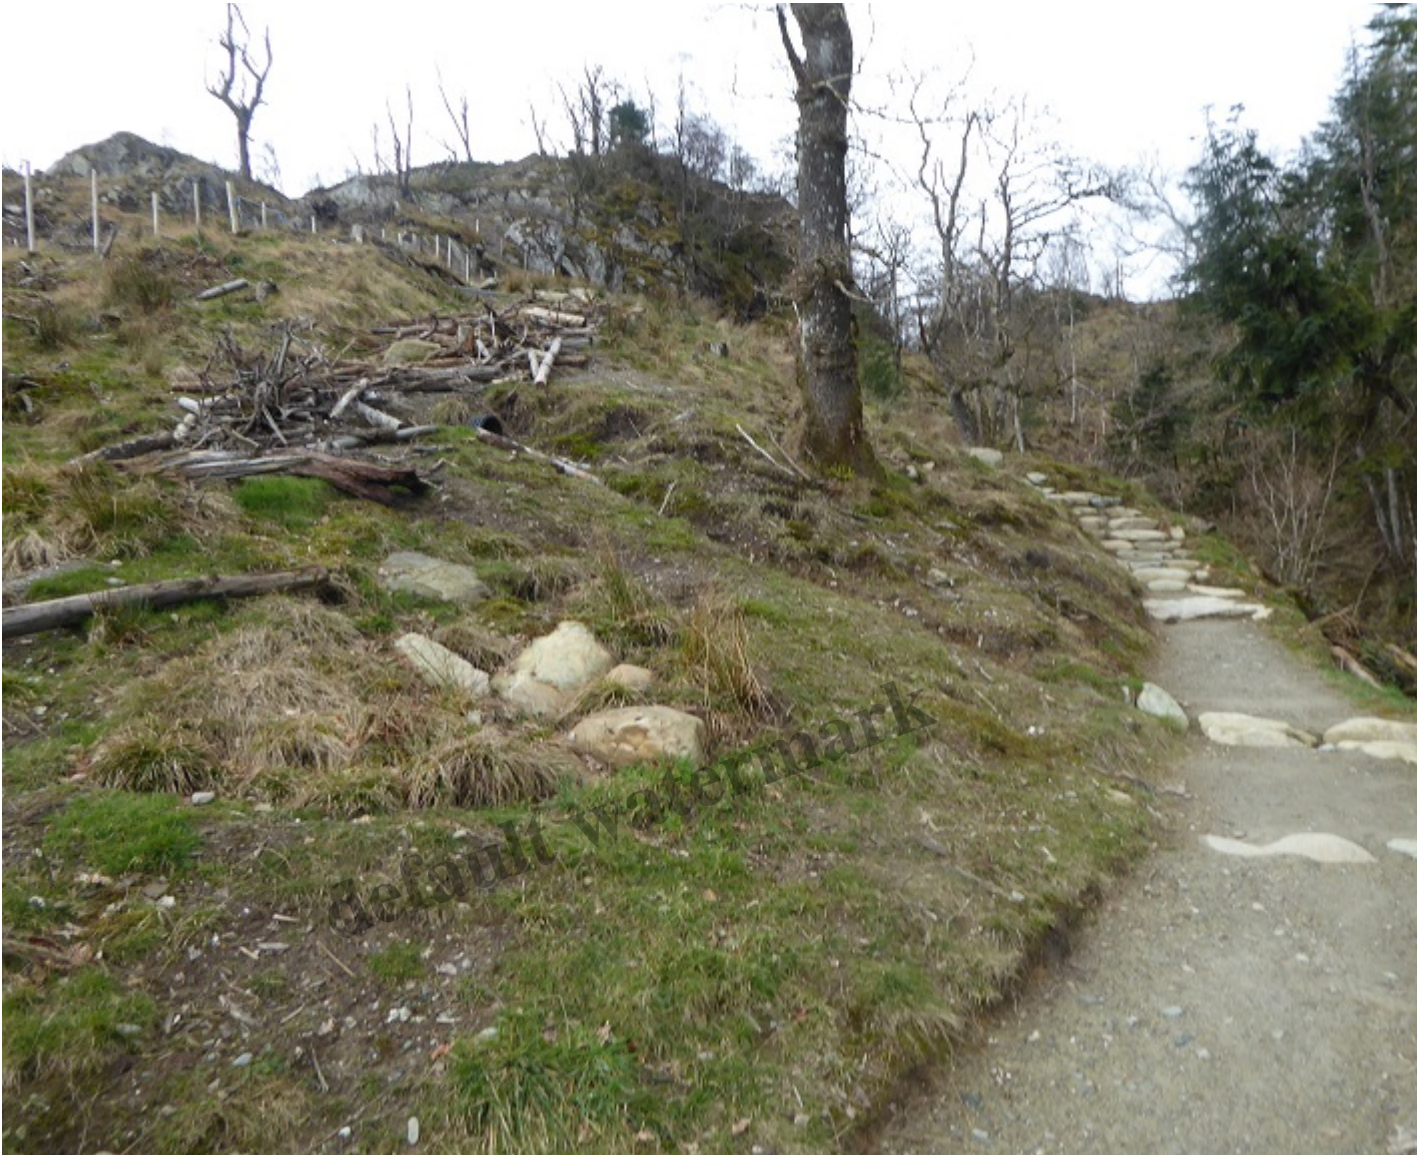
March 2019. Note the plastic culvert at the top of the obvious drainage ditch. The original new route directly up the hillside to the left of the large tree in the centre.

This steep section, about 800m after the start, began to erode very quickly after construction and as a result trainees from the Mountain and People project hand built the path you can see on the right. The logs were then placed over the steep section to prevent it being used as a shortcut. 18 months later, I don't know why, the logs had been removed but the decommissioned section of path is now being used as a shortcut:
