More destruction at Cairn Gorm as the landscape is “smoothed”

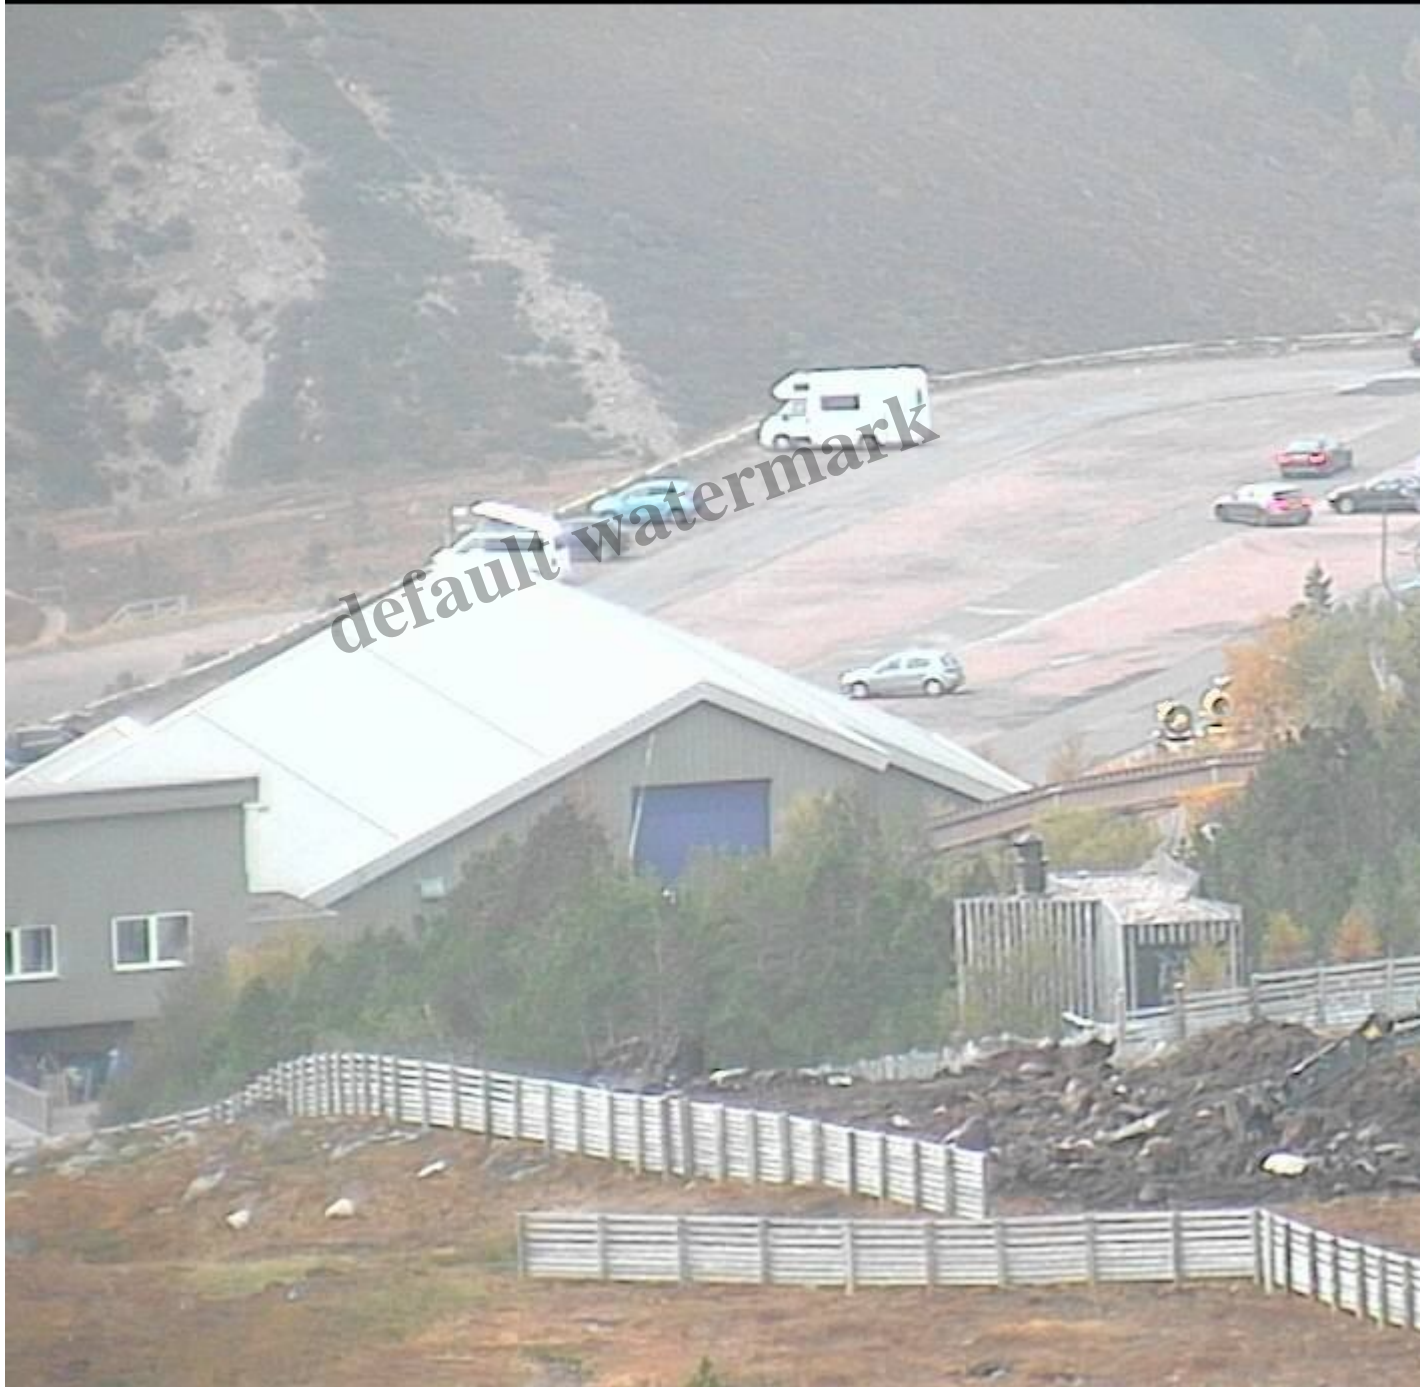
MainCarPark 2020-10-16 16:45:19

Photo credit CMSL webcam. You would never have seen a sight like this when the funicular was be

It is hard to reconcile what you can see in the screenshot above with that aim or with the detail of the Construction Method Statement:

Not much evidence in the screenshot of topsoil being stored separately, of a competent supervisor being continuously in the field – though maybe they are below the horizon or hidden behind one of the heaps of debris – or of individual boulders being picked out. But maybe they will be retrieved after the whole slope is turned over?

Even if the turf from the area turned over in the webcam photo has been stored out of sight, would it really be possible at 16.45 to replace it all “immediately”, i.e before dark? And will the contractors be working the weekend? One hopes that the destruction evident in the photo is not taking place in the various peatland restoration projects taking place in other locations in the National Park.
