More destruction at Cairn Gorm as the landscape is “smoothed”

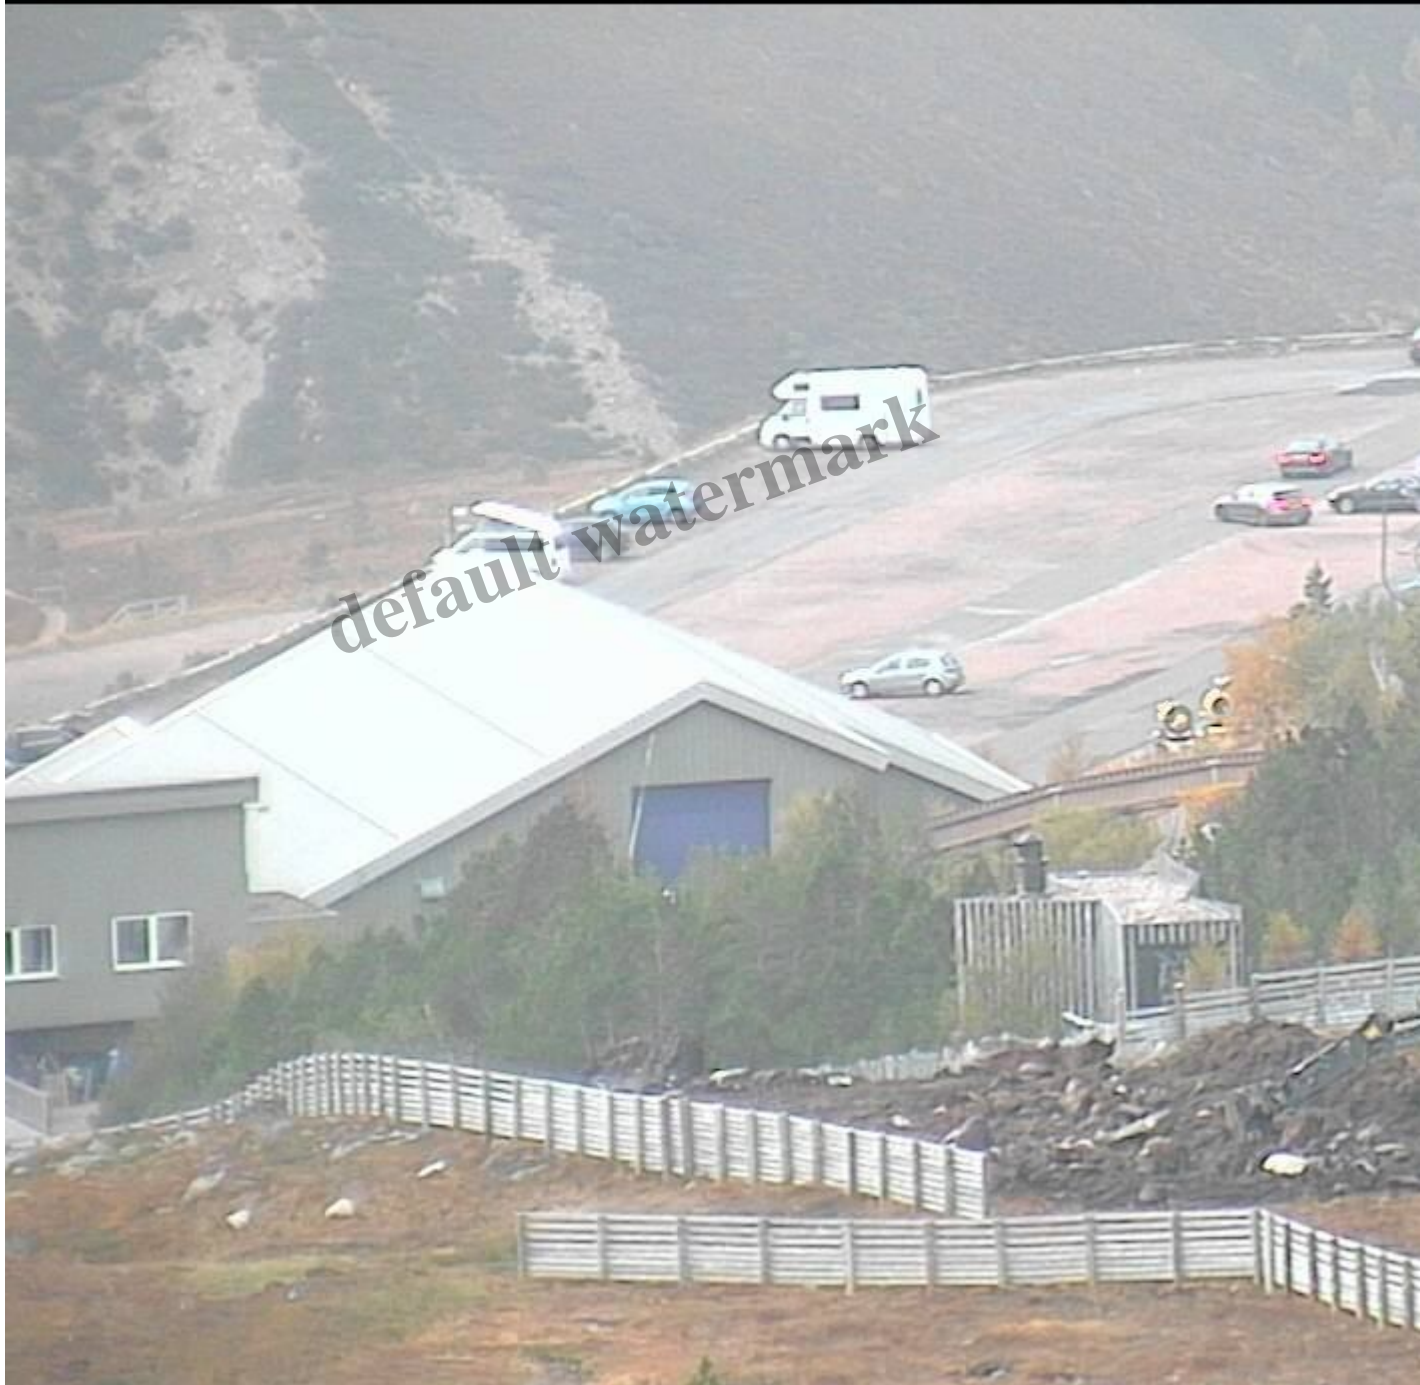
MainCarPark 2020-10-16 16:45:19

Photo credit CMSL webcam. You would never have seen a sight like this when the funicular was be

It is hard to reconcile what you can see in the screenshot above with that aim or with the detail of the Construction Method Statement:

Not much evidence in the screenshot of topsoil being stored separately, of a competent supervisor being continuously in the field – though maybe they are below the horizon or hidden behind one of the heaps of debris – or of individual boulders being picked out. But maybe they will be retrieved after the whole slope is turned over?

Even if the turf from the area turned over in the webcam photo has been stored out of sight, would it really be possible at 16.45 to replace it all “immediately”, i.e before dark? And will the contractors be working the weekend? One hopes that the destruction evident in the photo is not taking place in the various peatland restoration projects taking place in other locations in the National Park.

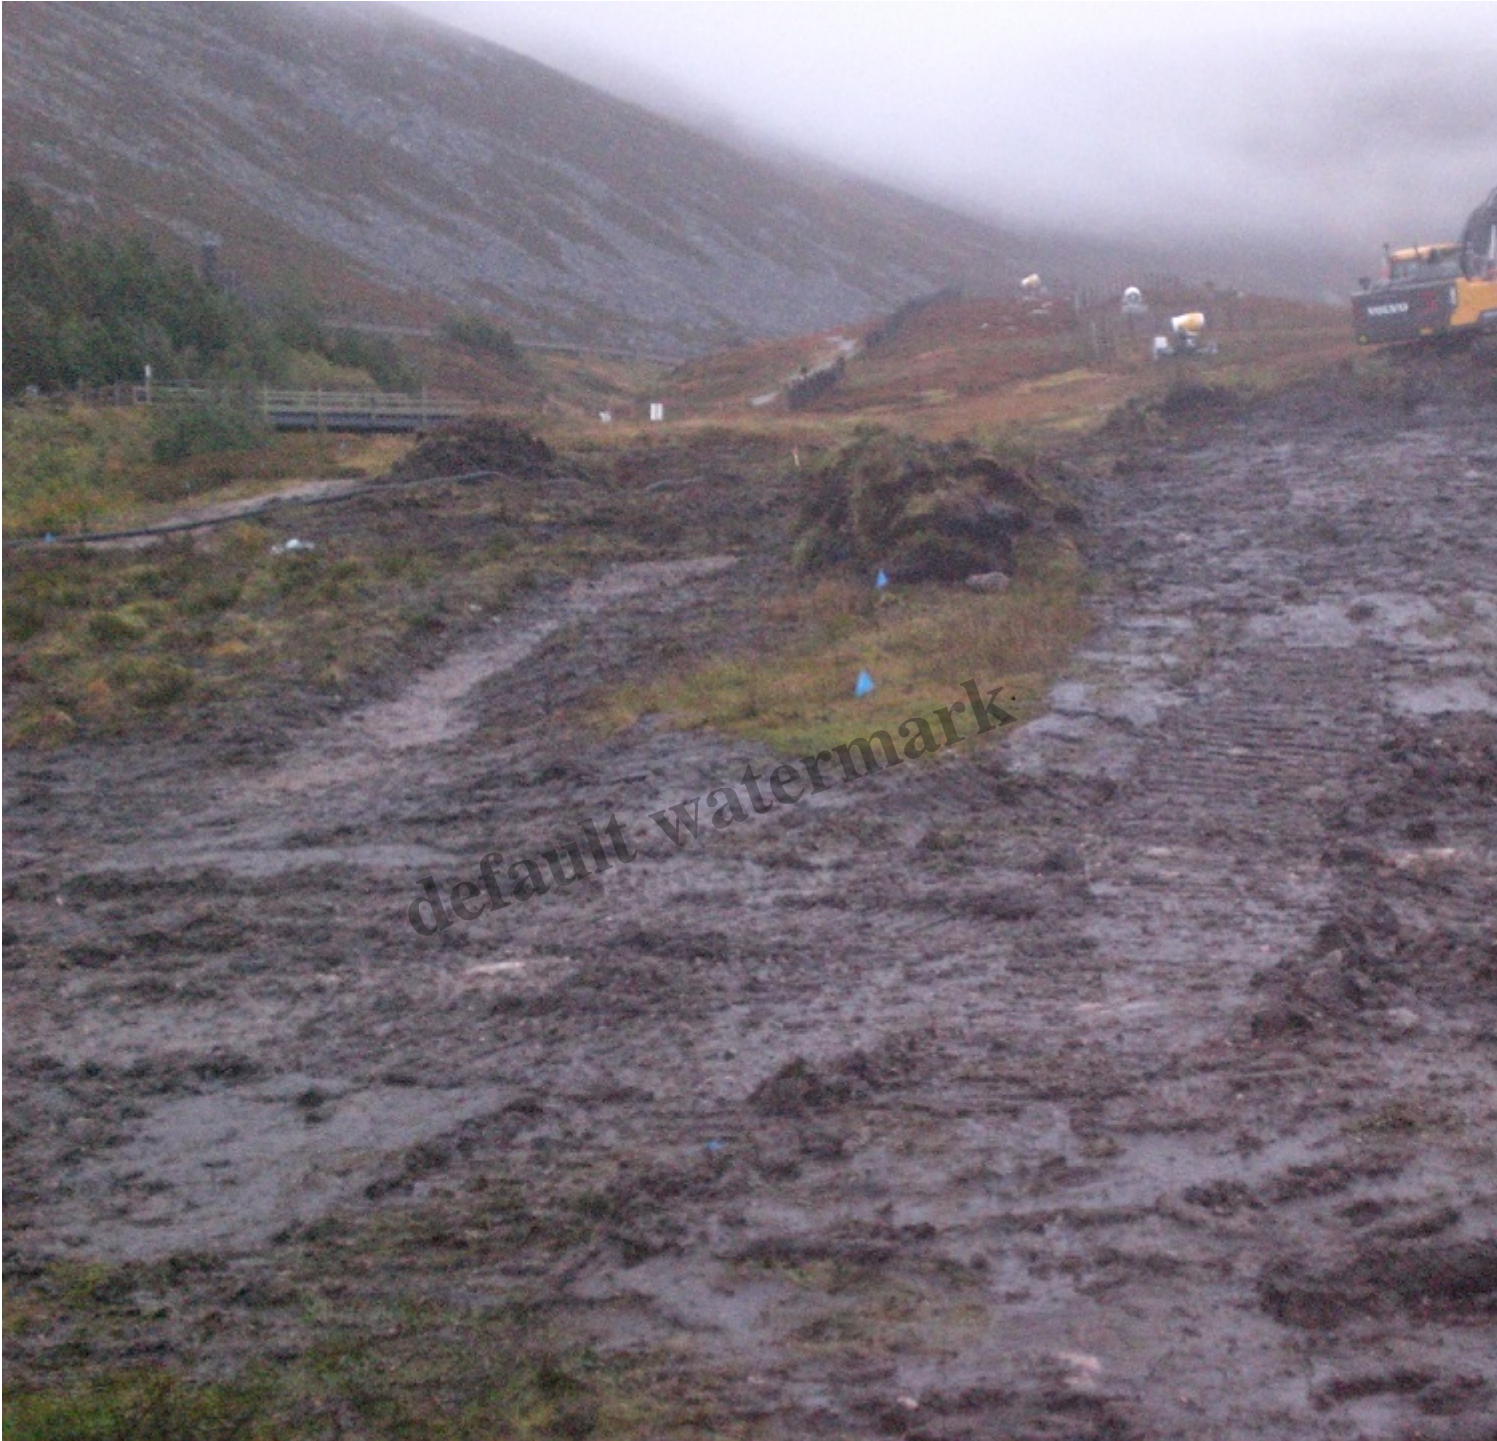
There certainly was evidence of turves being stored a week ago, even if it was hard to see how soils could be separated when the ground was as saturated as this. Indeed while boulders might have been picked out for use filling holes, you can see how stones have been mixed with peat:
