More destruction at Cairn Gorm as the landscape is â??smoothedâ?•

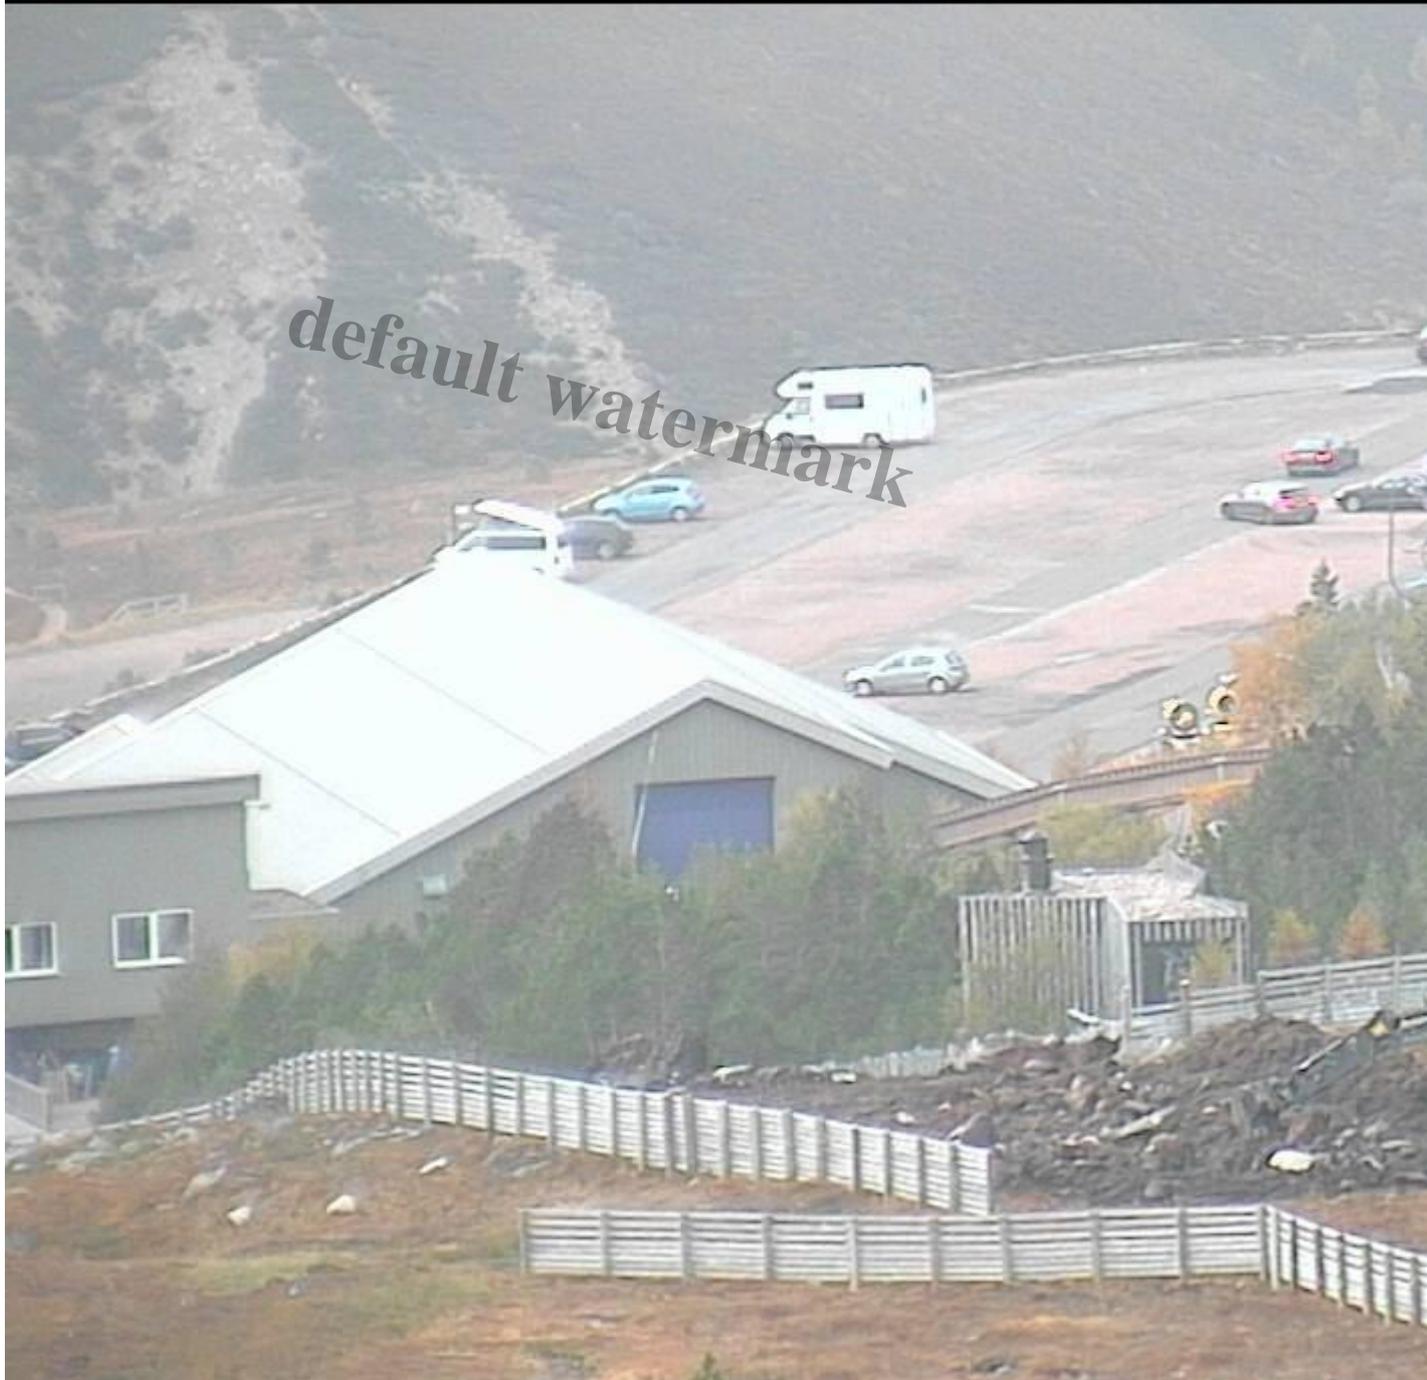
MainCarPark 2020-10-16 16:45:19

Photo credit CMSL webcam. You would never have seen a sight like this when the funicular was be

Not much evidence in the screenshot of topsoil being stored separately, of a competent supervisor being continuously in the field though maybe they are below the horizon or hidden behind one of the heaps of debris or of individual boulders being picked out. But maybe they will be retrieved after the whole slope is turned over?

Even if the turf from the area turned over in the webcam photo has been stored out of sight, would it really be possible at 16.45 to replace it all immediately? i.e before dark? And will the contractors be working the weekend? One hopes that the destruction evident in the photo is not taking place in the various peatland restoration projects taking place in other locations in the National Park.

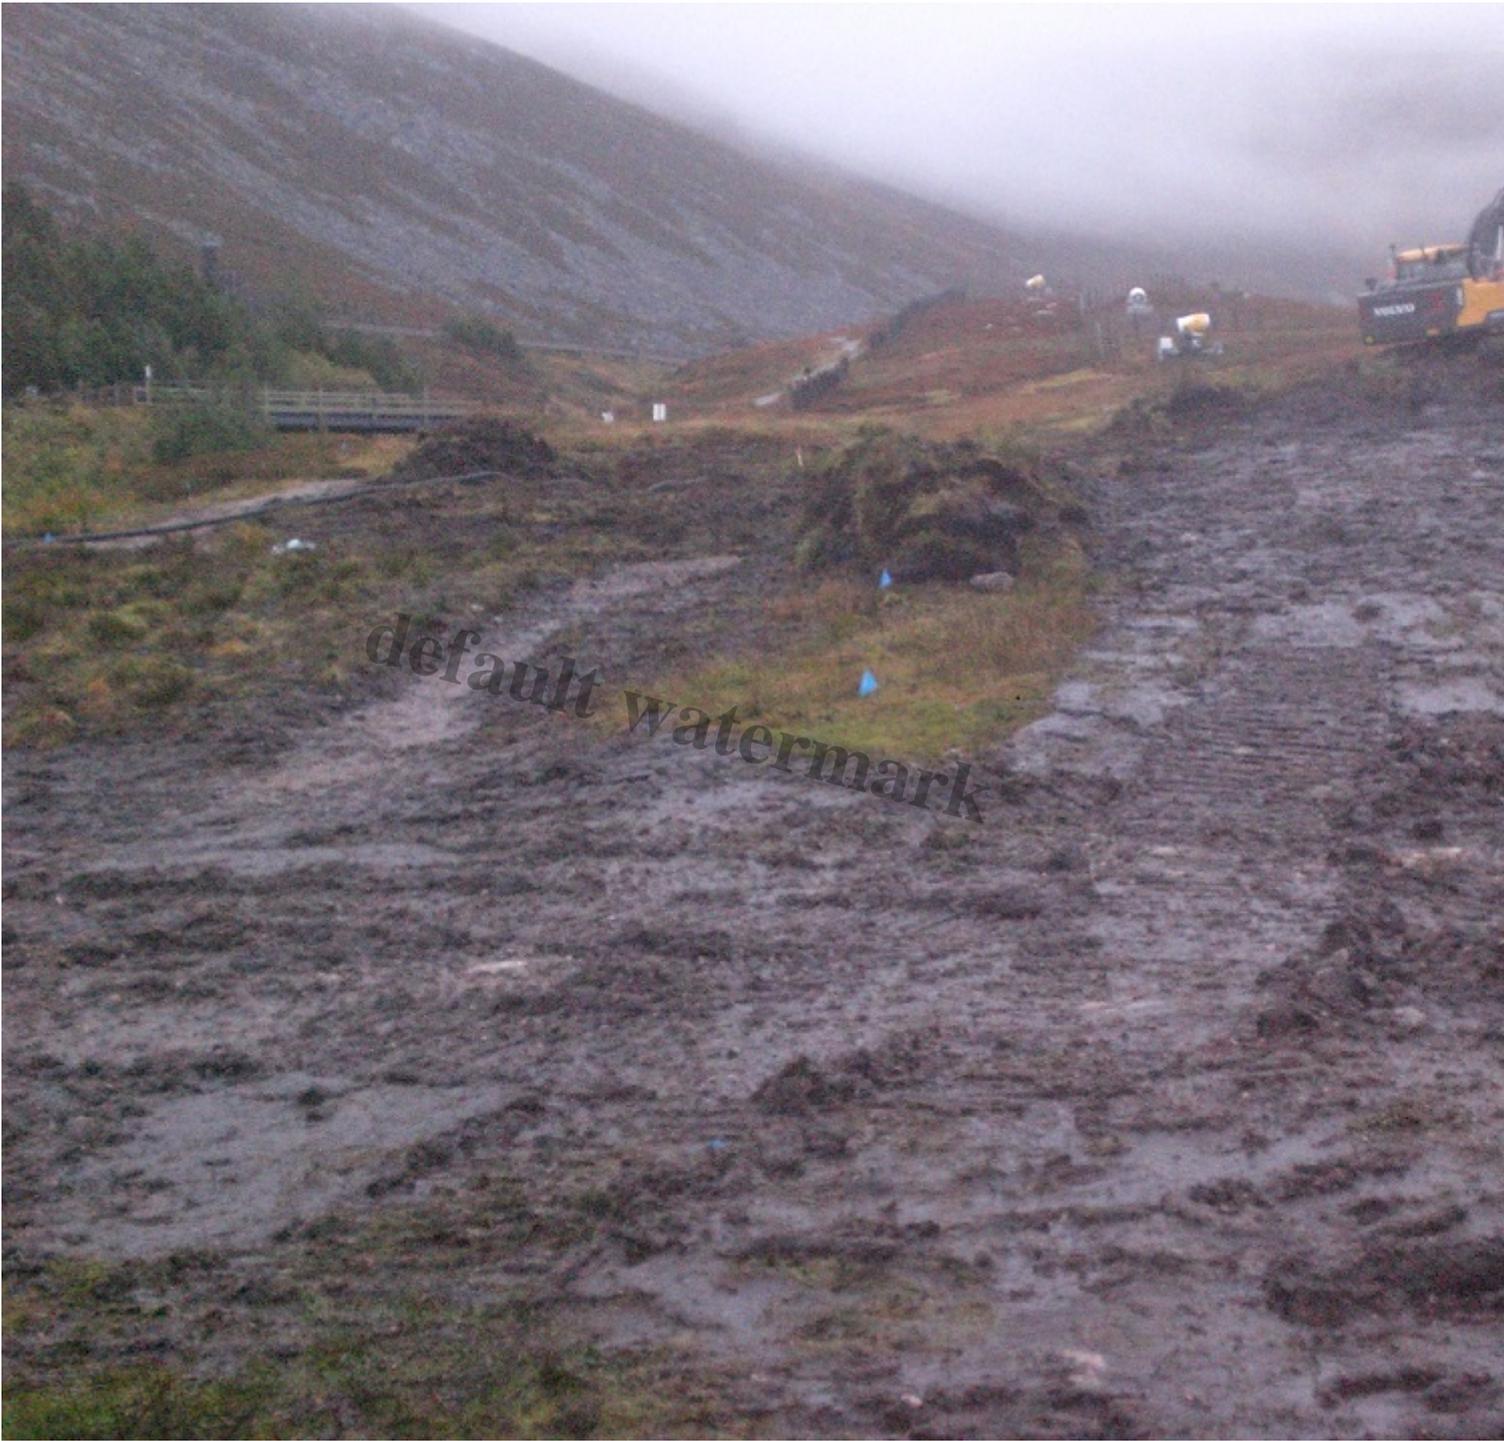
There certainly was evidence of turves being stored a week ago, even if it was hard to see how soils could be separated when the ground was as saturated as this. Indeed while boulders might have been picked out for use filling holes, you can see how stones have been mixed with peat:
