The folly at Cairn Gorm – work starts on the repair of the funicular

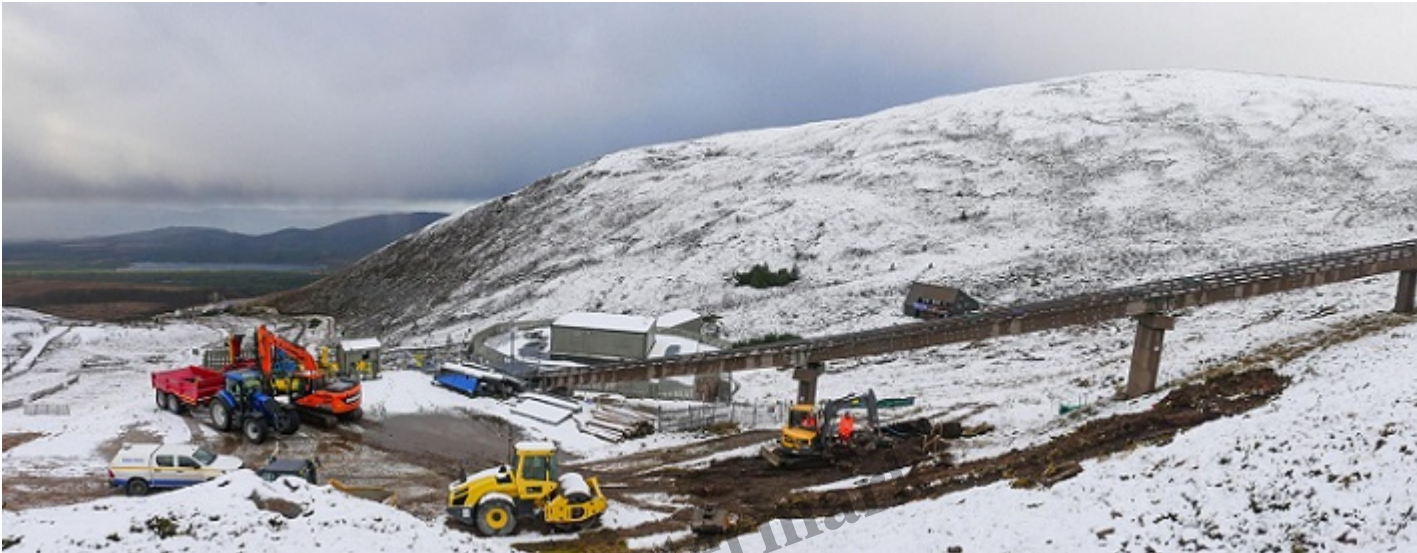
View of the repair works from above the mid-station, with compound on left and pillars 51,52 and 53 visible

The photo also shows a yellow digger on what appears to be another road being excavated towards the area between pillars 51 and 52. That does not appear on any plans. The issue is that the further the temporary access road is located away from the funicular, the greater the number of spurs will be needed to access the funicular and the more ground that will be disturbed. On current evidence much of slope could be dug up. It seems clear that the CNPA needs to start monitoring the works at Cairn Gorm on an almost daily basis if the repairs to the funicular are not to create far more damage than its original construction (which was undertaken with the greatest care).
