The folly at Cairn Gorm – work starts on the repair of the funicular

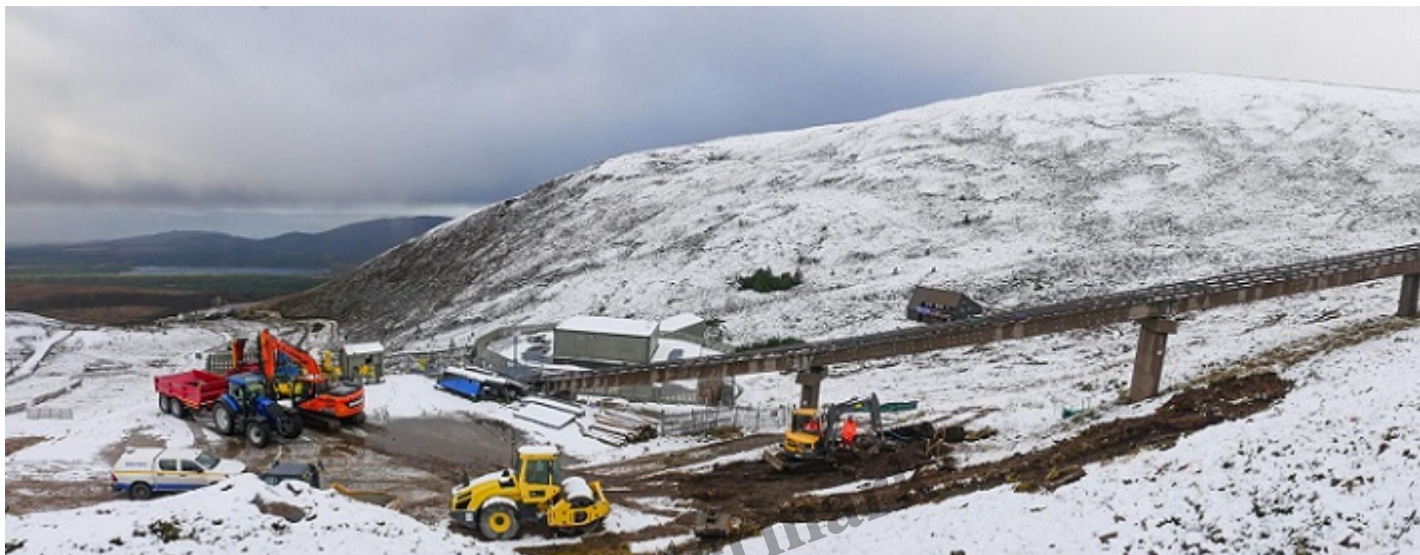
View of the repair works from above the mid-station, with compound on left and pillars 51,52 and 53 visible

The photo also shows a yellow digger on what appears to be another road being excavated towards the area between pillars 51 and 52. That does not appear on any plans. The issue is that the further the temporary access road is located away from the funicular, the greater the number of spurs will be needed to access the funicular and the more ground that will be disturbed. On current evidence much of slope could be dug up. It seems clear that the CNPA needs to start monitoring the works at Cairn Gorm on an almost daily basis if the repairs to the funicular are not to create far more damage than its original construction (which was undertaken with the greatest care).

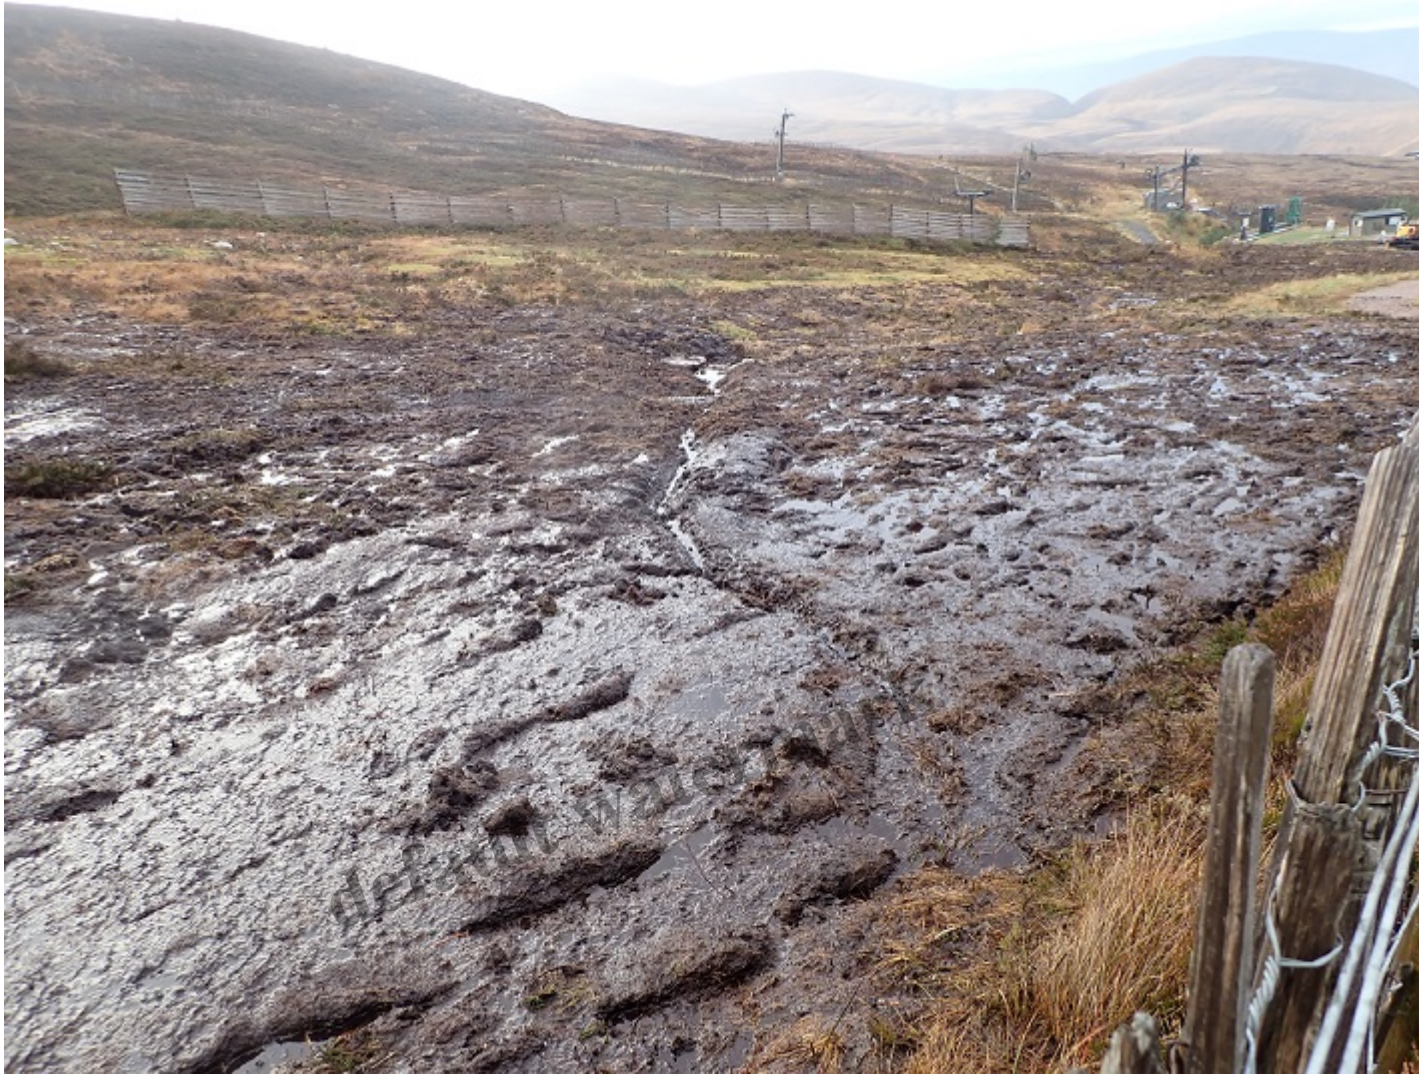
Photo taken end of October

Meantime work on smoothing the slopes near the Day Lodge to create the new beginner's ski area ([see here](#)) appears to have finished. While it is not all peat soup, apart from the environmental destruction (one wonders what impact a flash flood would have on this), it is difficult to think of a worse surface for artificial snow.

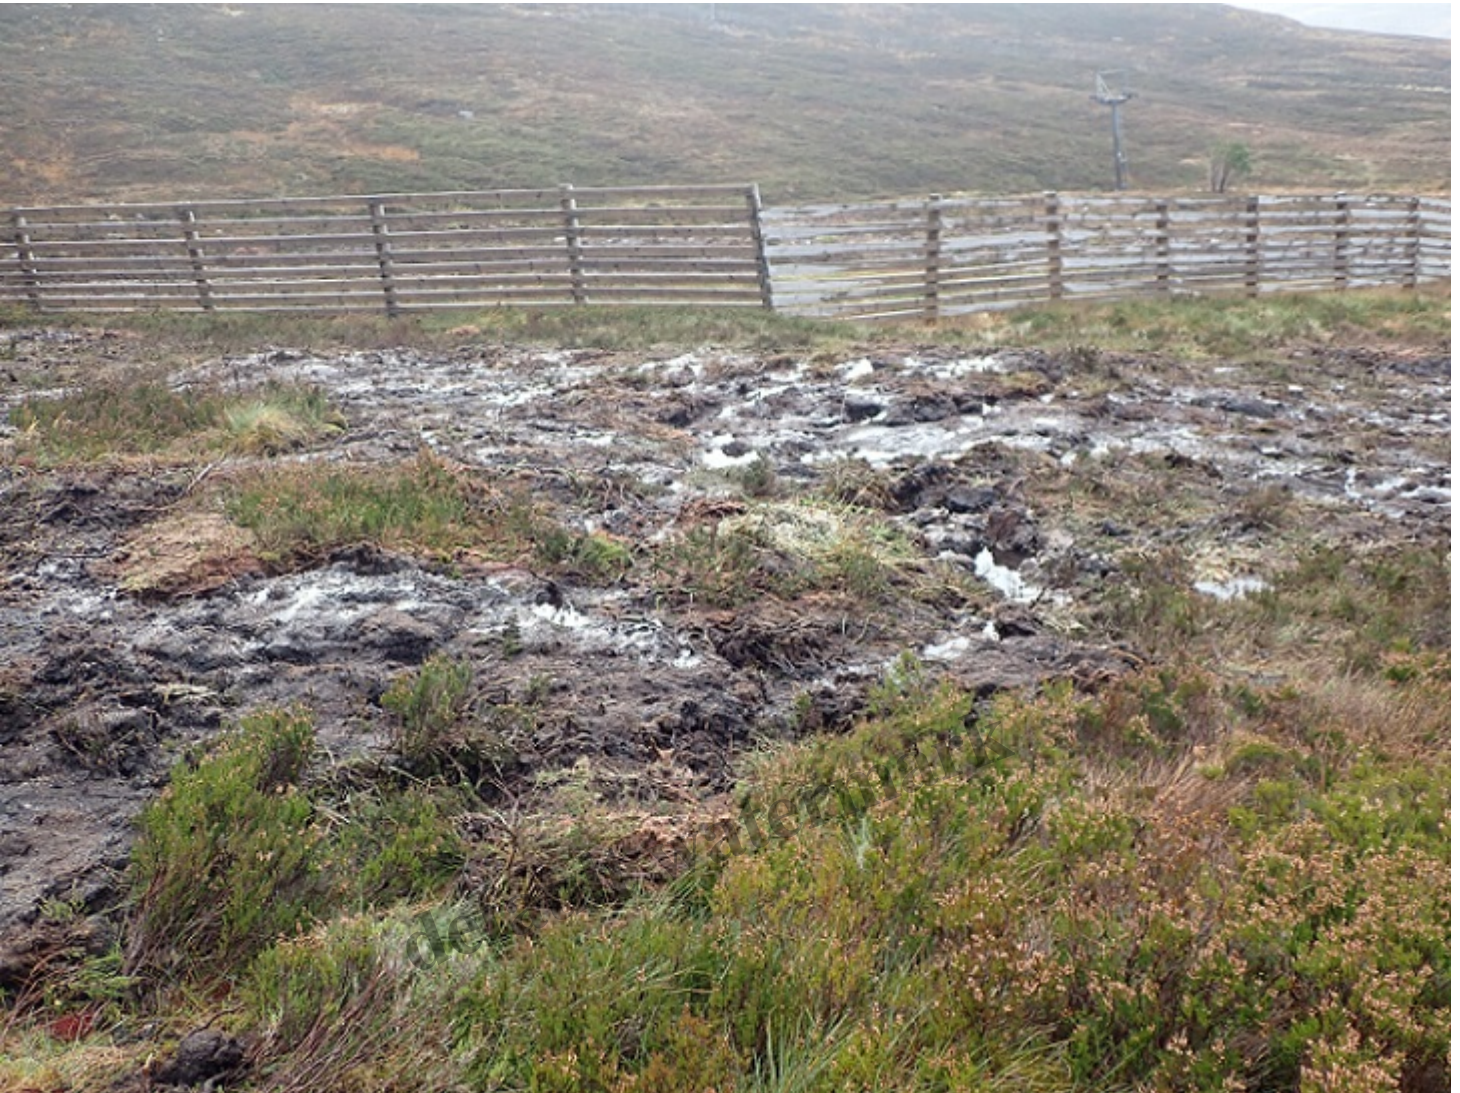
Unless the whole slope is frozen by a very hard frost, it looks as though much of the artificially created snow from the machines will melt into the mire. CMSL has announced these are due to start operating next week, planning permission or not. The evidence suggests that HIE's claims that flattening this slope would improve snow retention is very much in the balance and that, whatever the weather, there is little for downhill skiers to look forward to at Cairn Gorm this winter.
