Landslips and the Nature Emergency – the A83 is just part of the problem

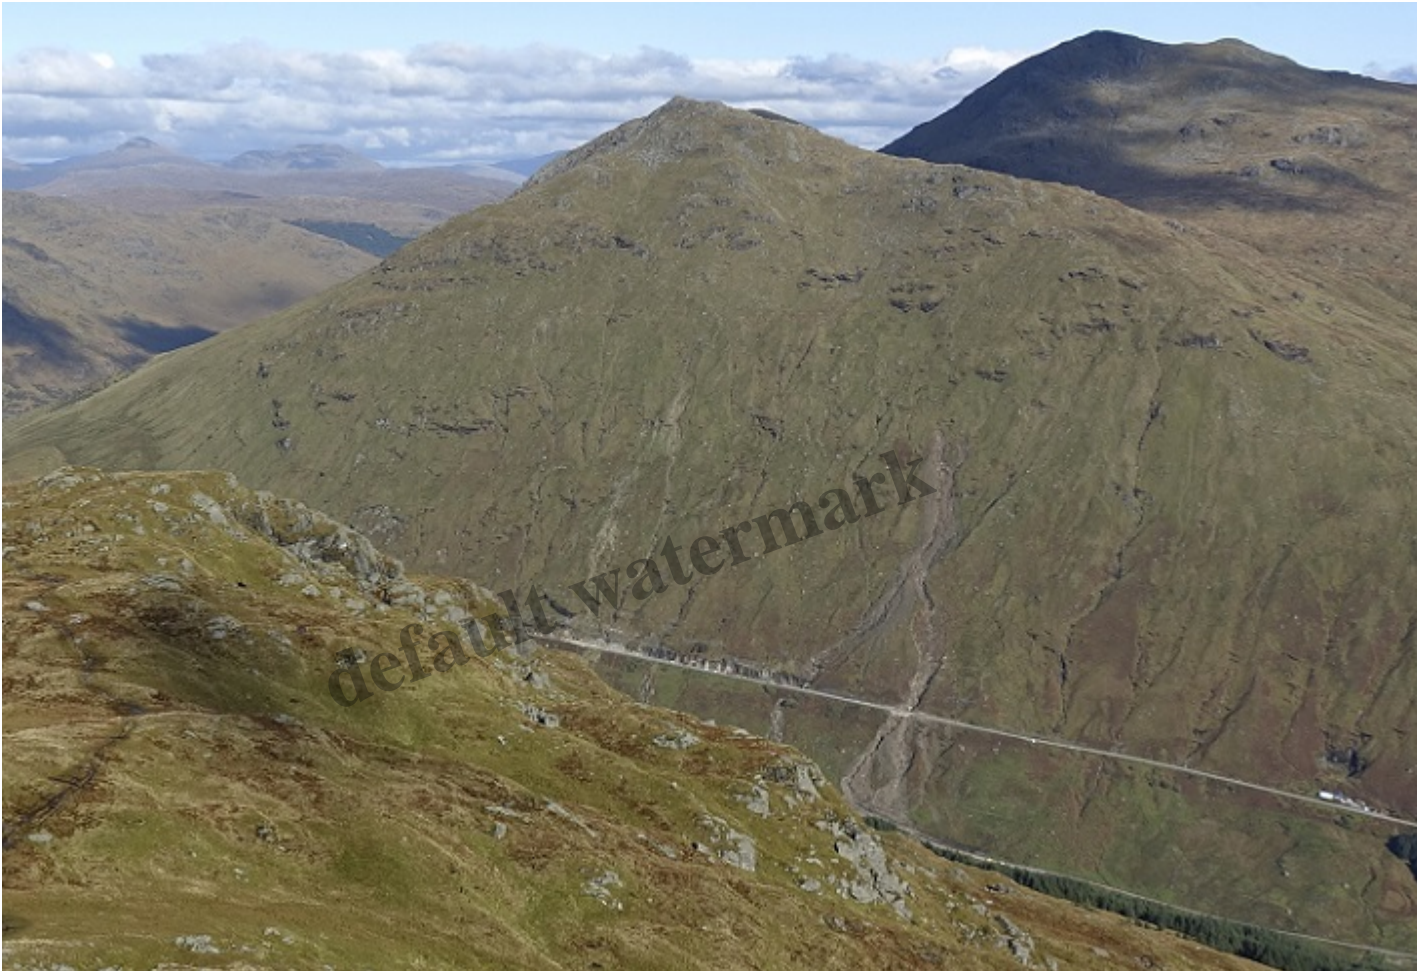
Slopes of Beinn Luibhean and A83 from Ben Donich Autumn 2020 – a huge volume of material still to go. Photo credit RP.

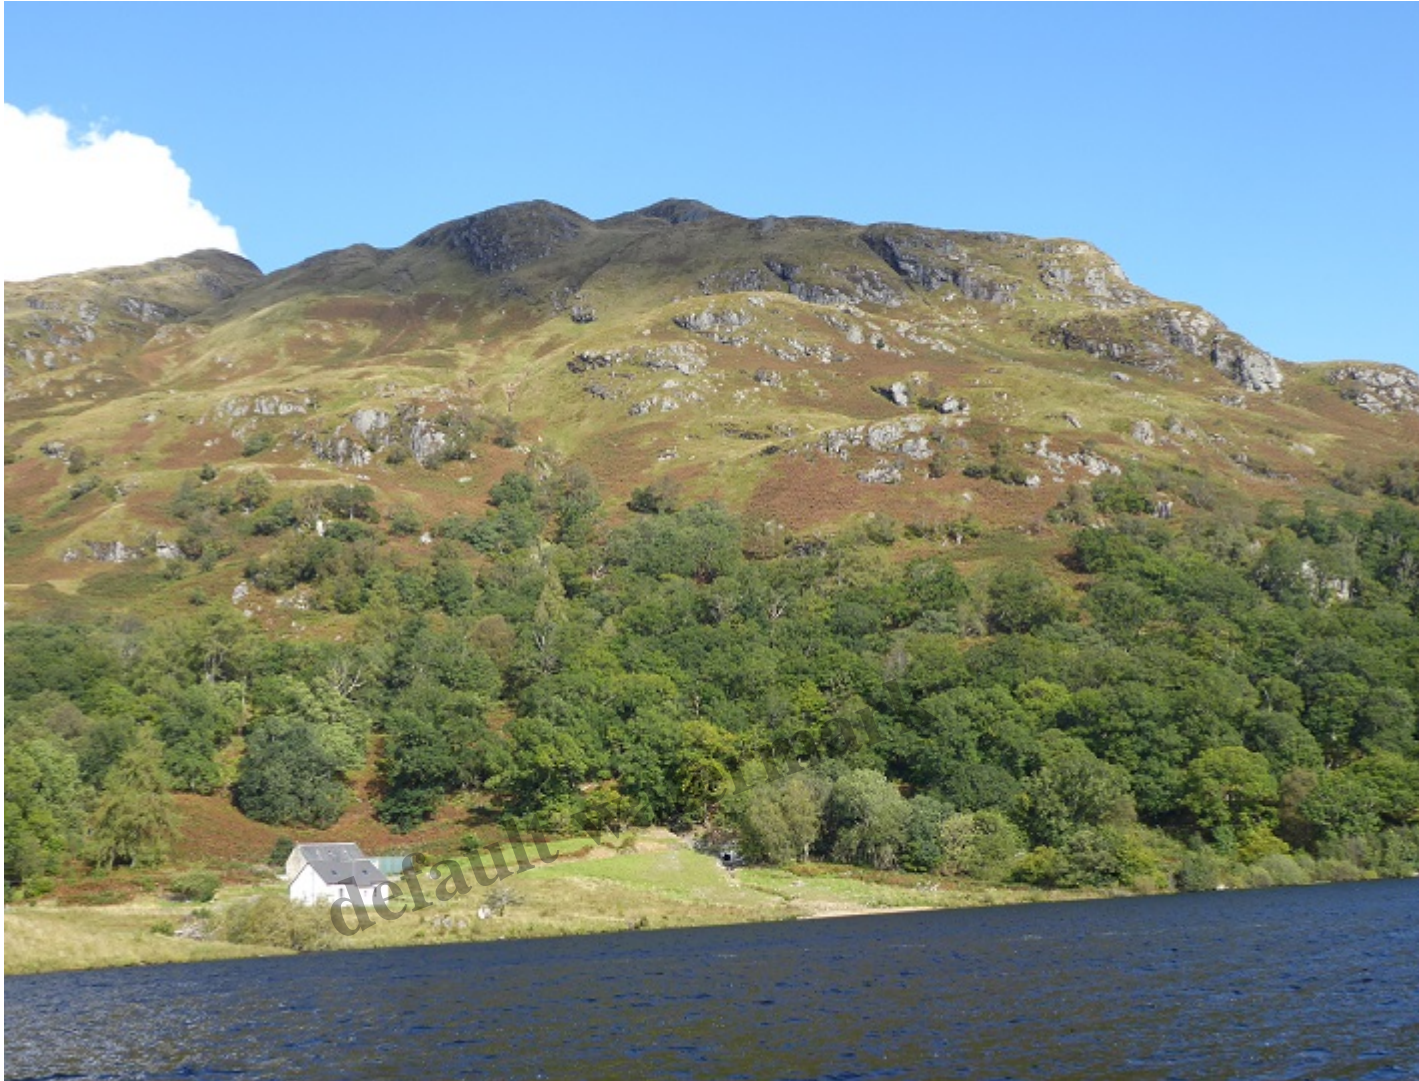
The landslip followed the gully line to the right the buildings, with bare patches just visible below skyline and debris reaching the shore below the trees

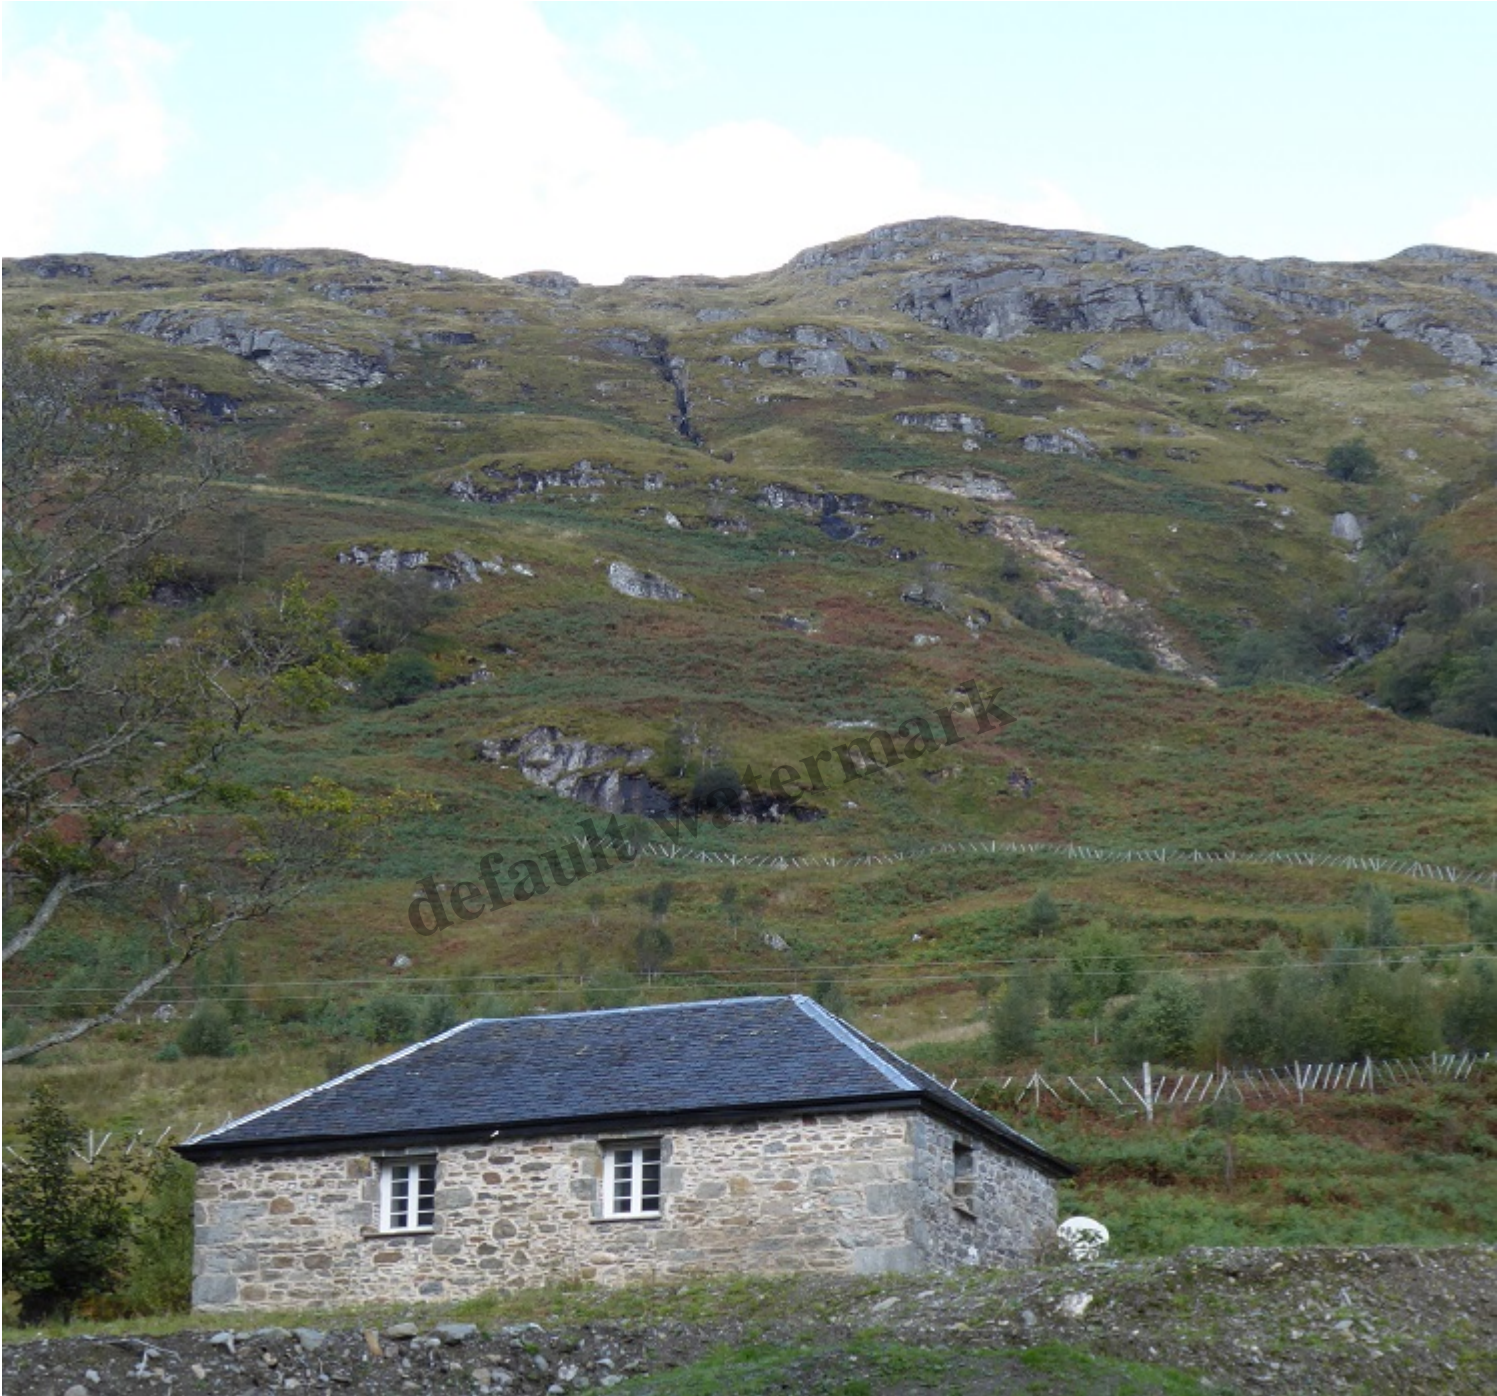
While the area around has now been restored by Scottish Water, debris from the landslip on this hillside piled up behind the house to its eaves. It must have been extremely frightening for the people staying there. Had the landslip moved fast like an avalanche, it would have probably destroyed the house. The debris moved slowly, however, giving time for people to escape.

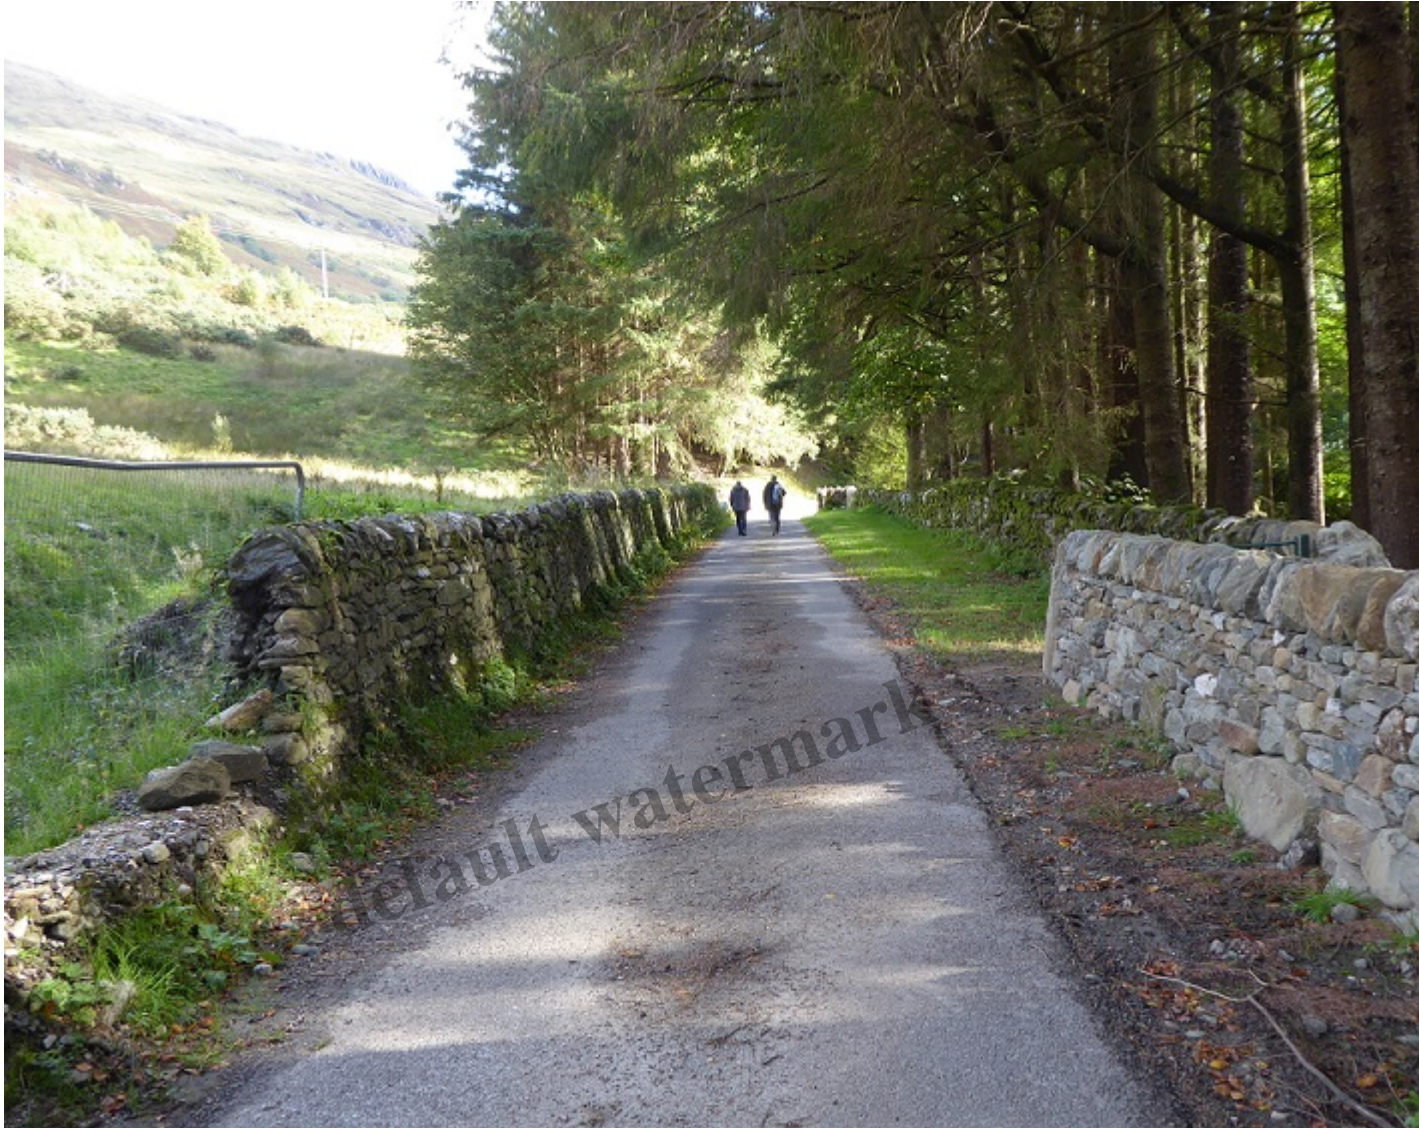
The road below the cottage in top photo, with demolished wall on left and new wall on right

Though slow, the landslip was powerful enough to carry away two dry stane dykes.

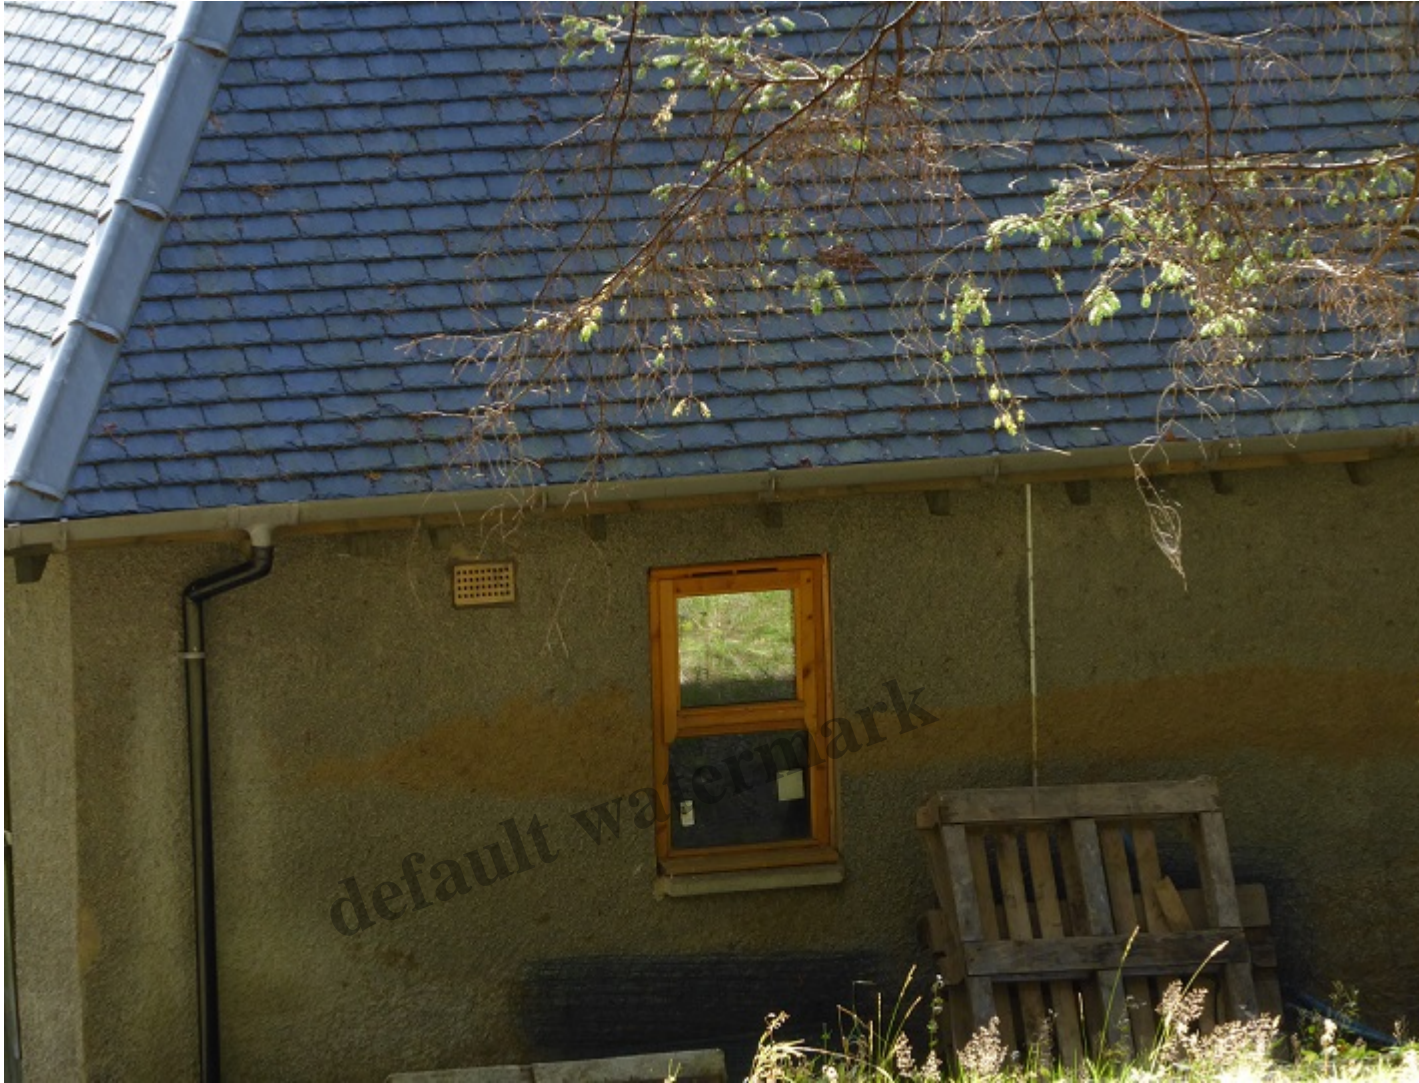
The brown line marks the height of the debris which piled up against a lower building

All the people staying at Glen Gyle had to take refuge in Rob Roy's old house, the only building unaffected. I understand the other buildings are unlikely ever to be used again – they have become uninsurable – and Scottish Water has been negotiating with their owners to buy them up. The threat of landslips has made most of Glengyle too dangerous to live.

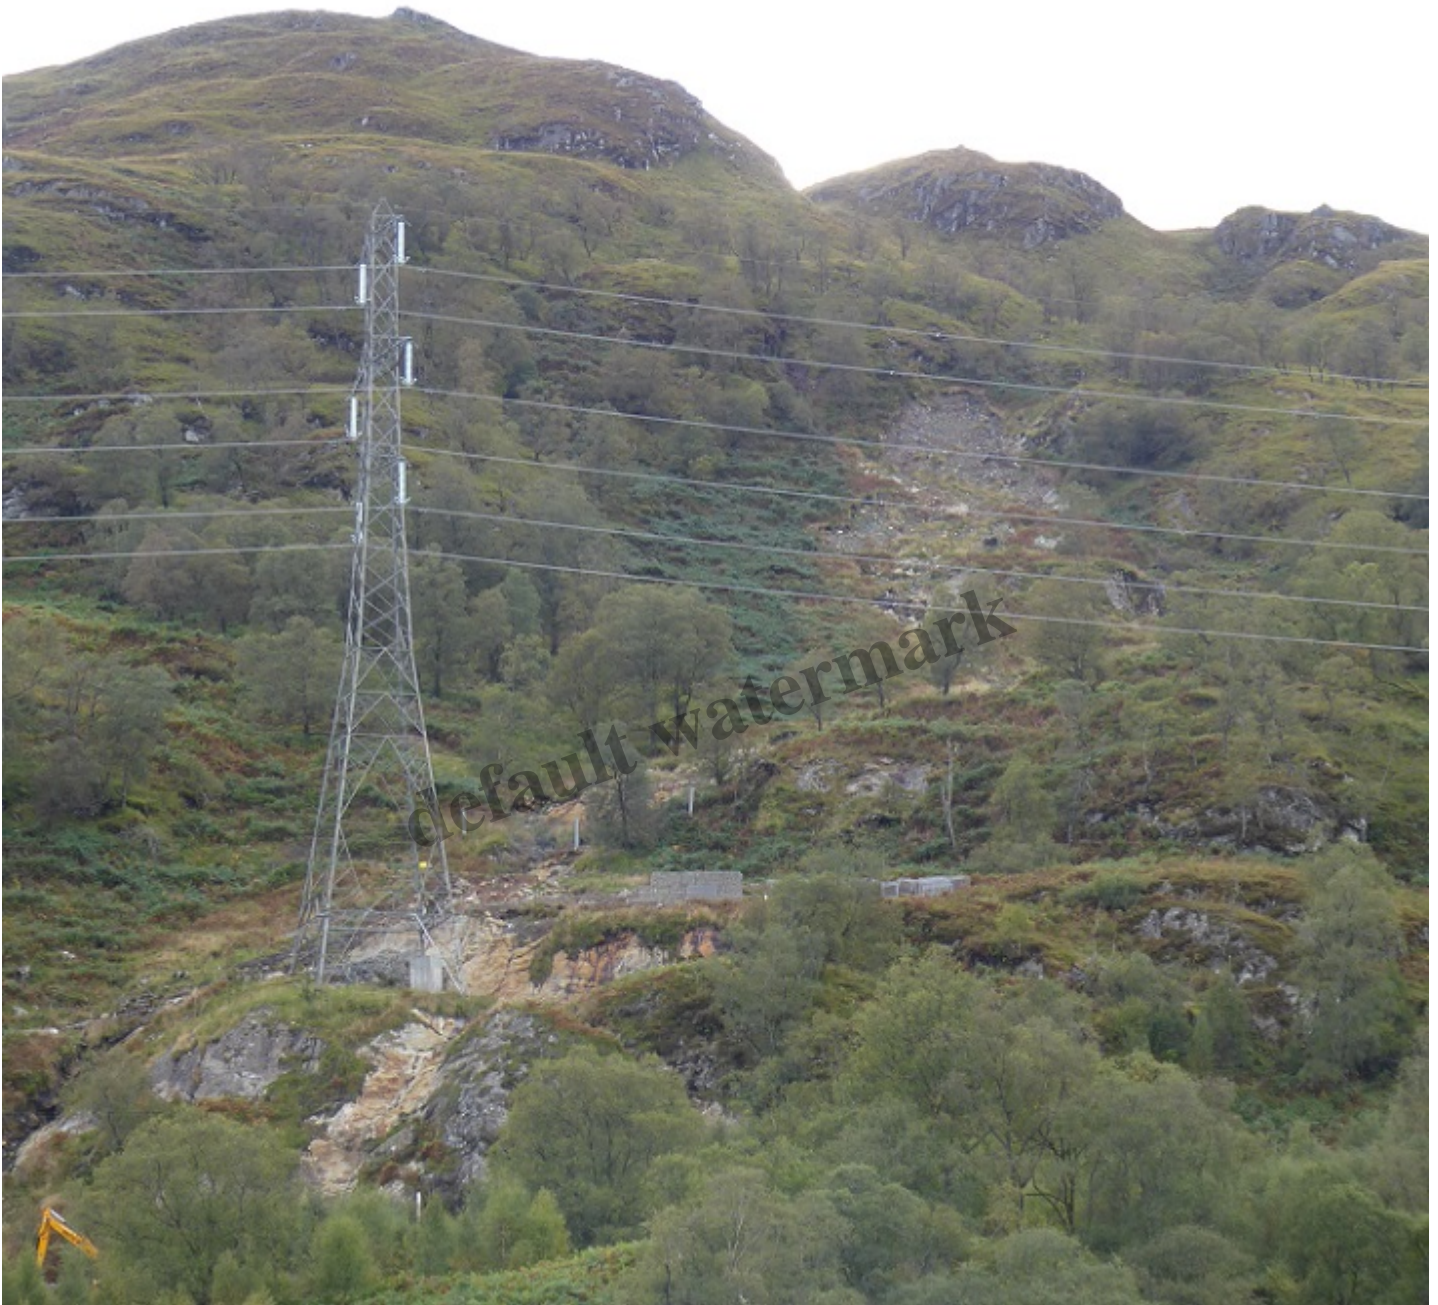
Had the landslips further round towards Stronachlachar actually toppled the powerline, that would have had a major impact on the national grid and we would have heard a lot more about it. As it is, it has taken more than a year to fix the damaged tower.

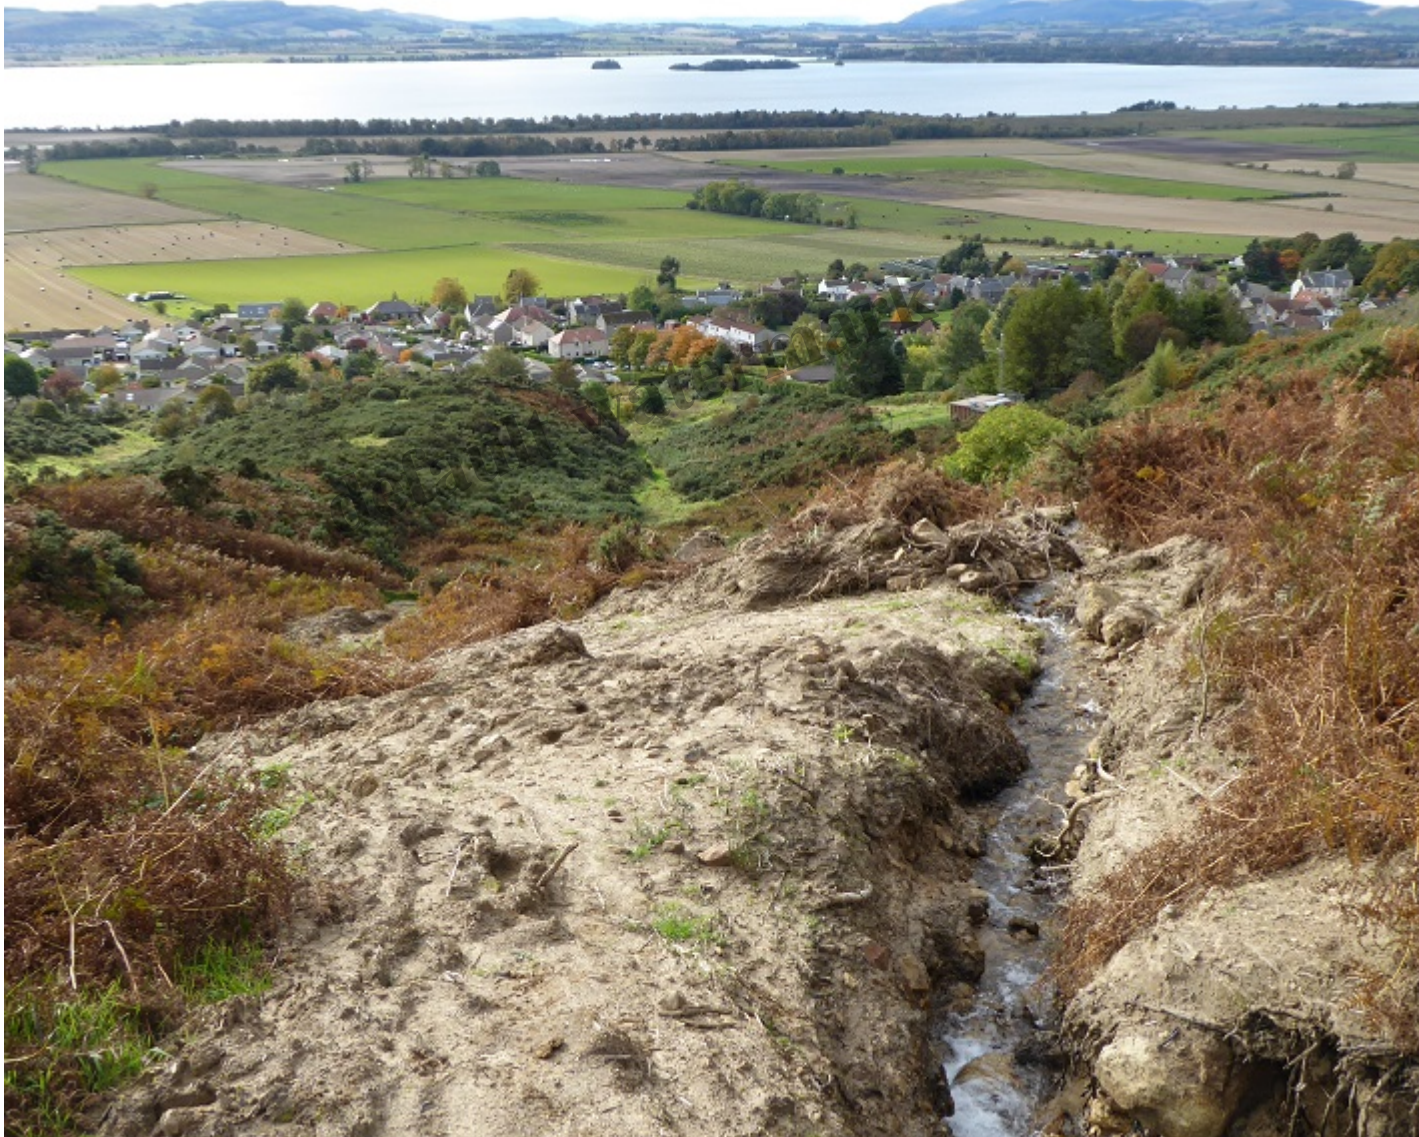
View down landslip from above the village of Kinnesswood, with Loch Leven in distance

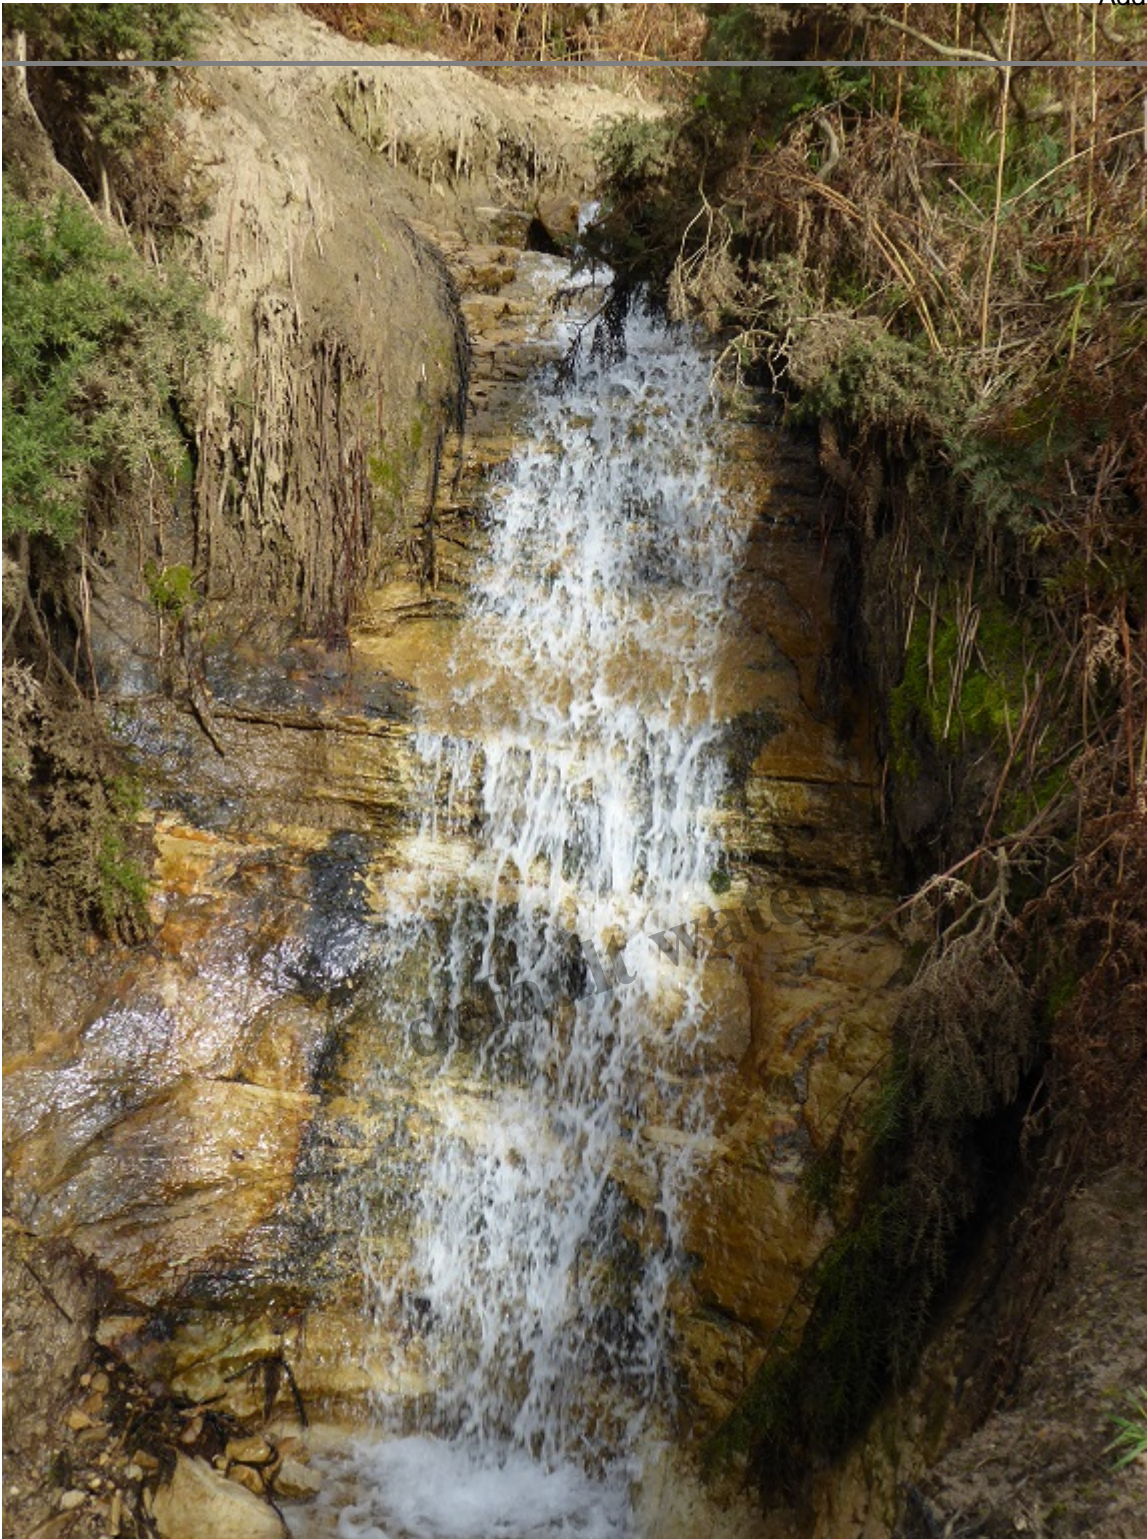
It appeared to have

been triggered by the force of water down a small burn cutting away part of the bank on some rock

slabs.

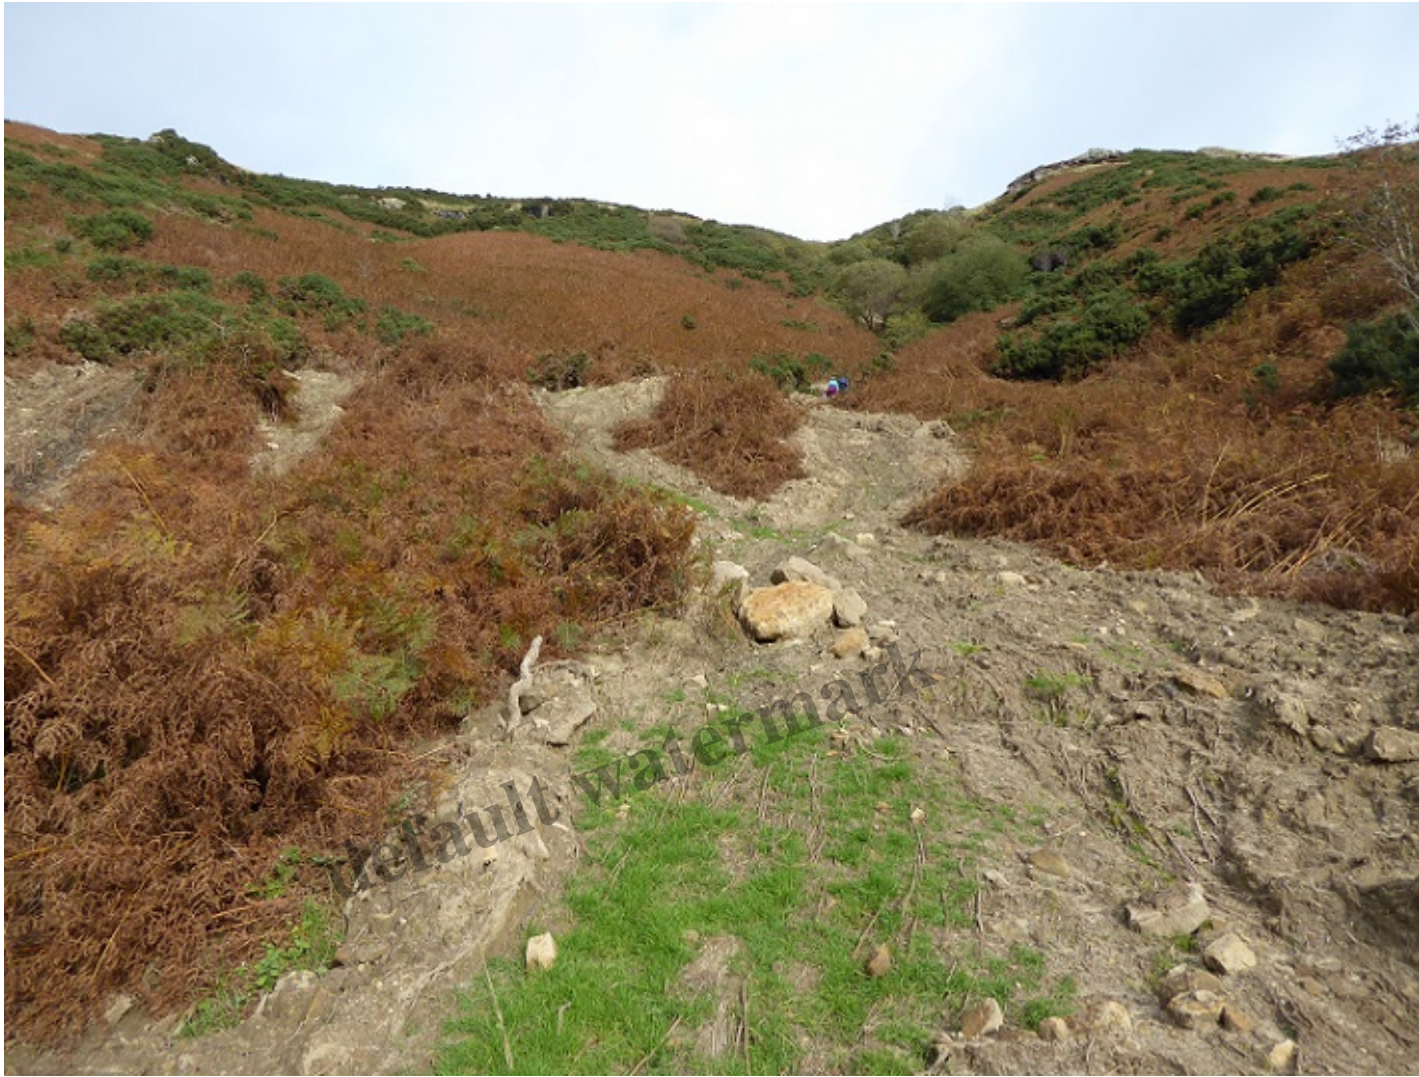
The landslide started just above the trees

Below the trees, the landslide gathered a significant amount of material and spread out like an avalanche. An interesting question is whether trees lower down might have limited its progress. In this case the landslide followed the line of the burn and its banks, so even if it had been much bigger and reached the village, it would probably have flowed through it.

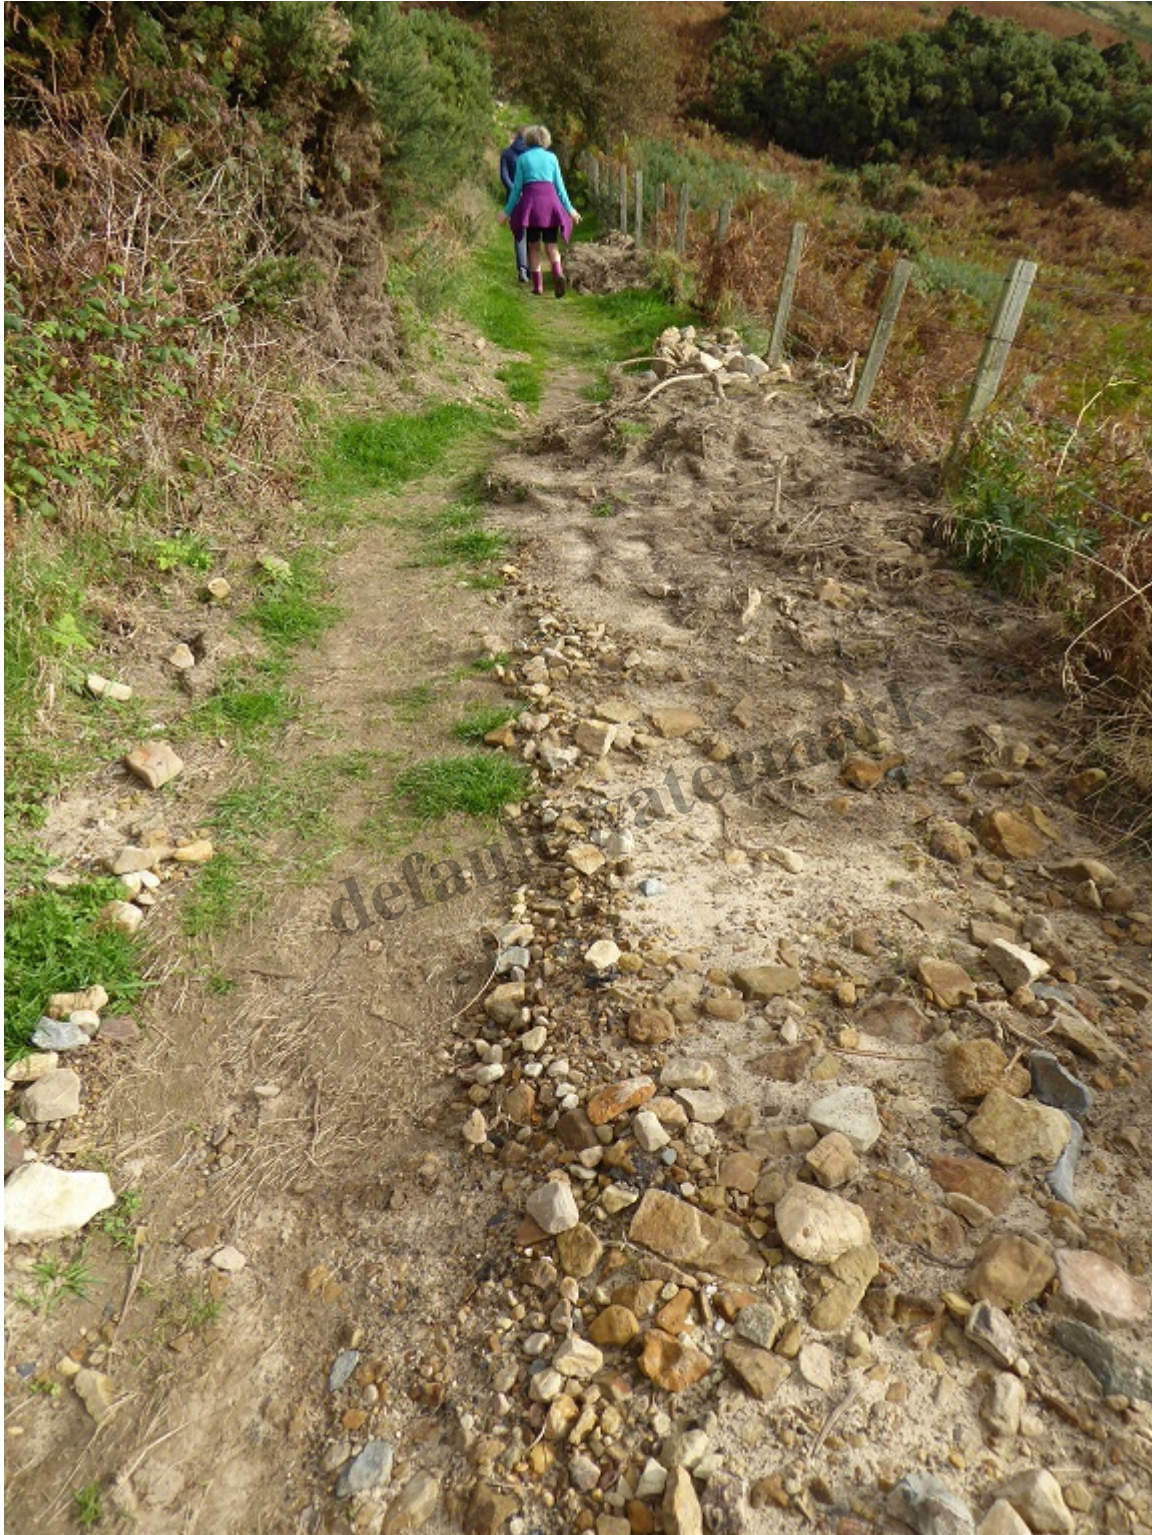
Footpath, partially cleared

I wouldn't, however, have liked to have been on the footpath.

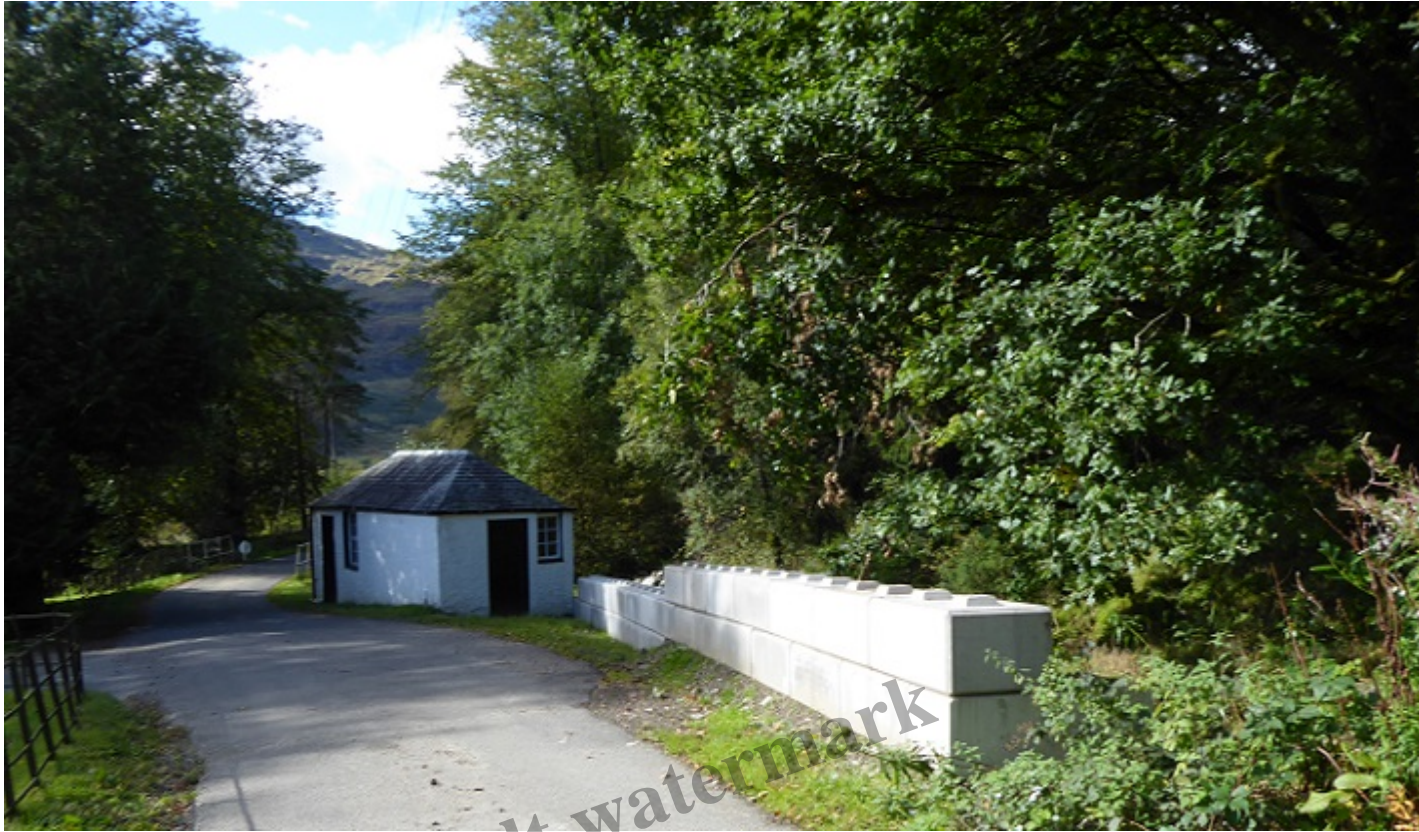
civil engineering solution Glengyle

Alongside understanding the risks, we need to develop nature based as well as civil engineering solutions to mitigate them.
