Landslips and the Nature Emergency â?? the A83 is just part of the problem

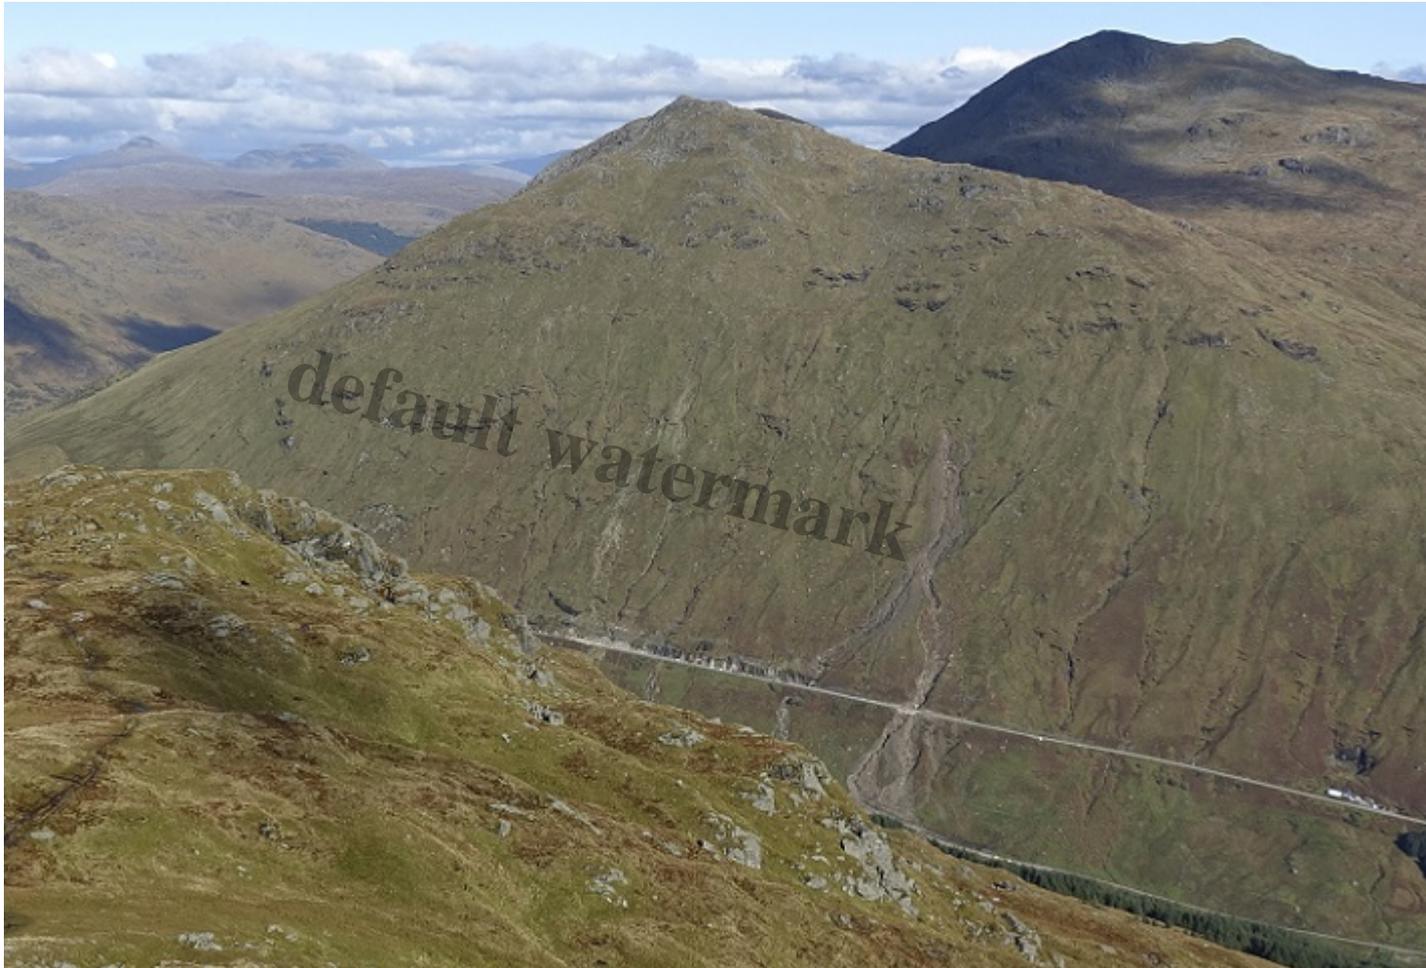
Slopes of Beinn Luibhean and A83 from Ben Donich Autumn 2020 â?? a huge volume of material st go. Photo credit RP.

In both landslips, what struck me was how small the scar on the hillside appeared compared to the area of ground affected. Just think of the amount of material and the damage it could do if the whole hillside went. Unlikely around Loch Katrine perhaps, because of the angle of the slope and because the hillsides are broken up with rocky outcrops and trees. But Beinn Luibhean, above the Rest and Be Thankful (top photo), is a different matter.

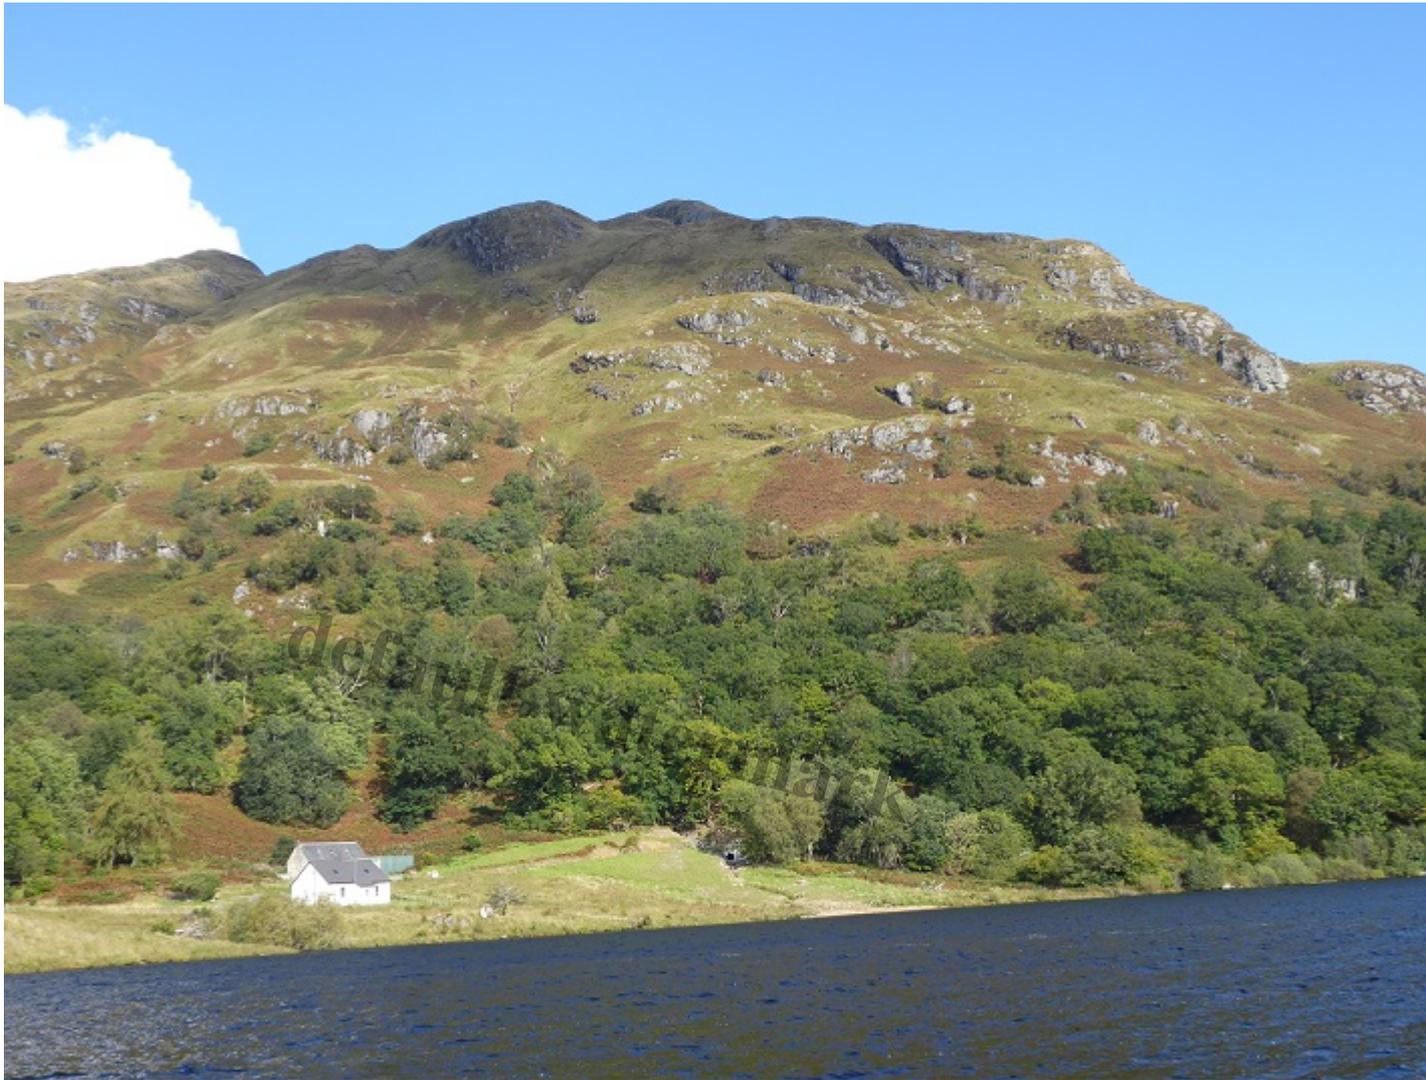
The landslip followed the gully line to the right the buildings, with bare patches just visible below skyline and debris reaching the shore below the trees

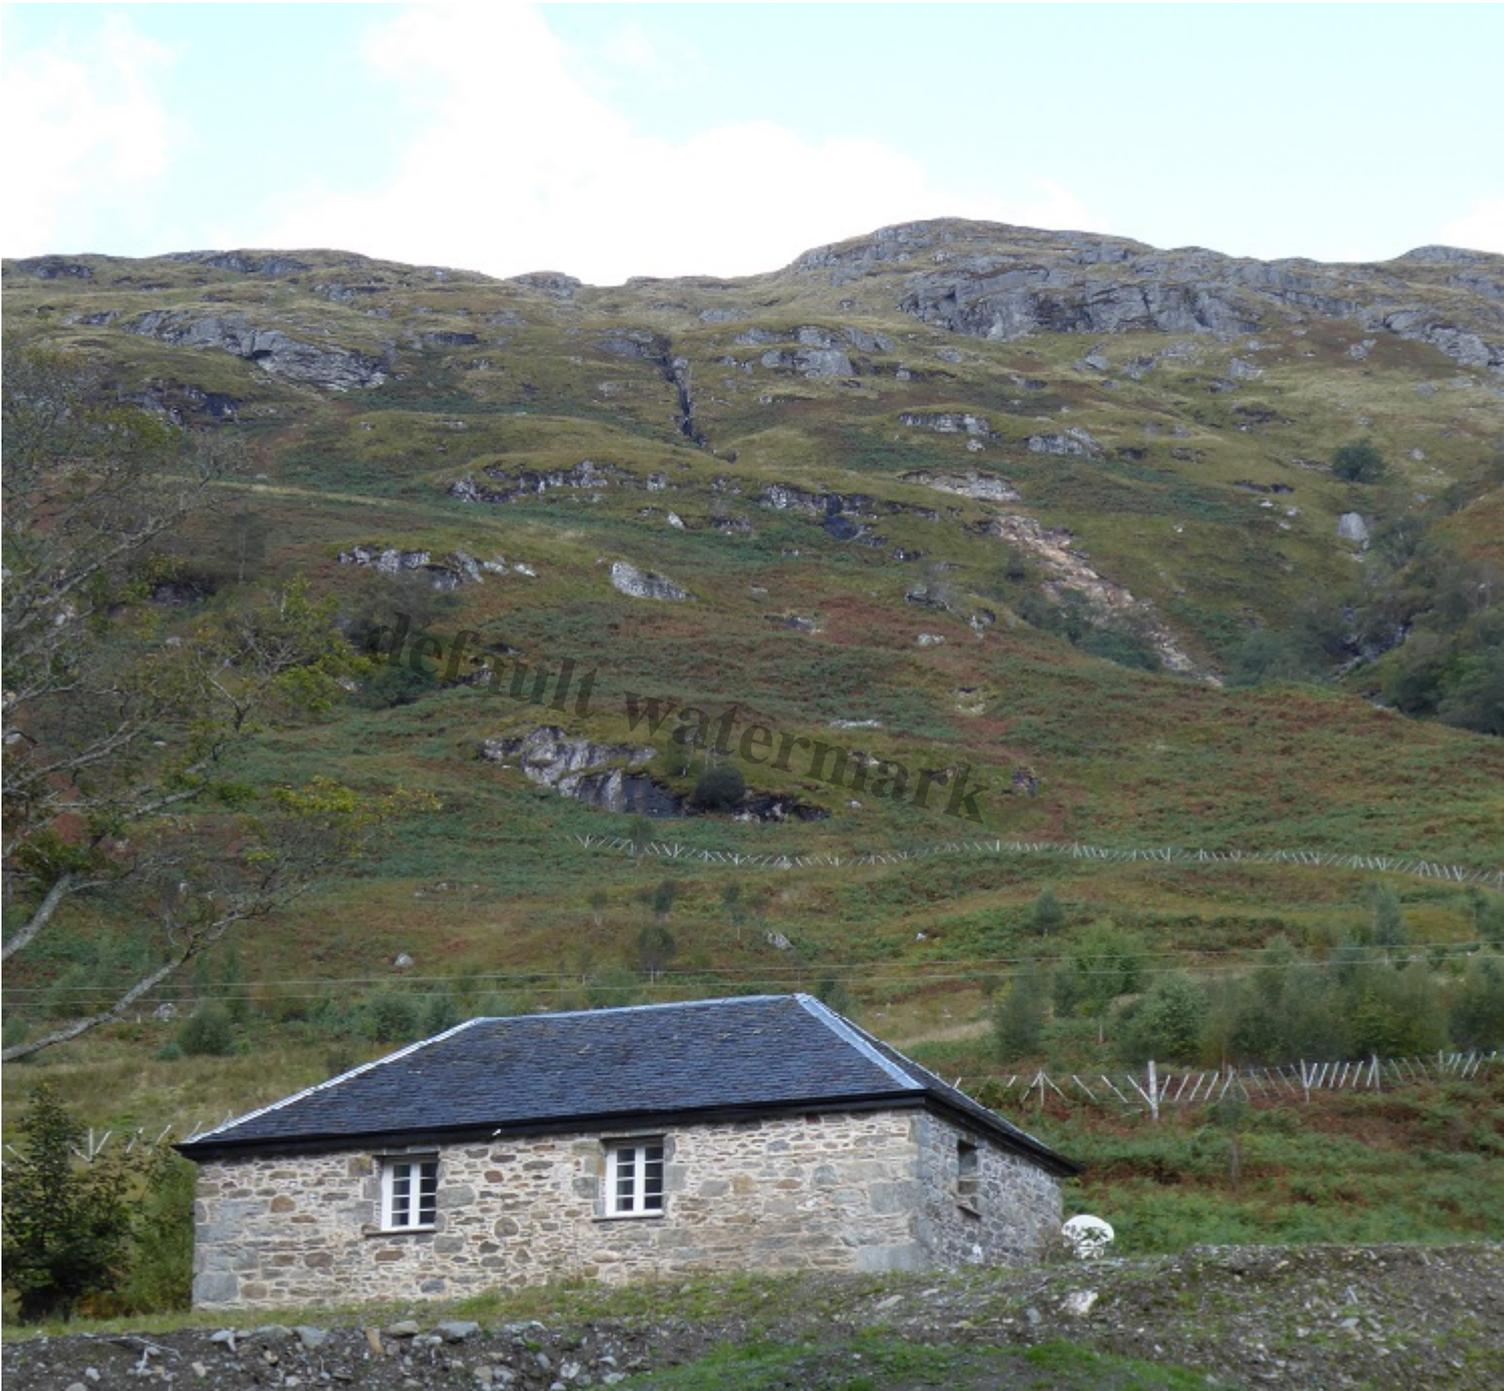
While the area around has now been restored by Scottish Water, debris from the landslip on this hillside piled up behind the house to its eaves. It must have been extremely frightening for the people staying there. Had the landslip moved fast like an avalanche, it would have probably destroyed the house. The debris moved slowly, however, giving time for people to escape.

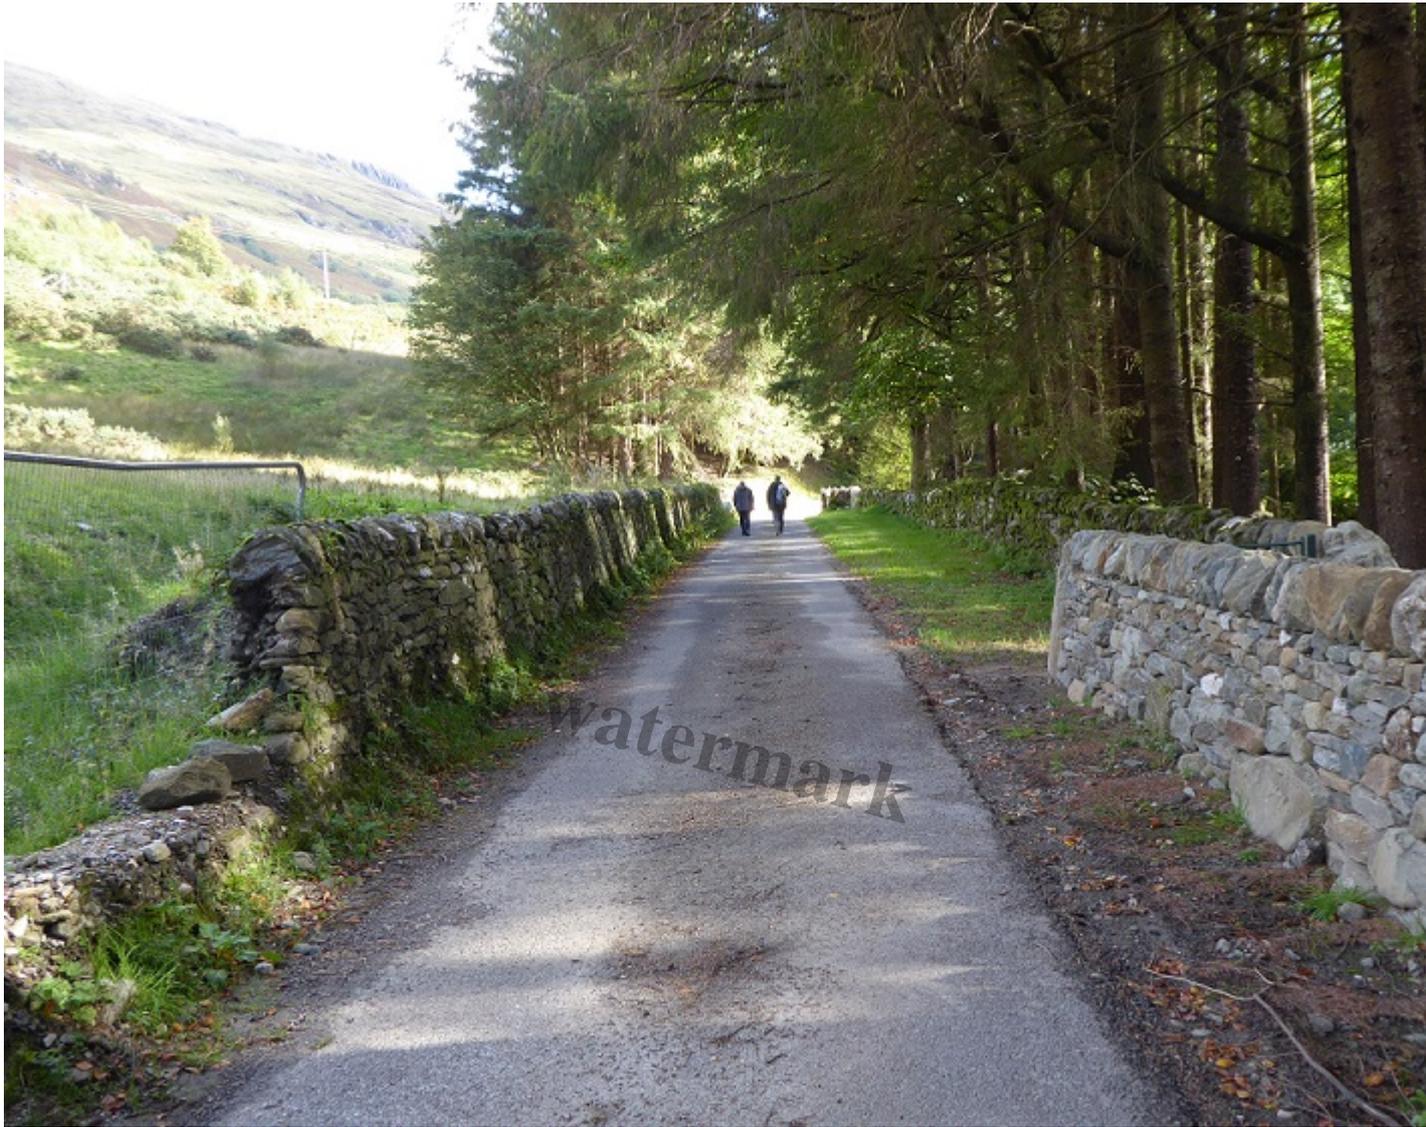
The road below the cottage in top photo, with demolished wall on left and new wall on right

Though slow, the landslip was powerful enough to carry away two dry stane dykes.

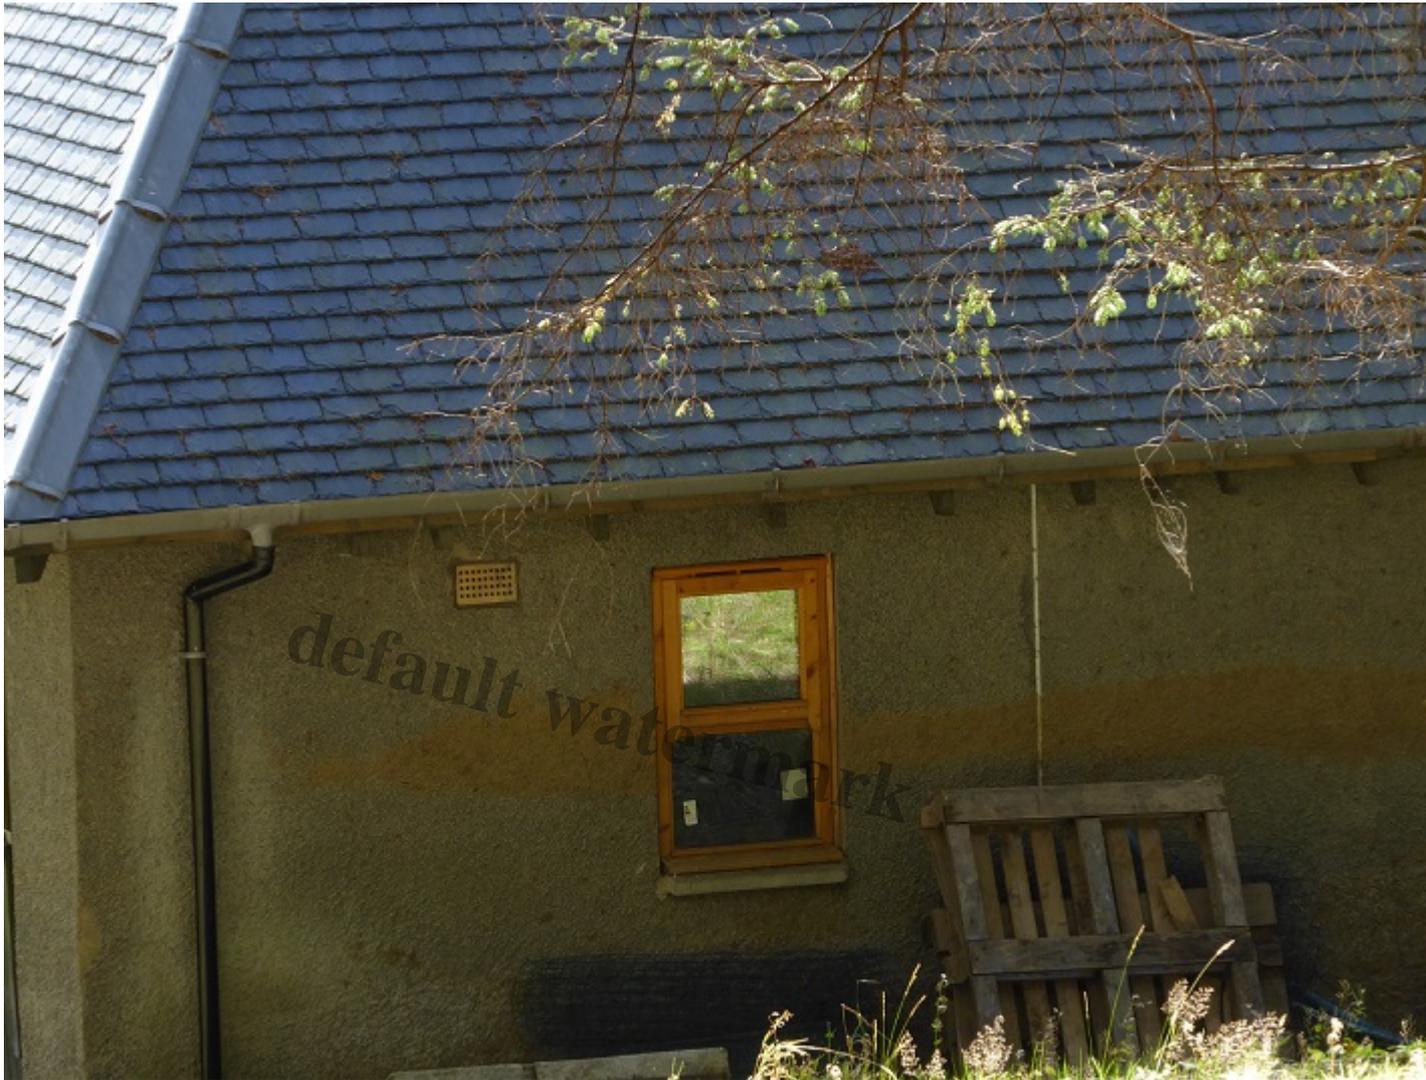
The brown line marks the height of the debris which piled up against a lower building

All the people staying at Glen Gyle had to take refuge in Rob Roy's old house, the only building unaffected. I understand the other buildings are unlikely ever to be used again - they have become uninsurable - and Scottish Water has been negotiating with their owners to buy them up. The threat of landslips has made most of Glengyle too dangerous to live.

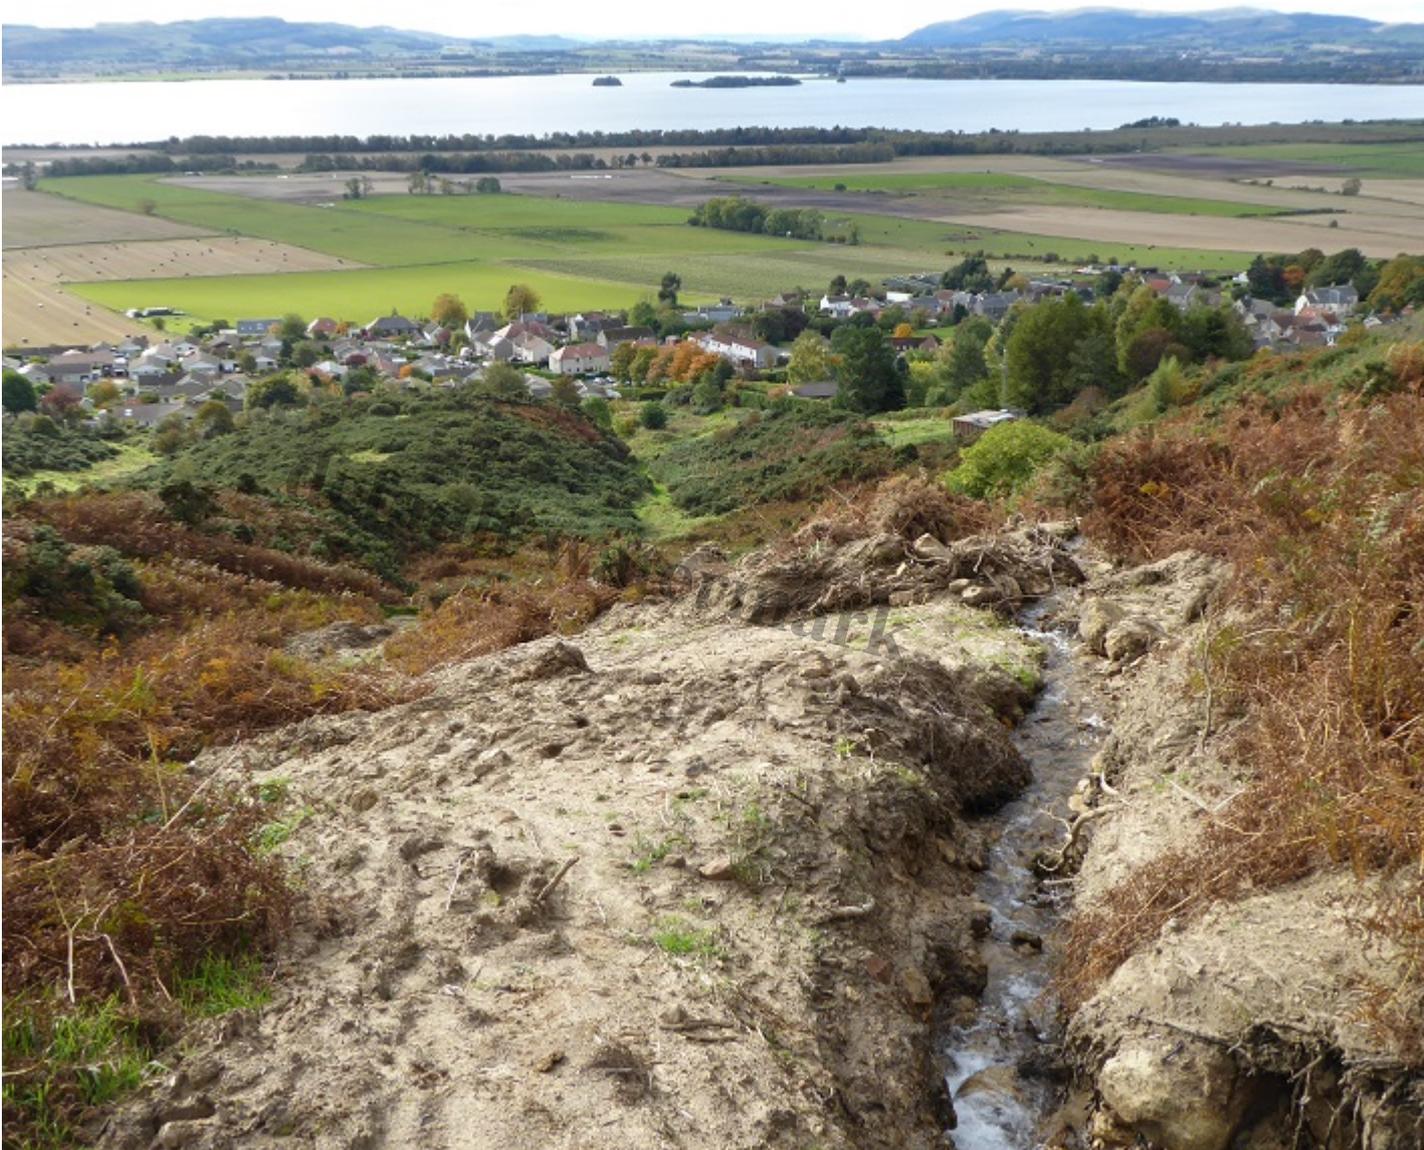
View down landslip from above the village of Kinnesswood, with Loch Leven in distance

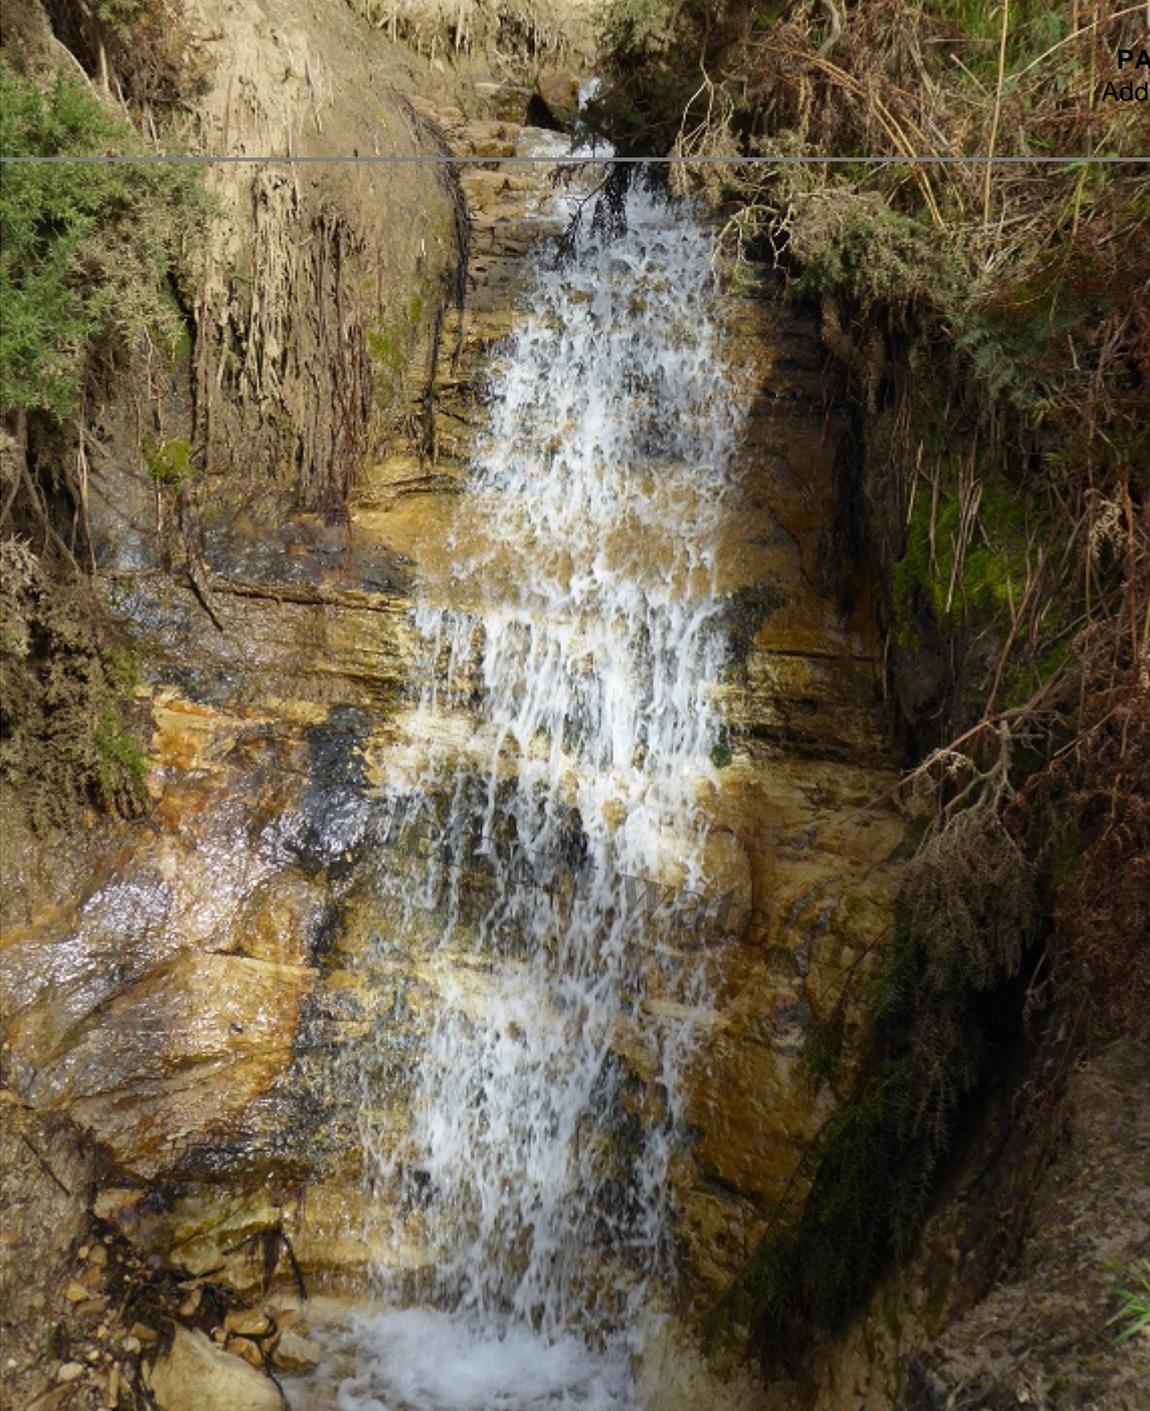
It appeared to have

been triggered by the force of water down a small burn cutting away part of the bank on some rock slabs.

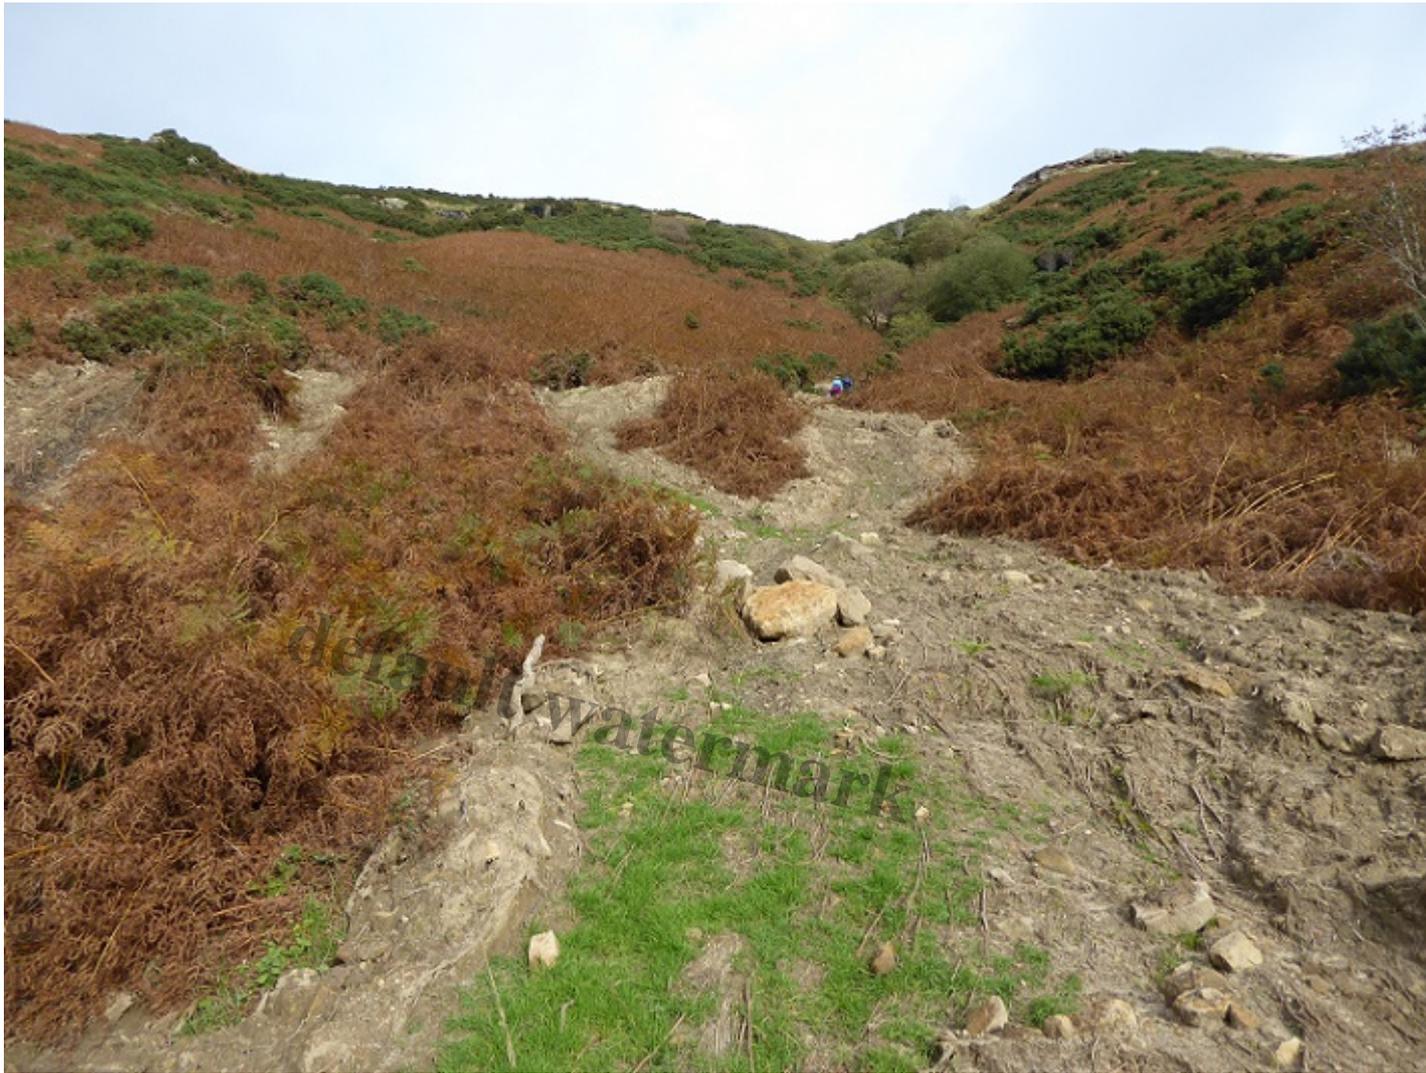
The landslide started just above the trees

Below the trees, the landslide gathered a significant amount of material and spread out like an avalanche. An interesting question is whether trees lower down might have limited its progress. In this case the landslide followed the line of the burn and its banks, so even if it had been much bigger and reached the village, it would probably have flowed through it.

Trees won't in themselves prevent landslips, as the photos here and in previous posts show. There are hints though (second photo) that woodland may help contain landslips. We know too that woodland helps hold back water which is what triggers most landslips in Scotland. The development of a scrub zone would have slowed and limited the volume of water flowing down the hill, potentially reducing the number of landslips triggered above the current tree line and in woodland on the lower slopes. That is not possible at present at Loch Katrine, Glen Falloch or many other parts of upland Scotland due to high deer numbers.

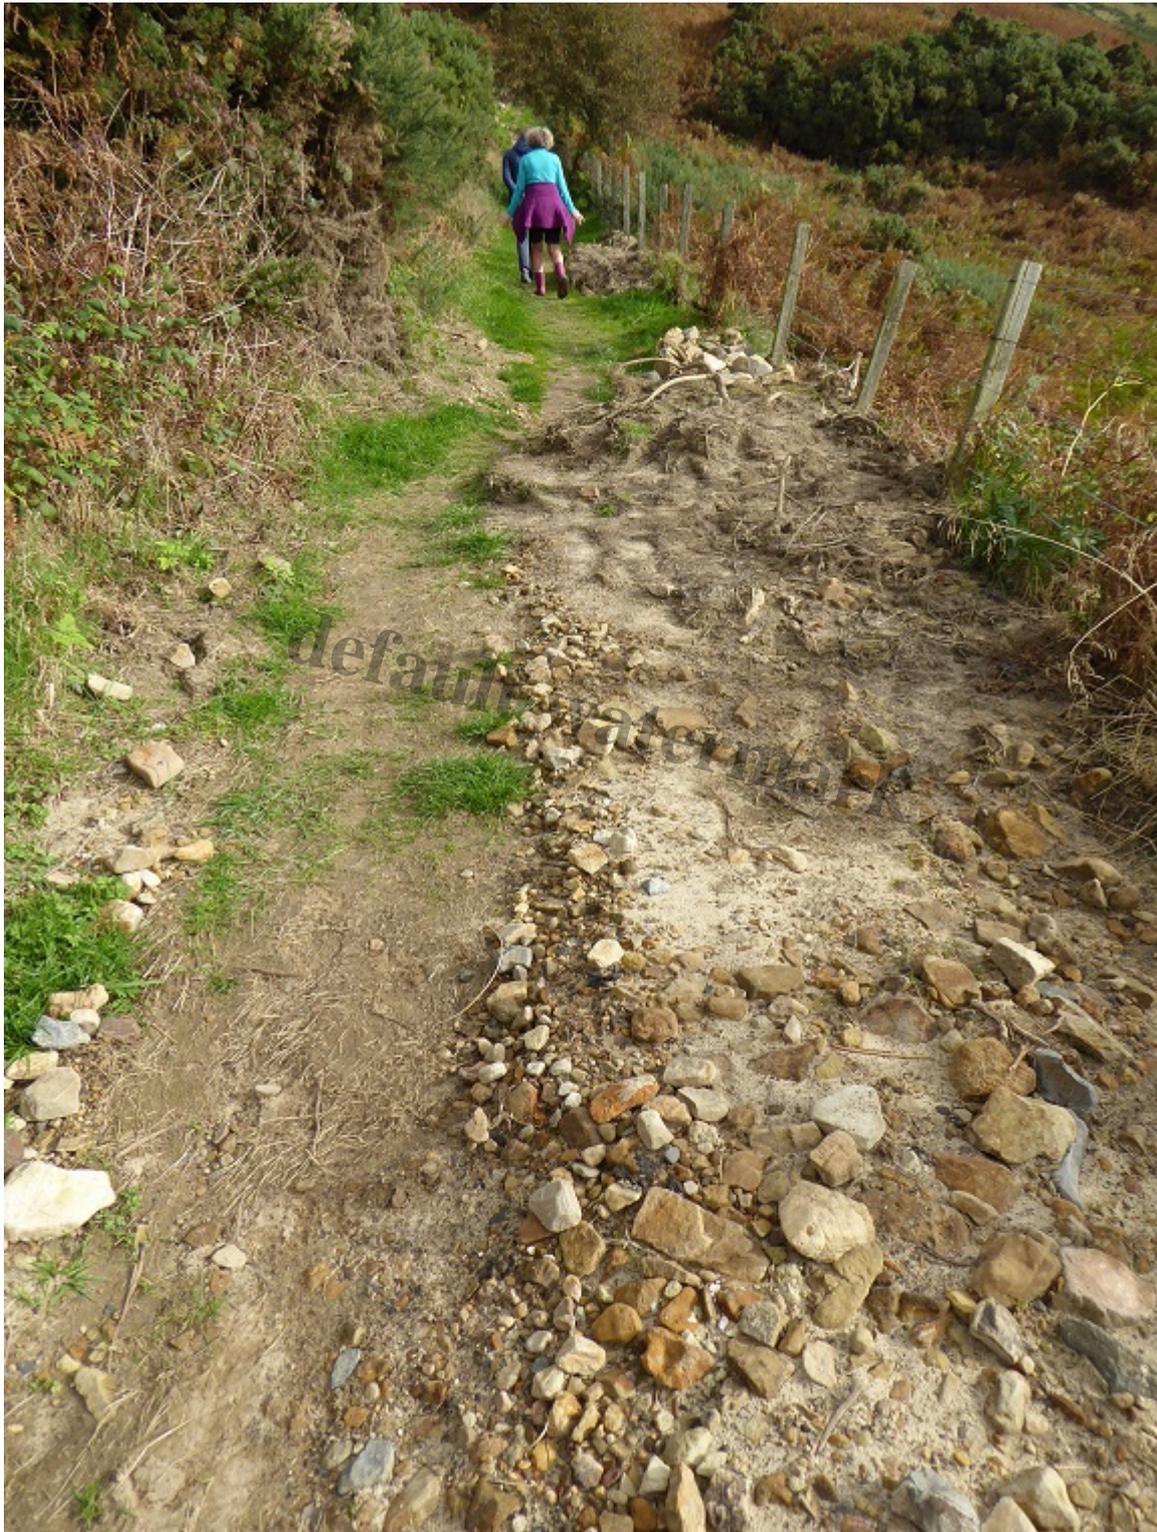
Footpath, partially cleared

I wouldn't, however, have liked to have been on the footpath.

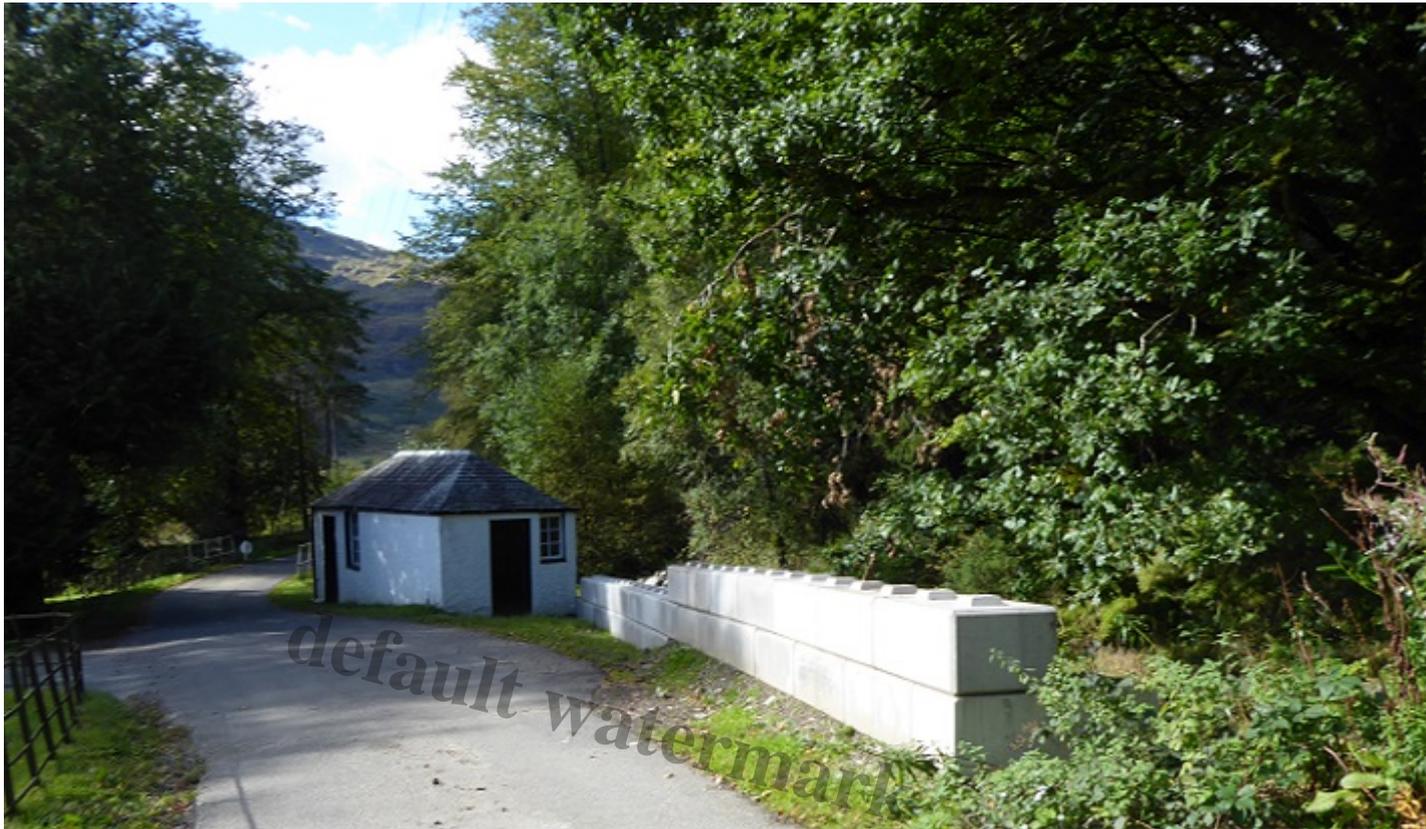
civil engineering solution Glengyle
