Landslips and the Nature Emergency – the A83 is just part of the problem

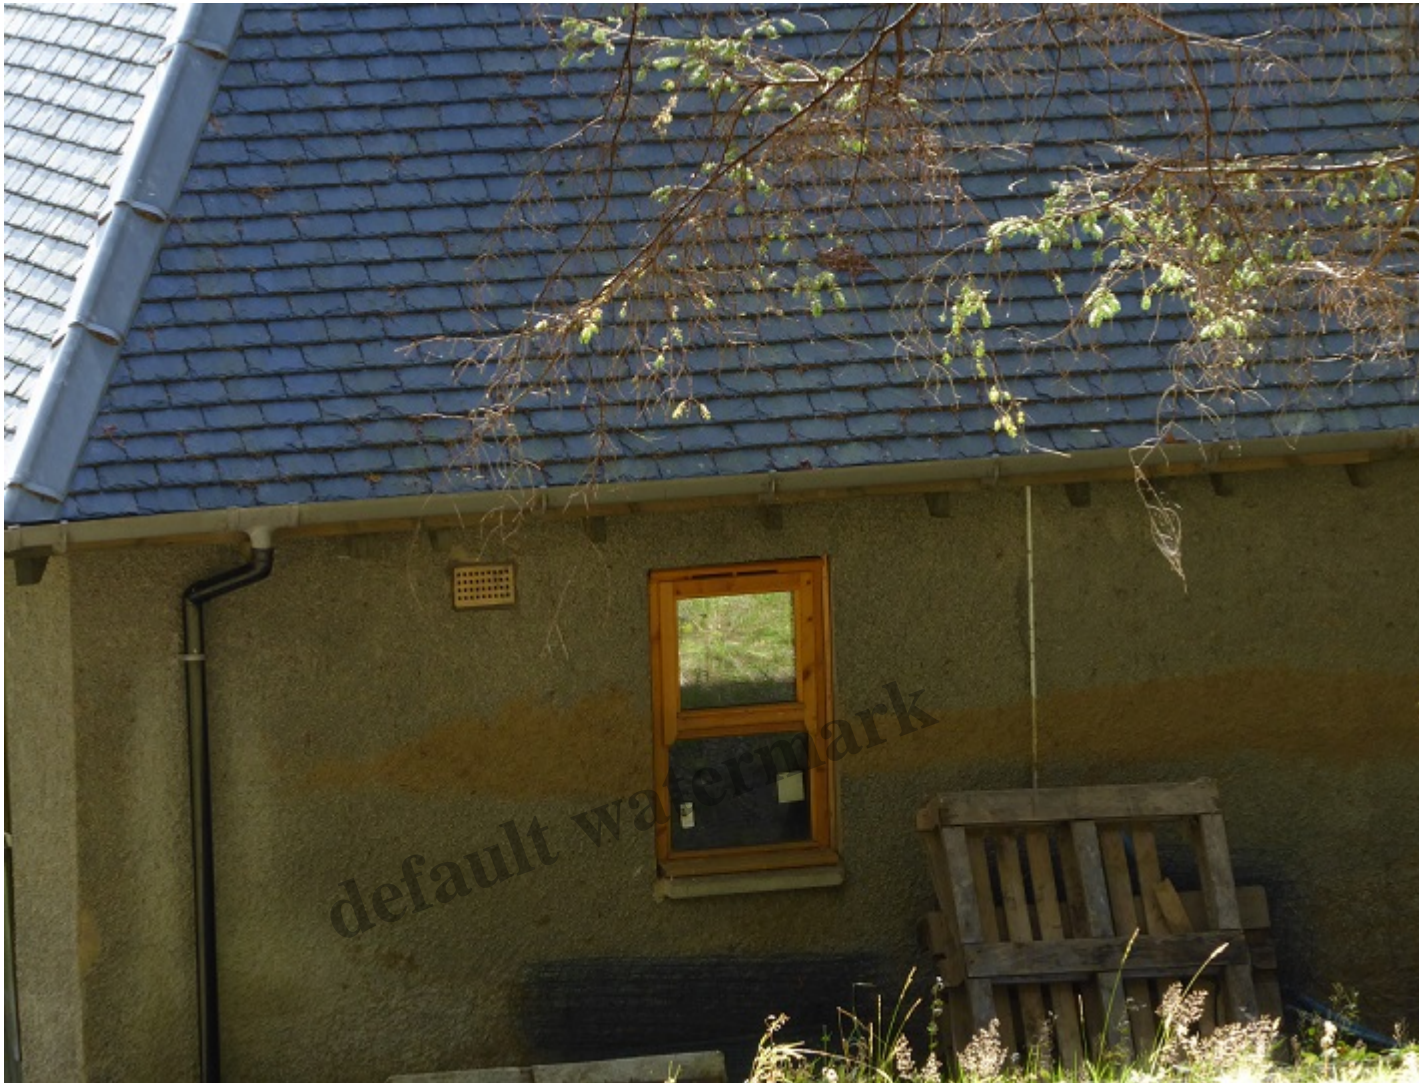
The brown line marks the height of the debris which piled up against a lower building

All the people staying at Glen Gyle had to take refuge in Rob Roy's old house, the only building unaffected. I understand the other buildings are unlikely ever to be used again – they have become uninsurable – and Scottish Water has been negotiating with their owners to buy them up. The threat of landslips has made most of Glengyle too dangerous to live.

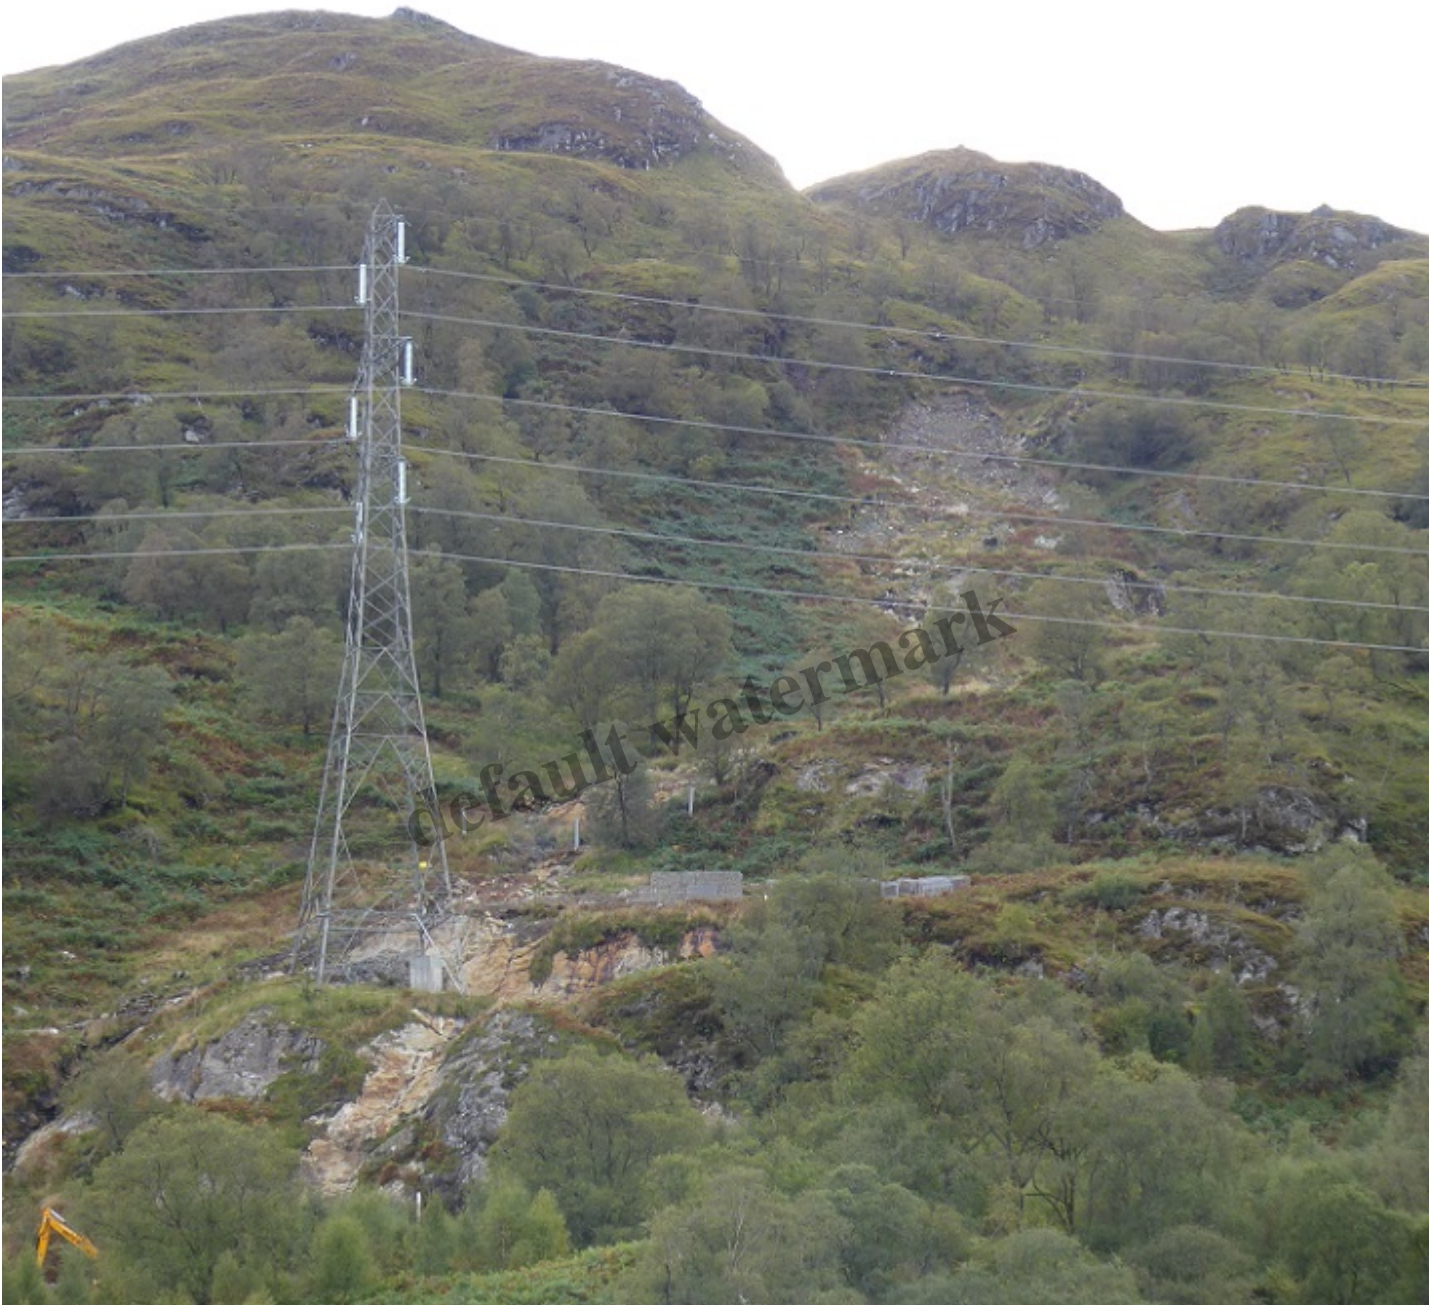
Had the landslips further round towards Stronachlachar actually toppled the powerline, that would have had a major impact on the national grid and we would have heard a lot more about it. As it is, it has taken more than a year to fix the damaged tower.

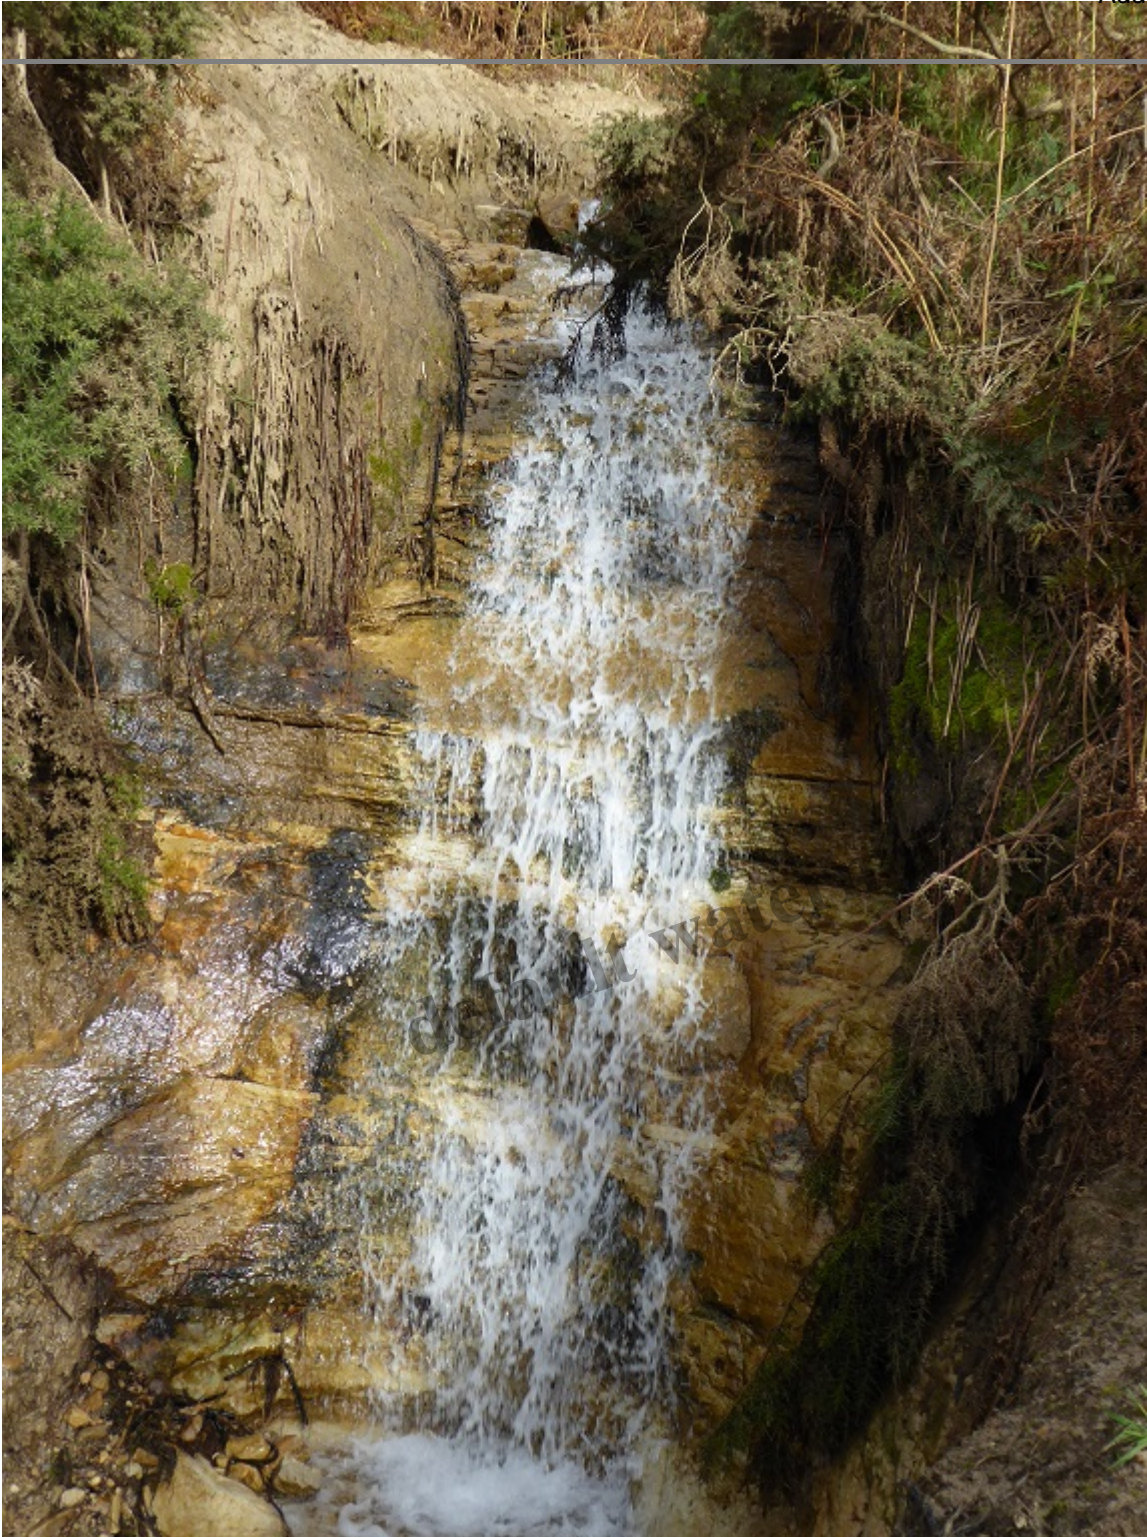
It appeared to have

been triggered by the force of water down a small burn cutting away part of the bank on some rock

slabs.
