The system failure at the Gynack overflow above Kingussie

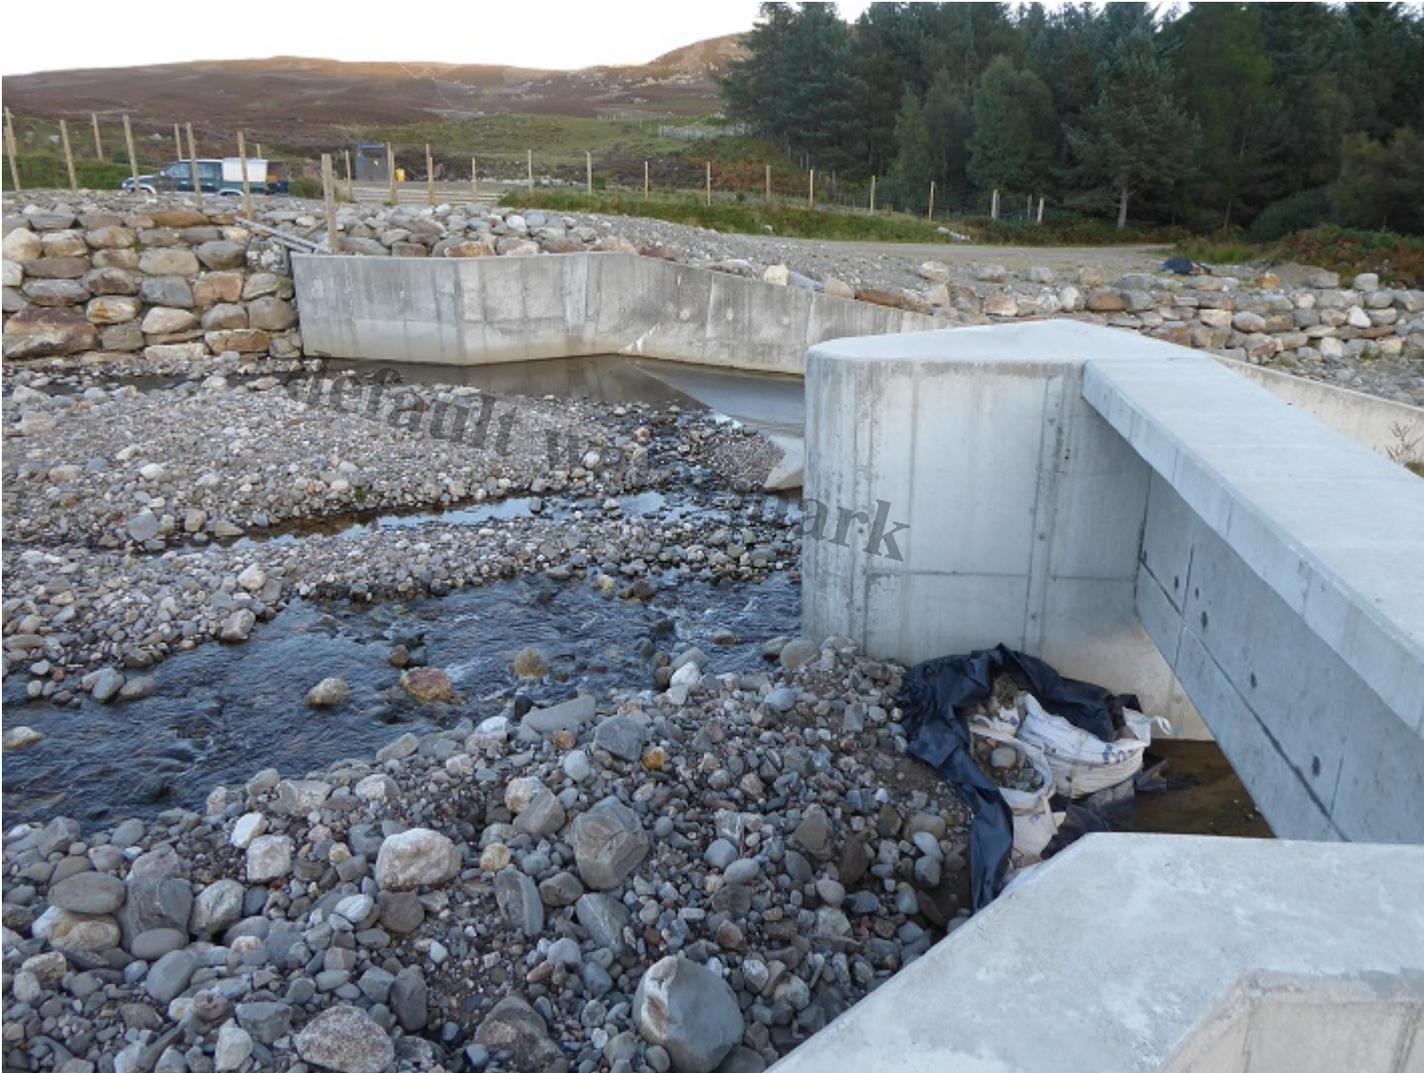
A year ago the bank of rocks and shingle on the front left was not there

At the end of September, almost three years after I had first seen it, I went back to look at the River Gynack overflow ([see here](#)) for the fourth time. It was still not functioning and since my last visit it appeared rocks had been bulldozed from the bed of the river against the stone filled sacks to re-inforce them further.

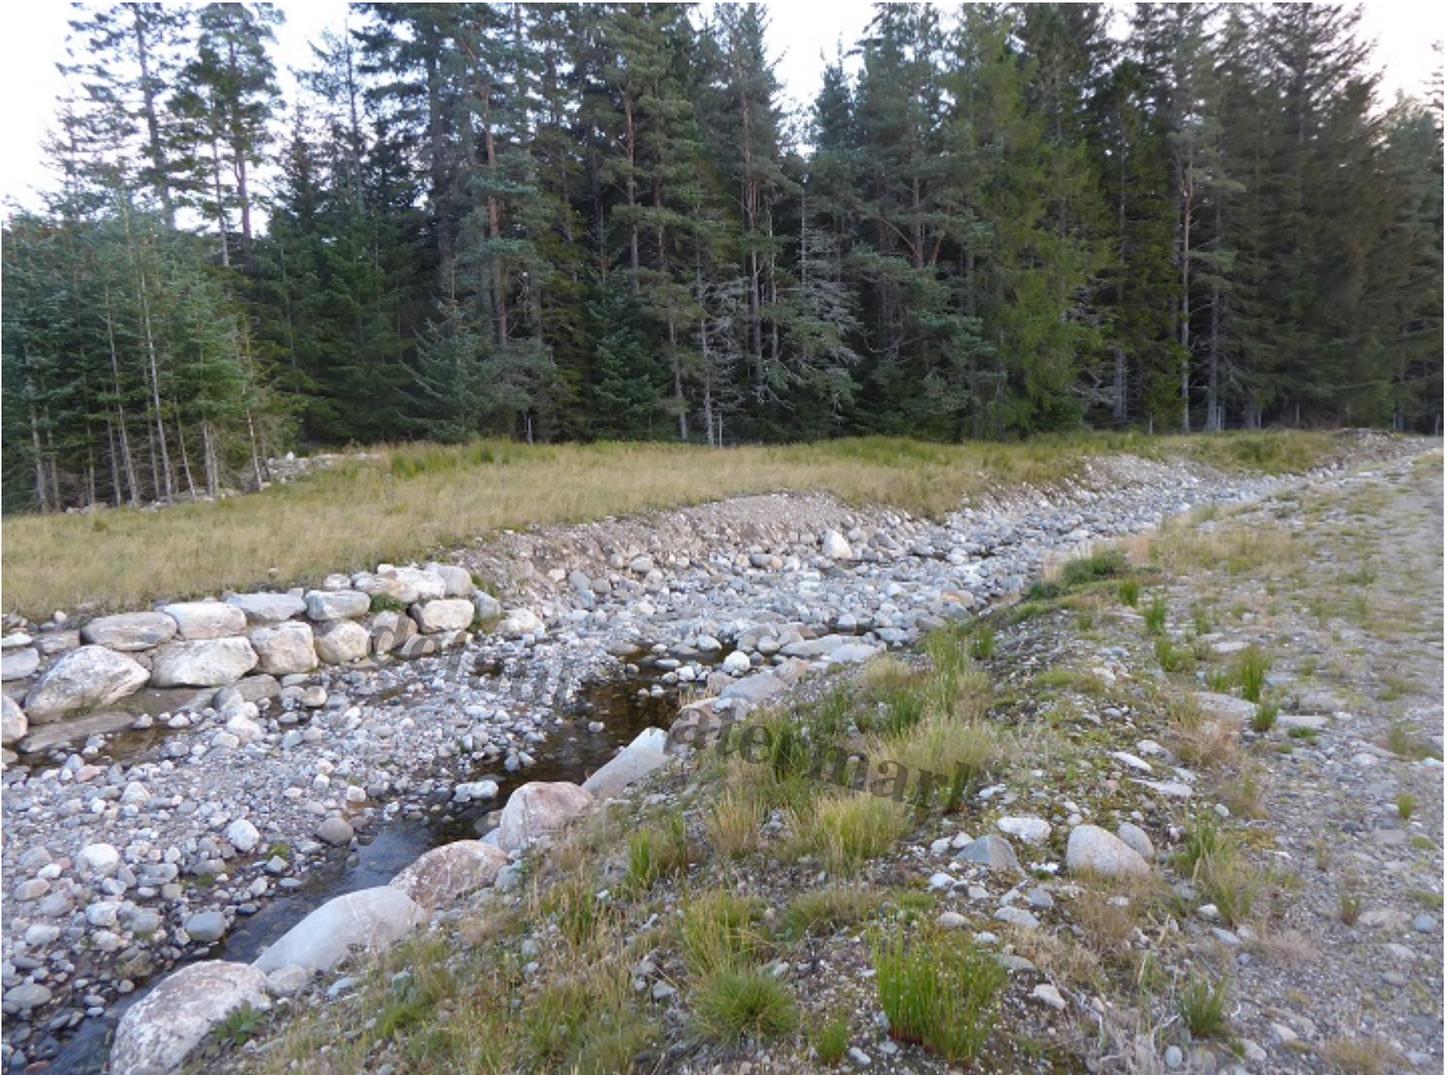
The design flaws and the problems they have caused are only two apparent as soon as you look beyond the rip rap bouldering below the entrance to the overflow. A shortish section of bank has collapsed, leaving earth vulnerable to erosion.

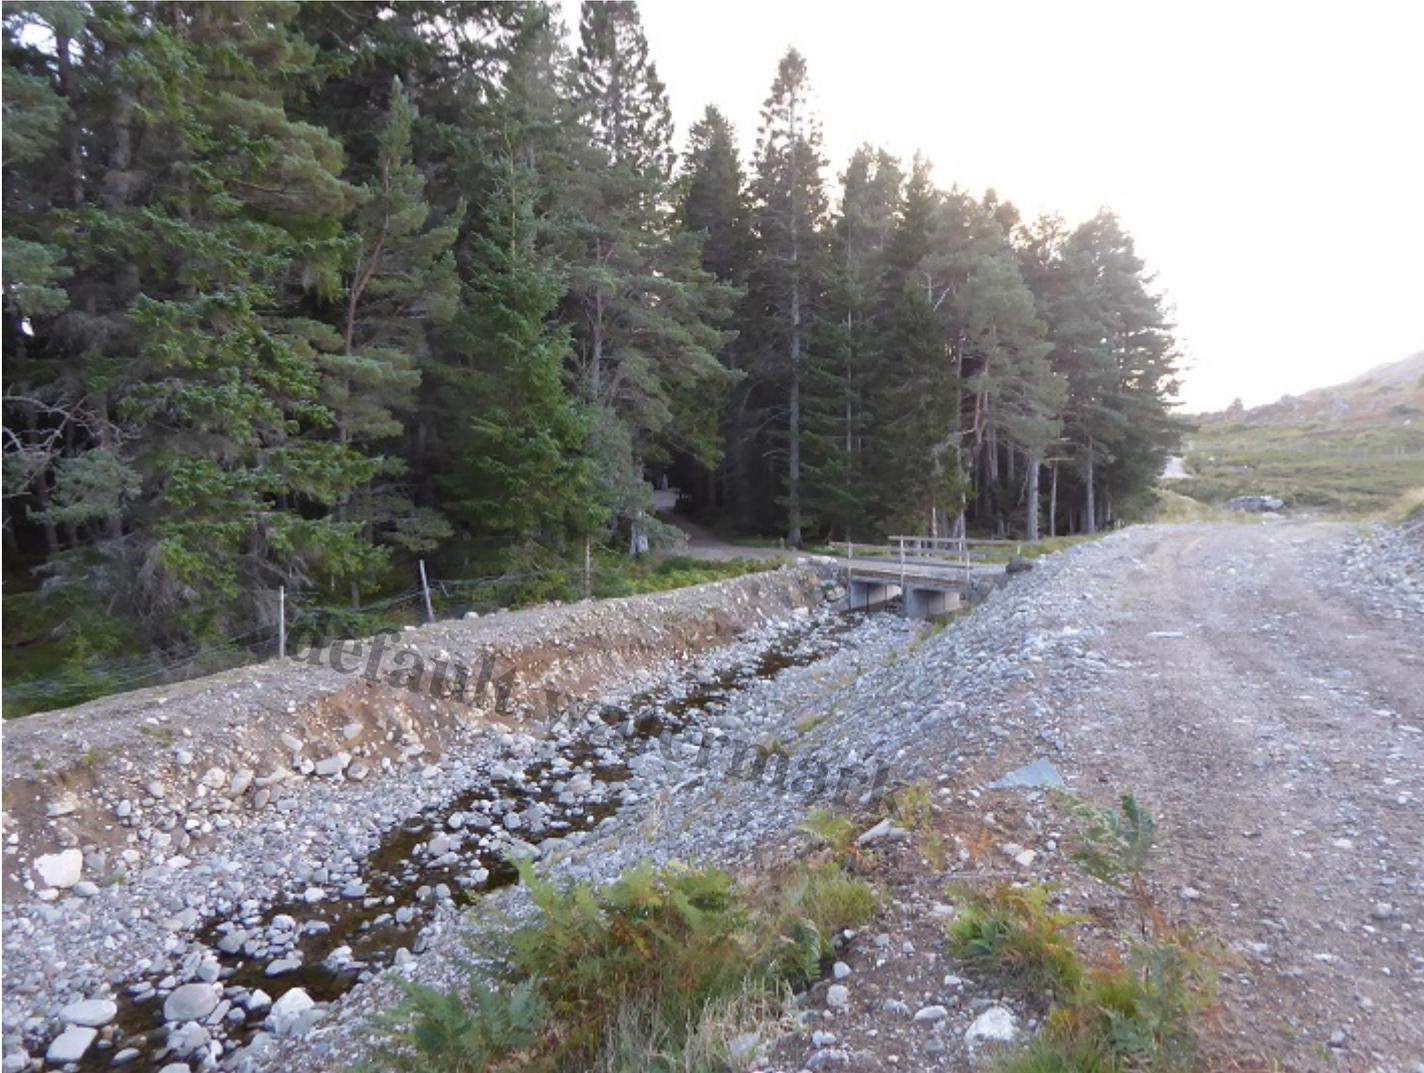
The bridge is taken by the track that takes the West side of the Allt Mor to Carn an Fhreicheadain

Just beyond is a longer section of collapsed bank, now so narrow that one flood could breach it. This would allow any diverted water to return rapidly to its original course, but in doing so it could convey tonnes of earth into the protected waters of the Spey. Note how nothing has been done to restore vegetation to the undamaged bank on the right hand side of the overflow, leaving it too prone to erosion.

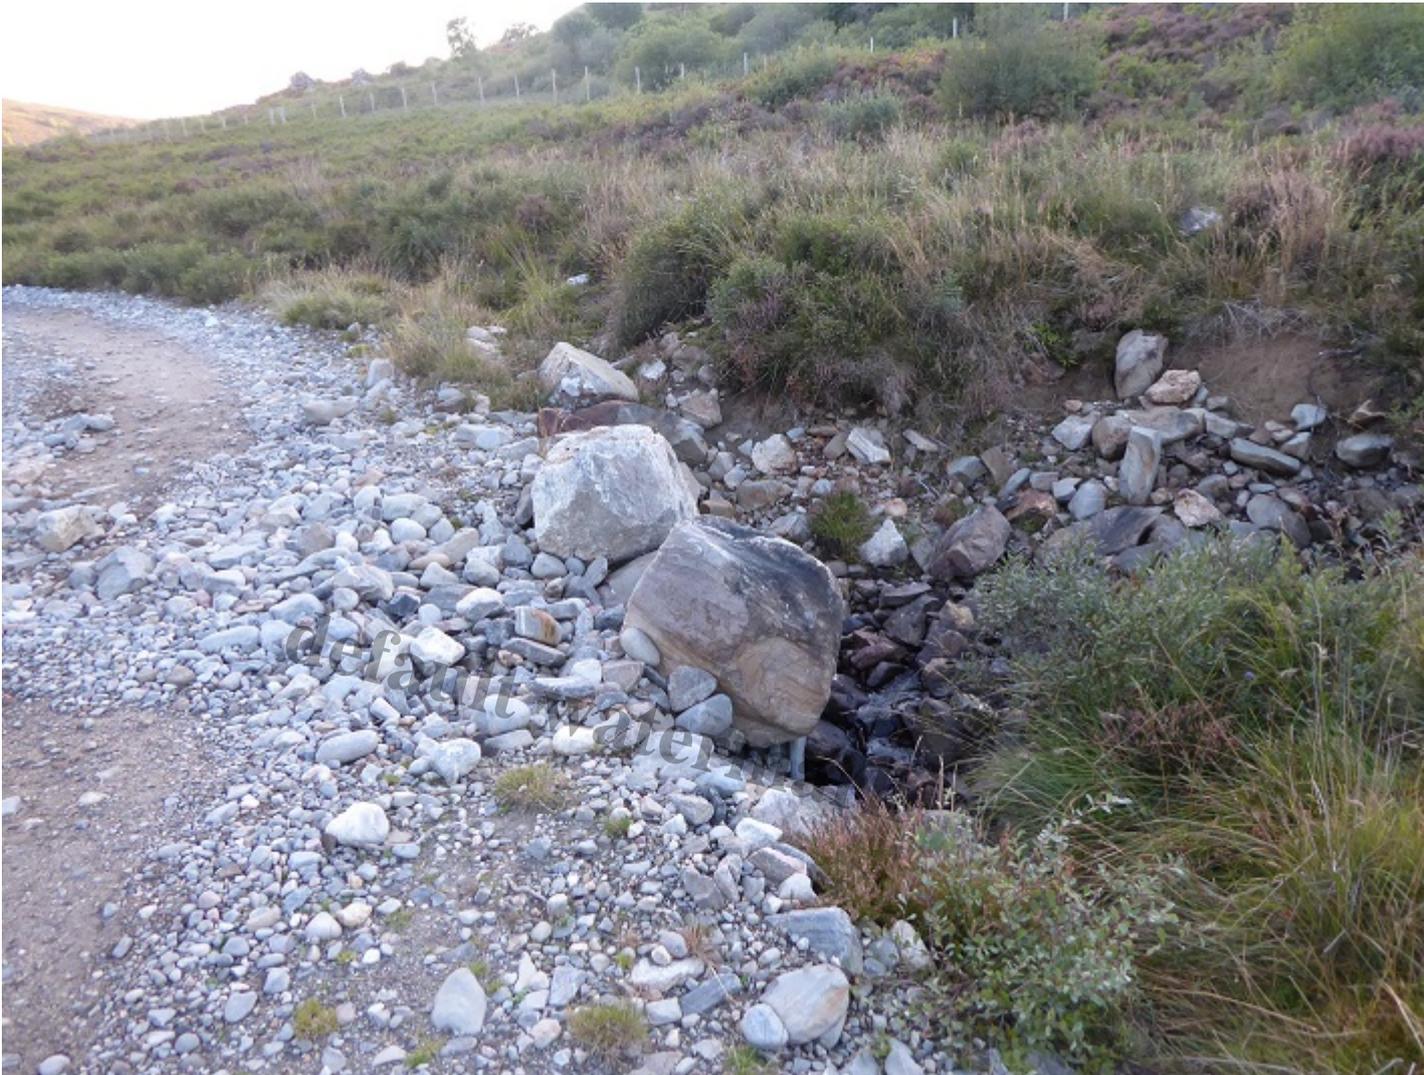
Temporary ??? or are they botched ??? repairs to the track?

Below the bridge a burn flows under the road and into the overflow, another example of seriously flawed design. The culverts are too small for the volume of water carried by the burn in flood, with the result that it has flowed over the track and come close to washing it away.

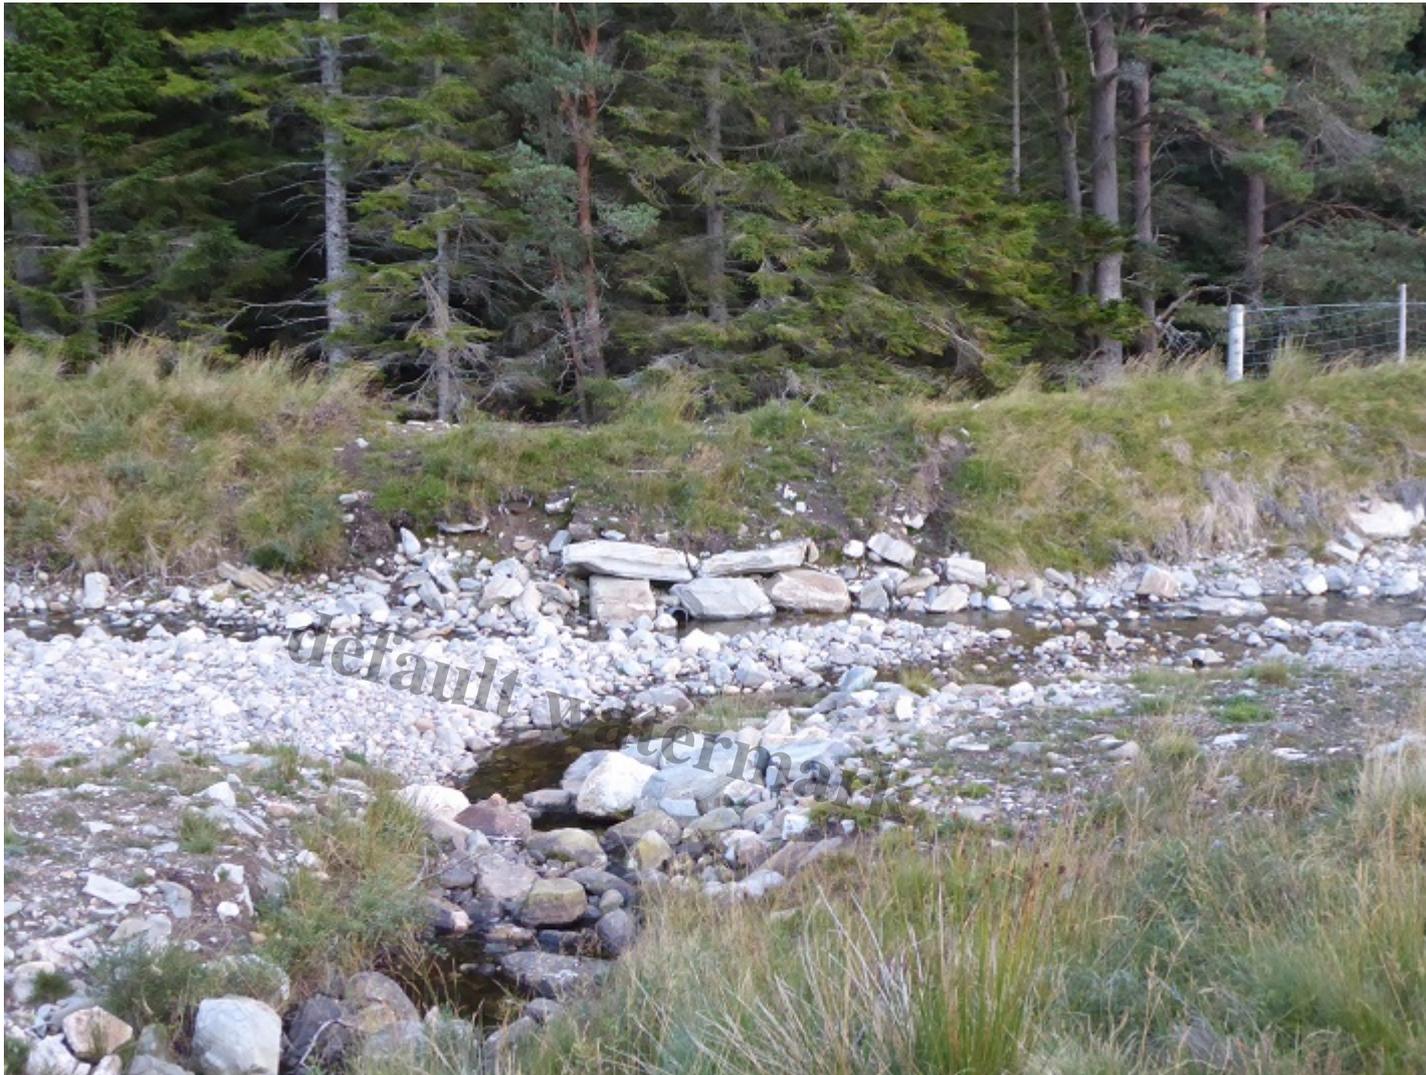
The view from the other side of the track to the overflow

It appears that in flood conditions that water from this small burn feeding into the main overflow applied additional erosive forces to the short section of bank opposite that it was almost breached. The bank has now been reinforced with five boulders, but if the water had broken through here it would almost certainly have flooded the estate buildings below. This risk should have been considered at the design stage.

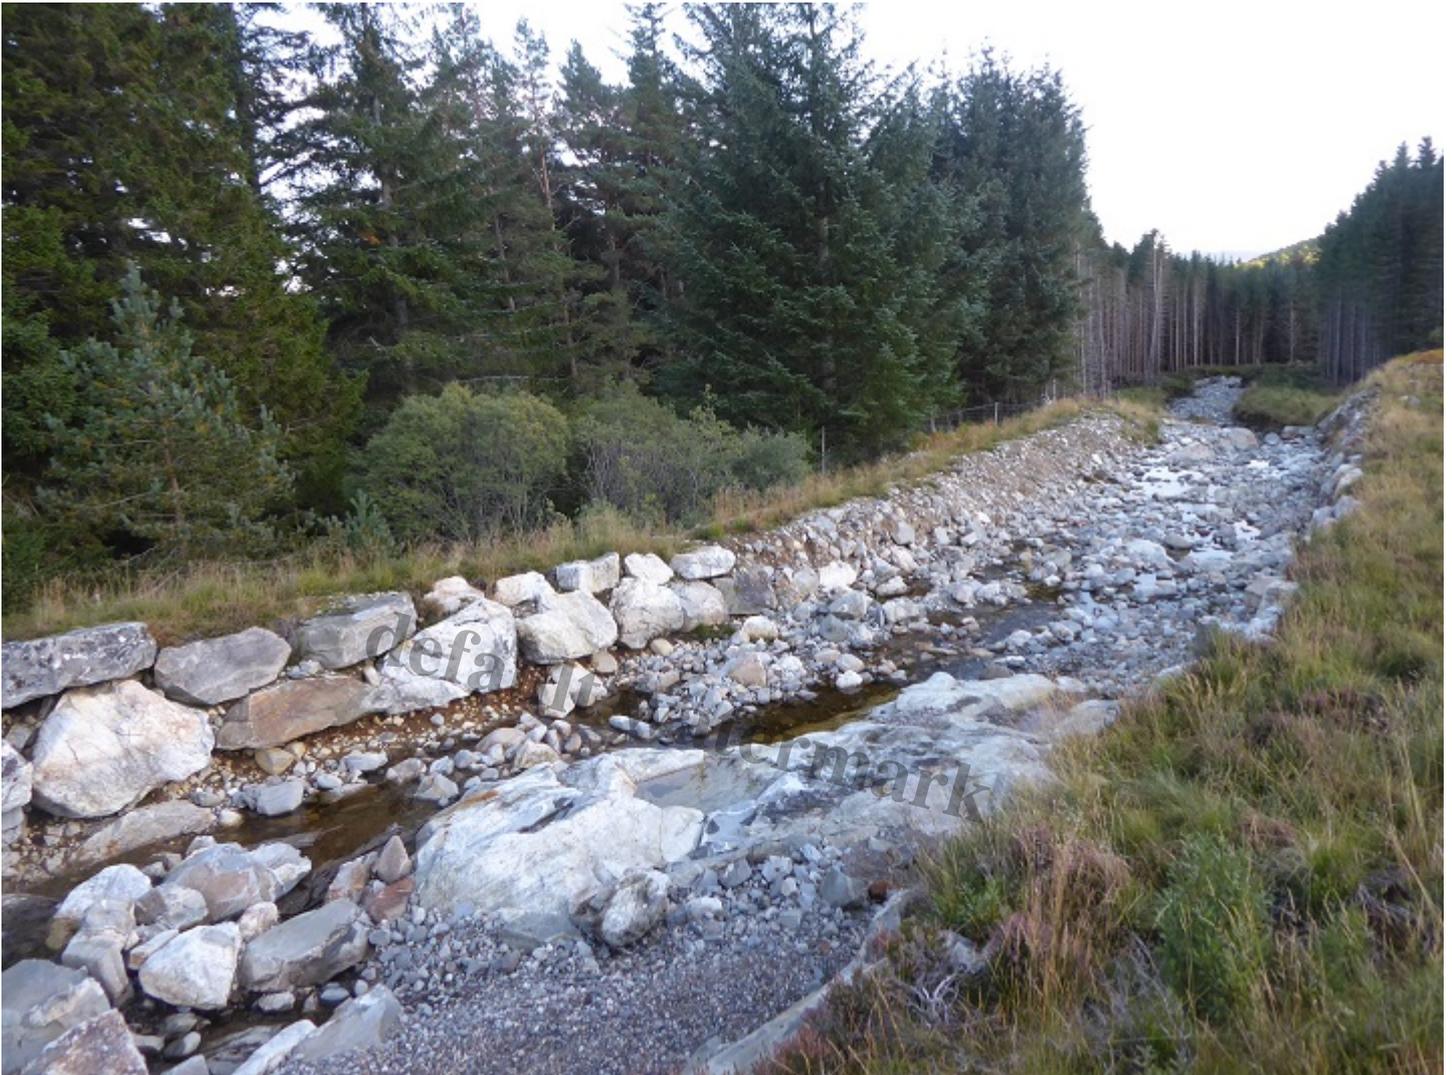
Some sections of rip rap bouldering appear poorly designed, with giant boulders sitting on earth vulnerable to erosion. It seems that almost the entire overflow channel will, if it is ever to function properly, require to be re-built. Highland Council contributed Â£135k to this project â?? for what?

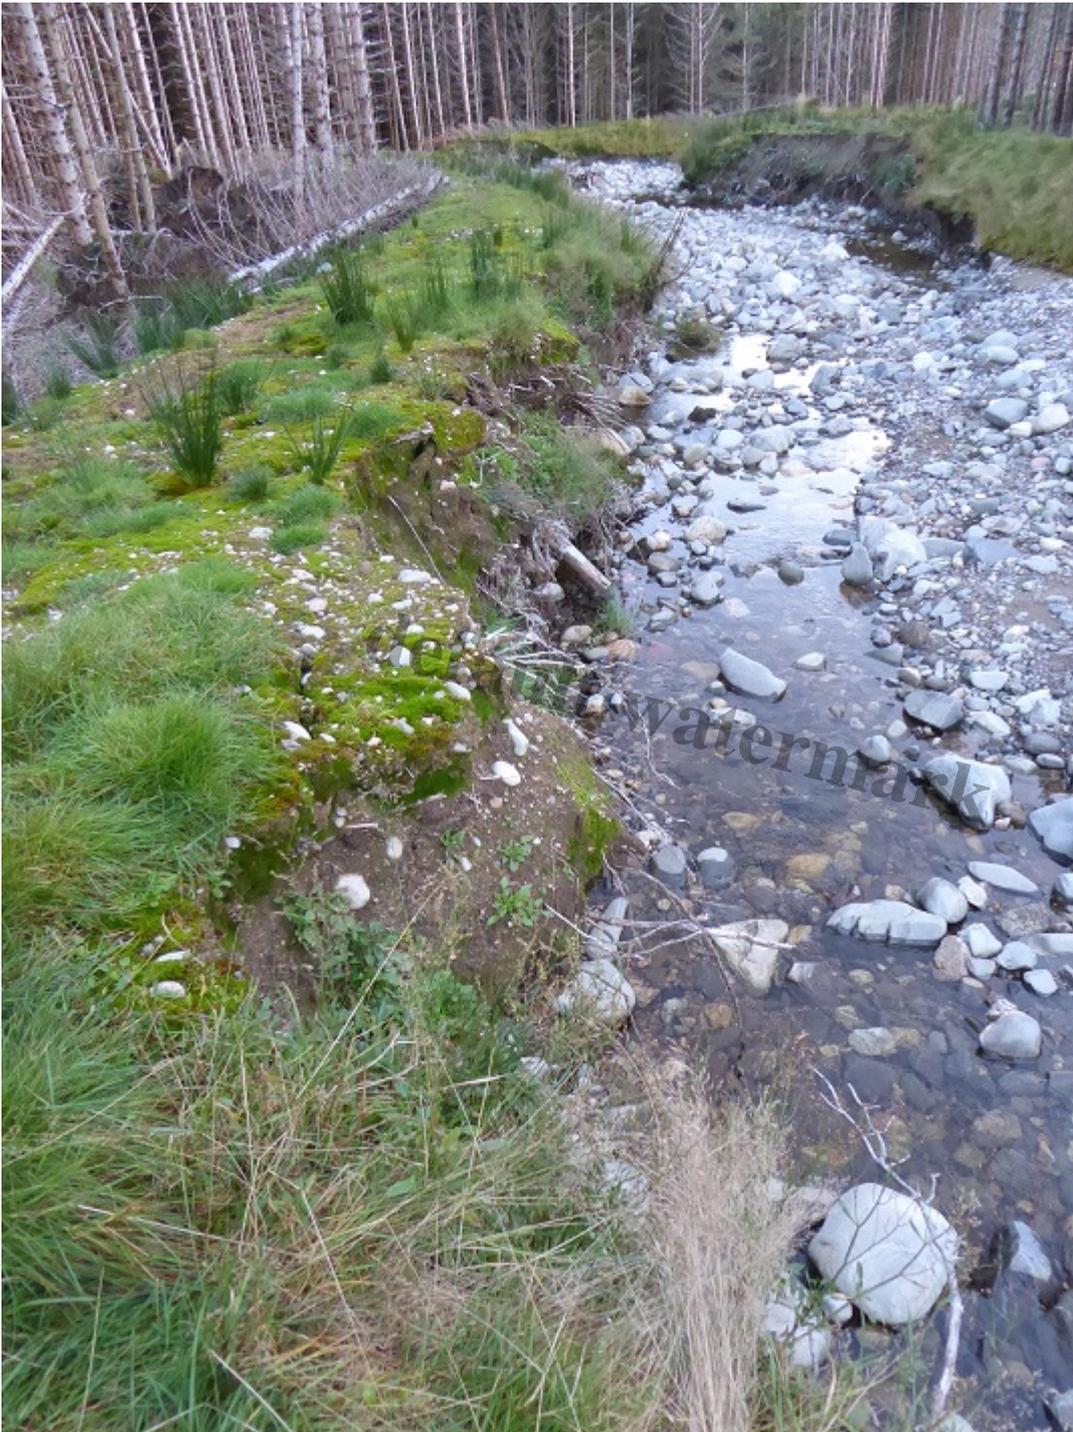
Lower down, what were bare earth banks have greened up slightly. But take a careful look and you can see how they are continuing to erode. If any volume of water was to run down the overflow, these banks would be swept away in no time at all.

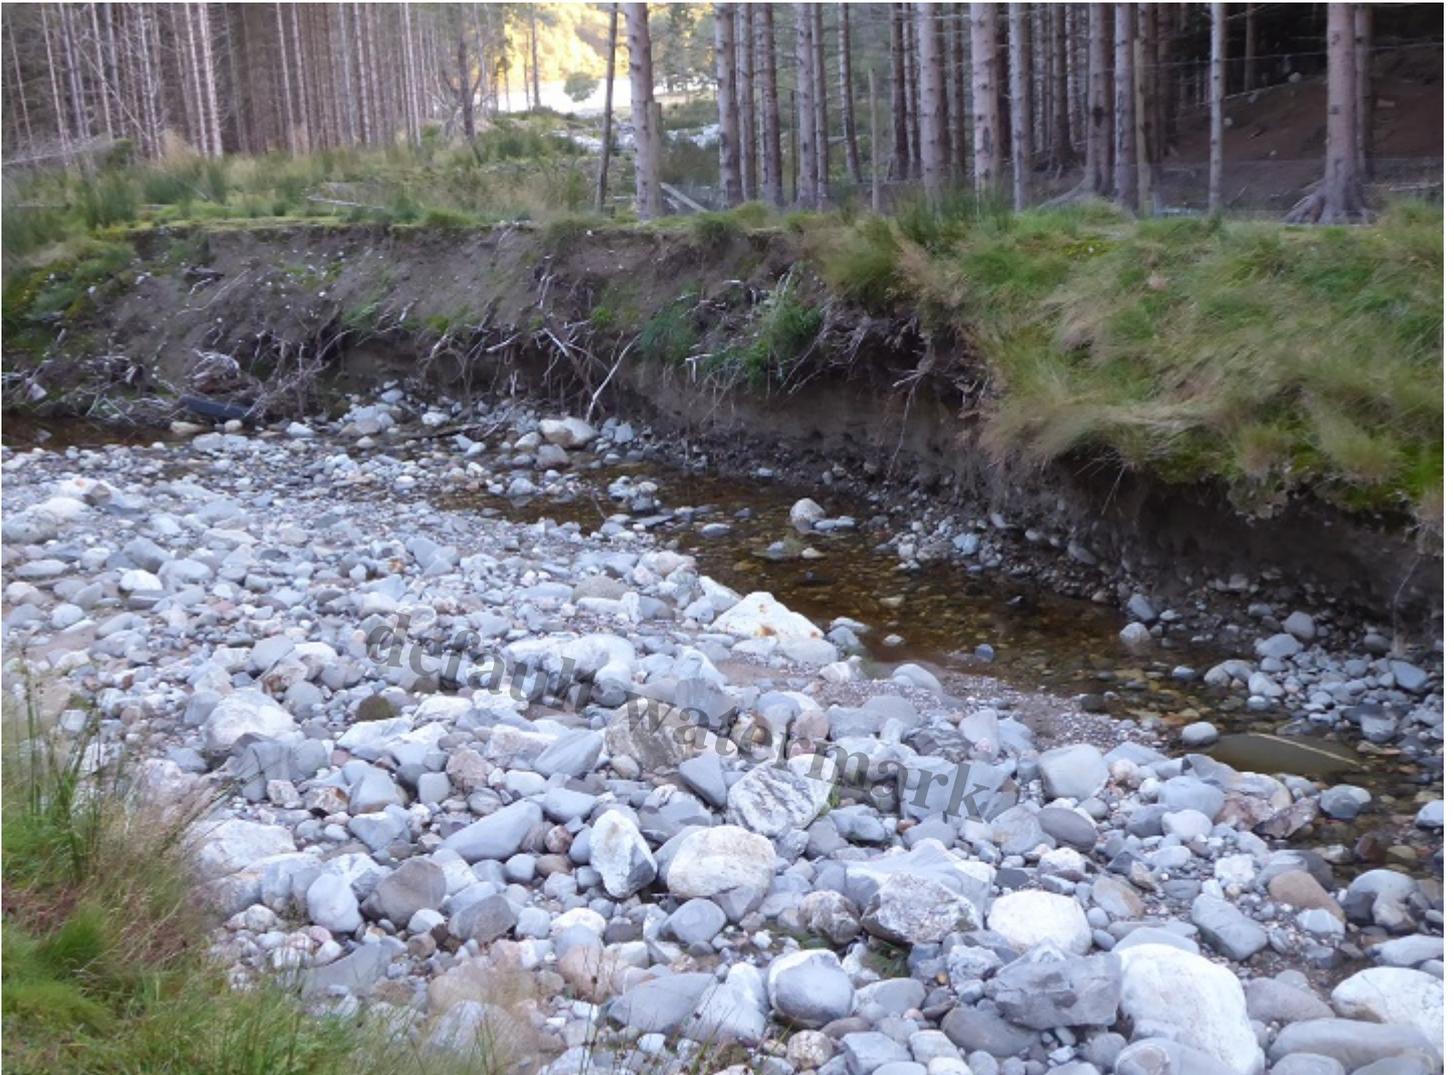
The little water still flowing is still sufficient to continue to undercut the banks in places.

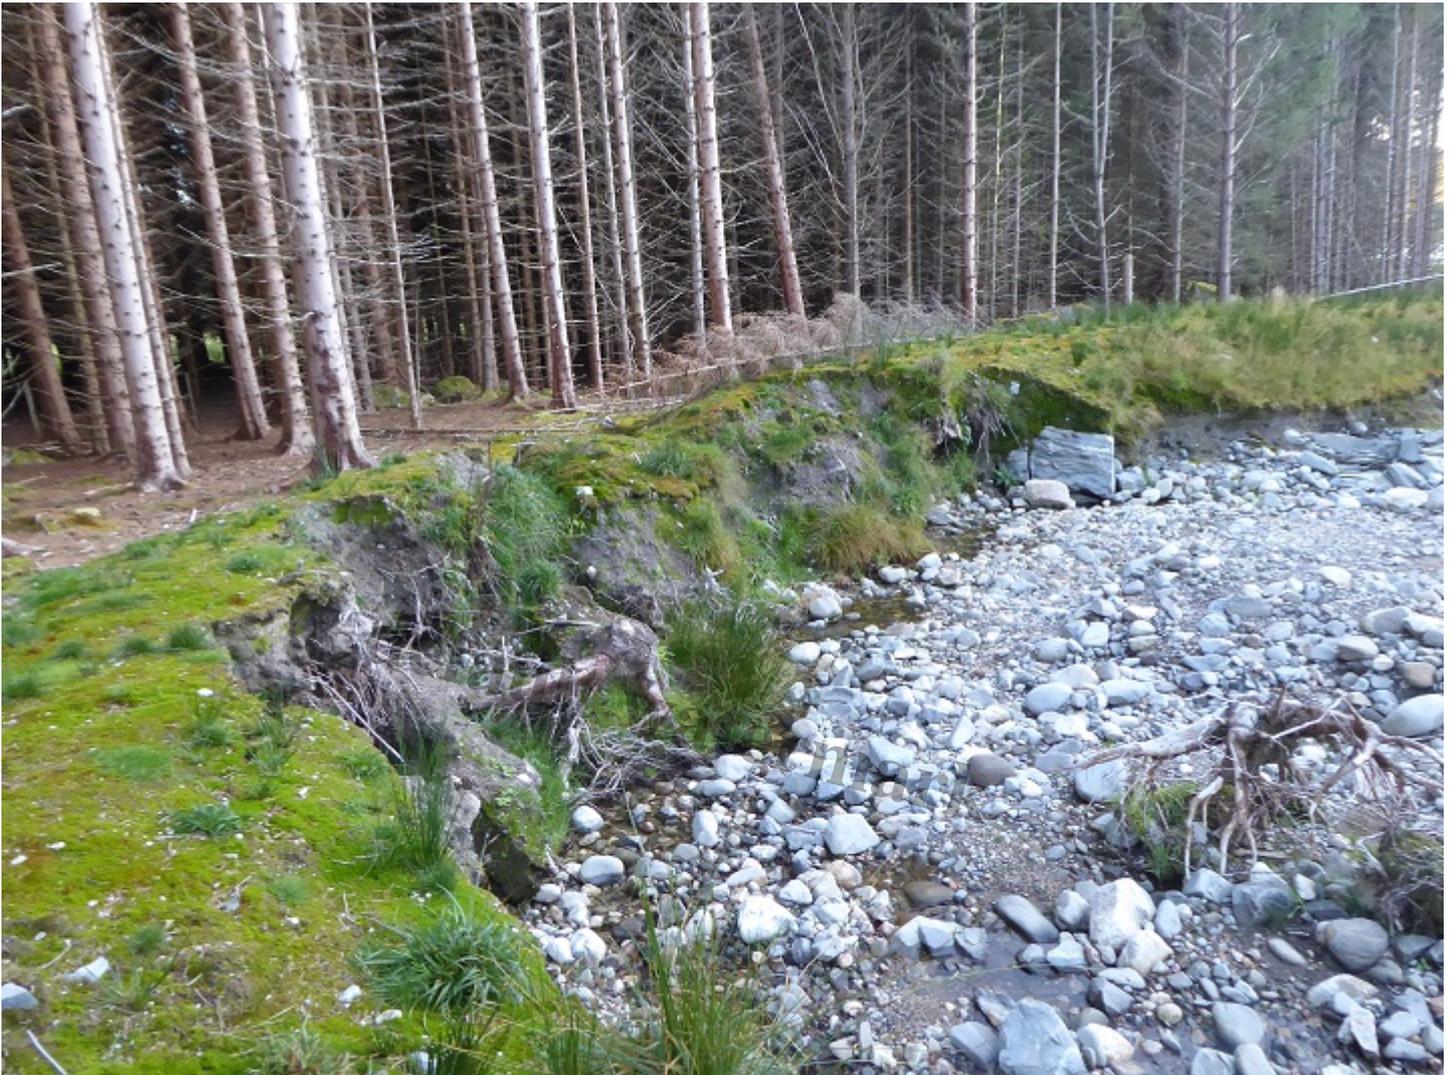
How long would this section of bank last? If it went it could flood a large area of land and threaten the lodge on the far side of the plantation.

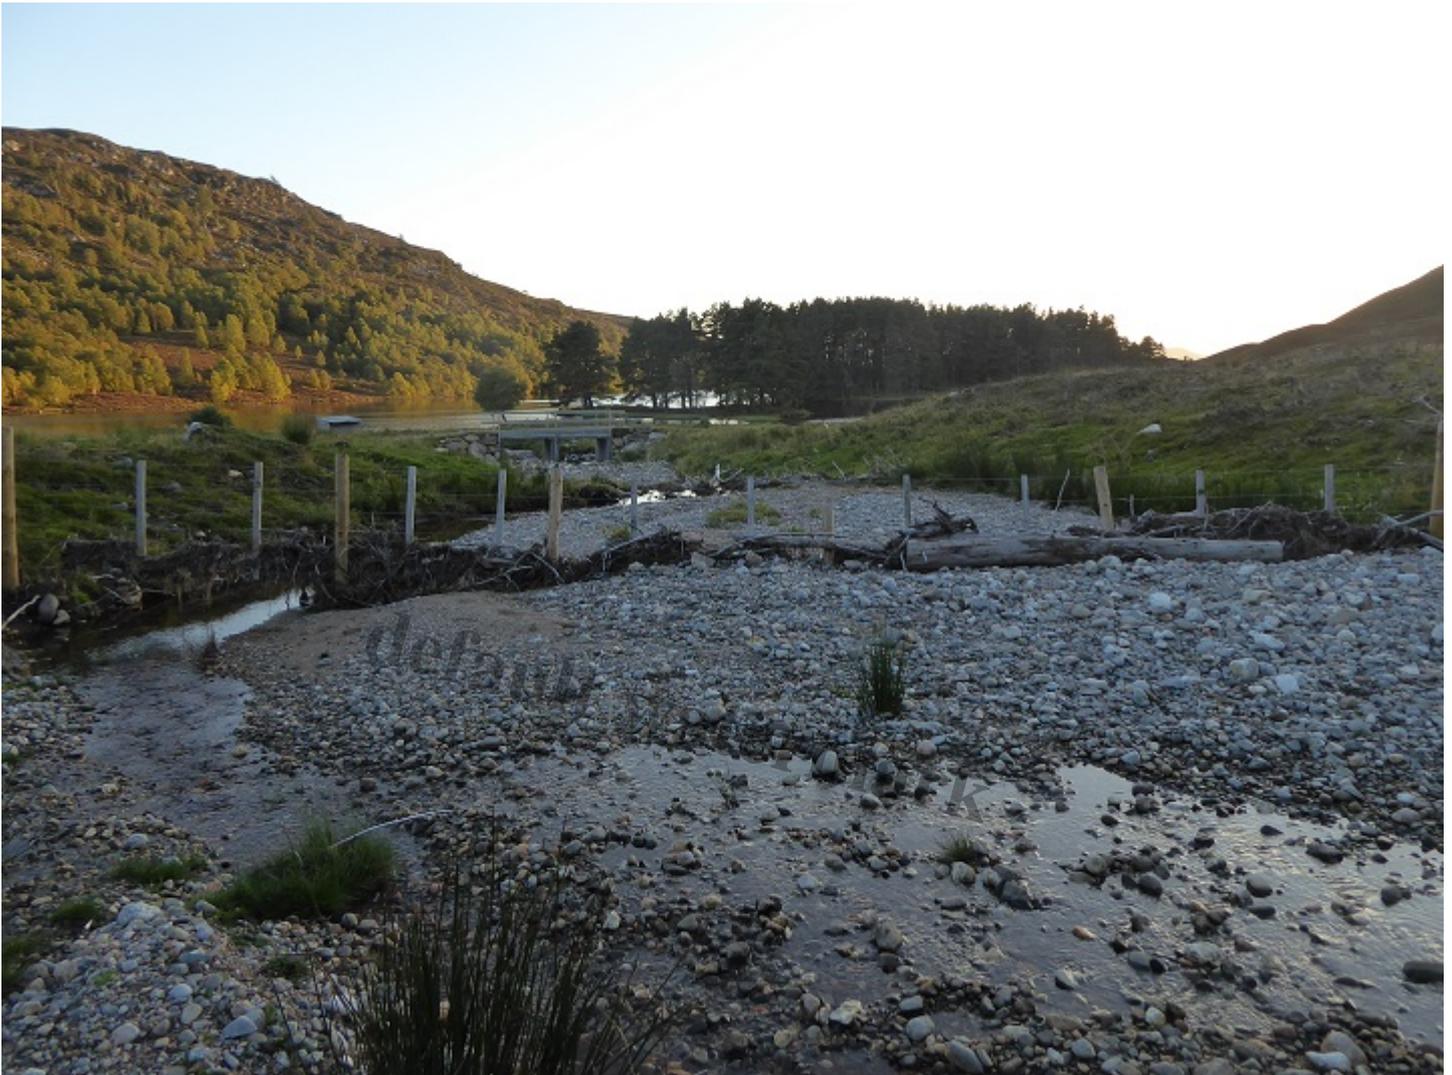
The area around Loch Gynack is now completely segmented by fencing. It appears this fence was erected after the overflow was shut off, sometime in 2019. The debris caught in the short time since, shows just how much water still enters the overflow from the small tributary and other sources in times of high rainfall.

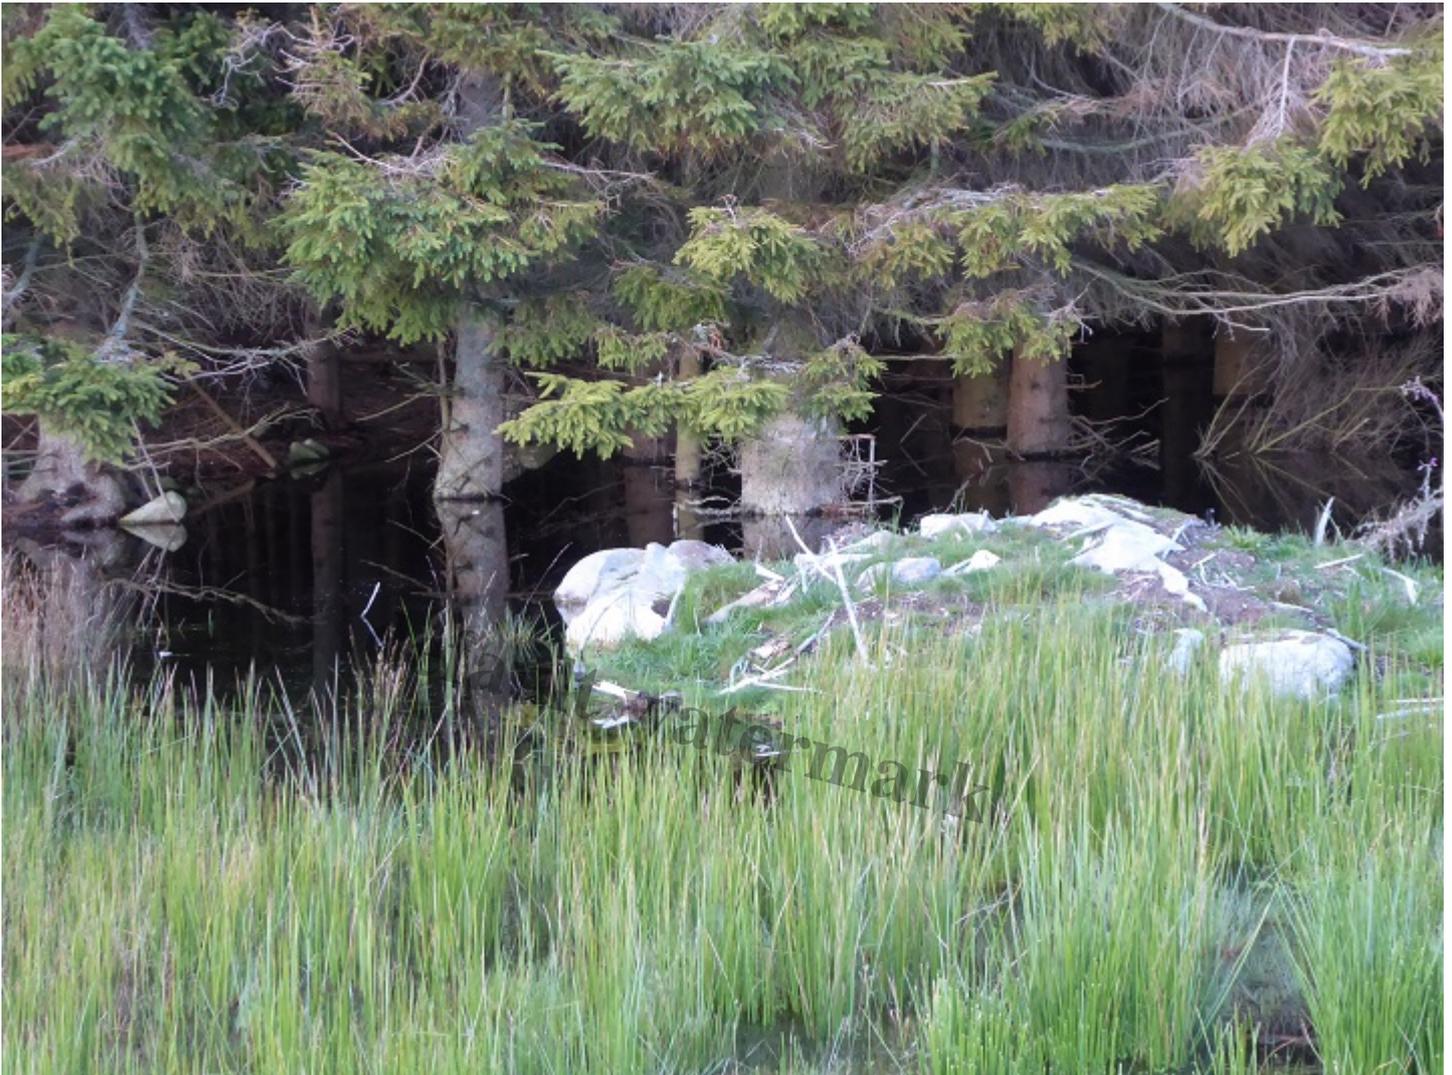
The edge of the plantation on the downside of the overflow was drowning in a large pool of water when I visited. I don't recall seeing this before. Could it be that some of the water that is still channelled down the overflow has found its way UNDER the banks and collected here? If so, the problems are even more serious than I had thought.

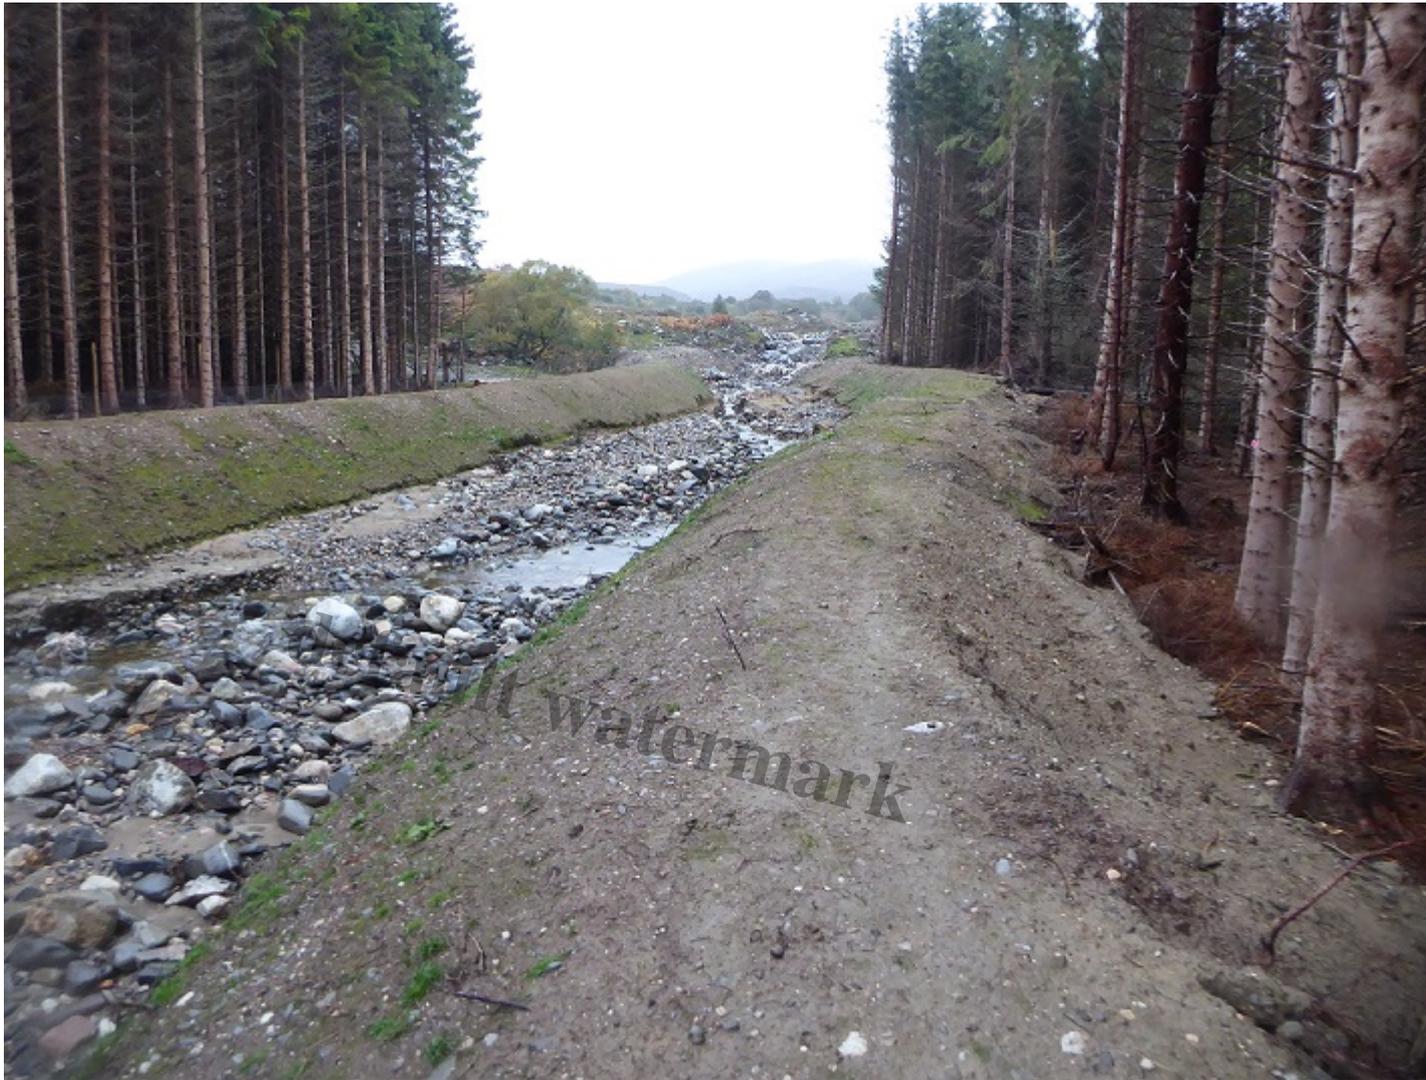
October 2018. The nearest photo I have for how the earth banks looked after construction

My first visit was during construction in 2017 and by the time I next visited there were already signs of serious damage. I would contend, however, that almost anyone looking at these banks on completion could have told those responsible that this was a disaster waiting to happen. The question therefore is how was the construction ever allowed to get this far?

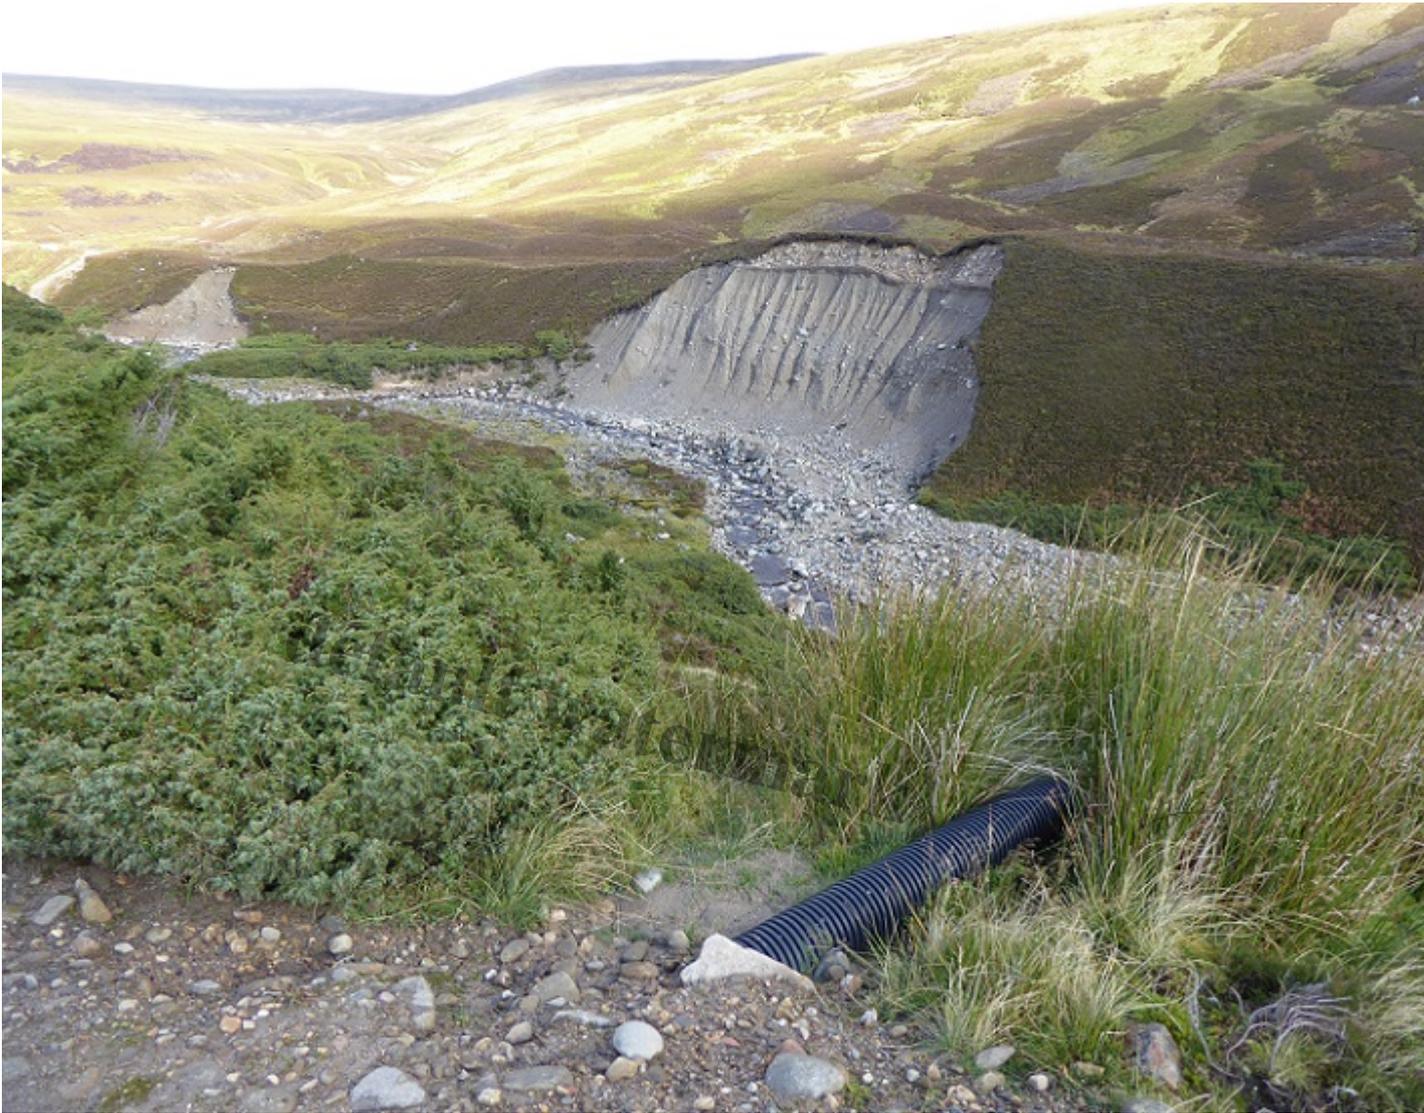
Allt Mhor, the upper part of the Gynack, in 2017.

Meanwhile, a wall of water carrying a mass of boulders could destroy parts of the village and the railway at any time. In my view a significant part of the flood risk to Kingussie has been caused by the way the land above has been managed by the Pitmain Estate. Muirburn speeds up run-off into the river and its tributaries. On sections of the river, there are huge quantities of debris which risk being washed into the river whose bed comprises large quantities of large boulders. If these were all to start moving in a massive flood, the destructive potential would be huge.

The photo also shows part of the solution. Juniper and other trees that would help retain the water and slow the rate it drains into the river system would flourish here, if given the chance. The problem is they are burned for grouse.
