The system failure at the Gynack overflow above Kingussie

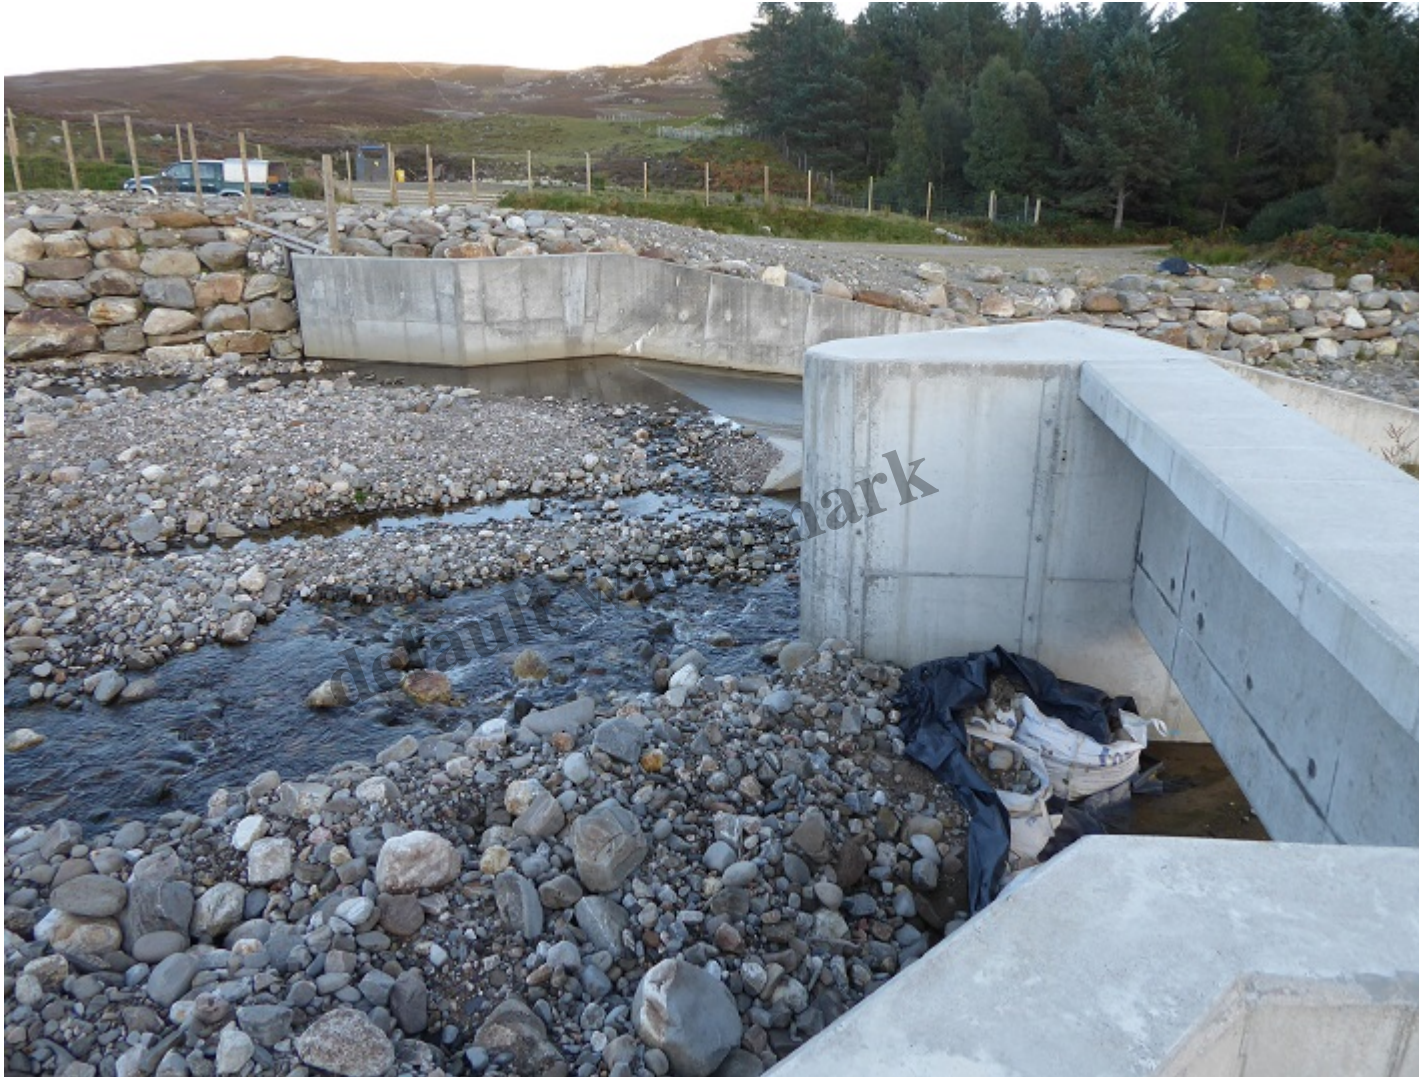
A year ago the bank of rocks and shingle on the front left was not there

At the end of September, almost three years after I had first seen it, I went back to look at the River Gynack overflow ([see here](#)) for the fourth time. It was still not functioning and since my last visit it appeared rocks had been bulldozed from the bed of the river against the stone filled sacks to re-inforce them further.

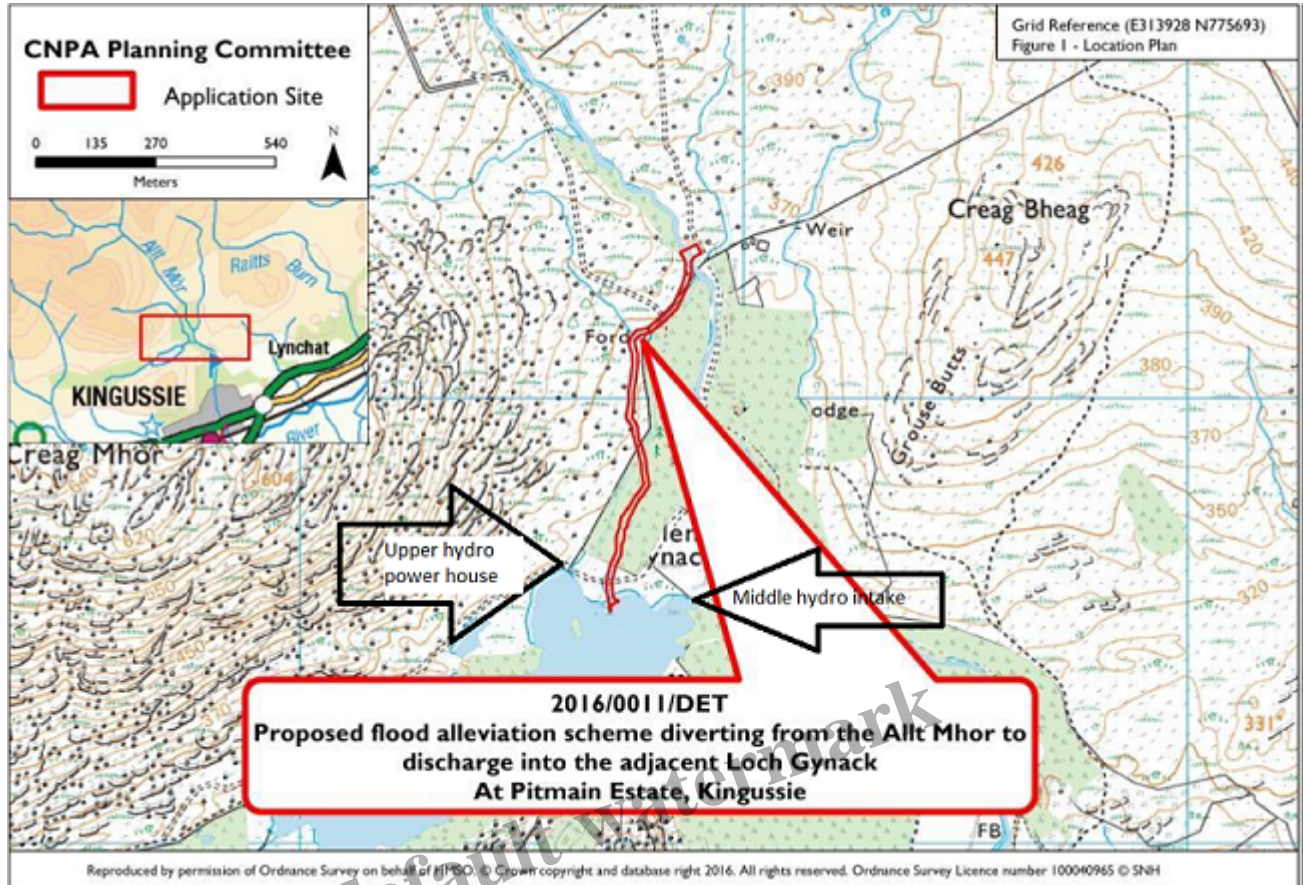
Location of River Gynack overflow, with hydro infrastructure added

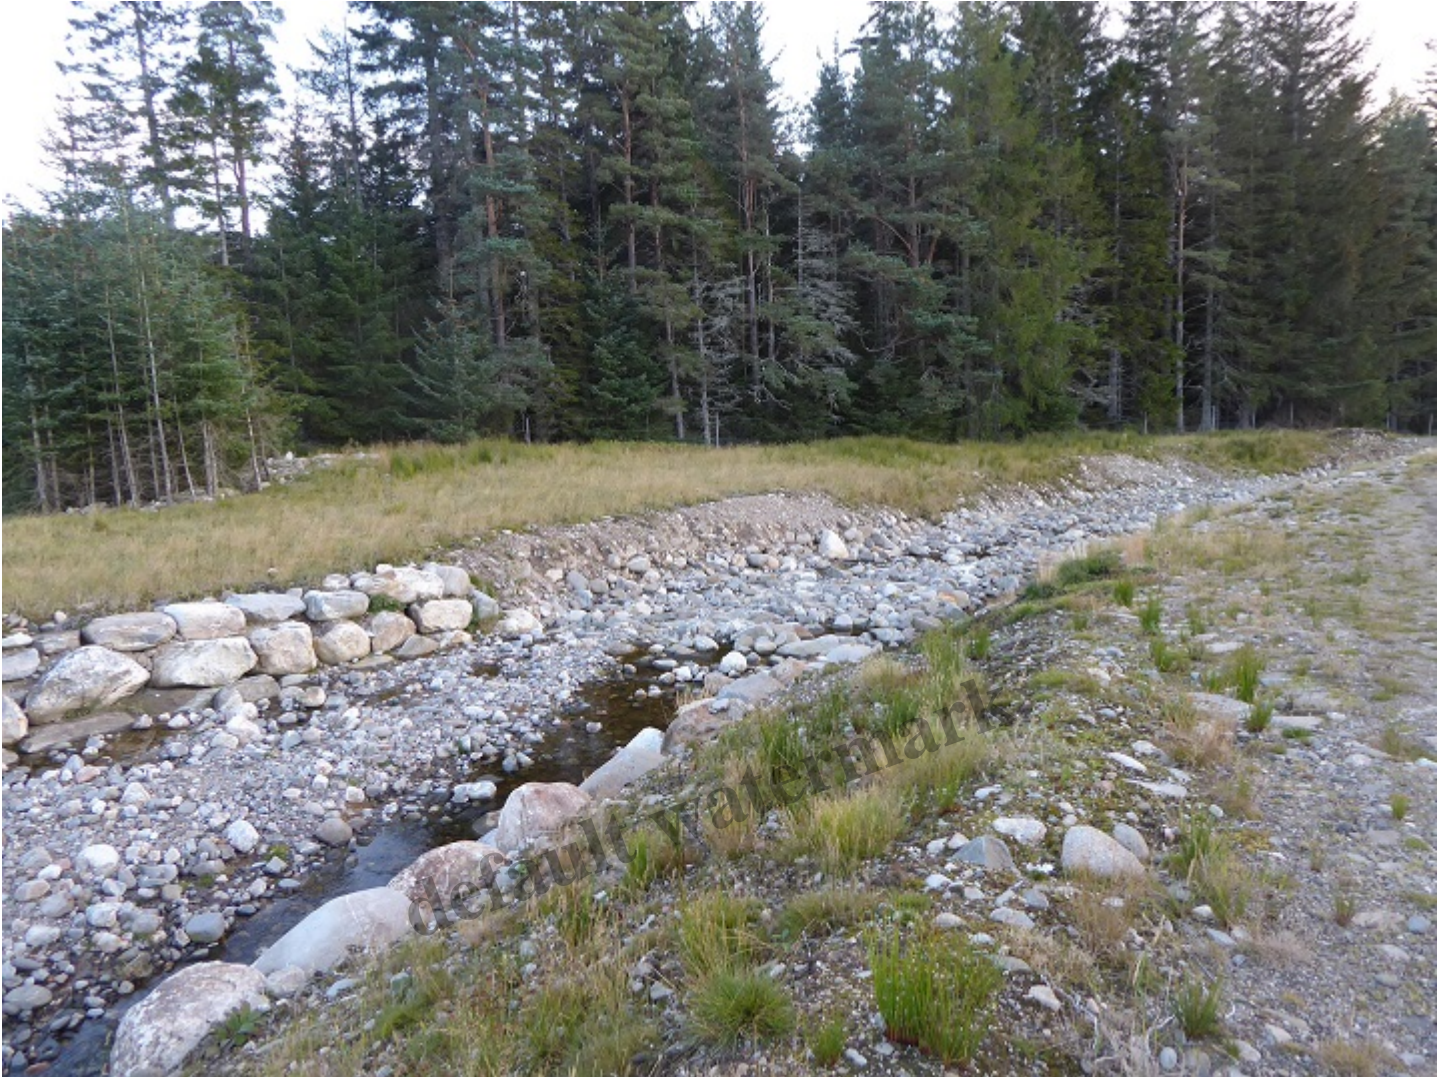
The design flaws and the problems they have caused are only two apparent as soon as you look beyond the rip rap bouldering below the entrance to the overflow. A shortish section of bank has collapsed, leaving earth vulnerable to erosion.

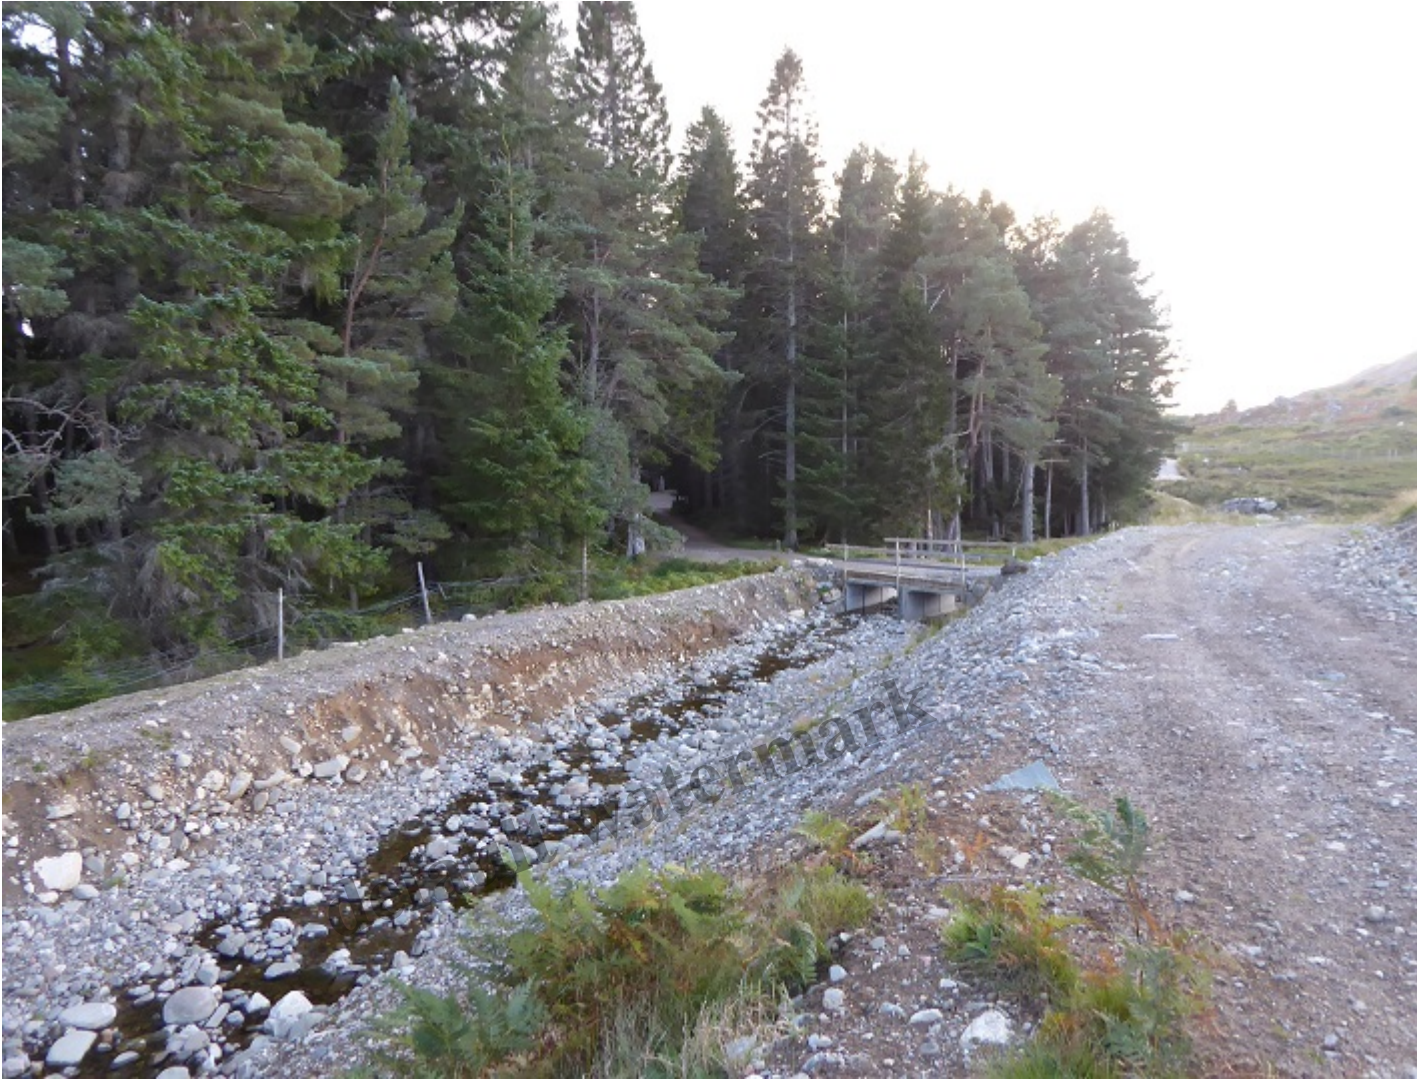
The bridge is taken by the track that takes the West side of the Allt Mor to Carn an Fhreicheadain

Just beyond is a longer section of collapsed bank, now so narrow that one flood could breach it. This would allow any diverted water to return rapidly to its original course, but in doing so it could convey tonnes of earth into the protected waters of the Spey. Note how nothing has been done to restore vegetation to the undamaged bank on the right hand side of the overflow, leaving it too prone to erosion.

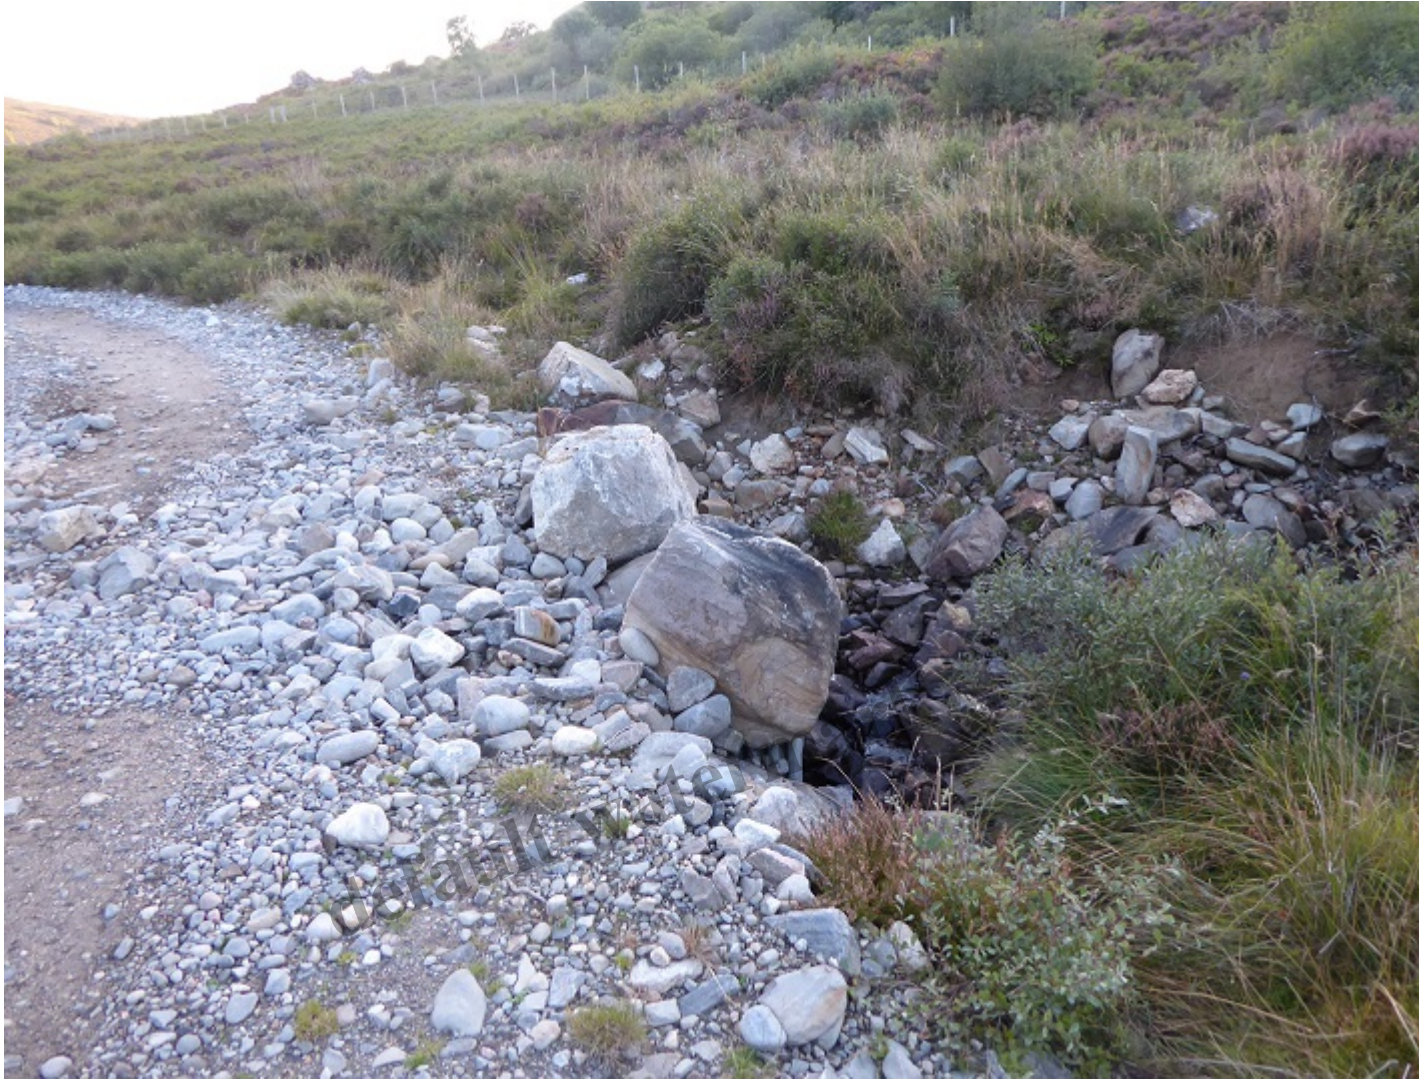
Temporary – or are they botched – repairs to the track?

Below the bridge a burn flows under the road and into the overflow, another example of seriously flawed design. The culverts are too small for the volume of water carried by the burn in flood, with the result that it has flowed over the track and come close to washing it away.

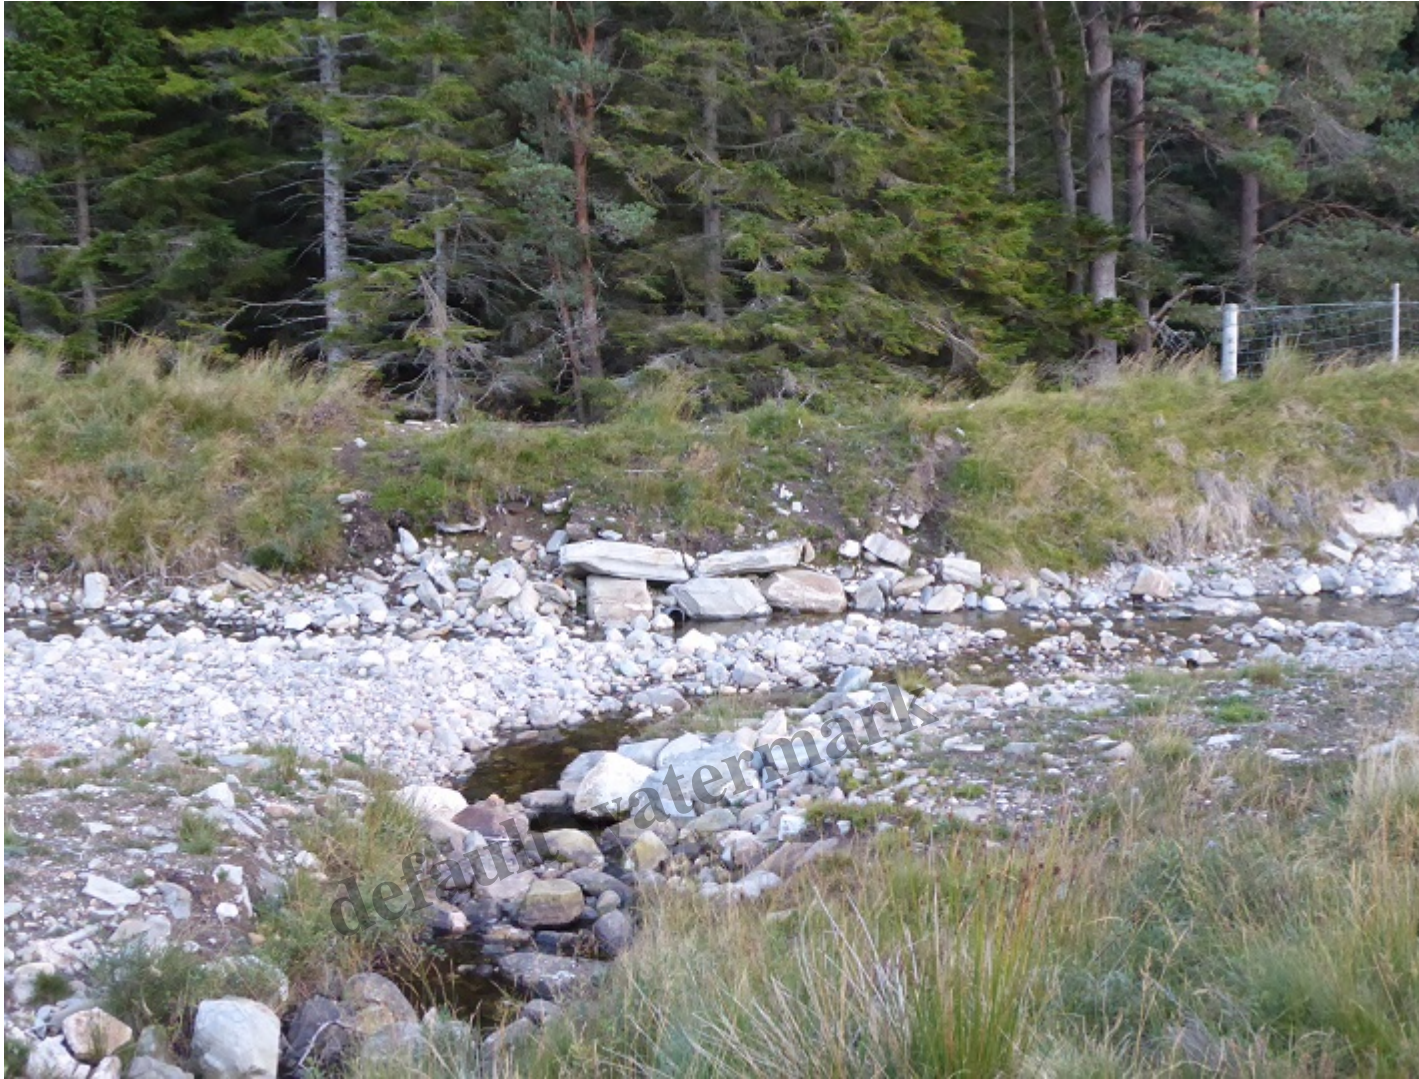
The view from the other side of the track to the overflow

It appears that in flood conditions that water from this small burn feeding into the main overflow applied additional erosive forces to the short section of bank opposite that it was almost breached. The bank has now been reinforced with five boulders, but if the water had broken through here it would almost certainly have flooded the estate buildings below. This risk should have been considered at the design stage.

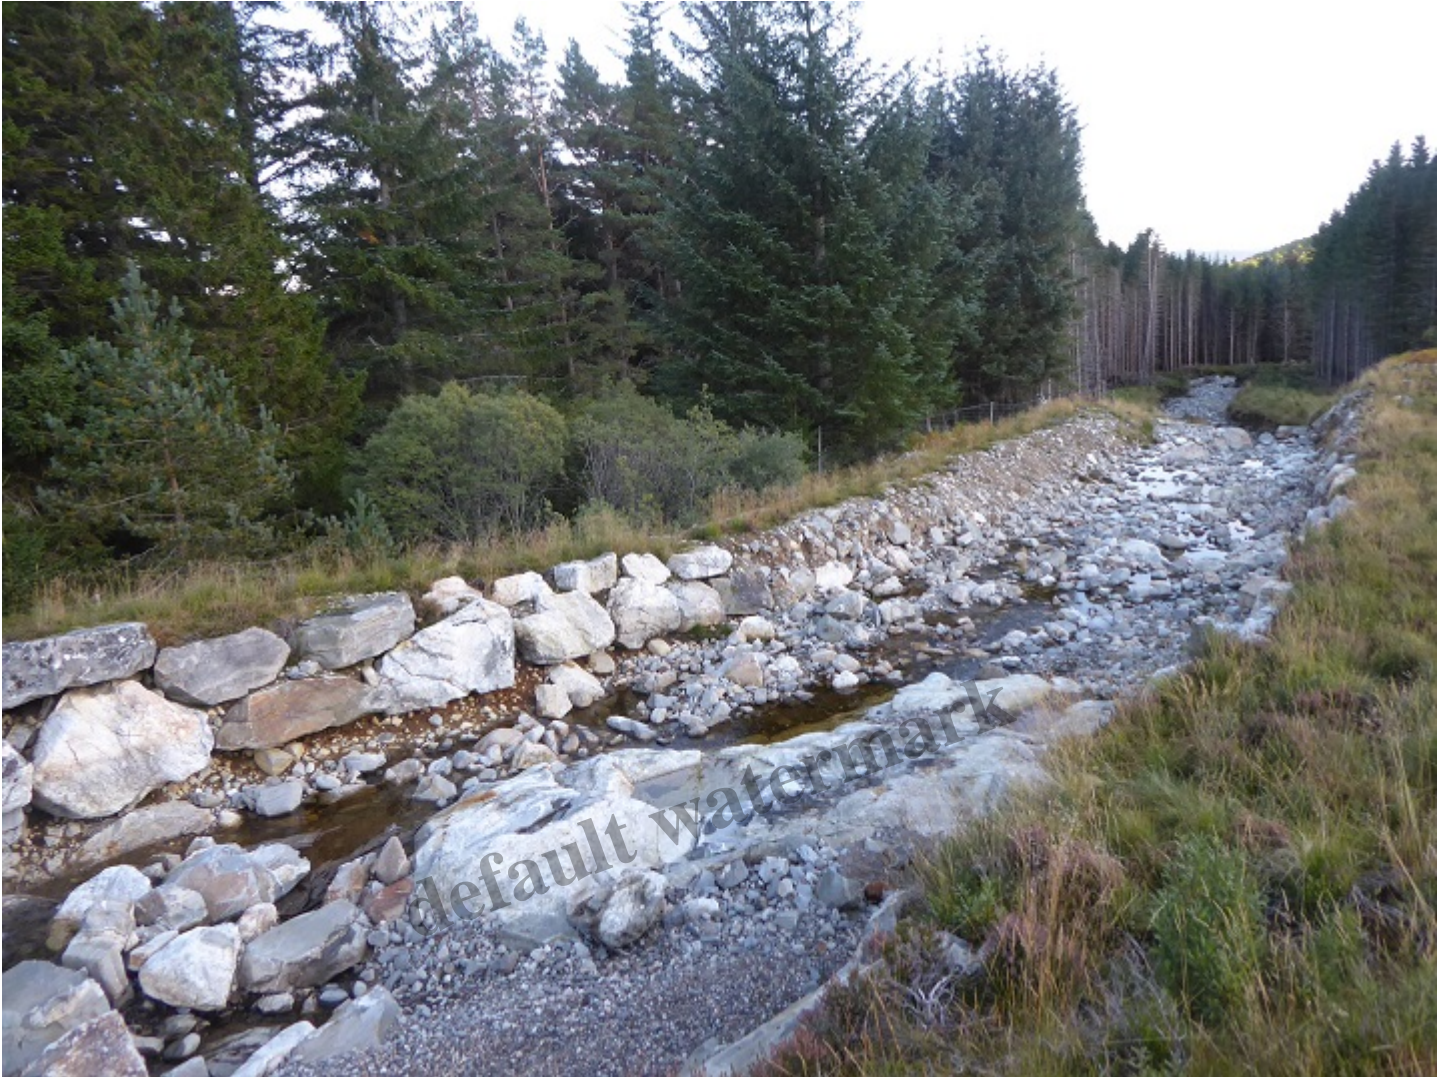
Some sections of rip rap bouldering appear poorly designed, with giant boulders sitting on earth vulnerable to erosion. It seems that almost the entire overflow channel will, if it is ever to function properly, require to be re-built. Highland Council contributed £135k to this project – for what?

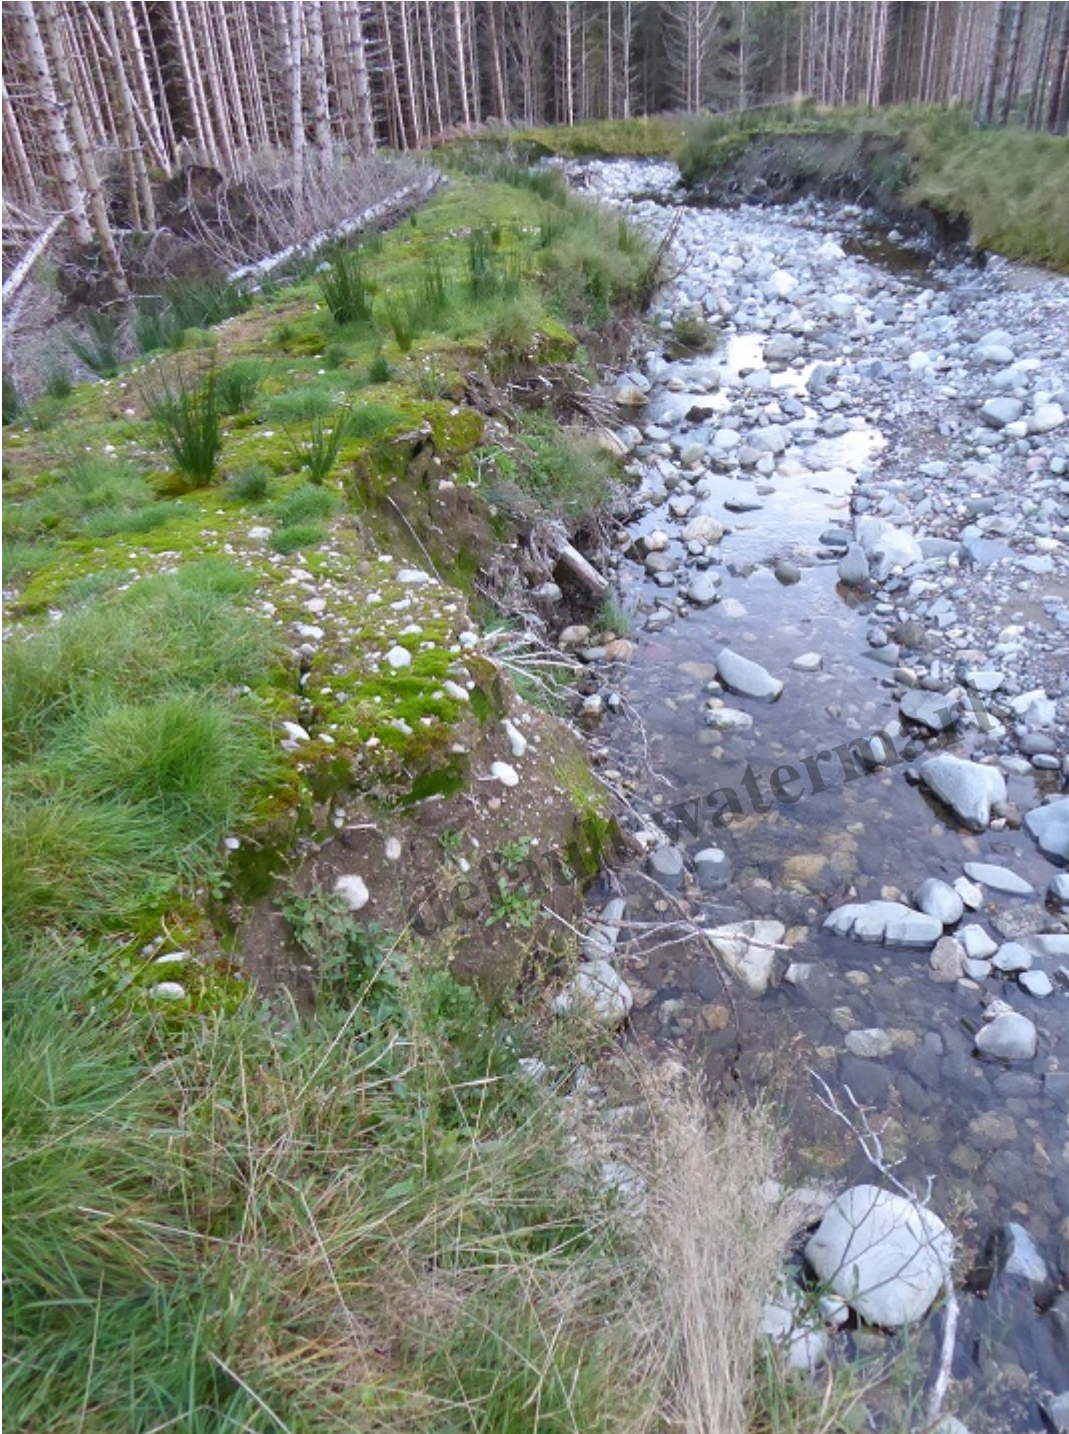
Lower down, what were bare earth banks have greened up slightly. But take a careful look and you can see how they are continuing to erode. If any volume of water was to run down the overflow, these banks would be swept away in no time at all.

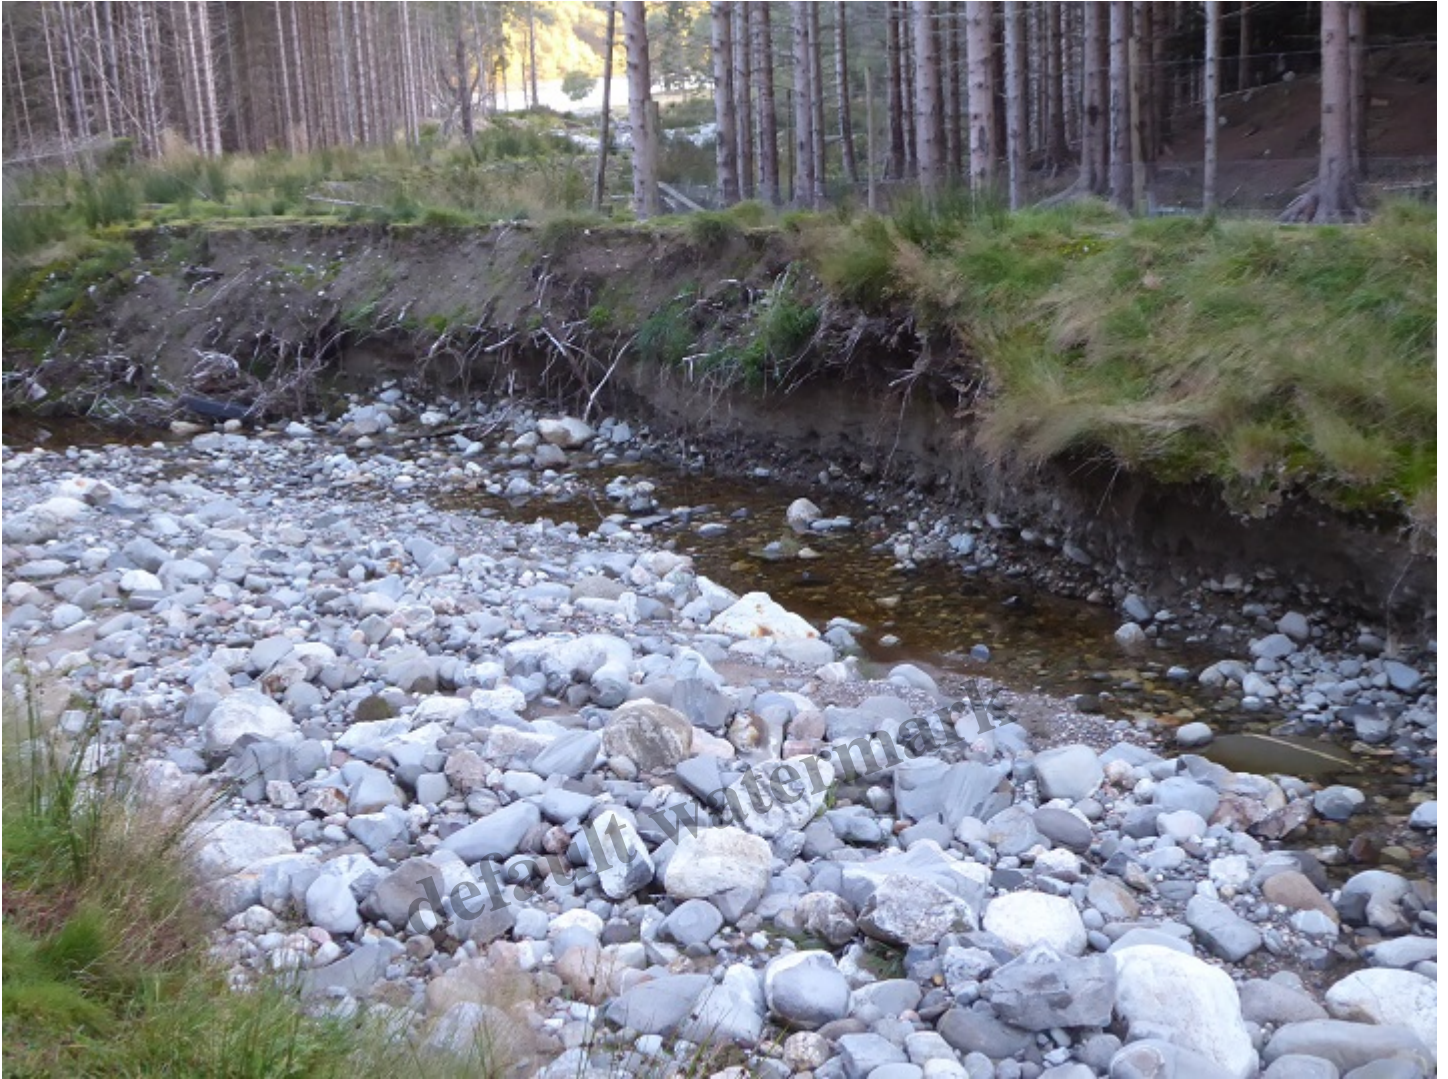
The little water still flowing is still sufficient to continue to undercut the banks in places.

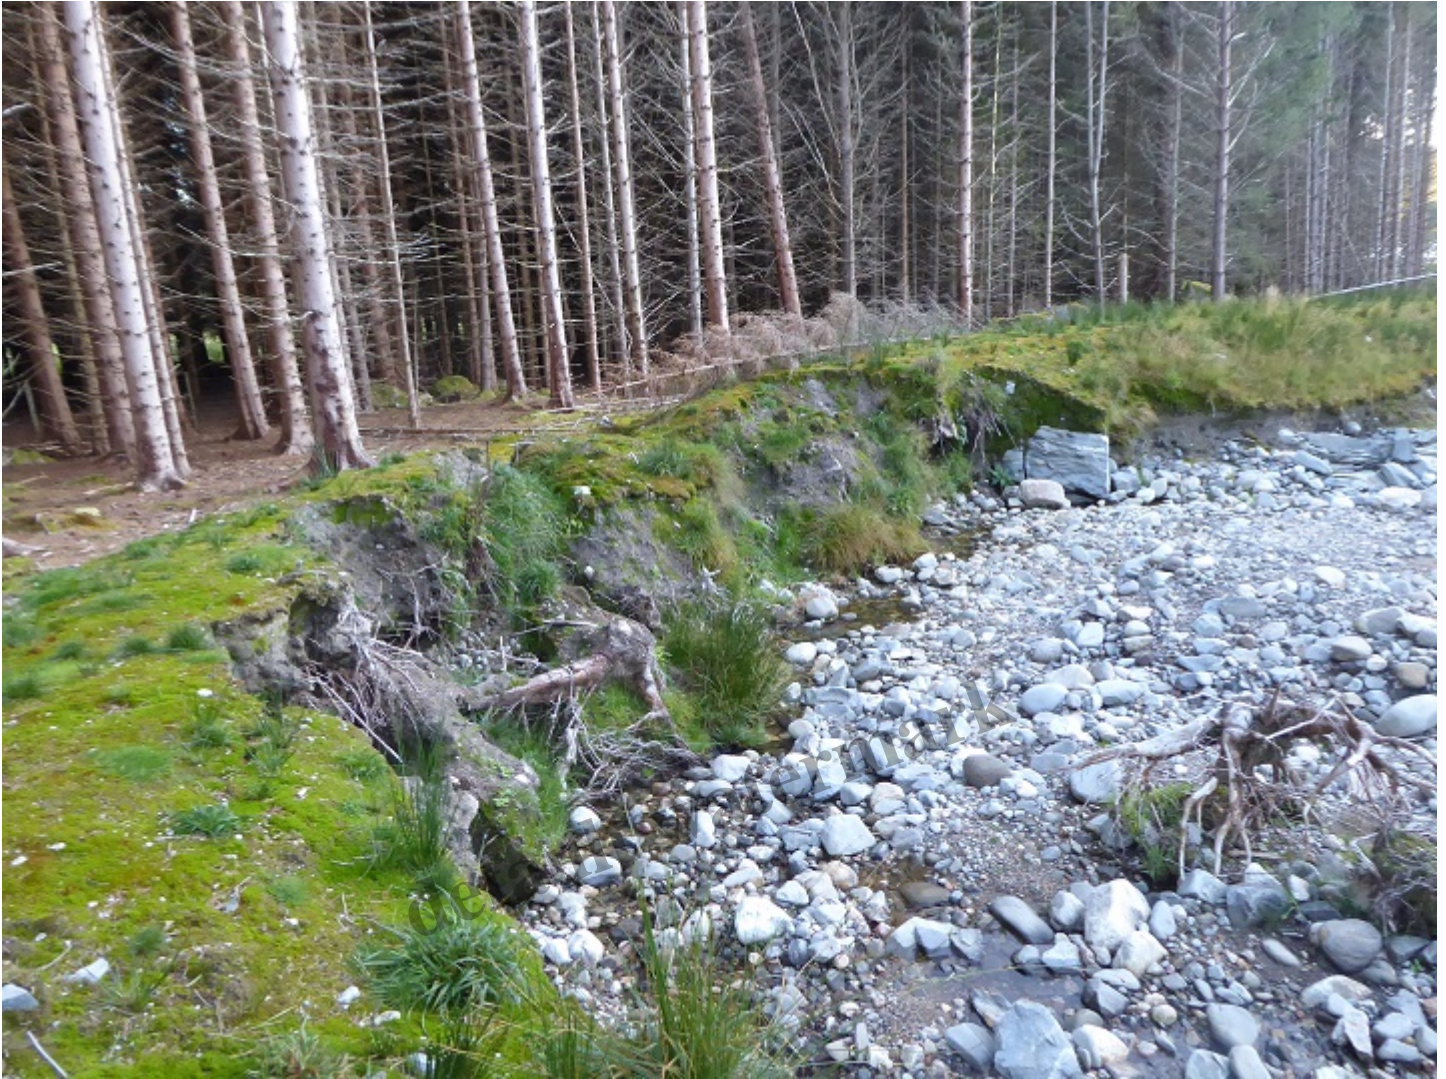
How long would this section of bank last? If it went it could flood a large area of land and threaten the lodge on the far side of the plantation.

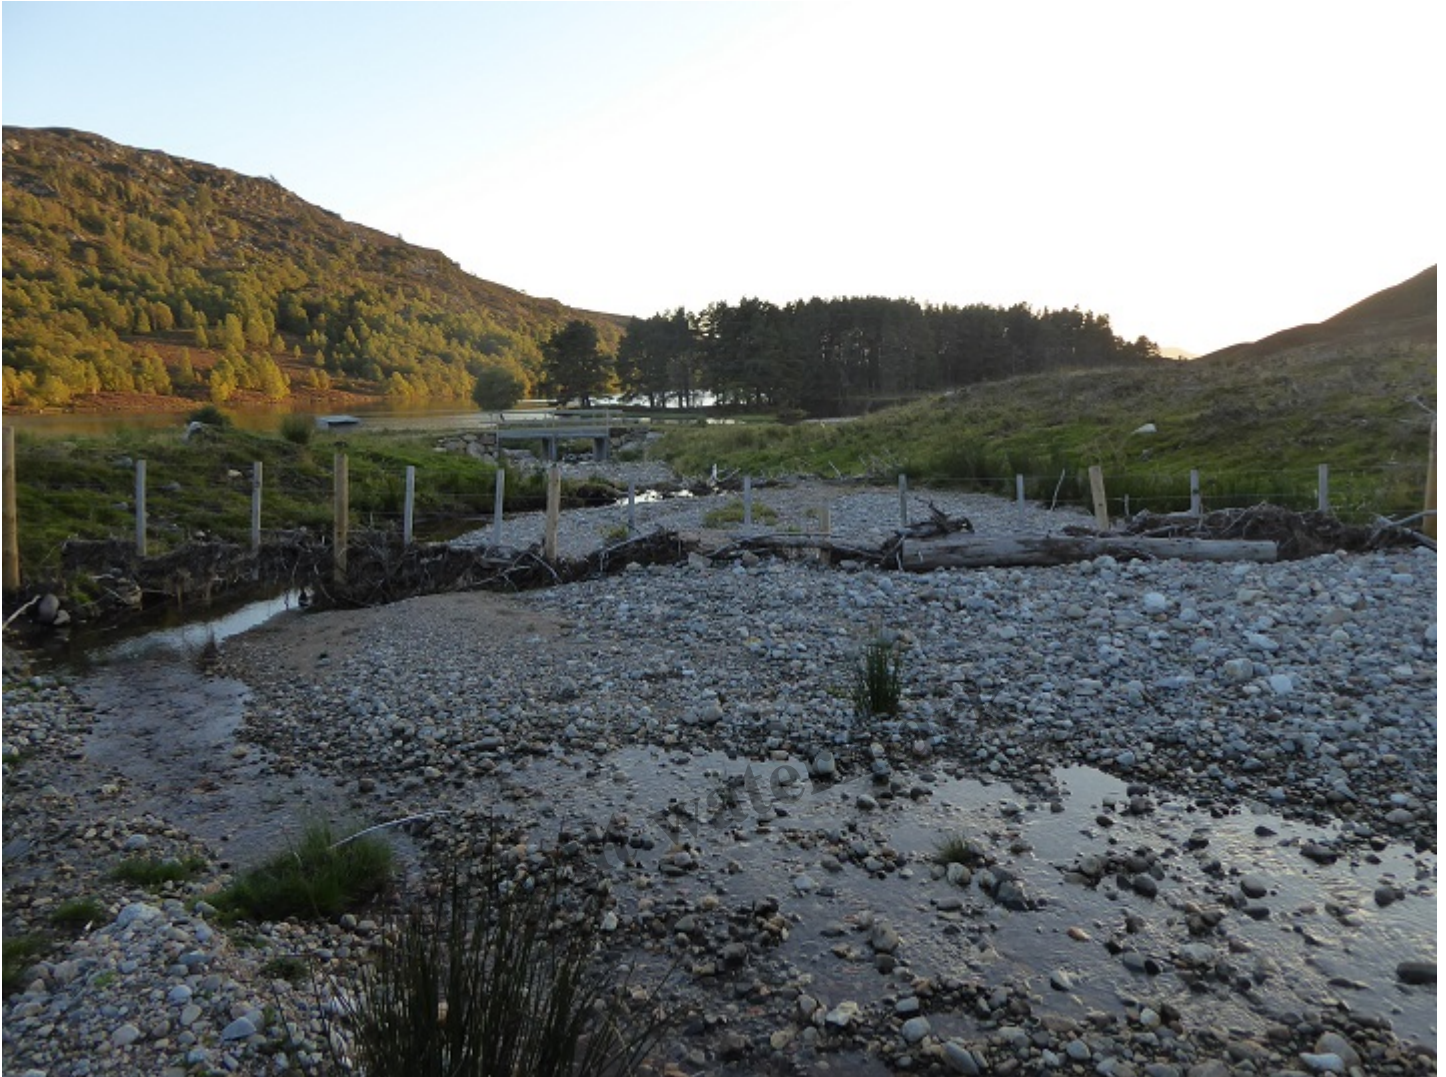
The area around Loch Gynack is now completely segmented by fencing. It appears this fence was erected after the overflow was shut off, sometime in 2019. The debris caught in the short time since, shows just how much water still enters the overflow from the small tributary and other sources in times of high rainfall.

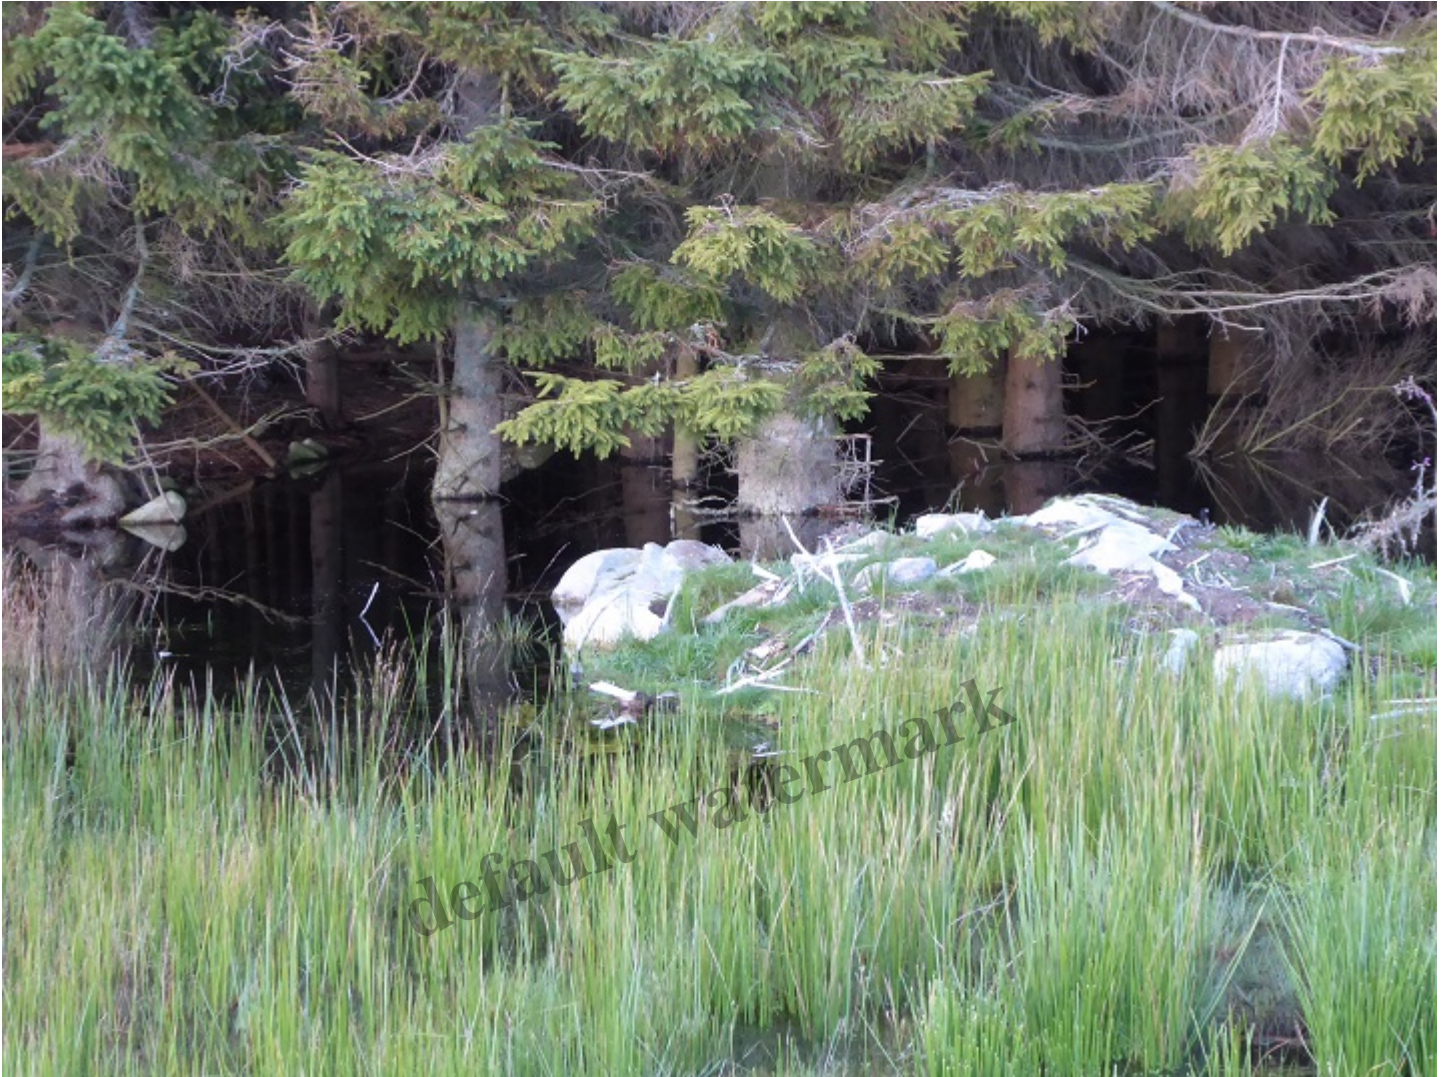
The edge of the plantation on the downside of the overflow was drowning in a large pool of water when I visited. I don't recall seeing this before. Could it be that some of the water that is still channelled down the overflow has found its way UNDER the banks and collected here? If so, the problems are even more serious than I had thought.

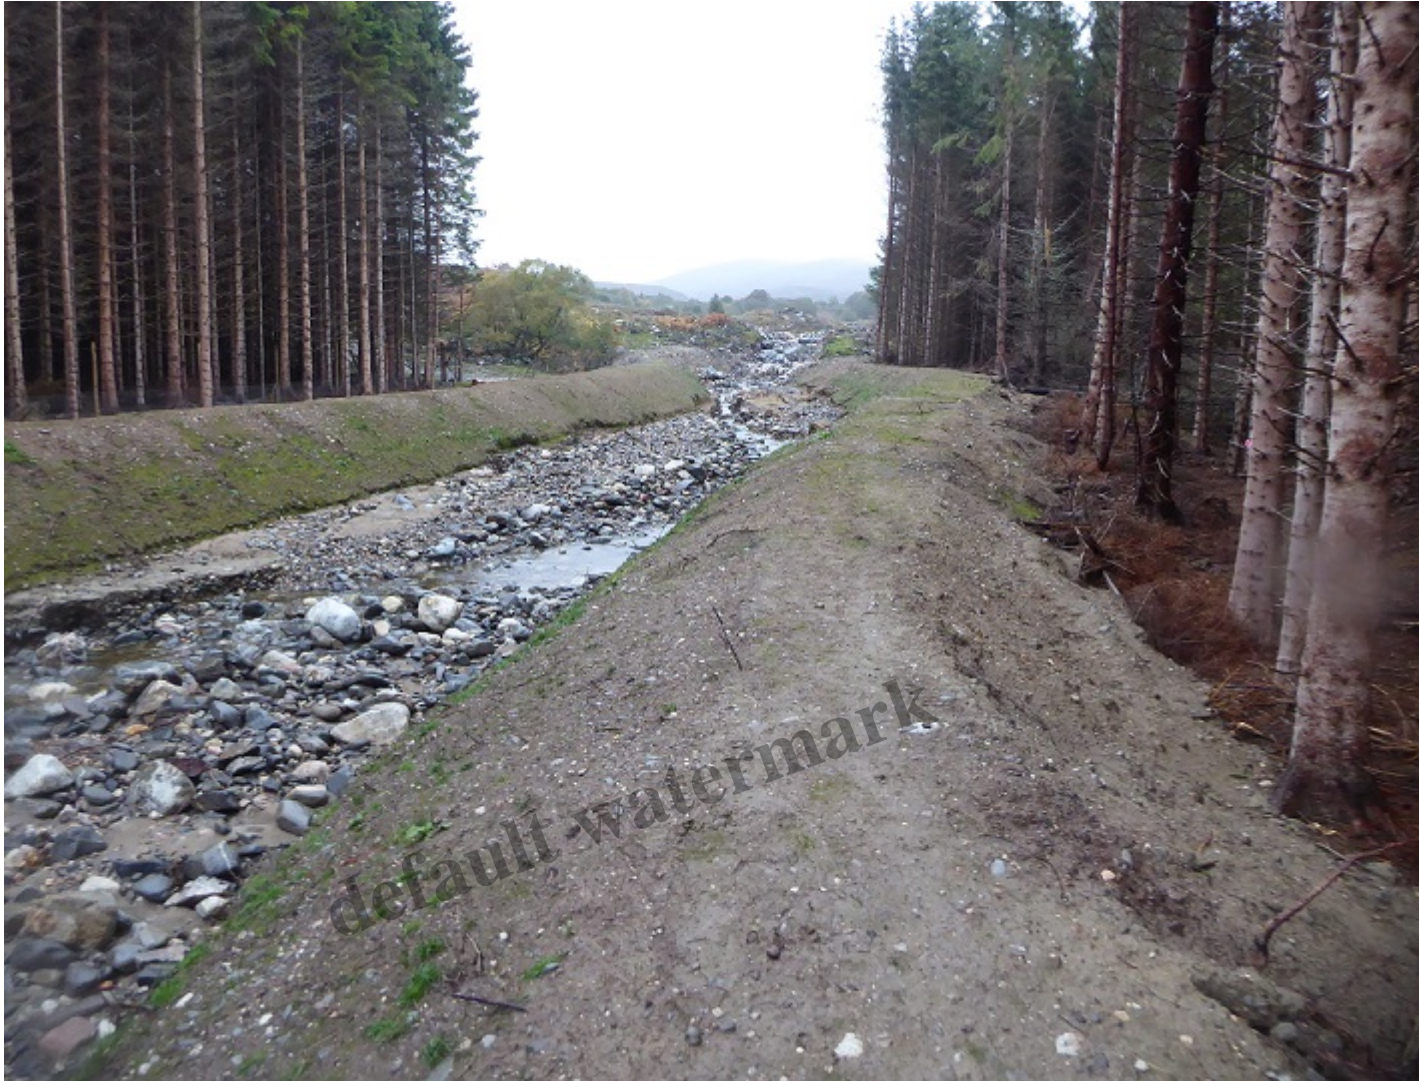
October 2018. The nearest photo I have for how the earth banks looked after construction

My first visit was during construction in 2017 and by the time I next visited there were already signs of serious damage. I would contend, however, that almost anyone looking at these banks on completion could have told those responsible that this was a disaster waiting to happen. The question therefore is how was the construction ever allowed to get this far?

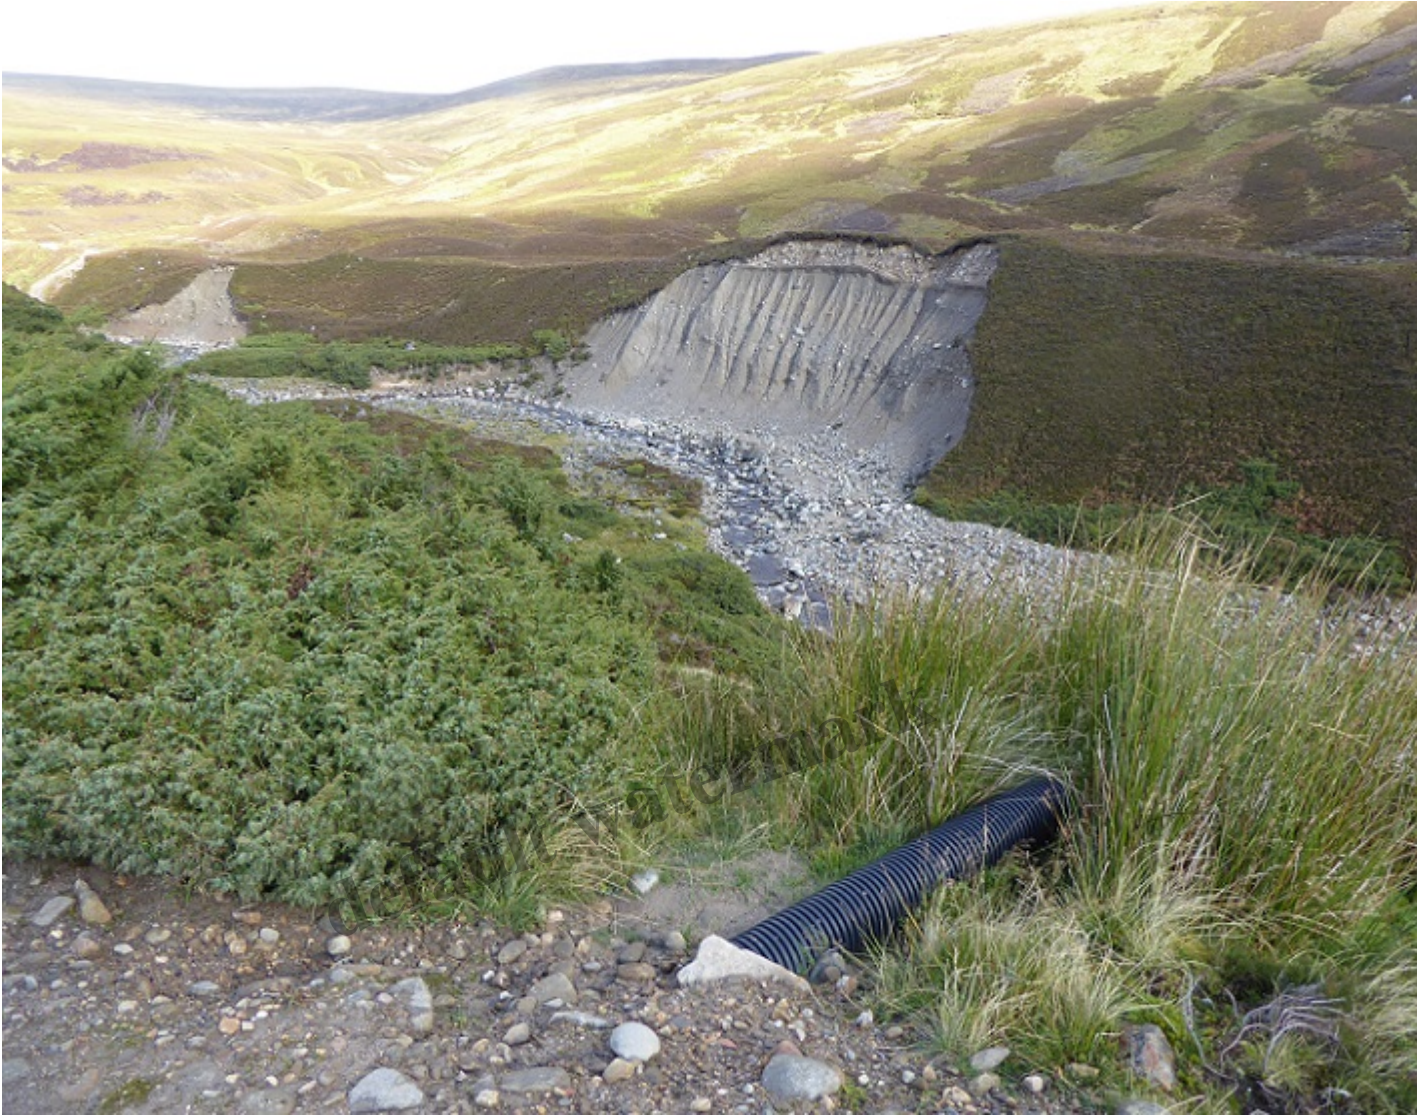
Allt Mhor, the upper part of the Gynack, in 2017.

Meanwhile, a wall of water carrying a mass of boulders could destroy parts of the village and the railway at any time. In my view a significant part of the flood risk to Kingussie has been caused by the way the land above has been managed by the Pitmain Estate. Muirburn speeds up run-off into the river and its tributaries. On sections of the river, there are huge quantities of debris which risk being washed into the river whose bed comprises large quantities of large boulders. If these were all to start moving in a massive flood, the destructive potential would be huge.

The photo also shows part of the solution. Juniper and other trees that would help retain the water and slow the rate it drains into the river system would flourish here, if given the chance. The problem is they are burned for grouse.
