HIE's failure to manage Cairn Gorm – the environmental neglect in Coire na Ciste.

In the summer of 2017, Highlands and Islands Enterprise (HIE) organised the demolition of the Coire na Ciste and West Wall chairlifts ([see here](#)). That work was done at the same time as other clear-up work and it came at a cost of £267k in public money.

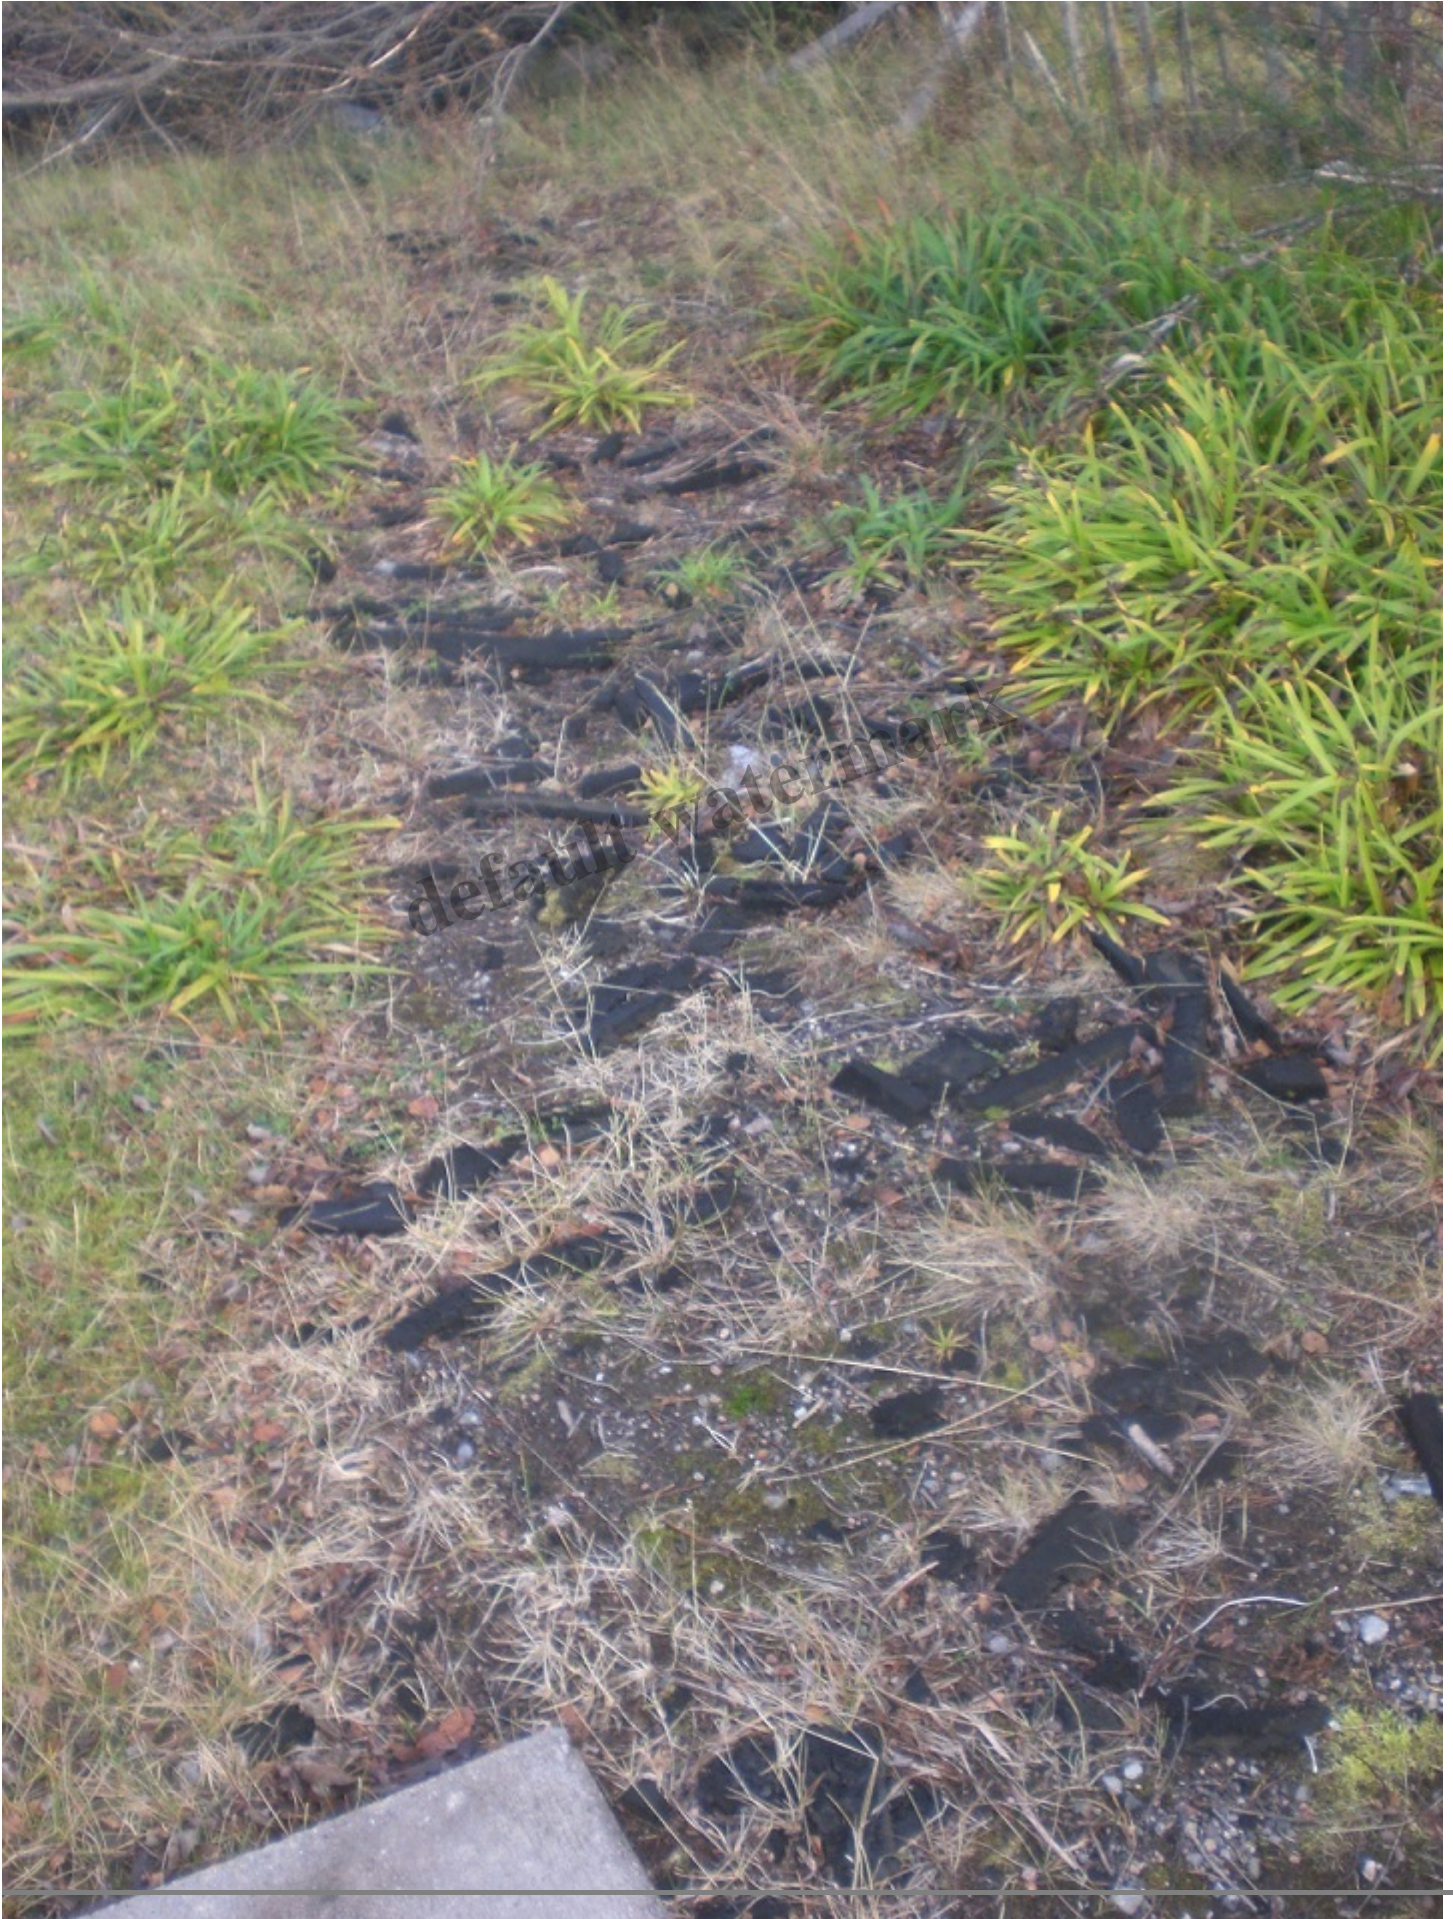
Pieces of Rubber in the car park

The out of use chairs from the chairlifts were stacked here for years. They were removed as part of the clean-up operation. Regrettably, that didn't include the removal of pieces of rubber which had perished and fallen off the chairs as they lay there uncovered and unmaintained. It's evident that the regeneration of natural vegetation is being retarded.

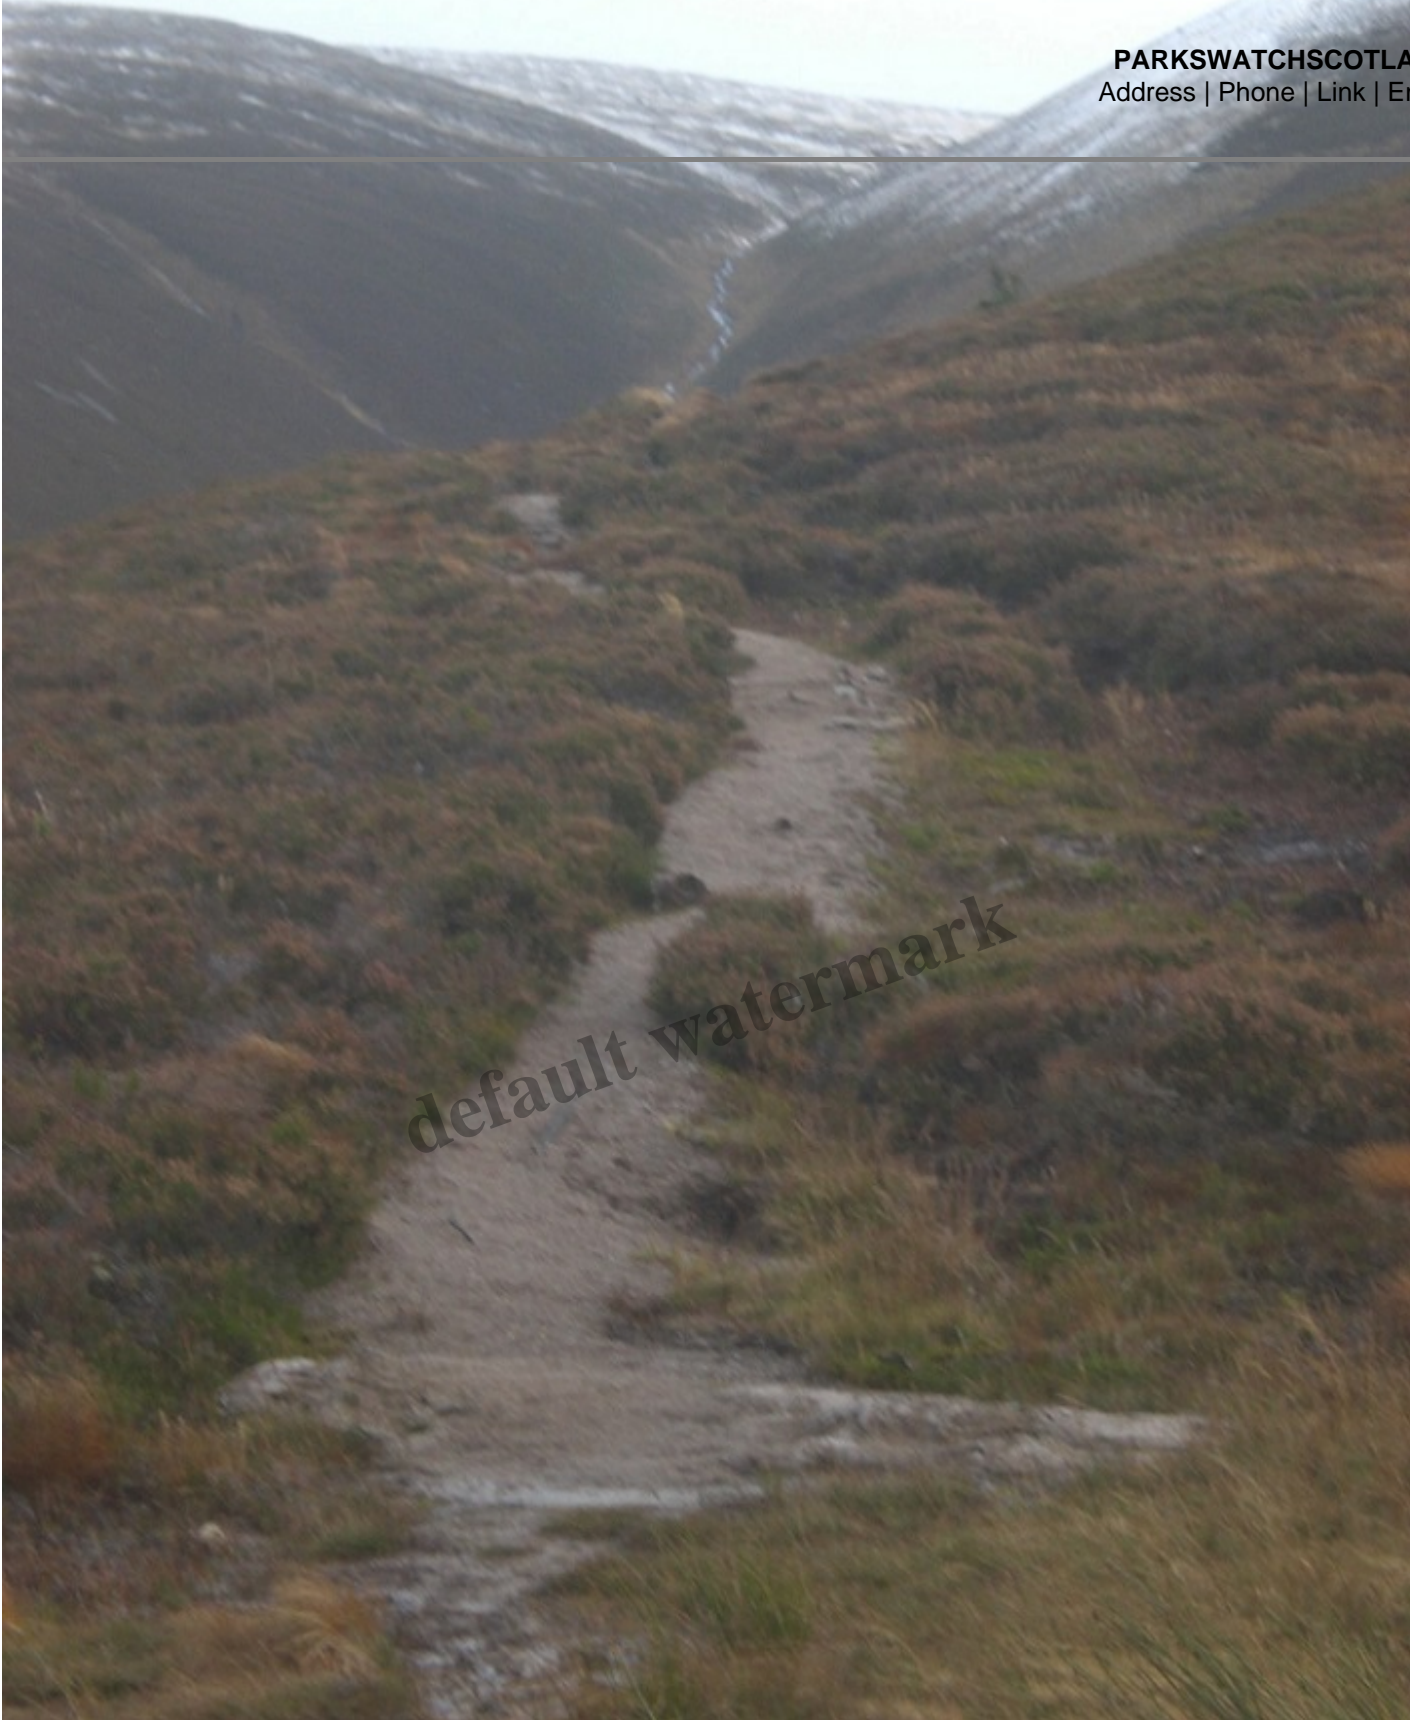
The footpath from behind the Ciste Base building

The path follows a route underneath the line of the Coire na Ciste chairlift but it was never a constructed path and is the result of footfall.

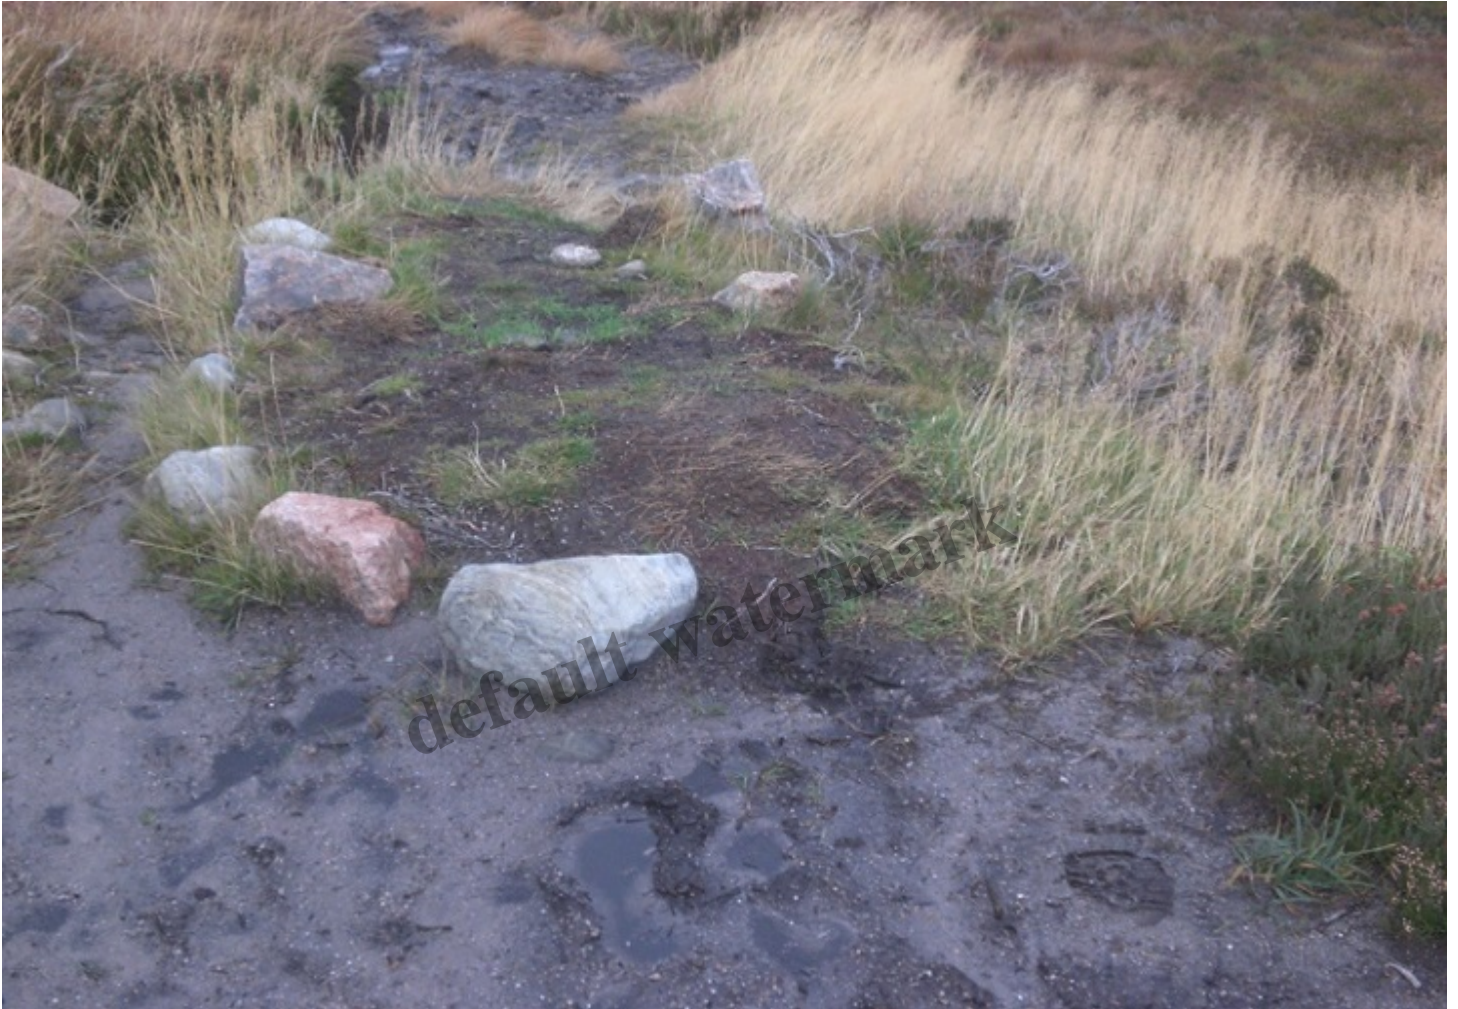
The first concrete tower foundation beyond the Ciste Base building

The clean-up work required the concrete tower foundations to be ground down to 200mm below the level of the surrounding ground. It's clear that there are a number of them where that wasn't done. The vegetation that was used to cover them over has generally died, having nothing but concrete to root into.

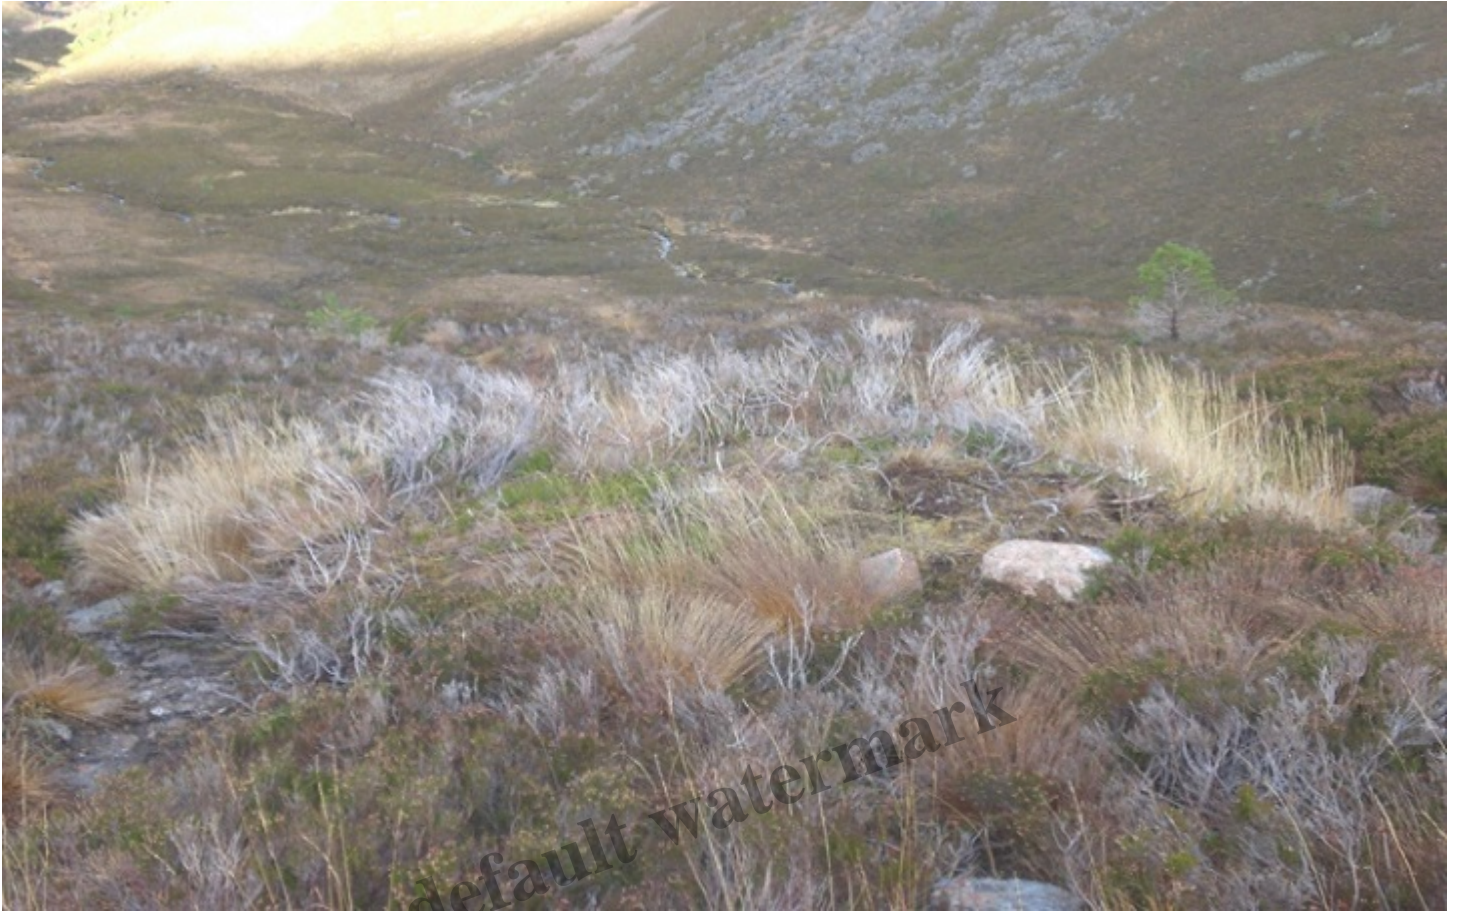
Concrete tower foundation, further up the hill.

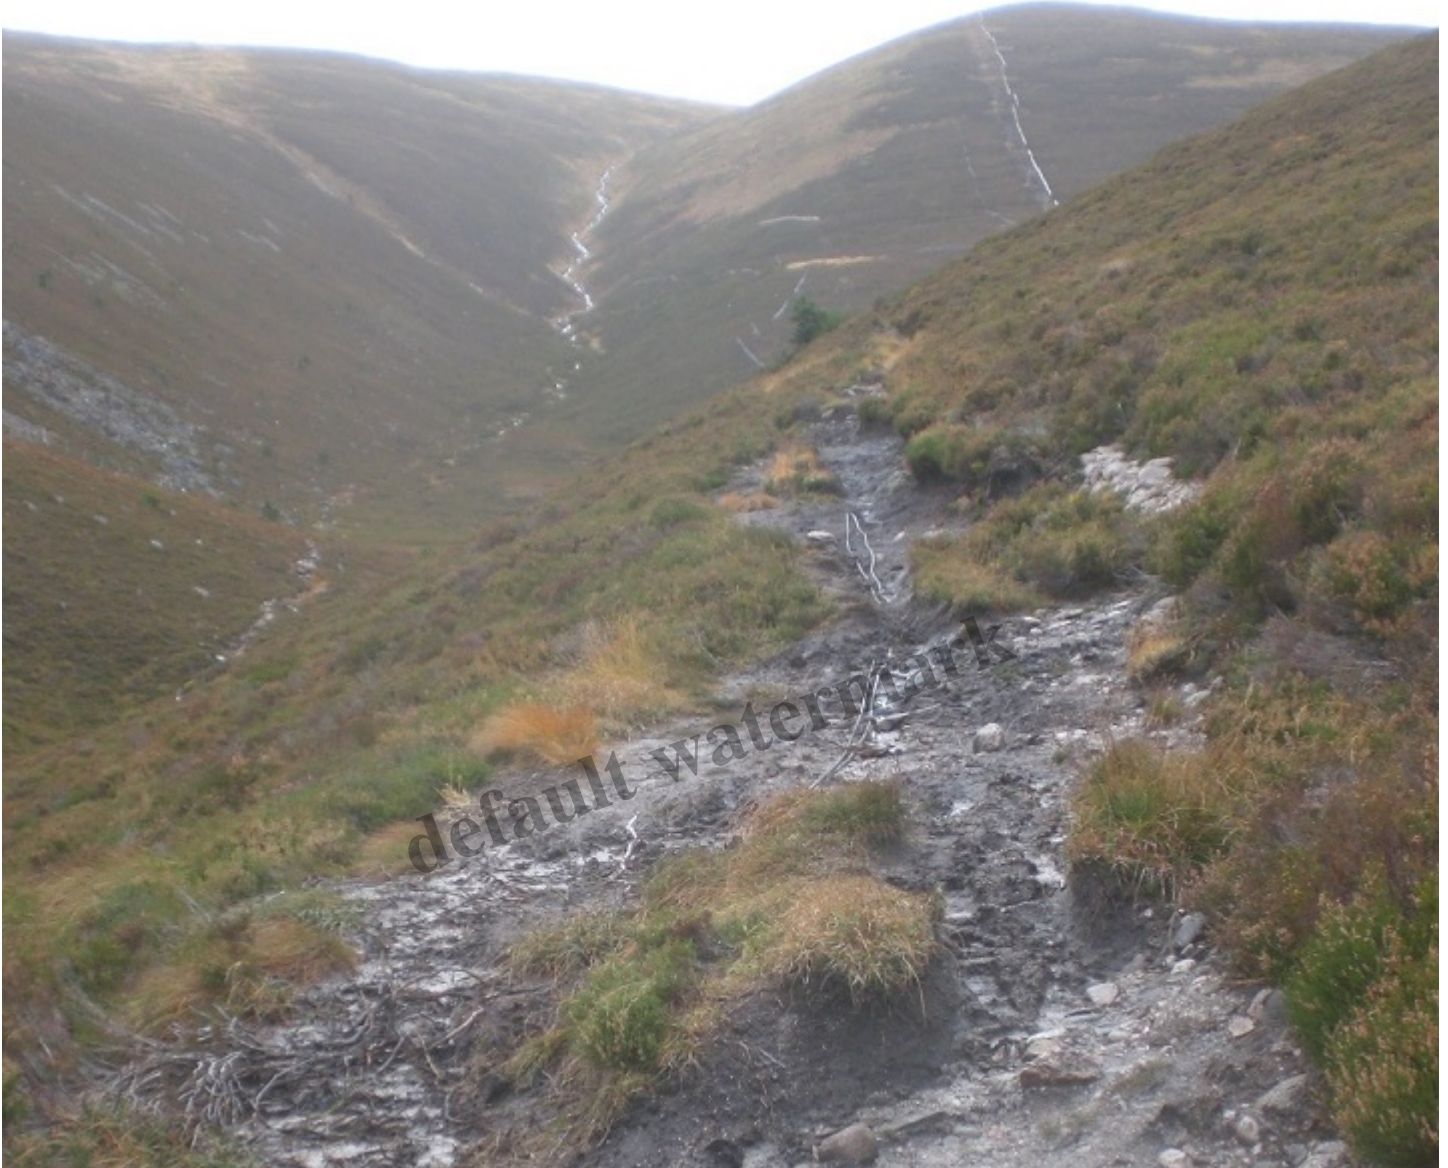
Eroded path just 200m from the Ciste car park

The path is badly eroded and there is cabling, associated with the demolished chairlift, that has just been left in the ground.

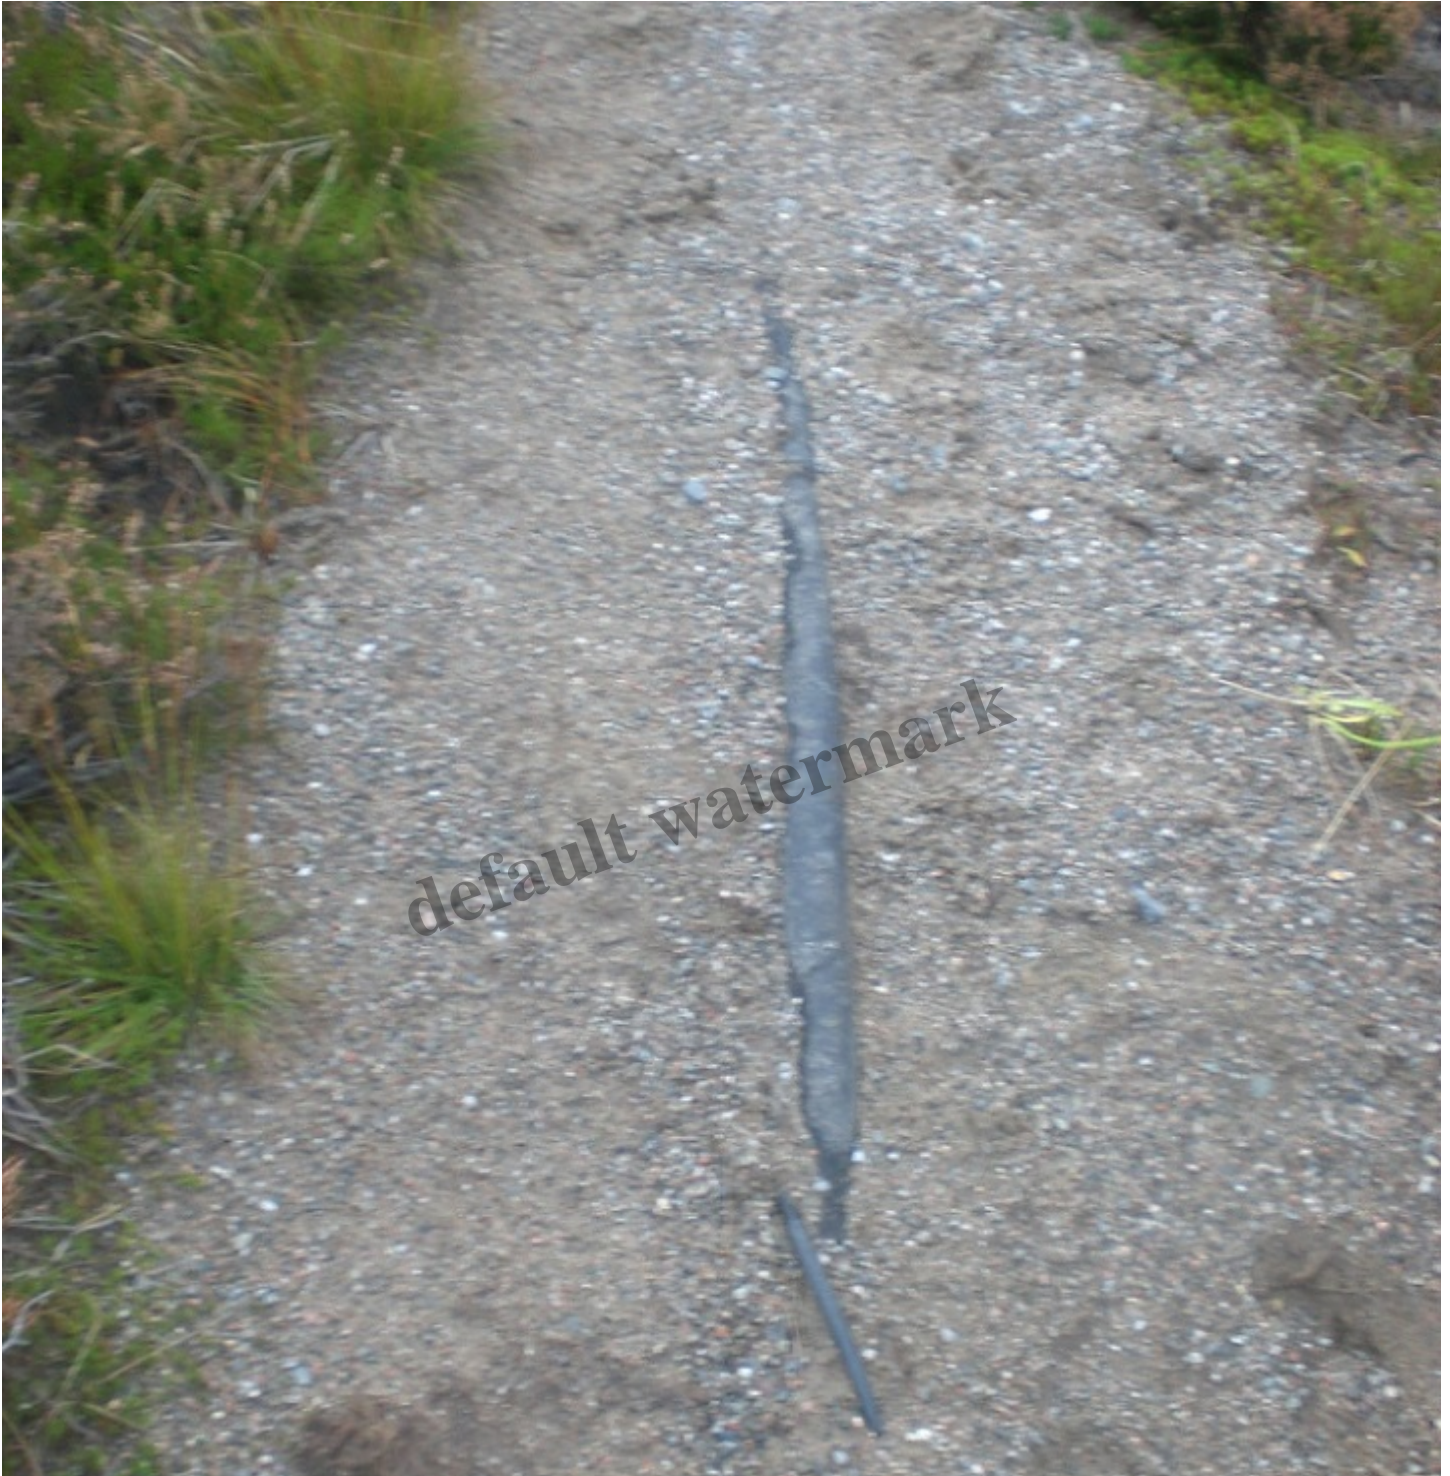
Power cable

The power supply for the West Wall Poma comes from the sub-station that's housed in the Ciste Base Building. Despite sandbags being placed over it on several occasions the cable is on the surface of the ground in a number of places. That cannot be entirely safe and the cable needs to be buried to an appropriate depth, as a matter of urgency.

Meantime, there appears no reason why Cairngorm Mountain, which is currently closed, shouldn't redeploy any spare staff capacity to make a start on a clear-up now. Whatever its position, it needs to ensure the exposed live electricity cable is buried as a matter of urgency.

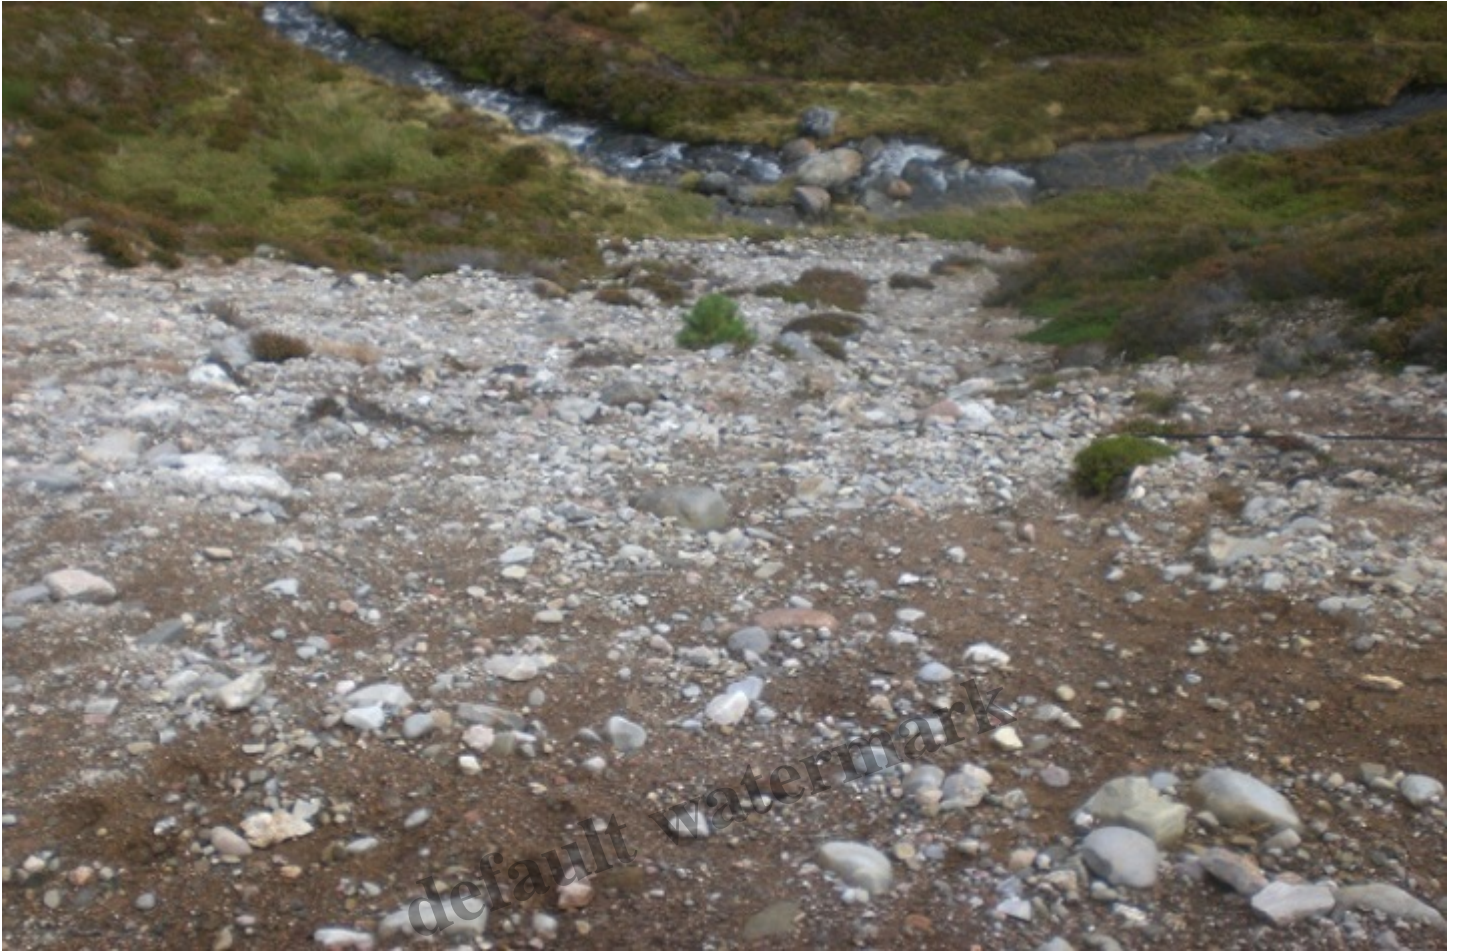
Collapsing hillside below the path.

The path cuts directly across the collapsing hillside. There's a danger that the hillside could slide down into the Allt na Ciste below and it would be expedient to re-route the path and keep people off this area.

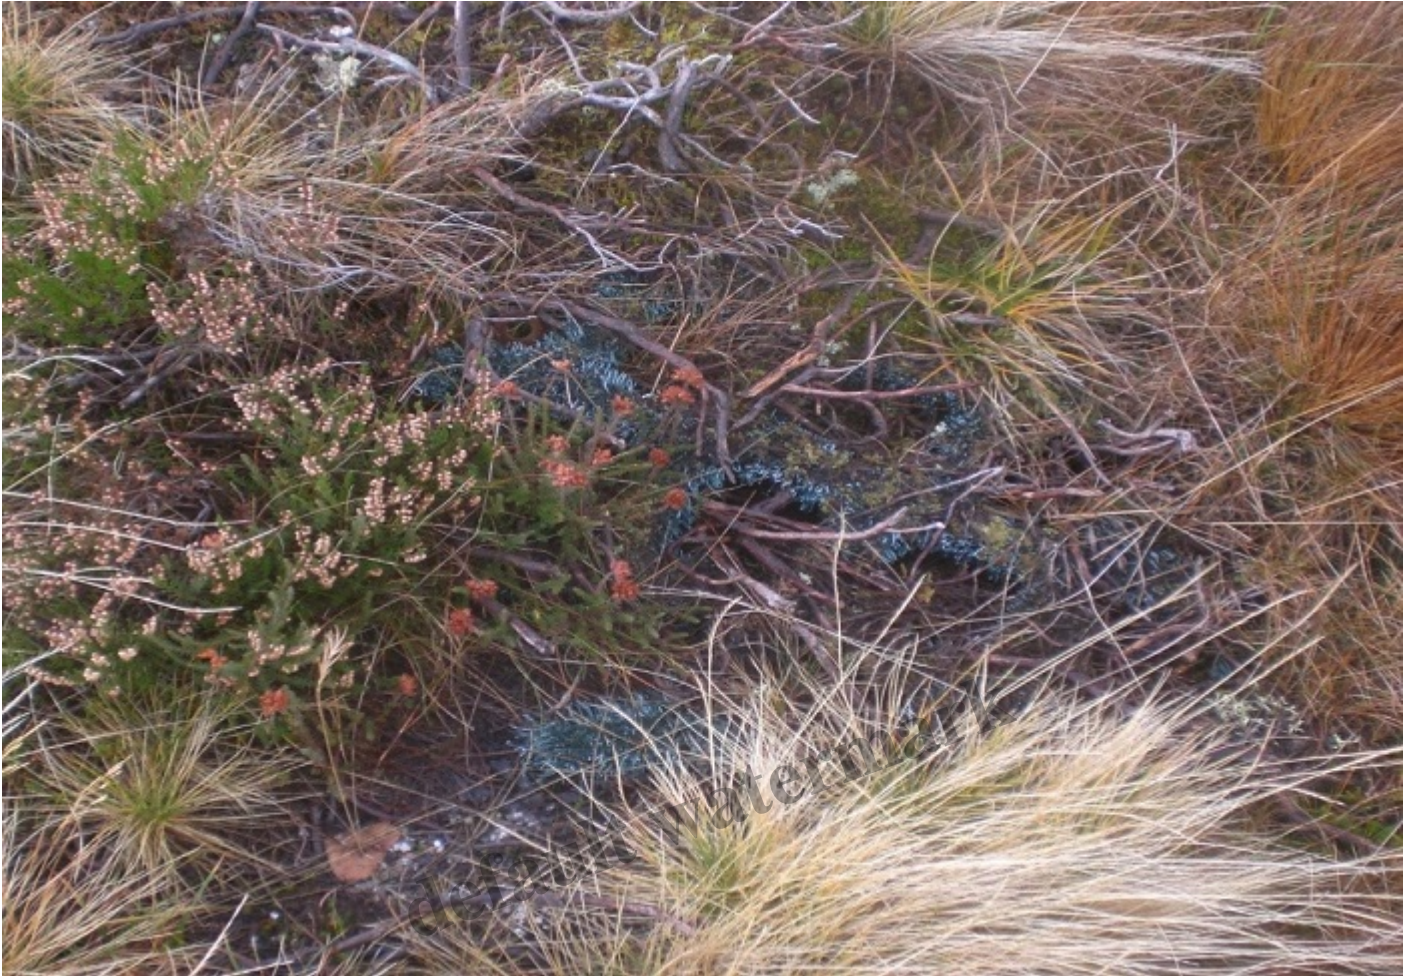
Ski matting.

That matting isn't biodegradable, is foreign to the area and it should have been removed during the clean-up operation.

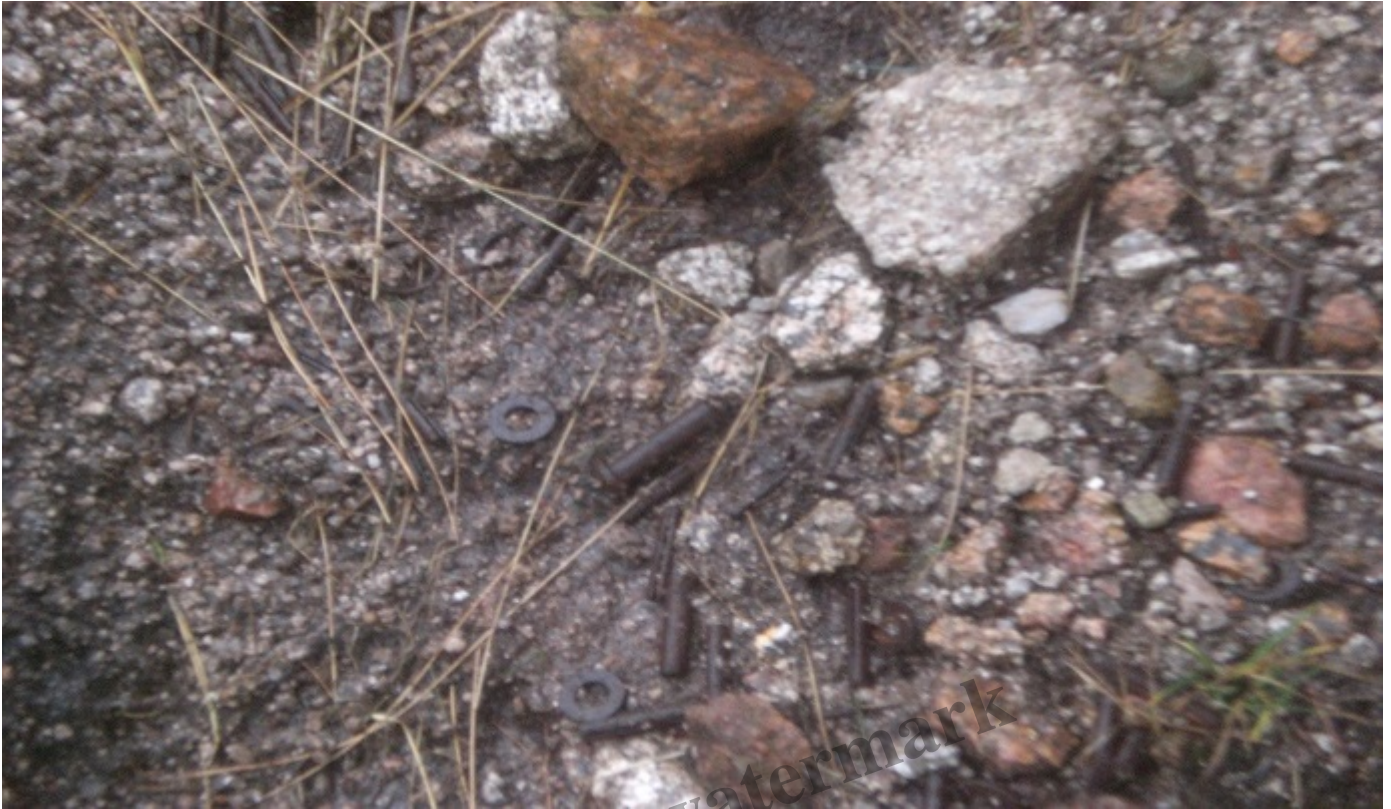
Rusting bolts and washers.

These have been discarded beneath the West Wall Poma loading gantry. Why?

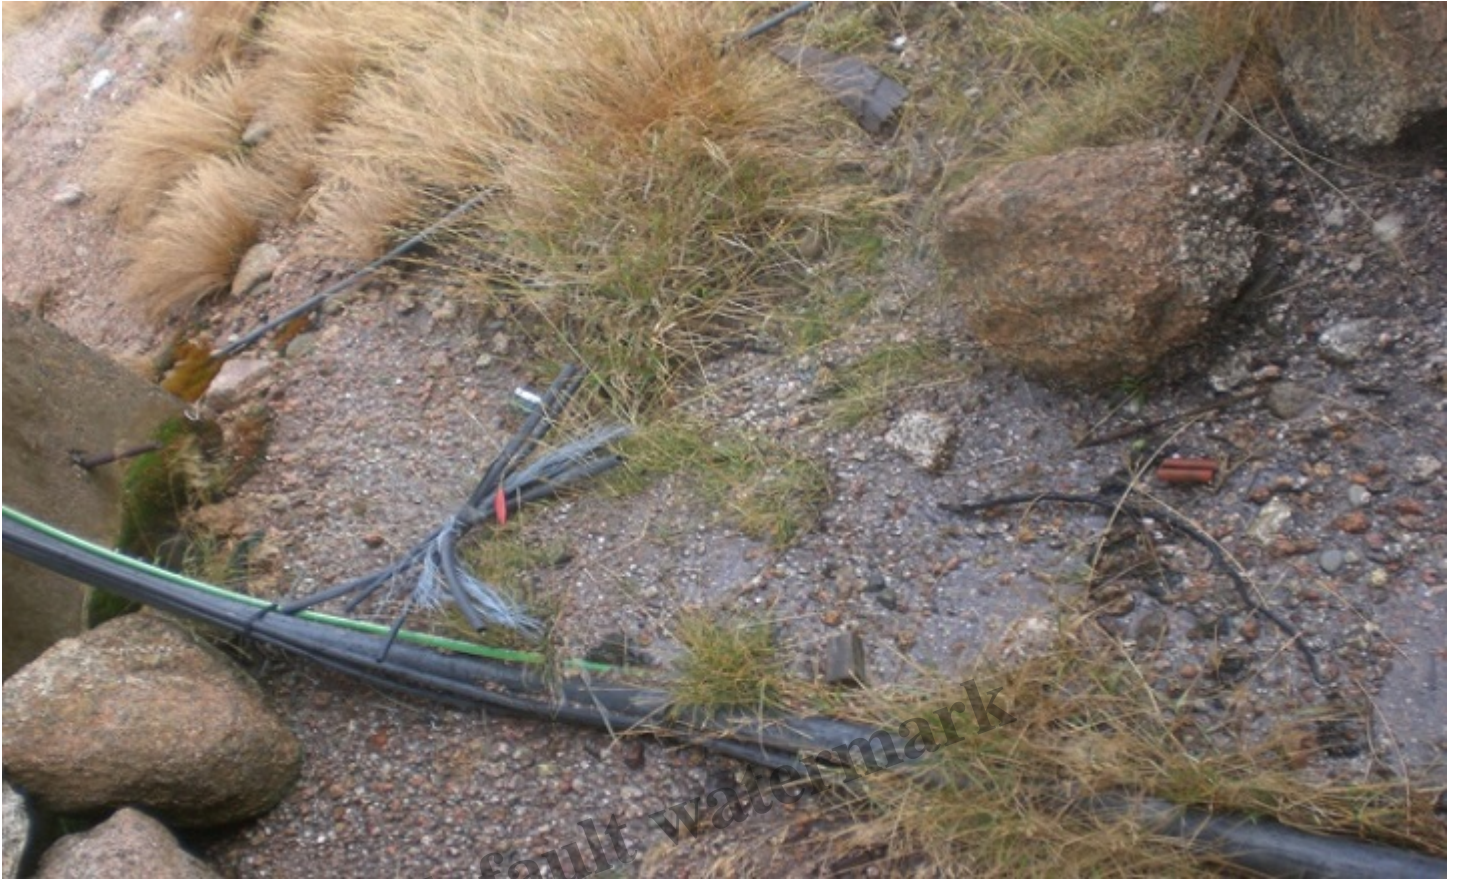
Assorted detritus

Abandoned materials that are scattered on the ground beneath the West Wall Poma loading gantry.
Why?

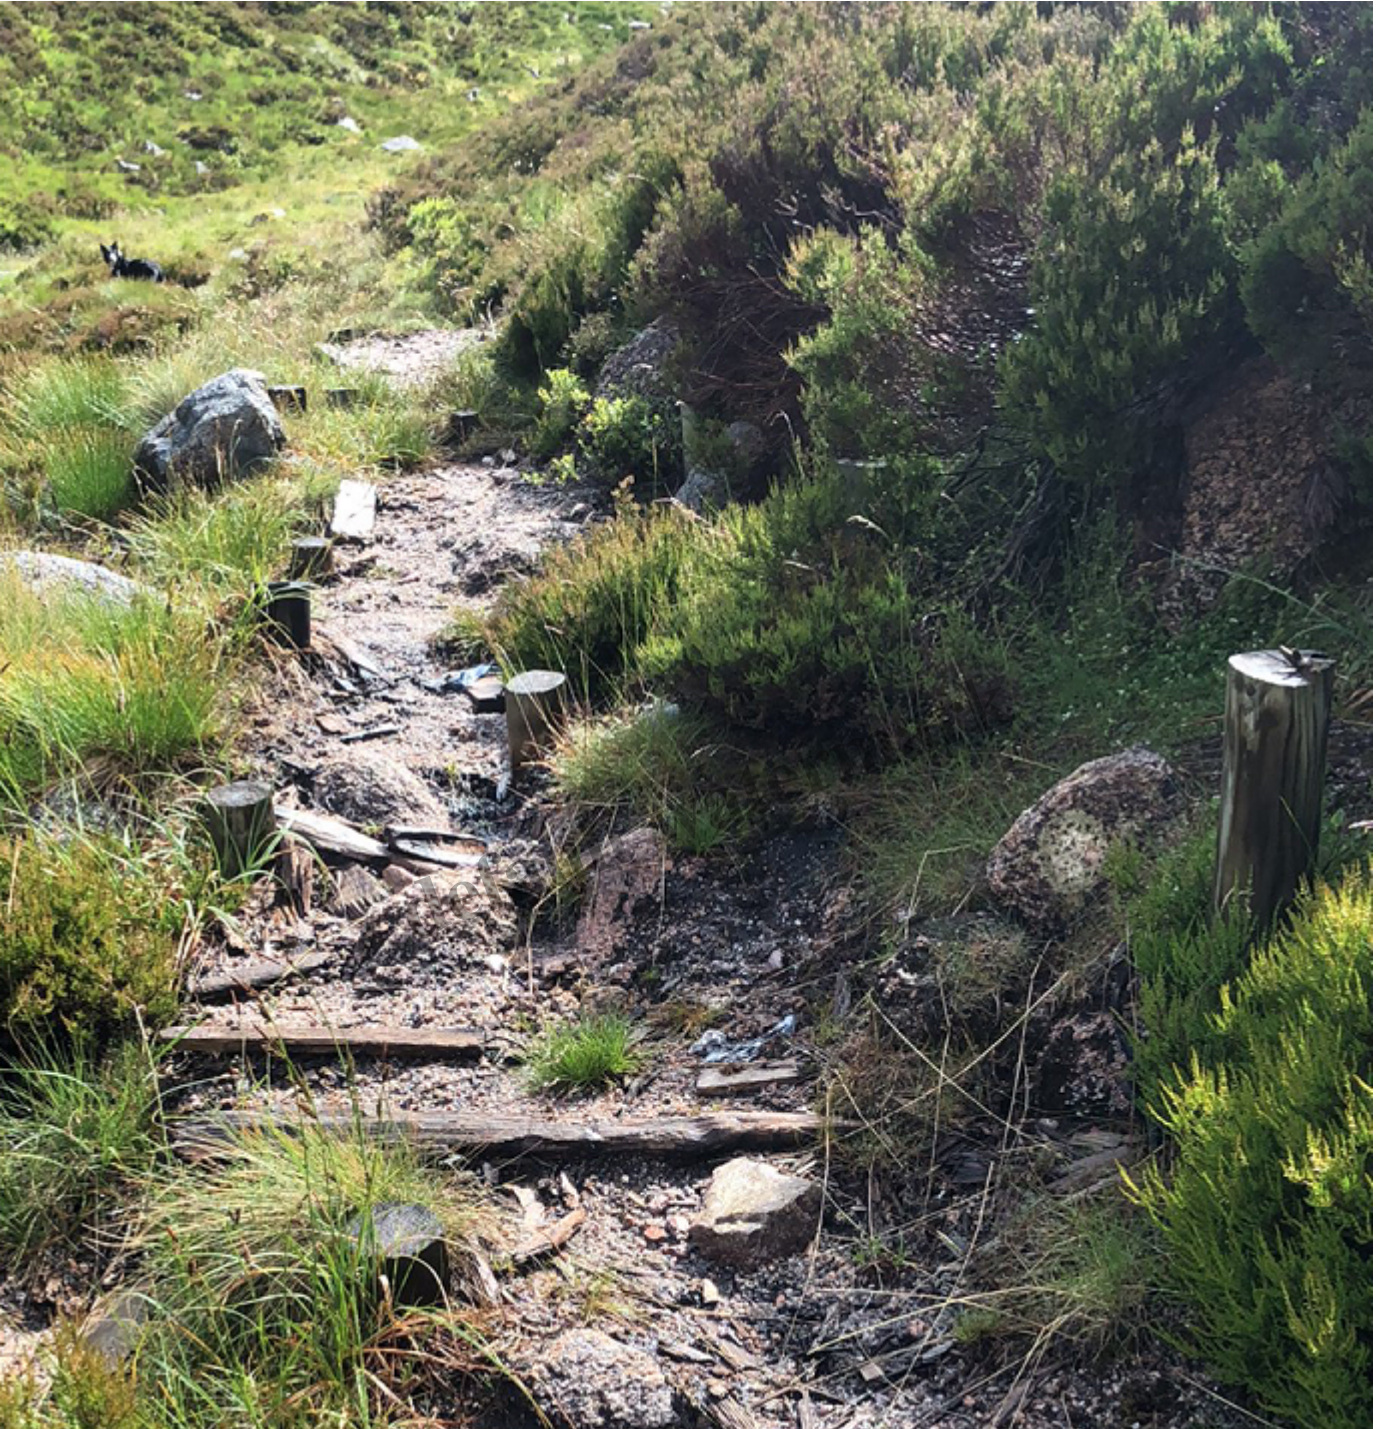
The boardwalk

It has been several years now since the boardwalk was removed. A very substandard job was done as evidenced by the mess that still lies on the site today. It can be clearly seen that there has been no vegetation regeneration.

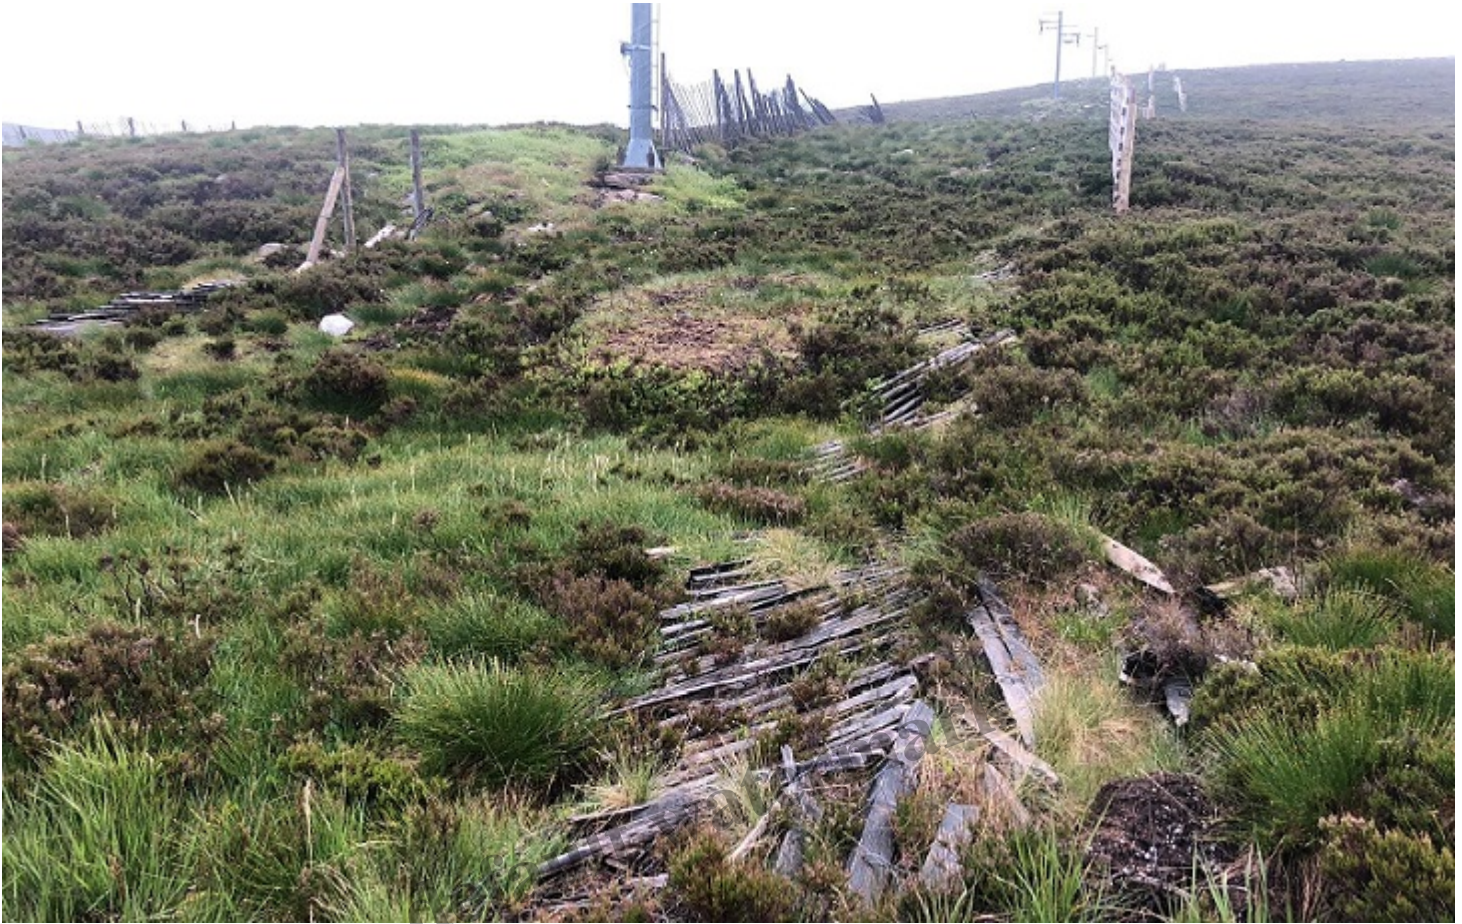
Broken fencing.

This has been lying on the ground for so long that some vegetation is growing through it while other plants will have died.
