HIE's failure to manage Cairn Gorm – the environmental neglect in Coire na Ciste.

In the summer of 2017, Highlands and Islands Enterprise (HIE) organised the demolition of the Coire na Ciste and West Wall chairlifts ([see here](#)). That work was done at the same time as other clear-up work and it came at a cost of £267k in public money.

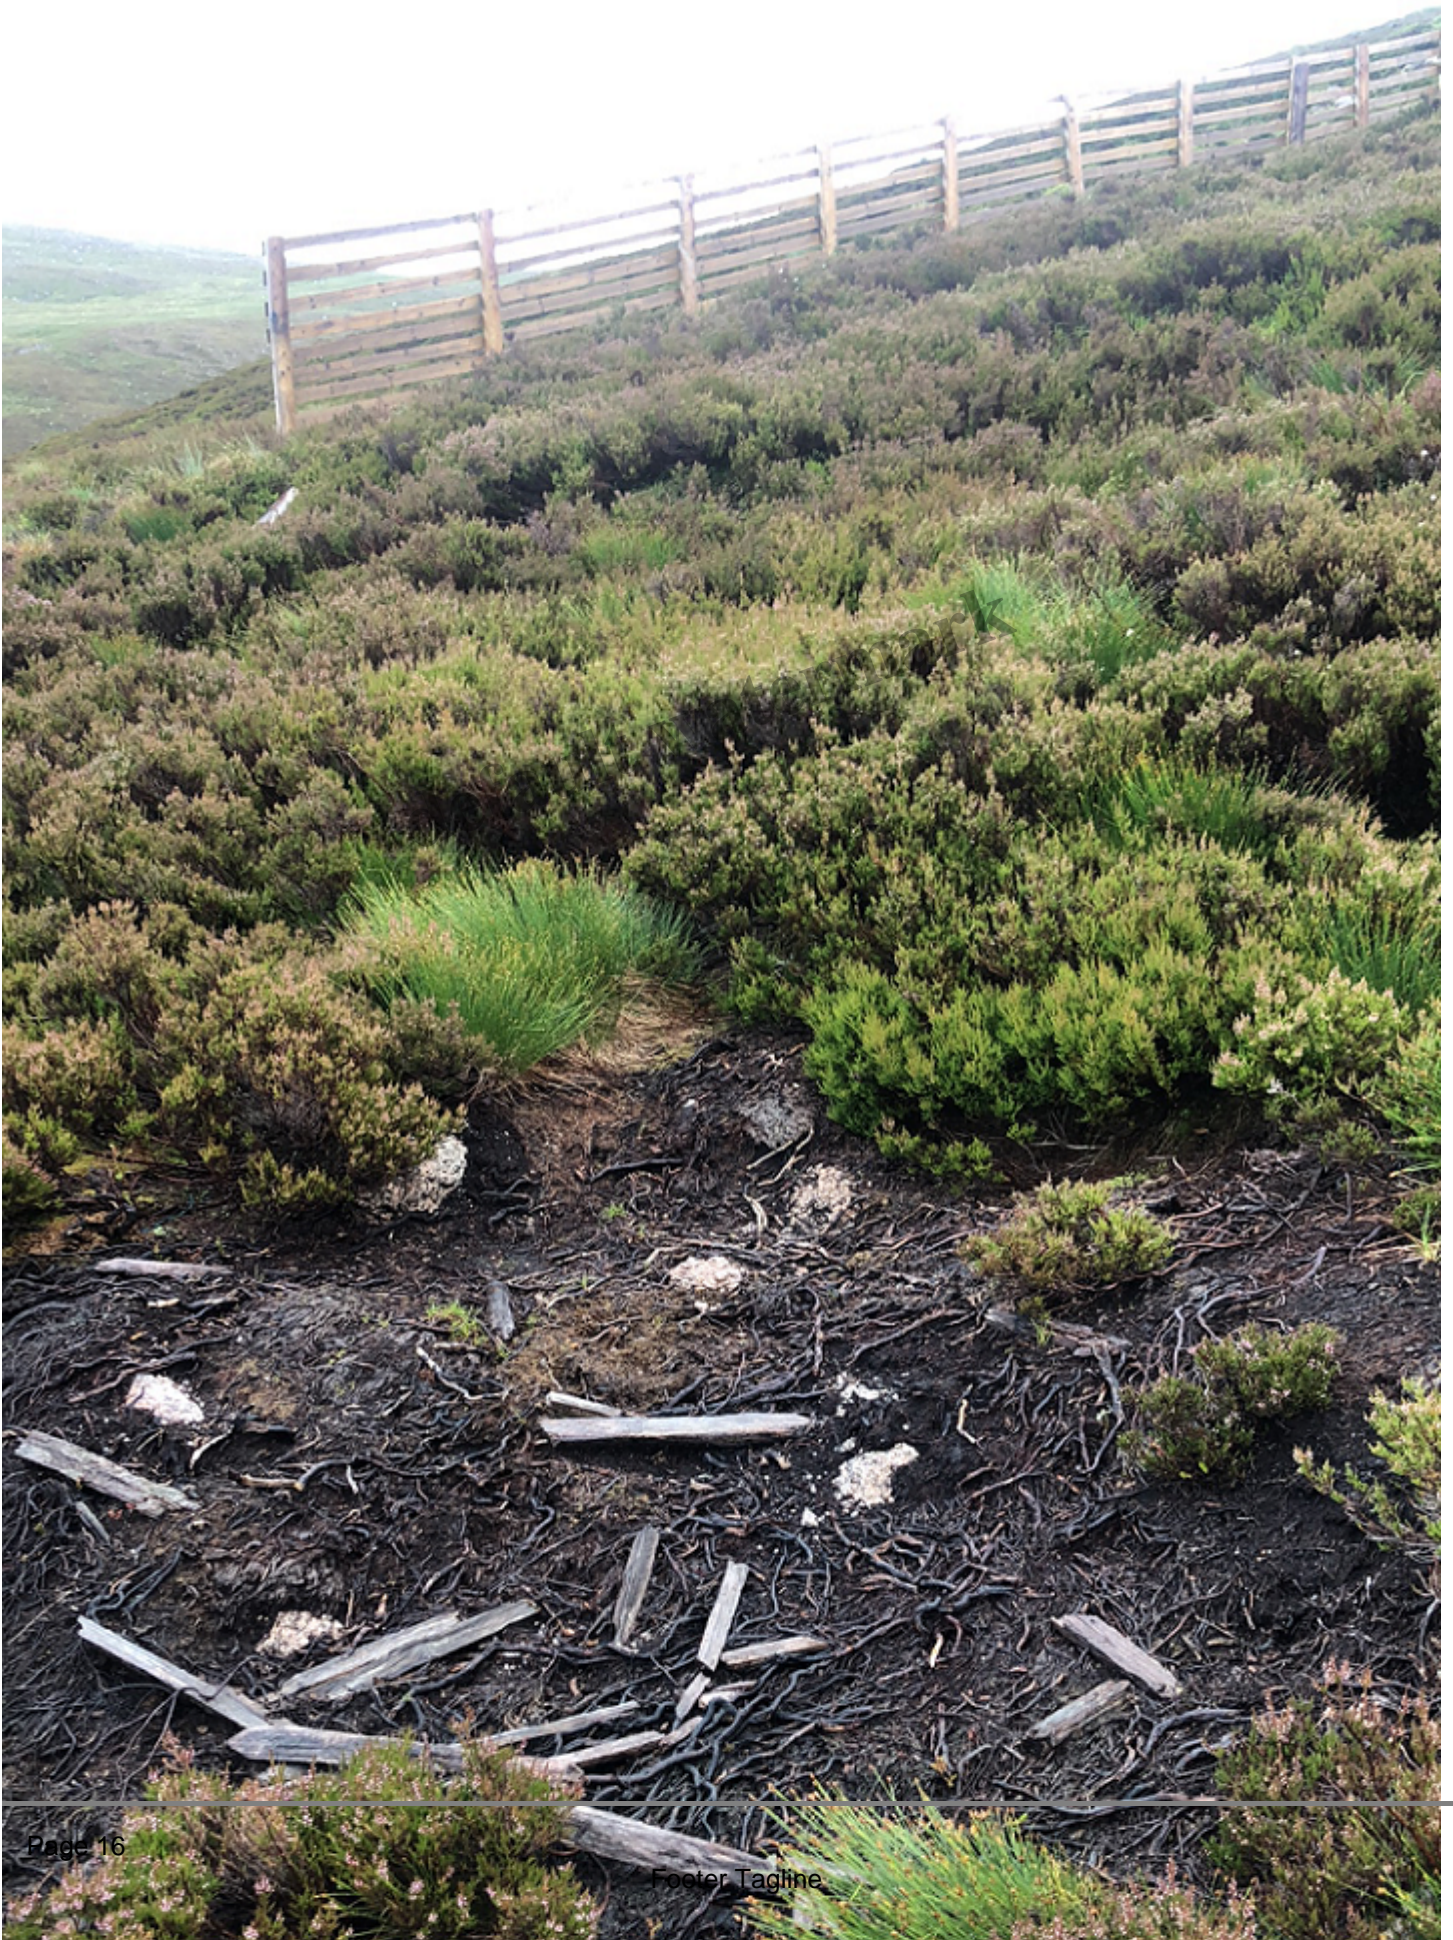
Dead ground higher up the coire.

Old Chesnut pailing fencing, which had been rolled up for removal and then left lying on the ground for years had the effect of killing the vegetation. Even when it was finally removed, the area wasn't cleaned up and that's preventing the vegetation from regrowing.
