HIE's failure to manage Cairn Gorm the environmental neglect in Coire na Ciste.

In the summer of 2017, Highlands and Islands Enterprise (HIE) organised the demolition of the Coire na Ciste and West Wall chairlifts ([see here](#)). That work was done at the same time as other clear-up work and it came at a cost of Â£267k in public money.

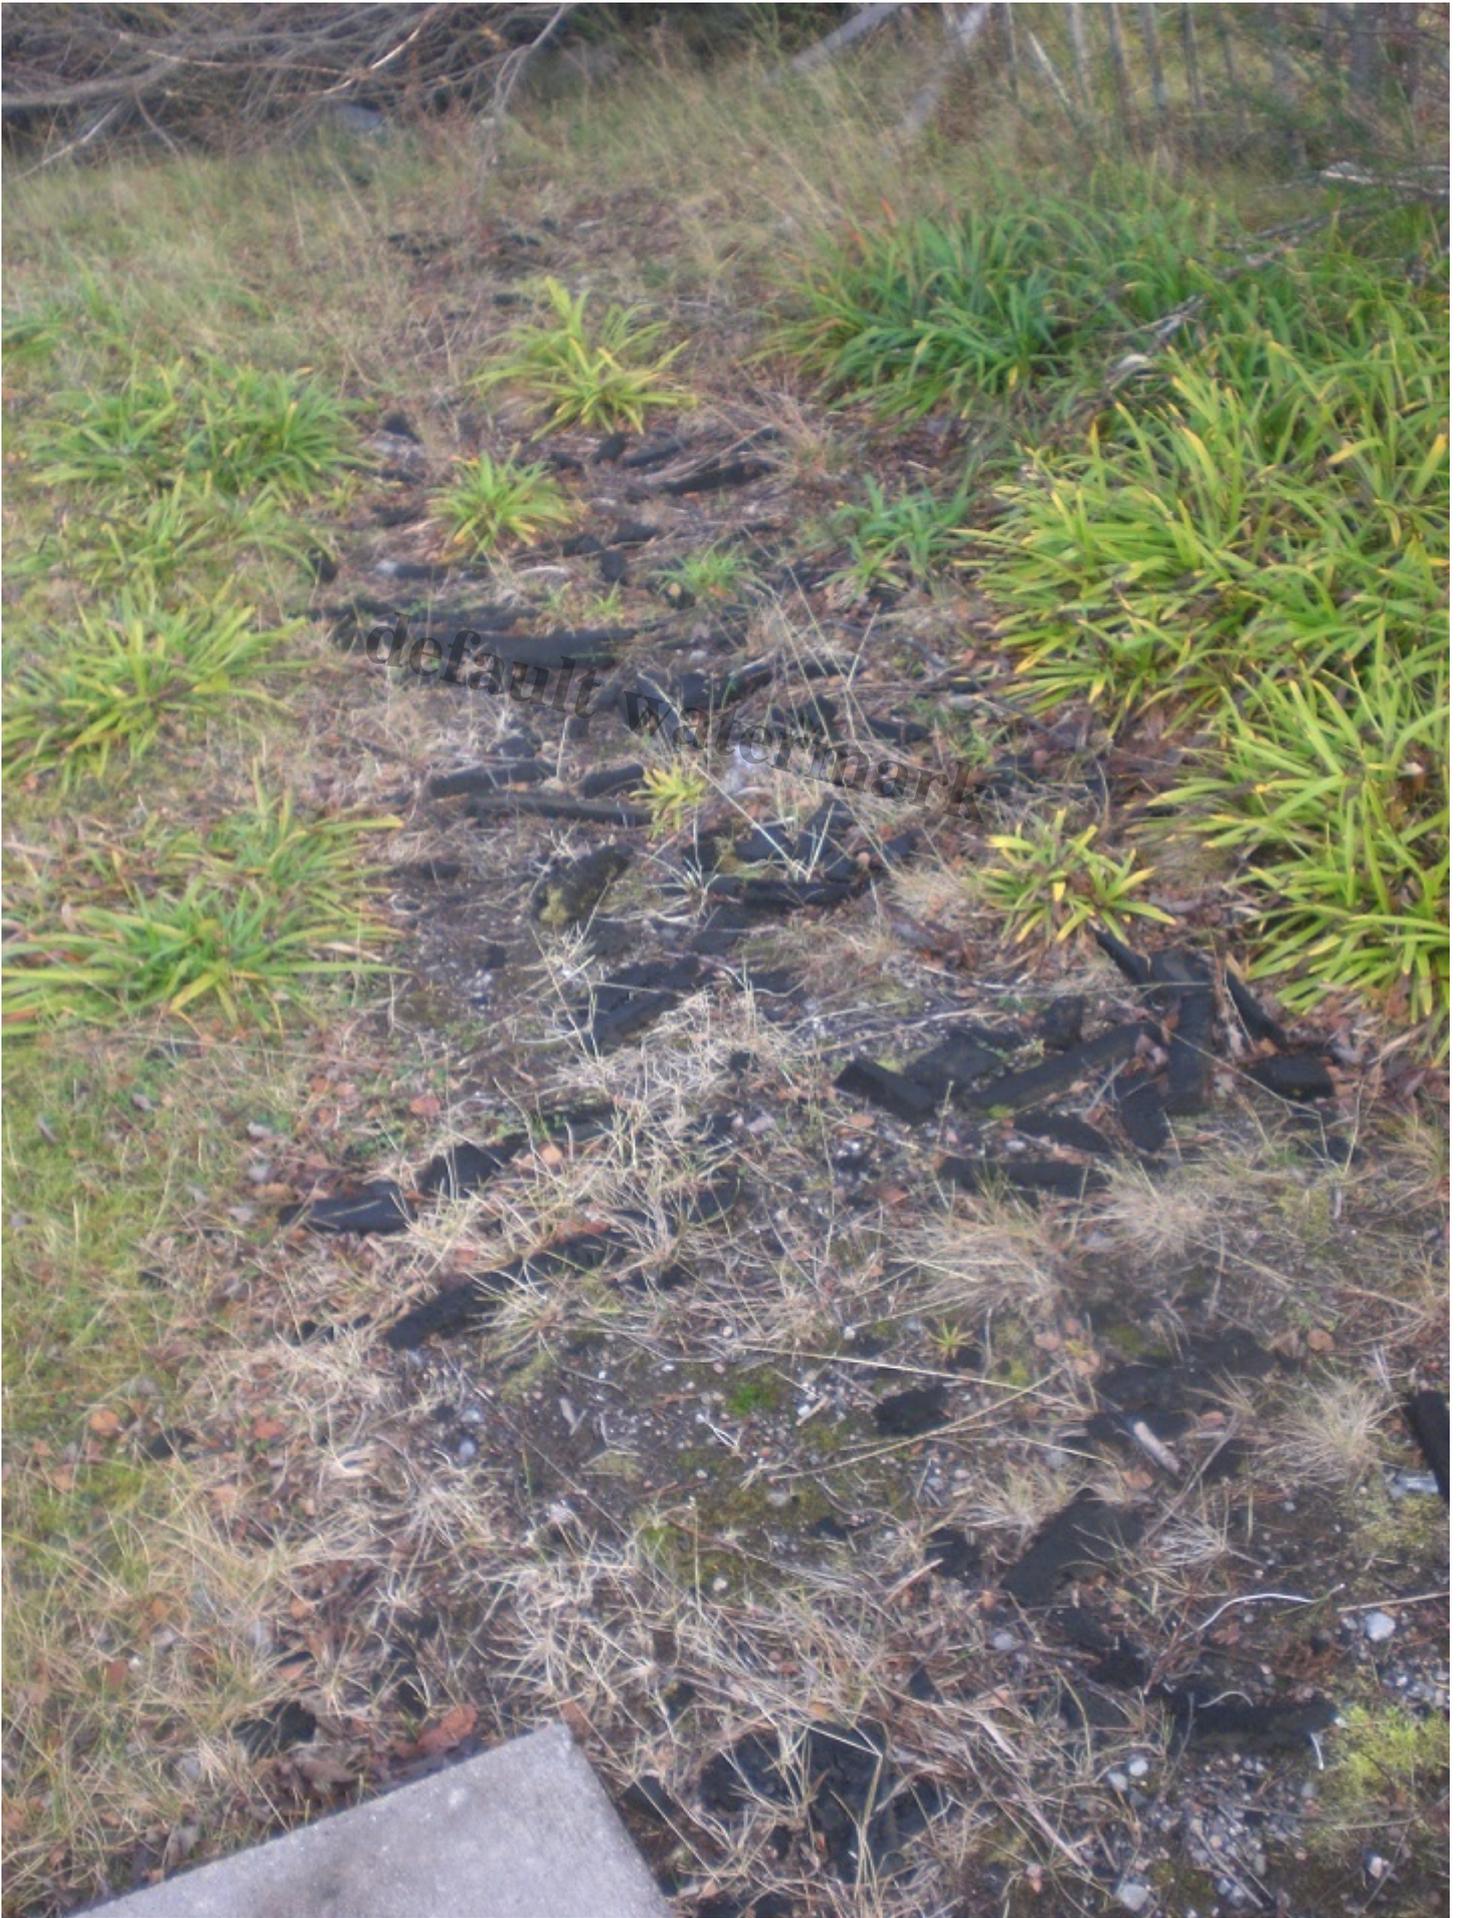
### **Pieces of Rubber in the car park**

The out of use chairs from the chairlifts were stacked here for years. They were removed as part of the clean-up operation. Regrettably, that didn't include the removal of pieces of rubber which had perished and fallen off the chairs as they lay there uncovered and unmaintained. It's evident that the regeneration of natural vegetation is being retarded.

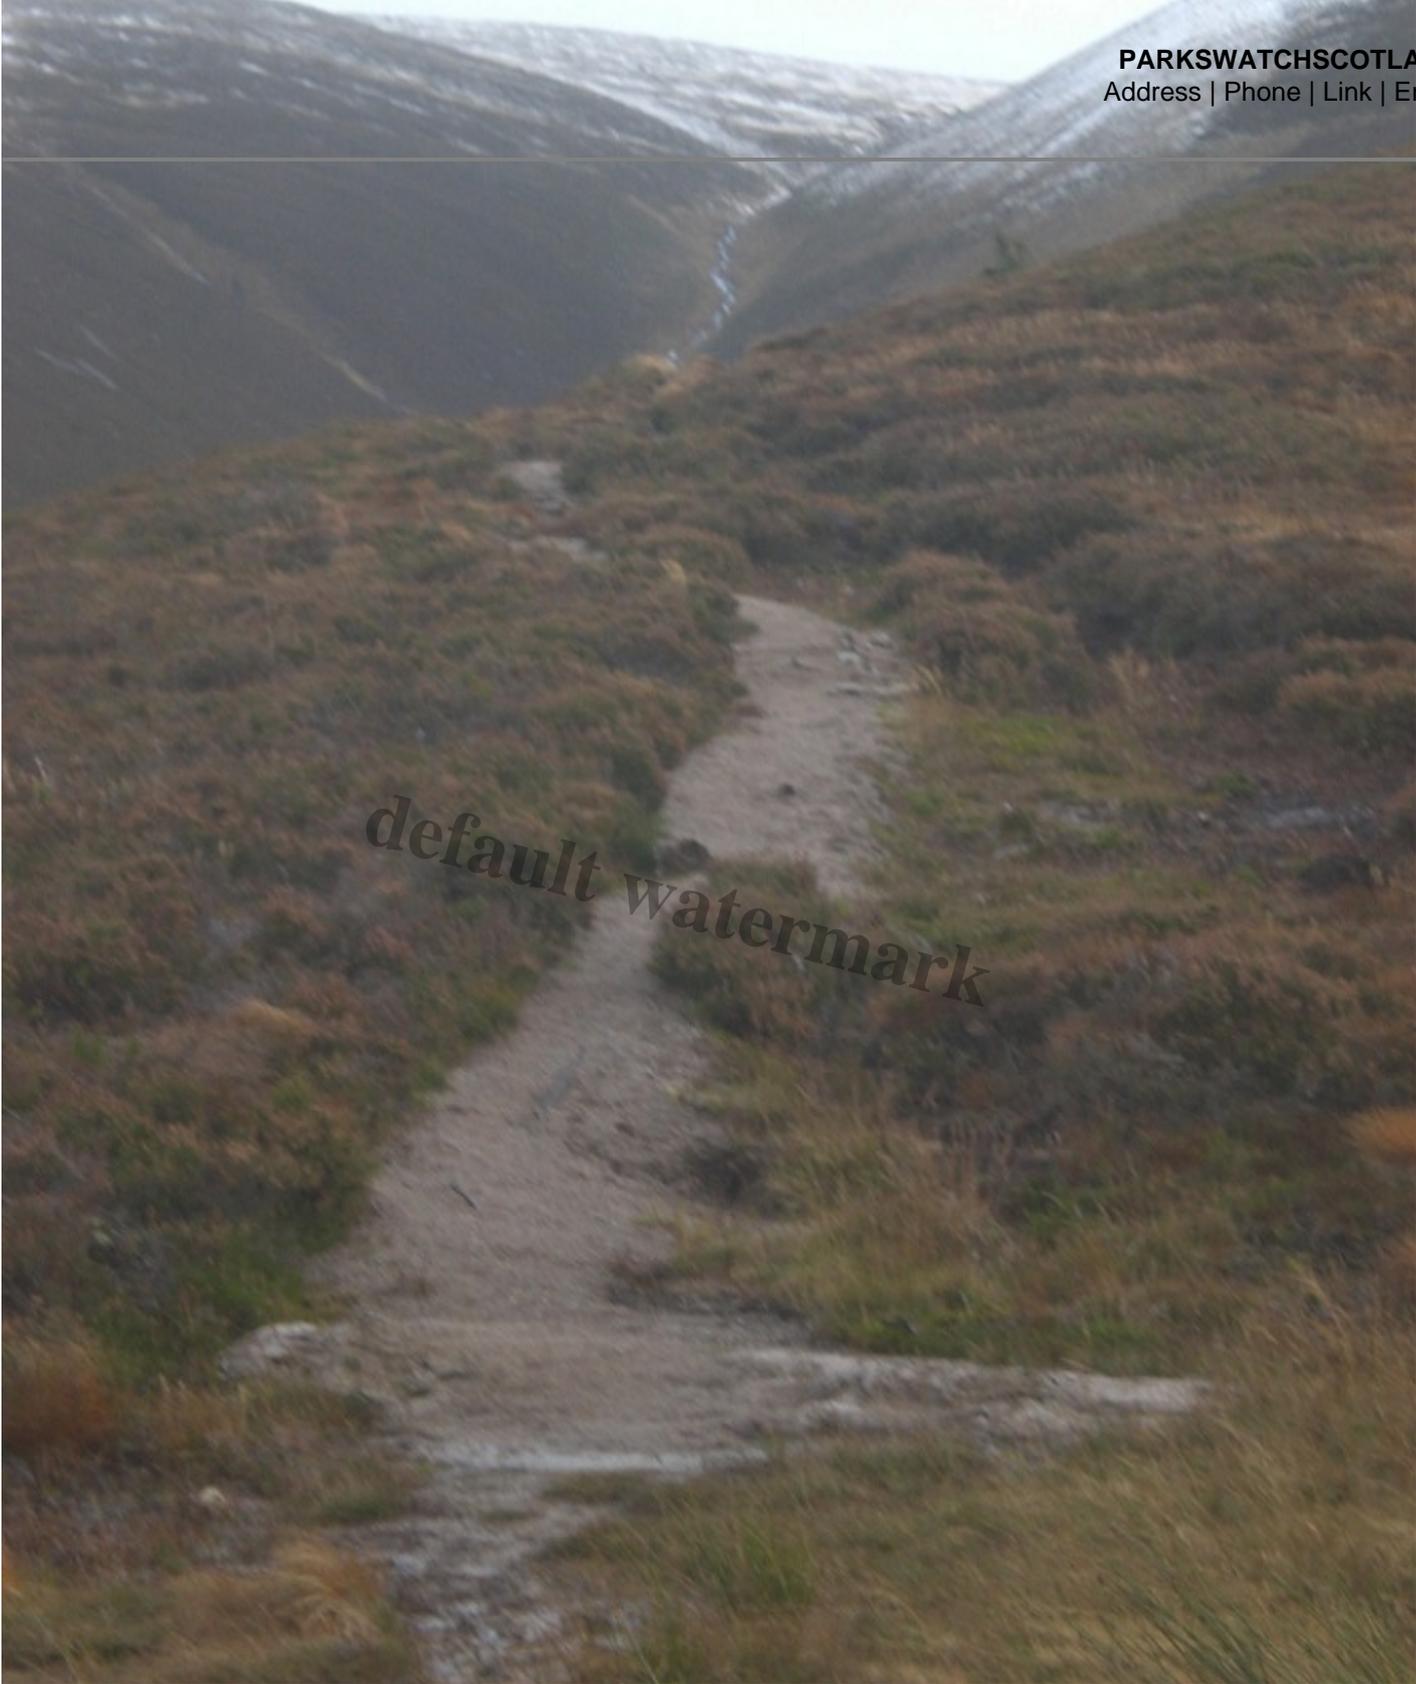
### **The footpath from behind the Ciste Base building**

The path follows a route underneath the line of the Coire na Ciste chairlift but it was never a constructed path and is the result of footfall.

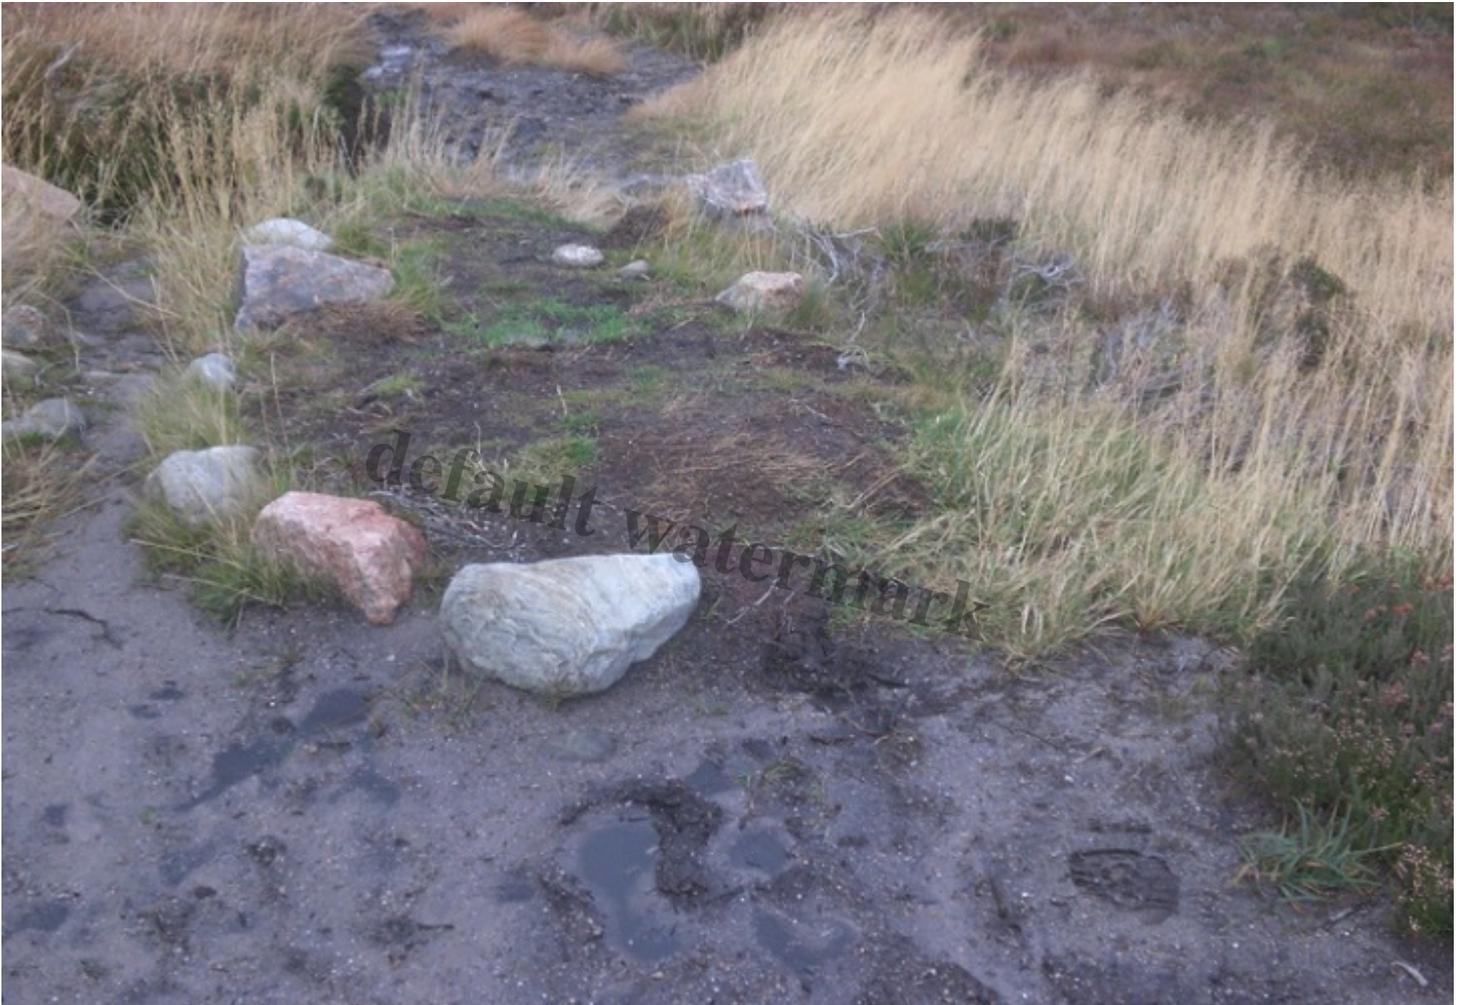
### **The first concrete tower foundation beyond the Ciste Base building**

The clean-up work required the concrete tower foundations to be ground down to 200mm below the level of the surrounding ground. It's clear that there are a number of them where that wasn't done. The vegetation that was used to cover them over has generally died, having nothing but concrete to root into.

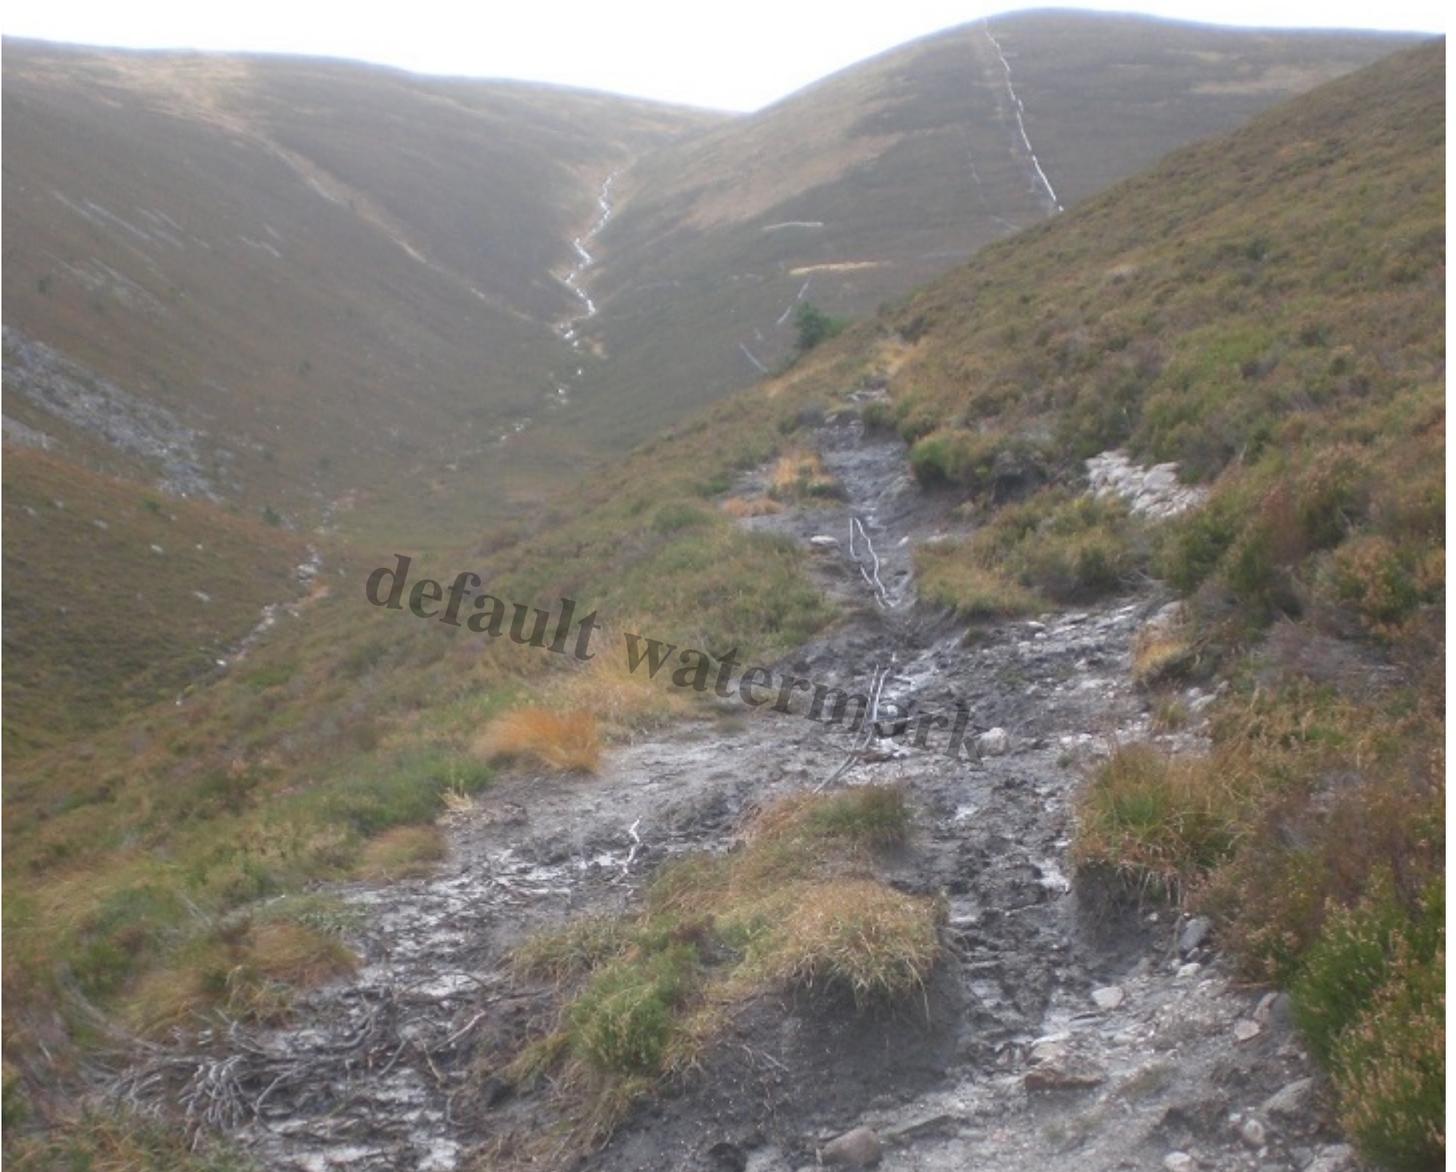
**Eroded path just 200m from the Ciste car park**

The path is badly eroded and there is cabling, associated with the demolished chairlift, that has just been left in the ground.

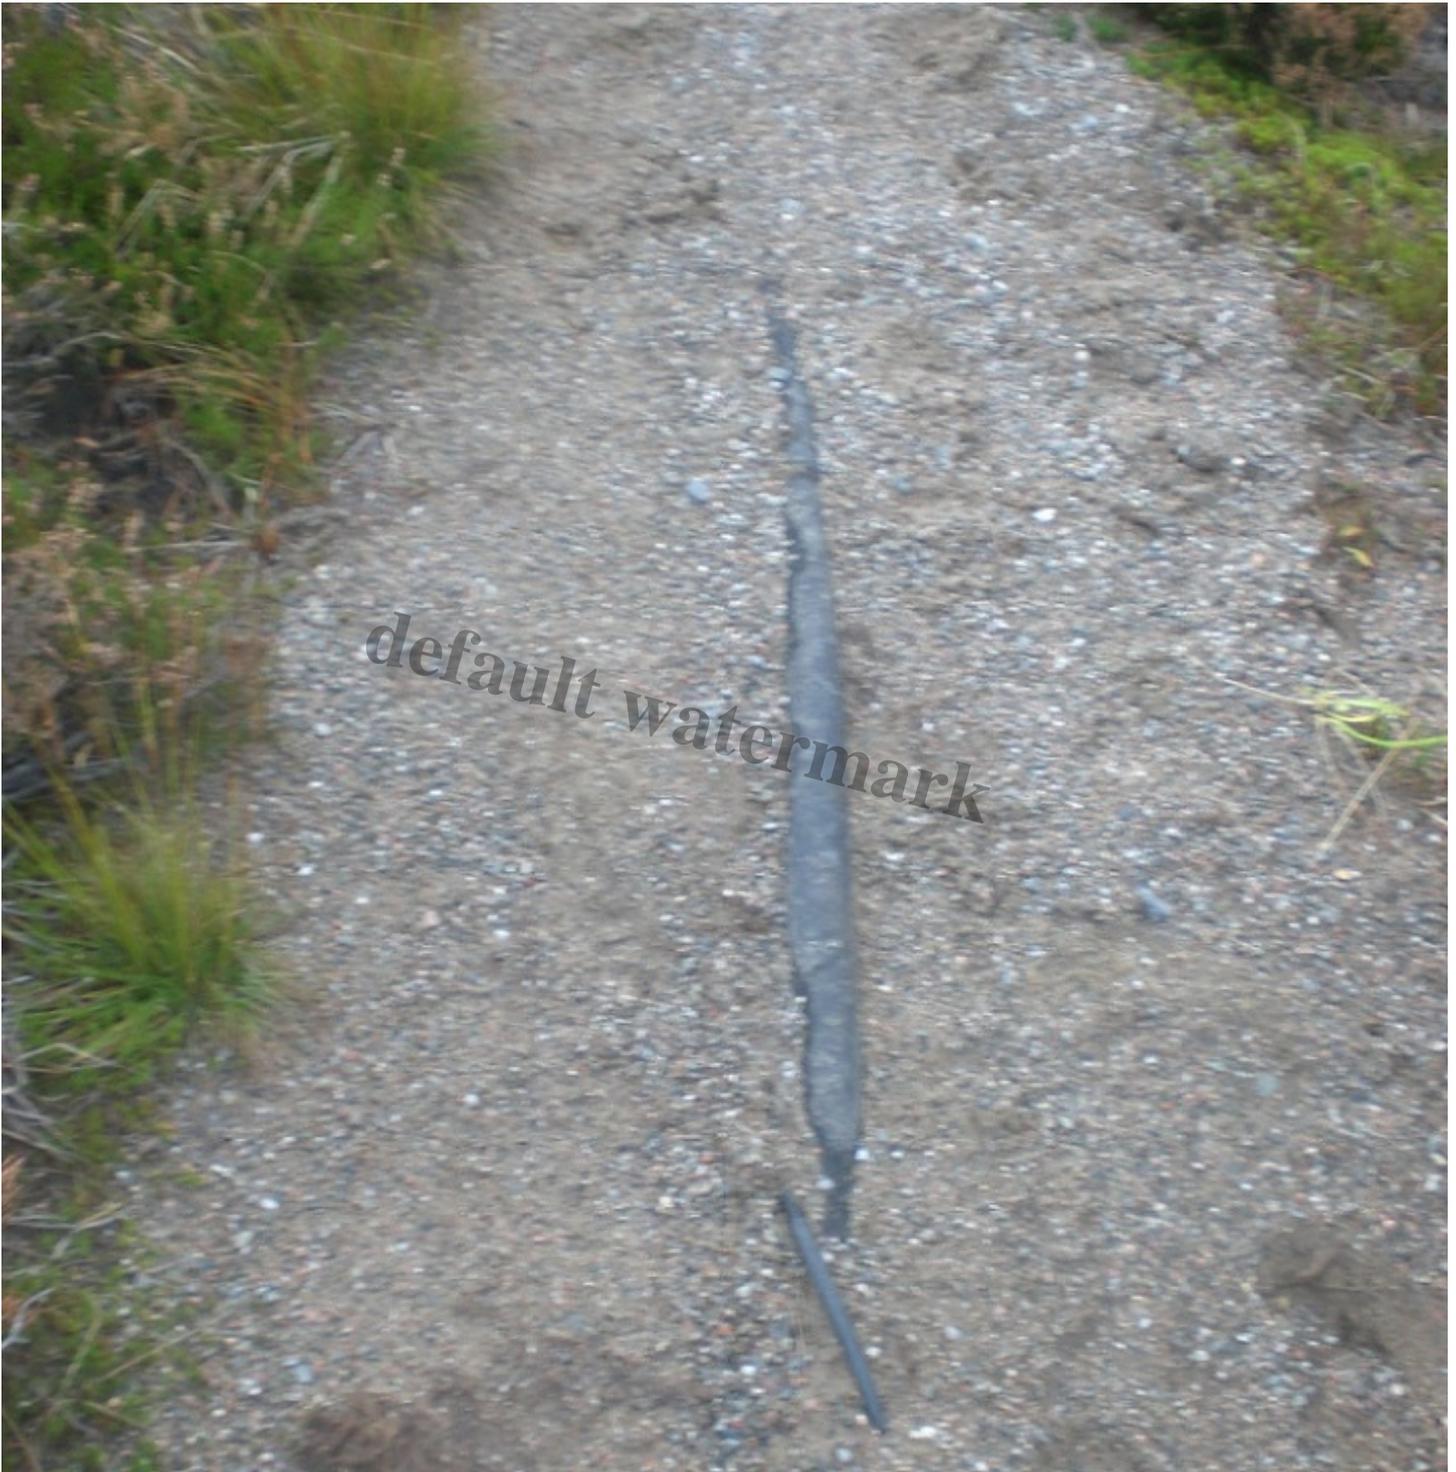
### **Power cable**

The power supply for the West Wall Poma comes from the sub-station that's housed in the Ciste Base Building. Despite sandbags being placed over it on several occasions the cable is on the surface of the ground in a number of places. That cannot be entirely safe and the cable needs to be buried to an appropriate depth, as a matter of urgency.

Meantime, there appears no reason why Cairngorm Mountain, which is currently closed, shouldn't redeploy any spare staff capacity to make a start on a clear-up now. Whatever its position, it needs to ensure the exposed live electricity cable is buried as a matter of urgency.

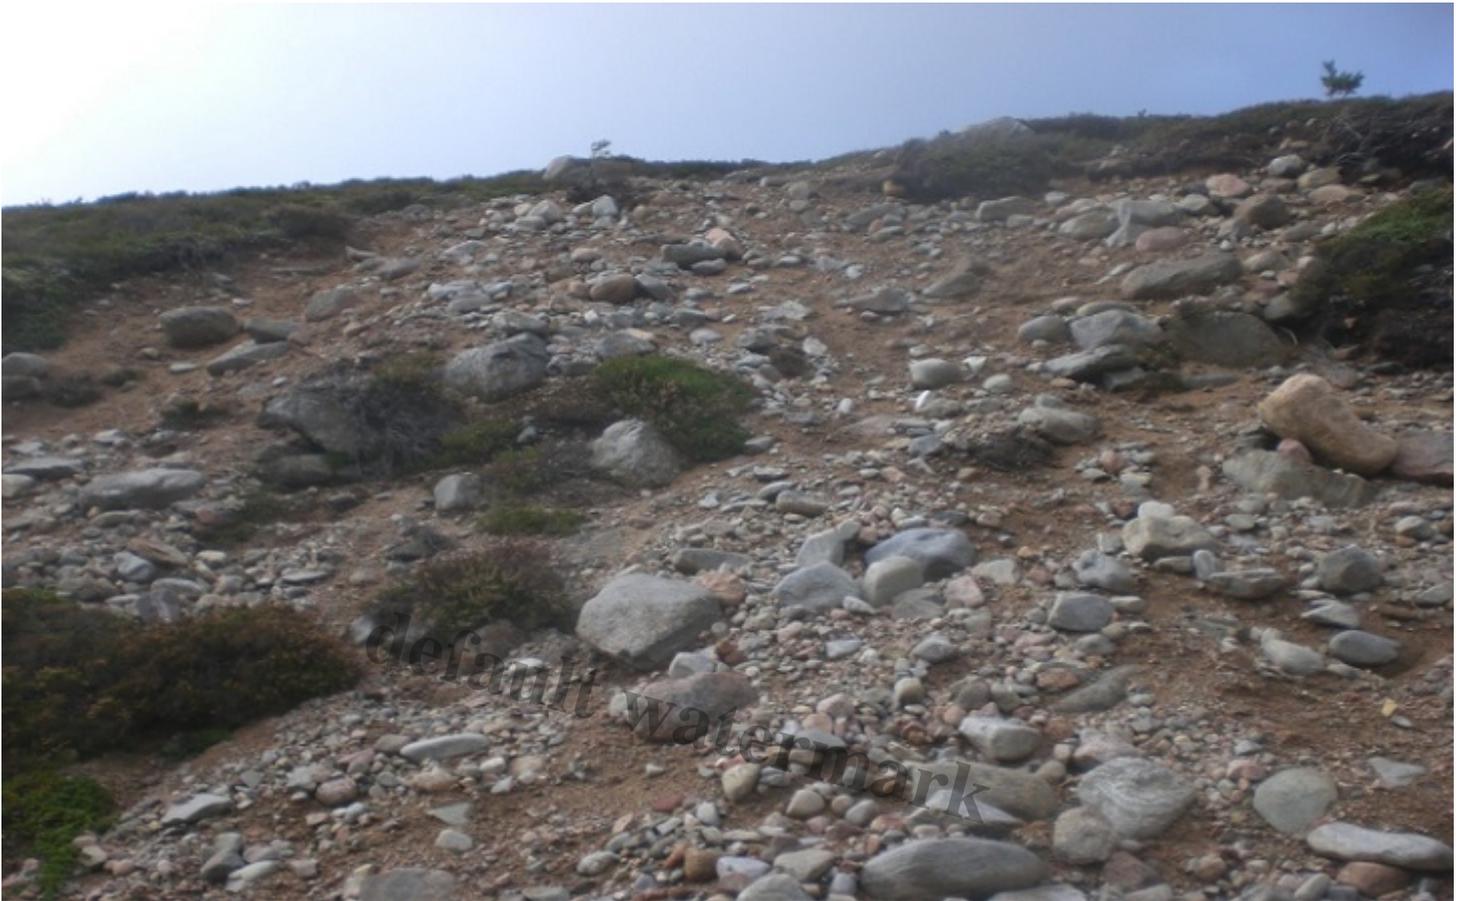
**Collapsing hillside above the path.**

The path cuts directly across the collapsing hillside. Thereâ??s a danger that the hillside could slide down into the Allt na Ciste below and it would be expedient to re-route the path and keep people off this area.

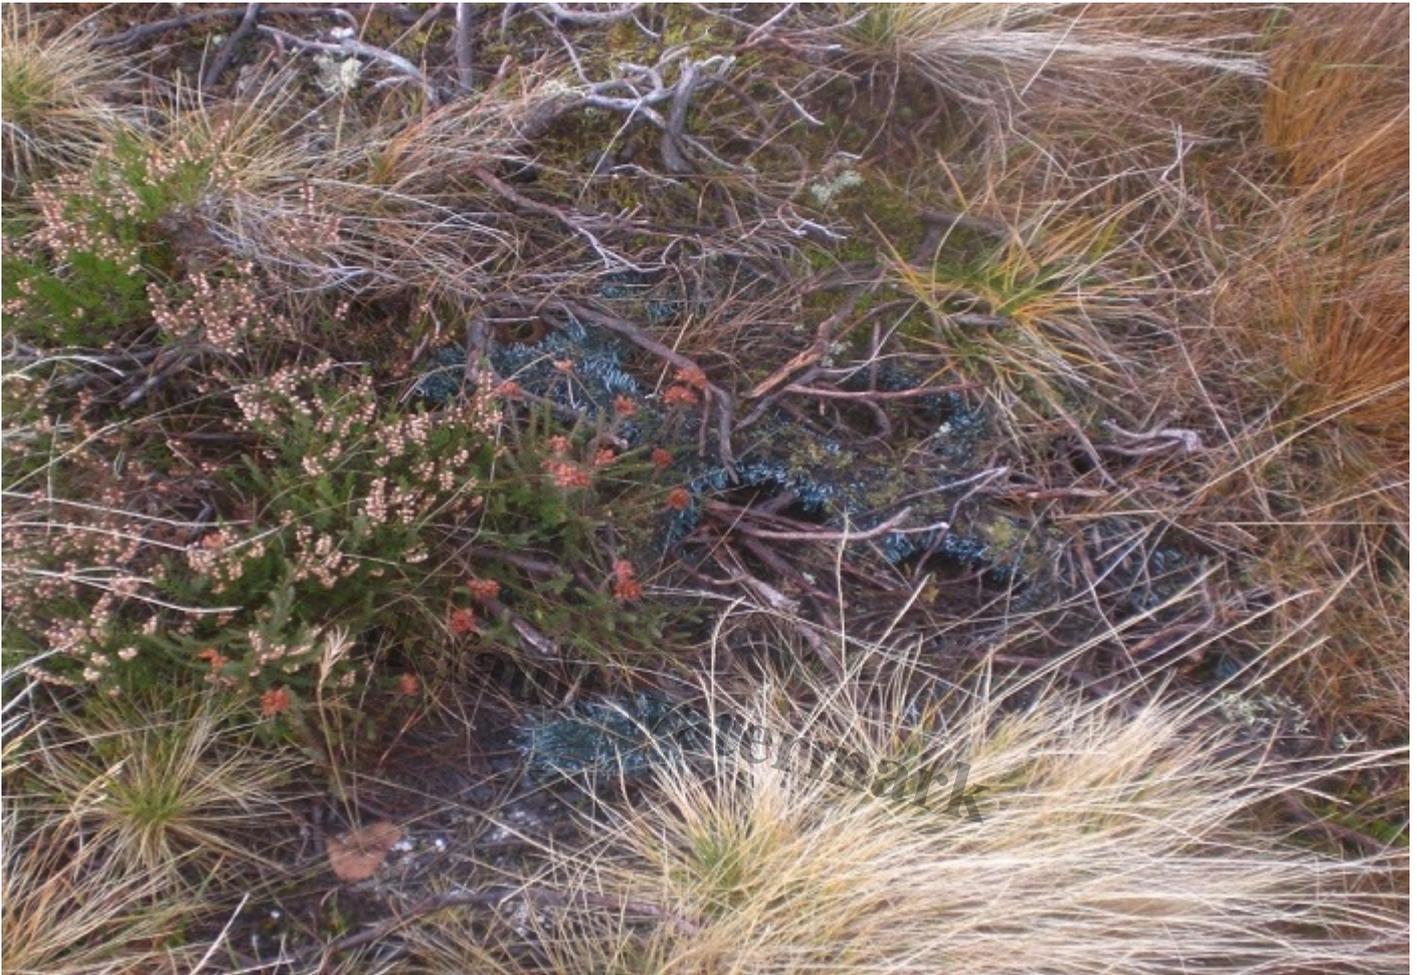
**Ski matting.**

That matting isn't biodegradable, is foreign to the area and it should have been removed during the clean-up operation.

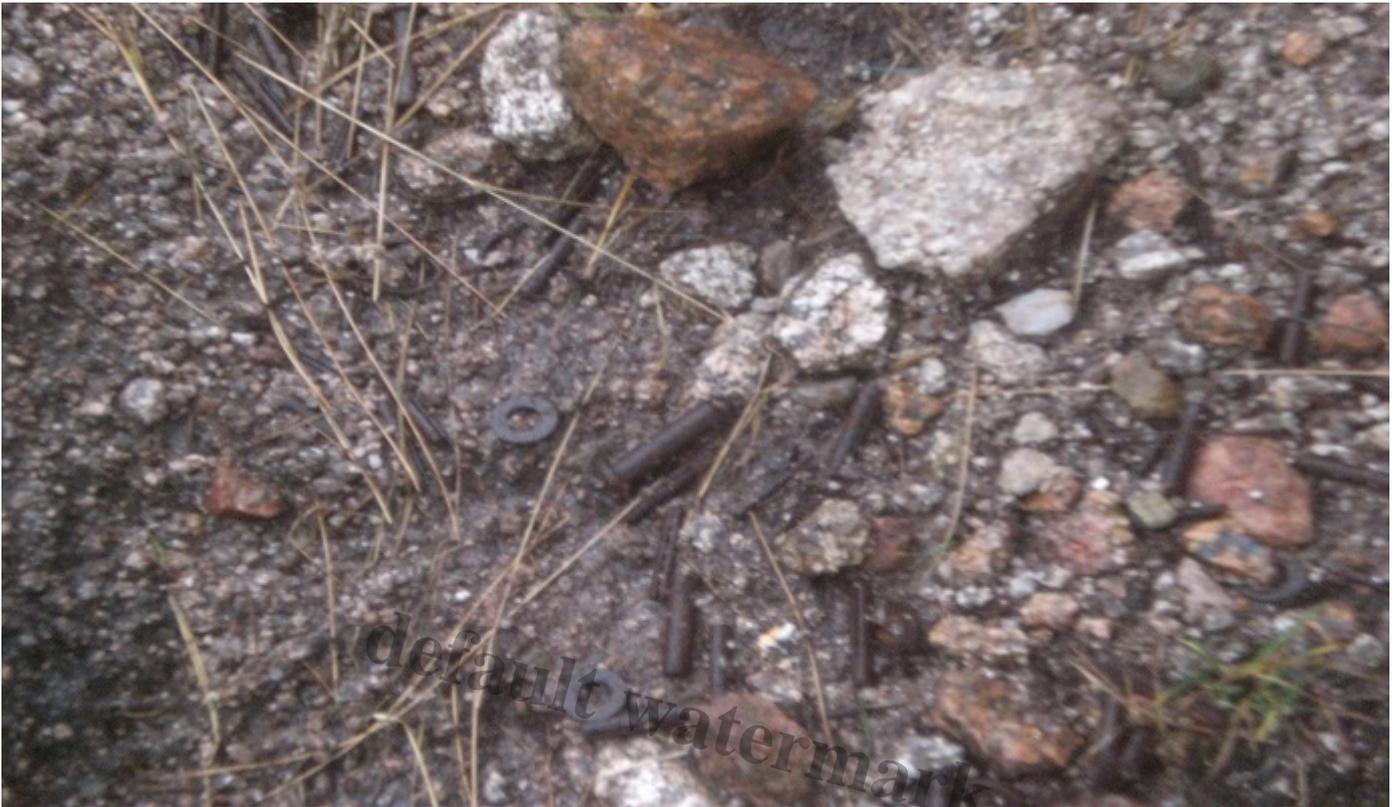
**Rusting bolts and washers.**

These have been discarded beneath the West Wall Poma loading gantry. Why?

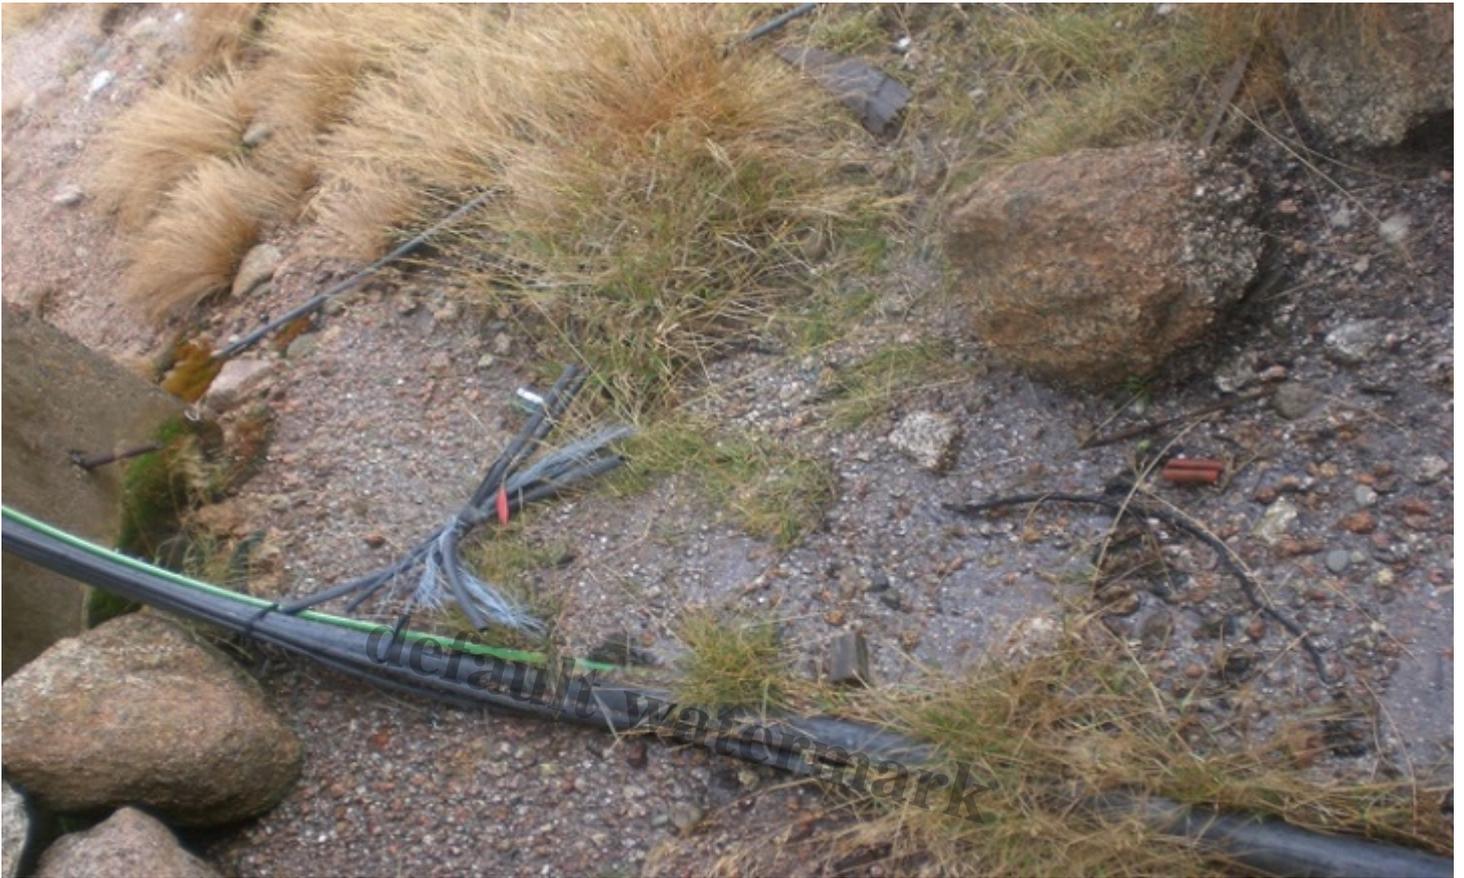
### **Assorted detritus**

Abandoned materials that are scattered on the ground beneath the West Wall Poma loading gantry.  
Why?

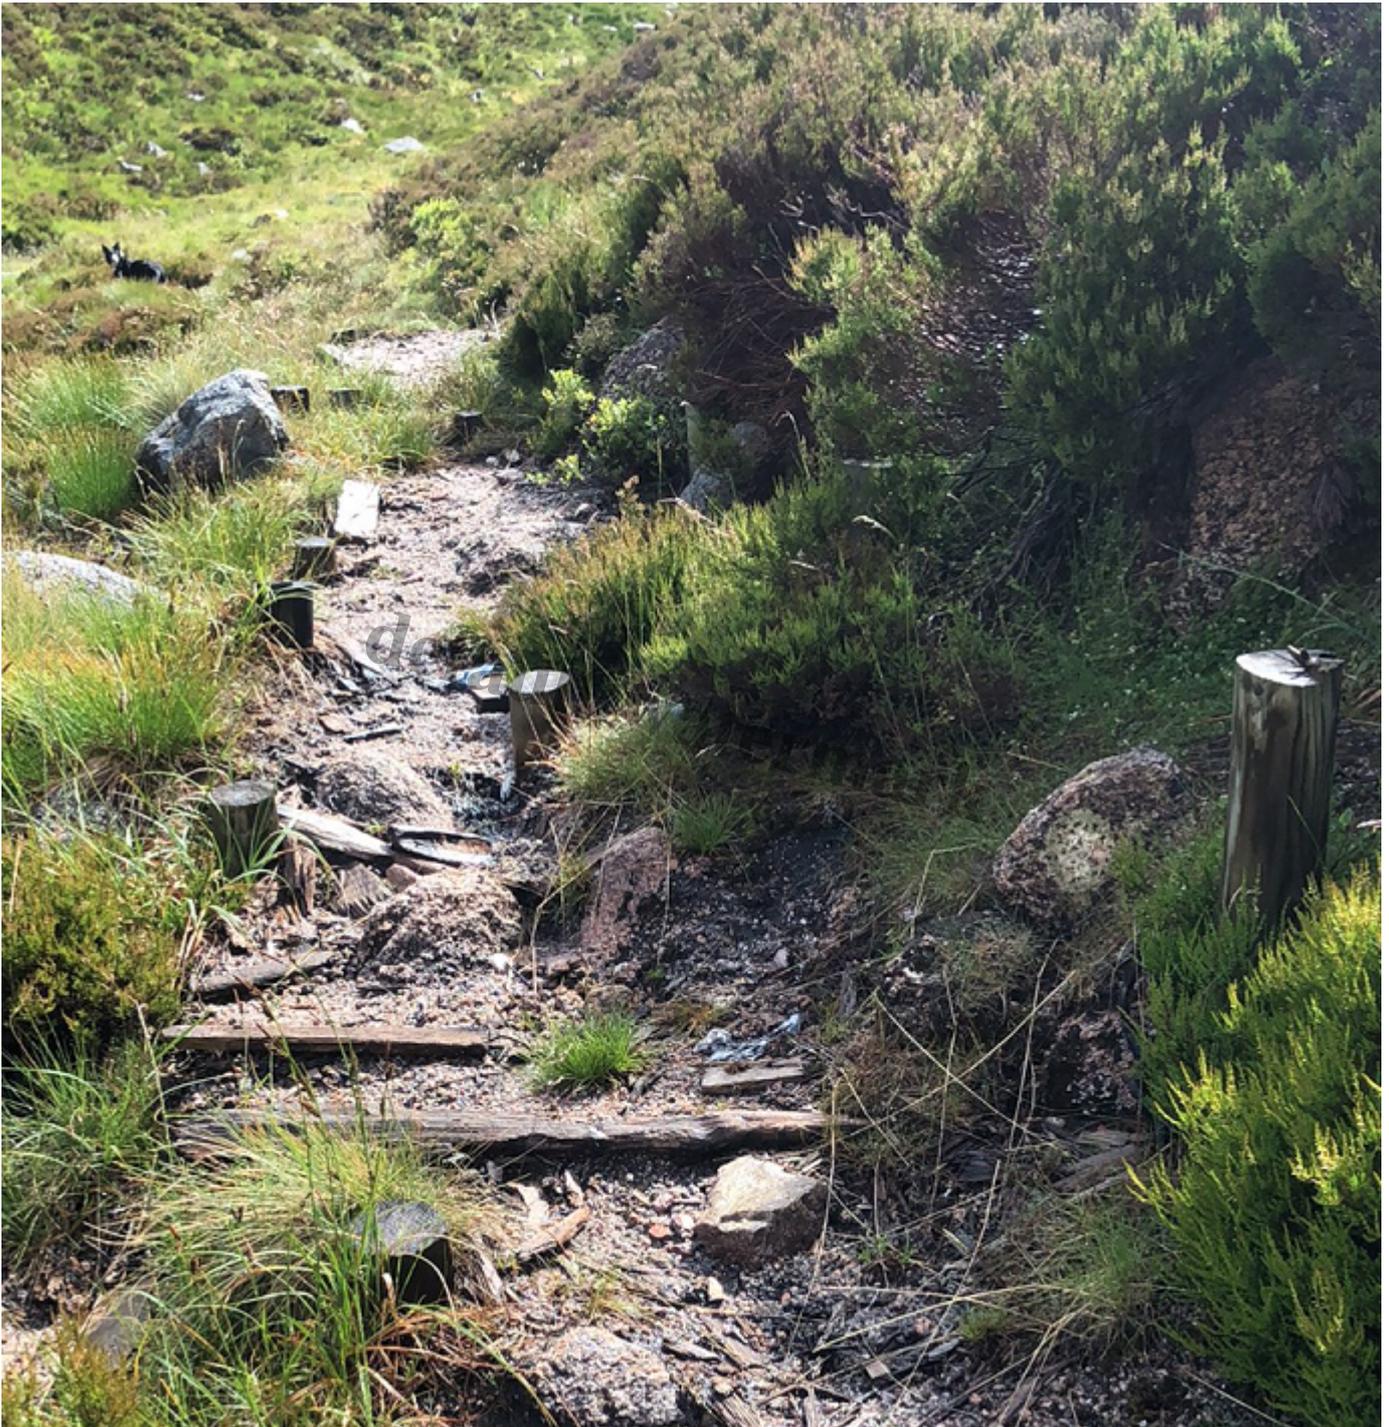
### **The boardwalk**

It has been several years now since the boardwalk was removed. A very substandard job was done as evidenced by the mess that still lies on the site today. It can be clearly seen that there has been no vegetation regeneration.

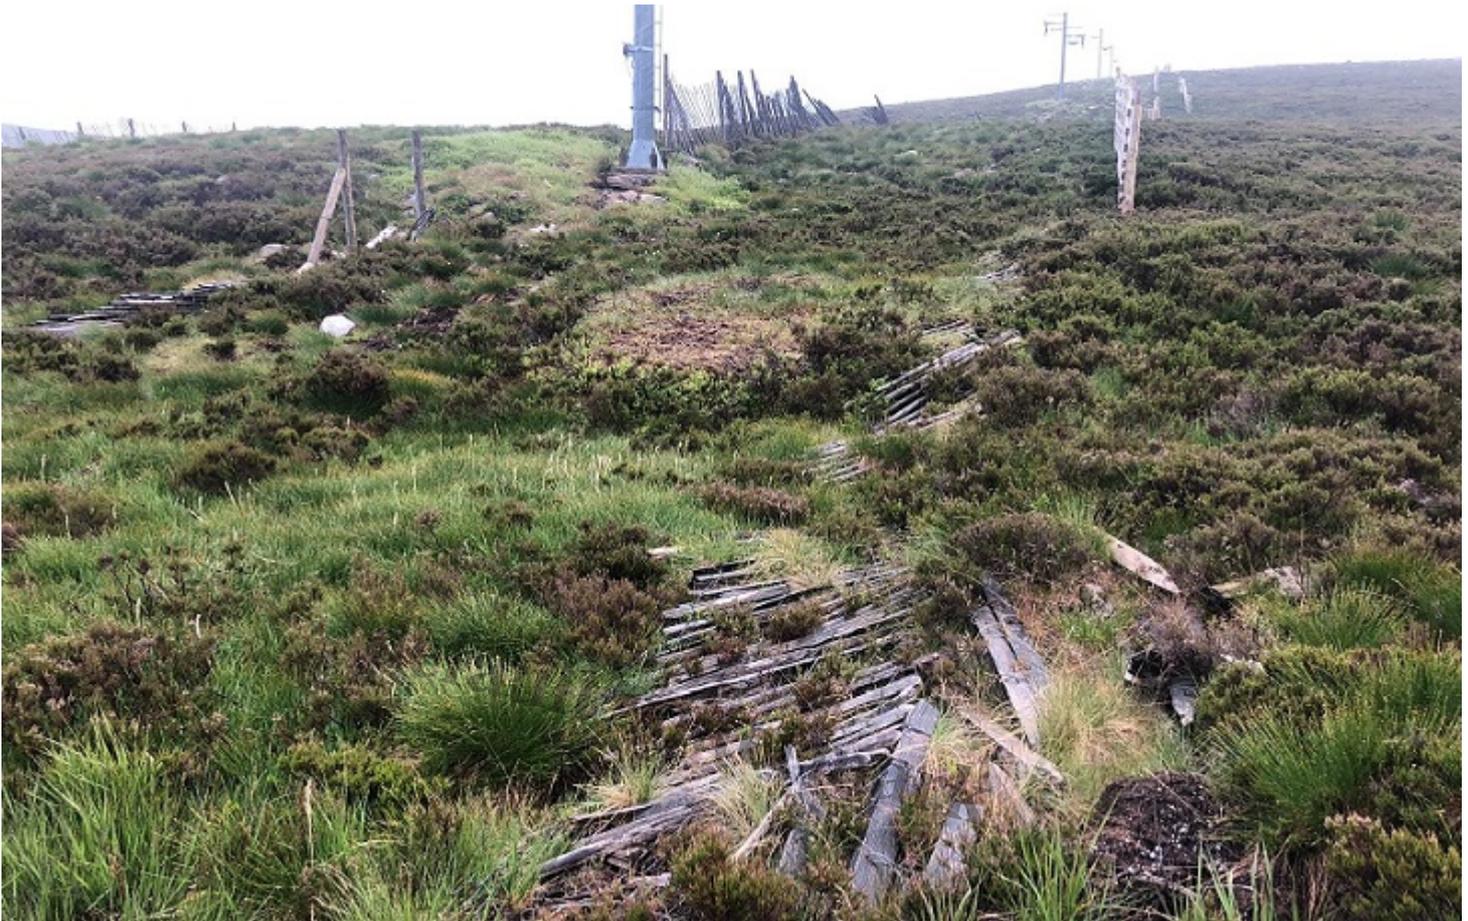
**Broken fencing.**

This has been lying on the ground for so long that some vegetation is growing through it while other plants will have died.

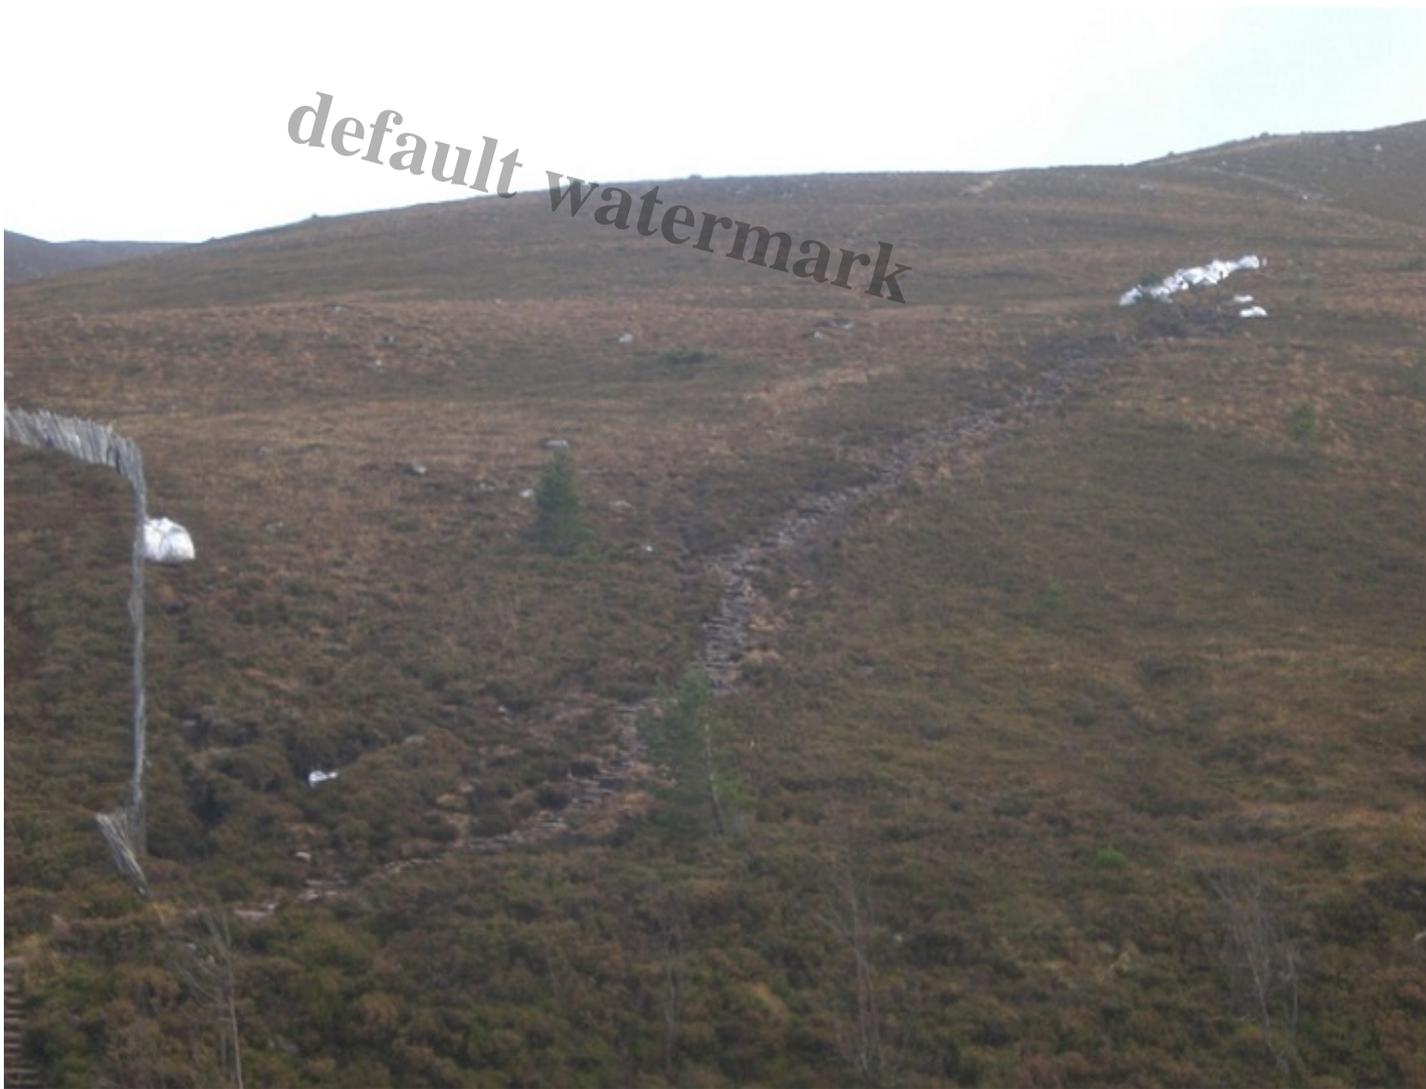
Stone path under construction on the east side of Coire na Ciste

There is however a glimmer of hope. Path construction work has been ongoing for several weeks on the east side of the Coire from just across the Allt na Ciste, above the damaged bridge. Many hundreds of metres of path construction are required but it is good to see that a decent start has been made.
