HIE's failure to manage Cairn Gorm – the environmental neglect in Coire na Ciste.

In the summer of 2017, Highlands and Islands Enterprise (HIE) organised the demolition of the Coire na Ciste and West Wall chairlifts ([see here](#)). That work was done at the same time as other clear-up work and it came at a cost of £267k in public money.

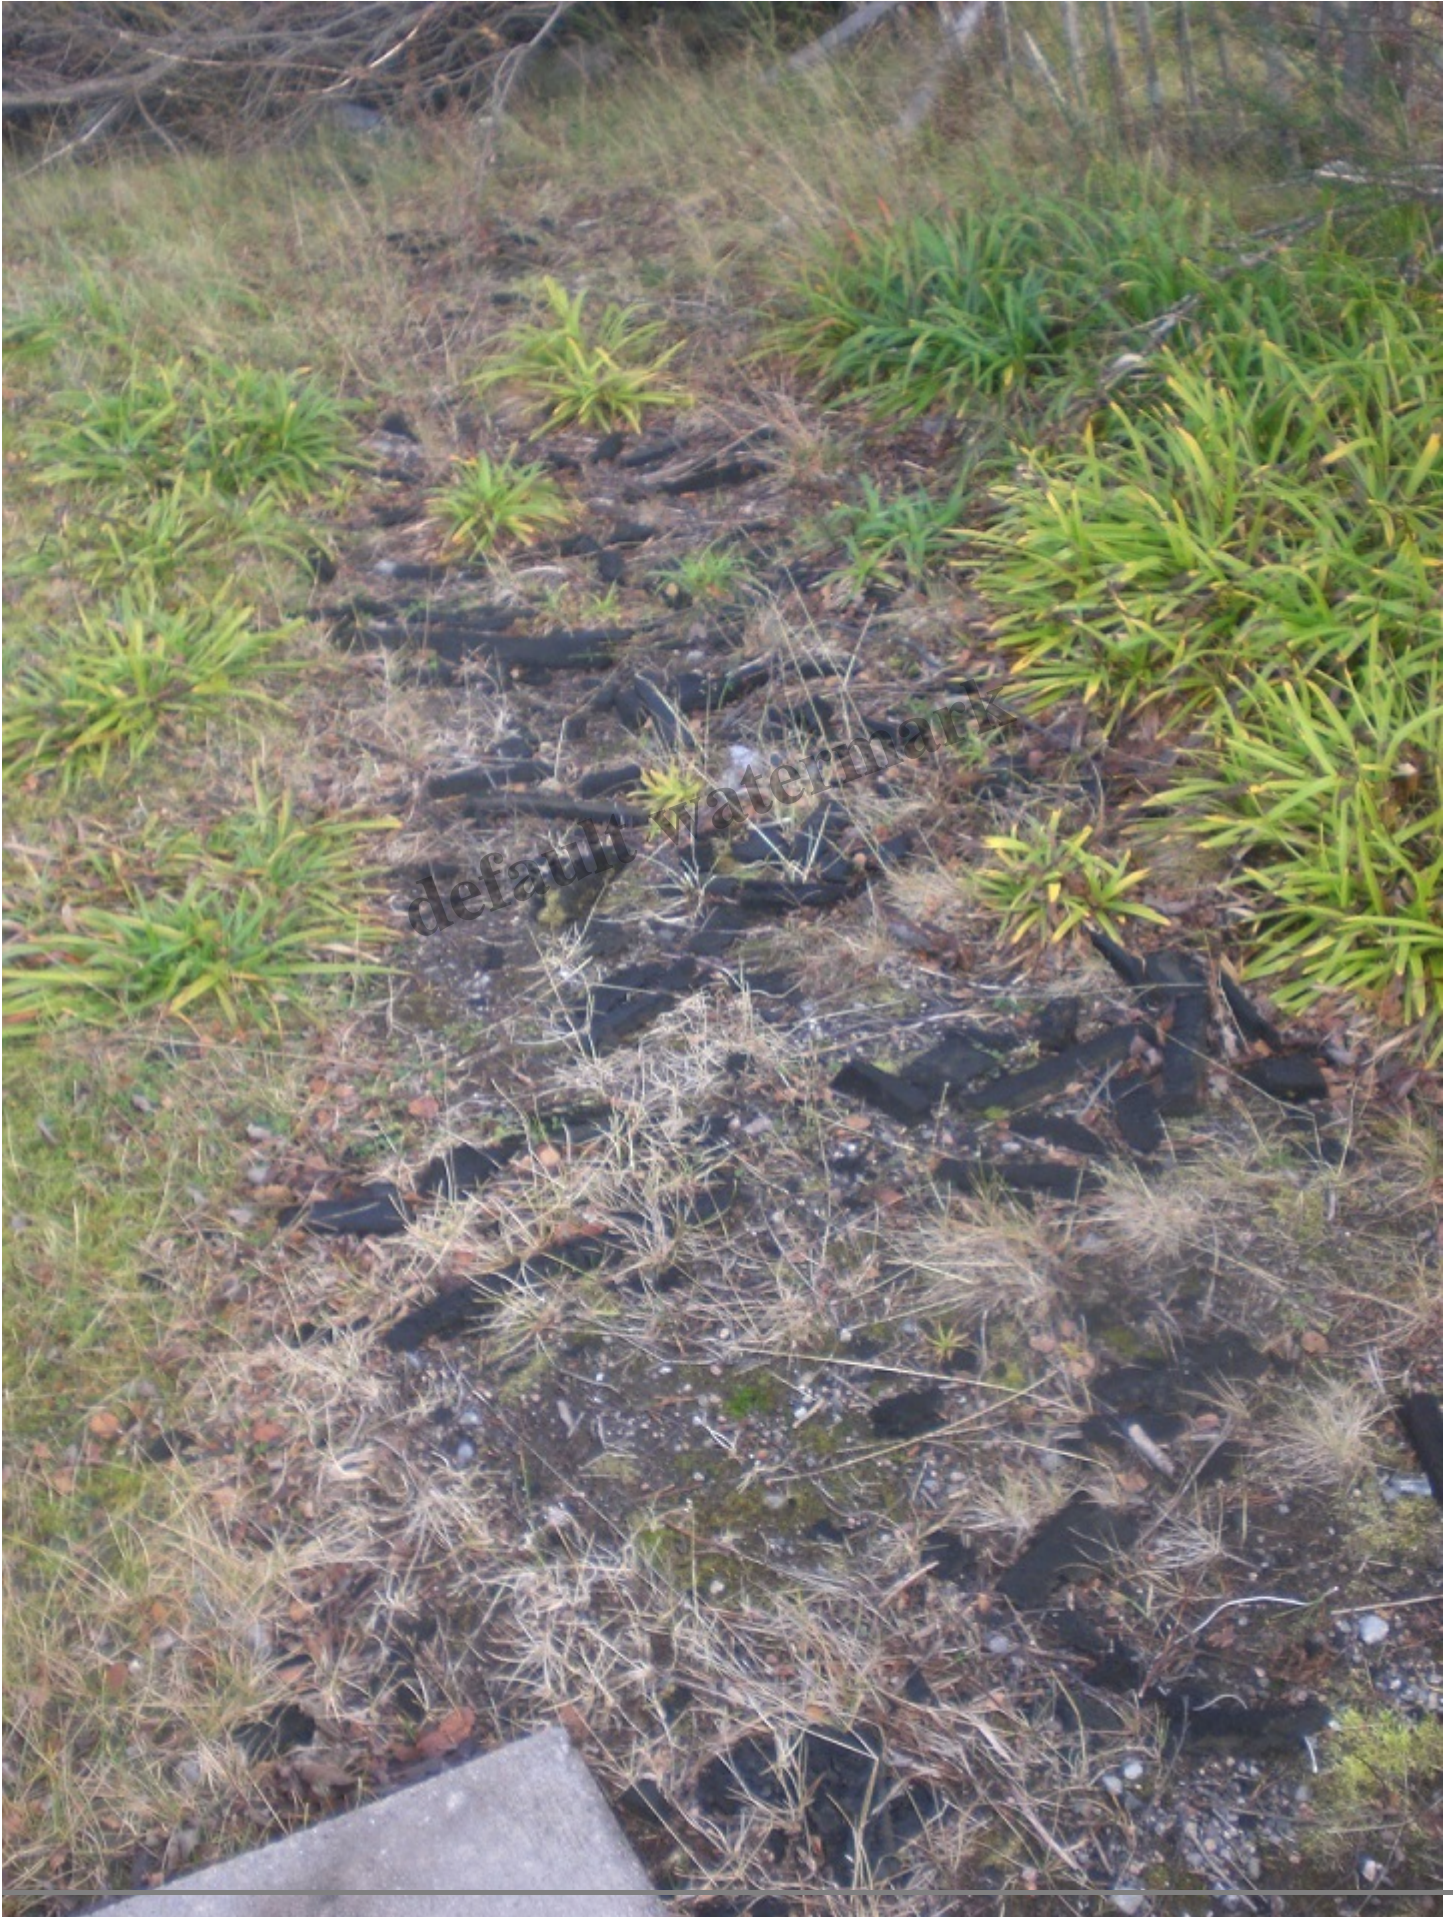
Pieces of Rubber in the car park

The out of use chairs from the chairlifts were stacked here for years. They were removed as part of the clean-up operation. Regrettably, that didn't include the removal of pieces of rubber which had perished and fallen off the chairs as they lay there uncovered and unmaintained. It's evident that the regeneration of natural vegetation is being retarded.

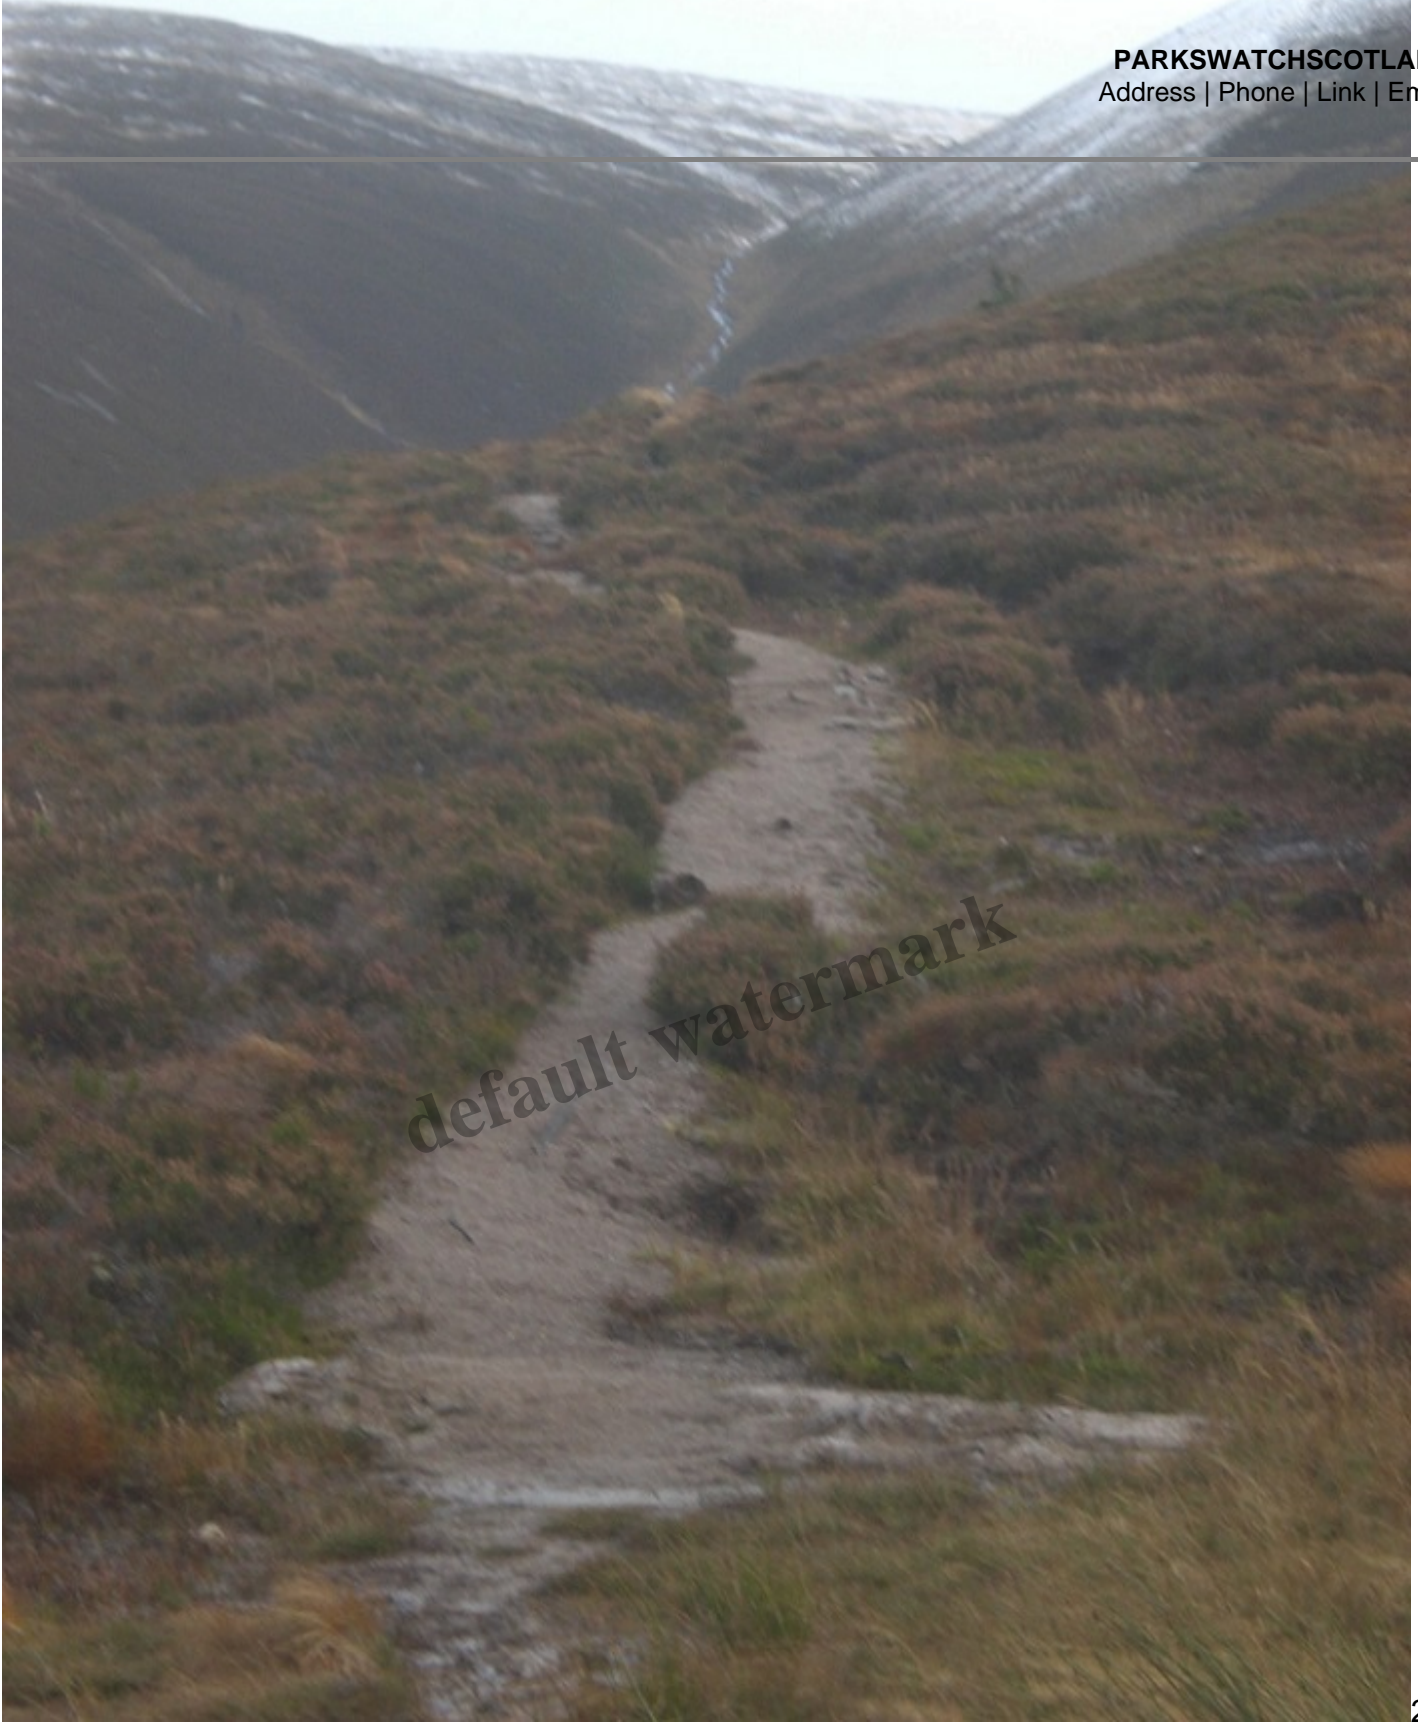
The footpath from behind the Ciste Base building

The path follows a route underneath the line of the Coire na Ciste chairlift but it was never a constructed path and is the result of footfall.

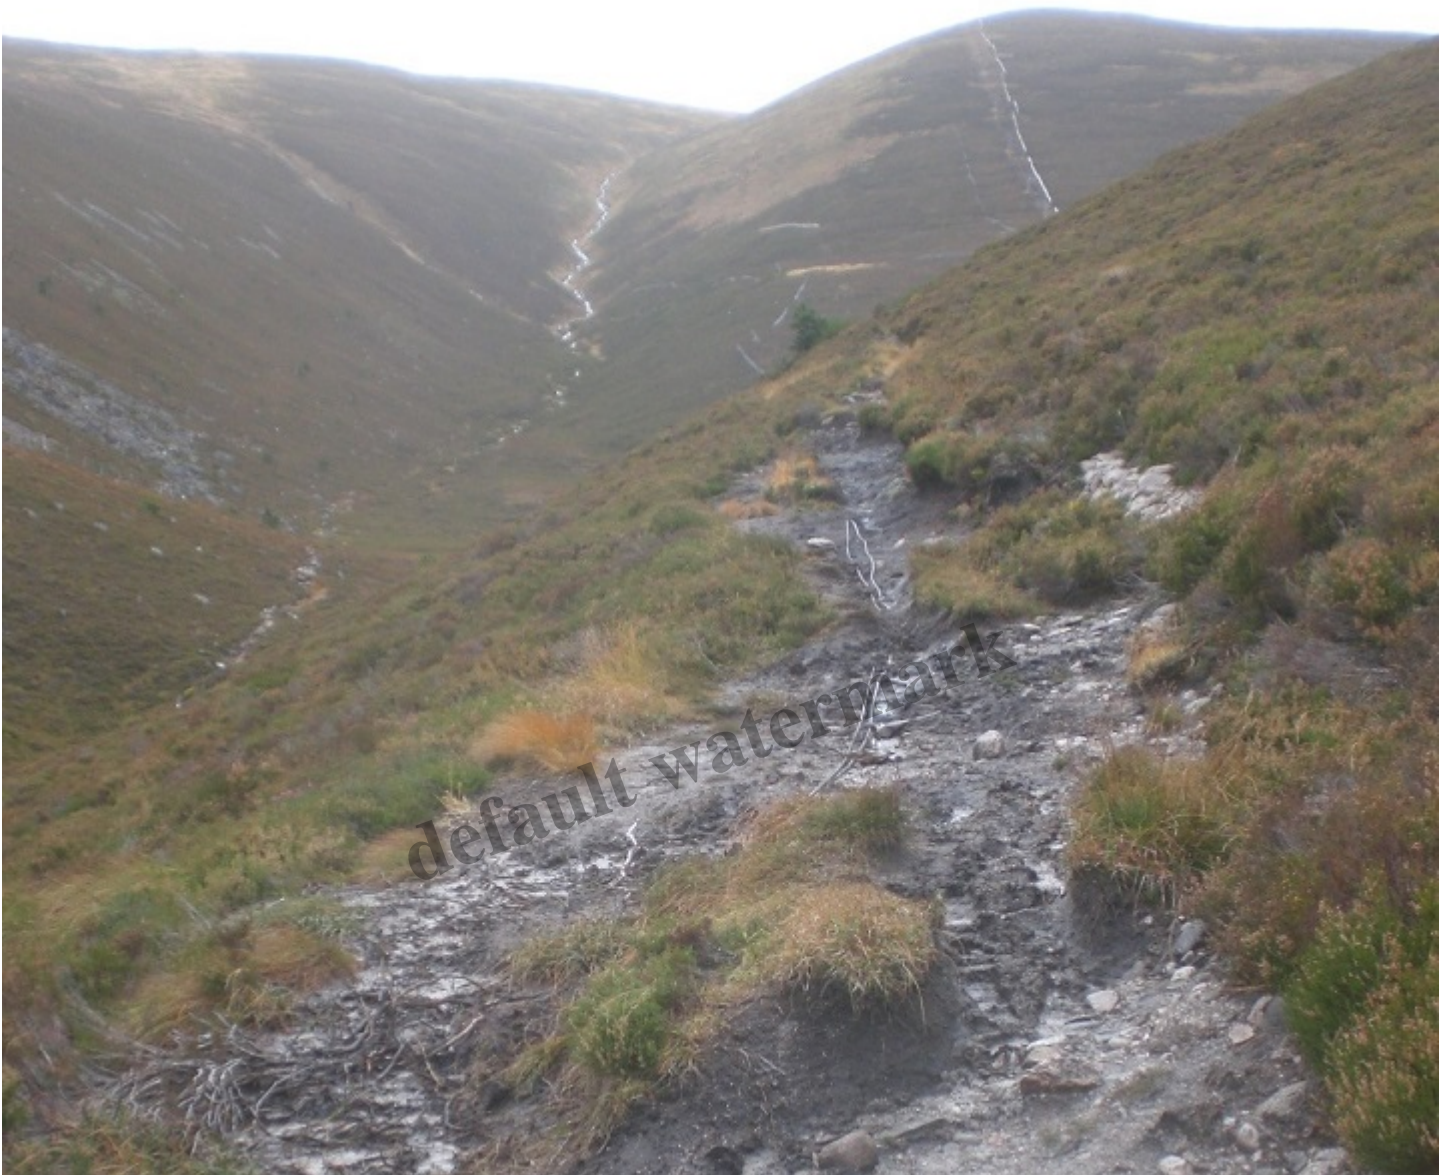
Eroded path just 200m from the Ciste car park

The path is badly eroded and there is cabling, associated with the demolished chairlift, that has just been left in the ground.

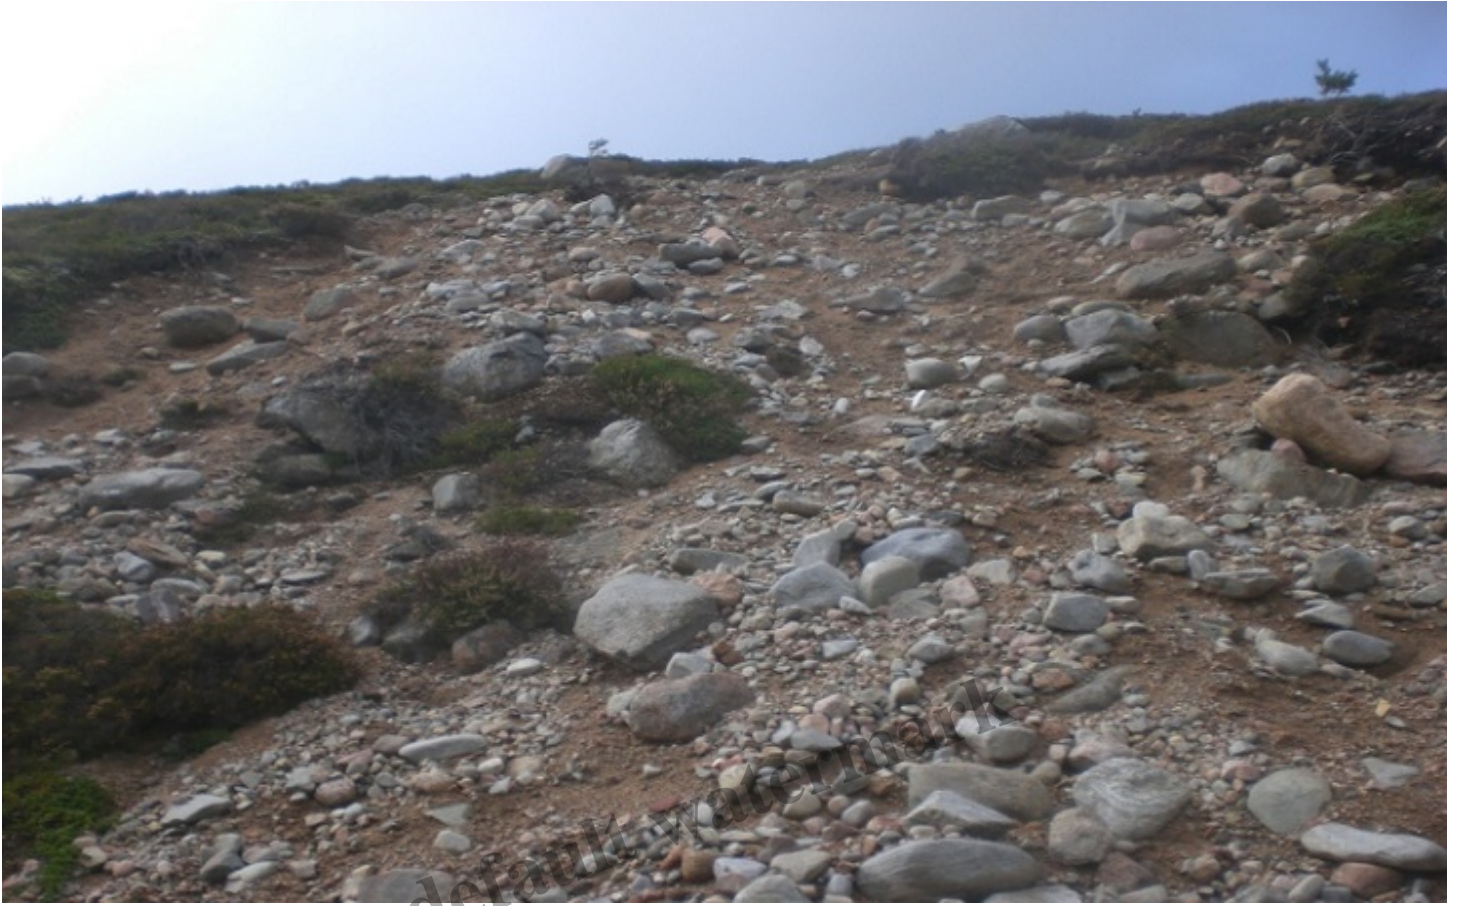
Collapsing hillside above the path.

The path cuts directly across the collapsing hillside. There's a danger that the hillside could slide down into the Allt na Ciste below and it would be expedient to re-route the path and keep people off this area.

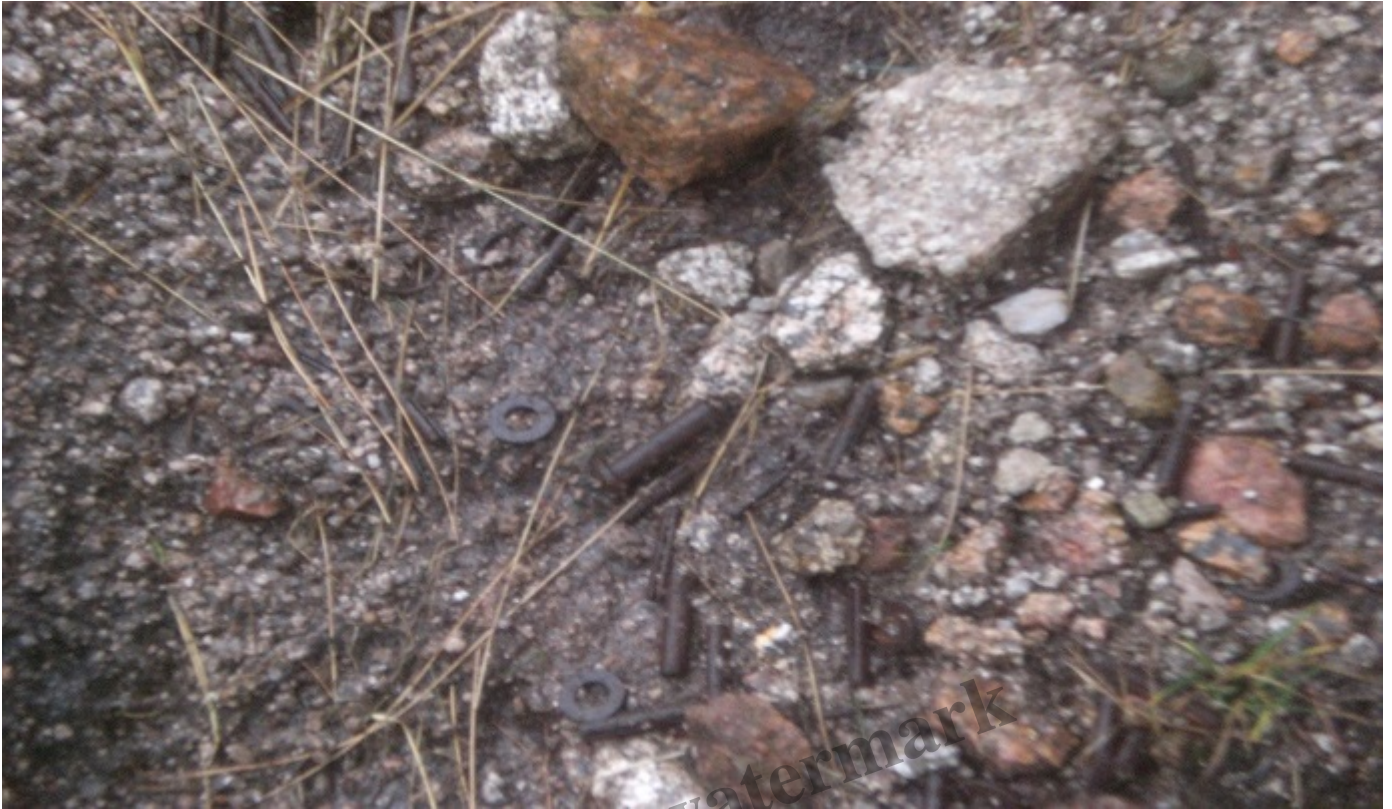
Rusting bolts and washers.

These have been discarded beneath the West Wall Poma loading gantry. Why?

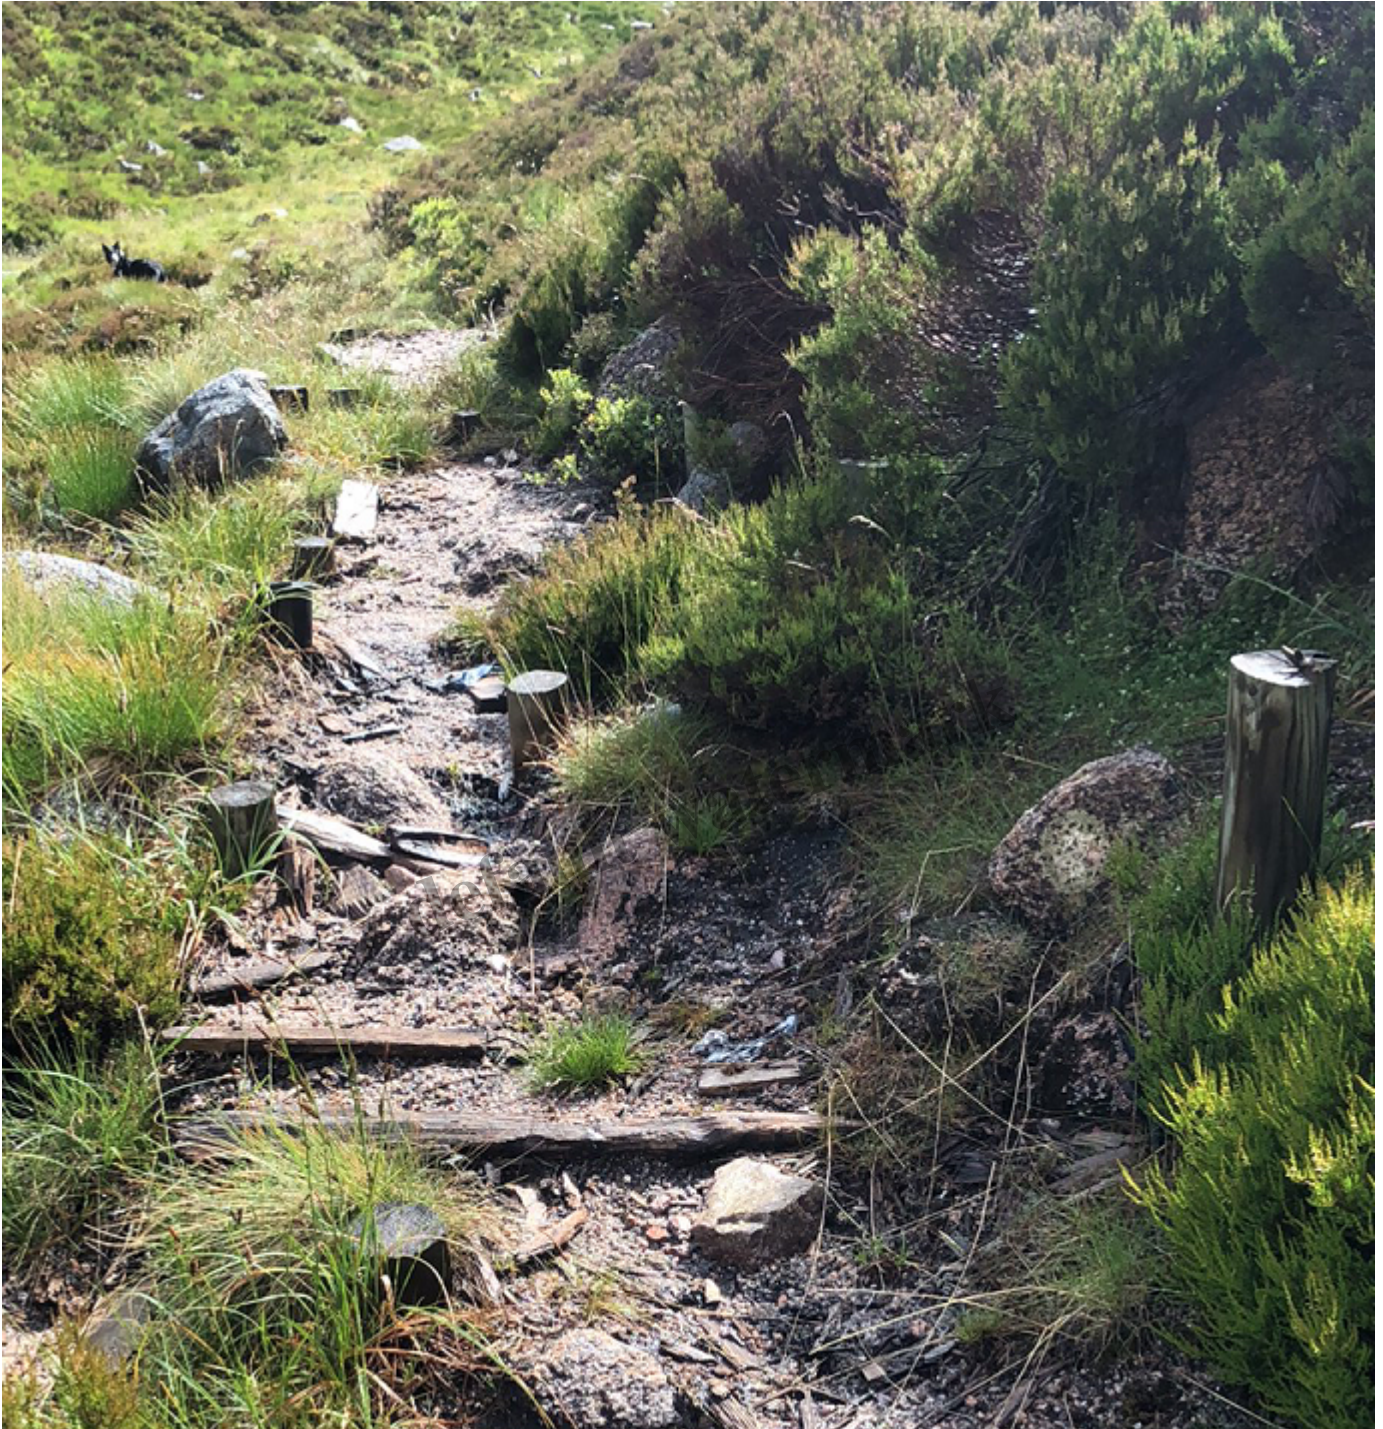
The boardwalk

It has been several years now since the boardwalk was removed. A very substandard job was done as evidenced by the mess that still lies on the site today. It can be clearly seen that there has been no vegetation regeneration.

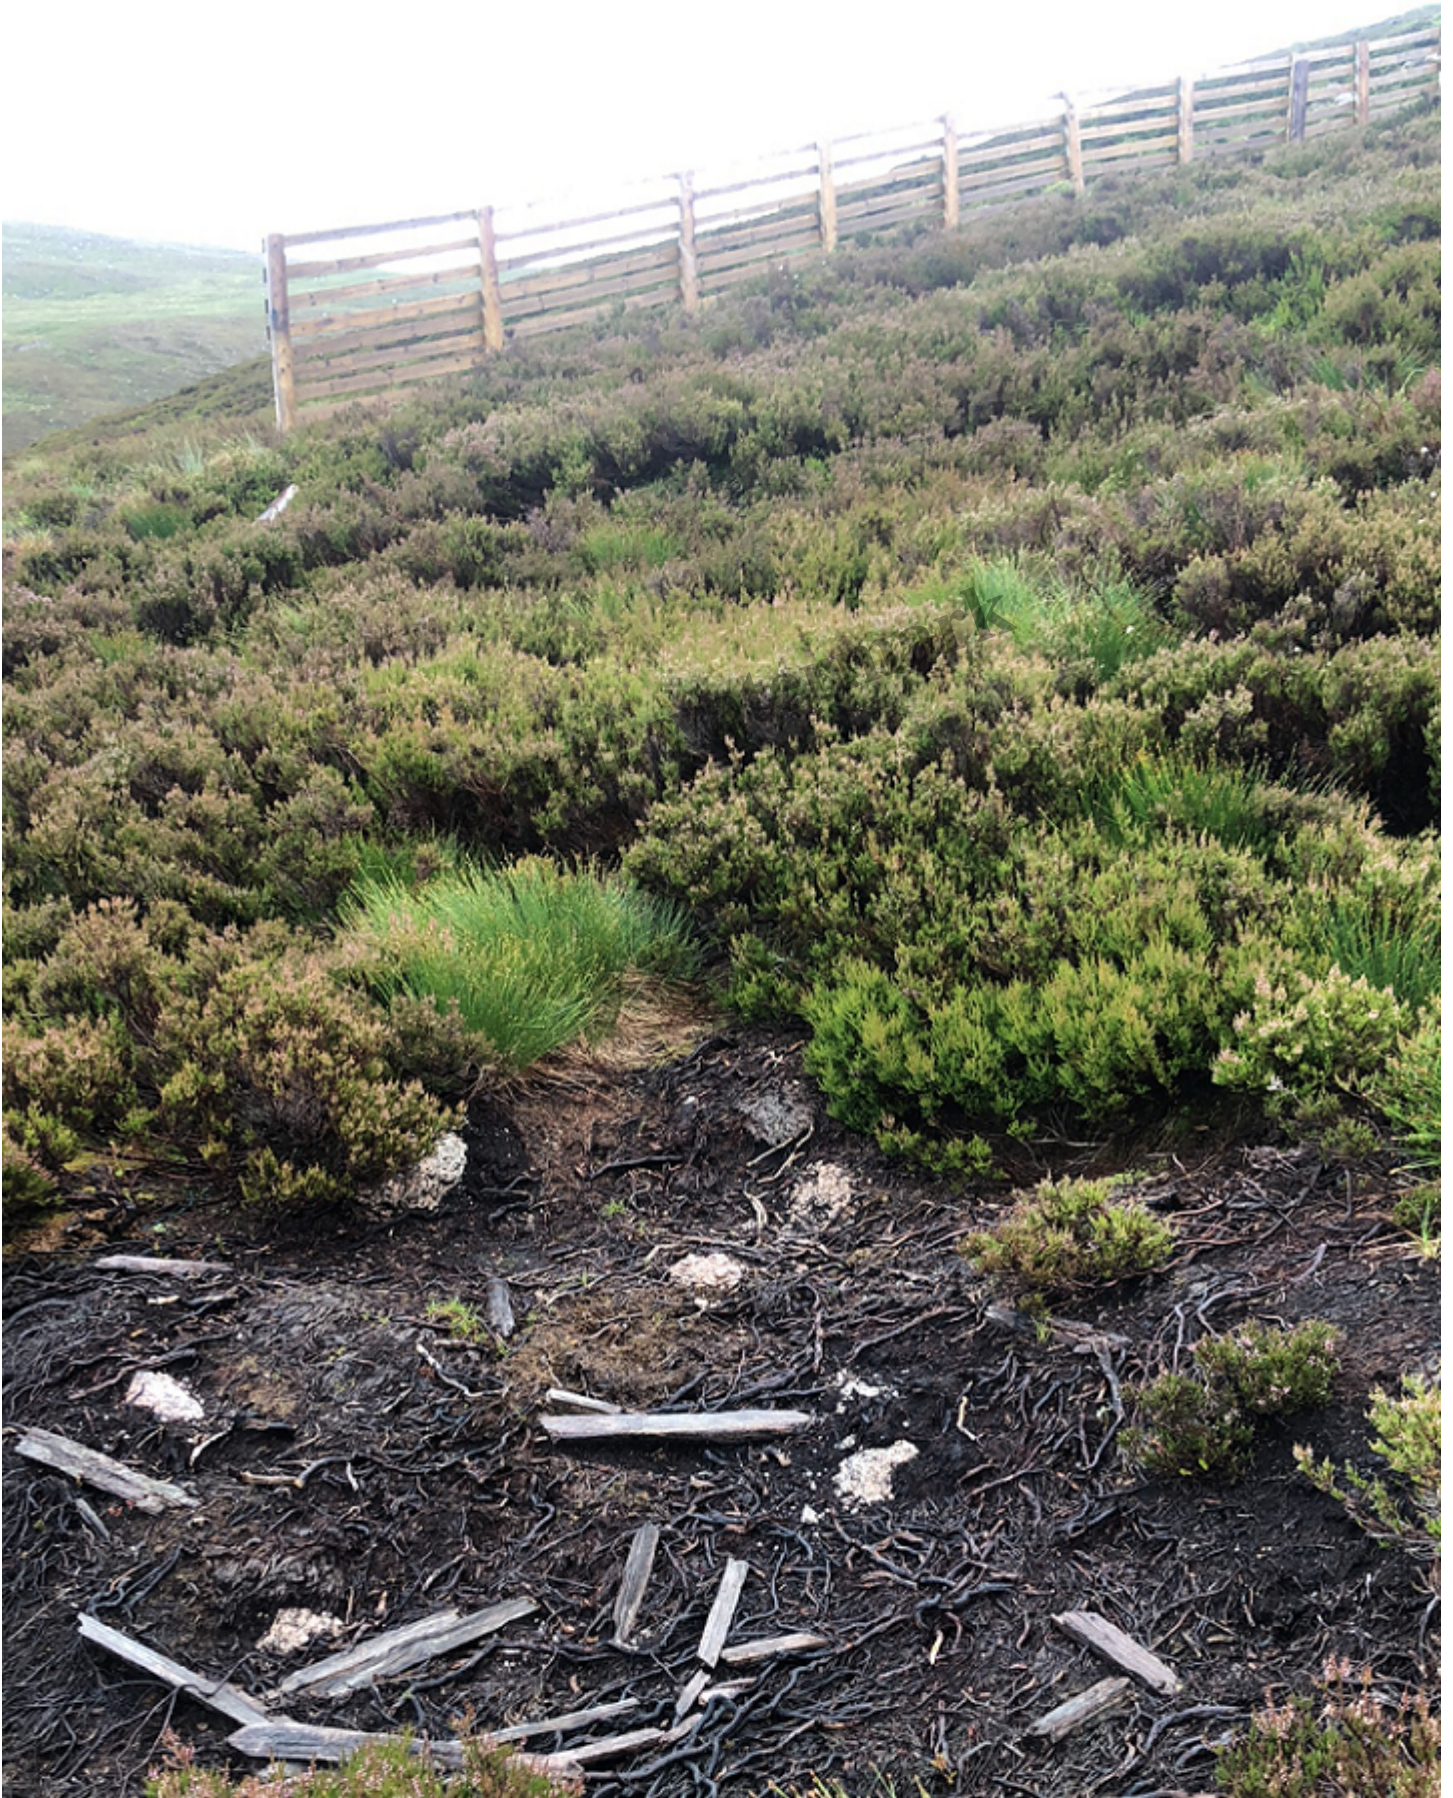
Dead ground higher up the coire.

Old Chesnut piling fencing, which had been rolled up for removal and then left lying on the ground for years had the effect of killing the vegetation. Even when it was finally removed, the area wasn't cleaned up and that's preventing the vegetation from regrowing.

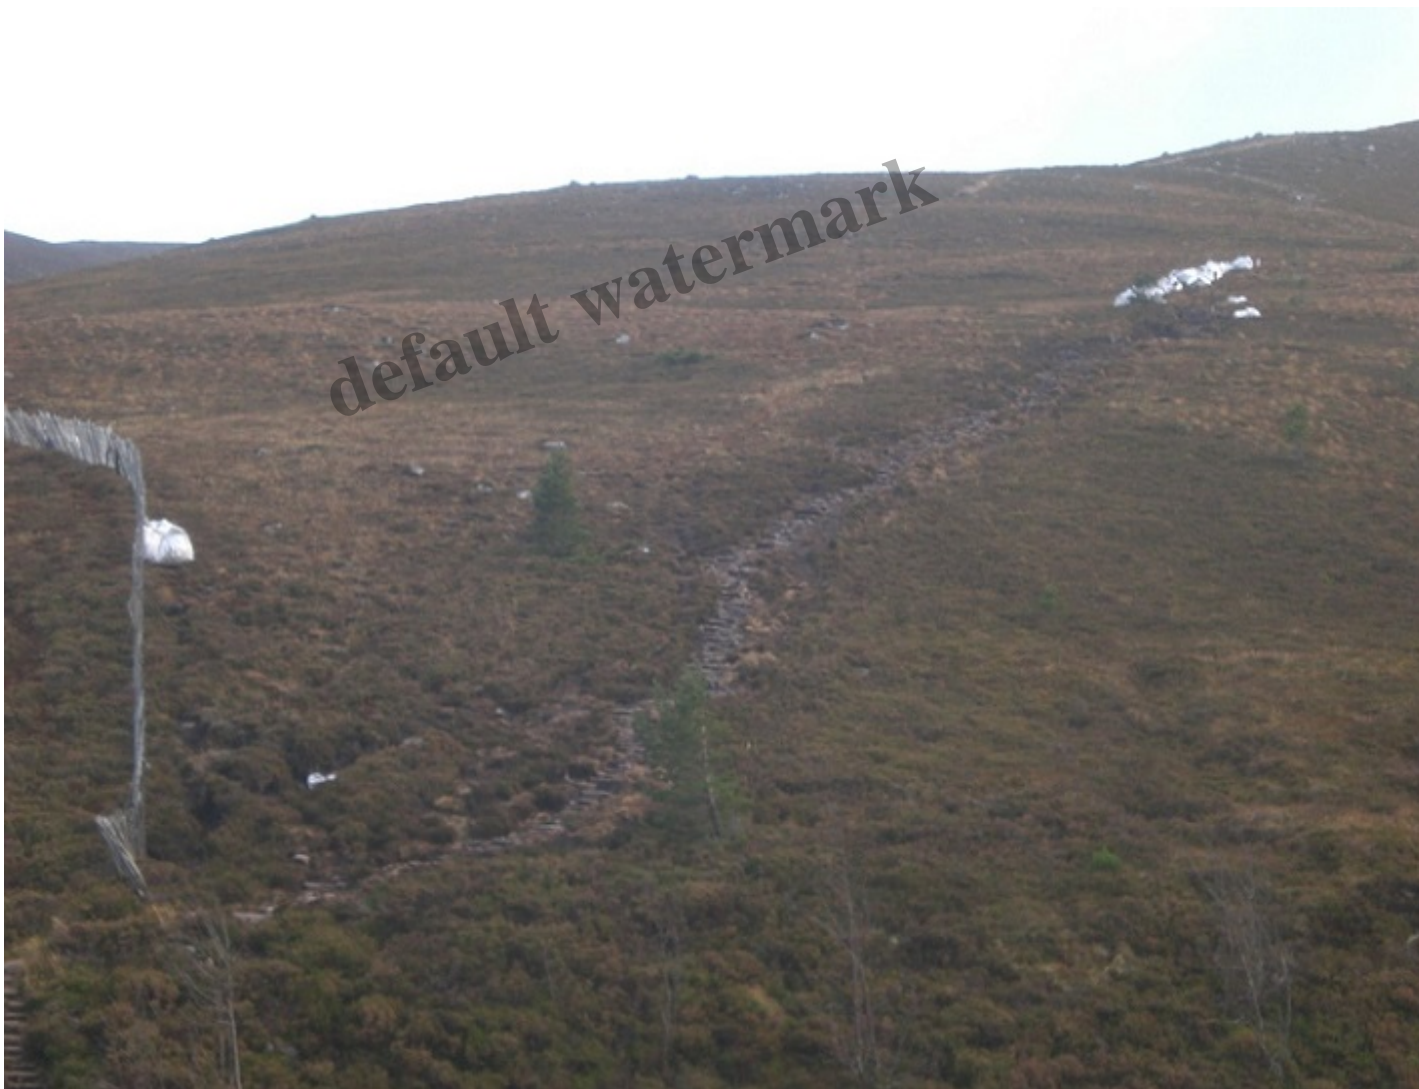
Stone path under construction on the east side of Coire na Ciste

There is however a glimmer of hope. Path construction work has been ongoing for several weeks on the east side of the Coire from just across the Allt na Ciste, above the damaged bridge. Many

hundreds of metres of path construction are required but it is good to see that a decent start has been made. Hats off to the gents who have been undertaking this work recently, in all weathers.
