HIE's failure to manage Cairn Gorm – the environmental neglect in Coire na Ciste.

In the summer of 2017, Highlands and Islands Enterprise (HIE) organised the demolition of the Coire na Ciste and West Wall chairlifts ([see here](#)). That work was done at the same time as other clear-up work and it came at a cost of £267k in public money.

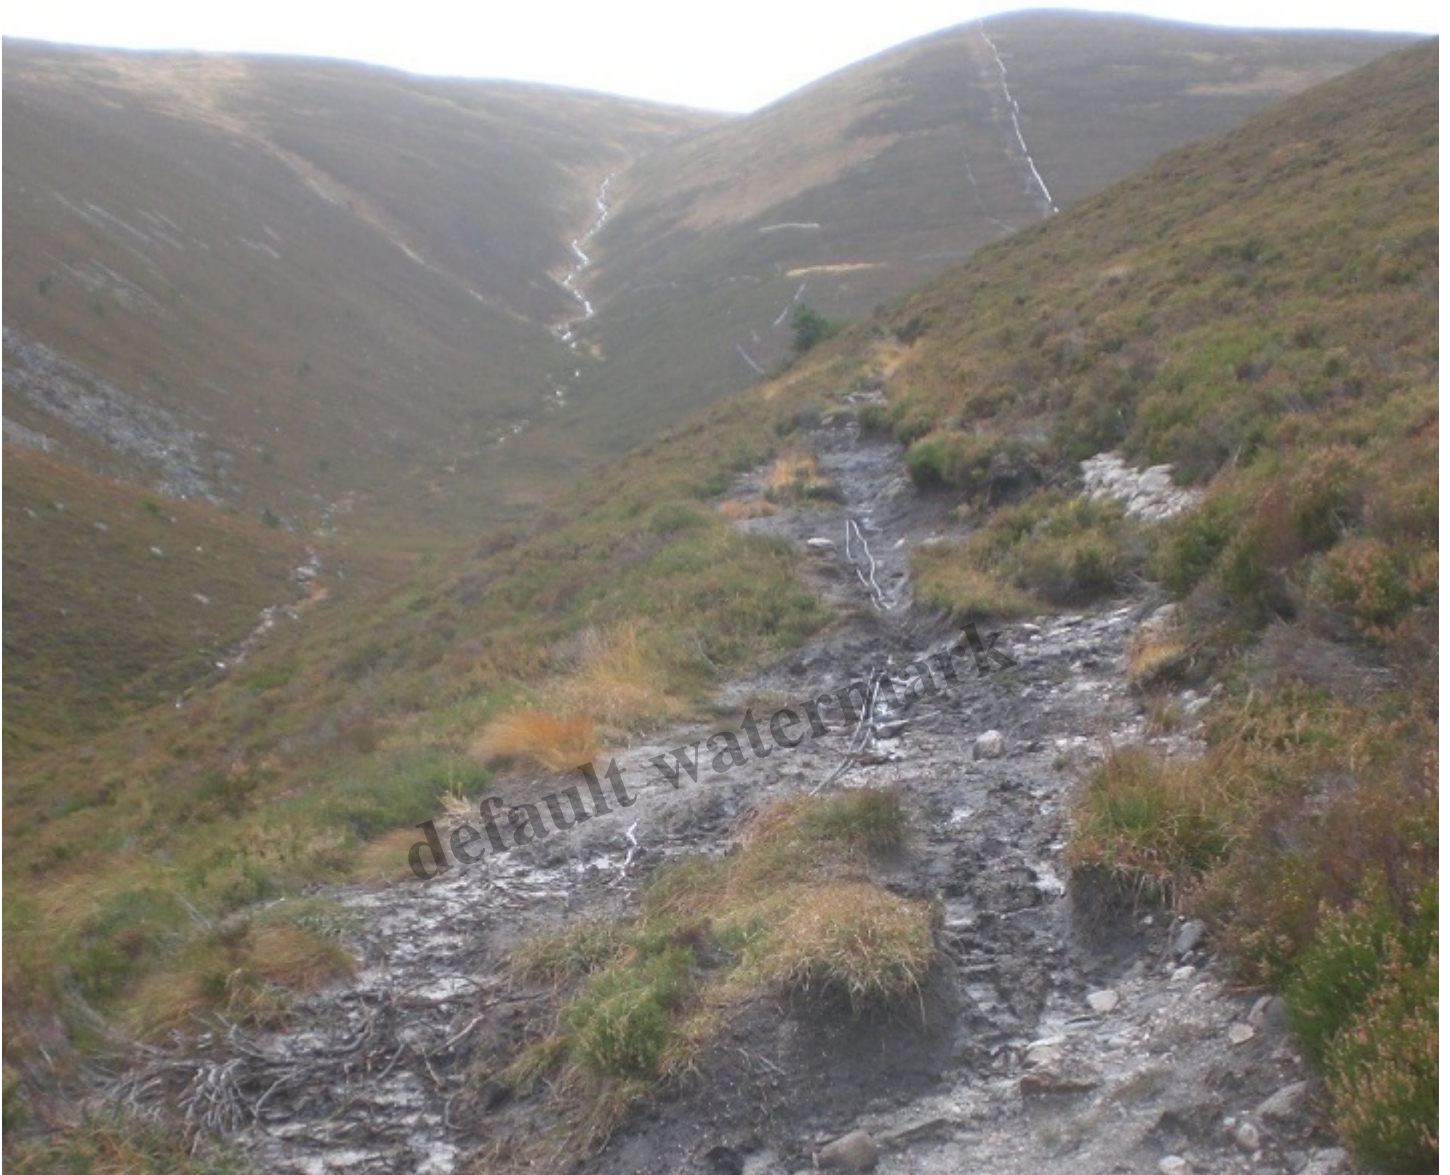
Eroded path just 200m from the Ciste car park

The path is badly eroded and there is cabling, associated with the demolished chairlift, that has just been left in the ground.

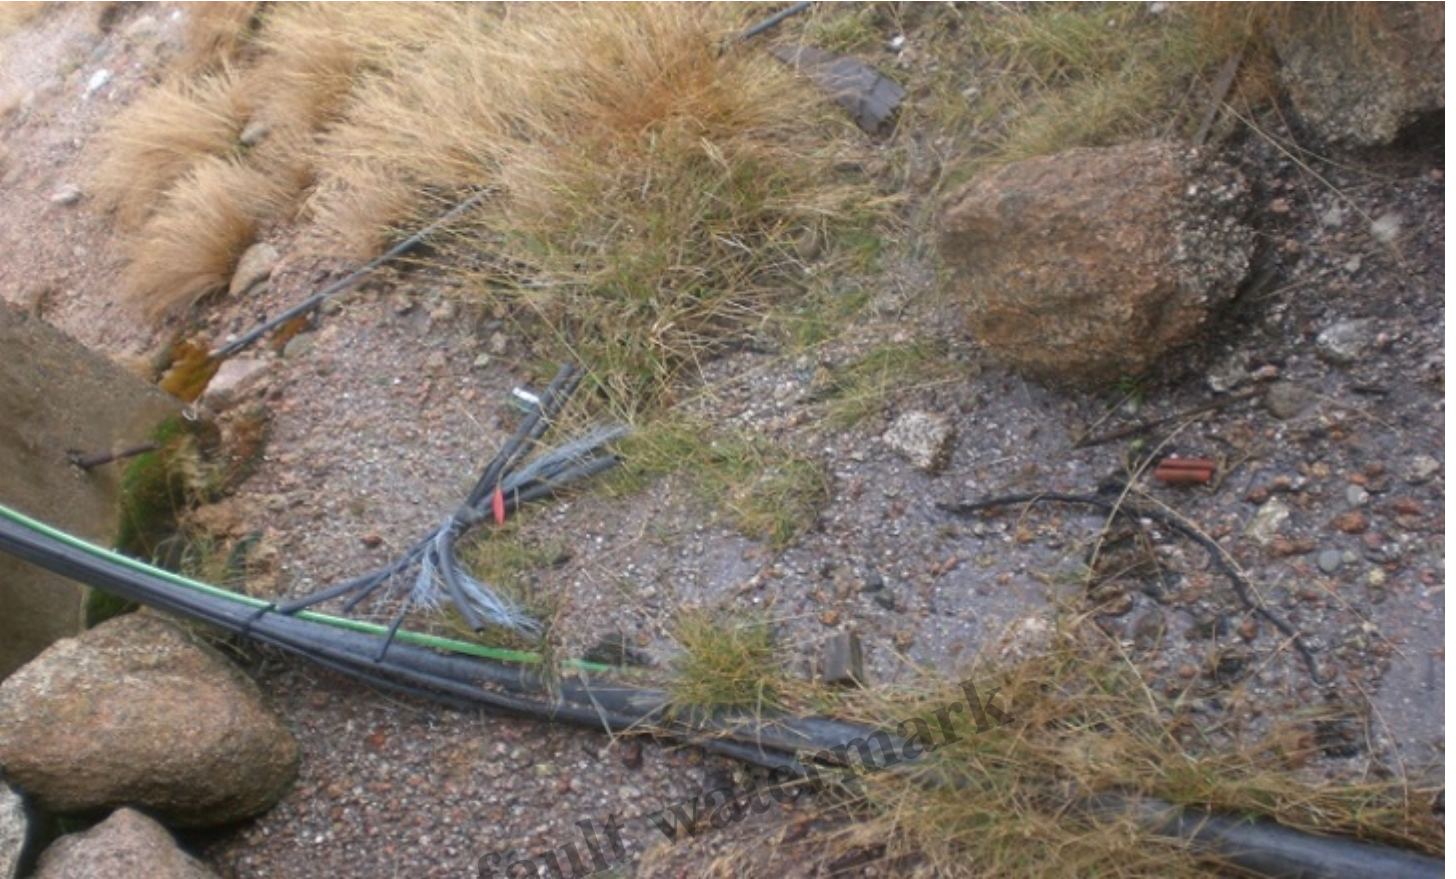
Assorted detritus

Abandoned materials that are scattered on the ground beneath the West Wall Poma loading gantry.
Why?

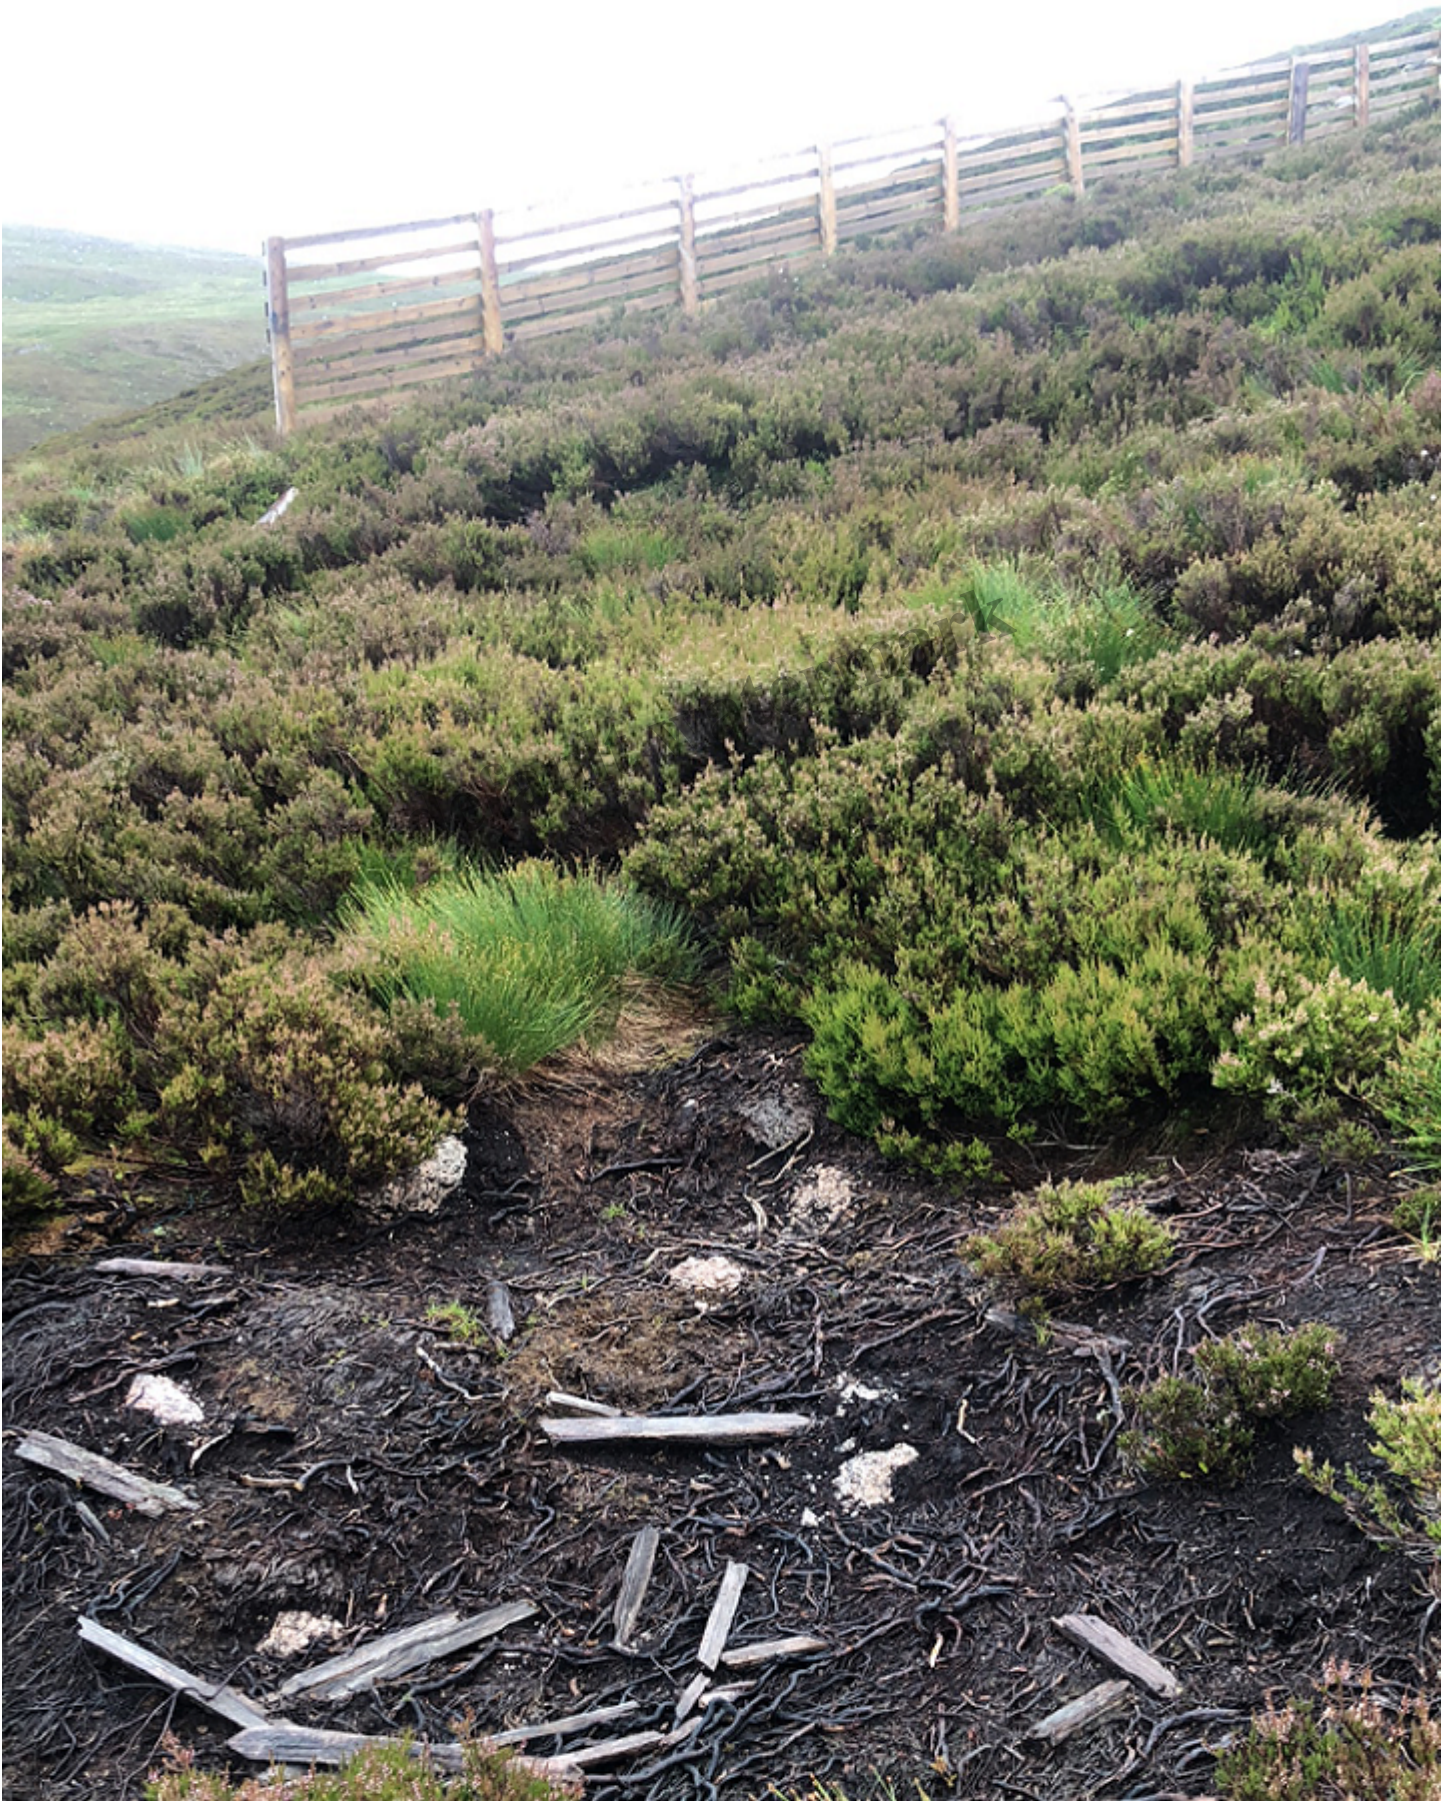
Dead ground higher up the coire.

Old Chesnut piling fencing, which had been rolled up for removal and then left lying on the ground for years had the effect of killing the vegetation. Even when it was finally removed, the area wasn't cleaned up and that's preventing the vegetation from regrowing.
