HIE's Health and Safety record at Cairn Gorm

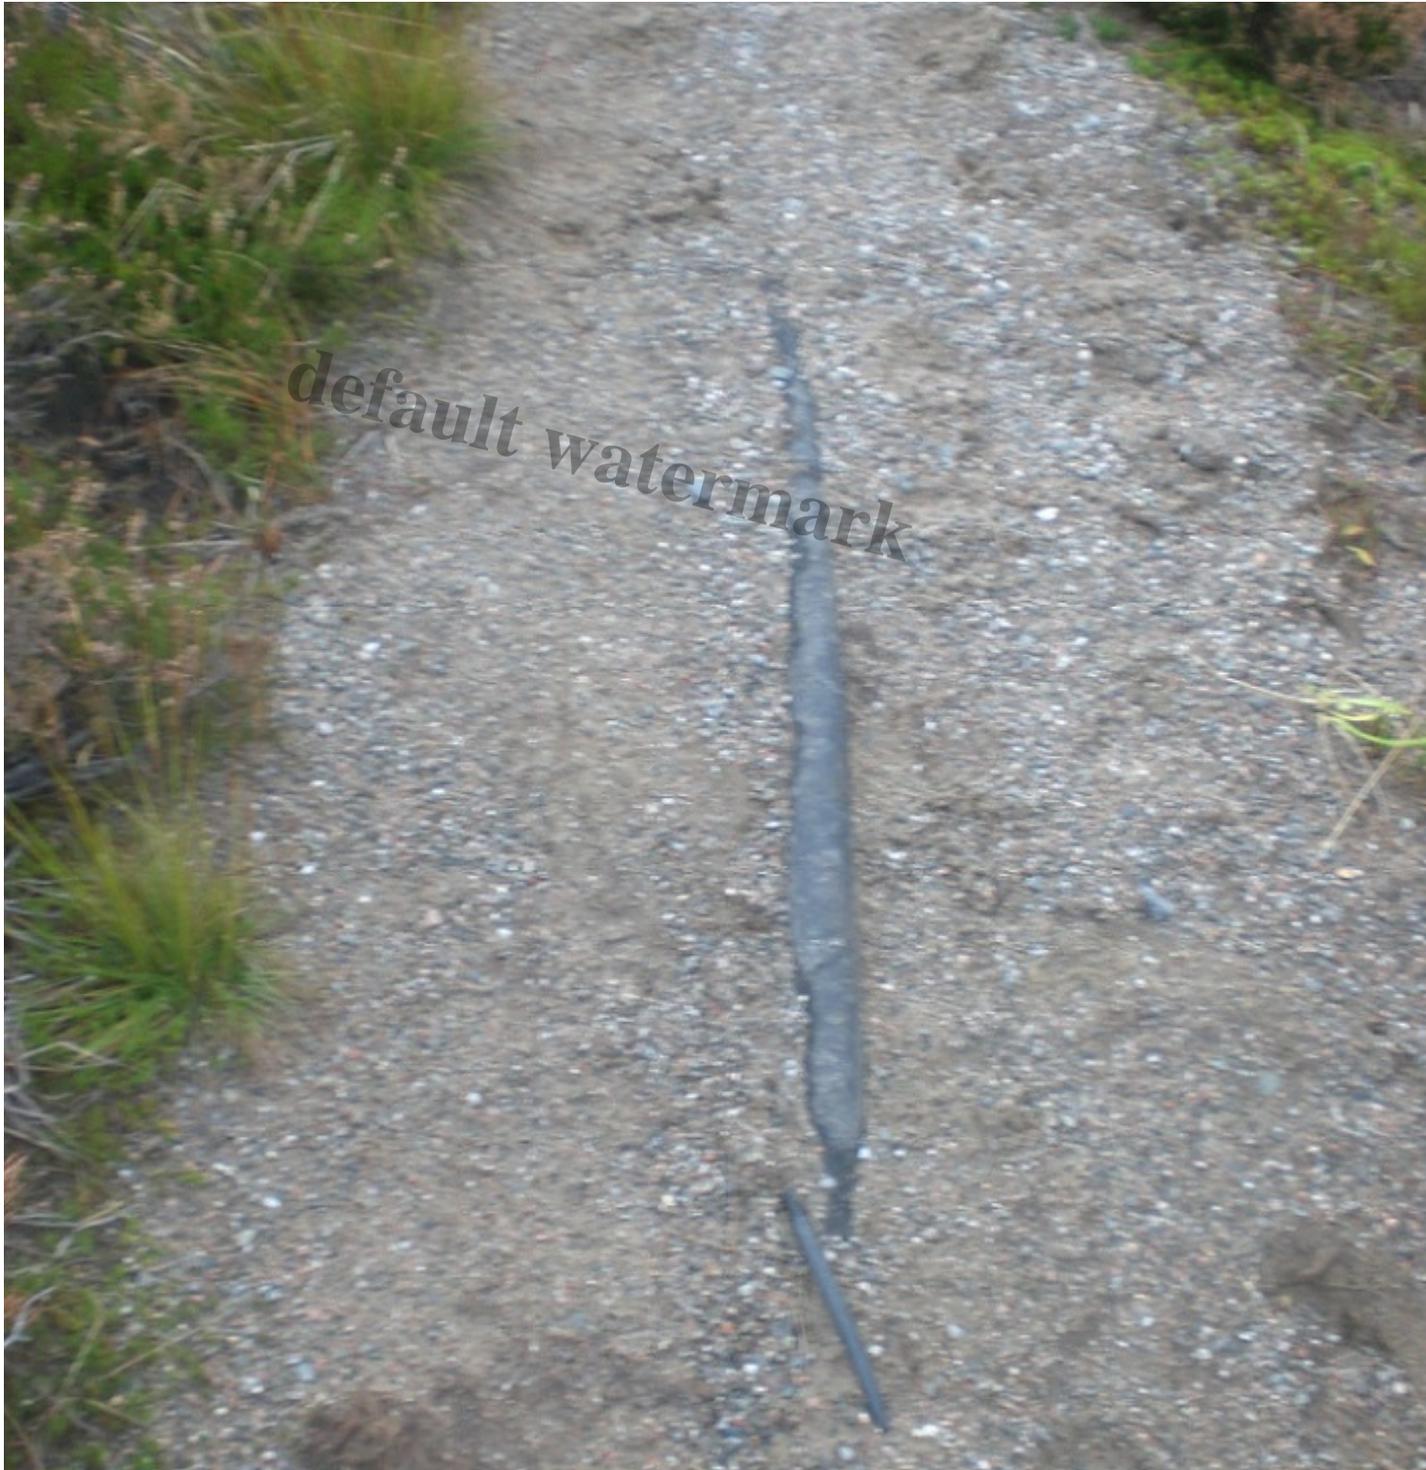
Exposed mains power cable in Coire na Ciste November 2020 - imagine someone walking along this path in crampons in winter

If that is the case why, after his post on Highland and Island Enterprise’s environmental neglect of the Ciste (see here), did it take several emails from Alan Bratney to get the exposed mains power cable covered up?

The cable is part of the SSEN ring main â?? HIE and CMSL have been in contact on a number of occasions with SSEN in relation to our concerns about sections which are either exposed or shallowly buried, and their planned replacement of the cable. Indeed, SSEN did an inspection of cable depths around 2 months ago. We have again made contact with them to advise them of the potential risk and we will follow up further with them on any actions required. CMSL are also fully aware of this specific concern and will take any necessary action.

â??I can confirm that SSEN has now attended site to make the cable safe and install further sand bagging. In addition, signage has been erected to make walkers and others aware of the cable location. To help explain, sand bagging and signage are a temporary measure to ensure public safety and protect the cable. Due to the terrain in the area and the elements certain sections are more vulnerable to exposure.

This situation will be rectified by a project currently in design to replace the existing cable. The on-site works are scheduled commence in the Spring, subject to obtaining all relevant consents.â??

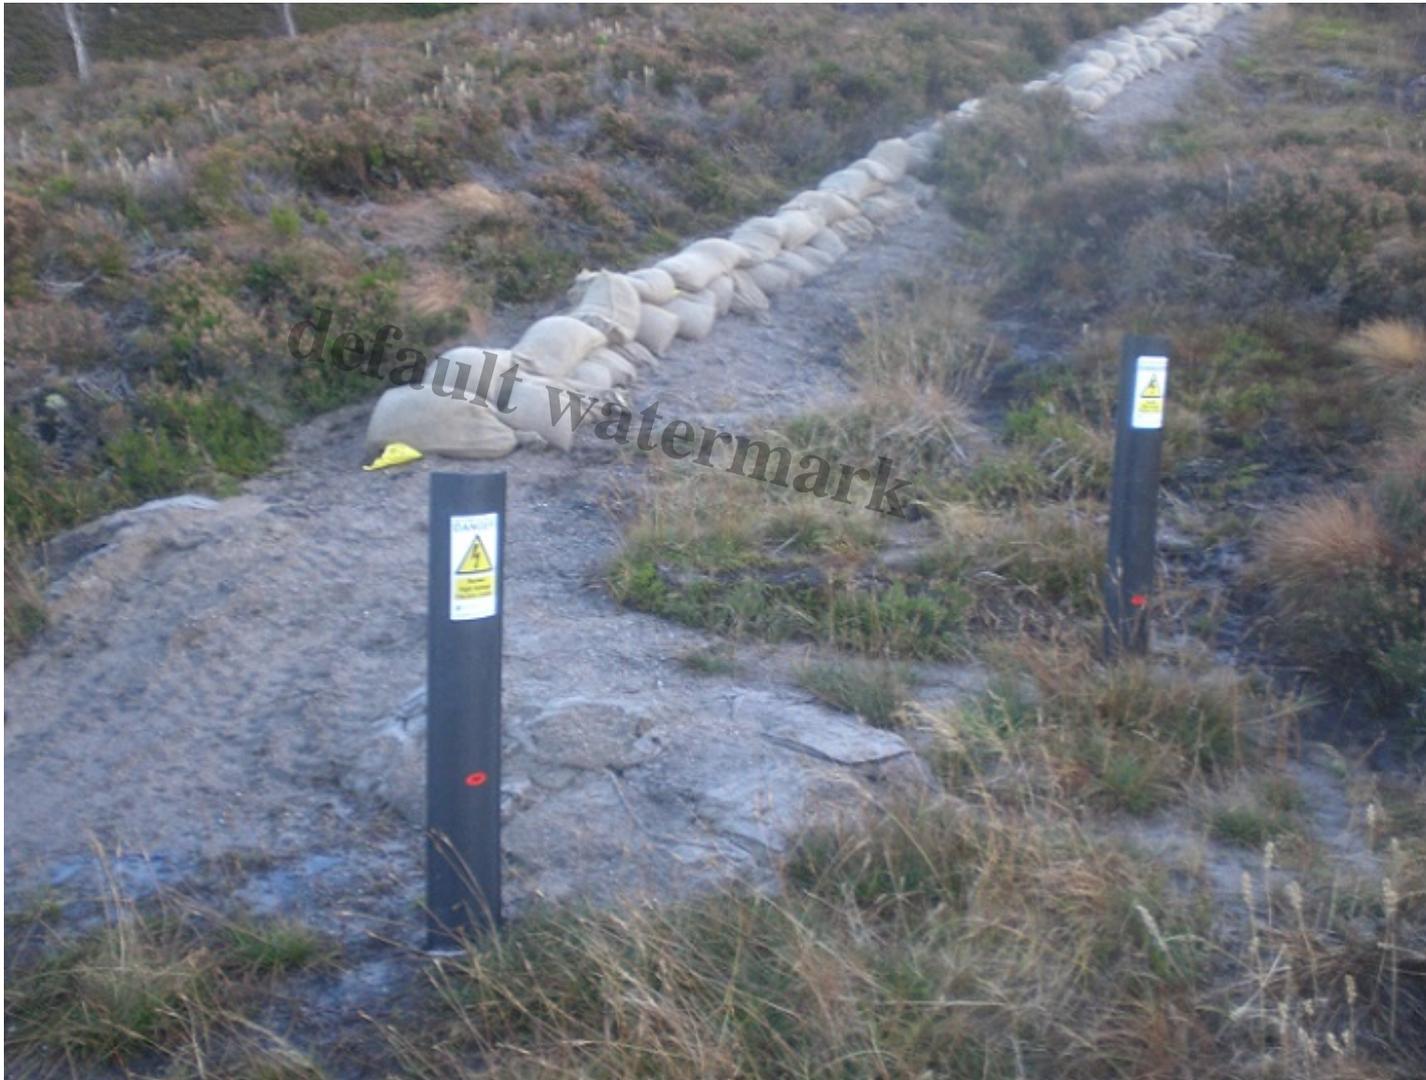
New warning signs – there were none before – and sandbags December 2020. Note the remain of former sandbags just behind the left hand sign

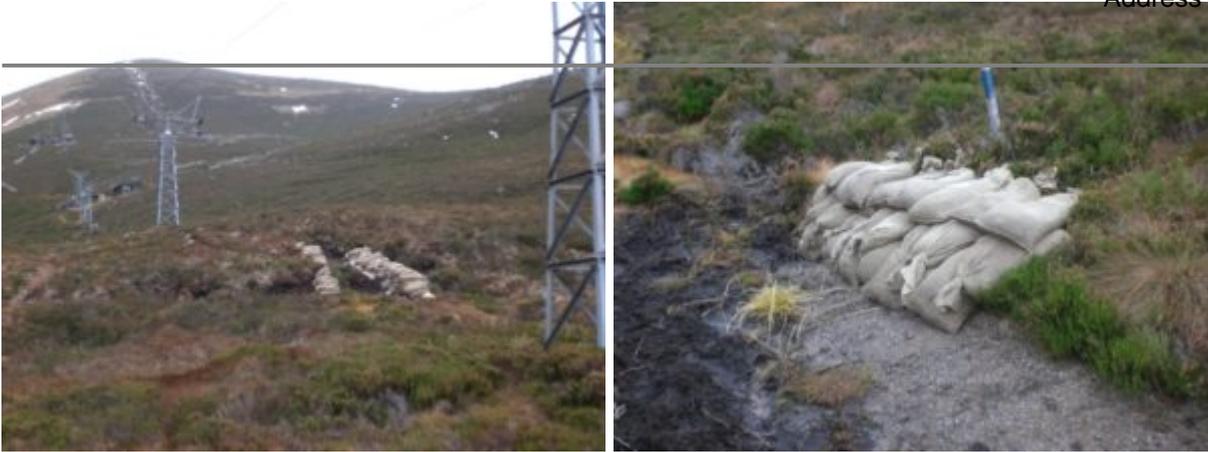
These photos of sandbags were both taken in 2016, when Natural Retreats was in charge, although many of the hill staff are the same as they are now. In 2017, the Aviemore and Glenmore Community Trust asked HIE what they intended to do about the section of the 11kv ring main cable which was exposed on the surface of the Sheiling piste (red area in map above). HIE did nothing to address that issue, hence why it appeared in the 2019 risk assessment, and it has taken the intervention of a member of the public to get anything done.

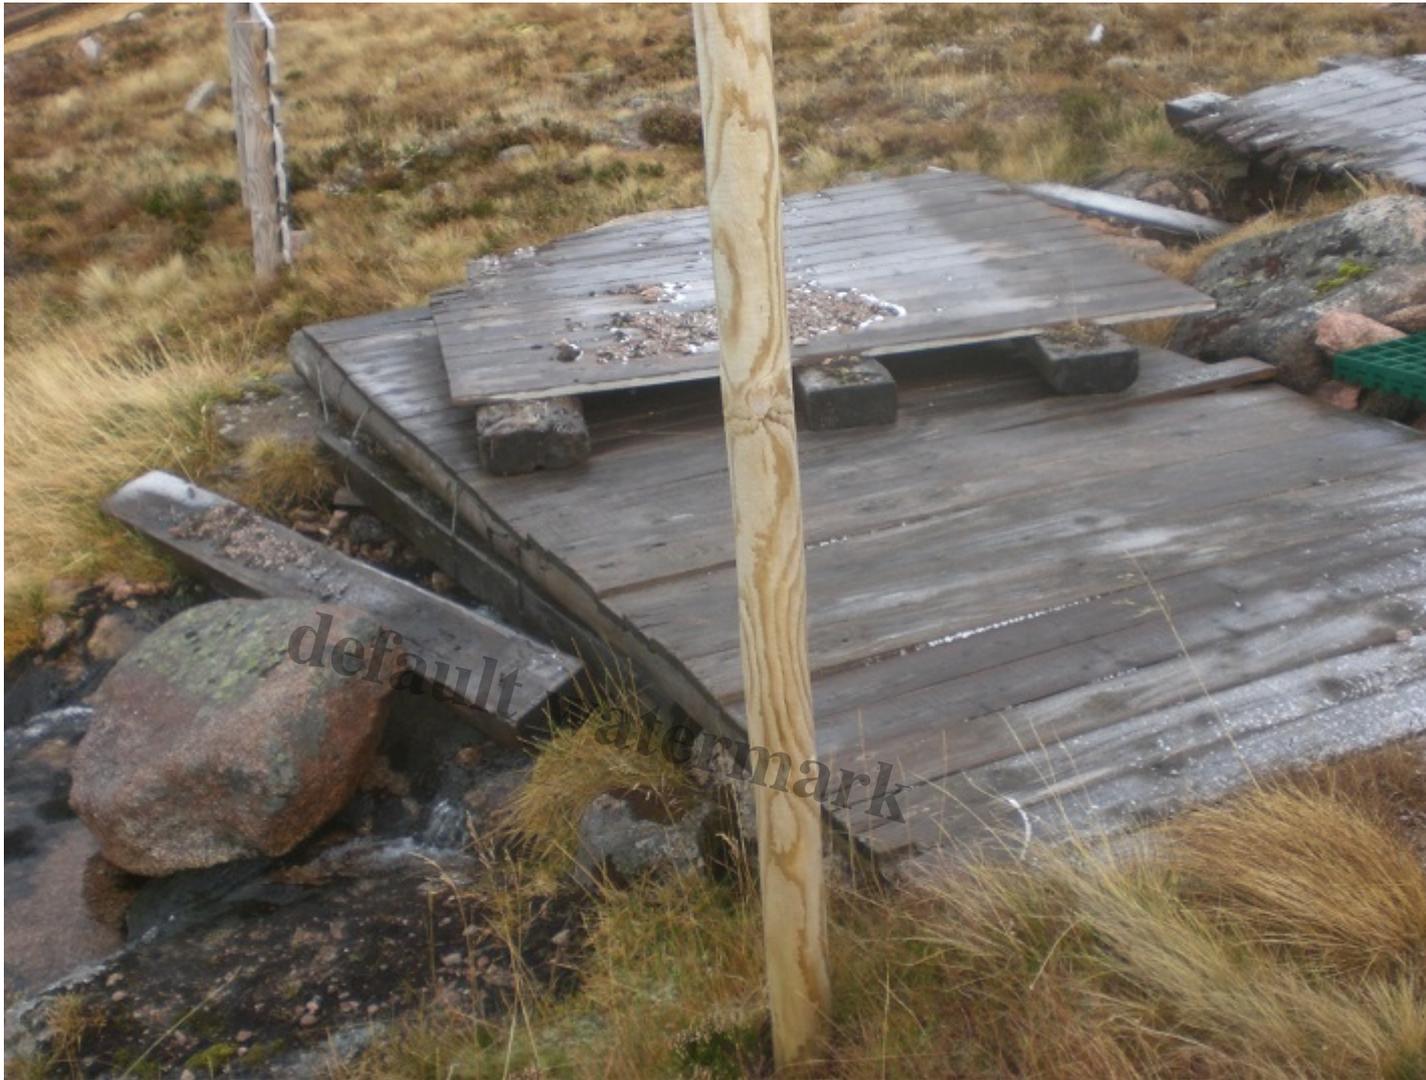
Bridge over the burn that runs down towards the Pump House on the lower Zig Zags known as chicken gully, so called as its less steep than the Cas gunbarrel

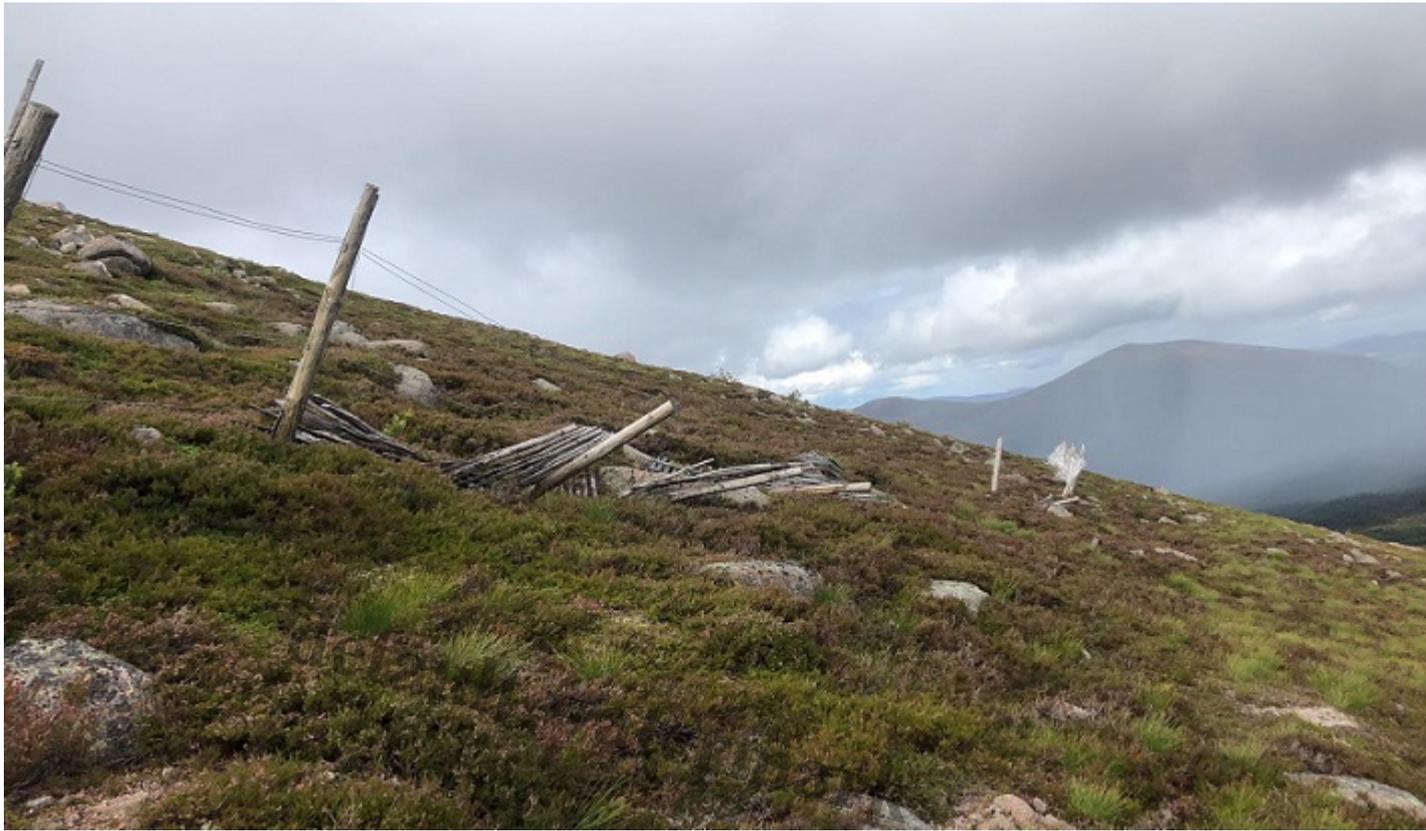
Ruined fencing high on the Aonach Ridge, also known as Rita's ridge, used by skiers and boarders to return to the Ciste Car Park

In cloud, a frequent occurrence on Cairn Gorm, these wires would be hidden from skiers and boarders and could cause a nasty accident.

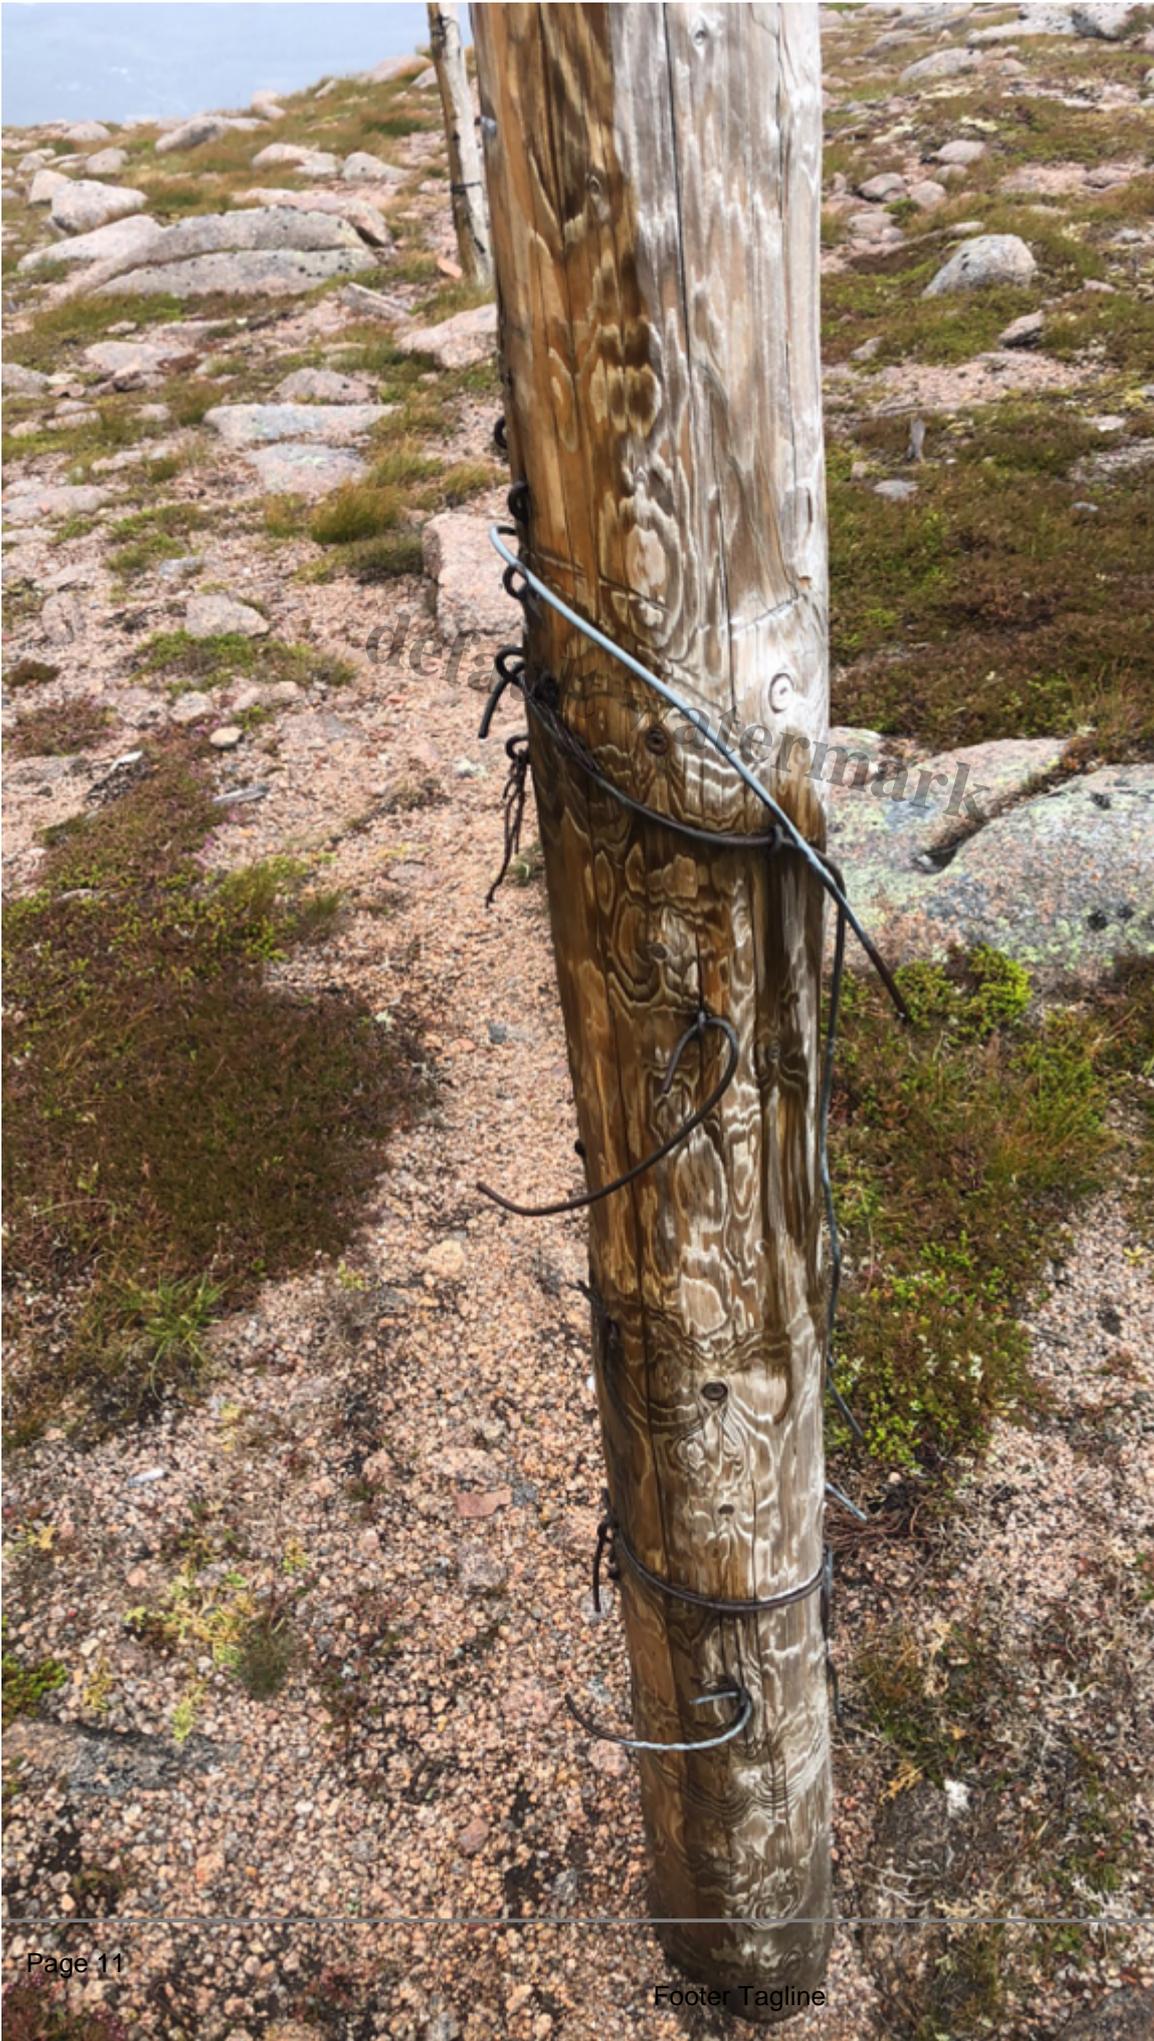
Imagine a beginner sliding out of control and being impaled on one of these wires. When were these posts wires ever clad in protective matting?
